# RISK-BASED ASSESSMENT OF LEVEES- LESSONS LEARNED FROM THE 2011 MISSISSIPPI RIVER FLOODS

**J. David Rogers, Ph.D., P.E., P.G., C.E.G., C.HG.**

**ASCE Geo-Institute's Geoconfluence 2012  
Geotechnical and Geo-environmental Conference**

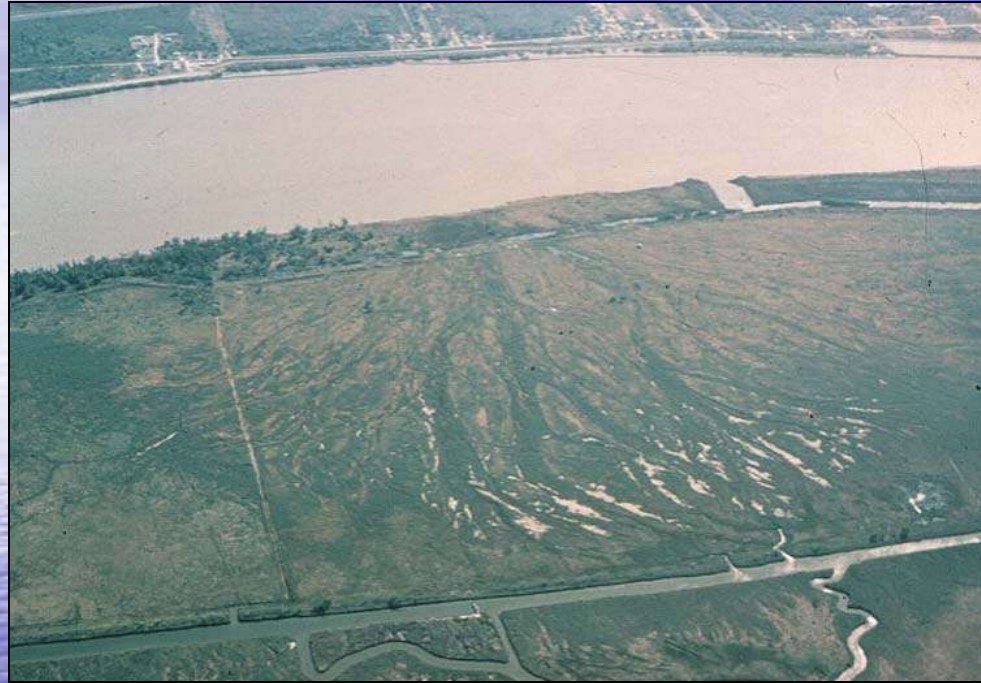
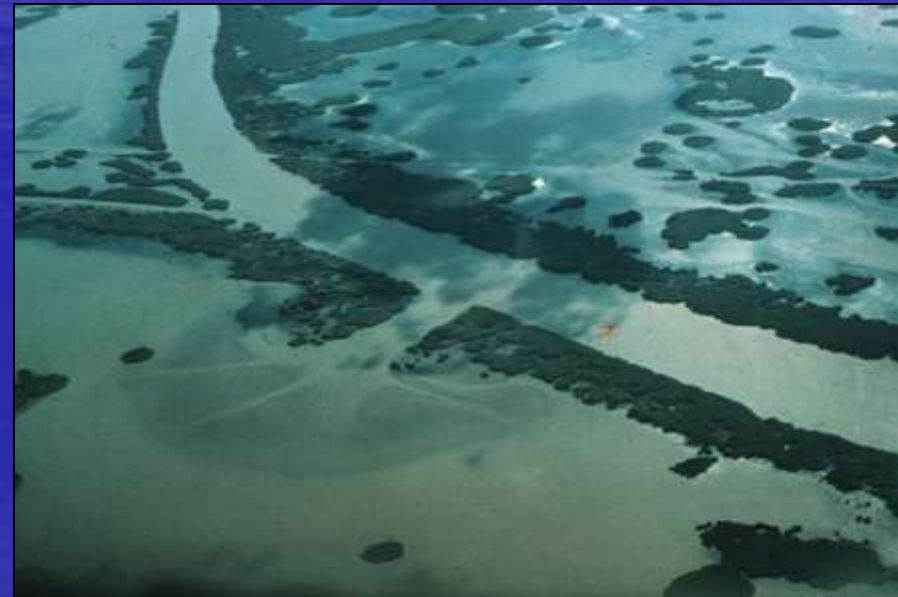
# Natural crevasses beneath levees

Crevasses lie beneath earthen levees like *ticking time bombs*, waiting to explode.
