# BRIEF OVERVIEW OF THE 2011 MISSISSIPPI RIVER FLOODS

**J. David Rogers, Ph.D., P.E., P.G., C.E.G., C.HG.**

**Society of American Military Engineers**

**August 17, 2011**

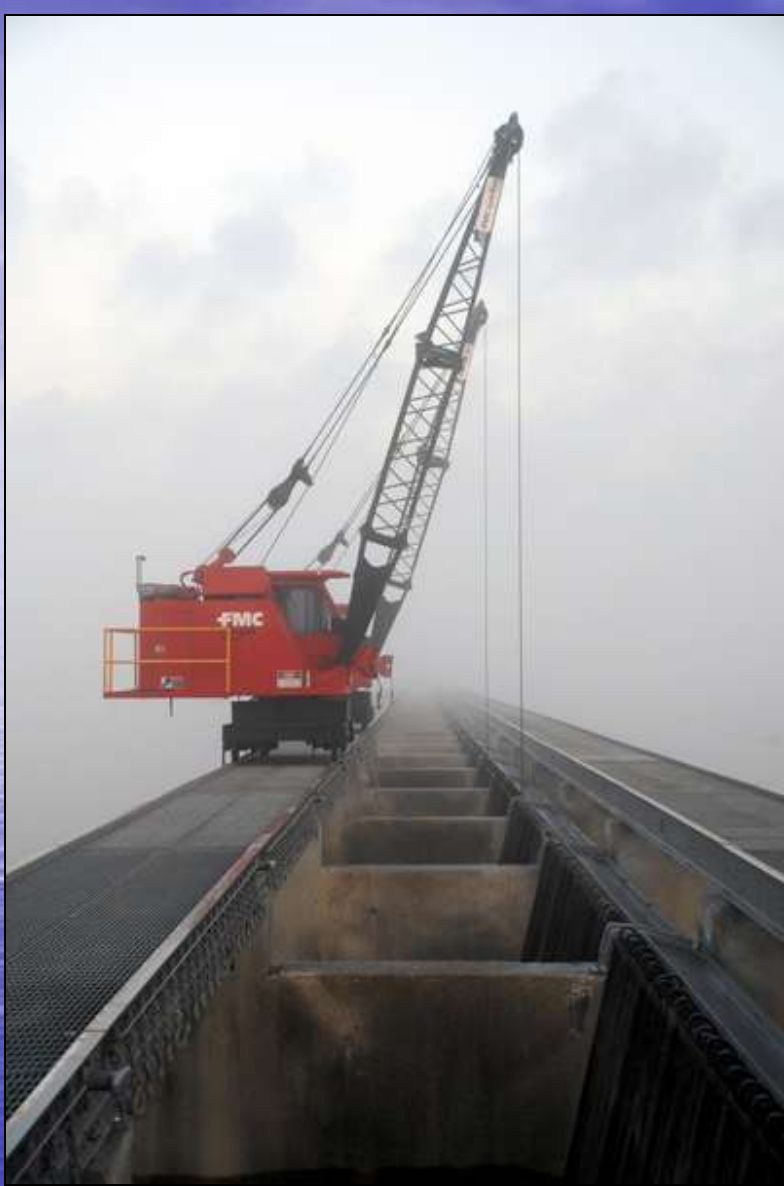
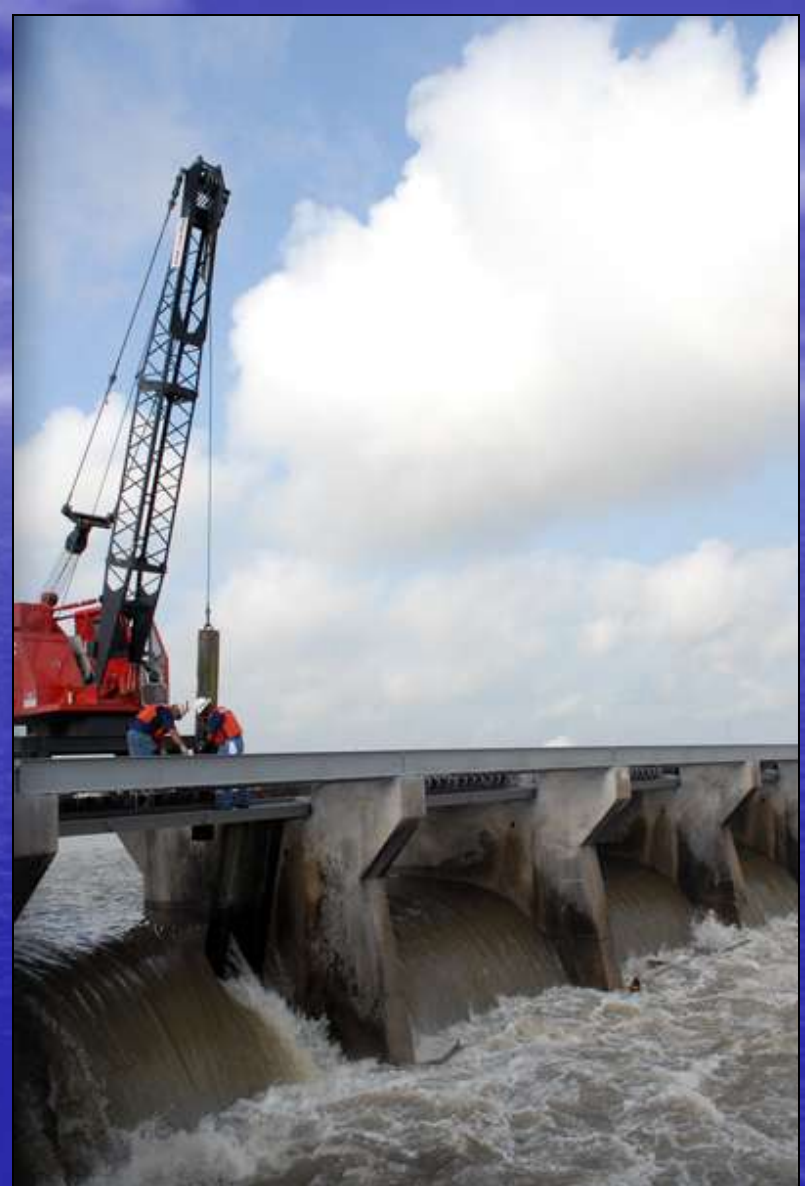
- **About 1300 cfs was leaking through the needle logs prior to their being lifted at Bonnet Carre for the 10<sup>th</sup> time since 1932, on May 9th. The spillway is 7000 ft long.**

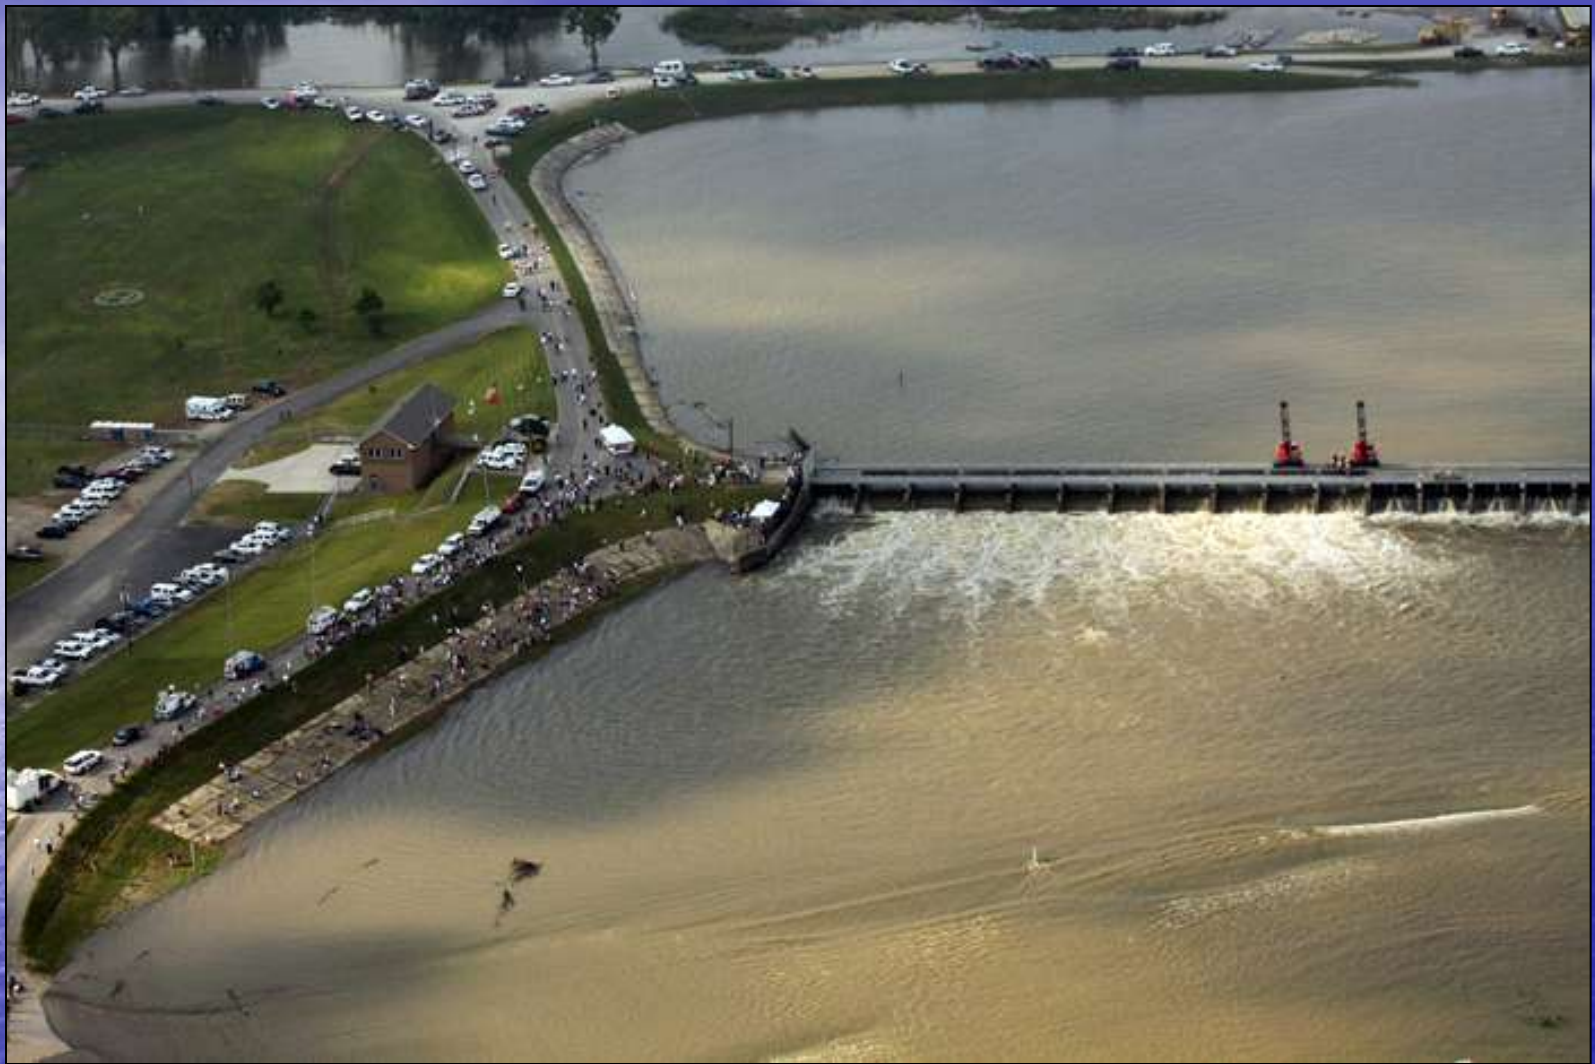
- Bystanders gather to view the opening of the needle log gates at the southern end of the Bonnet Carre Spillway, constructed in 1929-32. 330 of the 350 spillway bays were opened in May 2011, discharging up to **316,000 cfs**.

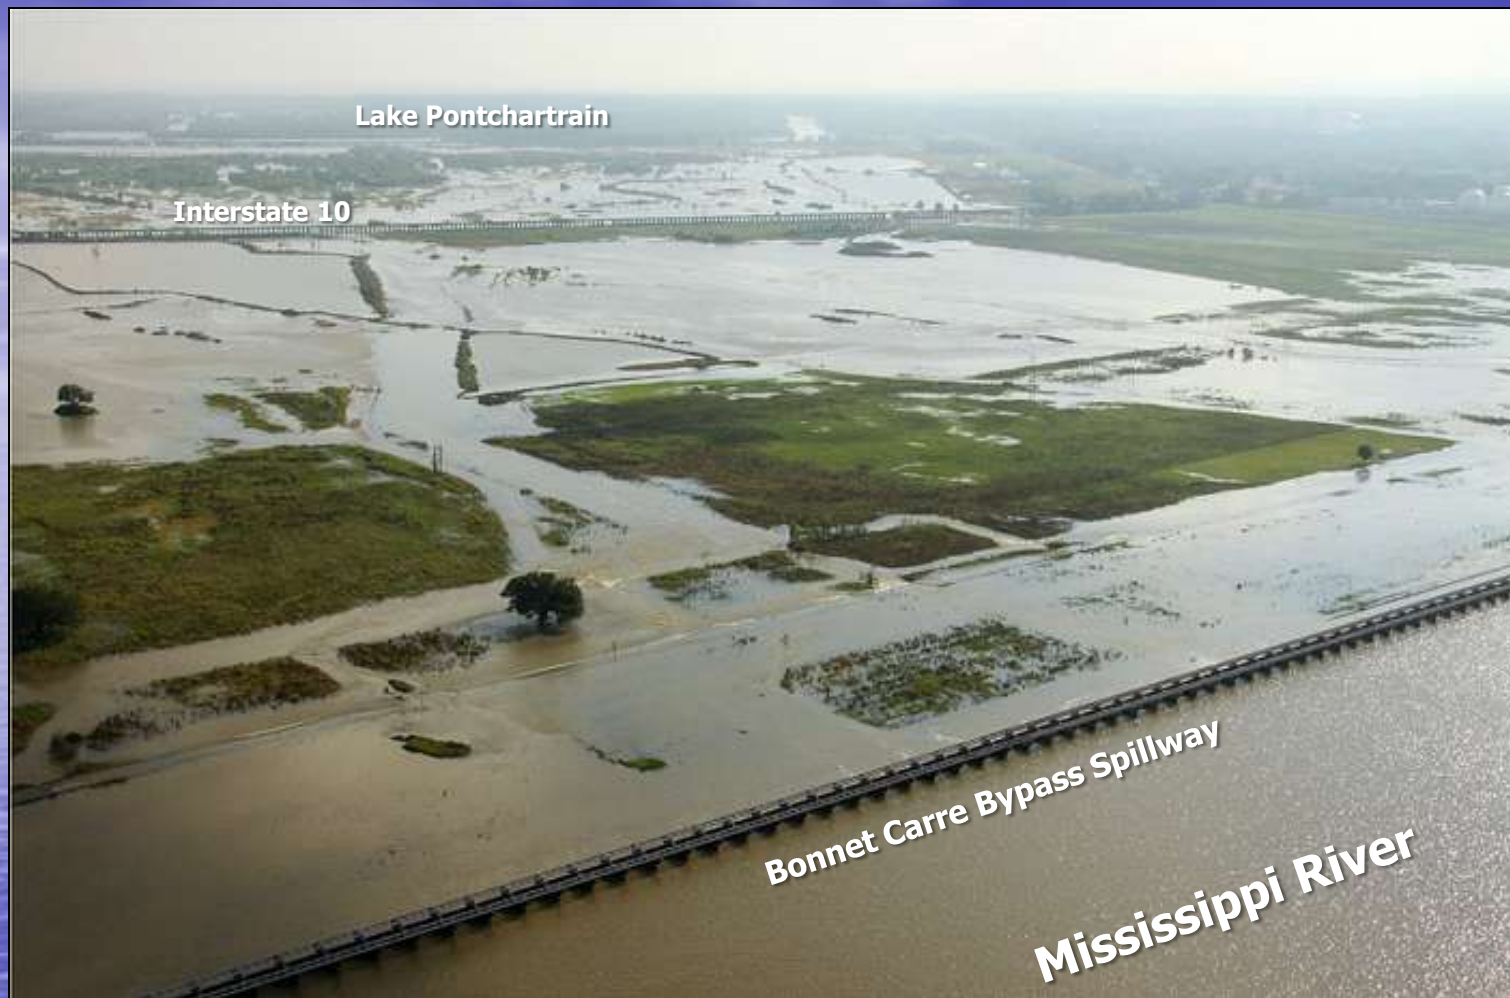
- The **Bonnet Carre Bypass Spillway** diverts flow 6 miles, into Lake Pontchartrain, which is at sea level. It was constructed a few miles downstream of a natural crevasse, which had breached 6 times in the previous 120 years.
- Four million cubic yards of sediment was mucked from the spillway channel after the 1997 overflows, increasing the spillway capacity.

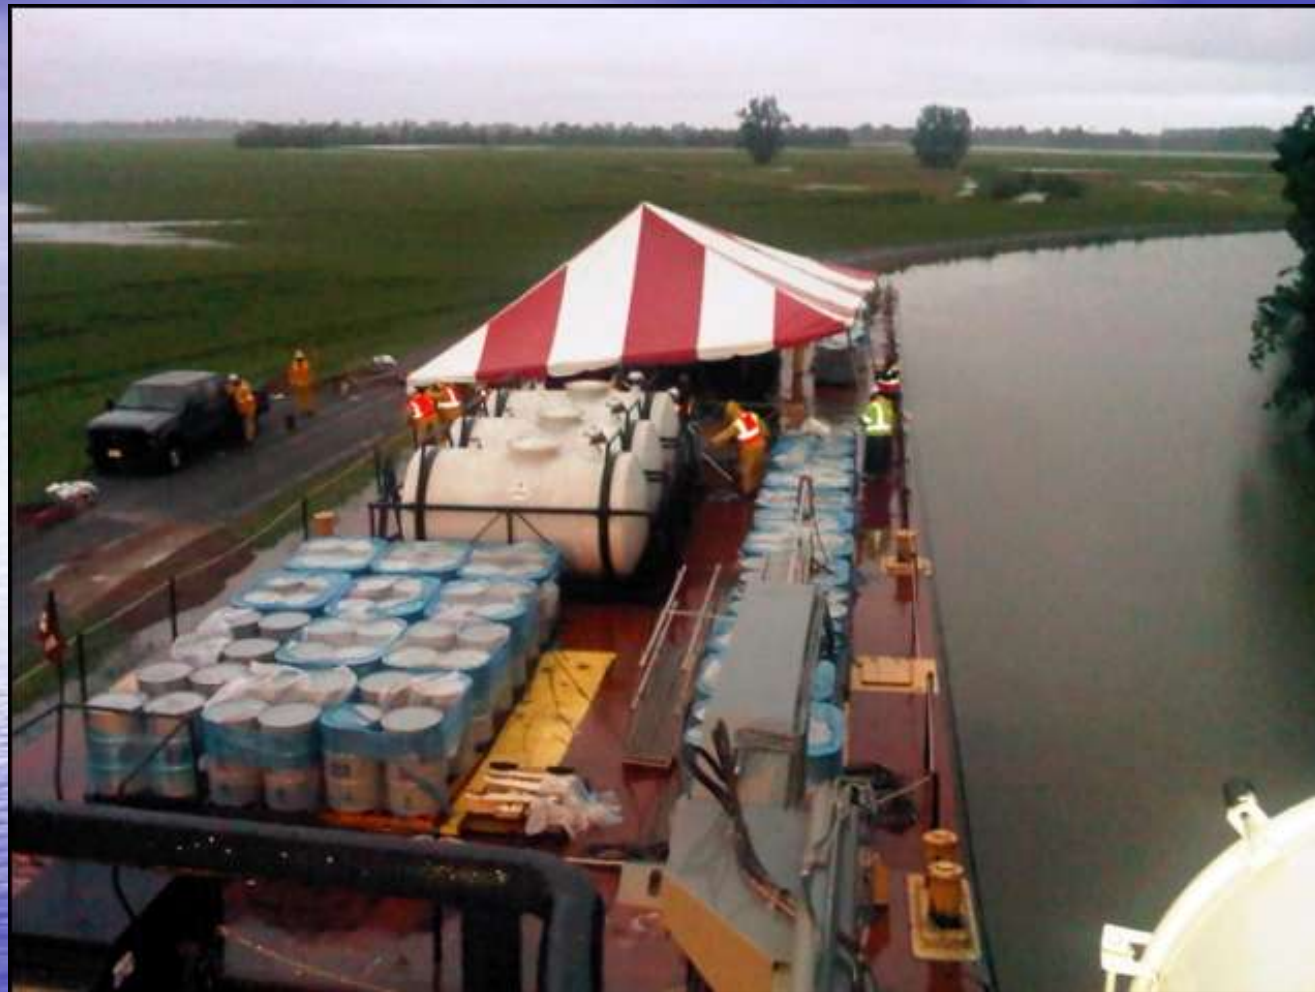
The explosives barge carry the ANFO components was parked at this location throughout the memorable 1993 flood of the lower Missouri and middle Mississippi Rivers

- Several thousand lineal feet of hollow PVC pipe was embedded in the *fuse plug levee* at Bird's Point. When the time came to blow the dike, the pipes were filled with a mixture of ammonium nitrate fertilizer and diesel fuel (ANFO)

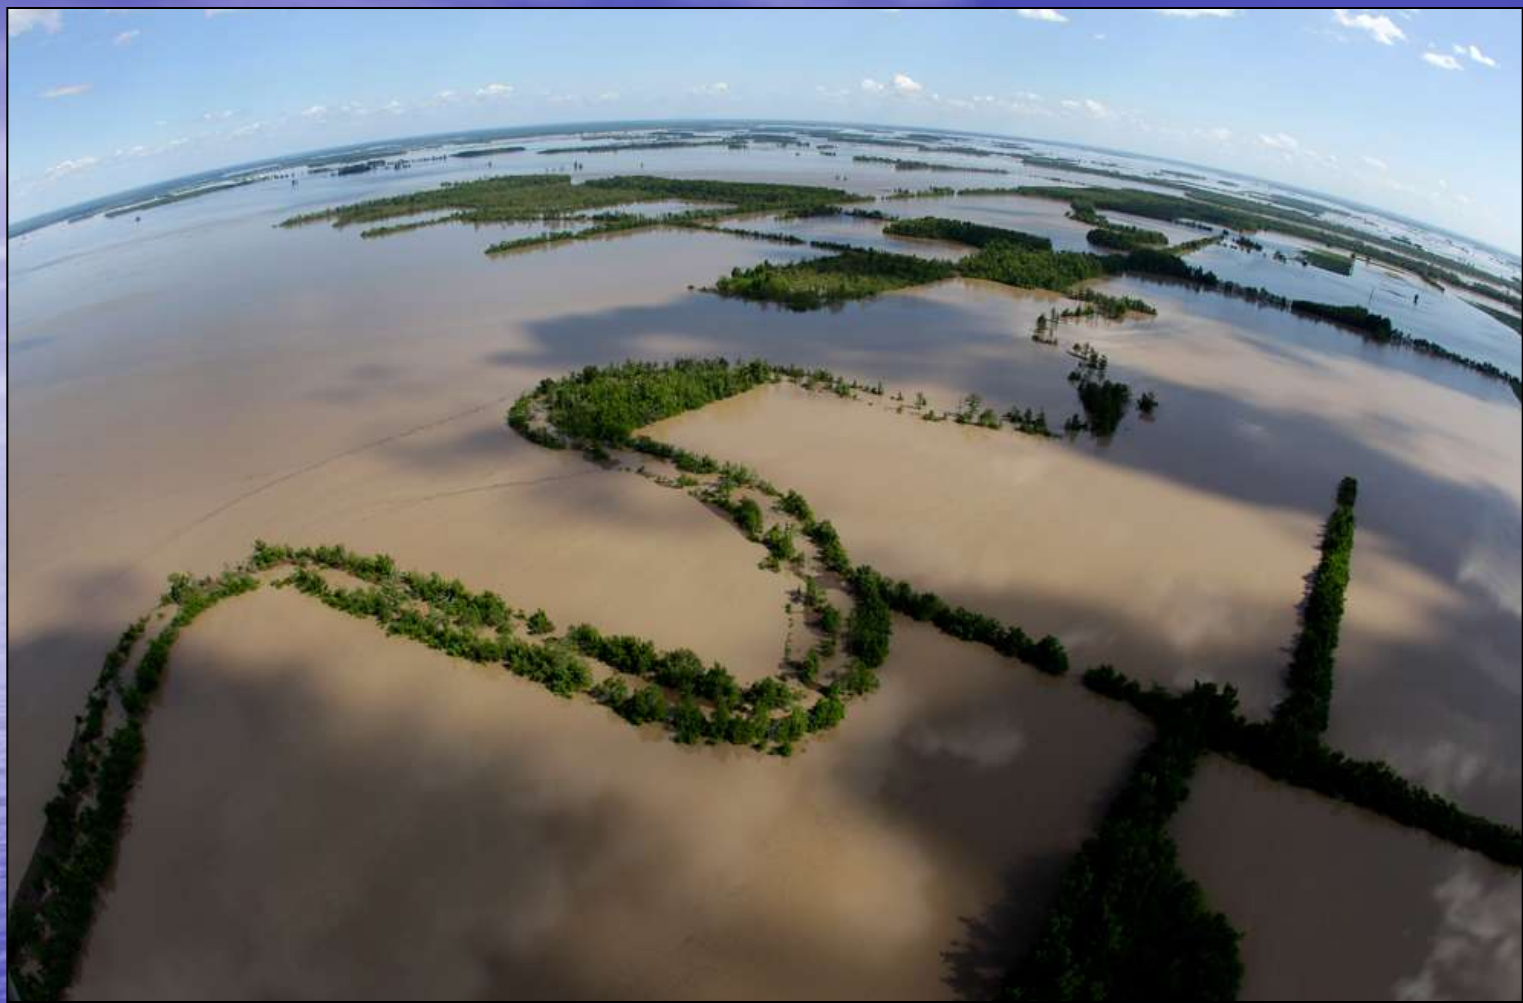
- The middle-of-the-night detonation on May 2-3, 2011 created an artificial crevasse 11,000 feet long, diverting 335,000 to 375,000 cfs of the river's flow

- Approximately 200,000 acres of essentially level flood plain within the **Bird's Point-New Madrid Floodway** was inundated within 36 hours of the detonation.
- The USGS deployed 40 hurricane *storm surge sensors* to monitor excavation of the crevasse scour hole and flow velocities, every 30 seconds.

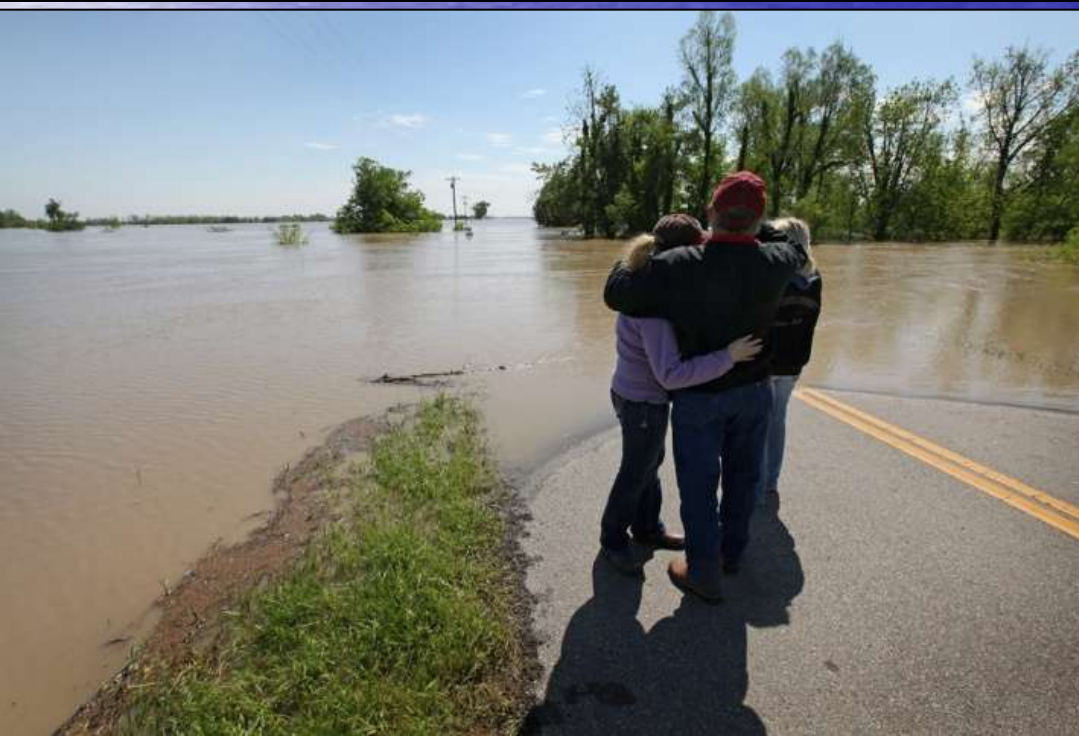
Fuse plug dike blown at New Madrid to allow flood waters to flow back into the Mississippi River

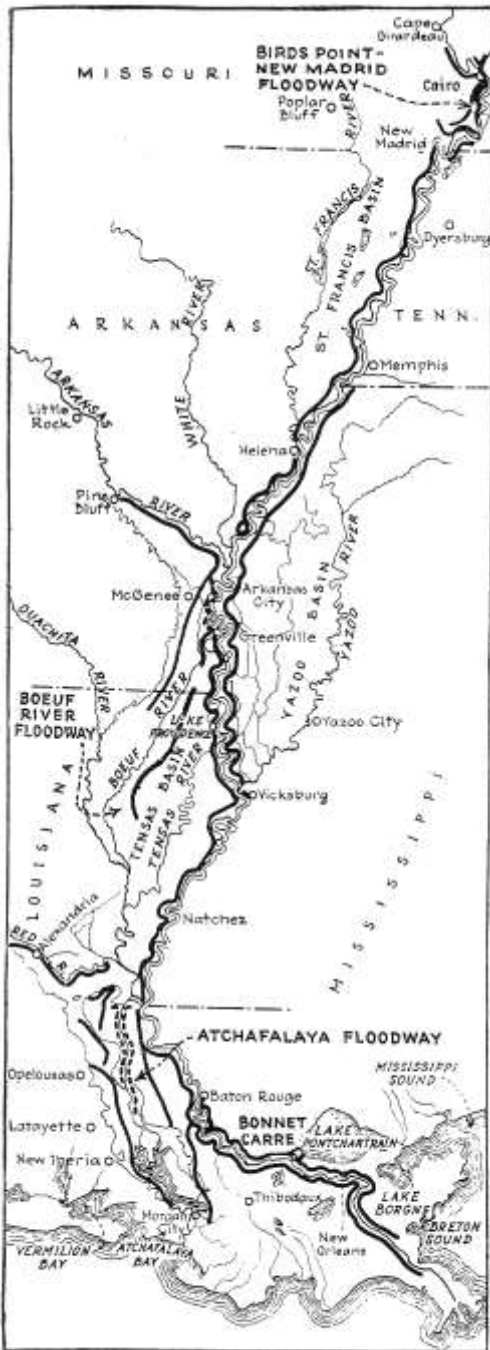
Levee and diversion system of Mississippi flood control adopted by act of Congress approved May 15, 1928

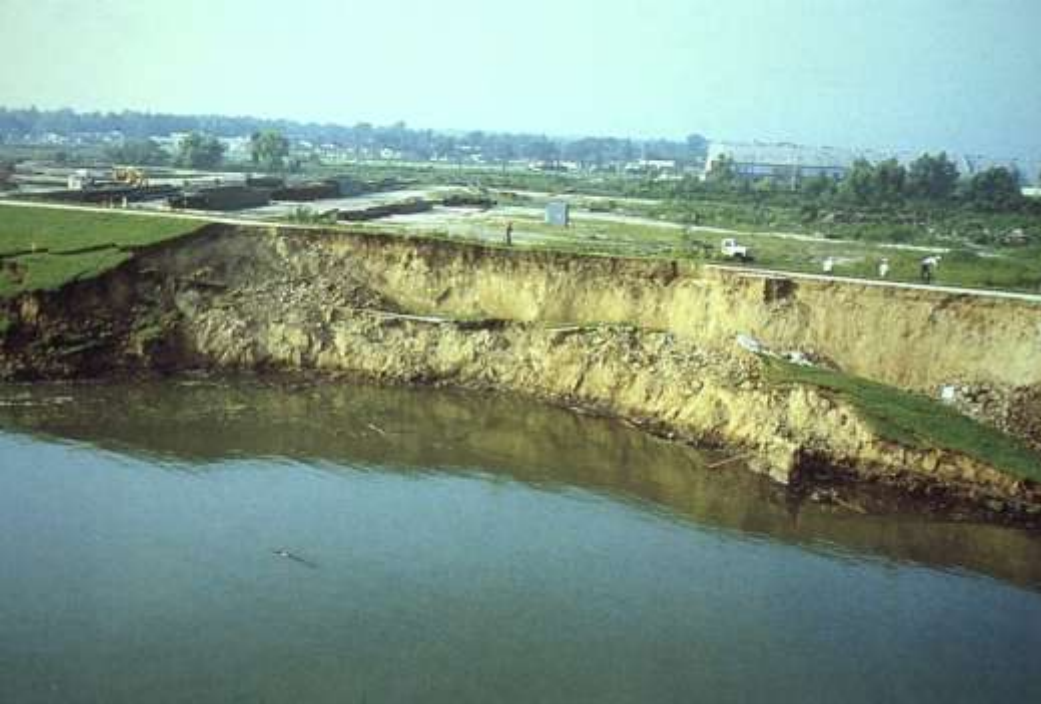
- The 1973 flood was unusual in its duration (62 to 90 days), and its multiple cycles (loop effect)
- Levees resisted peak flows, but many failed when the river dropped precipitously, after its initial early season peak, in January, February, and April

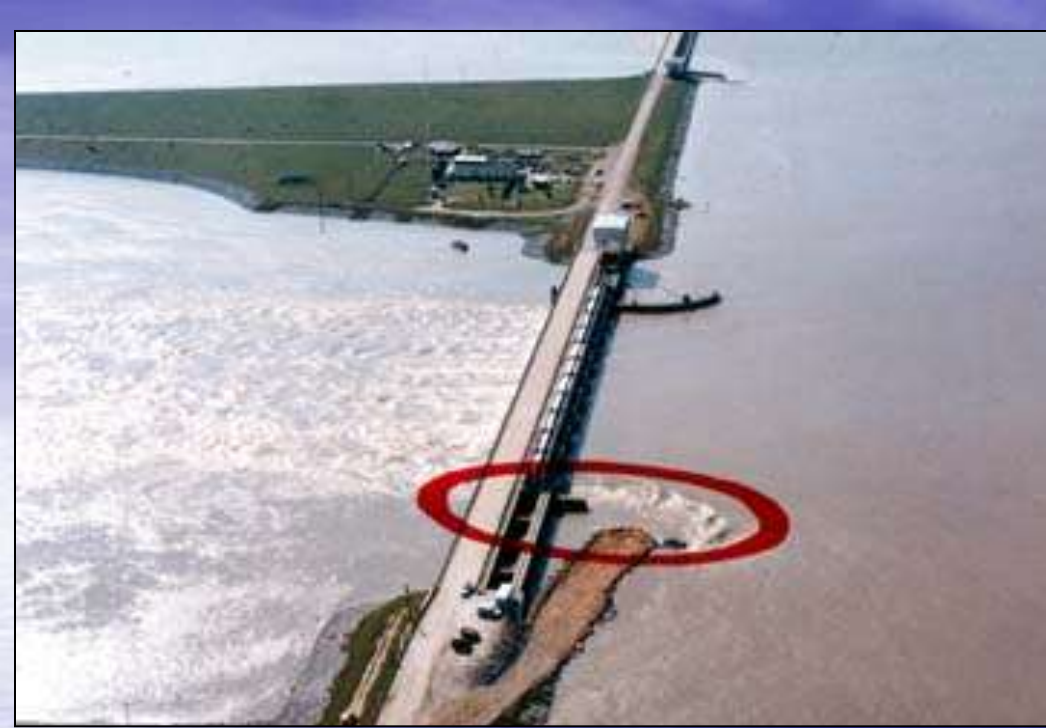
- During the '73 flood a large *back-eddy scour hole* developed on the up and downstream sides of the left abutment of the Low-Sill Diversion Structure
- Without the battered steel piles a new Mississippi River channel would have been carved down the Atchafalaya River to the Gulf !

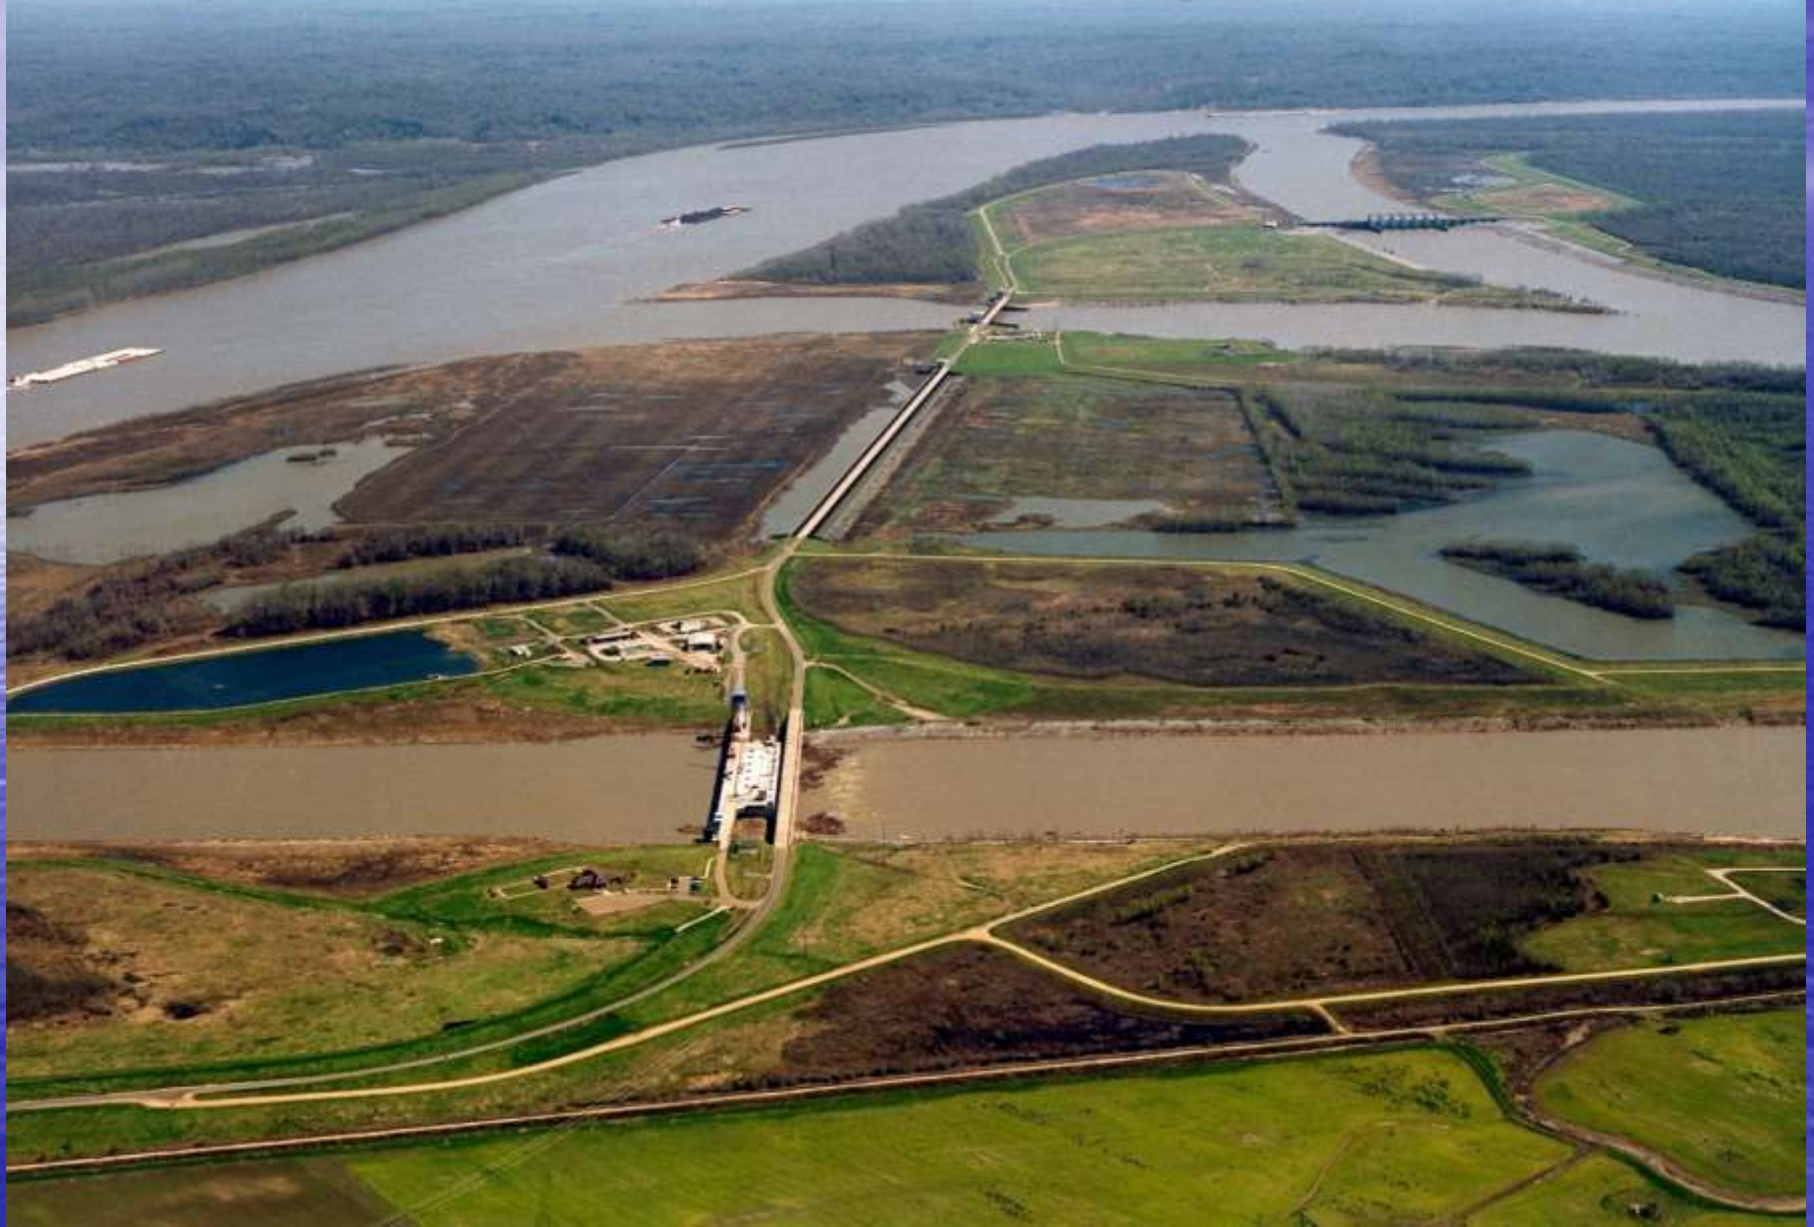
**Old River Control Structure Complex was completely rebuilt following the '73 flood**

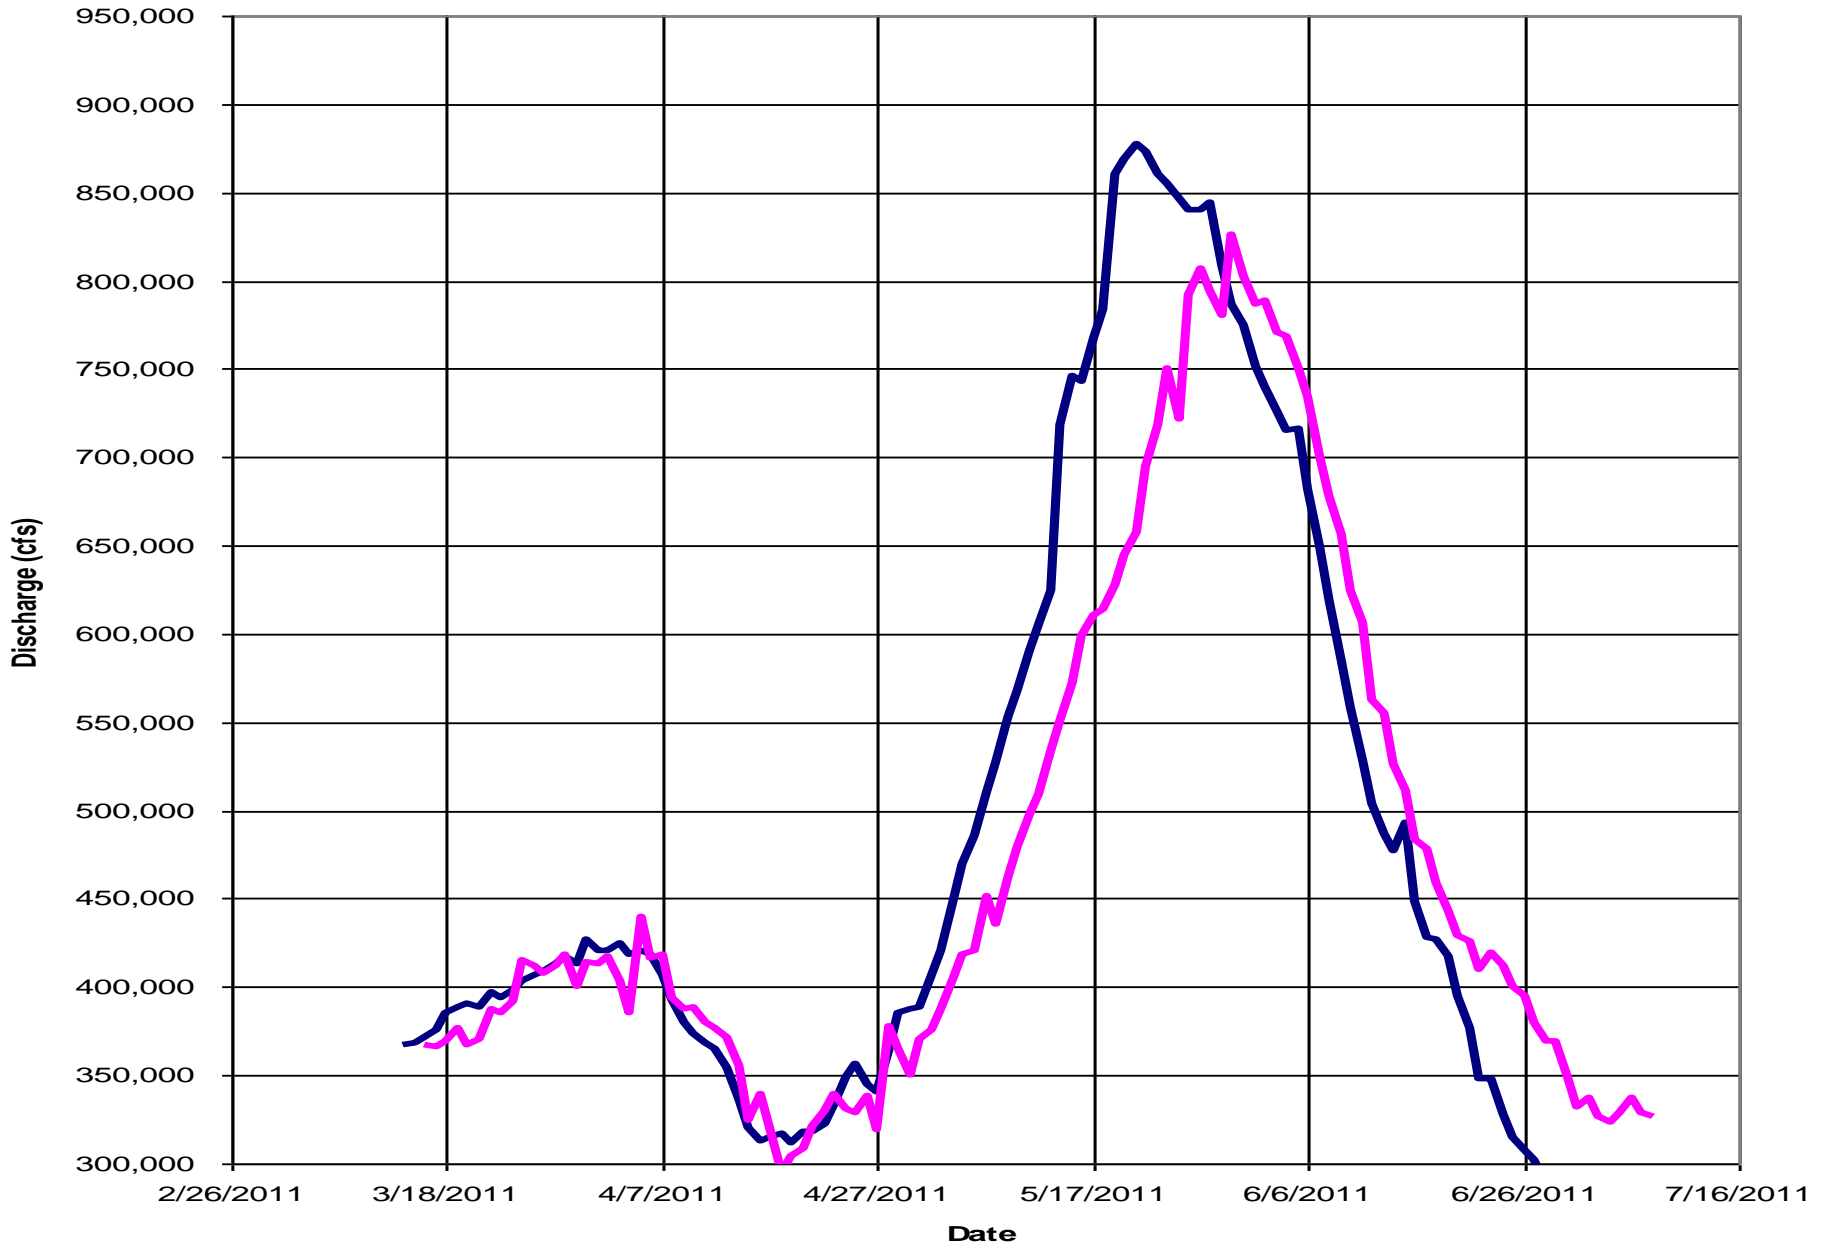
**Atchafalaya Input and Output Hydrographs Showing Lag (10 days) and Diminishment of Peak Q (50,000 cfs)**

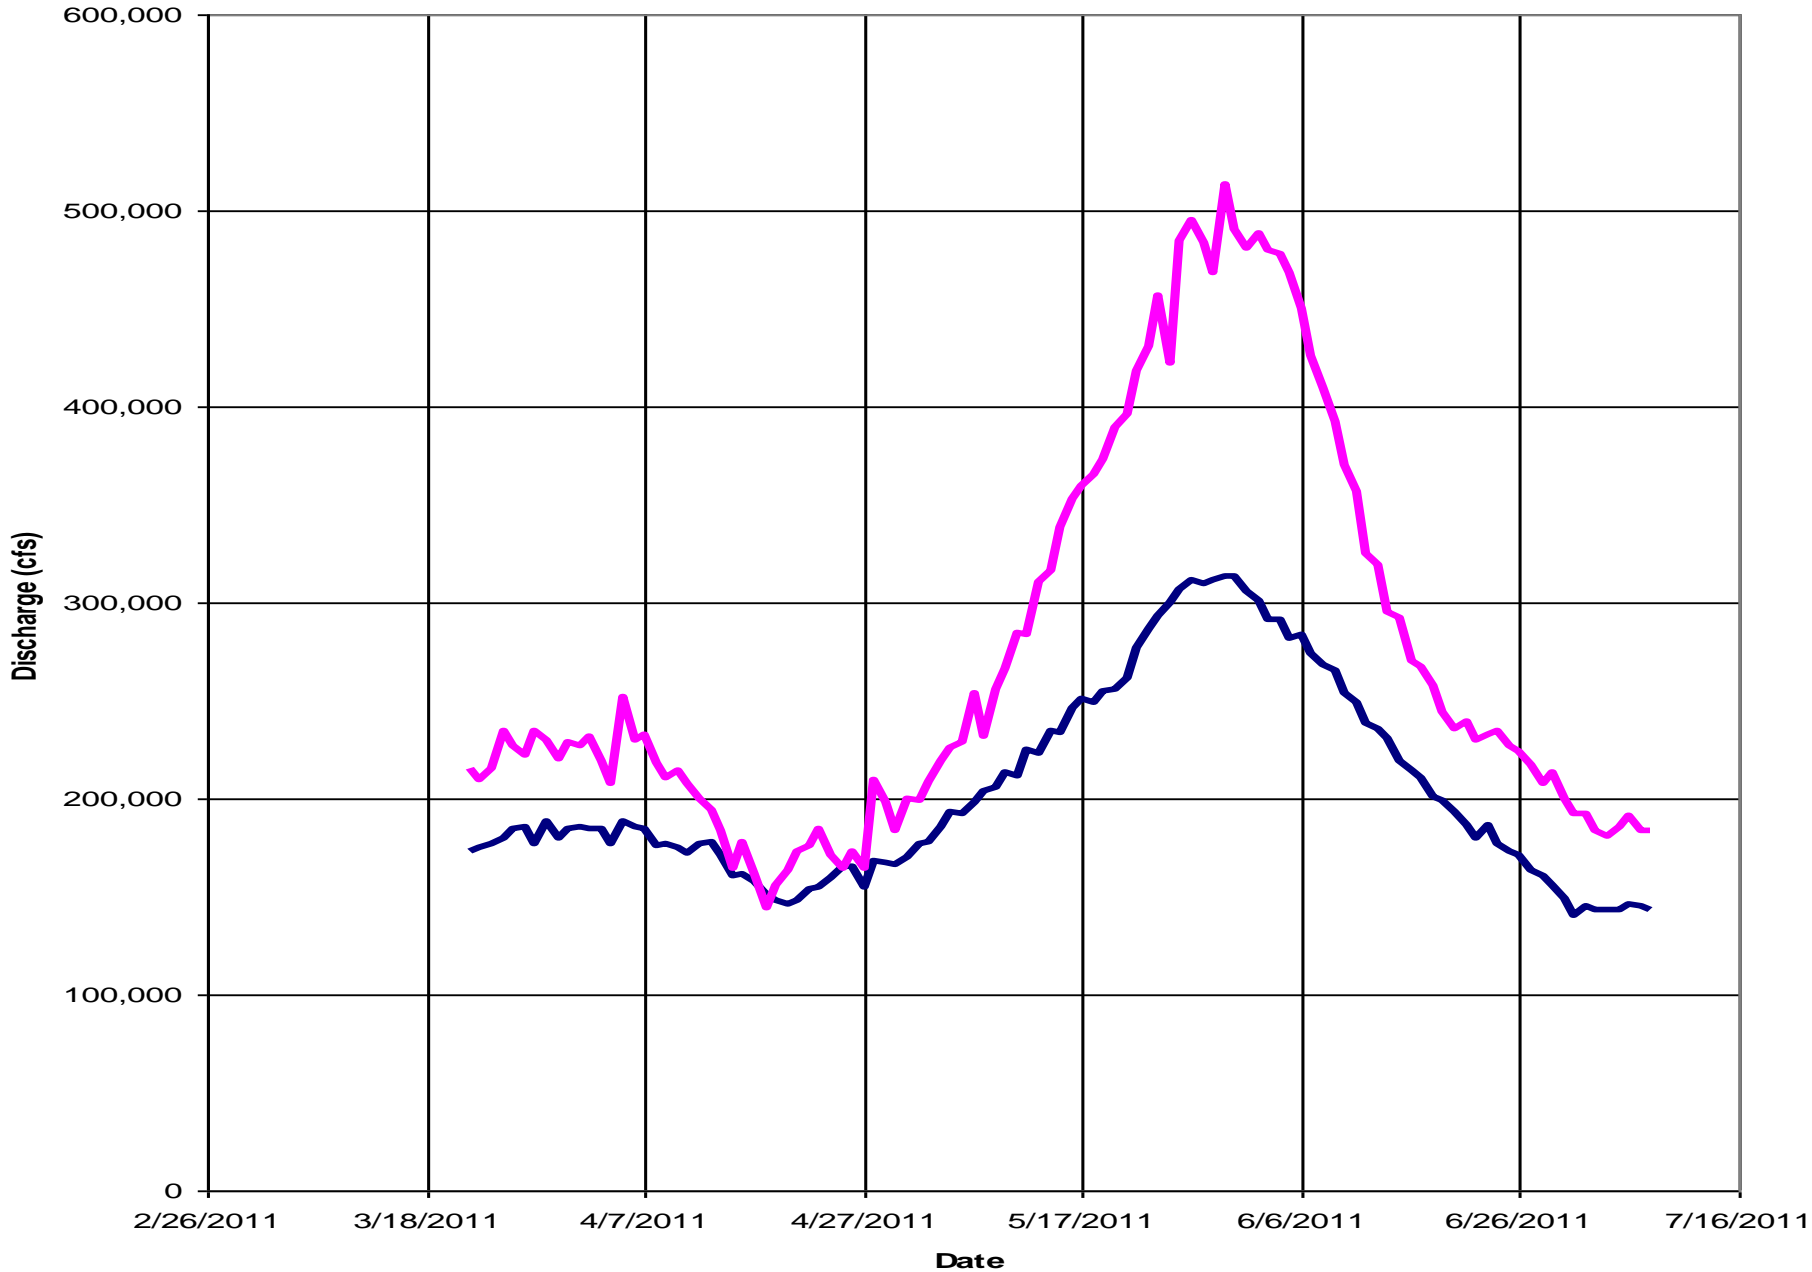
**Atchafalaya Basin Discharge through Lower Atchafalaya (56%) and Wax Lake Outlet (44%)**

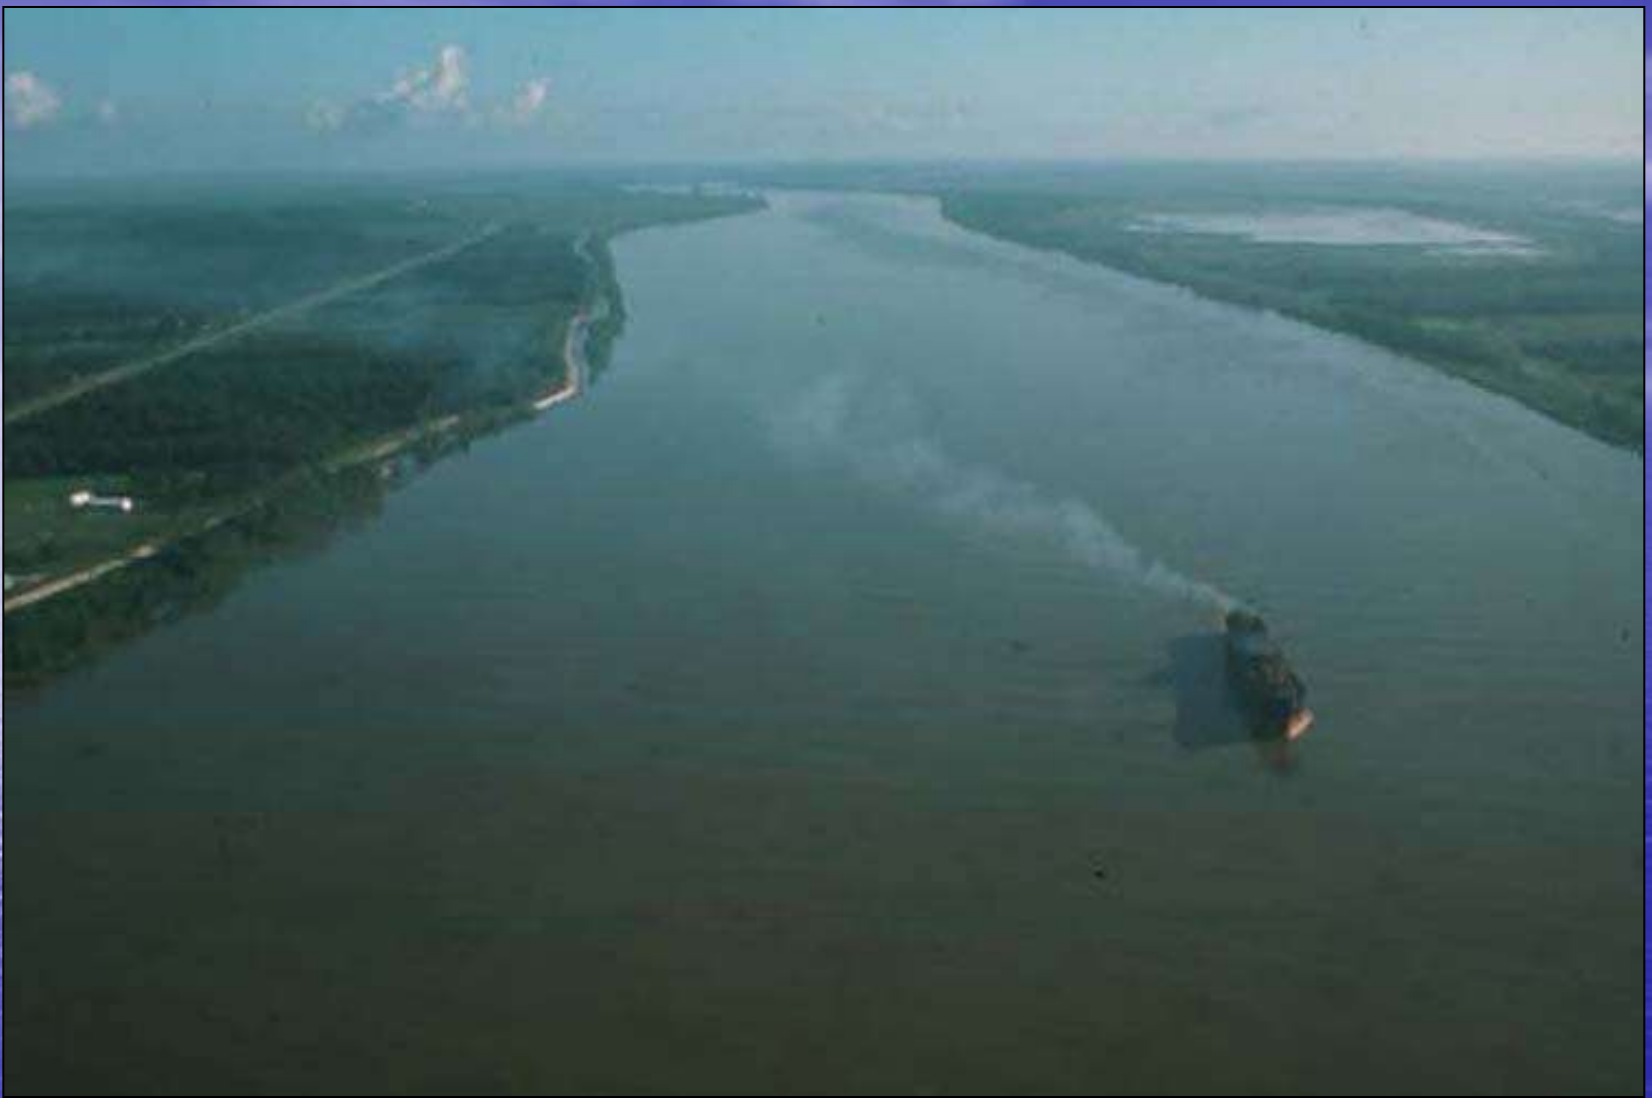
The employment of dual levees, lengthening of the jetties, and the silt load of the river have combined to **heighten the channel bed** and **lower the hydraulic grade**, lifting the river's flow surface.

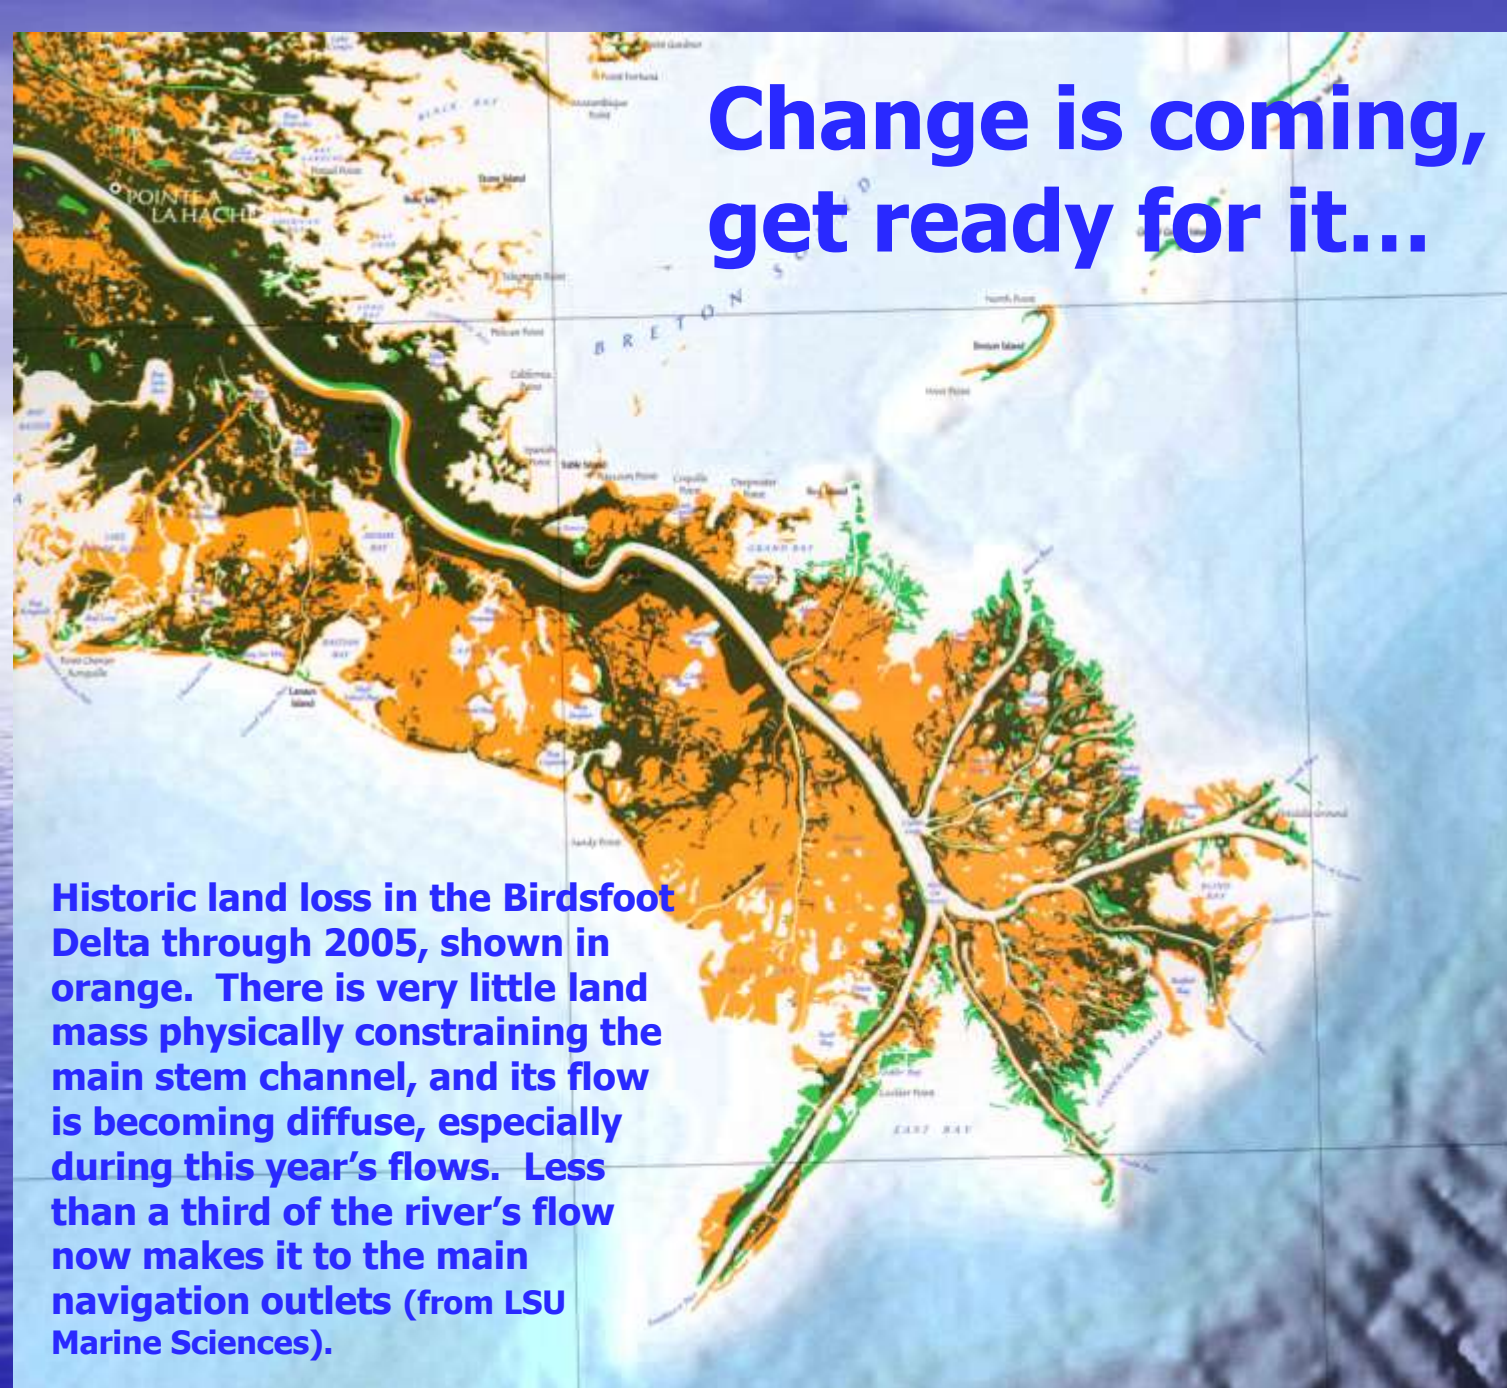
Historic land loss in the Birdsfoot Delta through 2005, shown in orange. There is very little land mass physically constraining the main stem channel, and its flow is becoming diffuse, especially during this year's flows. Less than a third of the river's flow now makes it to the main navigation outlets (from LSU Marine Sciences).
