# BRIEF OVERVIEW OF THE 2011 MISSISSIPPI RIVER FLOODS

**J. David Rogers, Ph.D., P.E., P.G., C.E.G., C.HG.**

**Society of American Military Engineers**

**August 17, 2011**

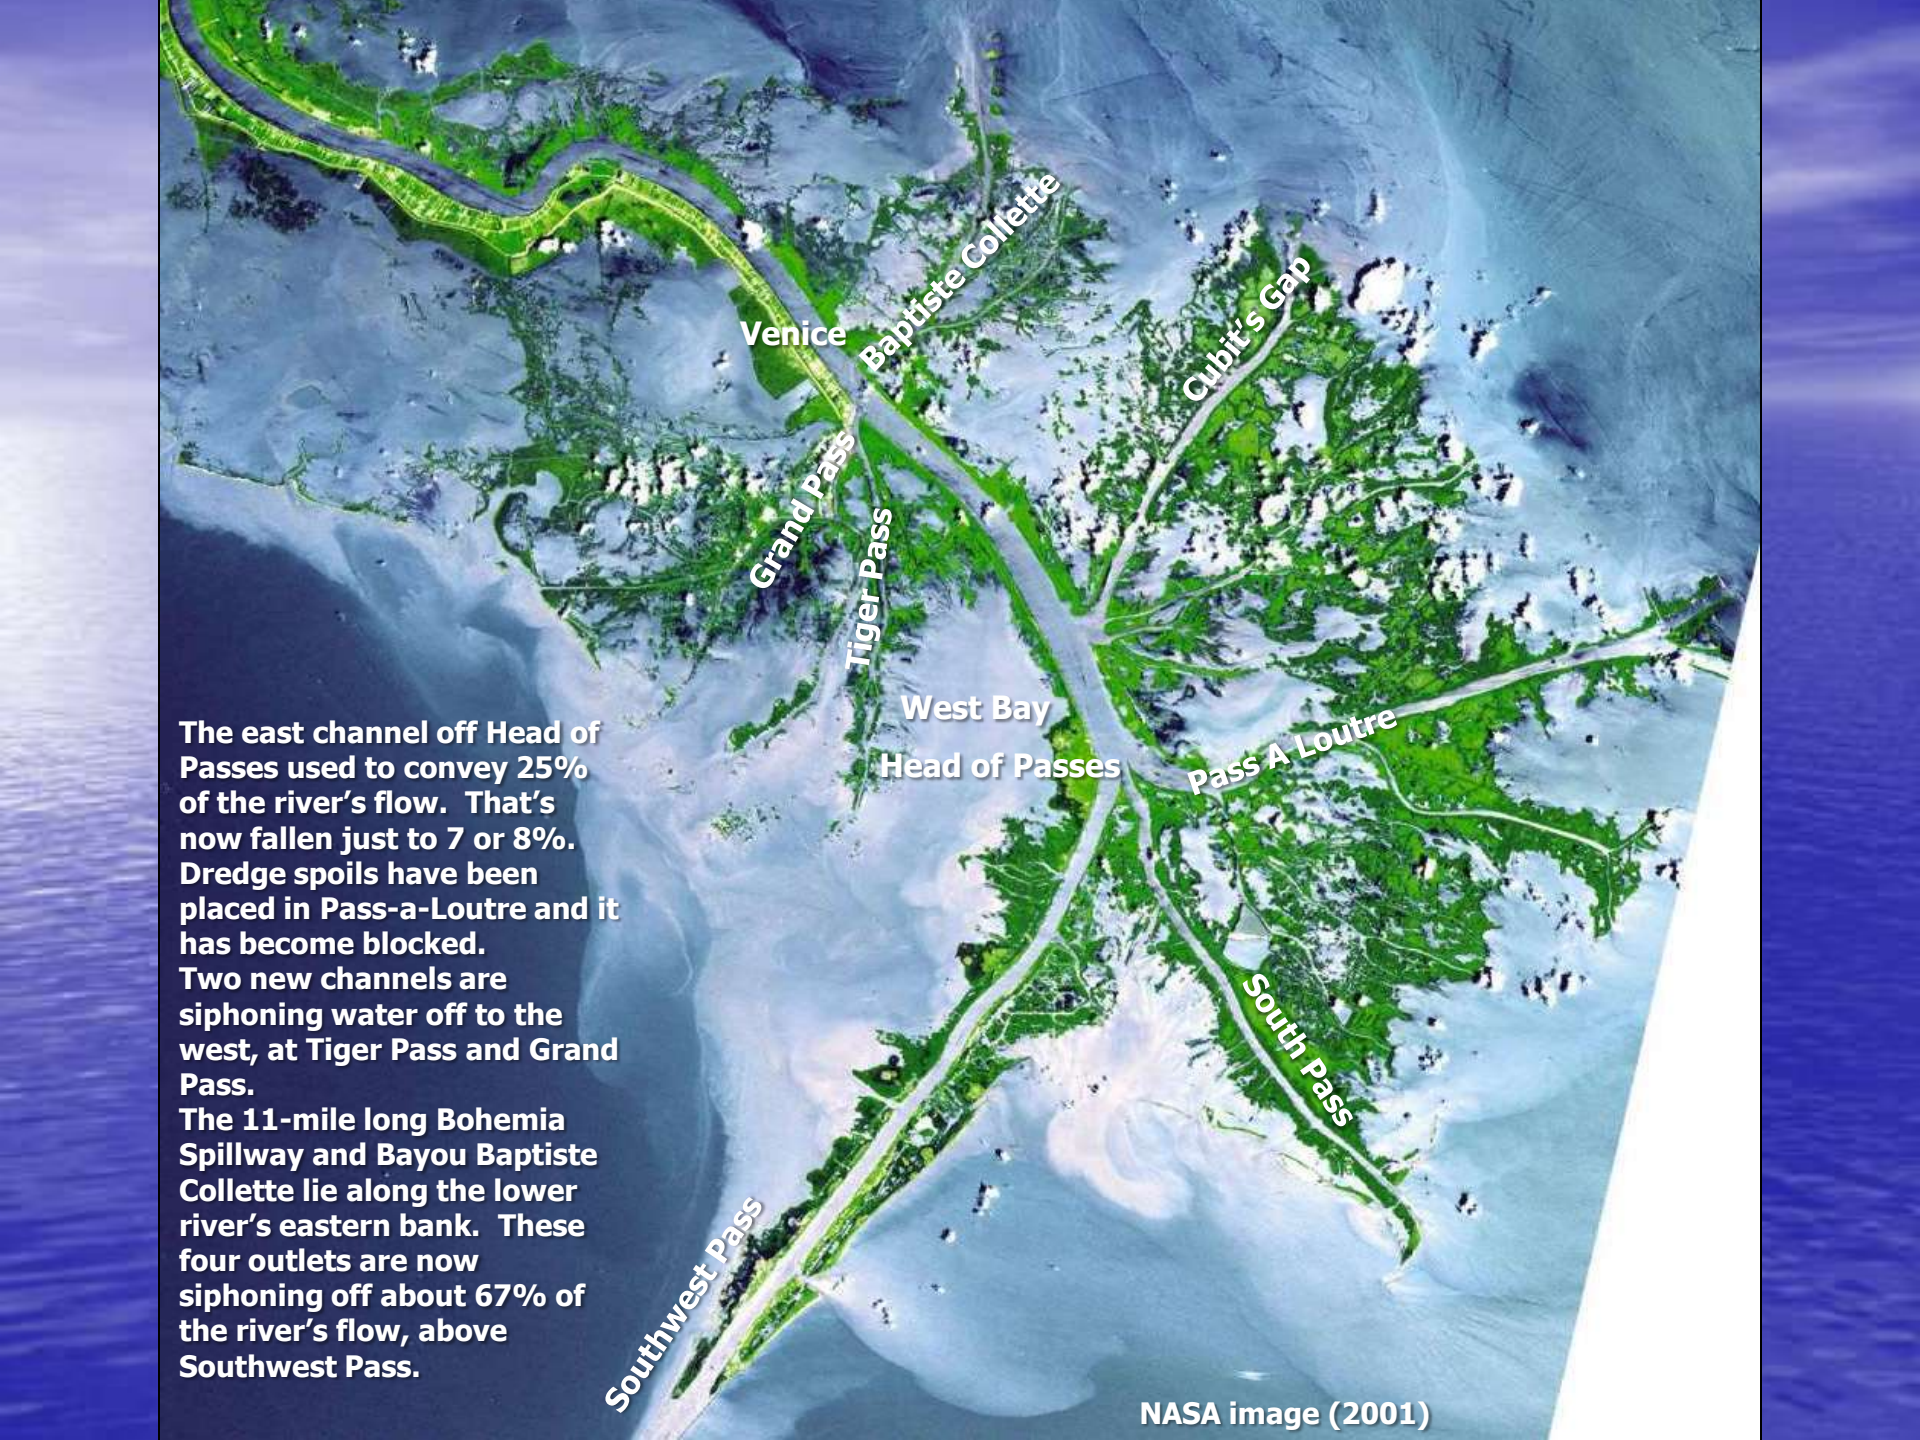
An aerial satellite image of a river delta system, likely the Mississippi River delta. The image shows a complex network of channels and passes. The main river channel flows from the top left towards the center. From this main channel, several passes branch out: Grand Pass and Tiger Pass to the west, and Baptiste Collette, Cubit's Gap, Pass A Loutre, and South Pass to the east. West Bay is located between Grand Pass and Tiger Pass. Venice is a small island or area near the top left. The surrounding area is a mix of green vegetation and light-colored sediment or sand. The image is tilted slightly to the right.

**The east channel off Head of Passes used to convey 25% of the river's flow. That's now fallen just to 7 or 8%. Dredge spoils have been placed in Pass-a-Loutre and it has become blocked. Two new channels are siphoning water off to the west, at Tiger Pass and Grand Pass.**

**The 11-mile long Bohemia Spillway and Bayou Baptiste Collette lie along the lower river's eastern bank. These four outlets are now siphoning off about 67% of the river's flow, above Southwest Pass.**

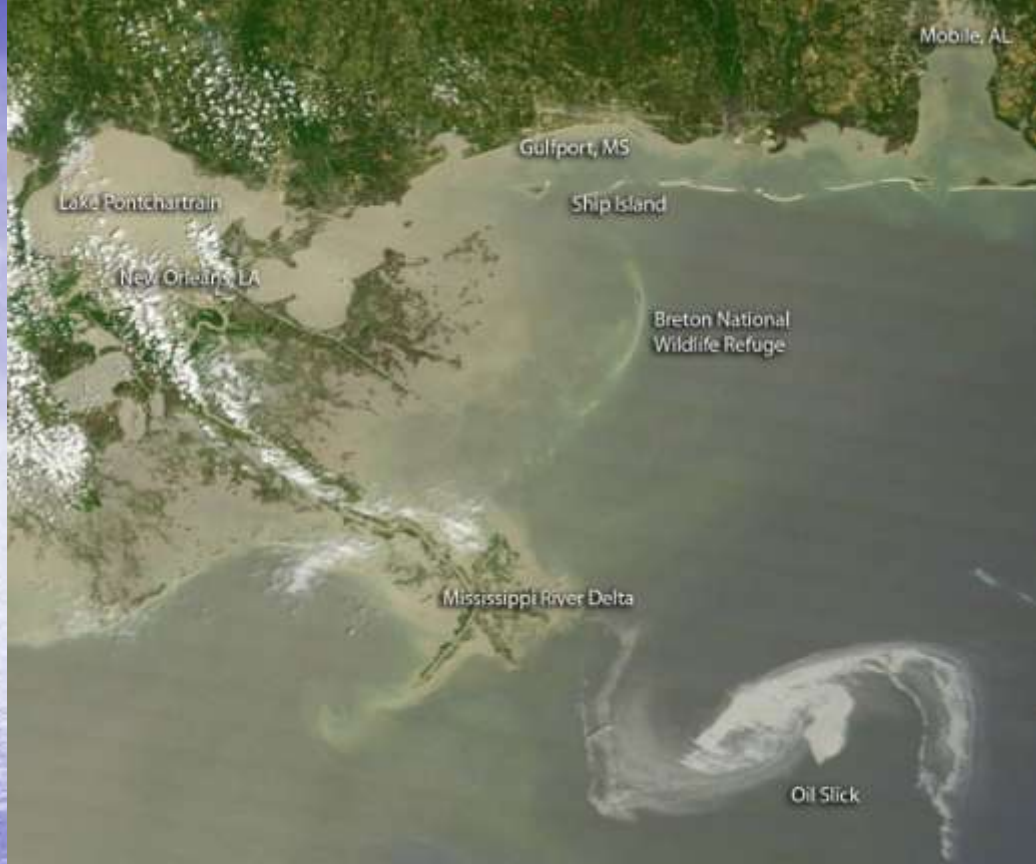
Since 1877 the jetties have extended the river's length by 11.3 km, lowering the hydraulic gradient, while sea level has risen 13 inches.
