BRIEF OVERVIEW OF SEISMIC THREAT POSED BY THE NEW MADRID SEISMIC ZONE

**Earthquakes Mean Business Seminar
AT&T Data Center St. Louis, MO**

J. David Rogers, Ph.D., P.E., R.G.

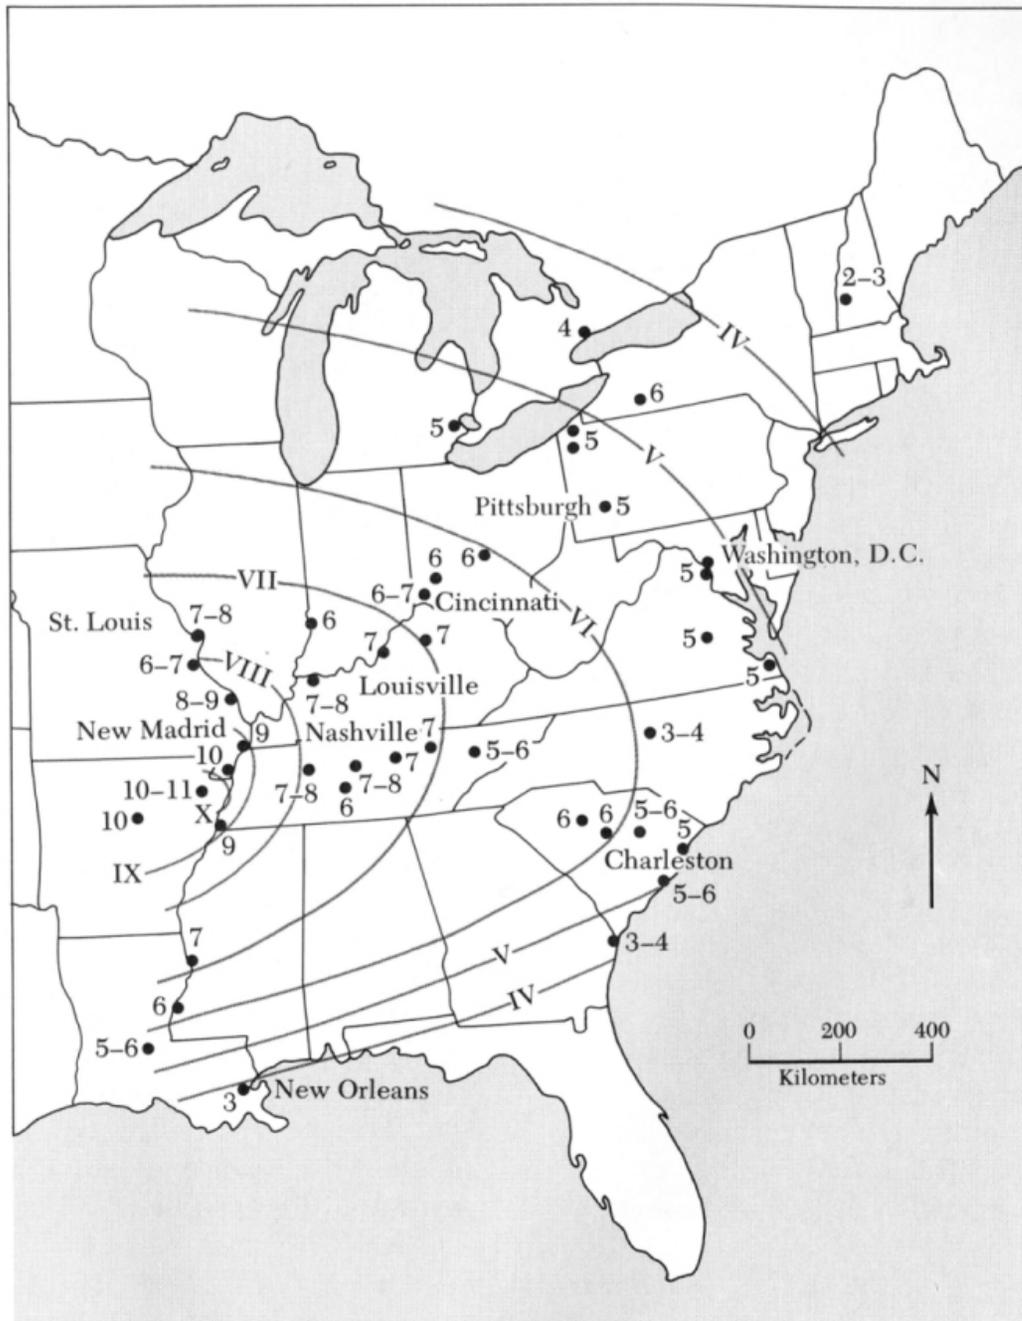
- **Isoseismal lines for the December 16, 1811 M 7.7 New Madrid earthquake**
- **Felt over an area greater than 1 million square miles**
- **Extensive damage to masonry in Cincinnati**
- **Rang church bells in Boston**
- **Most people lived along rivers in Midwest and no inhabitants west of the Mississippi**

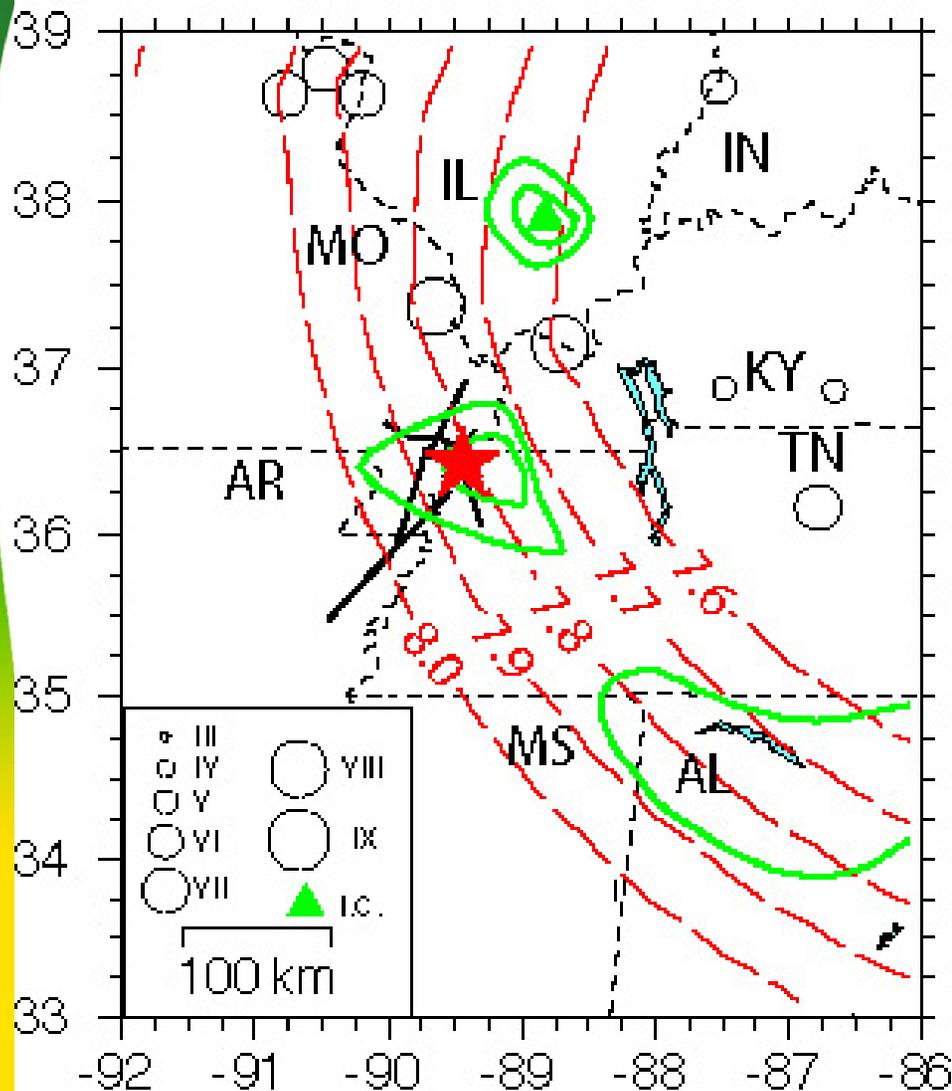
M_l 7.8 quake of 7 February 1812

- Location: Reelfoot blind thrust
 - M_l = 7.8
 - M_w = 7.0-8.1 ($\pm 2s$ range)
- **Best constrained event:**
- 1) Largest quake
 - 2) Physical evidence of thrusting
 - 3) Reelfoot fault well imaged

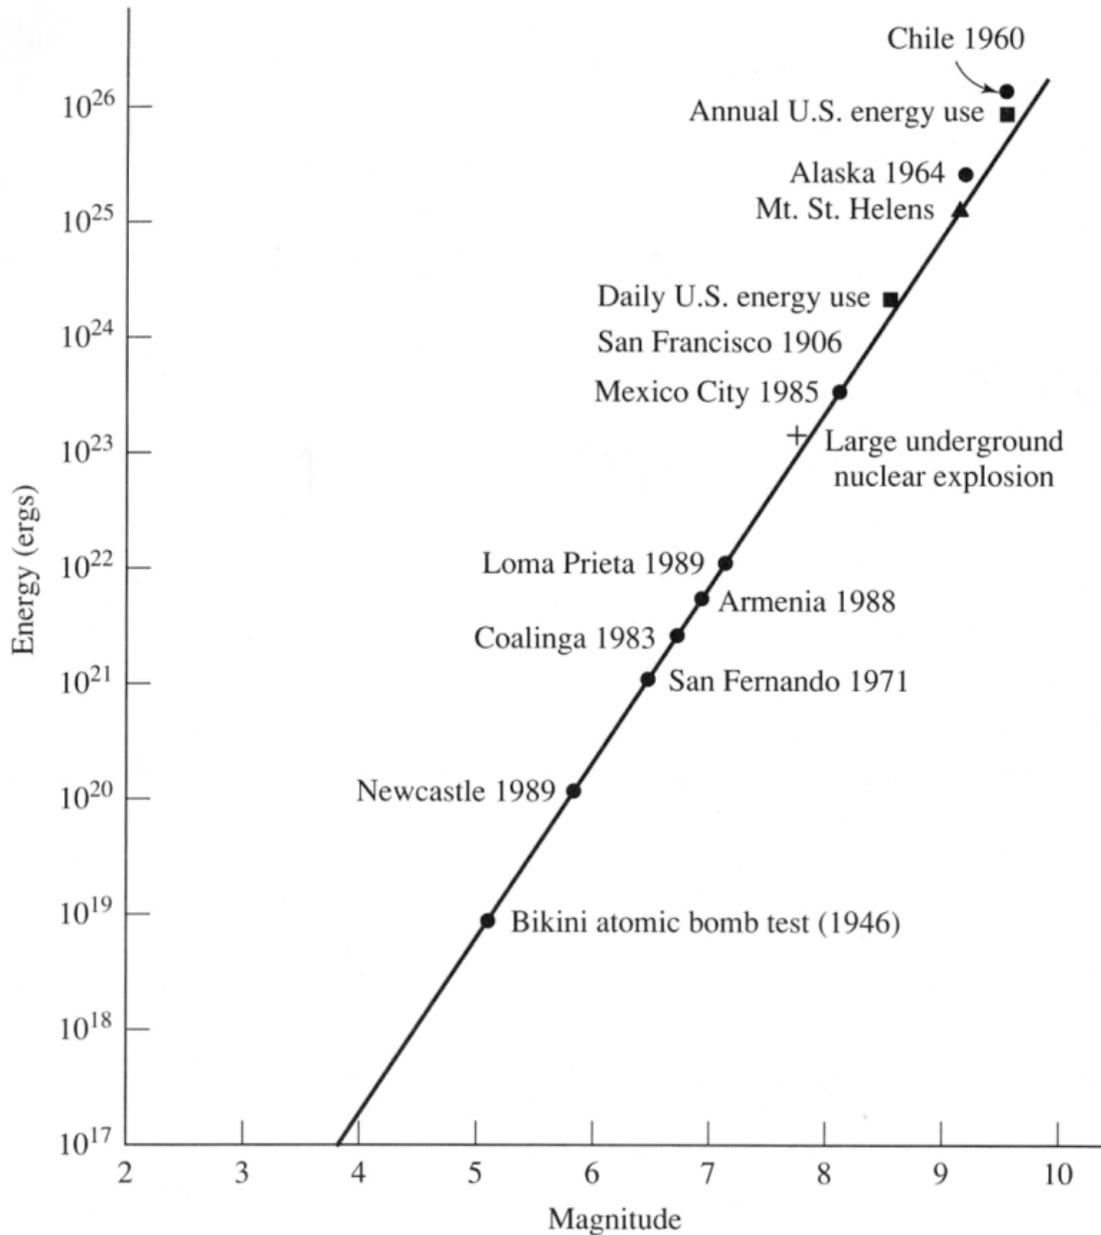
Earthquake Magnitude versus Energy Release

- Modern earthquake magnitudes are based on energy release using a logarithmic scale
- Each numerical magnitude is about 33X the energy release of preceding numerical value

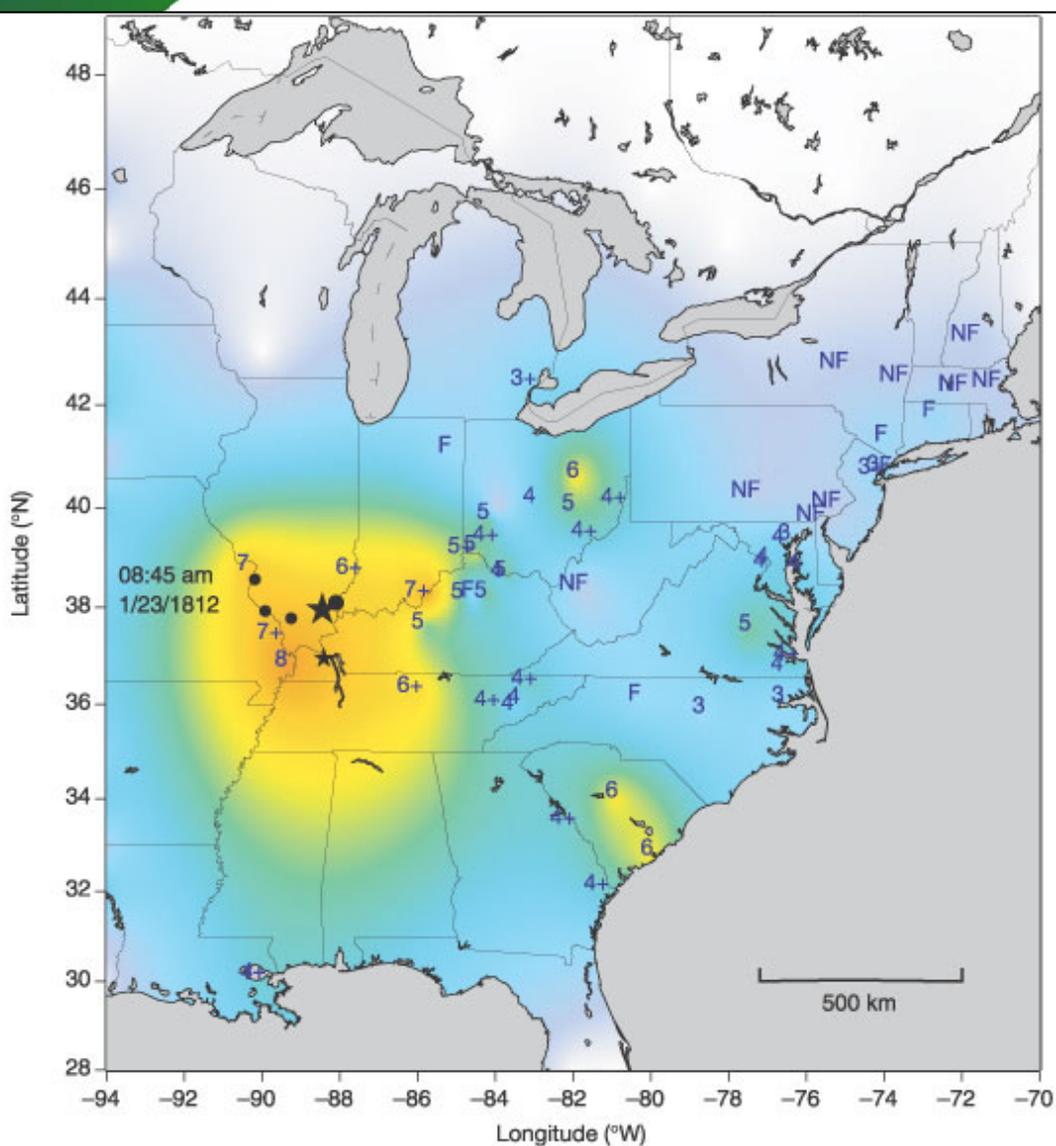
- Recently, the destructive effects of the 1811-12 New Madrid events has been attributed to site amplification effects, since most of the inhabited areas were in Holocene channels along major drainages.

- This is a revised map illustrating shaking severity for the January 23, 1812 event, thought to have been something between M_w 6.8 and M_w 7.8

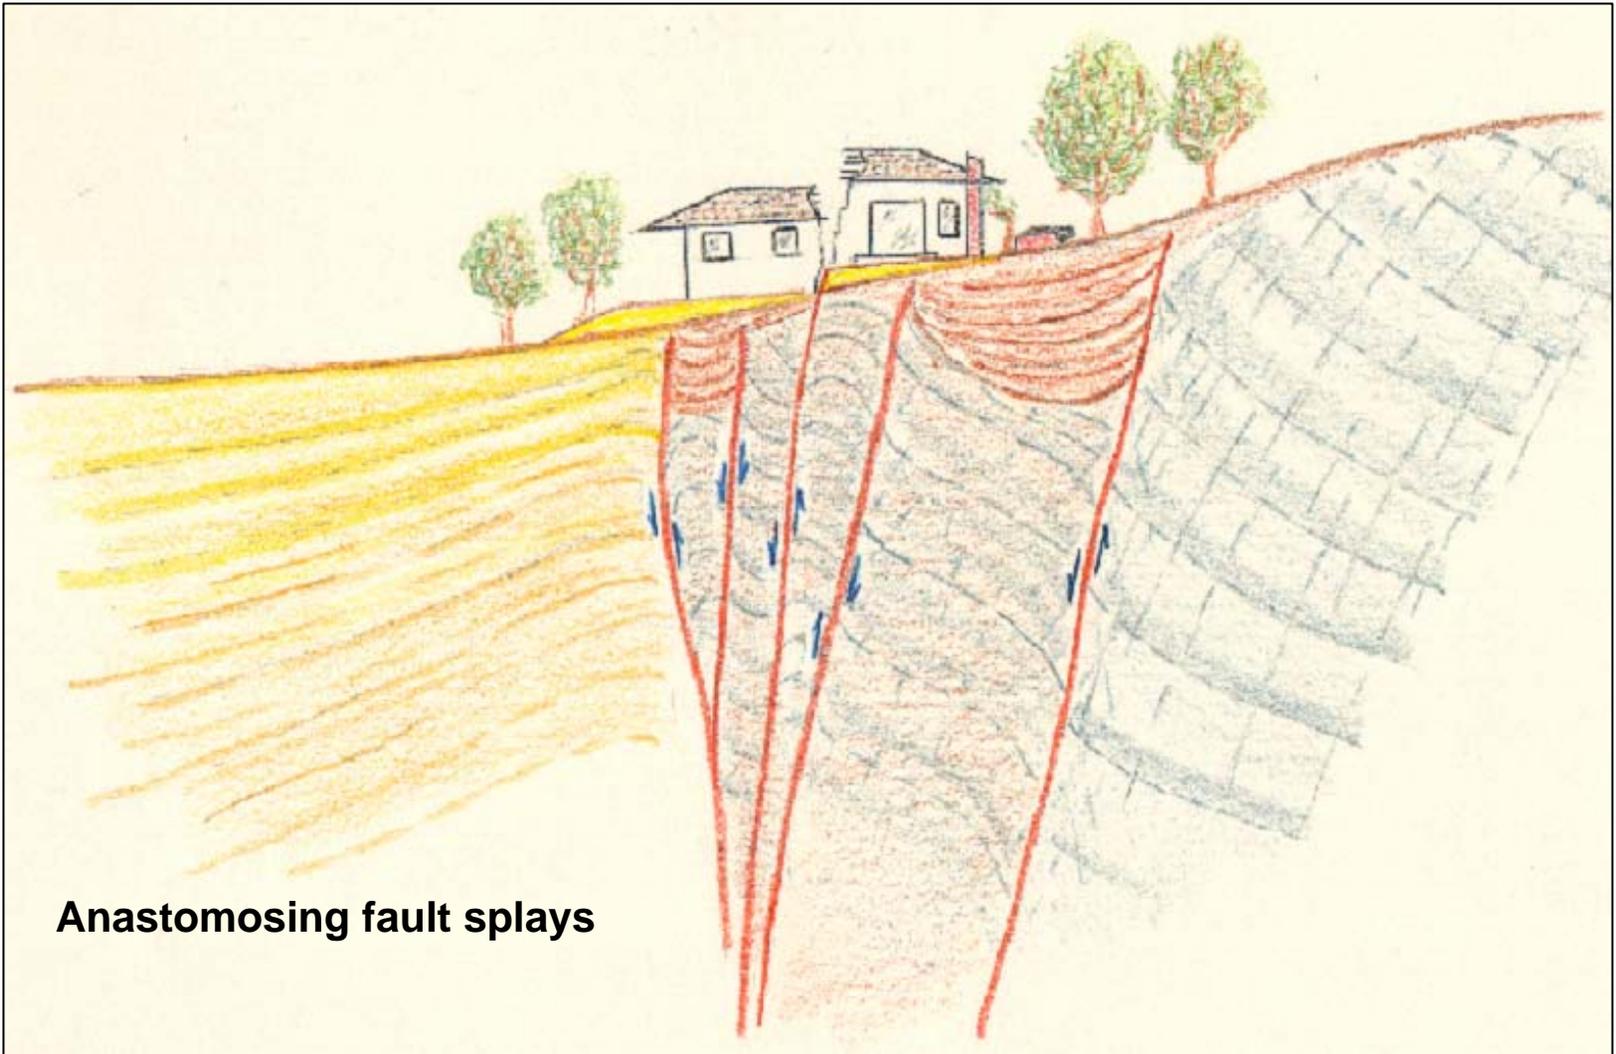
SURFACE FAULT RUPTURE HAZARDS

- Major active faults usually extend up to the ground surface, where they can pose a threat to structures. Only about 2% of earthquake-induced structural damage is caused by surface fault rupture. Various fault strands identified near the ground surface may be active, dormant or ancient, as shown above.

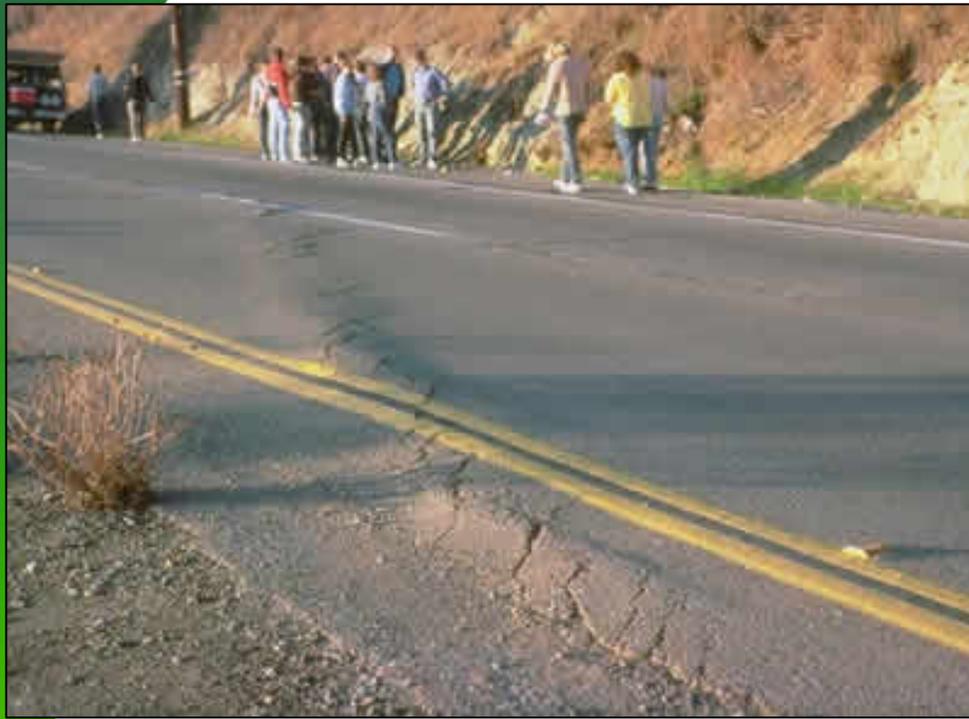
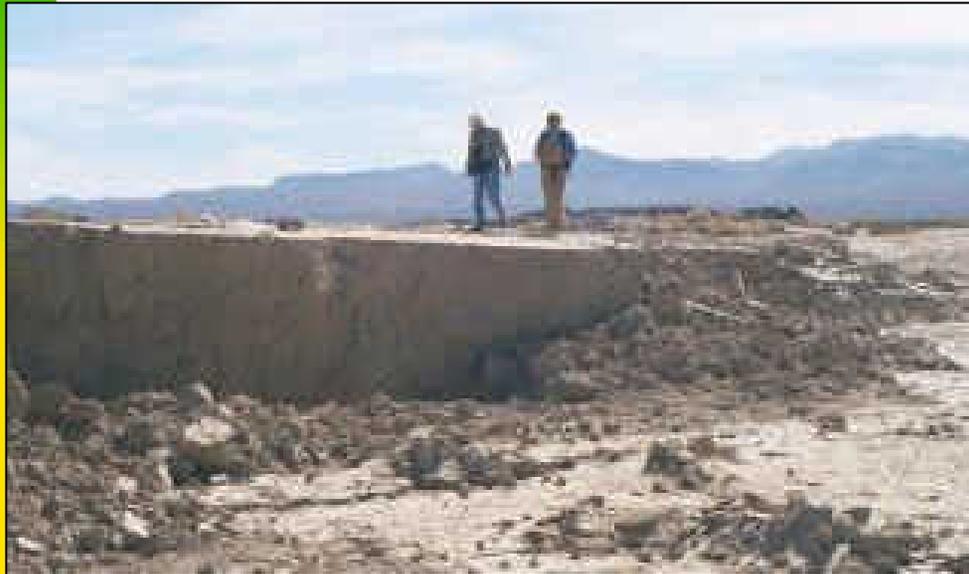
SURFACE RUPTURE

- Only a small percentage of earthquakes actually cause noticeable surface fault rupture

- Sometimes it is rather discrete (upper left)

- On other occasions it can be very abrupt and graphic (lower left)

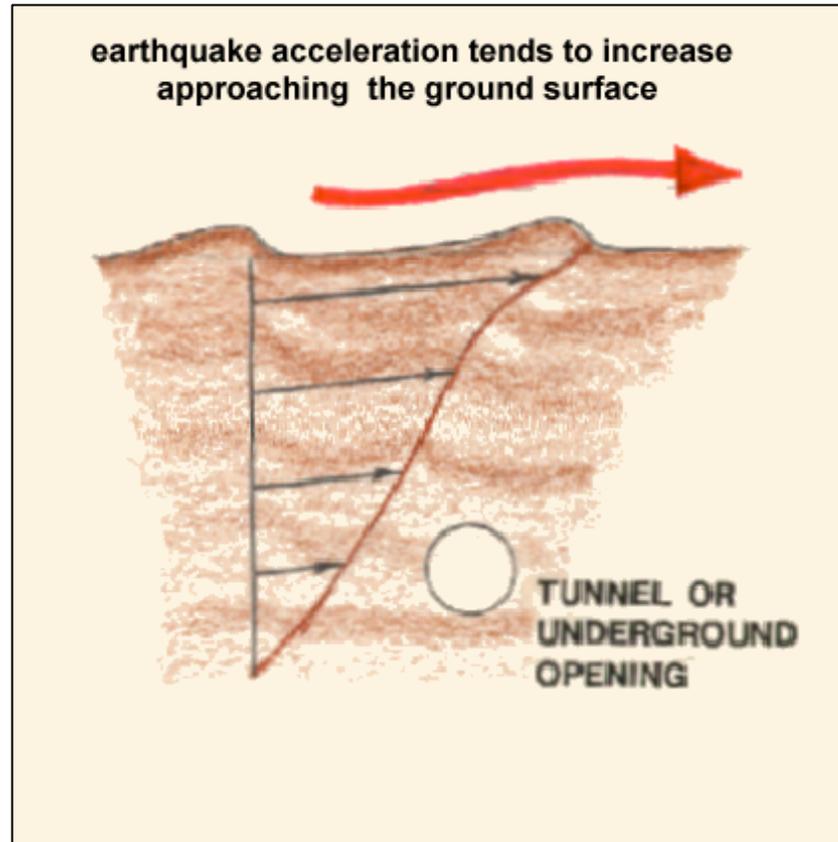
FREE BOUNDARY/ GROUND WAVE EFFECT

- As the seismic wave train propagates upward and along the Earth's surface, the peak ground accelerations will tend to increase at the ground surface because there is no confinement. Tunnels and underground openings usually record much lower values of acceleration due to their increased confinement.

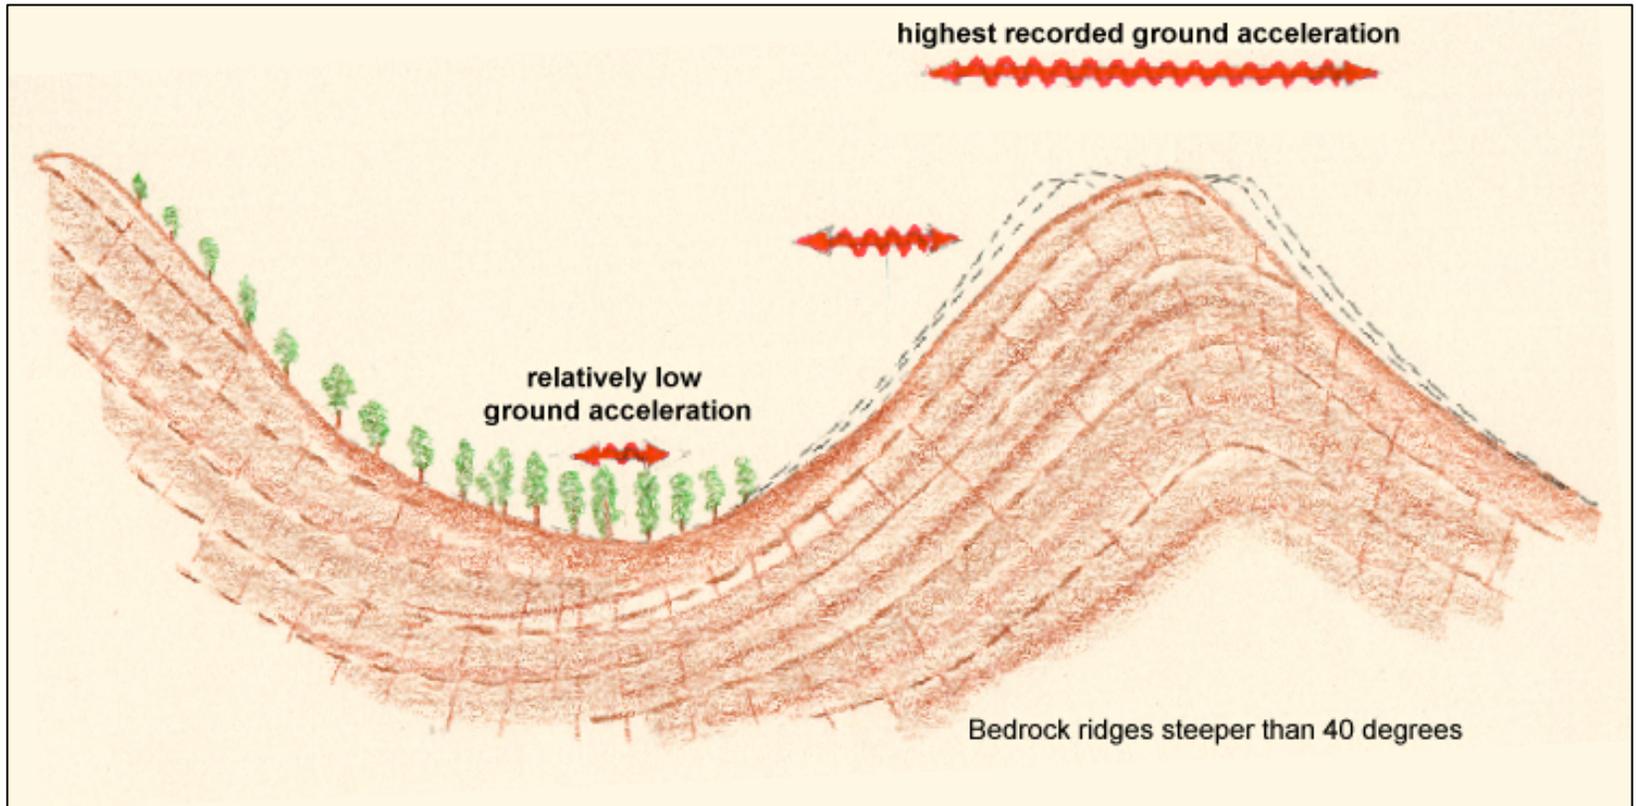
TOPOGRAPHIC INFLUENCE ON SITE RESPONSE

■ Steep-sided bedrock ridges usually experience much higher accelerations during earthquakes because they are less laterally constrained. In the October 1989 Loma Prieta earthquake the PGA of 0.77g was recorded in the valley bottom at Corralitos. Estimates of PGA values for the adjoining ridges were in excess of 1.30g.

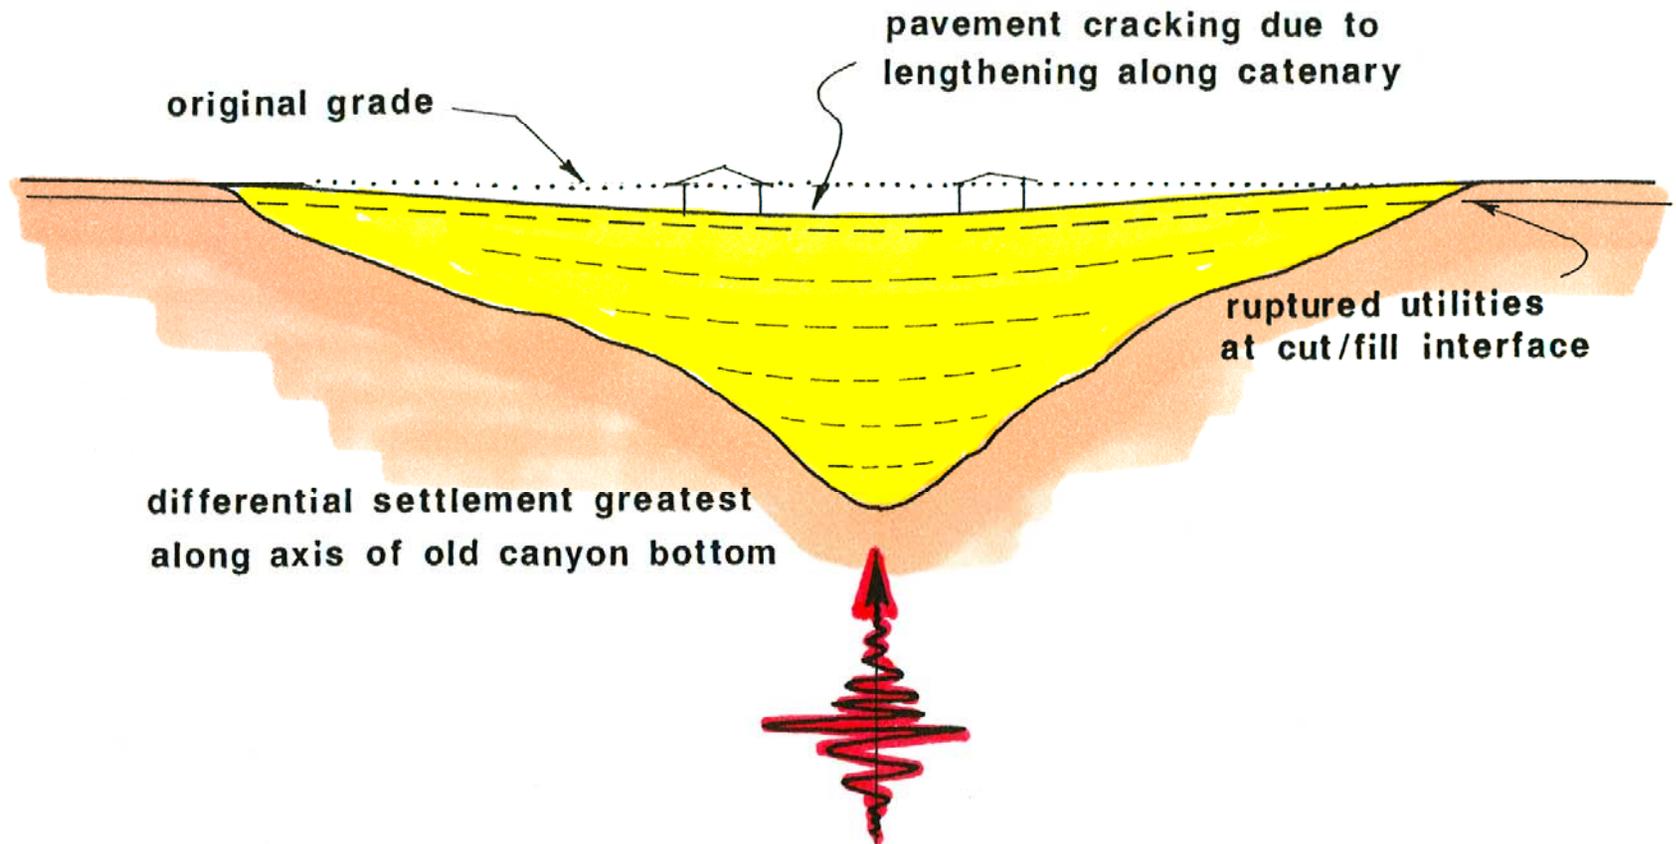
DYNAMICALLY-INDUCED SETTLEMENT OF A VALLEY FILL

- **Fill embankments tend to consolidate and settle under dynamic loading in the near-field zone**

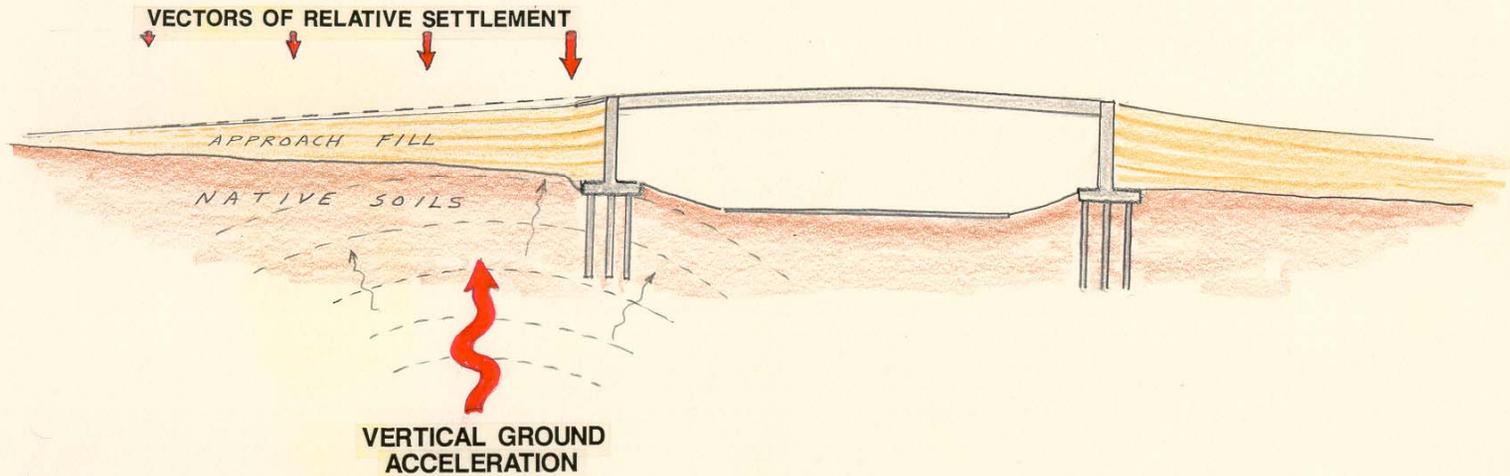
QUAKE-INDUCED SETTLEMENT OF APPROACH FILLS

- Regardless of the compactive effort engendered to filled ground during placement, these materials tend to compress during earthquake-induced shaking, often causing abrupt settlement of the approach fills at the abutments.

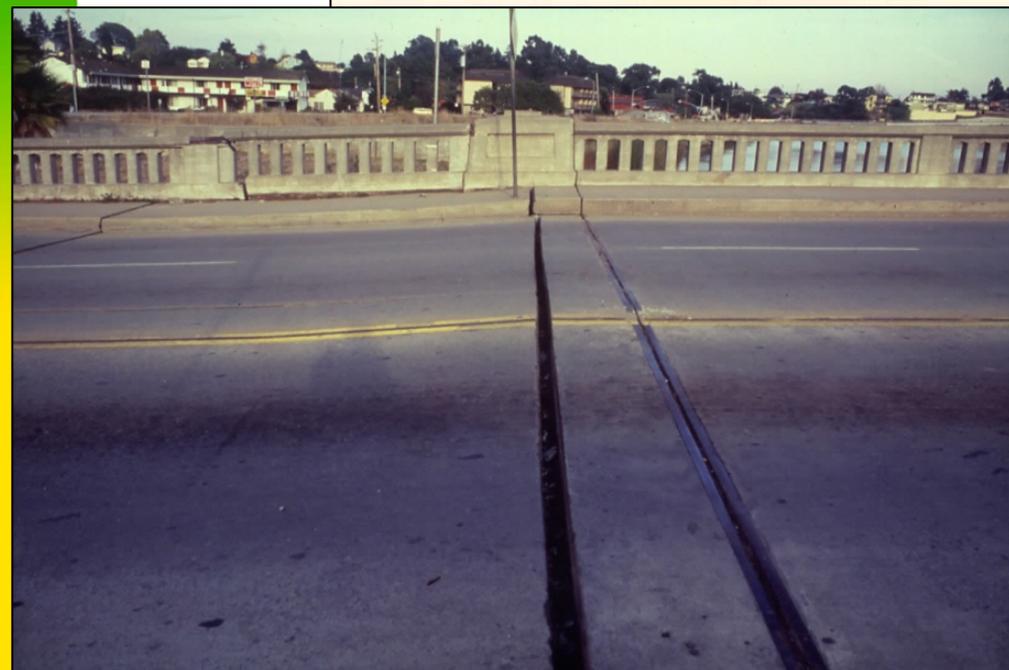
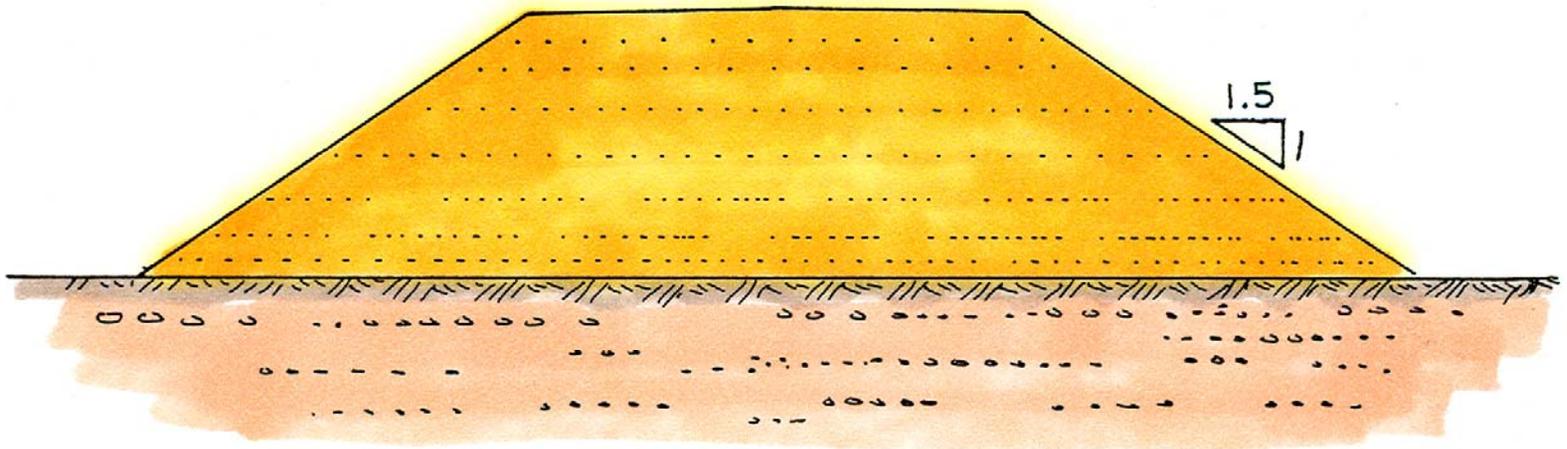
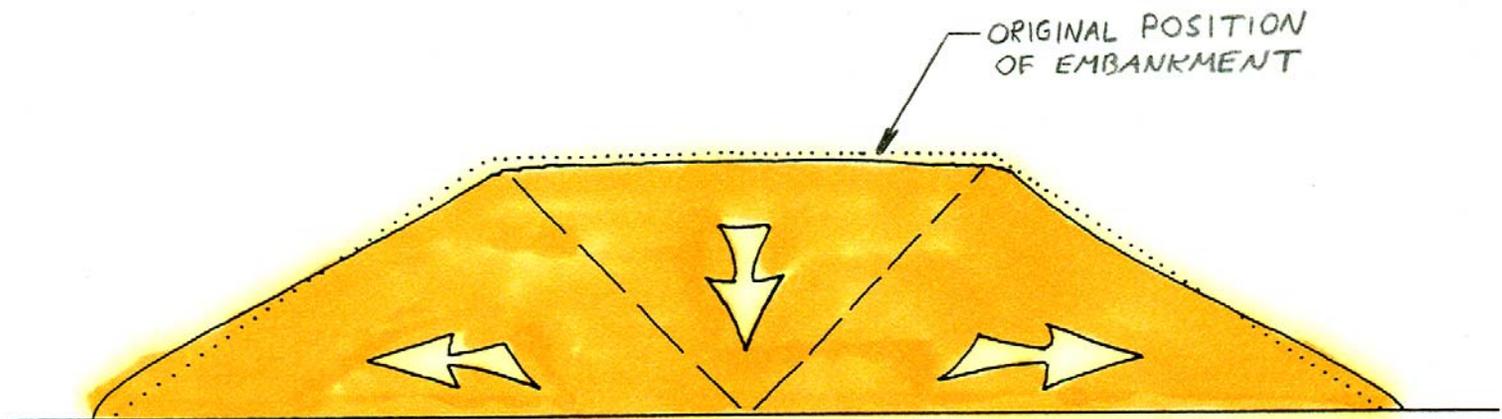
- **Mechanism of seismically-induced settlement of bridge approach fill prisms**

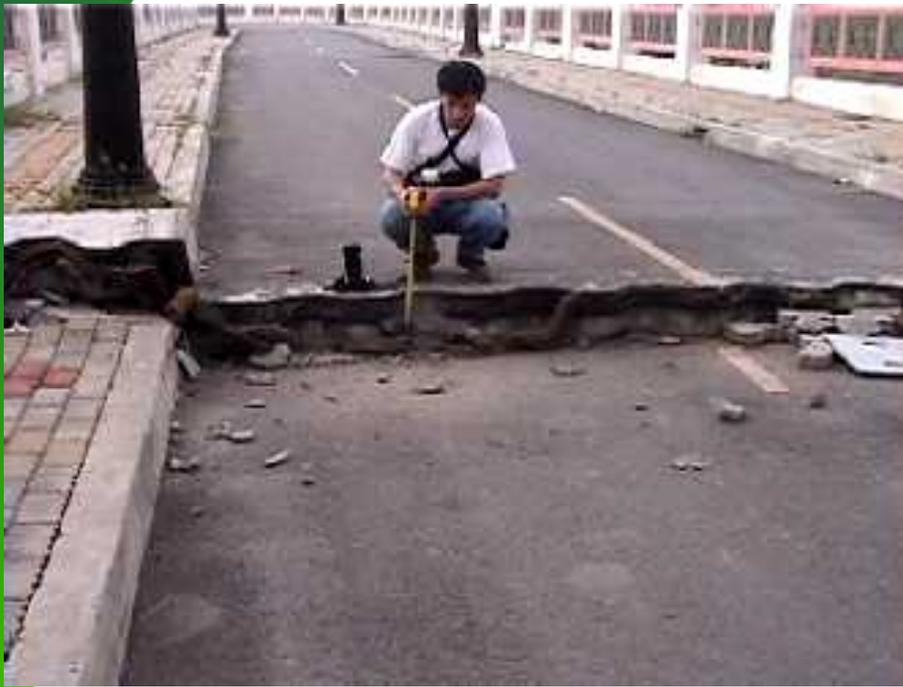
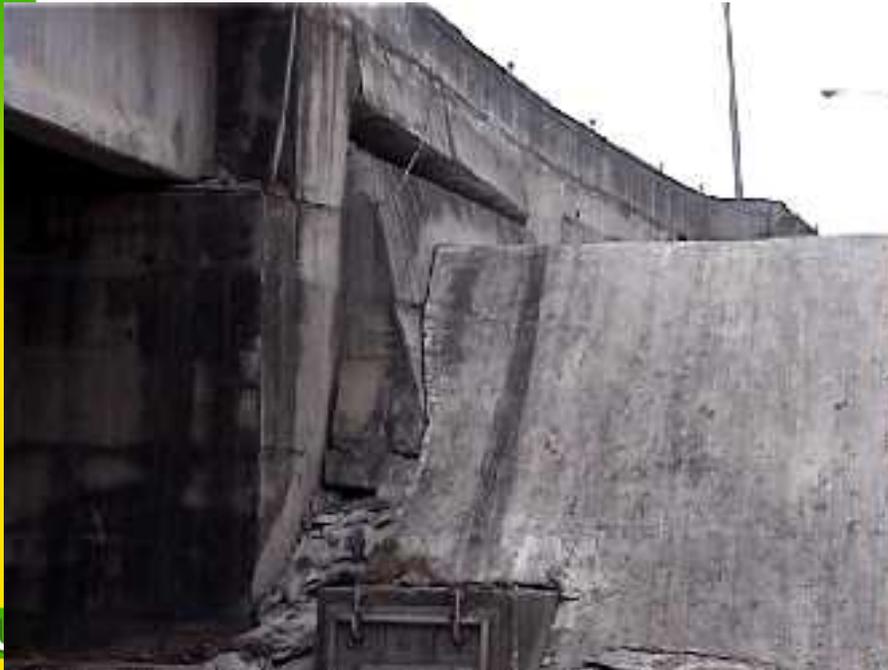
QUAKE-INDUCED SETTLEMENT

- Approach fills for pile supported bridges commonly exhibit grievous differential settlement
- Impacts traffic flow and any entrained utilities, like fire mains
- These examples are from Aug 1999 Chi Chi earthquake in Taiwan

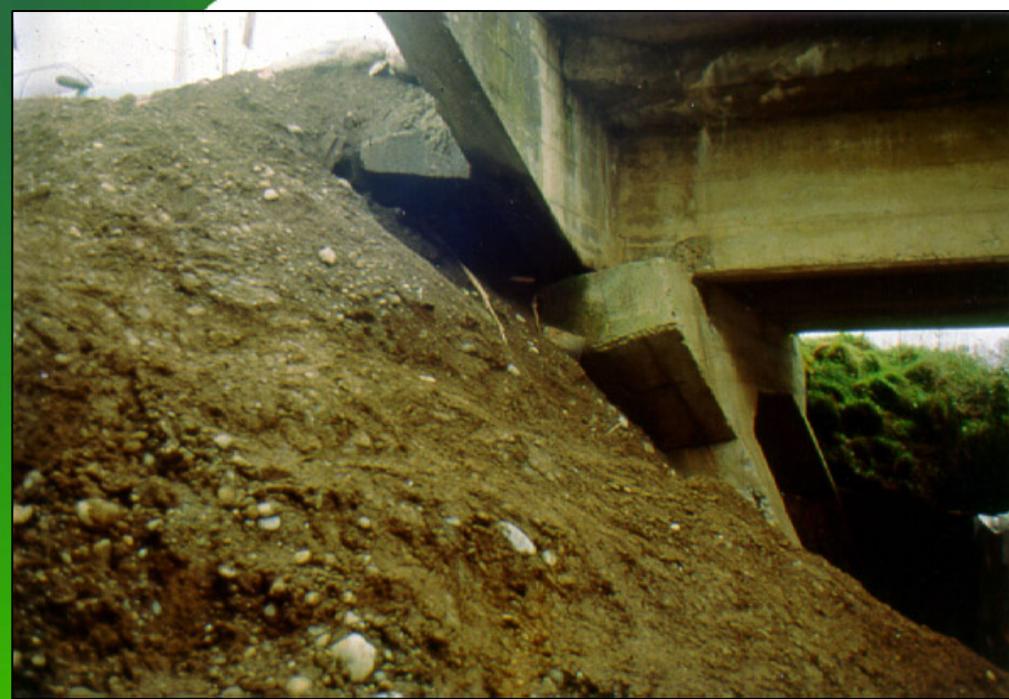
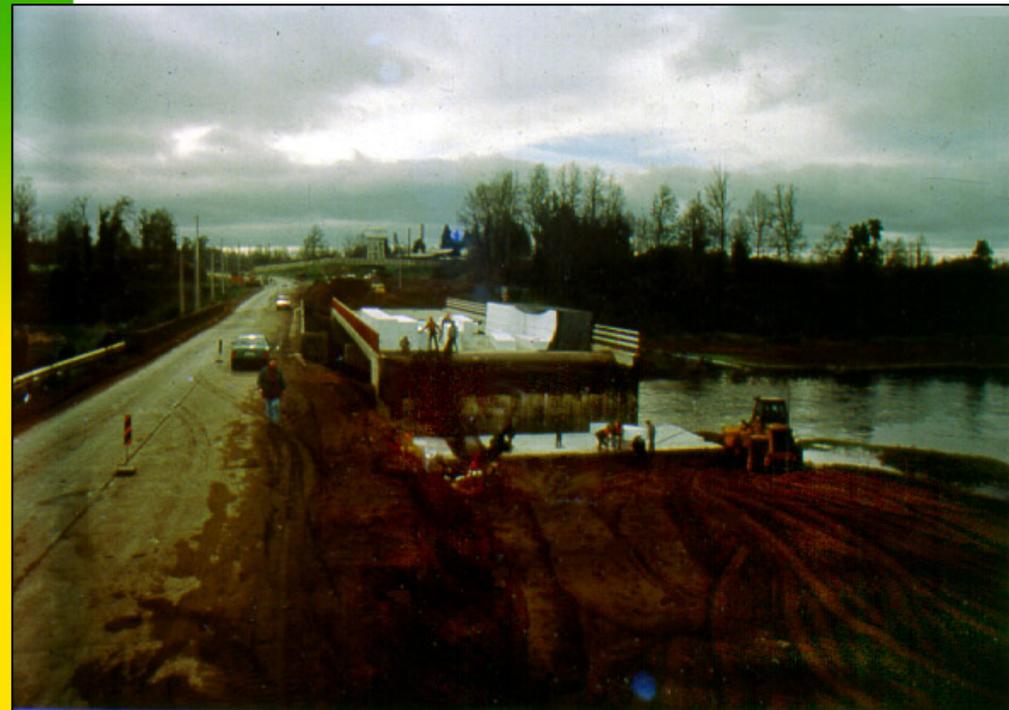
APPROACH FILL SETTLEMENT

- Seismically-induced settlement and lurching of approach fills for the Cayumapa River Bridge near Valdivia, Chile, which occurred during the M9.5 May 1960 earthquake
- Replacement structure being constructed in lower view, using Geoforam

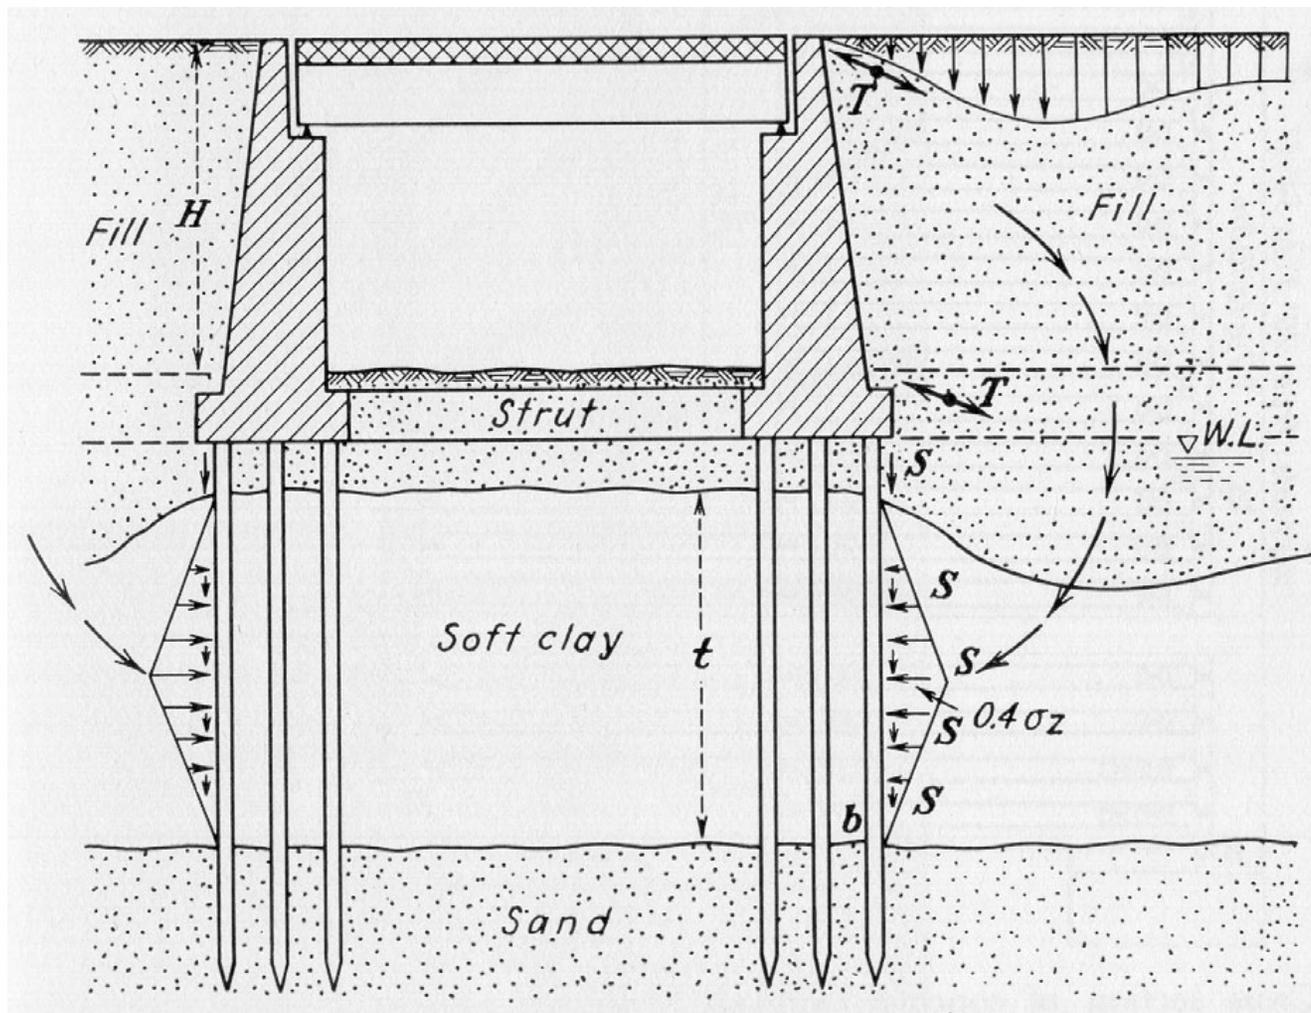
- **Tschebotarioff (1973) presented case studies of pile supported bridges that failed because of approach fill settlement.**

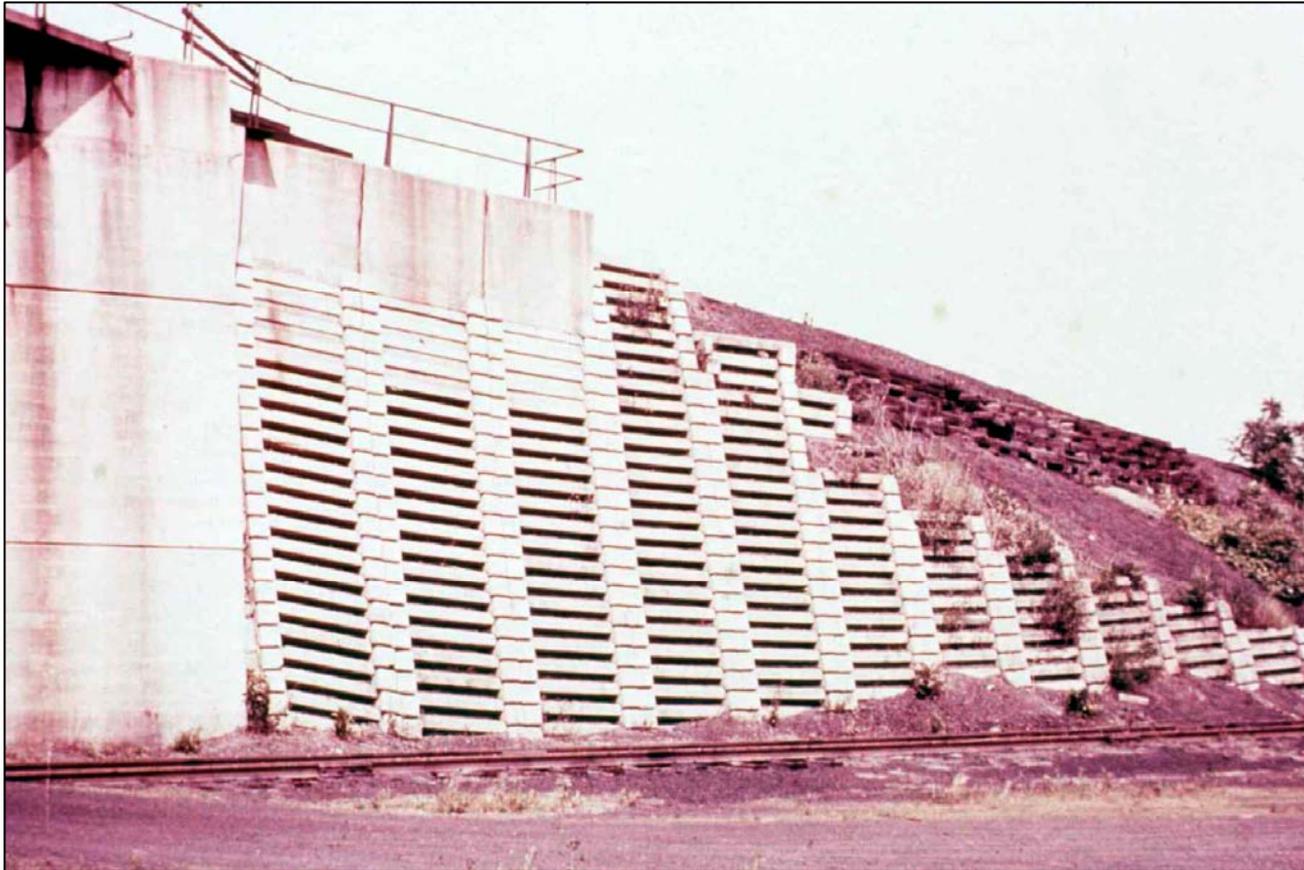
SETTLEMENT OF APPROACH FILL

- **Crib wall supported approach fill for pile supported bridge. As fill consolidated, crib wall deformed and supporting piles deflected inward, towards channel. Taken from Tschetarioff (1973).**

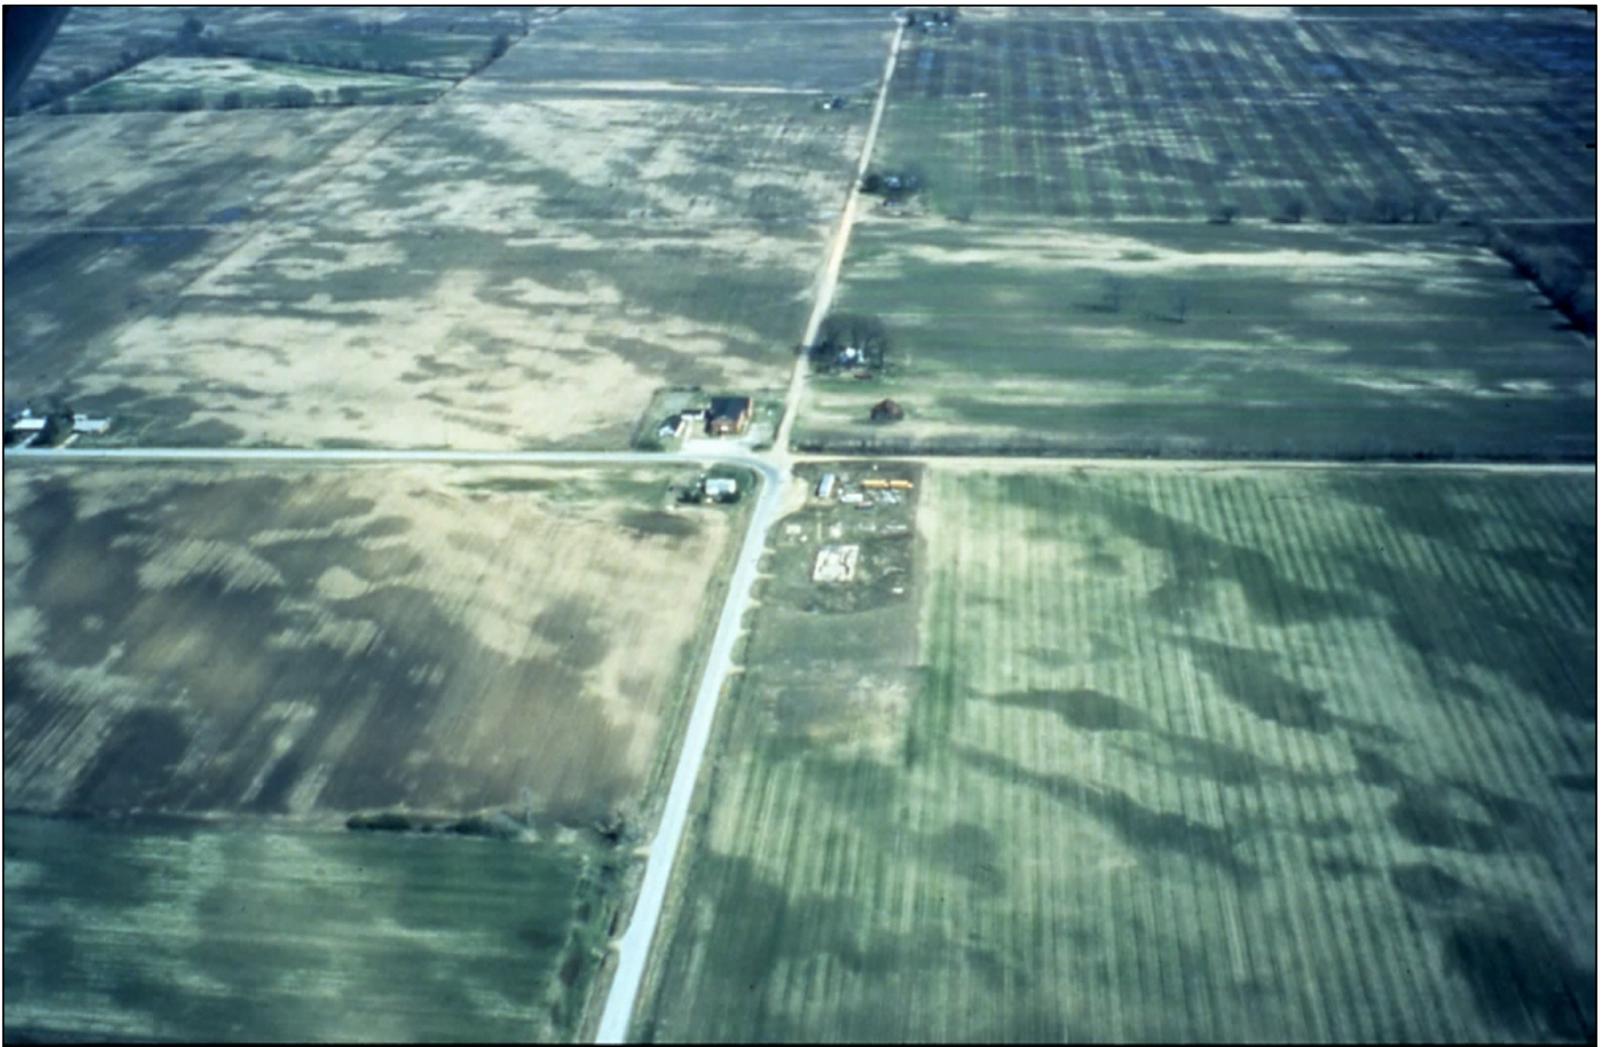
- **Farm lands west of Big Lake, AR reveal a series of linear fissures which disgorged liquefied sand from beneath a silt cover.**
