BRIEF OVERVIEW OF SEISMIC THREAT POSED BY THE NEW MADRID SEISMIC ZONE

**Earthquakes Mean Business Seminar
AT&T Data Center St. Louis, MO**

J. David Rogers, Ph.D., P.E., R.G.

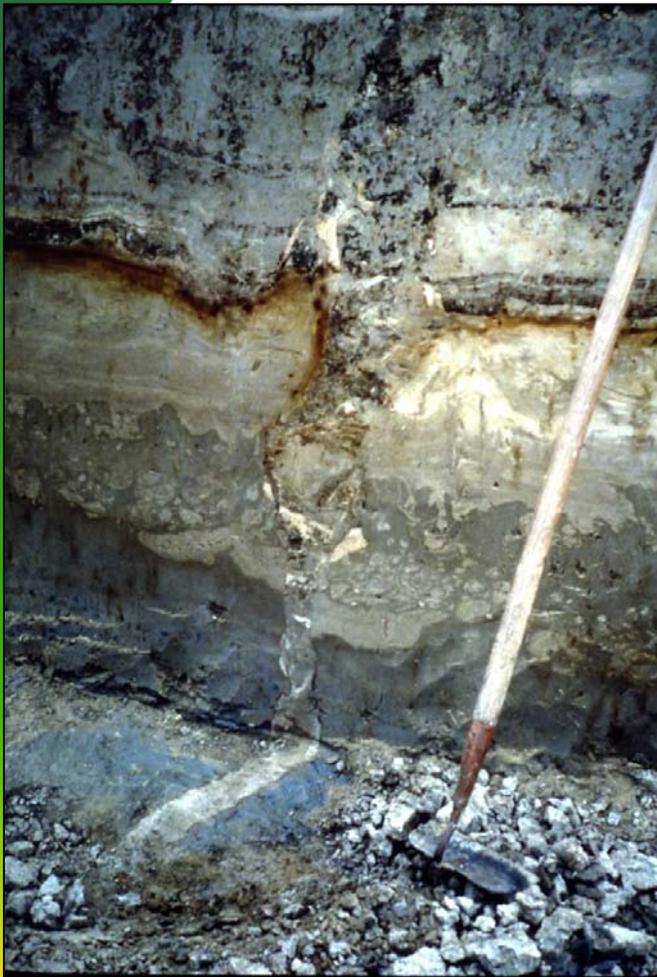
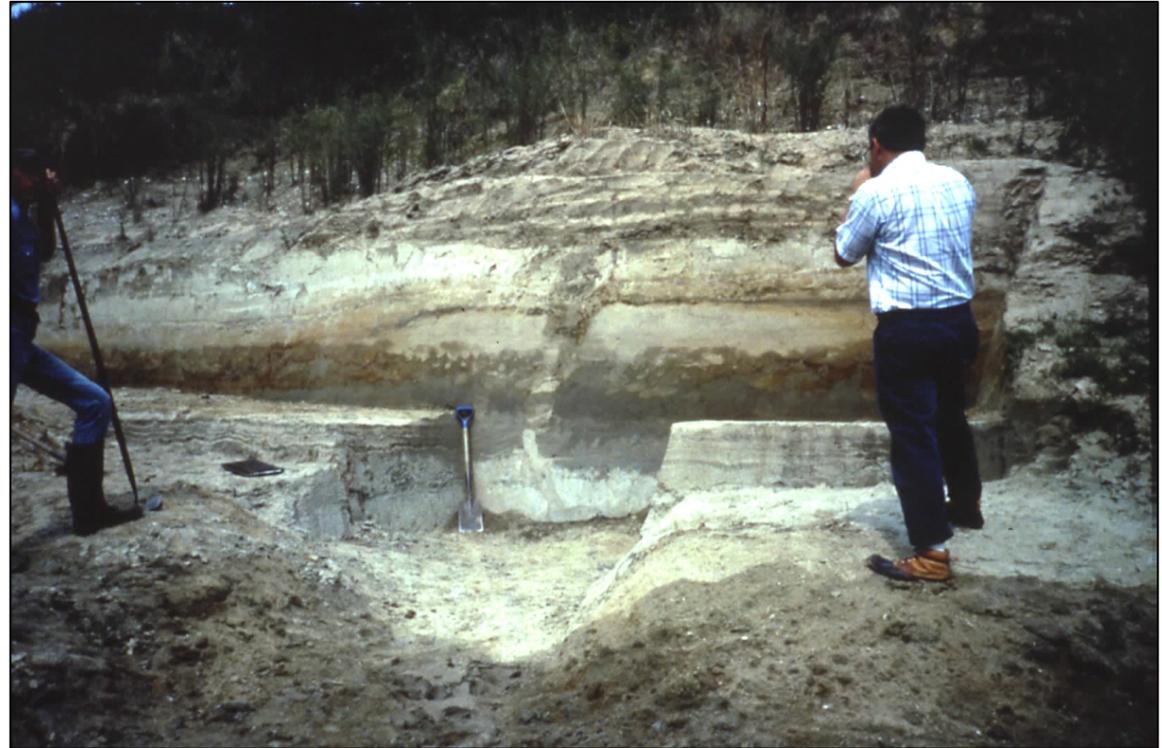
PALEOLIQUEFACTION STUDIES

- **C14 dating of organics caught in sand boils and dikes are used to date past earthquakes. Three M7.5 to M8 paleoevents have been conclusively dated: ~1450, ~900 and ~550 AD.**

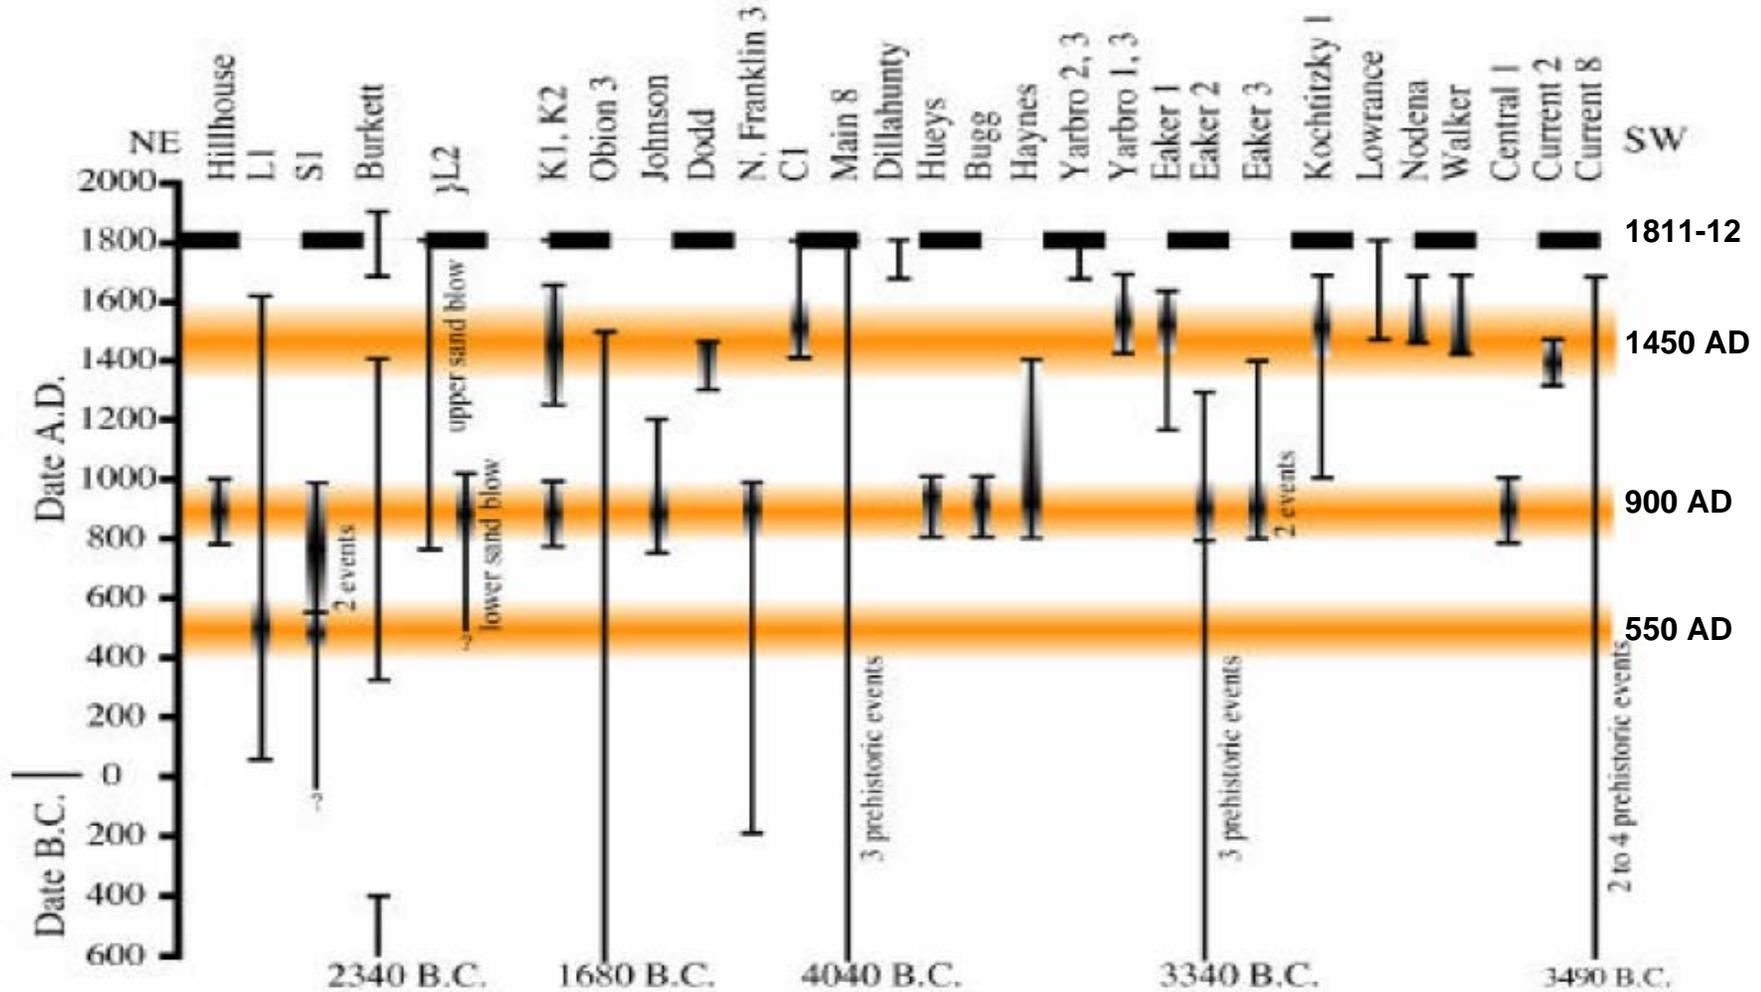
Paleoliquefaction Assessments

Shaded orange lines show most probable ages of major earthquakes in the NMSZ prior to 1811-12 (shown as dashed line)

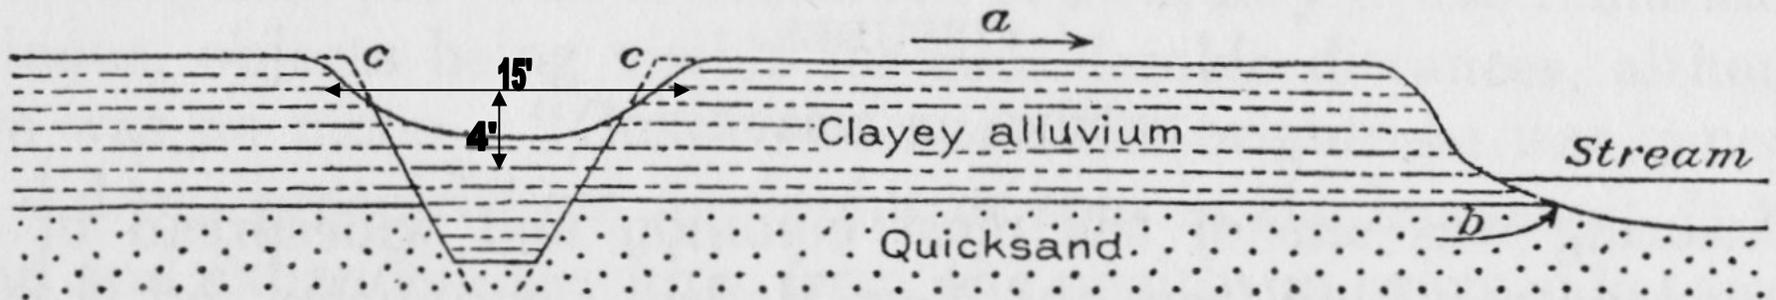
Liquefaction of Confined Horizons Causes Lateral Spreads

- **Lateral spreads** were initially recognized and identified by USGS geologist Myron Fuller while studying the effects of the 1811-12 New Madrid earthquakes between 1905-12. Fuller made the sketch above, noting that: *“The depth of the openings was not usually very great, probably being in most cases limited to the hard clayey zone extending from the surface down to the quicksand which usually underlies the surface soil at depths of from 10 to 20 feet.”*

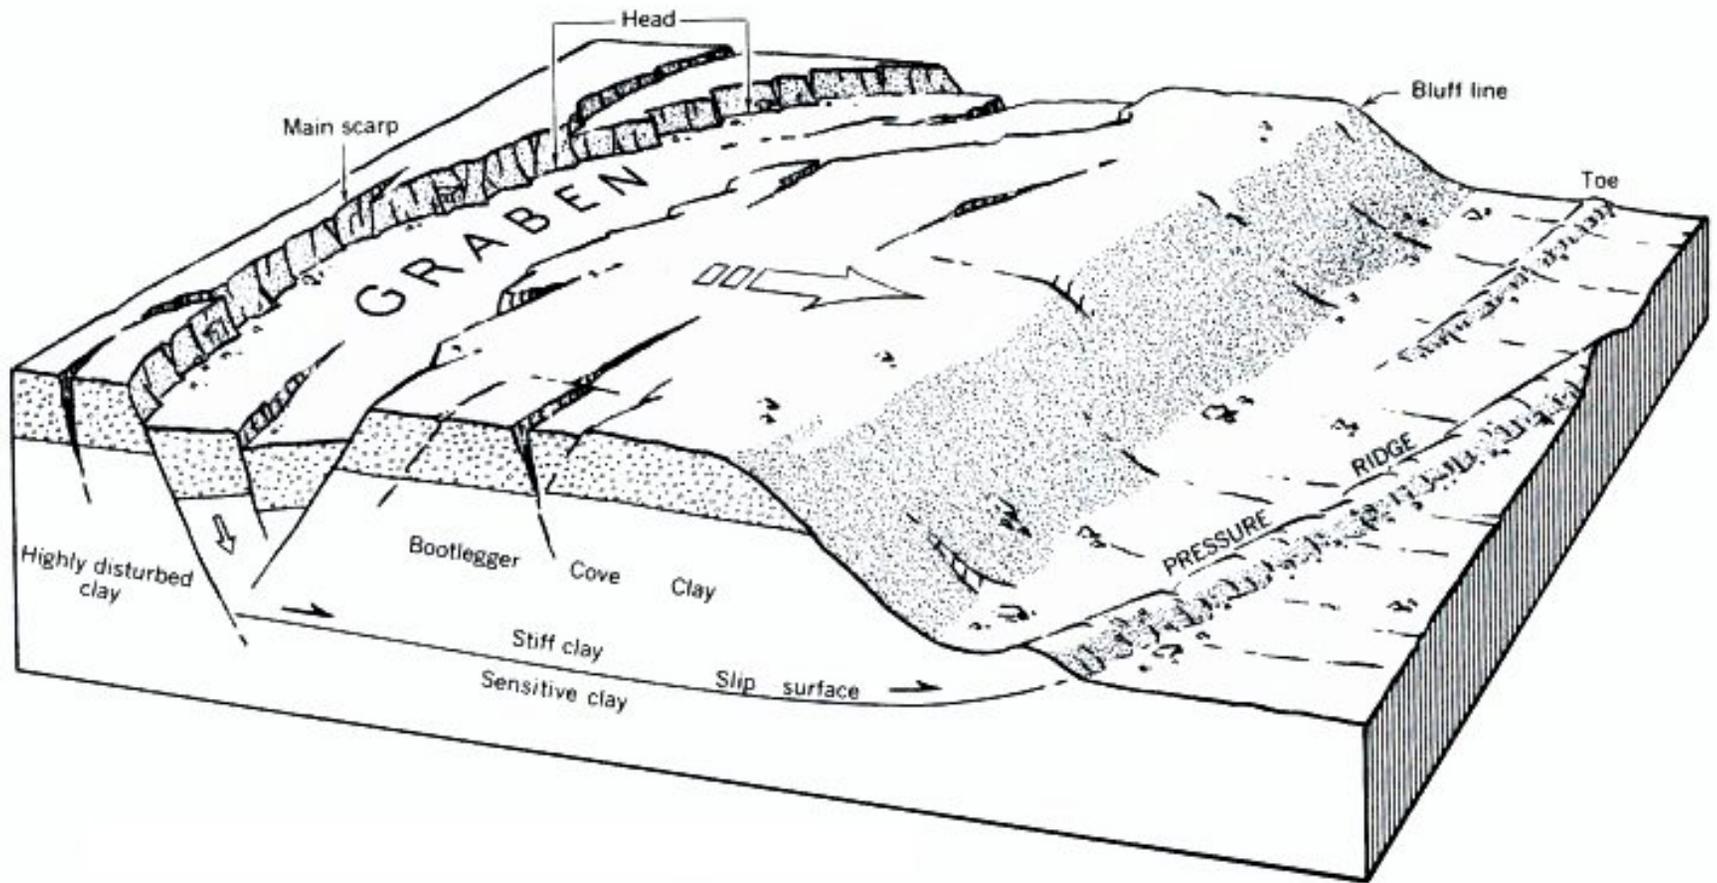
Block diagram of a lateral spread which evolved from post-1964 earthquake evaluations in Alaska by Walt Hansen in USGS Professional Paper 542-A (1966)

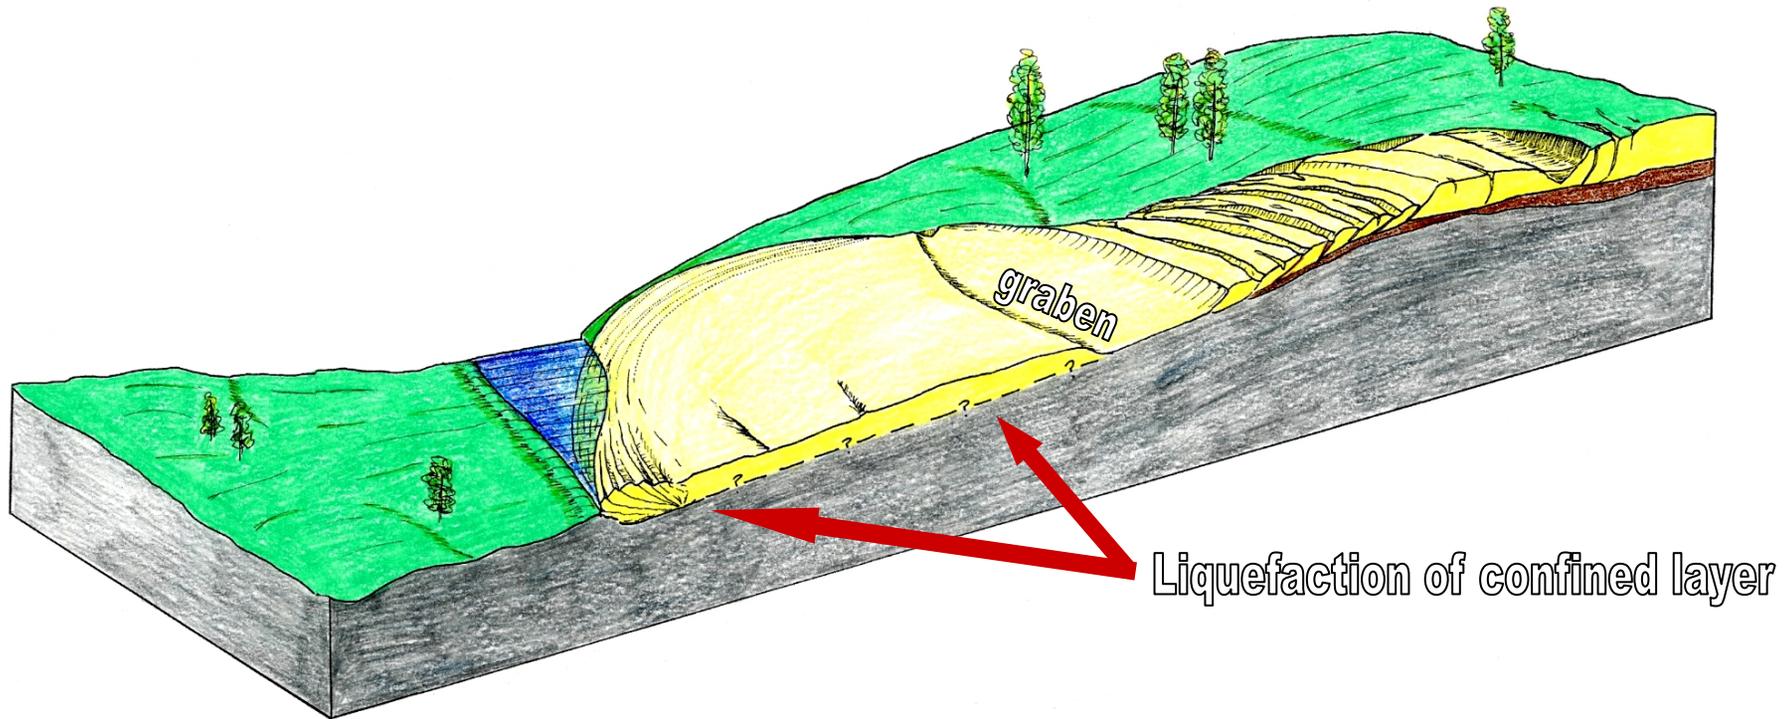
LATERAL SPREADING

- Lateral spreads can exhibit different length-to-depth ratios, depending on soil sensitivity. Liquefaction occurs along discrete horizons which are confined, allowing lateral translation of rafted material, usually towards open channels or depressions.

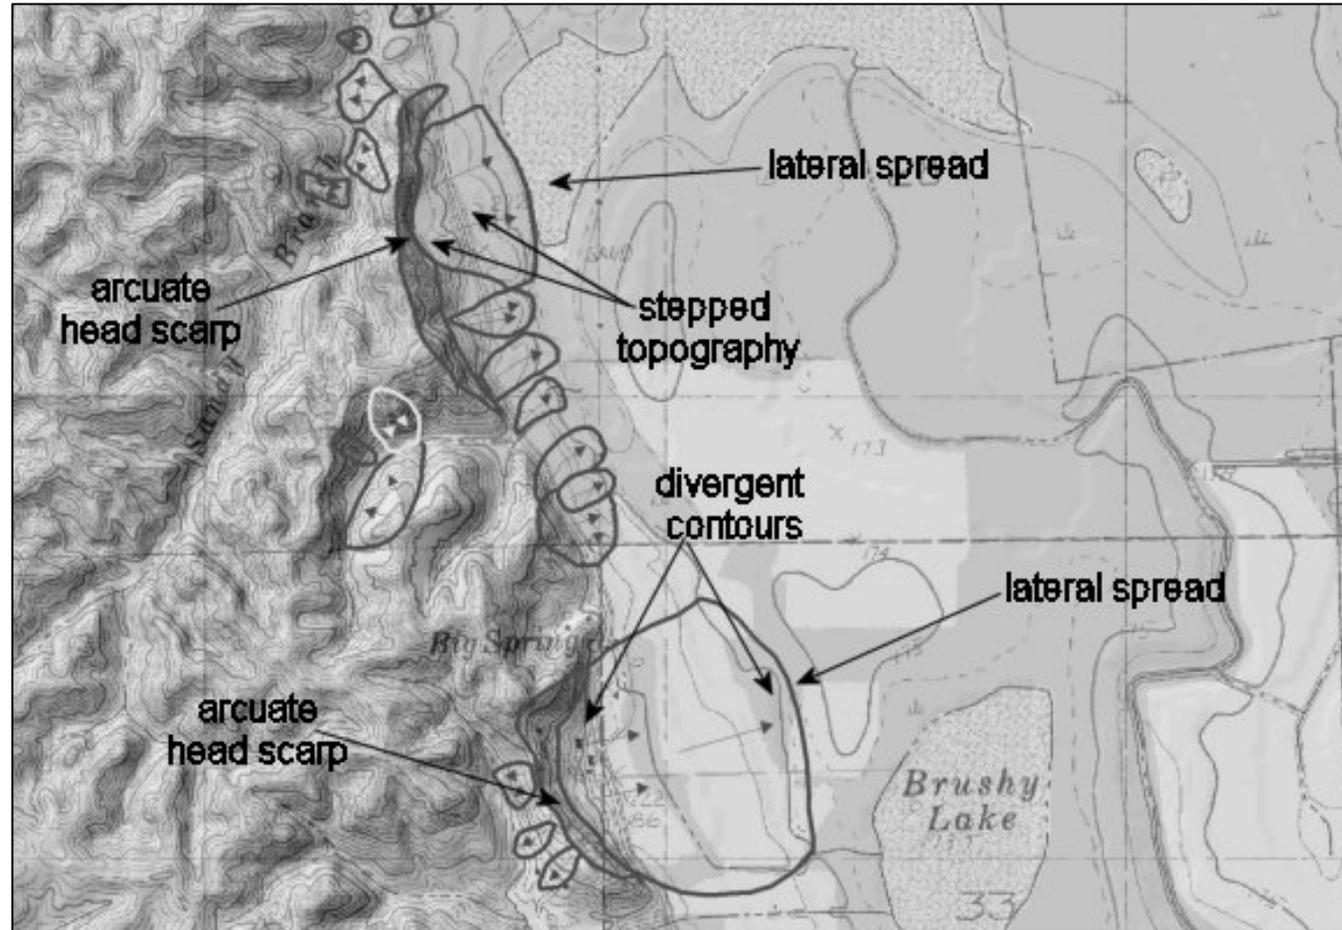
Topographic Expression of Lateral Spreads Near Helena, Arkansas

- Divergent contours
- Stepped topography
- Headscarp evacuation grabens
- Arcuate headscarps

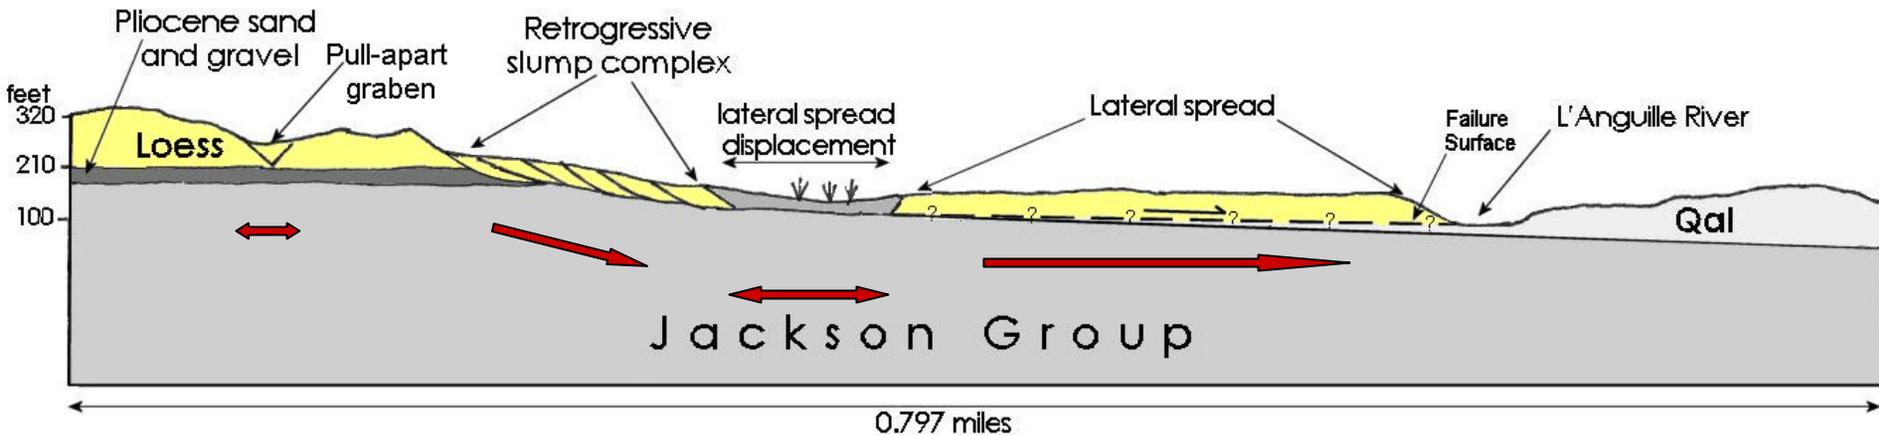
Cross-section through Jeffersonville Lateral Spread and Crowley's Ridge

The Jeffersonville Lateral Spread feature appears to have been triggered by the 1811-12 New Madrid earthquake sequence, with the ground translating easterly into the L'Anguille River, near its mouth with the St. Francis River. The eastern escarpment of Crowley's Ridge is peppered with similar features.

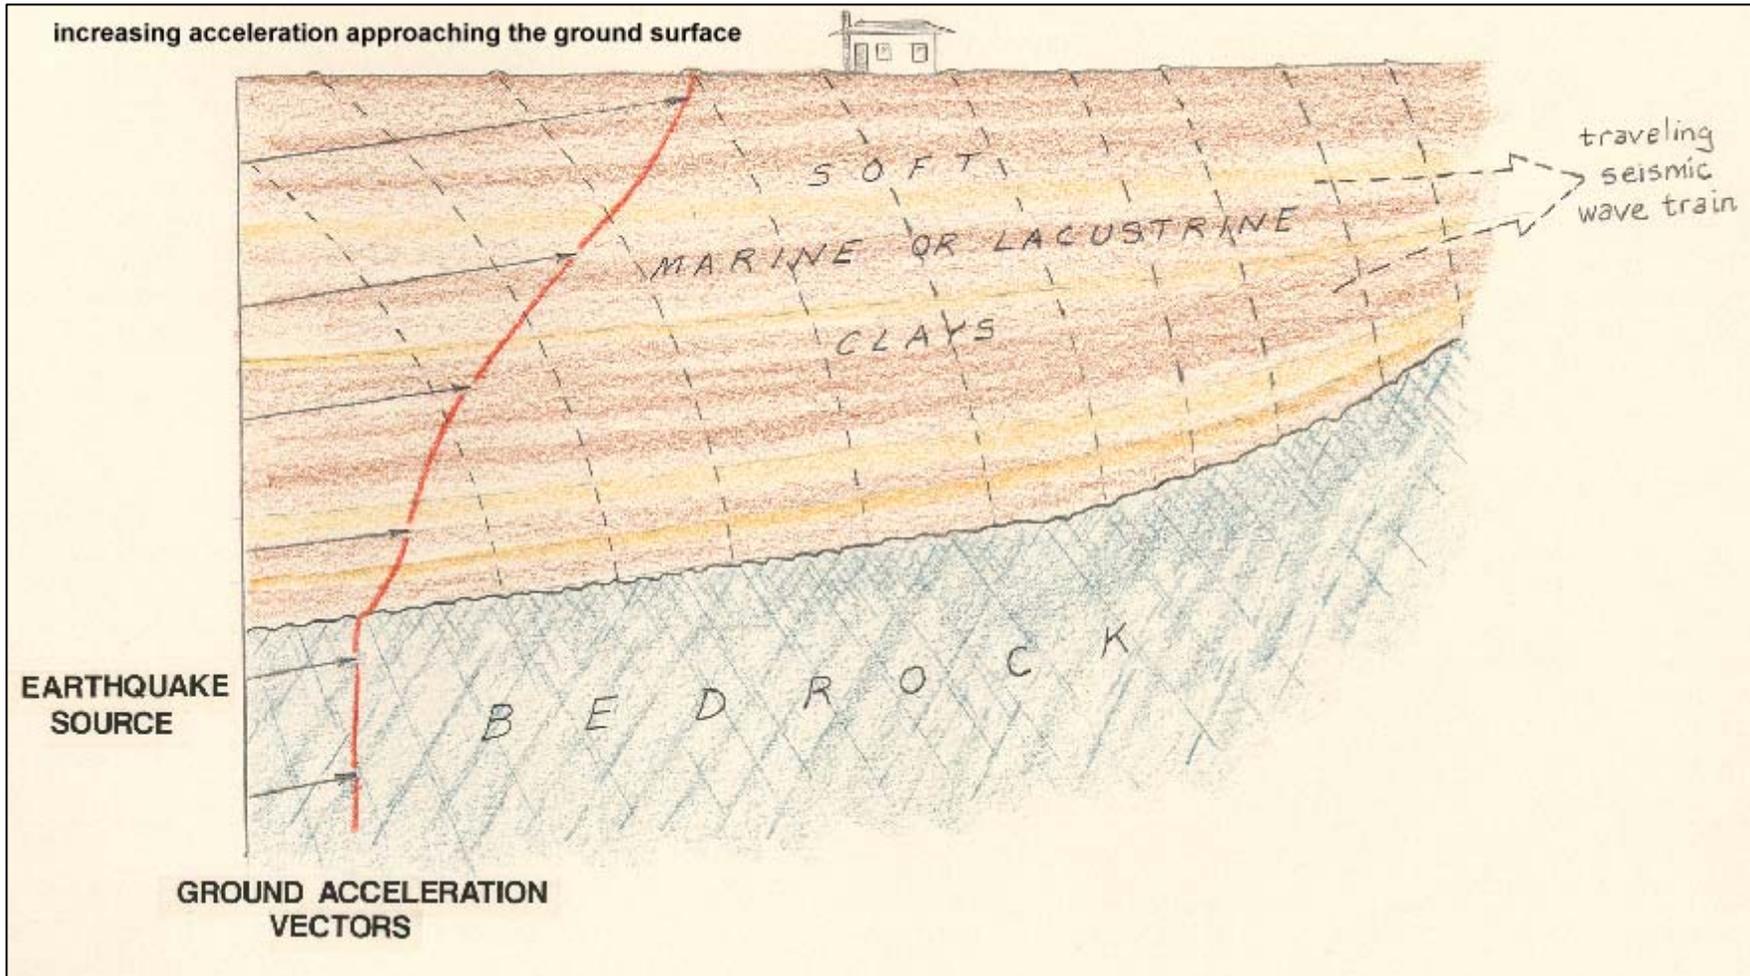
WHAT IS SITE RESPONSE ?

Site response is used to describe the fundamental period of vibration generated by a typical earthquake at any particular site. If soft unconsolidated sediments overlie resistant bedrock an impedance contrast develops at this boundary which causes incoming seismic energy to be absorbed at a rate faster than it can be transferred through the upper layers, causing significant amplification of ground motions.

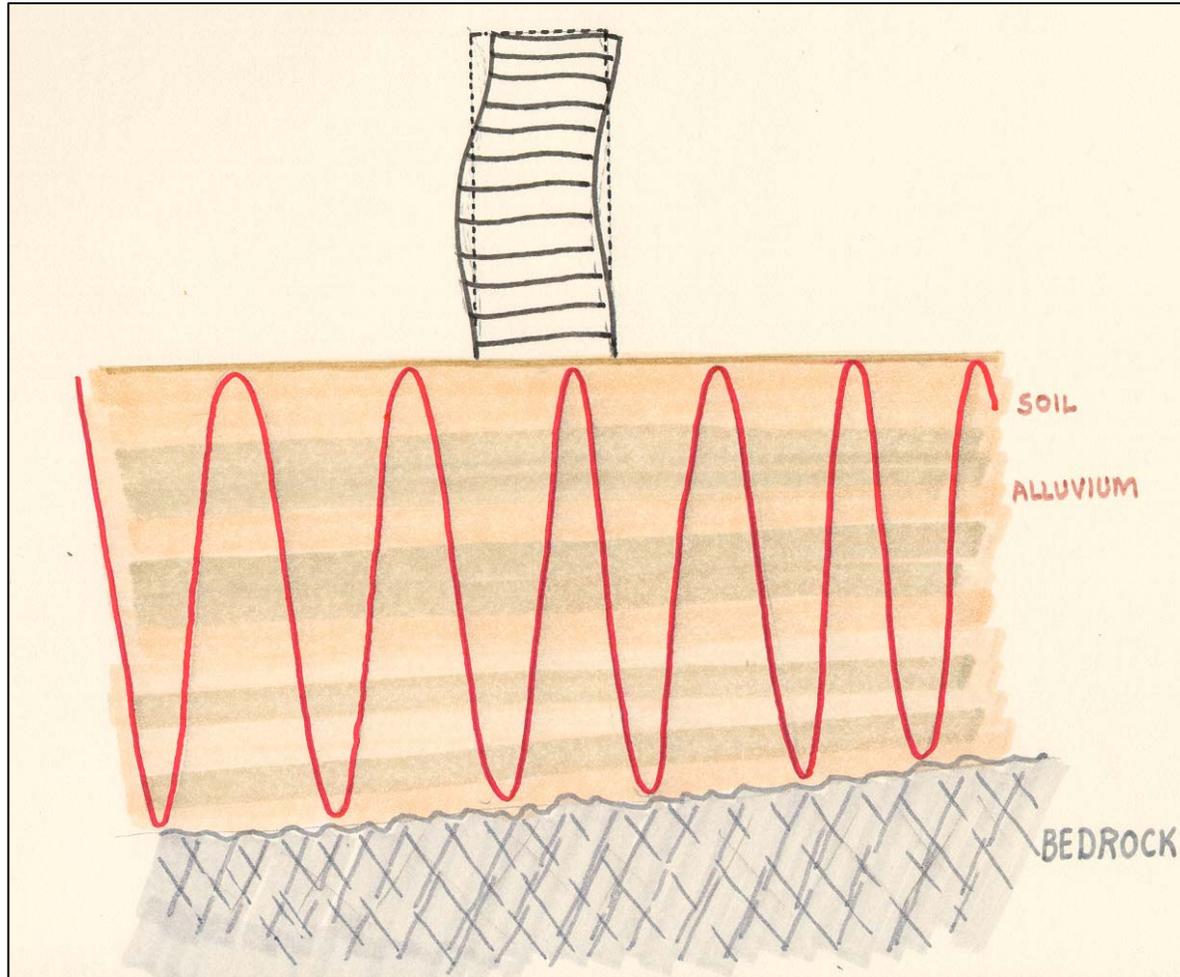
SITE RESPONSE VERSUS STRUCTURAL RESPONSE

- The fundamental period of vibration of any structure depends on its design and construction details. If the site period and structural period converge, a resonant frequency results which may be an order of magnitude greater than the natural site period, and the structure will be severely damaged or destroyed.

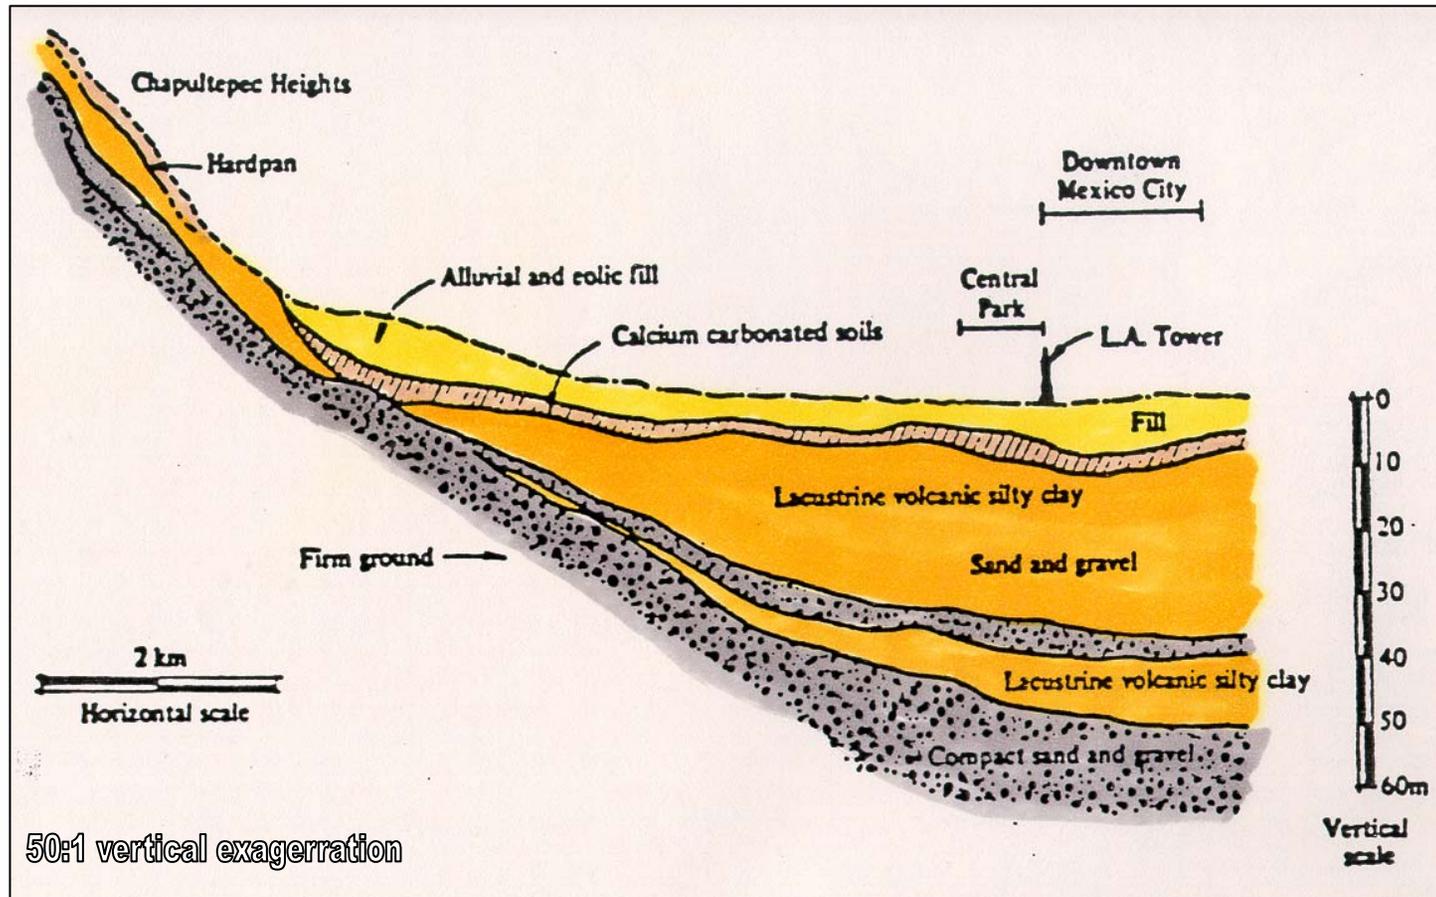
SOFT SEDIMENTS UNDERLYING MEXICO CITY

- **Generalized geologic cross section of the southern margins of the lacustrine basin underlying Mexico City. The lacustrine sediments were covered with fill as the city developed. These soft materials amplified the incoming seismic wave train from a M.8.1 earthquake located 52 km off the coast of Michoacan Province, some 350 km from Mexico City!**

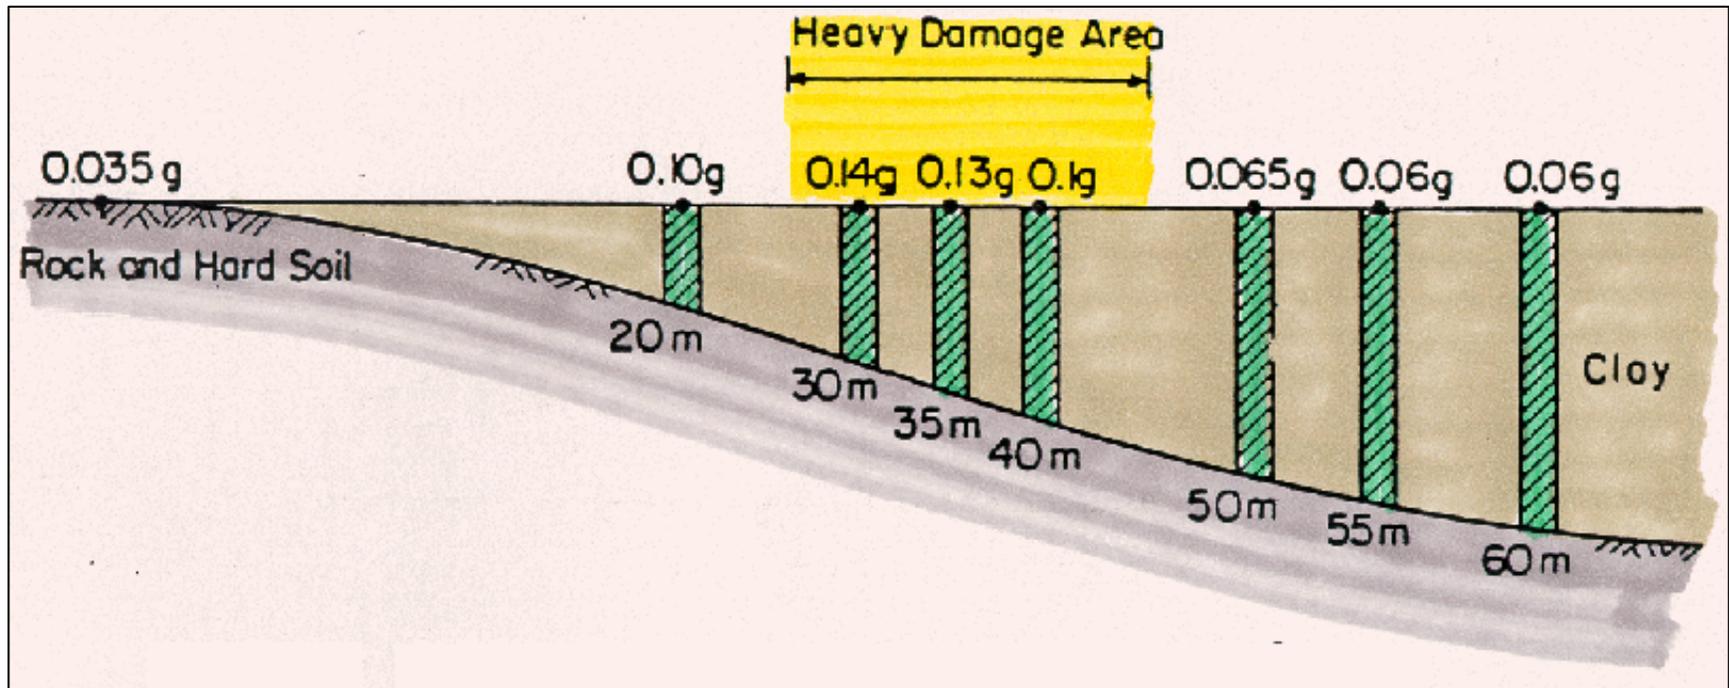
ZONE OF HEAVIEST DAMAGE DURING 1985 MEXICO CITY EARTHQUAKE

- Computed distribution of peak ground surface accelerations for typical soil profiles in Mexico City, bounding the zone that experienced severe damage during the 1985 M. 8.1 Michoacan earthquake. The earthquake epicenter was 350 km from Mexico City and lasted close to 3 minutes. More than 500 buildings within the highlighted zone were severely damaged and 100 buildings between 6 and 22 stories high actually collapsed; killing 9,500, injuring 30,000 and leaving 100,000 homeless.

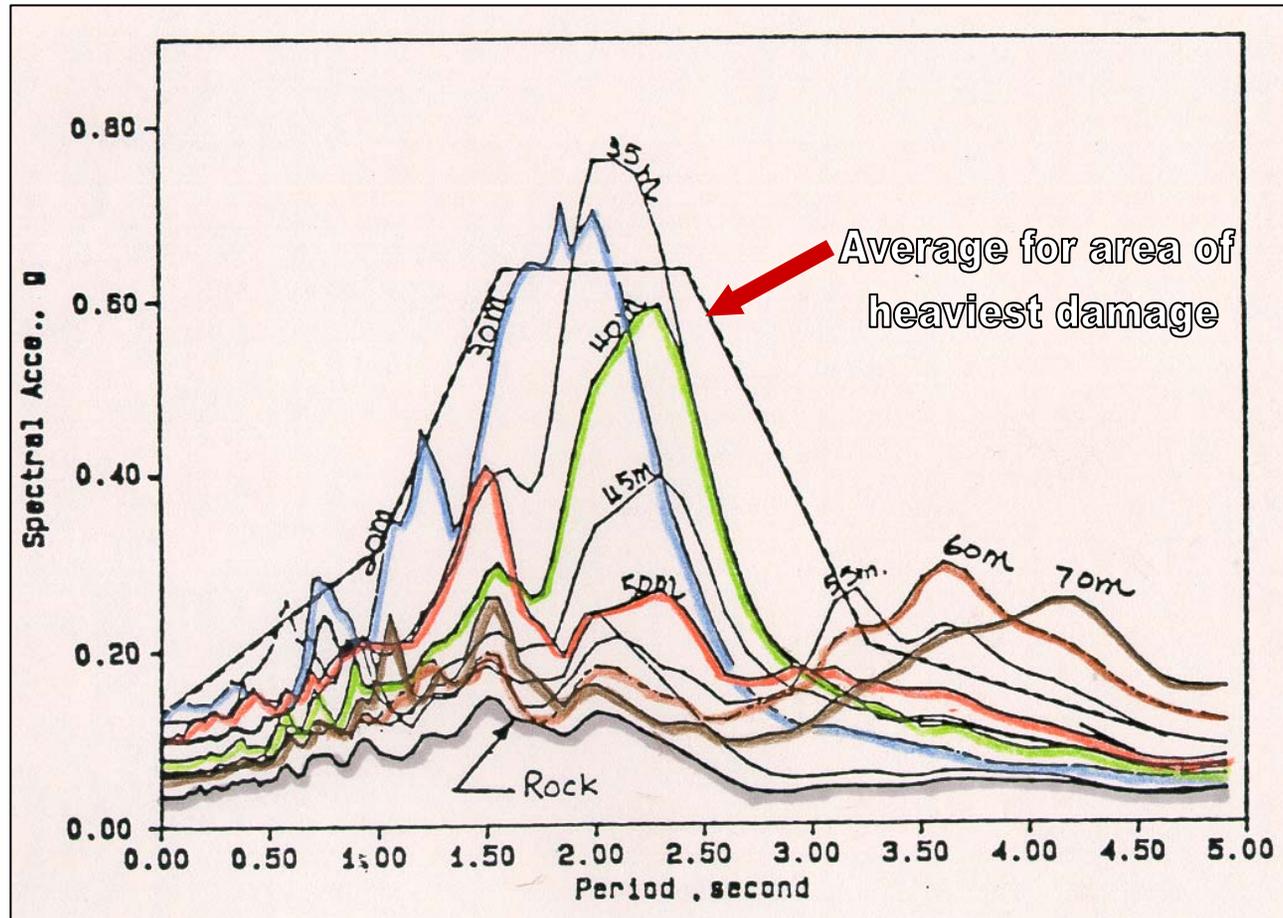
VARIANCE OF RESPONSE SPECTRA WITH SEDIMENT THICKNESS IN MEXICO CITY

- Response spectra calculated for different thicknesses of soft sediments in southern Mexico City, between downtown and Chapultepec Heights. **Note impact of 30 to 45 m thickness.**

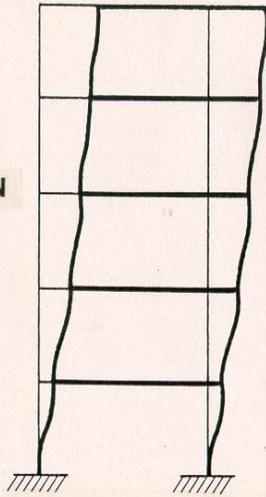
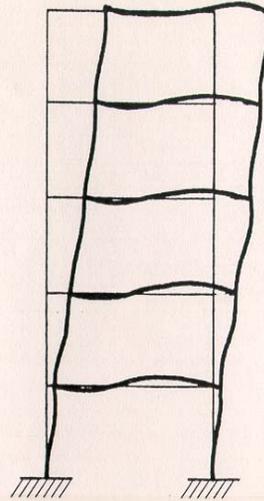
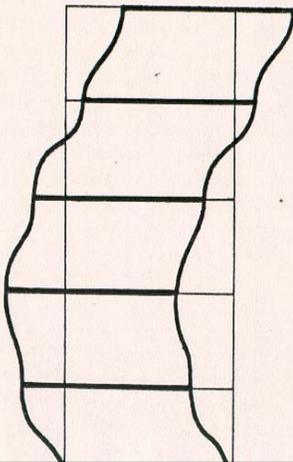
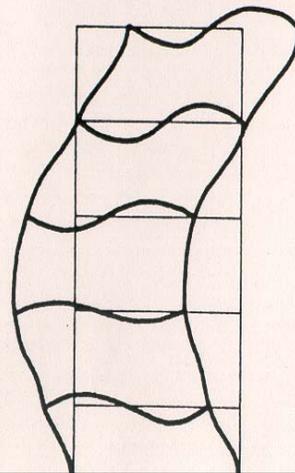
MODES OF VIBRATION

- All structures possess fundamental modes of vibration which depend on their skeletal make-up: including material type, shear panels, connections, span distances and symmetry.
- This fundamental mode is known as the “first mode of vibration” and it generally controls the seismic design of most symmetrical structures.
- Secondary modes of vibration become increasingly important in complex structures with asymmetrical form or stiffness, or structures with damaged frames.

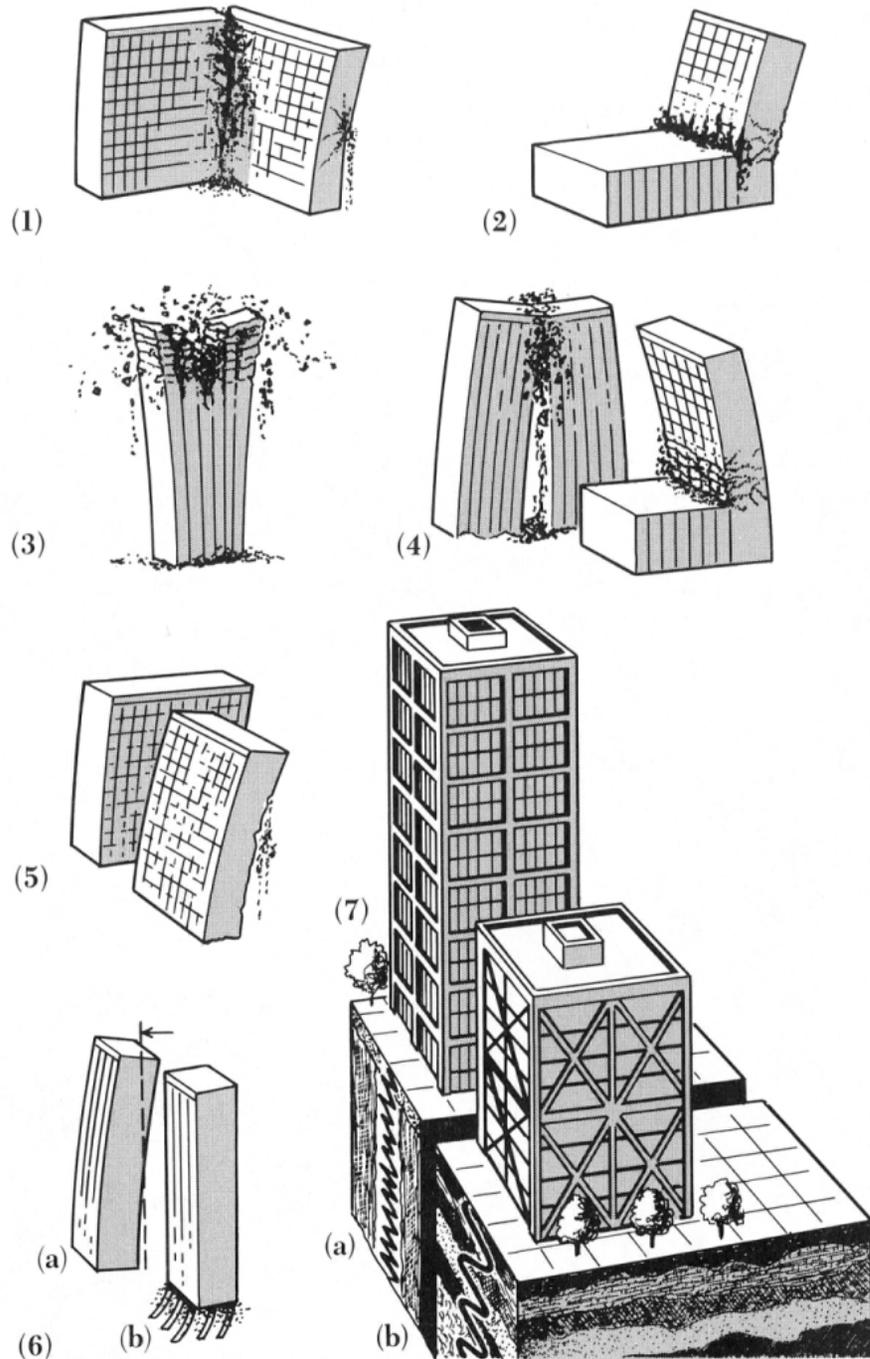
OUT-OF-PHASE MOTION

- Adjacent structures can react differently to seismic excitation, depending on focal aspects of incoming energy, long period motion, site amplification, and degrading structural response as frames become damaged

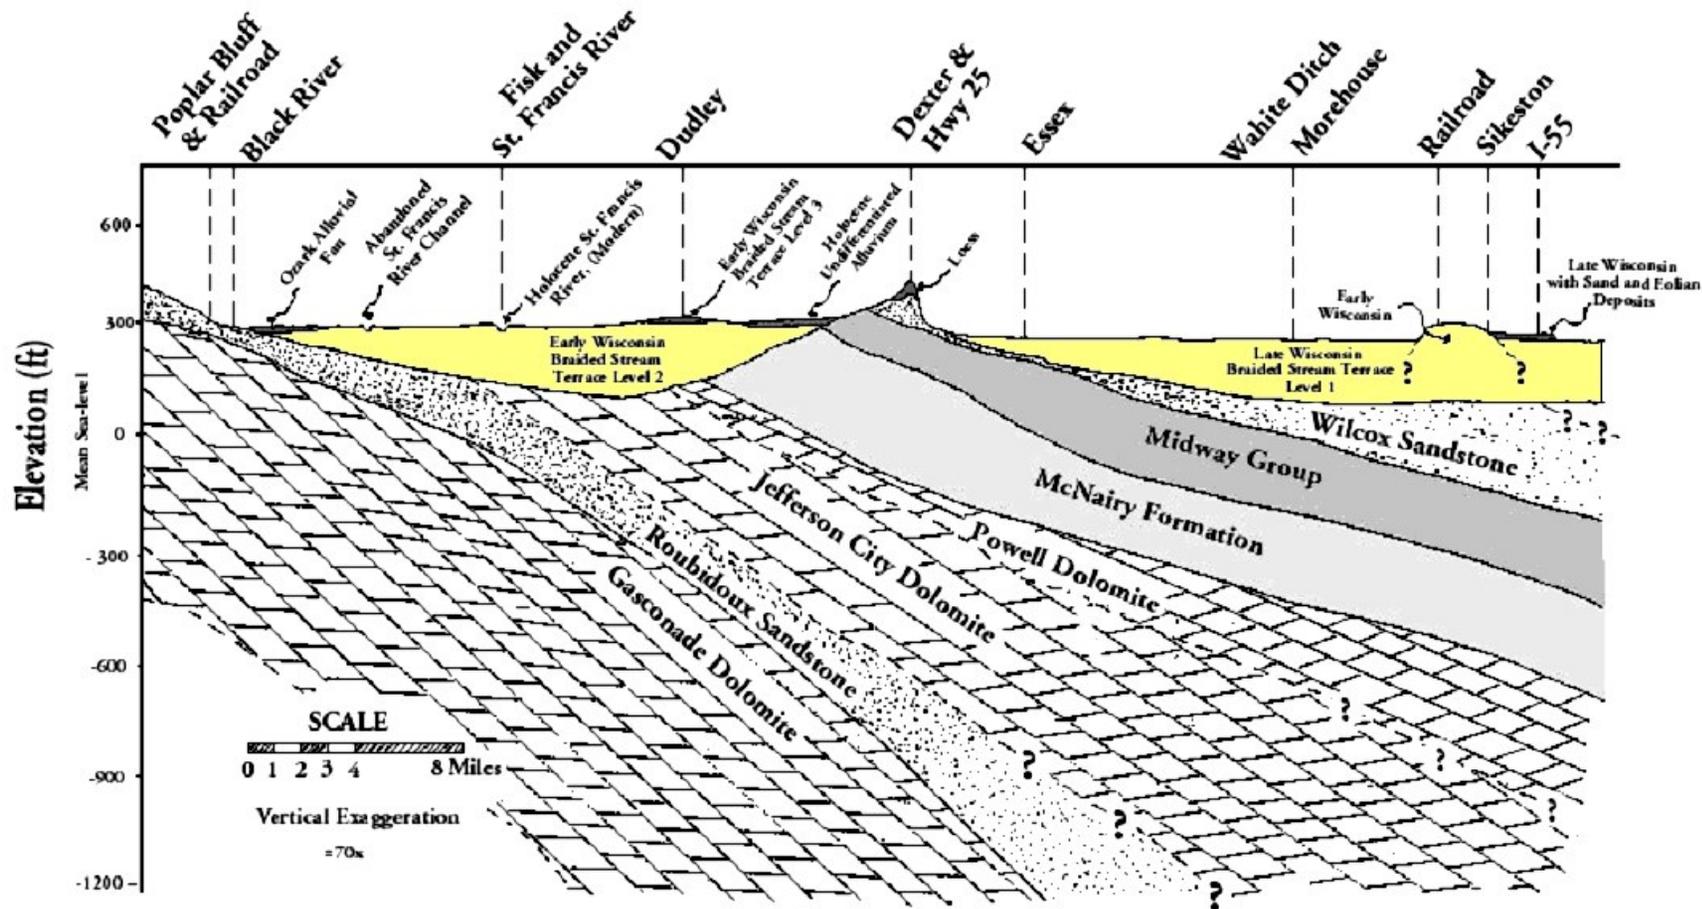
Geology Northern Mississippi Embayment

Impedance contrasts within the Wisconsin age river channels (yellow) likely pose the greatest seismic threat to highway infrastructure in the Midwest.

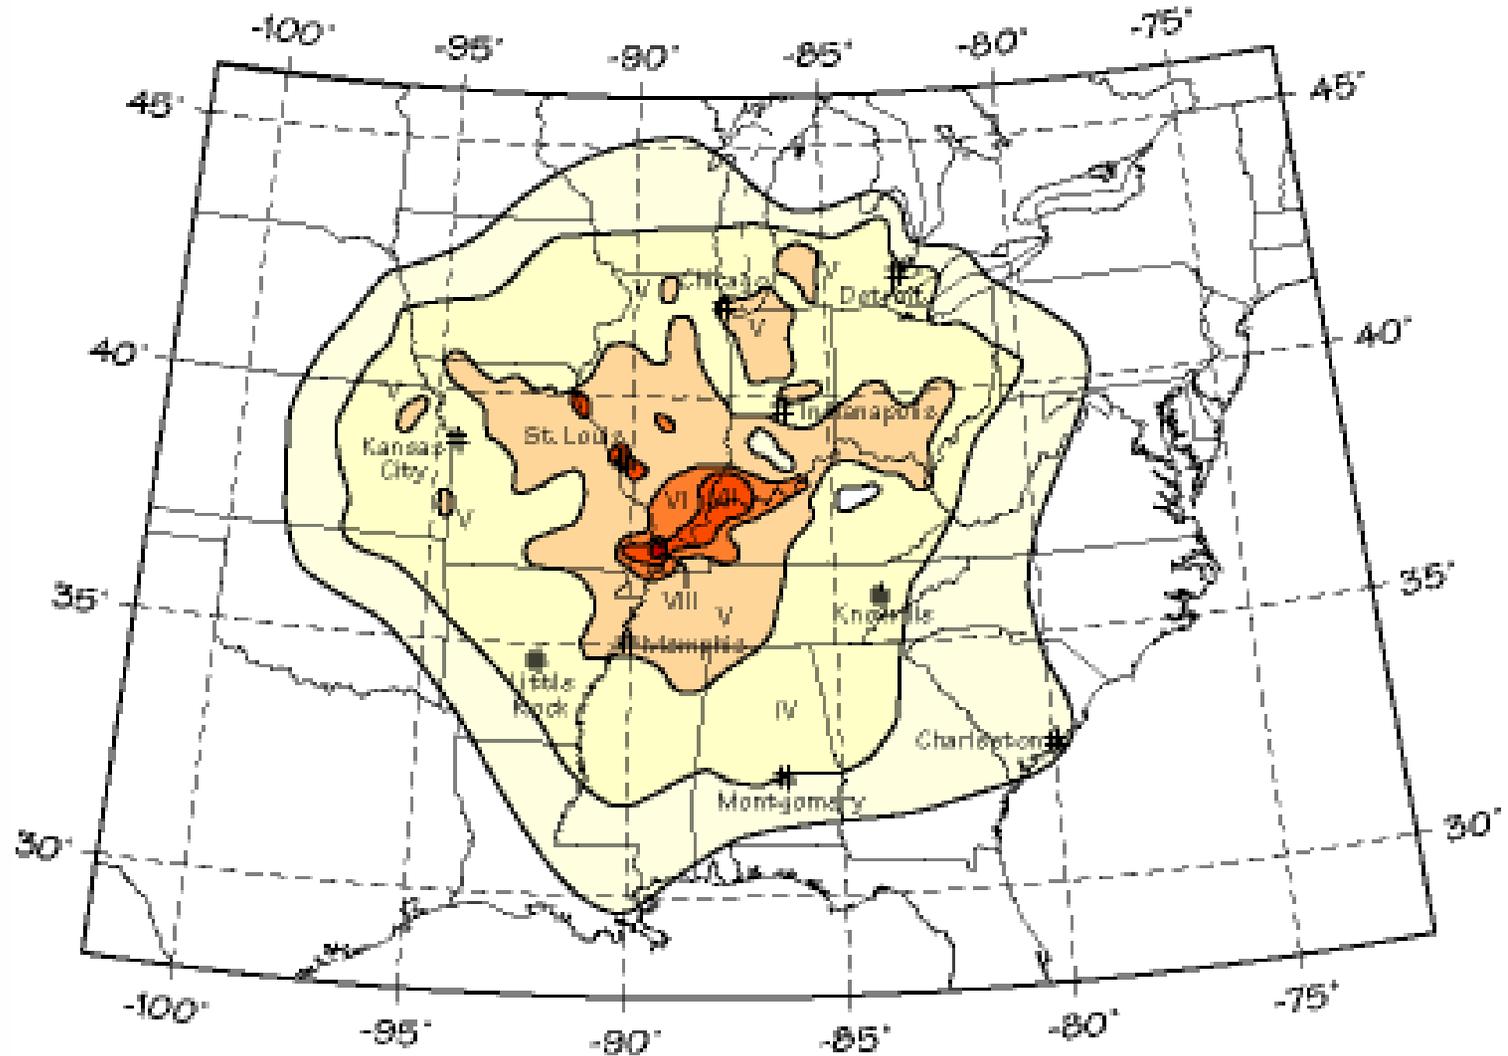
Earthquake Shaking Intensity Map

- **1895 M6.6 Charleston, MO earthquake**

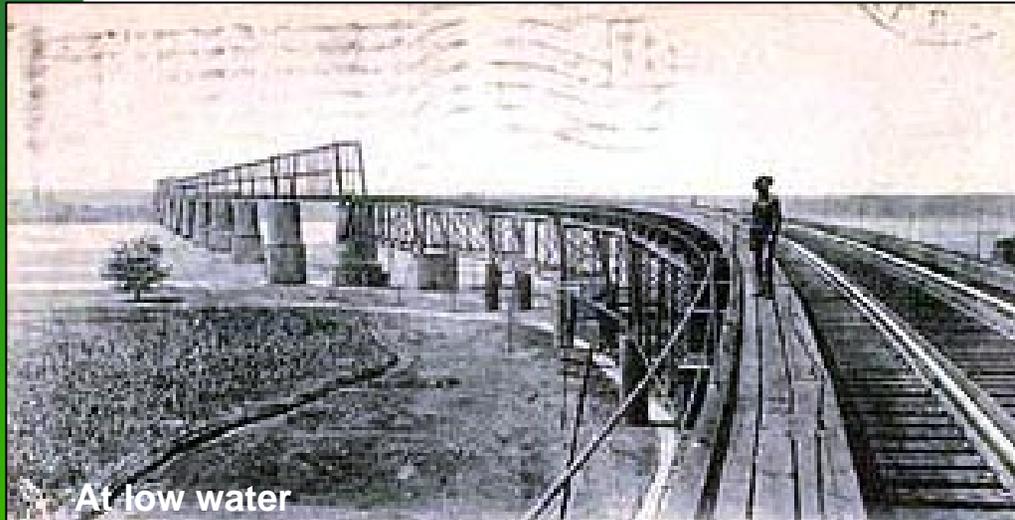
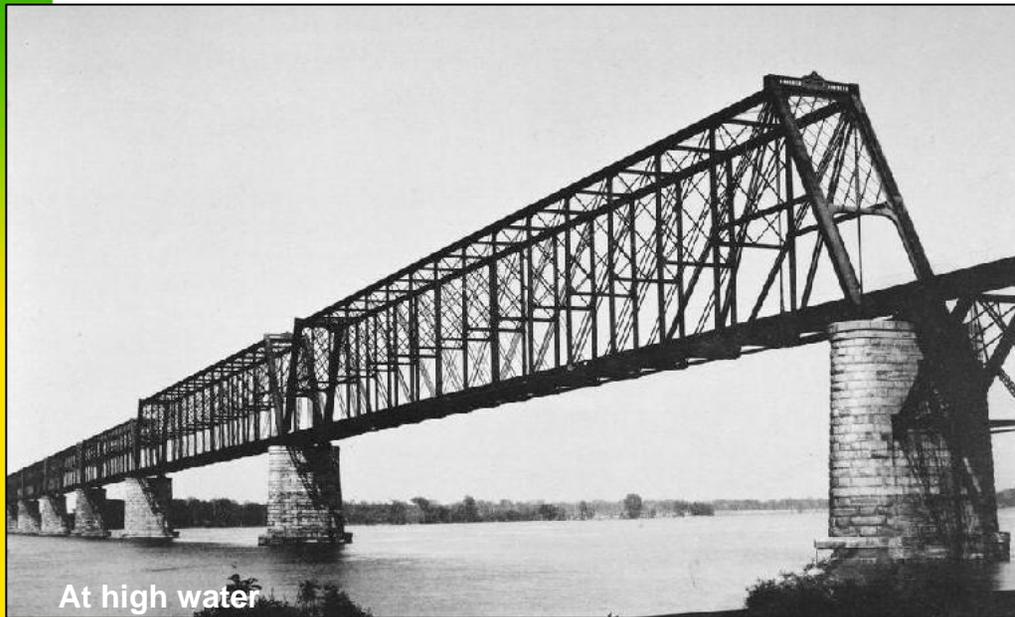
Illinois Central Bridge at Cairo, IL

- The Illinois Central Railroad bridge across the Ohio River at Cairo, IL was the longest iron or steel bridge in world when completed in 1889 (4 miles).
- One of its masonry bents was cracked and severely damaged during Oct 1895 Charleston, MO quake
