BRIEF OVERVIEW OF SEISMIC THREAT POSED BY THE NEW MADRID SEISMIC ZONE

**Earthquakes Mean Business Seminar
AT&T Data Center St. Louis, MO**

J. David Rogers, Ph.D., P.E., R.G.

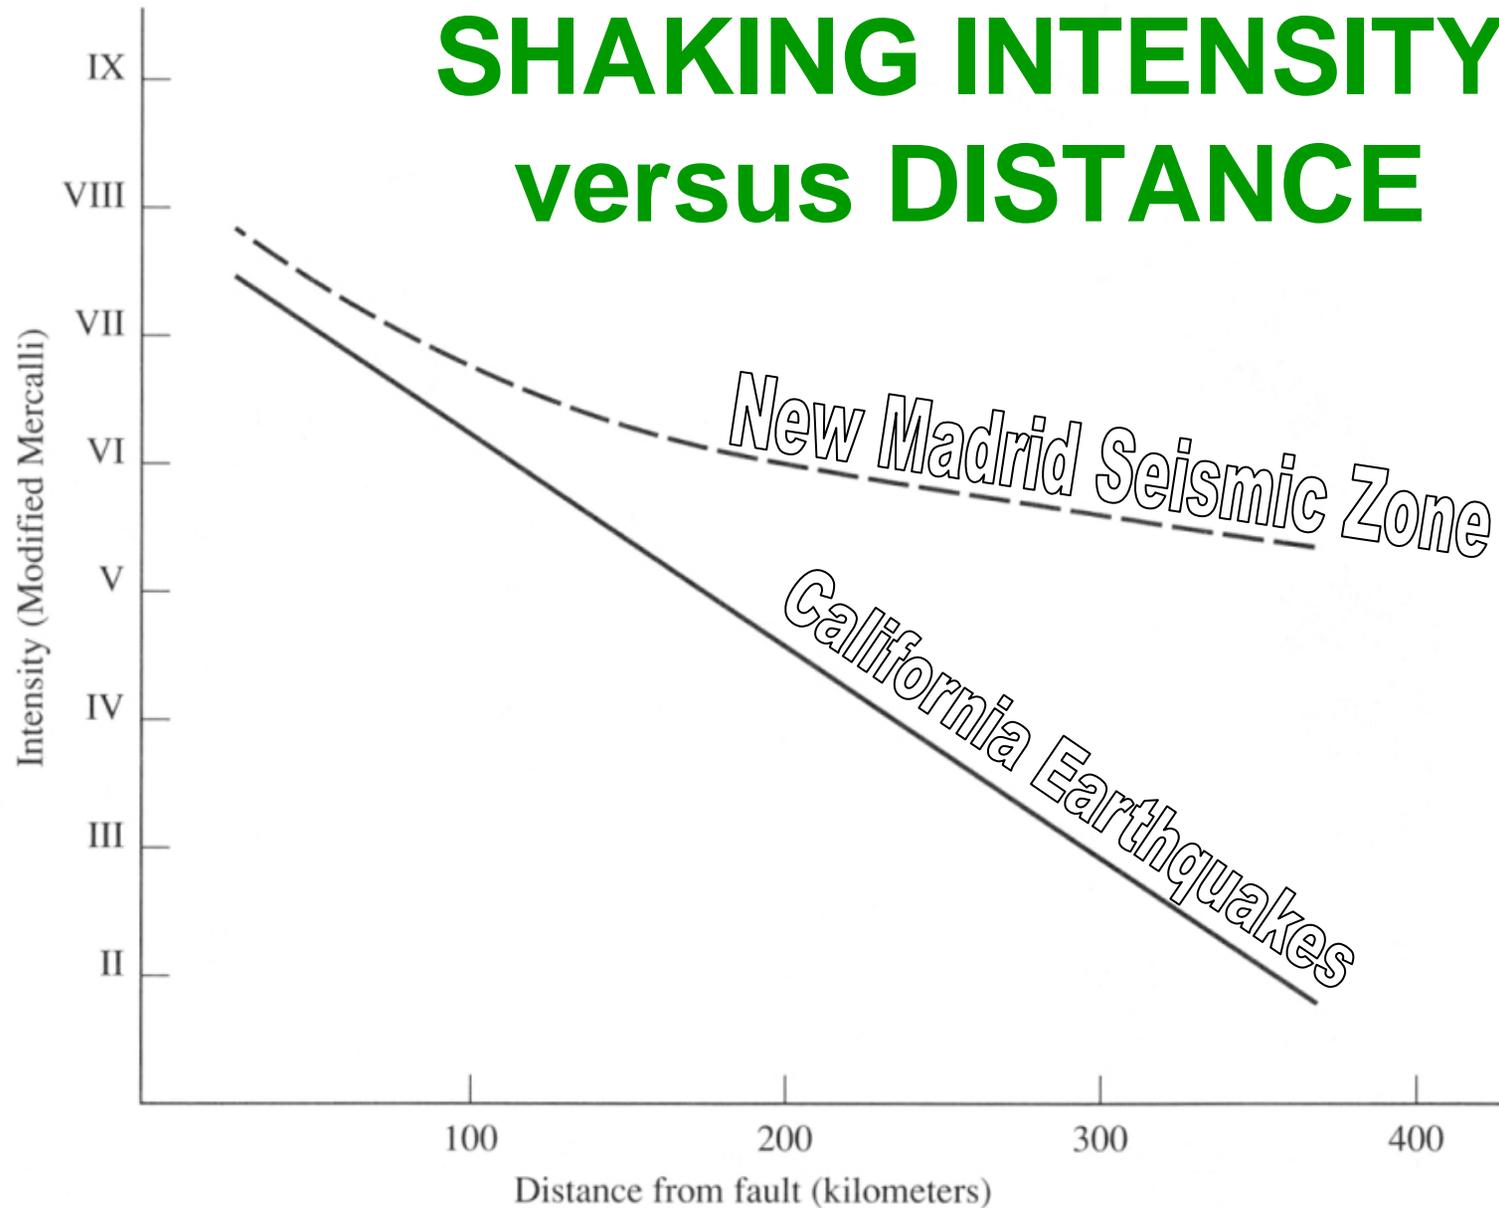
SHAKING INTENSITY versus DISTANCE

Midwest quakes are less frequent, but much more lethal than California quakes because there is less damping of seismic energy.
