## Part 6

# TIED BACK OR RESTRAINED WALL SYSTEMS

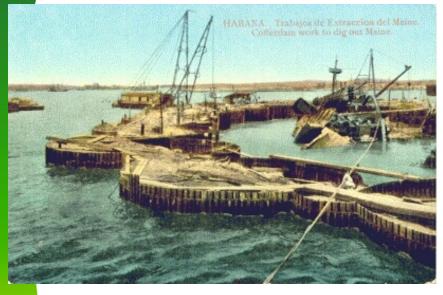
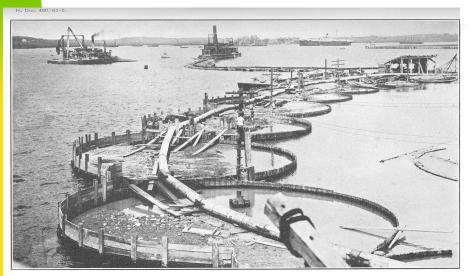
### Circular cofferdam used to exhume the sunken battleship Maine

PLATE 21.-FILLING CYLINDERS, HYDRAULIC DREDGE "NORMAN H. DAVIS" AND DIPPER DREDGE "SAGUA."

Upper left: The initial dewatering attempt (shown here) was unsuccessful because the caissons were filled with dredged silt and clay from the perimeter of the sunken hulk, which would not drain.

Lower left: The stability problems were finally solved by using filling the cells with freedraining sand dredged from some distance away, as seen in the background.

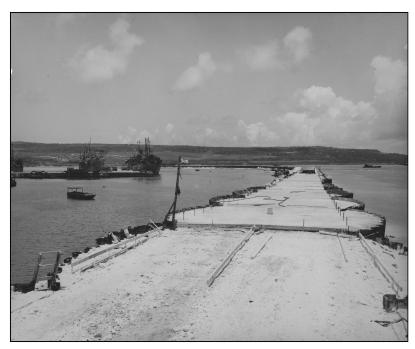
#### **Cellular Cofferdams**

Navy Seabee construction battalions built hundreds of breakwaters (above right) and harbor facilities during the Second World War using cellular cofferdams. The cells were filled hydraulically (upper left) using dredges feeding crushed coral (lower left), which was free darining. These structures were usually protected with zinc strips for cathodic protection.

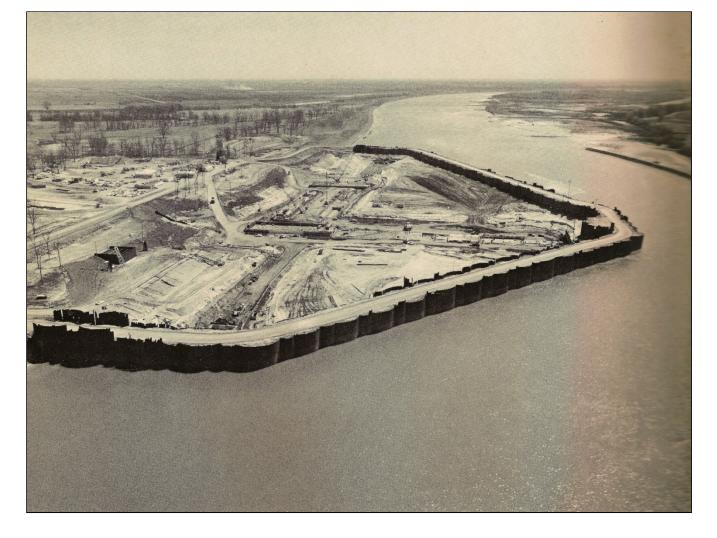
• Self-sustaining sheetpile cofferdams can be used to dewater entire construction sites, as shown here. This is for a Corps of Engineers lock and dam structure.

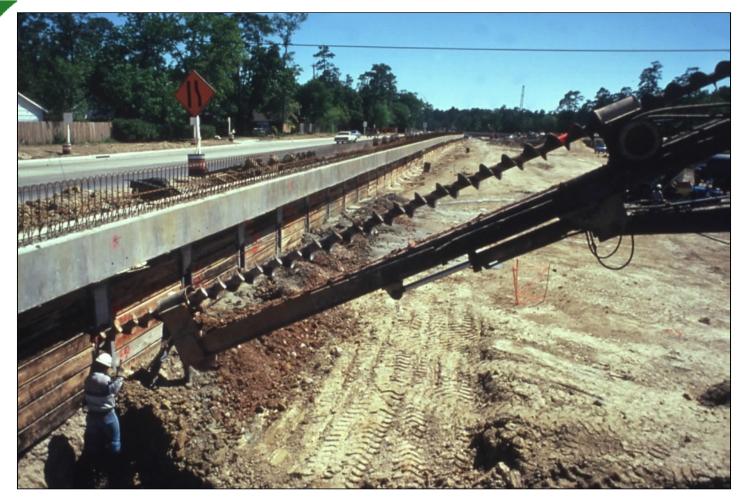
Tiebacks are usually excavated using continuous flight augers, as shown here. Care must be exercised to drill the holes in exact locations, alignments and inclinations

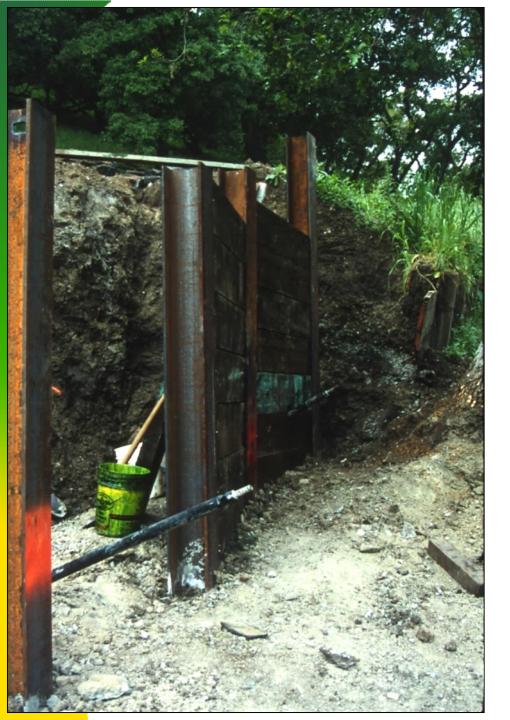
- Another critical component of tiebacks is the detail of the anchor head attachment between the tieback and the cantilever elements.
- These must be strong enough to resist twisting and eccentric loading of the cantilever

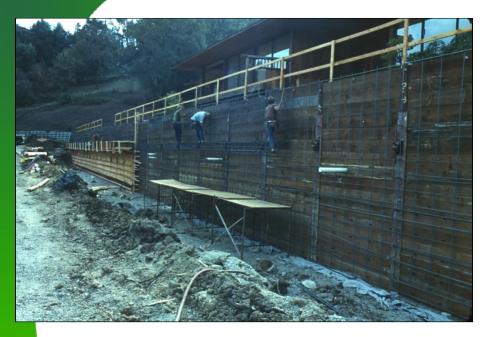
Tied-back wall systems are often employed behind finish walls, as shown here. Finish or interior walls cannot be allowed to deflect noticeably, hence the need for tiebacks. The tiebacks also reduce the earth pressures on the permanent wall, constructed inboard of the temporary wall.

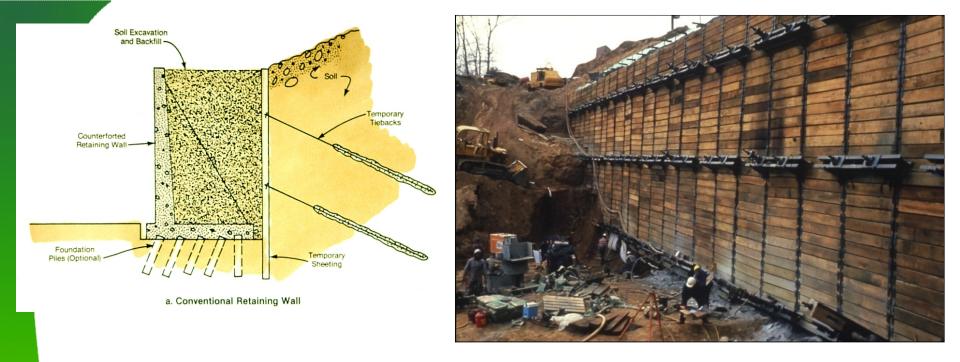
The example at right shows three rows of incined tiebacks. Note the employment of inverted channels being used as waler stiffeners for the anchors at right. This allows spreading of load between adjacent tieback anchors and lessens reliability on individual anchors.

These walls are often constructed as temporary support for permanent walls that will later be constructed inboard of them, as sketched above left.

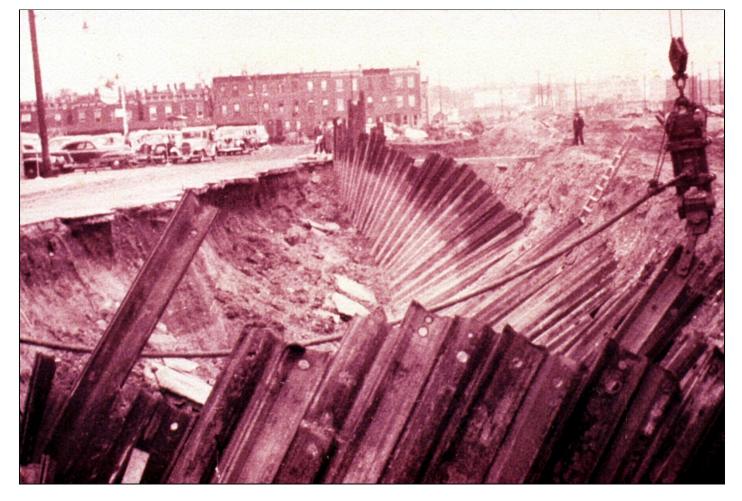
Collapse of a sheetpile bulkhead wall due to failure of turnbuckle hooks on short deadman anchors, which were ties to a concrete road (from Tschebotarioff, 1951)

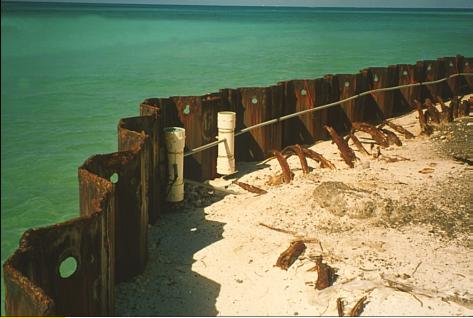
Steel sheetpile bulkhead walls must be provided with cathodic protection if placed in proximity to brackish or saline water.

The upper left figure shows a bulkhead wall on Midway Atoll, with conventional deadman anchors. Note waler at waterline.

The lower view shows anodes installed on back side of PZP-38 sheetpiles at Midway Atoll inner harbor/wharf facility.

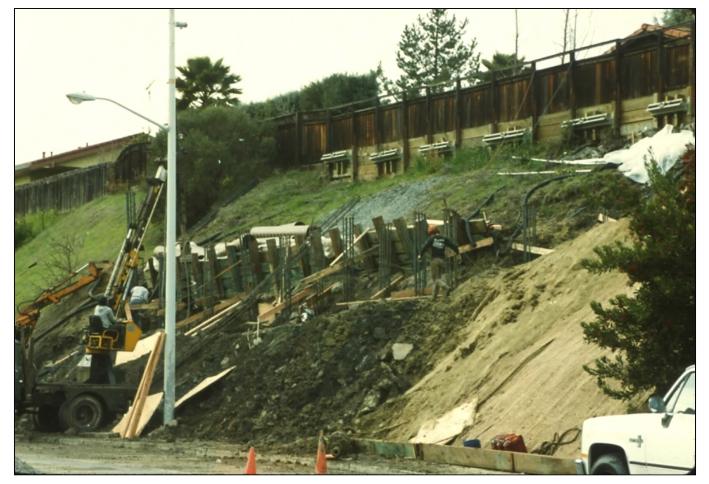
Titled tied-back cantilever retaining wall being replaced. It is very difficult to design a cantilever wall on a slope because of the paucity of passive reaction area, not to mention slope creep.
