**BACKGROUND ON
FAILURE OF TETON DAM
Near Rexburg, Idaho
June 5, 1976**

J. David Rogers, Ph.D., P.E., R.G.

Part 1

EVOLUTION OF THOUGHT ON HYDRAULIC PIPING POSING A THREAT TO DAM STABILITY 1922-65

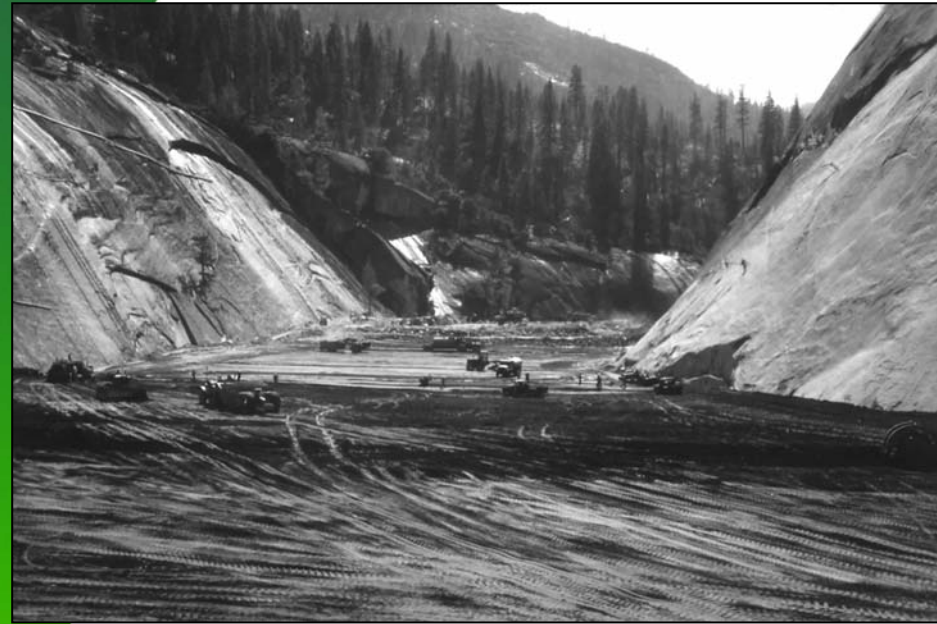
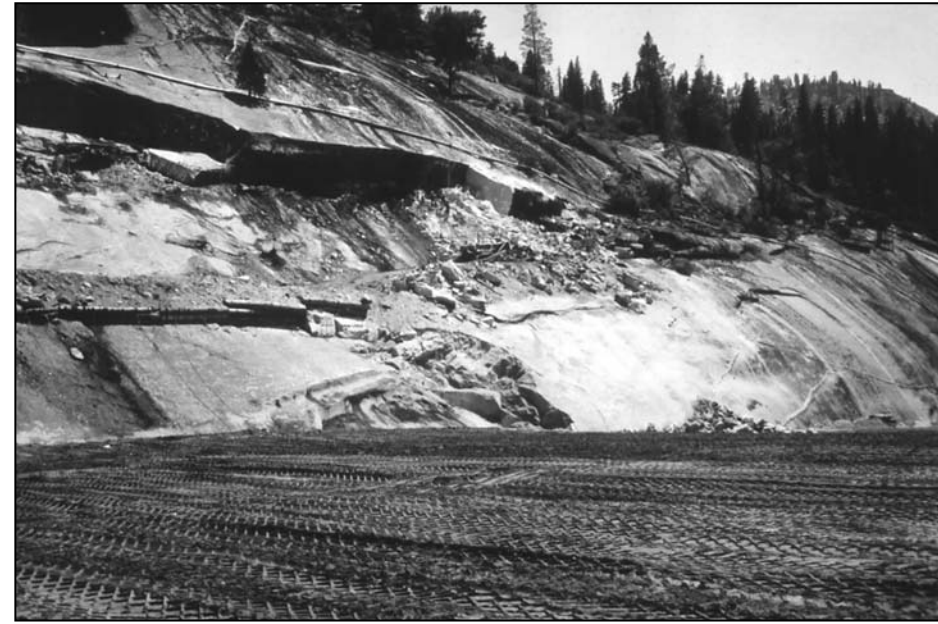
- When **Mammoth Pool Dam** was being constructed in the late 1950s along the San Joaquin River in California's Sierra Nevada Mountains, the builders encountered valley-side sheet joints which kept opening up as the abutments were excavated, through-going creating voids in the abutments.
- As these blocks were excavated, new sheet joints formed beneath the abutments. Reservoir seepage could pass through these open joints without significant head loss.

- Terzaghi was brought in as a consultant on Mammoth Pool Dam. He recommended grouting the open sheet joints in the abutments **after** the dam was complete and added a massive rockfill rip rap toe to the embankment, as well as zoned chimney and blanket drains downstream of the core. These were intended to decant any excess seepage through the abutments.

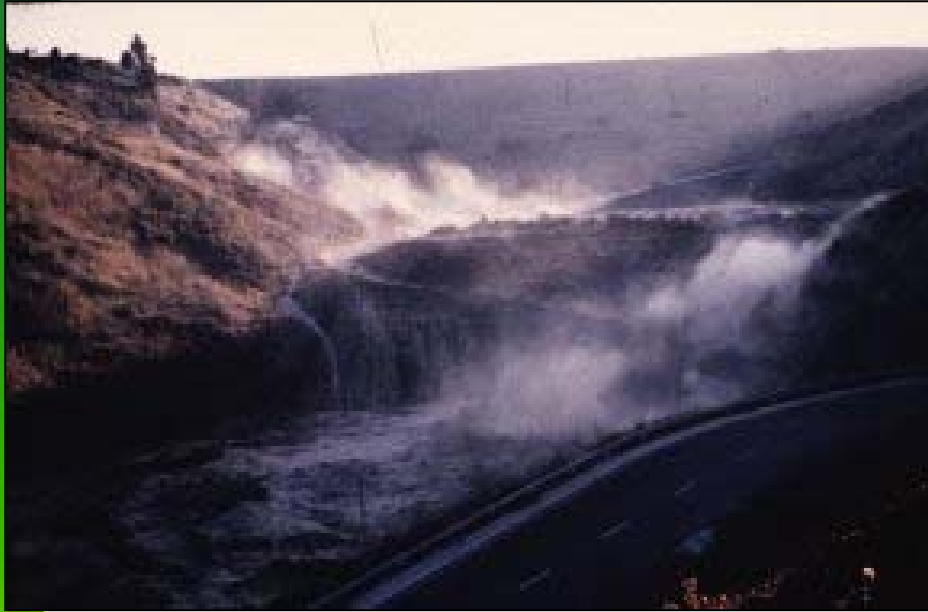
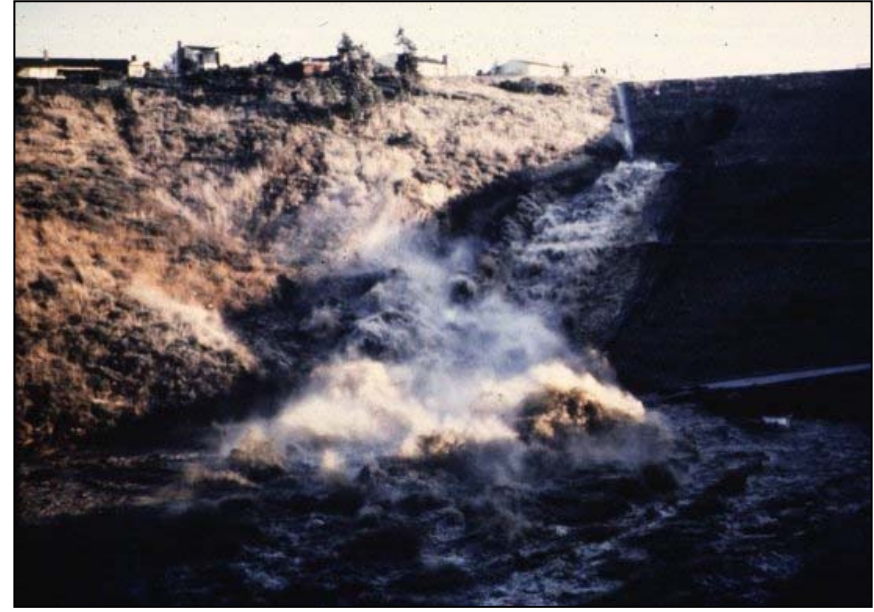
BALDWIN HILLS RESERVOIR

- Baldwin Hills Reservoir was an offstream municipal reservoir designed and built by the Los Angeles DWP in 1947-54. Its design capacity was 897 acre-feet. The grading volume was 859,000 yds³
- On **Saturday December 14, 1963** the caretaker noticed an unusual sound of water at the spillway intake, beginning around 11:15 AM
- By noon a DWP engineer was summoned and all outlets and inlets were opened to drain the reservoir of 738 ac-ft of water in storage. It would have taken 24 hrs to drain the entire reservoir

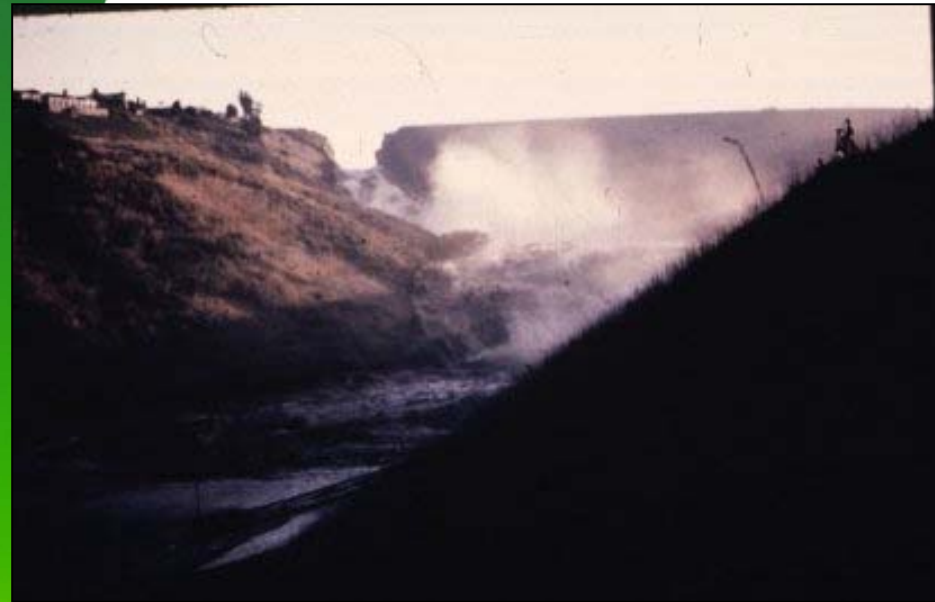
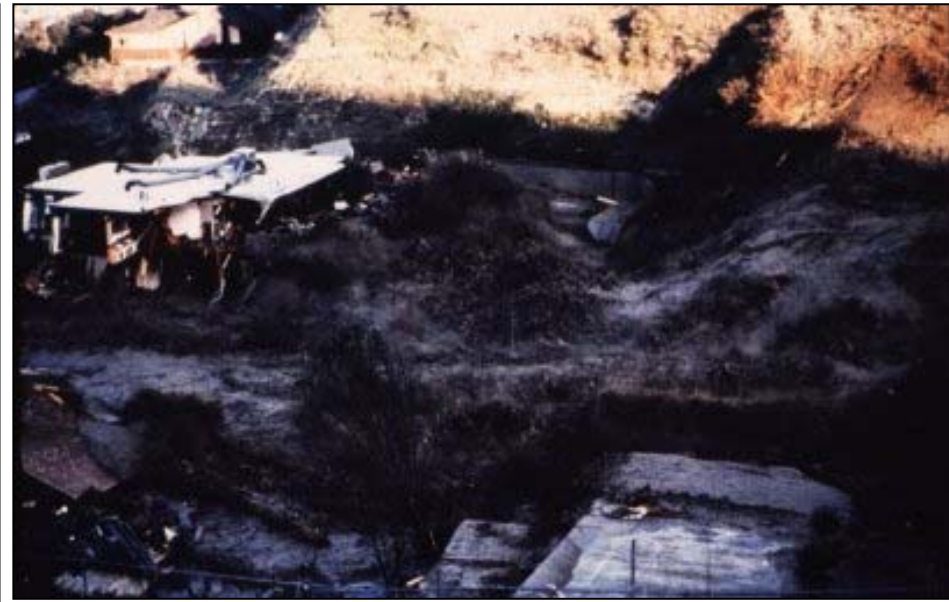
LIVE TELEVISION COVERAGE

- Police and media were alerted shortly after noon that a failure was imminent and a full evacuation was ordered.
- At 3:38 PM a complete breach of the south embankment occurred, with increasing discharge spilling up to 4,300 cfs
- The flow spilled down a steep ravine towards Cloverdale Ave., destroying 41 and damaging 986 homes, and killing 6
- The failure was shown live on local television stations

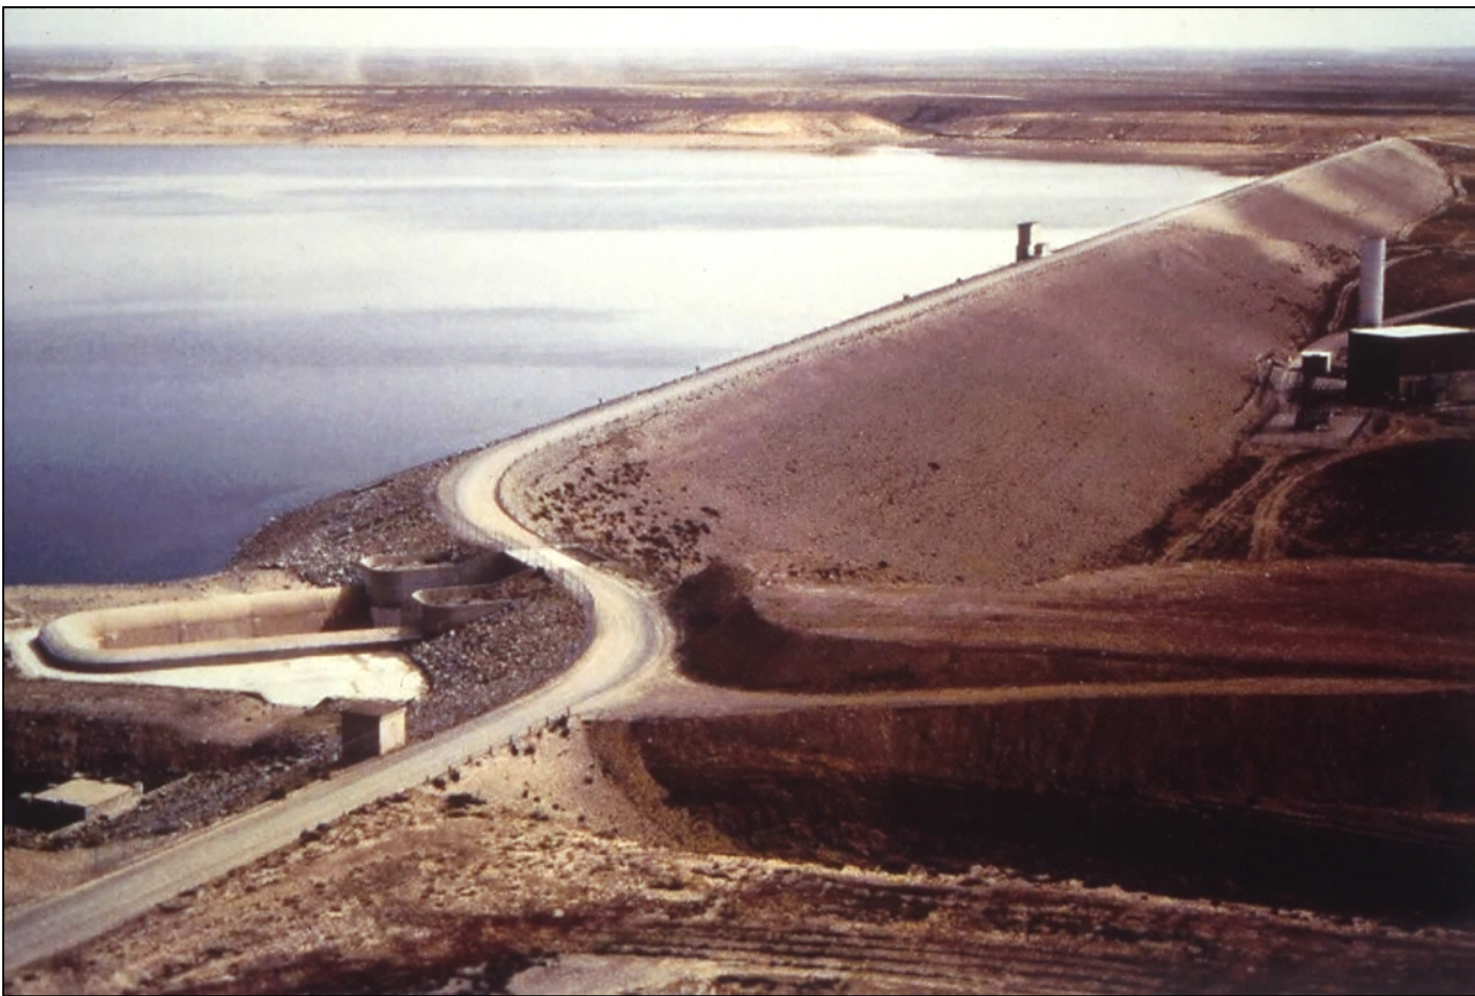
- **Fontinelle Dam** performed admirably following the near catastrophe in 1965. A decade later, the same kind of hydraulic piping failure occurred in the right abutment of Teton Dam, also during initial filling.
