Retrospective on
THE FAILURE OF
TETON DAM

Near Rexburg, Idaho
June 5, 1976

J. David Rogers, Ph.D., P.E., R.G.

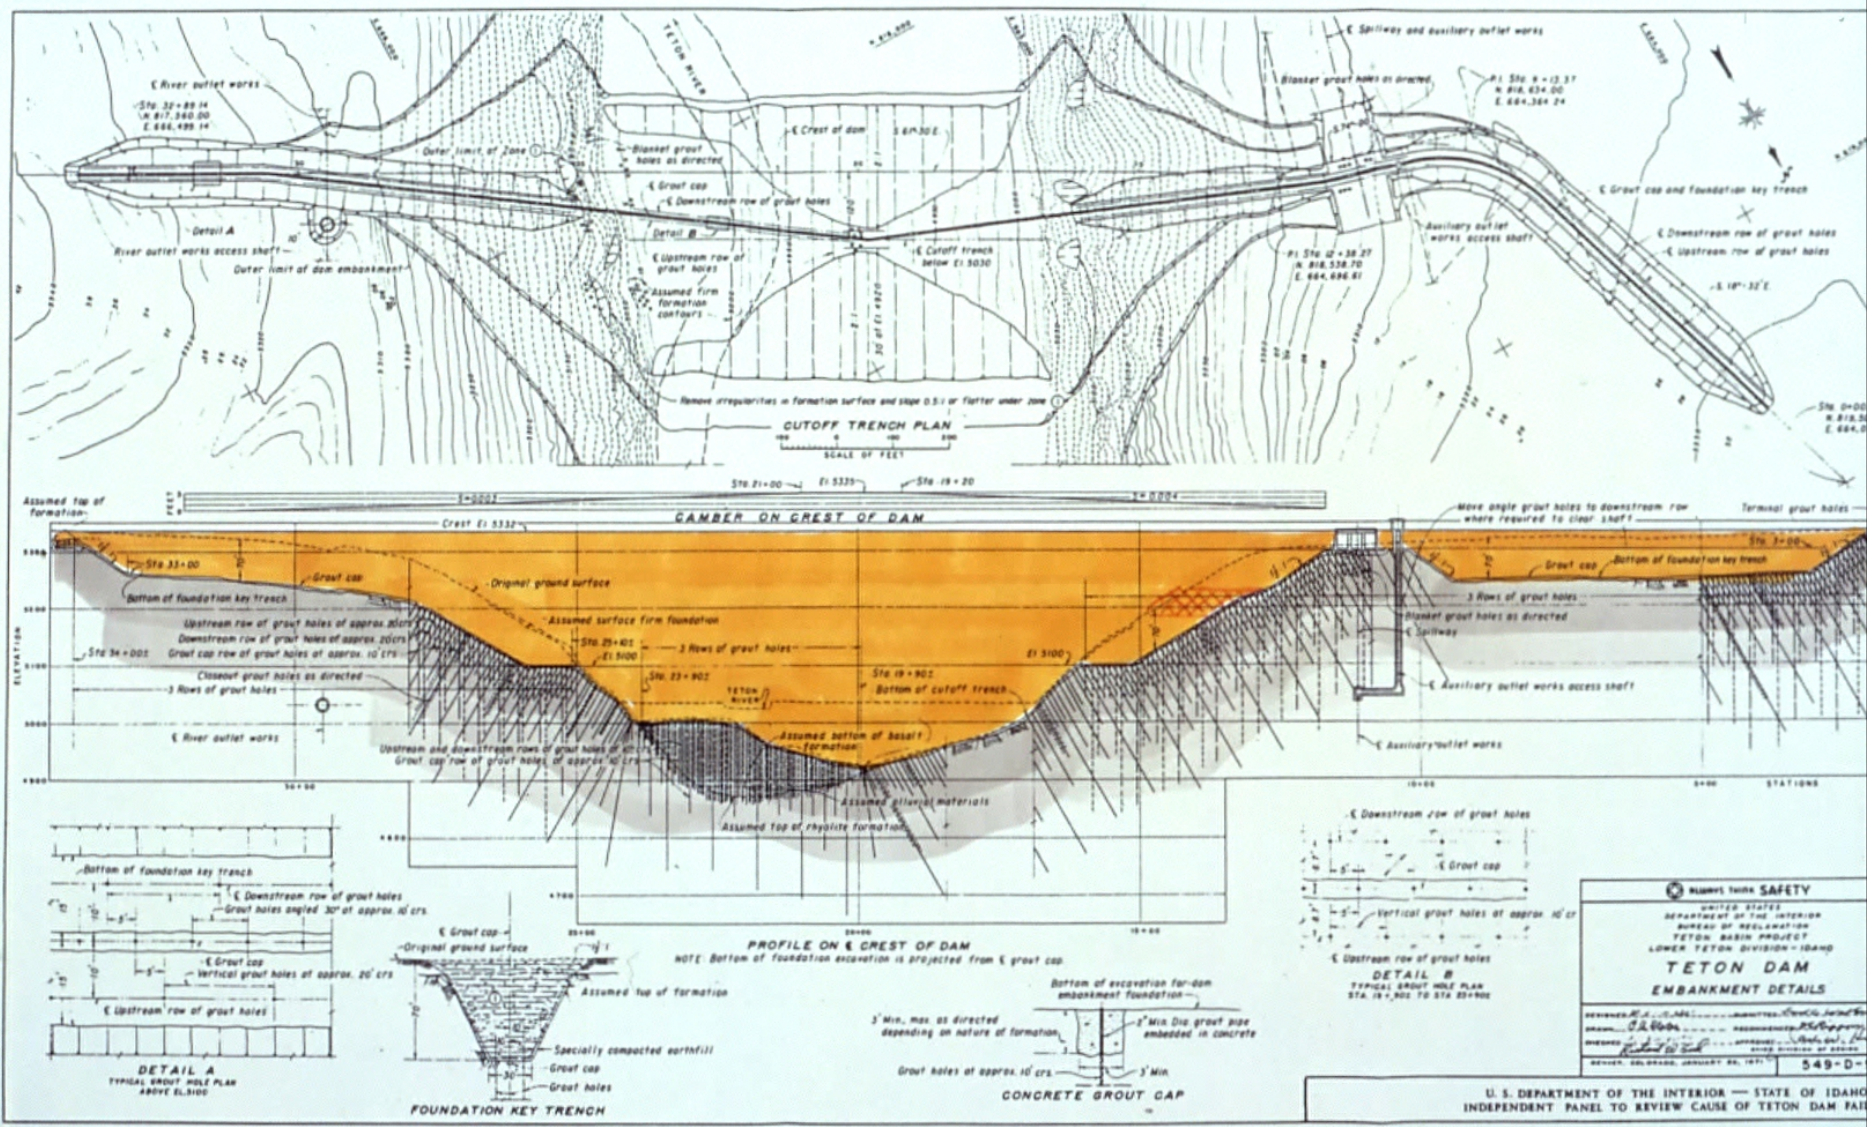
- Teton Dam was designed with a triple line grout curtain beneath the earth embankment. But, the grout curtain ended up being built as a single-line because the grout take was more than double what had been allotted for the project.

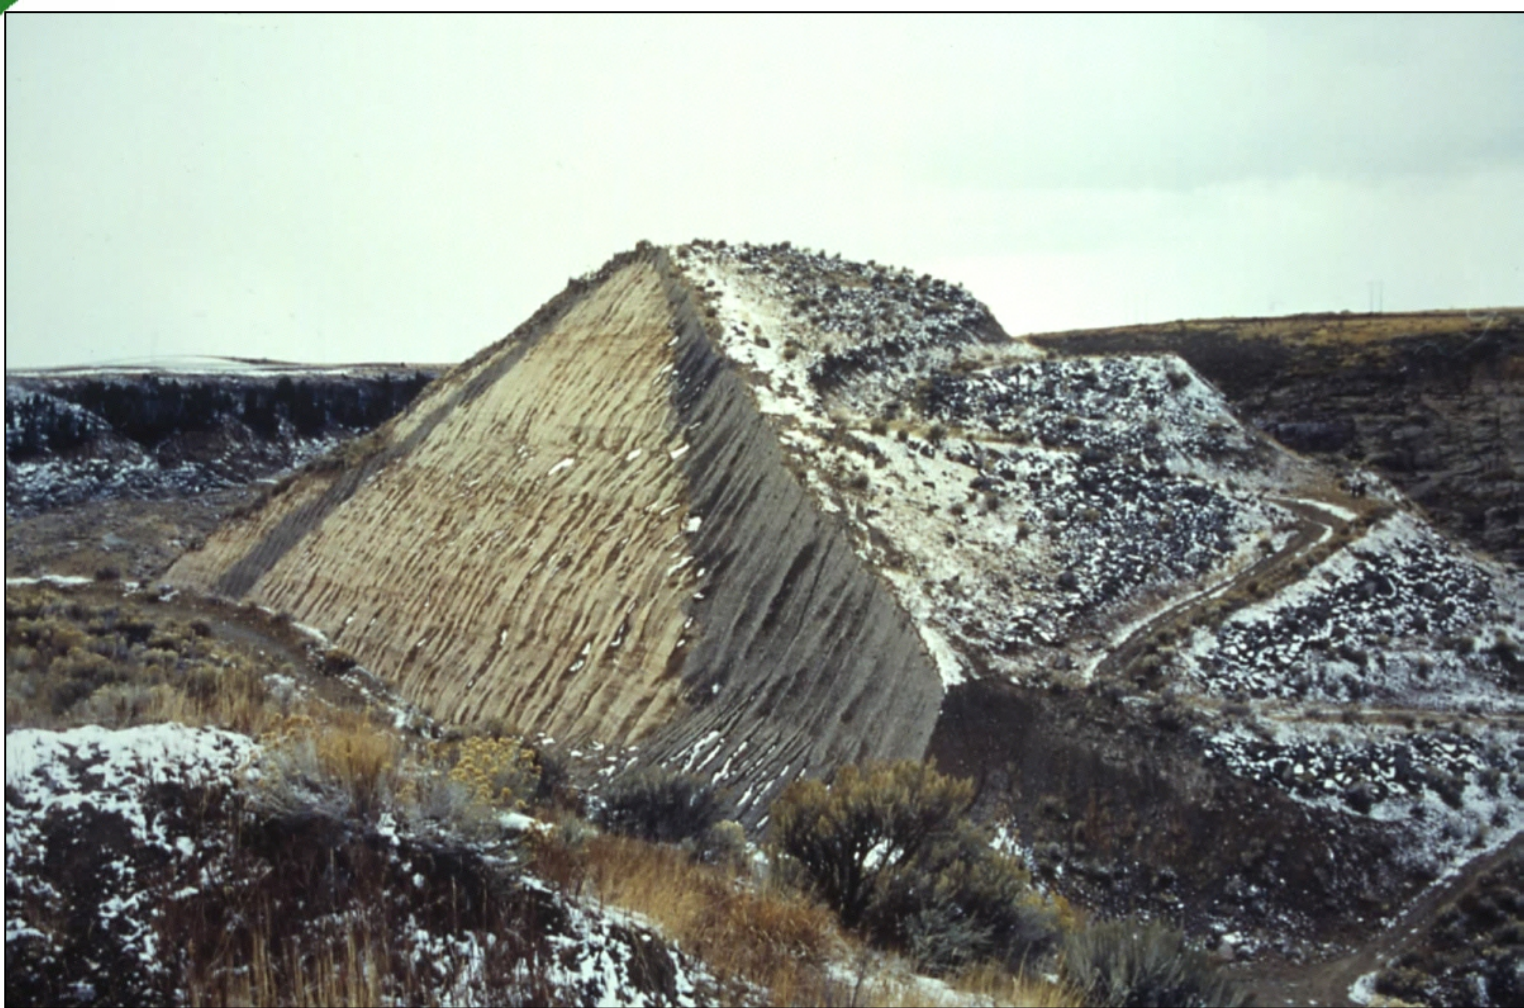
- **Teton Dam was designed as an earthfill embankment using wind blown loess as the principal fill material (seen here as light colored material) with river sand and gravel (shown as grey color), as the free draining material.**

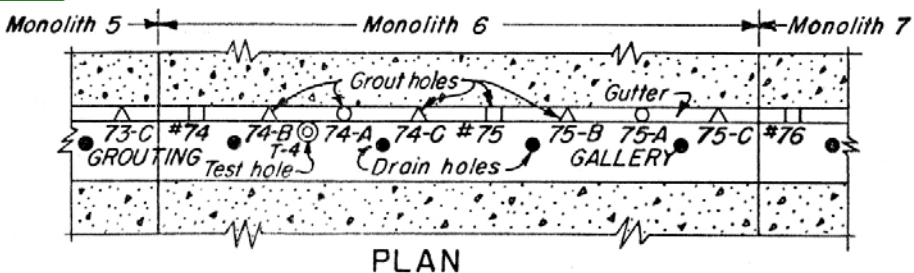
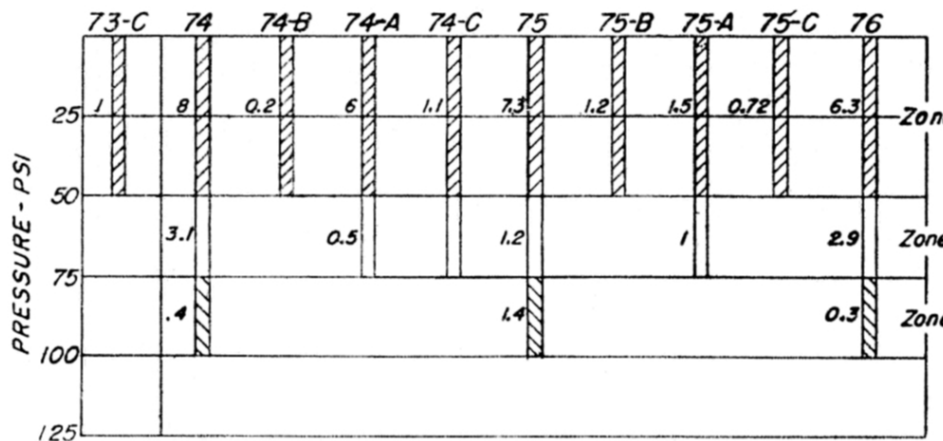
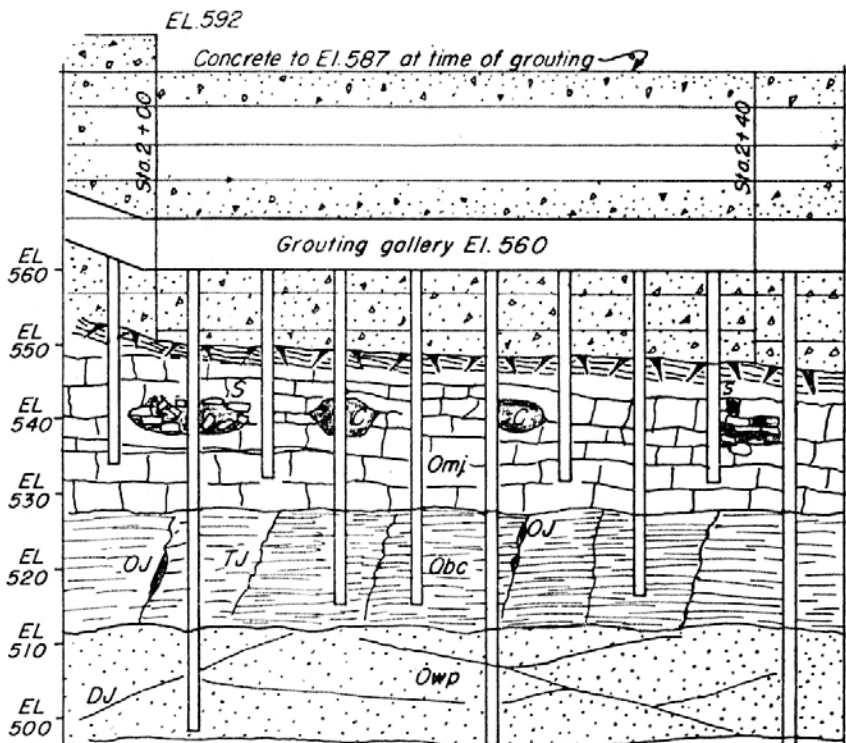
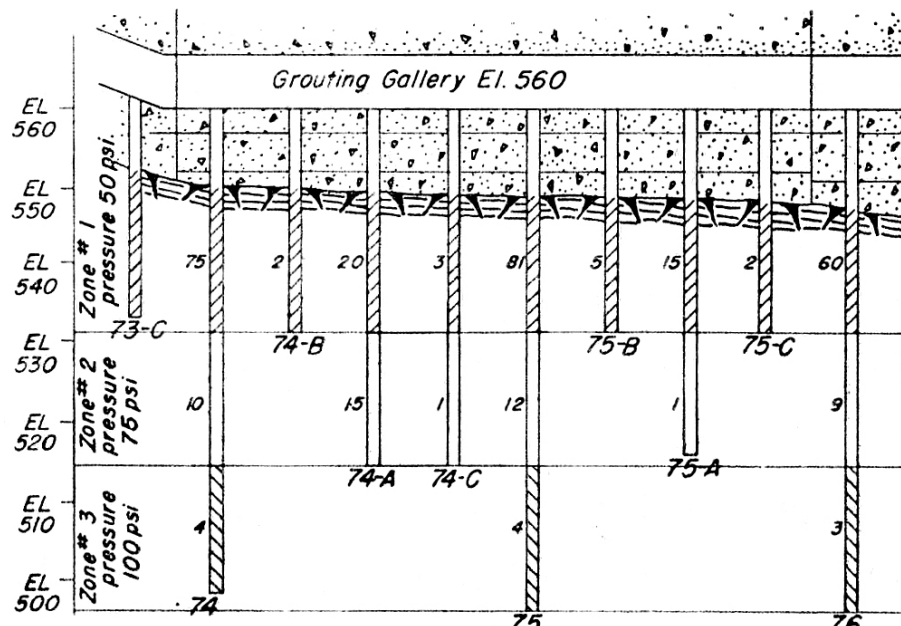
TYPICAL GROUTING PROGRAM

- A single line of grout holes was utilized beneath the embankment because the grout takes were more than double what had been allotted for the project. The portion of the right keyway trench that failed is shown in red cross hatching.

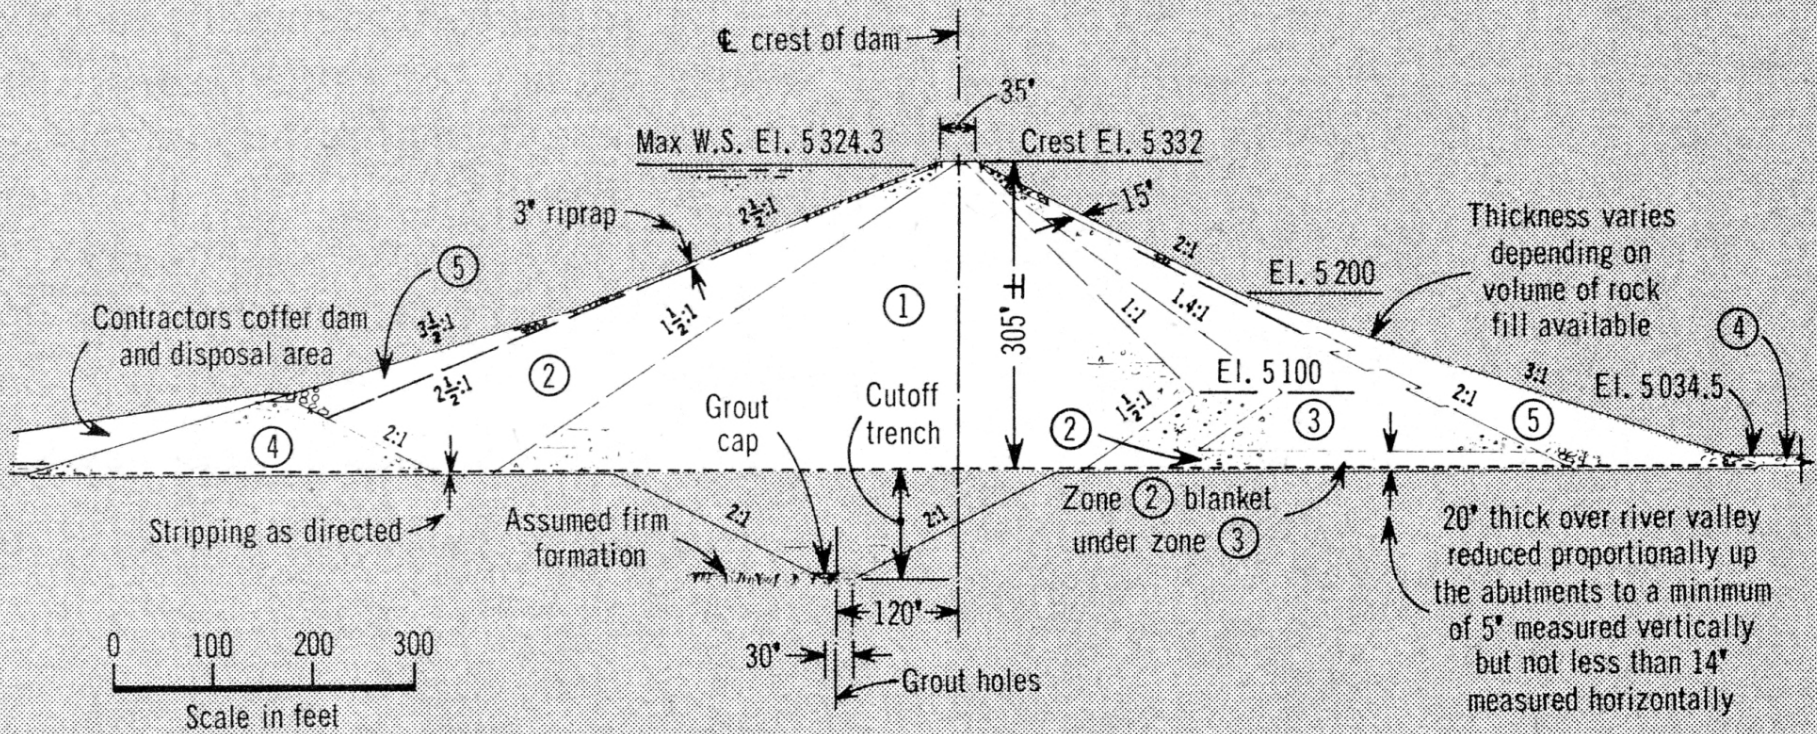
- Design section through Teton Dam, showing the five principal fill zones. There were only three kinds of on-site materials: 1) wind blown loess (silt); 2) river gravels and sands; and 3) disaggregated rhyolite tuff from the abutment excavations**

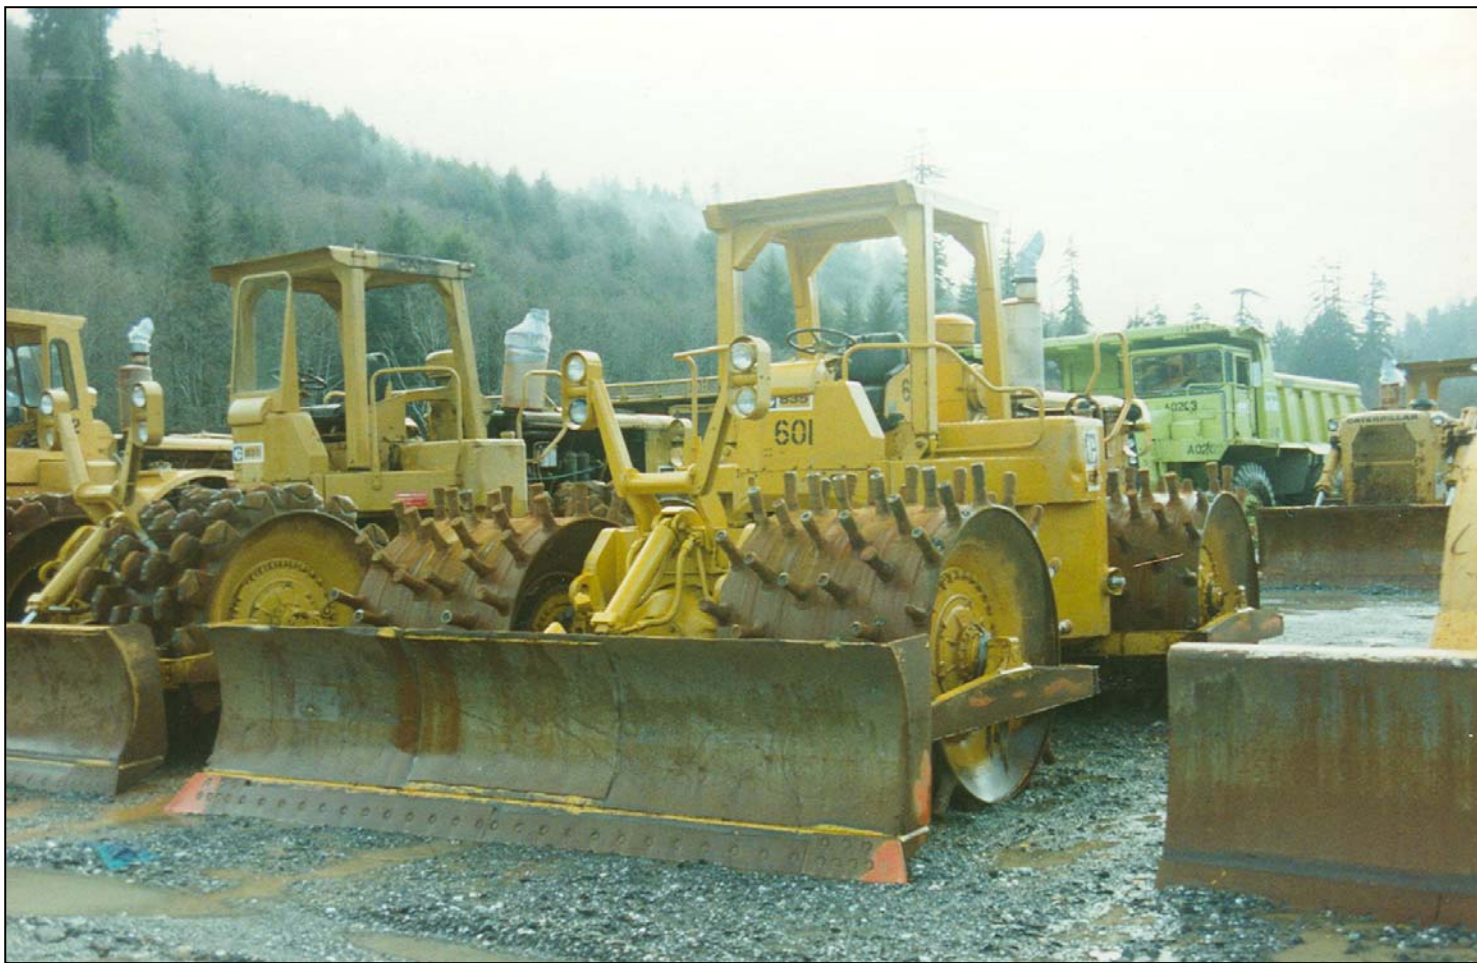
- The June 27, 1975 pass-on log notes that the decision was made to change to a CAT 825B sheepsfoot compactor in the abutment keyways because of failing compaction tests

- **CAT 826B self-propelled sheepfoot compactor, similar to that employed in the abutment keyways after June 27th. Their compactive effort is between 175 and 475 psi, depending on the type of wheel used. A pad roller is at left (175 psi) and sheepfoot at center (475 psi).**

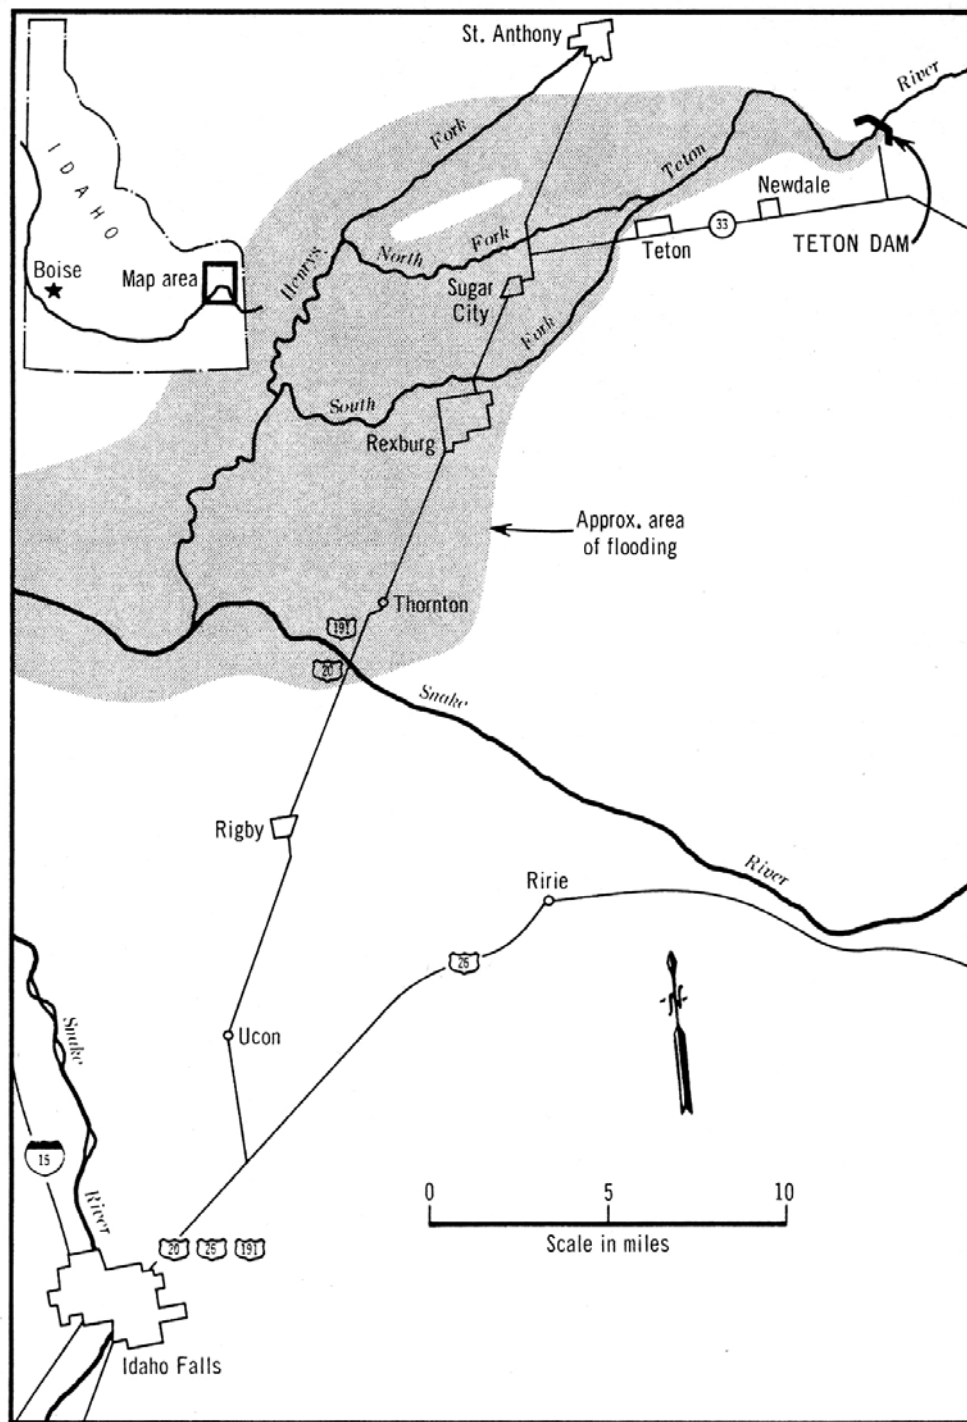
- The flood inundated the towns of Sugar City and Rexburg, only killing 6 because of the advance warning
- The loss ended up costing the federal government close to \$1 billion dollars
- At 350 feet high, Teton was the highest dam to ever fail
- It's untimely failure signaled an end to the era of big dam building in America

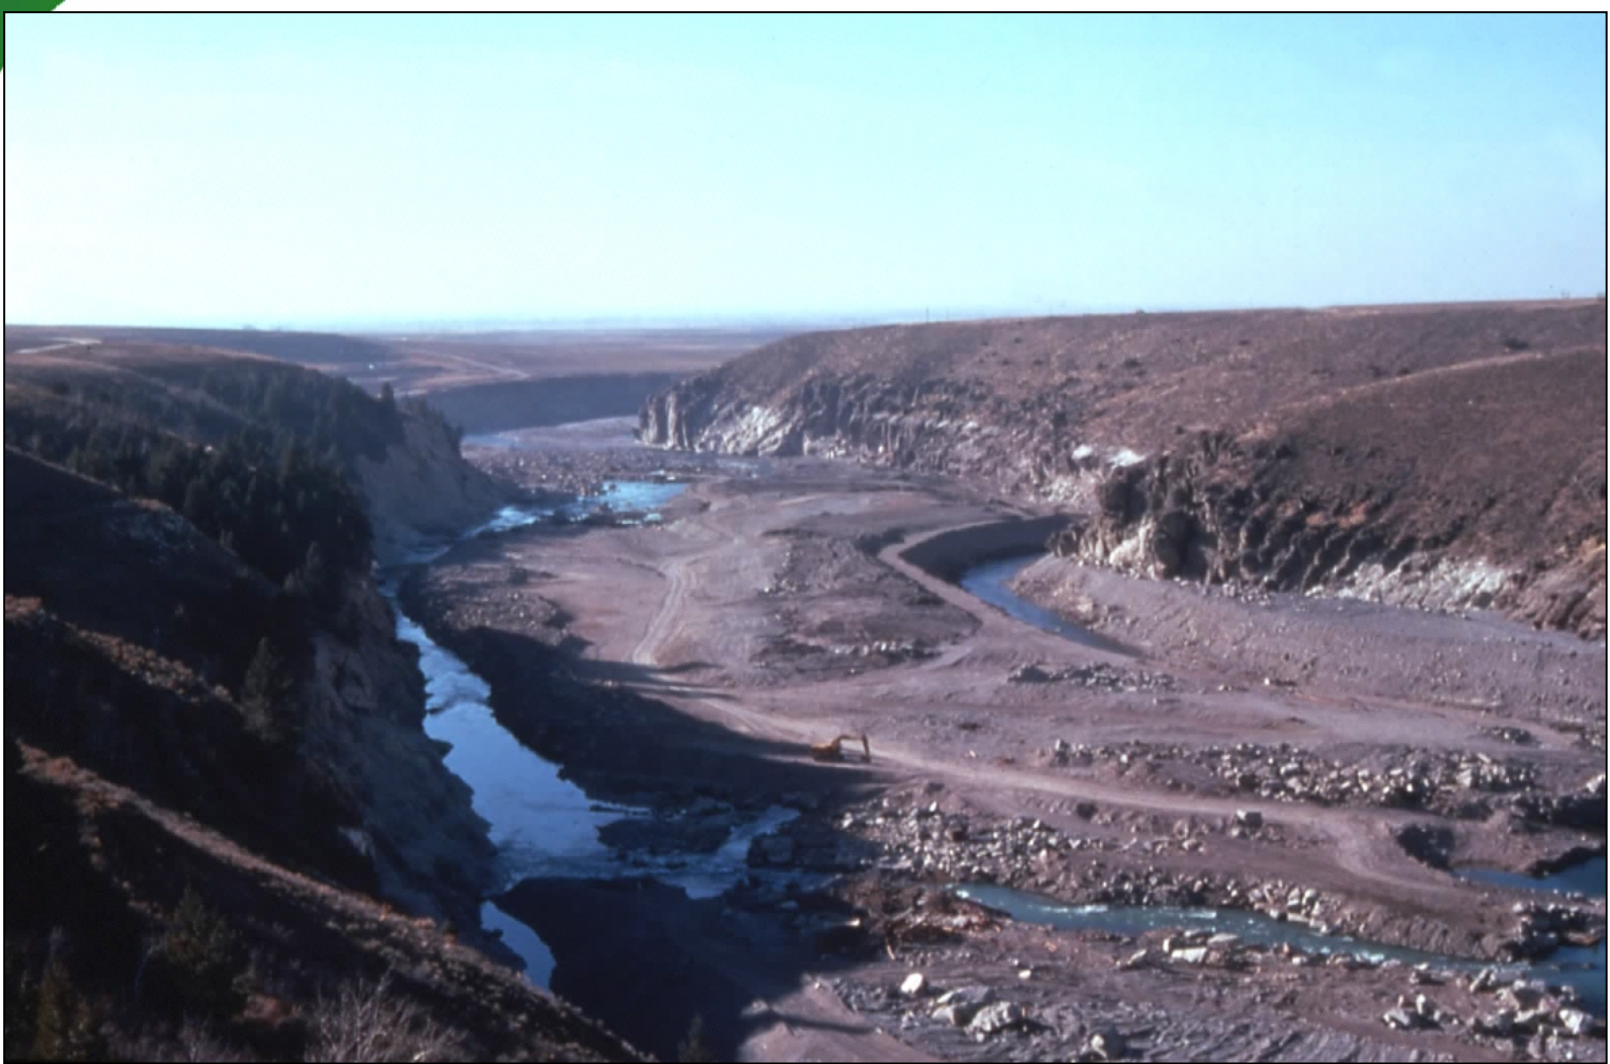
- **View looking downstream in 1977, after channelization of the outbreak flood debris choking the channel.**

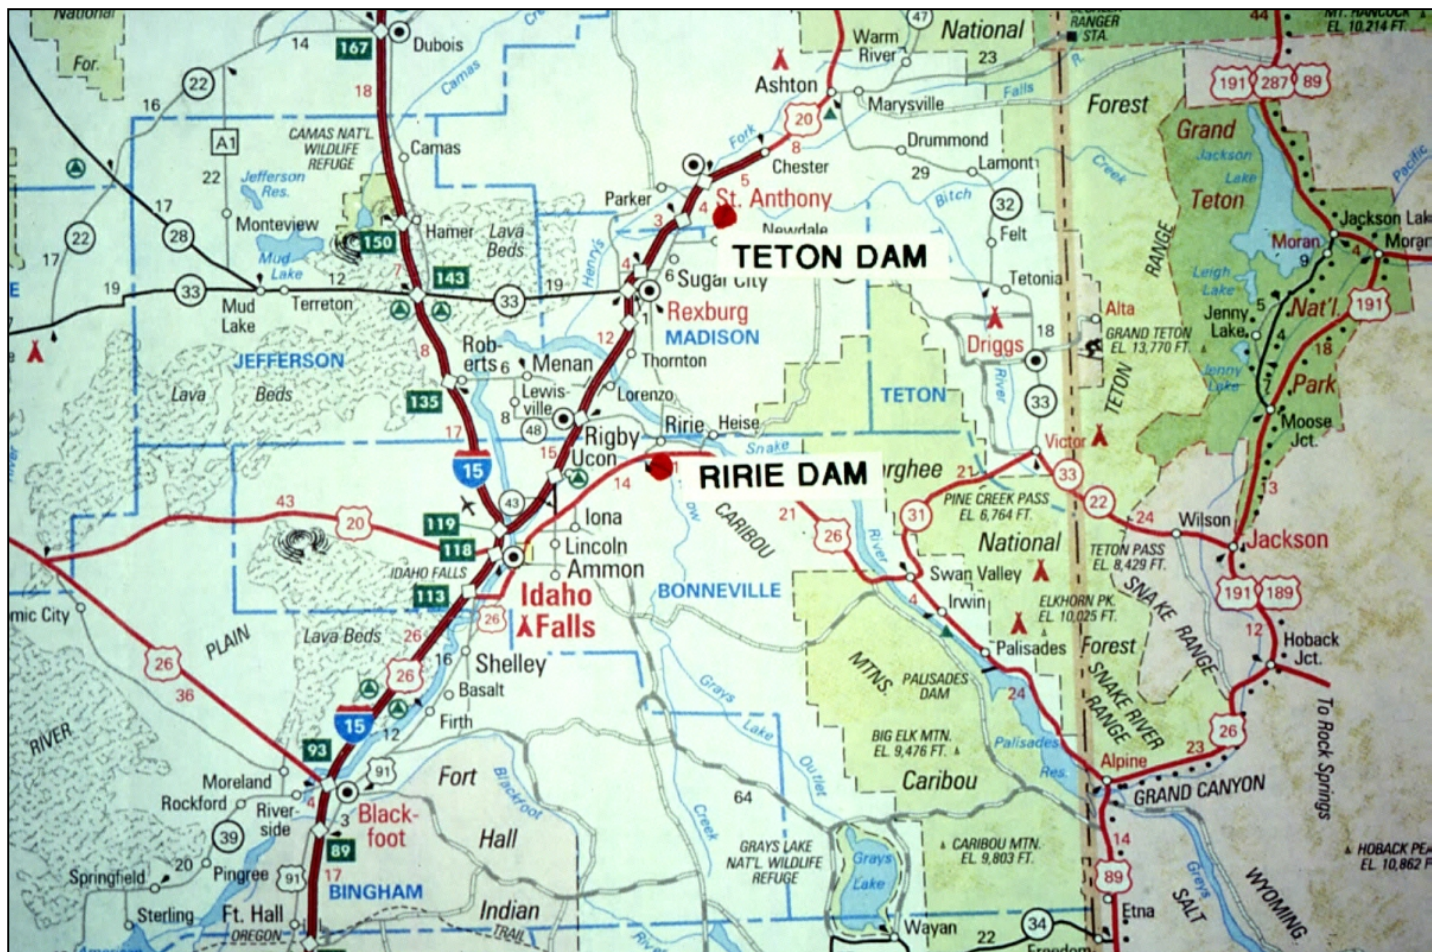
- Ririe Dam was built by the Walla Walla District of the Corps of Engineers in an adjoining watershed with near-identical geology - at the same time as Teton. It did not fail. Why?
