Geologic Conditions Underlying the 2005 17th Street Canal Levee Failure in New Orleans

J. David Rogers, Ph.D., P.E., P.G.
Missouri University of Science & Technology

for Technical Session #15 on
New Orleans Levees and Hurricane Katrina

17TH Street Drainage Canal Failure:

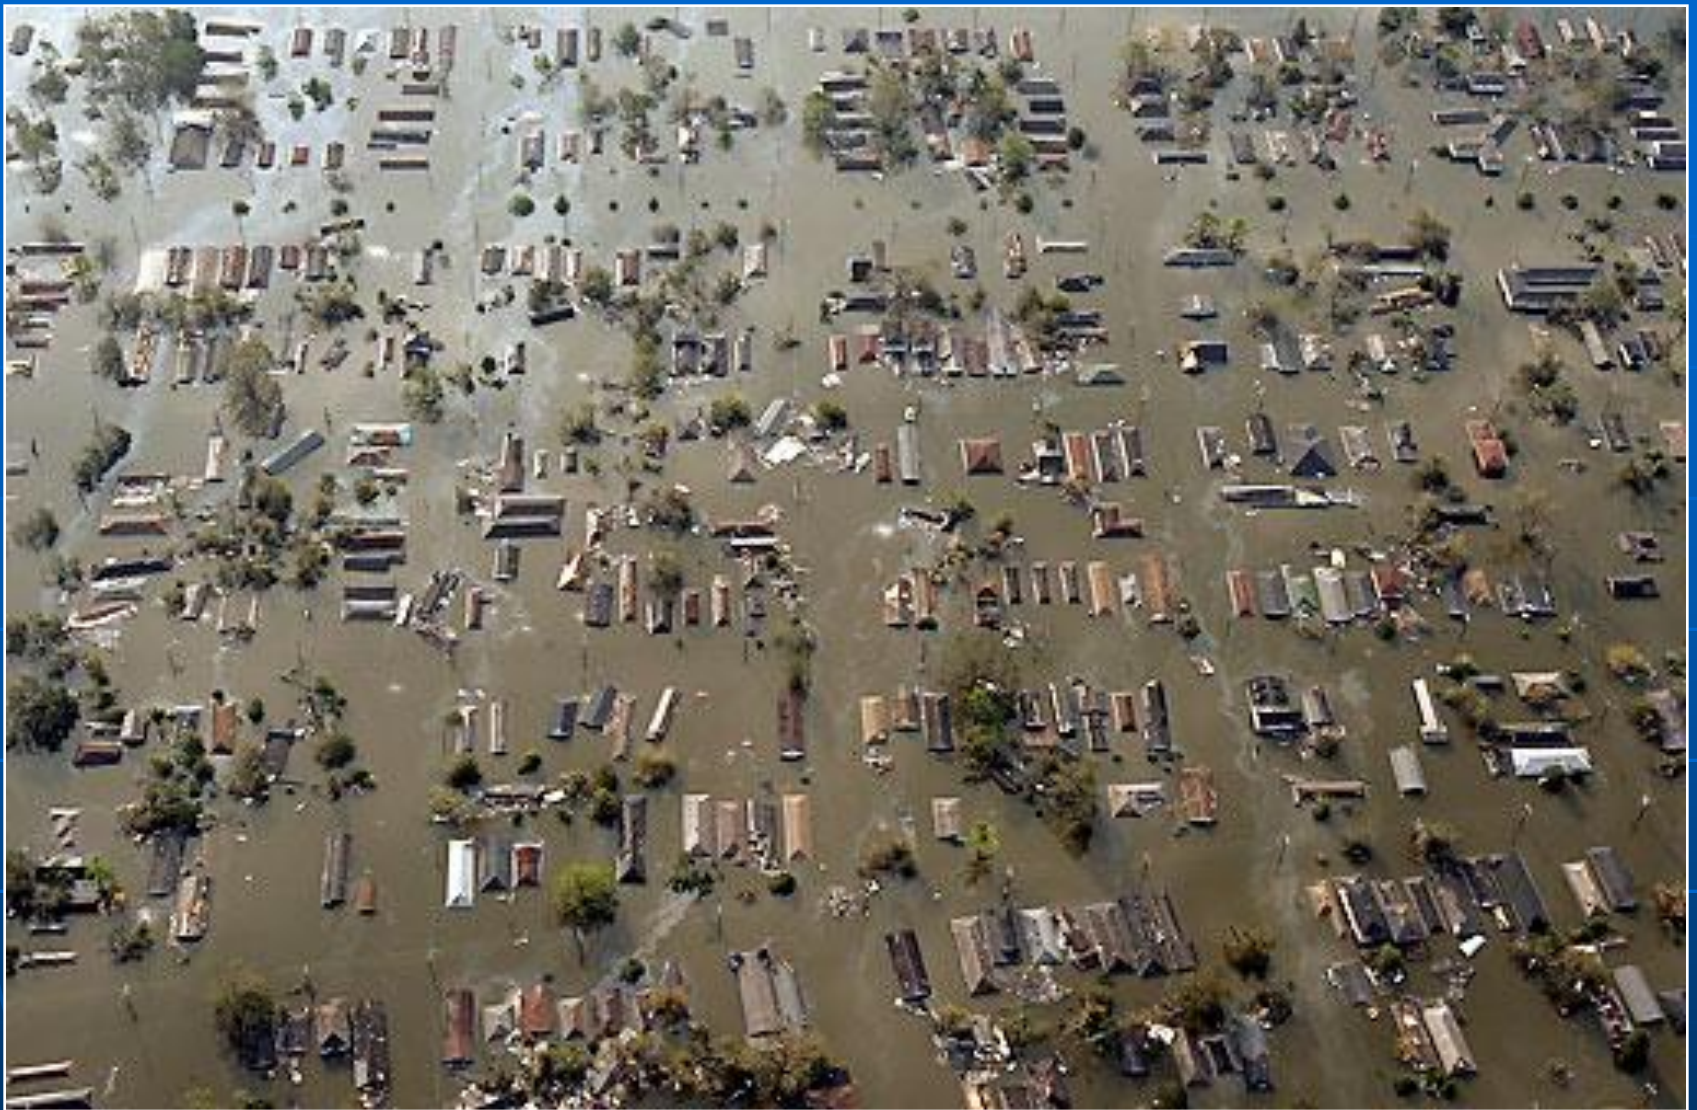
- **New Orleans neighborhoods were filled with as much as 12 feet of water, for up to 6 weeks**

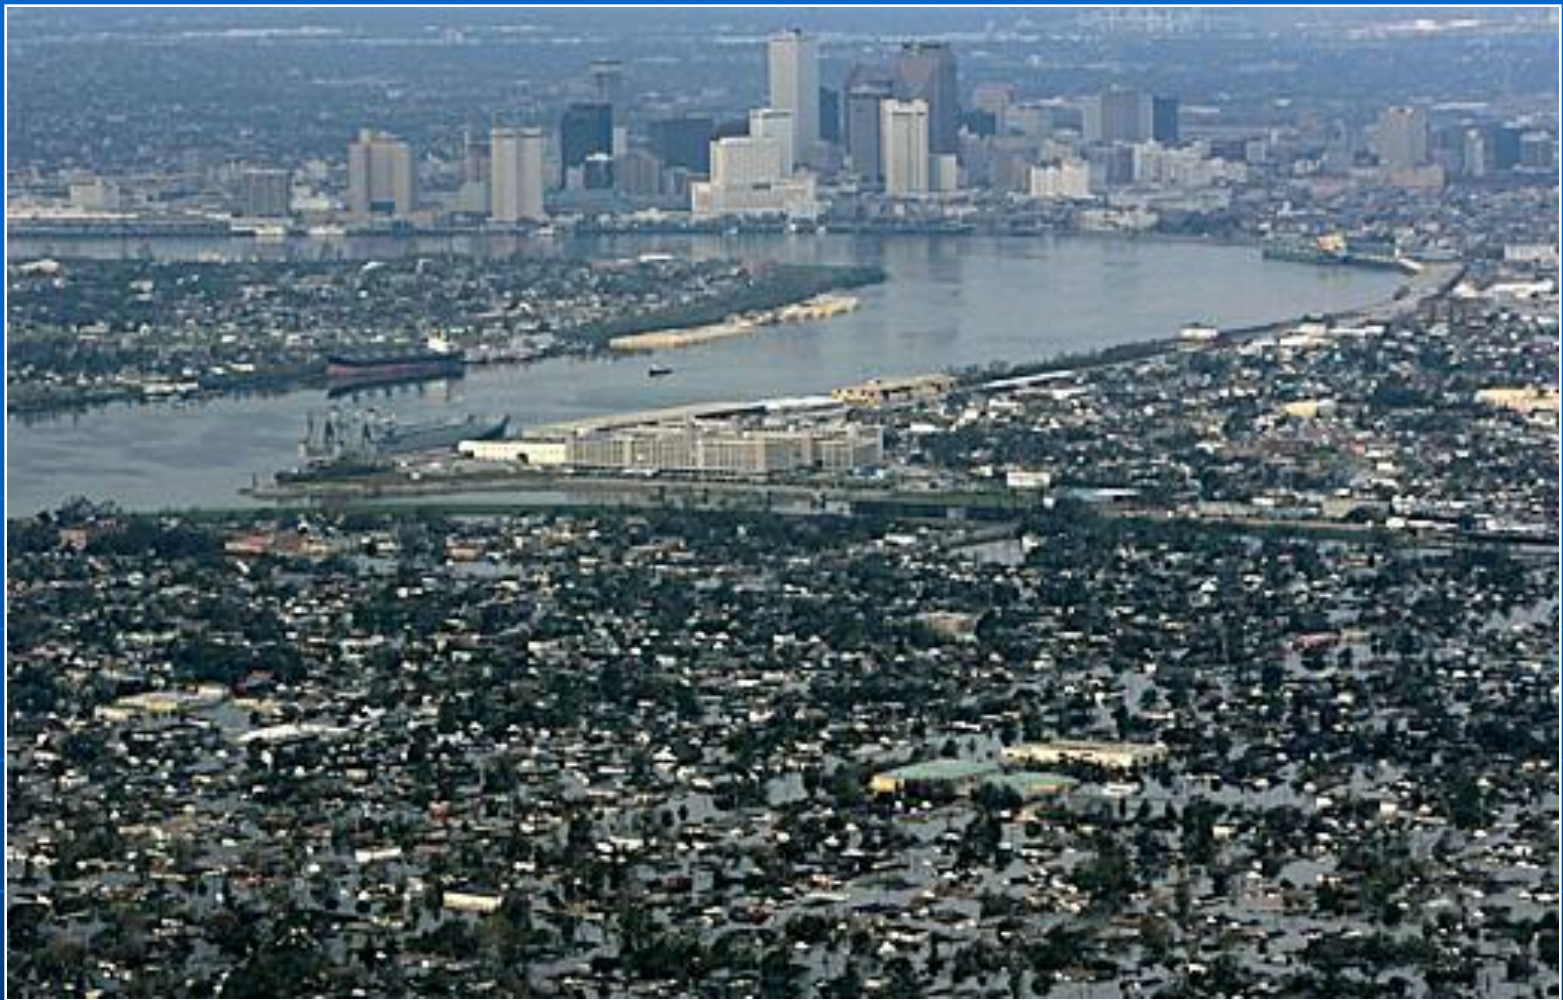
- **Katrina left New Orleans under water, creating the worst flood in American history and the most expensive disaster, causing \$24 billion in claims to the National Flood Insurance Program and \$200 billion in overall damage.**

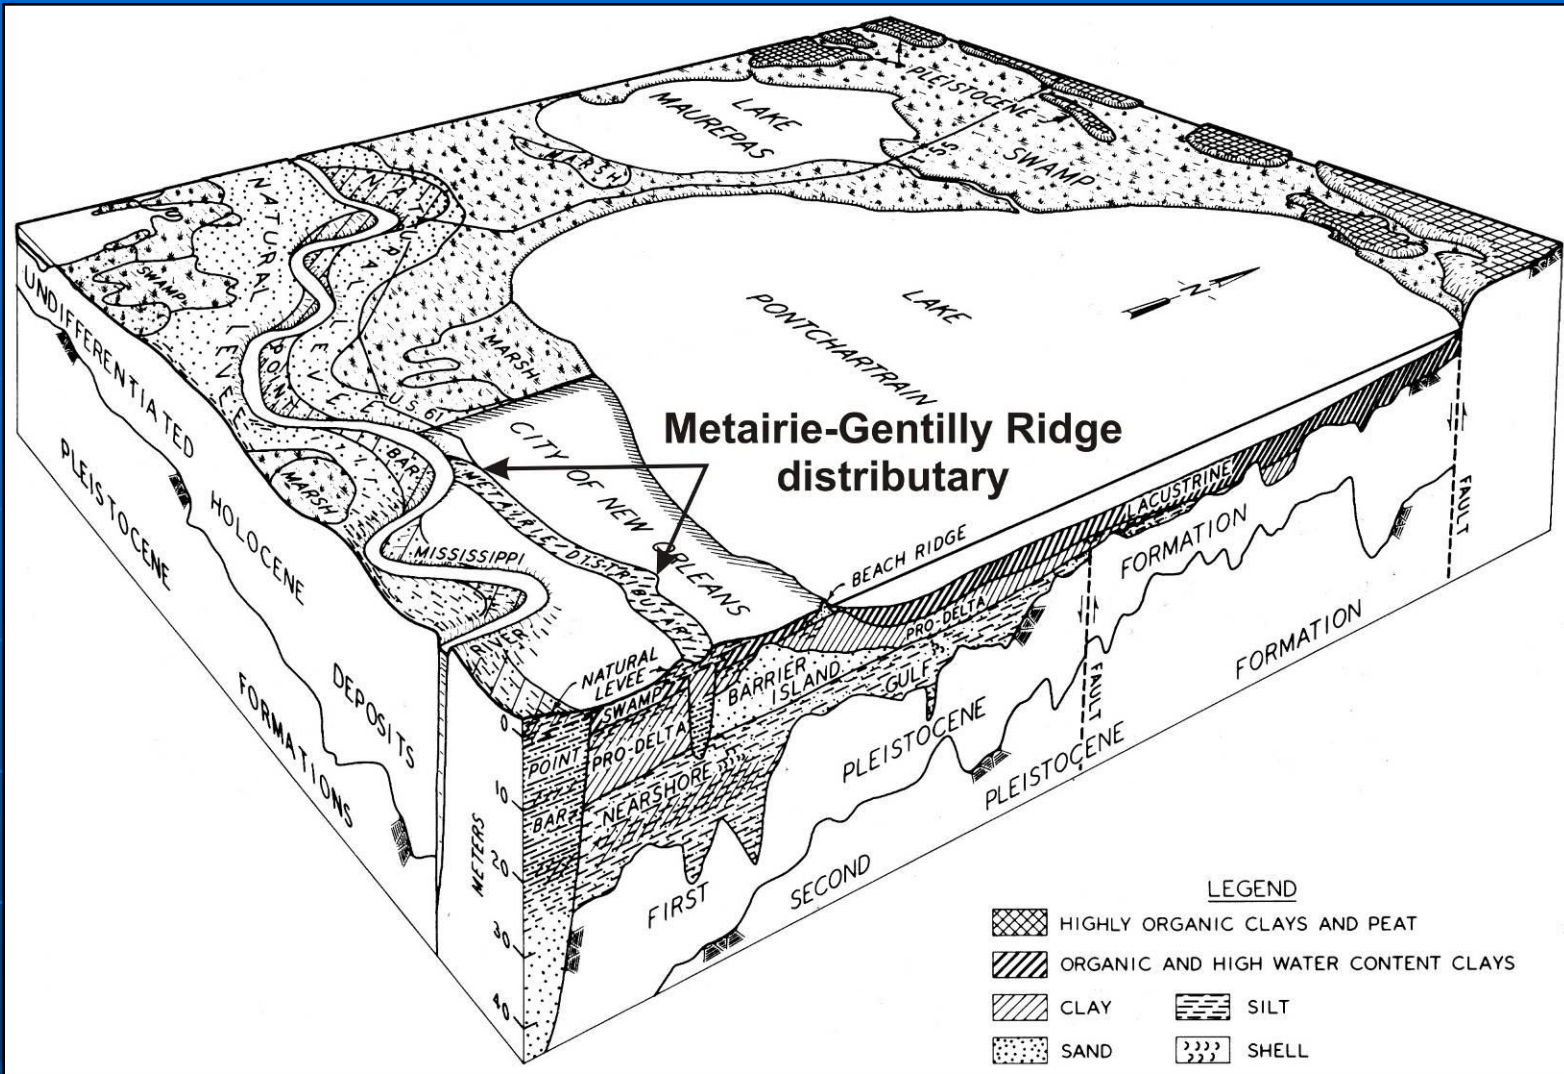
- **Block diagram of the geology underlying New Orleans. The principal feature dividing New Orleans is the Metairie distributary channel, shown here, which extends to a depth of 50 feet below MGL and separates geologic regimes on either side. Note the underlying faults, beneath Lake Pontchartrain.**

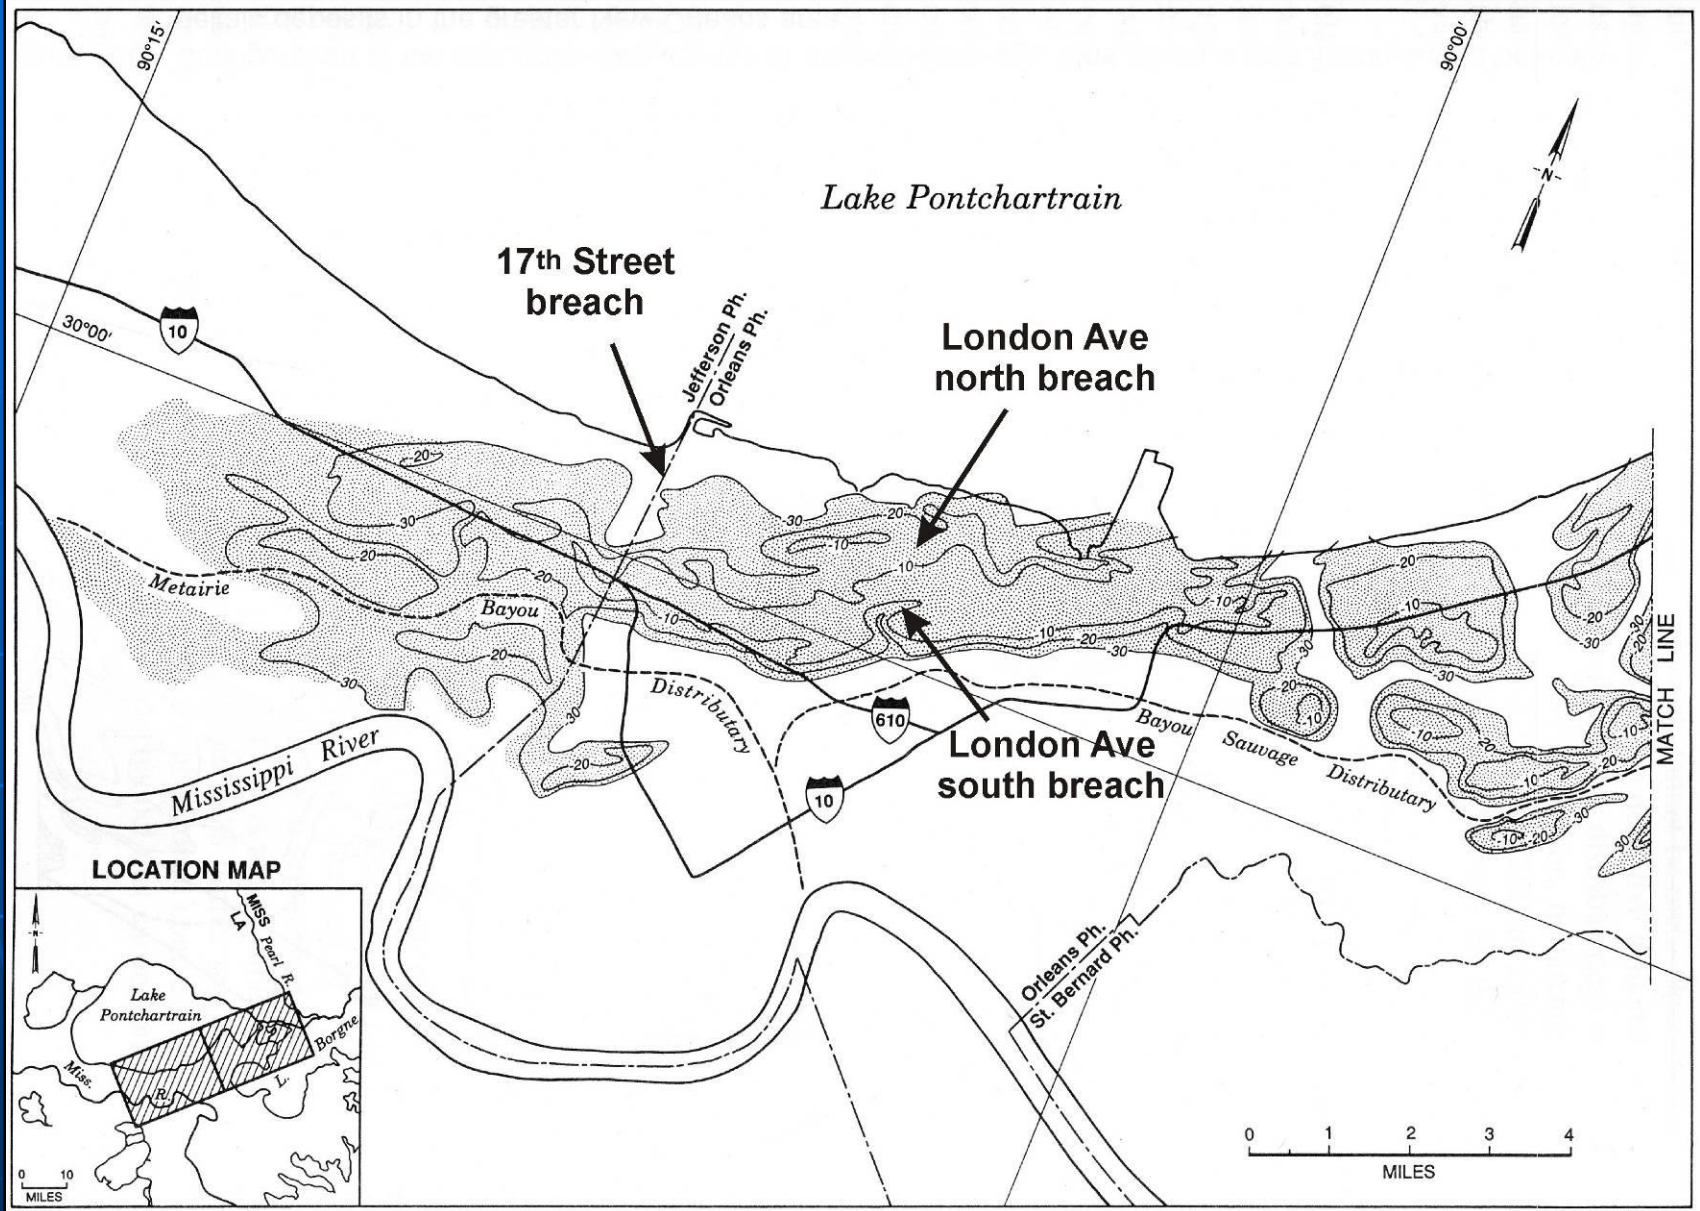
- **Areal distribution and depth to top of formation isopleths for the Pine Island Beach Trend beneath lower New Orleans.**

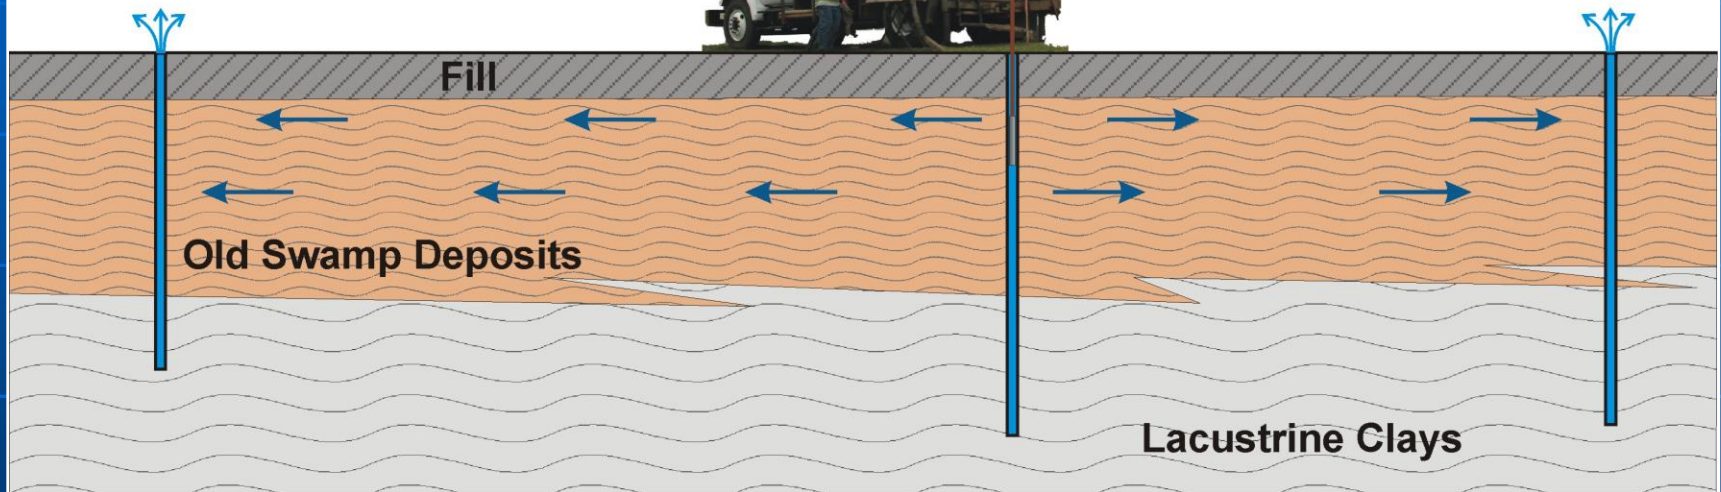
Water squirted up adjacent boreholes when advancing Shelby tubes

- The porous and **highly conductive** nature of the backswamp deposits was revealed during post-Katrina drilling and sampling operations.
- Highly conductive in horizontal plane, especially, parallel to the line of original surface drainage.

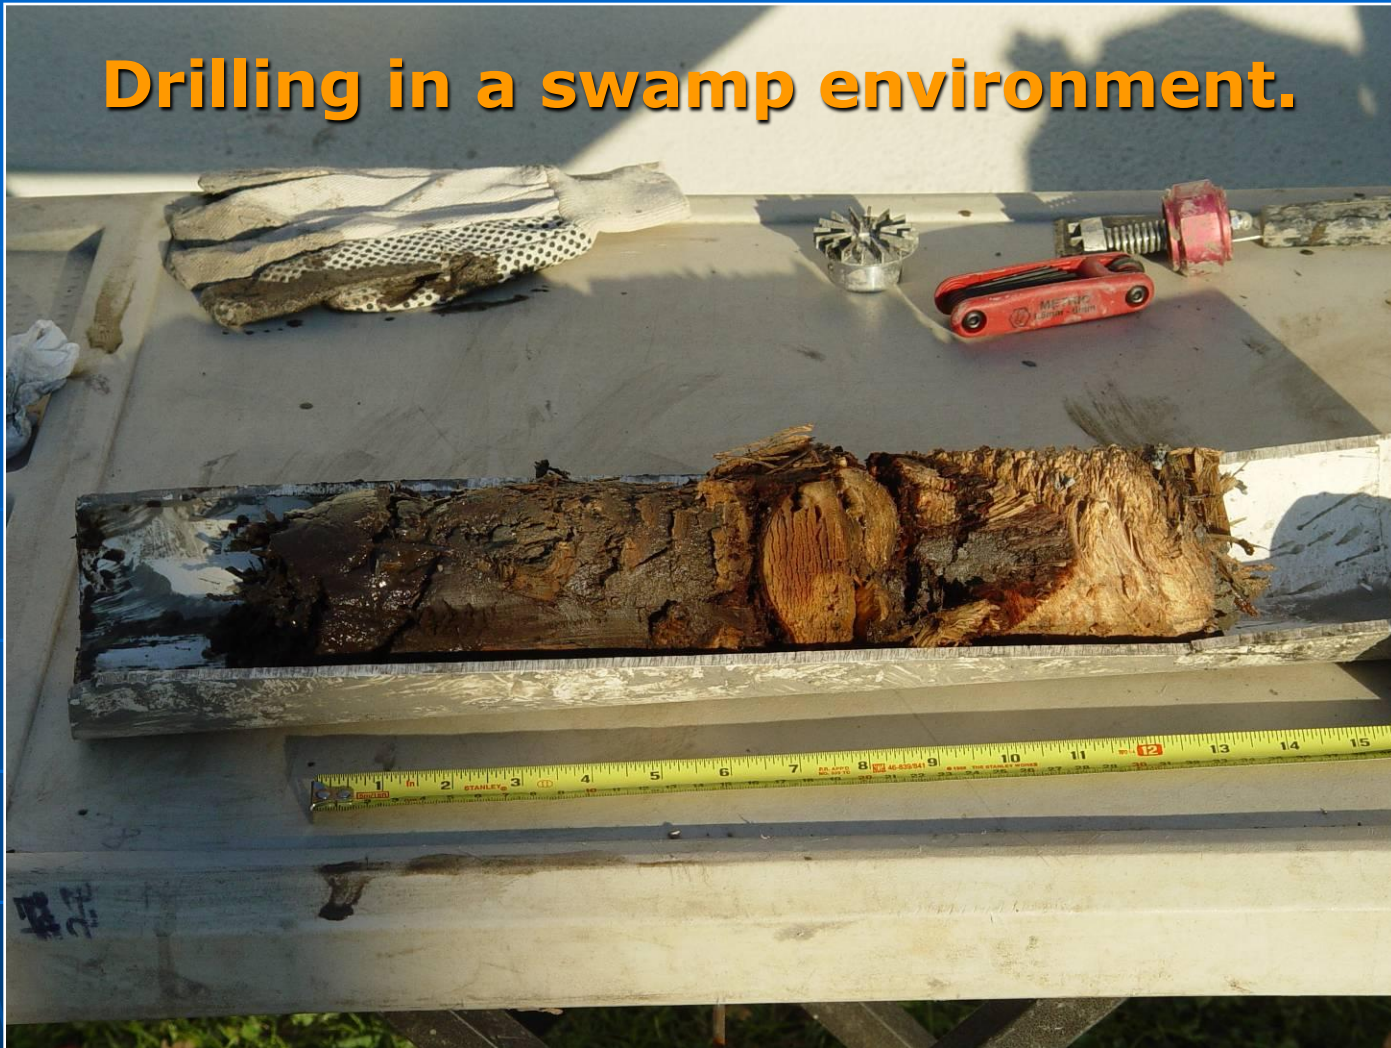
- On average, it took us three tries to get one successful sample of the basal slip surface at each place we drilled; or **27** holes to get **9** complete logs

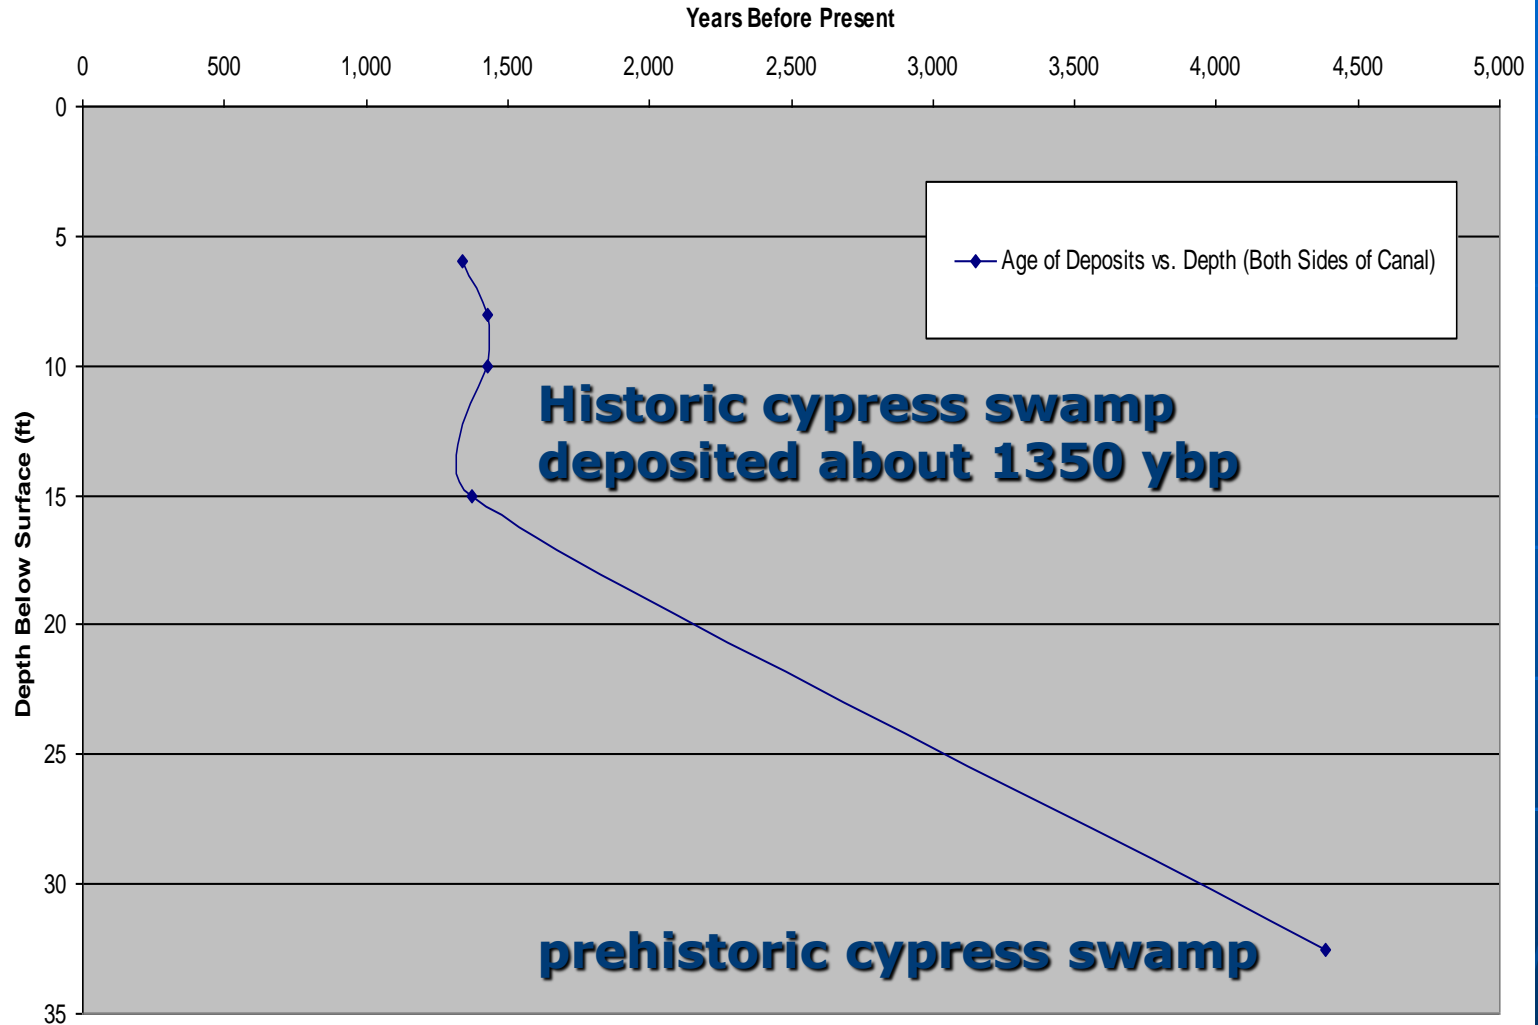
Age of Deposits vs. Depth in Vicinity of 17th St. Canal Breach

- **C14 dates and depths suggest a rapidly filling paludal environment during the late Holocene**

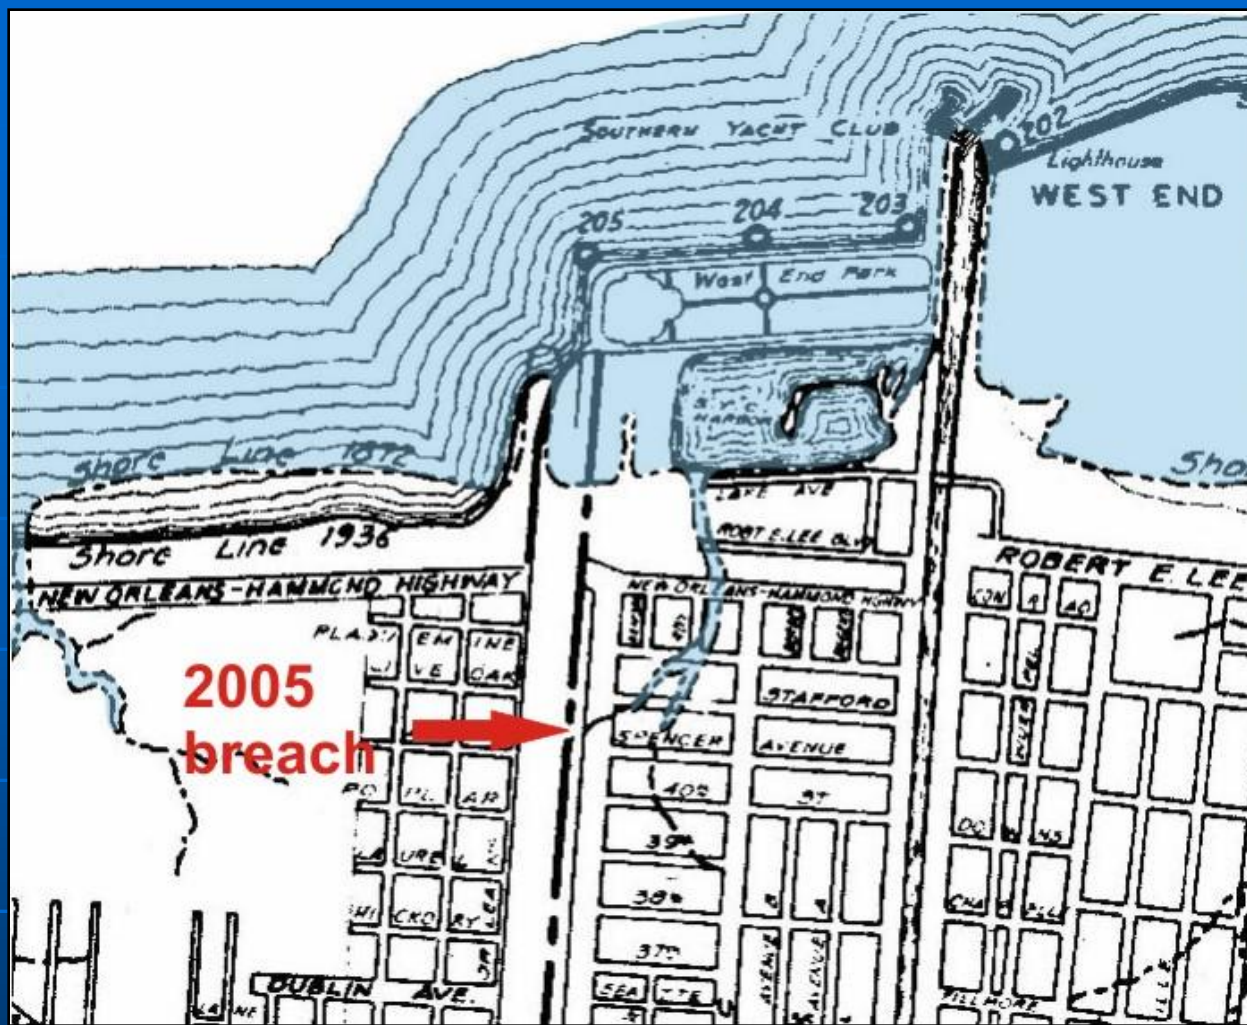
- Map overlaying 1872 Sulakowski map on the 1937 WPA map, showing the 1872 shoreline and sloughs (in blue) along Lake Pontchartrain.
- The position of the 2005 breach along the east side of the 17th Street Canal is indicated by the red arrow.

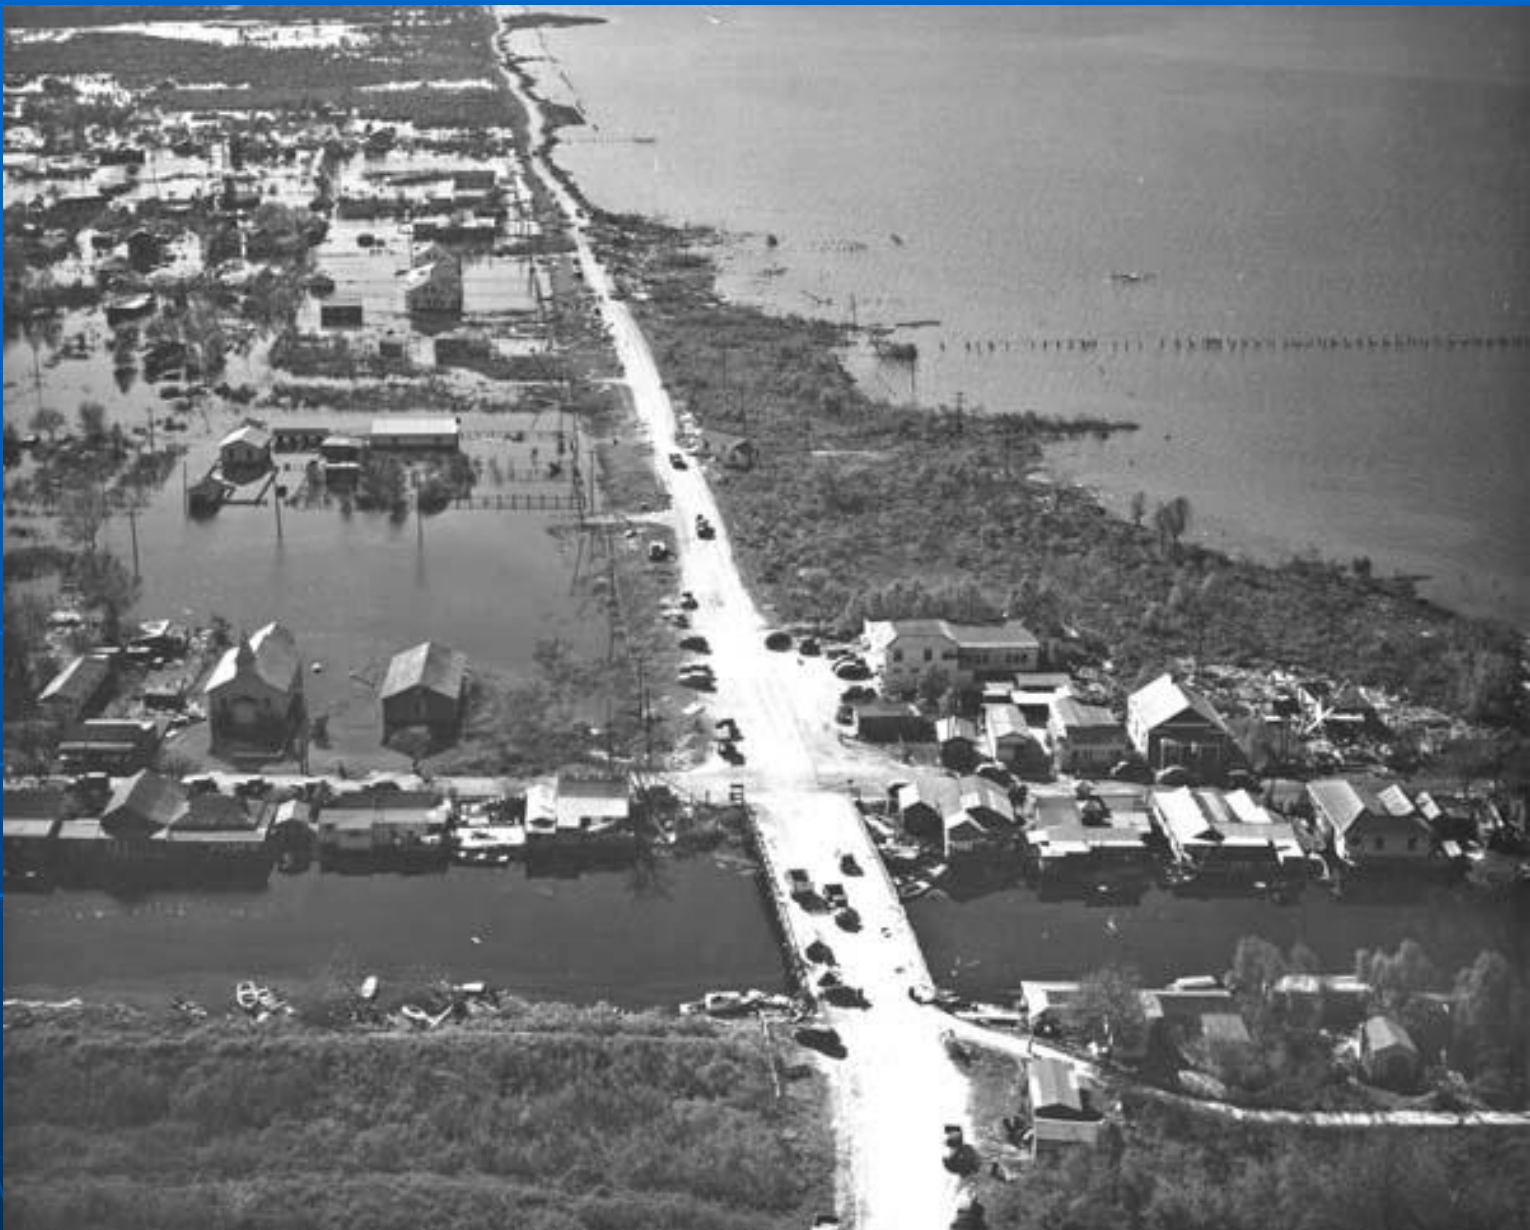
- **Aerial oblique view of flooding adjacent to lower 17th St Canal caused by 1947 hurricane.**

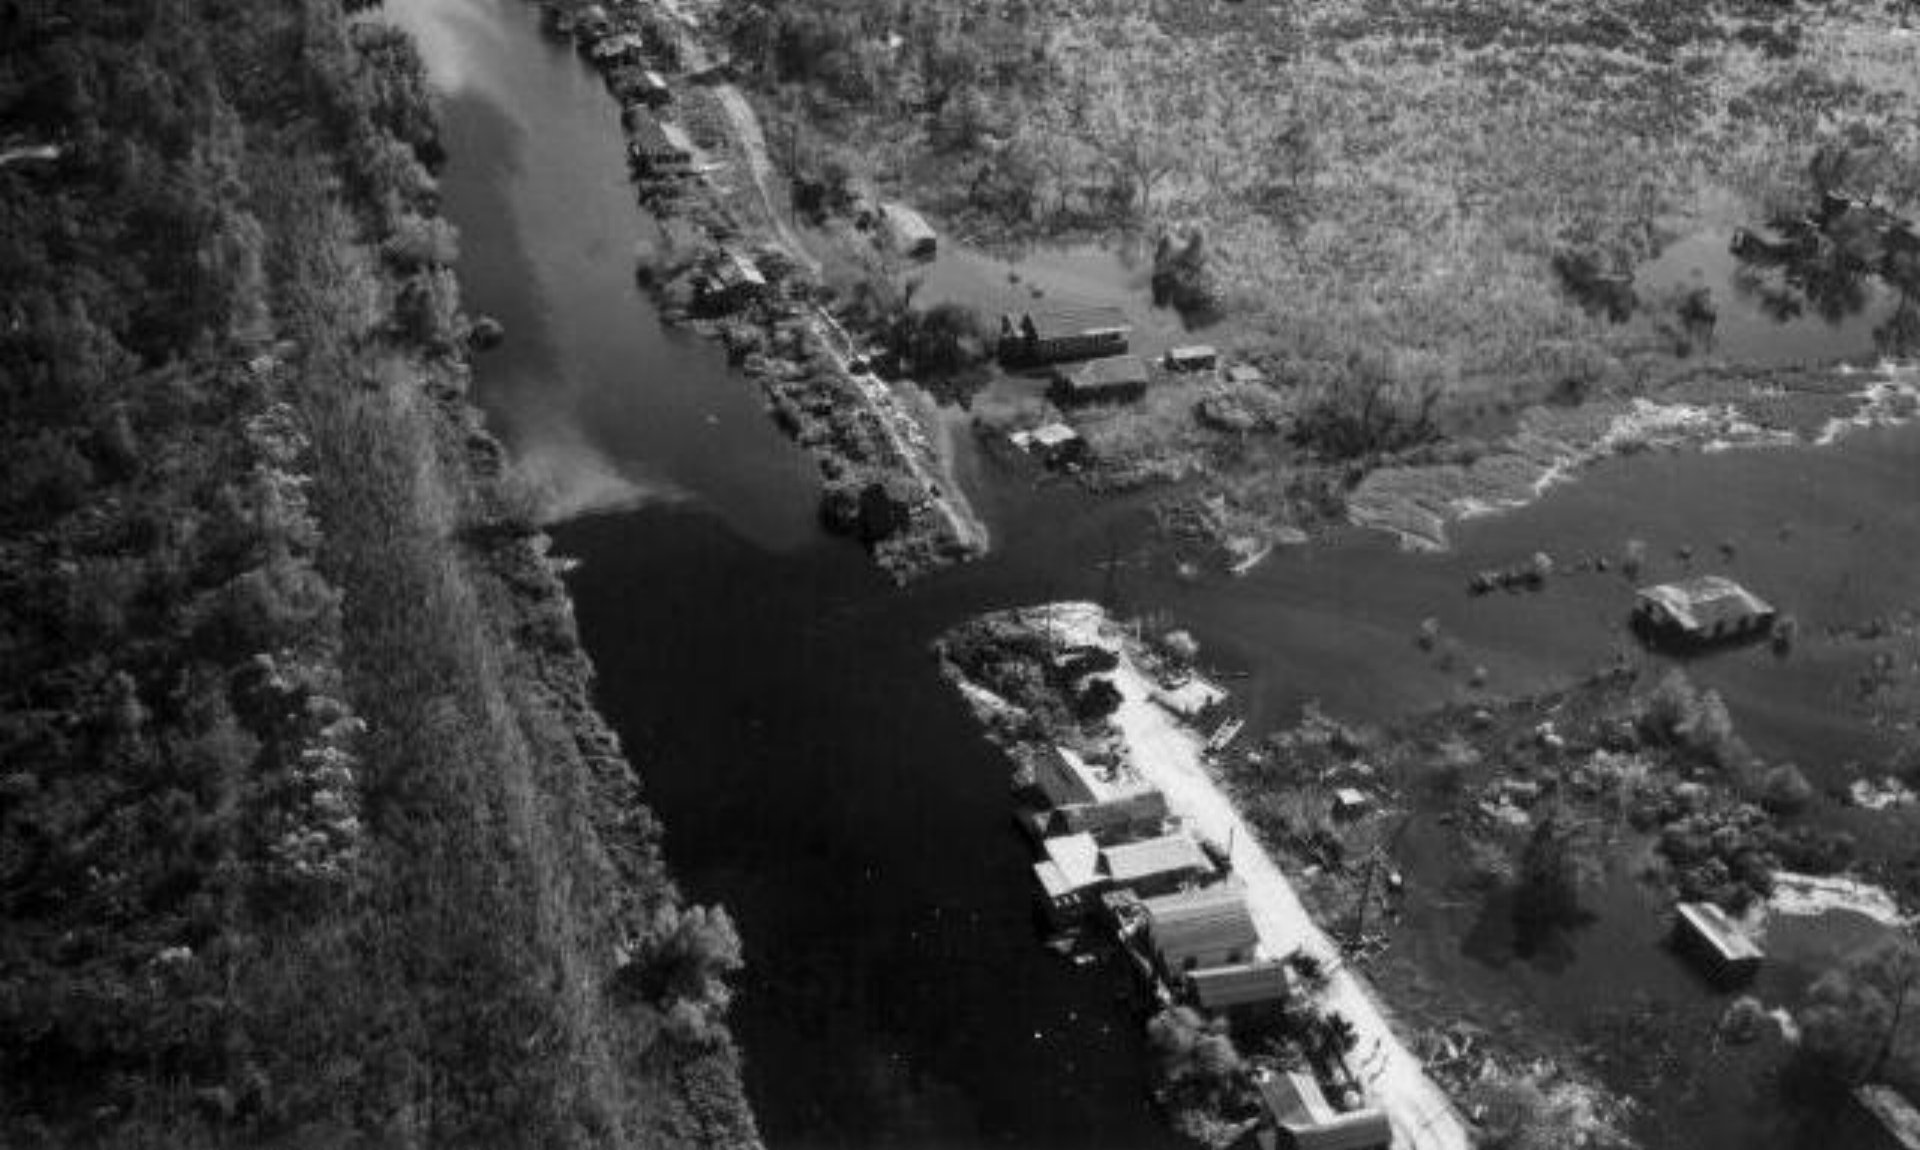
- **Flooding of Jefferson Parish and Metairie was caused by a breach along the western side of the 17th Street Canal, across from site of the 2005 breach.**

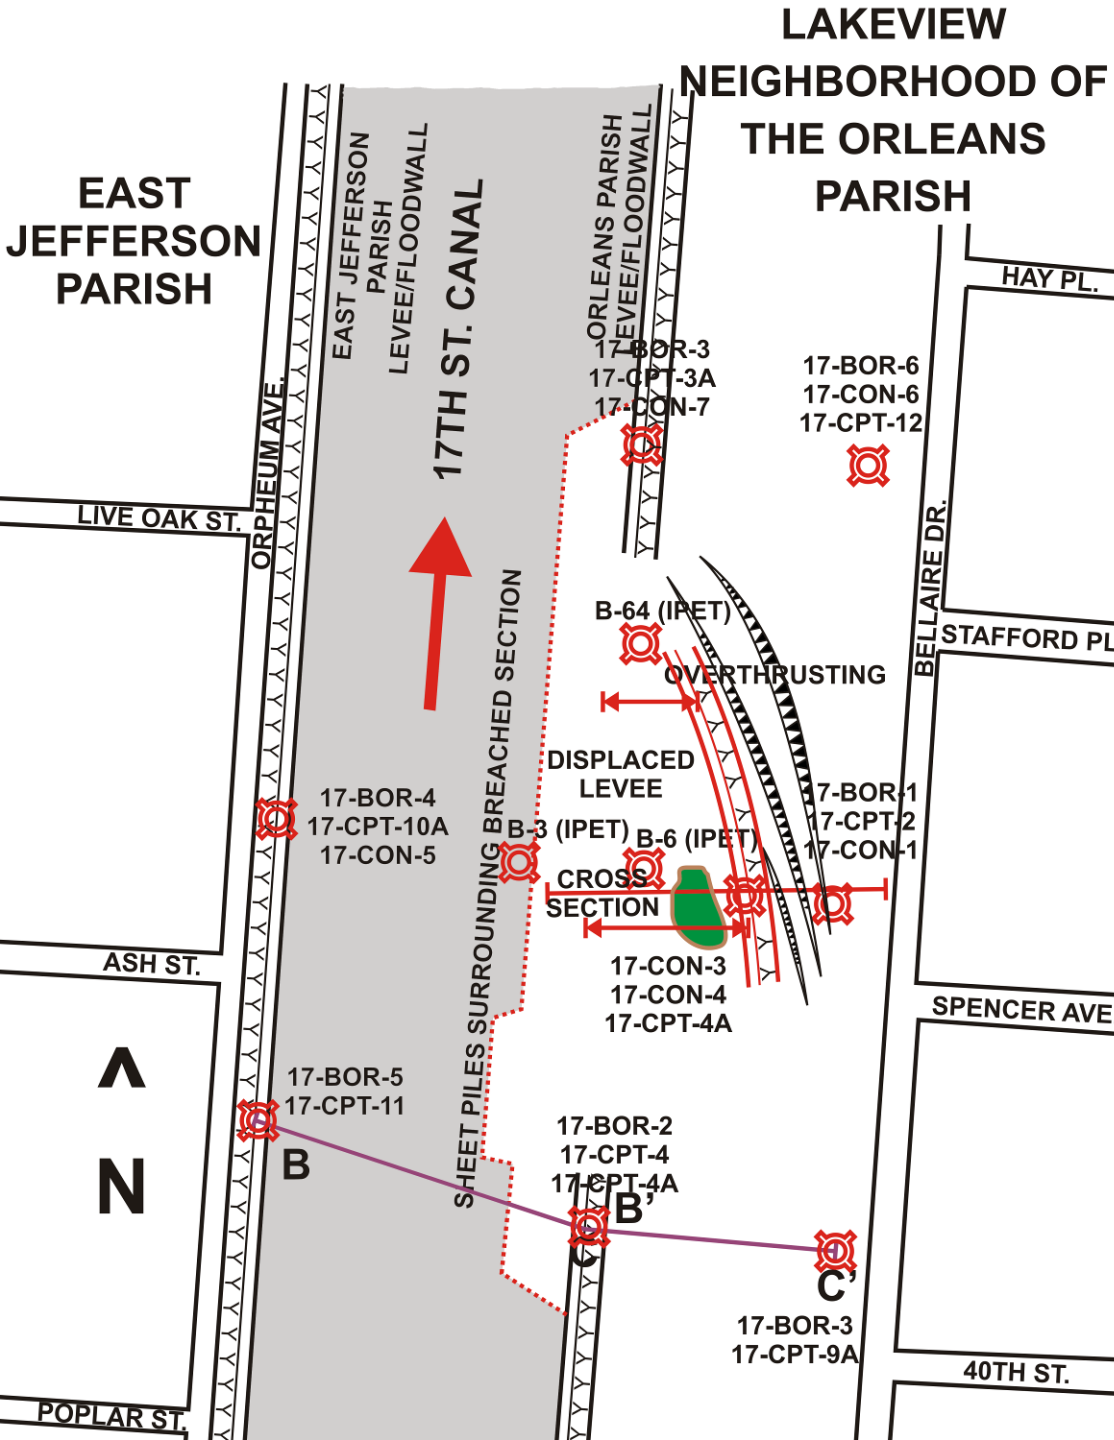
17th St Canal failure area

- Plan view of the 17th Street Canal breach site
- Locations of NSF team borings and CPT soundings noted in red
- The red lines indicate the positions of the NSF team's geologic sections.

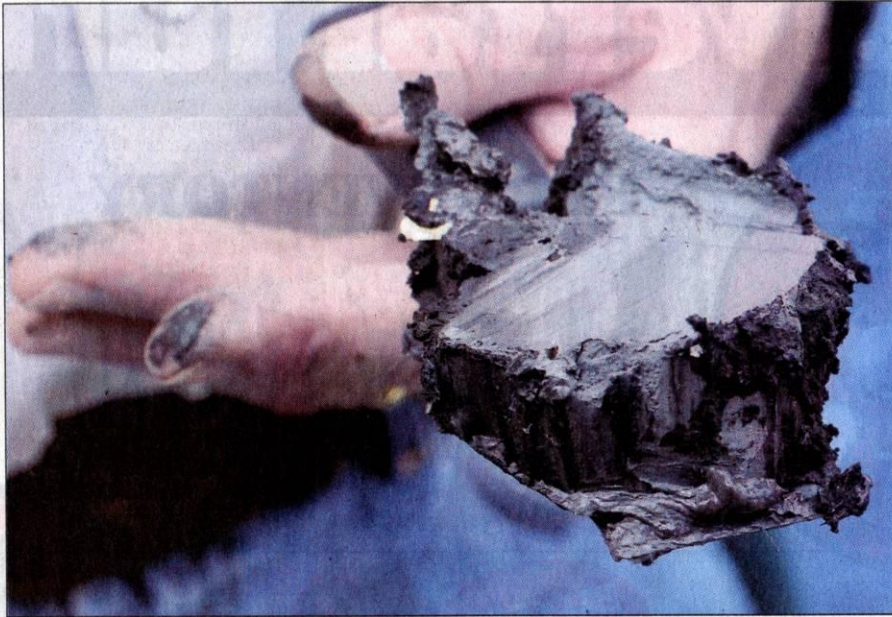
This piece of clay was just above the peat area at the site of the 17th Street Canal floodwall breach.

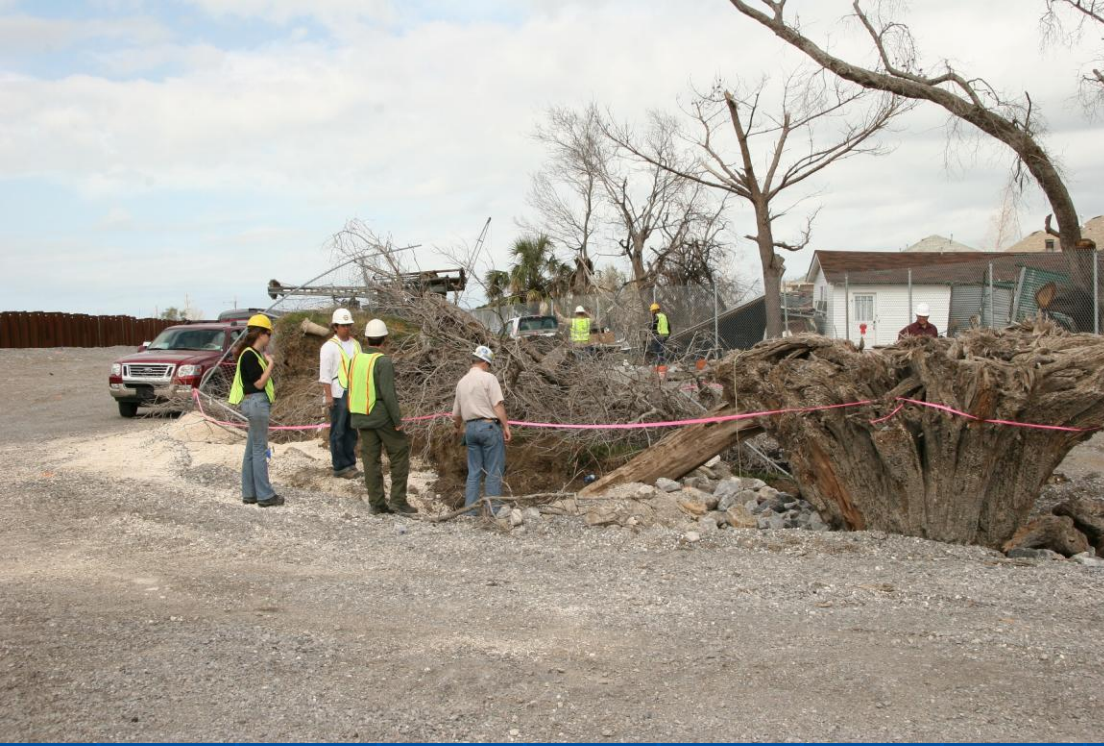
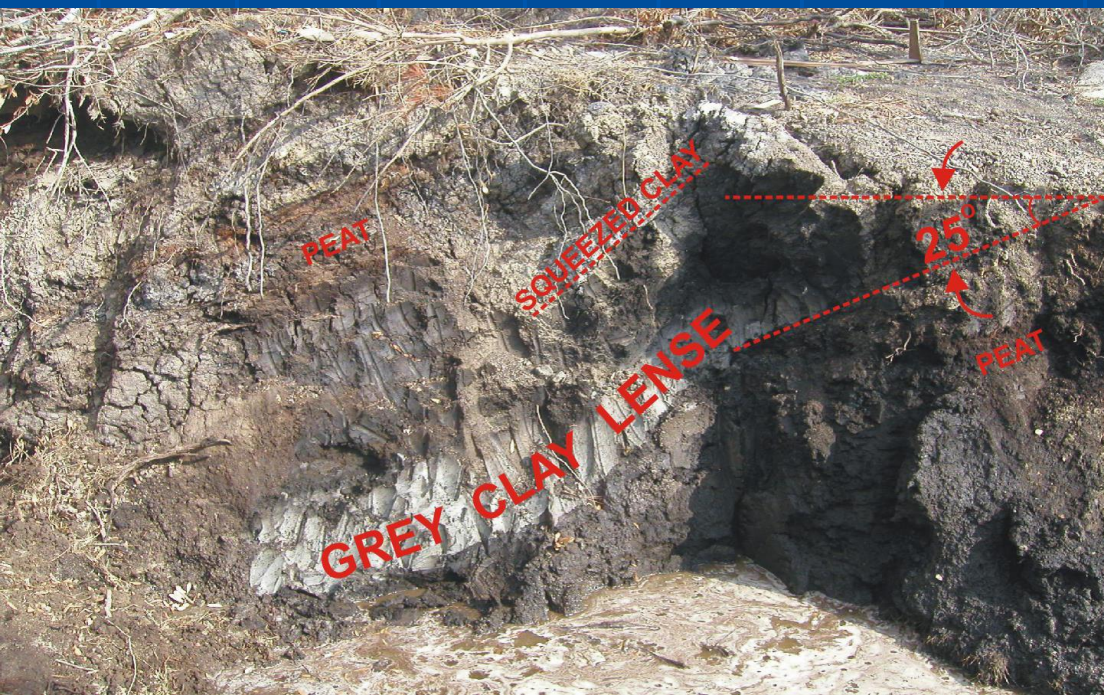
- We examined the displaced block of the 17th Street Levee
- Measured offsets, subsidiary scarps, and took attitudes of slip surfaces and marker beds
- Brunton and tape surveys of thrust plates

As the I-wall tilted, a tension crack, or gap, formed which allowed pore water pressures to be transferred to the passive reaction wedge

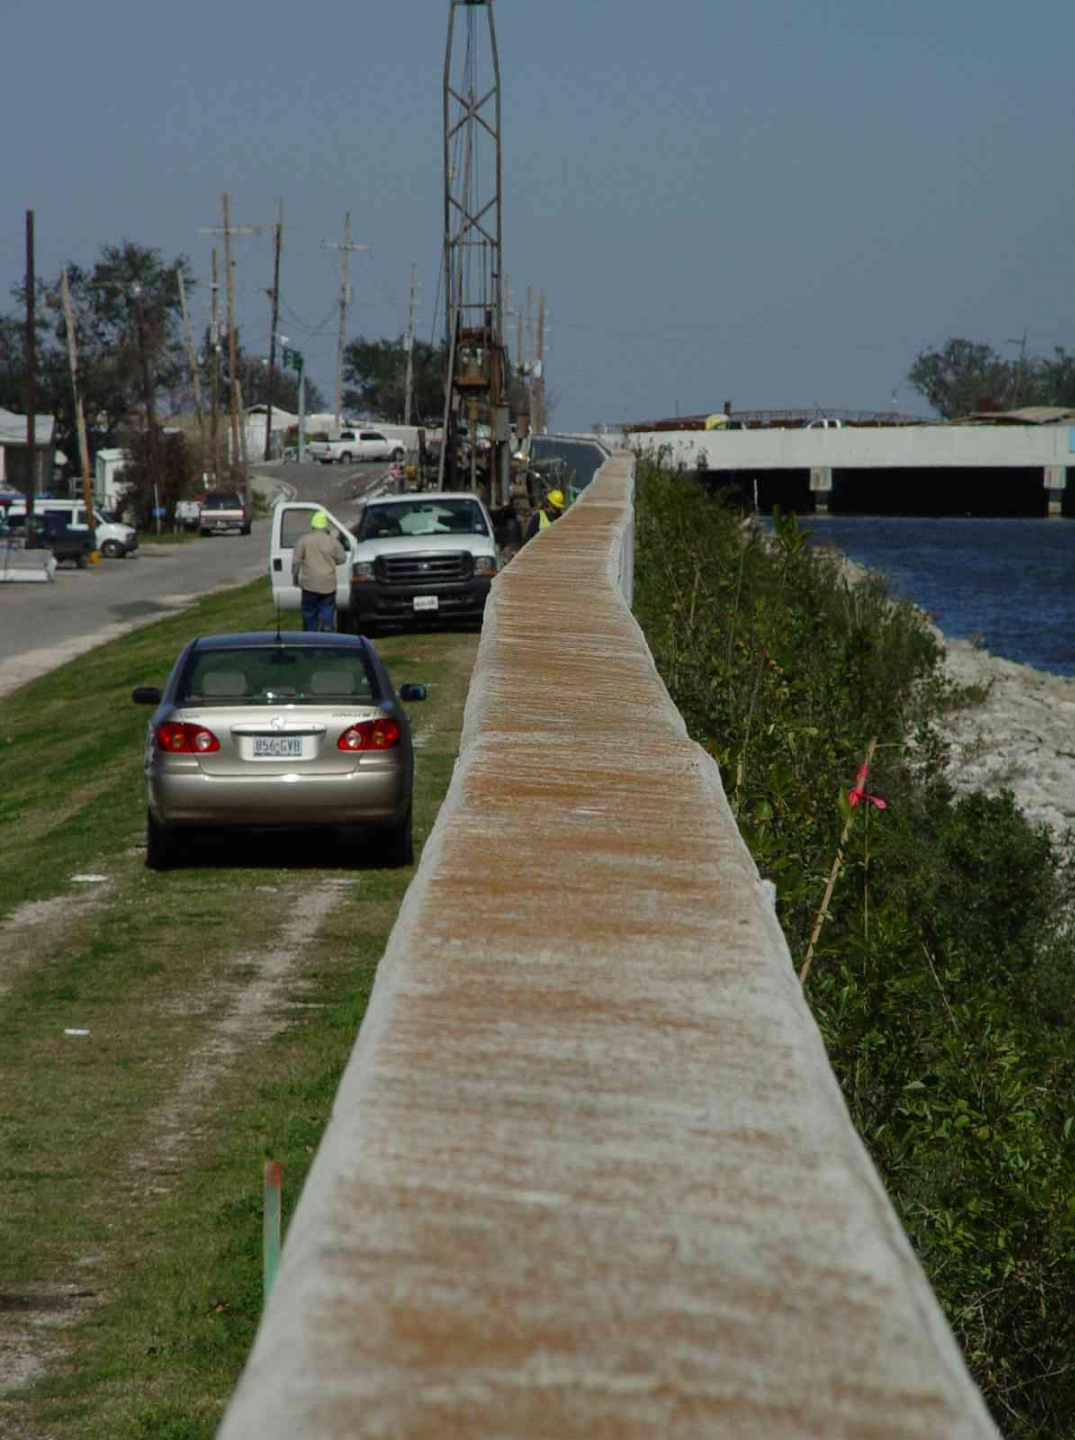
17th Street Canal East Side Analysis

(Water Elev. +12.5 feet)

(FS = 1.3)
