GEOLOGIC INFLUENCE ON FLOOD CONTROL INFRASTRUCTURE DURING HURRICANE KATRINA

J. David Rogers, Ph.D., P.E., P.G.

Missouri University of Science & Technology

October 6, 2011

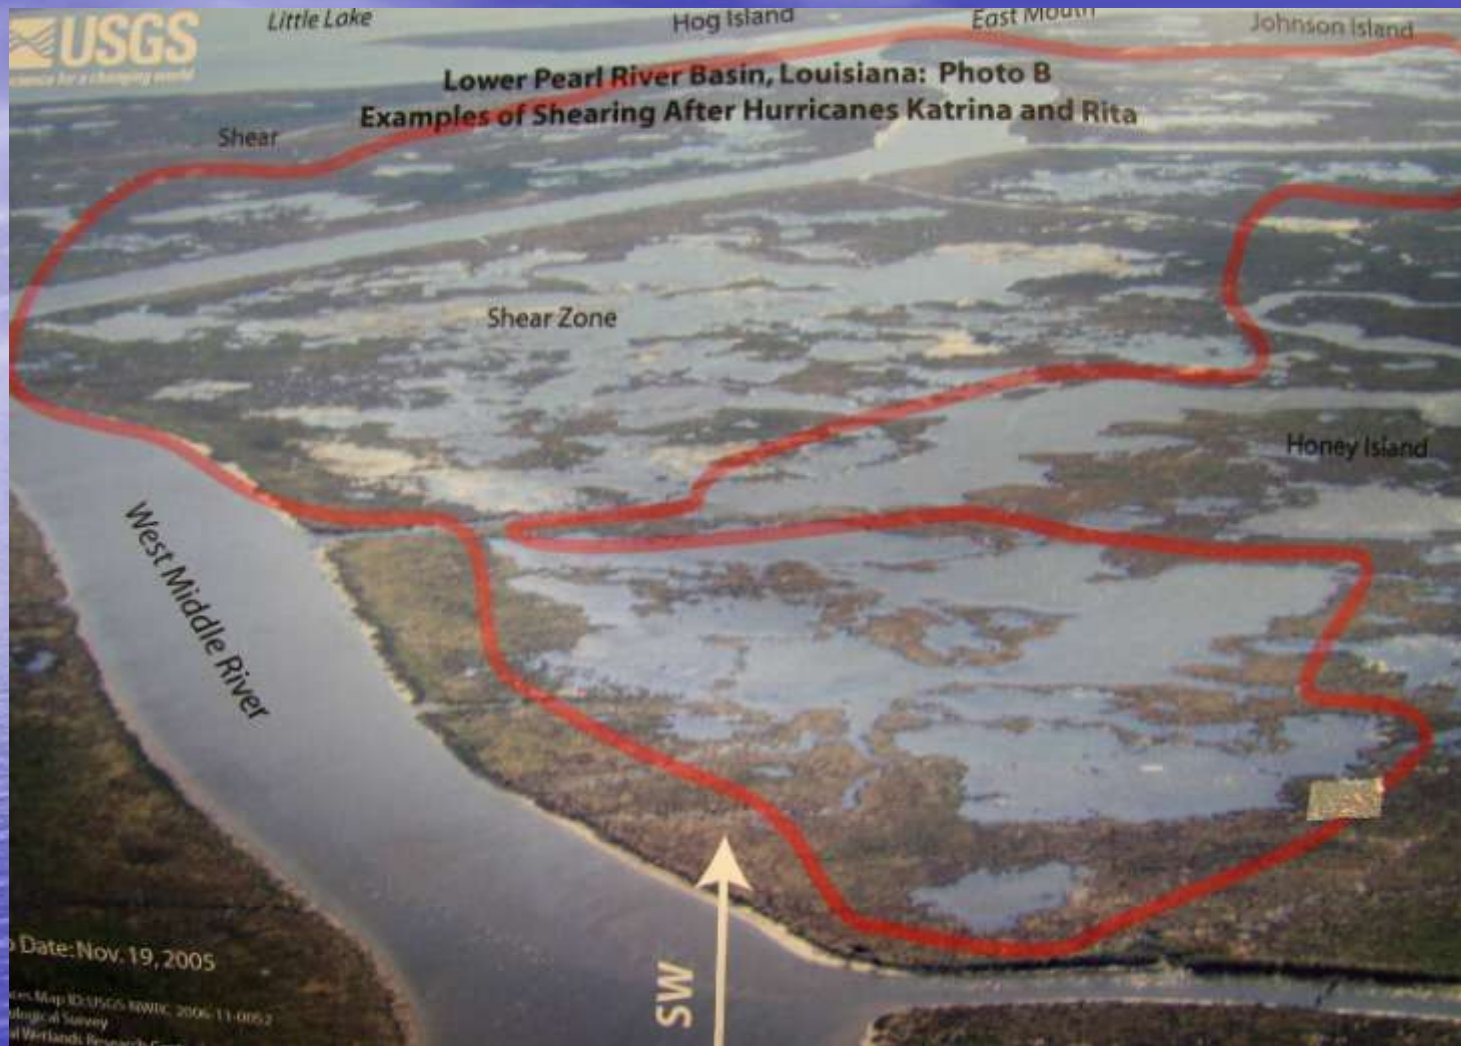
- Acute wind shear from Hurricane Katrina stripped off large tracts of floating marsh across the Mississippi Delta (from USGS). ***How can we construct sustainable levees on these kinds of materials?***

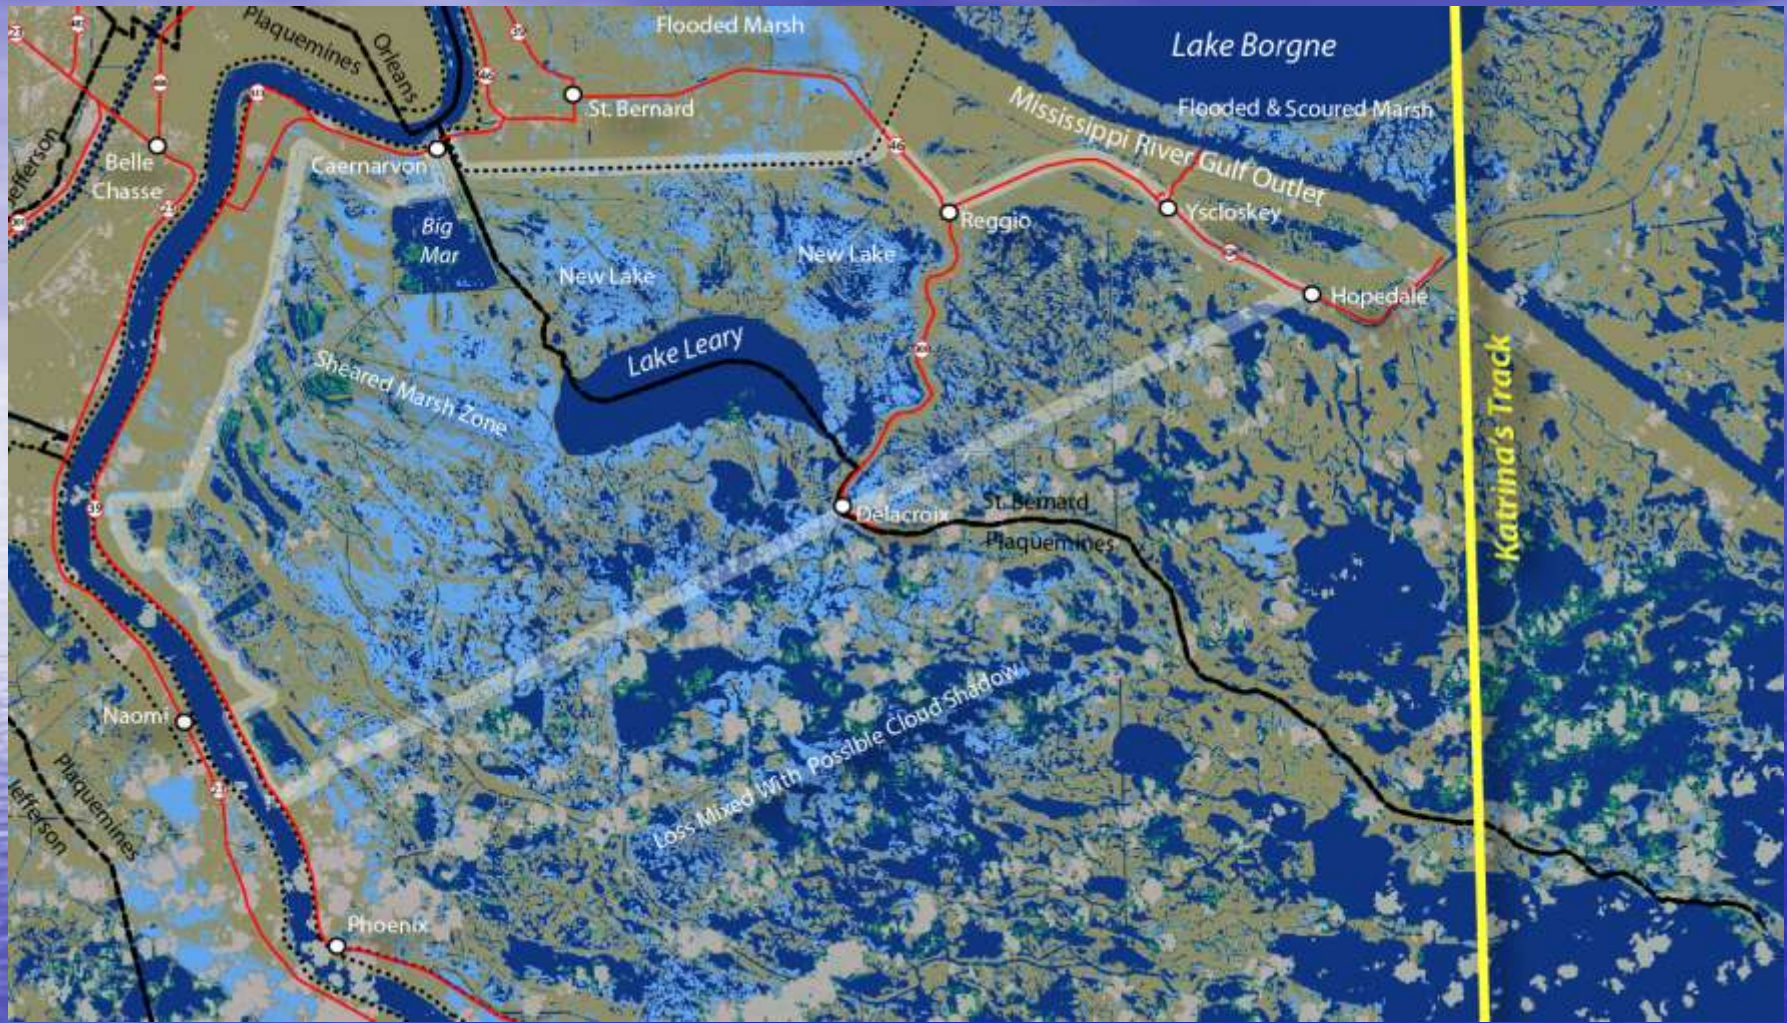
- “Land loss” in Breton Sound (shown in light blue) after Hurricanes Katrina and Rita in 2005 (from USGS-NWRC).

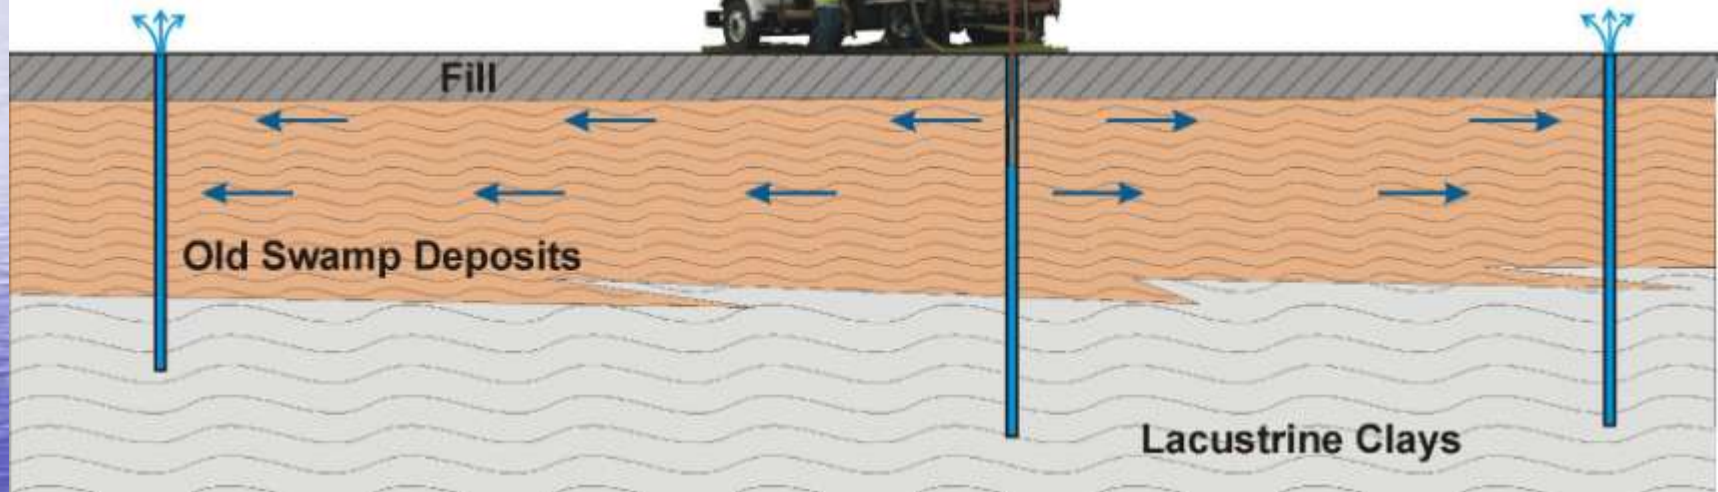
Water squirted up adjacent boreholes when advancing Shelby tubes

Drill rig advancing Shelby tubes in backswamp deposits

- The porous and highly conductive nature of the backswamp deposits was revealed during post-Katrina drilling and sampling operations.
- Highly conductive in horizontal plane

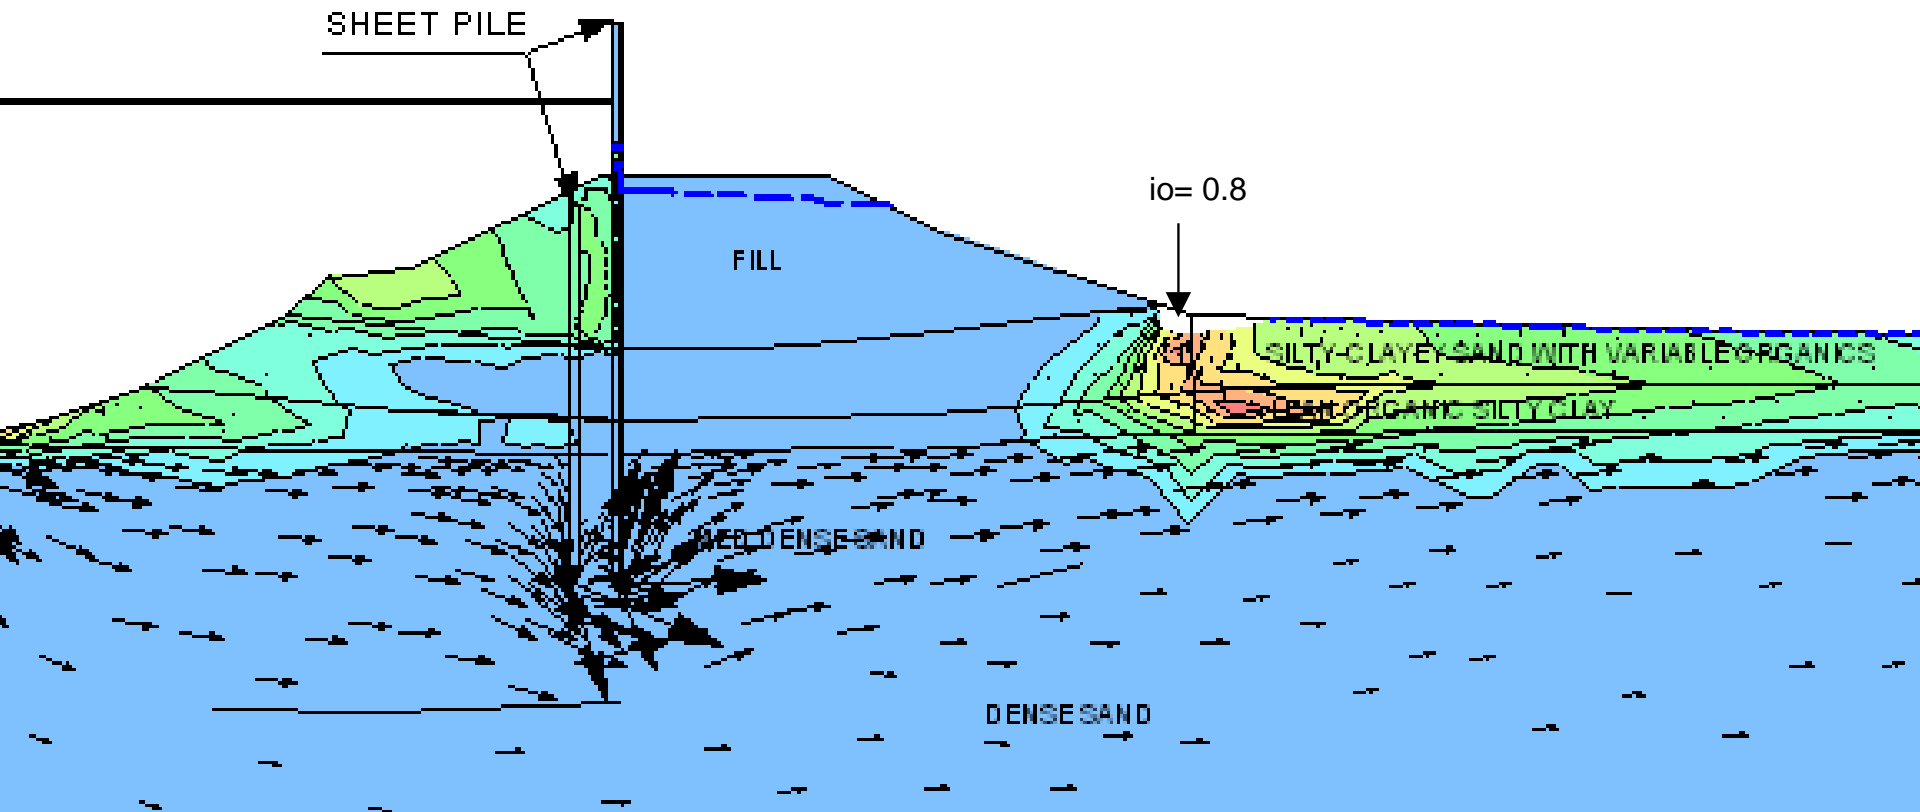
Pervious foundation materials most at risk - London Avenue Canal (South Breach)

Very little reliable data exists on horizontal hydraulic conductivity of foundation soils in the Mississippi Delta

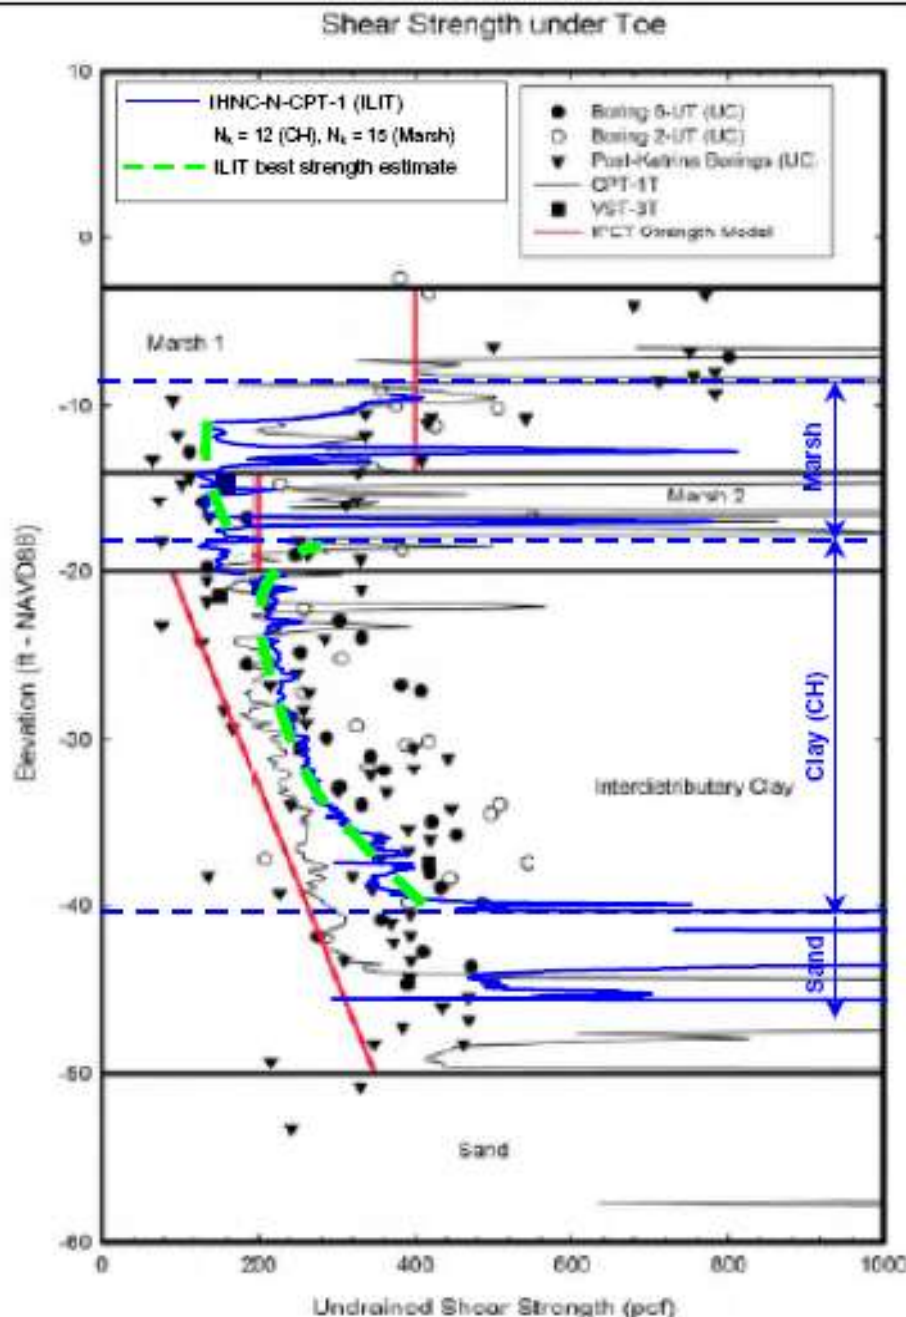
Undrained shear strength vs depth at the East IHNC North Breach

Blue lines shows profile of CPT-1, with NGI tip corrections for the three units encountered

Green line shows strength profile selected by the NSF team

Red lines shows the strength distribution at the toe of the levee calculated by Duncan and Brandon at VPI using an undrained strength ratio of 0.27 and vertical geostatic stresses

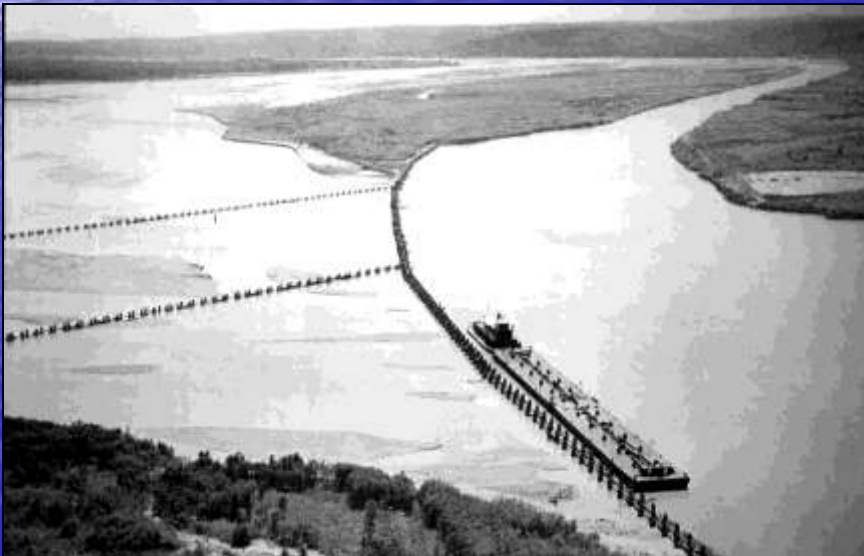
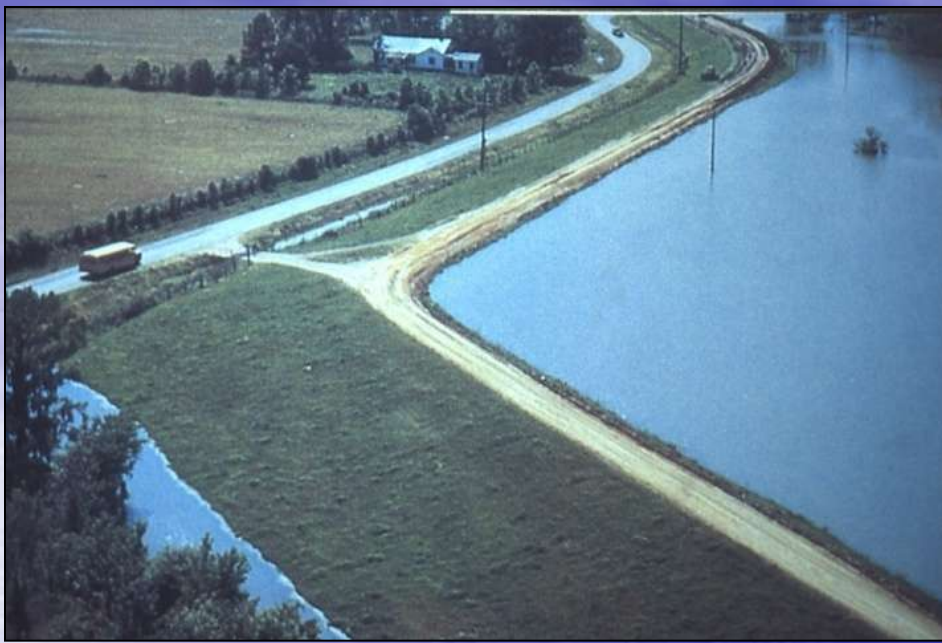
- 700 ft section of levee that slid into the Mississippi River on August 23, 1983 at Darrow, in Ascension Parrish, LA. The slide occurred shortly after a high water stage had receded, suggesting that toe undercutting & rapid drawdown likely contributed to the failure.
- After the MR&T Project was quasi completed in 1960, occasional levee failures have occurred because of **underseepage problems, toe scour, and overtopping**

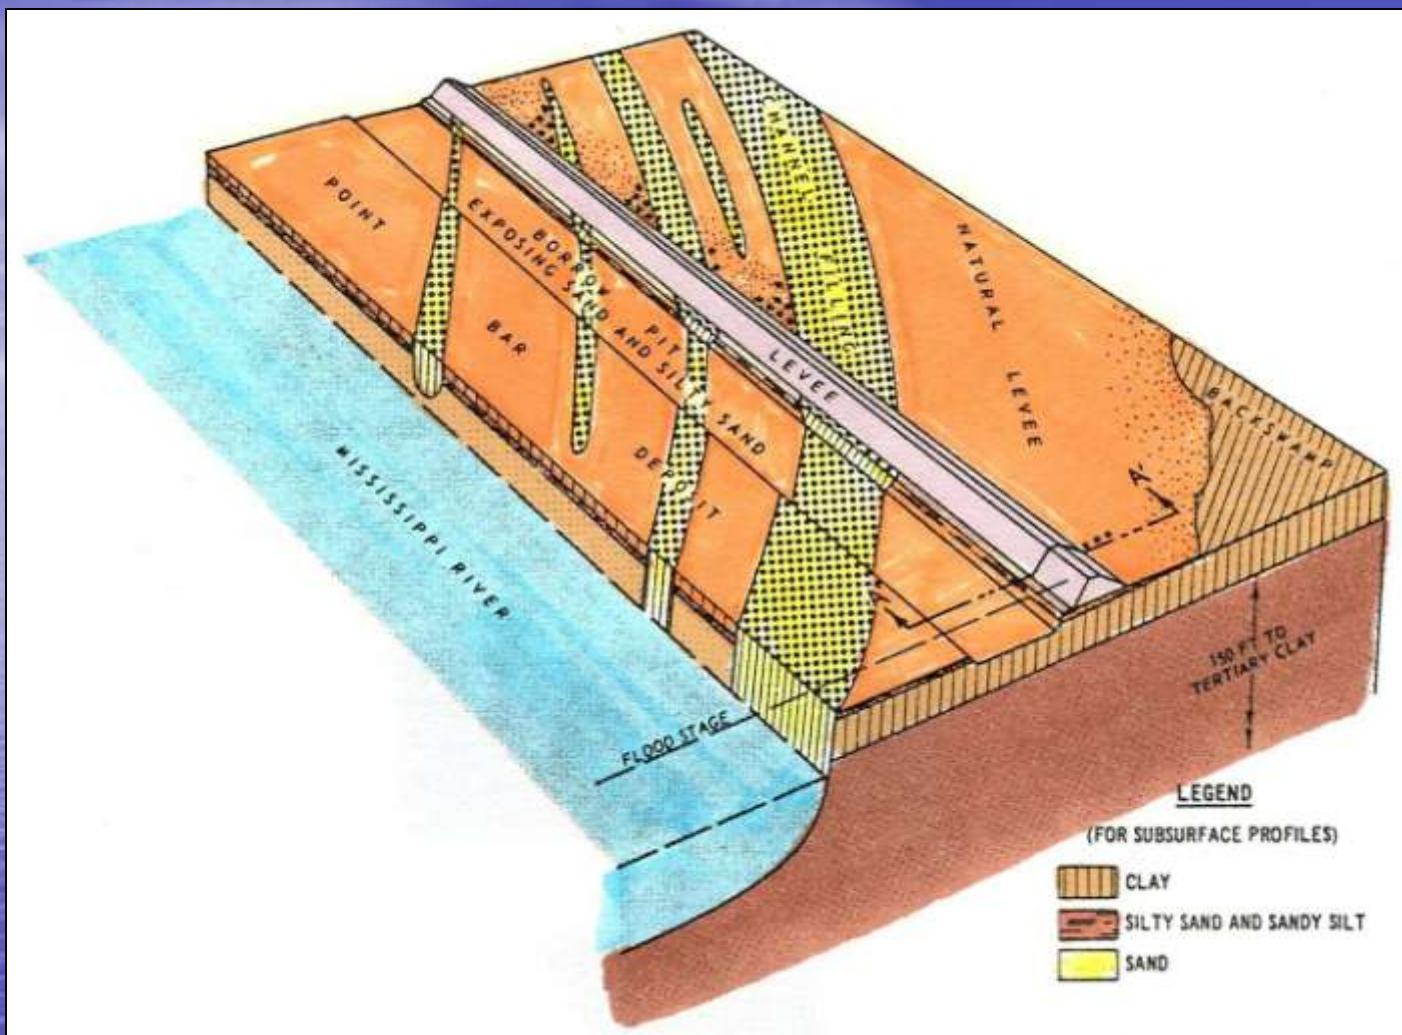
- **Permeability contrasts** caused by clay filled oxbows create treacherous and contrasting foundation conditions beneath levees.

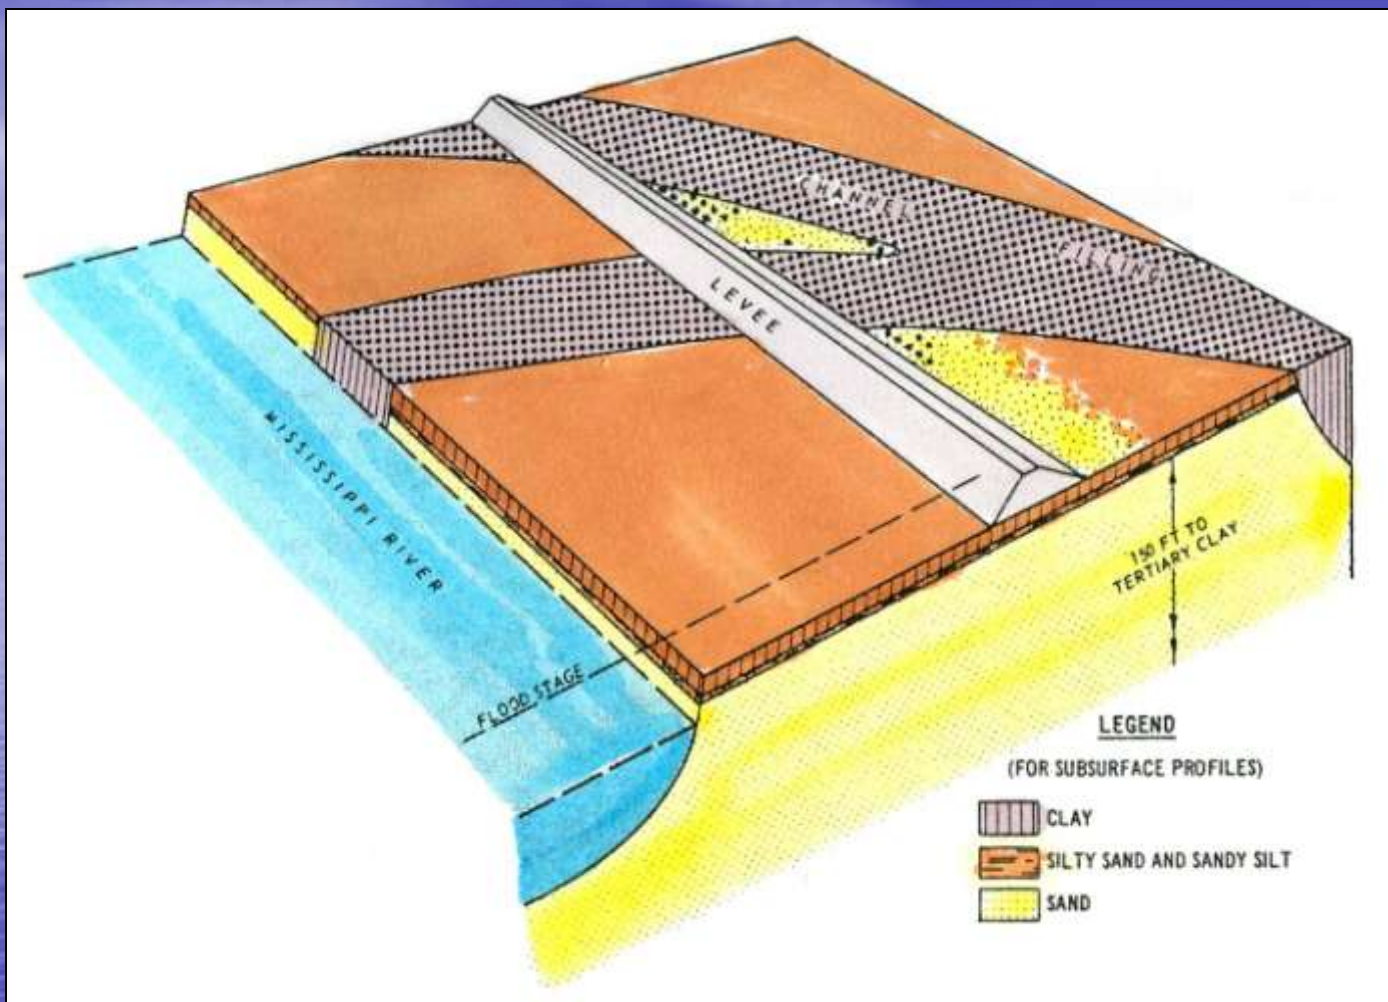
- One of the worst foundation conditions is the '**gore point**' situation depicted here, which is formed between two infilled oxbows.

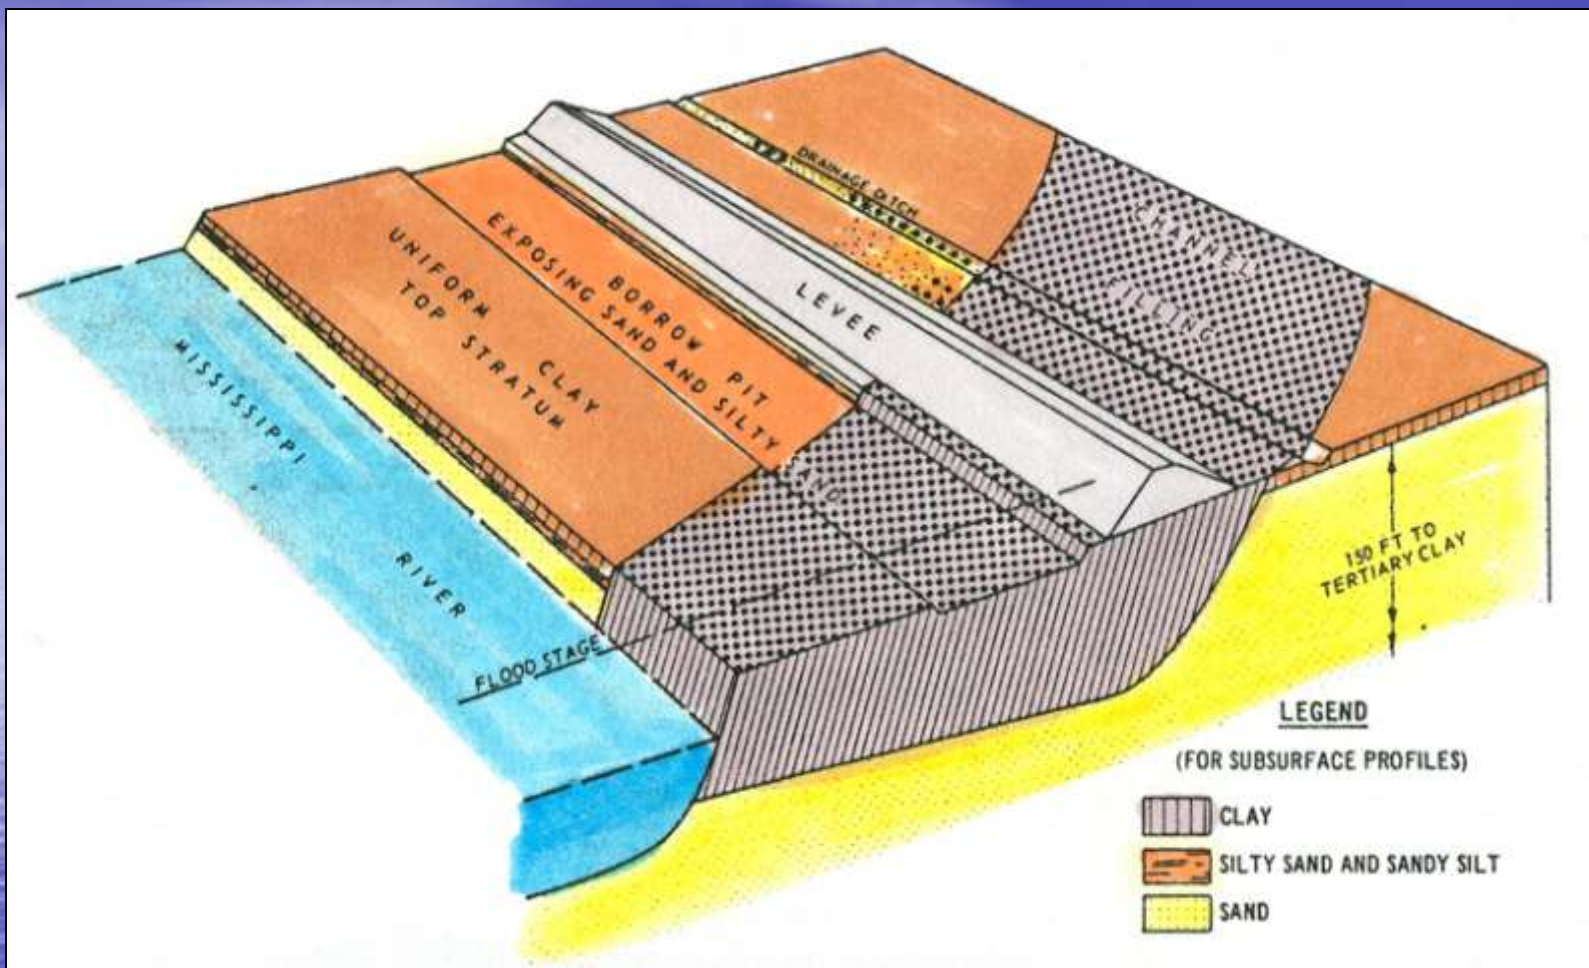
- Clay filled oxbows consolidate under the load imposed by the earthen levees, causing these levees to settle and sink.
- Differential settlement is a major obstacle in maintaining levees.

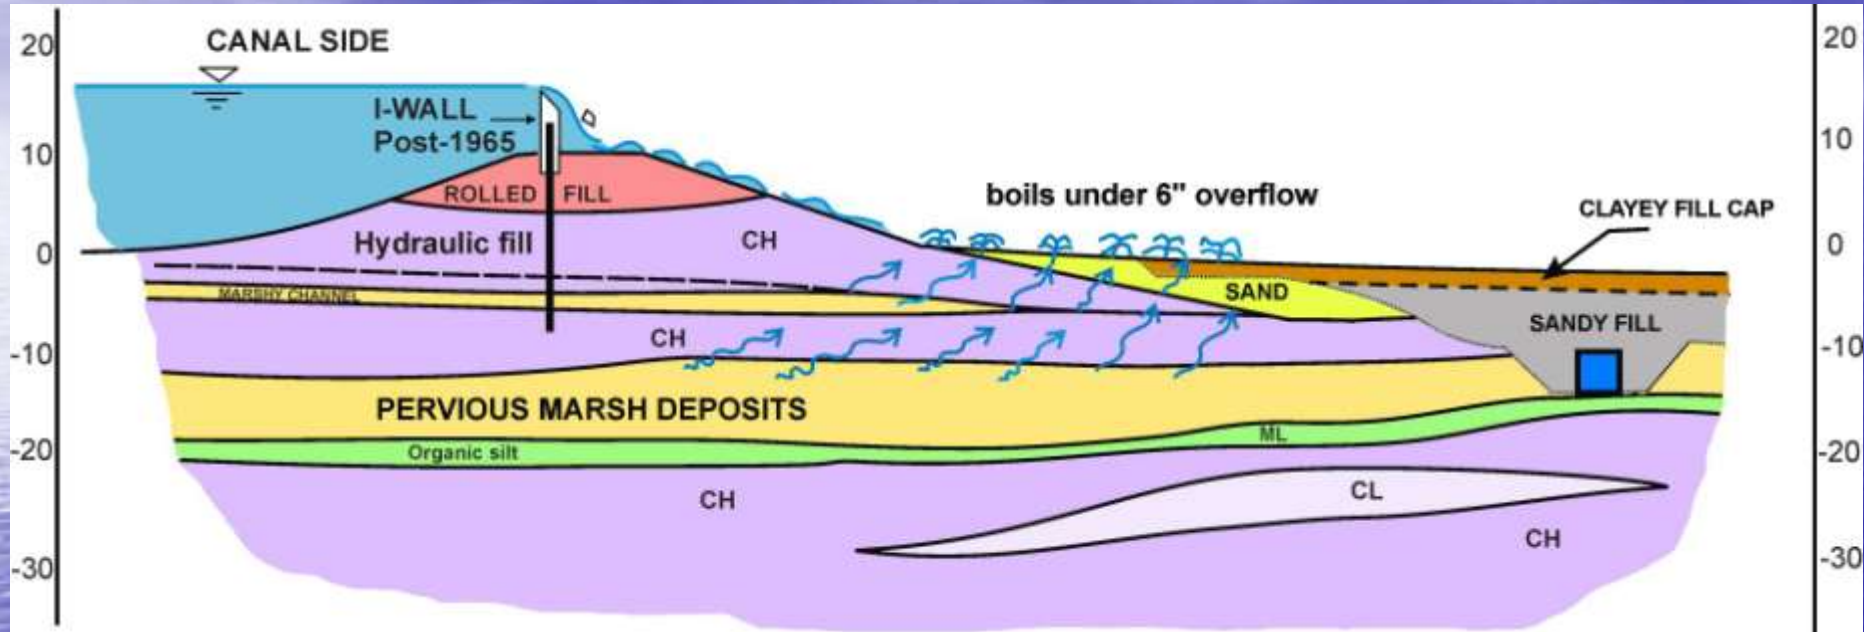
Compound failure modes very common

- The two biggest enemies of earthen levees are: 1) **underseepage** (pore water) pressures; and 2) **time** (flood duration).
- Overtopping often obscures seepage-driven levee foundation failures

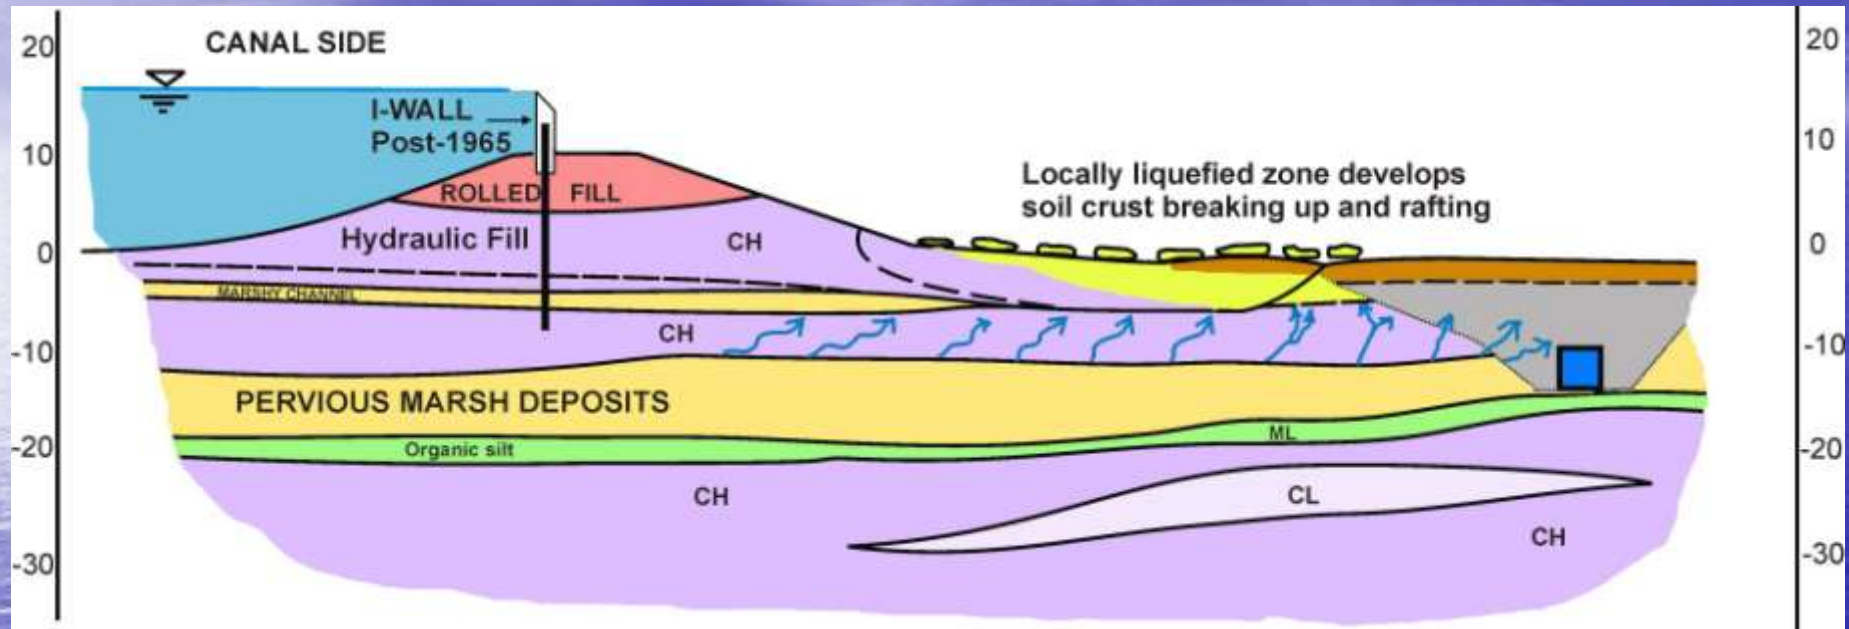
Seepage-induced soil softening

- If the hydraulic gradient exceeds 0.75, the foundation can begin to experience localized partial liquefaction, or *soil softening* – which is a failure mechanism common in cohesionless materials.

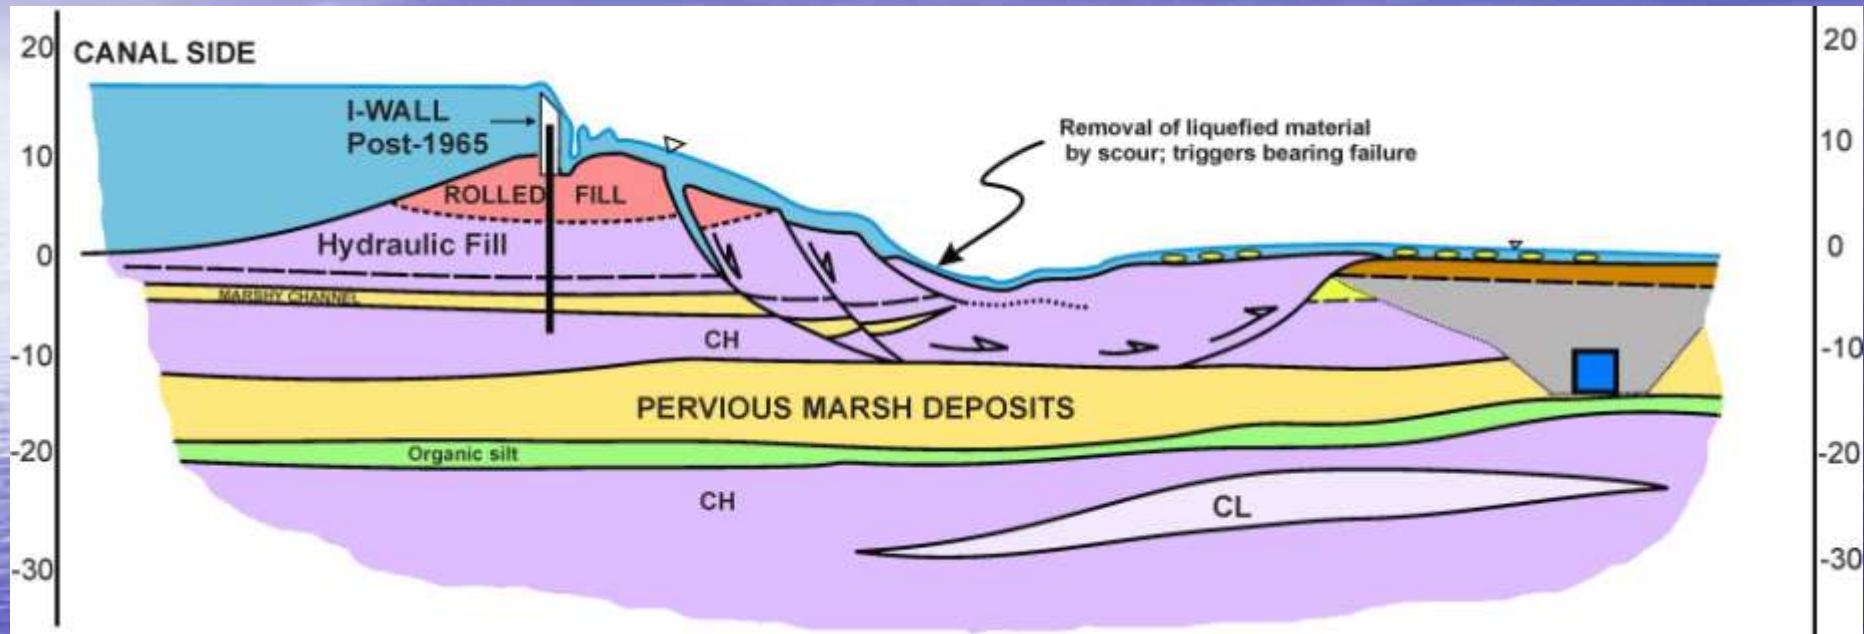
... followed by Local Bearing Capacity Failure

- The loss of soil shear strength in the levee's land side toe area can trigger a massive slope failure on the outboard side of the levee.

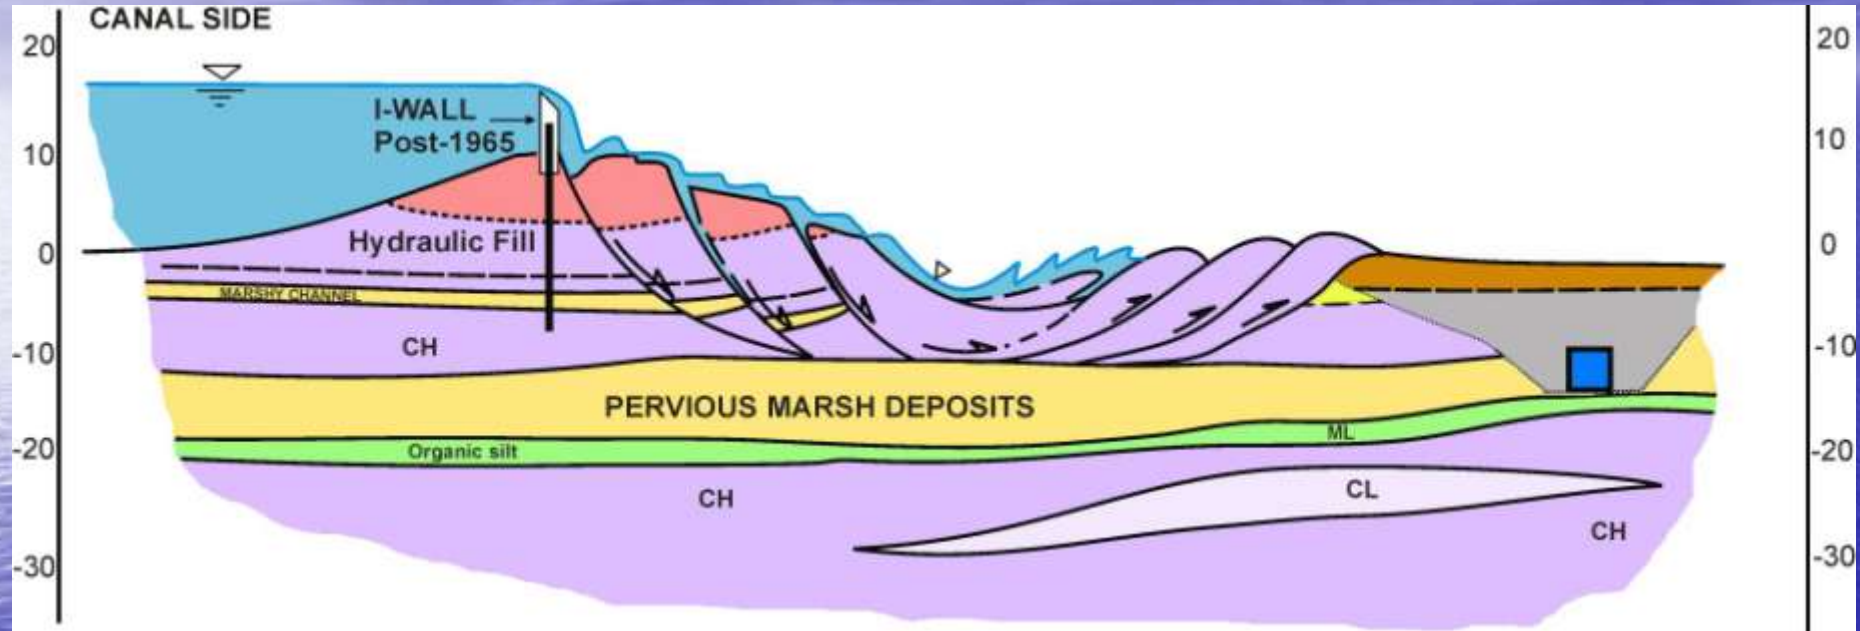
... followed by Retrogressive Slope Failure

- The loss of foundation bearing capacity can trigger a series of retrogressive slope failures, as sketched here. Four critical mechanisms may occur more or less simultaneously. Analytical programs not currently set up to analyze concurrent failure modes.

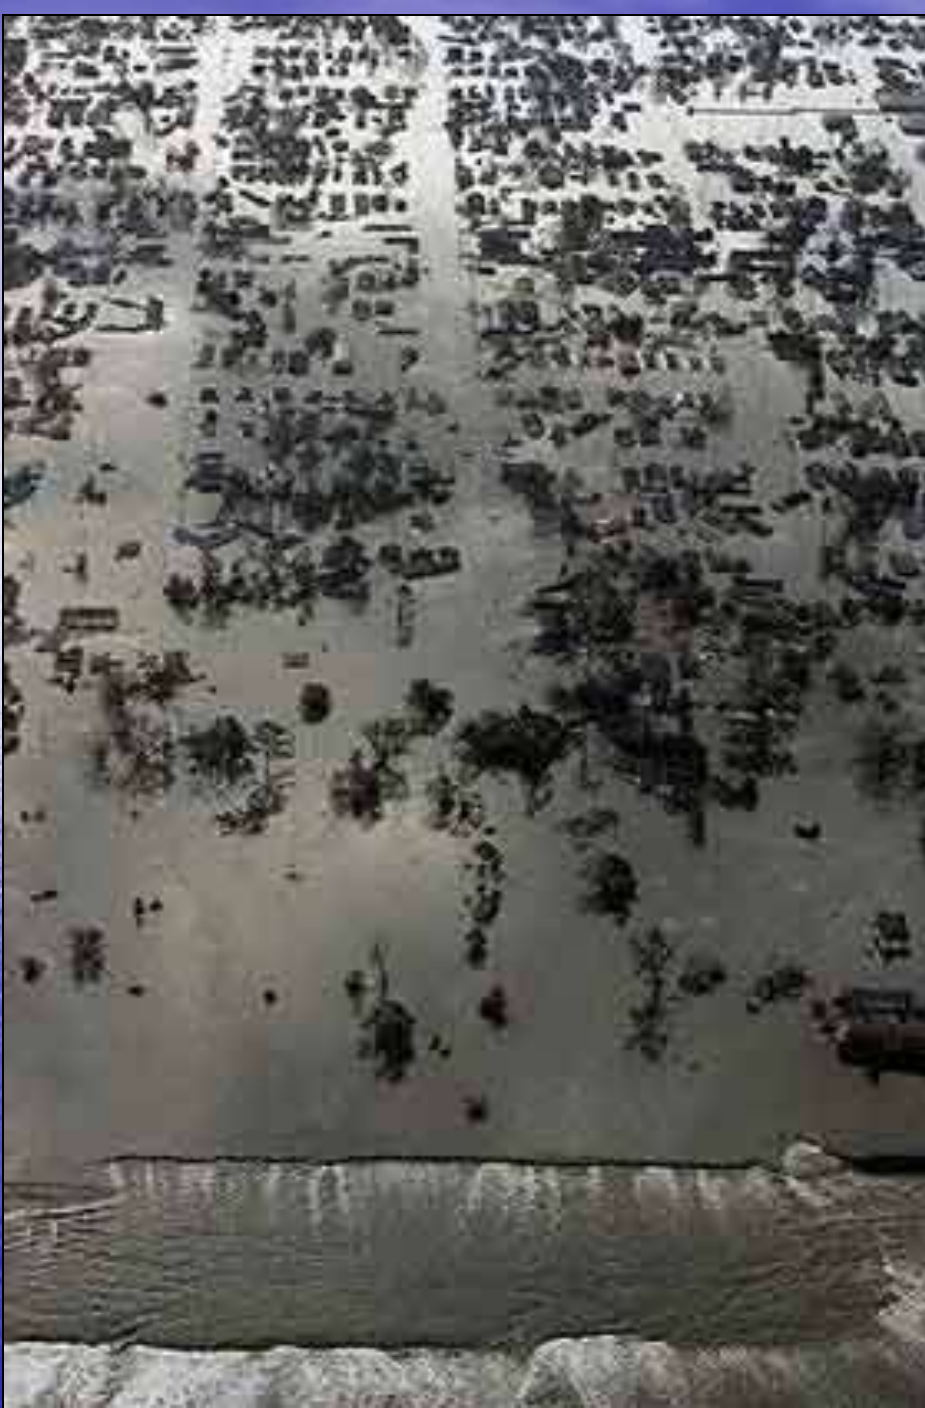
Once flood waters overtop an embankment they quickly scour the land-side toe of the embankment, and deep scour holes develop on either side of the “hydraulic jump” that forms at the point of overflowage, enlarging the breach, as shown here.

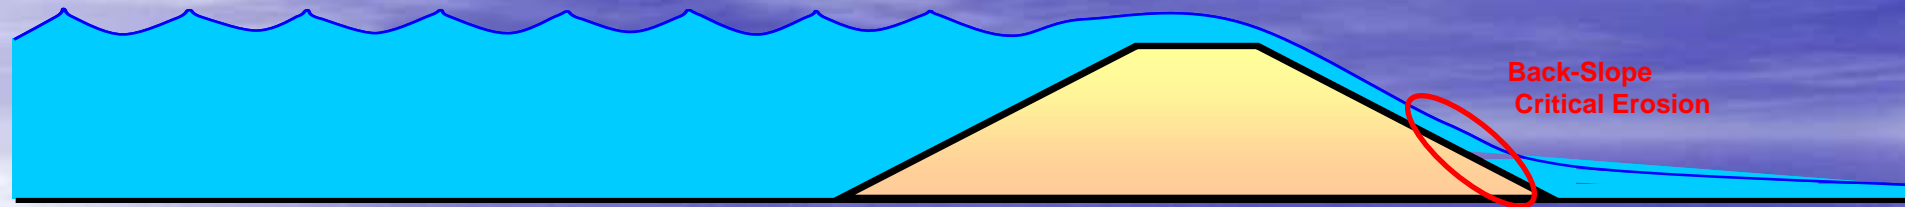
Velocity-induced scour at toe of back slope, at flow transition. Accelerates when vegetation stripped off, depending on **cohesion** of embankment materials

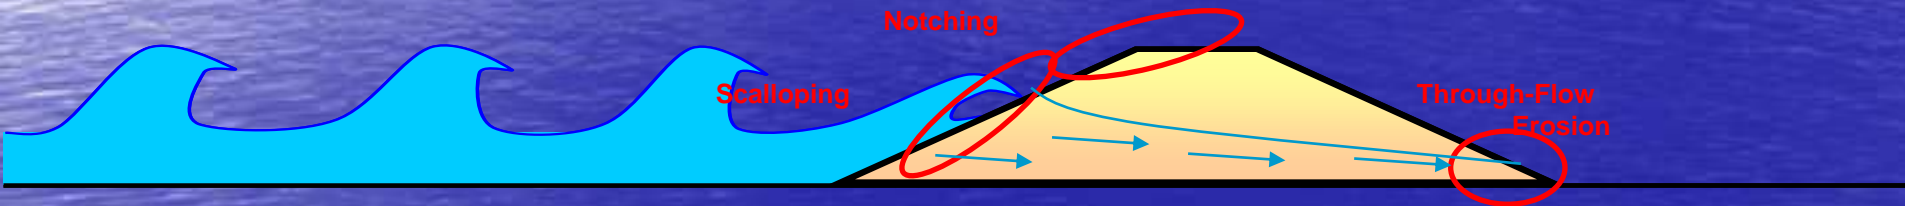
Scalloping and notching on the fetch side of the levee, due to wave pounding; and piping fomented by emergent seepage at the toe of the back slope

Note: damage at back slope toe looks similar for both modes

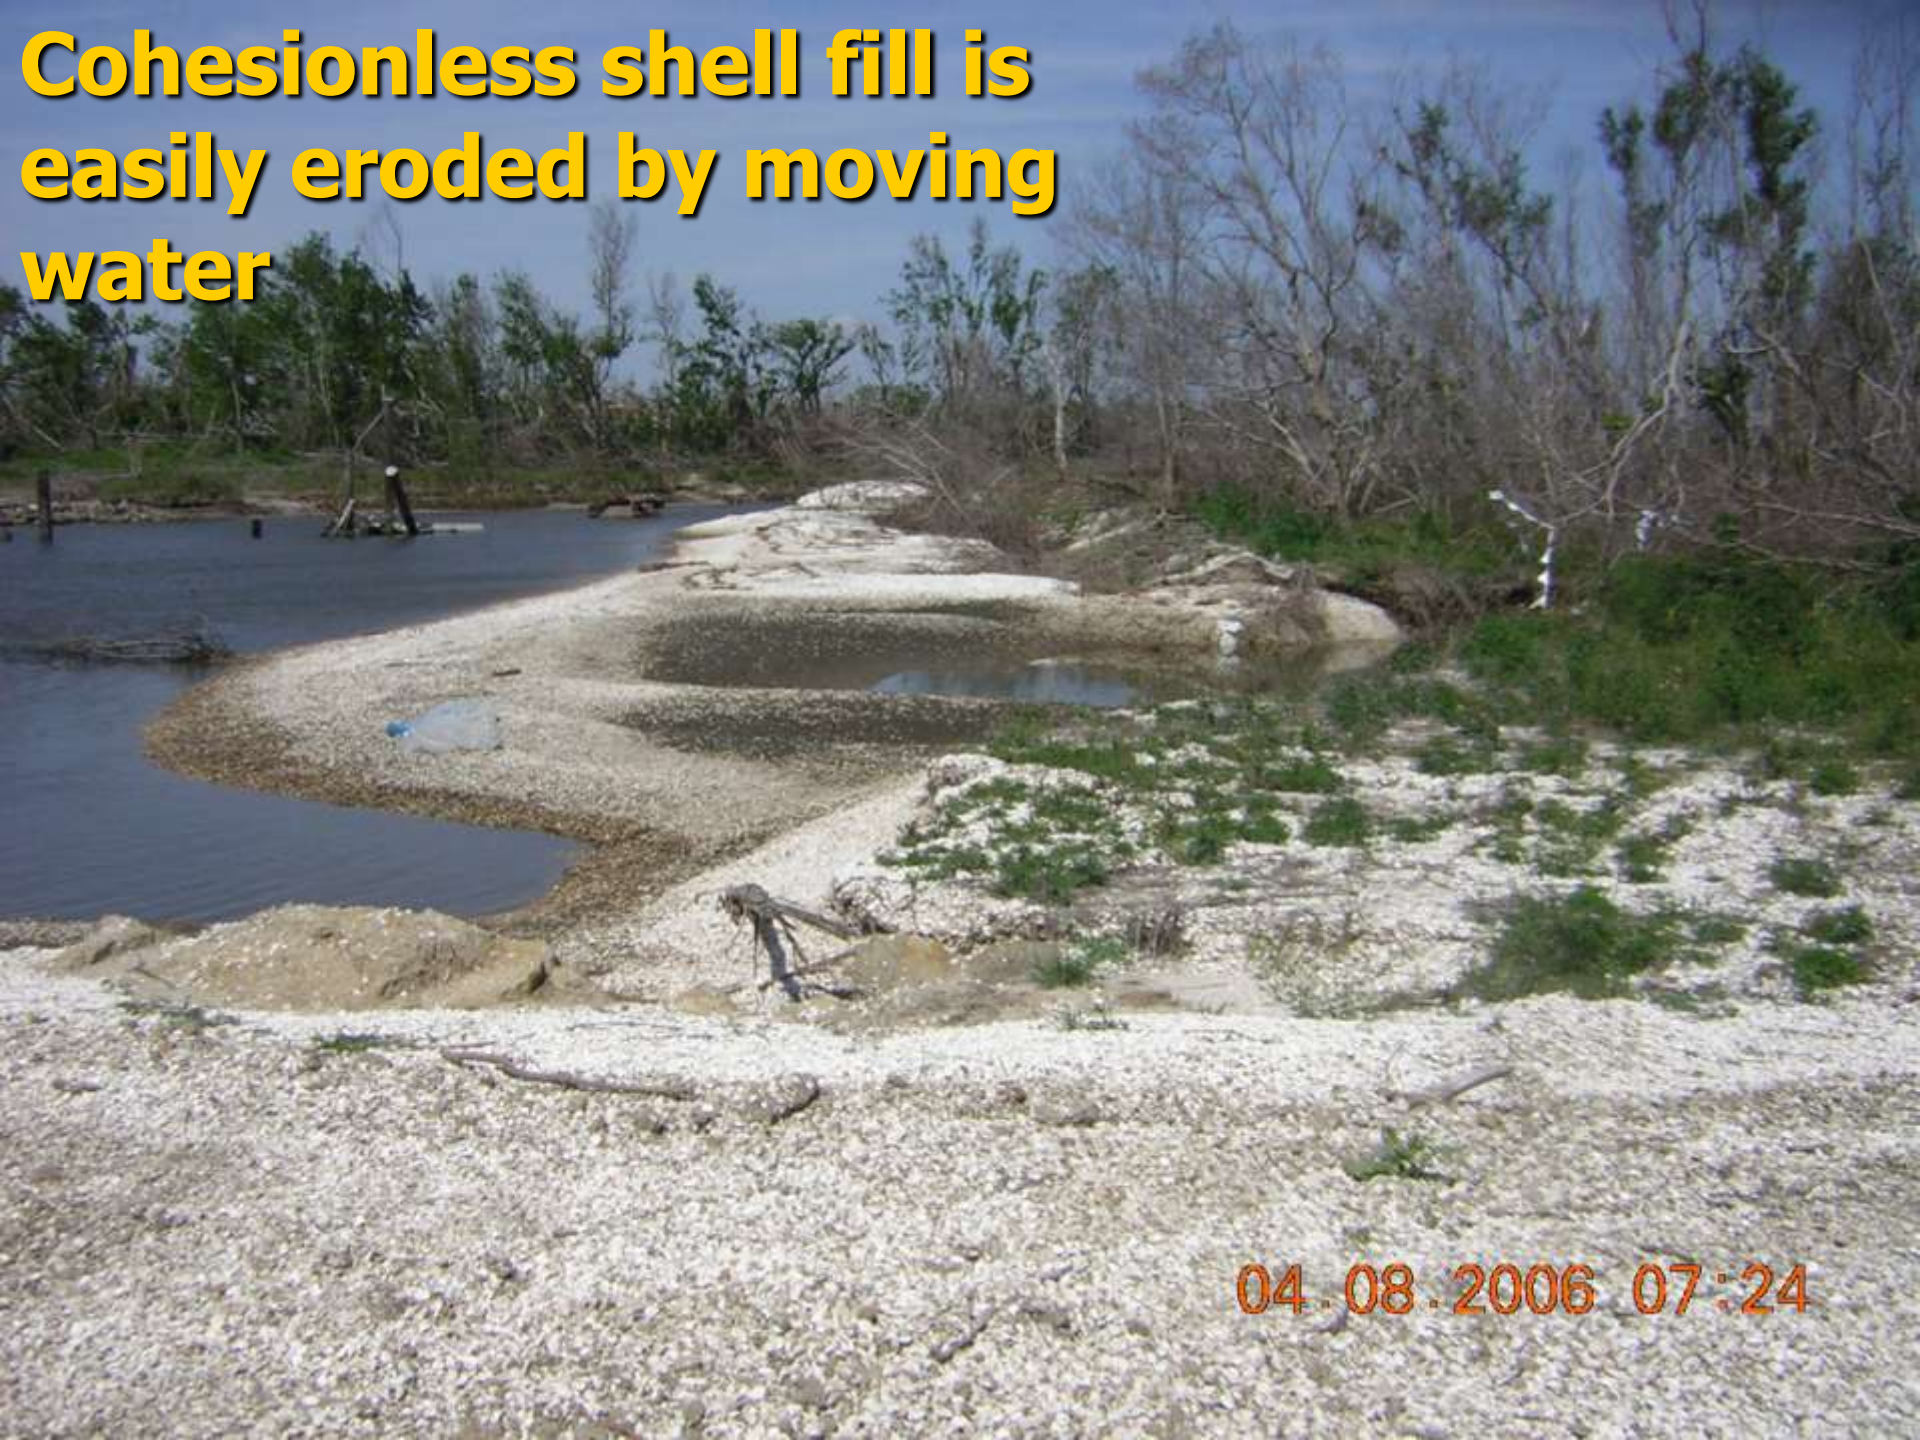
Cohesionless shell fill is easily eroded by moving water
