GEOLOGIC INFLUENCE ON FLOOD CONTROL INFRASTRUCTURE DURING HURRICANE KATRINA

J. David Rogers, Ph.D., P.E., P.G.

Missouri University of Science & Technology

October 6, 2011

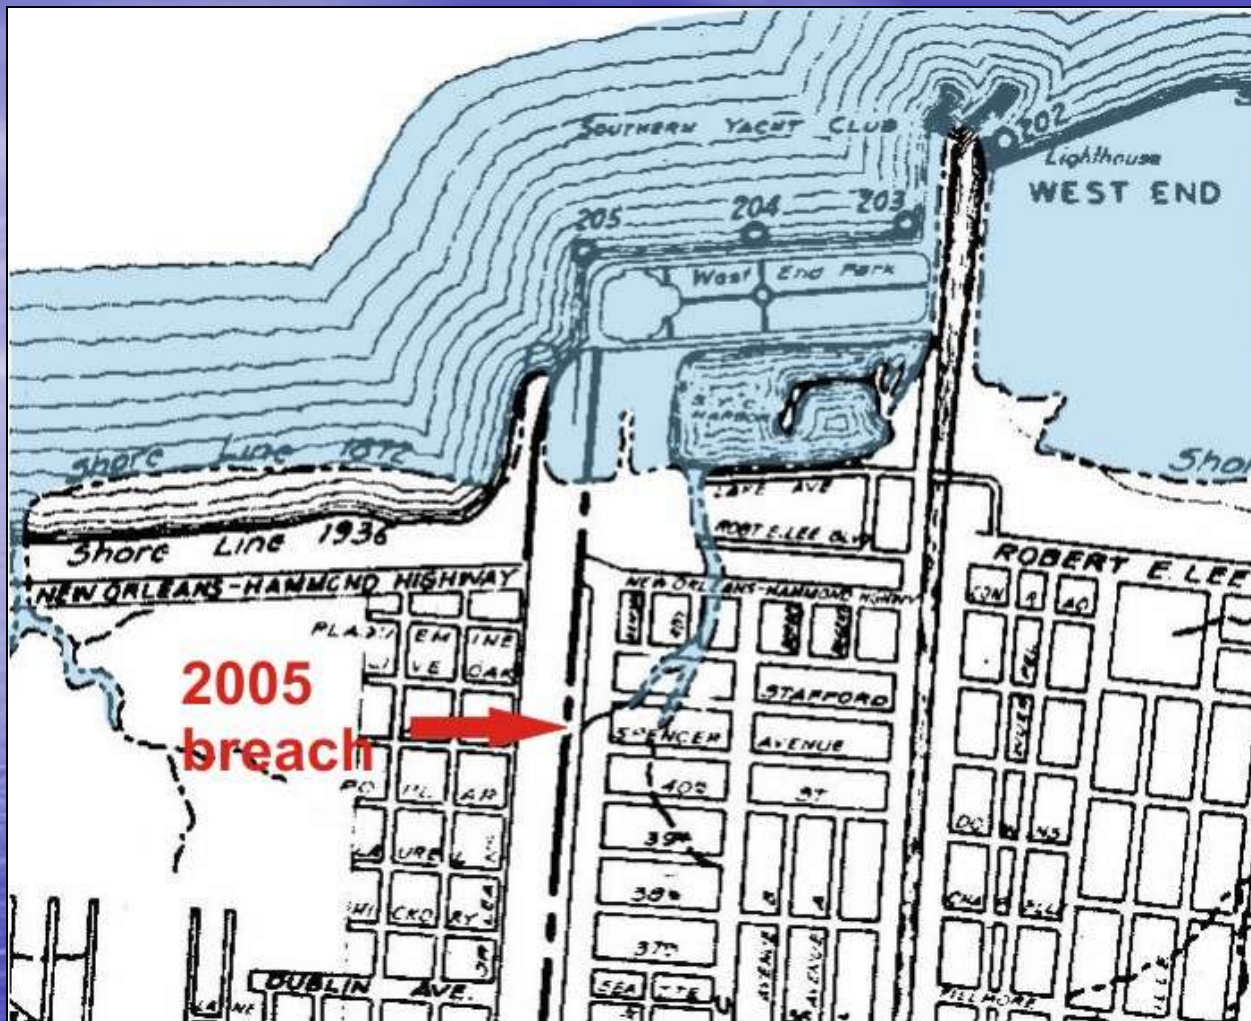
- **Overlay of 1872 map by Valery Sulakowski on the WPA-LA (1937) map, showing the 1872 shoreline and sloughs (in blue) along Lake Pontchartrain. Although subdivided, only a few structures had been built in this area prior to 1950. The position of the 1947 and 2005 breaches along the 17th Street Canal are indicated by the red arrow.**

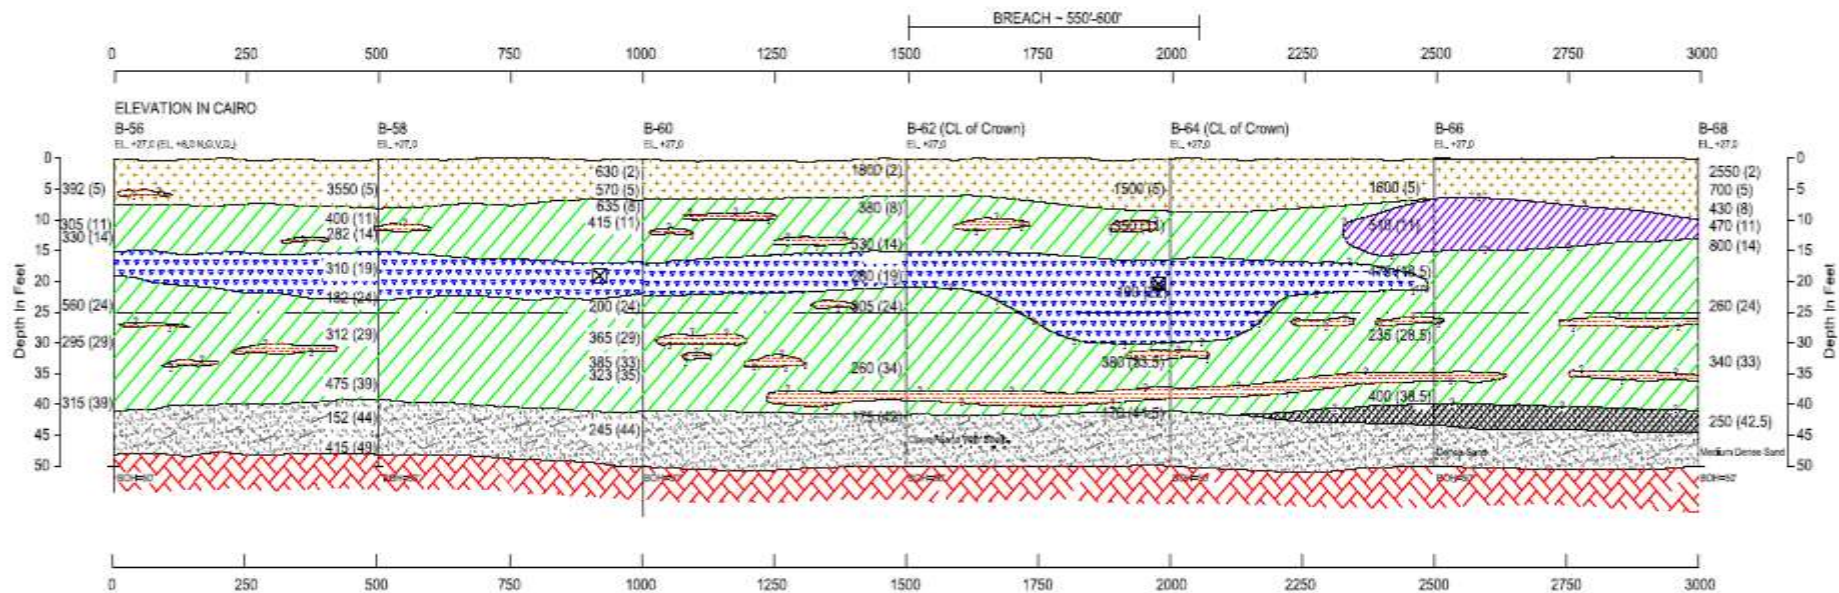
17th Street Canal East Levee- Draft Soil Profile
 New Orleans, Louisiana

- **Alternative interpretation of the Eustis 1982 borings for the 17th Street Canal East Levee, near the 2005 break**

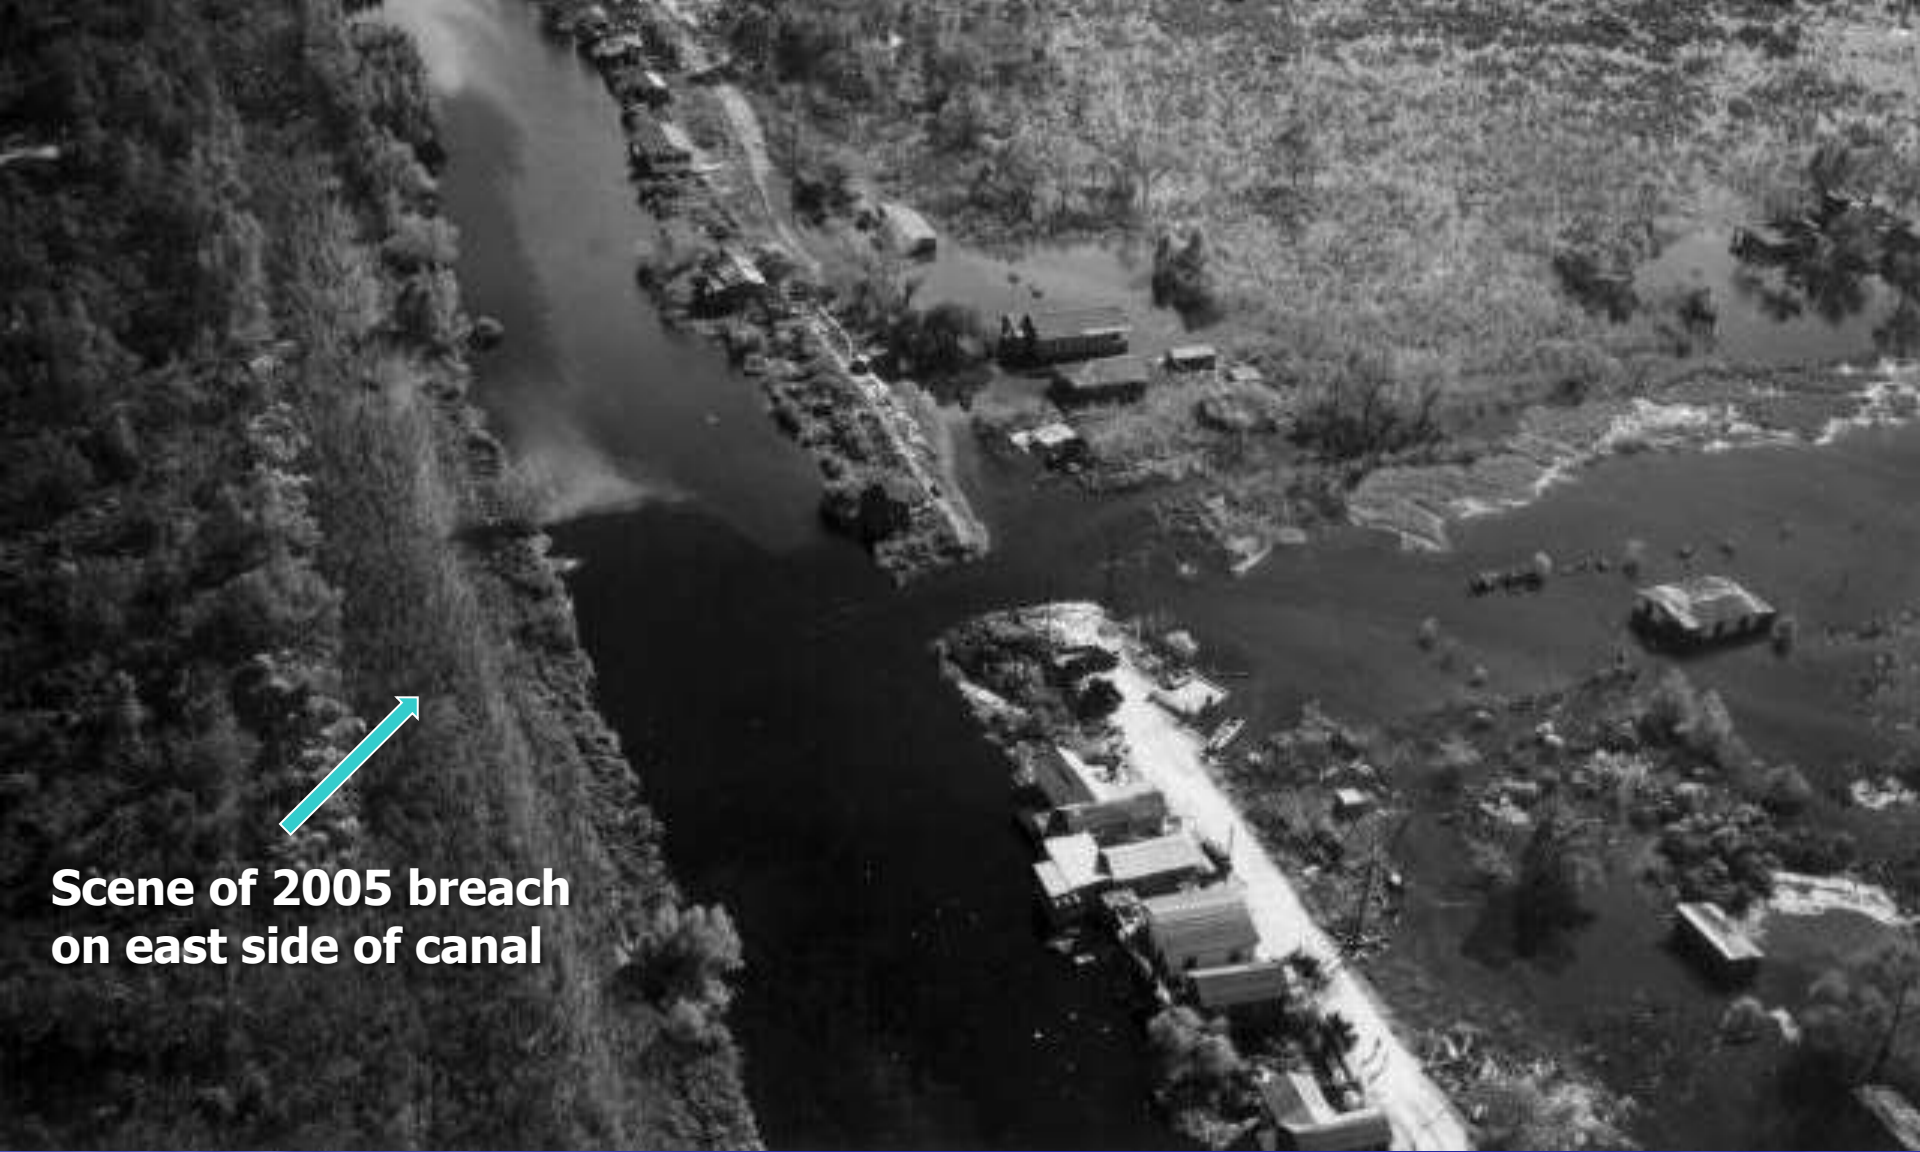
**Scene of 2005 breach
on east side of canal**

- Flooding of Jefferson Parish and Metairie in the 1947 hurricane was allowed by a forced breach on the west side of the 17th Street Canal, across from site of the 2005 breach (blue arrow).**

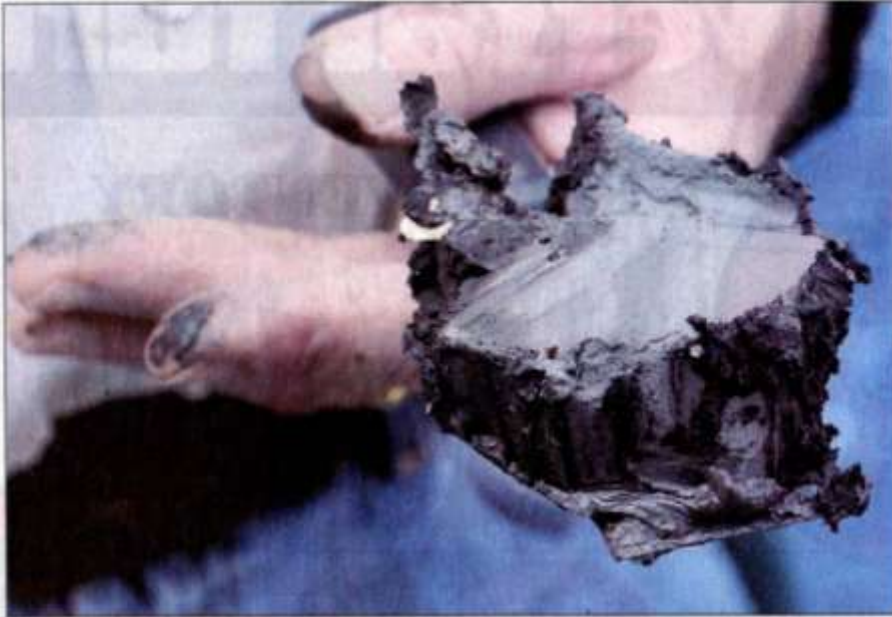
This piece of clay was just above the peat area at the site of the 17th Street Canal floodwall breach.
