Overview and History of the Taum Sauk Pumped Storage Project Reynolds County, Missouri

**J. David Rogers, Conor Watkins, and
David J. Hoffman**

Missouri University of Science and Technology – Rolla, MO

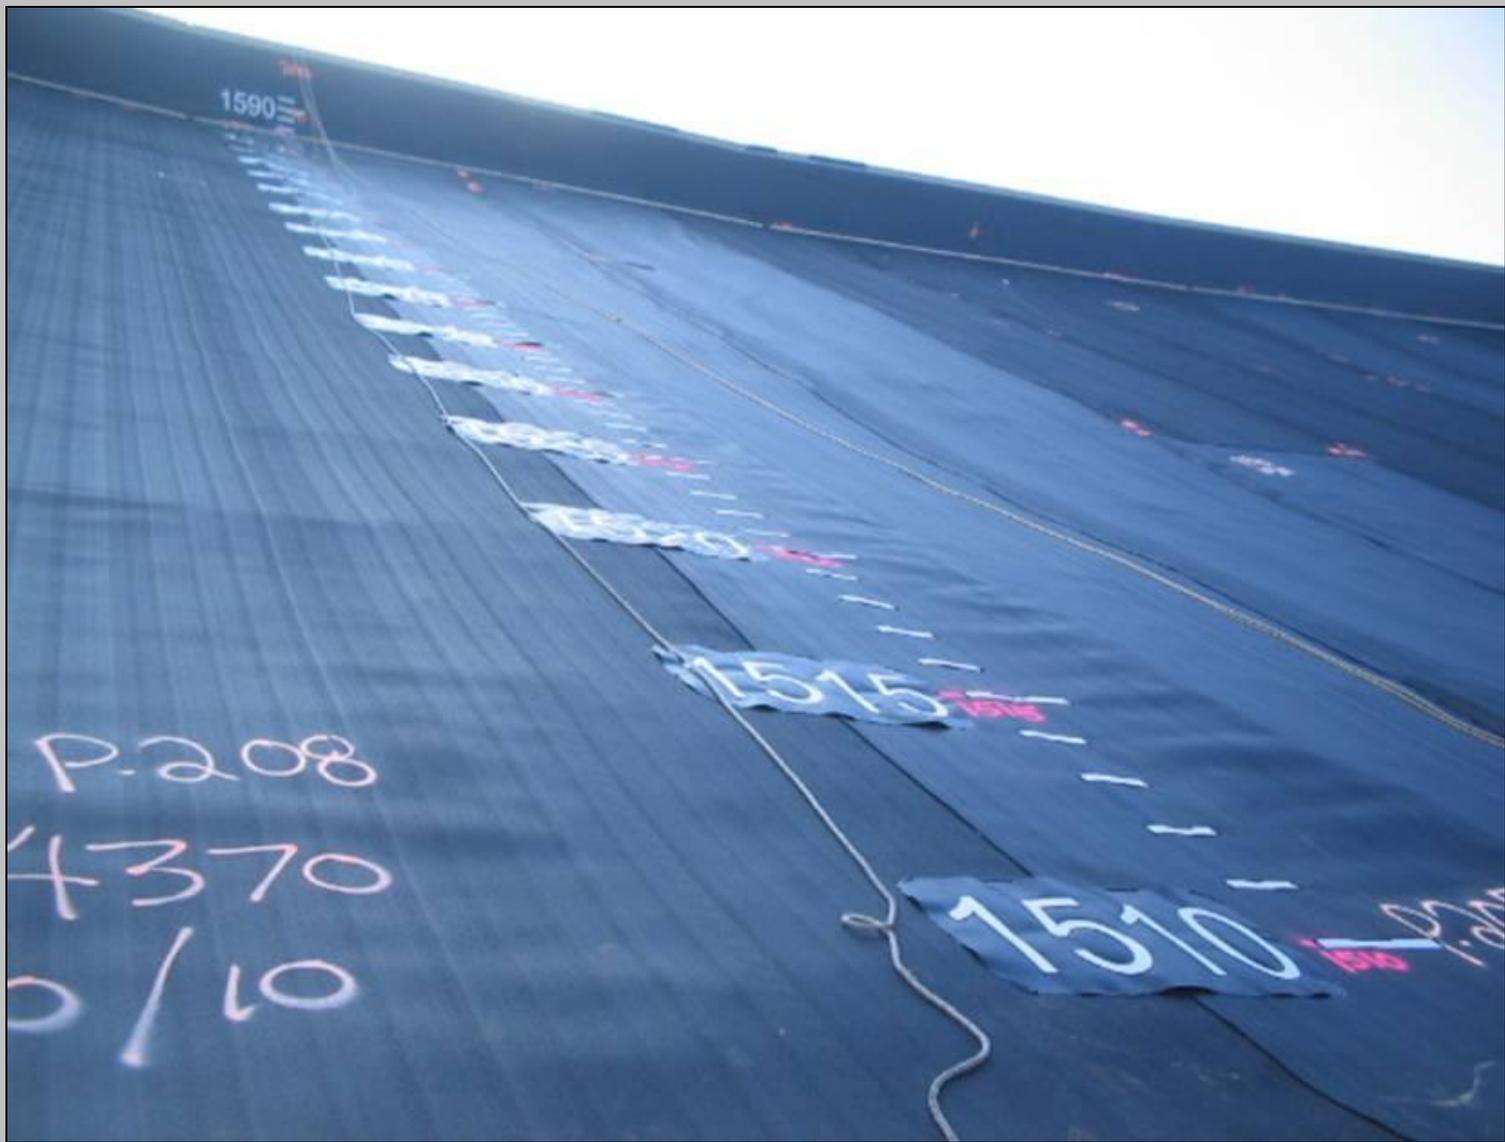
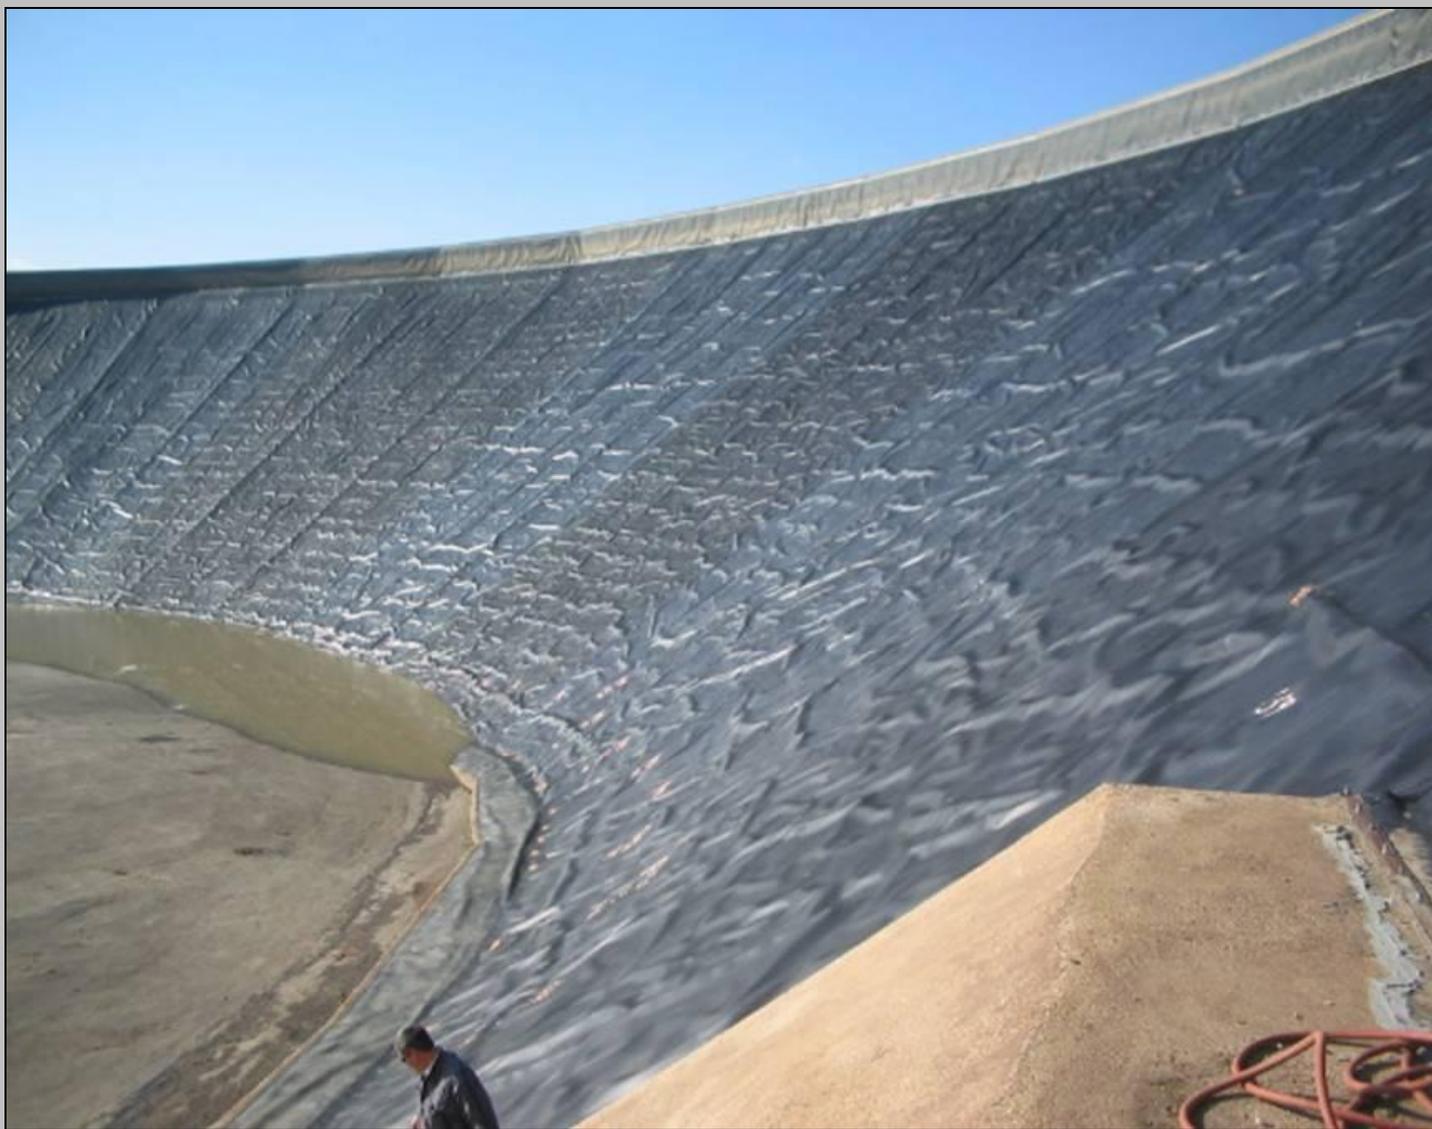
In 2004 AmerenUE installed an HDPE geomembrane liner to retard ongoing seepage losses from the upper reservoir, at a cost of ~\$2.4 million.

GSI supervised the placement of 1.3 million square feet of 80 mil HPDE textured geomembrane and geocomposite material. They also covered five rock outcroppings on the side slope with 80 mil textured LLDPE material.

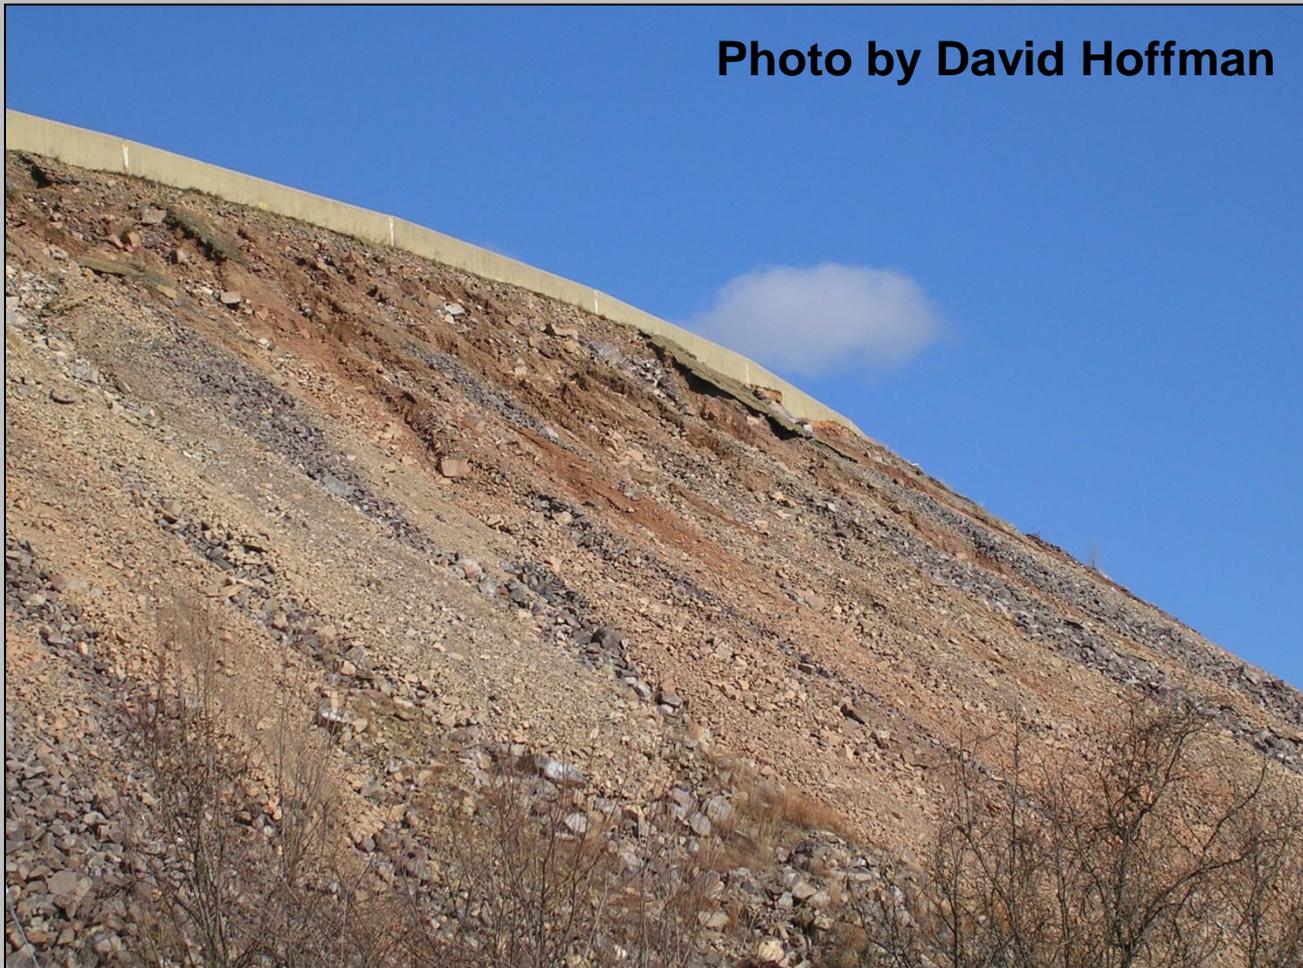
- Plant operators first experienced trouble with upper reservoir water levels on September 25, 2005. A large quantity of water was observed pouring over the NW portion of the reservoir wall in what was described as “**Niagara Falls.**” Scour up to 1’ deep was noted.
- Pumps were manually turned off and the generators turned on to lower the reservoir level. Operators warned of catastrophic failure if such an occurrence was repeated and maximum water levels were reduced by 3 feet by recalibrating the controls.
