New Orleans and Hurricane Katrina.

IV: Orleans East Bank (Metro) Protected Basin

DOI: 10.1061/(ASCE)1090-0241(2008)134:5(762)

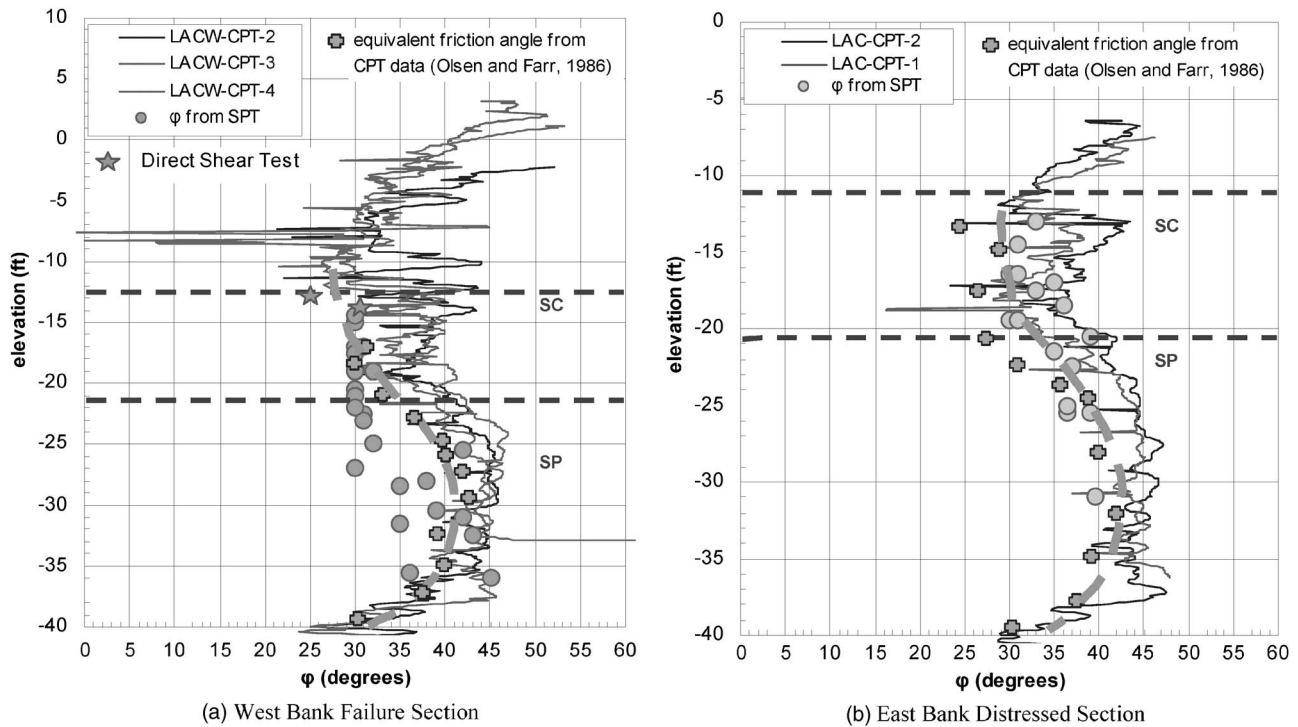
Fig. 11. Estimation of friction angle for cohesionless materials for the London Avenue North Breach section on the west bank and for the distressed section on the east bank: (a) West Bank Failure Section; (b) East Bank Distressed Section

Figs. 11(a and b) show the characterization of effective friction angles in the materials across the progressive interface (or transition) between the upper sands, the silty and clayey sands, and the overlying paludal clays at both the west bank breach site, and the east bank distressed section, respectively. Multiple approaches were used to assess the effective friction angles. The thin, solid traces in these figures are cone penetrated test (CPT)-based interpretations based on Robertson and Campanella (1983), the large solid “crosses” are CPT-based interpretations based on Olsen and Farr (1986), and the closed circles are SPT-based estimates based on Seed (2005). Finally, the large, closed stars in Fig. 11(a) represent the results of a pair of laboratory direct shear tests on samples obtained by means of a modified 2.8 in. diameter, thin-walled, fixed piston sampler that was advanced as described in Seed et al. (2008c).

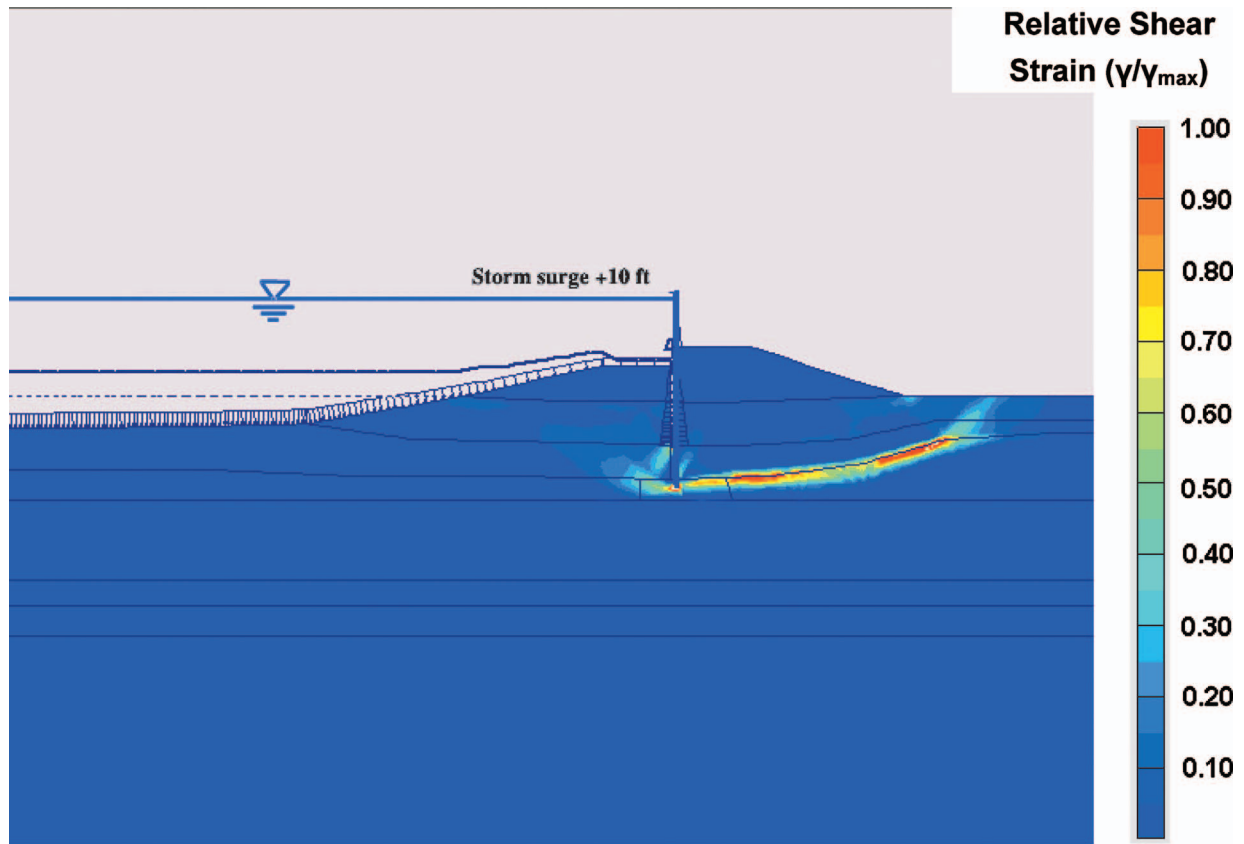
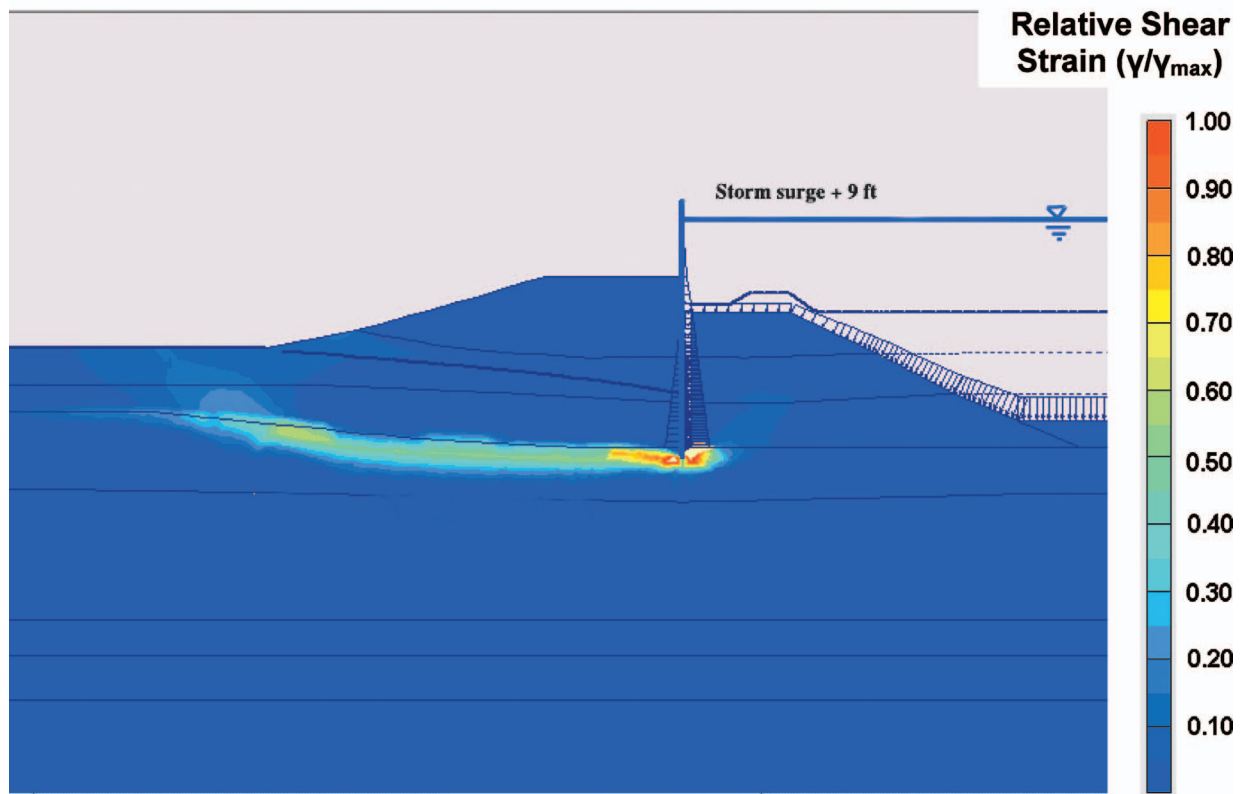
Figs. 12(a and b) show the results of finite-element analyses of the west bank (breach) and east bank (distressed) section, respectively. The best-estimate properties within this critical transition zone used in both analyses are provided in Table 2. Fig. 12(a) shows an incipient translational failure begins to occur, by sliding along the transitional zone within the foundation soils, at a canal water elevation of +9 ft (MSL). Fig. 12(b) shows that the incipient failure is only just beginning to occur at a slightly higher canal water level of Elev. +10 ft (MSL). Essentially identical results were obtained using conventional coupled transient seepage/limit equilibrium analysis methods. In these analyses, transient seepage analyses were first performed using the program SEEP/W, and at each stage (each point in time, and thus each stage of progressively increasing canal water elevation), the calculated fields of pore pressure were then imported into the limit equilibrium slope stability analysis program SLOPE/W and overall stability analyses were then performed using Spencer’s method (Spencer 1967).

Fig. 12. (Color) (a) Normalized shear strain contours (shear strain divided by strain to failure) for a storm surge at Elev. +9 ft (MSL) at the London Avenue Canal breach site (west bank); gapping at outboard toe of floodwall is developed to full depth; (b) Normalized shear strain contours (shear strain divided by strain to failure) for a storm surge at Elev. +10 ft (MSL) at the London Avenue Canal distressed site (east bank); gapping at outboard toe of floodwall is partially developed

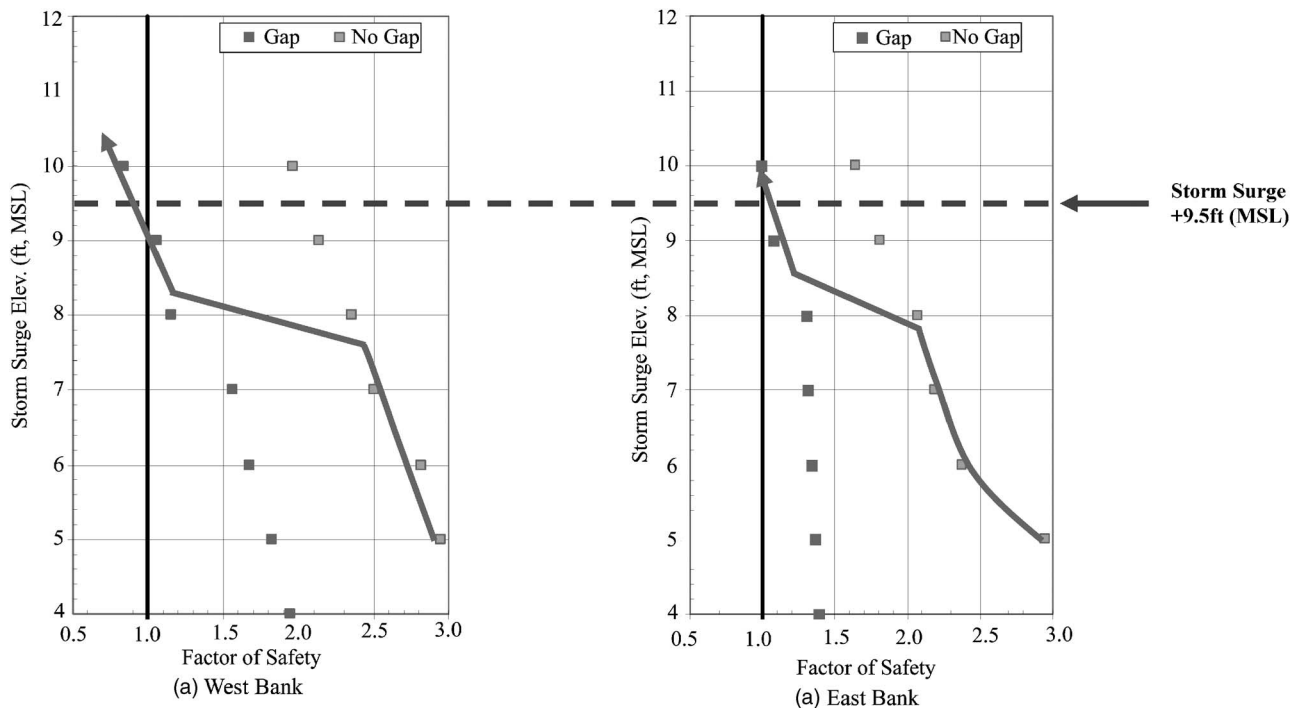
Fig. 13 shows the resulting calculated overall factors of safety (based on Spencer’s method) as a function of canal water level

increase for (a) the west bank breach section; and (b) the east bank distressed section. The lightly infilled squares in Fig. 13 represent the results of analyses performed without including the presence of a water-filled gap on the outboard side of the sheetpile curtains, and the more darkly infilled squares at the left sides of these figures represent the results of analyses that model a water-filled gap at that location, which illustrates the importance of considering the formation of a water-filled gap in the analyses.

Fig. 13. Evolution of calculated factors of safety (versus rising canal water elevations) based on limit equilibrium analyses of (1) the London Avenue Canal North Breach; (2) the east bank distressed section; shows the best-estimated paths to failure

Lastly, it should be noted that the design objective at these two sections was a minimum factor of safety of $FS \geq 1.3$ for the transient conditions associated with a hurricane-induced canal water level of at least Elev. +12.5 ft (MSL). As shown in Fig. 13, these sections did not achieve this targeted performance. This was due in large part to: (1) the failure to include the possibility of a water-filled gap in the stability analyses for the initial design studies; and (2) the failure to appreciate fully the dangers associated with underseepage flows passing through the foundation sands and beneath the inadequately deep sheetpile curtain. The initial design studies assumed that the canal would be lined with sufficient silt to preclude the possibility of significant underseepage flow during the relative short duration of a hurricane-induced storm surge. Unfortunately, that did not recognize the possibility of (1) subsequent dredging to increase the canal capacity, which could remove the silt blanket; and (2) potential for scour due to flow along the canal in response to a storm surge on Lake Pontchartrain. Both the failure to analyze the water-filled gap, and the failure to adequately recognize underseepage risk, occurred at other failure sites during Hurricane Katrina as well (ILIT 2006).

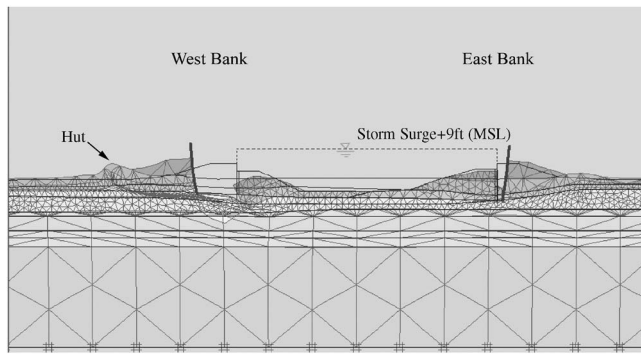
Fig. 14. Deformed mesh for a storm surge elevation +9 ft (MSL), North Breach failure section (west bank) and the east bank distressed section, London Avenue canal. Calculated displacements are scaled by a factor of 2 for clarity.

Finite-element analyses were also performed to simultaneously model the progressive rise on canal water levels on the morning of August 28, the resulting changes in underseepage-induced pore pressures, and the resulting displacements and overall stability of both the east bank and west bank sections. The program PLAXIS (Brinkgreve 2007) was used, and the parameters and models used to represent the different soil strata are presented in Table 2. Fig. 14 shows results from these PLAXIS analyses, for both sides of the canal at the same time, and for a canal water elevation of +9 ft, MSL at approximately 7:15 a.m., representing the best estimate of conditions at the point of inception of the west bank failure. Fig. 14 shows calculated displacements (exaggerated by a factor of 2 for visual clarity) at that time and water stage. As shown in Fig. 14, the west bank section has begun to experience large lateral displacements, whereas the east bank side has opened a water-filled gap but has not yet experienced large overall movements associated with global instability (instead just a bit of shearing at the inboard toe). This is in good agreement with the posthurricane field observations (see Figs. 8–11).

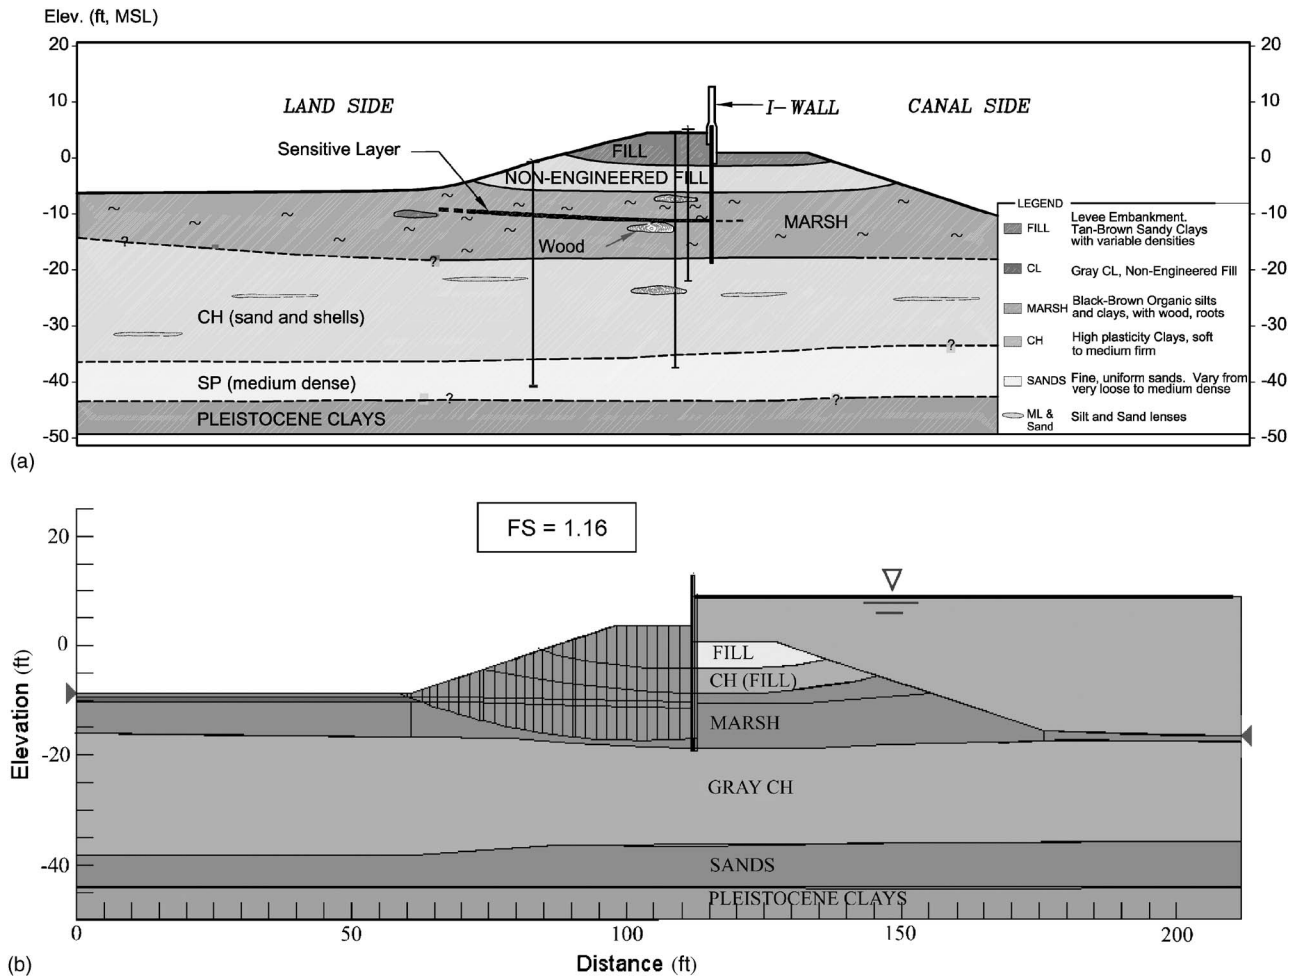
Fig. 16. (a) Cross section at distressed levee embankment and I-wall section on the west bank of the 17th Street drainage canal; (b) stability analysis of the west side of the 17th Street canal with water at Elev. +9 ft (MSL) for case of failure along the base of the marsh layer (with water-filled gap)

critical potential failure mechanism was found (both by finite-element analyses, and by conventional limit equilibrium analyses) to be a deeper, semirotational/translational failure through either the weak organic marsh/swamp deposits, or through the soft gray clays (CH) underlying these marsh deposits. Fig. 16(b) shows the most critical failure mechanism at this site, based on limit equilibrium analyses (Spencer's method) and indicates that the calculated factor of safety (with a water-filled gap on the outboard side of the sheetpile curtain) is approximately $FS=1.16$ with a canal water level of Elev. +9 ft (MSL). Strengths of the critical embankment and soil strata in this analysis are exactly the same as for the same strata (on the west bank) as presented previously in Tables 1 and 2 of Seed et al. (2008c).
