THE ST. FRANCIS DAM FAILURE

**worst American civil engineering
disaster of the 20th Century**

J. David Rogers, Ph.D., P.E., P.G., C.E.G., C.HG.

Shlemon Specialty Conference

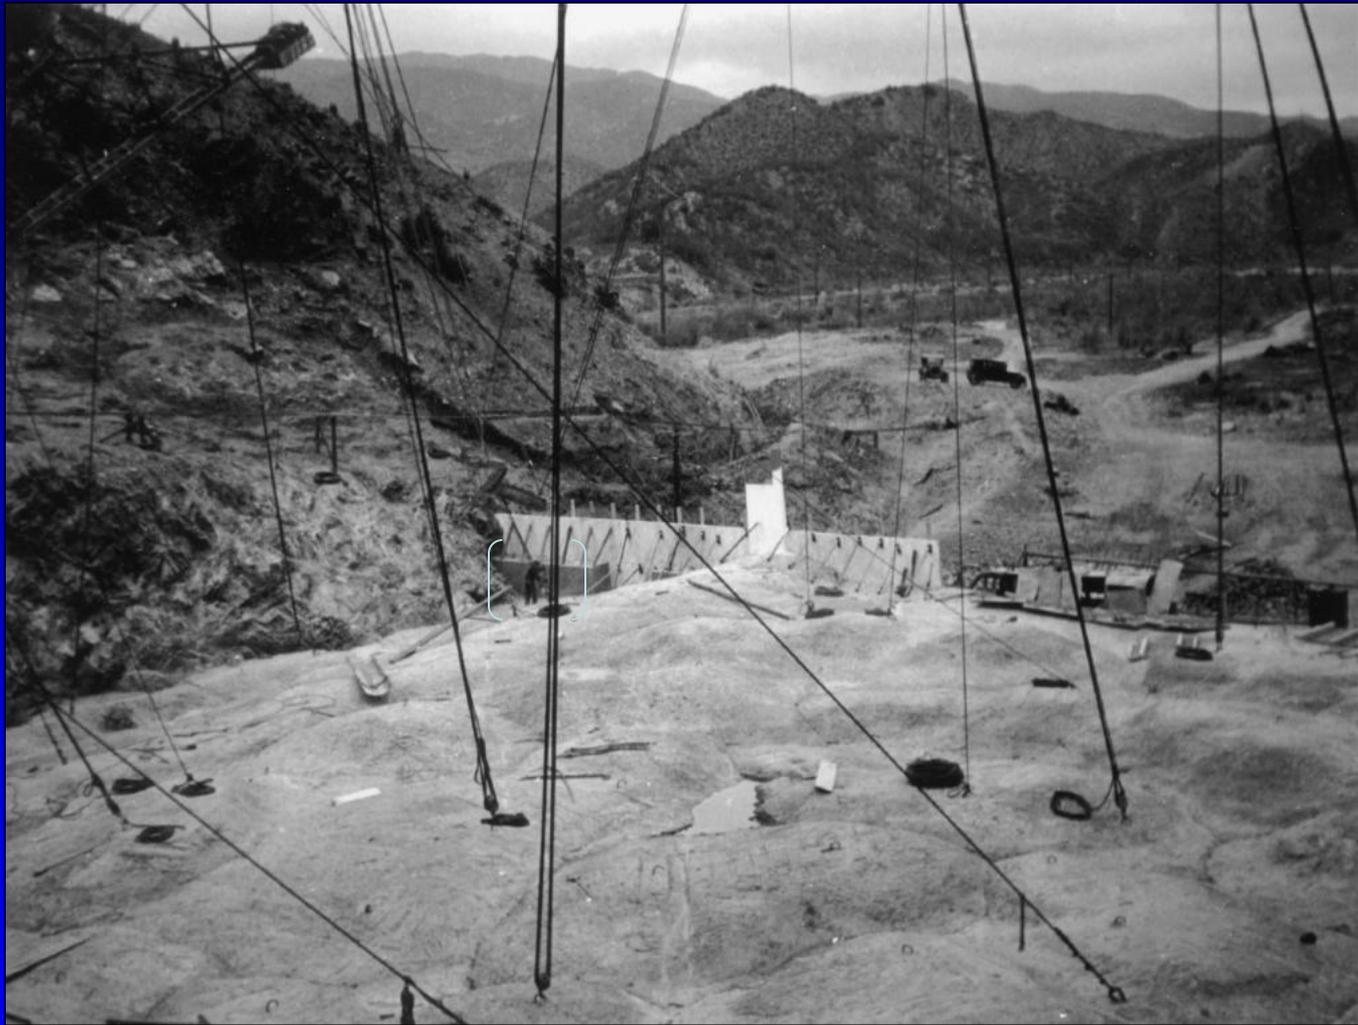
- **View looking upstream at the first forms being placed for the upstream heel of the dam, against the 8 ft high cofferdam wall. Note pillows of mass concrete and absence of contraction joints.**

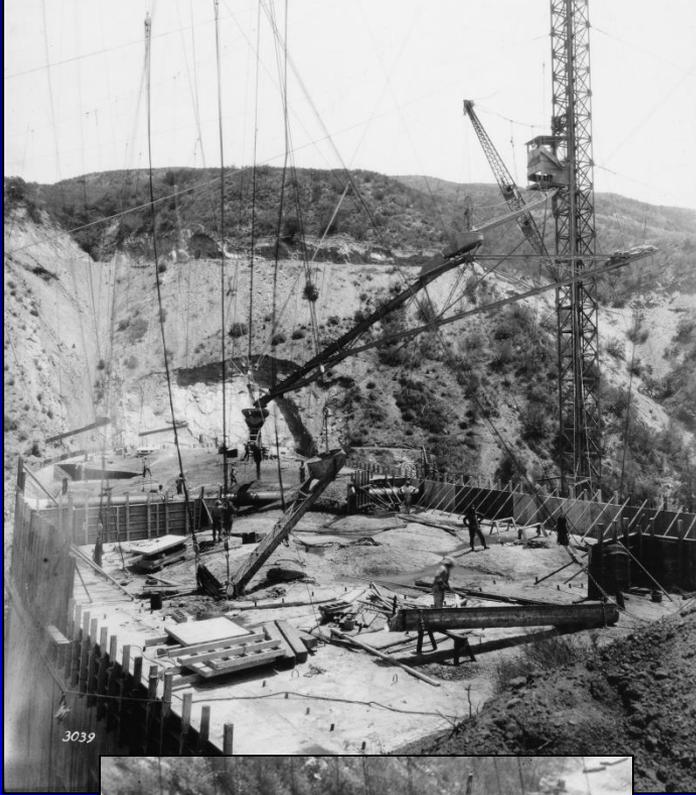
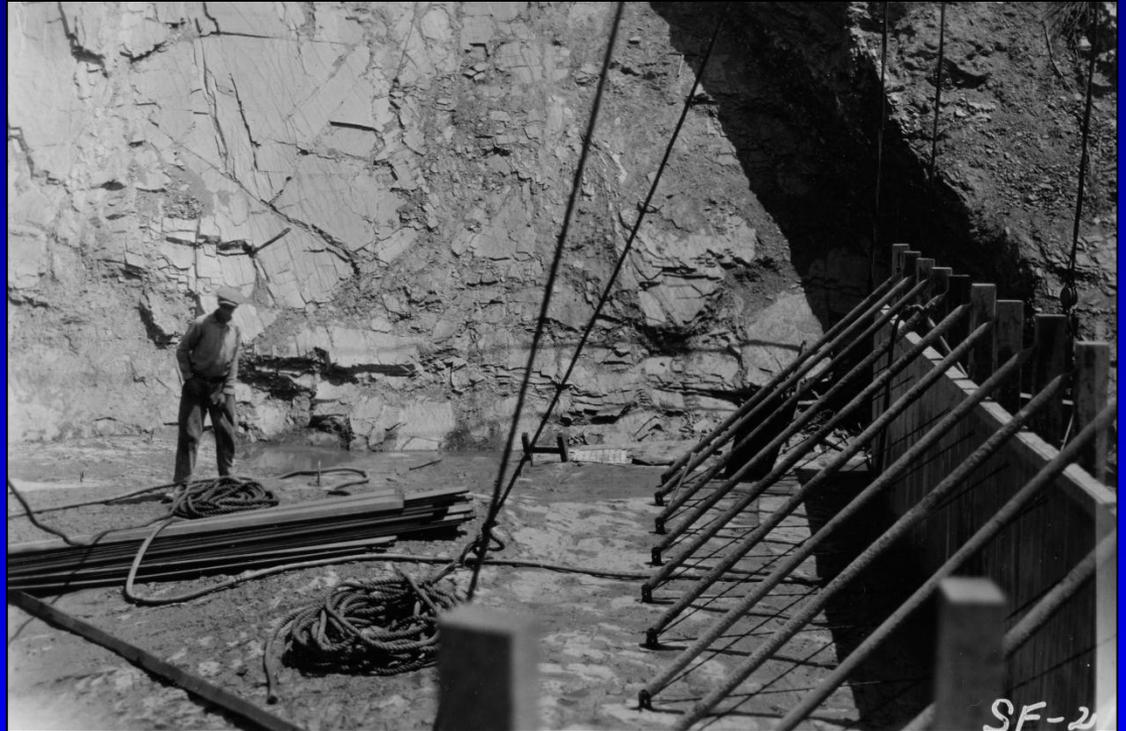
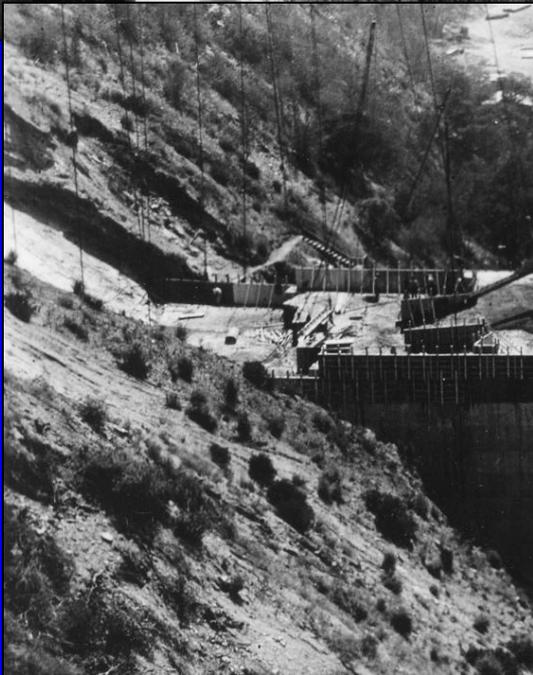
Minimal Abutment Excavation 1924-25

Views at left show the left abutment excavation into the Pelona Schist – between 6 and 15 ft deep, while on the right abutment the depth of excavation averaged only about 4 ft deep.

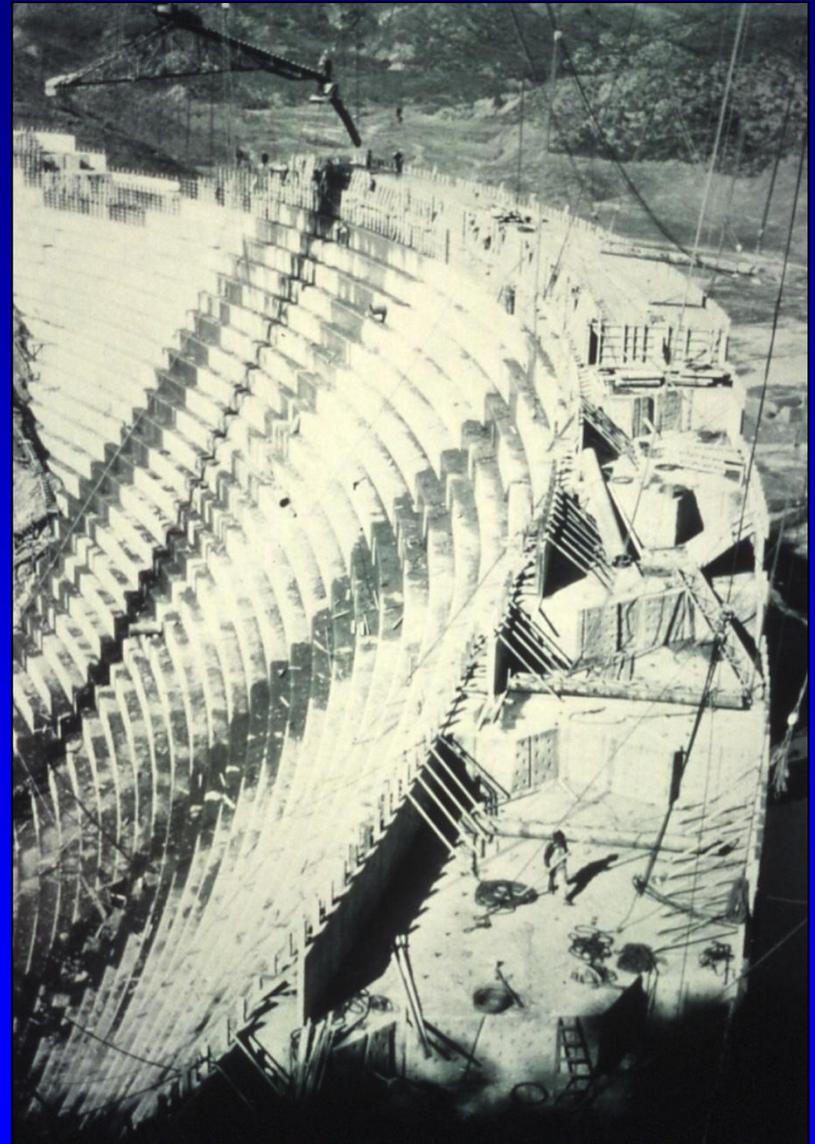
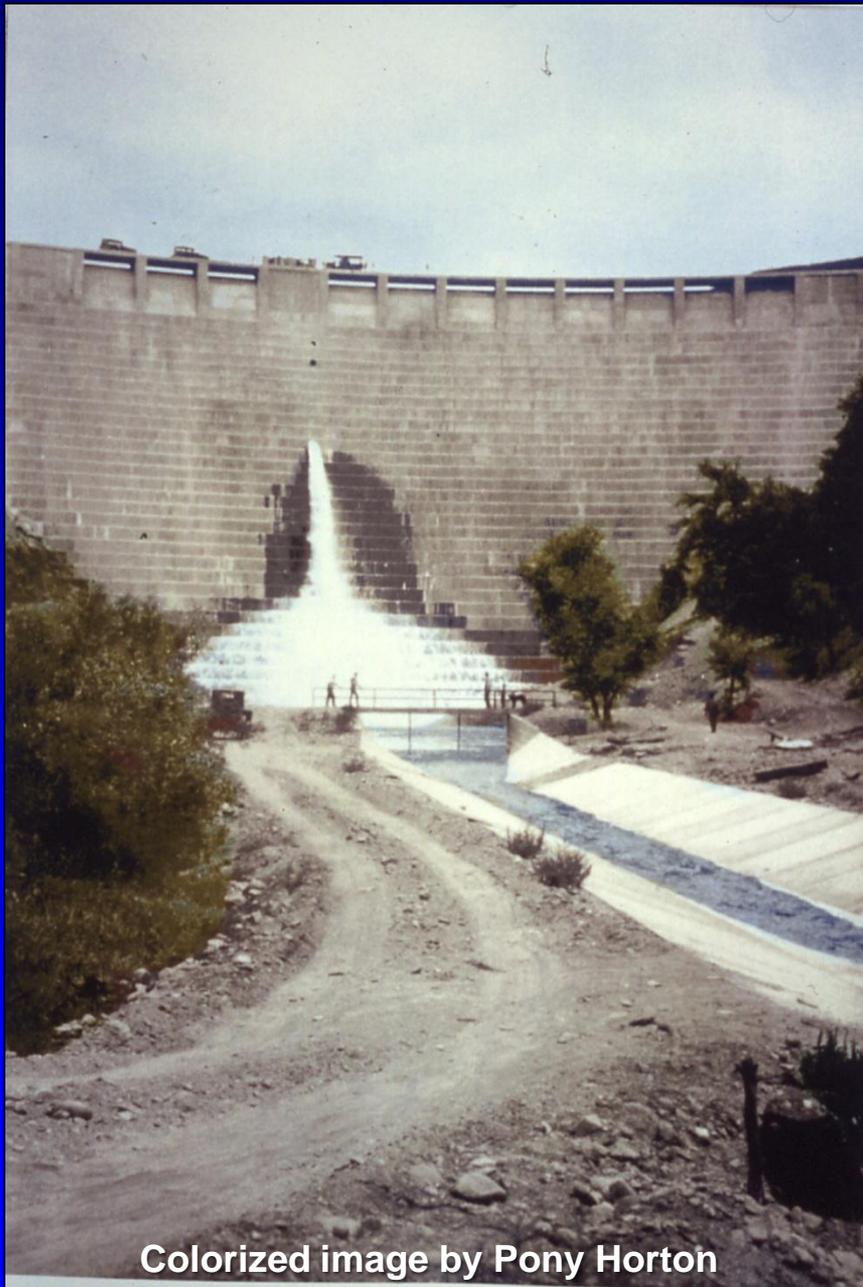
Dam had a stepped downstream face

- A unique aspect of both the Mulholland and St. Francis Dams was their stepped downstream faces
- The width of each step was unique to its respective elevation, varying between 5.5 feet at elevation 1645 and 1.45 feet at elevation 1815
- This figured prominently in subsequent forensic evaluations

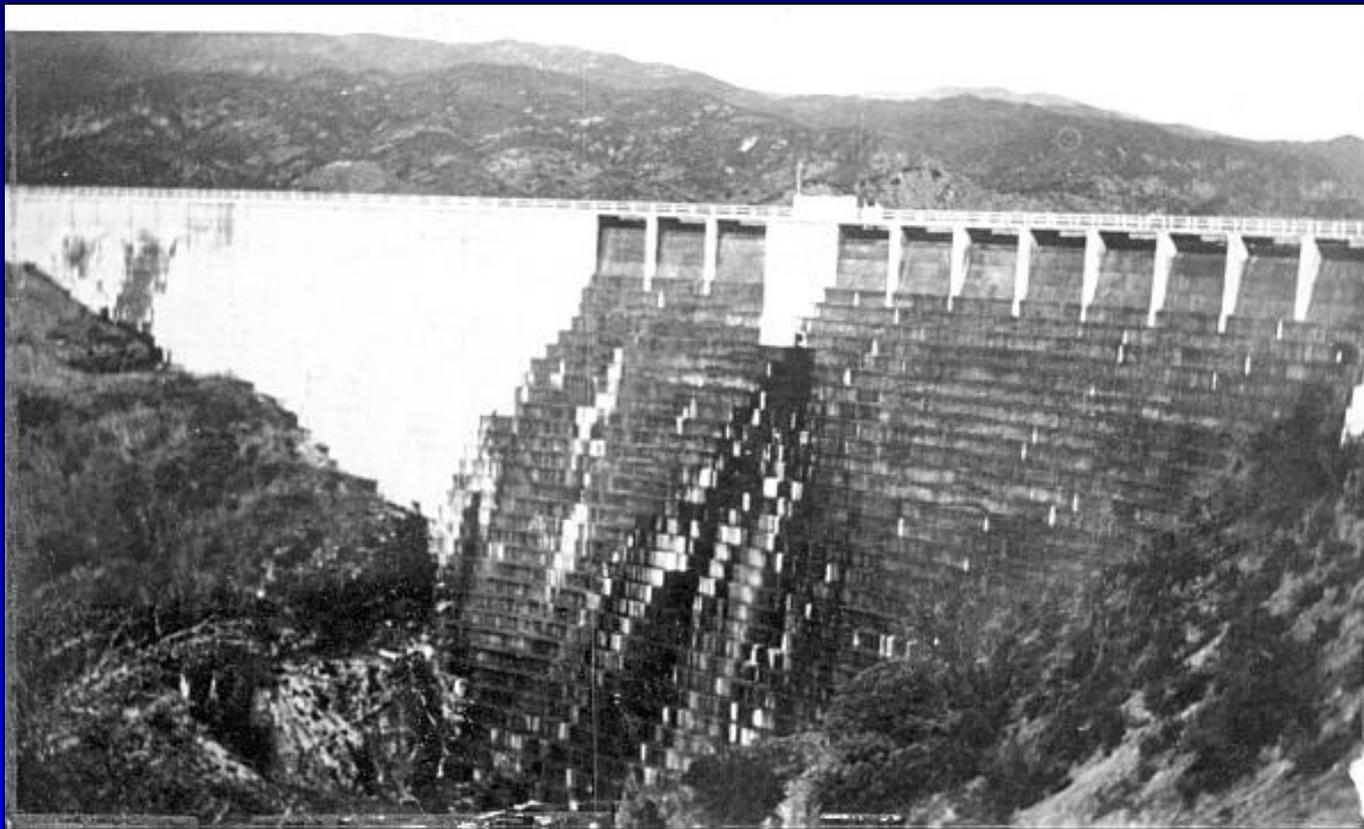
- The reservoir was brought up to within 3 inches of spillway crest for the first time on Wed., March 7, 1928. All city reservoirs were full by the following Sunday, March 11th.
- Damkeeper Tony Harnischfeger called Mulholland on the morning of the 12th to report spillage of “*dirty water*” from the right abutment area. That morning about 2 cfs spillage was coming over the spillway panels from wind-whipped waves, shown here above around noon on March 12th.

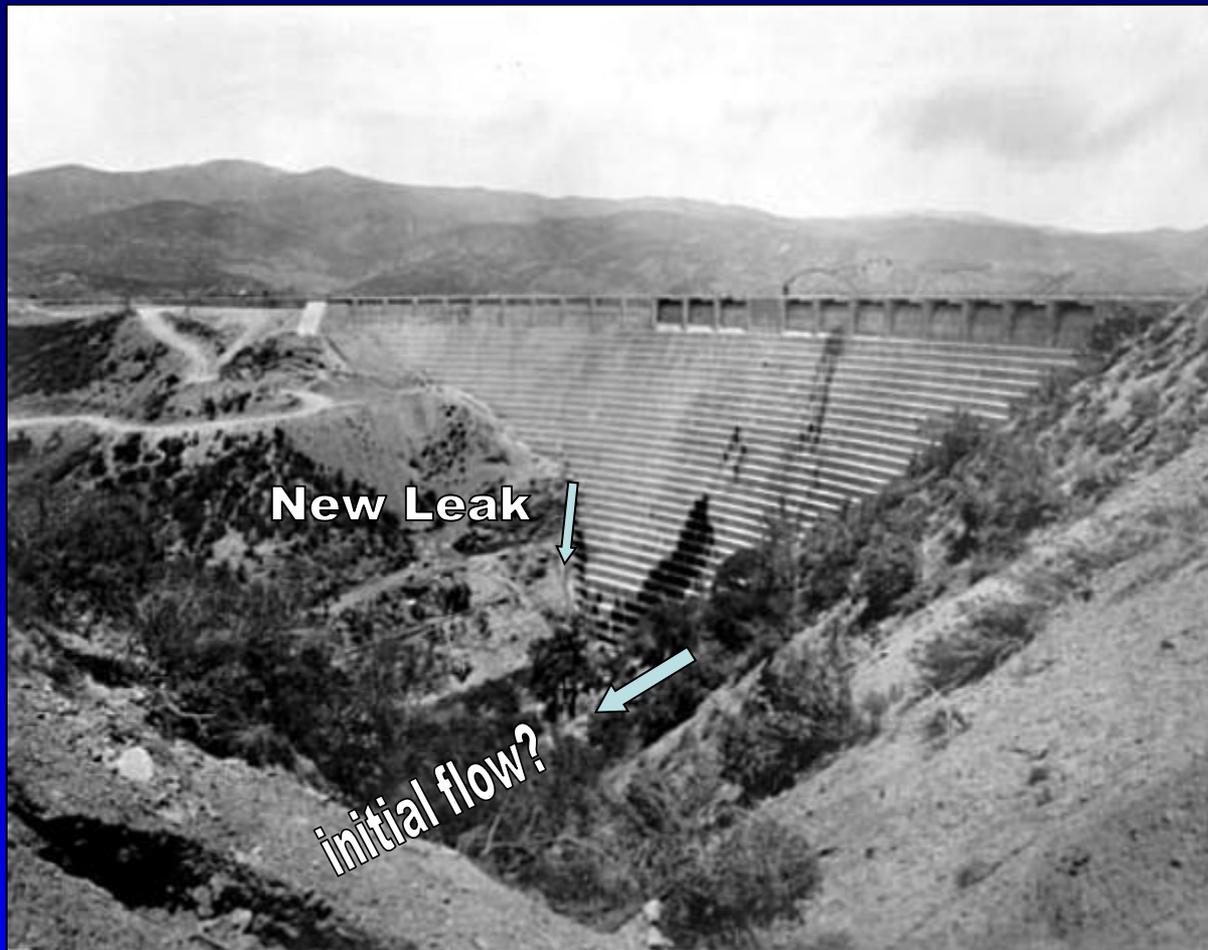
- The dam burst open at 11:57-1/2 PM on Monday evening March 12, 1928, sweeping everything in its path. The damkeeper, his wife and 6-year old son lived $\frac{1}{4}$ mile downstream. They became the flood's first victims. One passerby noted lights down in the canyon below the dam within an hour of the failure. There were no lights on the dam.

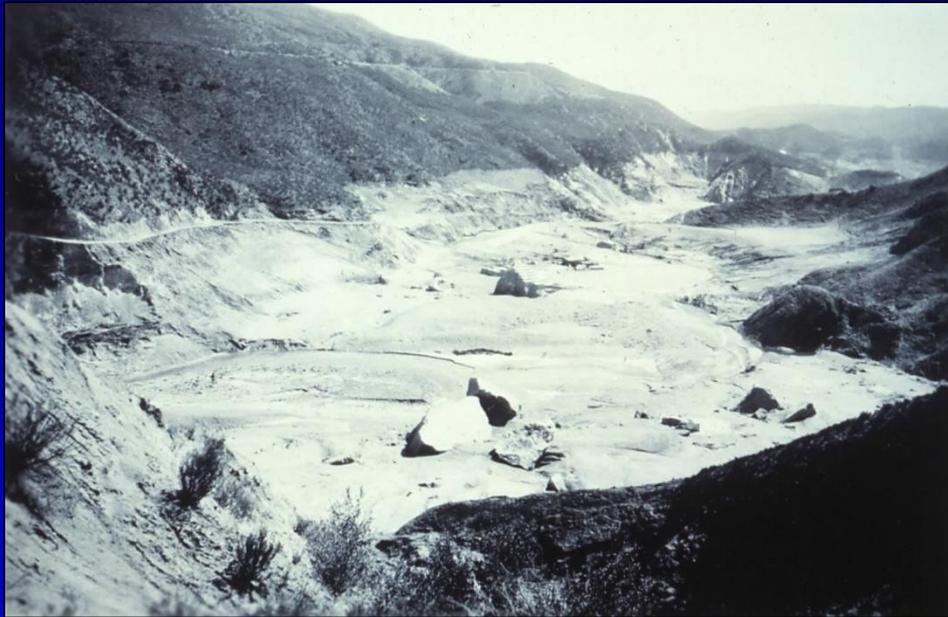
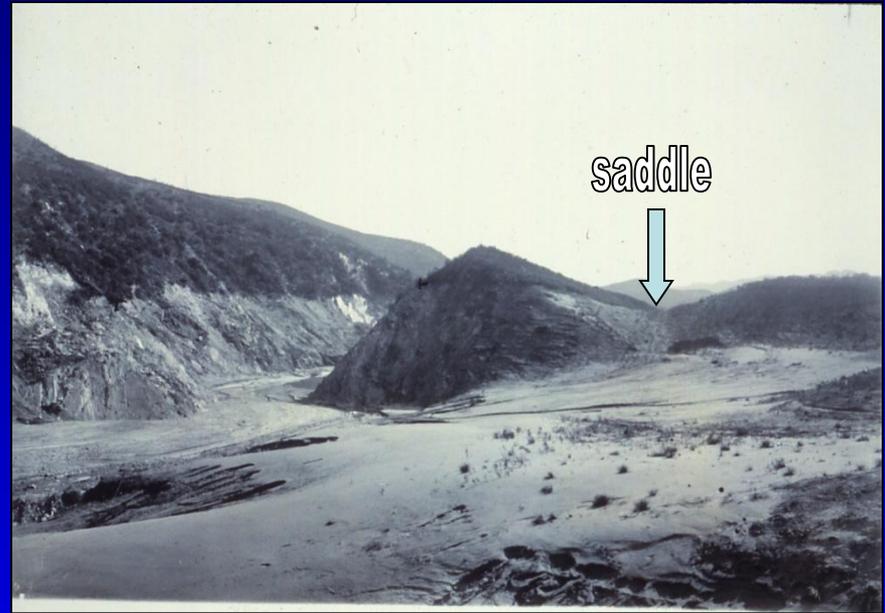
Tidal wave of destruction

- **Just downstream of the dam the maximum depth of the flood was about 125 feet, shown at left.**
- **Almost a mile downstream the floodwaters spilled over a natural saddle 120 feet above the channel**
- **The average velocity in this reach was about 26 feet per second, or 18 miles per hour.**

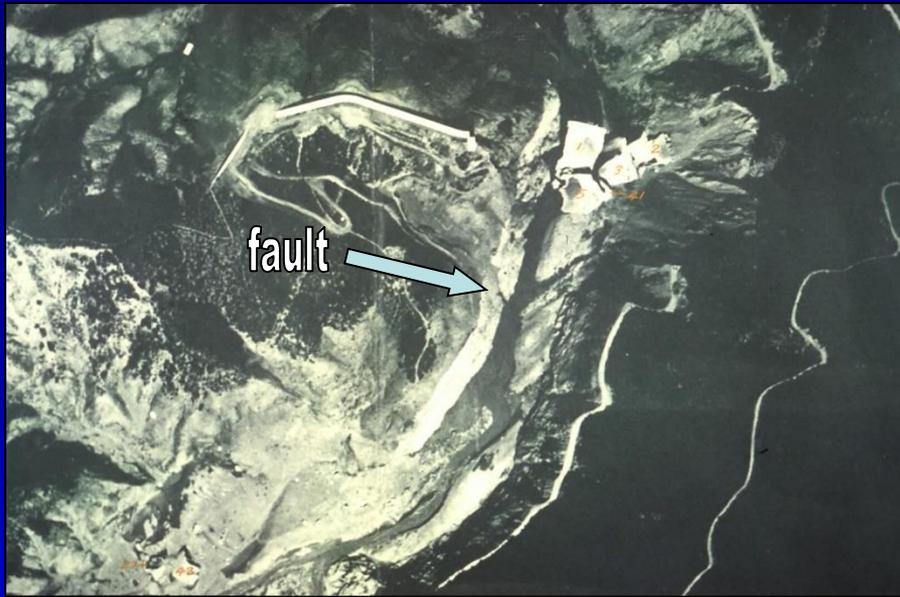
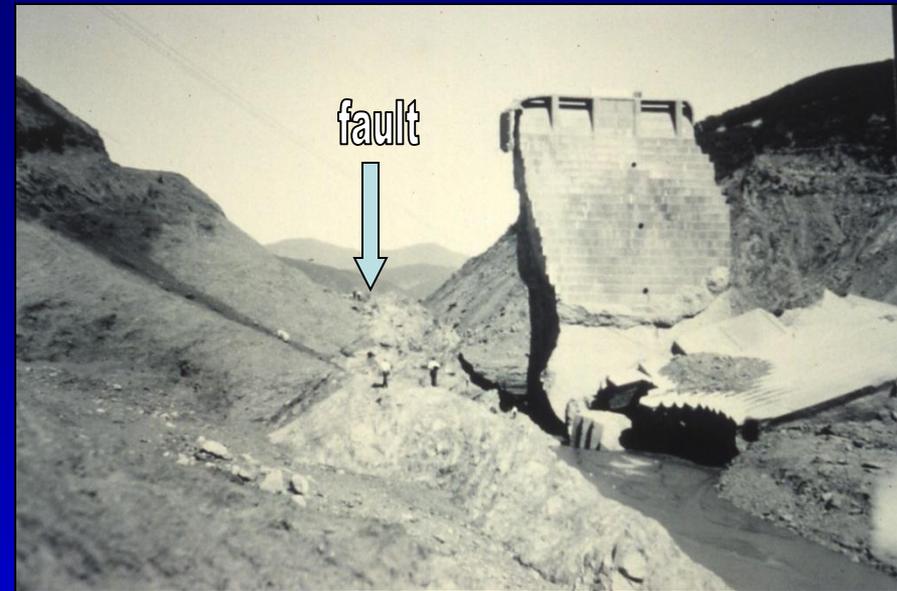
- The geologists were impressed by the sharp contact between the Pelona Schist and Vasquez formation (misnamed the Sespe formation in 1928), along the old San Francisquito fault (an inactive feature)
- The panel suspected that hydraulic piping may have occurred along the fault because the Vasquez beds were subject to disintegration (slaking) when submersed in water

- The Commission met on March 19th and issued their report 5 days later
- They concluded that the red conglomerate underling the dam's right abutment was unsuitable for a dam foundation, and that the failure began in that area, along the old San Francisquito fault

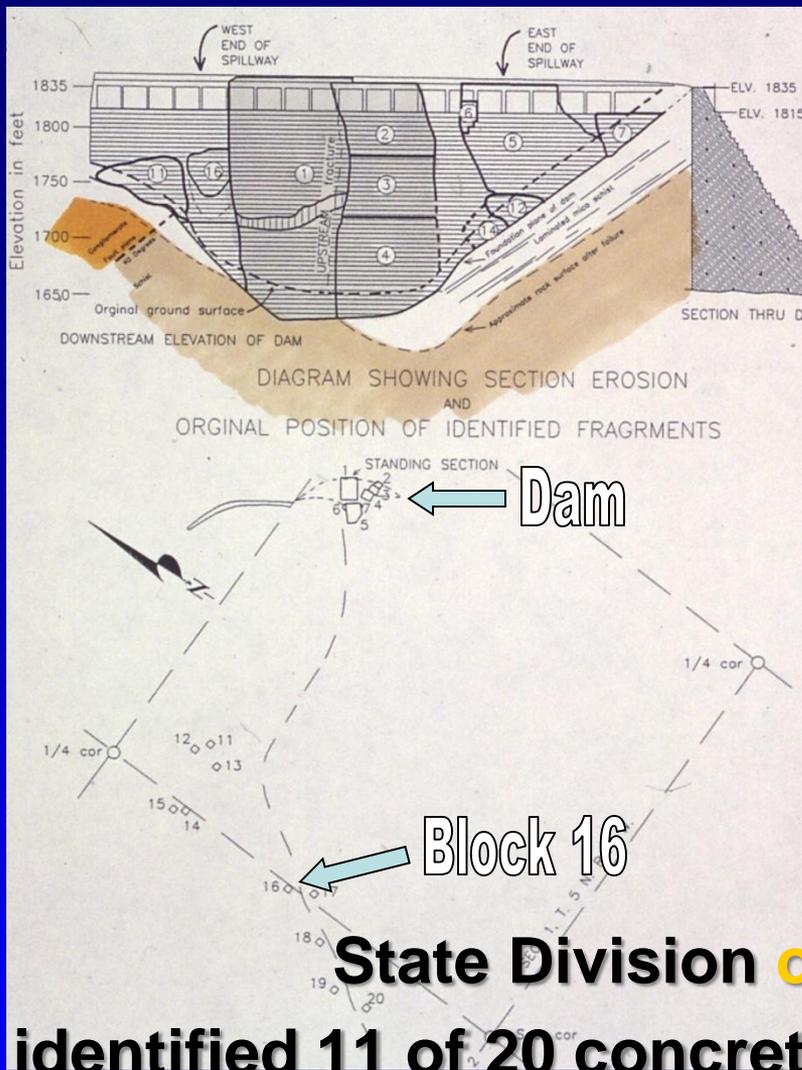
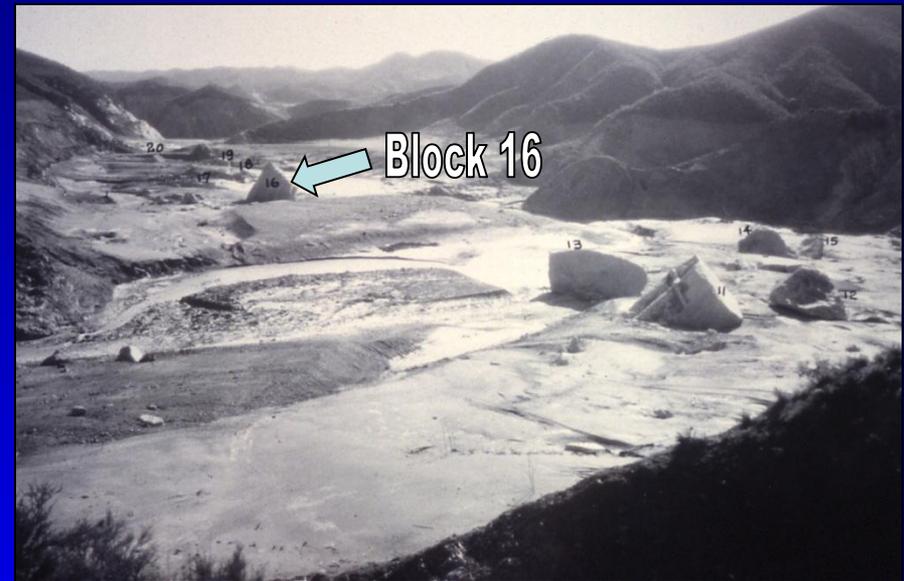
Post-failure survey of displaced blocks

State Division of Highways surveyor Horace Wildy identified 11 of 20 concrete monoliths displaced by the outbreak flood. The panel focused on Block 16 because it was found further downstream than Blocks 11, 12, or 14.

- One of the shortcomings of the plane table map of the displaced blocks was that it *did not include the relative elevations* of the objects. Blocks 12 and 14 from the base of the left abutment were located 26 feet higher than Block 16 and well off the right side of the channel. Block 11 may have helped form a dam with Blocks 12 and 13 that deflected subsequent flows off to the left, where Block 16 was found, further downstream.

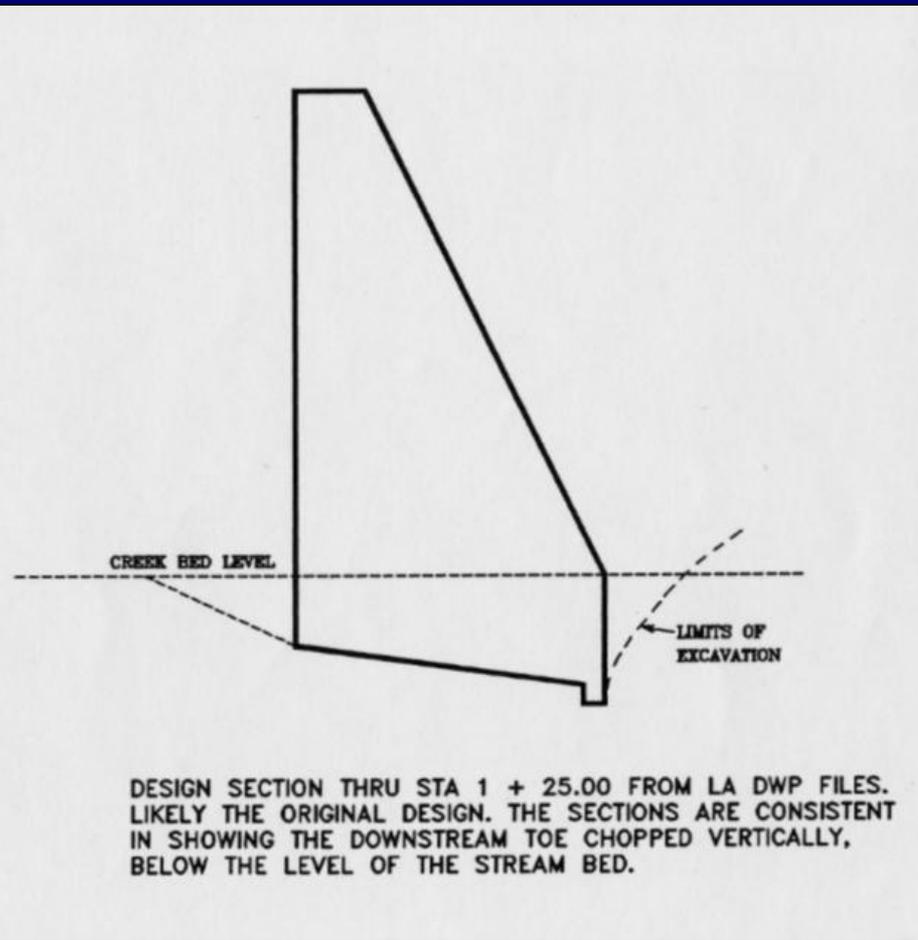
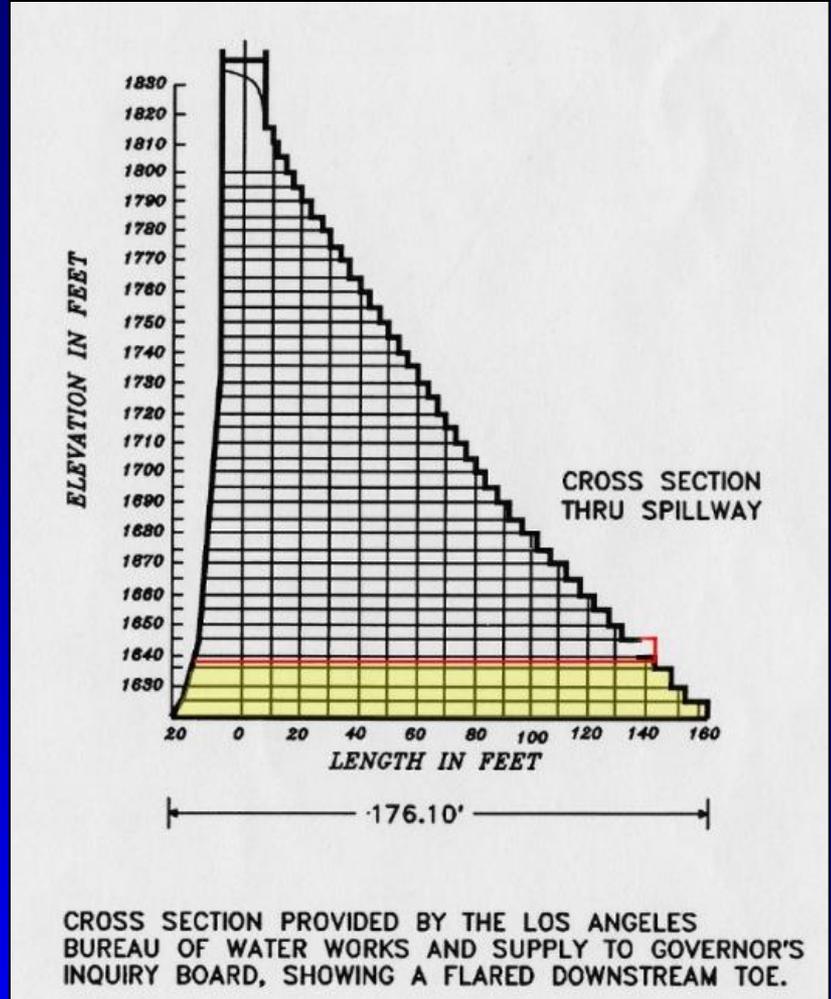
- Charles Outland discovered inconsistencies with the City's official cross section when he examined this construction photo, which clearly shows a 'chopped' downstream toe, beginning at Elevation 1650. This suggests that the base was ~152 ft wide instead of the 176 feet shown on the design section given to the Governor's Commission.

- Original (1923) design concept for the St. Francis Dam by the LA BWWS, shown at left
- The cross section given to the Governor's Commission by BWWS is presented on the right. It extends down to Elevation 1620. The red line approximates the actual limits of the dam.

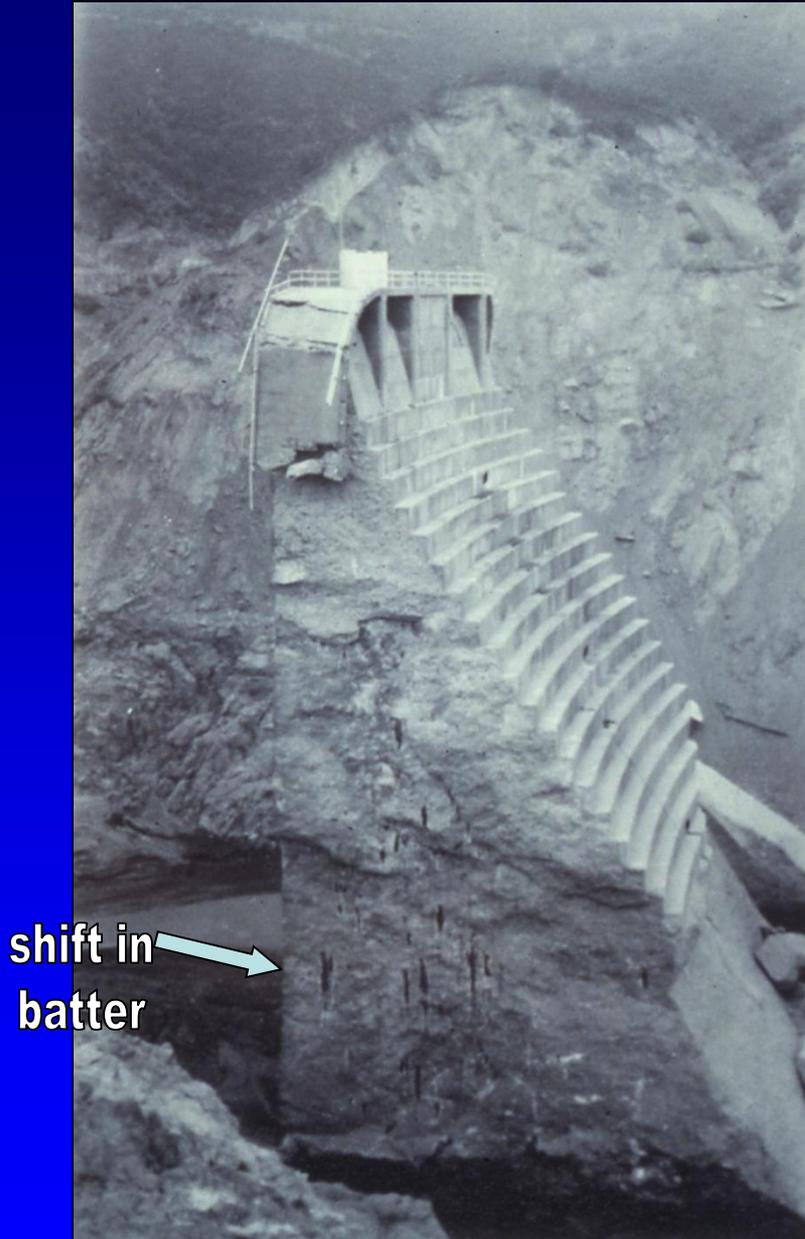
Battered upstream face ?

- The St. Francis Dam appears to have been constructed with a 1:27 and 1:10 batter of the upstream face.
- To date, no evidence has been found to show that the upstream batter was increased to 3.5:10 below Elevation 1645, as shown on the design section given to the Governor's Commission, dated November 1924.

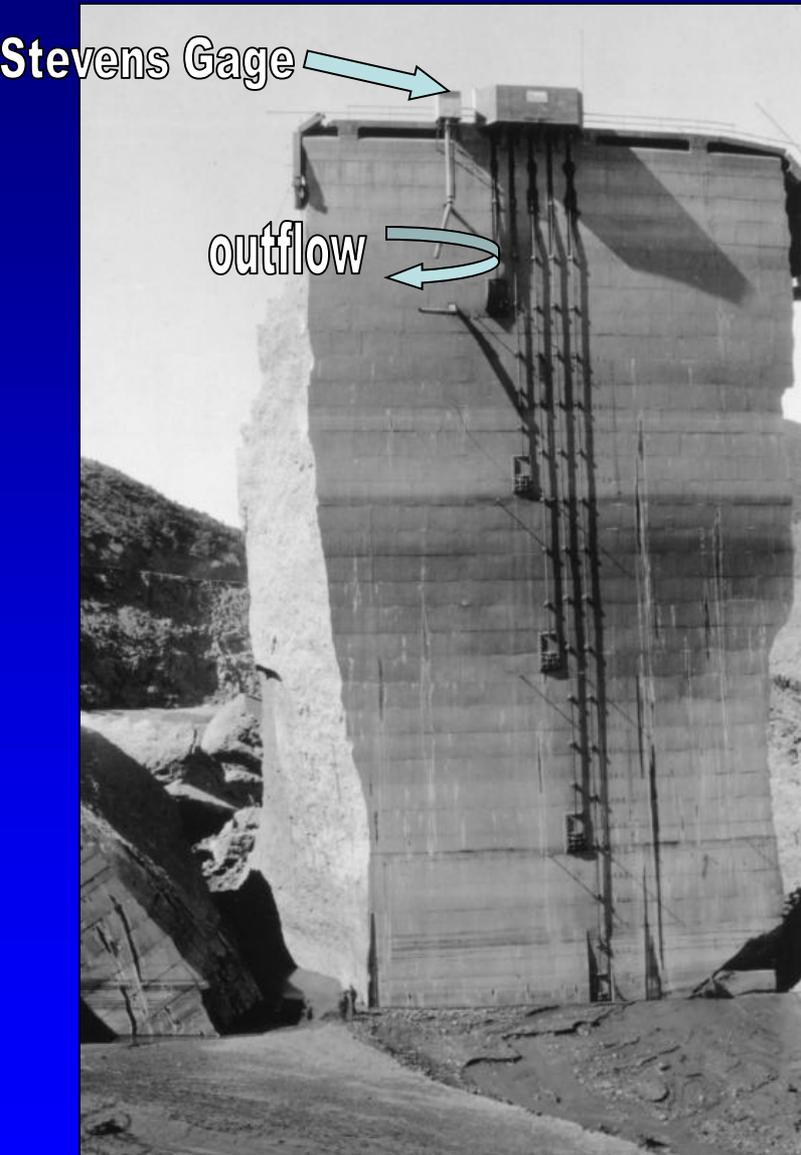
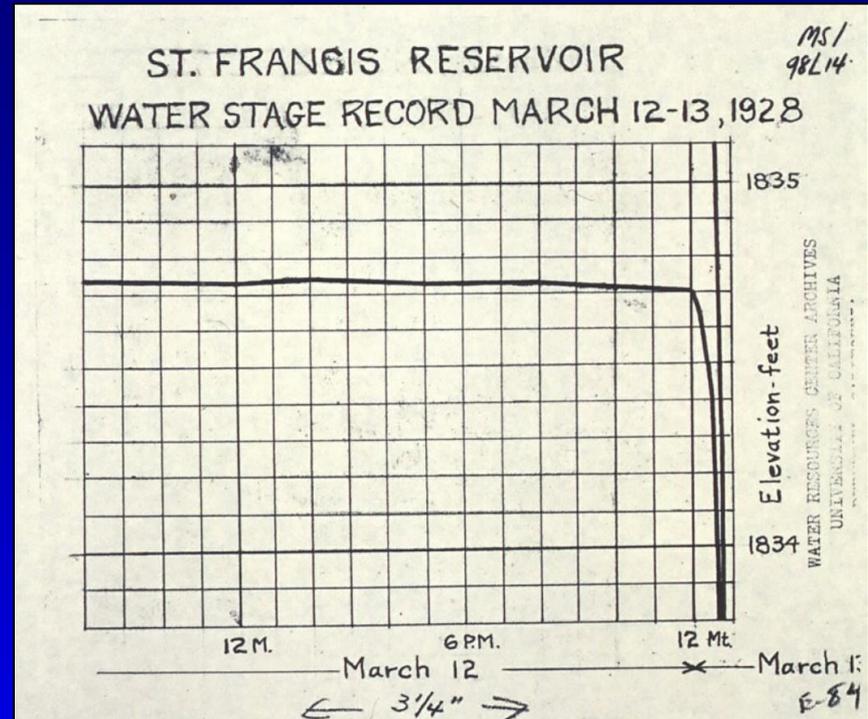
The Stevens Stage Record

A Stevens reservoir level recorder was mounted on the crest of Block 1 (left view). It recorded a slight drop of the reservoir beginning around 8 PM, then an increasingly sharp drop beginning around 12 Midnight. The timing mechanism may have been slightly ahead of schedule.

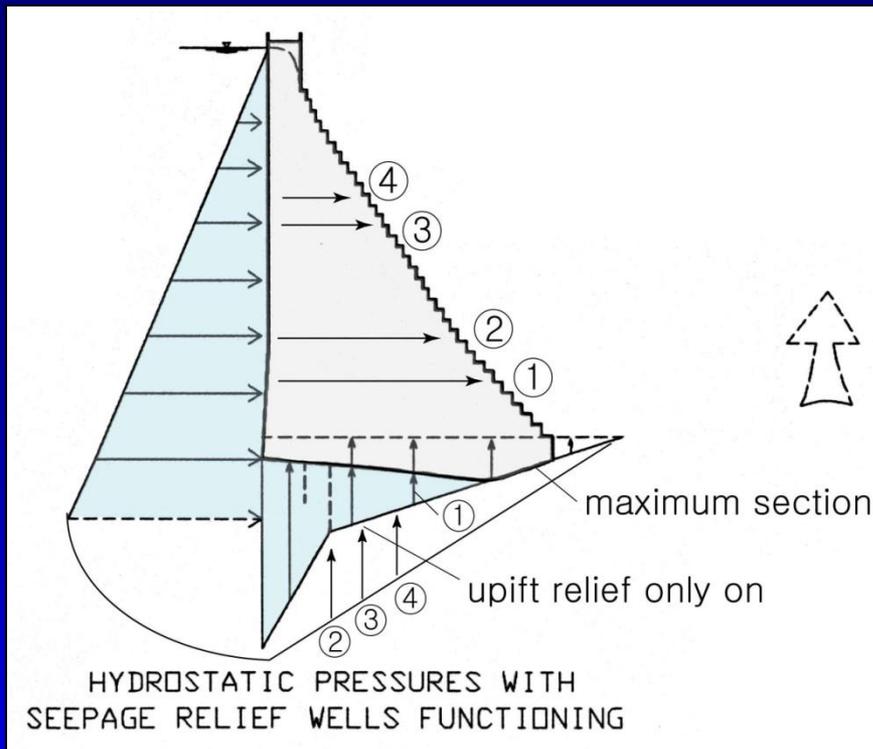
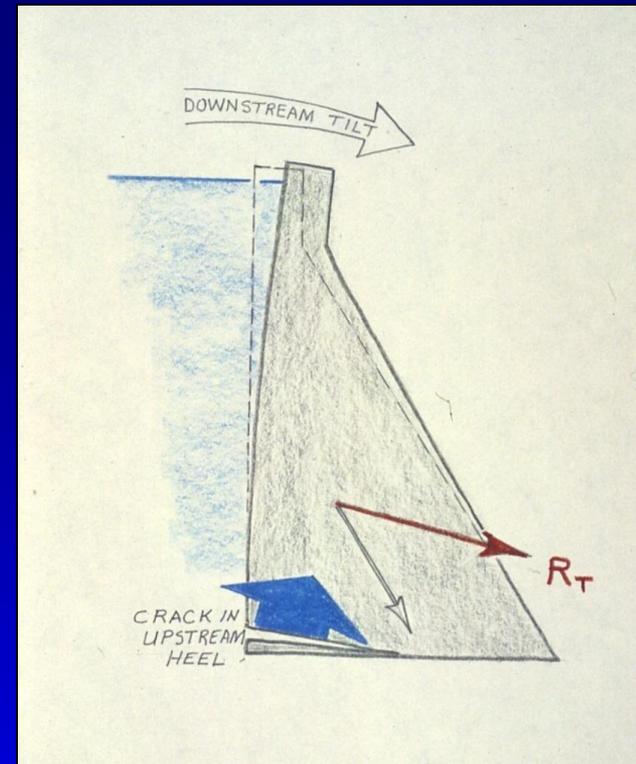
- The main section of the St. Francis Dam was constructed with 10 uplift relief wells set in two rows, as shown above. This portion of the dam did not fail, only the sloping abutments, which did not have uplift relief wells.

- **Hydrostatic, or uplift forces act equally in all directions and serve to reduce the effective weight of the dam, causing it to become unstable.**
- **If the dam tilted forward $\frac{1}{2}$ degree, this would explain the 3.67 inch drop of the reservoir, recorded 40 minutes before the failure.**
- **When the dam cracked at its upstream toe, the resultant thrust would have been shifted 240 feet downstream, promoting overturning instability.**

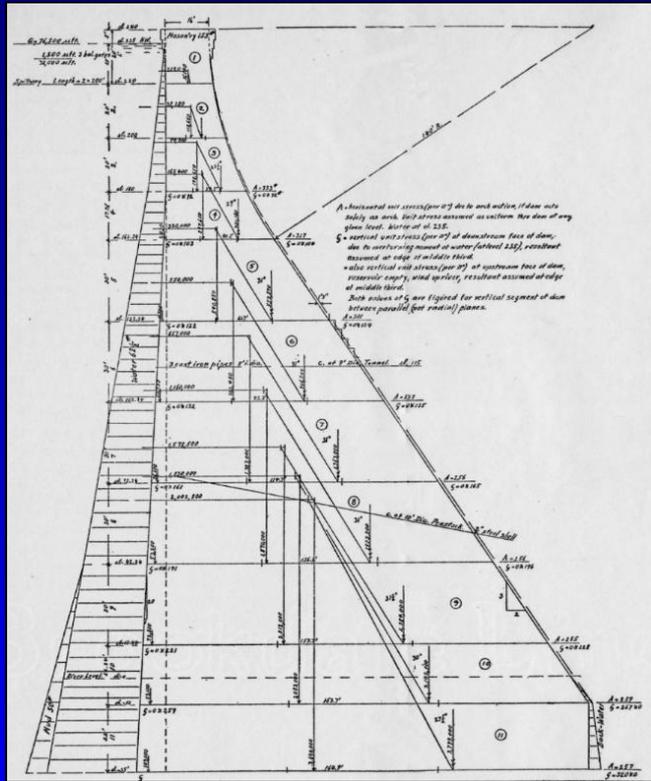
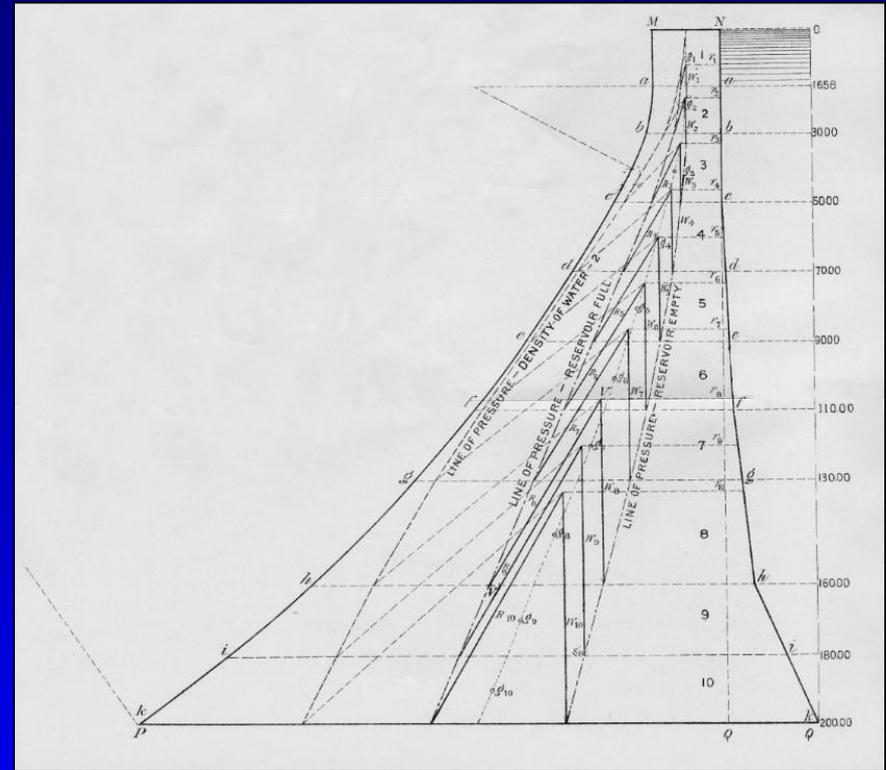
The development of full hydrostatic uplift was a controversial subject, before and, especially, after the St. Francis Dam failure

- Prior to 1928, engineering texts did not specify how to account for, or mitigate uplift, in their design examples for masonry gravity dams. These examples are from Smith's Construction of Masonry Dams (1915) and Wegmann's The Design and Construction of Dams (1917, 1922, 1927).

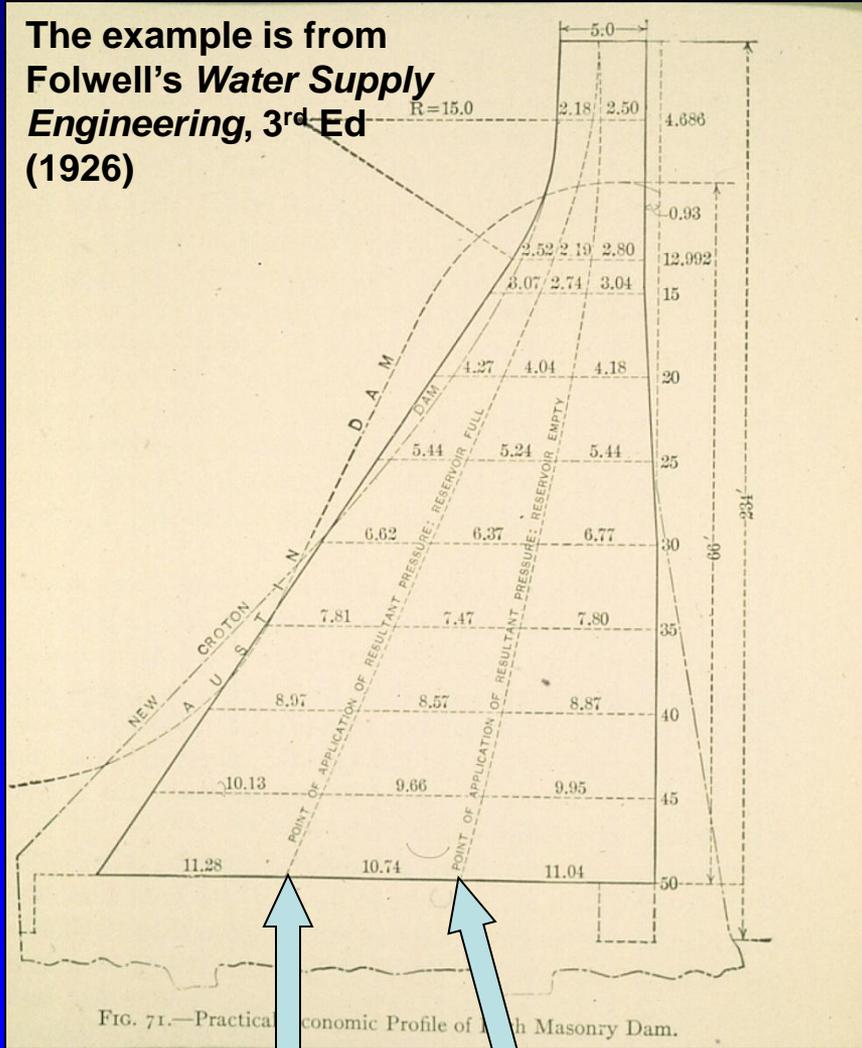
The example is from
 Folwell's *Water Supply
 Engineering*, 3rd Ed
 (1926)

resultant thrust with
 full reservoir pressure

resultant thrust of
 dam's dry weight

- Prior to 1928, the example designs presented in textbooks summed the gravity forces as a line of thrust without reservoir pressure and another line of thrust with full reservoir pressure.
- Until 1945 most engineers assumed that concrete was sufficiently impervious to resist complete saturation, and that dams founded on relatively impervious strata, such as granite or gneiss, would not be subject to hydraulic uplift.

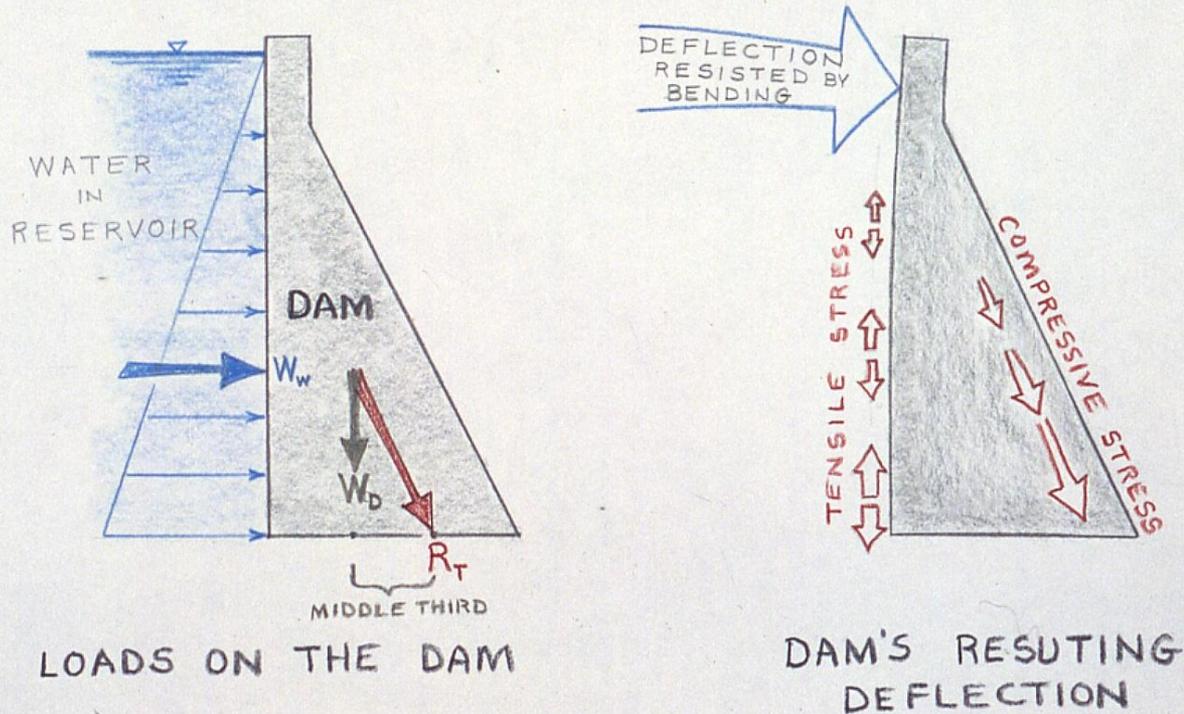
CANTILEVER ACTION

- Prior to 1928, most concrete gravity dams were analyzed assuming the concrete to be perfectly dry. The dead weight of the concrete was then compared to the hydrostatic force of the water and see if the resultant thrust, R_T , fell within the middle third of the dam's base.

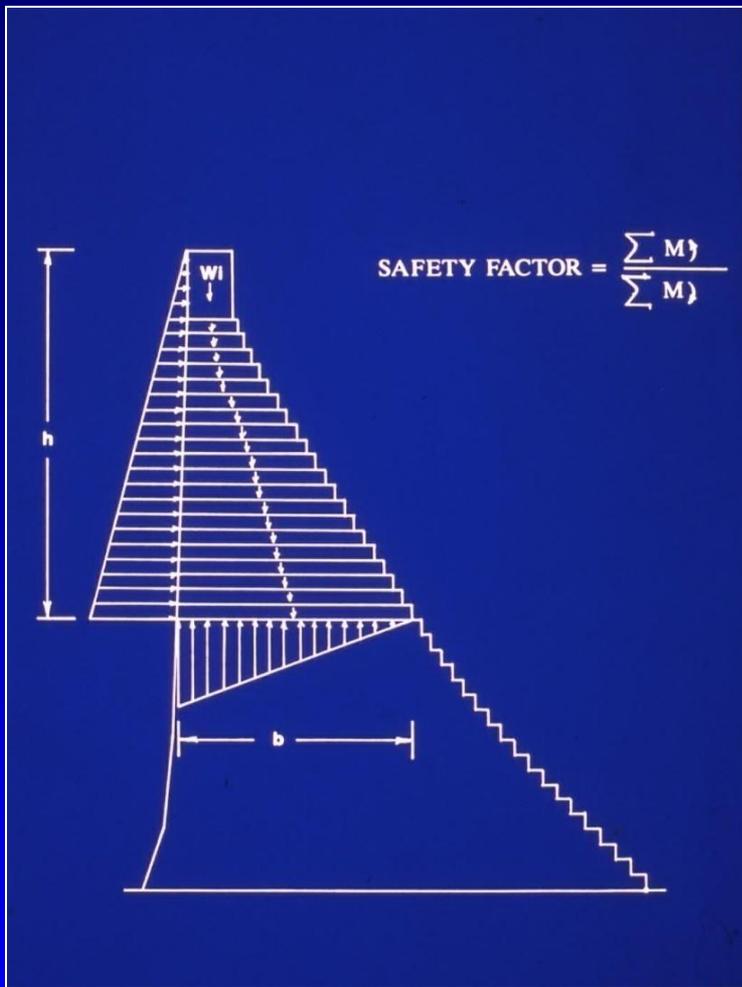
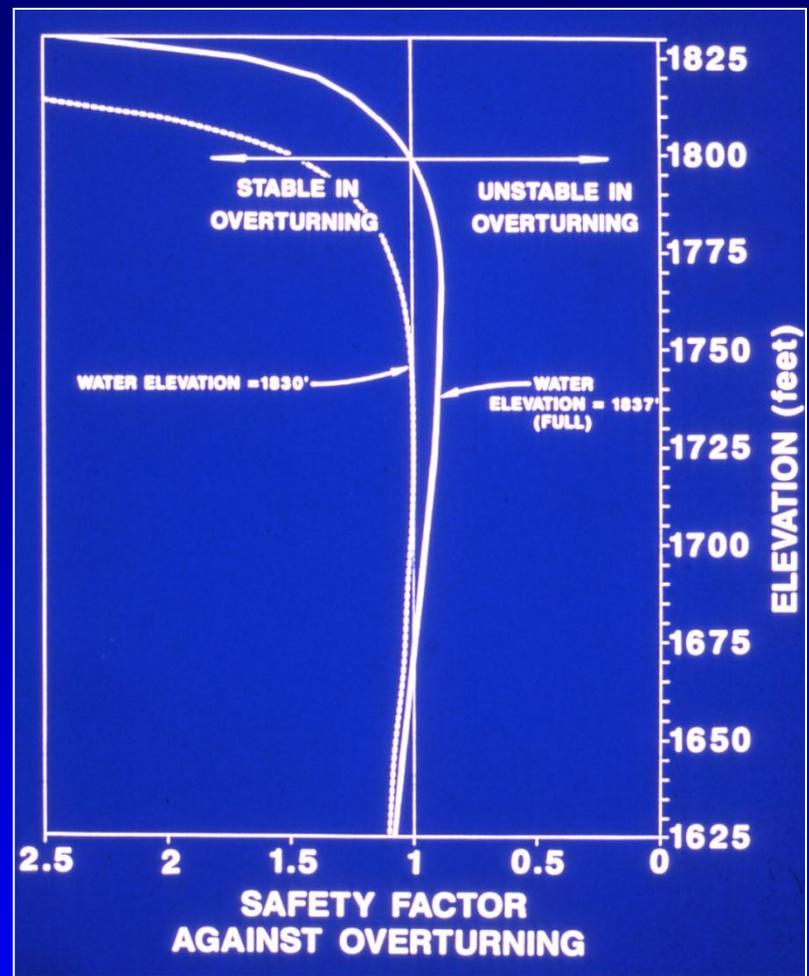
- In 1945 Karl Terzaghi published an article which demonstrated that water pressure could infiltrate mass concrete, saturating it.
- A conventional analysis of cantilever stresses in St. Francis Dam assuming full uplift reveals that the dam becomes unstable in overturning when the reservoir rose to within 7 feet of its crest! Full uplift may have developed beneath the sloping abutments, which were not afforded uplift relief wells.
