THE ST. FRANCIS DAM FAILURE

**worst American civil engineering
disaster of the 20th Century**

J. David Rogers, Ph.D., P.E., P.G., C.E.G., C.HG.

Shlemon Specialty Conference

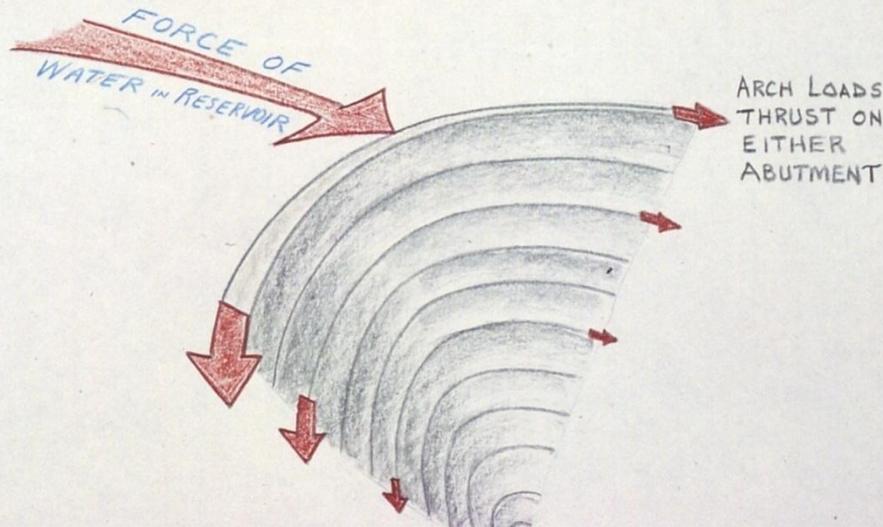
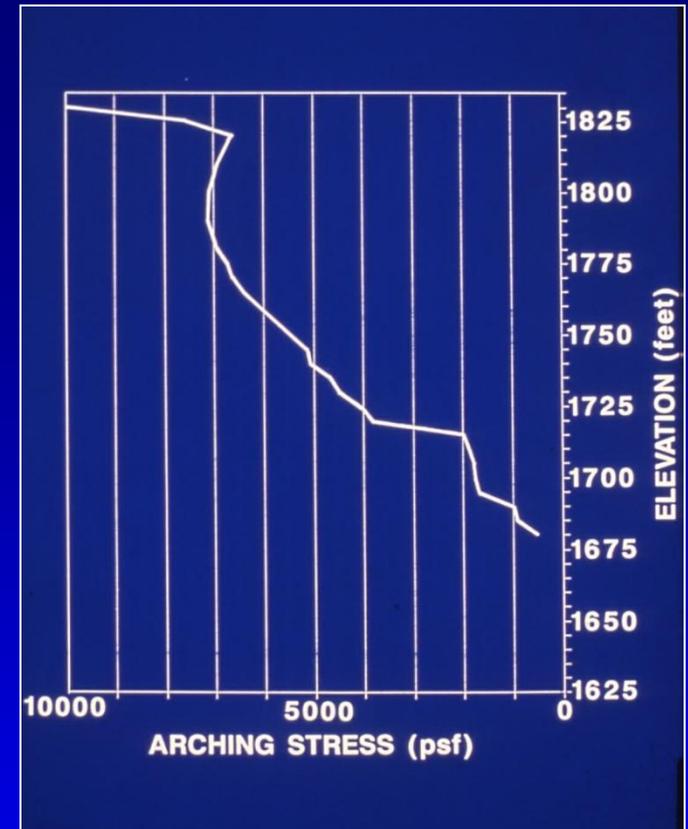
THE ACTION OF ARCHING
SPLITS LOADS TO BOTH SIDES,

- The arch stresses on the St. Francis Dam became very high when the reservoir was raised to within 11 feet of spillway crest.
- The dam was designed before the Trial Load Theory of Arch Stress Distribution was developed, so it was not designed to incorporate the contribution of arching to its stability.

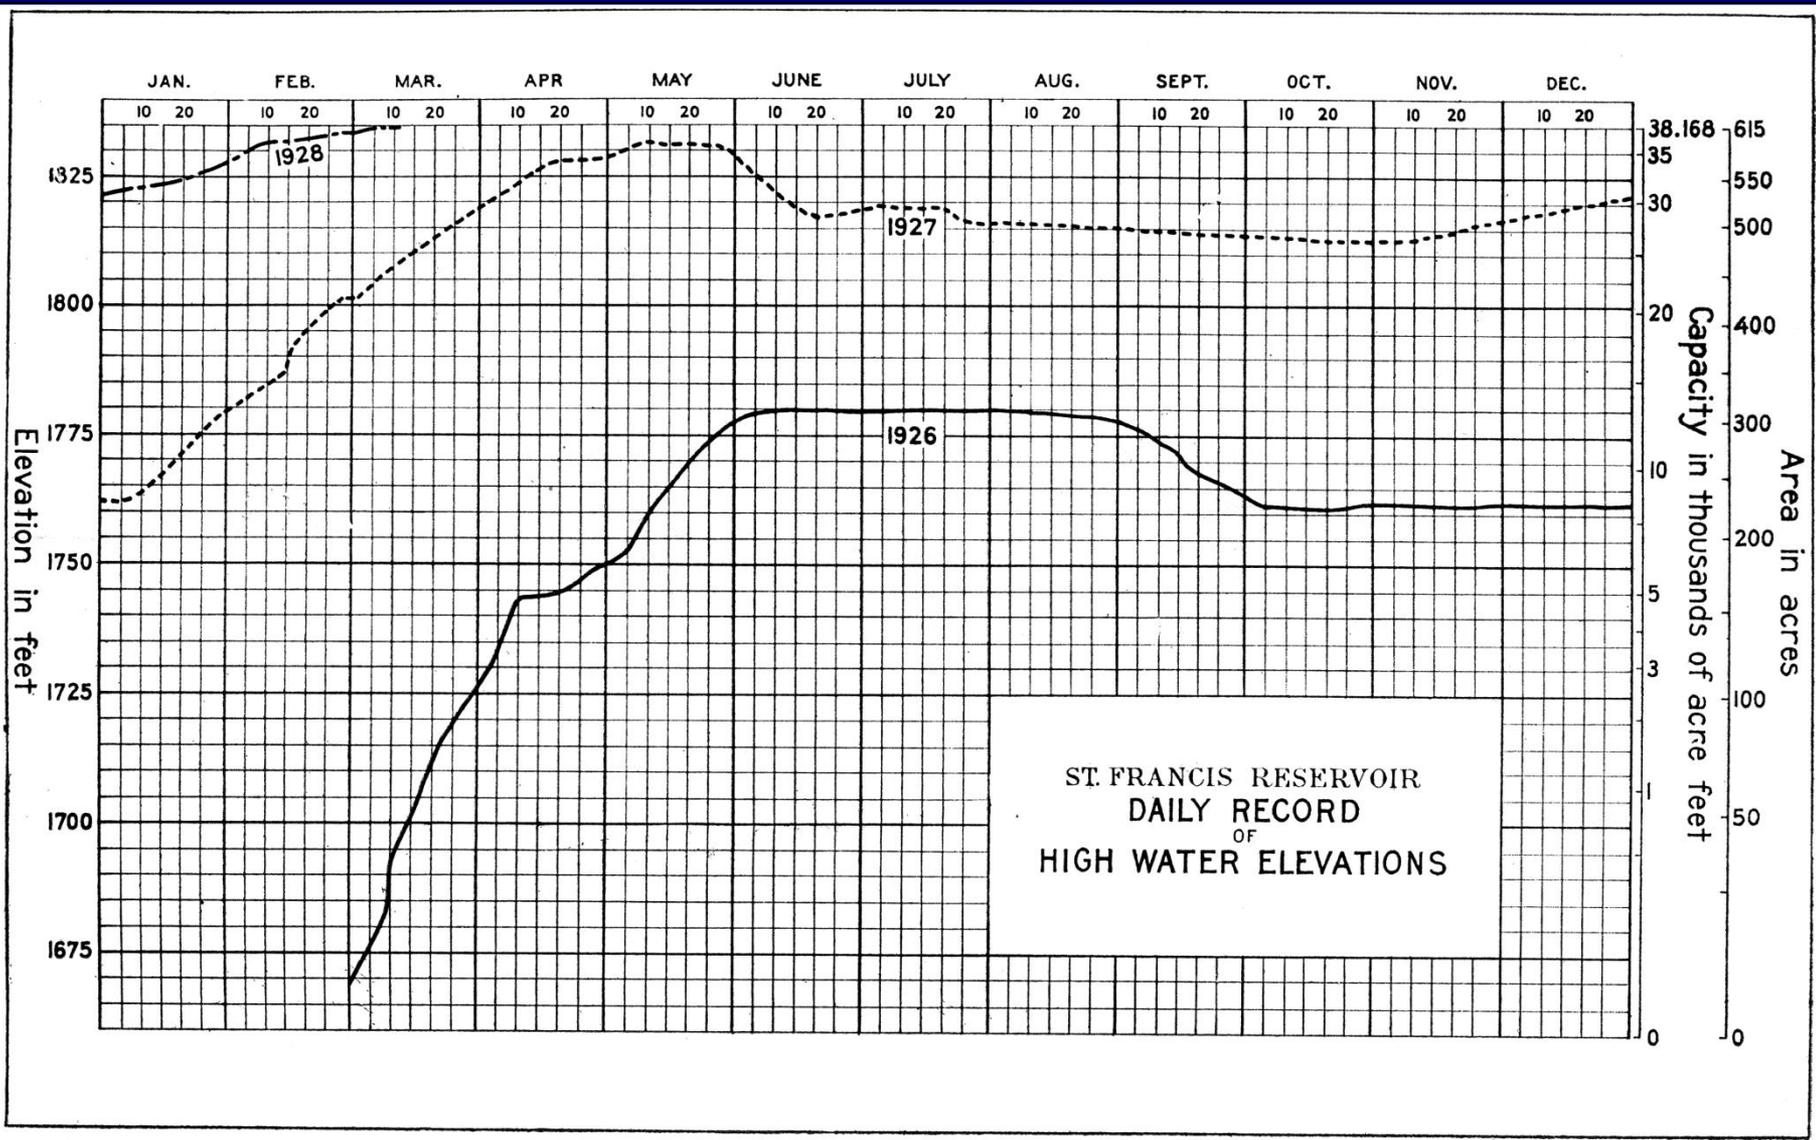
- Reservoir Stage Curve for St. Francis Reservoir between March 1, 1926 and March 13, 1928

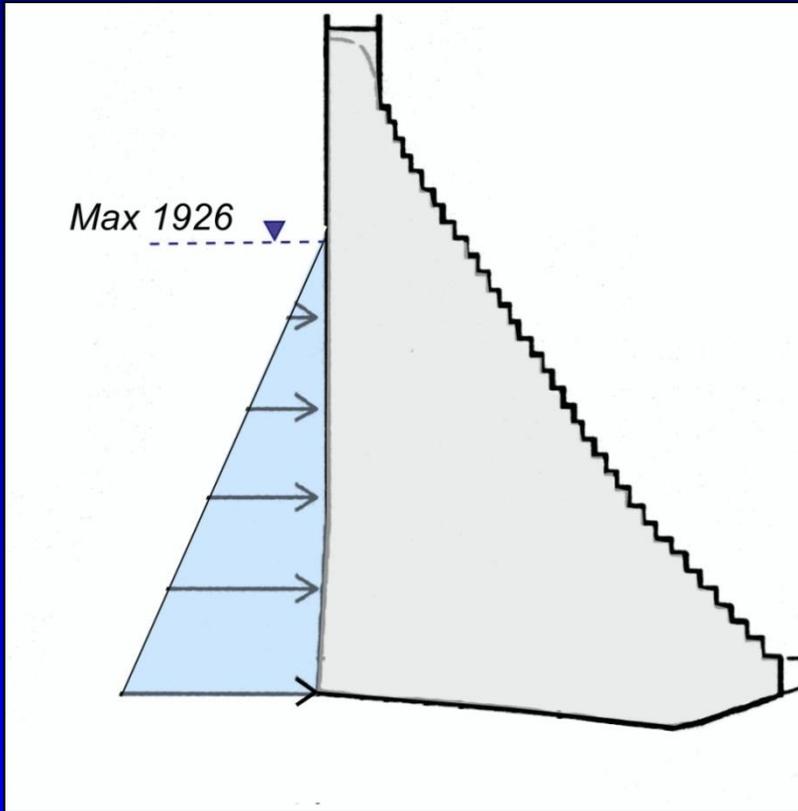
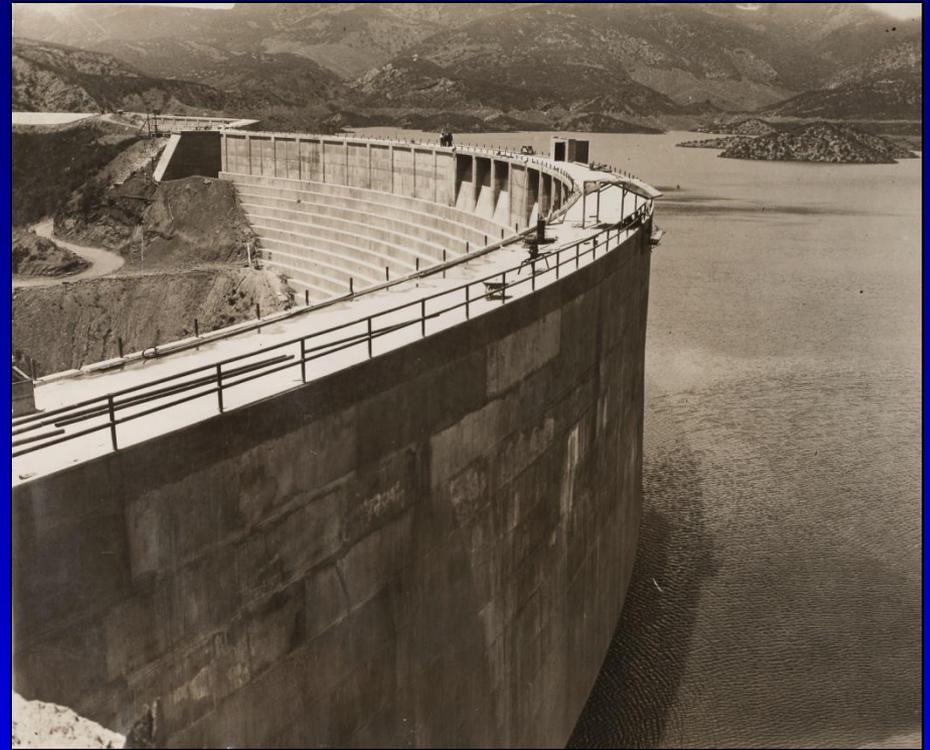
In 1926 the reservoir was filled 110 feet, up to elevation 1780 feet between June 1st and September 1st, then drawn down about 20 feet through the fall and winter months, when demand was lowest.

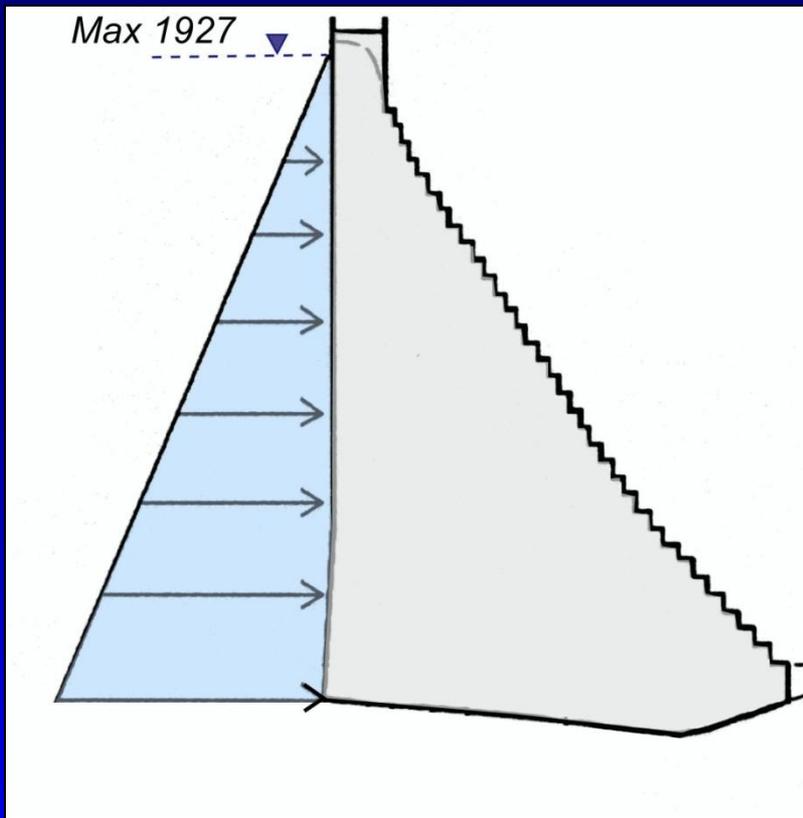
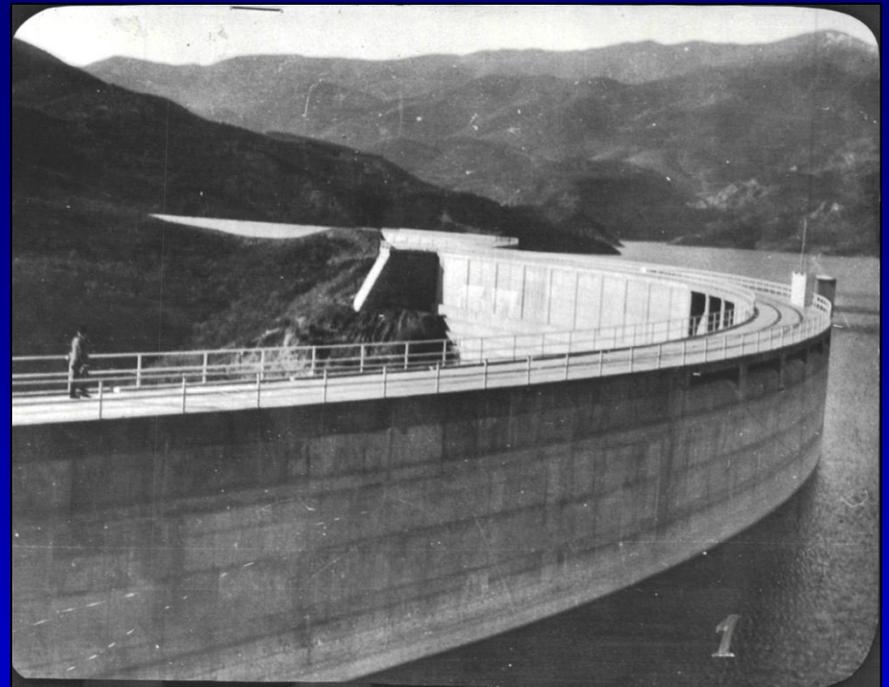
From January 5 to May 8, 1927 the reservoir was raised another 52 feet, to elevation 1832, within three feet of the spillway sills, and held there for 3 weeks, then drawn down to elevations 1813 to 1819 ft, until November 10th.

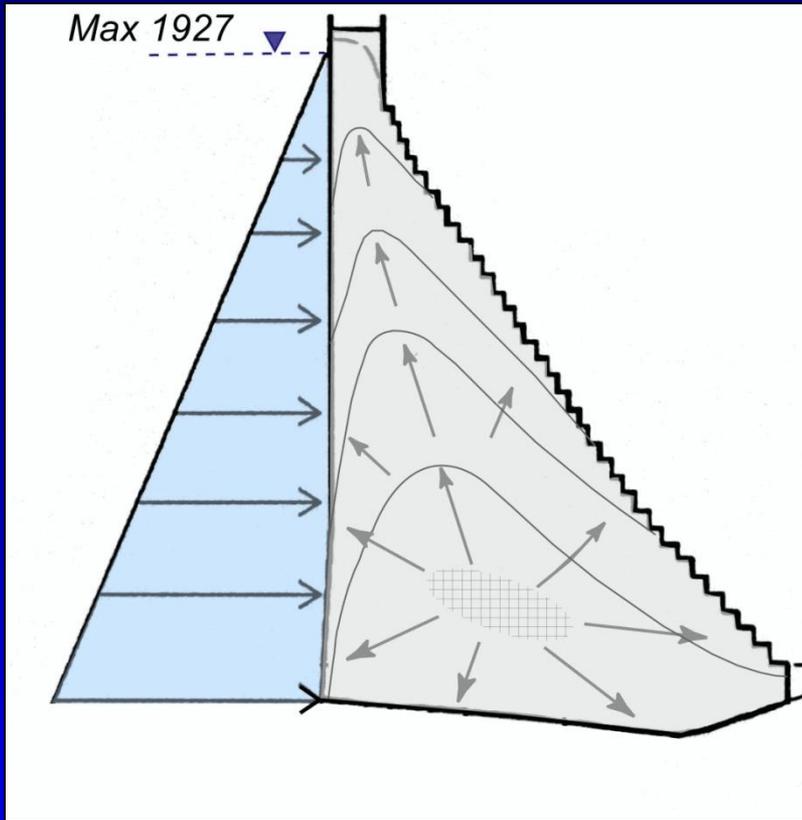
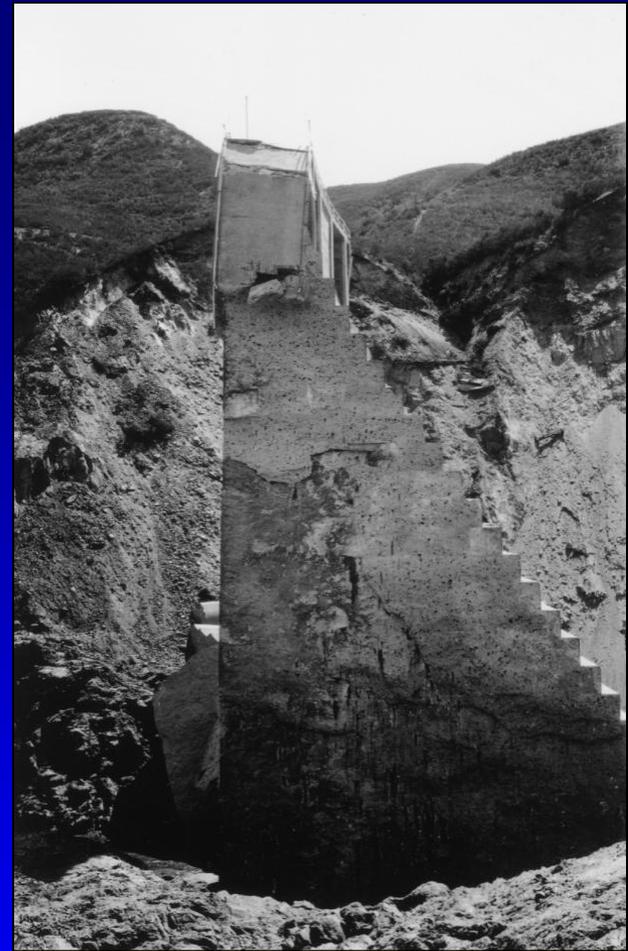
During the first year of operation several large tension cracks formed transverse to the dam's axis. These were likely in response to the cement heat of hydration, which would have been considerable for 130,000 yds³ of mass concrete.

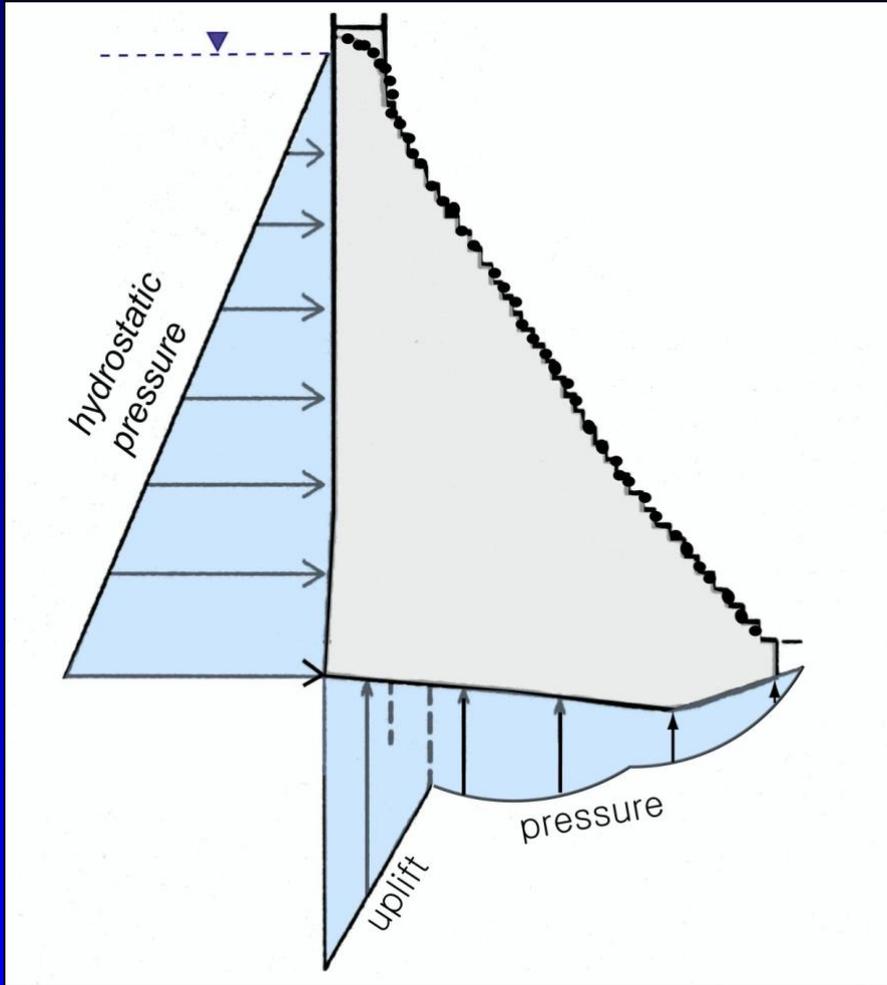
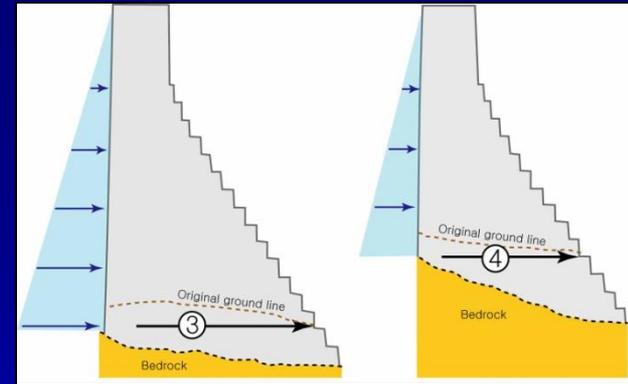
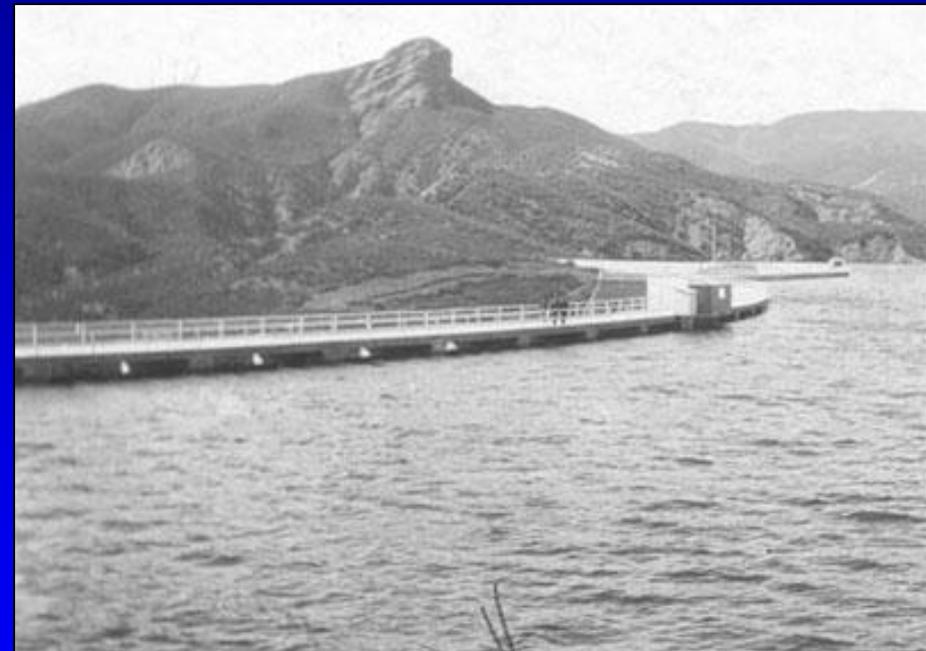
During the high water stand of 1927 seepage increased markedly through the downstream face of the dam. Mulholland ordered the four prominent cracks to be caulked with oakum, to prevent loss of cement grout injected into these cracks.

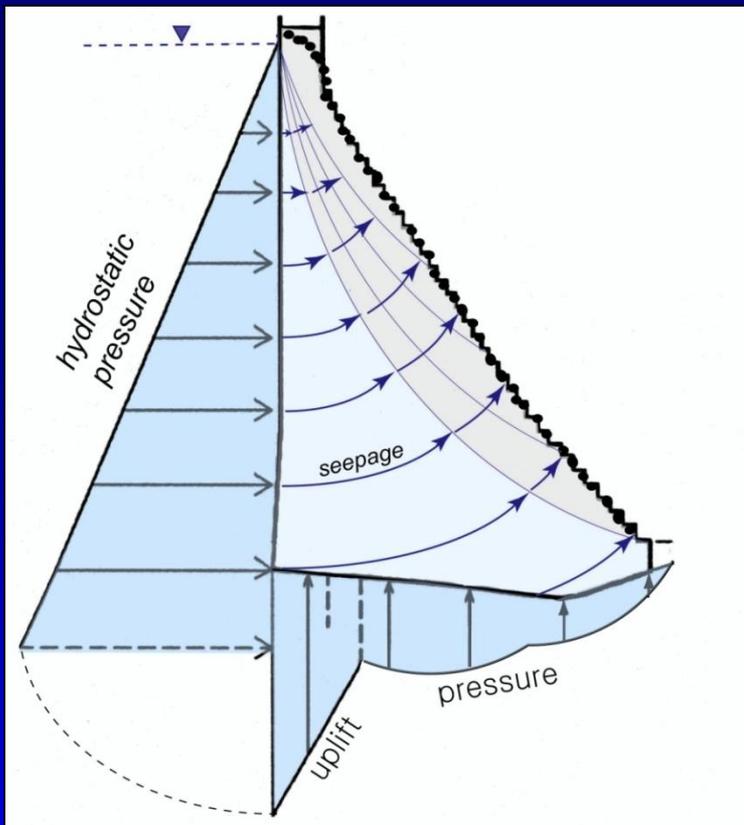
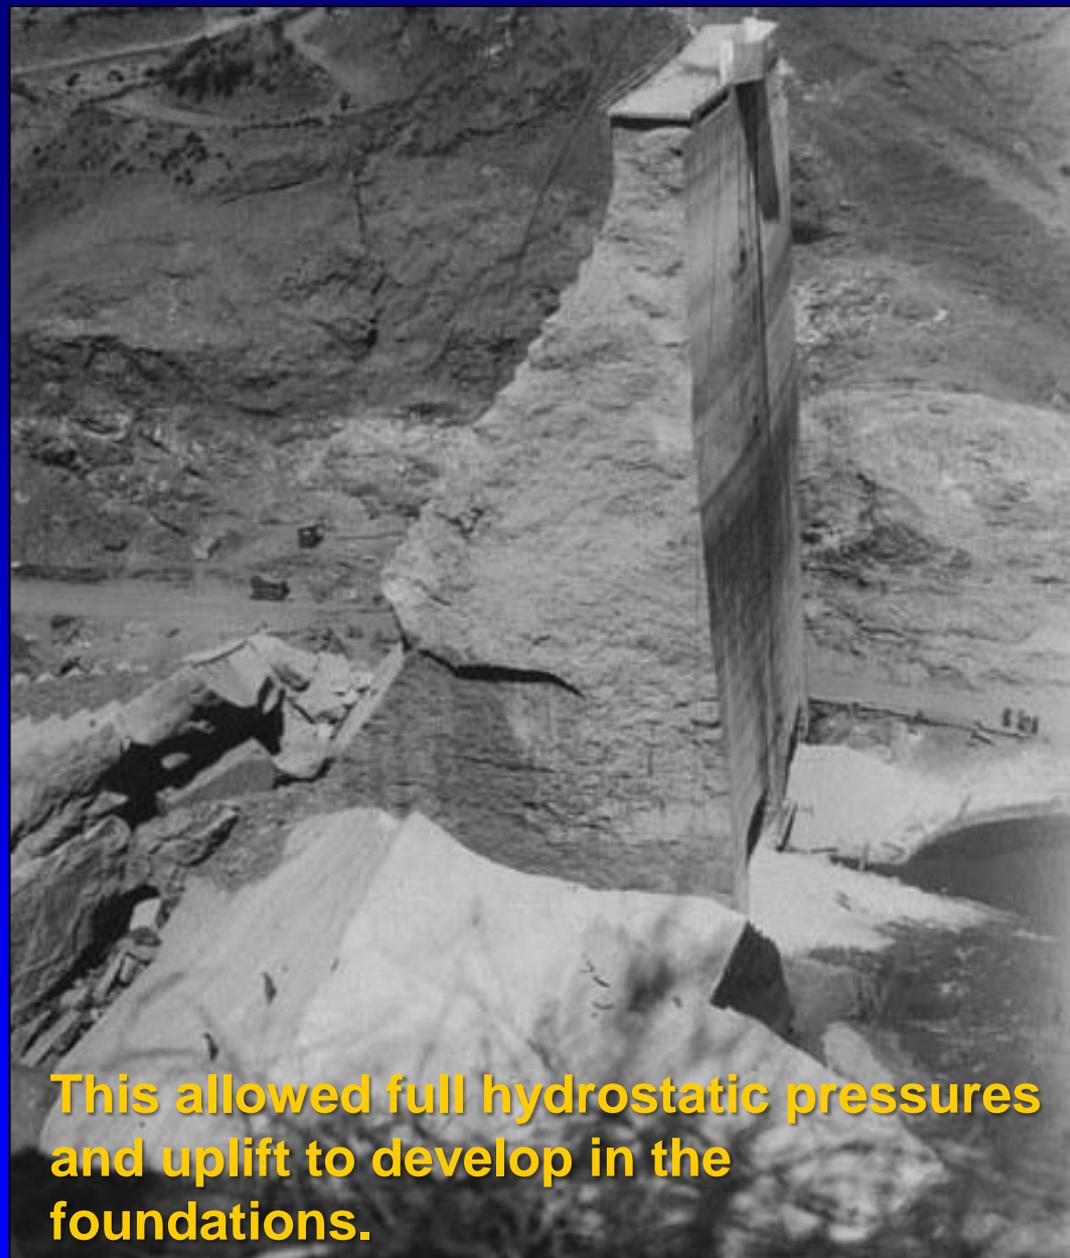
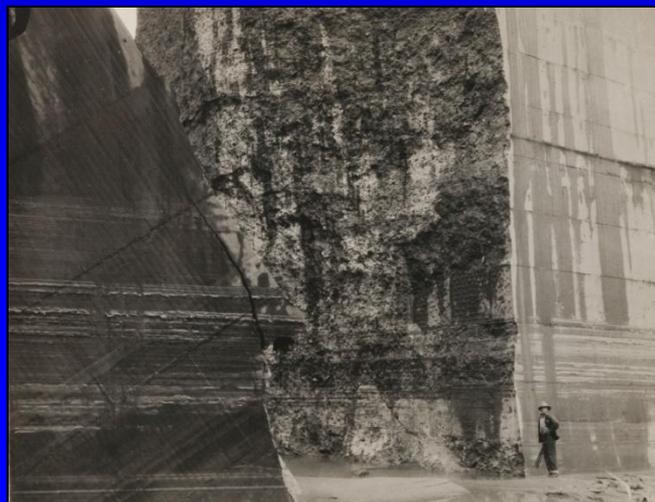
The reservoir was raised to within three inches of the spillway sill elevation of 1835 feet on March 2, 1928

**Prominent
shrinkage
crack
observed
cutting
through
Block 5 after
the failure**

**The oakum caulking can be
discerned on the post-failure
images as dark lines across
the dam's downstream face**

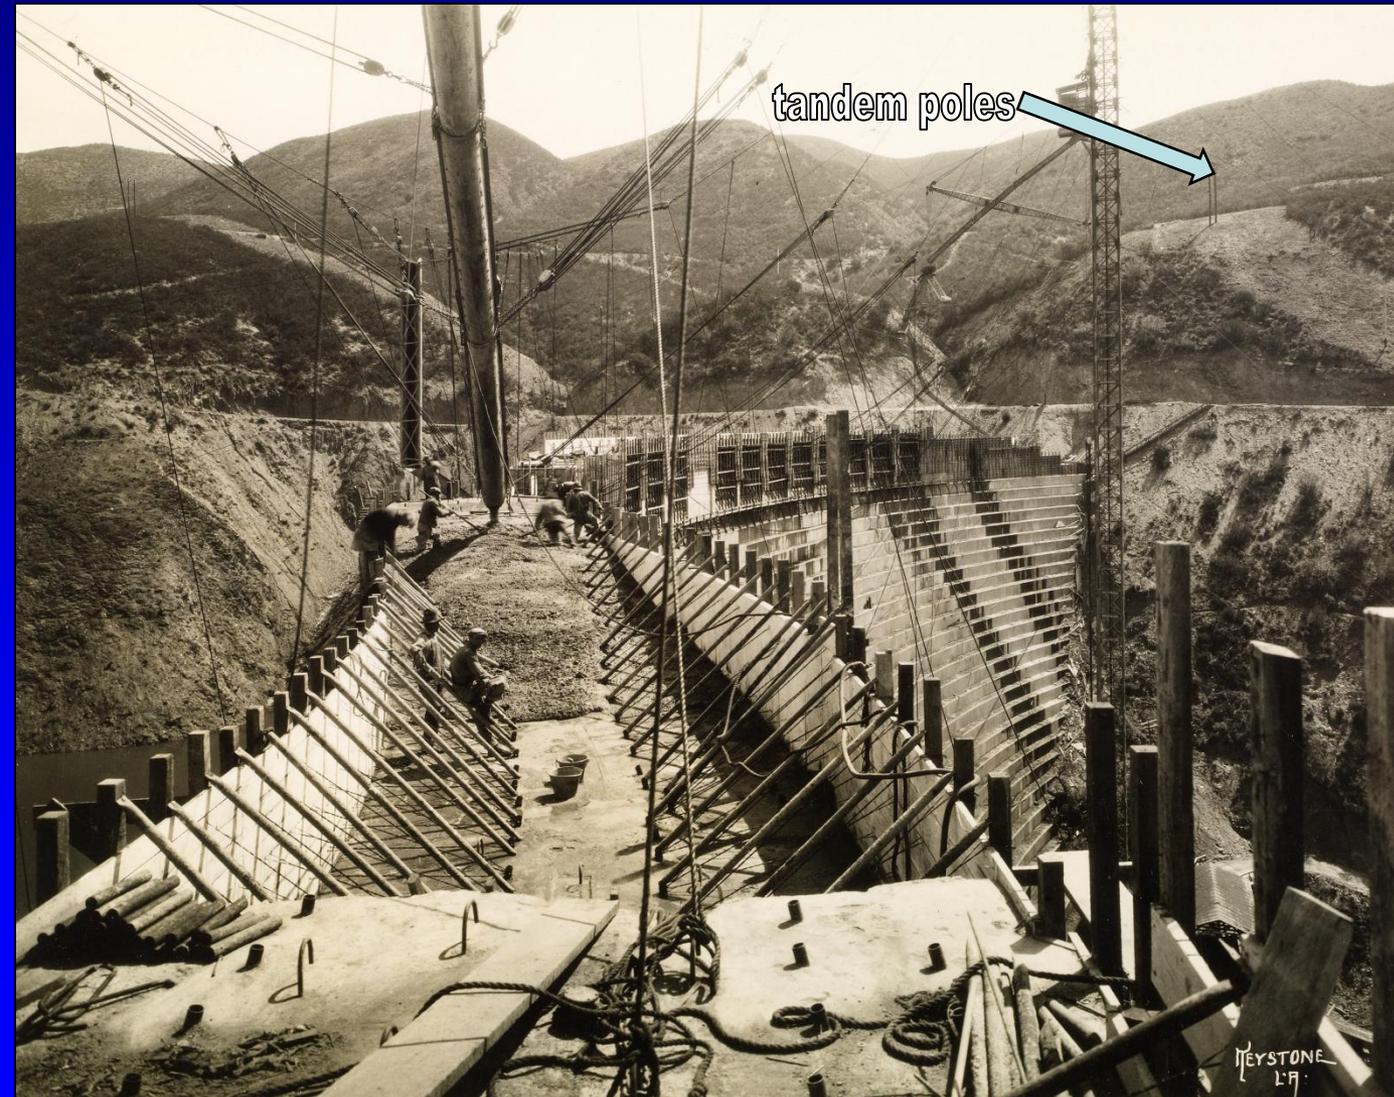
The tandem 70 Kv Power line poles were high above the dam's left abutment

- The tandem power poles were situated *well above* the maximum reservoir level, shown by arrow at left
- It would appear that the power line was severed by the left abutment landslide

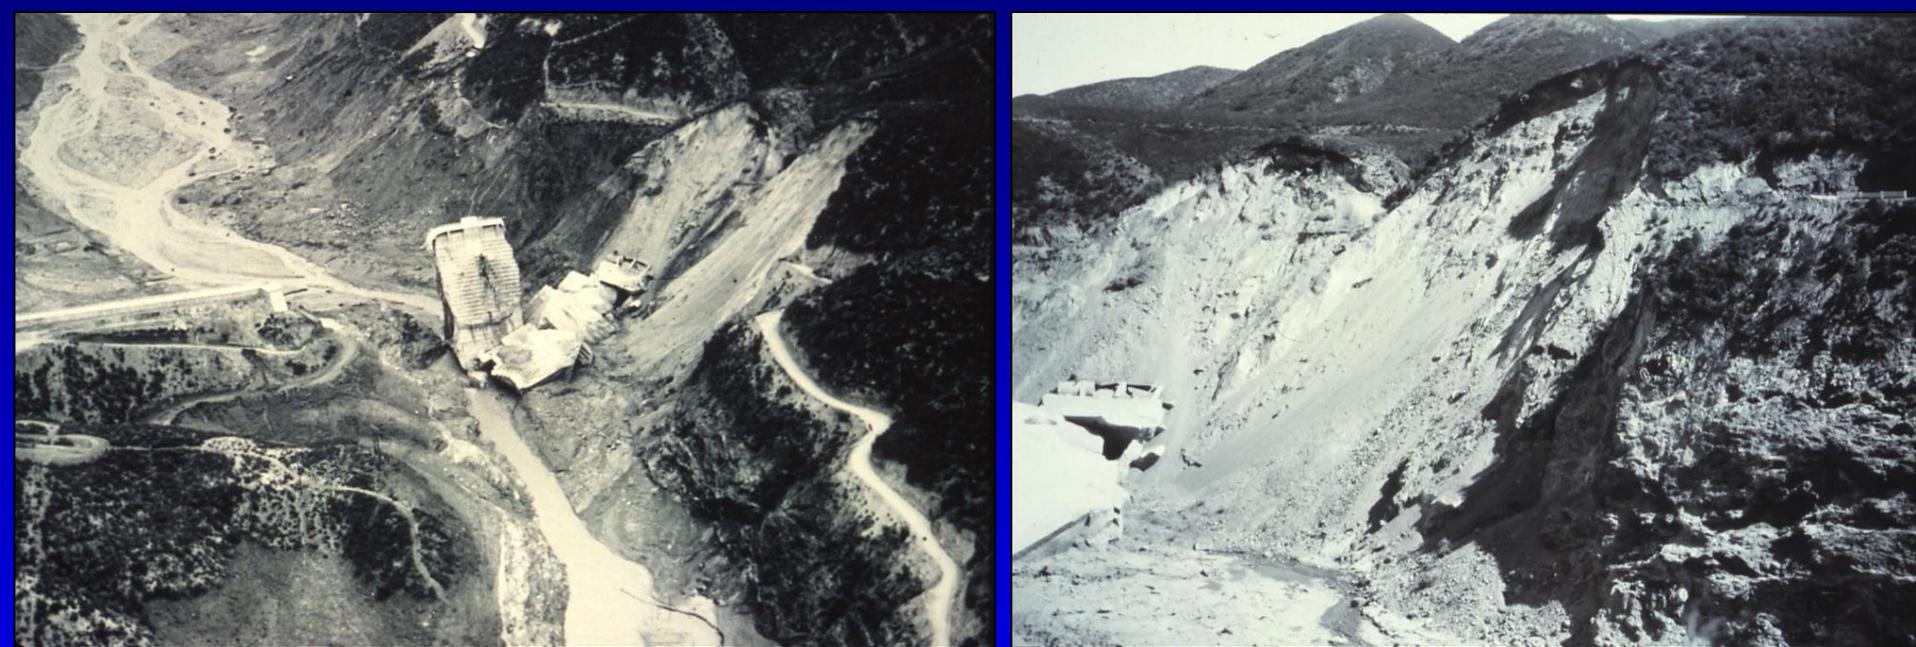
The East Abutment Landslide

- The east abutment landslide involved about 700,000 cubic yards of Pelona Schist, removed in a short period of time. The landslide scar extended 130 feet *above* the reservoir water surface.

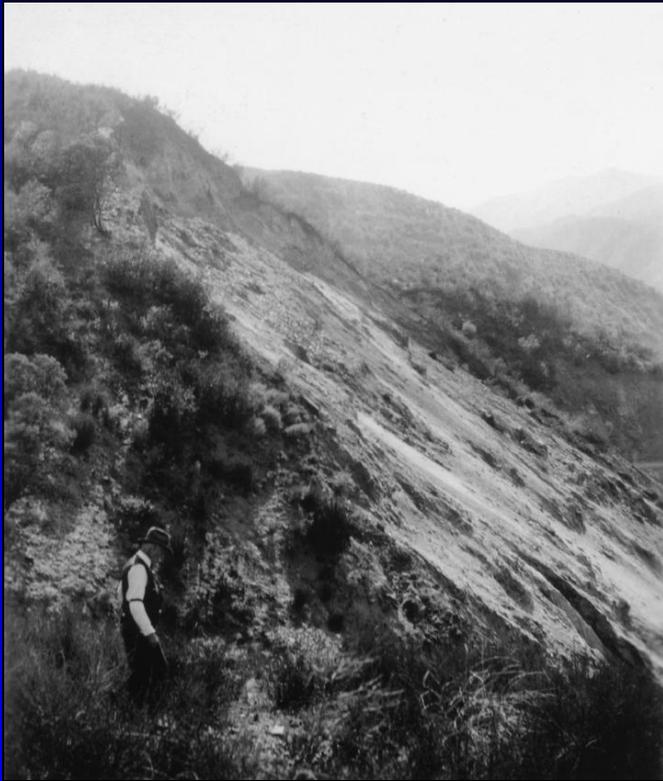
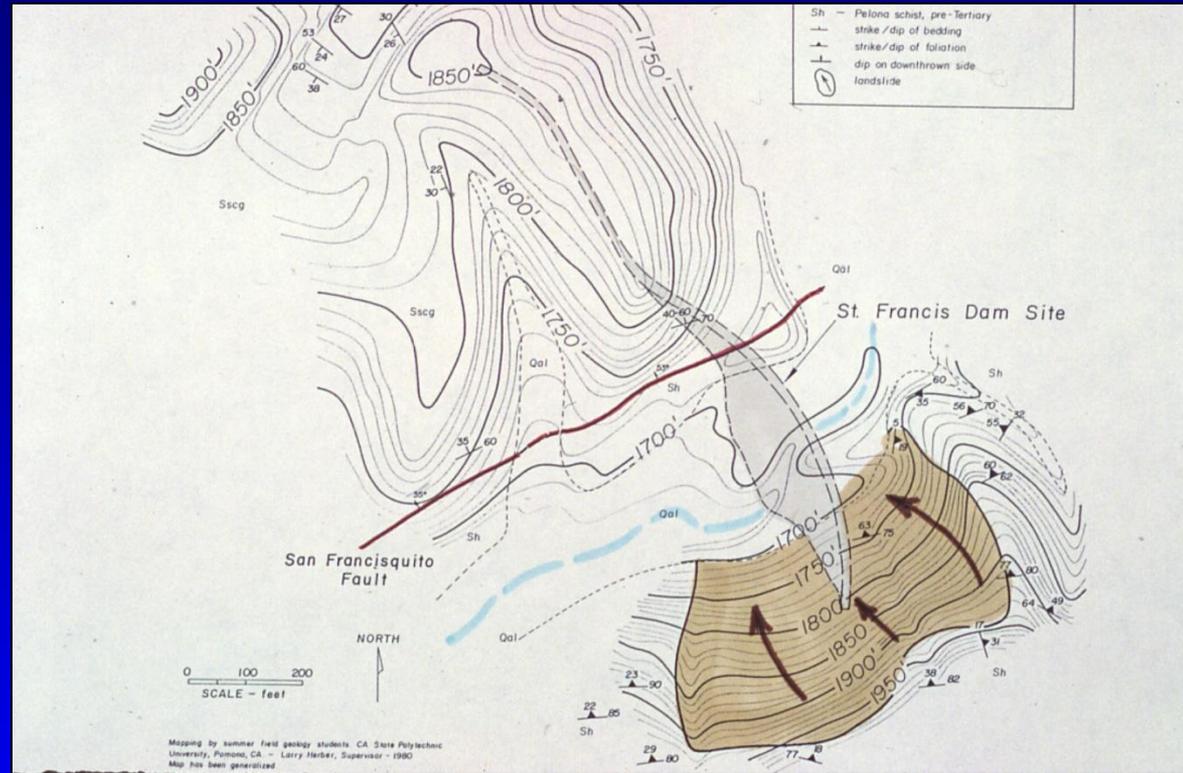
Map of the East Abutment Landslide

- The reservoir water was only in direct contact with about 25% of the landslide material that was removed during the outbreak flood
- The dam's left abutment thrust against the center of the landslide area, shown in brown

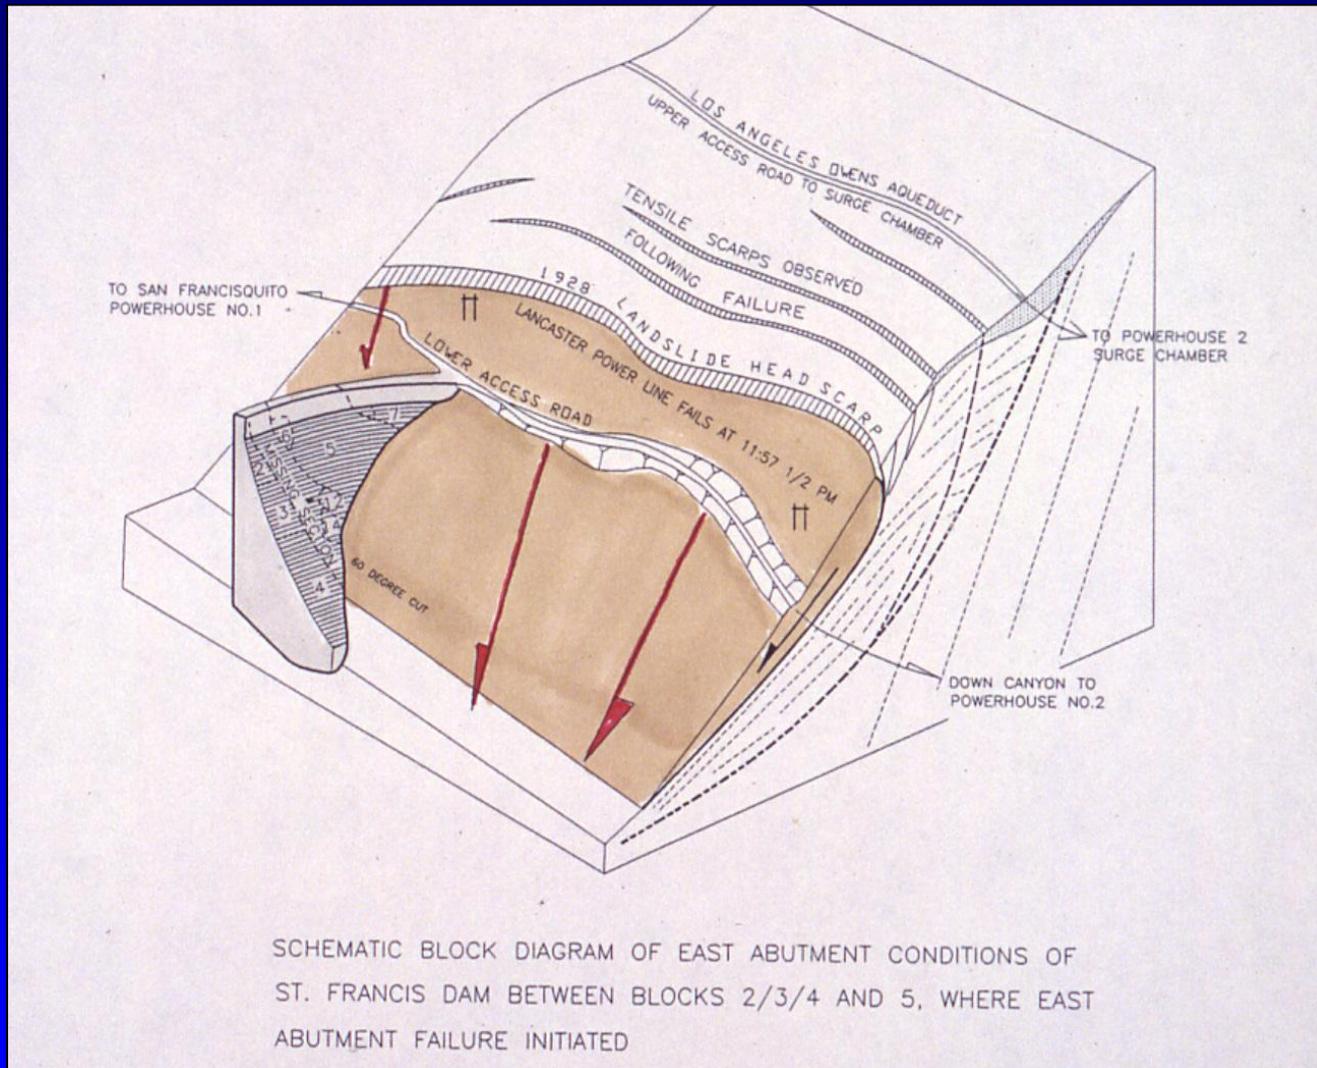
- The landslide of March 12, 1928 was only a portion of a much larger paleo-landslide developed deep within the Pelona Schist.

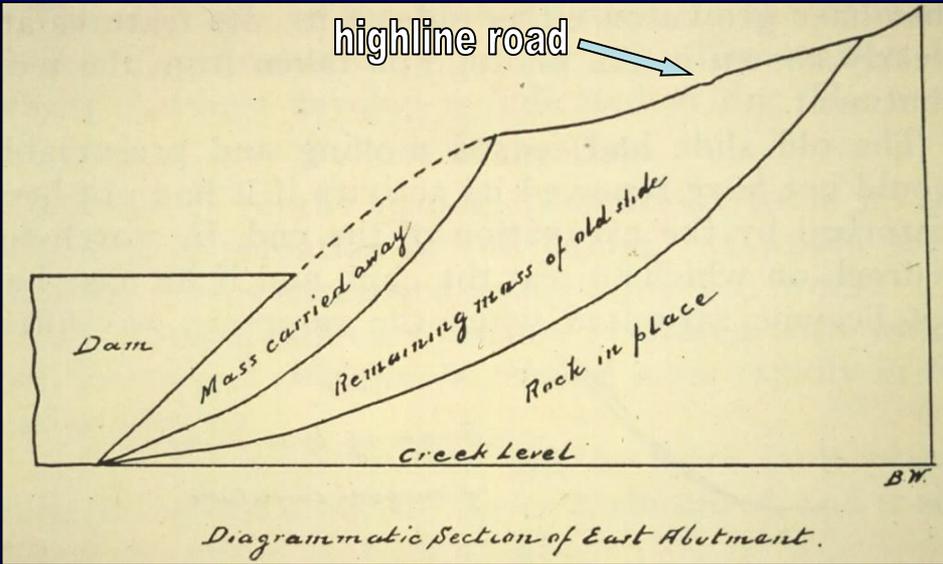
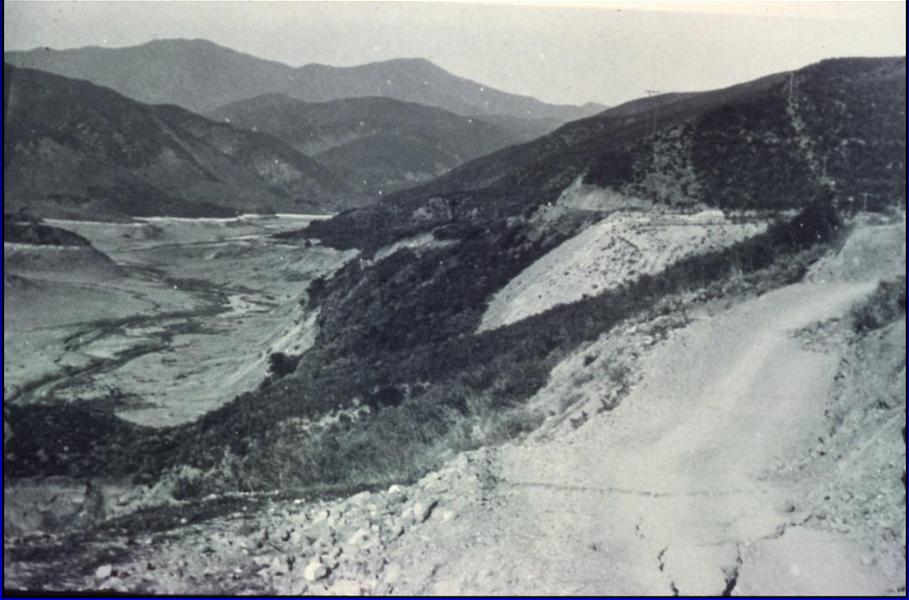
Professor Willis' sketch of paleolandslide

Higline Road dropped 2 to 9 feet

- **Stanford Geology Professor Bailey Willis recognized the significance of en-echelon tensile scarps that cut across the Bee High Line Road, 200 feet above the reservoir's high water line (see photo at right).**
- **He drew the sketch at left showing relation of the 1928 landslide to a much deeper-seated paleolandslide complex, developed in the Pelona Schist**

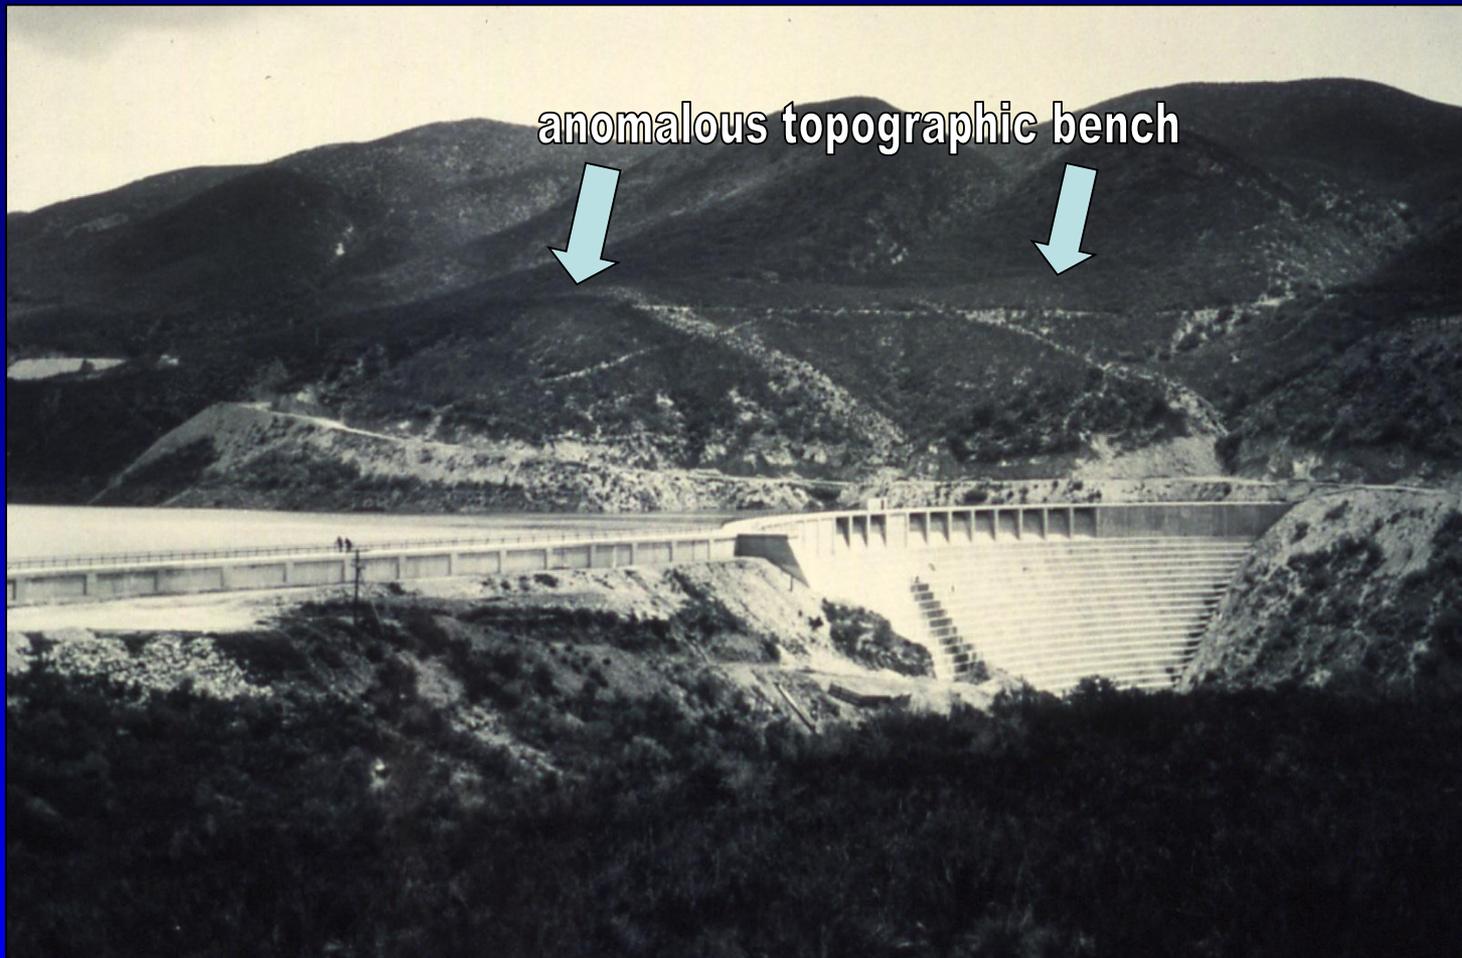
anomalous topographic bench

- The prominent topographic benches developed on the Sierra Pelona are relicts of enormous landslide grabens. At various intervals these massive slides must have blocked San Francisquito Creek, creating temporary landslide dams, which promoted the development of the tree-filled glen on fluvial and lacustrine sediments that underlie the old reservoir floor.

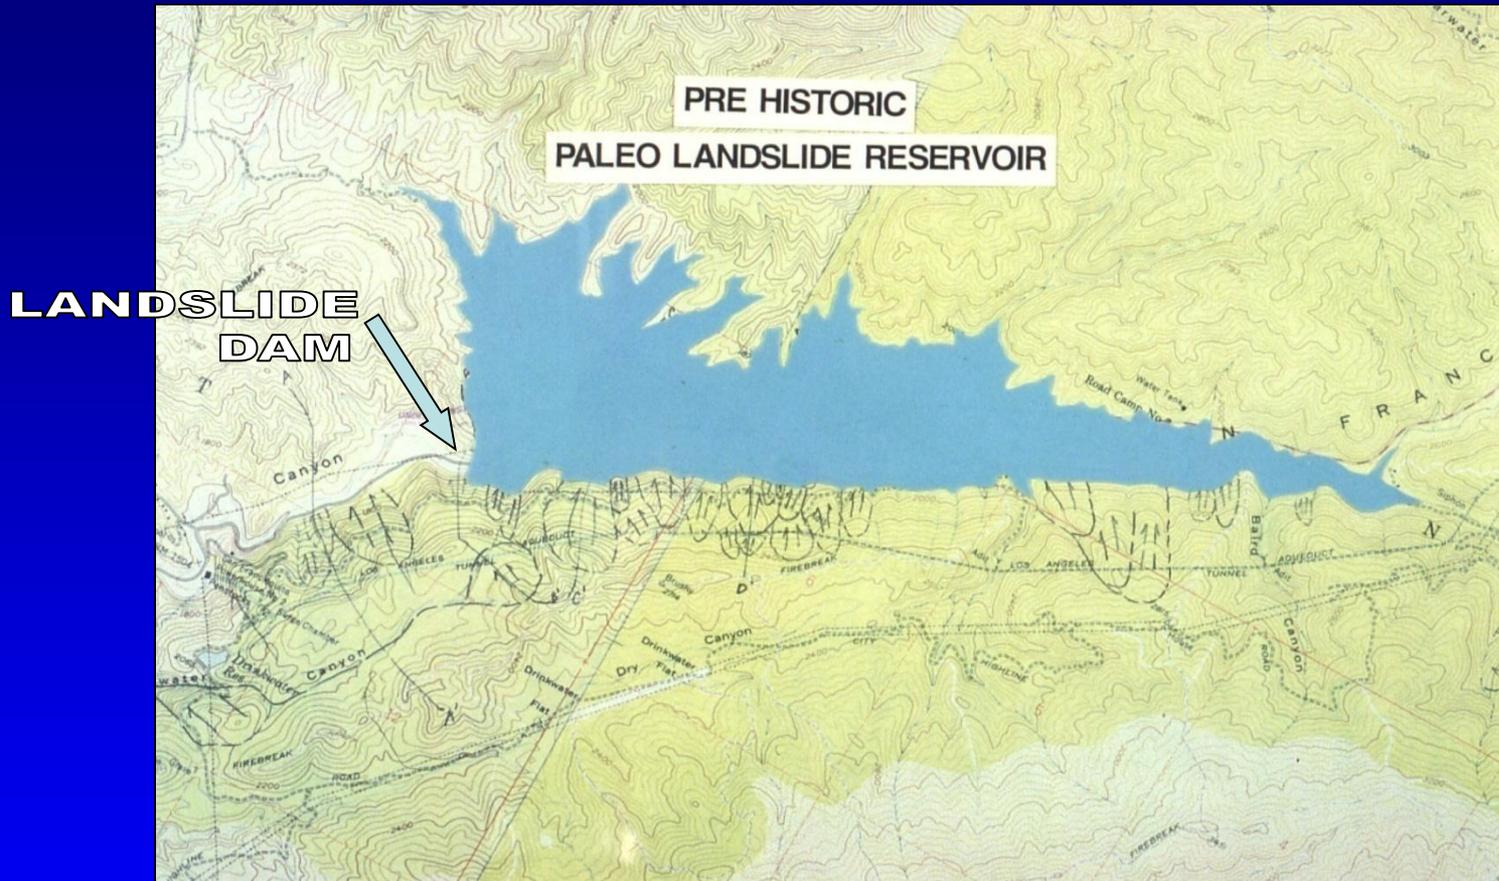
Ancient Landslide Dam

- A paleolandslide in vicinity of the St. Francis Dam site appears to have dammed the creek during late Pleistocene time (the last 100,000 years). This dam constricted the canyon and created a much larger reservoir than St. Francis, and the areal limits of the pool are shown here. It also created favorable topography for a man-made dam

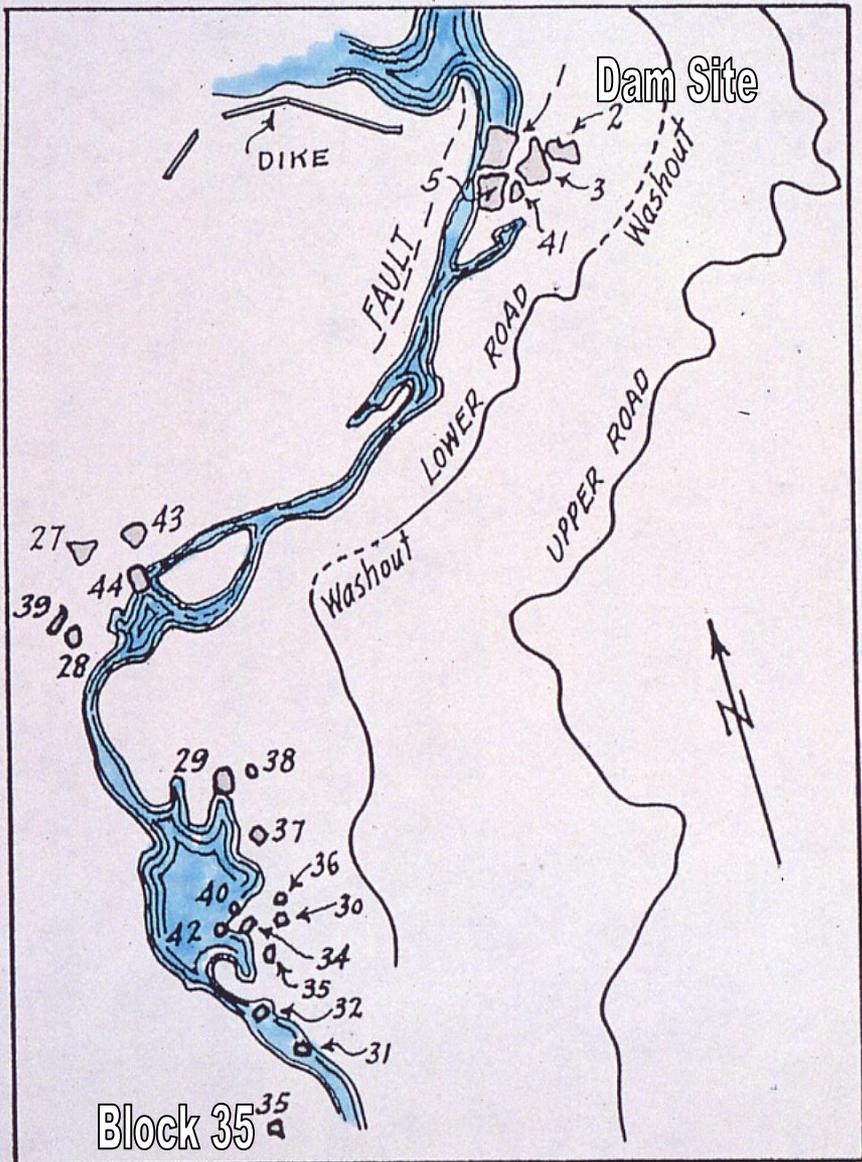
City's block map

- City engineers Ralph R. Proctor, H.C. Gardett, and A.R. Arledge made careful surveys of the flood aftermath
- Proctor had been BWWS resident engineer on St Francis, while Gardett and Arledge were BPL engineers supervising reconstruction of Powerhouse 2
- They identified the source locations of 17 of the dam's displaced blocks
- Two candidates for Block 35 were identified, one of which was located the furthest distance downstream

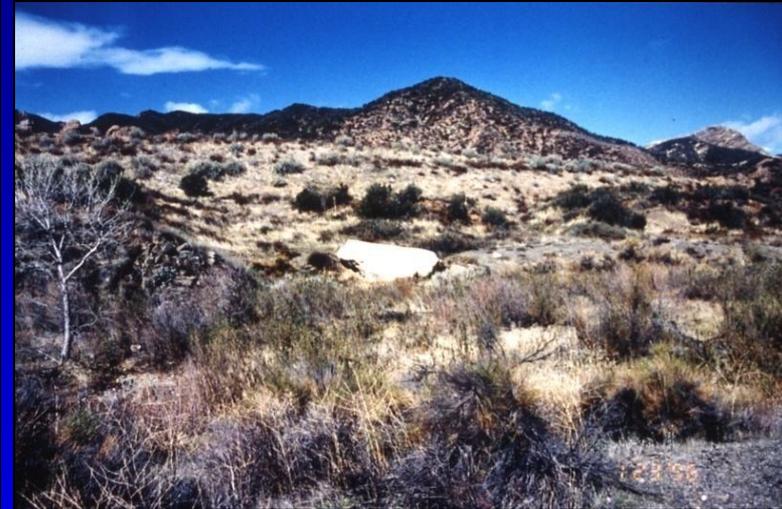
Block 35 found furthest downstream

- Proctor, Gardett and Arledge identified two candidates for Block 35. The one located furthest downstream is shown at right. Block 35 came from the base of the dam's "missing section," at the bottom of the dam's left abutment. Blocks 27, 28 and 35 were identified by adhesions of schist on their base relative to original horizontality of the concrete cold pour joints (pillows), which are easily discerned.
