THE ST. FRANCIS DAM FAILURE

**worst American civil engineering
disaster of the 20th Century**

J. David Rogers, Ph.D., P.E., P.G., C.E.G., C.HG.

Shlemon Specialty Conference

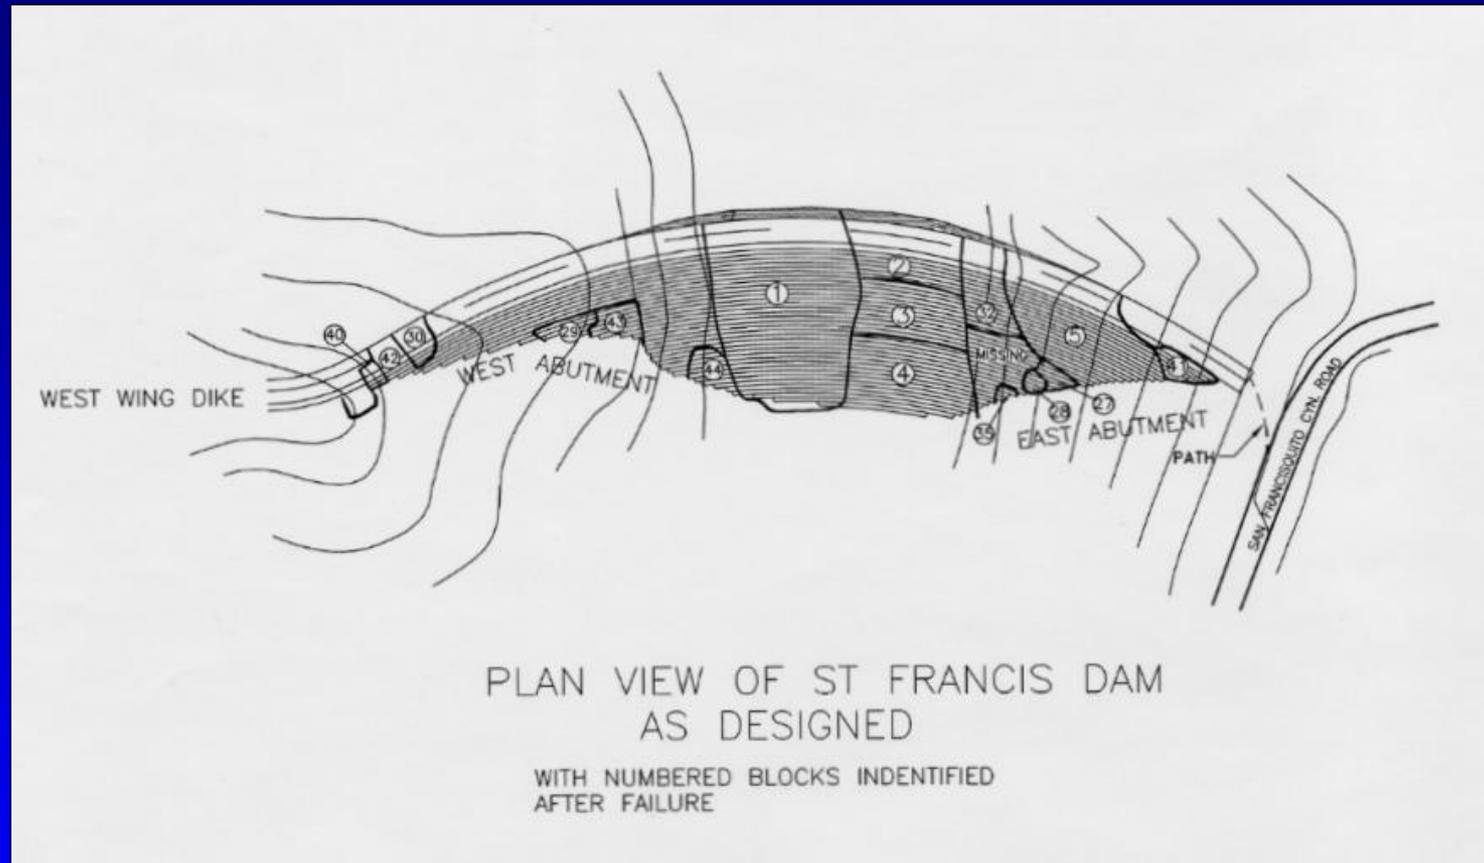
Like a Giant Jigsaw Puzzle

- Many of the dam's concrete blocks were located downstream on the basis of their step widths and the foundation material adhering to them (channel alluvium, schist or conglomerate).

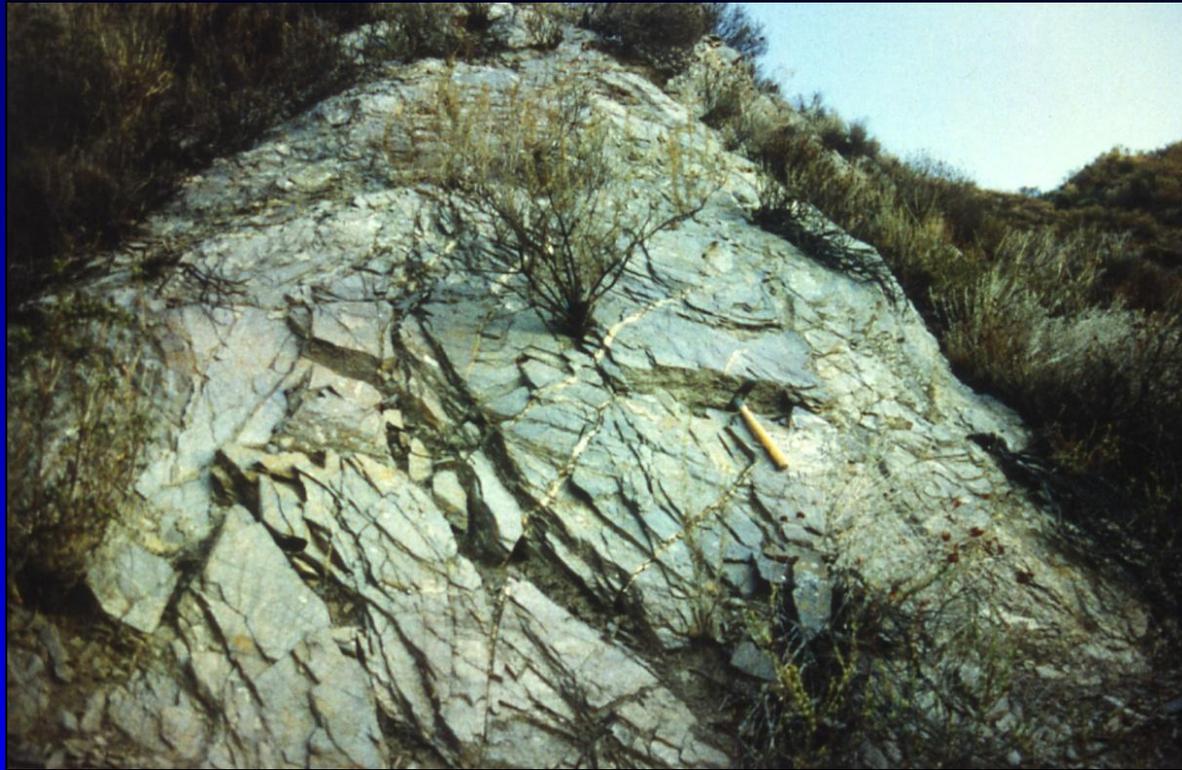
Rock Mechanics Evaluations

- In the mid-1980s I began visiting the dam site to map the geology; focusing much of my efforts on collecting attitudes of foliation and jointing in the Pelona Schist.
- These data were plotted up on stereographic projections and input into computerized databases for subsequent manipulation and evaluation.

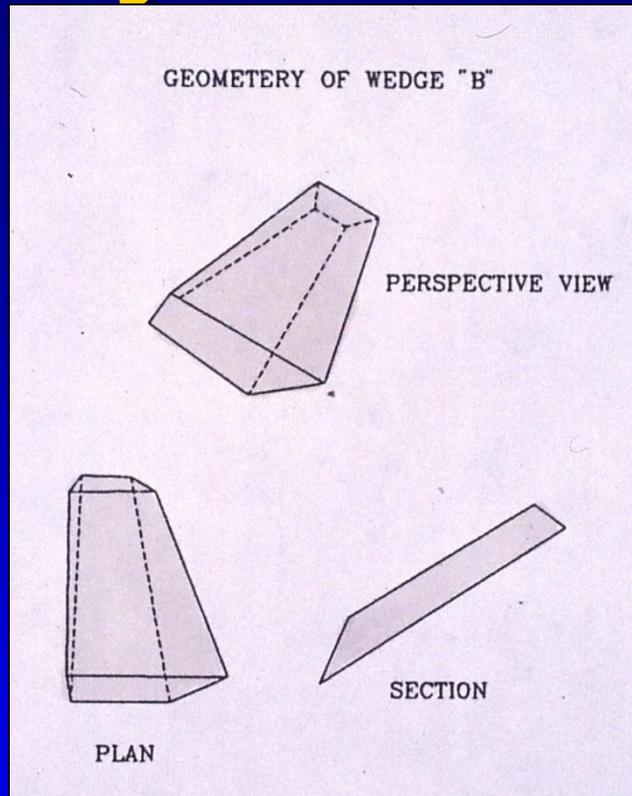
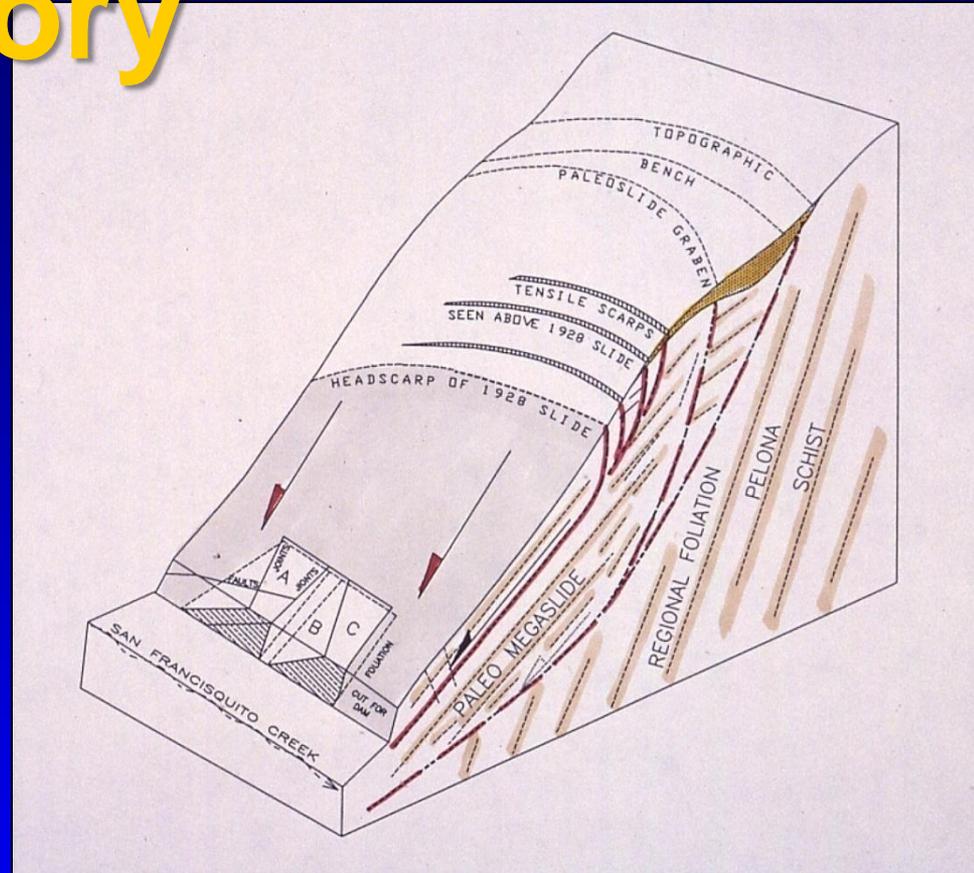
Keyblock Theory

- The Keyblock computer program sorts out the combinations of discontinuity intersections which could form complex blocks of varying form. In this area, three interesting types of blocks were identified at the base of the dam's left abutment

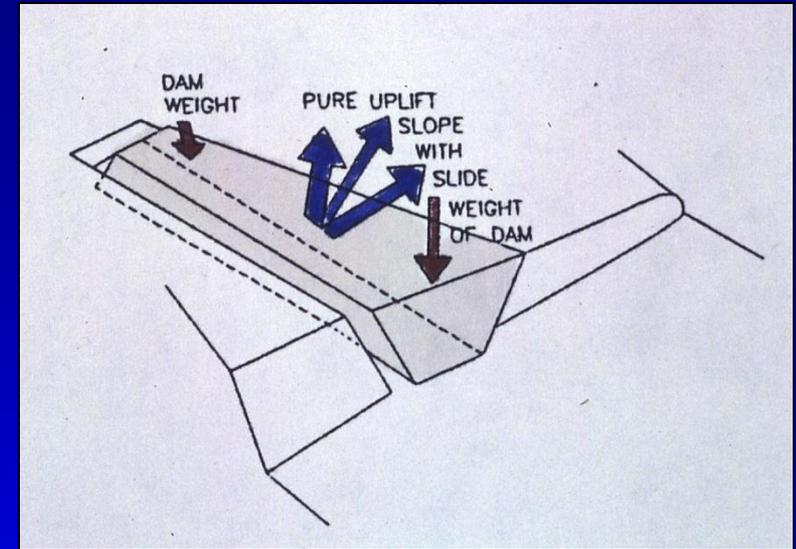
Uplift of 'Wedge B' at base of left abutment

- Full reservoir pressure was applied to Rock Wedges A, B and C identified at the base of the left abutment in the Keyblock program.
- These were found to lift upward, even under the weight of the dam in that area (which diminishes rapidly progressing up the left abutment)
- Such lifting could have destabilized the dam's left abutment

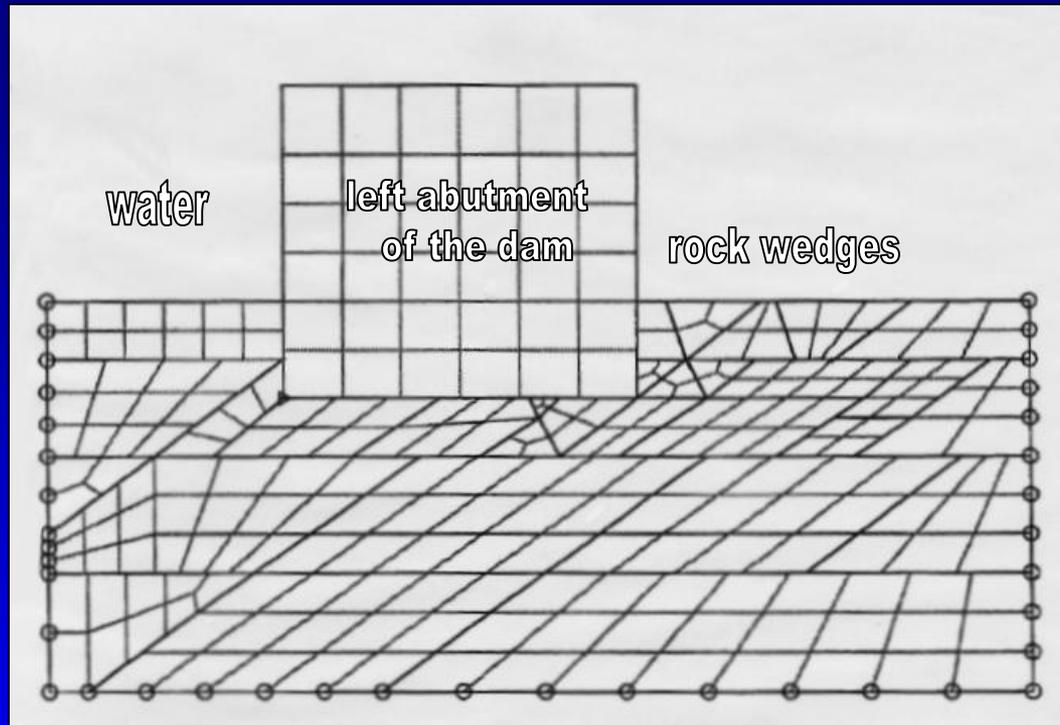
Discontinuous Deformation Analyses

- A joint-bordered element mesh was constructed of the dam's lower left abutment area, assuming rock wedges A, B and C; in vicinity of Block 35. The dam is represented by the rectangular block shown above. The reservoir pool (water) is to the left of this block.

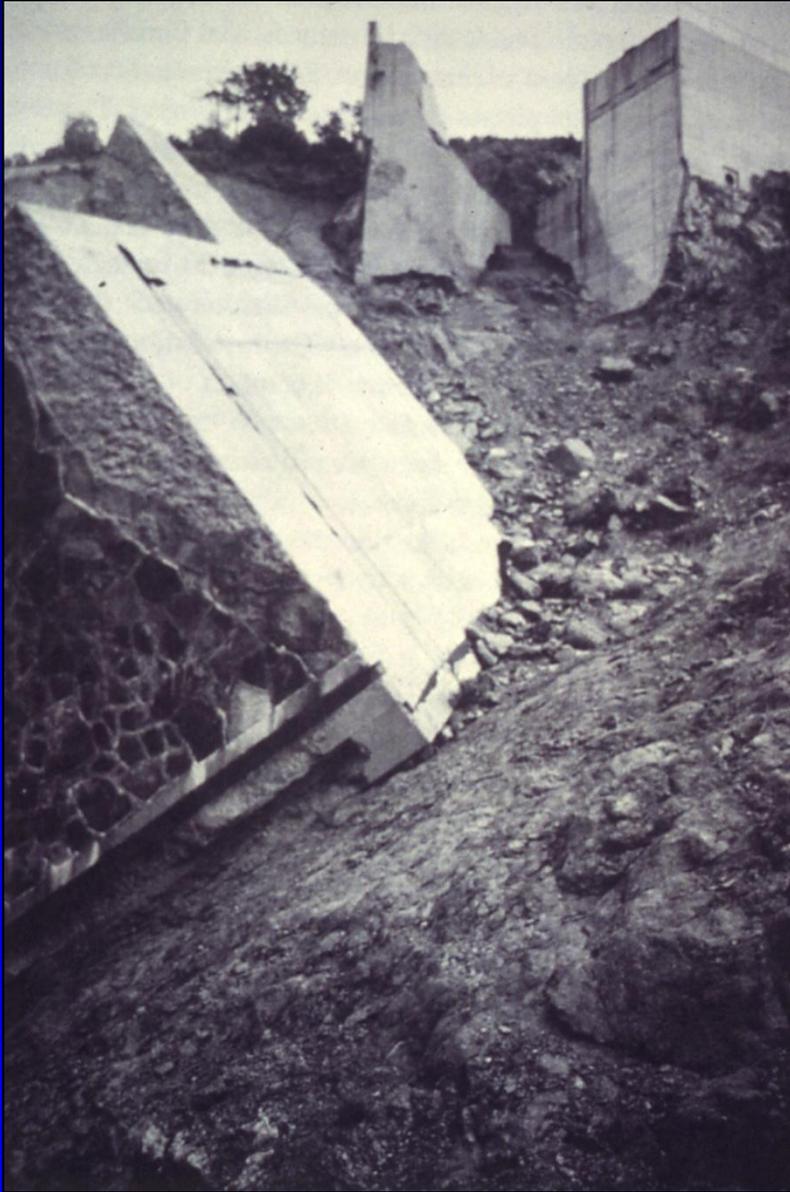
Malpasset Dam

- The Malpasset arch dam in France failed on its initial filling in 1959
- The dam was designed by Dr. Andre Coyne, the world's foremost expert in arch dam engineering
- Dr. Pierre Londe spent 8 years unraveling the failure mechanism
- It was caused by hydraulic uplift of a large rock wedge lying beneath the dam's left abutment

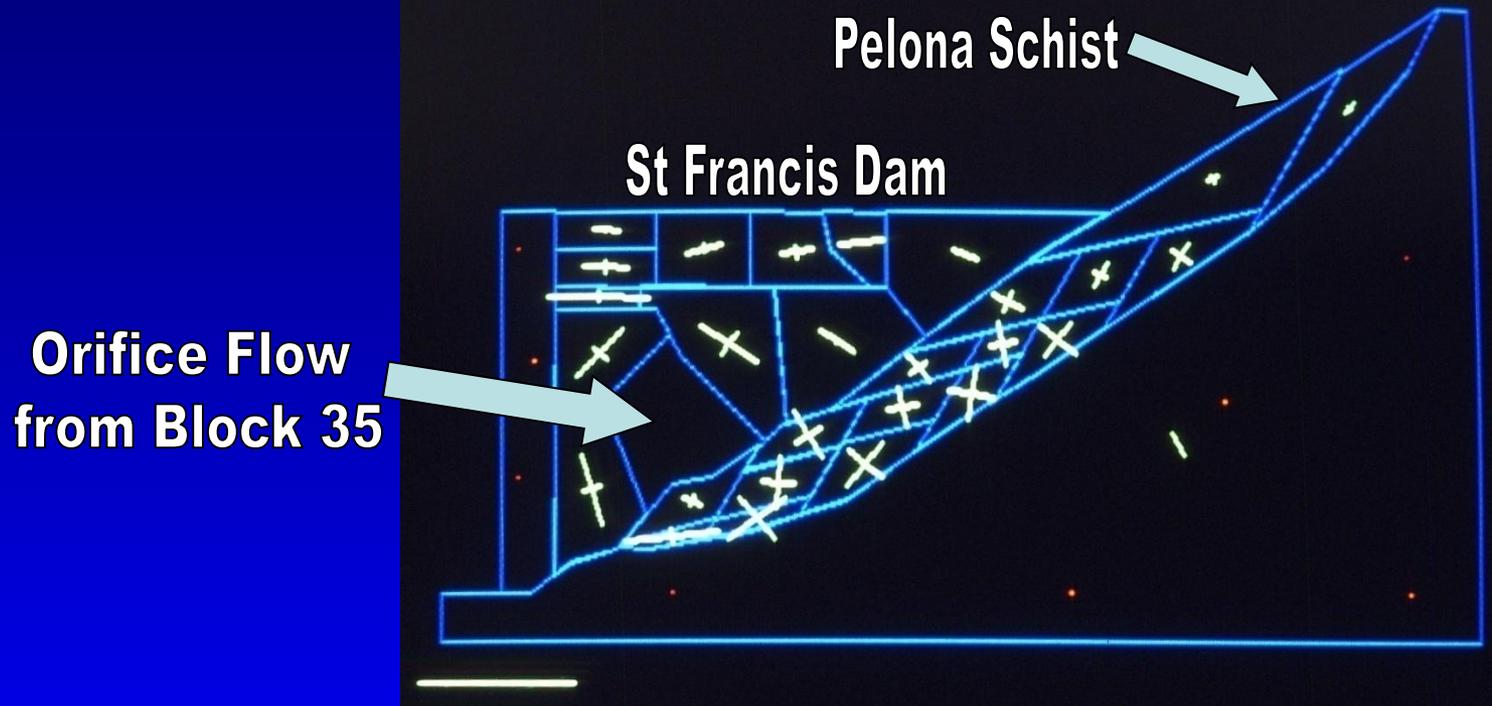
Modeling a high pressure leak

- The possible impact of high pressure orifice flow emanating from the base of the left abutment was also modeled, using Discontinuous Deformation Analysis.
- This model predicted slope instability resulting from flow emanating from the base of the “missing section”

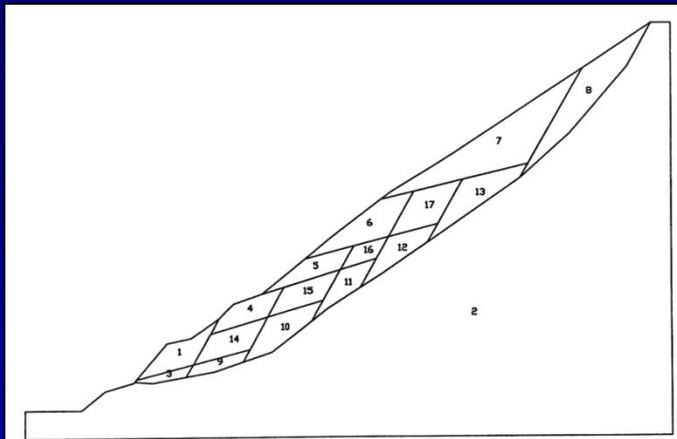
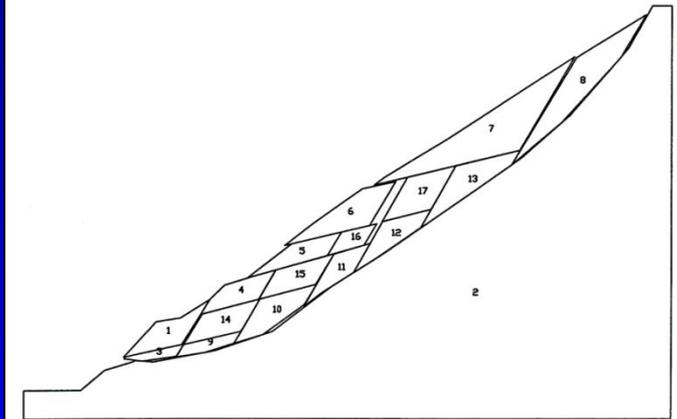
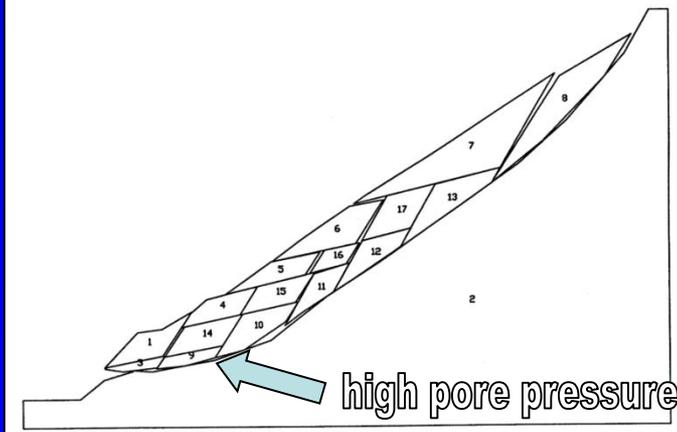
Evaluation of East Abutment Slide

- **Discontinuous Deformation Analysis was used to evaluate the East Abutment Landslide**
- **This illustrates the destabilizing effects of lateral loss of restraint that may have triggered upward migration of the slide mass**
- **Large pore pressures may have developed along the basal detachment surface due to entrapment in the mica schist, greatly reducing inter-particle friction**
- **The reservoir extended about halfway up the slope shown here**

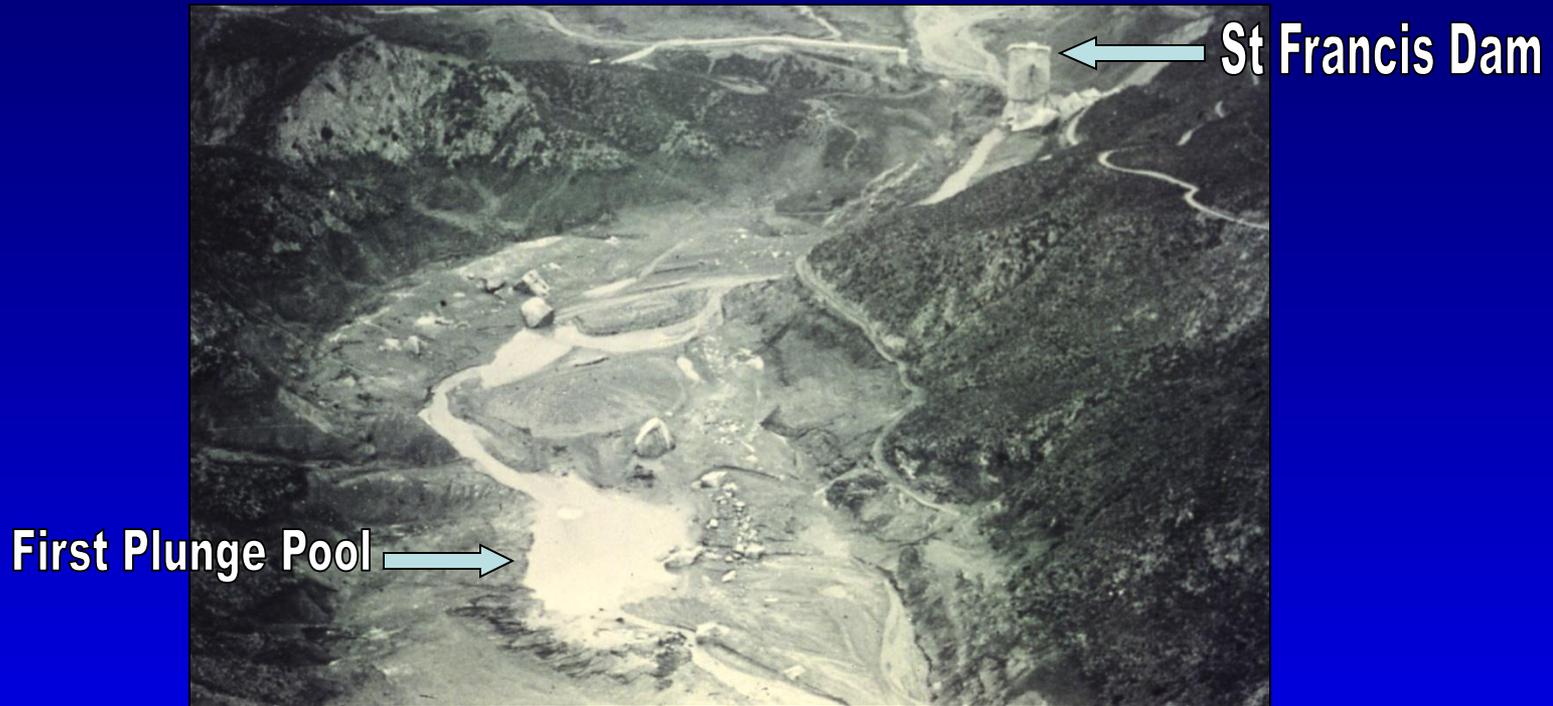
Dead Fish and the Sabotage Theory

- After the failure thousands of dead fish were observed floating in deep plunge pools excavated downstream of the failed dam. Some suggested they must have been 'killed by dynamite'
- Autopsies of the dead fish revealed that they succumbed to silt ingestion of their gills; suggesting a very turbid outflow
- Based on later tests performed during the Second World War, it would have taken more than 12,000 lbs of dynamite beneath 30 feet of water on the dam's upstream side to sabotage the structure

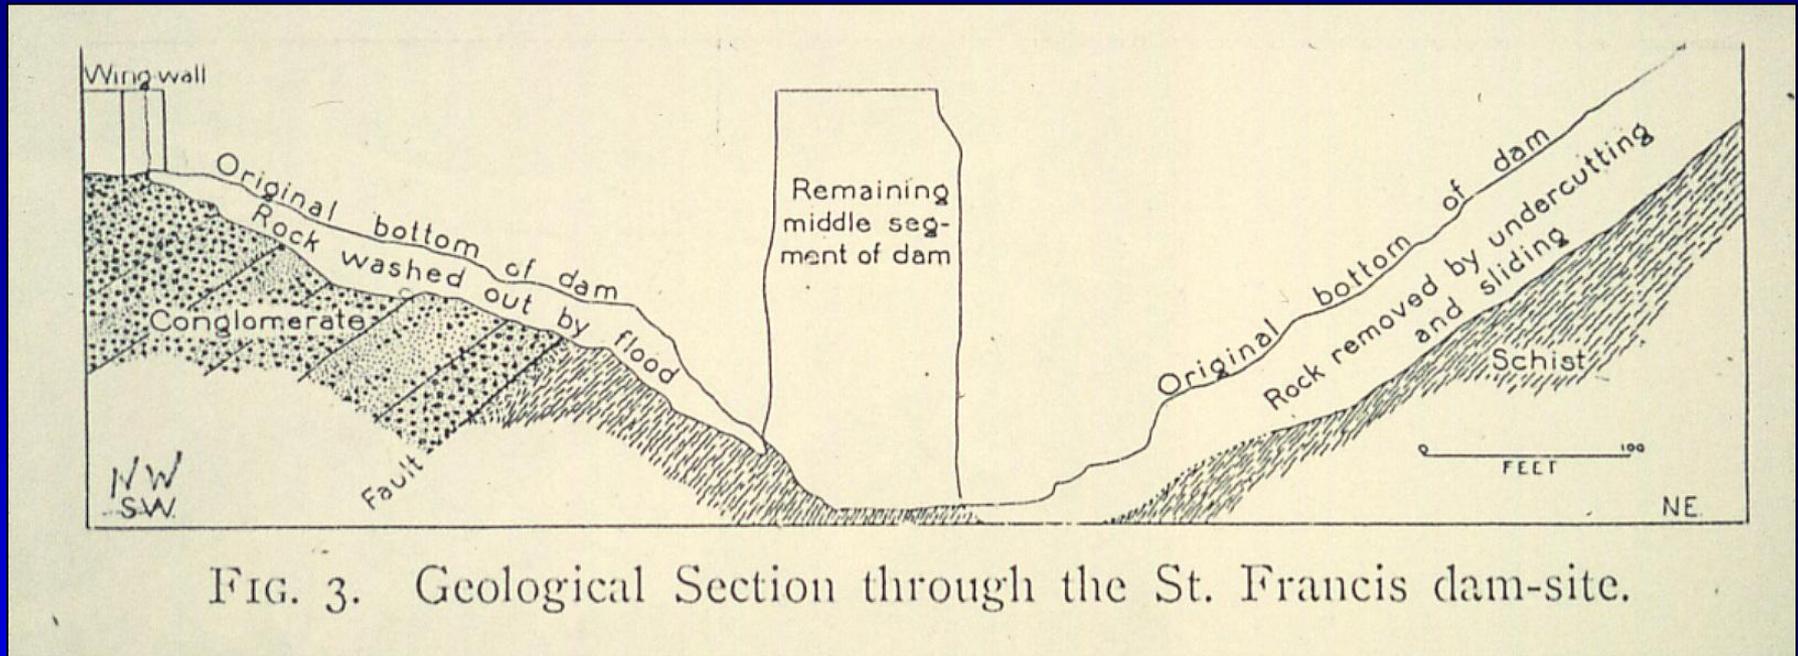
Back-analysis of the outbreak flood

- The dam site could not be used for a back-analysis of the outbreak flood hydrograph (quantity of flow versus time), because the cross-sectional area was varying with each passing minute of the failure; beginning with a small area and concluding with the maximum area, shown here.

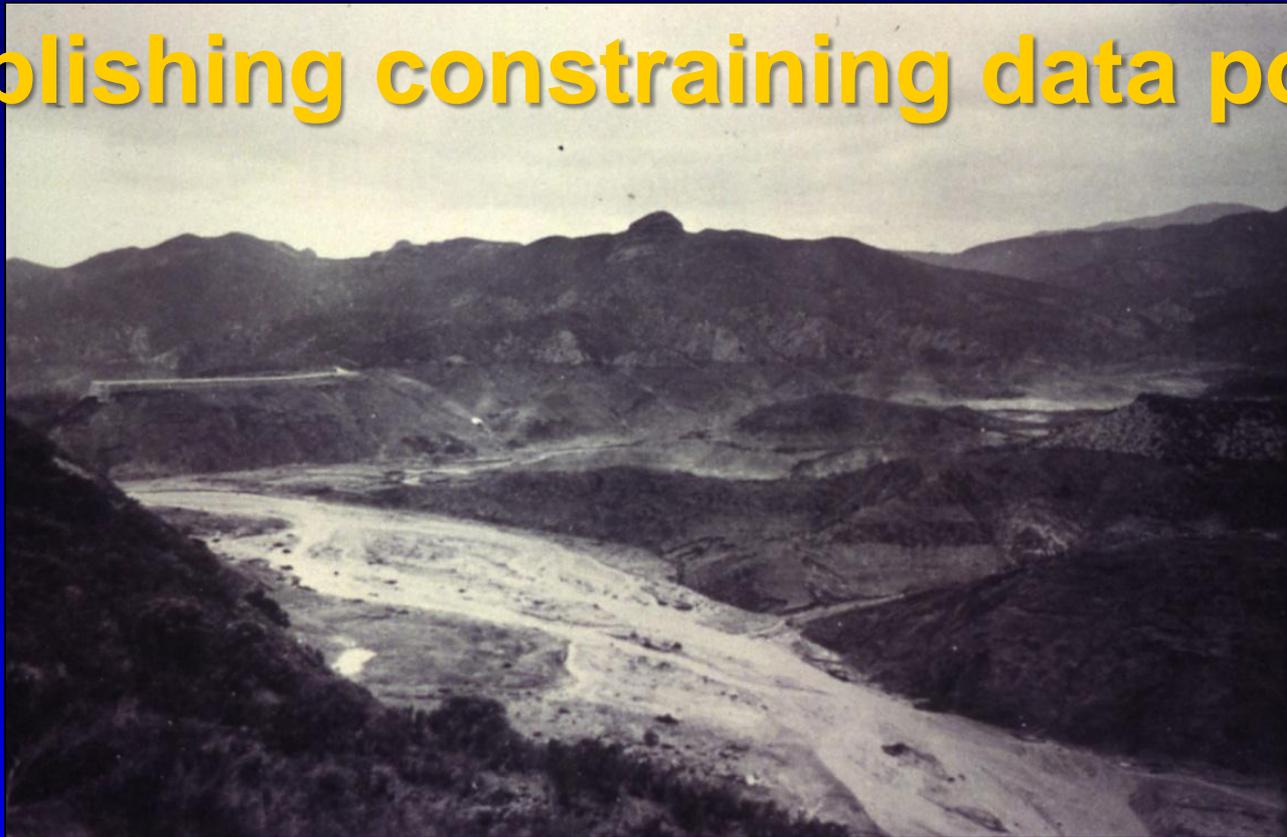
Establishing constraining data points

- We know from eye witness accounts that the reservoir was essentially empty by 1:09 AM, as shown above
- We know that the SCE's Lancaster power line went down at 11:57-1/2 PM in vicinity of the dam site
- Exactly five minutes later, we know that Powerhouse 2, located 7300 feet downstream, went offline at 12:02-1/2 AM

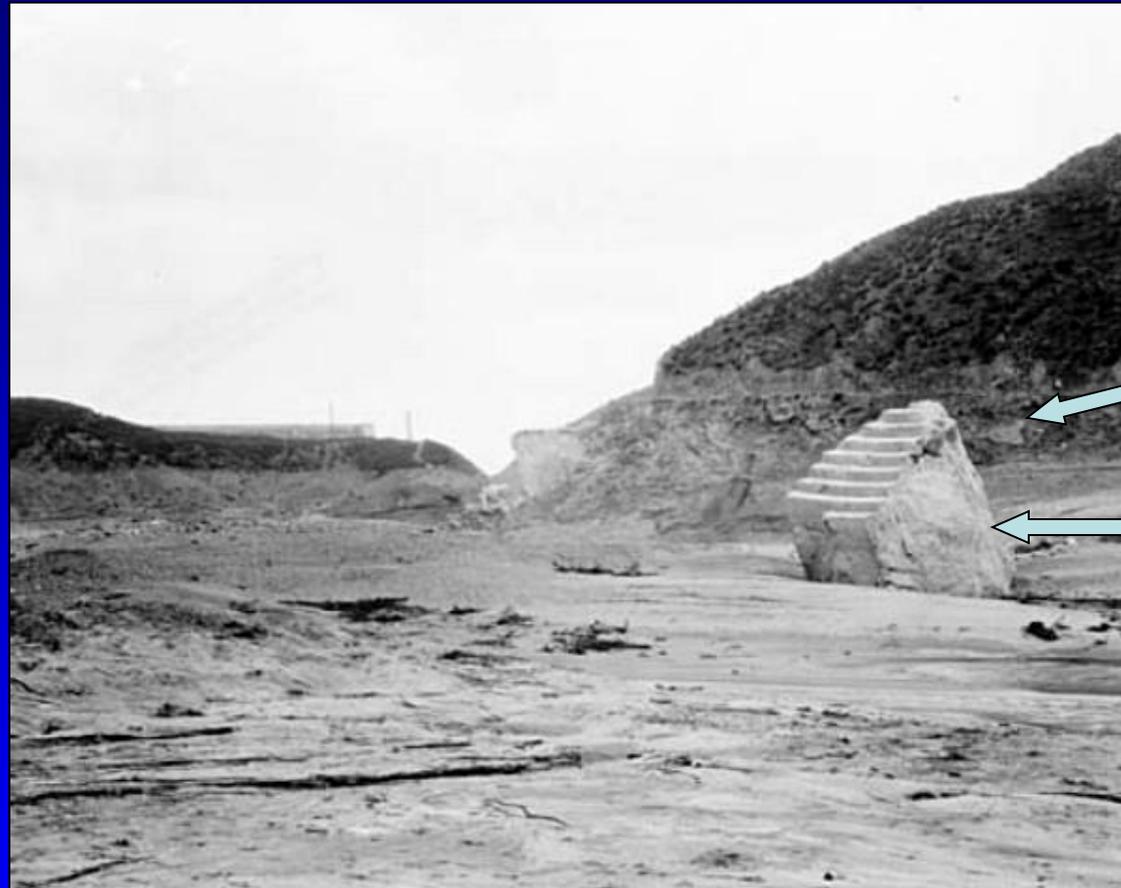
Establishing constraining data points

- We know the maximum depth of the outflow from the measurements made at the time and used terrestrial photogrammetry to fill in the gaps
- The depth of flood water was about 140 feet just downstream of the dam and had diminished to about 110 feet at Powerhouse 2, 1.4 miles downstream

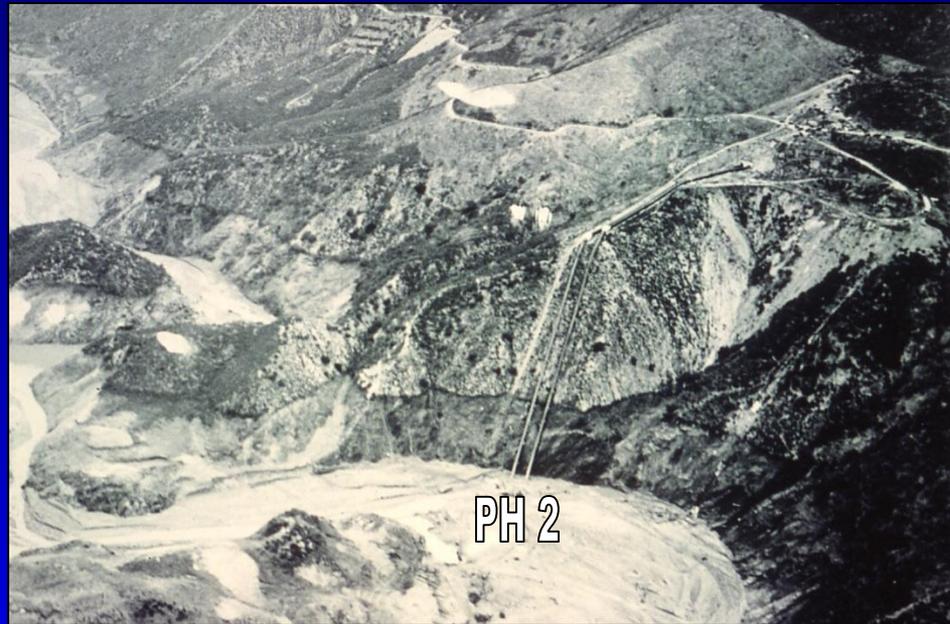
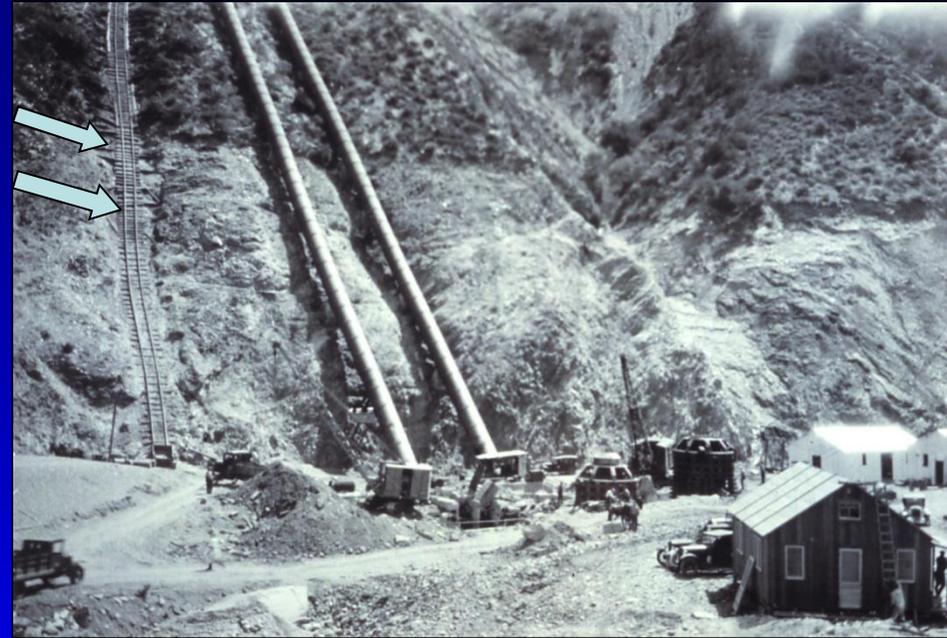
Crucial data for a credible analysis

- At Powerhouse 2, the surge chamber attendant E. H. Thomas climbed down the tramway tracks during the flood
- He reached the high water line at 12:15 AM, and noted that the level had already dropped 20 feet; shown by the parallel blue arrows at left side of the photo at right

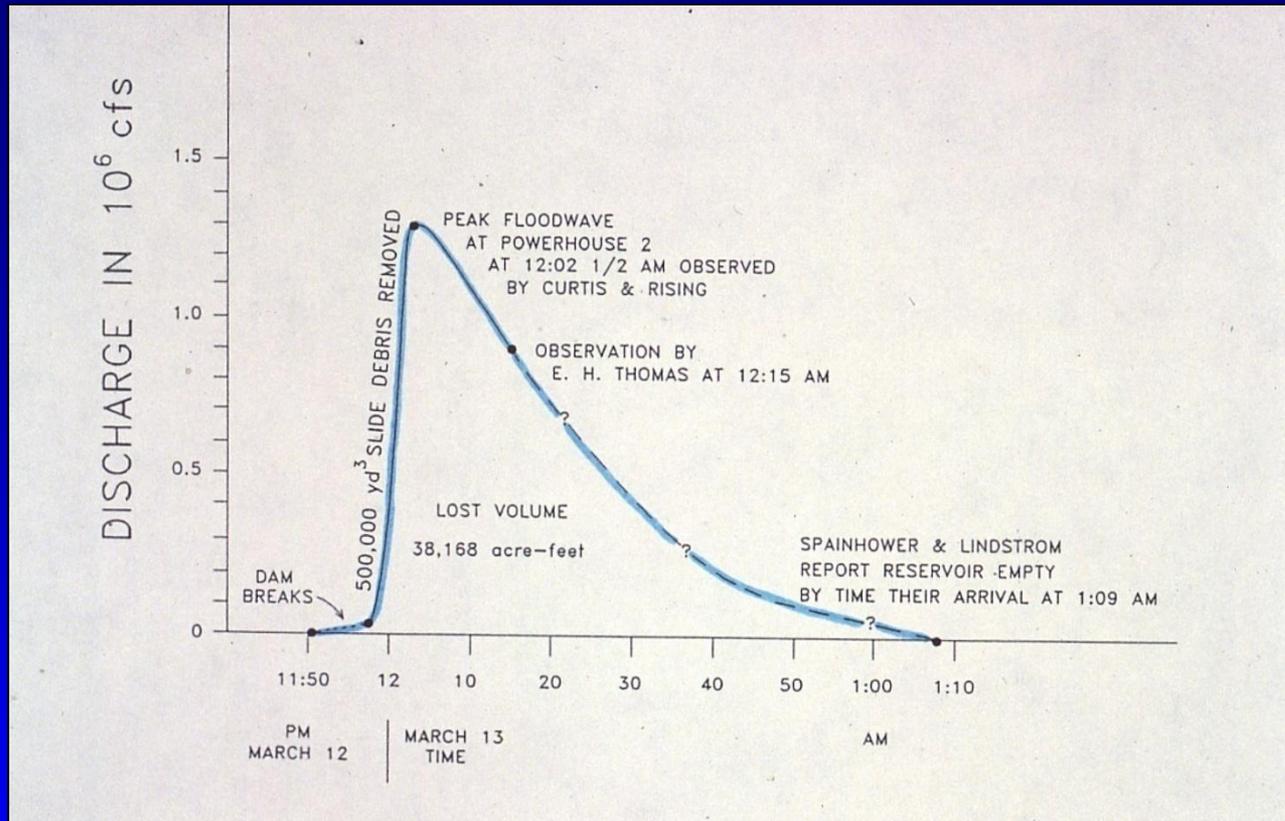
Reconstructed hydrograph at Powerhouse 2

- A peak flow of 1.3 million cfs was calculated for Powerhouse Two; 7,400 ft downstream of the dam
- The peak flow at the damsite was likely close to 1.7 million cfs

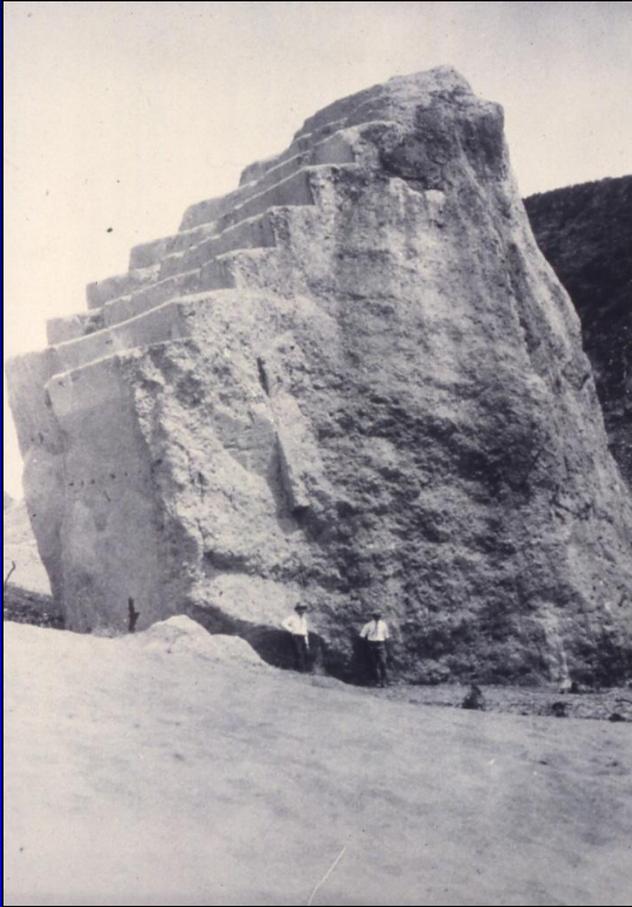
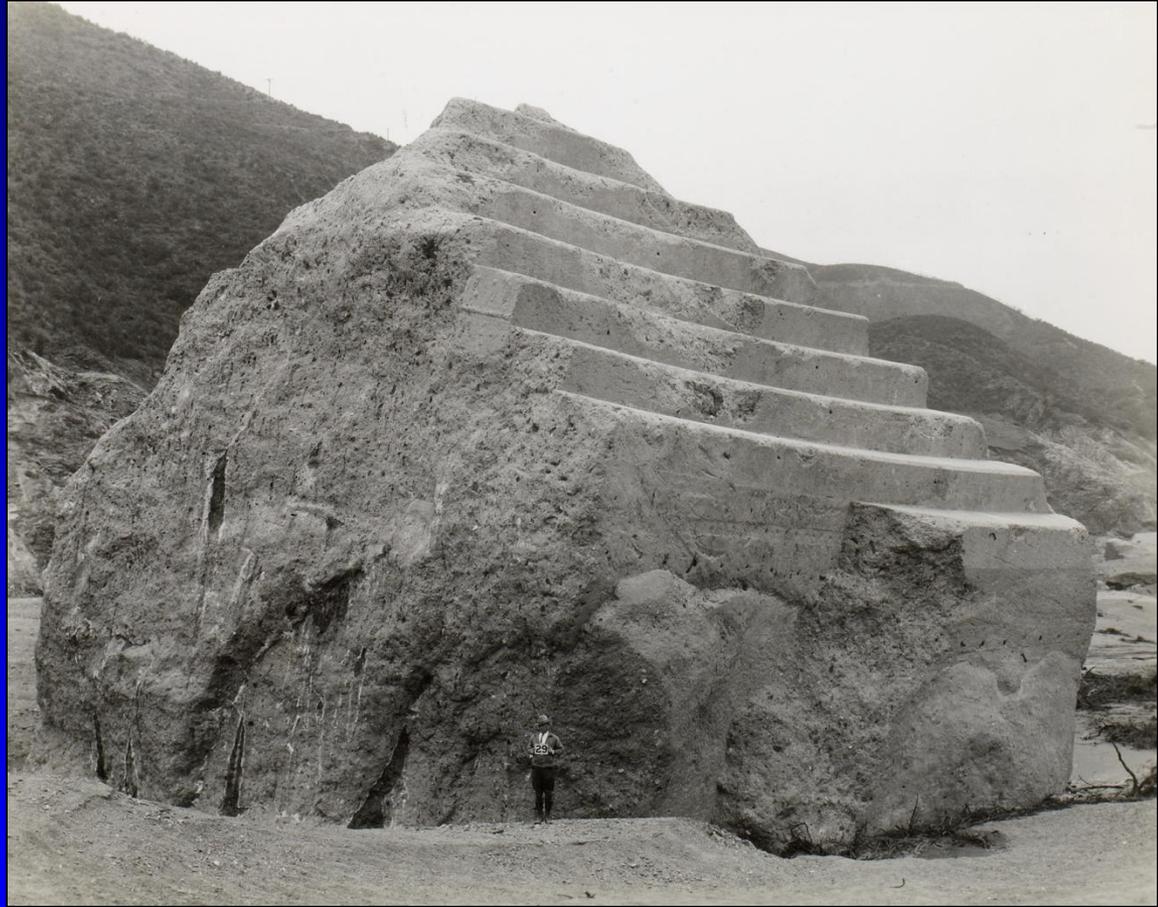
Freighting of massive blocks

- How were such massive blocks of concrete, weighing as much as 10,000 tons, moved as much as a half mile downstream?

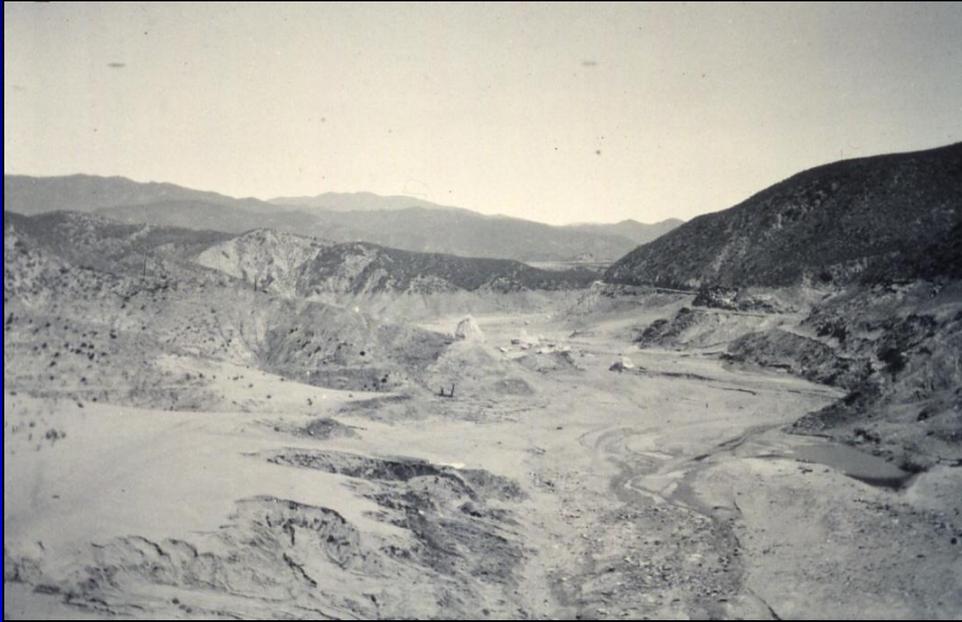
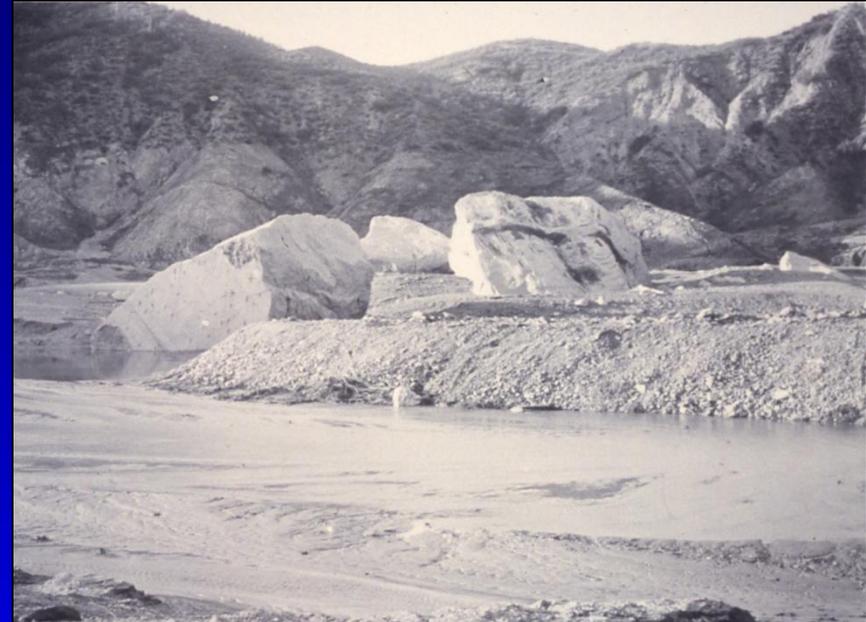
Evidence of hydraulic sorting

- Flood outwash particles are typically sorted in inverse fashion; with coarse material on the bottom and progressively finer material upward, because the stream power of the flood subsides with decreasing flow.
- Medium grained sand overlies coarse schist detritus (at left)
- The average particle size was 12” in photo at right

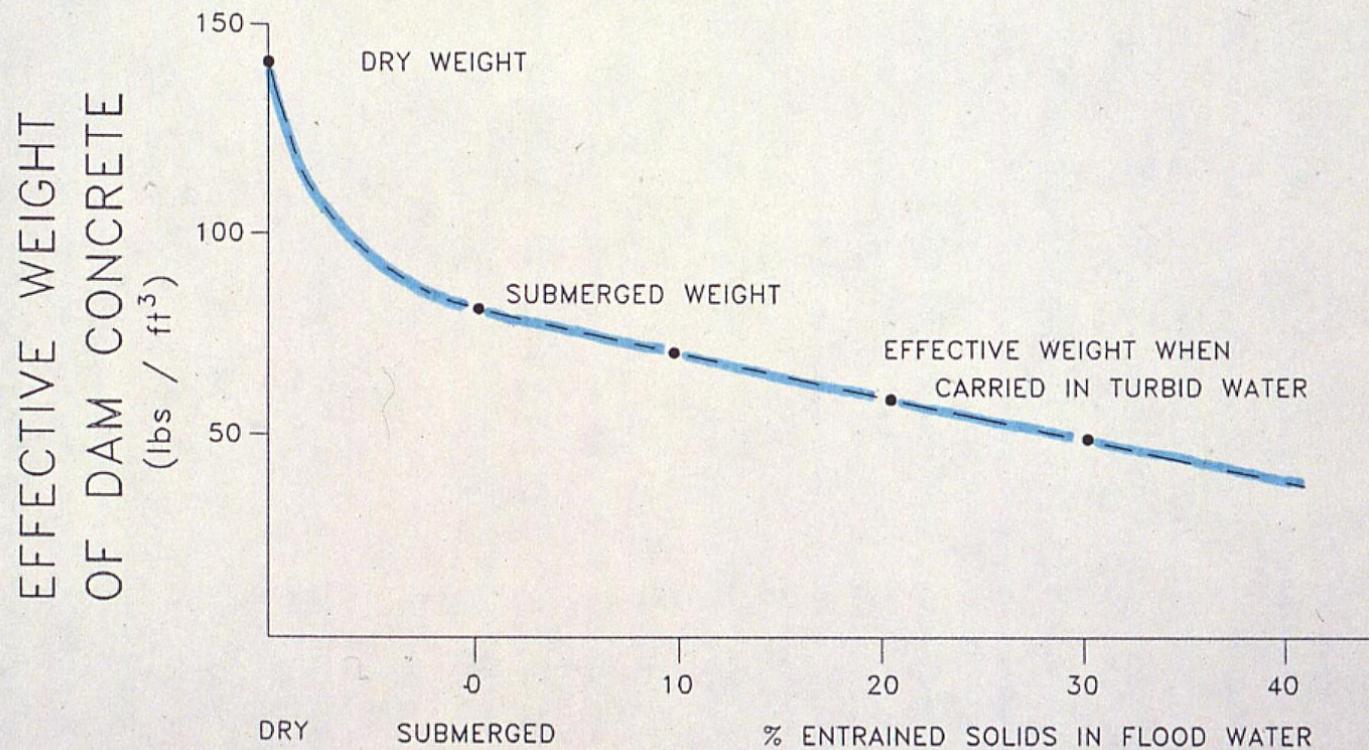
BOUYANCY EFFECT ON SUBAQUEOUS TRANSPORT OF DAM'S CONCRETE BLOCKS

- The coincident excavation of 700,000 yards of schist with the outpouring flood waters created an extremely turbid mixture.
- As the percentage of entrained solids in the flood water increases, the effective weight of the concrete blocks diminishes to a fraction of their dry weight. This is how large blocks were rolled so far downstream.

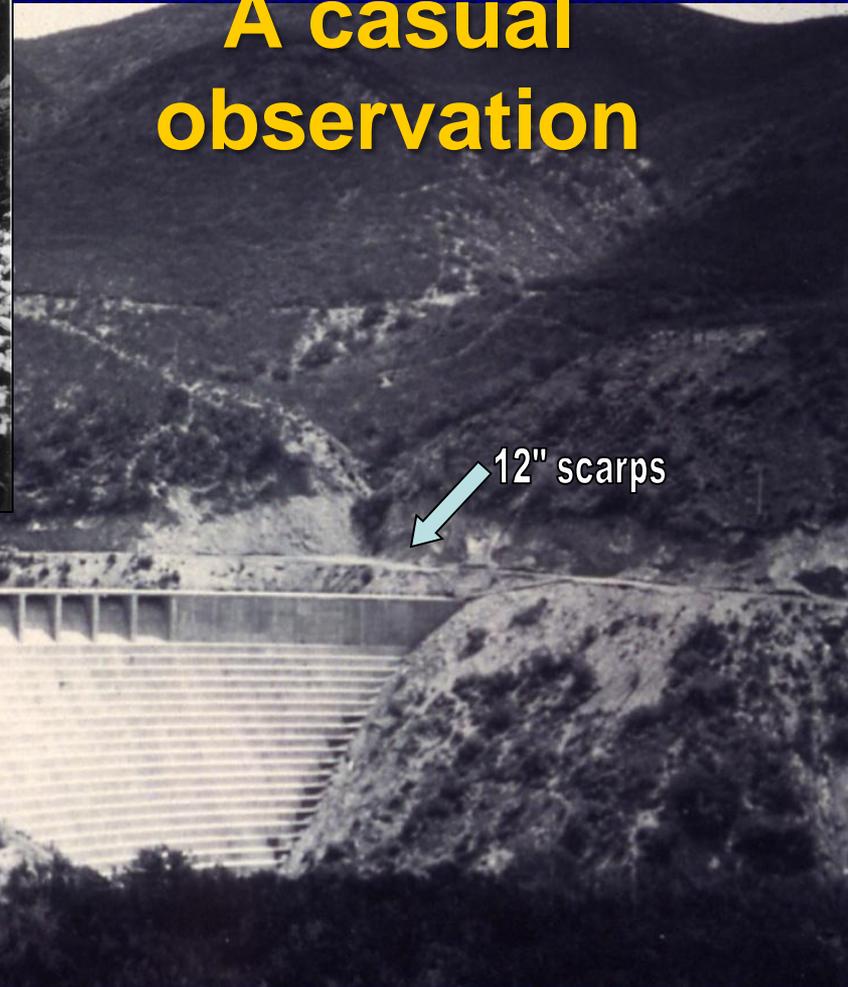
En-echelon scarps across road

12" scarp

- The Ray Silvey family was driving up San Francisquito Road past the dam around 8:30 PM on March 12th
- They had gone about 100 feet past the dam's left abutment when they were forced to stop by a 12-inch high scarp cutting across the road, in the Pelona Schist!

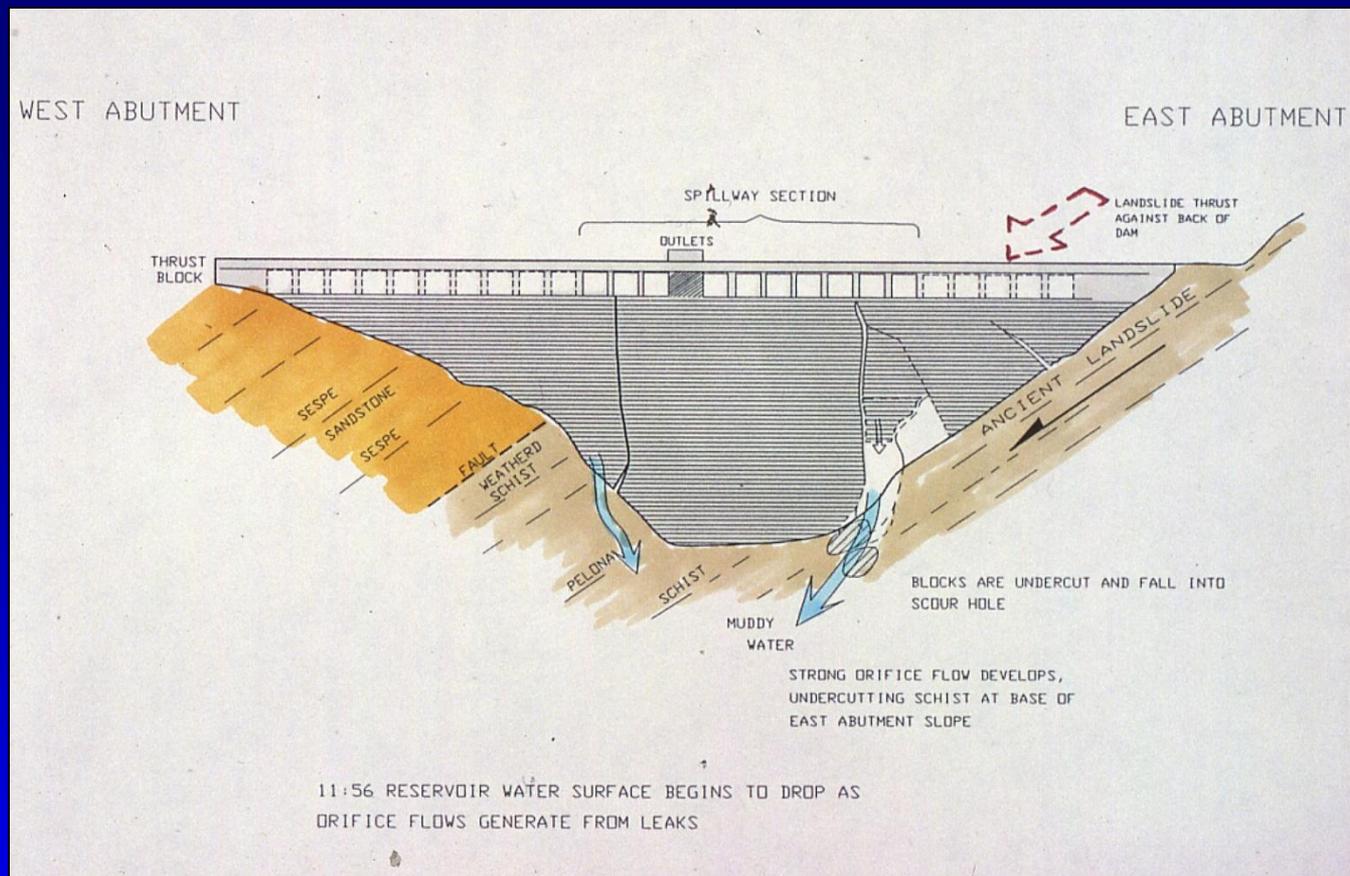
- High velocity orifice flow may have sprung from the base of the right abutment, shortly before the failure.
- A light was observed in the canyon below the dam by passersby in the 45 minutes preceding the failure.
- The damkeeper wife's body was found fully clothed, wedged between two blocks near the base of the structure, $\frac{1}{4}$ mile upstream from where she lived. This suggests the couple was up at the dam looking at something.

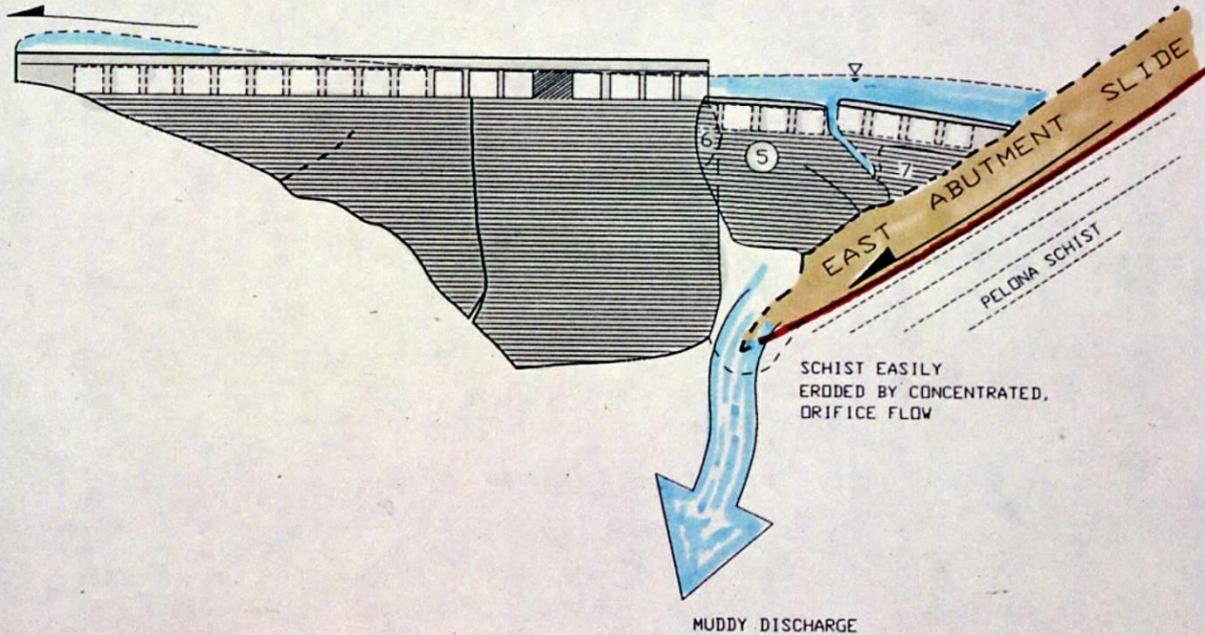
Landslide- induced seich

AT 11:57 1/2 PM EAST ABUTMENT SLIDES
INTO RESERVOIR, CUTTING EDISON POWER LINES

LANDSLIDE-DRIVEN WAVE SWEEPS
ONTO SHORELINE, 4' ABOVE HIGH RESERVOIR LEVEL

- Around 11:57-1/2 PM a massive landslide of the dam's eastern abutment initiated, severing the SCE 70 Kv Lancaster power lines.
- The entirety of the dam's left abutment was carried across the downstream face of the main dam.
- A landslide-driven displacement wave washed flotsam 4 ft above the reservoir high water line, 3/4 mile to the north
