THE ST. FRANCIS DAM FAILURE

**worst American civil engineering
disaster of the 20th Century**

J. David Rogers, Ph.D., P.E., P.G., C.E.G., C.HG.

Shlemon Specialty Conference

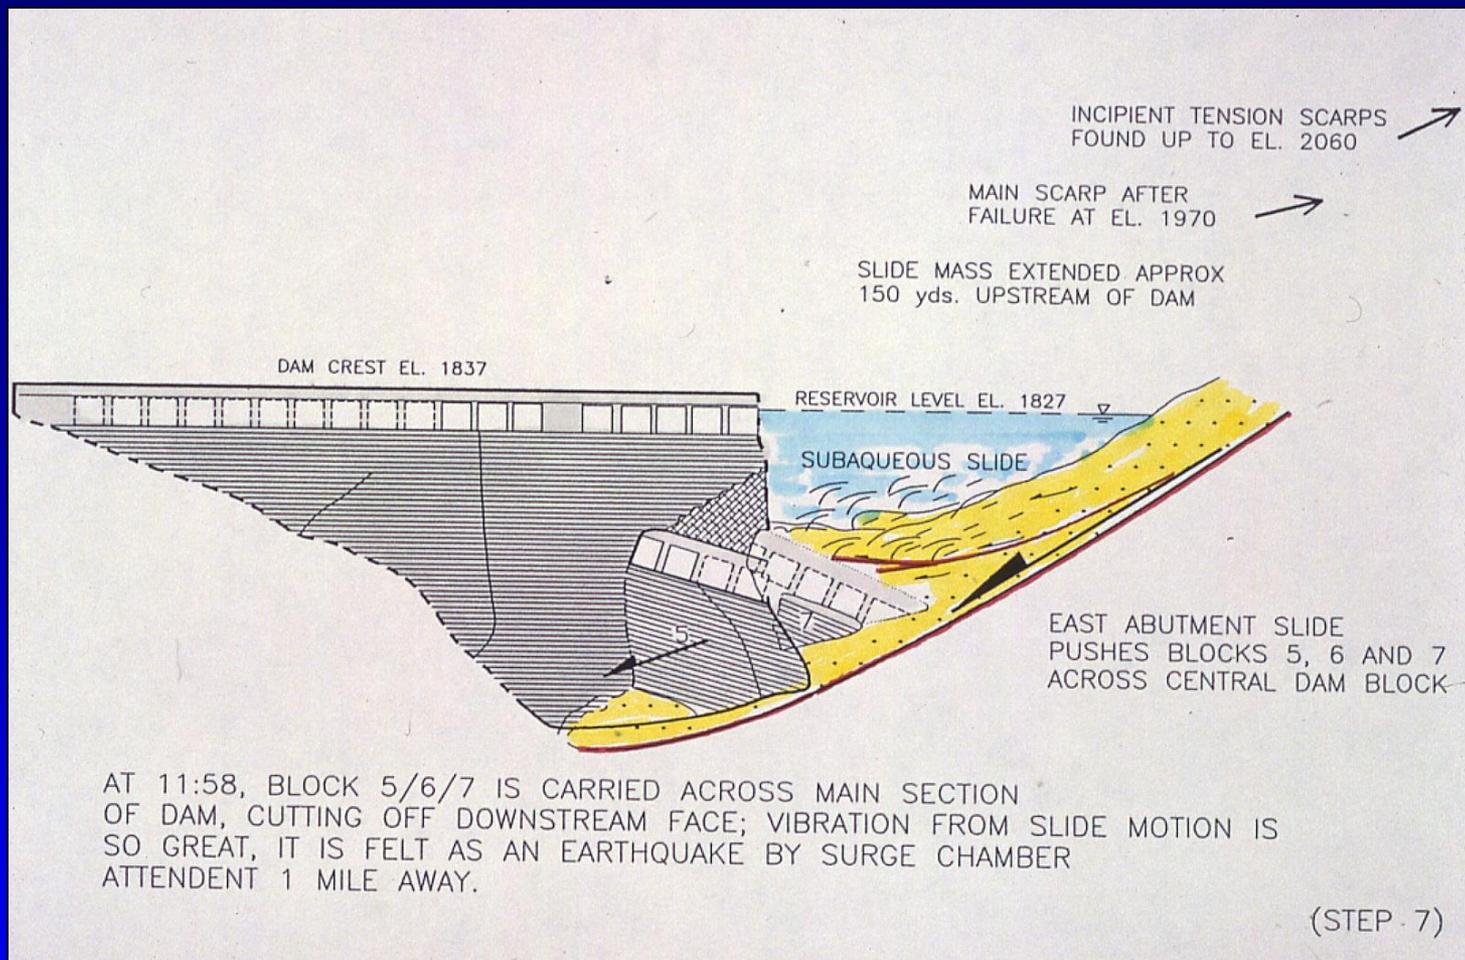
- As the slide carried the dam's left abutment section across the canyon, the heavy blocks sheared off 10 to 20 feet of the dam's stepped concrete face.

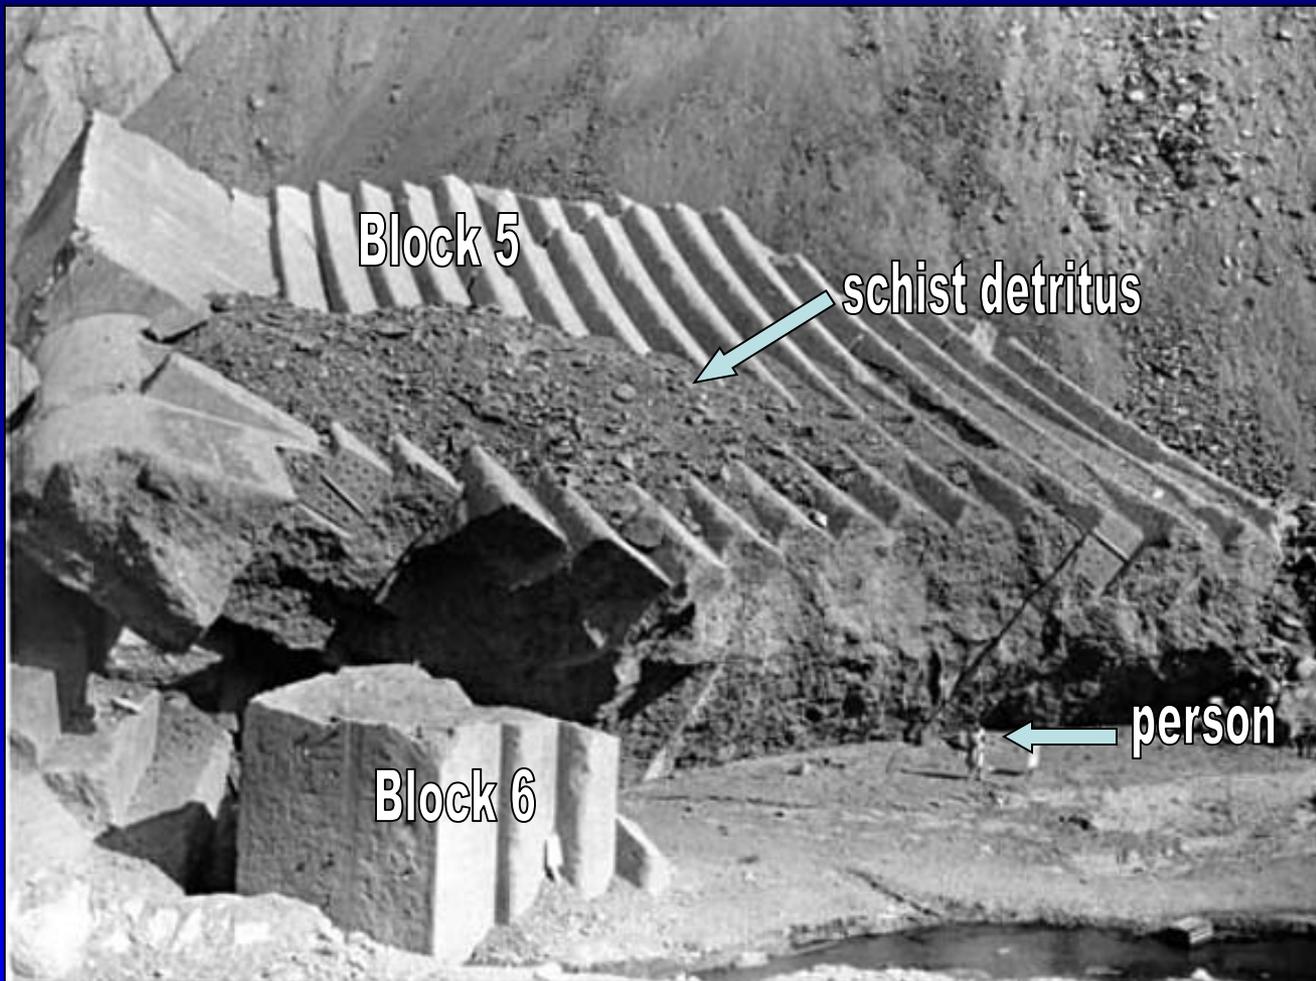
- The sheer size of Blocks 5 and 6 can be appreciated in this photograph, with a person for scale (arrow)
- Note the 5 to 10 feet cover of schist detritus preserved in the steps of the block, 35 feet above the creek level.

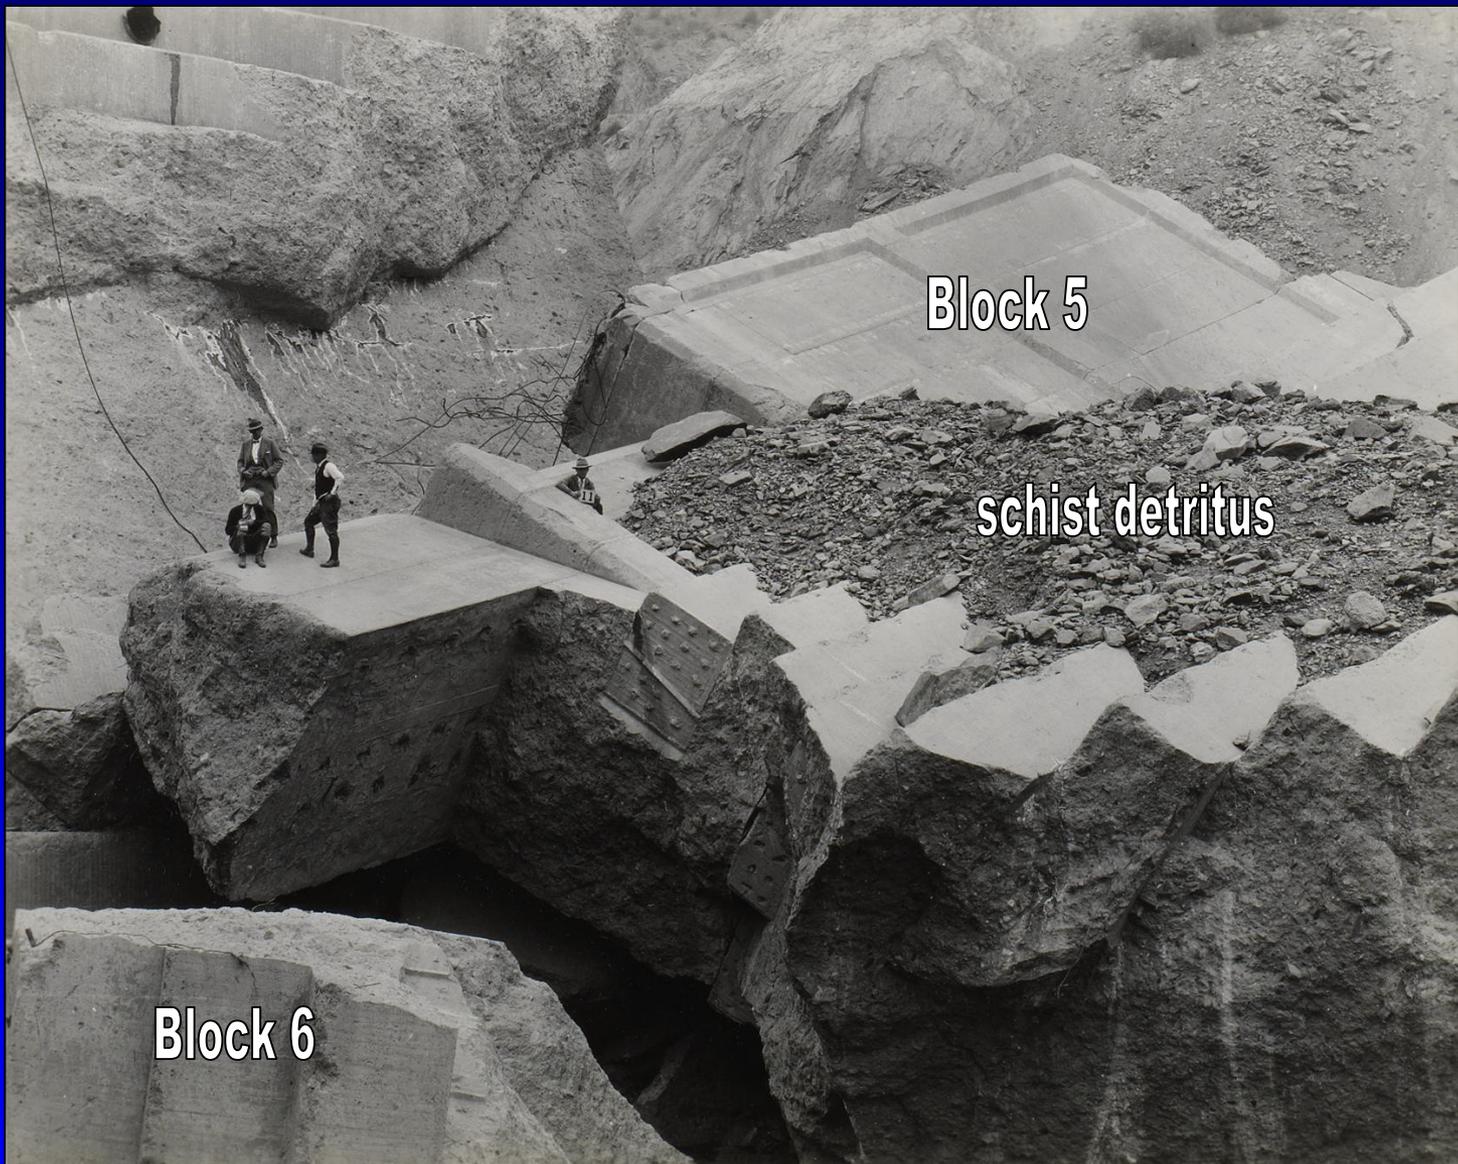
Block 5

- Another photo, showing the detachment of Block 6 from Block 5. Note the four men for relative scale.

- Profile view taken from left abutment looking at the massive cleavage of the dam's stepped downstream face.
- Note the angle of the cleavage is tilted downstream
- Note the position of Block 5, which slid all the way to the right abutment, then fell about 35 feet (arrows)

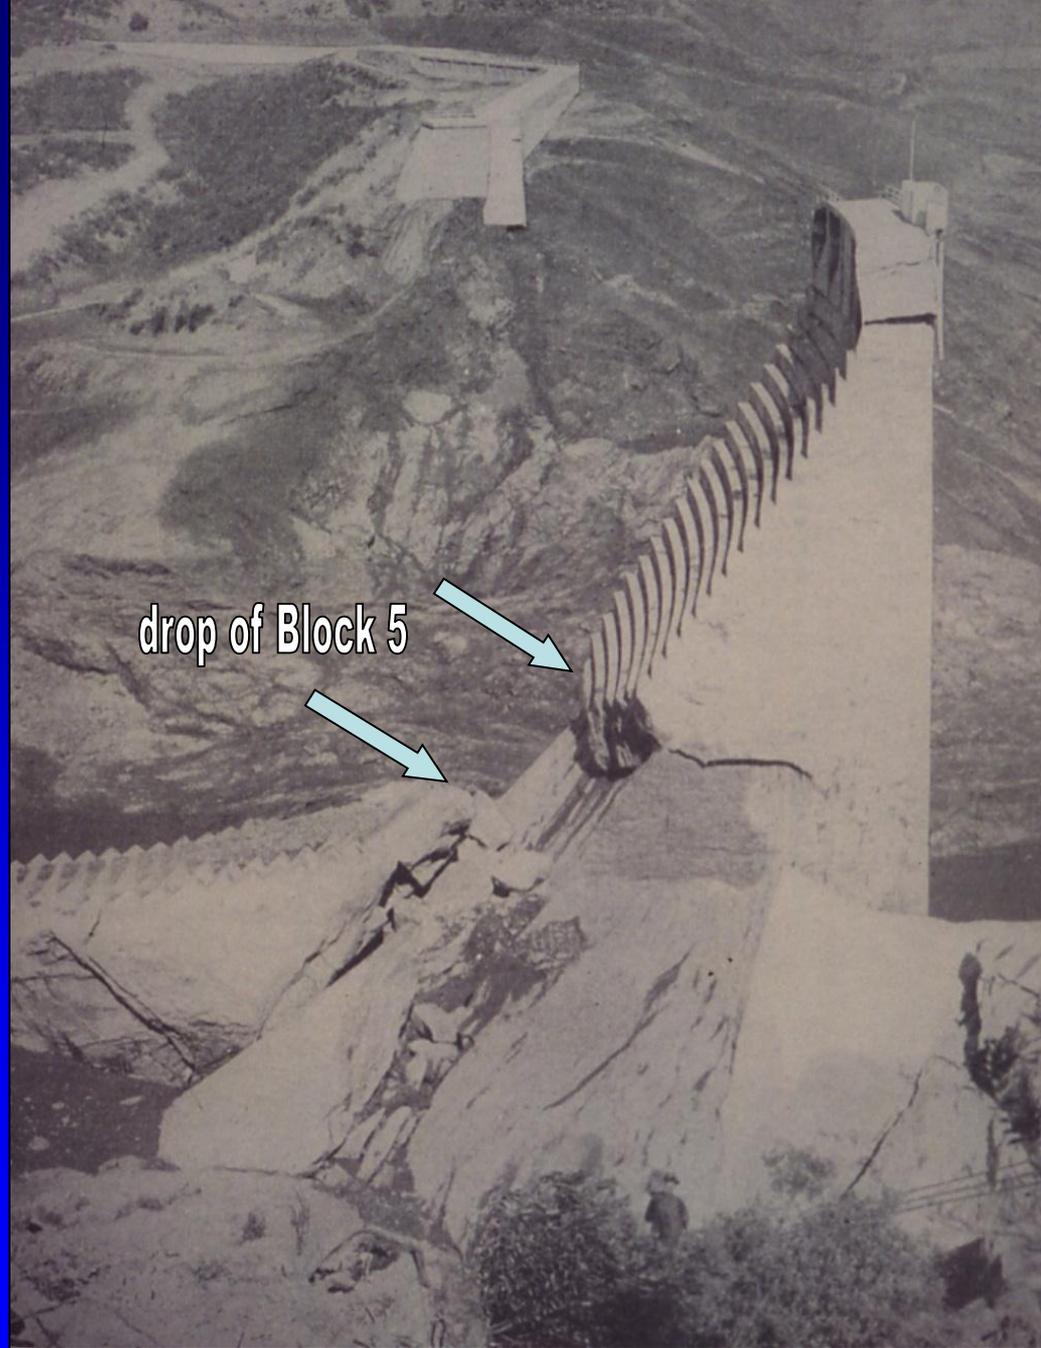
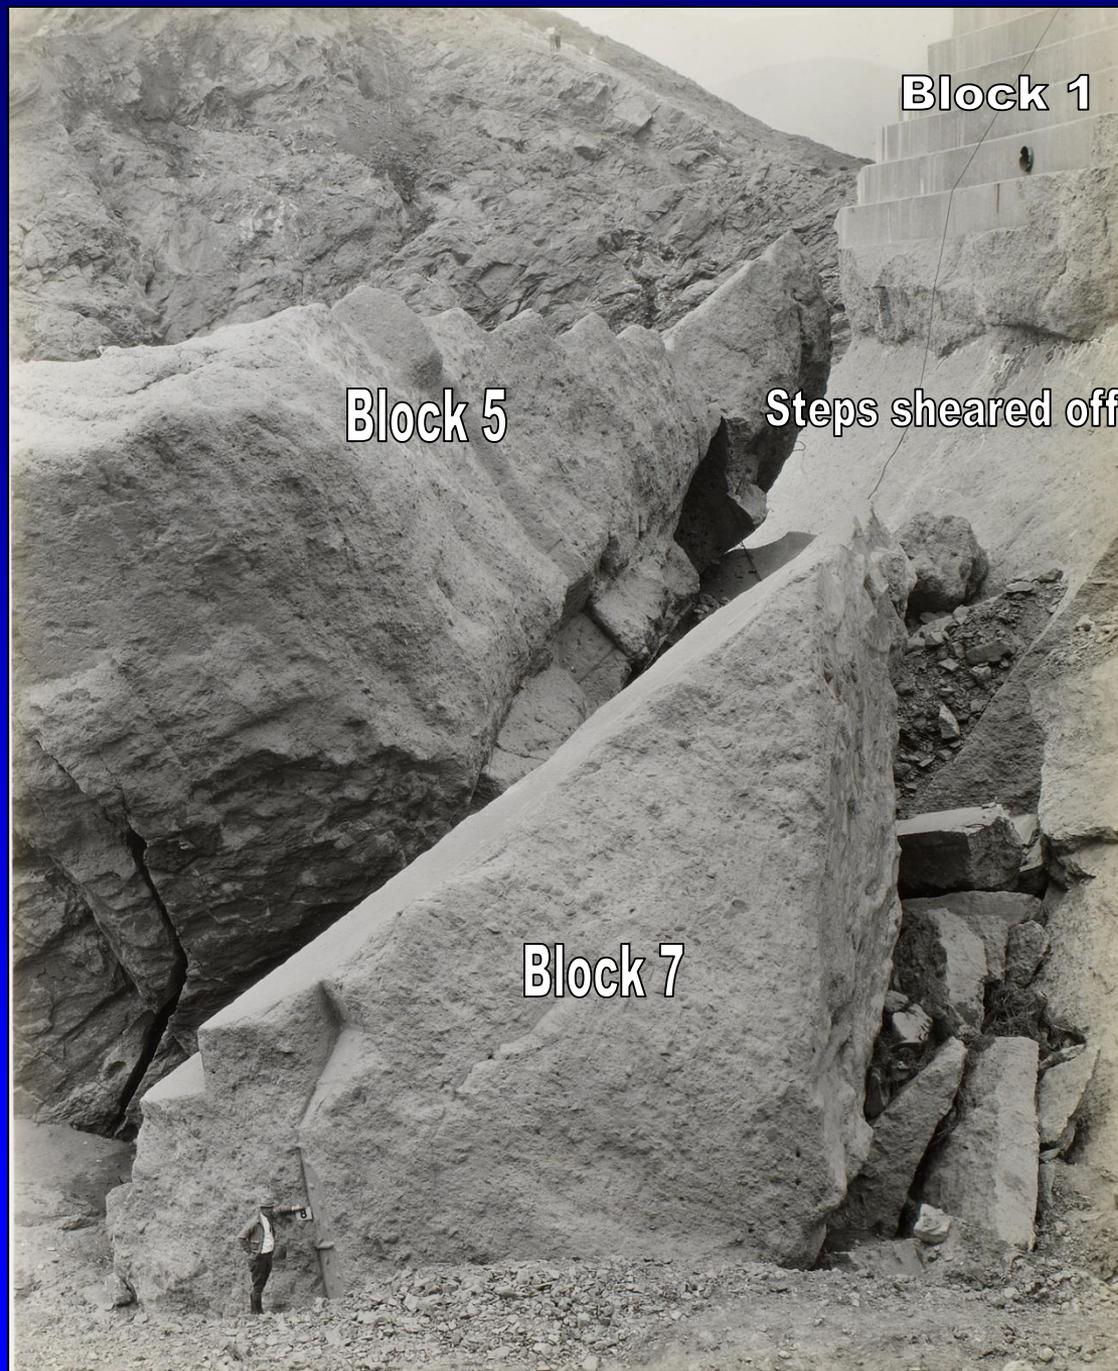
Sheared face of Block 1

- Another photo, showing the final position of Block 7, wedged between Blocks 1 and 5.
- Block 7 came from the dam's upper left abutment, which slid in behind Block 5.
- Note the man at bottom left for scale.

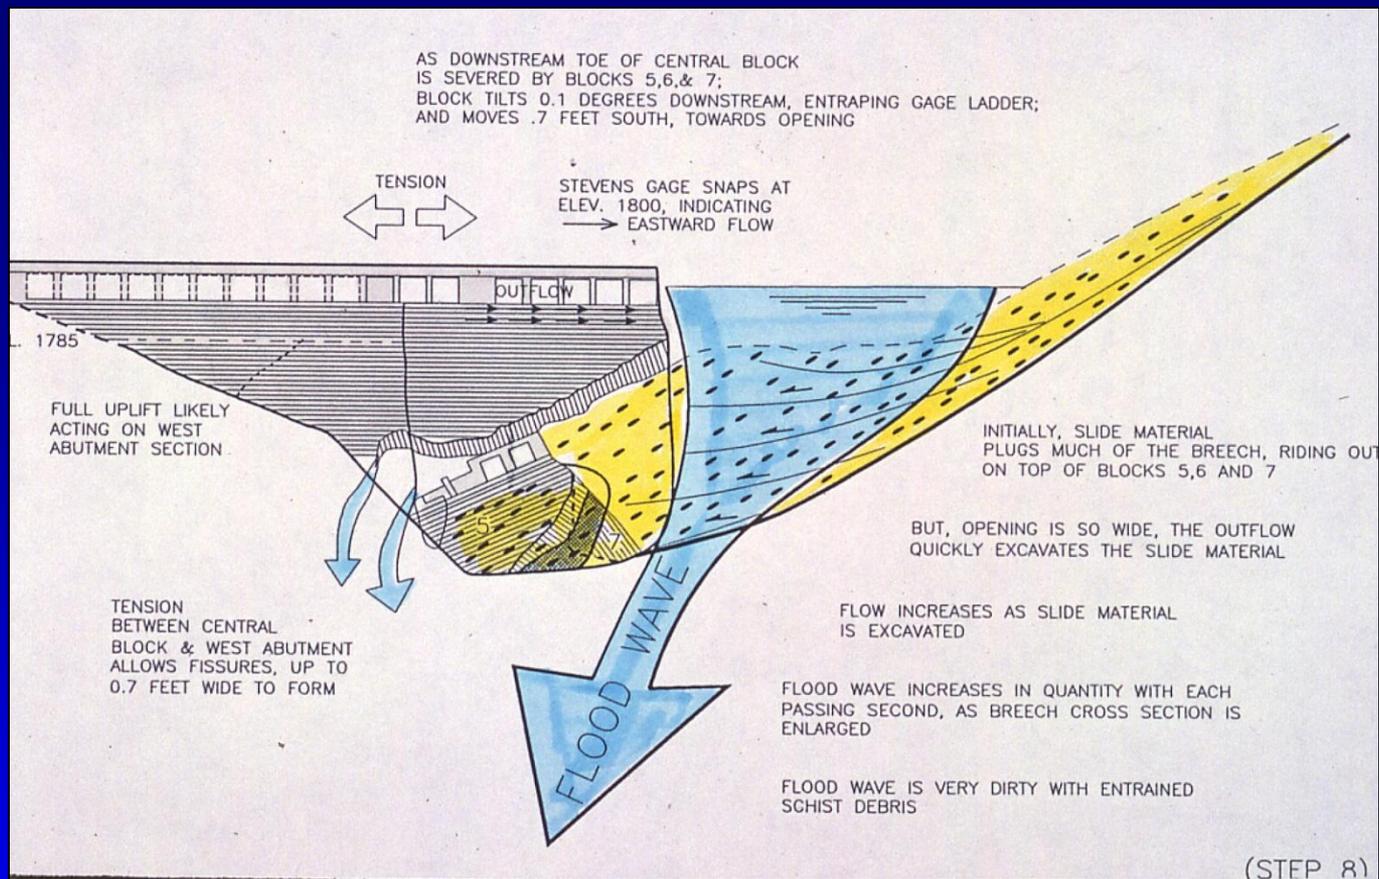
- The landslide debris dam is eroded by the outpouring water over a period of probably less than five minutes
- The out-rushing flow bent the cylindrical stilling well of the Stevens Gage towards the left abutment
- Block 5 originally turned upward, against the right abutment

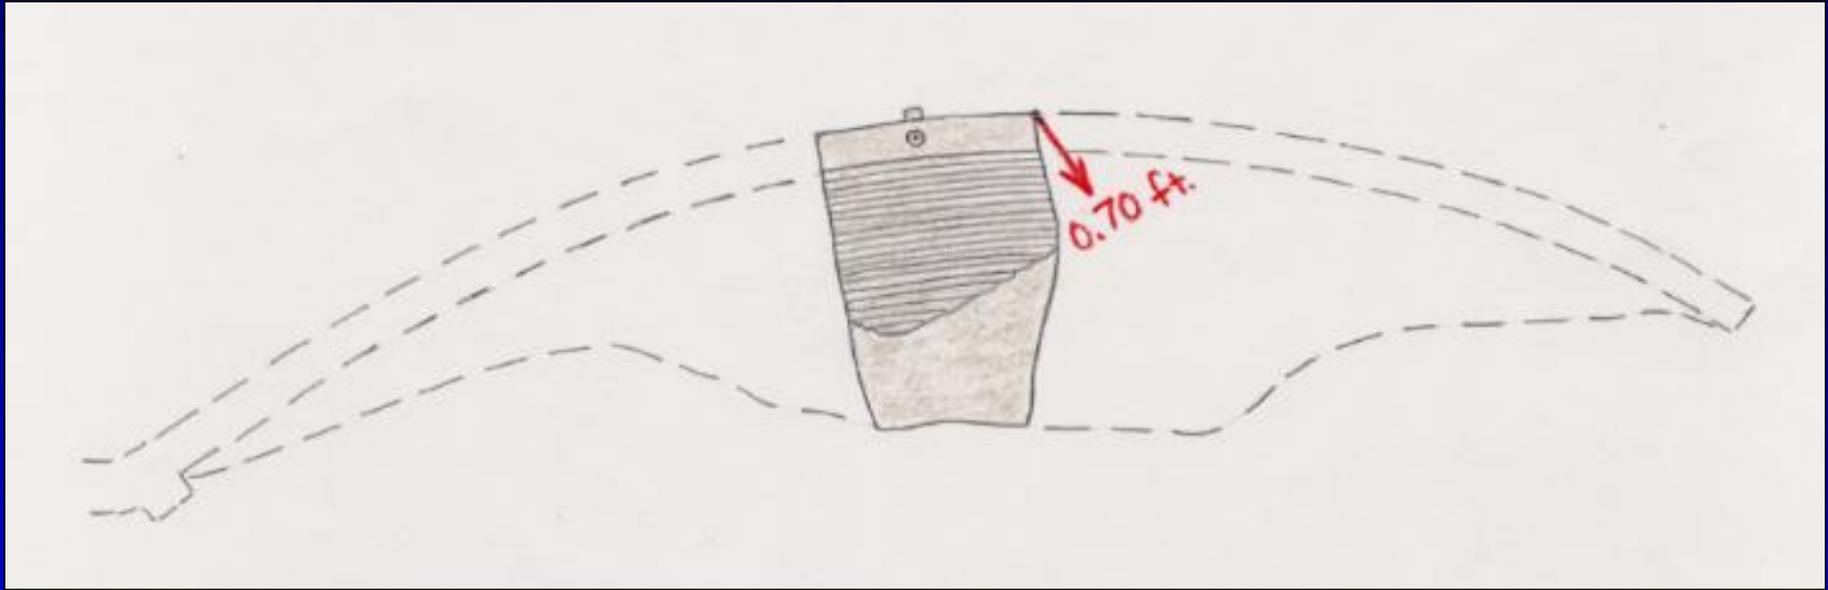
Rotation of Block 1 during outbreak flood

- Five benchmarks were set in the crest of the dam
- After the failure, the surviving stations were re-occupied and it was determined that Block 1 rotated clockwise, with the south edge shifting 8.4 inches towards the southwest, as shown here
- This rotation of Block 1 was likely caused by the outpouring flood waters passing around the left side of the dam, undercutting Block 2/3/4, before it toppled backward

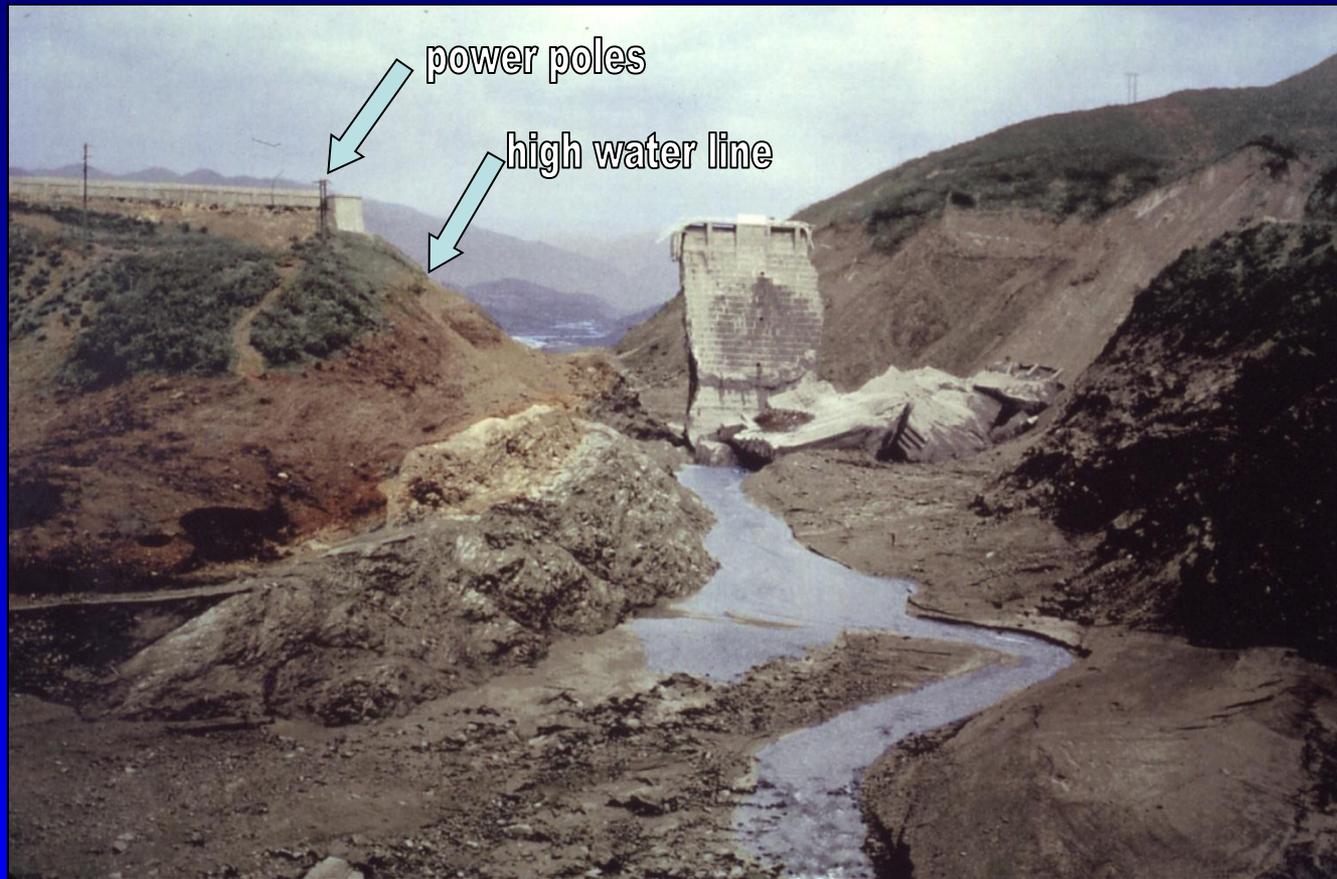
The Final Configuration

- The following morning this is how the dam site appeared.
- Note the tandem SCE power poles well above the high water line downstream of the right abutment (arrow)

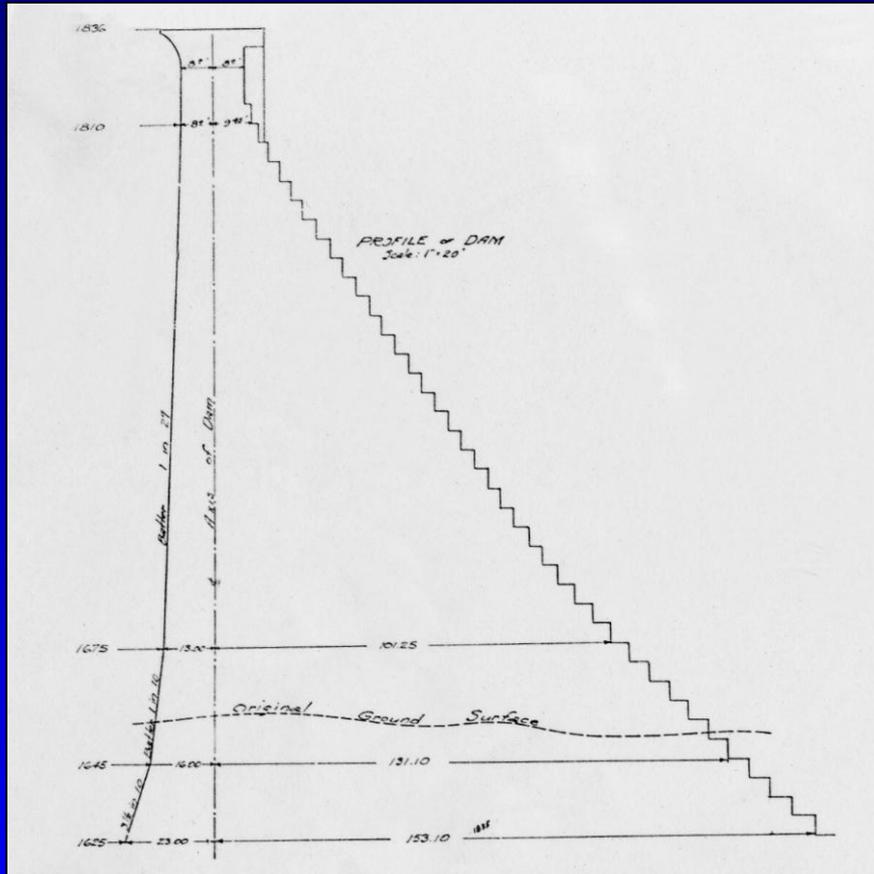
So, who actually ‘designed’ the dam?

- Mulholland Dam was “laid out” by BWWS office engineer Edgar A. Bayley (1877-1943)
- No cores or tests of the foundation rock were undertaken
- No formal calculations were made
- The design method used followed the examples presented in Smith’s *Construction of Masonry Dams* (1915), Fowler’s *Water Supply Engineering* (1926) and Wegmann’s *The Design and Construction of Dams* (1918, 1922, 1927)

The design for Mulholland Dam was simply ‘transferred’ to the St. Francis site, with a number of minor changes; nobody actually claiming credit for having “designed” the structure. This is the dam’s maximum section in October 1925, after being raised the first 10 ft.
