Levee Failures Along the Inner Harbor Navigation Channel in New Orleans

J. David Rogers, Ph.D., P.E., P.G.

for Technical Session #15 on

New Orleans Levees and Hurricane Katrina

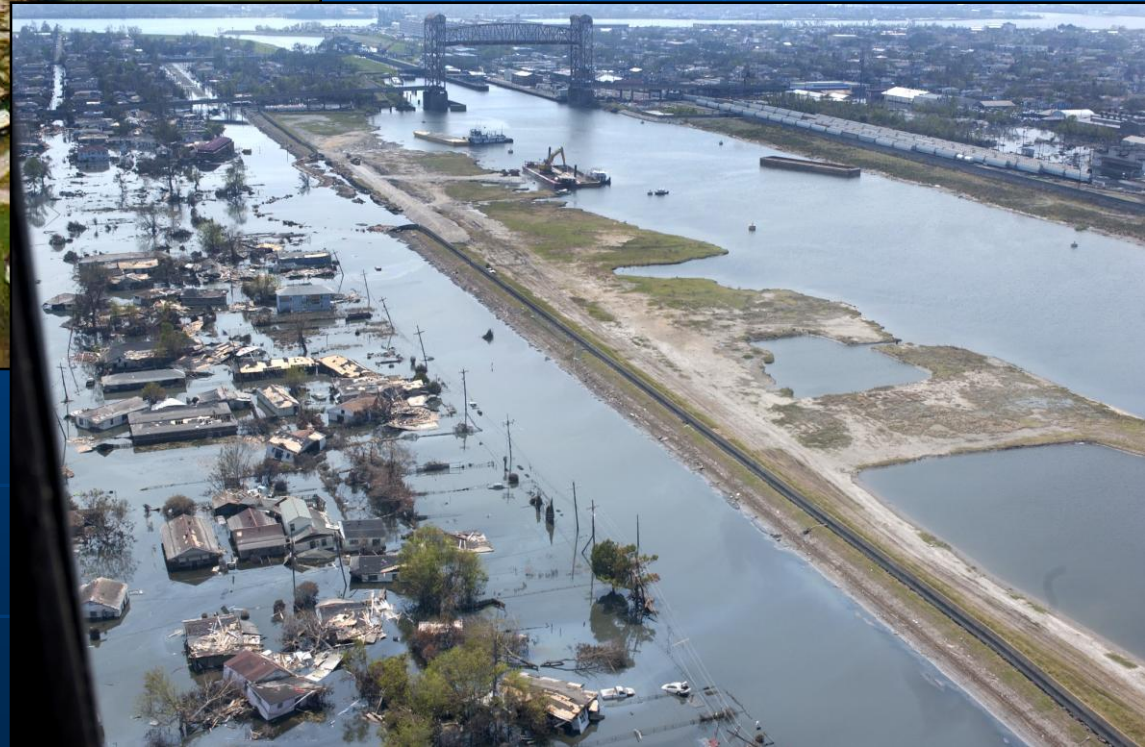
Same area after re-flooding by Hurricane Rita in late September 2005

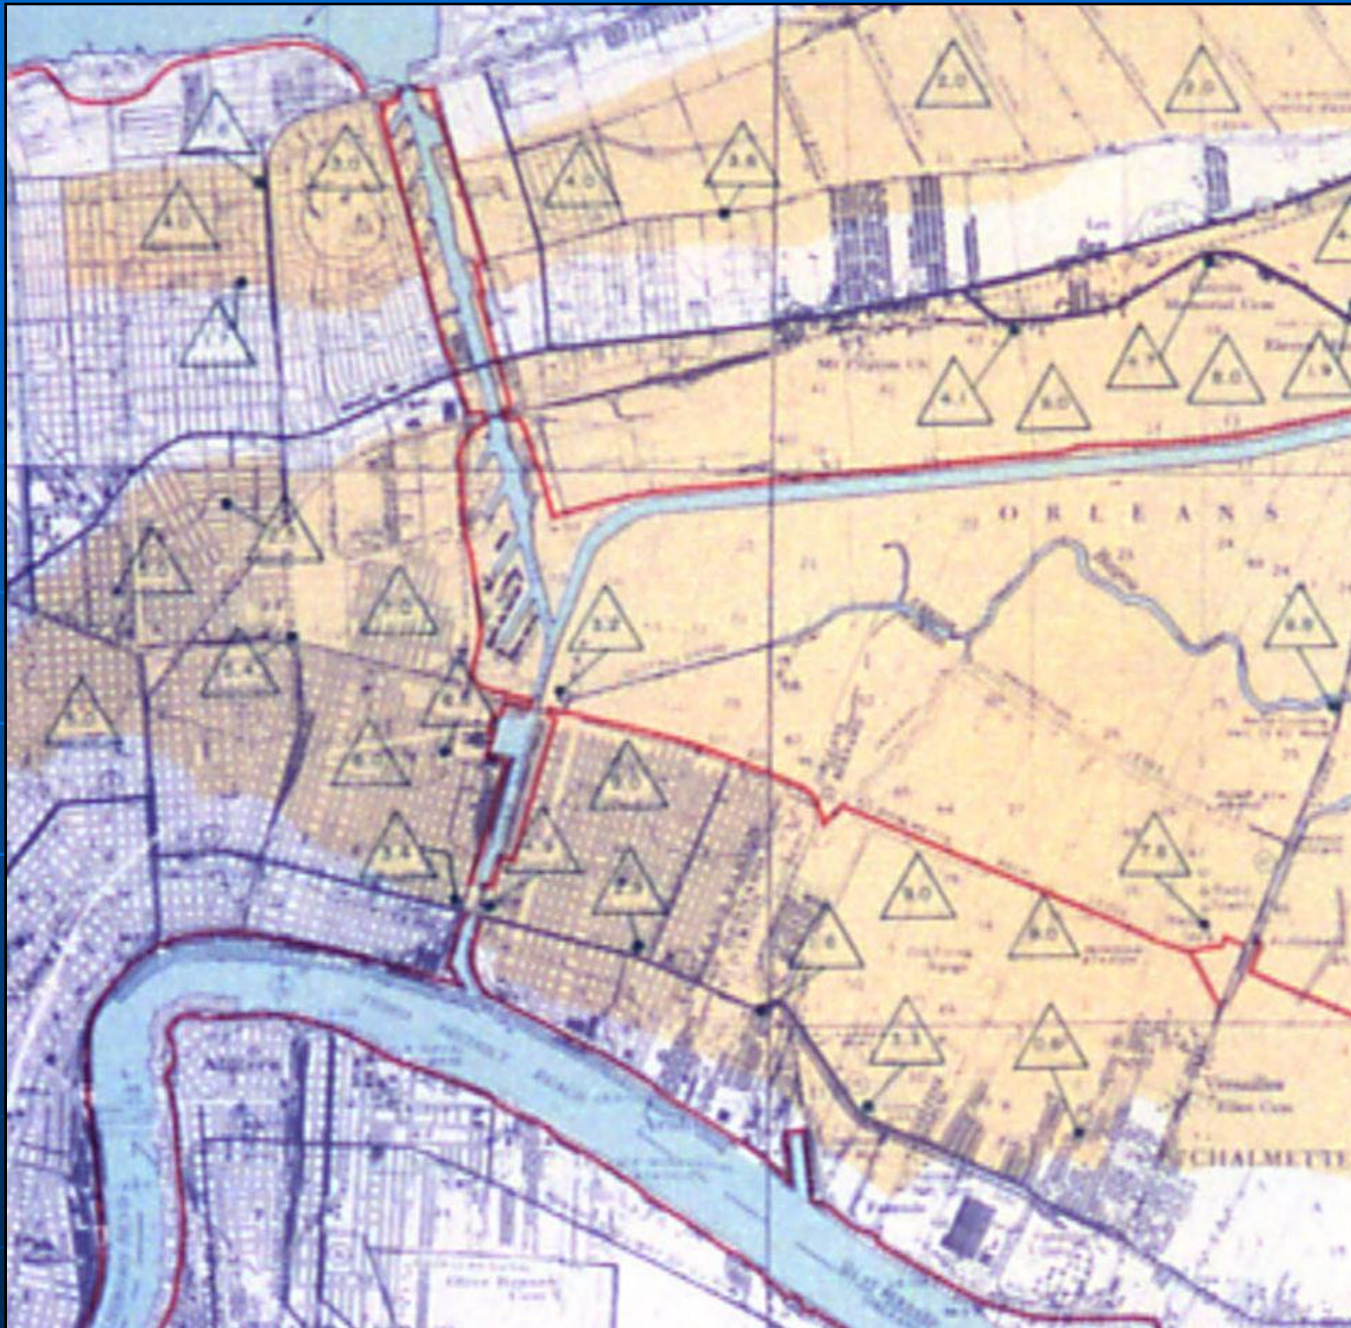
1965 flooding

The Lower Ninth Ward was flooded by overtopping of the levees along the IHNC in 1947 and 1965

The levee was heightened using rolled fill after both floods

Sheetpiles added after Hurricane Camille in 1969

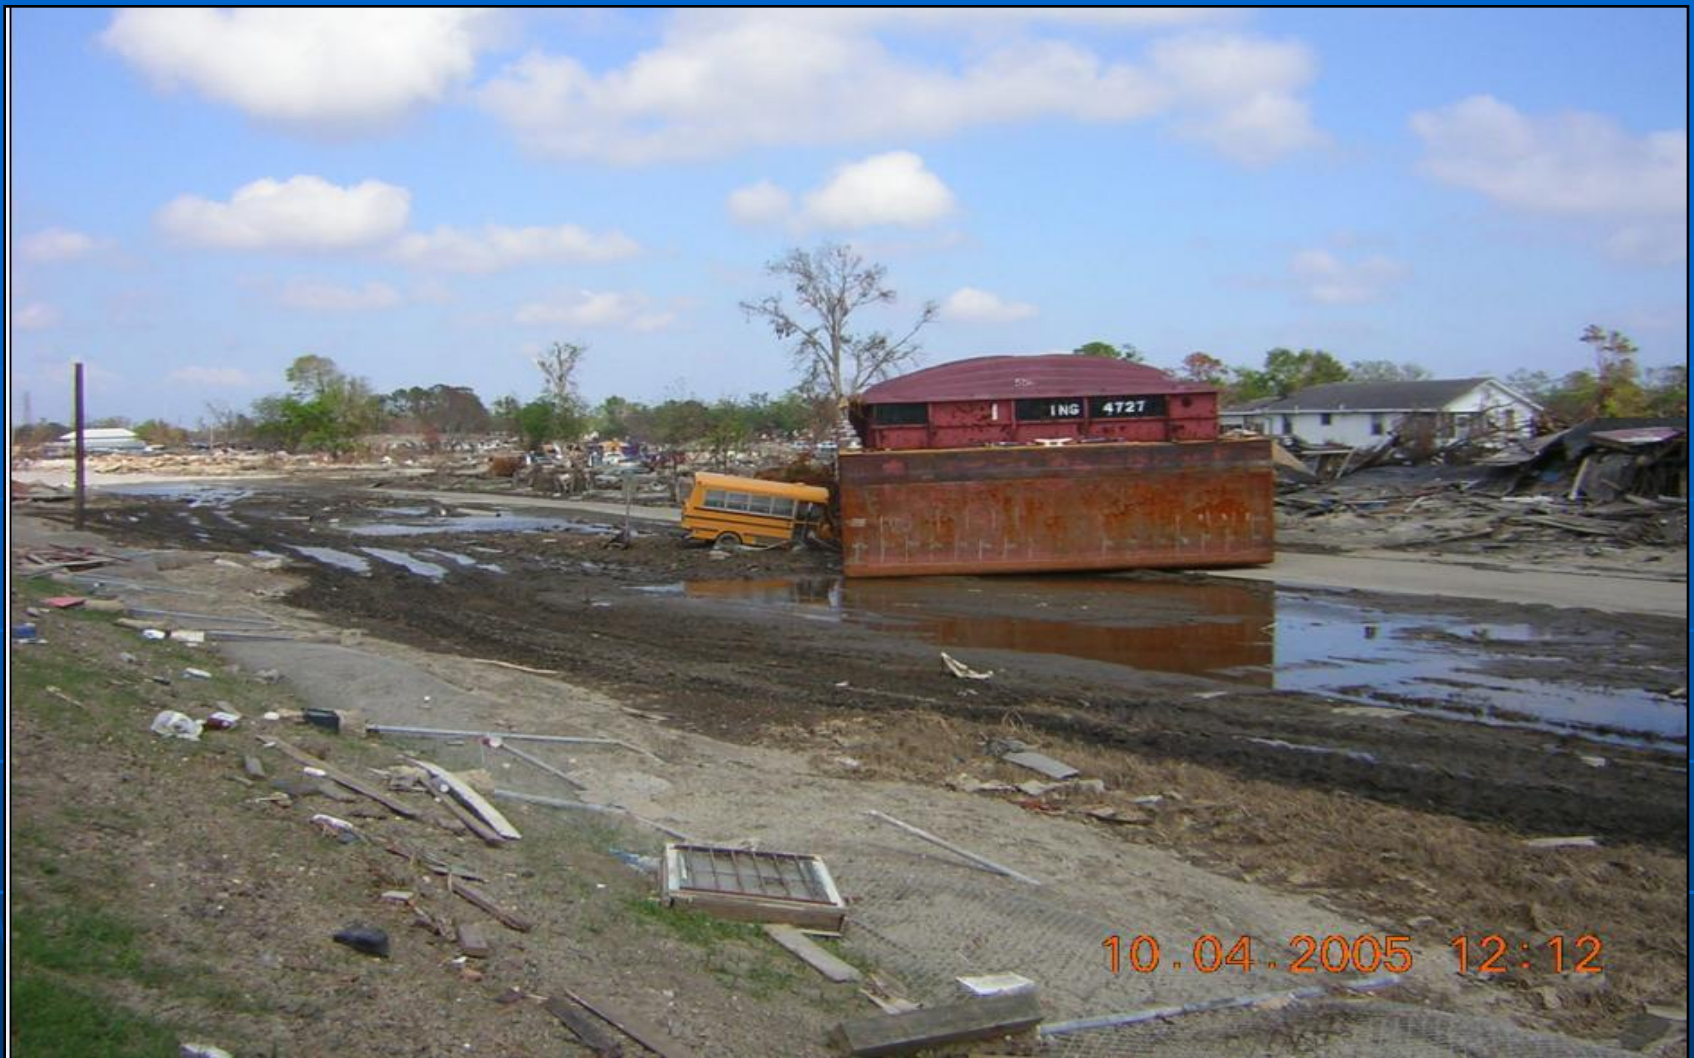
- **ING 4727 was built in 1990 as a dry cargo cover-top barge with a steel hull. It was 200 feet long, 35 feet wide, and 12 ft high, with a cargo volume of 84,659 ft³ (1877 tons). It was being leased to Lafarge North America and was tied up along the MRGO-IGWW channel.**

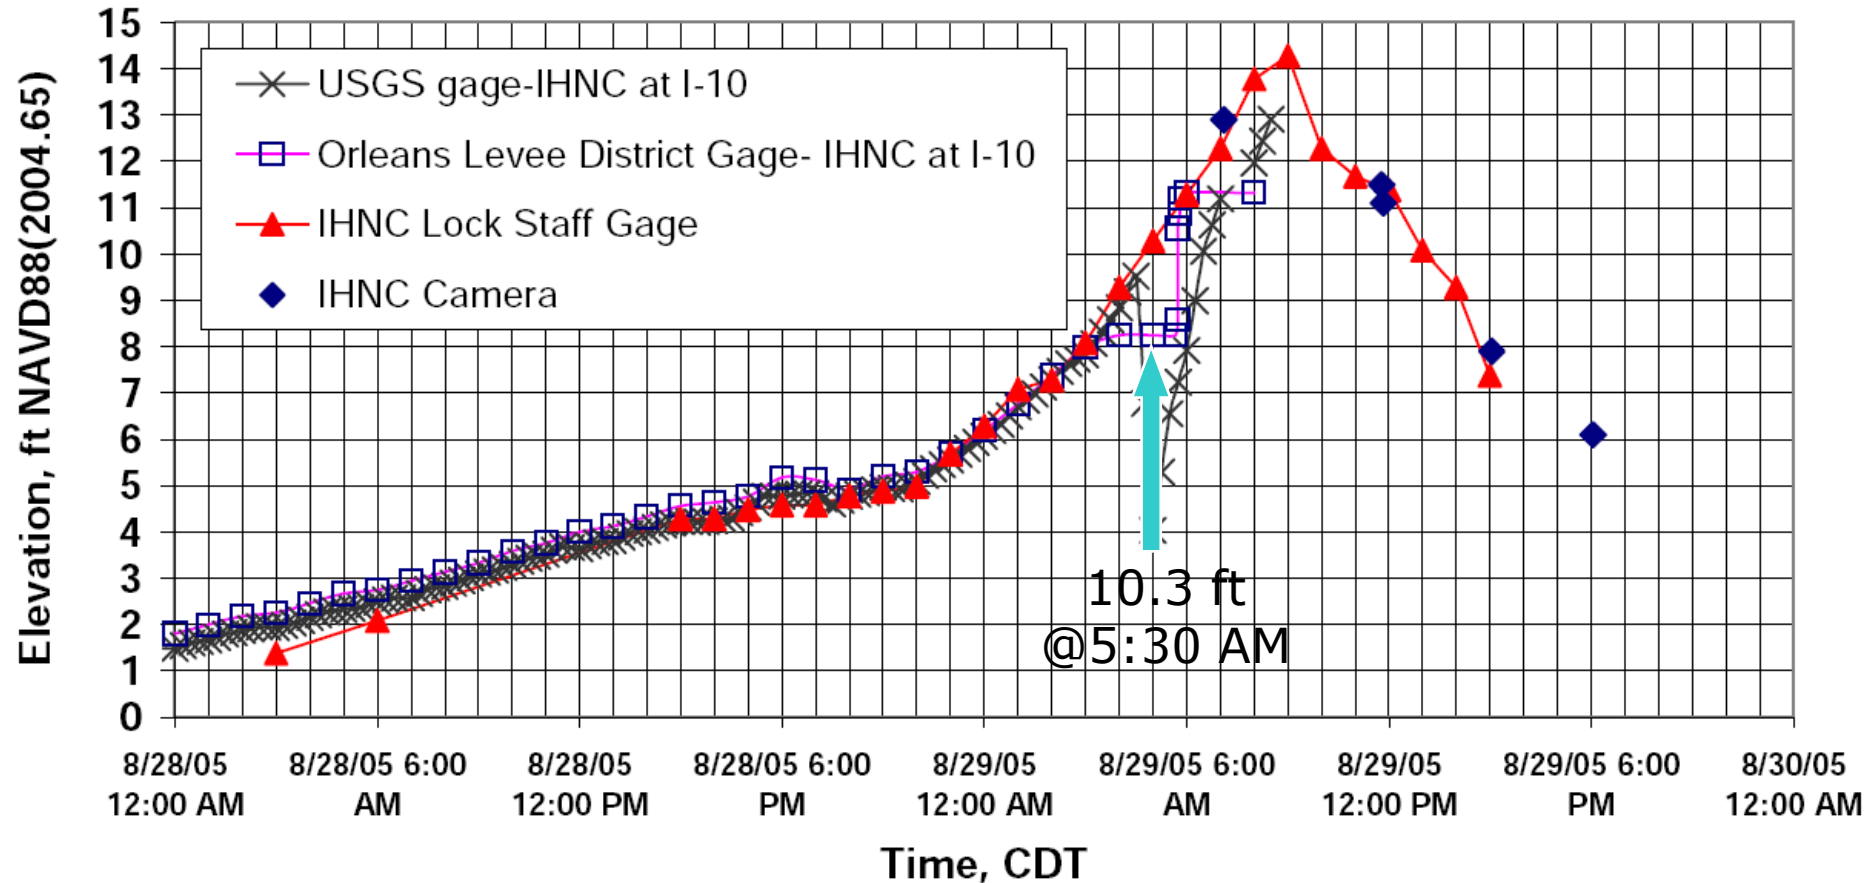
Hydrographs on IHNC

The storm surge caused by Katrina began three days before it made landfall, seen here as the gradual increase at left, about 0.32 ft/hr. Around midnight on August 29th, the rate increased 4X, to about 1.2 ft/hr . These rates and levels were used in our seepage analyses.

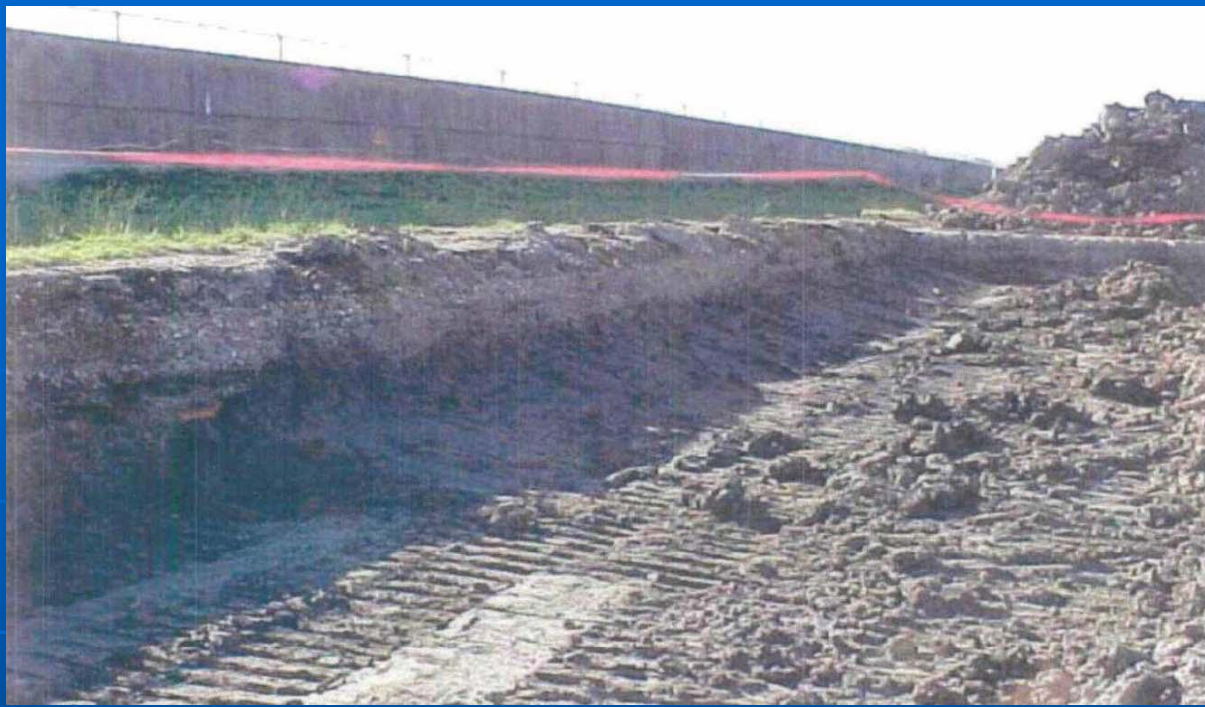
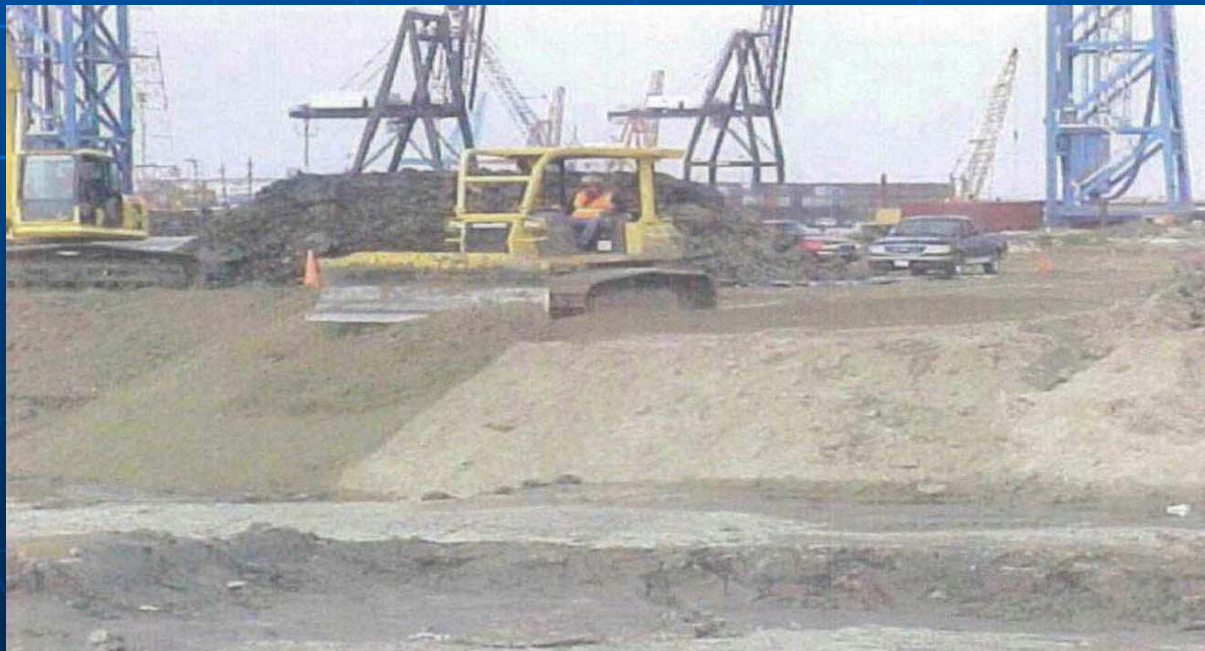
Boland Marine Site - EBIA

- **Upper-
Excavation of
contaminated
fine-grained
soils on water
side of IHNC
flood wall just
prior to
Katrina**
- **Lower -
Backfilling
with pervious
sand**

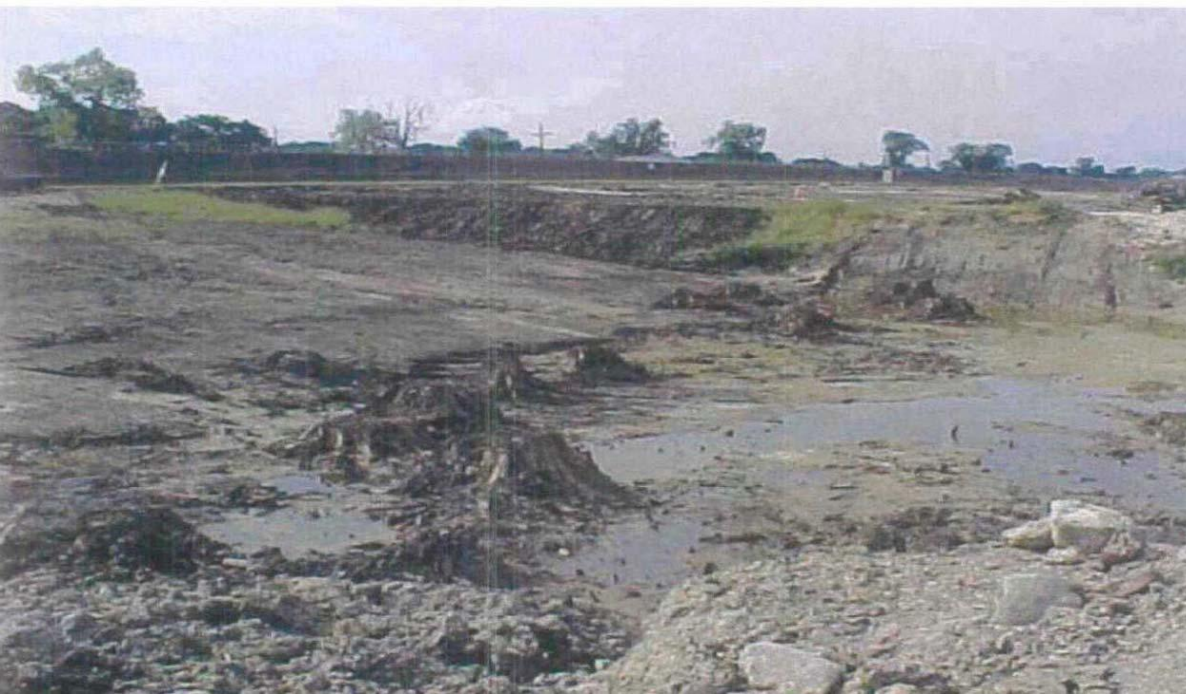
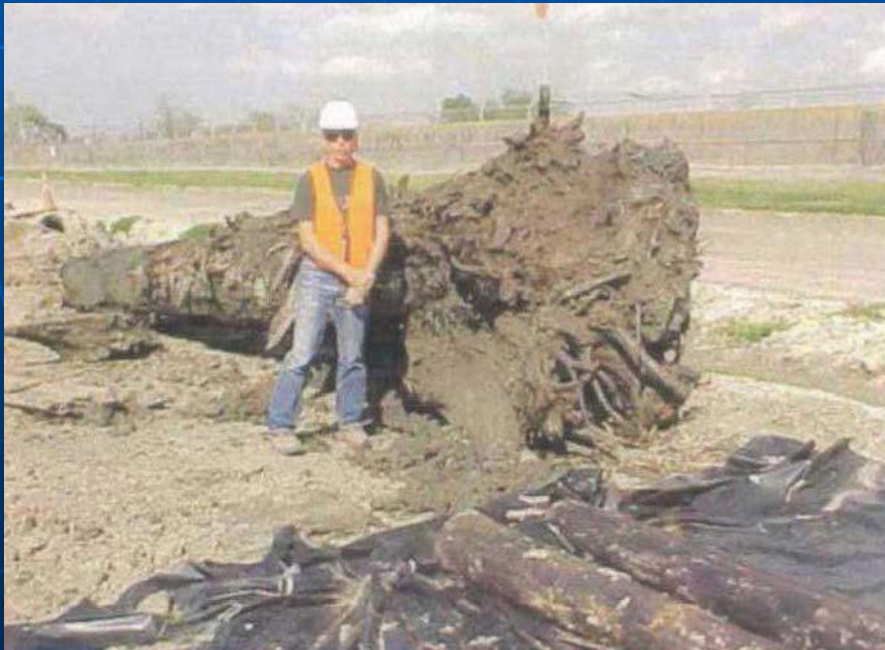
Old Cypress Swamp

- **The pre-Katrina excavations for the East Bank Industrial Area penetrated the old cypress swamp deposits, which lie beneath the IHNC levee and flood wall**

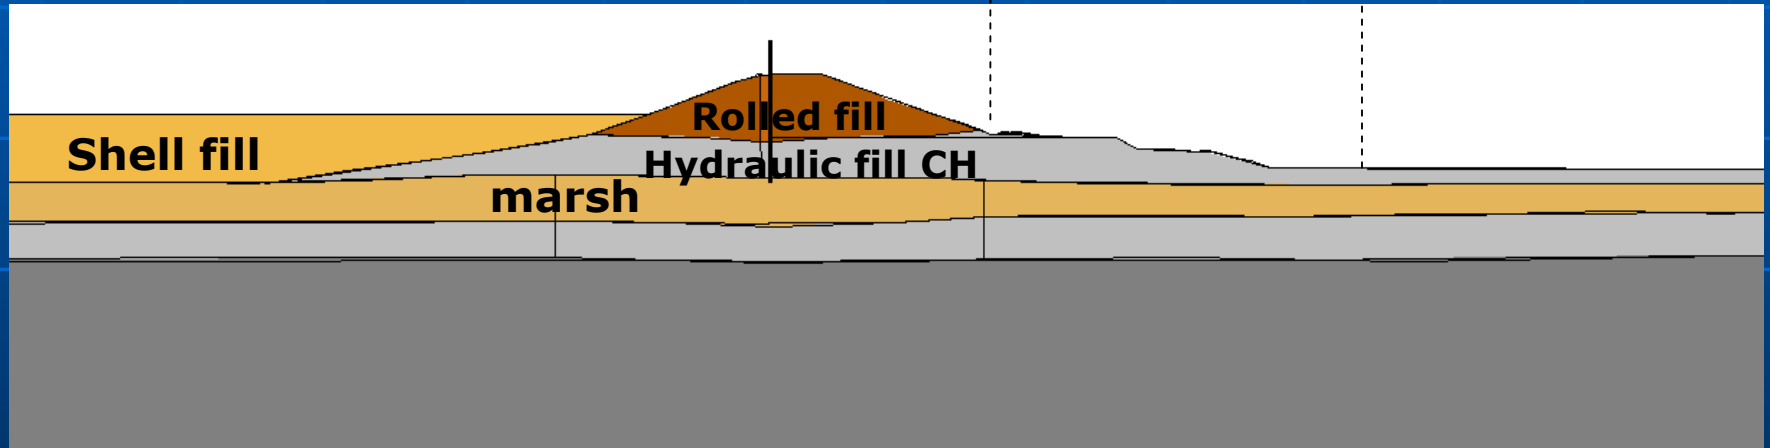
East Bank IHNC North Breach

Cross section used for limit equilibrium and coupled seepage analyses. Upper plot shows pore pressure versus horizontal distance and time for this section. Note modeling of pervious backfill at EBIA site.

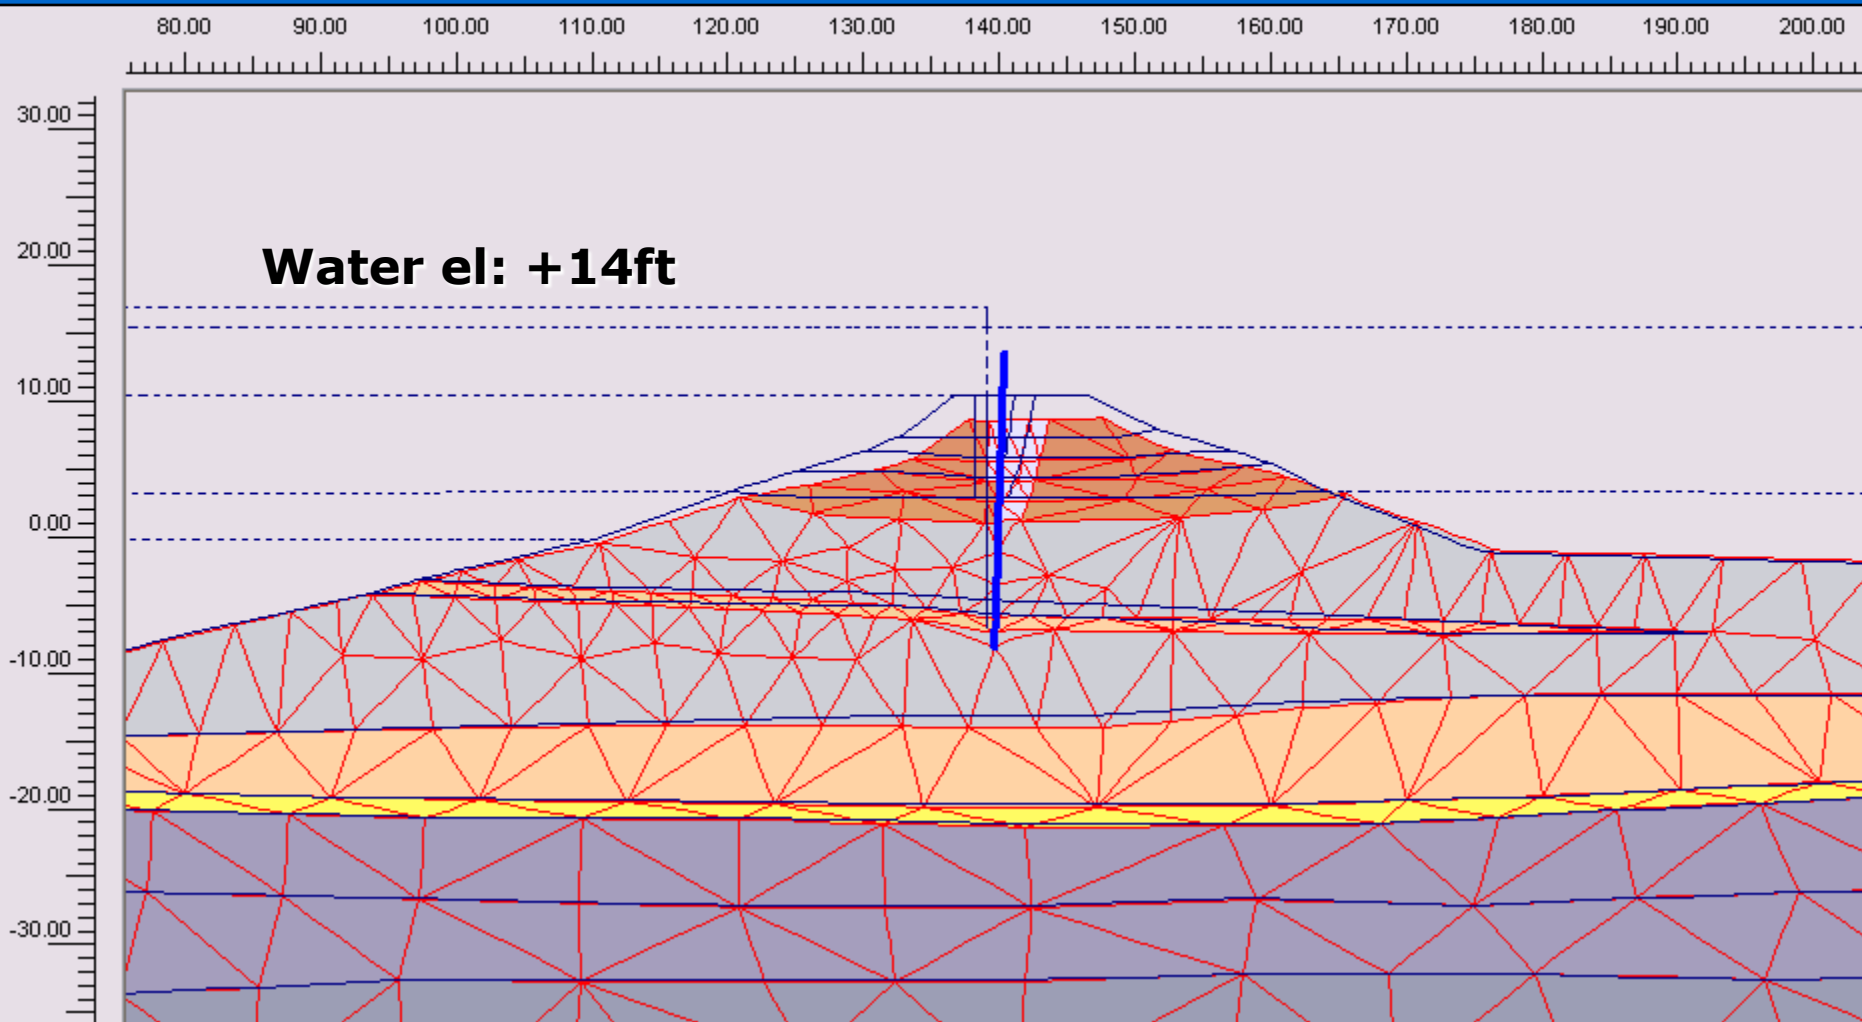
Plaxis soft soil constitutive modeling of 7.5 ft deep scour trench and 4.5 ft gap – deformed mesh – true scale (max displacement of embankment crest = 1.2 ft)

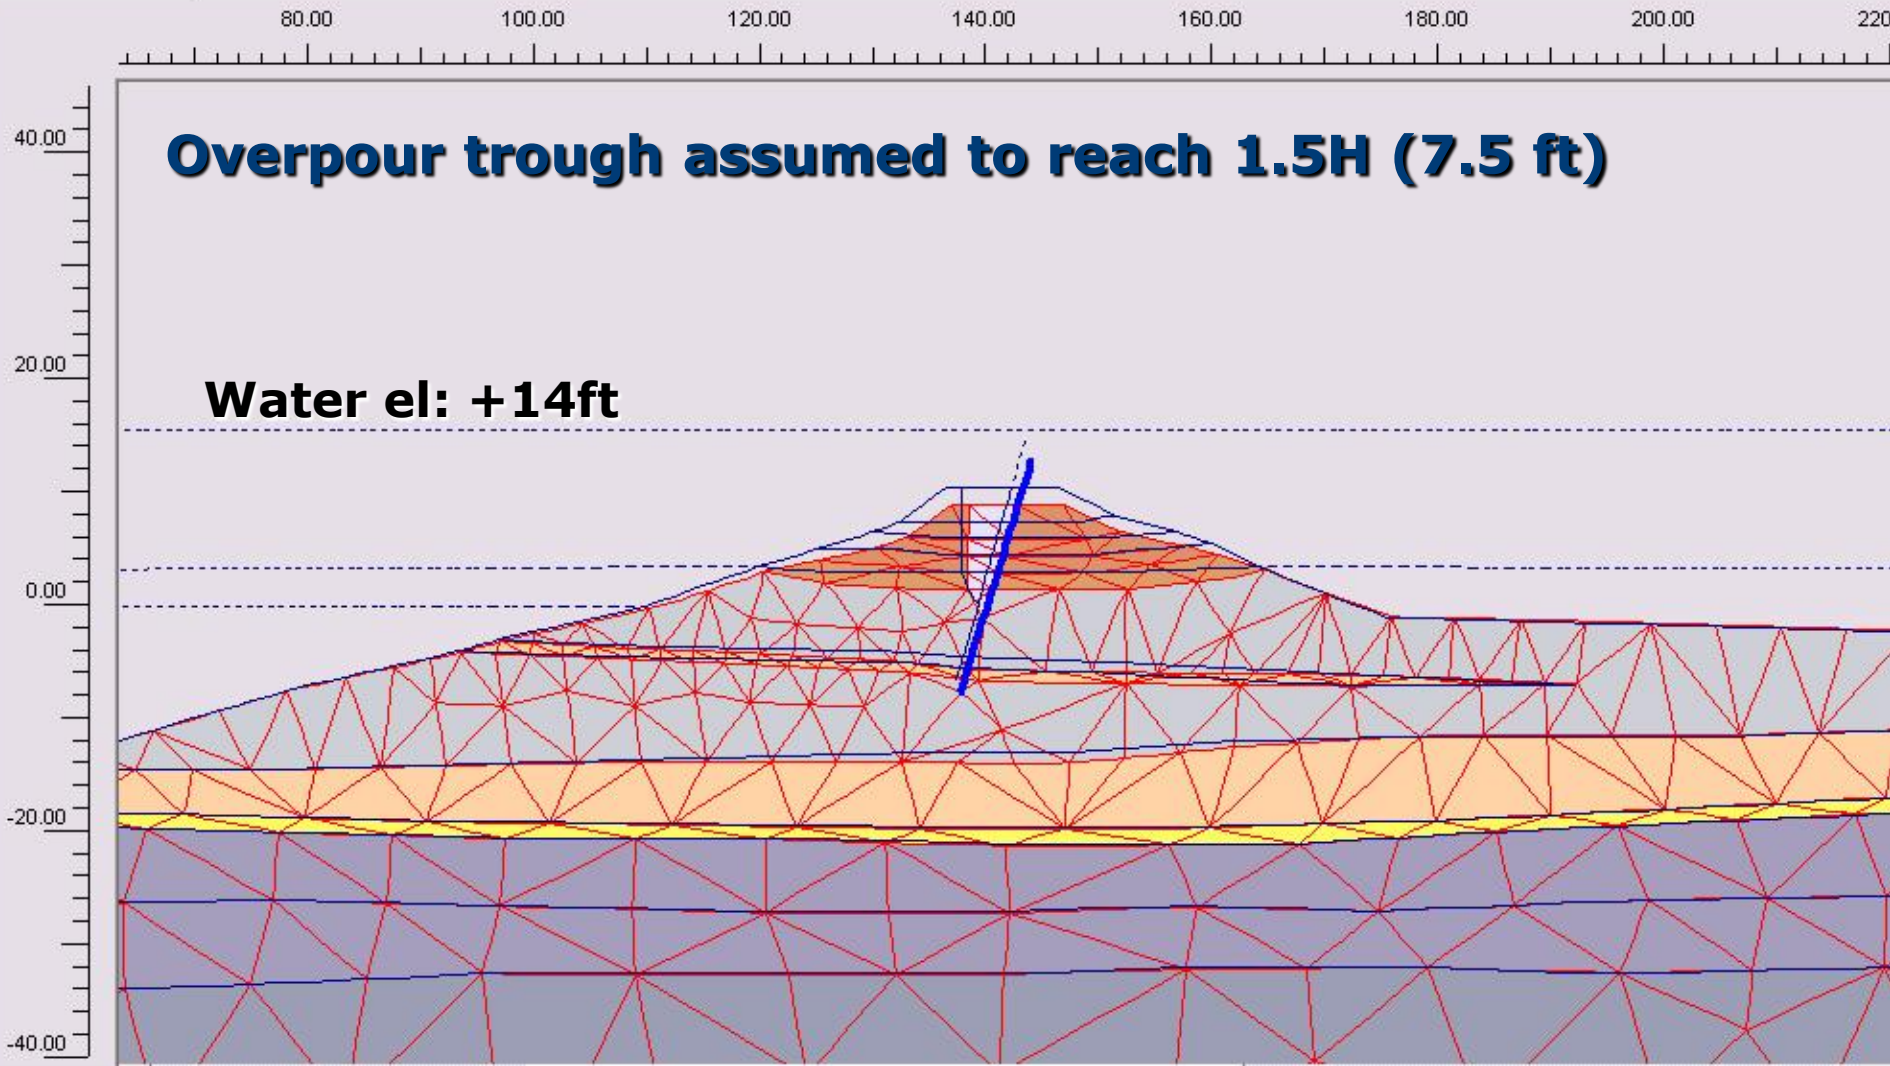
**Leaning wall with 8.5 ft of gap – deformed mesh
– true scale (max displacement = 1.71 ft)**

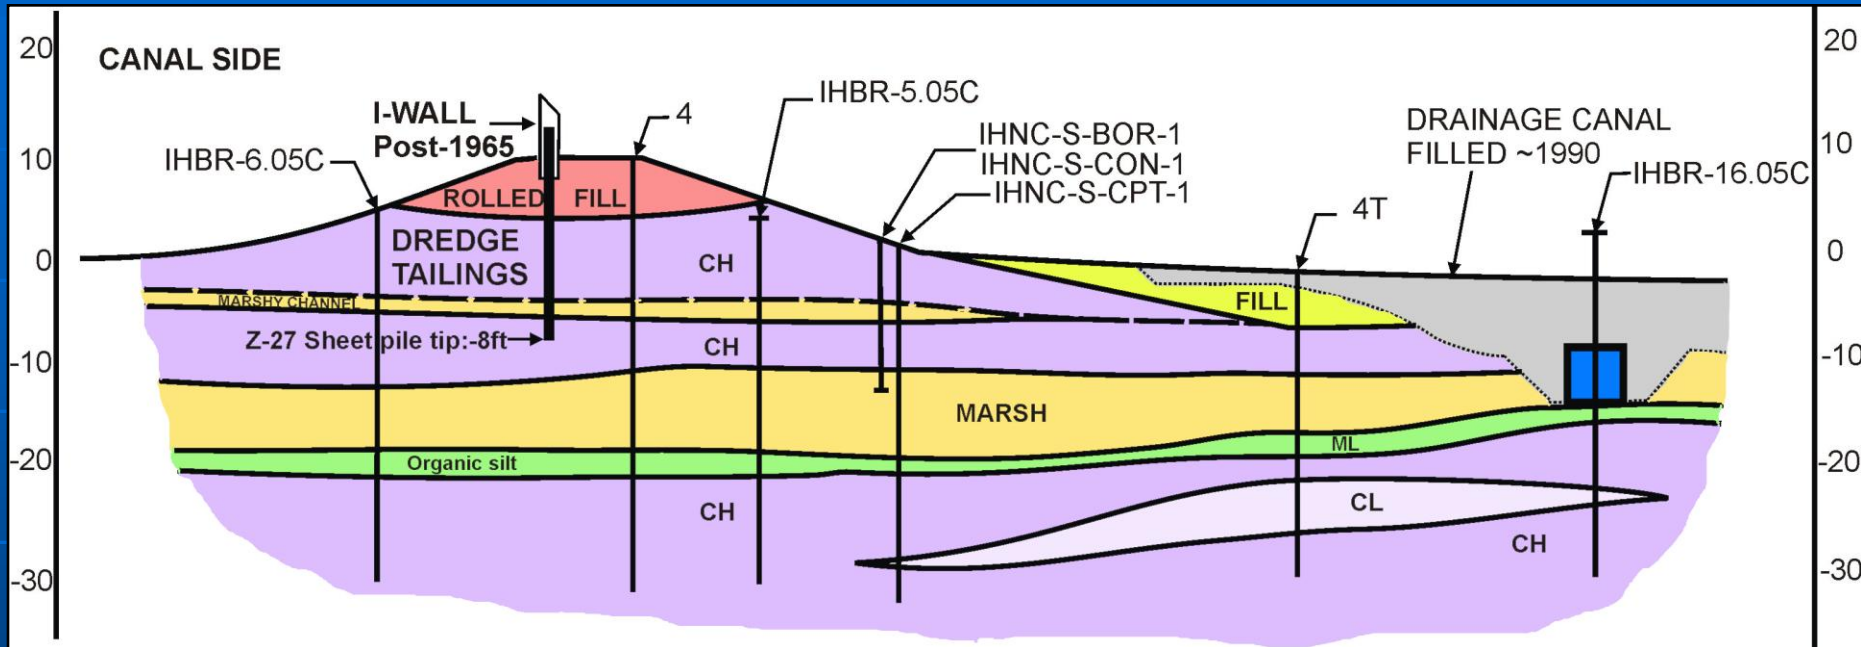
East Bank IHNC South Breach

Geologic cross-section showing projections of borings and tentative stratigraphic correlations for the 800 ft long IHNC East Bank-South Breach, adjacent to the Lower Ninth Ward

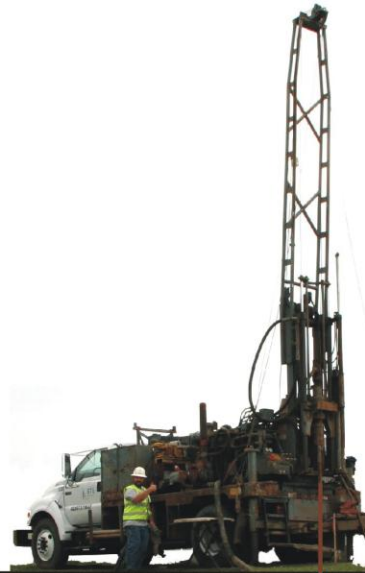
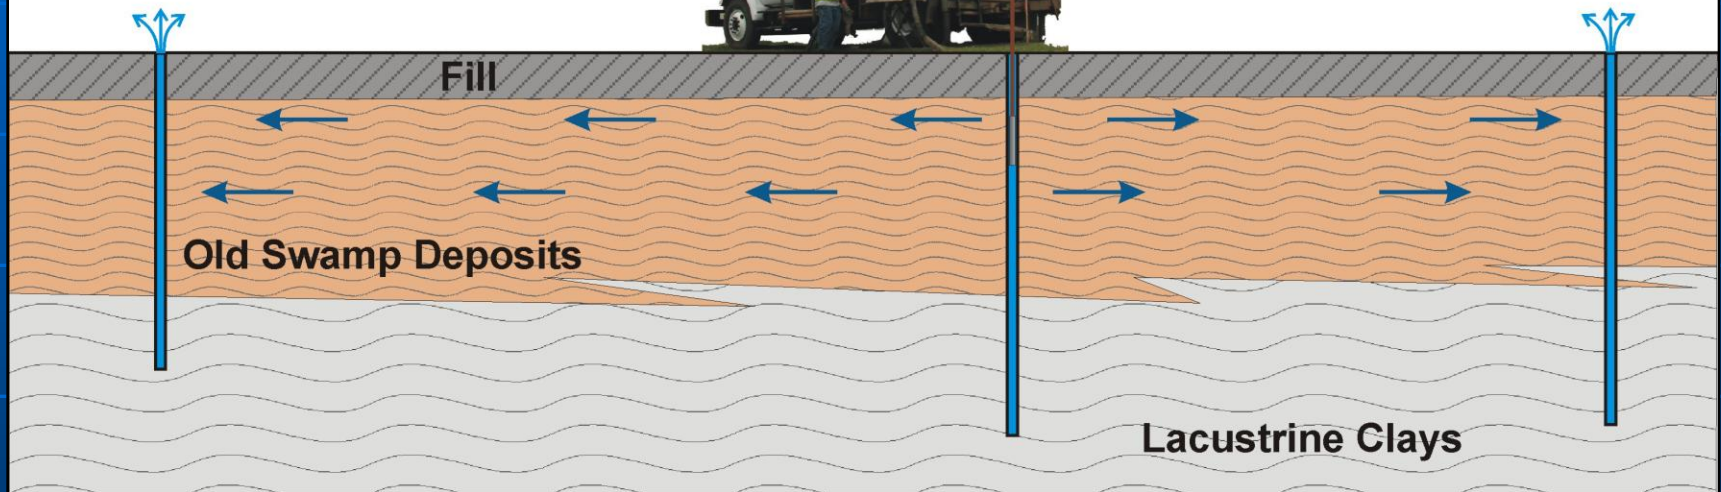
Water squirted up adjacent boreholes when advancing Shelby tubes

Drill rig advancing Shelby tubes in backswamp deposits

- The porous and **highly conductive** nature of the backswamp deposits was revealed during post-Katrina drilling and sampling operations.
- Highly conductive in horizontal plane, especially, parallel to original surface drainage.

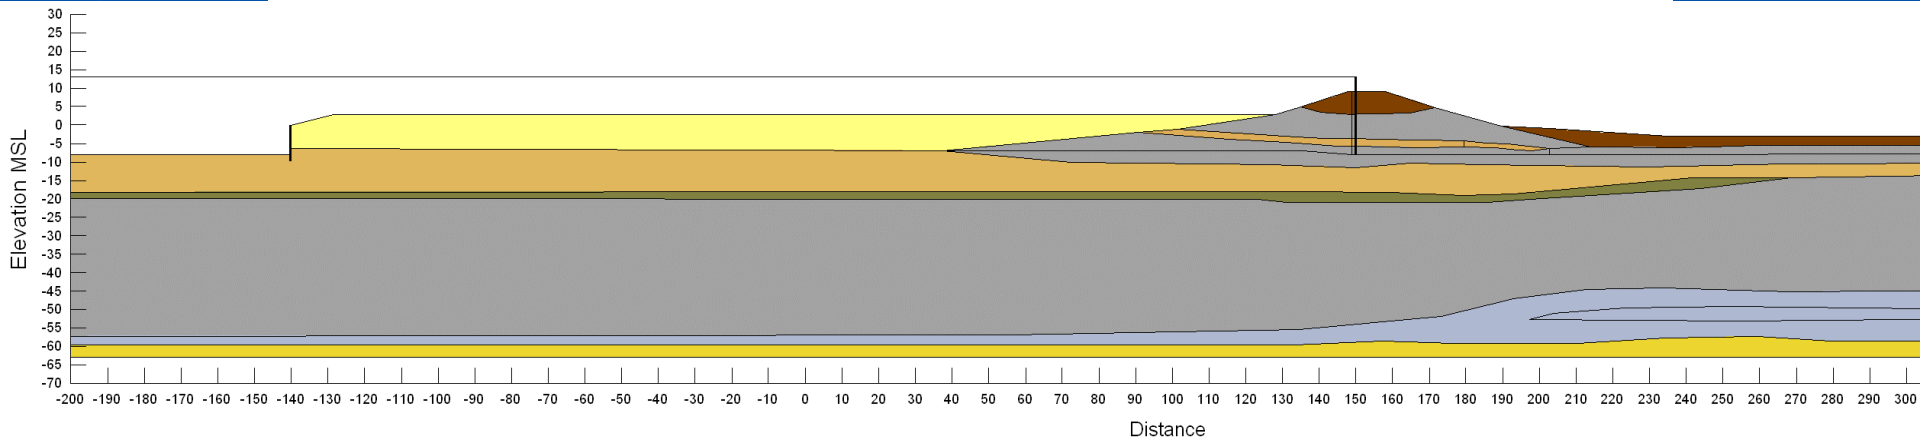
Geotechnical cross-section for conventional limit equilibrium and coupled seepage analyses of the east bank IHNC south breach.

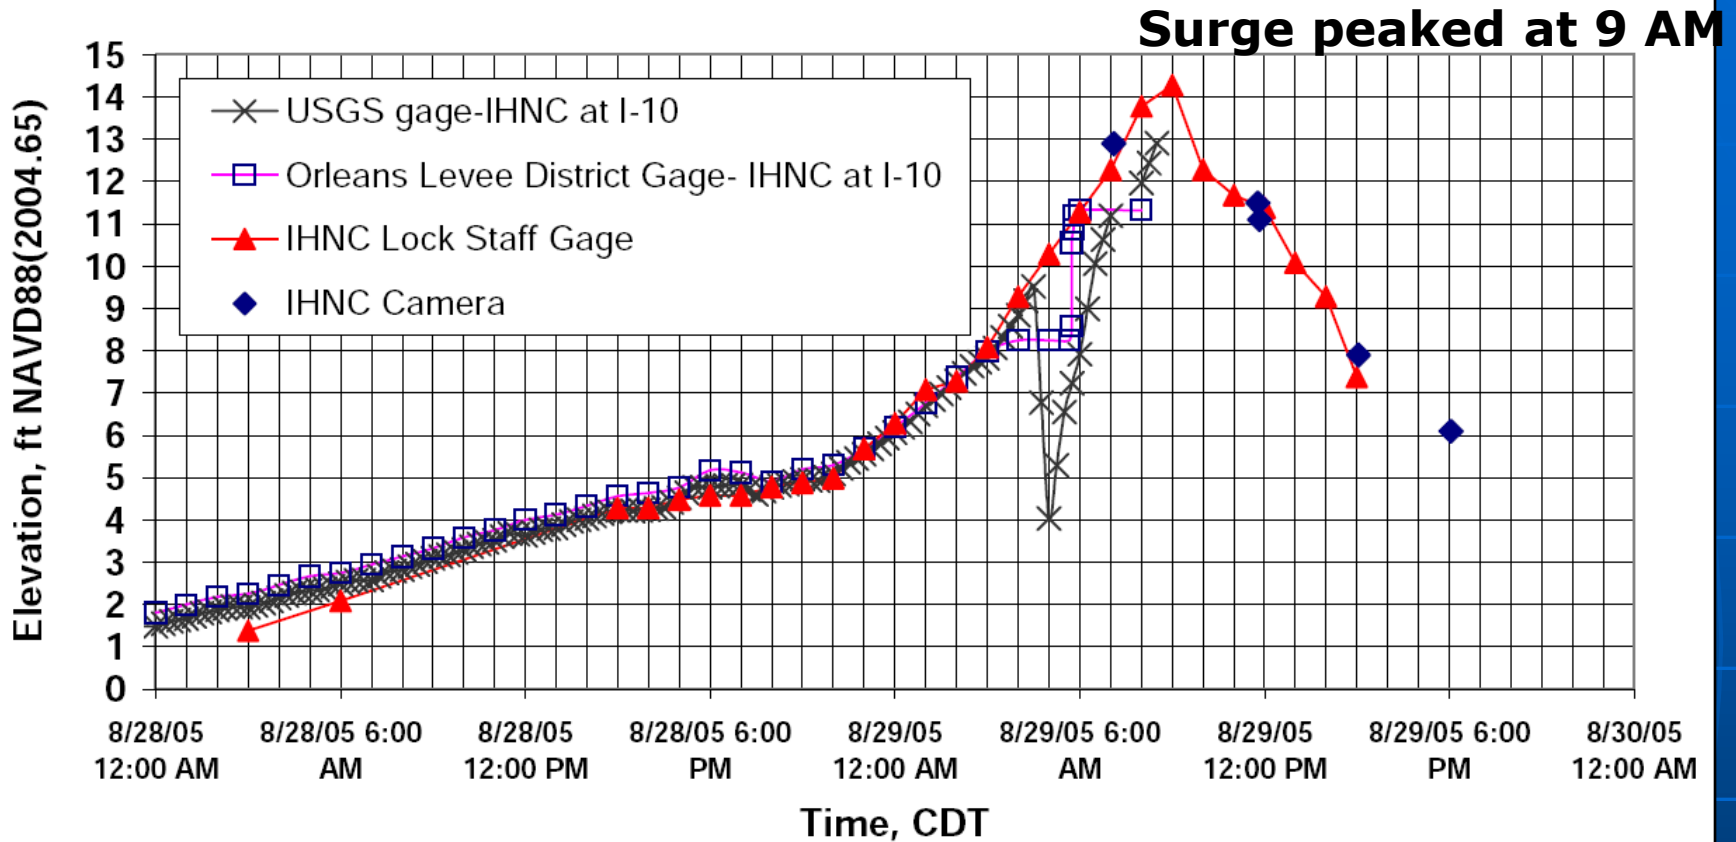
Hydrographs on IHNC

The horizontal permeability in the pervious marsh deposits likely varies between 1×10^{-3} and 1×10^{-6} cm/sec., locally (within the marsh stratum), depending on a number of factors.

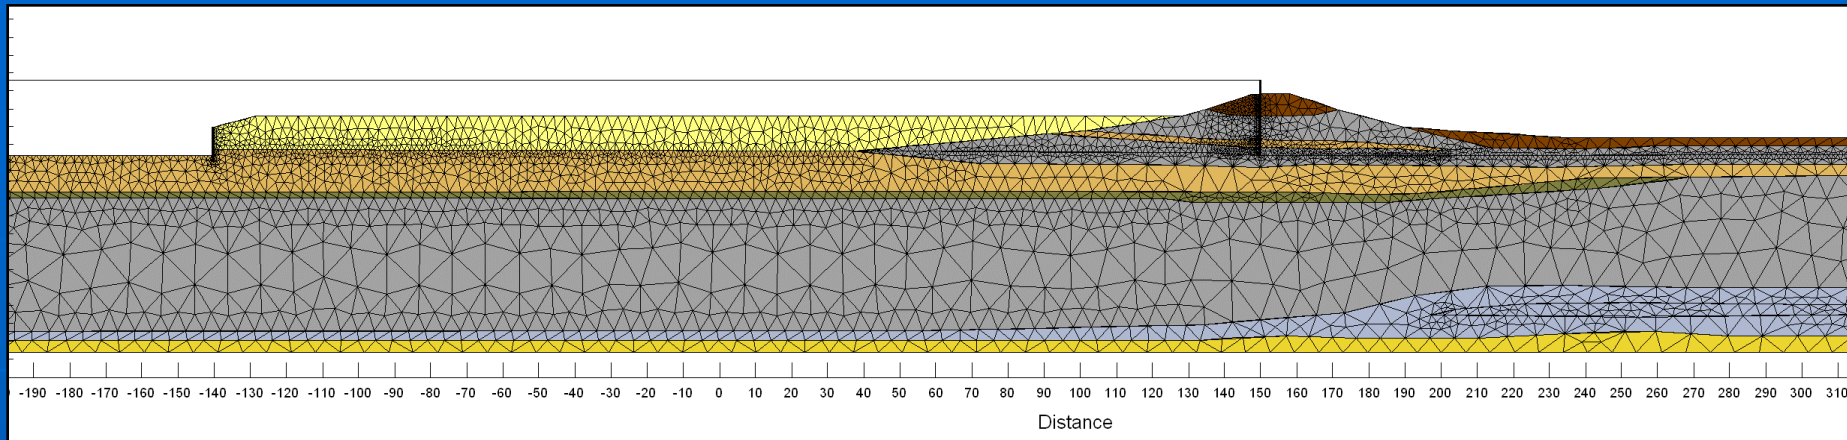
Finite difference mesh for seepage analyses for east bank IHNC south breach.

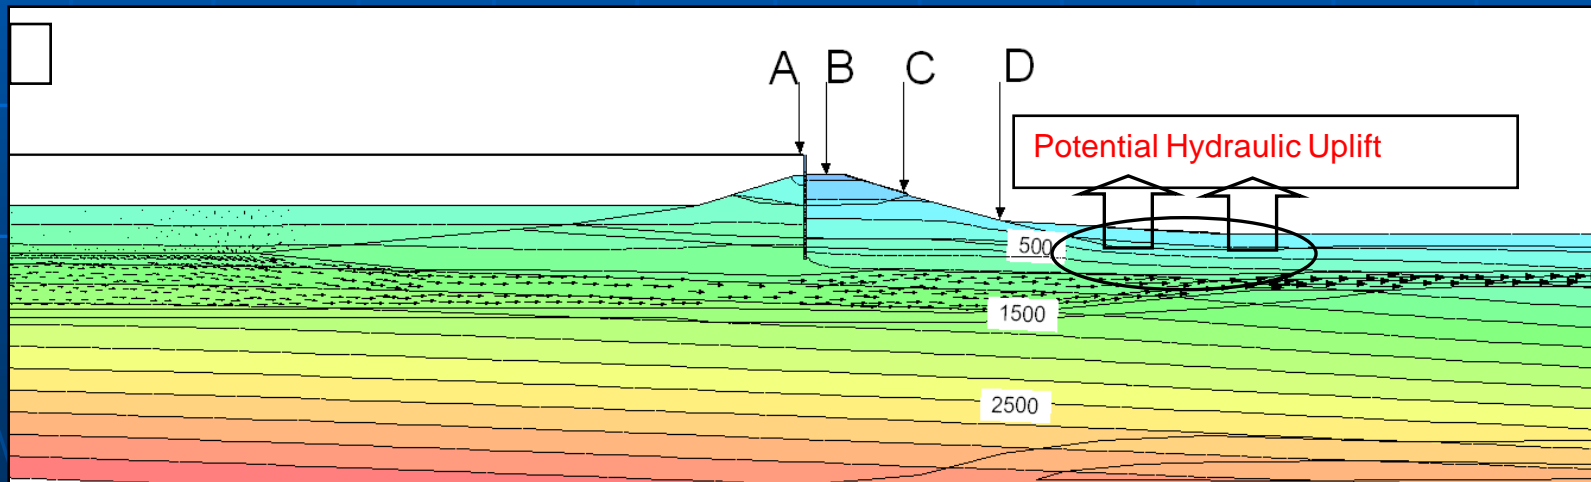
Pressure contours for the south breach on IHNC with storm surge at 14.4ft (MSL).

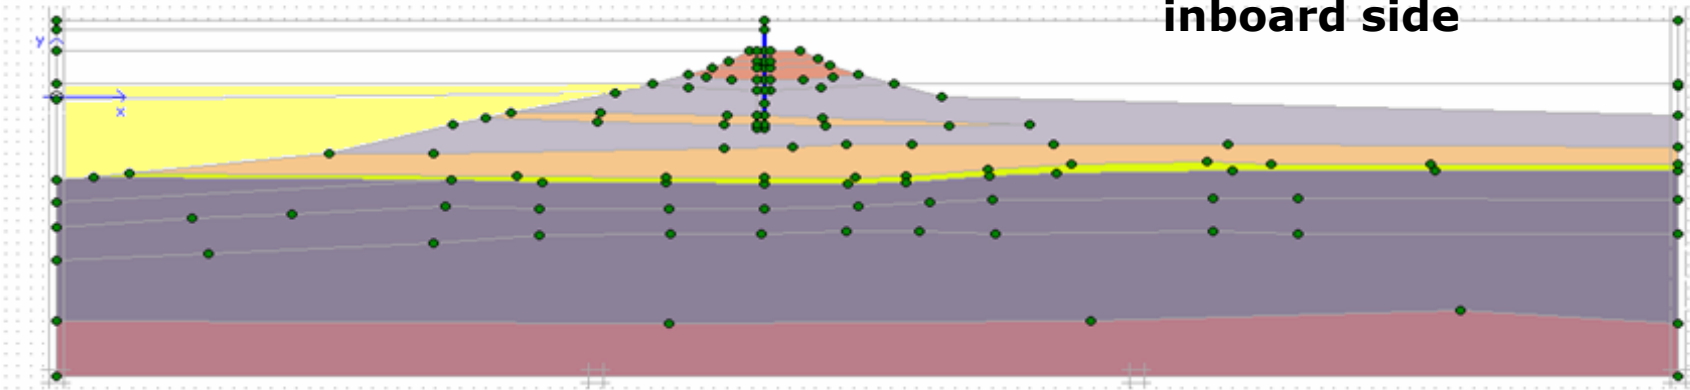
Ignored backfilled drainage canal on inboard side

Geometry and input parameters for FEM (PLAXIS) stability analyses for Lower Ninth Ward, IHNC East Bank, South Breach.

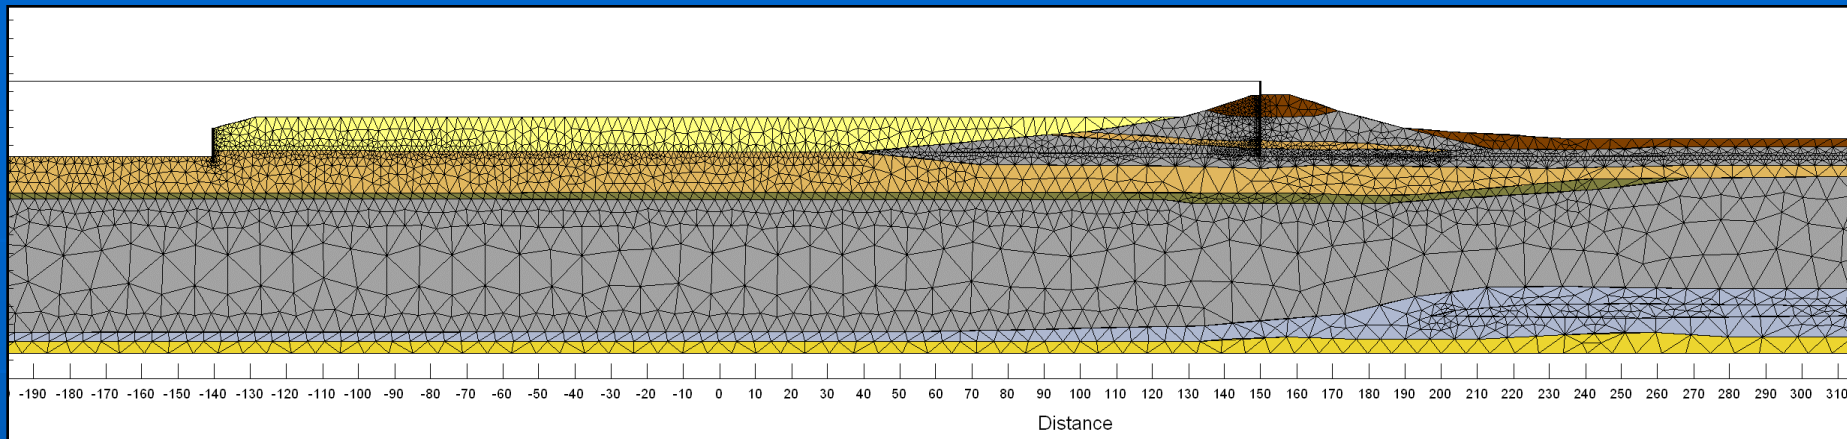
Finite difference mesh for seepage analyses for east bank IHNC south breach.

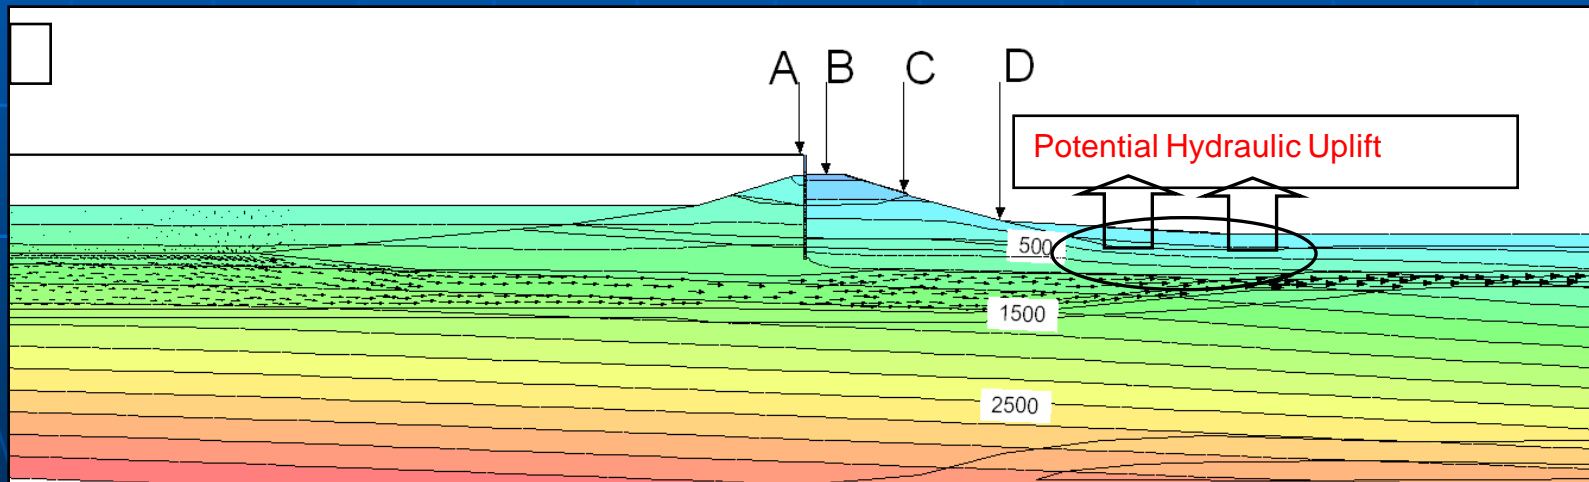
Pressure contours for the south breach on IHNC with storm surge at 14.4ft (MSL).
