HALES BAR DAM

POTENTIAL PITFALLS OF CONSTRUCTING DAMS ON KARST FOUNDATIONS

J. David Rogers, Ph.D., P.E., P.G.
Missouri University of Science & Technology
for the symposium on

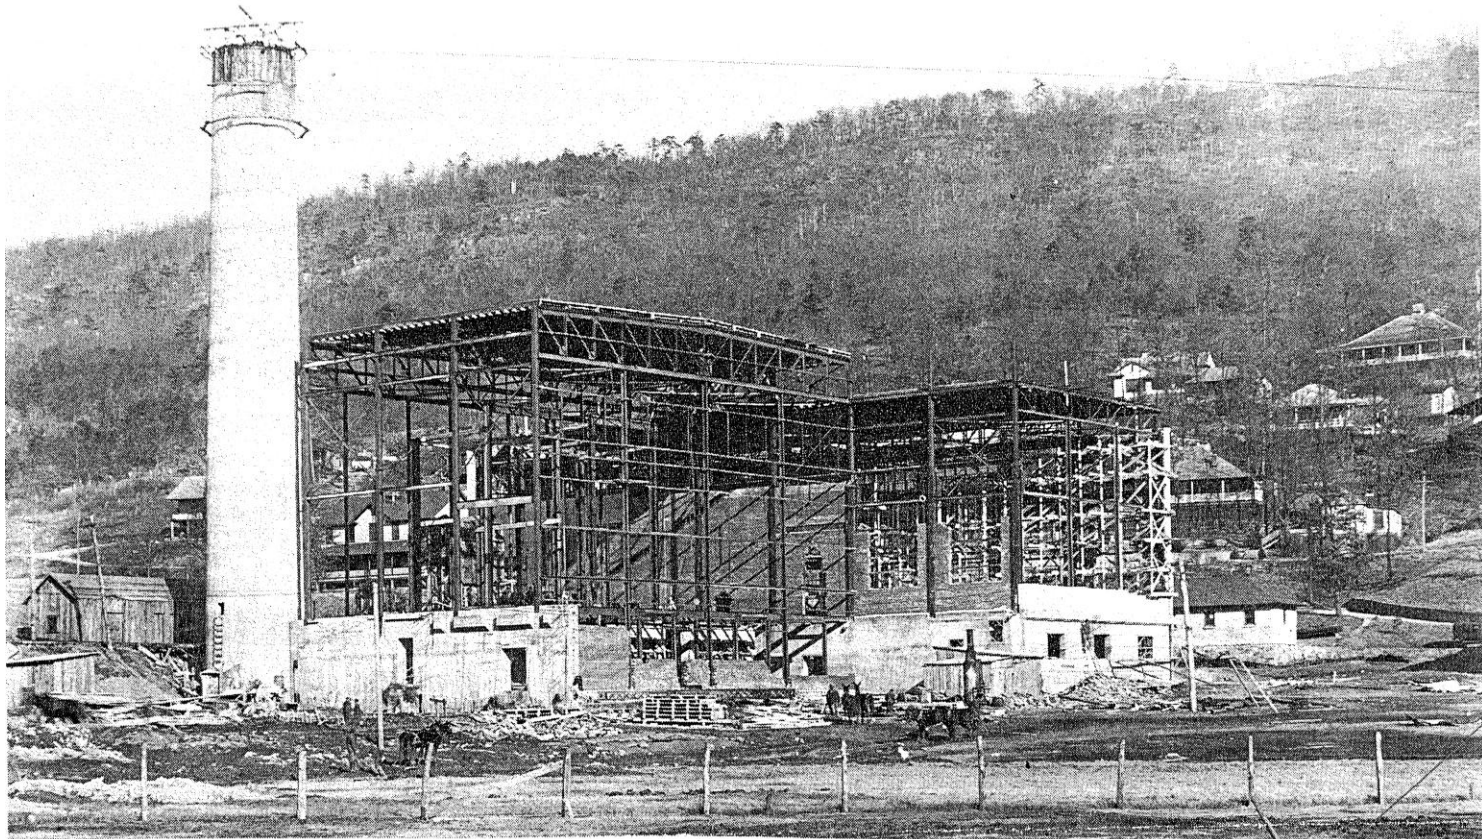
Hales Bar Steam Plant Under Construction 1923

- **In 1922-24 a new coal-fired steam power plant was constructed along the river's left bank, with two prominent stacks.**

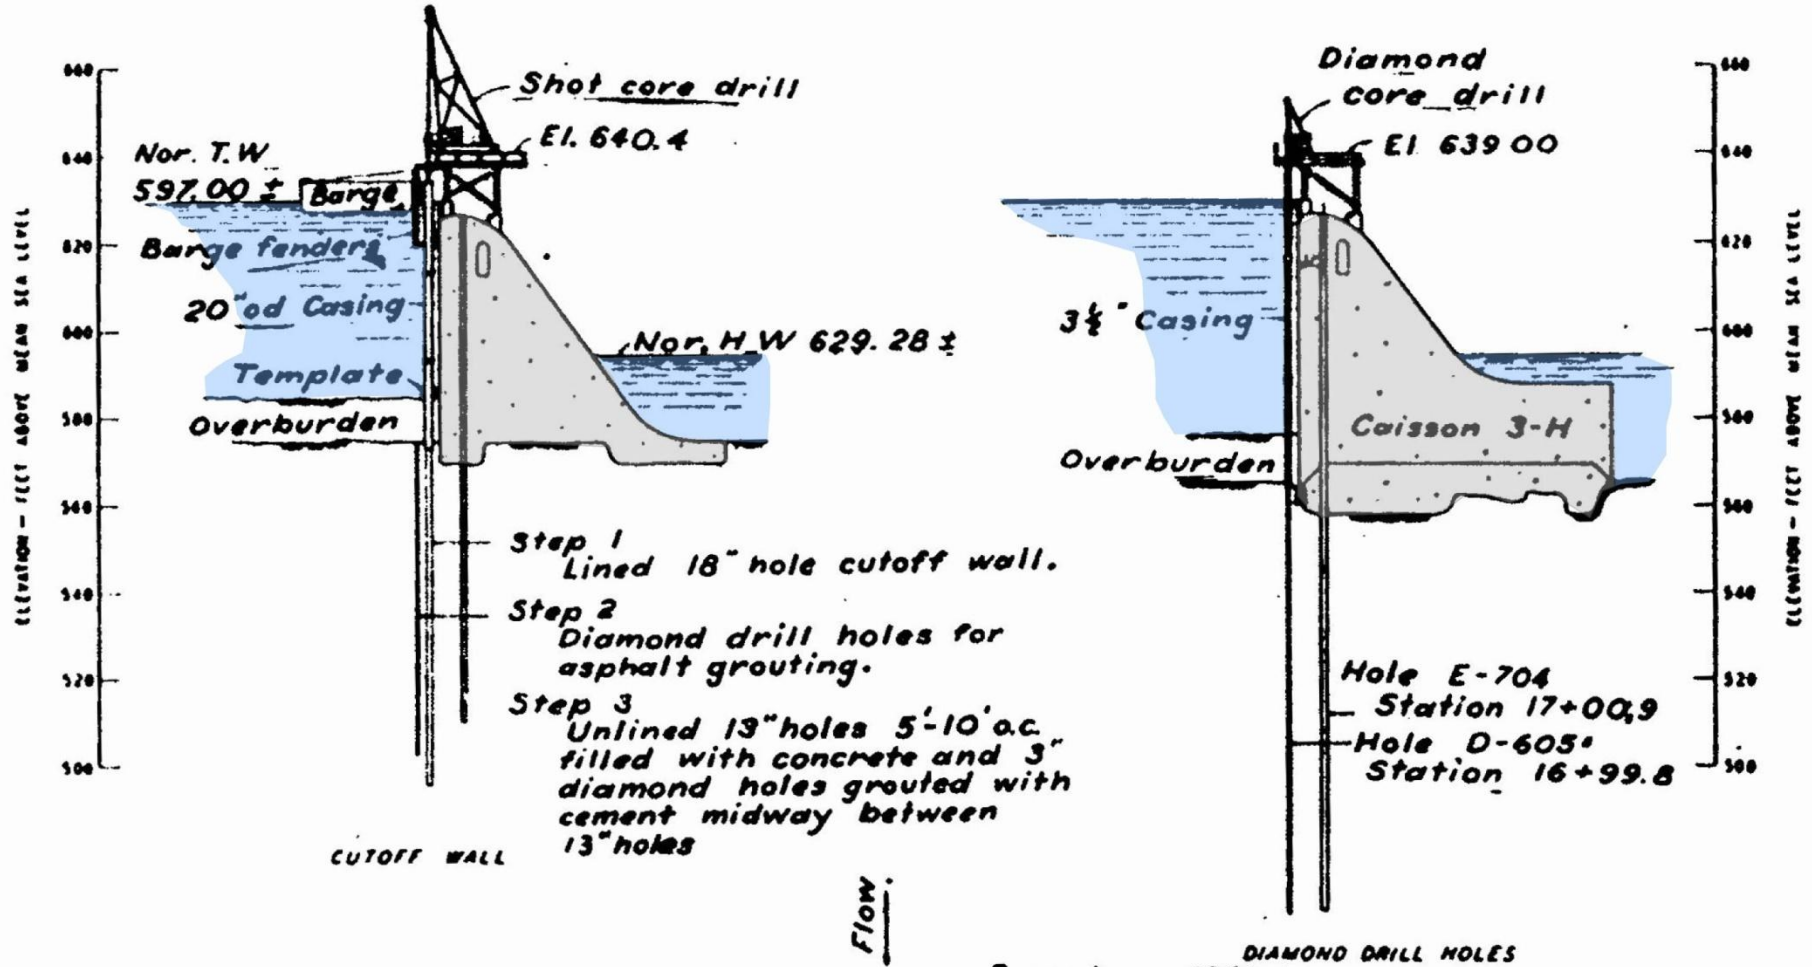
- The Tennessee Valley Authority purchased the dam in **August 1939** and began investigating the problems in **November 1940**, using 3-inch diameter diamond drill holes along the upstream face of the dam and its overflow section (shown here)
- The seepage cutoff wall was subsequently drilled along the dam's centerline, downstream of the diamond drill holes

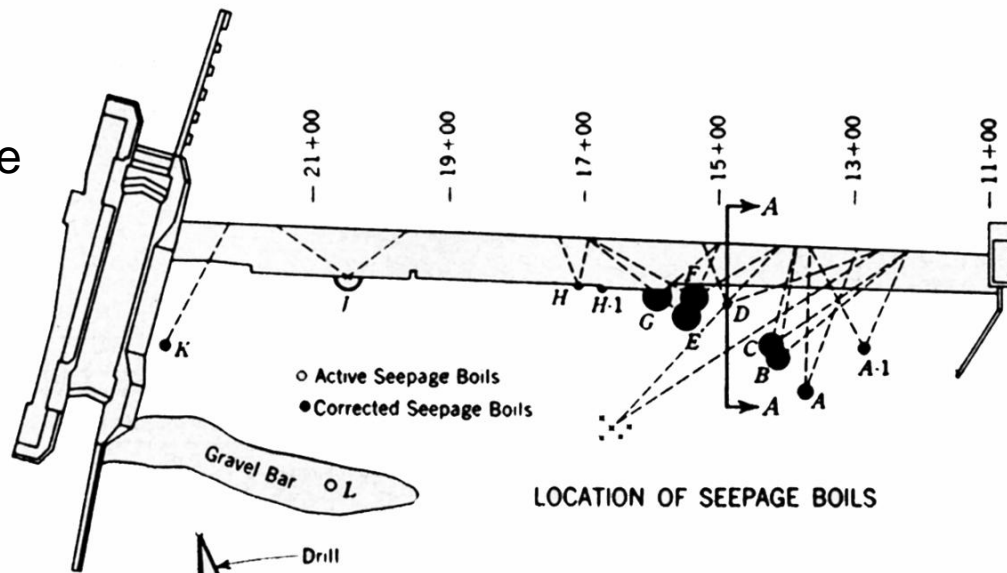
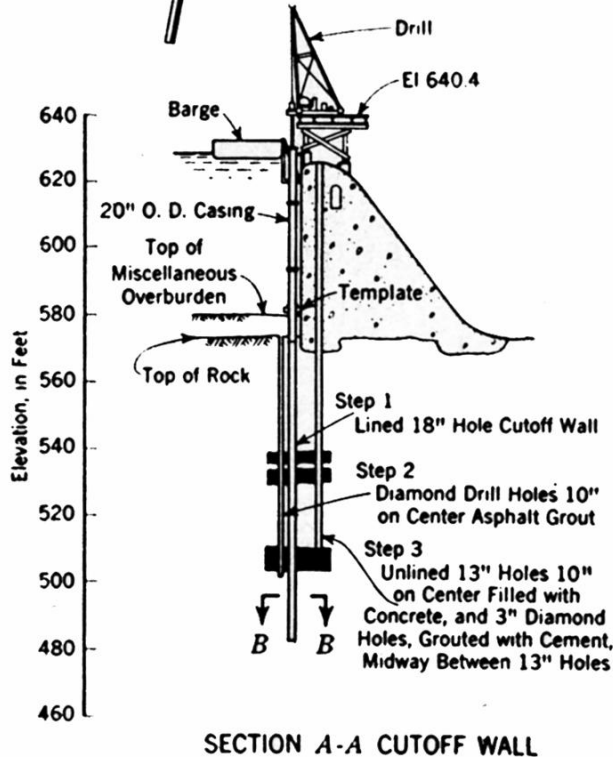
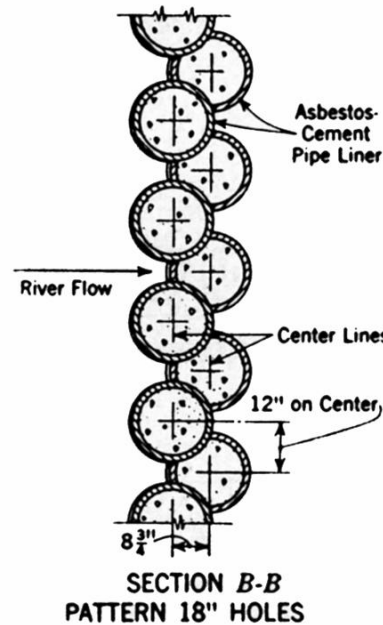
Cutoff Walls

- The TVA developed a three step process for installing a redundant series of **deep cutoff walls**, shown at left:
 - 1) the main staggered 18" diameter cut off wall (plan lower right);
 - 2) Diamond drill holes on 10" centers filled with asphalt; and
 - 3) 13" diameter holes drilled on 10" centers filled with concrete, along with 3" diameter grouted holes between the 13" holes

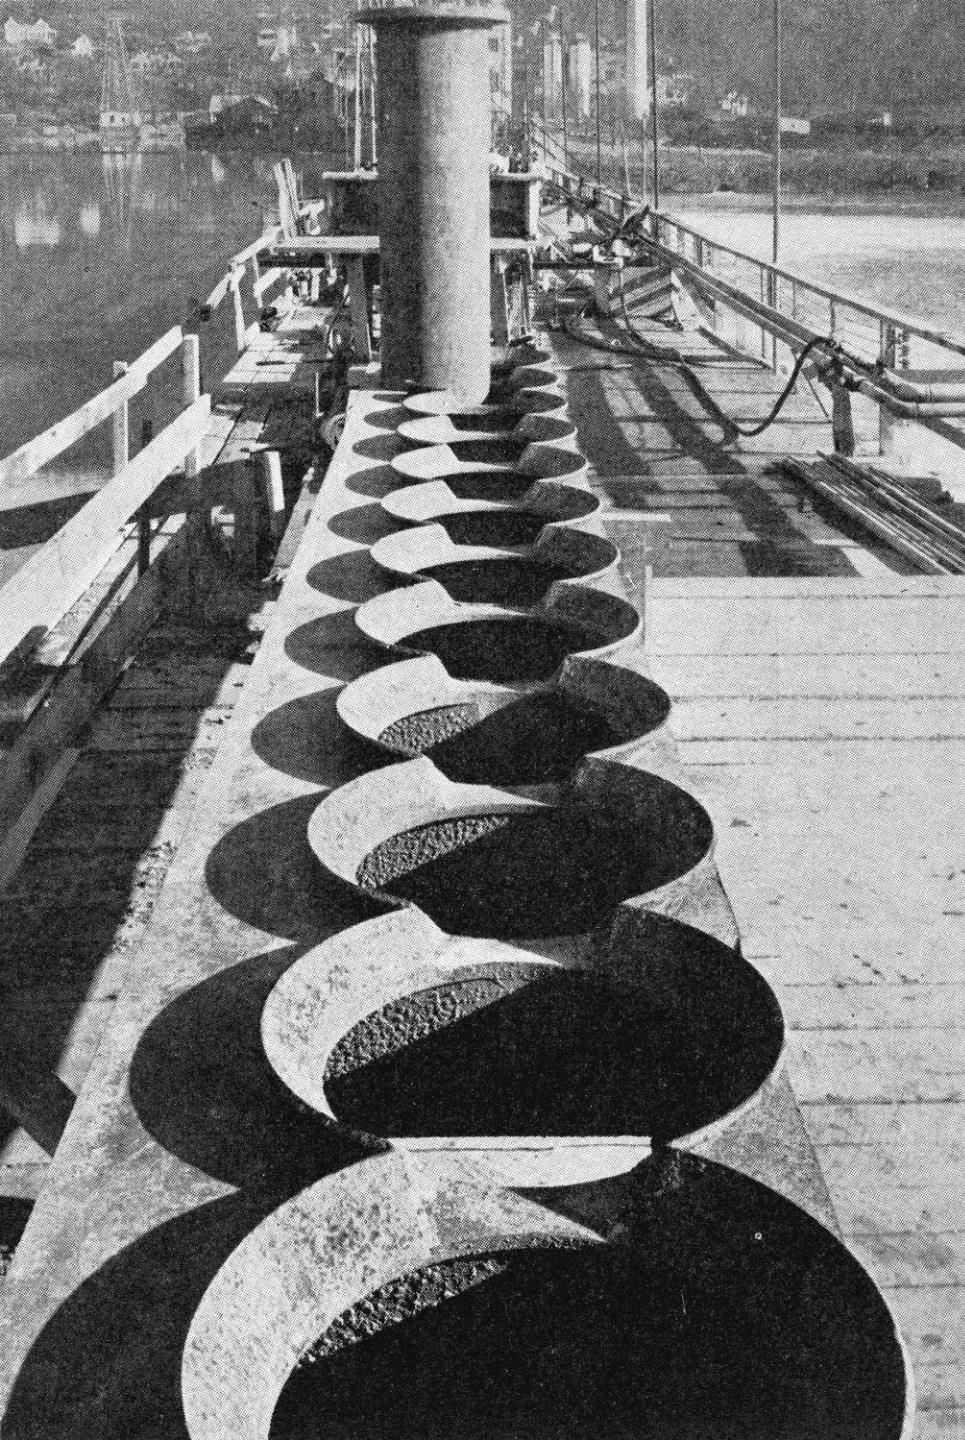
Drilling Template for tandem 18" cutoff wall

- The **cutoff walls** were constructed between **1940-44**, the largest utilizing this 18-inch diameter drilling template and two overlapping lines of lined holes, filled with concrete
- **Diamond drill holes** upstream and downstream of this main cutoff wall were also grouted, using asphalt and cement grout

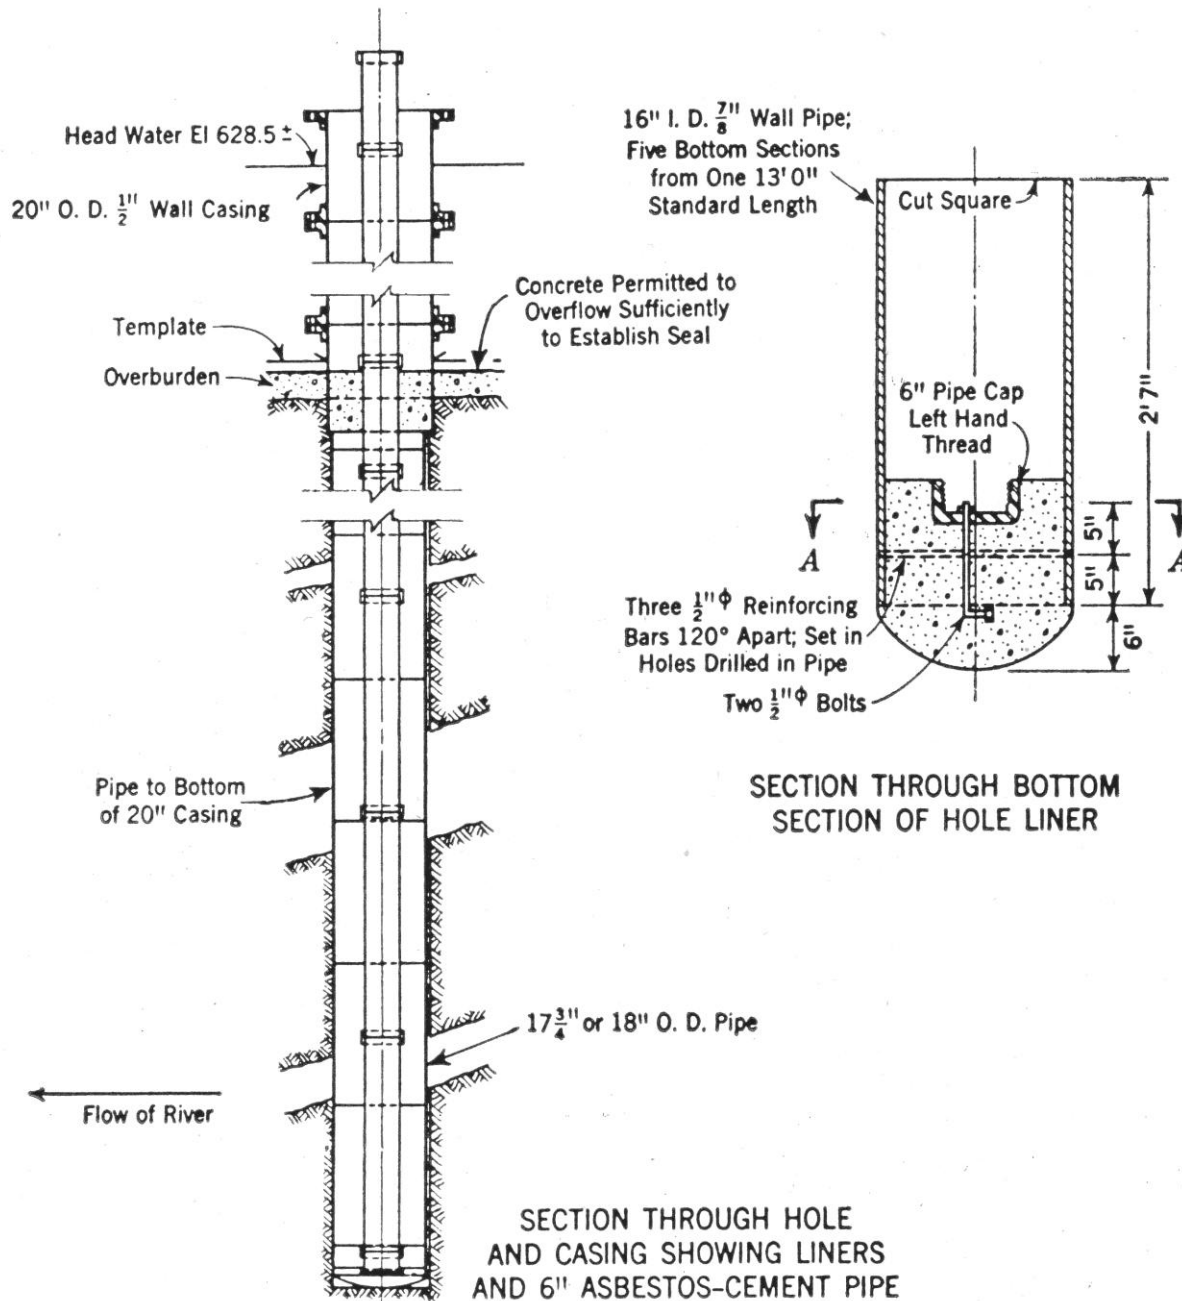
- The asbestos-cement casings used at Hales Bar in the 1940s set new standards for the installation of deep cutoff walls for dams in karst; which were imitated for years thereafter

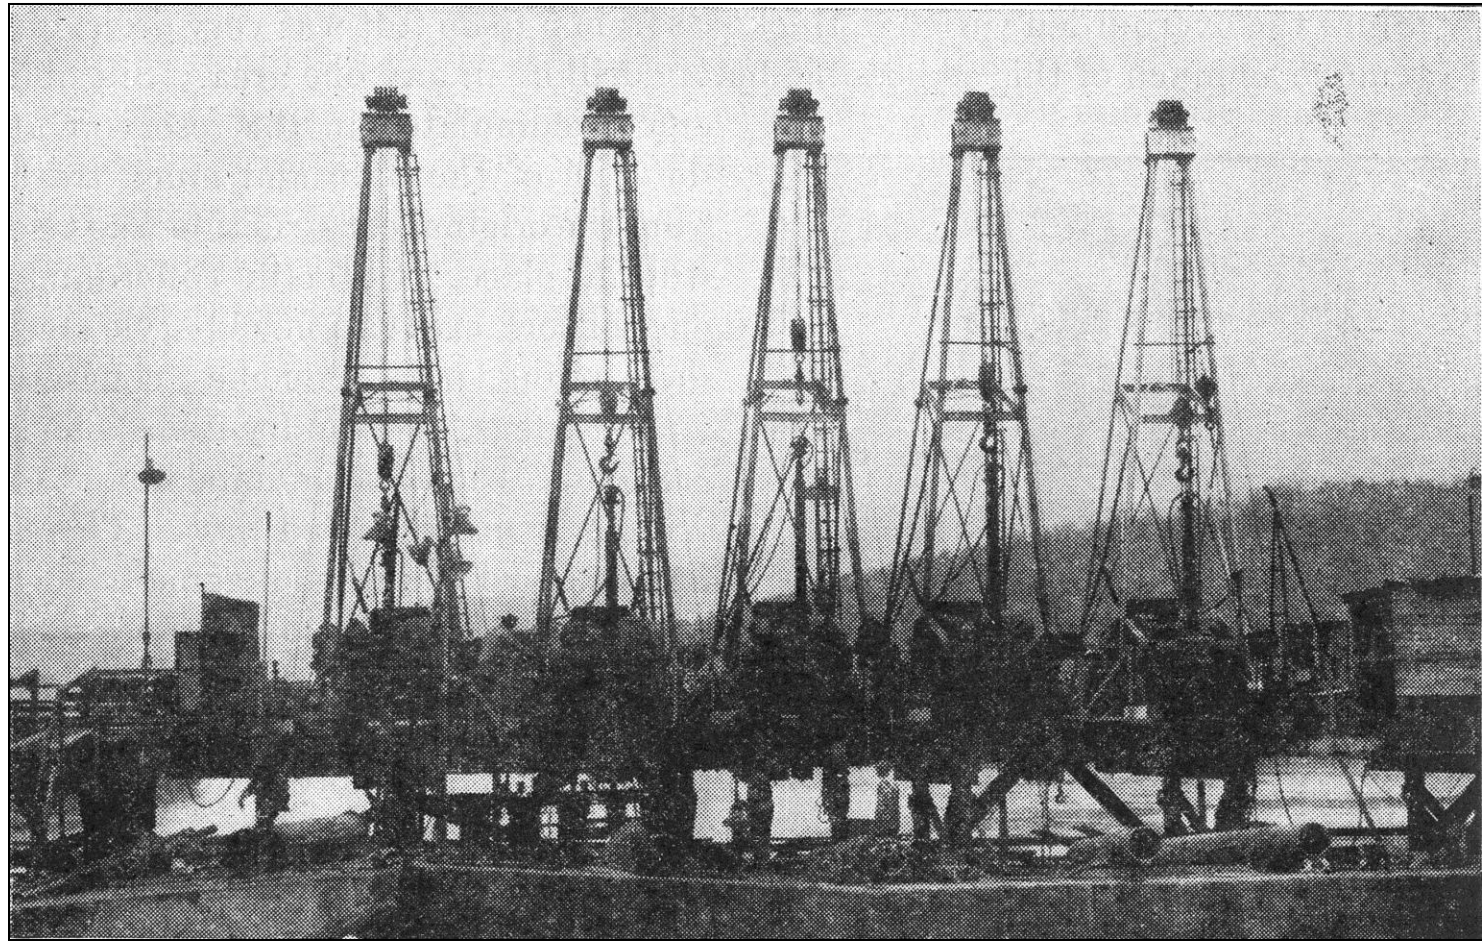
- The contractor operated five 48-inch diameter **Calyx drill rigs** simultaneously. These were capable of drilling 13, 18, 24, 36 and 48 inch diameter core holes. Cores were usually recovered in 12 foot long sections (taking about 30 minutes to drill each section). The 18-inch cutoff **holes were drilled 24 inches on center.**
- After the cores were removed a **current meter** was inserted into each hole to record the underflow velocities, which were as high as **4.5 ft/sec**. This was factored into the grout mix for each depth interval

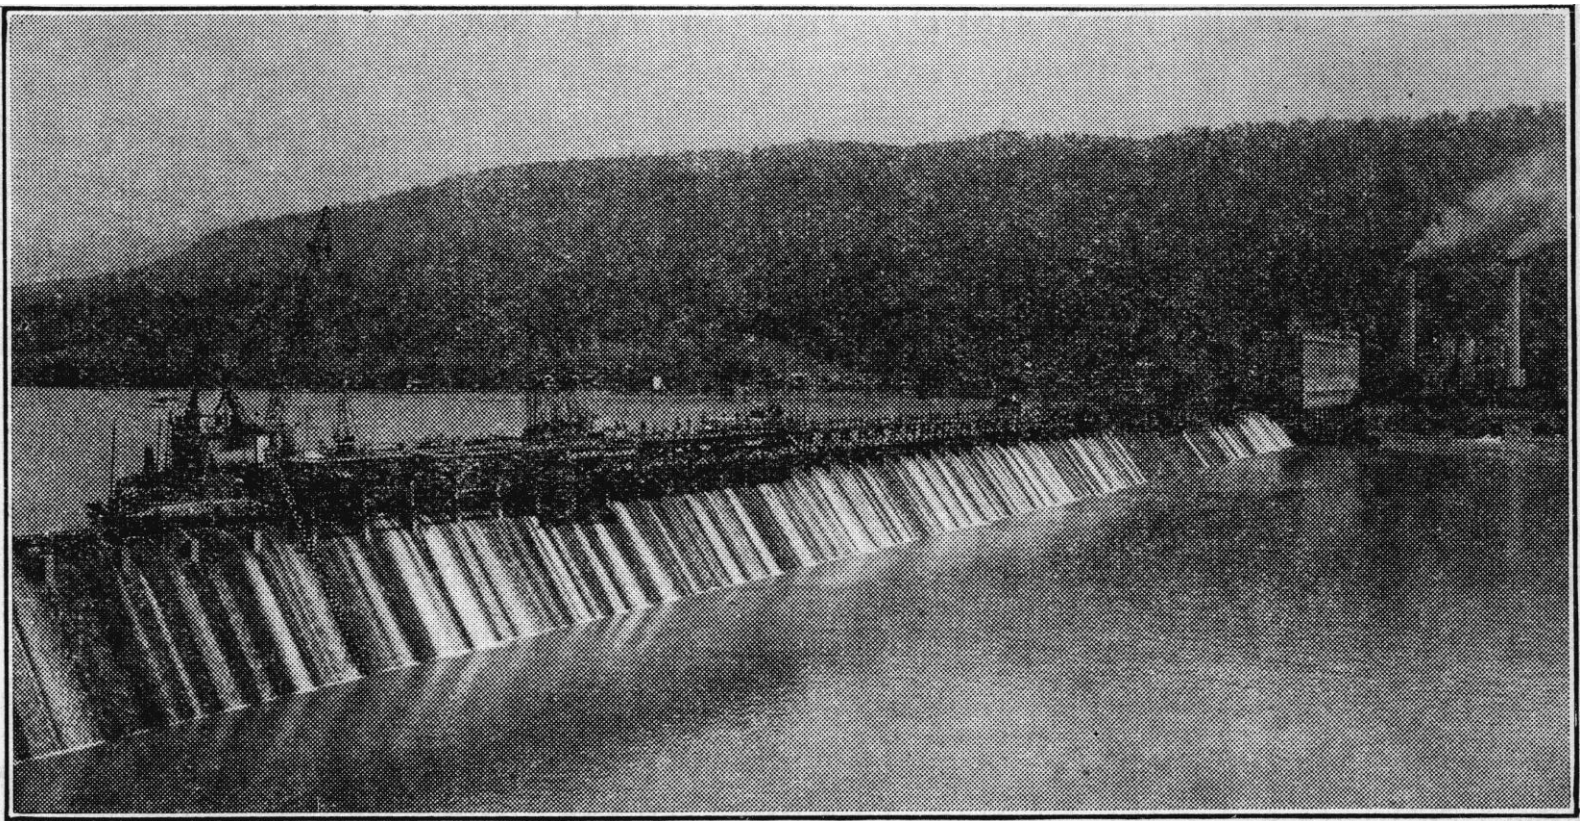
- A temporary **timber work bridge** was constructed over the concrete spillway section to support the contractor's drill rigs and grouting crews during construction of the deep cutoff wall, between 1941-45. New tainter gate spillways were also added.

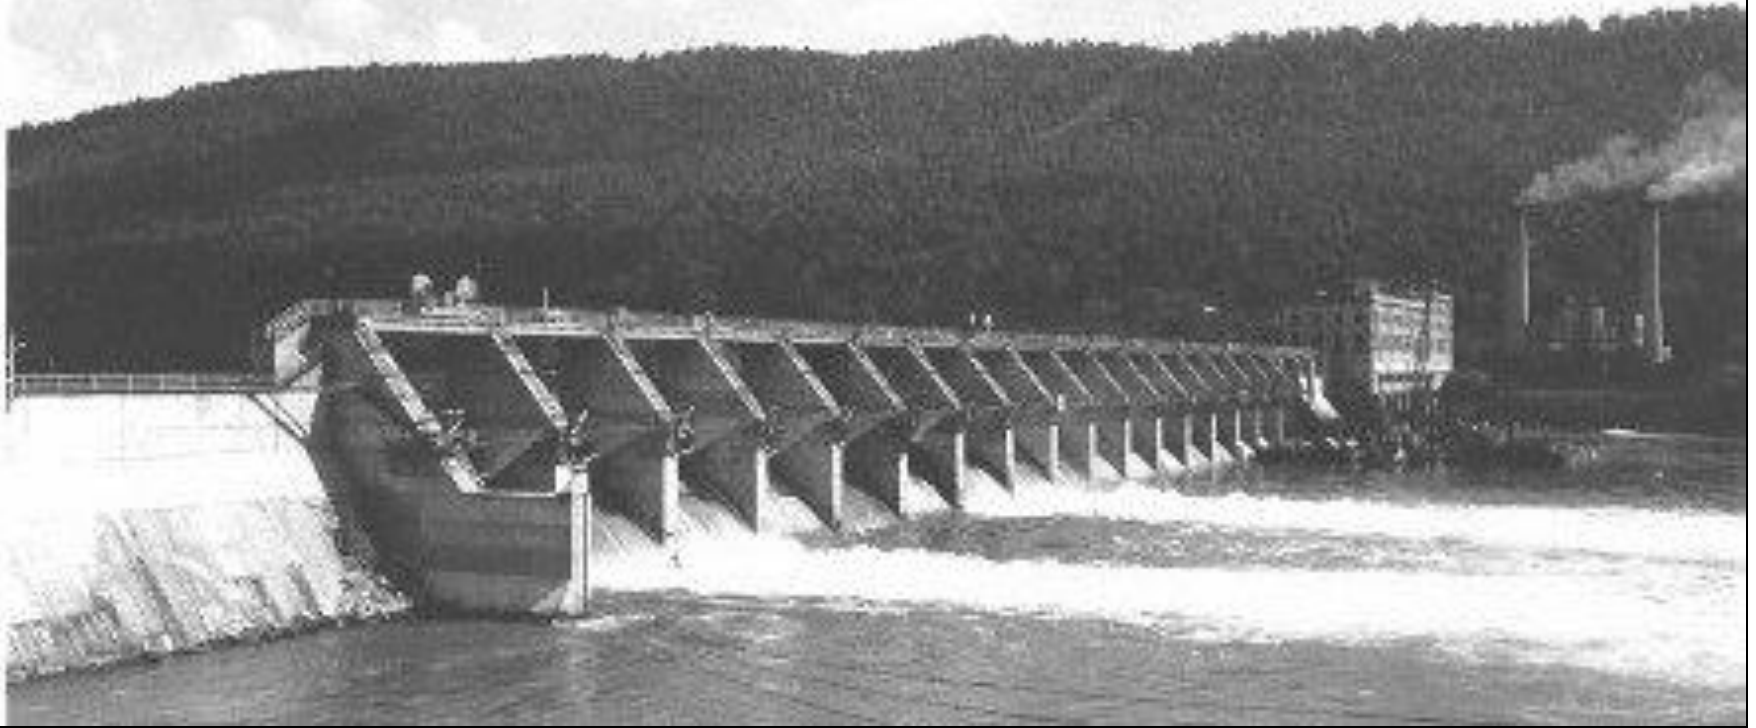
- During a 1947-48 retrofit Hales Bar Dam was reconfigured with **radial gates** to provide increased flood storage and enhance pressure head, which allowed for expansion of the hydropower plant a few years later.

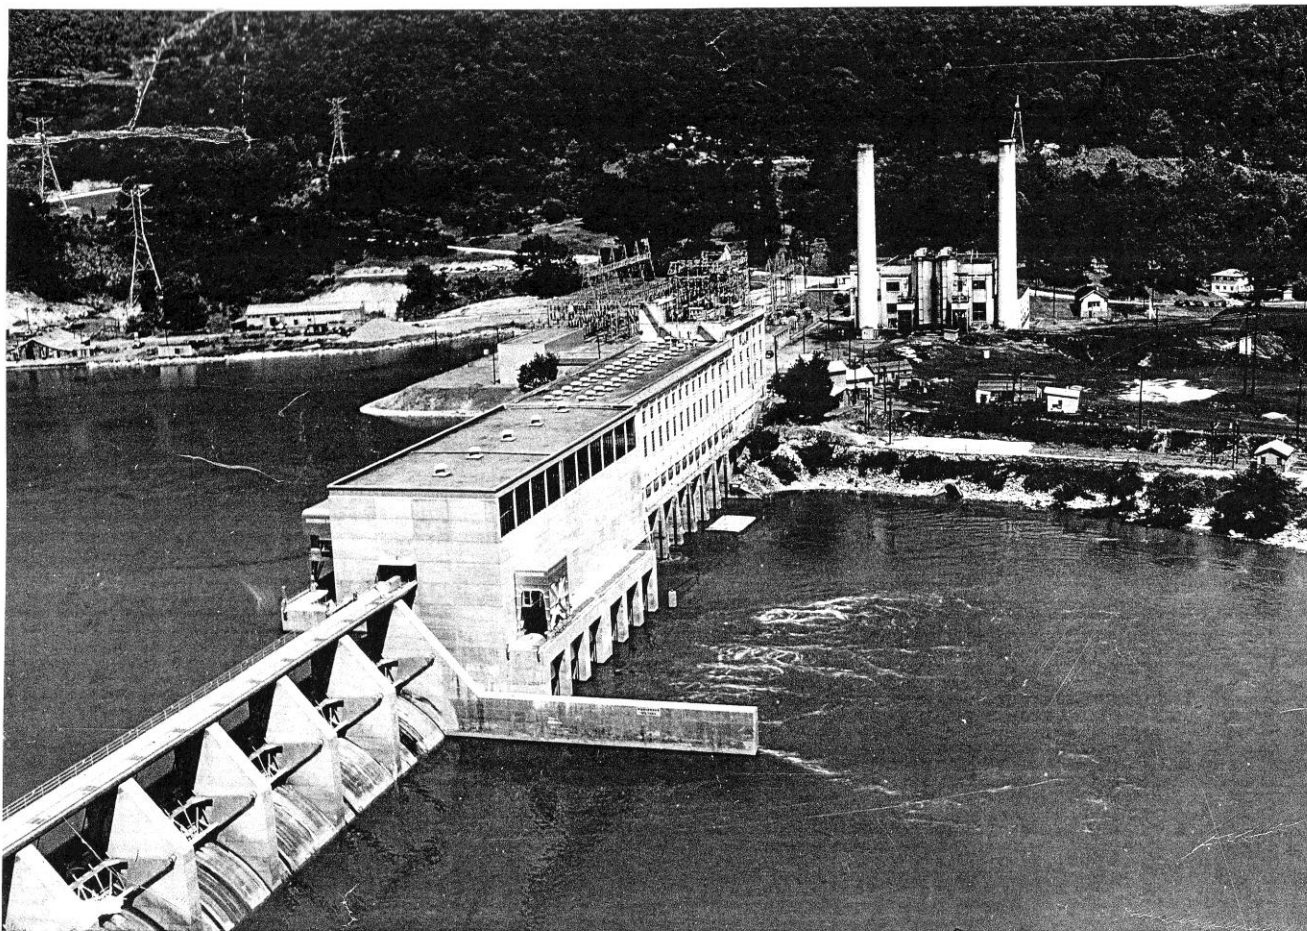
- **Hales Bar Dam in its final configuration after 1949, with a series of 20 tainter gates across the central overflow weir. The aggregate spillway capacity was 224,000 cfs.**

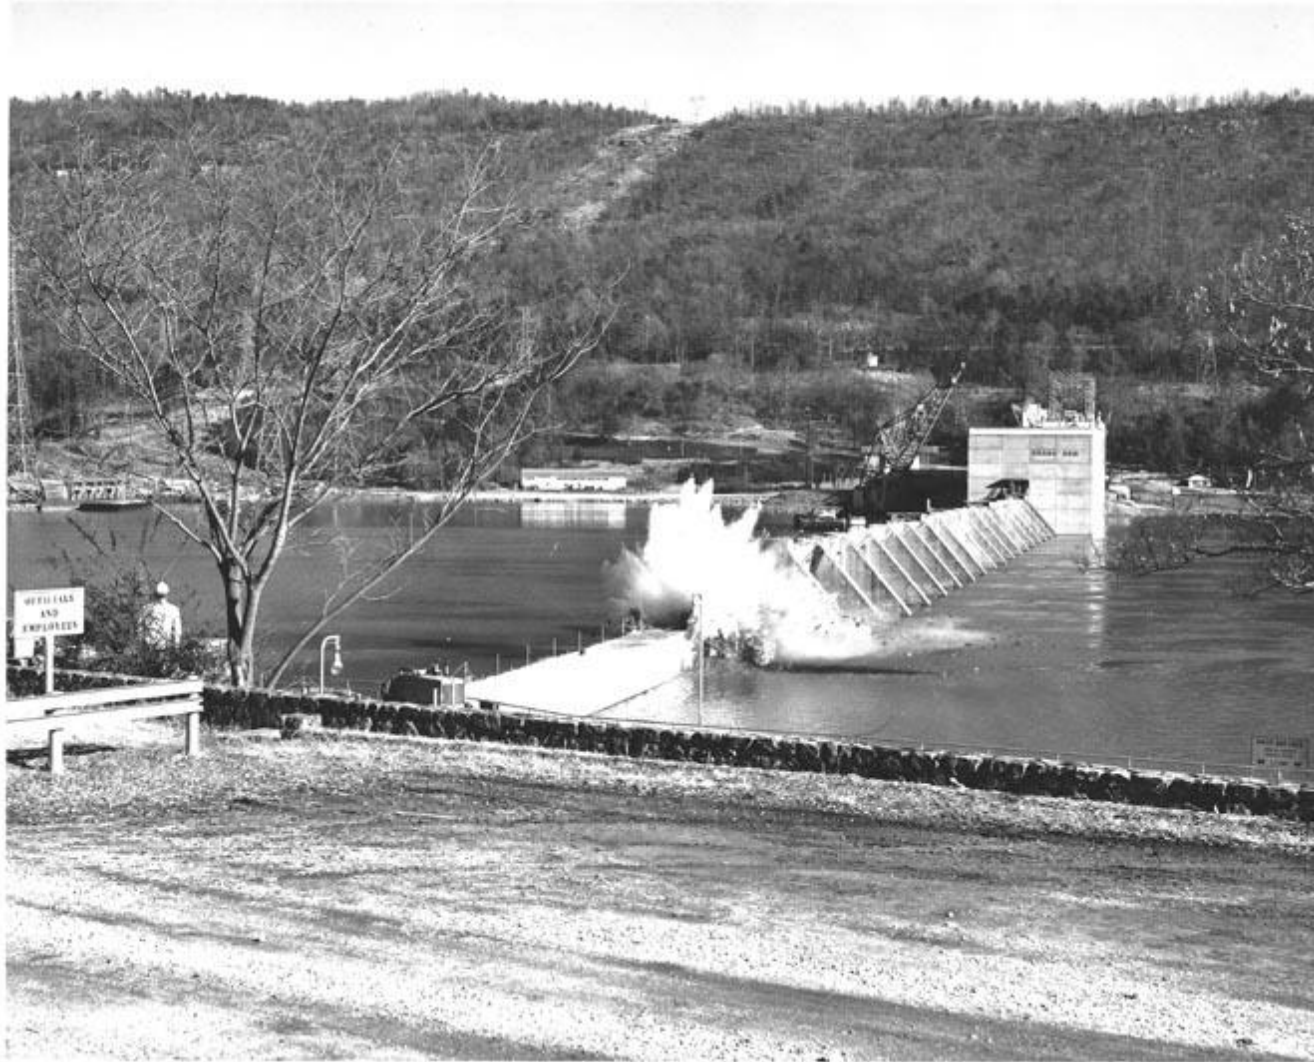
- **Demolition of the 1000-ft wide spillway overflow section of the old Hales Bar Dam was carried out in 1967-68, as seen here from the right bank. The hydro powerhouse was gutted of all equipment, but left in-place.**
