# THE CASE FOR REMOVING MATILIJA DAM

**J. David Rogers, Ph.D., P.E., P.G.**

2007 Annual Meeting

Association of Environmental and Engineering Geologists

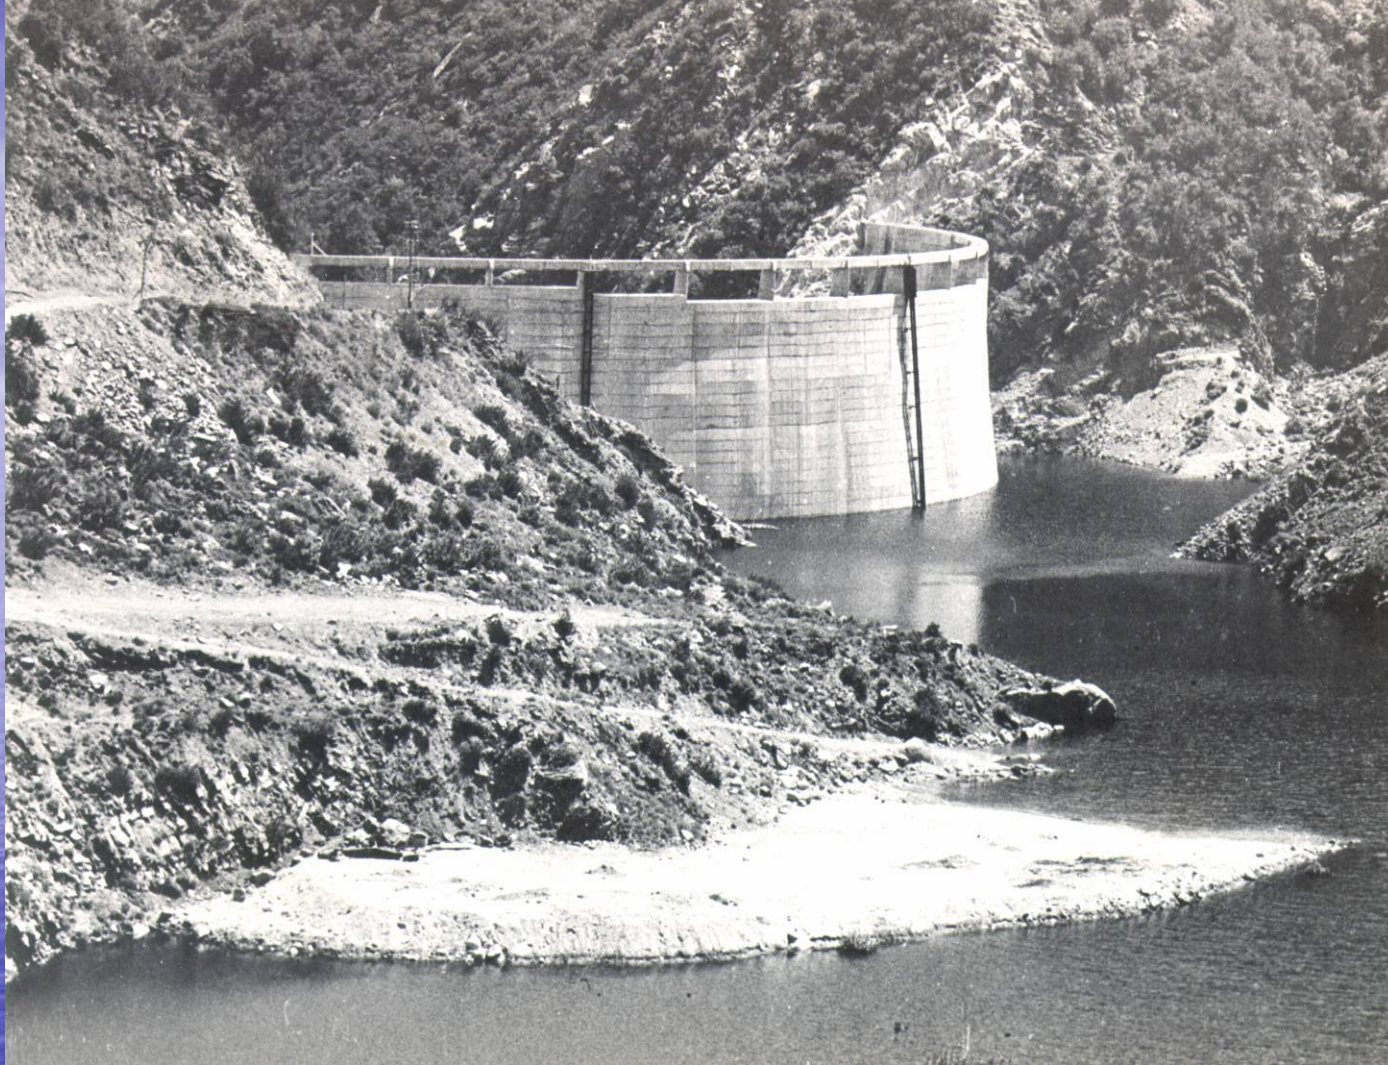
- Unfortunately, the contractor obtained his sand aggregate from a nearby source at Saticoy, along the lower Santa Clara River, near Ventura, which contained chalcedonic chert and glassy andesites, which are very reactive.

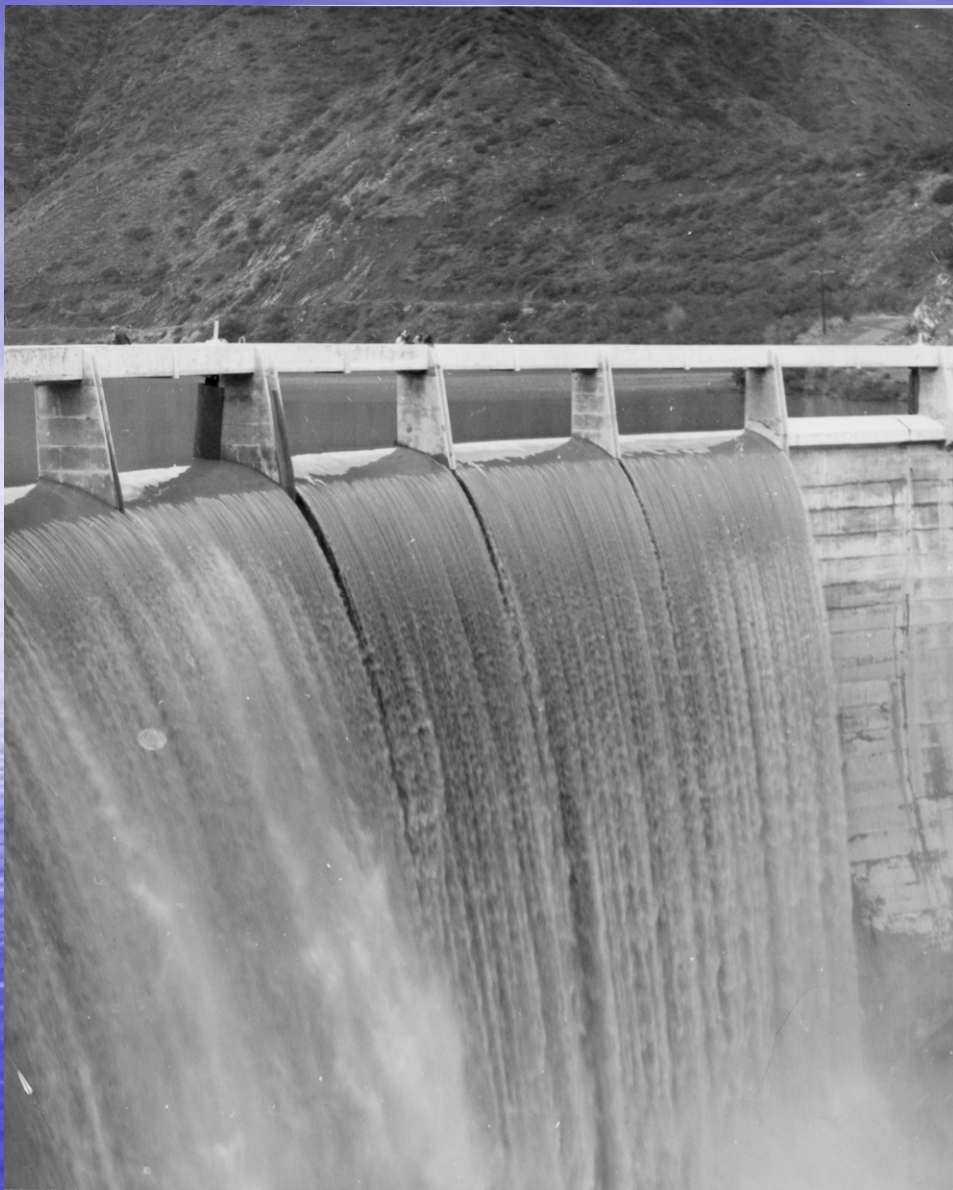
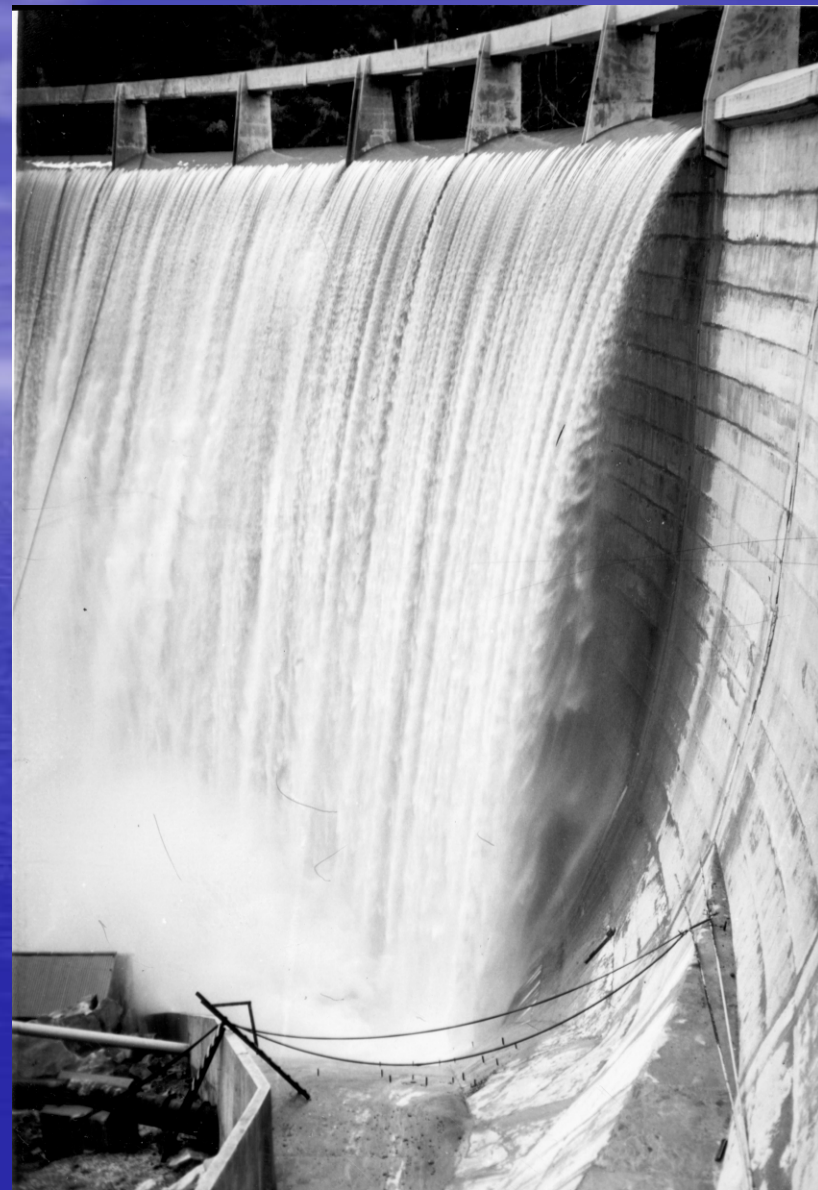
Initial spillage in 1952. Note people standing on 8-foot wide walkway for scale. The design capacity was 60,000 cfs

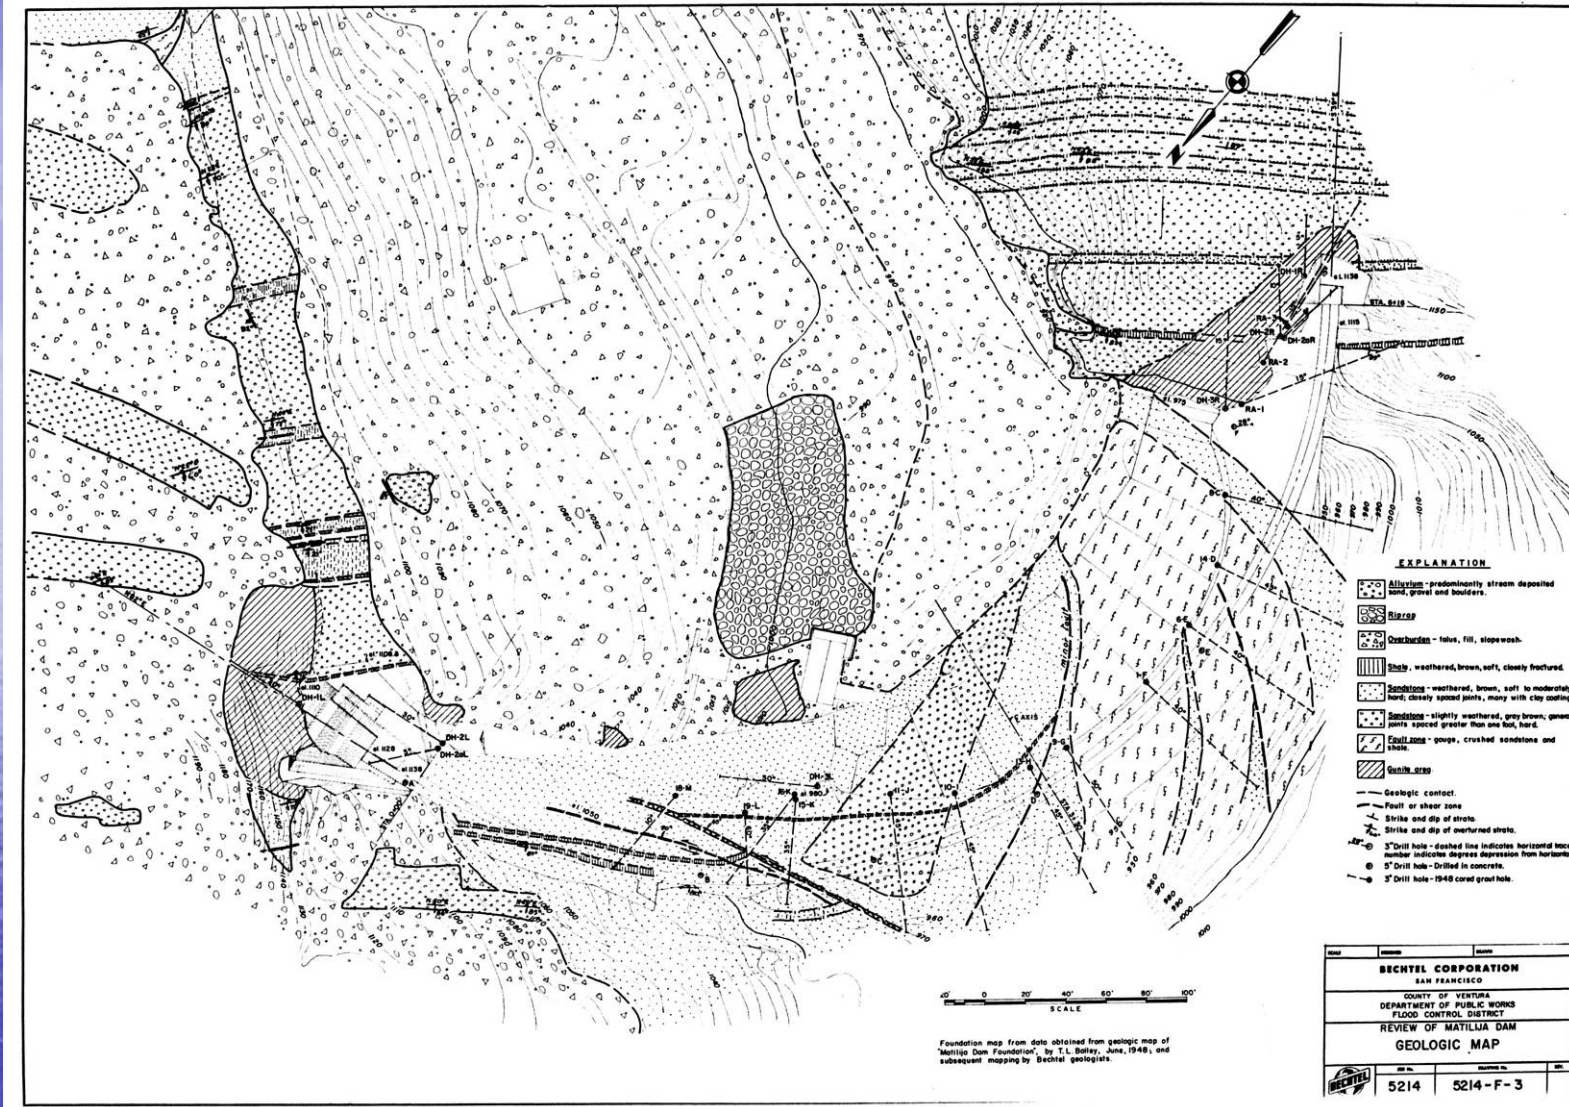
- In 1964 the water district retained Bechtel to evaluate excessive cracking problems in the dam's concrete. The cracking was most severe in the upper 40 feet.

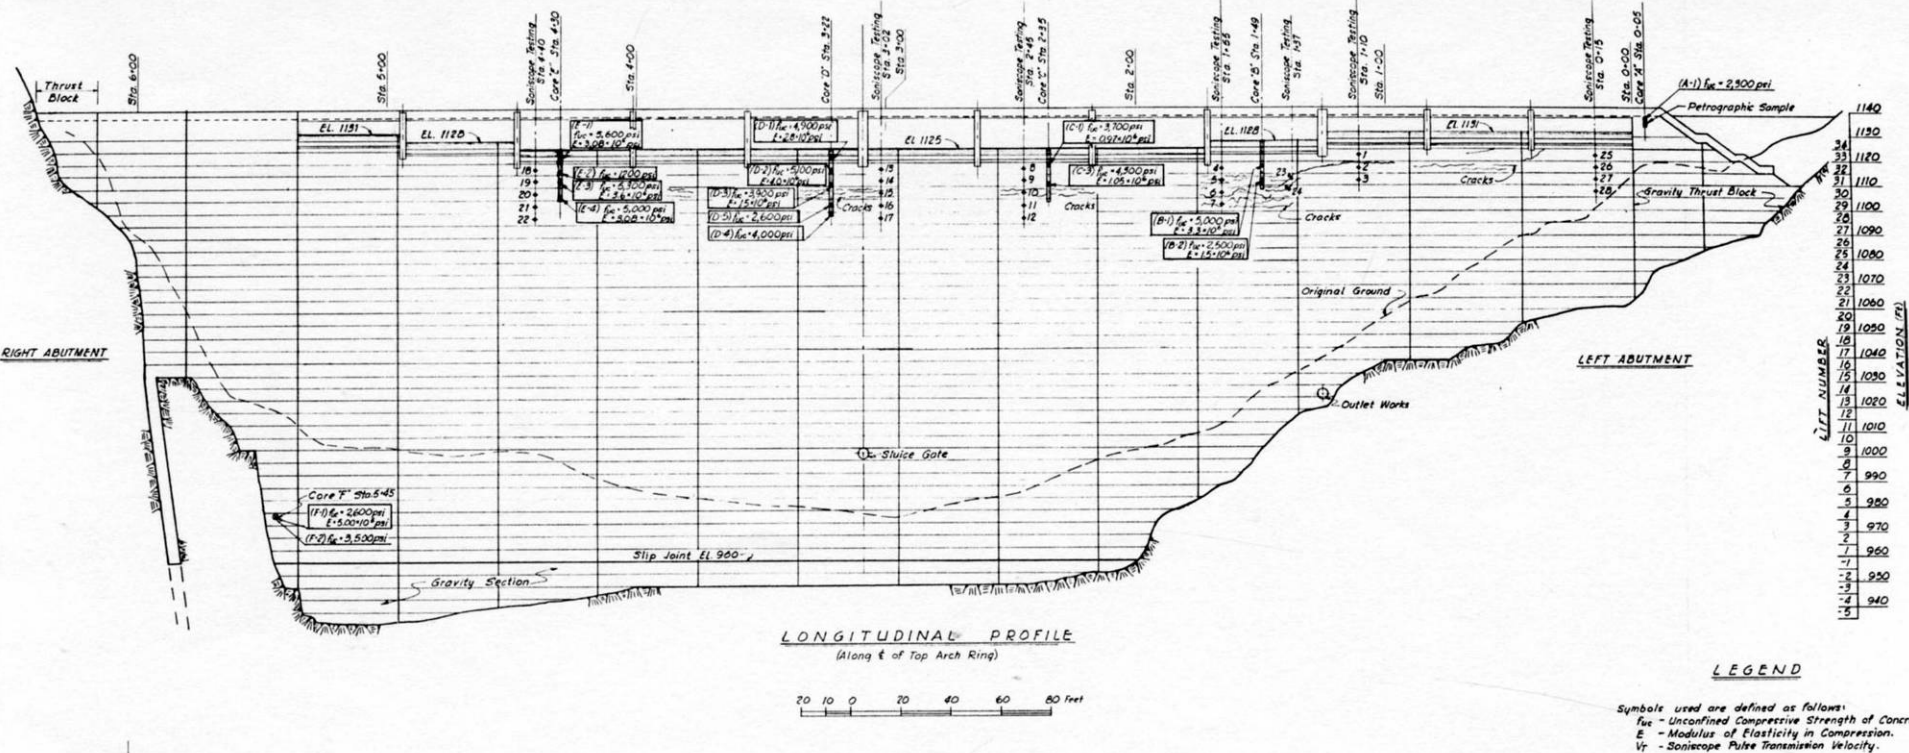
- The alkali aggregate reaction was caused by inclusion of glassy andesite and chalcedonic chert in the fine aggregate fraction.
- Cores from the dam showed concrete strength had deteriorated to between 1,200 and 2,600 psi; while the original tests at time of construction were 4,500 to 5,000 psi.
- The precise mechanism was not ascertained until the mid 1970s; that being a chemical reaction between opaline quartz and the cement paste.

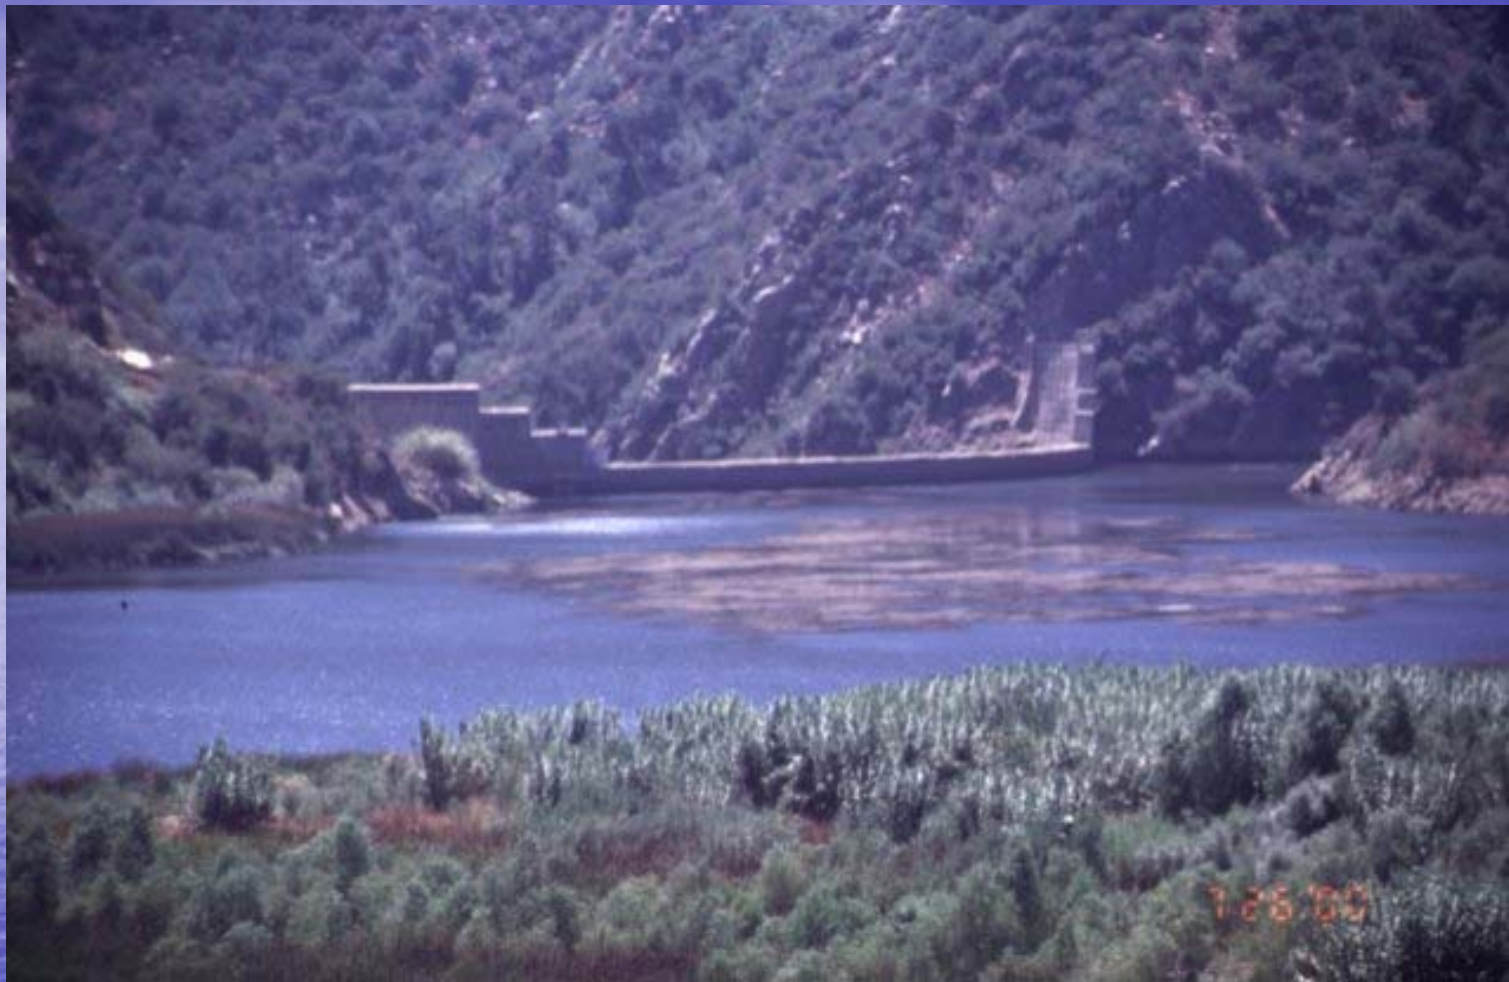
- With a tributary watershed area of 55 square miles, the reservoir filled at an average rate of about  $85,000^3$  yds per year between 1947-64.
- The floods of Jan-Feb 1969 followed fires in the upper watershed. These storms brought 1,067 ac-ft of sediment into the reservoir, reducing its capacity to just 34% of the original design in just 22 years.
