OVERVIEW OF THE TAUM SAUK UPPER RESERVOIR FAILURE

December 14, 2005
Reynolds County, Missouri

J. David Rogers, Jae-won Chung,
Conor M. Watkins, and
David J. Hoffman

Missouri University of Science & Technology

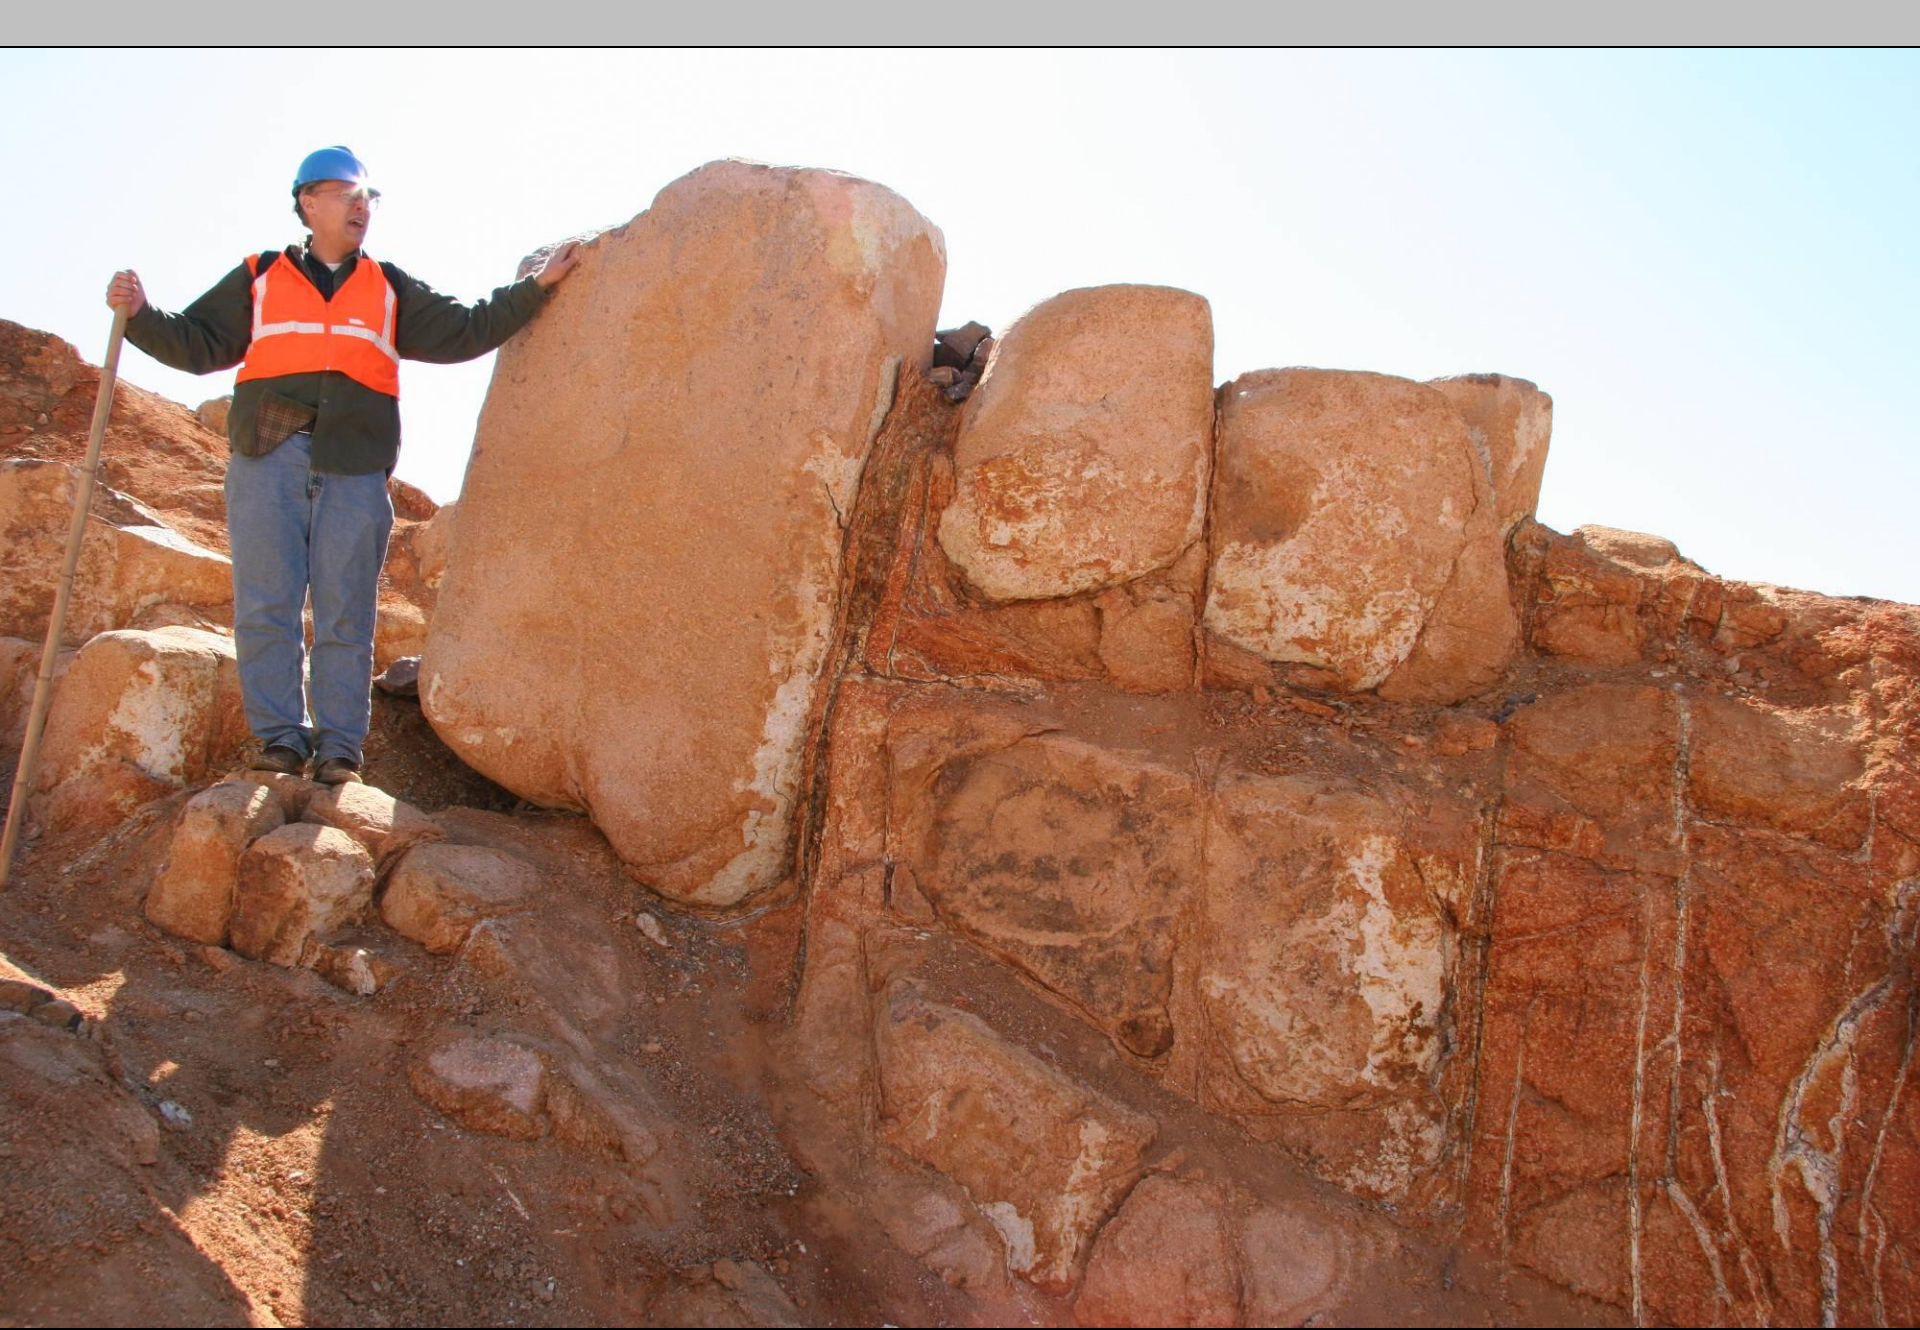
Zones of deeply weathered granite and diabase were exposed on the upper slopes of Proffit Mountain during the flood. Materials similar to this may have ended up in the embankment fill during construction, contributing to its contamination by fines, which led to the high rates of settlement.

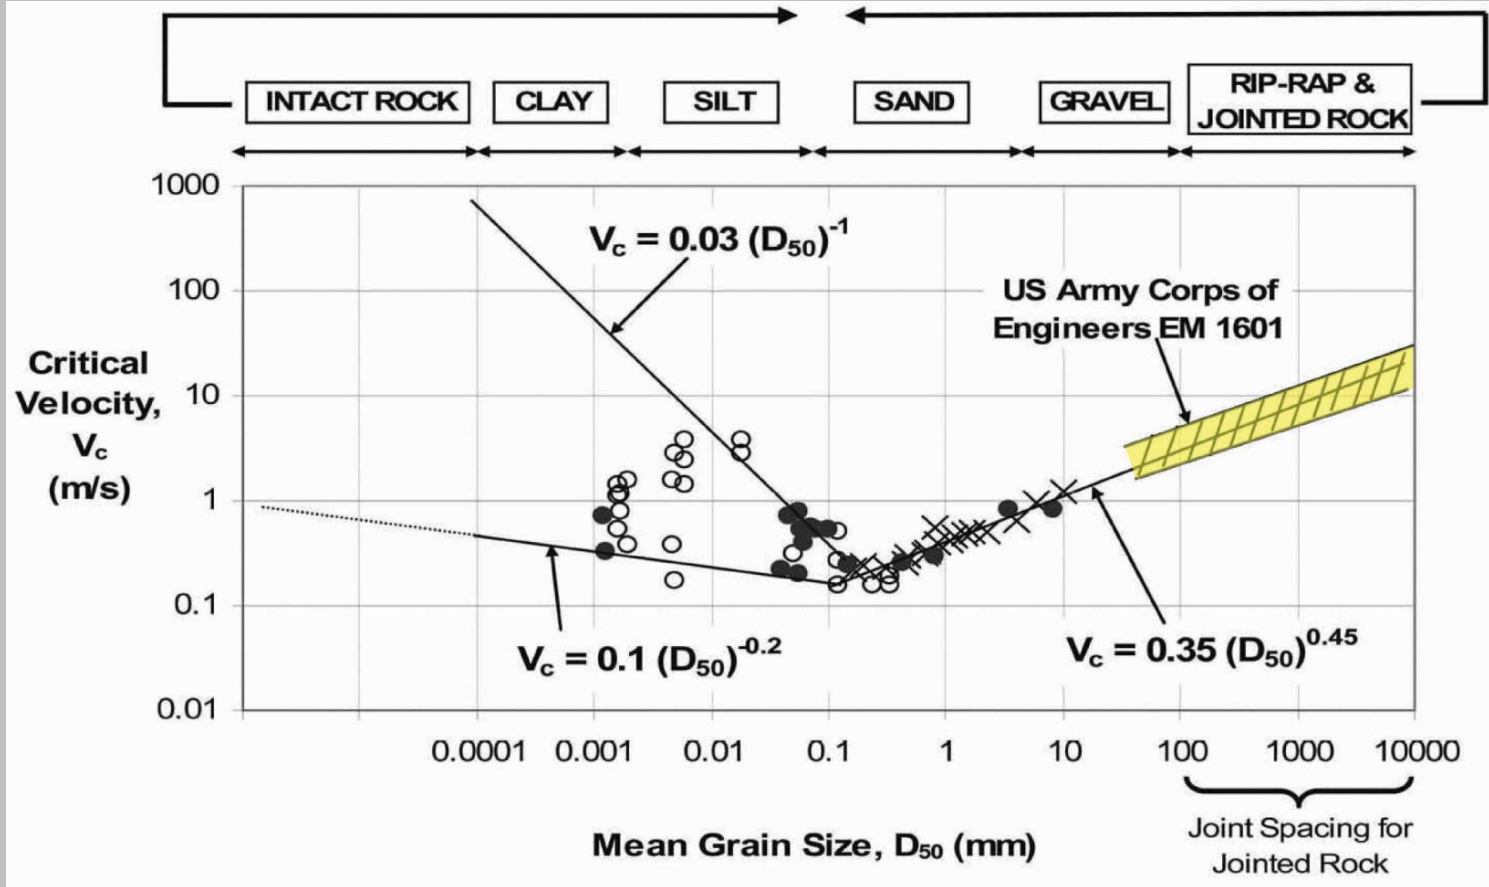
- Critical velocity triggering erosion versus mean grain size, taken from Briaud (2008).
- The yellow shaded zone represents data for coarse gravel, rip-rap, and jointed rock. Sediment carrying capacity of noncohesive materials like sand and gravel is a power function of velocity.
- Data points from measurements at Texas A&M and Army Corps of Engineers Waterways Experiment Station, described in Briaud (2008).

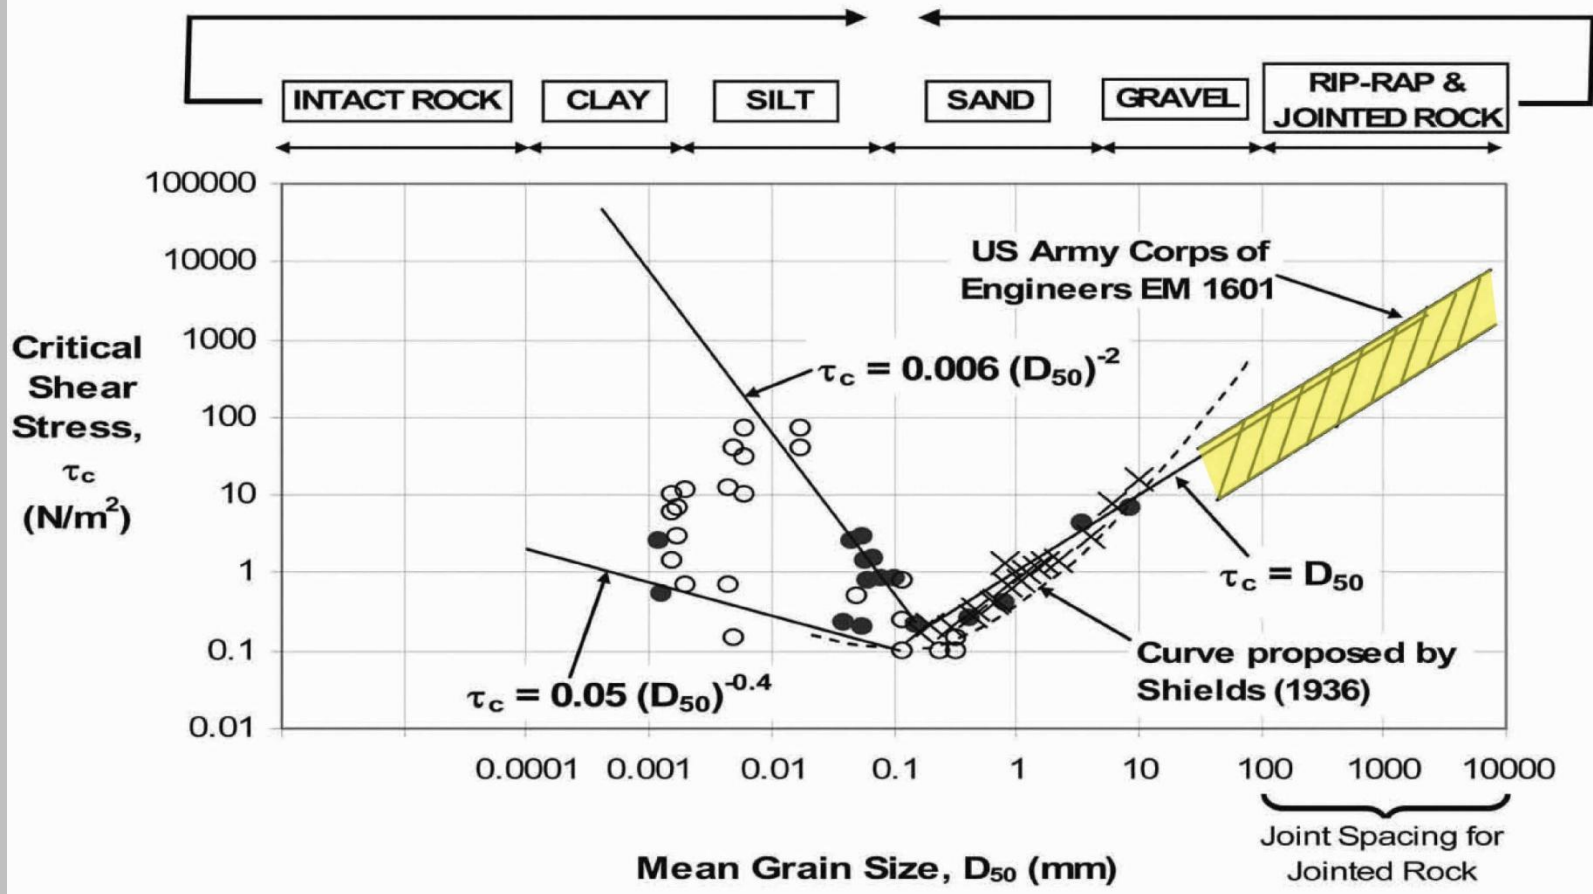
- Critical boundary shear stress as a function of mean grain size, taken from Briaud (2008). The yellow shaded zone represents data for coarse gravel, rip-rap, and jointed rock.
- Data points from measurements at Texas A&M and Army Corps of Engineers Waterways Experiment Station, described in Briaud (2008).

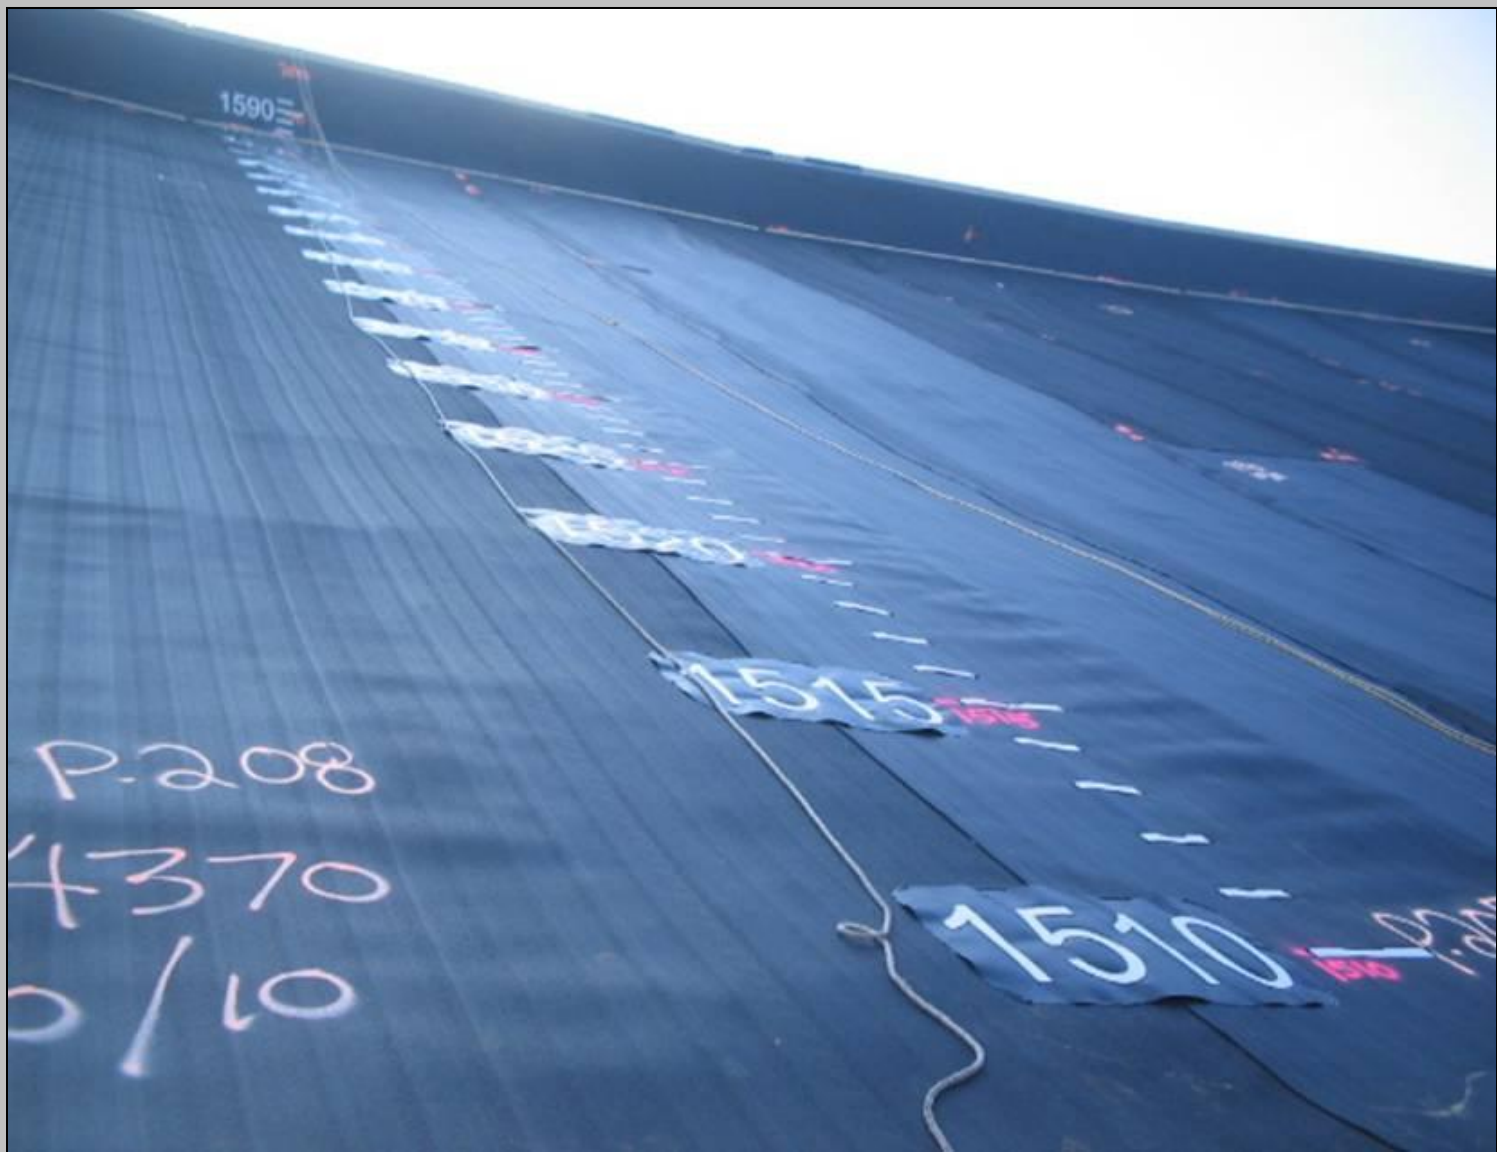
In 2004 AmerenUE installed an HDPE geomembrane liner to retard ongoing seepage losses from the upper reservoir, at a cost of ~\$2.4 million.

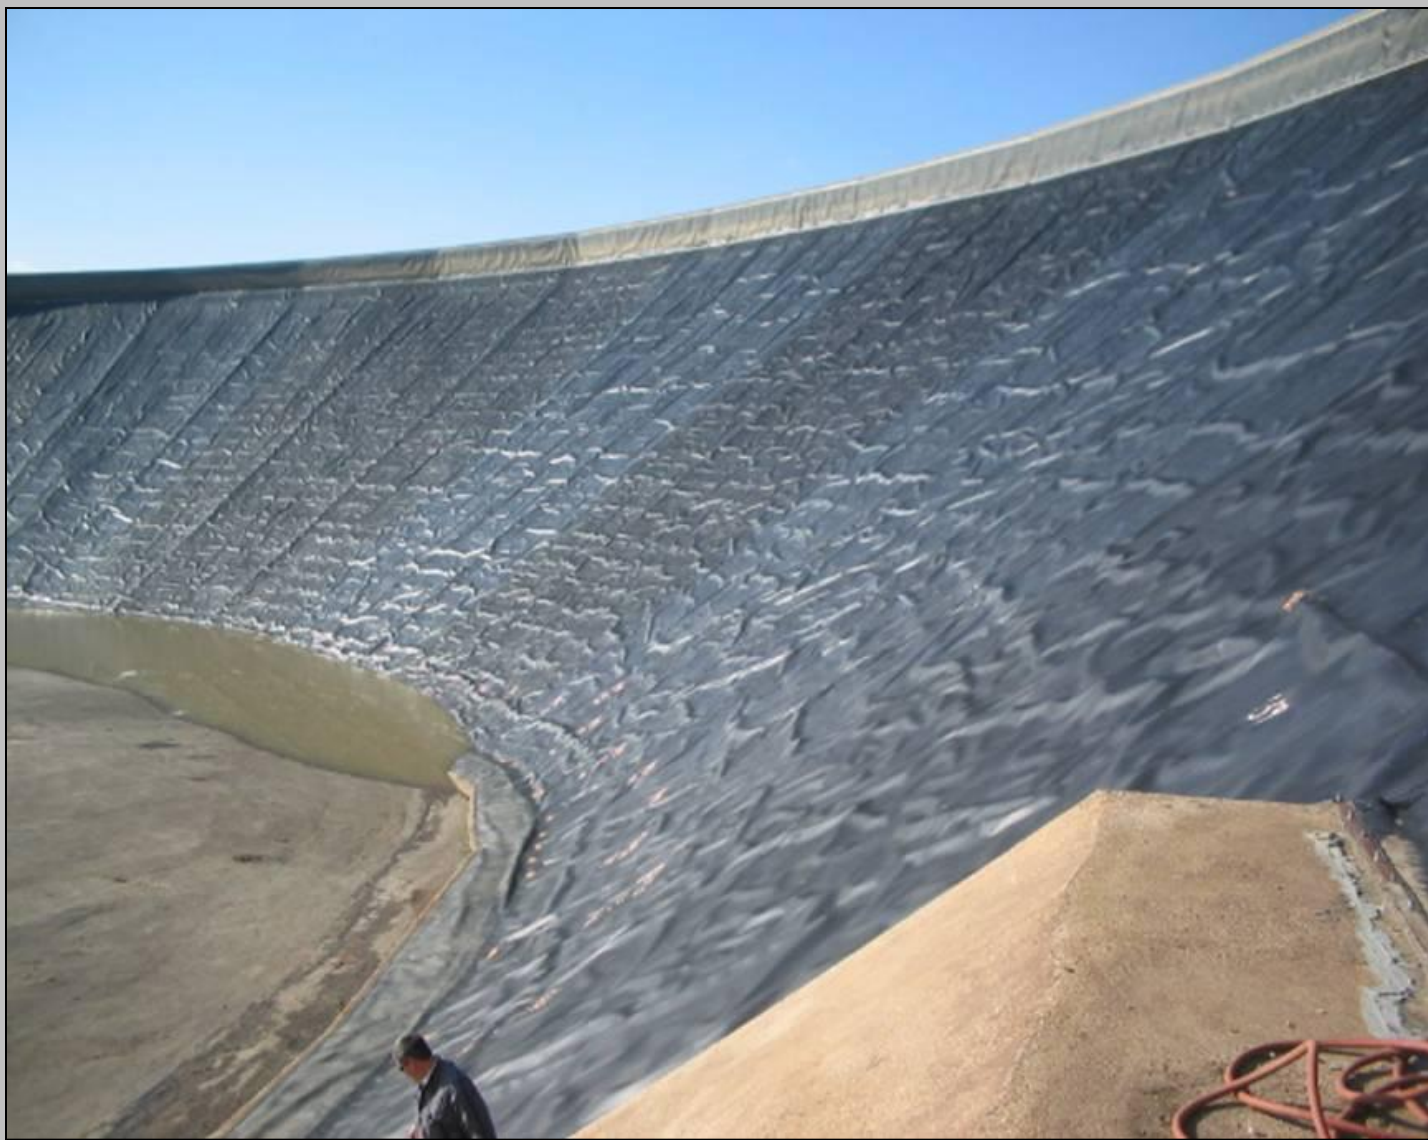
GSI supervised the placement of 1.3 million square feet of 80 mil HPDE textured geomembrane and geocomposite material. They also covered five rock outcroppings on the side slope with 80 mil textured LLDPE material.

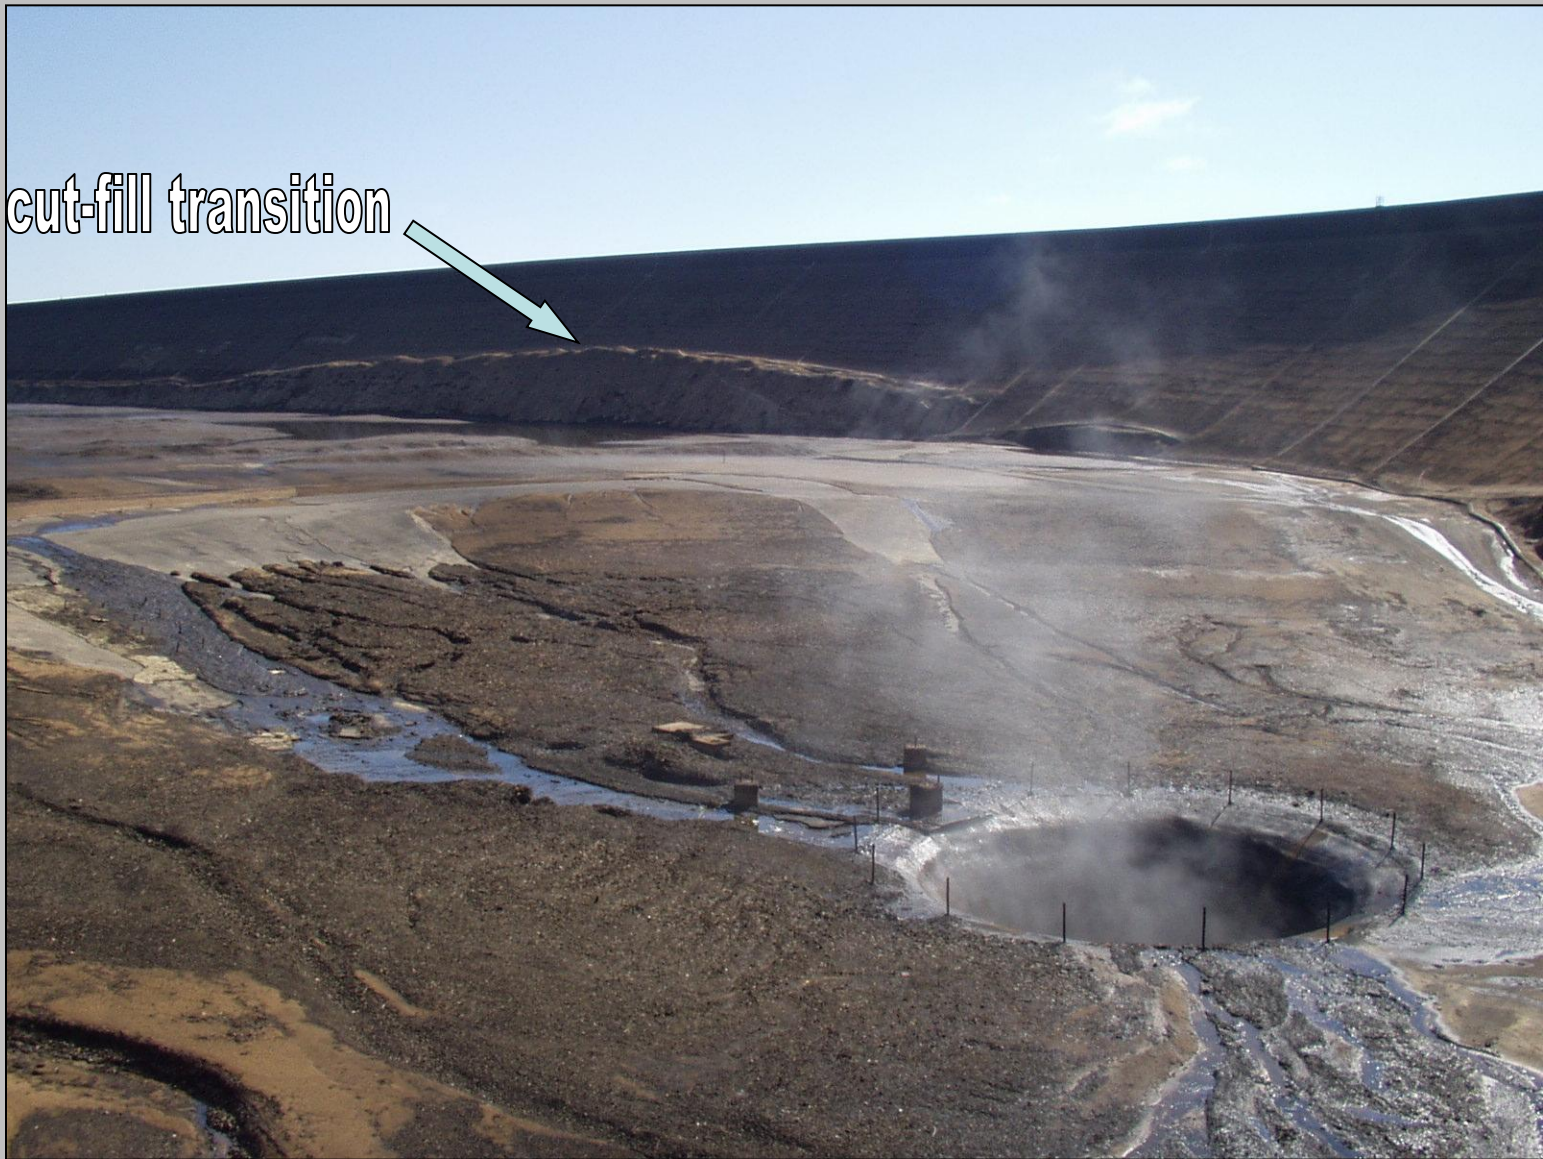
- The 35 ft diameter glory hole entry to the 25 ft diameter feeder line was located about 120 ft from the base of the instrumentation ducts.
