HOOVER DAM:

Grout Curtain Failure and Lessons Learned in Site Characterization

J. David Rogers

**Dams Symposium
Association of Engineering Geologists
Annual Meeting Las Vegas, Nevada
September 22, 2005**

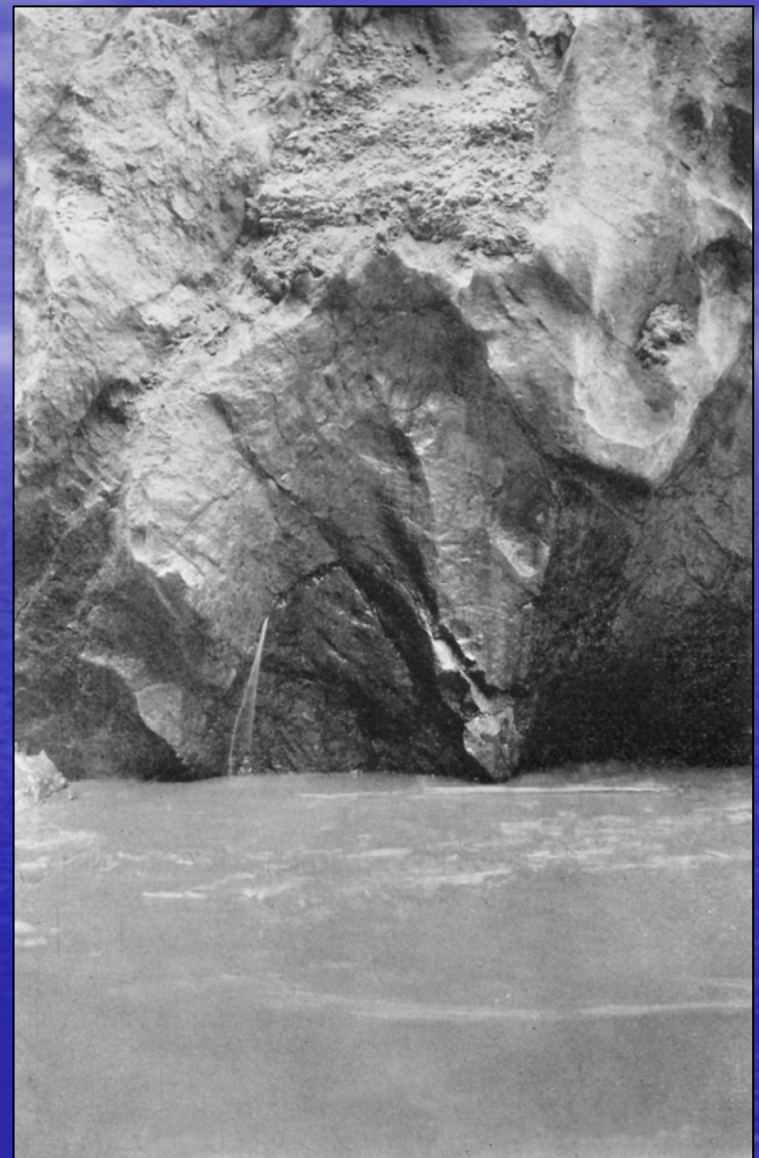
Hot springs at upstream base of right abutment, at river level.

• Warm water from the natural hot springs was collected along the right abutment drainage gallery near elevation 555, emanating from several "shattered zones." During the original construction, grouting of this area was ineffective due to premature set of the cement grout.

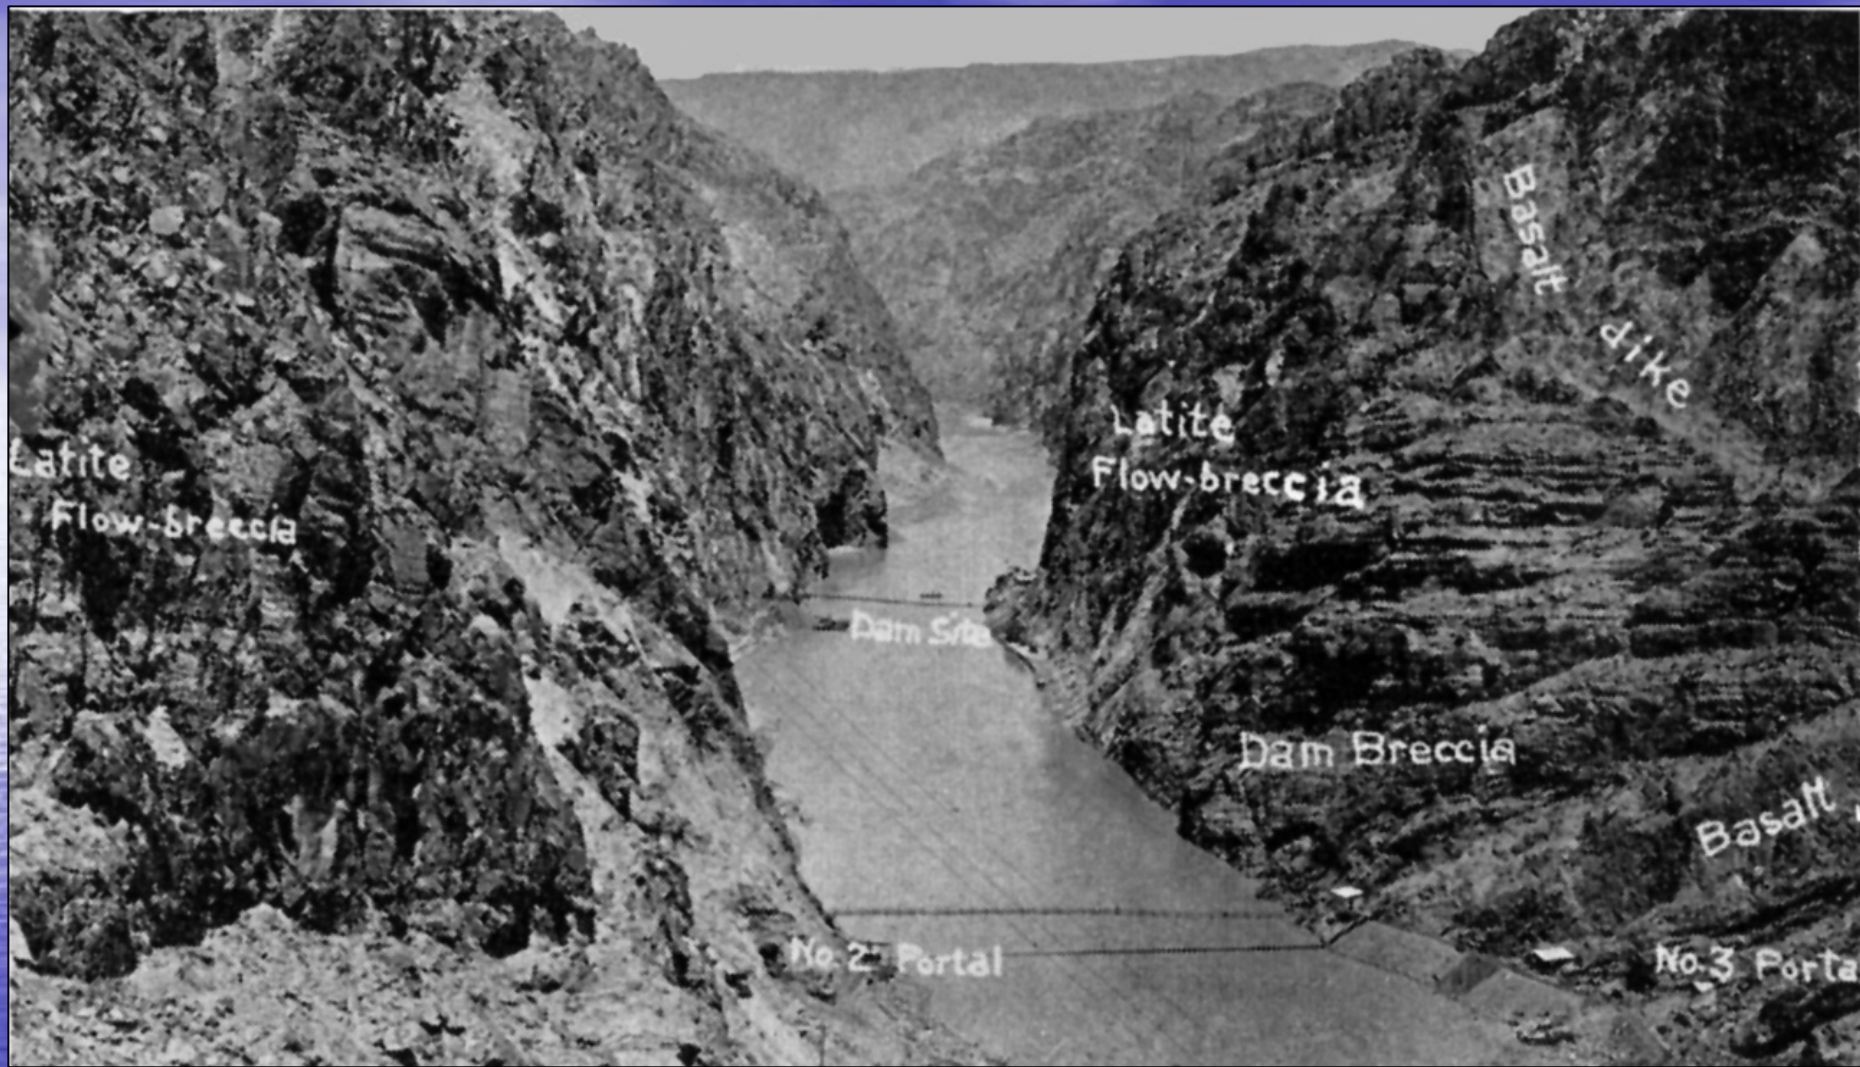
View of dam site looking upstream, annotated with geology. Note basalt dike at right, on Arizona abutment. These dikes perturbed both abutments.

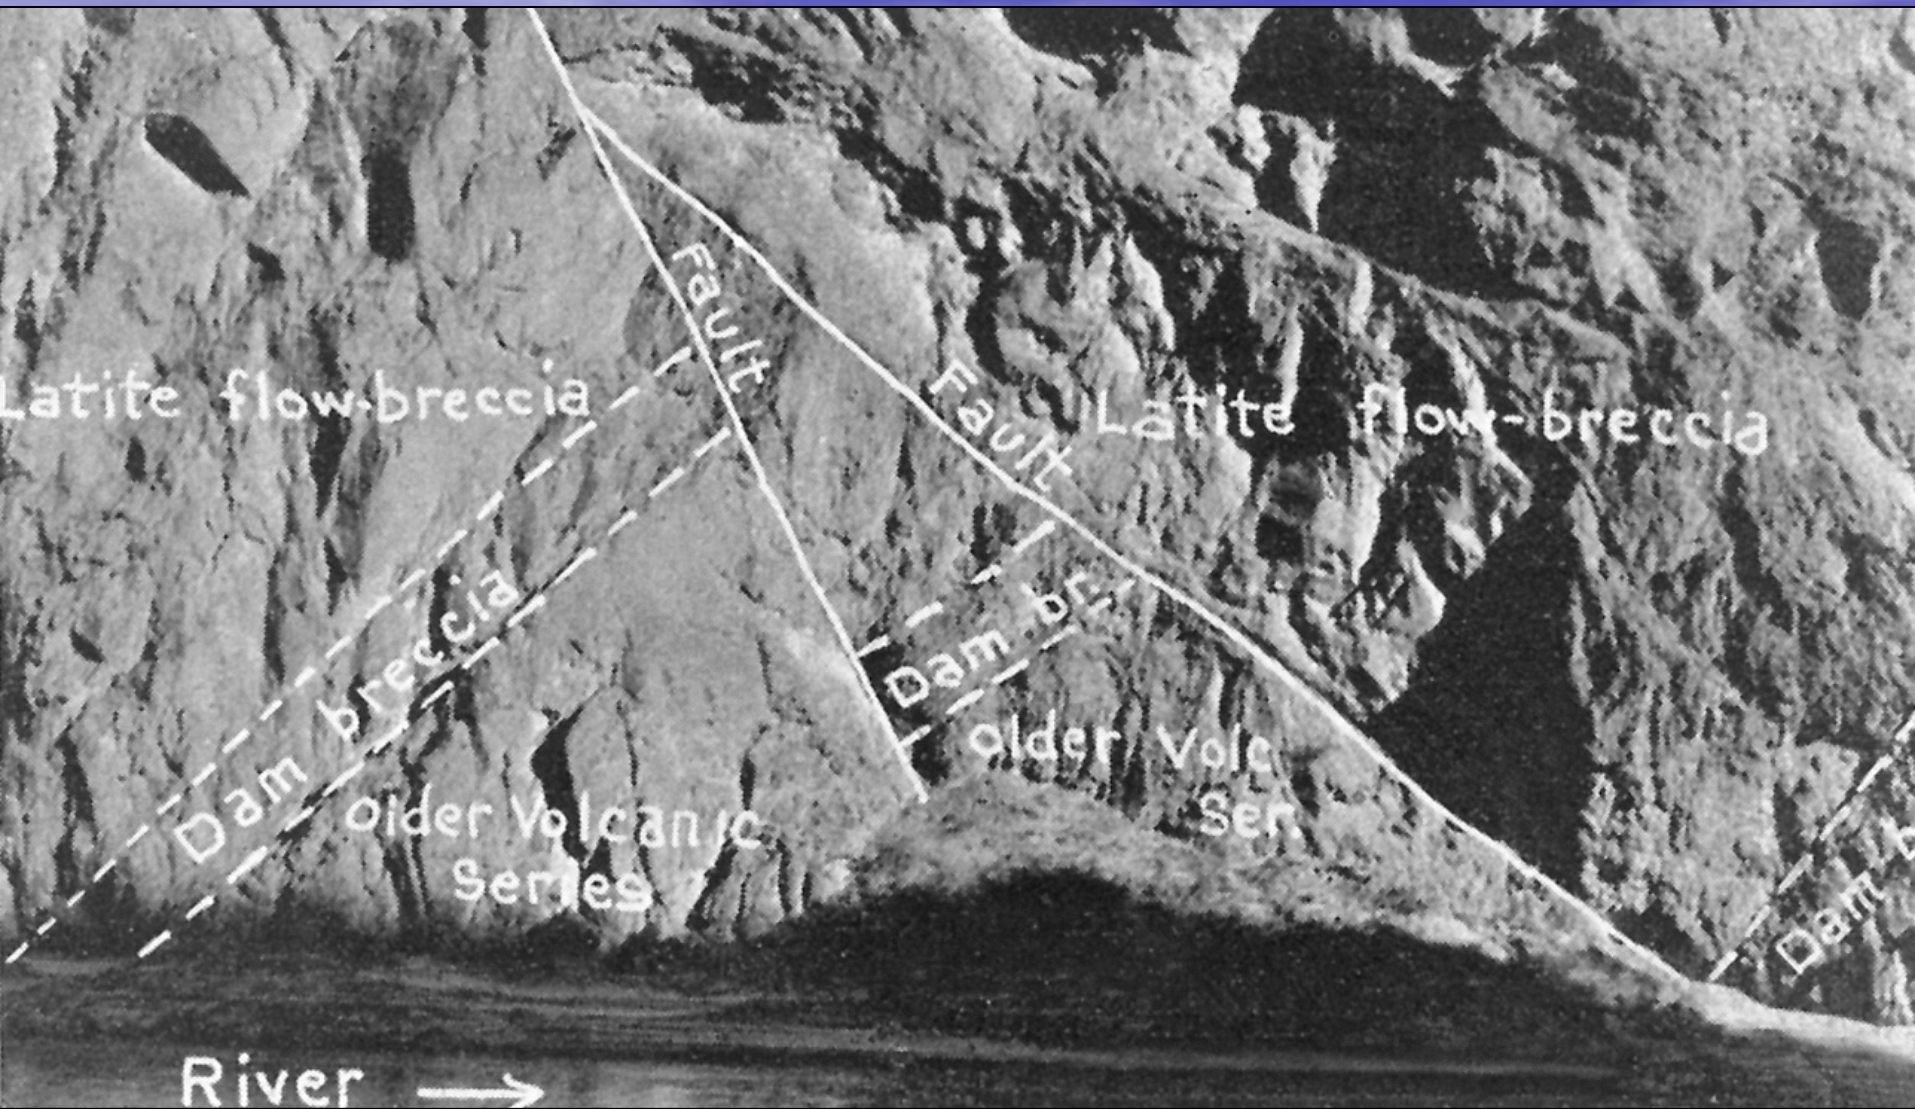
Normal faults mapped near base of the left (Arizona) abutment.

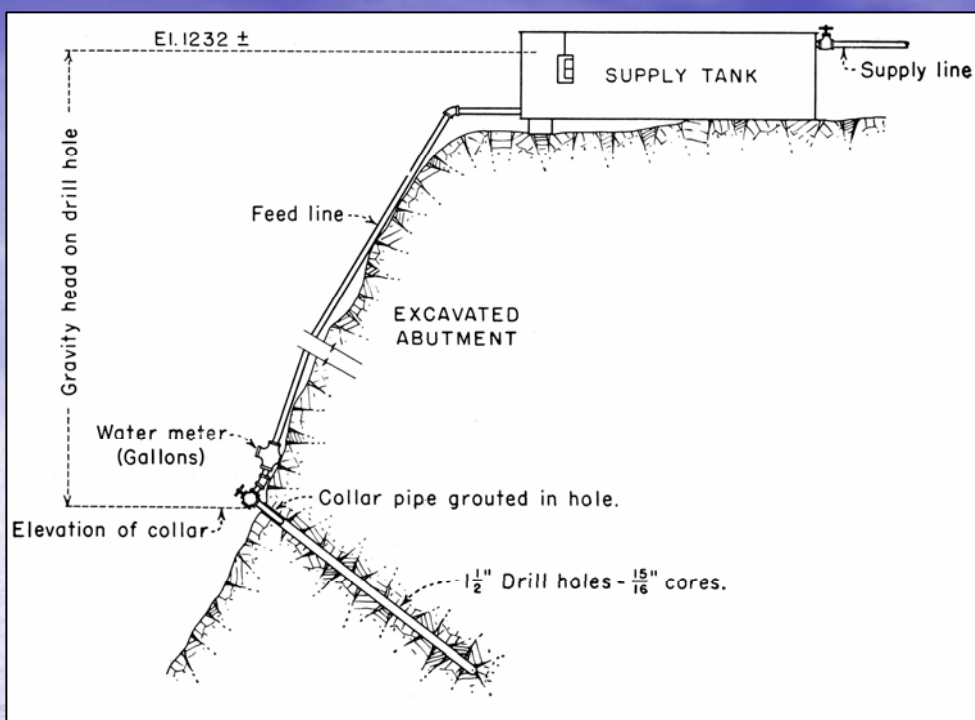
Crude percolation tests employed a gravity-feed reservoir that fed to drill holes through sealed pipes. These could not replicate pore pressures induced by 500 to 800 feet of head.

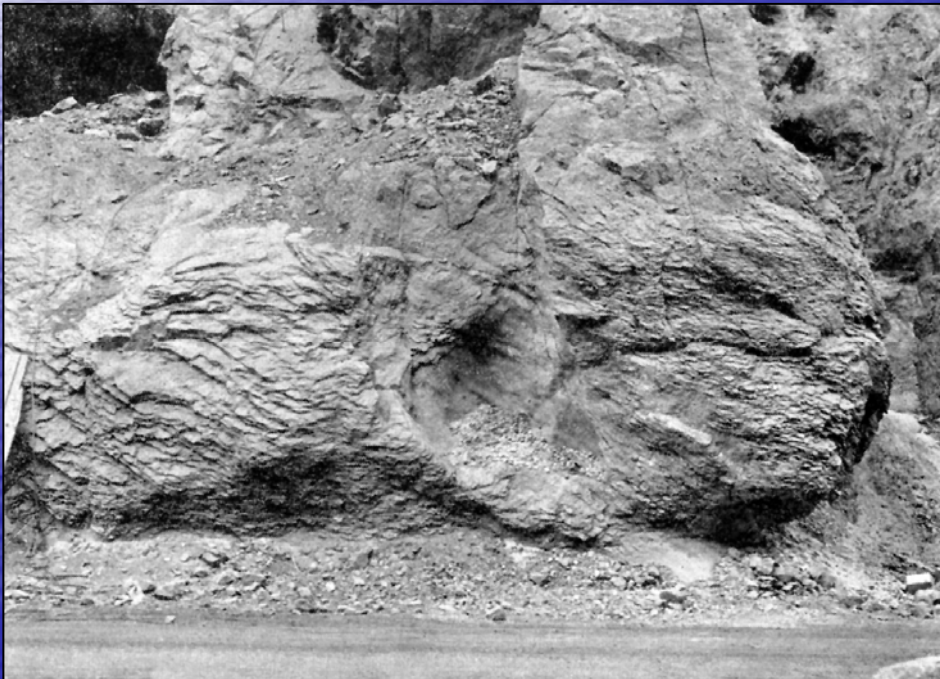
The latite breccia was characterized by locally intense fractures, especially along faults and shear zones. These inclined faults also crisscrossed one another.

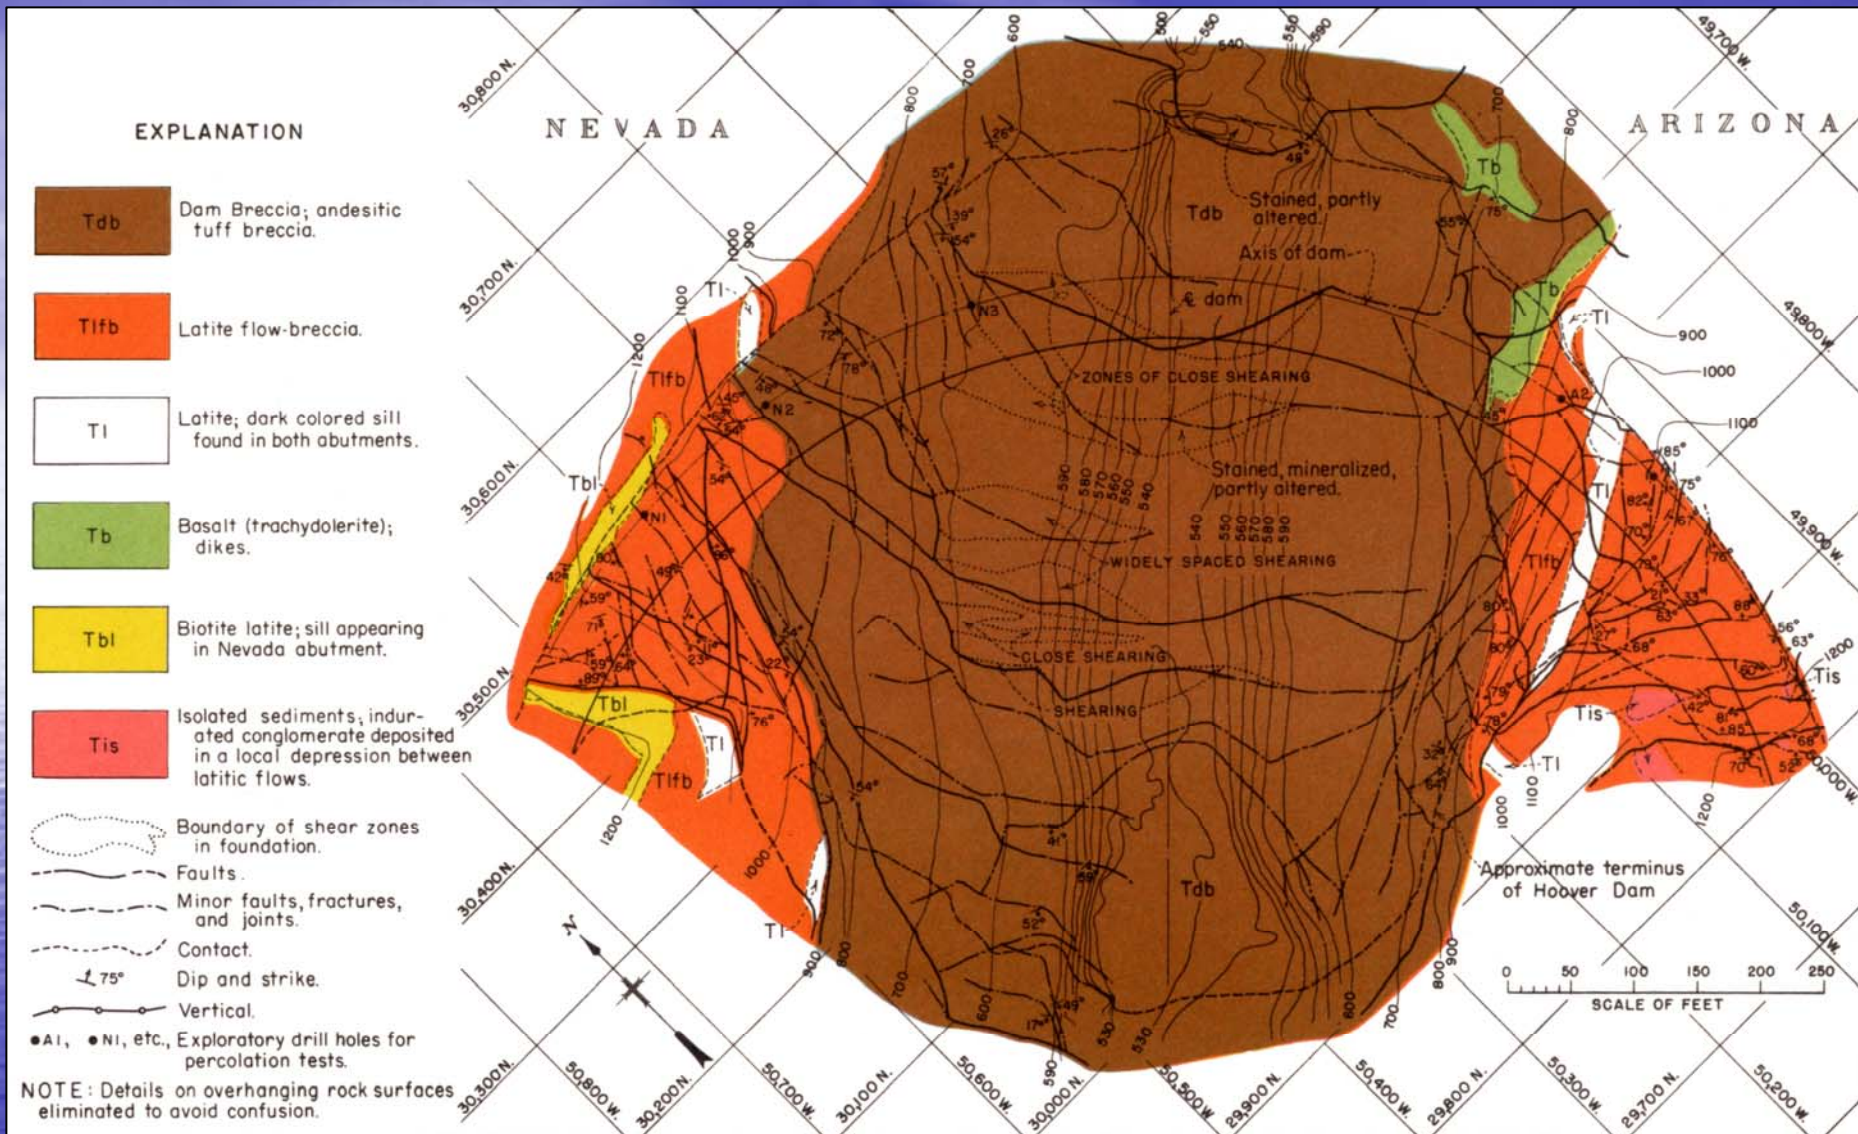
- The geology of the dam base was mapped after excavation of the channel gravels. Note faults and adjacent zones of intense shearing.

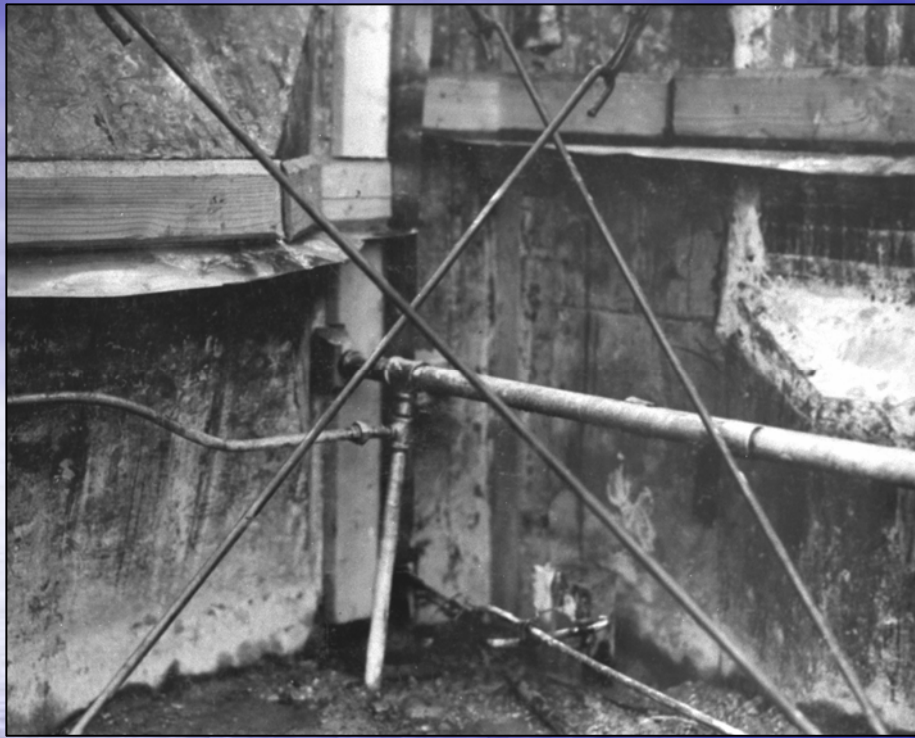
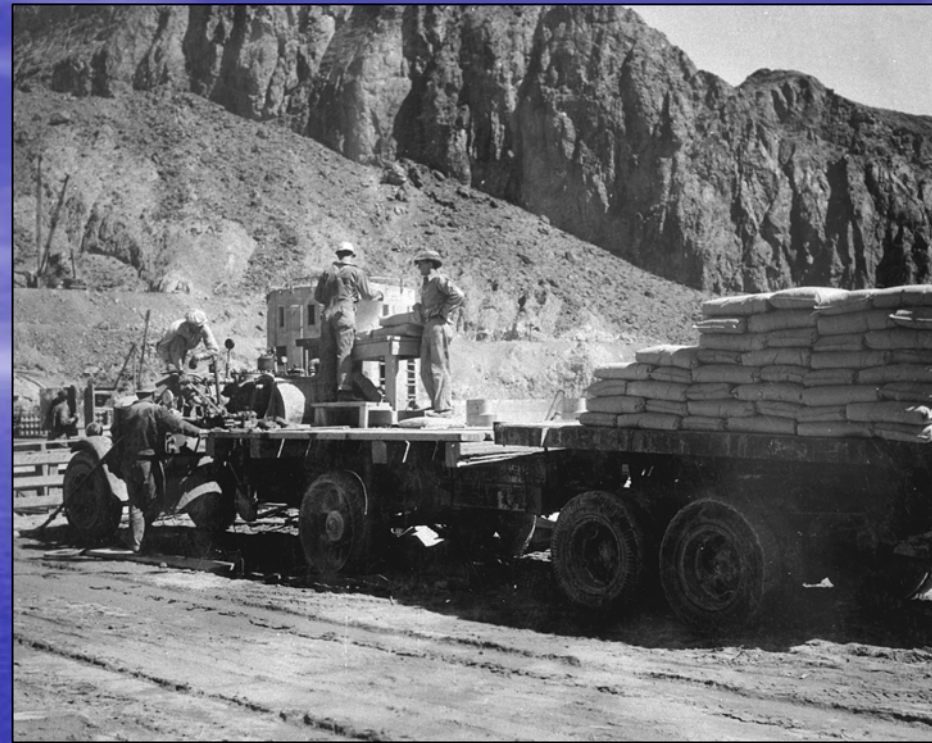
- A specially designed joint was employed between the dam concrete and the rock abutments. These joints were not grouted prior to the reservoir filling because the designers believed the dam would deflect downstream under full reservoir load.

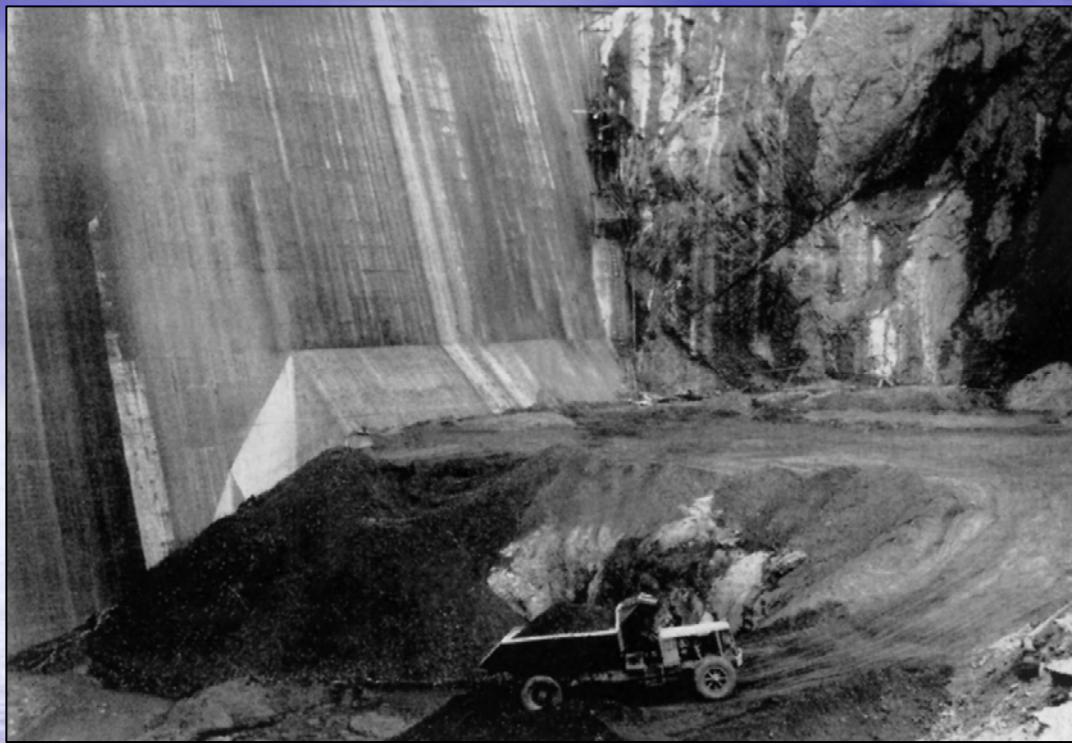
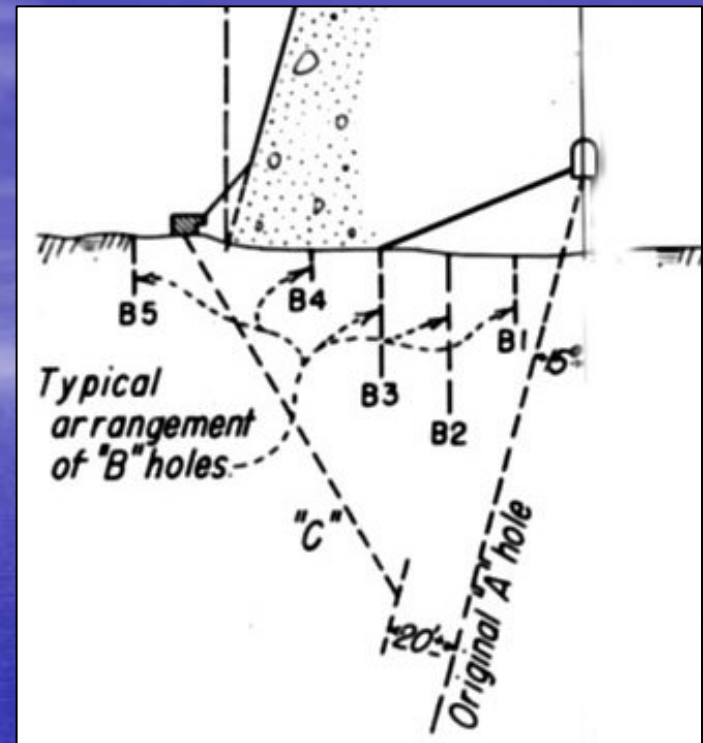
- Four rows of shallow **B holes** were drilled 30 to 50 ft deep, spaced 20 ft apart. These would be considered “dental work.”
- The **C holes** were drilled on an incline from outside the upstream heel of the dam (above left) on 10-foot spacings to a maximum depth of 100 feet.
- The C holes were grouted with pressures of up to 900 psi prior to drilling of the **A holes**, which were inclined upstream, from the lower drainage gallery (upper right).

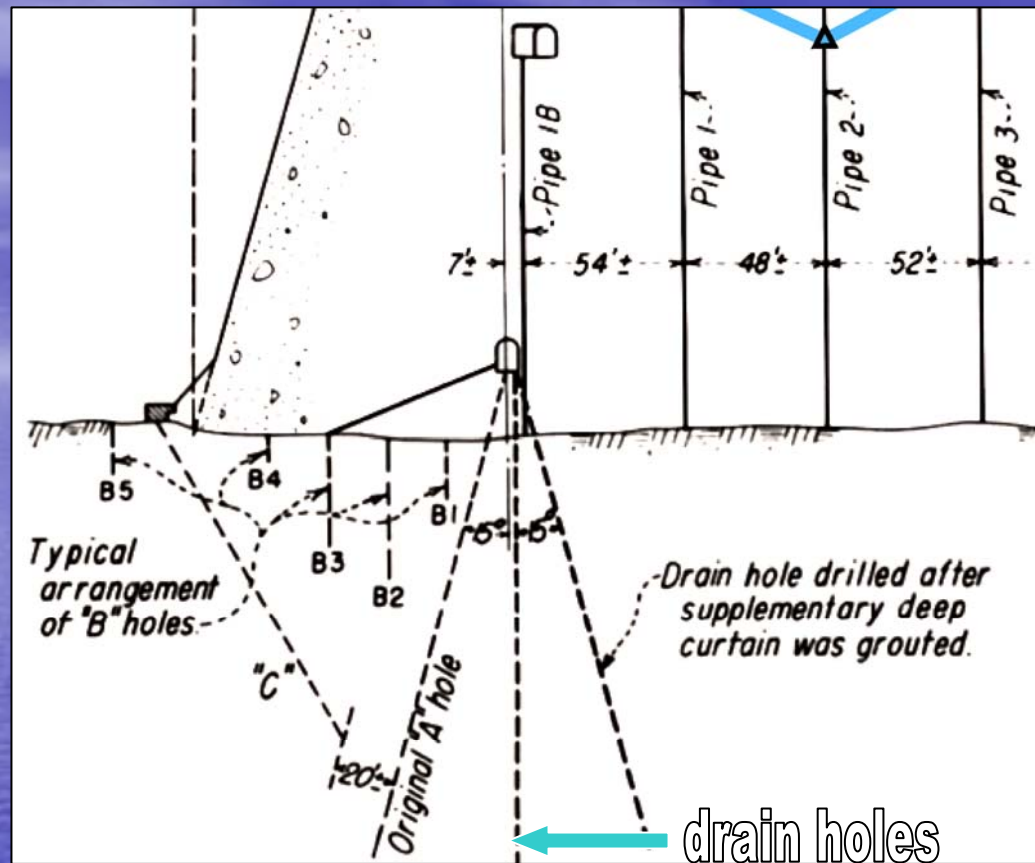
- The **"A holes"** forming the curtain were 150 feet deep, on 5 –ft centers, inclined 15 degrees upstream
- 191 A holes on Nevada side, 33 being abandoned
- 202 A holes on Arizona side, 21 abandoned
- Vertical drain holes 100 feet deep

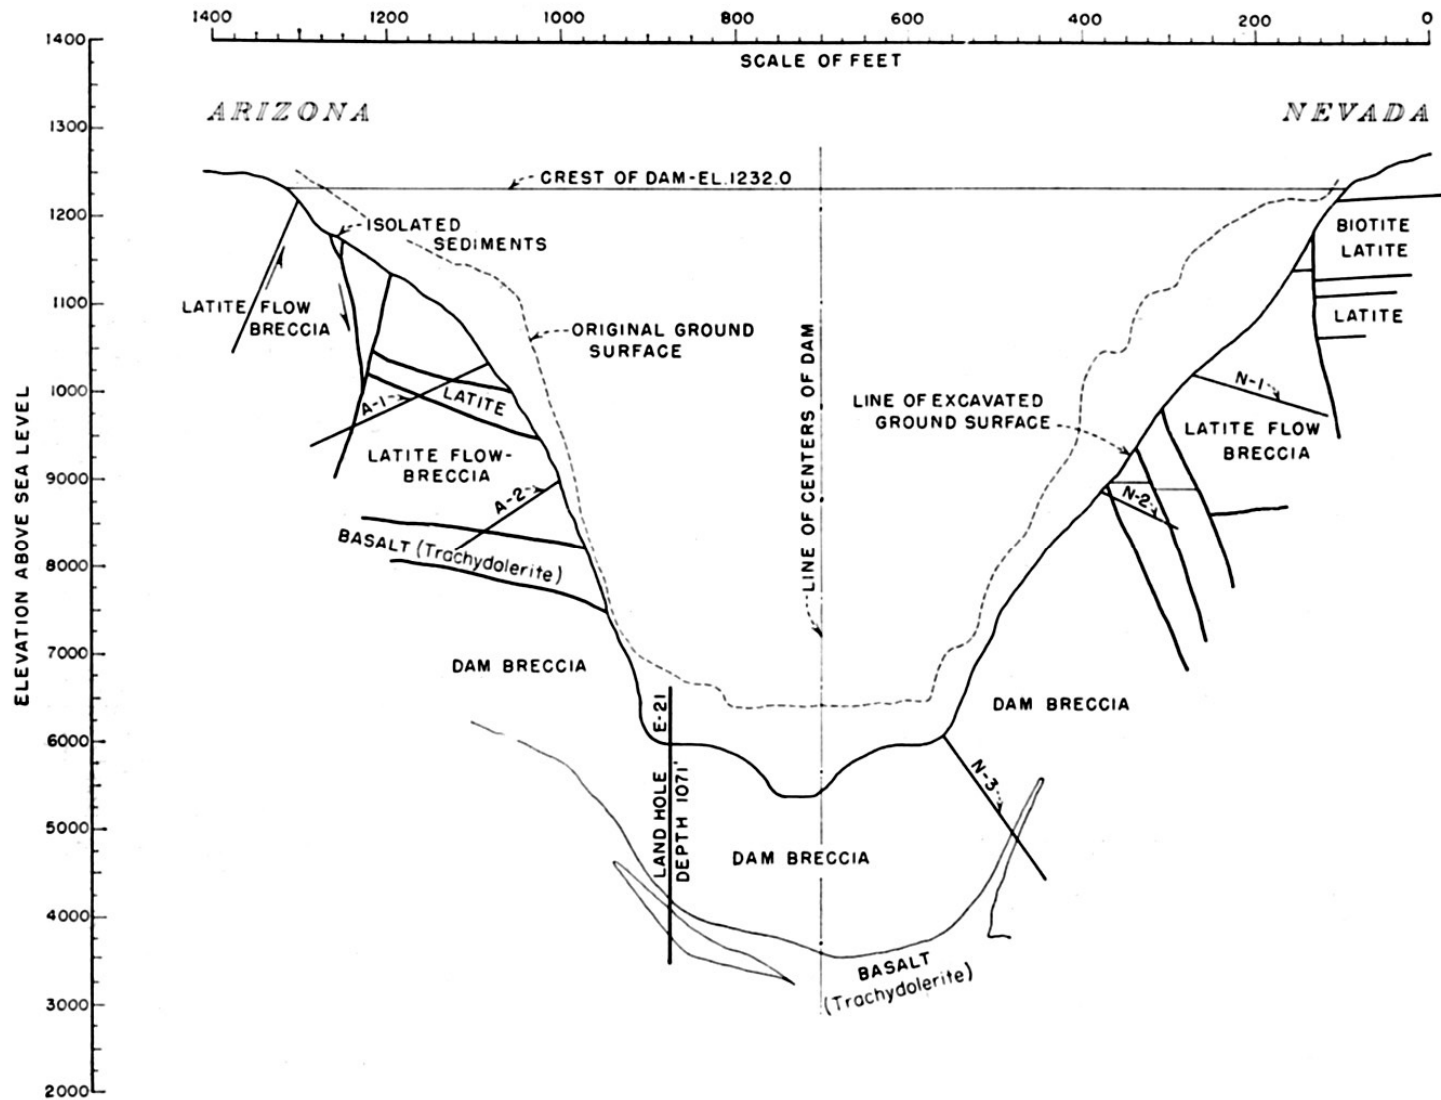
- System of block faults identified during construction. Note absence of data beneath the dam.

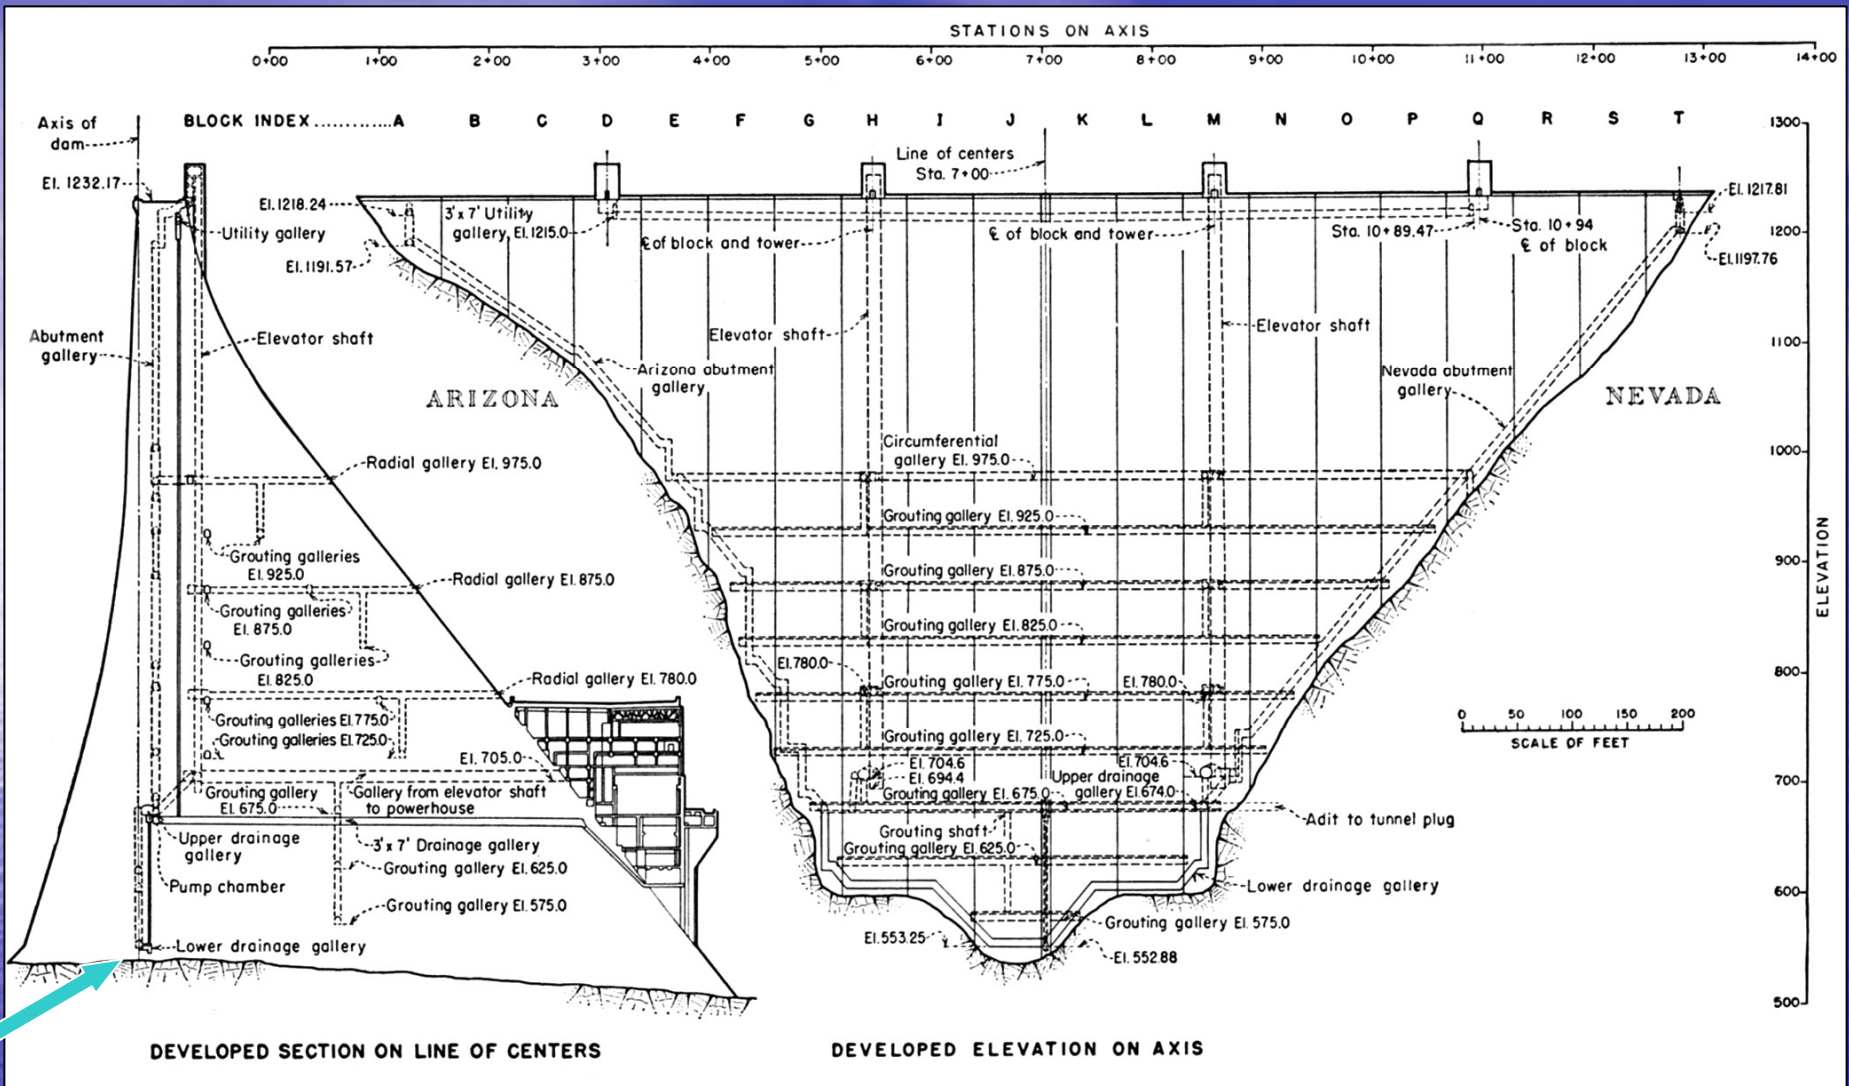
- Distribution of internal galleries in Hoover Dam. Note lower drainage gallery (arrow), from which the new, deeper grout curtain and drainage holes were drilled.

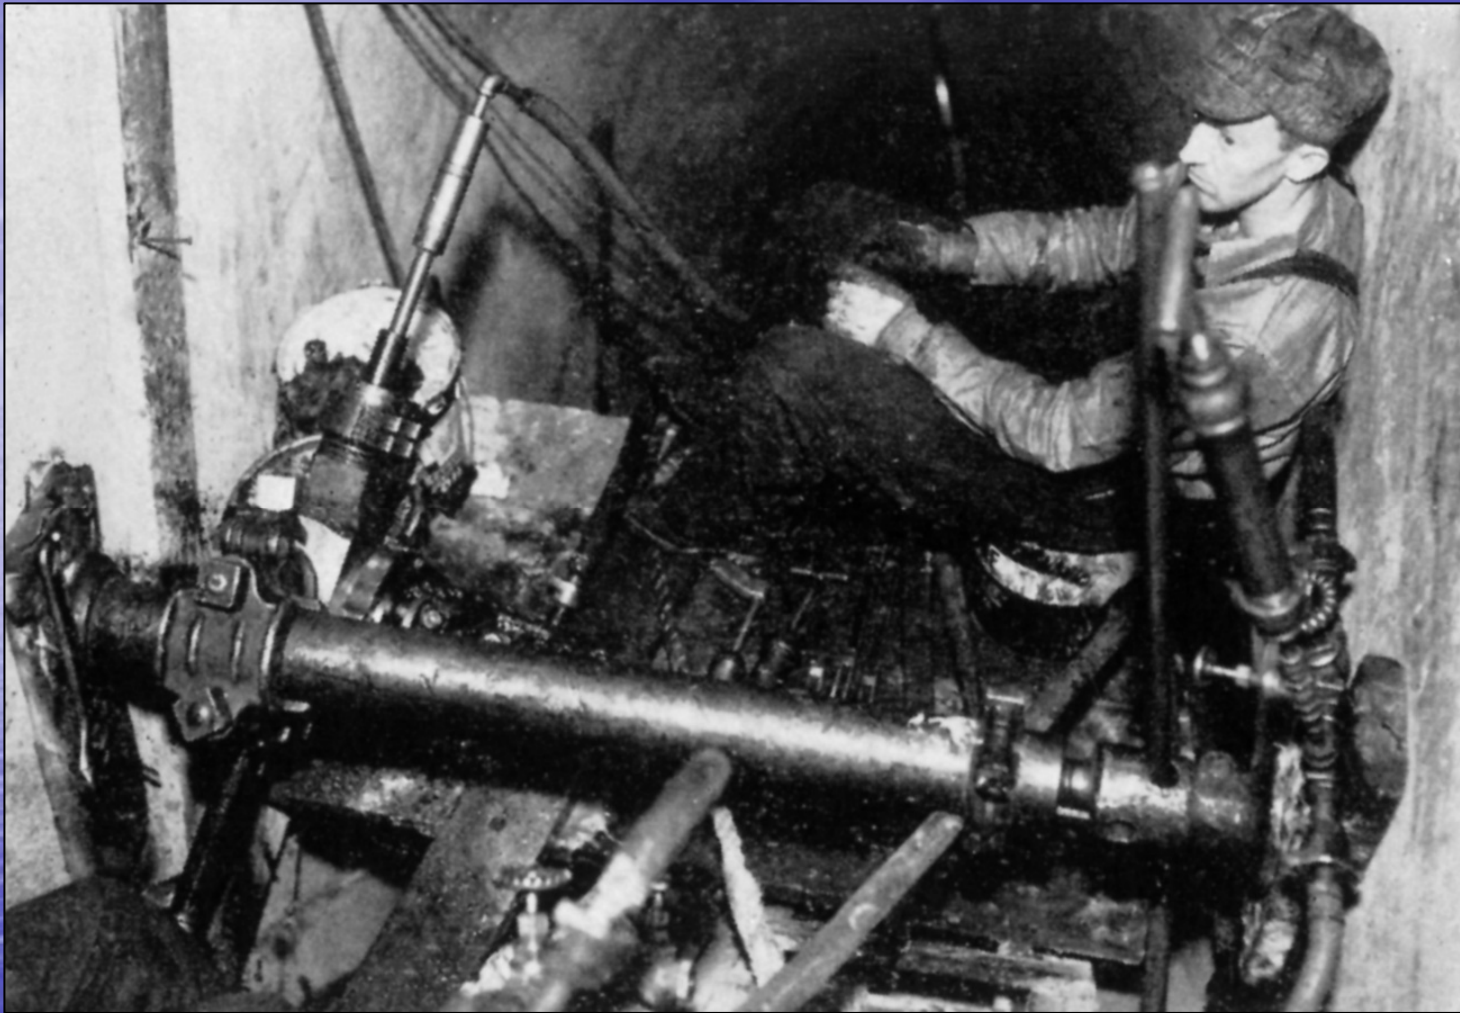
- Tight working spaces typified the 9 year program of extending the grout curtain, between 1938-47.
