PART 4

**HURRICANE
KATRINA STRIKES
NEW ORLEANS
AUGUST 2005**

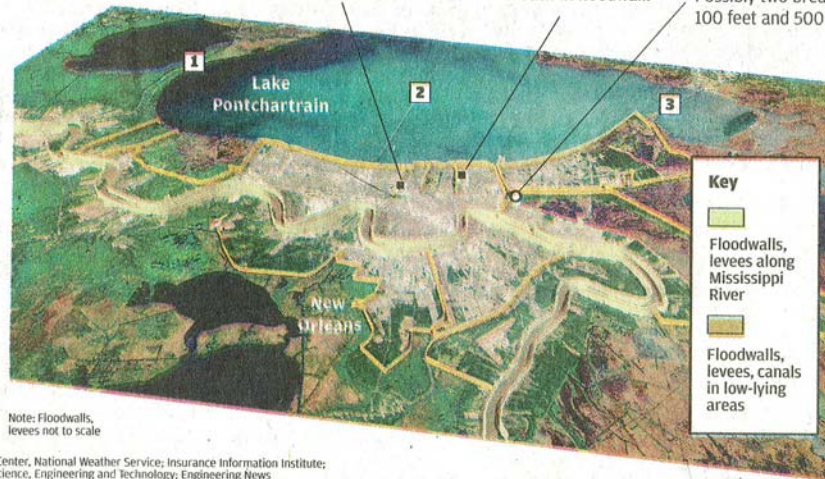
CRACKS IN THE WALL

First built in 1897, the aging system was breached in at least three places.

17th St. Canal

About 300-foot breach created when storm surge from lake topped floodwall and moved levee wall horizontally about 20 feet.

London St. Canal

About 300-foot breach in floodwall.

Industrial Canal

Possibly two breaches, 100 feet and 500 feet.

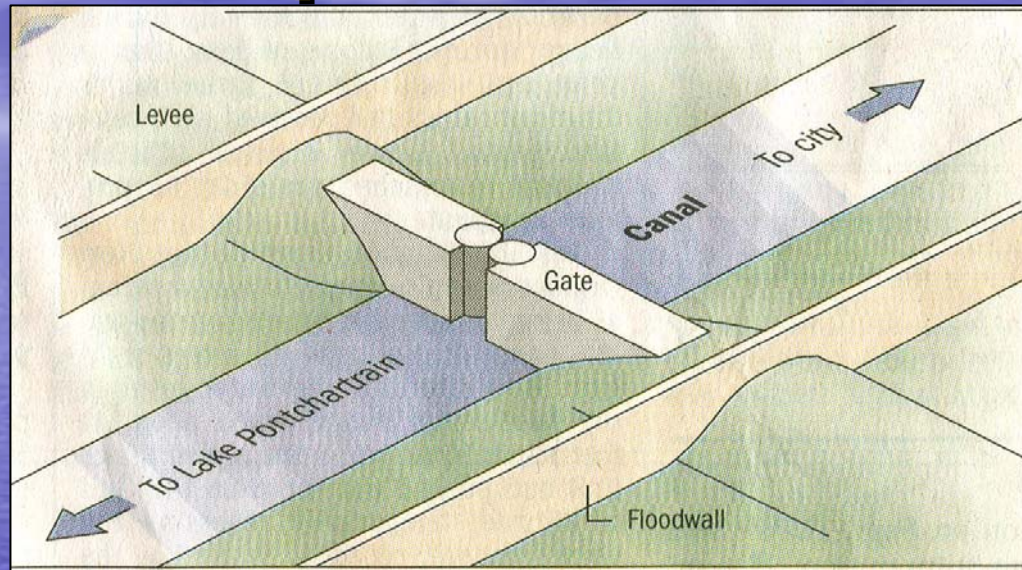
Tidal Gates on Drainage Canals could have prevented flooding

- In 1955 Congress directed the Army Corps of Engineers to survey coastlines to study how to build hurricane protection systems as a part of the Lake Pontchartrain and Vicinity Hurricane Protection Plan.
- In 1961 the Corps proposed a hurricane flood plan for New Orleans area whose main feature is barriers at the passes into Lake Pontchartrain that will prevent storm surge water from entering the lake. These were opposed by local agencies, so never built.

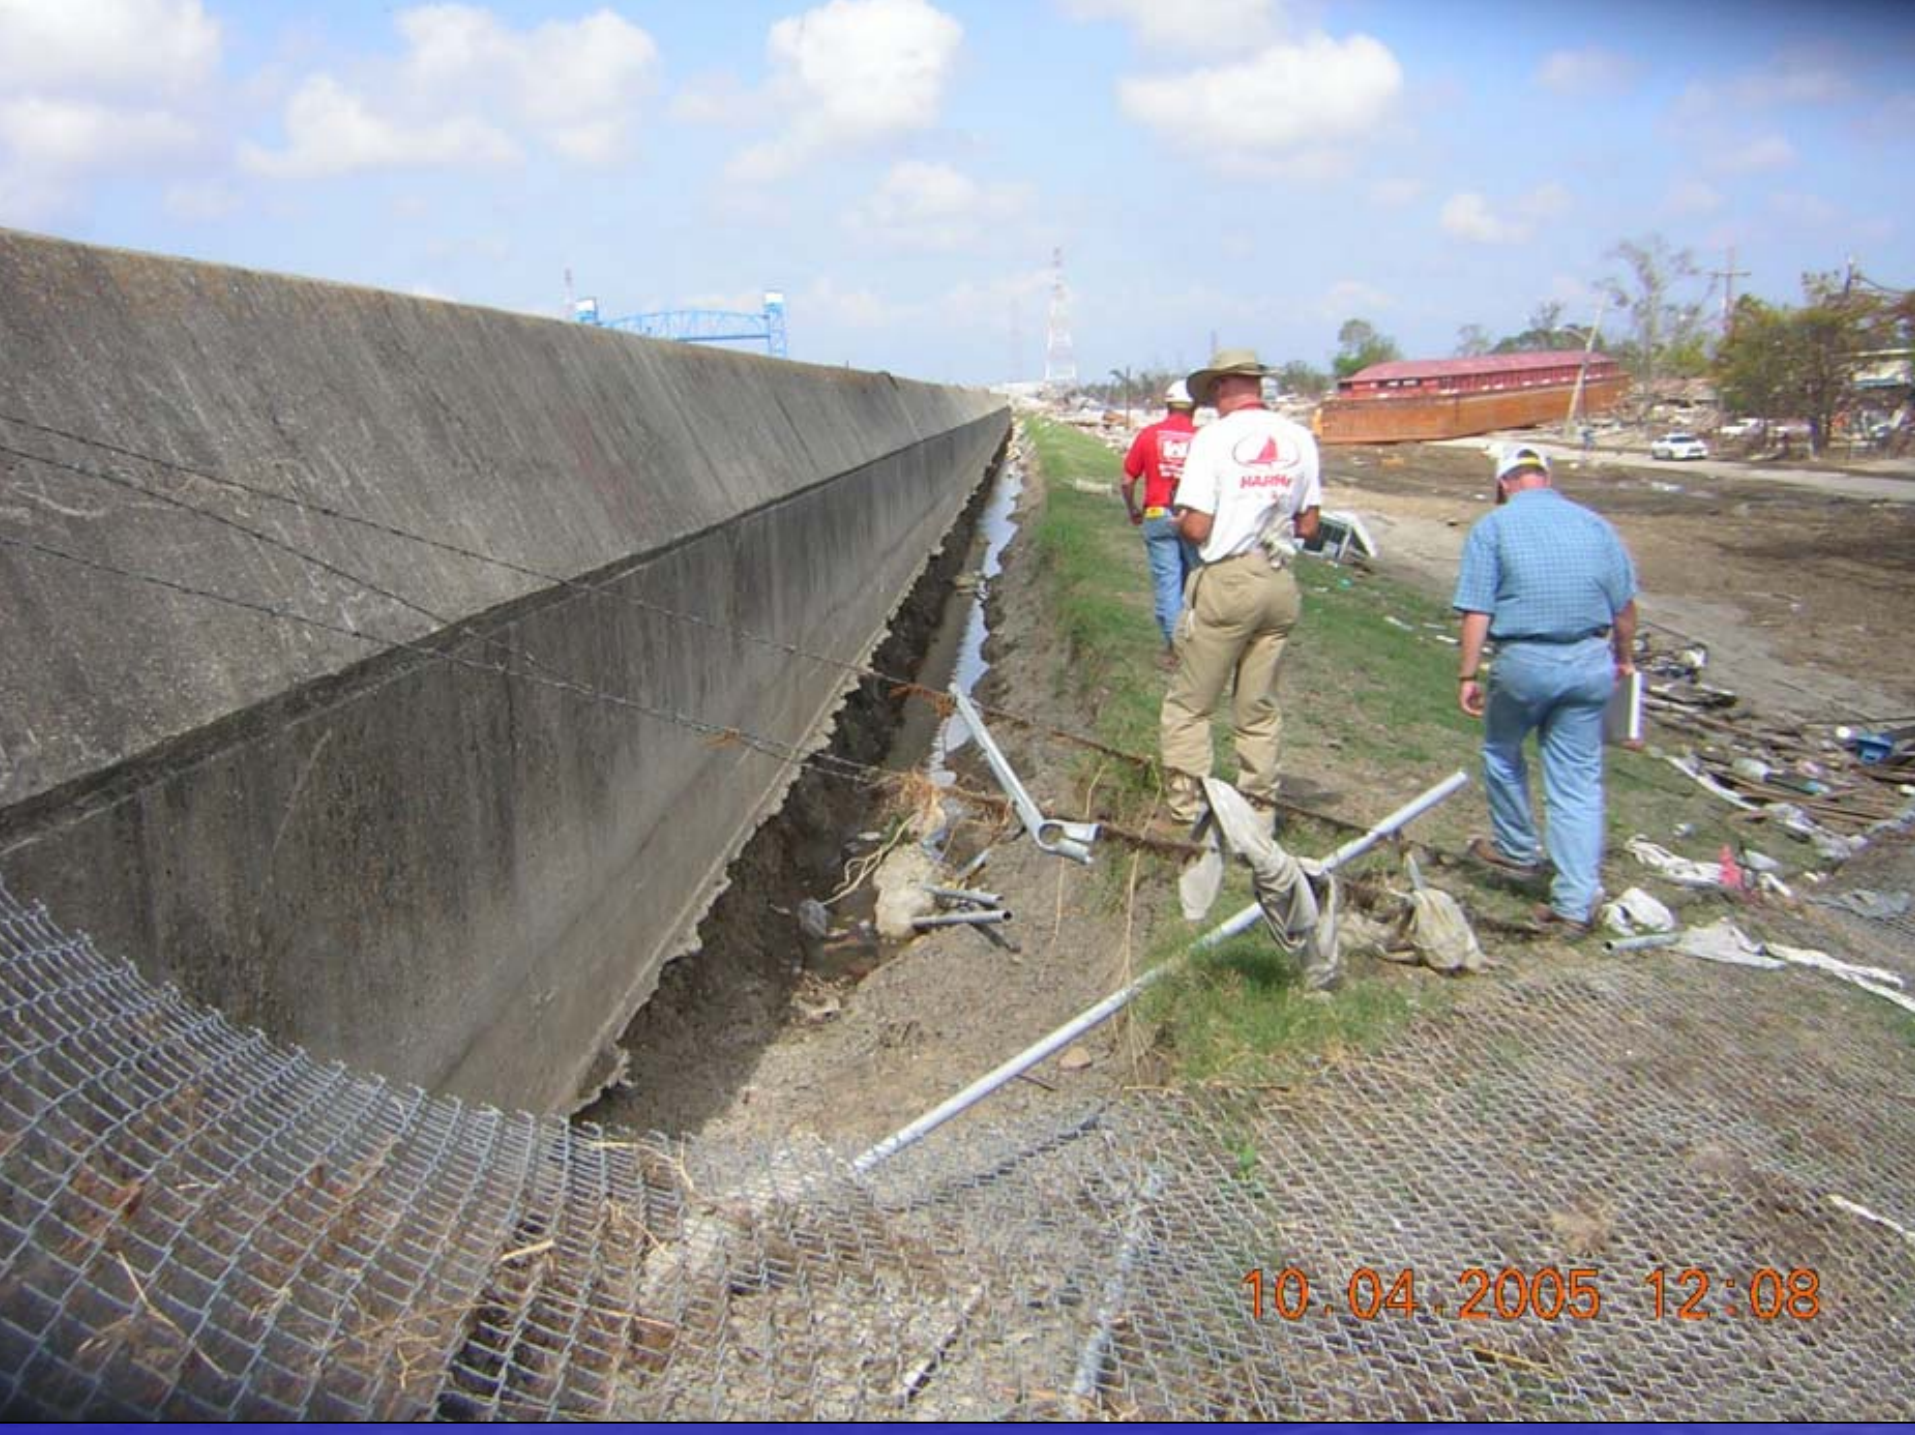
10.04.2005 12:08

Deflection of concrete I-walls along eastern side of Inner Harbor Navigation Channel. Photo Ivor van Heerden.

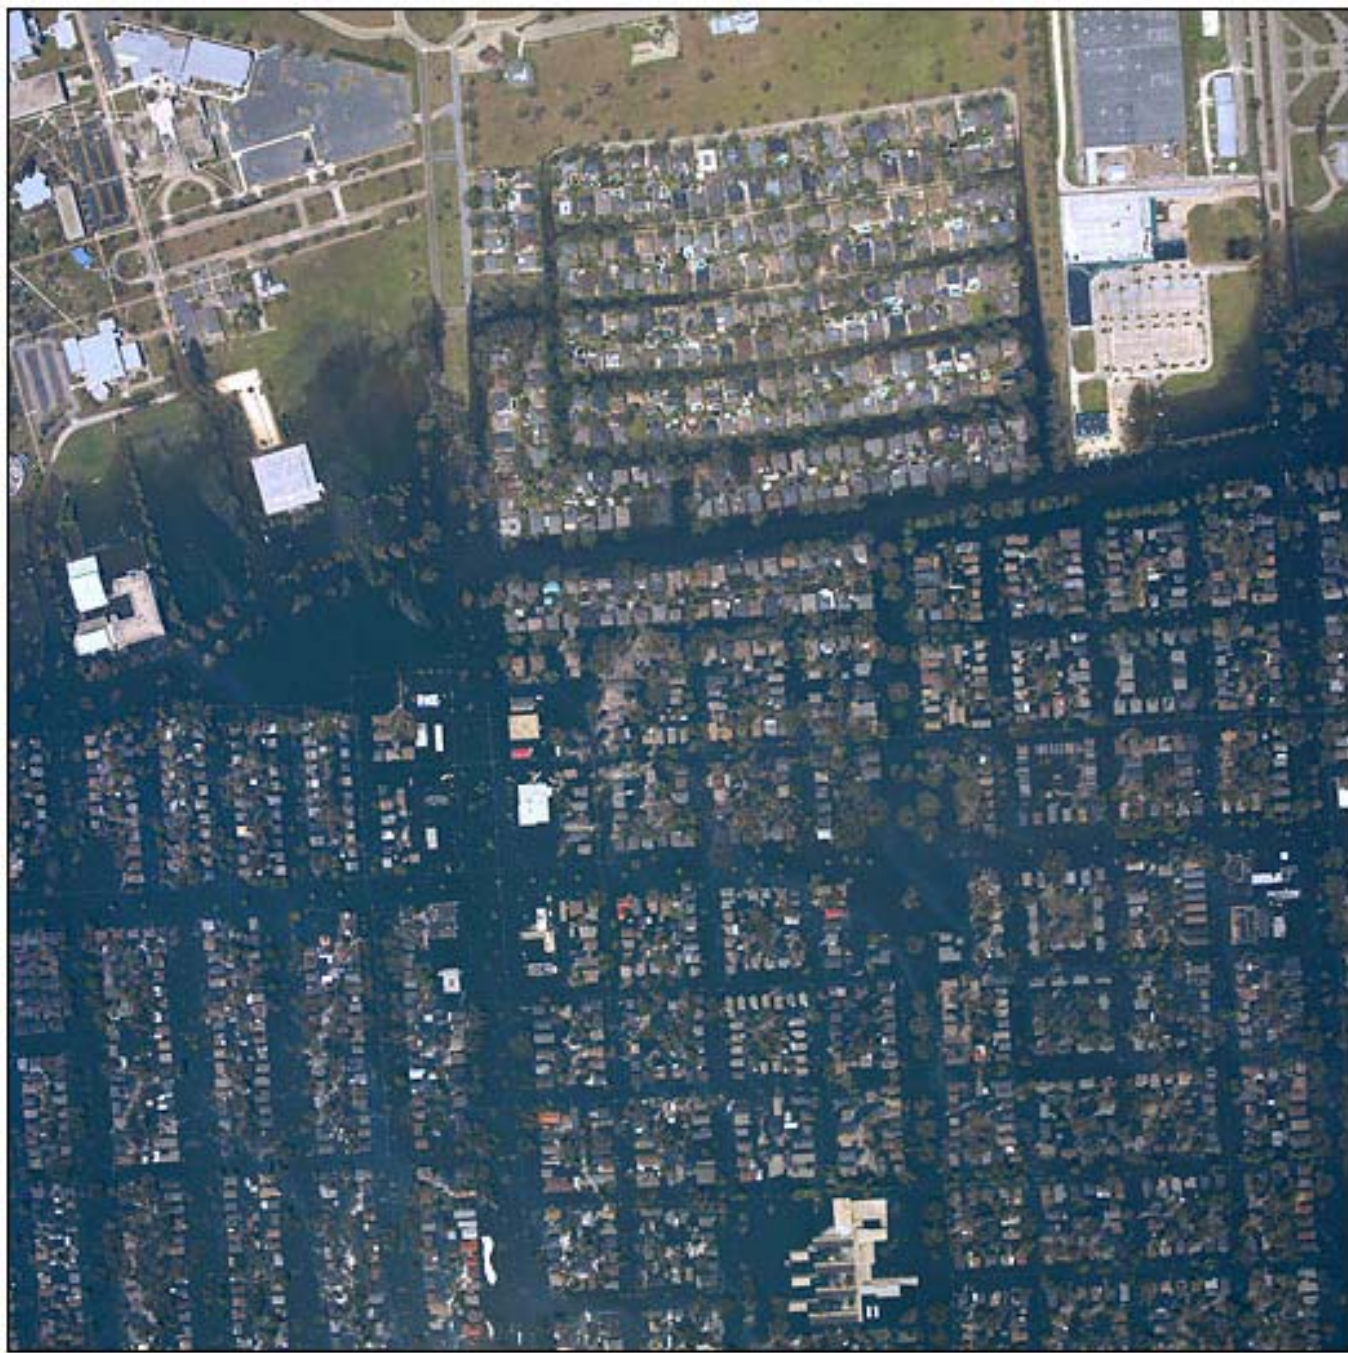
Aerial view of flood inundated urban neighborhood in New Orleans.

The pool level extends to the upper fifth of the image, which is higher ground, lying above the inundated zone.

Old river channels form the high ground across old New Orleans because these channels deposited silty sand levees, which now form low ridges.

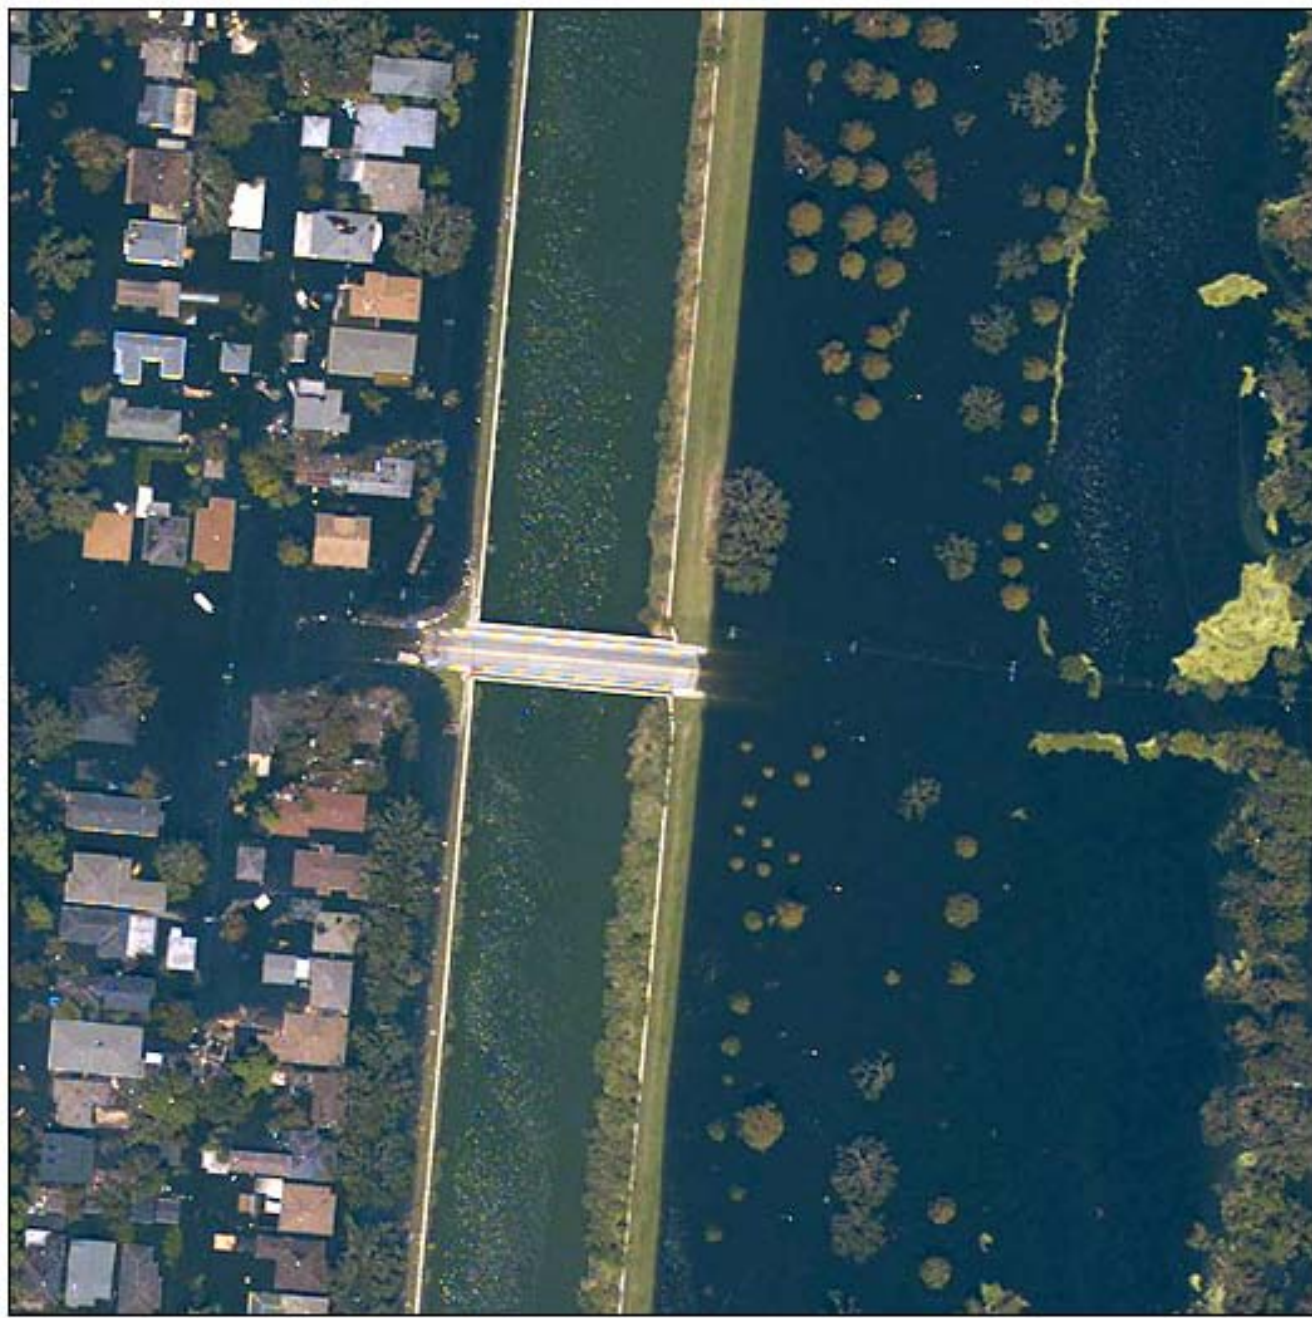
Post flood aerial image showing inundated zones on either side of a drainage canal.

Note how the street crossing the canal is higher than on either side of the canal

Variances in reflectance of the ponded water is ascribable to dissolved and entrained solids, depth, temperature, oxygen content, temperature, turbidity, and current.

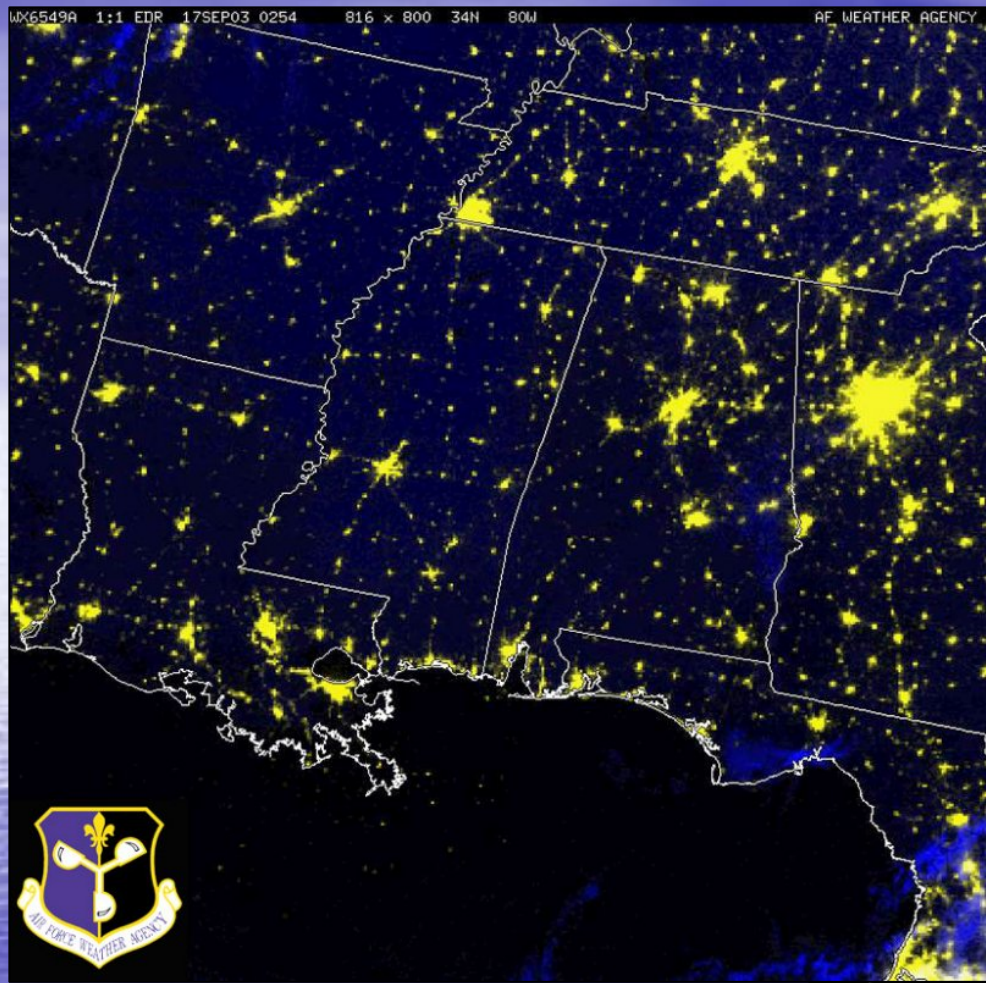
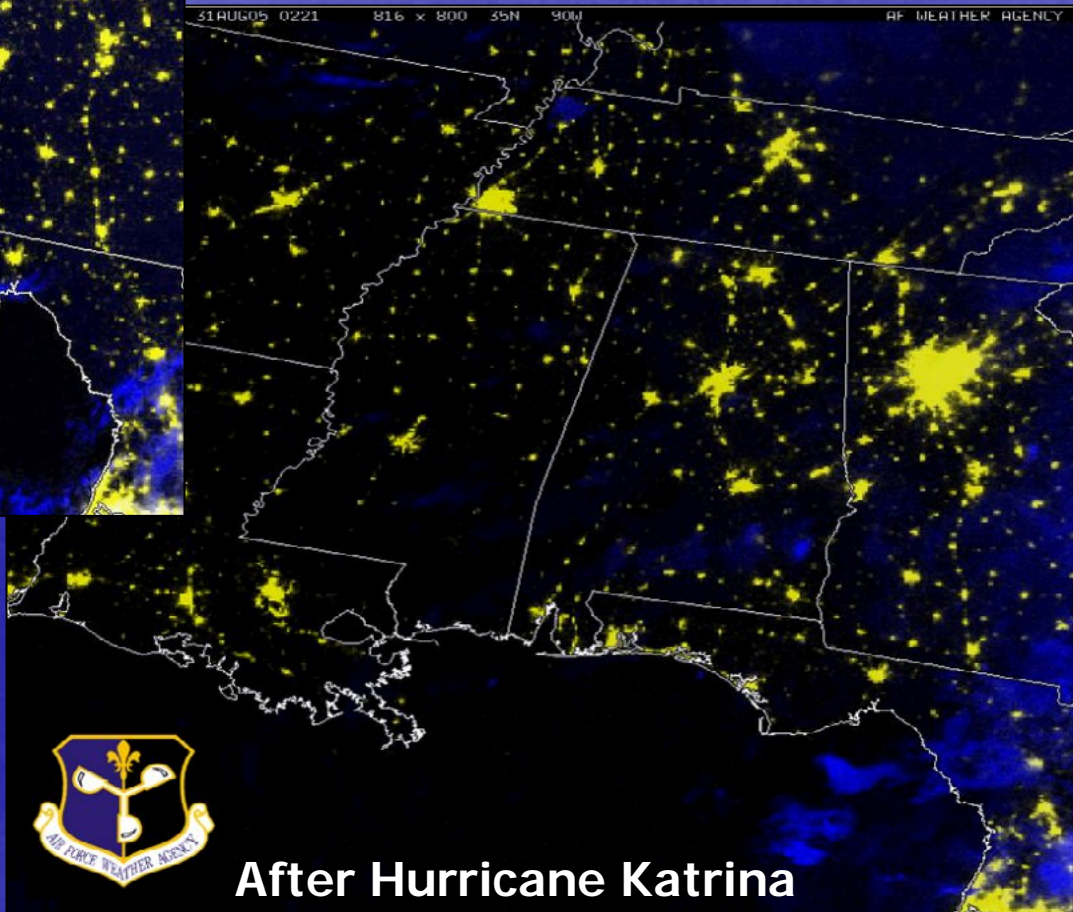
Impacts on Electrical Power

These ELINT images show how much electrical power was knocked out throughout much of the region.

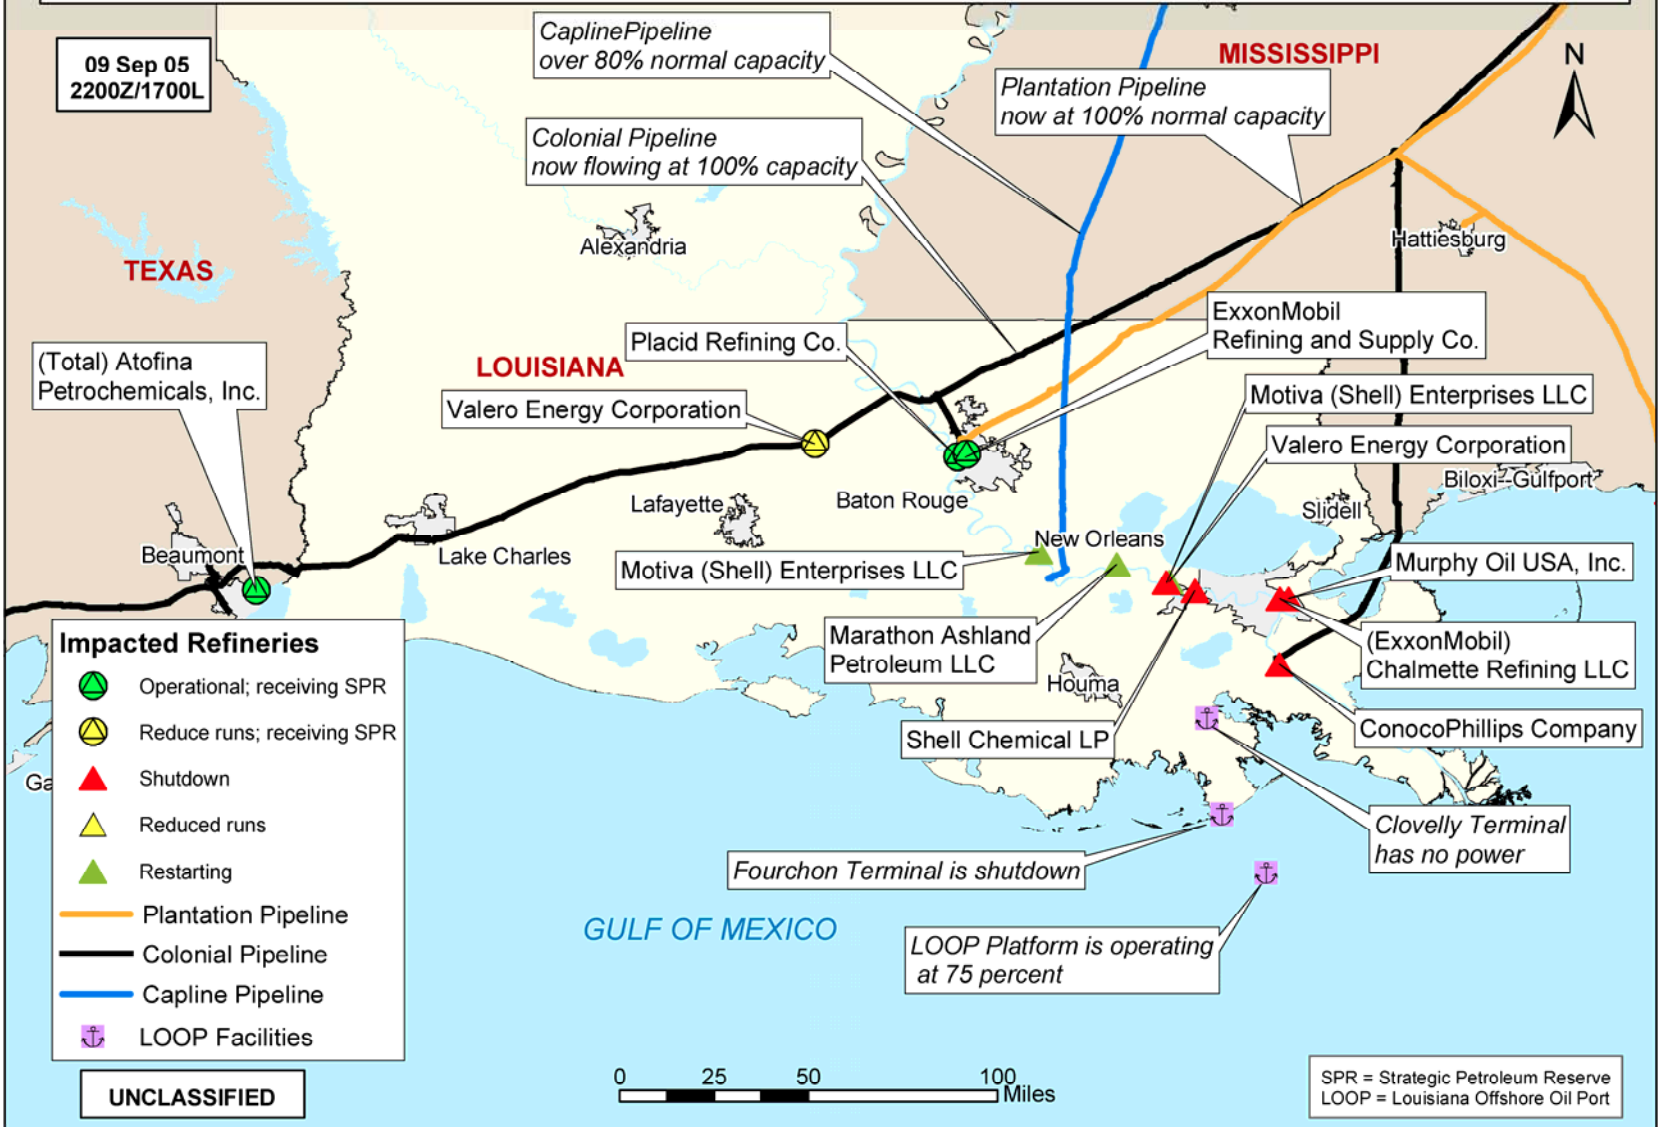
Hurricane Katrina - Impact to Petroleum Industry Infrastructure

Clovelly Terminal
has no power

Fourchon Terminal is shutdown

LOOP Platform is operating
at 75 percent
