New Orleans and Hurricane Katrina.

II: The Central Region and the Lower Ninth Ward

Abstract: The failure of the New Orleans regional flood protection systems, and the resultant catastrophic flooding of much of New Orleans during Hurricane Katrina, represents the most costly failure of an engineered system in U.S. history. This paper presents an overview of the principal events that unfolded in the central portion of the New Orleans metropolitan region during this hurricane, and addresses the levee failures and breaches that occurred along the east–west trending section of the shared Gulf Intracoastal Waterway/Mississippi River Gulf Outlet channel, and along the Inner Harbor Navigation Channel, that affected the New Orleans East, the St. Bernard Parish, and the Lower Ninth Ward protected basins. The emphasis in this paper is on geotechnical lessons, and also broader lessons with regard to the design, implementation, operation, and maintenance of major flood protection systems. Significant lessons learned here in the central region include: (1) the need for regional-scale flood protection systems to perform as systems, with the various components meshing well together in a mutually

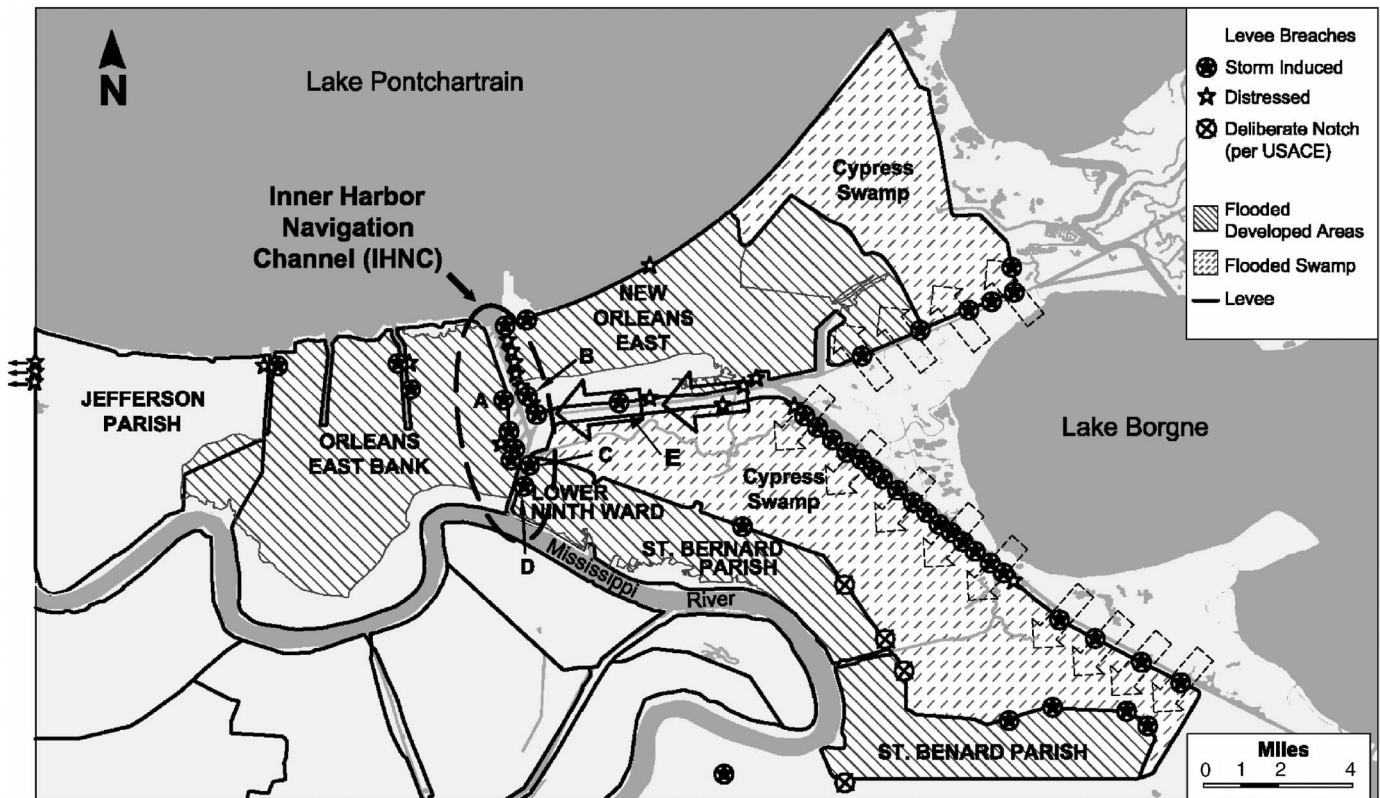
Fig. 1. Map schematically illustrating the lateral flow from Lake Borgne to the IHNC, and showing the locations of breaches and partial breaches in the IHNC region and vicinity

Bernard and Lower Ninth Ward protected basin; and (3) the main (“downtown”) Orleans East Bank metropolitan basin. Fig. 1 also shows the locations of levee failures (breaches), partial breaches, and incipient failures that occurred in this region. The closed stars within circles in Fig. 1 show the locations of levee breaches and/or floodwall failures, and the open stars without circles show the locations of partial breaches and/or significant levee distress. The ×’s in Fig. 1 show the locations of deliberate “notches” in the levees that were created after the storm had passed to facilitate outward drainage of floodwaters from within the flooded basins.

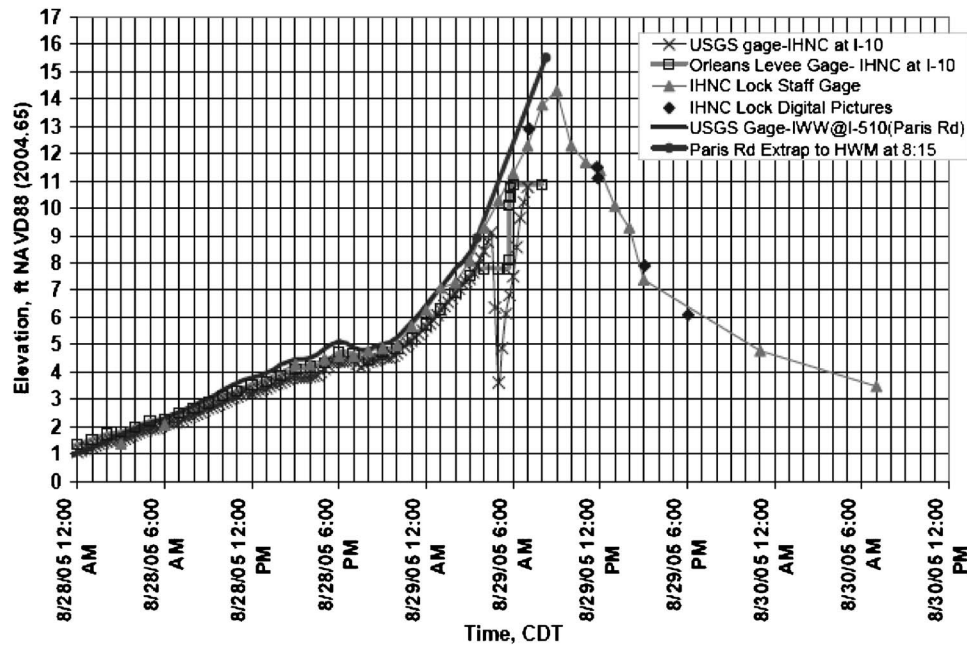
Fig. 2 shows a hydrograph of water elevations produced at five locations within the IHNC waterway as the storm surge was pushed westward from Lake Borgne through both the GIWW/MRGO and IHNC channels (IPET 2007). The storm surge rose at a moderate pace until it reached an elevation of approximately +5 ft (MSL) at approximately 10:00 p.m. on August 28, then it rose more rapidly over the next 11 h to a maximum elevation of approximately +14 to +14.5 ft (MSL) at approximately 8:45 to 9:00 a.m., after which it subsided relatively quickly. The dip in the rising hydrograph at one of the stations (where Highway I-10 Bridge crosses the IHNC) and the partial dip in a second gauge (also adjacent to the I-10 Bridge) were caused by a localized temporary drawdown due to the occurrence of a breach in that vicinity at approximately 5:00 a.m. The Highway I-10 Bridge is located immediately north of the two breaches labeled as Points A and B in Fig. 1. These two breaches are the most likely candidates for the source of this localized drawdown, and they are associated with penetrations of a rail line through the levee perimeter on both sides of the IHNC. The localized and temporary drawdown did not appear to extend far from the I-10 bridge, and it is the gauge levels without dips, representing conditions farther to the

Fig. 2. Hydrographs showing measured (and photographed) water levels at gange stations along the IHNC (IPET 2007, Vol. V)
