# UNRAVELLING THE LEVEE FAILURES IN NEW ORLEANS DURING HURRICANE KATRINA – WHAT WE ALL SHOULD KNOW

**J. David Rogers, Ph.D., P.E., R.G.**

Member, National Science Foundation Independent Levee Investigation Team and  
Karl F. Hasselmann Chair in Geological Engineering  
University of Missouri-Rolla

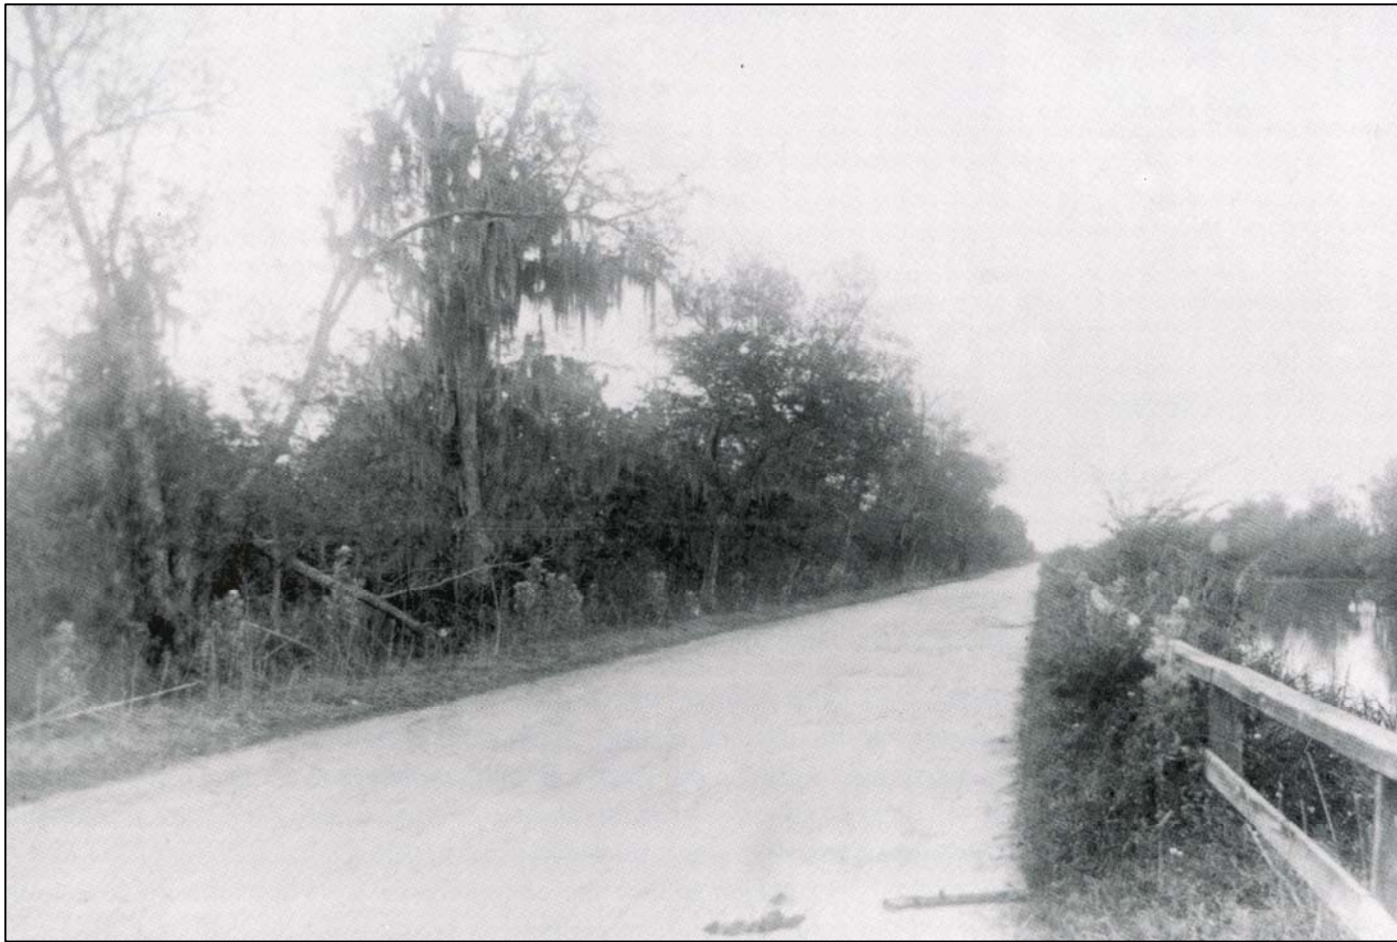
- **Photo taken in 1890 looking north along the “shell road” than ran along the west side of the [New Basin Canal](#), seen at extreme right.**
- **Note the modest height of the embankment, no more than 5 feet above the adjacent cypress swamp. The canal embankments were heightened by earth filling after hurricane-induced overtopping of these canals in [1915](#) and [1947](#) (image from University of New Orleans historic collection).**

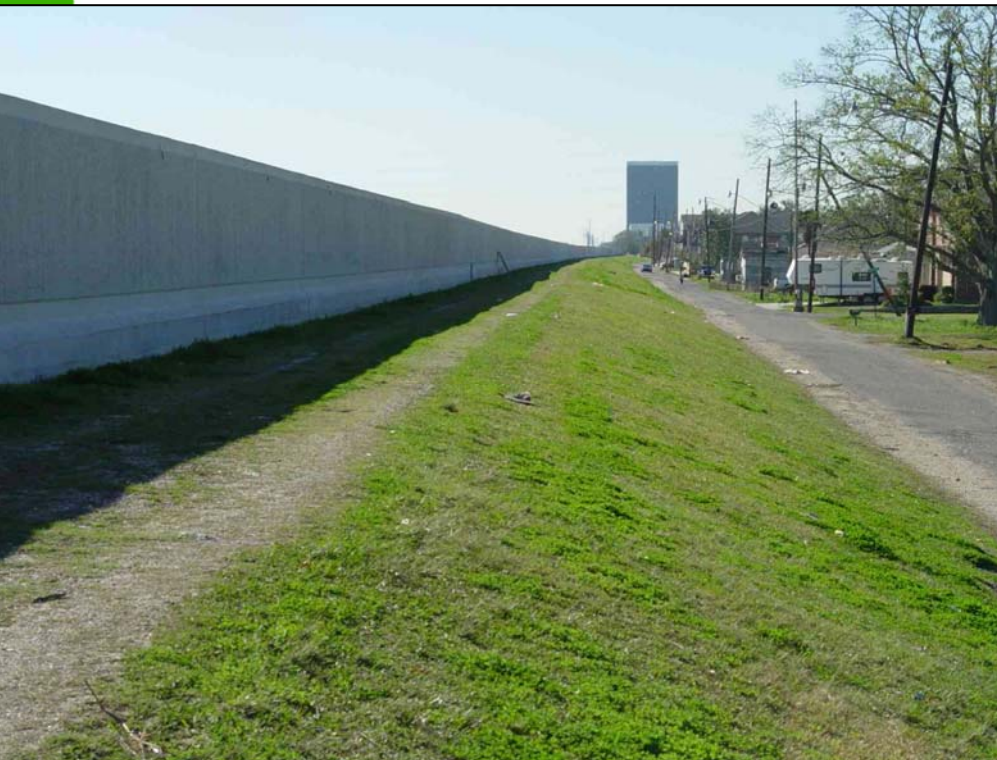
- **Concrete flood wall** along the west side of the 17<sup>th</sup> Street Canal in Jefferson Parish, where a street runs along the toe of the embankment. This scene is typical of the concrete I-walls constructed on steel sheetpiles driven into the crest of the drainage canal embankments in New Orleans in the 1990s to provide additional flood freeboard from hurricane-induced storm surges

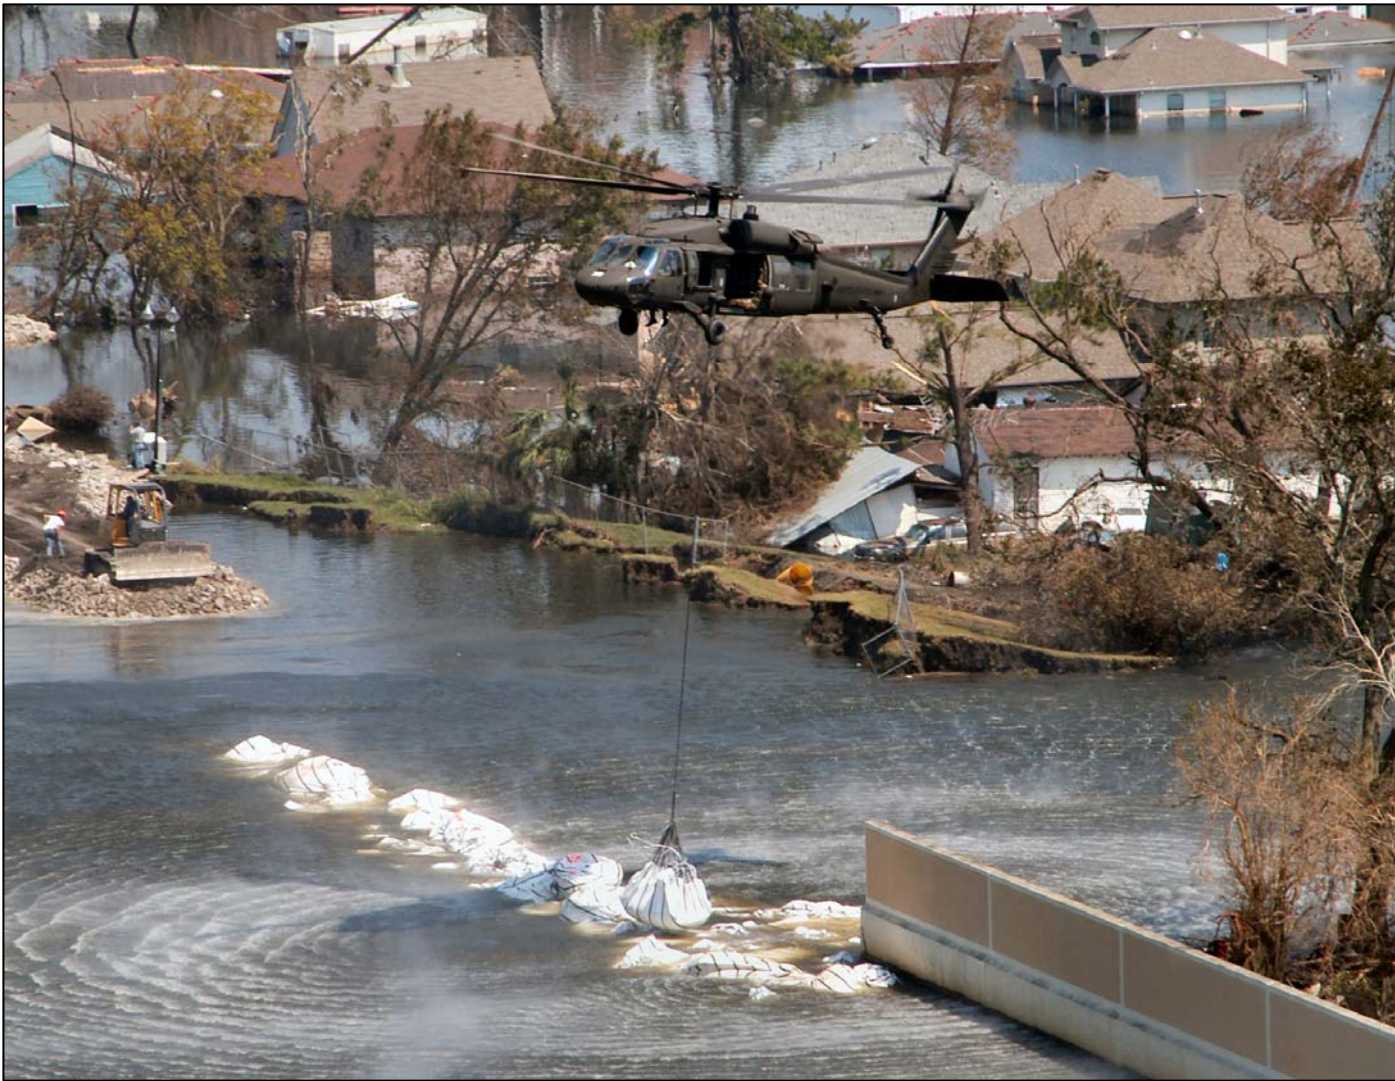
- **Army helicopters and contractors worked for weeks to fill the enormous gaps in the levee system, BEFORE pumping could begin.**

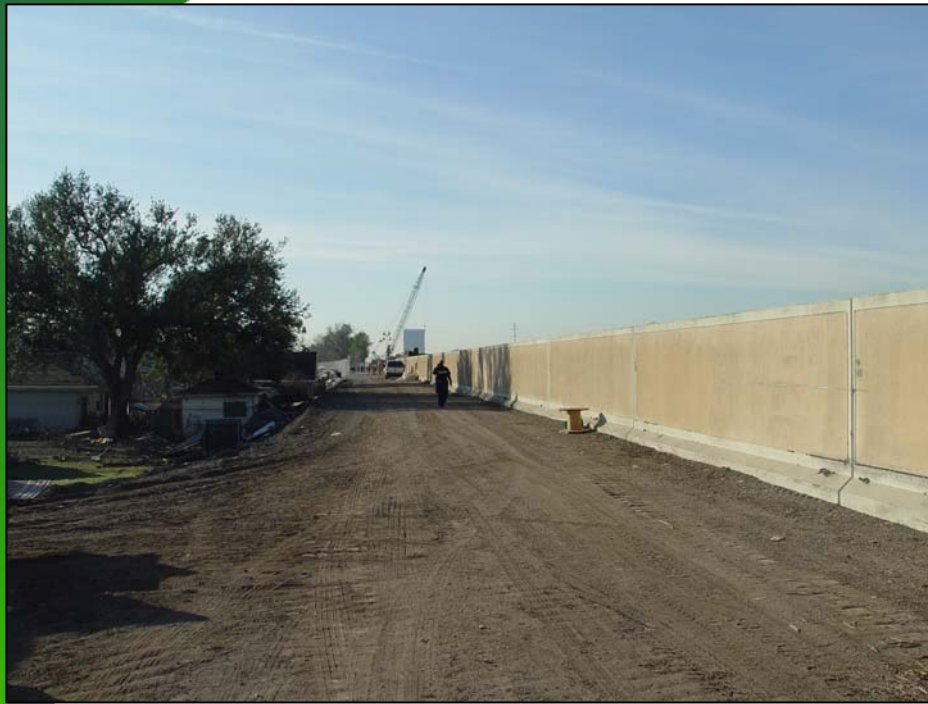
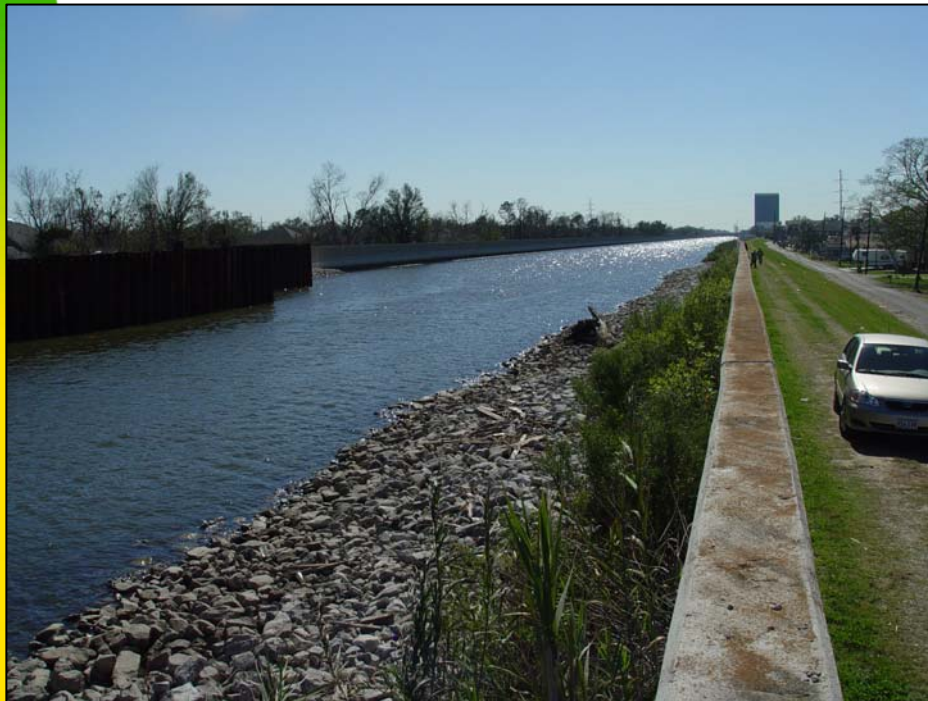
- In 1992-95 these 10 ft high concrete I-walls were constructed on the crests of the three principal drainage canals of lower New Orleans feeding into Lake Ponchartrain.
- These canals predate the residential development along their margins, which abuts the canal embankments.

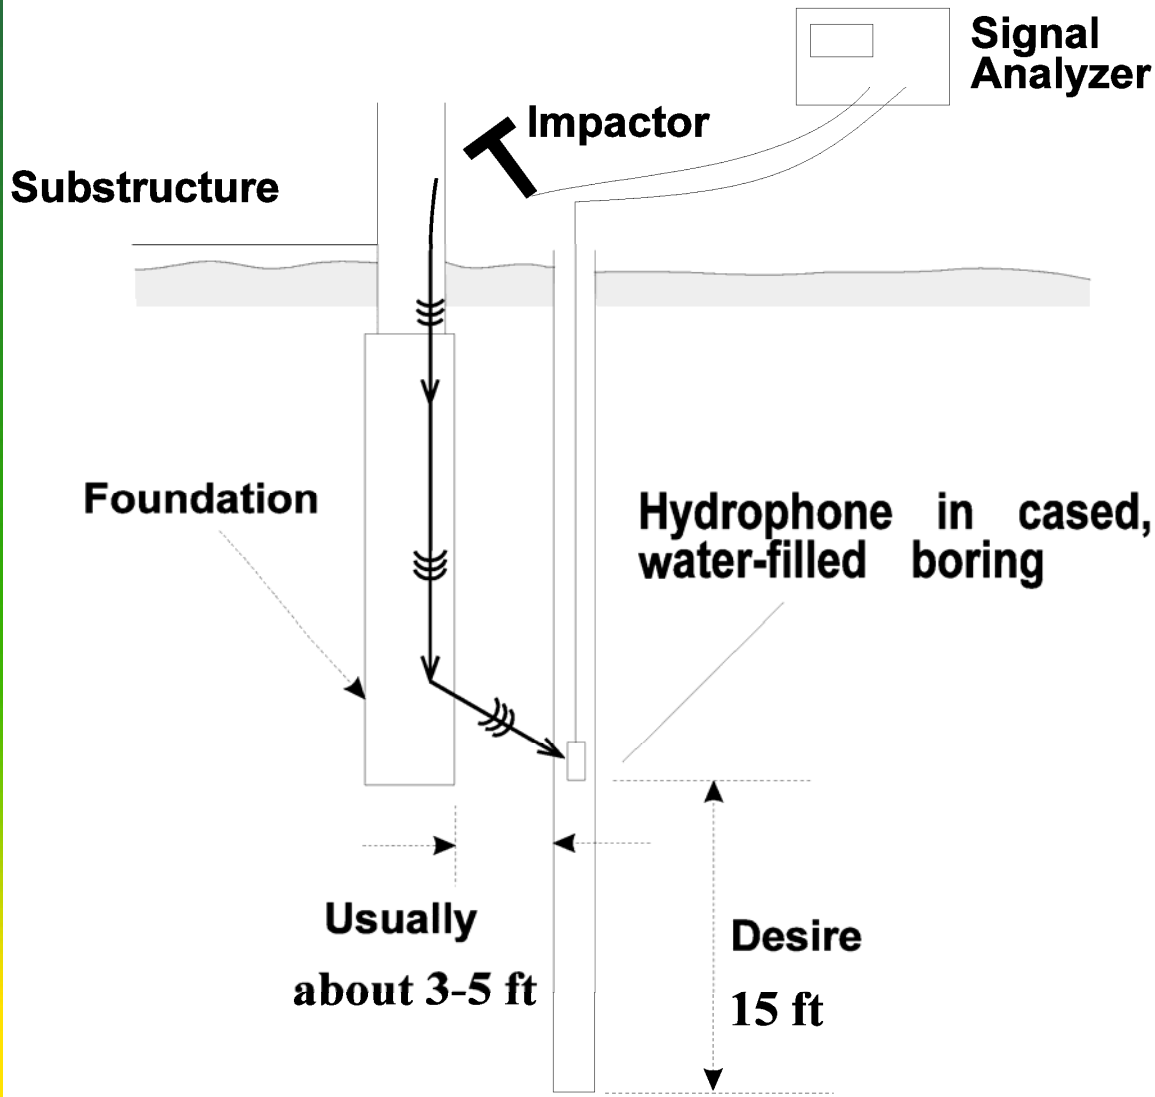
- The Corps of Engineers had drilled holes to 50 feet, but only cased them to 25 feet; when casing needed to extend about 15 feet below the hydrophones placed in these holes

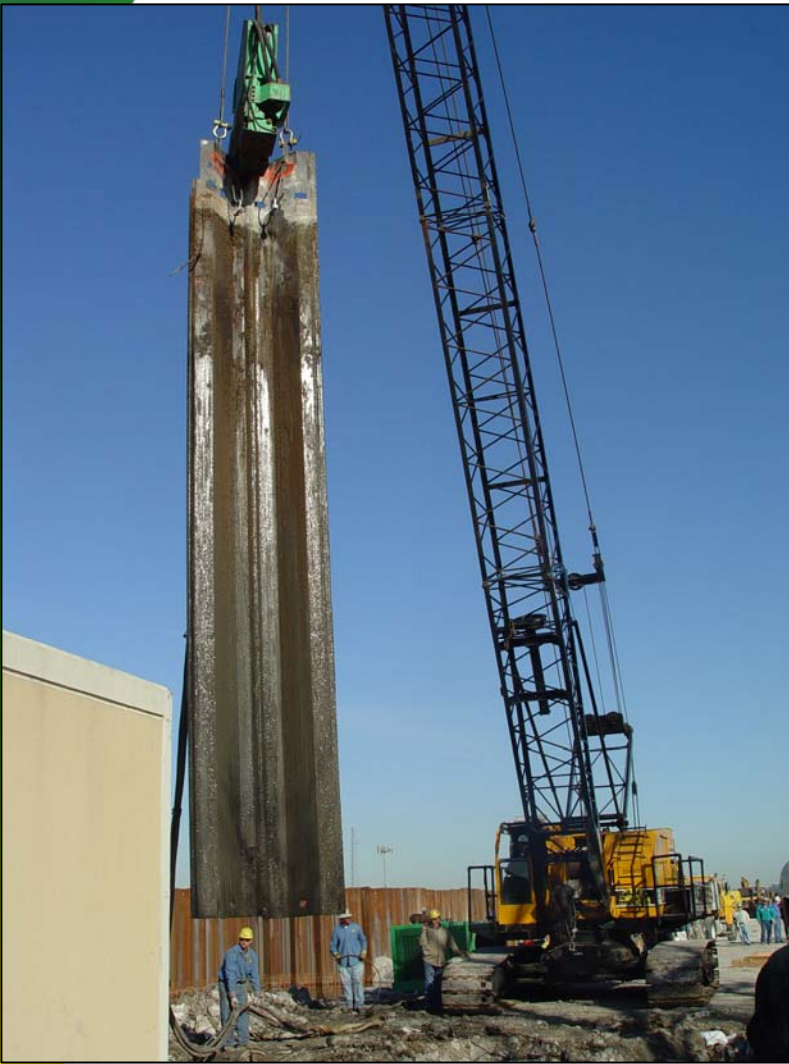
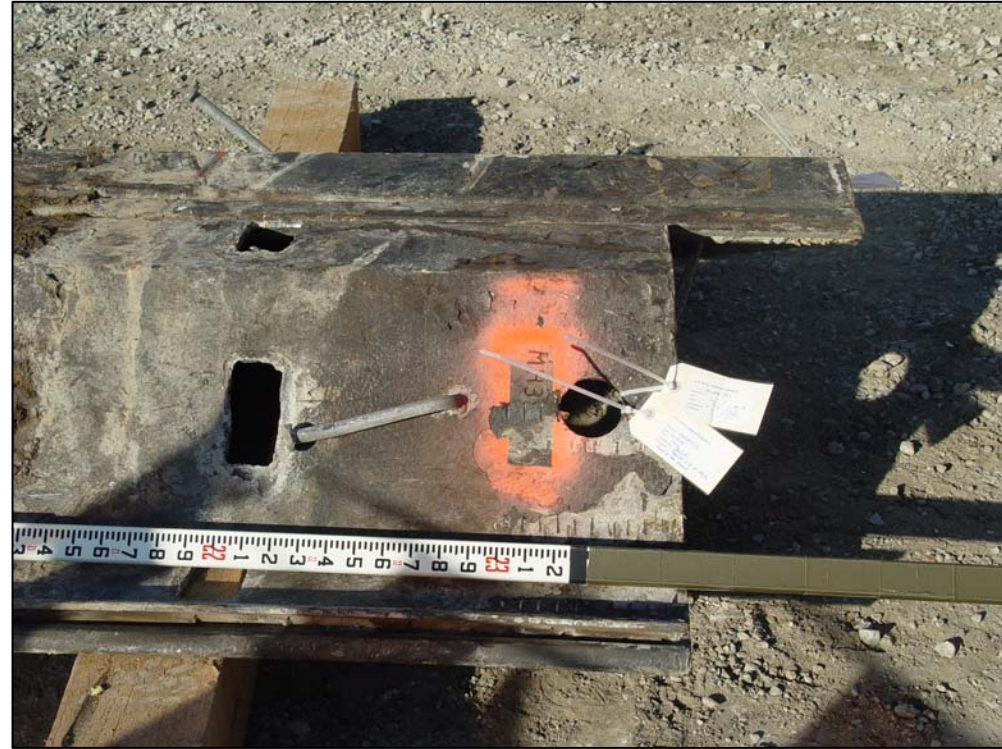
- The sheetpiles turned out to be 23'-6" long, slightly longer than required in the 1993 construction documents

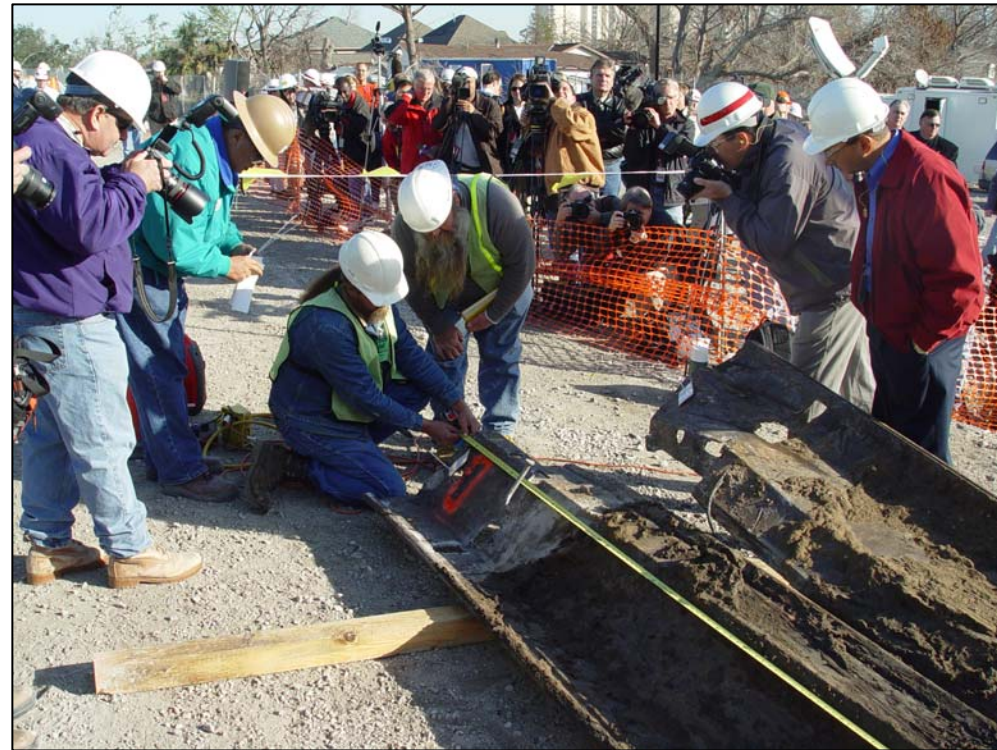
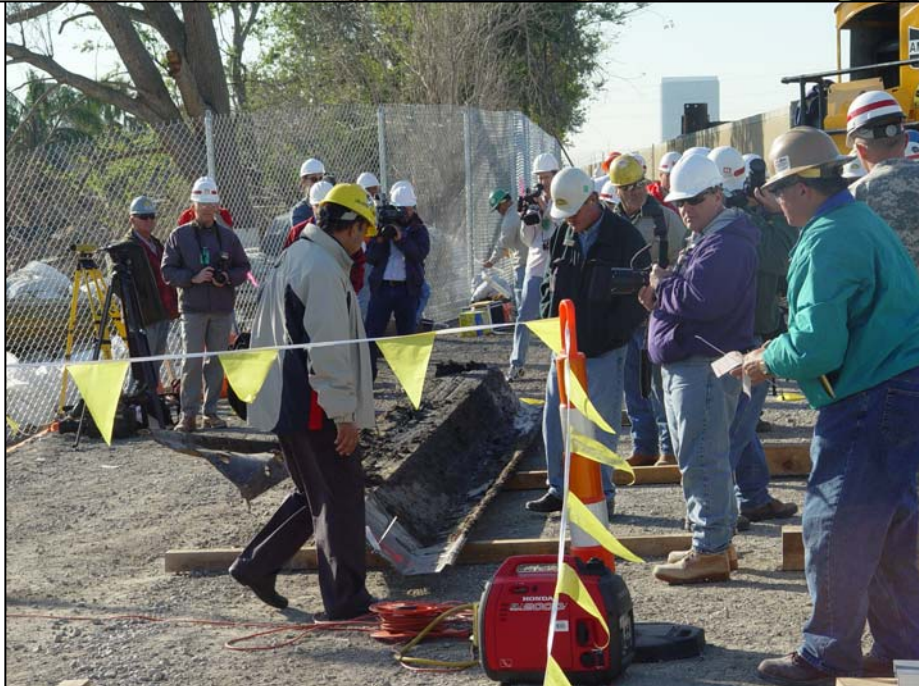
- All the major news services covered the sheetpile pull-out tests
- The Corps of Engineers and the local contractors felt vindicated, even though the sheetpiles were of inadequate length to cutoff underseepage

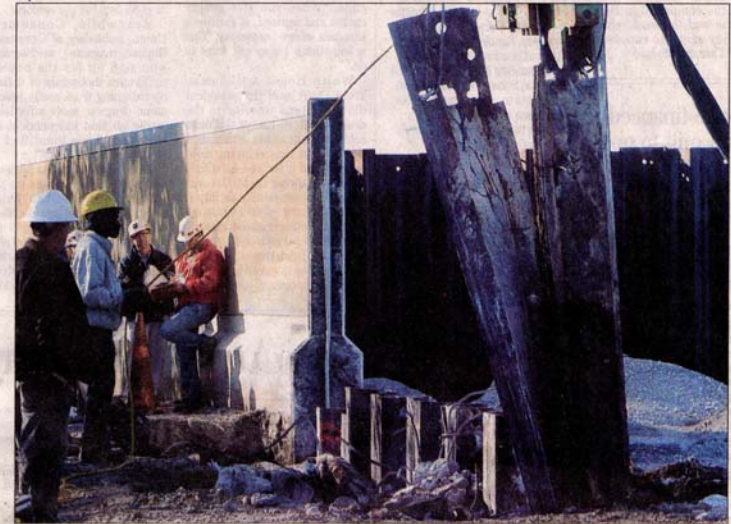
Sections of sheet pilings are pulled Tuesday from the Orleans Parish side of the 17th Street canal. The removed pilings extended to about 17 feet below sea level, as described in corps design documents. However, recent seismic and sonar testing had predicted that the sheet piles near the breach reached to only about 10 feet below sea level.

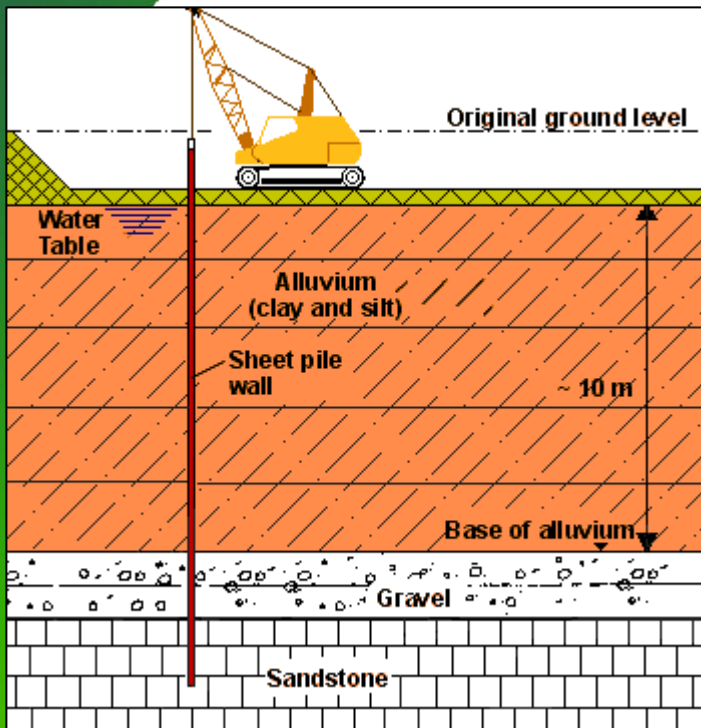
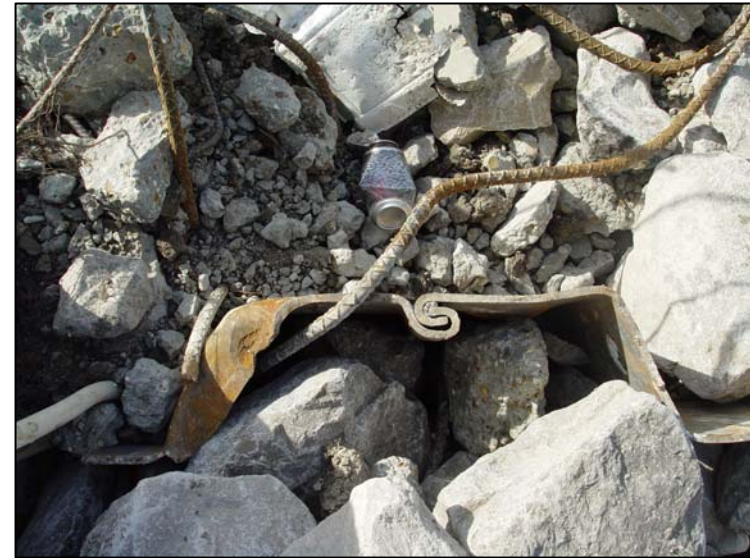
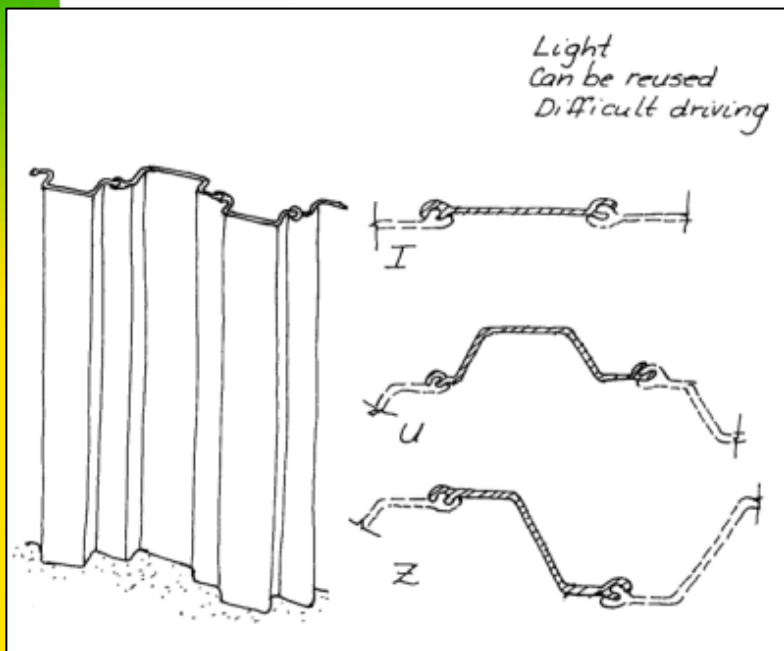
They are mechanically interlocked, but without any continuous contact, such as welds or integral structural attachments

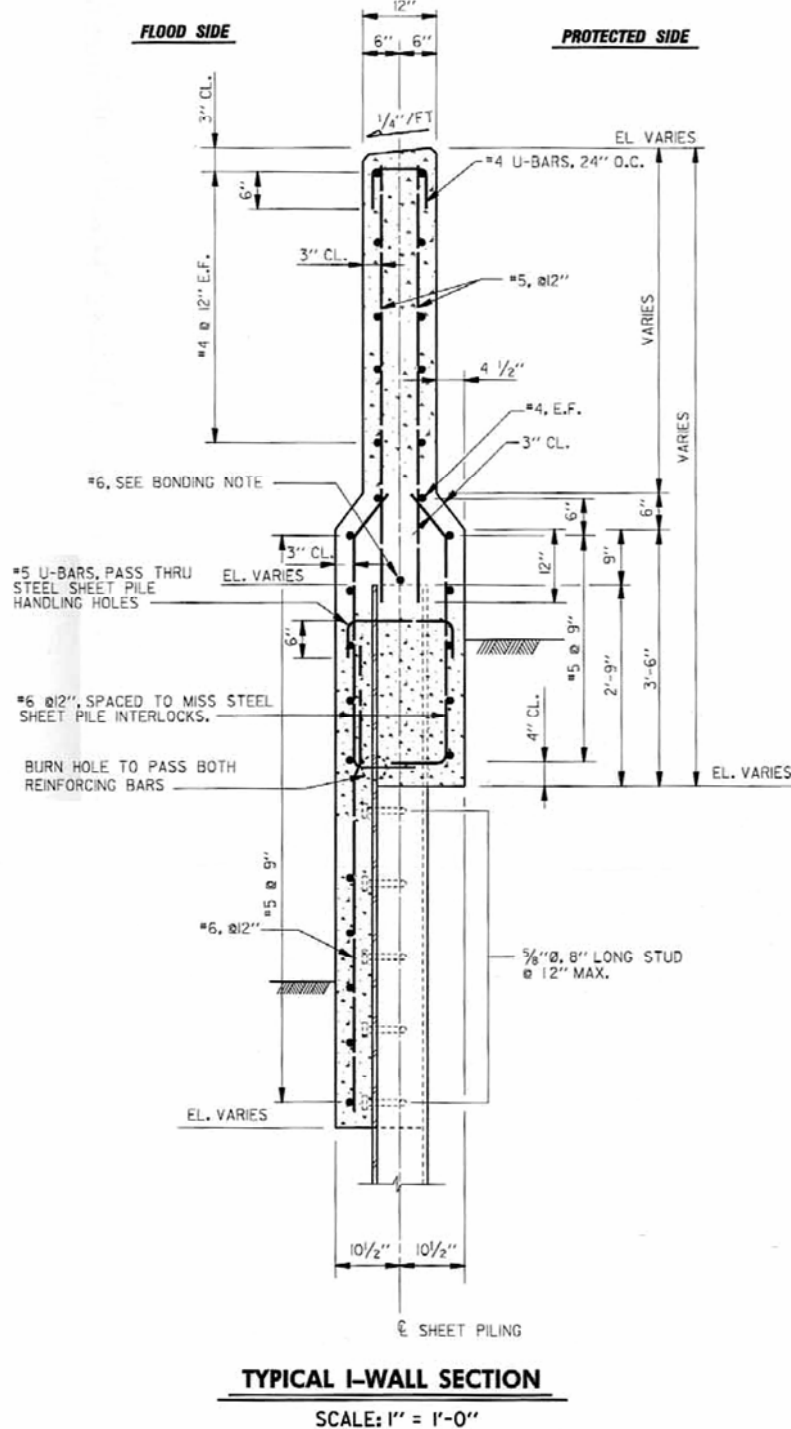
- The methods developed for parallel seismic tests had been calibrated for thick steel H-piles, not for thin, flimsy, irregularly connected sheetpiles
- Significant energy loss through concrete cap into foundation soils and into the discontinuous sheetpiles

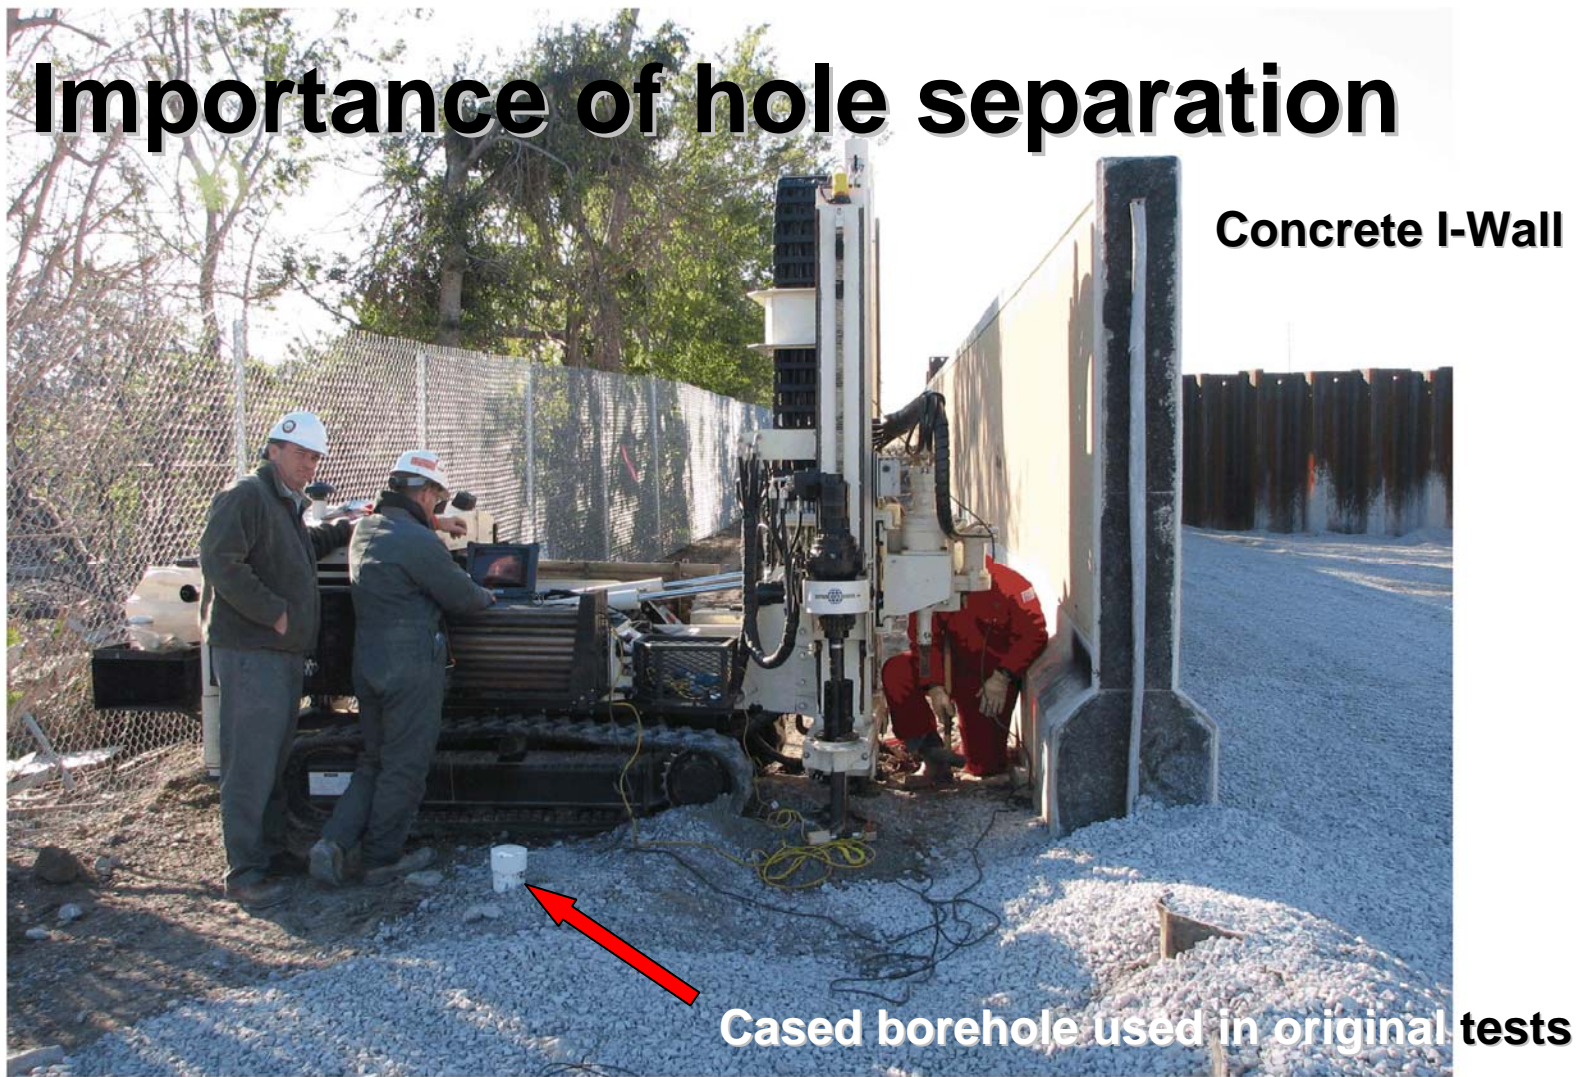
Photo 1 - Geoprobe Rig for PS/SCPT testing at South End of Breach of 17<sup>th</sup> Street Levee at Station 17+78 where sheet piles were exposed by USACE PS Cased Borehole (white PVC cap visible)

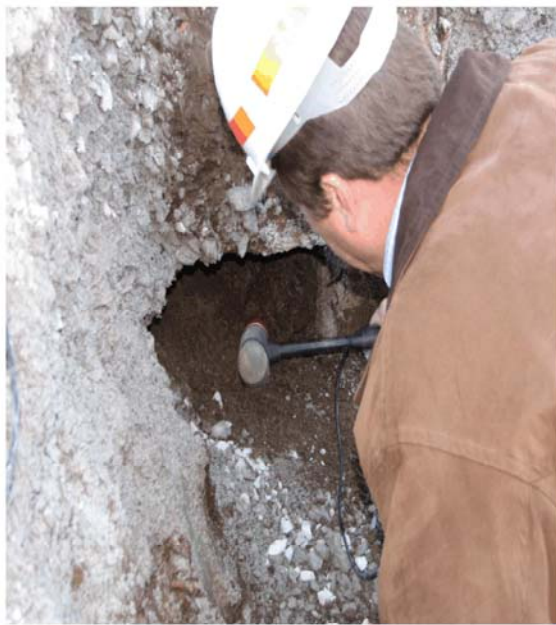
Photo 3 (Fig. 1) - Horizontal impact to sheet pile at 0.5 ft below concrete wall - protected levee side

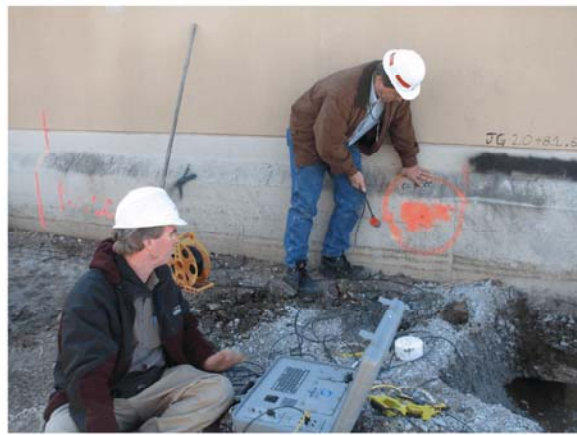
Photo 4 (Fig. 2) - Horizontal impact to side of concrete wall at el. 5 about 0.5 ft below chamfer

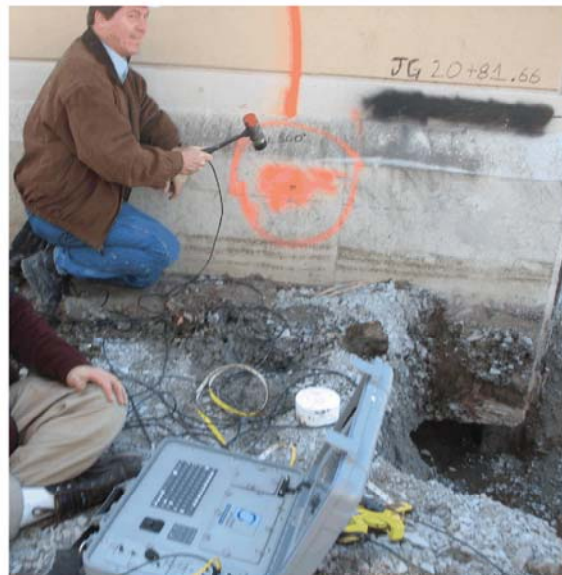
Photo 5 (Fig. 3) - Angled downward impact to chamfer of wall at ~ el. 5.75

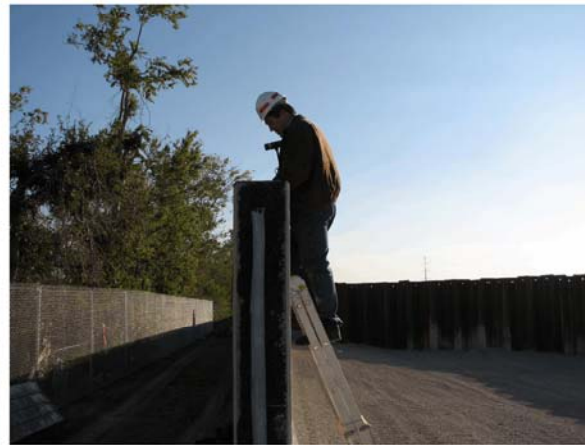
Photo 6 (Fig. 4) - Vertical downward impact to top of wall

**Hammering on top of the concrete wall (Photo 6) produced the best results, without any site modification**

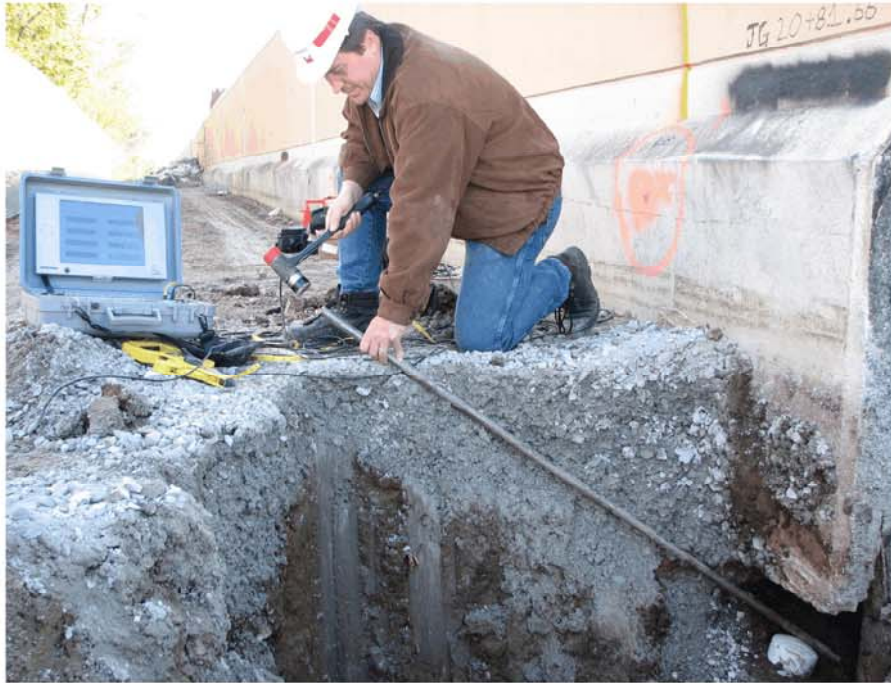
Photo 7 (Fig. 5) - Angled impact to 1 inch diameter, 6 ft long steel rod held at an angle on sheet pile side at 0.5 ft below concrete - protected levee side

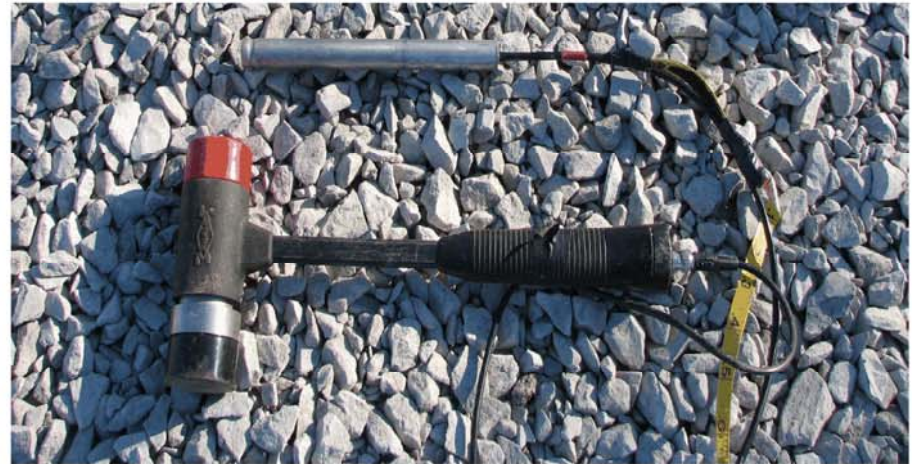
Photo 8 - 3-lb Impulse Hammer with black hard plastic tip and small diameter hydrophone used in PS re-tests

- **The energy input method that gave the best results was employed hammer impact to steel rod actually contacting the sheetpile. This required some local excavation of the footing.**

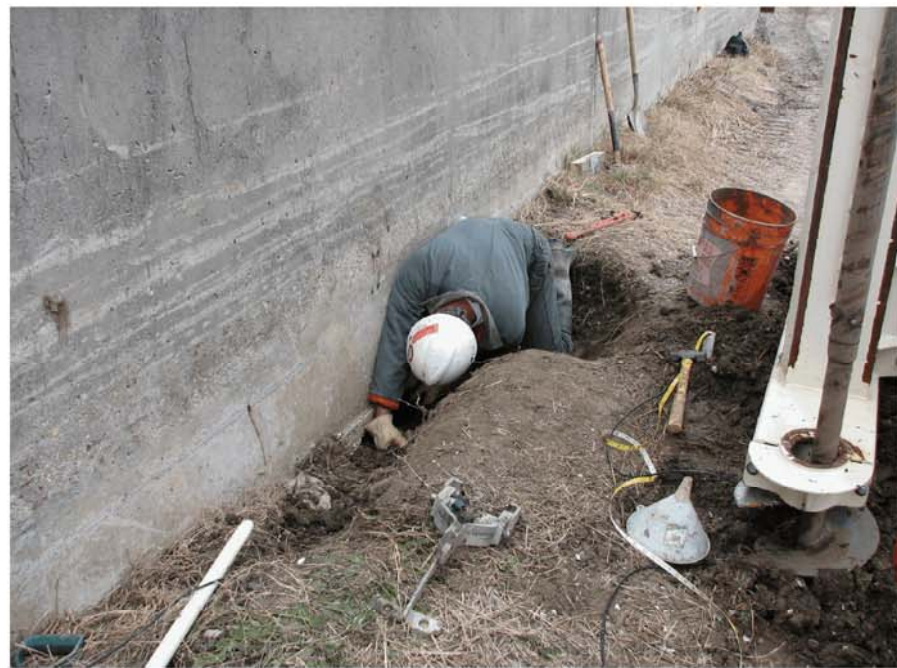
Photo 9 - IHNC 3-lb Impulse hammer impacts to sheet pile on canal side at Station 17+11

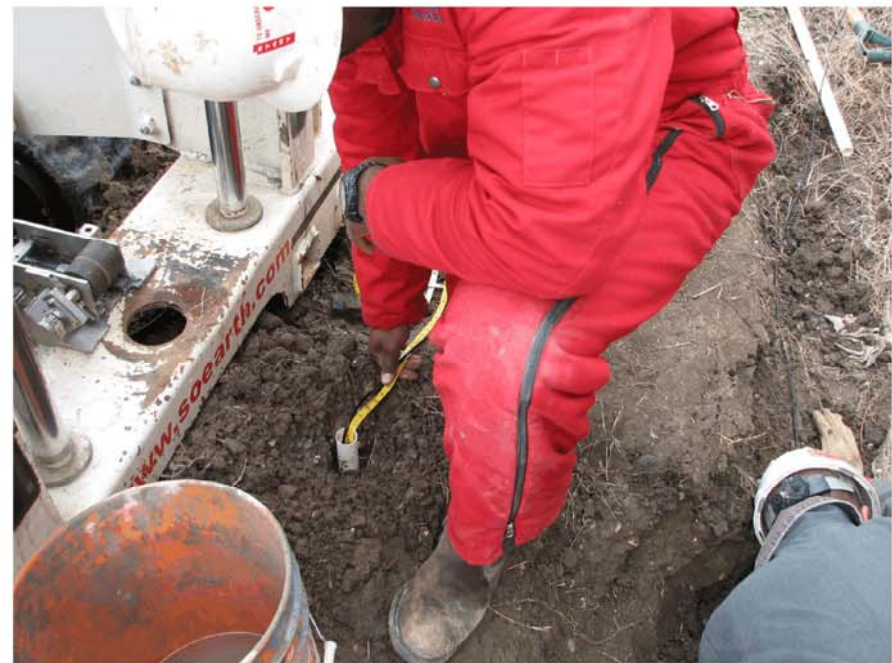
Photo 10 - Small Hydrophone receiver on tape in 1 inch PVC casing installed by Geoprobe Rig at IHNC

- **Another method used on the Inner Harbor Navigation Canal walls employed an impact hammer directly against the sheetpiles, after excavating a small trench. Olson Engineering also inserted hydrophones in small Geoprobe cone penetrometer sounding holes (right).**

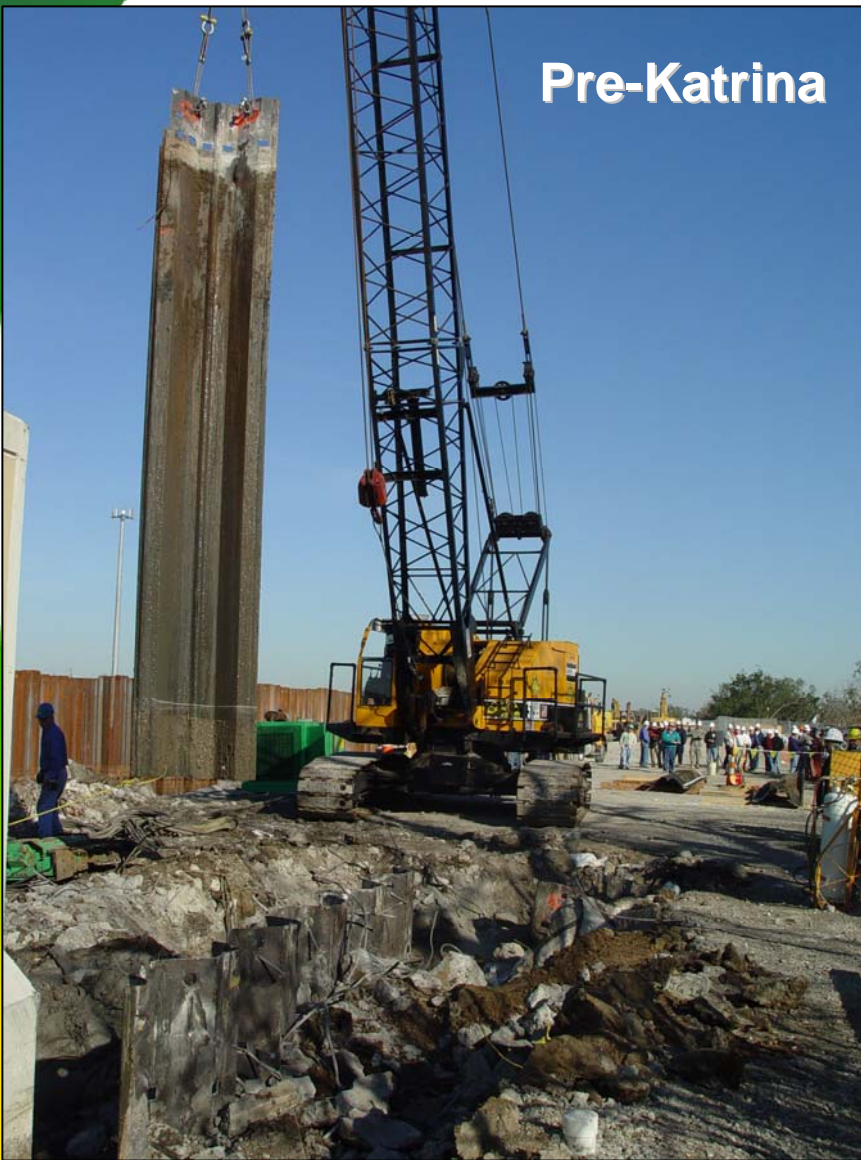
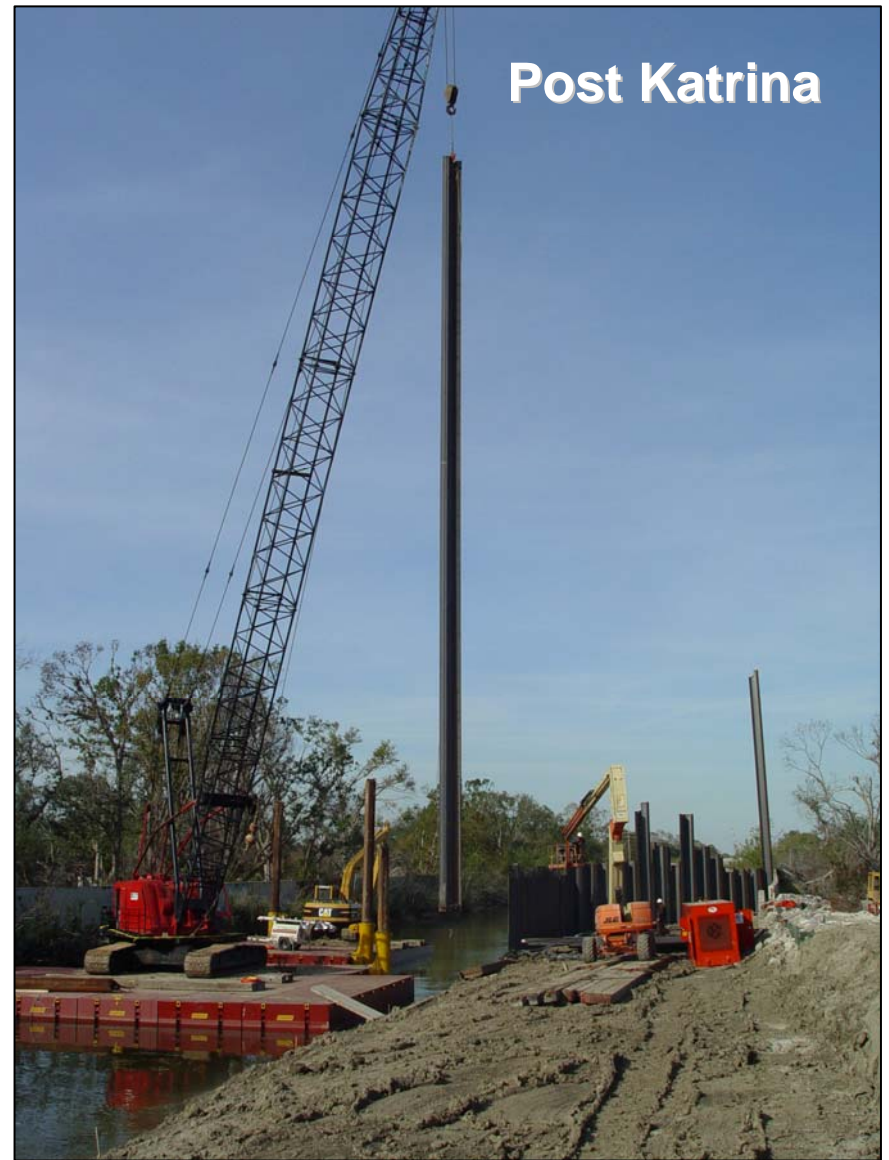
- Contrast between **pre and post-Katrina** sheetpile lengths on the drainage canal walls

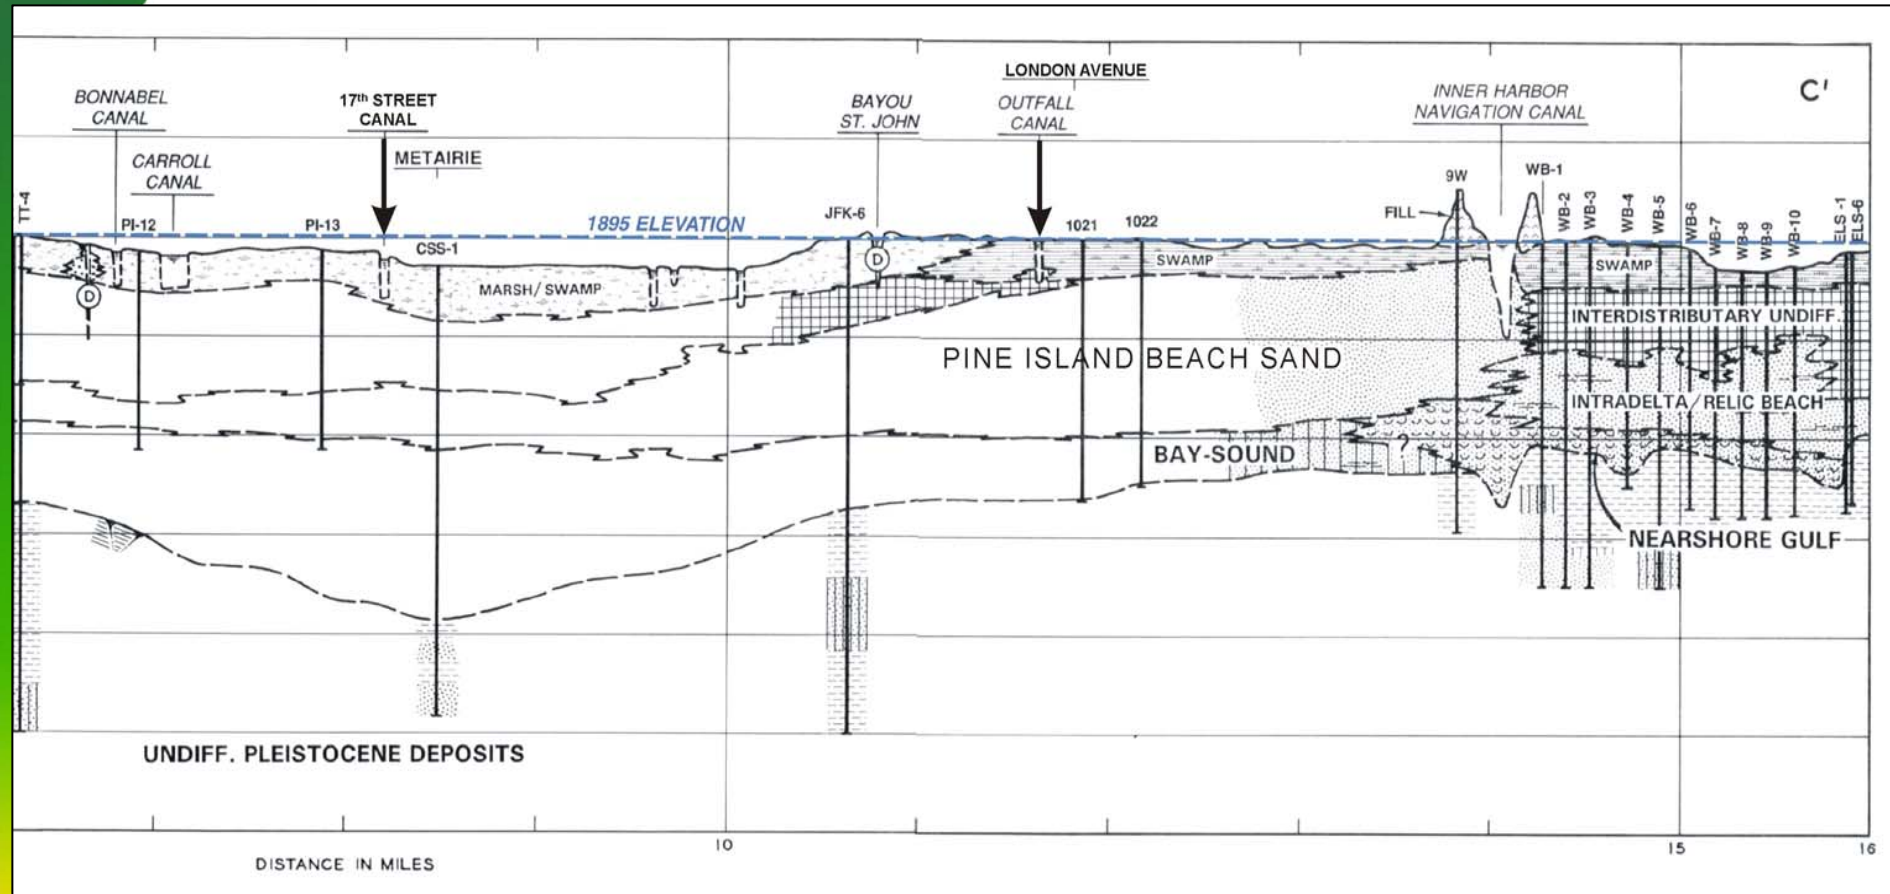
- **Geologic cross section along south shore of Lake Pontchartrain in the Lakeside, Gentilly, and Ninth Ward neighborhoods, where the 17<sup>th</sup> Street, London Avenue, and IHNC levees failed during Hurricane Katrina on Aug 29, 2005. Notice the apparent settlement that has occurred since the city survey of 1895 (blue line), and the correlation between settlement and non-beach sediment thickness.**
