# UNRAVELLING THE LEVEE FAILURES IN NEW ORLEANS DURING HURRICANE KATRINA – WHAT WE ALL SHOULD KNOW

**J. David Rogers, Ph.D., P.E., R.G.**

Member, National Science Foundation Independent Levee Investigation Team and  
Karl F. Hasselmann Chair in Geological Engineering  
University of Missouri-Rolla

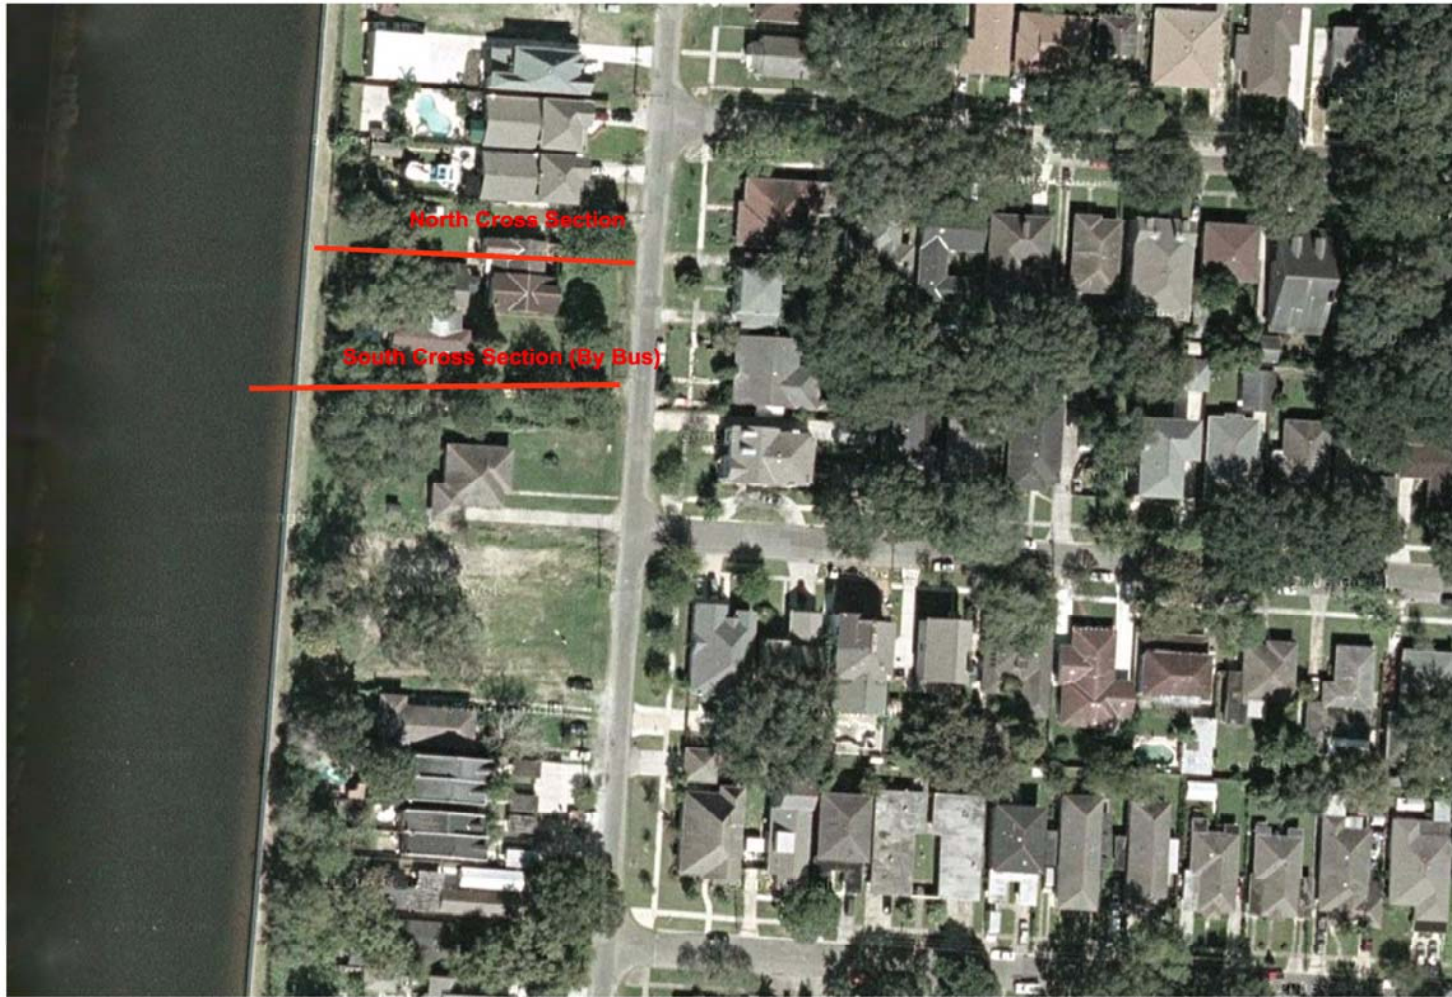
## 17th St. OUTFALL CANAL LEVEE BREAK CROSS SECTION LOCATIONS

- **Aerial photo of the 17<sup>th</sup> Street Canal breach site before the failure of August 29, 2005. The red lines indicate the positions of the NSF team's geologic sections.**

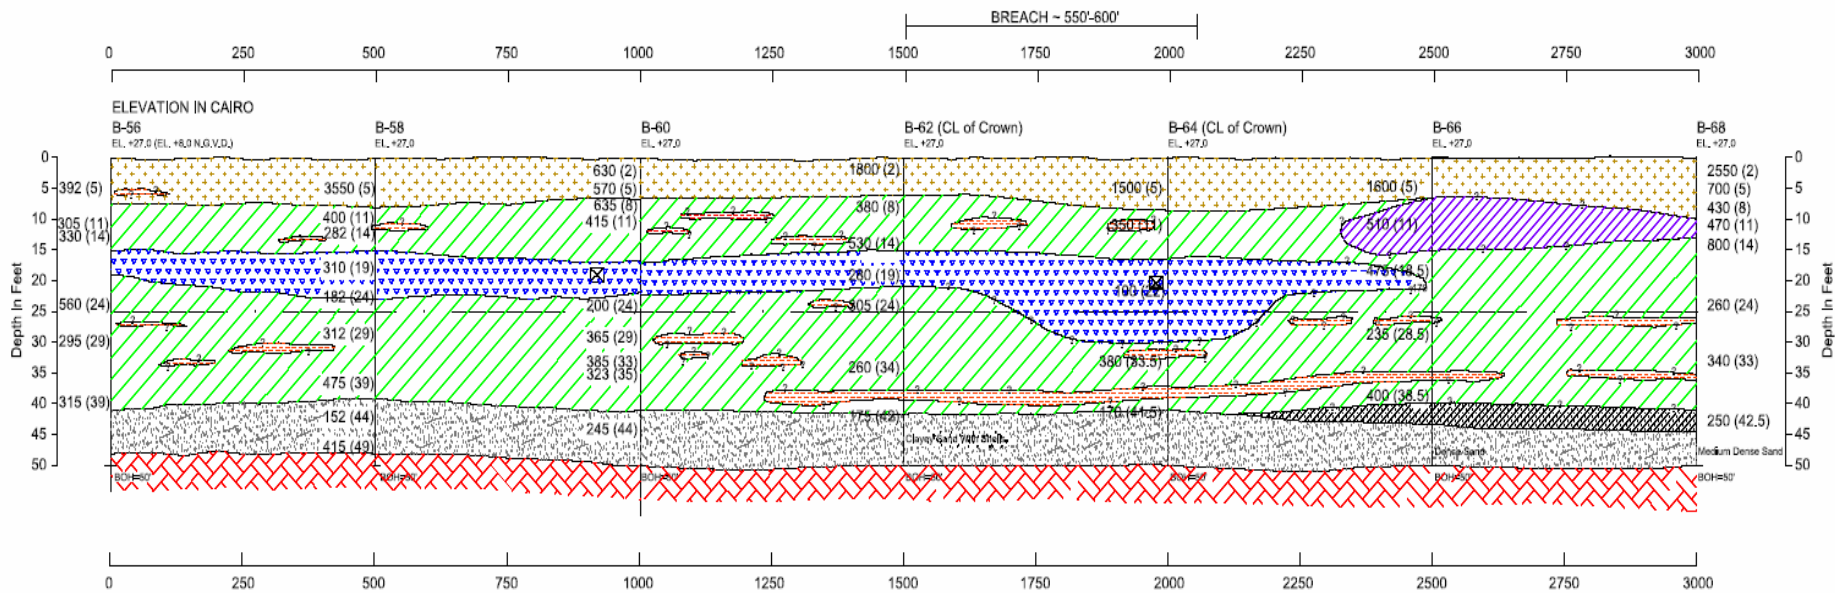
17th Street Canal East Levee- Draft Soil Profile  
New Orleans, Louisiana

- **Alternative interpretation of the Eustis 1982 borings for the 17<sup>th</sup> Street Canal East Levee, near the 2005 break. In this case the swamp deposits would extend beneath the sheetpile tips over a zone 300 feet long, where the break occurred.**

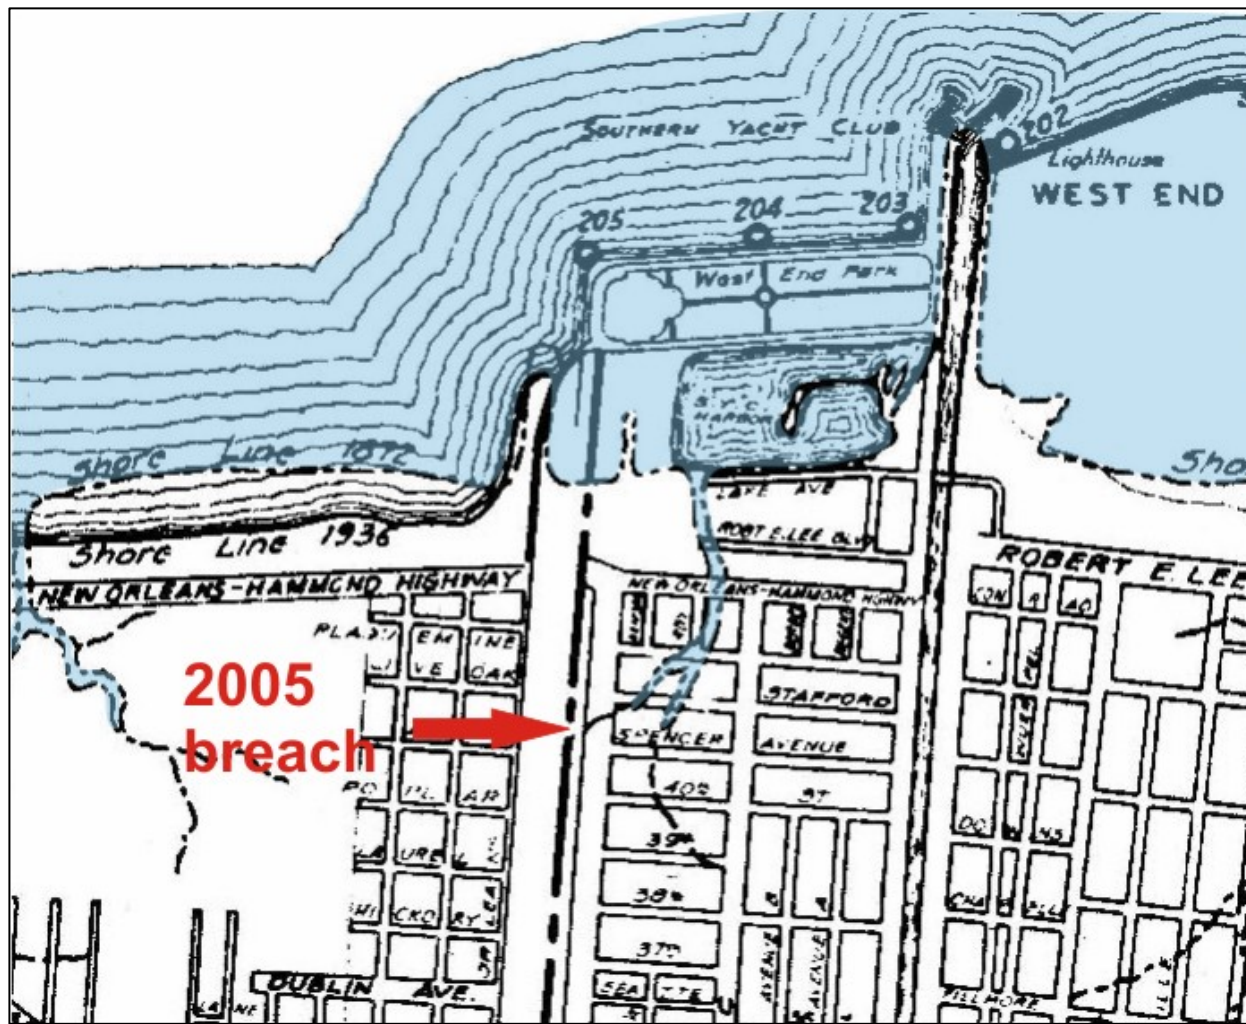
2005  
breach

- **Map overlay** assembled by Prof. Joe Suyhada at LSU by overlaying 1872 Sulakowski map on the 1937 WPA map, showing the 1872 shoreline and sloughs (in blue) along Lake Pontchartrain.
- The position of the 2005 breach along the east side of the 17<sup>th</sup> Street Canal is indicated by the red arrow.

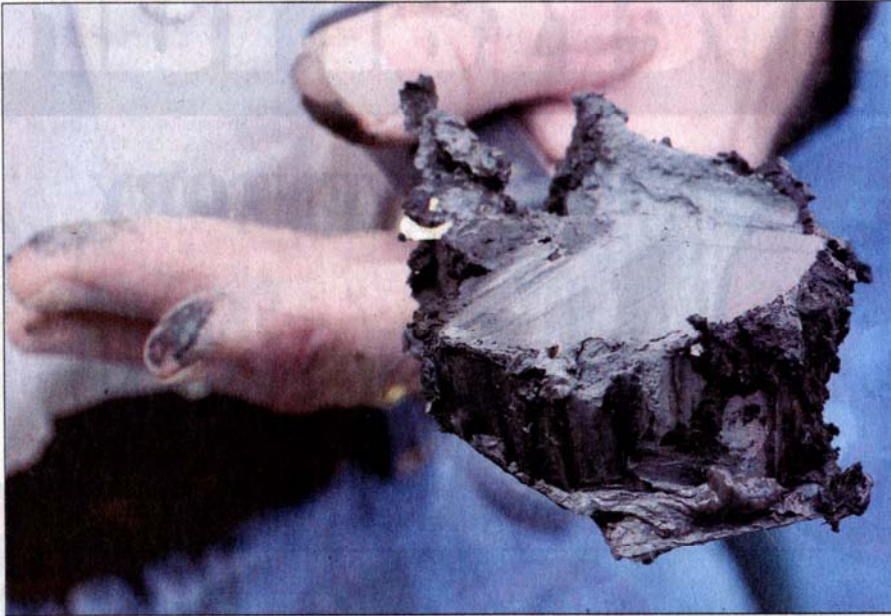
This piece of clay was just above the peat area at the site of the 17th Street Canal floodwall breach.

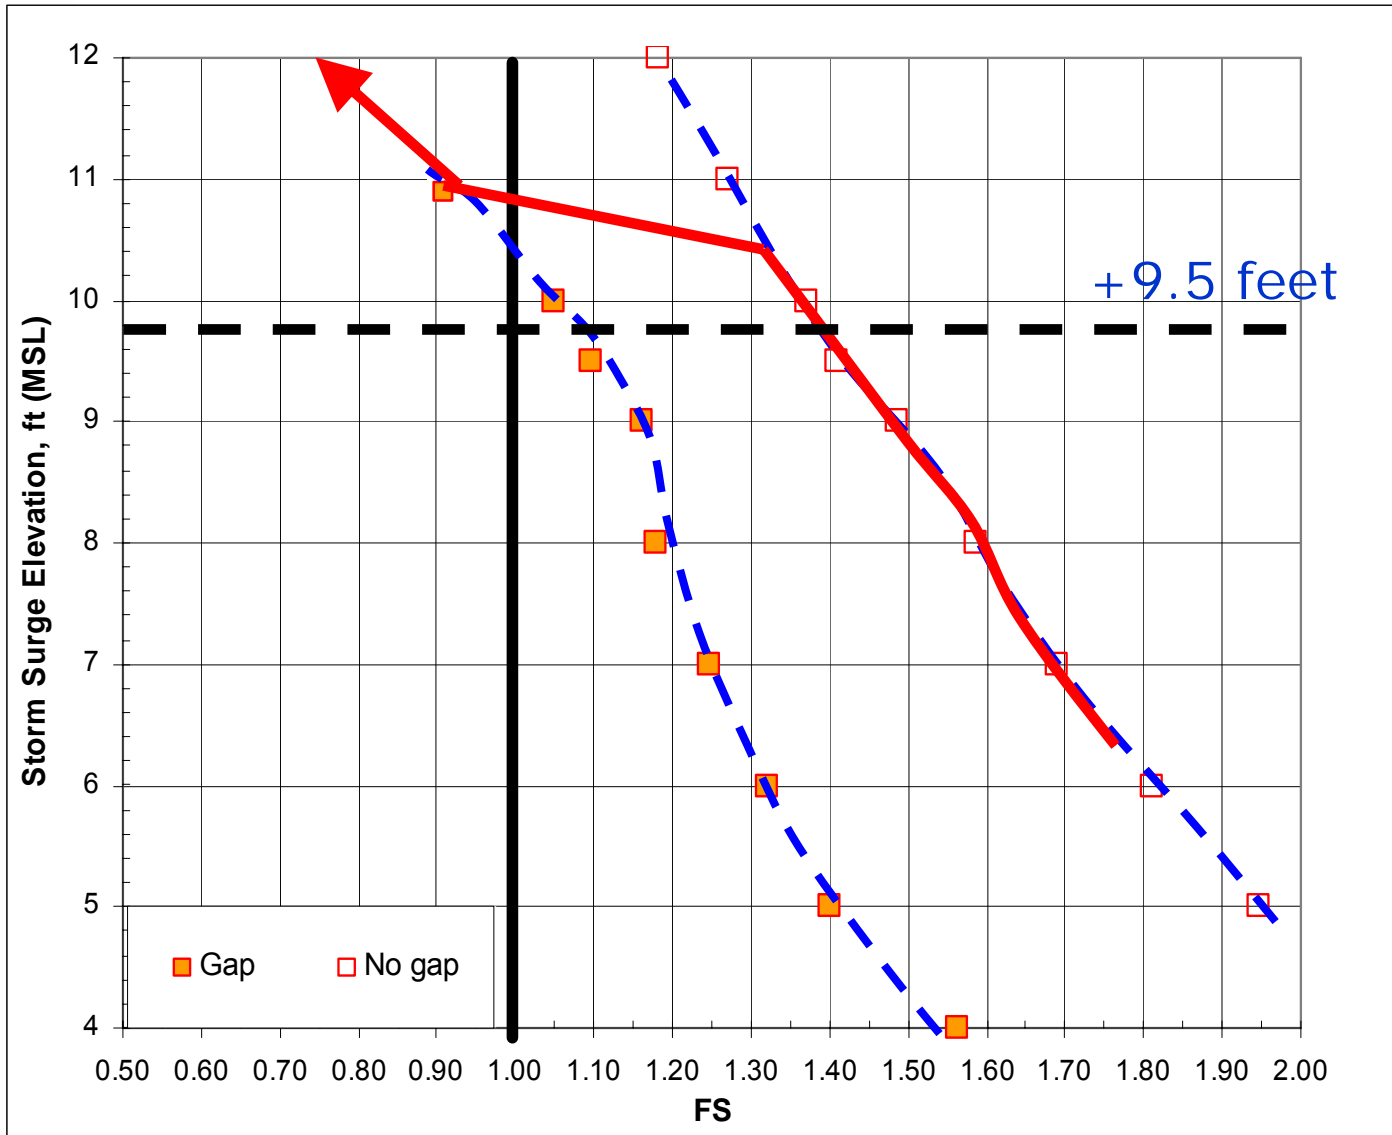
# 17<sup>th</sup> Street Canal, West Bank

- The NSF team assuaged that the bend in the flood wall on the west (unfailed) side of the 17<sup>th</sup> St Canal was evidence of an incipient failure
- The Corps didn't initially agree publicly

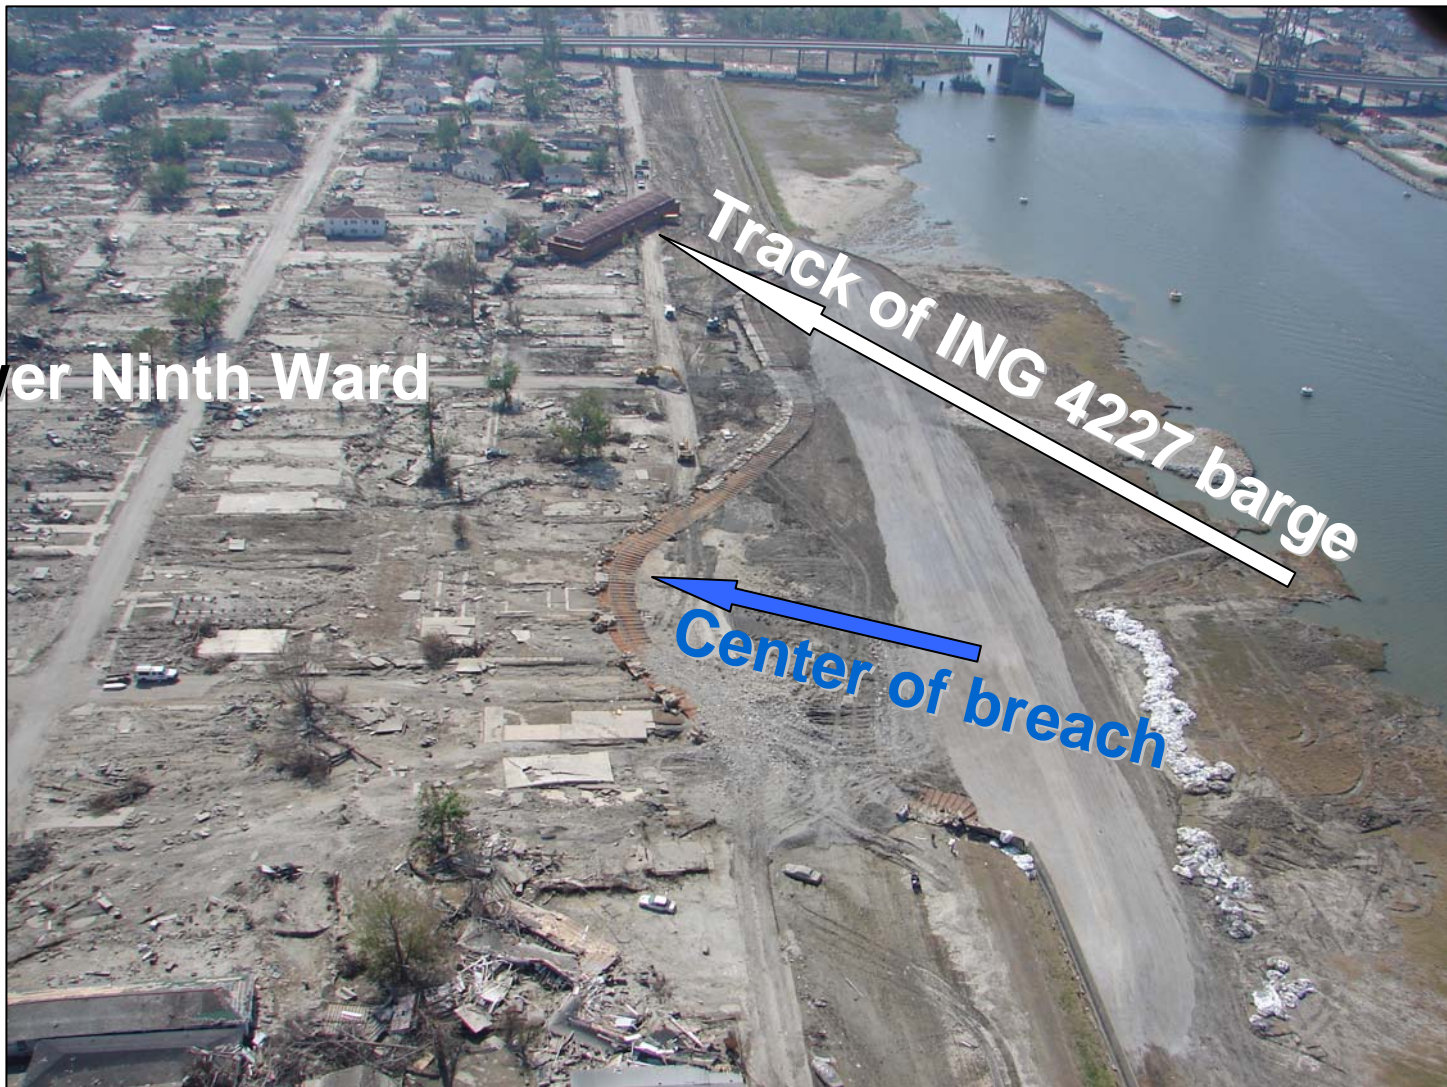
- **Aerial view of the south breach of the Inner Harbor Navigation Channel (IHNC) in the Lower Ninth Ward of New Orleans.**
