# **Levee Design Issues revealed by Post- Katrina Studies in Louisiana**

**J. David Rogers, Ph.D., P.E., P.G.**

**American Society of Civil Engineers**

**Central Pennsylvania Geotechnical Conference**

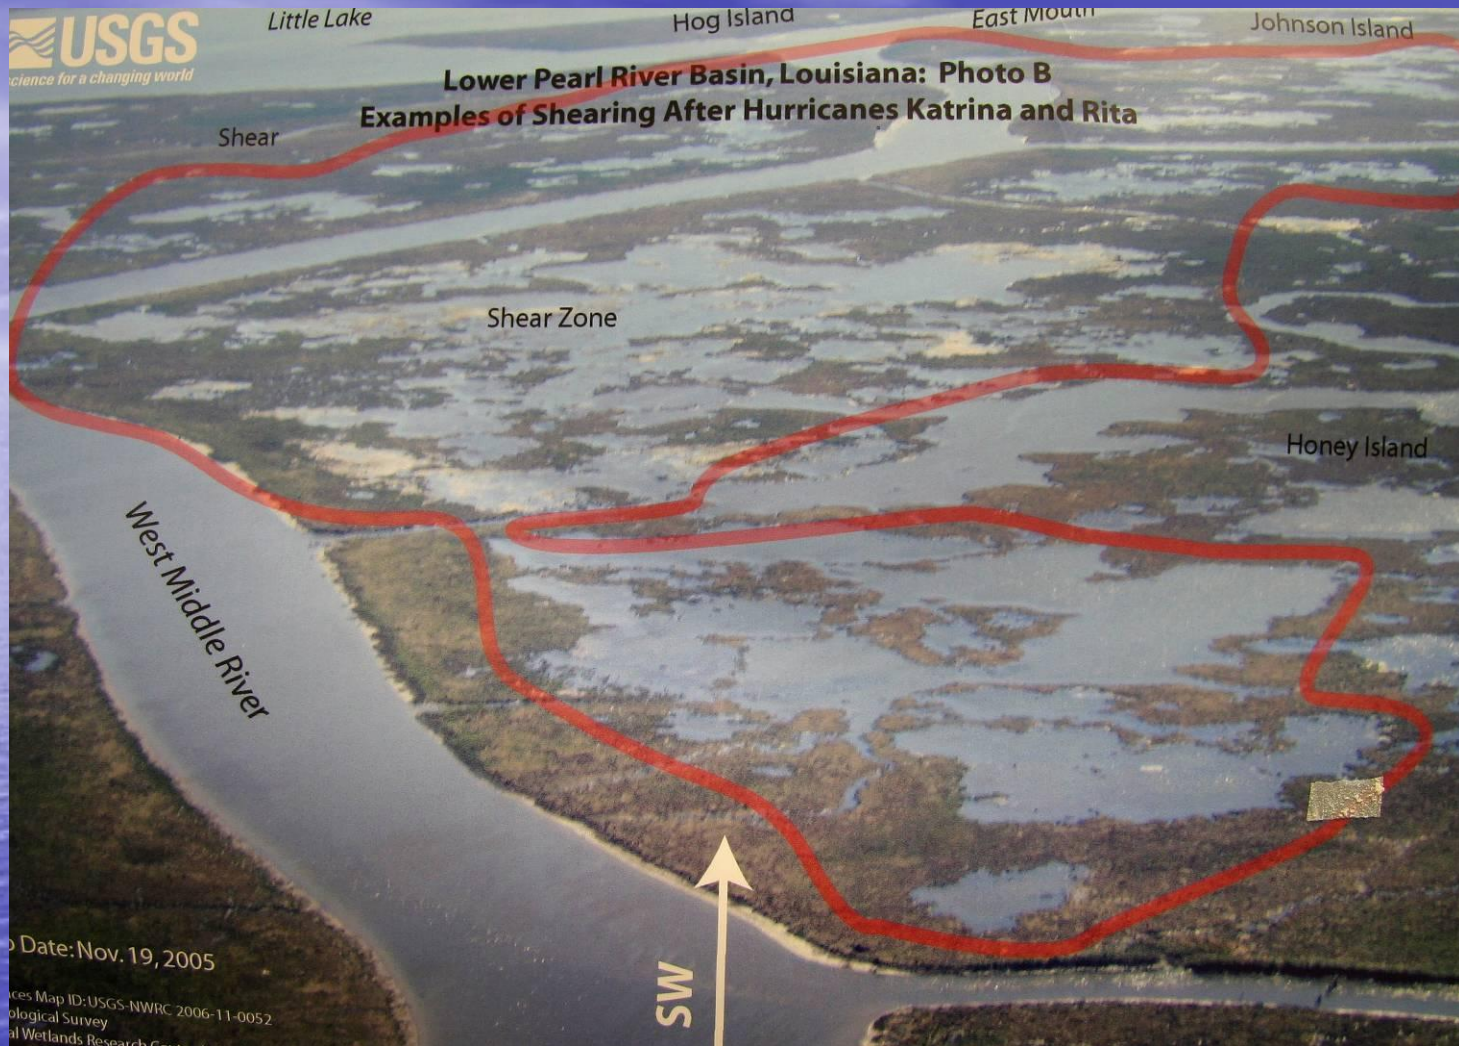
- Acute wind shear from Hurricane Katrina stripped off large tracts of floating marsh across the Mississippi Delta (from USGS). ***How can we construct sustainable levees on these kinds of materials?***

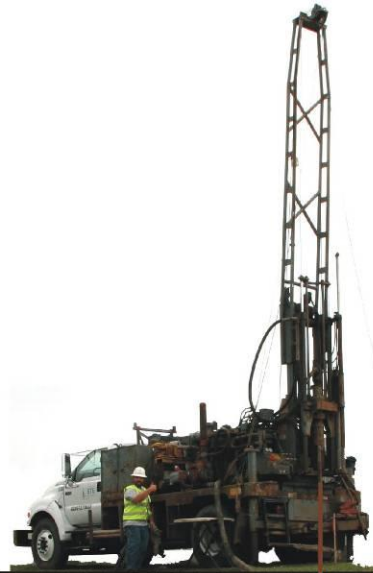
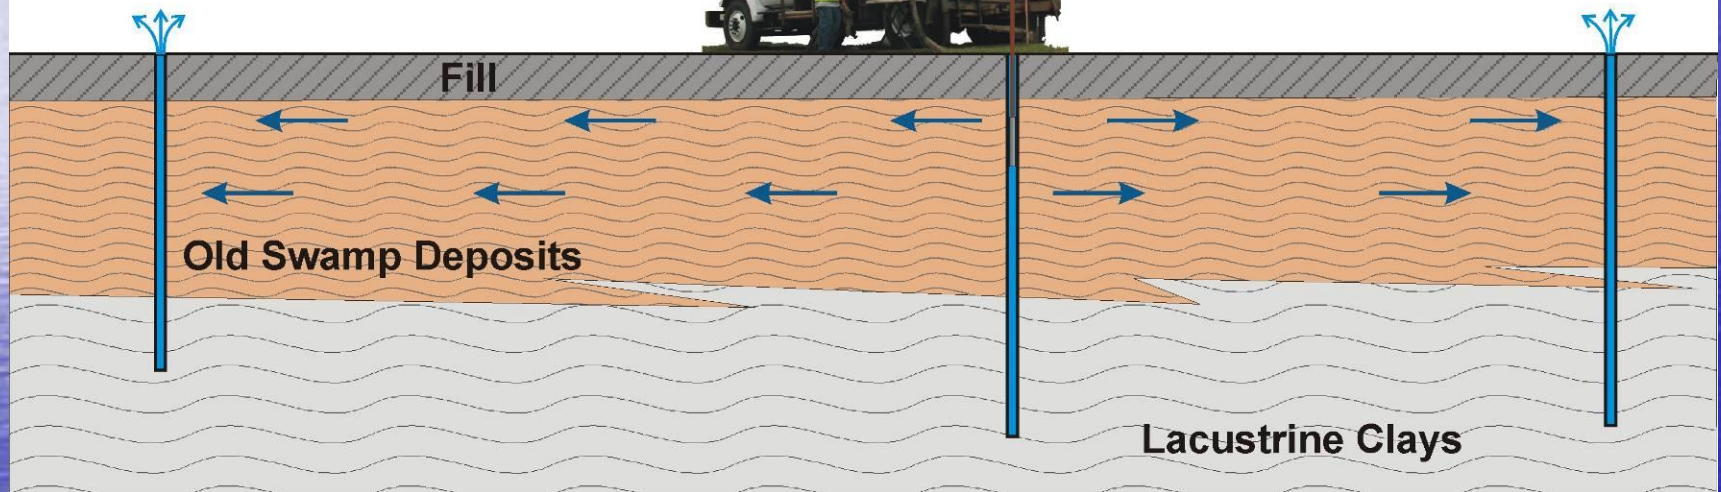
Water squirted up adjacent boreholes when advancing Shelby tubes

Drill rig advancing Shelby tubes in backswamp deposits

- The porous and highly conductive nature of the backswamp deposits was revealed during post-Katrina drilling and sampling operations.
- Highly conductive in horizontal plane

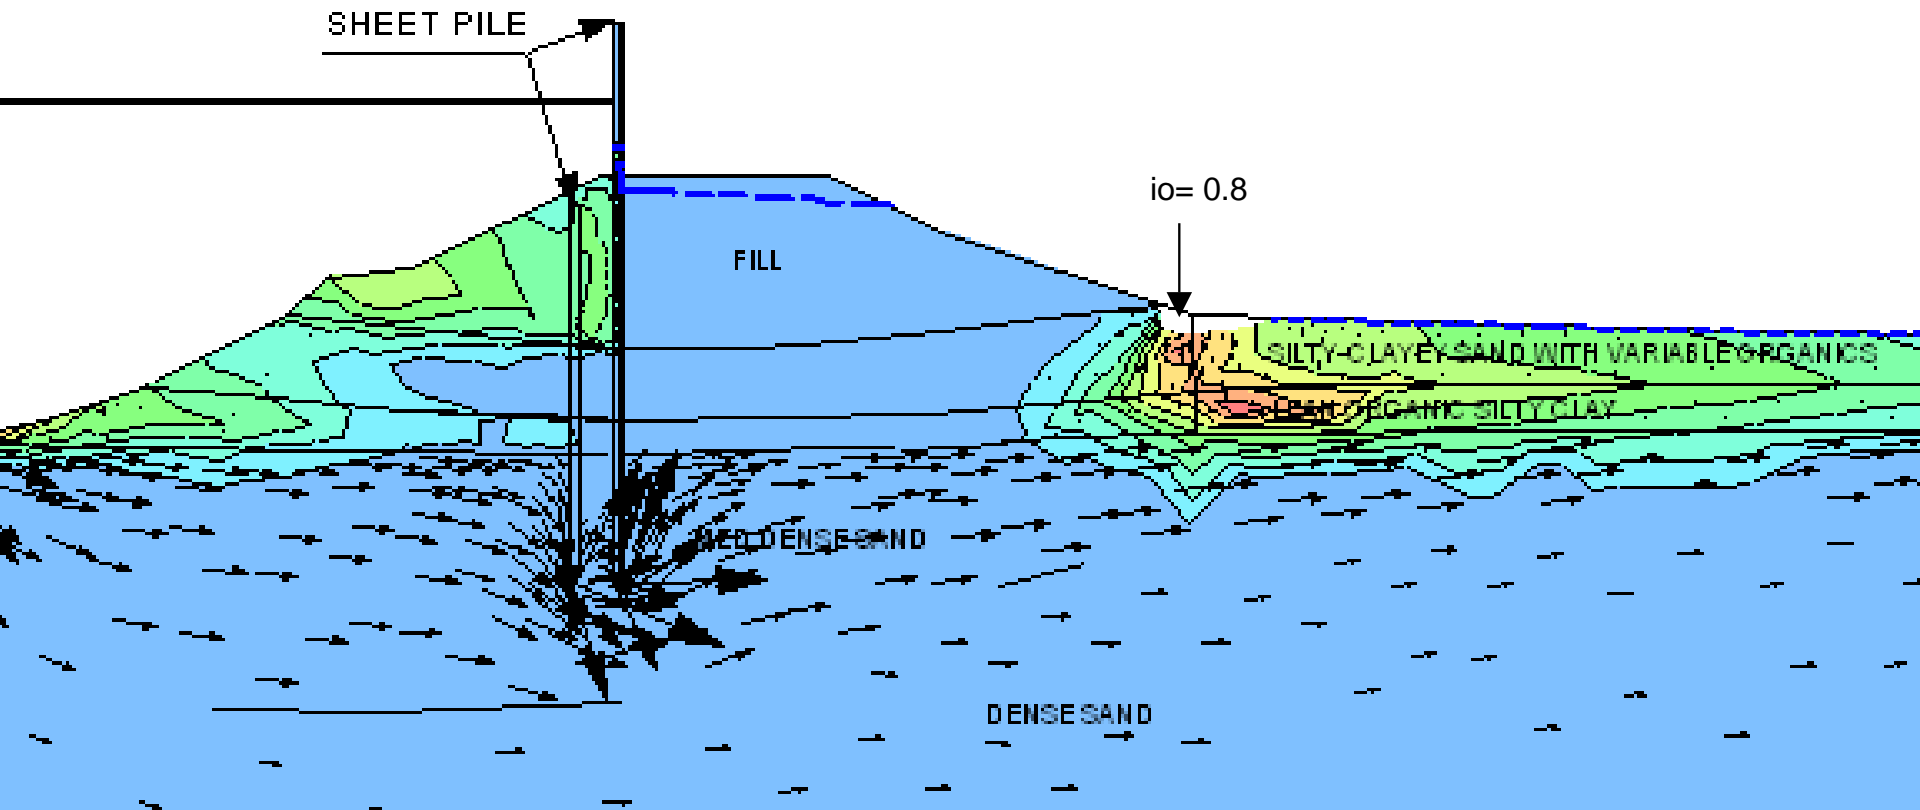
# Pervious foundation materials most at risk - London Avenue Canal (South Breach)

**Very little reliable data exists on horizontal hydraulic conductivity of foundation soils in the Mississippi Delta**

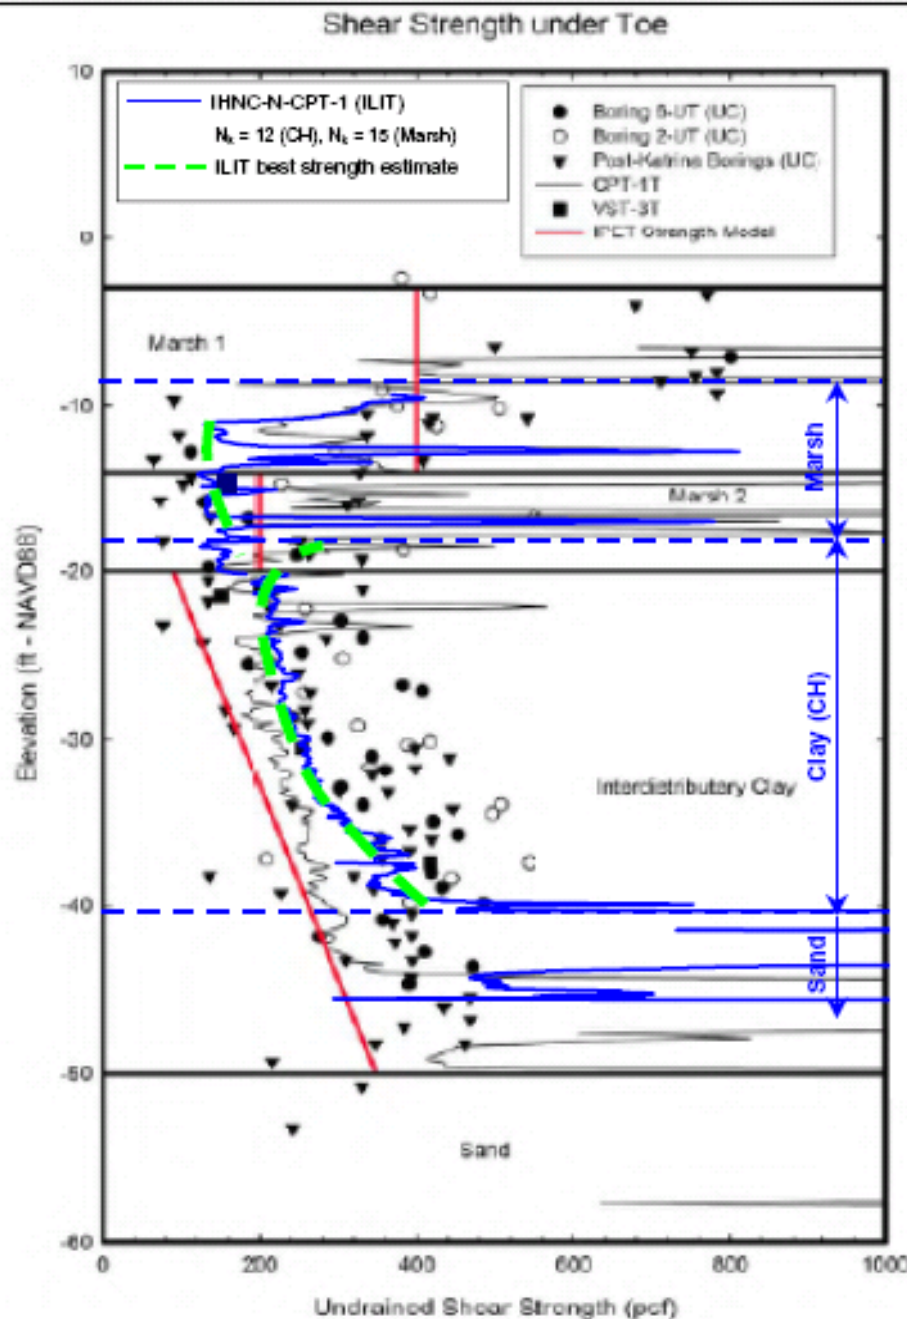
Undrained shear strength vs depth at the East IHNC North Breach

Blue lines shows profile of CPT-1, with NGI tip corrections for the three units encountered

Green line shows strength profile selected by the NSF team

Red lines shows strength profile used by the IPET team; which allows a rotational stability failure sometime between 5:30 and 6:00 AM

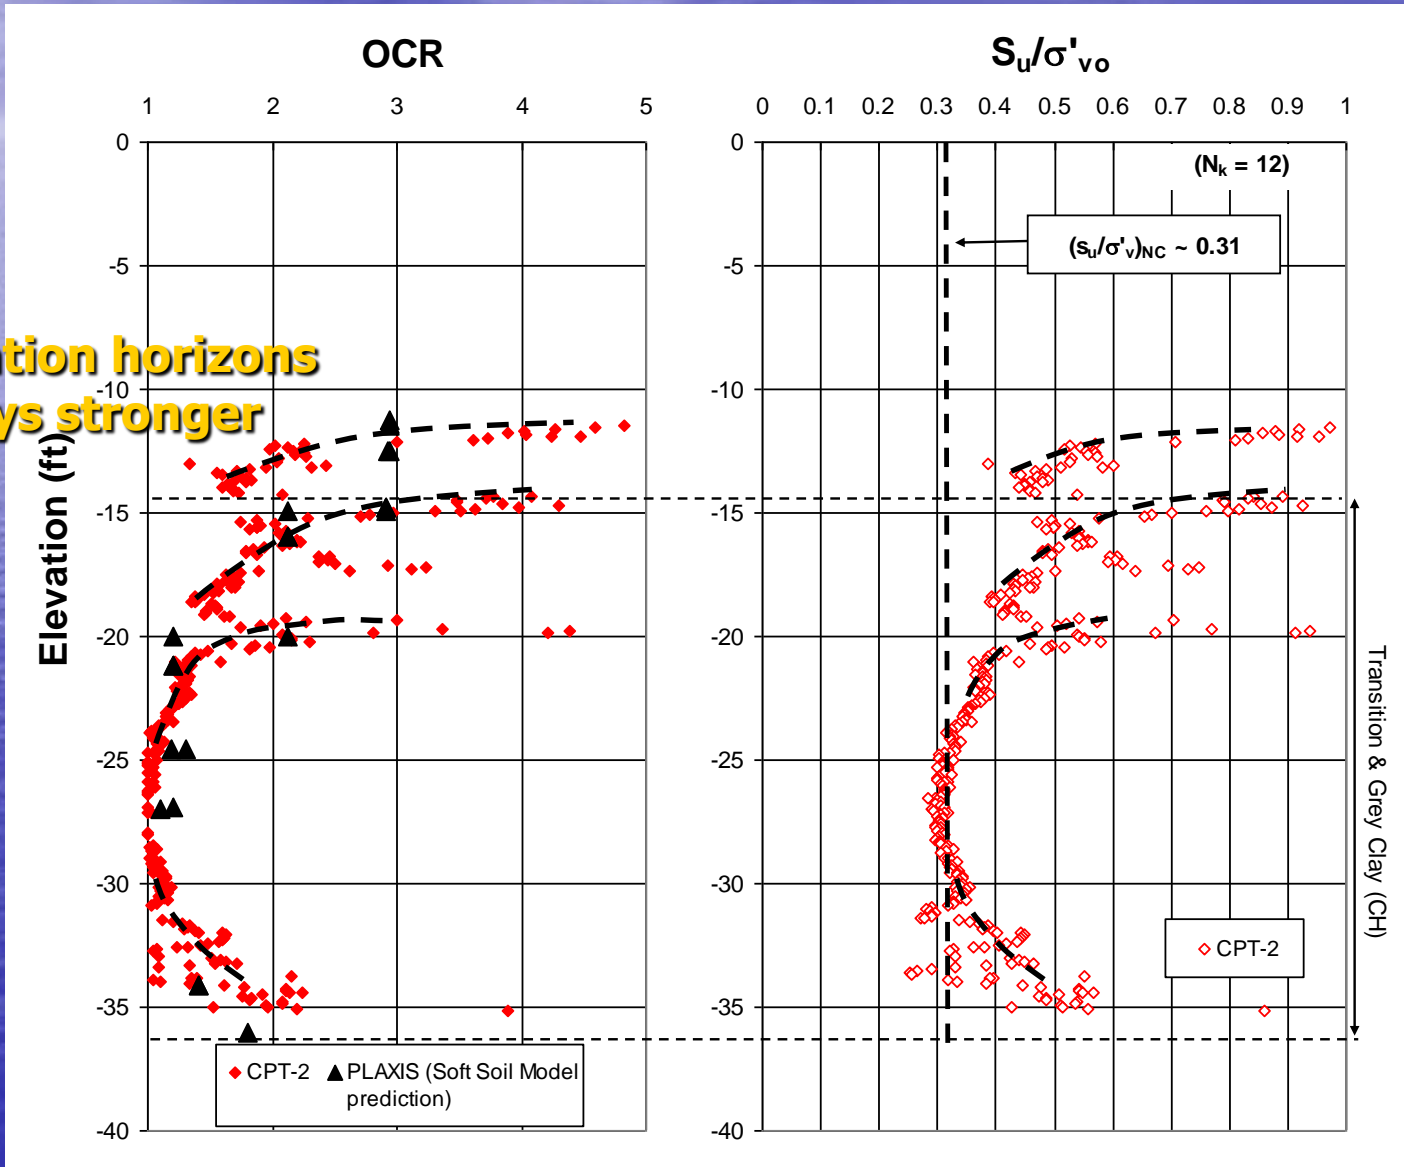
# 17<sup>th</sup> Street Canal: Soft Gray Clay (CH) Desiccation Horizons Beneath Levee Toe

Desiccation horizons  
always stronger

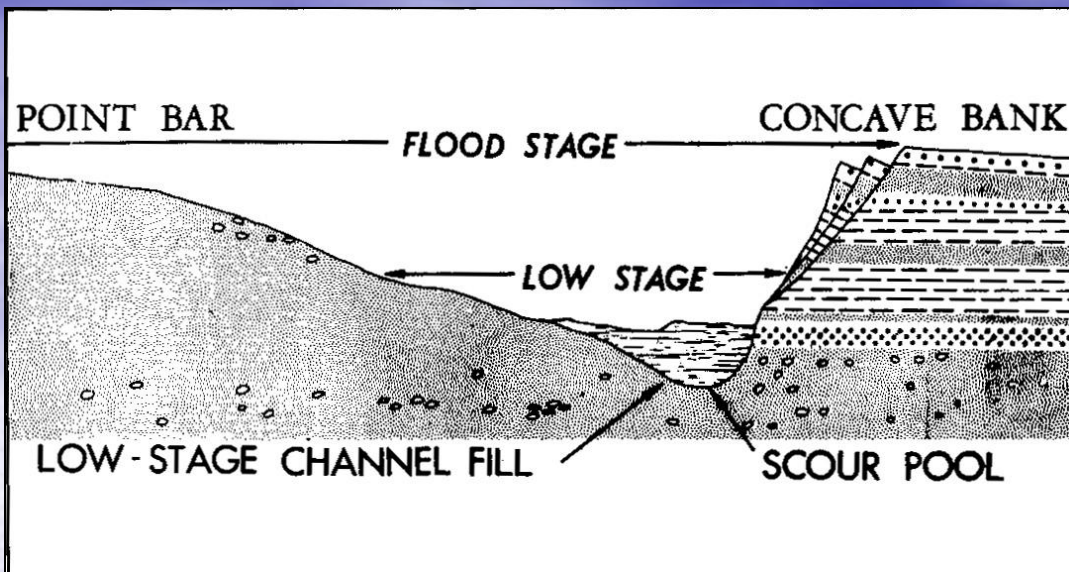
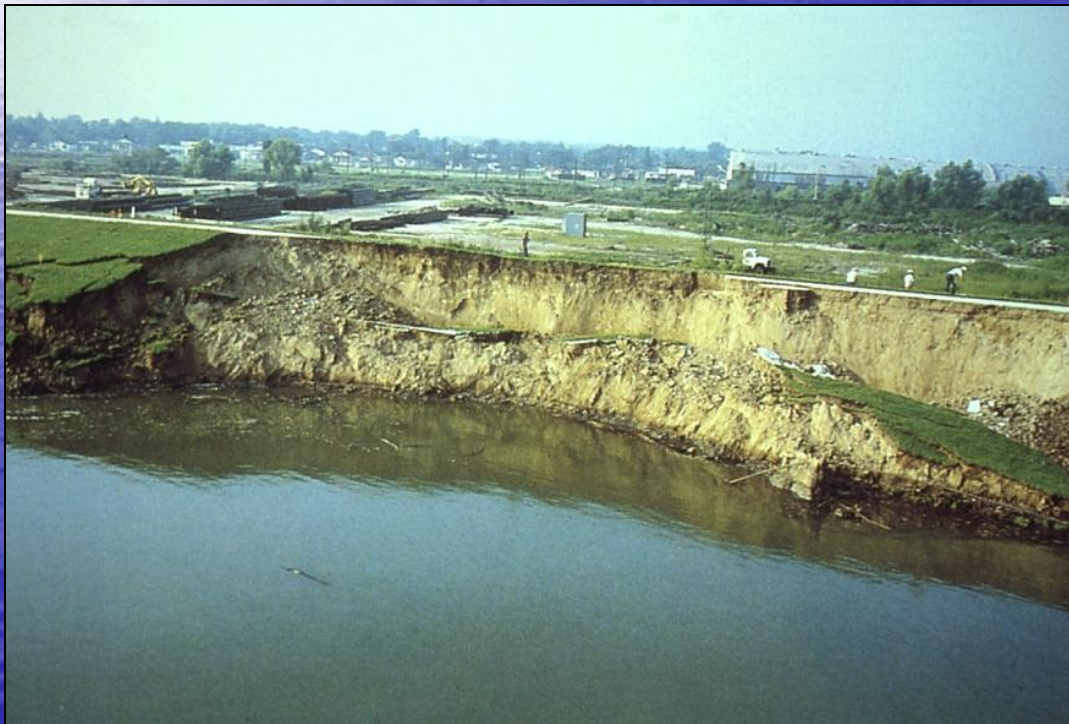
- The Mississippi channel is **sinuous**; migrating towards the outside of downstream bends through bank undercutting. Levees had to set back from these bends.
- The **Celotex levee failure** of July 31, 1985 was a sizable flow failure that involved a substantive portion of the *natural riverbank* along the Mississippi near River Mile e 100 in the West Jefferson Parish.
- This was one of the Corps of Engineers "**standard project levees**," expected to protect adjacent land for the **500-year recurrence frequency flooding**.

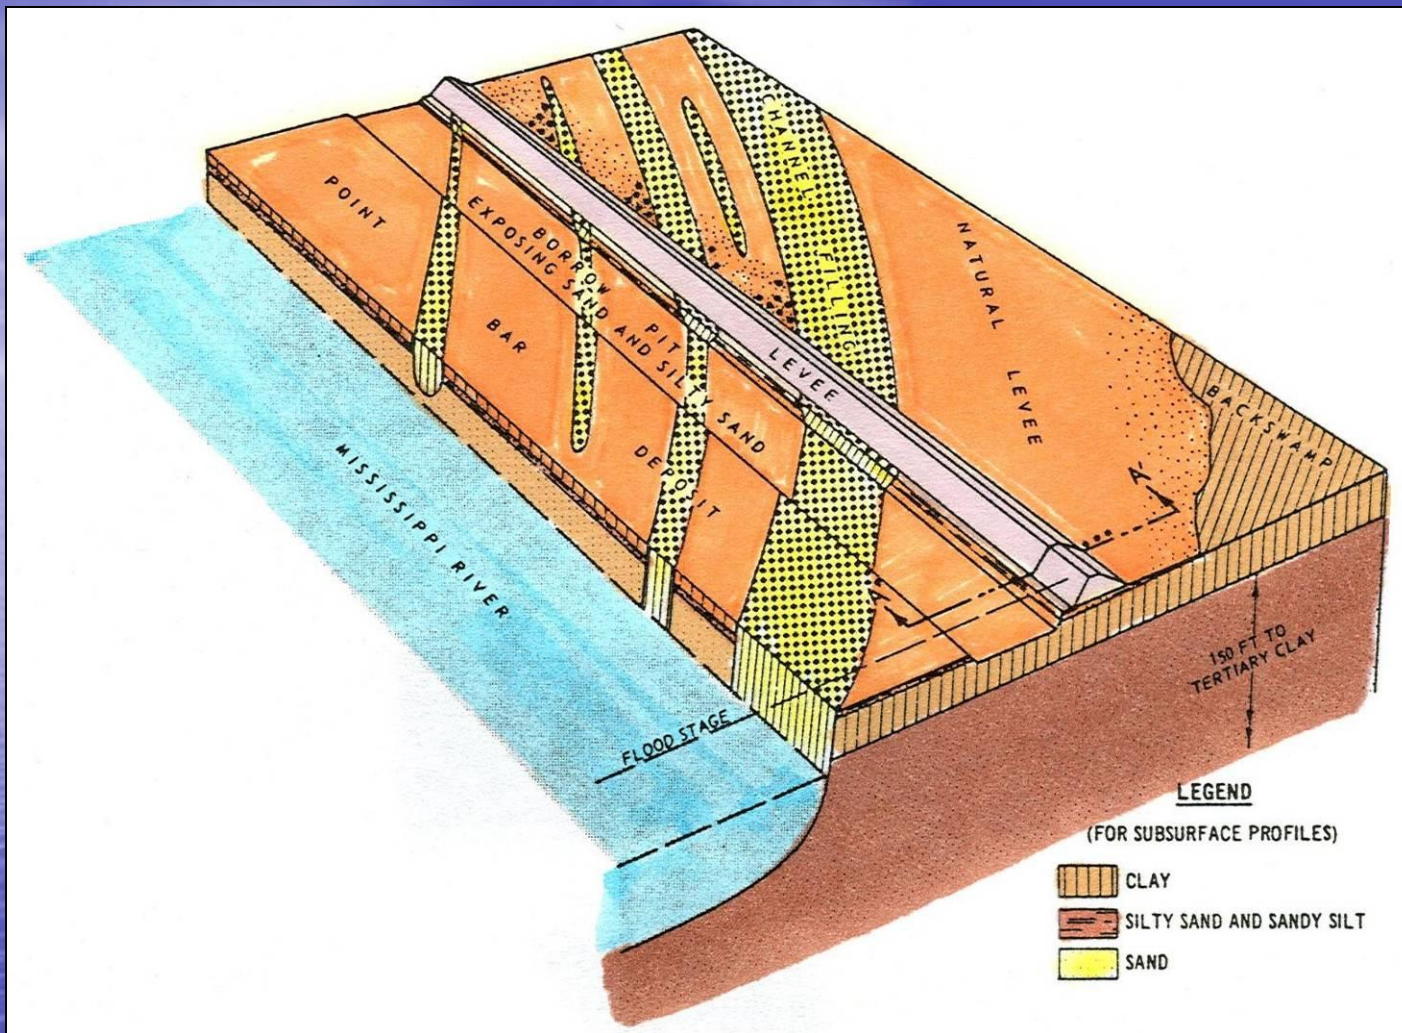
- **Permeability contrasts** caused by clay filled oxbows create treacherous and contrasting foundation conditions beneath levees.

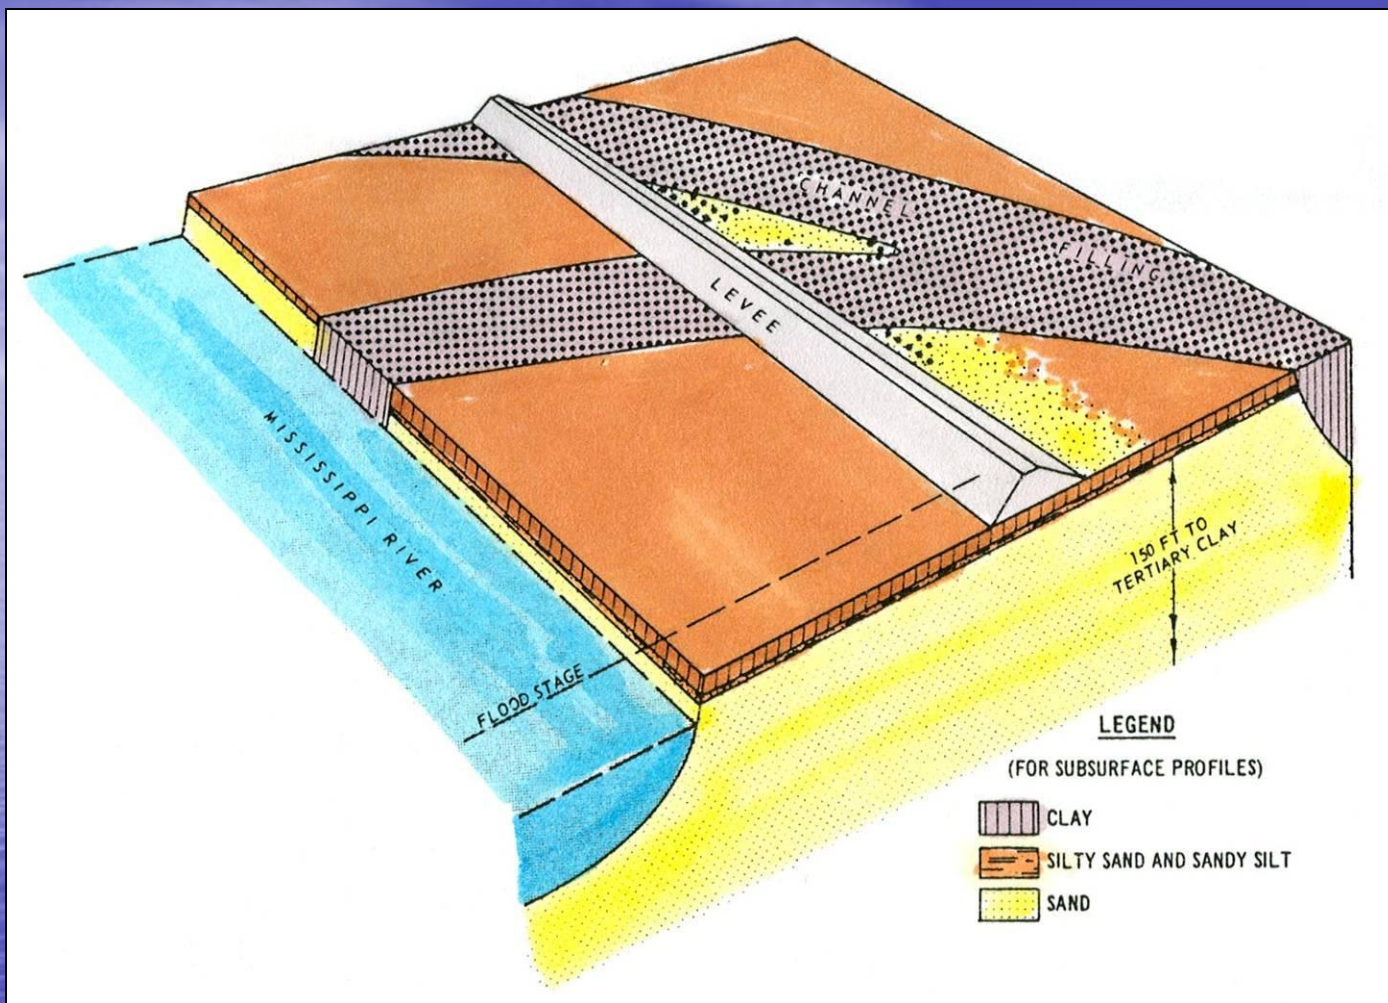
- One of the worst foundation conditions is the '**gore point**' situation depicted here, which is formed between two infilled oxbows.

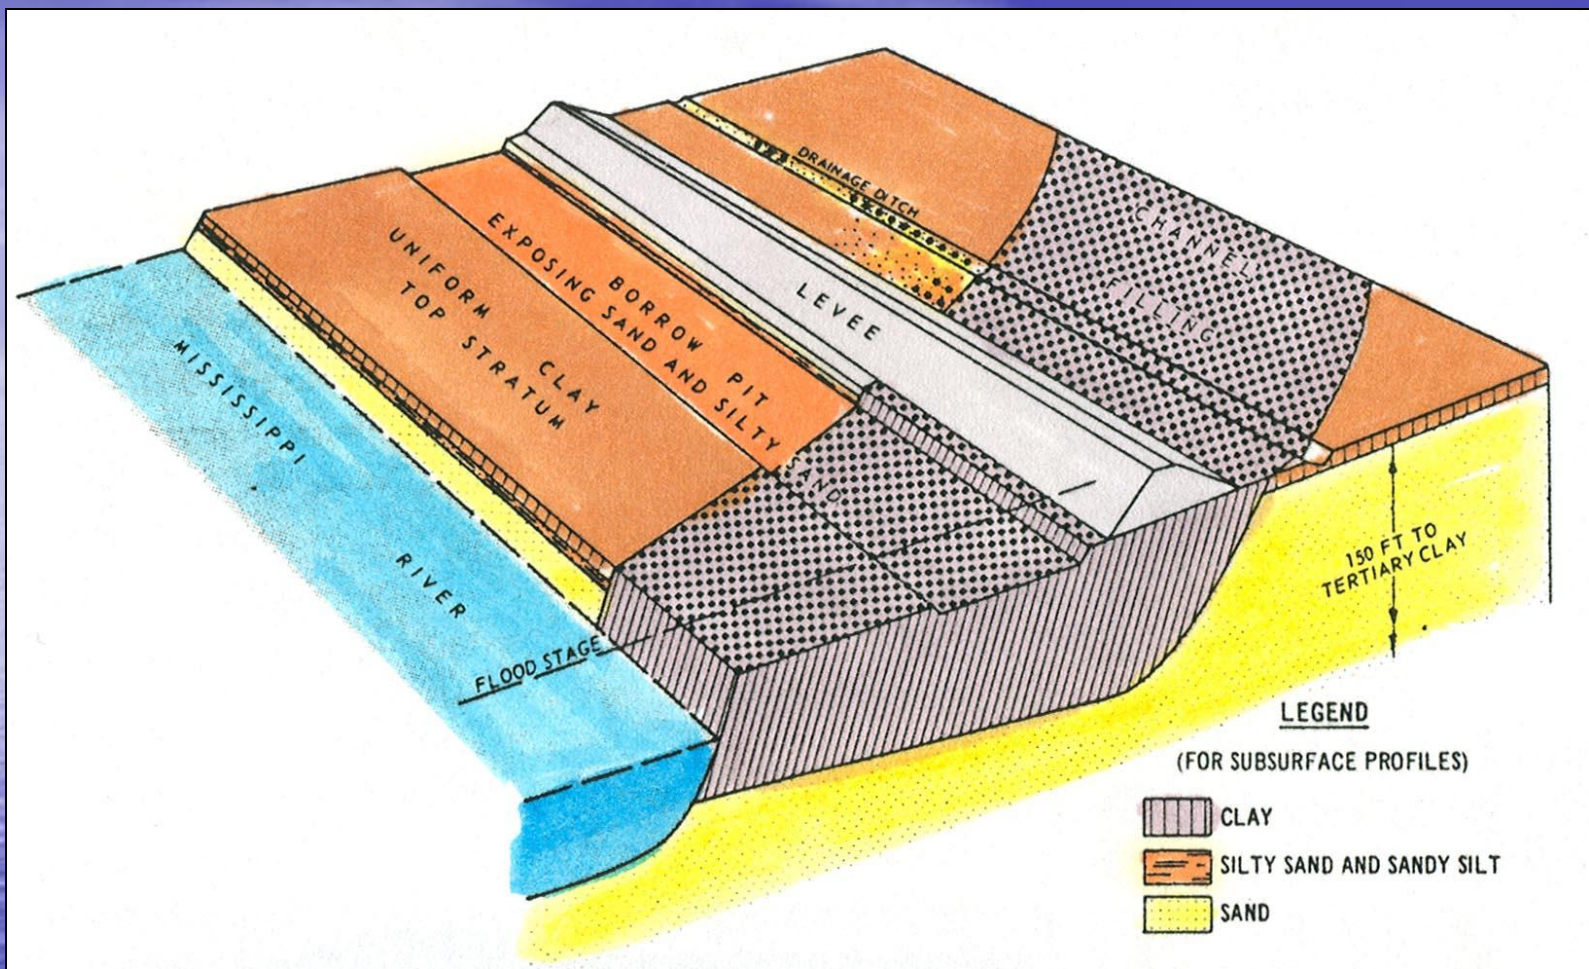
- Clay filled oxbows consolidate under the load imposed by the earthen levees, causing these levees to settle and sink.
- Differential settlement is a major obstacle in maintaining levees.

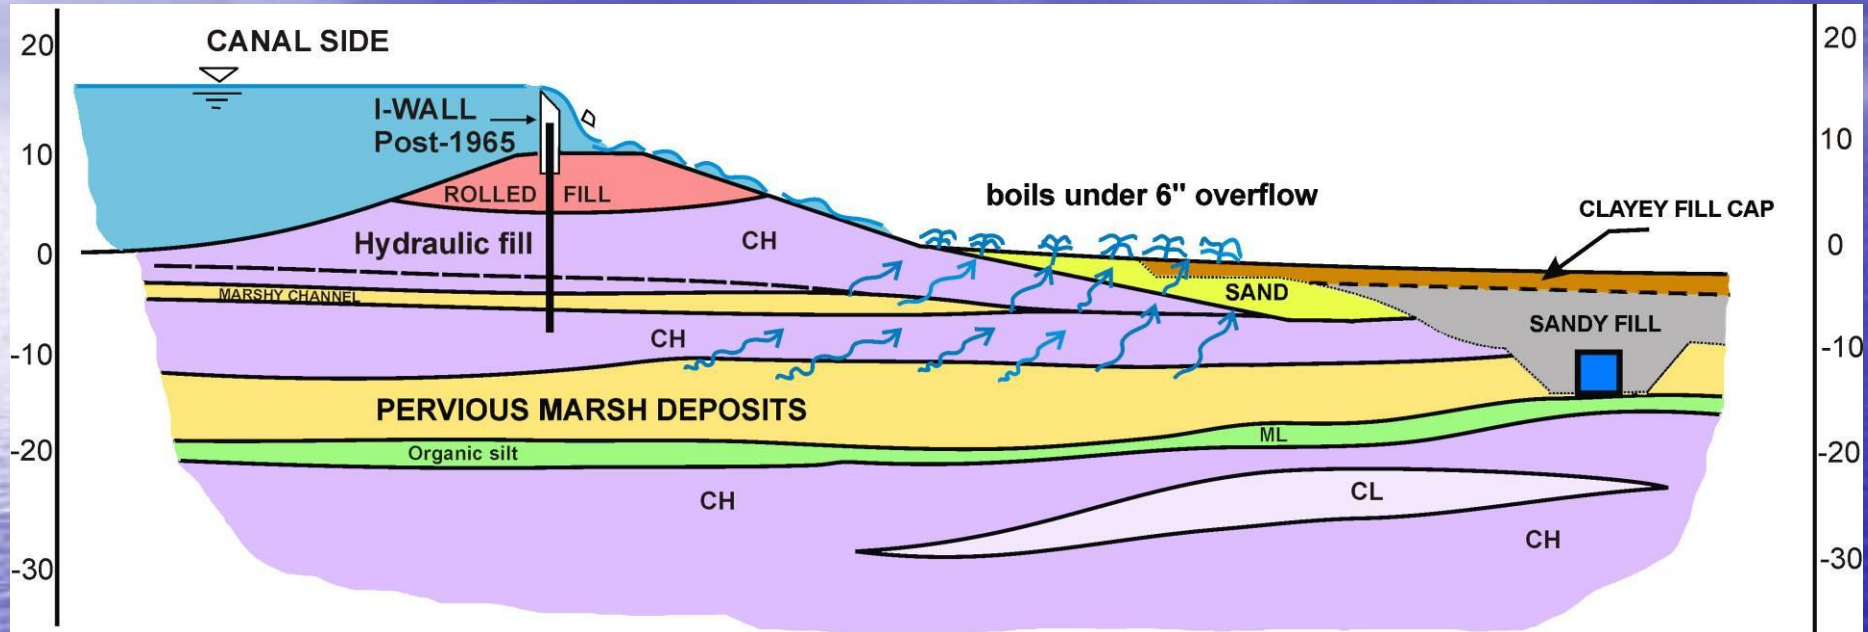
# Compound failure modes very common

- The two biggest enemies of earthen levees are: 1) **underseepage** (pore water) pressures; and 2) **time** (flood duration).
- Overtopping often obscures seepage-driven levee foundation failures

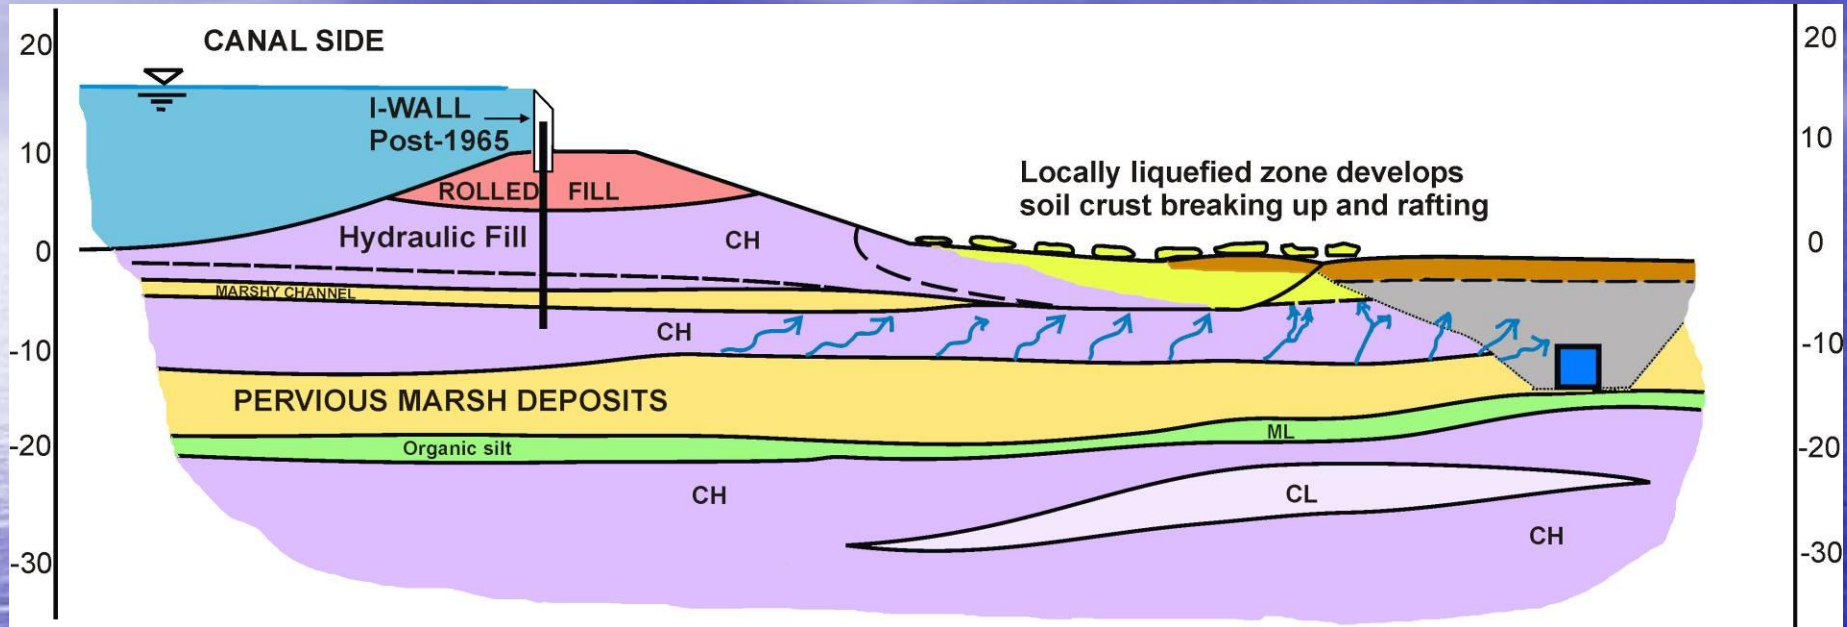
# Seepage-induced soil softening

- If the hydraulic gradient exceeds 0.75, the foundation can begin to experience localized partial liquefaction, or *soil softening* – which is a failure mechanism common in cohesionless materials.

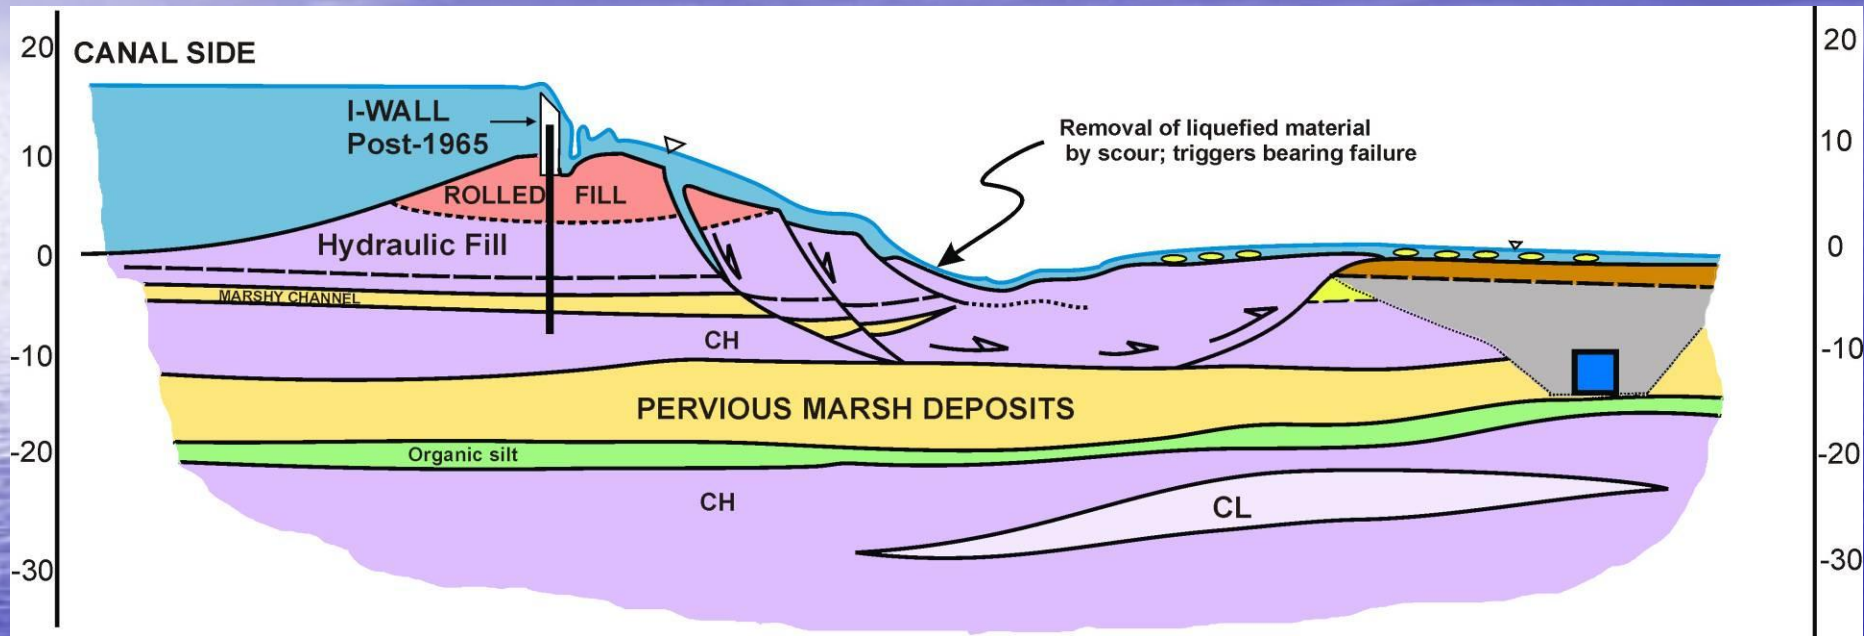
# ... followed by Local Bearing Capacity Failure

- The loss of soil shear strength in the levee's land side toe area can trigger a massive slope failure on the outboard side of the levee.

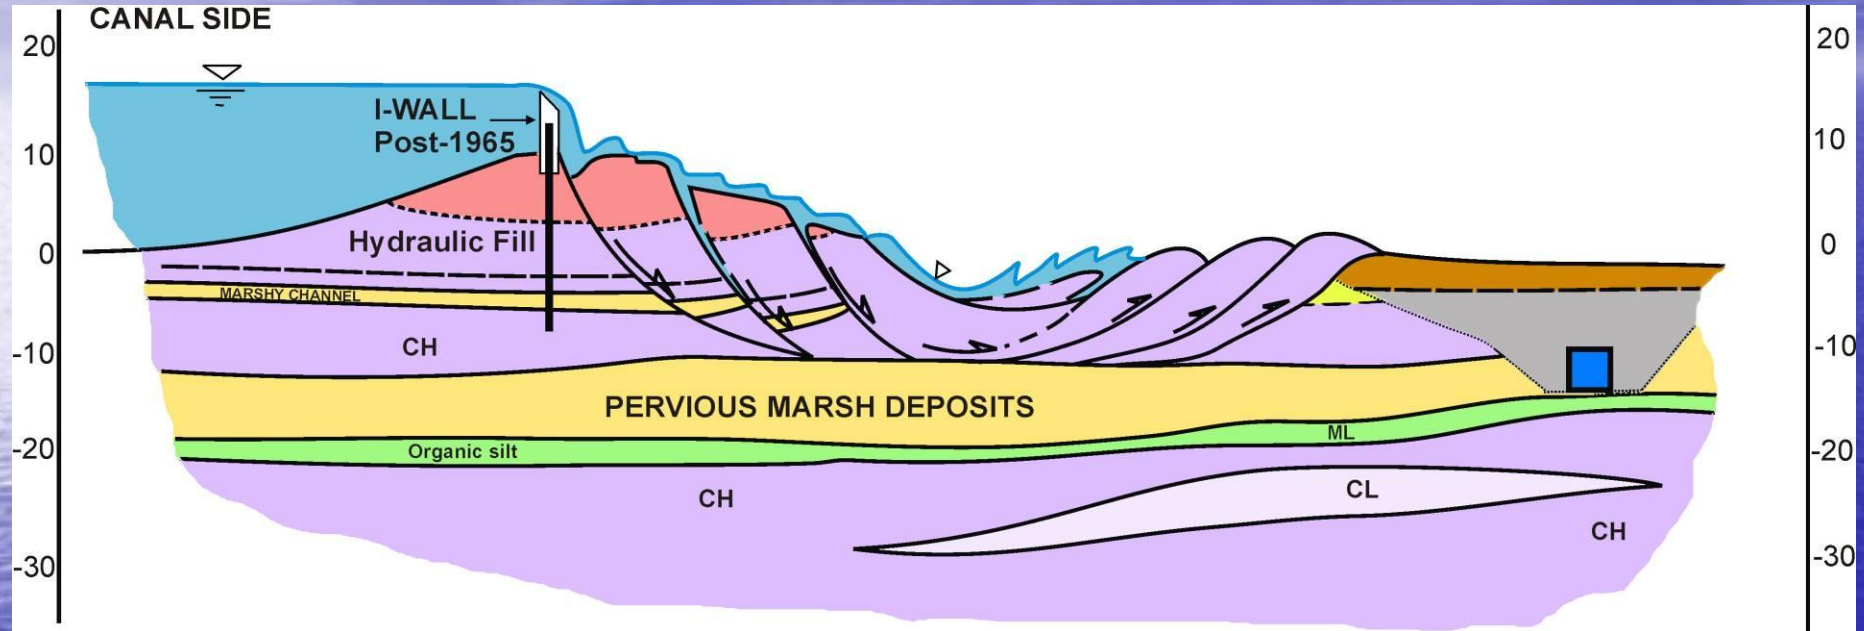
# ... followed by Retrogressive Slope Failure

- The loss of foundation bearing capacity can trigger a series of retrogressive slope failures, as sketched here. Four critical mechanisms may occur more or less simultaneously. Analytical programs not currently set up to analyze concurrent failure modes.

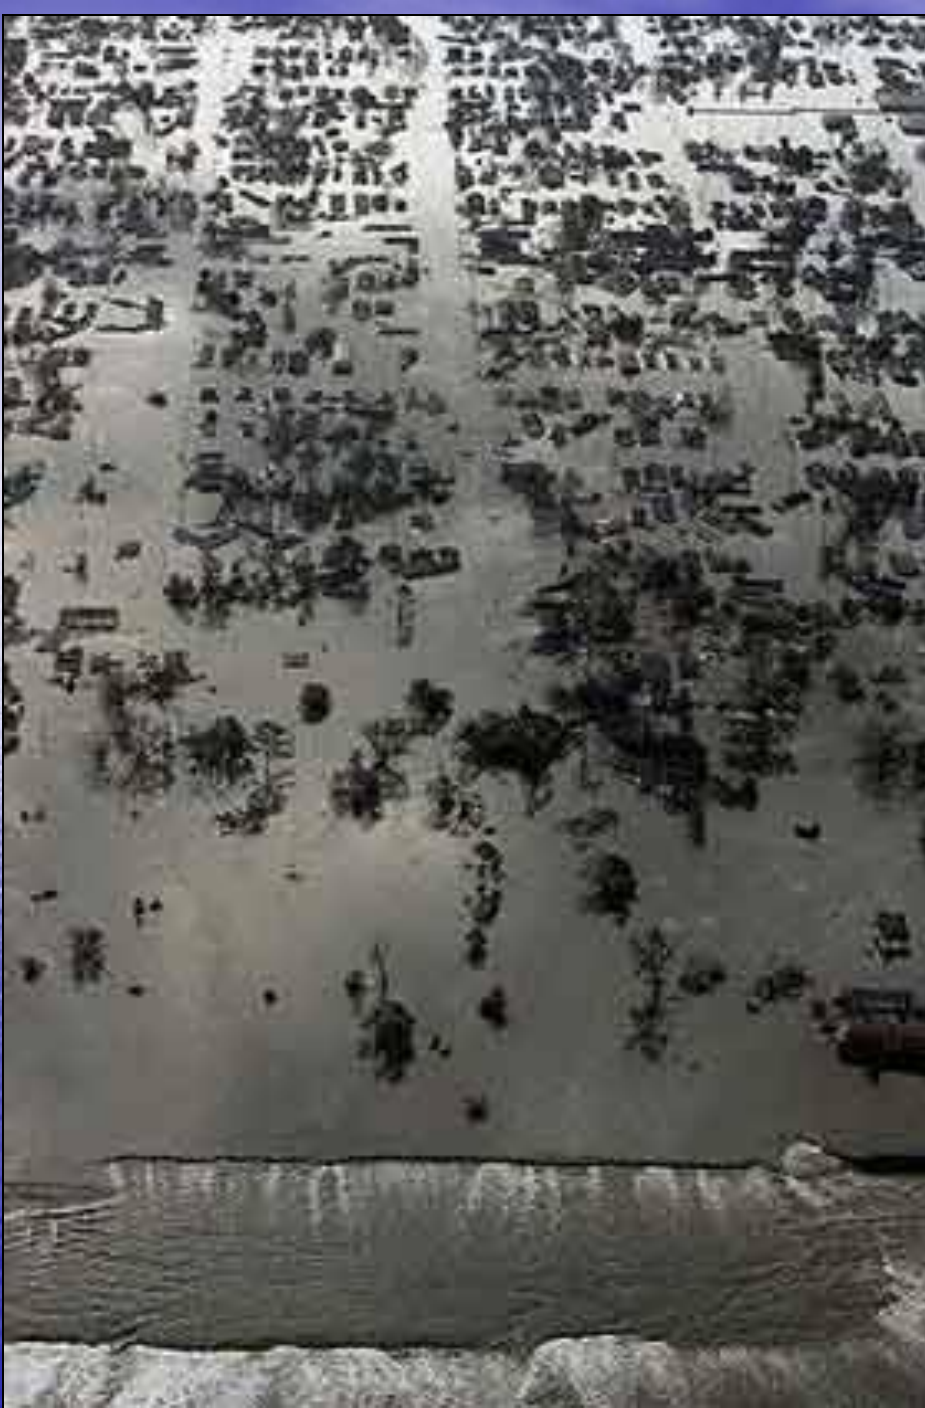
Once flood waters overtop an embankment they quickly scour the land-side toe of the embankment, and deep scour holes develop on either side of the “hydraulic jump” that forms at the point of overflowage, enlarging the breach, as shown here.

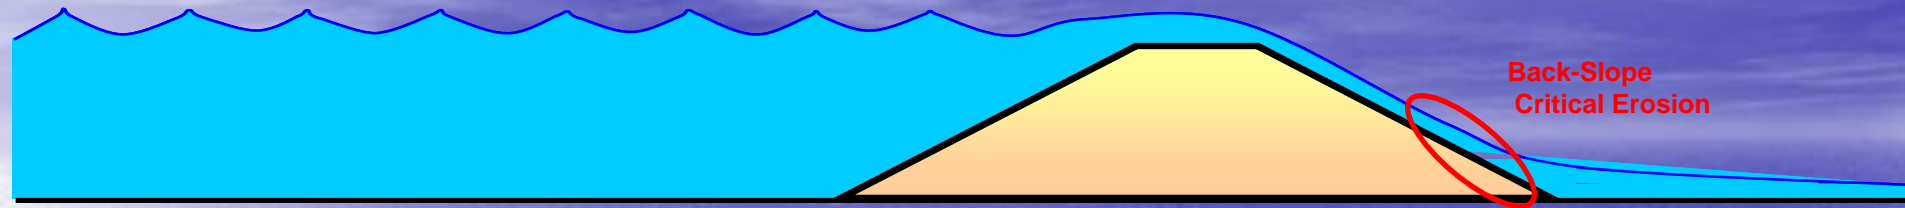
Velocity-induced scour at toe of back slope, at flow transition. Accelerates when vegetation stripped off, depending on **cohesion** of embankment materials

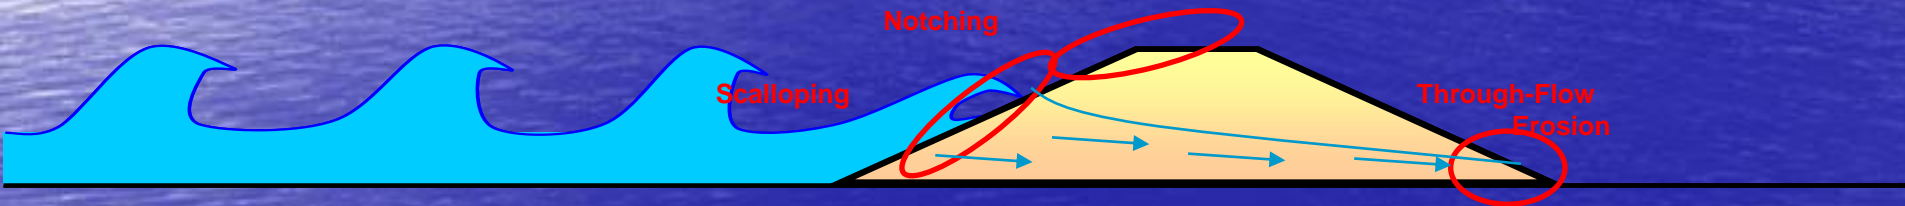
Scalloping and notching on the fetch side of the levee, due to wave pounding; and piping fomented by emergent seepage at the toe of the back slope

Note: damage at back slope toe looks similar for both modes
