# **Levee Design Issues revealed by Post- Katrina Studies in Louisiana**

**J. David Rogers, Ph.D., P.E., P.G.**

**American Society of Civil Engineers**

**Central Pennsylvania Geotechnical Conference**

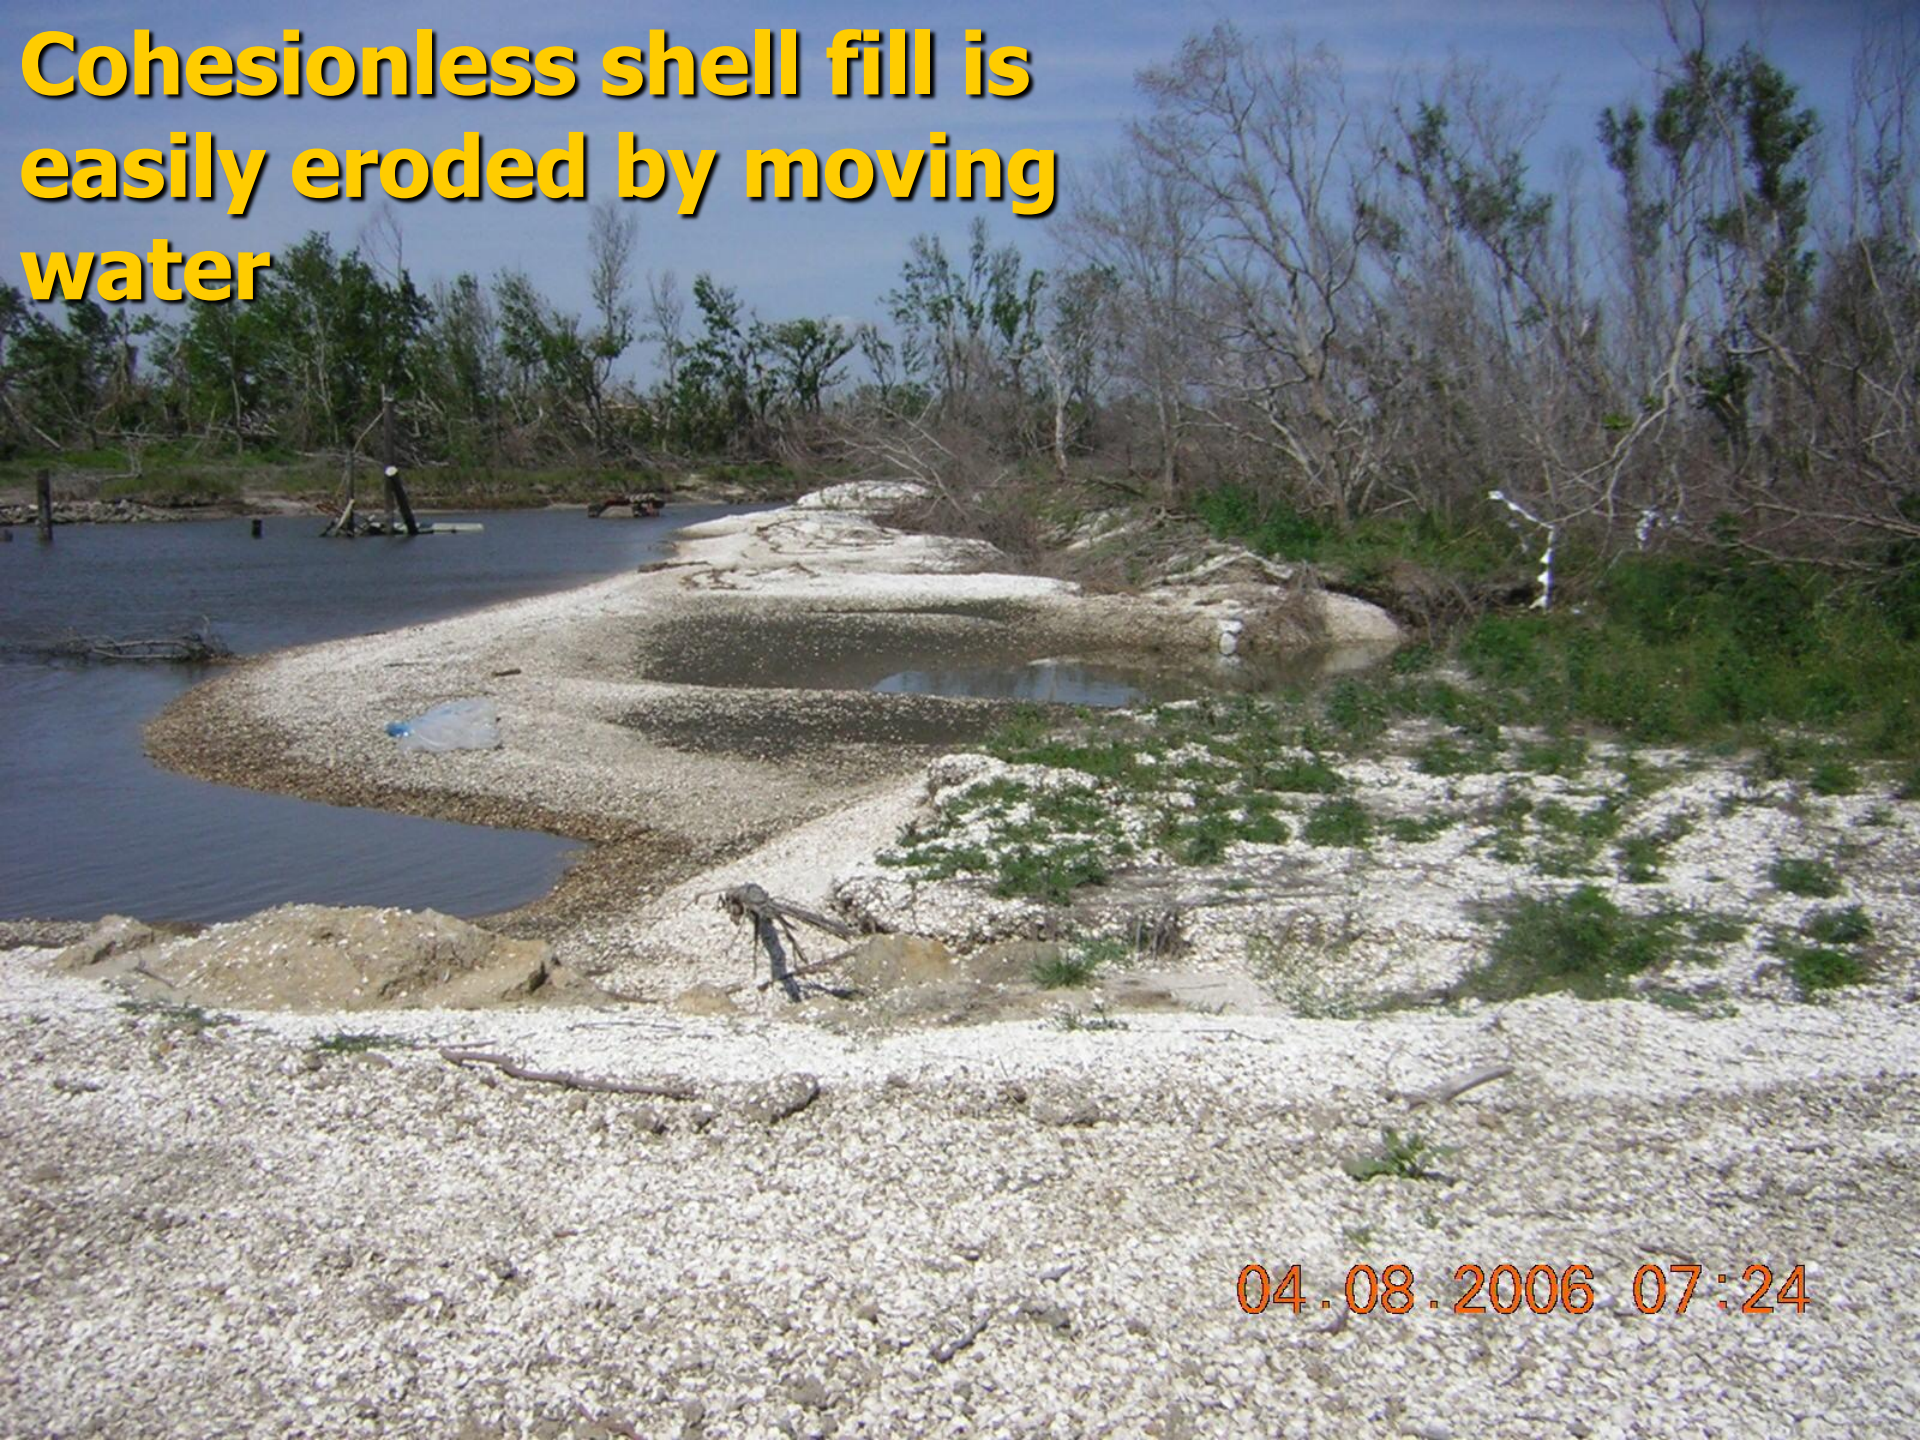
**Cohesionless shell fill is easily eroded by moving water**

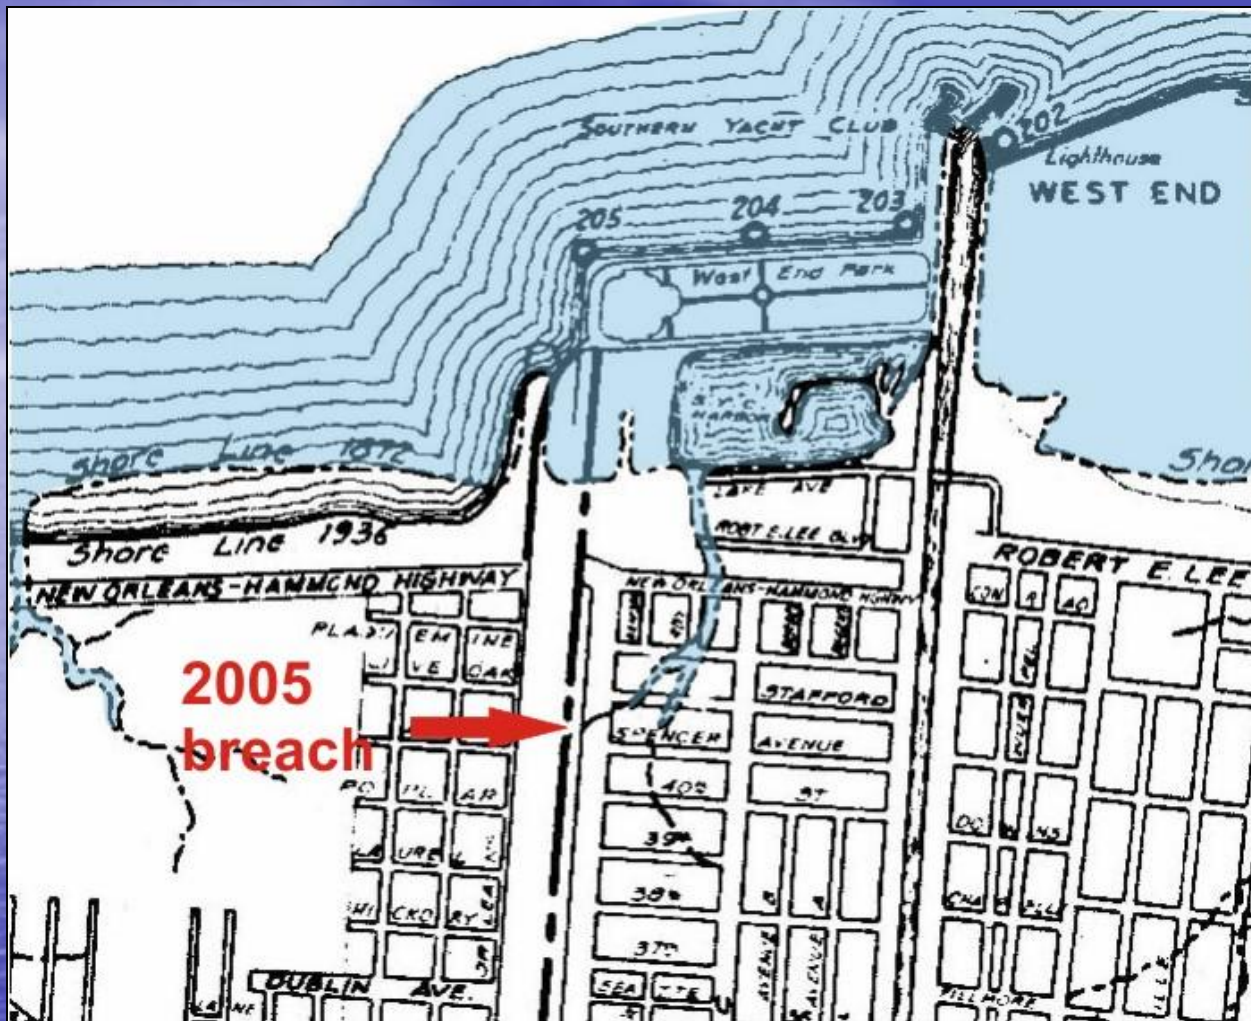
- **Overlay of 1872 map by Valery Sulakowski on the WPA-LA (1937) map, showing the 1872 shoreline and sloughs (in blue) along Lake Pontchartrain. Although subdivided, only a few structures had been built in this area prior to 1950. The position of the 1947 and 2005 breaches along the 17<sup>th</sup> Street Canal are indicated by the red arrow.**

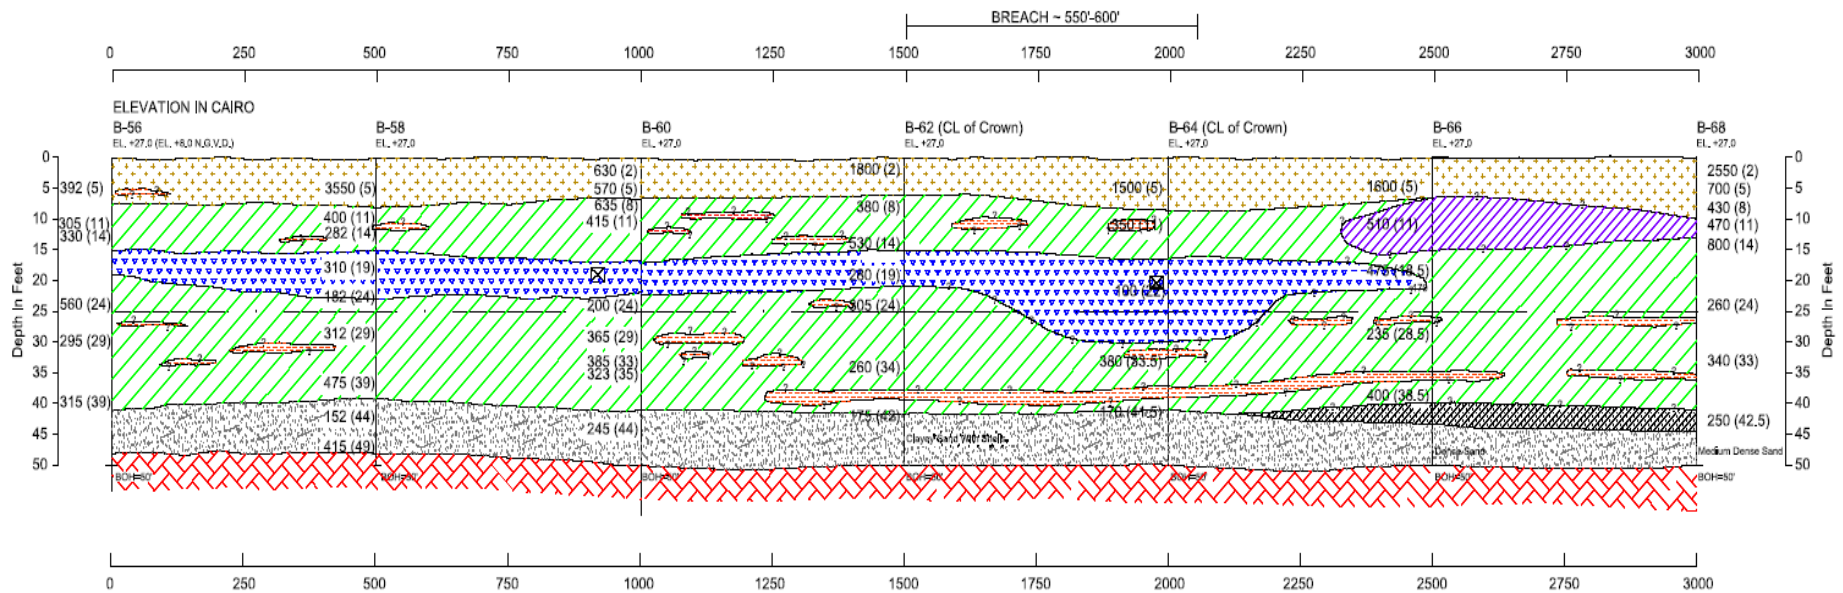
17th Street Canal East Levee- Draft Soil Profile  
New Orleans, Louisiana

● **Alternative interpretation of the Eustis 1982 borings for the 17<sup>th</sup> Street Canal East Levee, near the 2005 break**

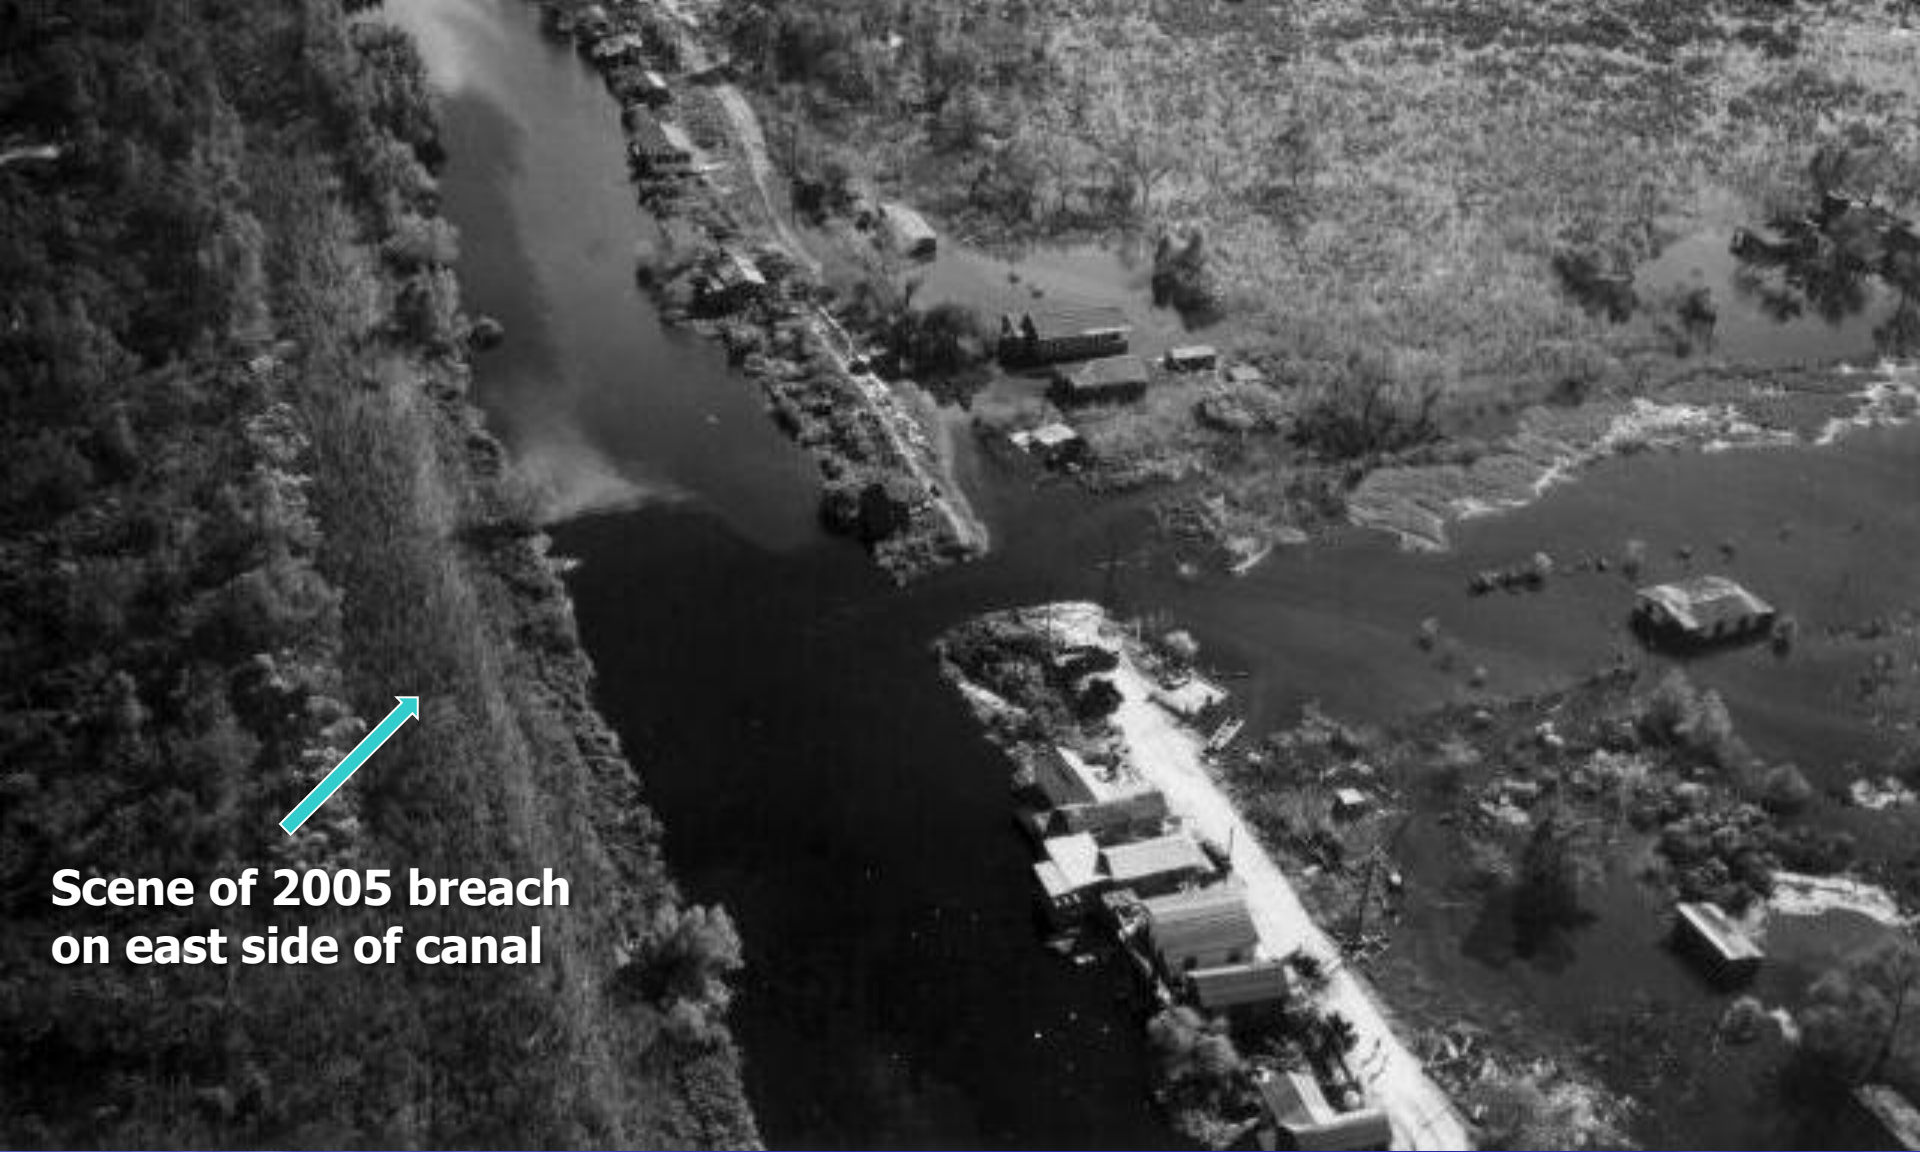
Scene of 2005 breach  
on east side of canal

- Flooding of Jefferson Parish and Metairie in the 1947 hurricane was caused by a breach along the western side of the 17<sup>th</sup> Street Canal, across from site of the 2005 breach.

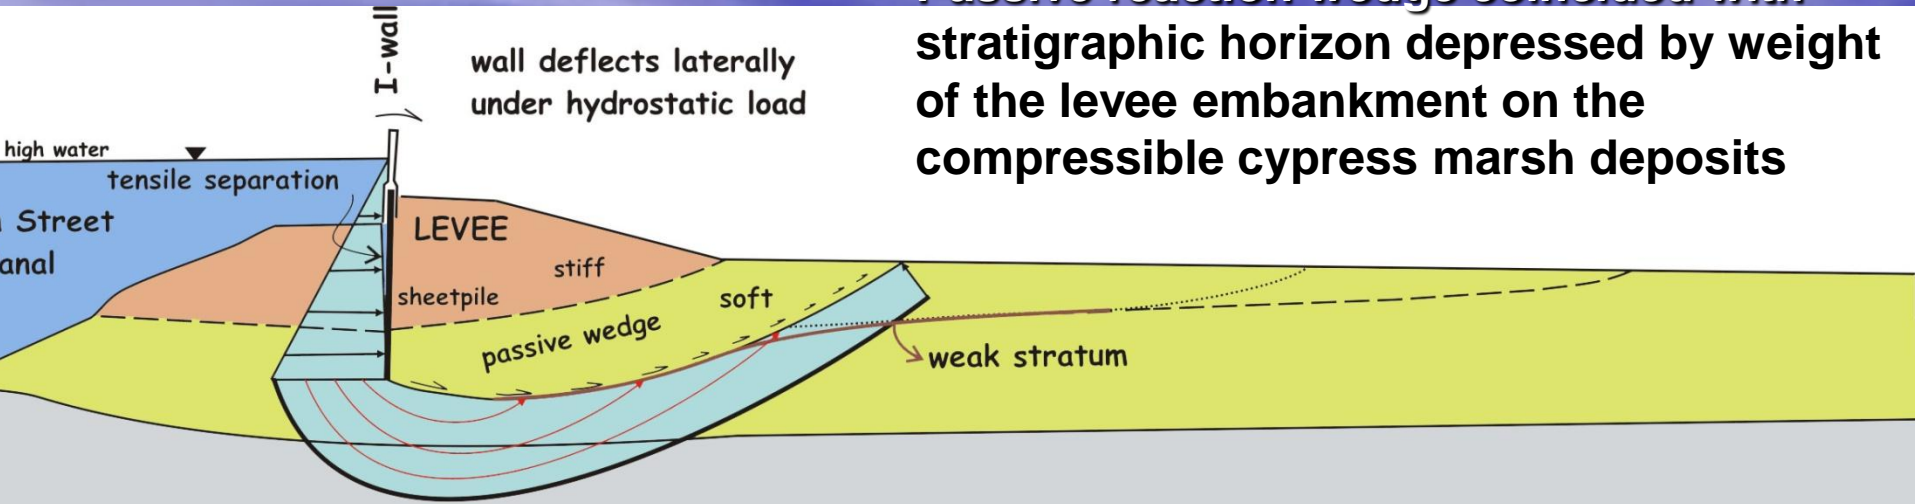
Passive reaction wedge coincided with stratigraphic horizon depressed by weight of the levee embankment on the compressible cypress marsh deposits
