POST-FLOOD RECONNAISSANCE: UPPER MISSISSIPPI RIVER FLOODING OF 2008

J. David Rogers, Ph.D., P.E., R.G.

Natural Hazards Mitigation Institute

November 11, 2008

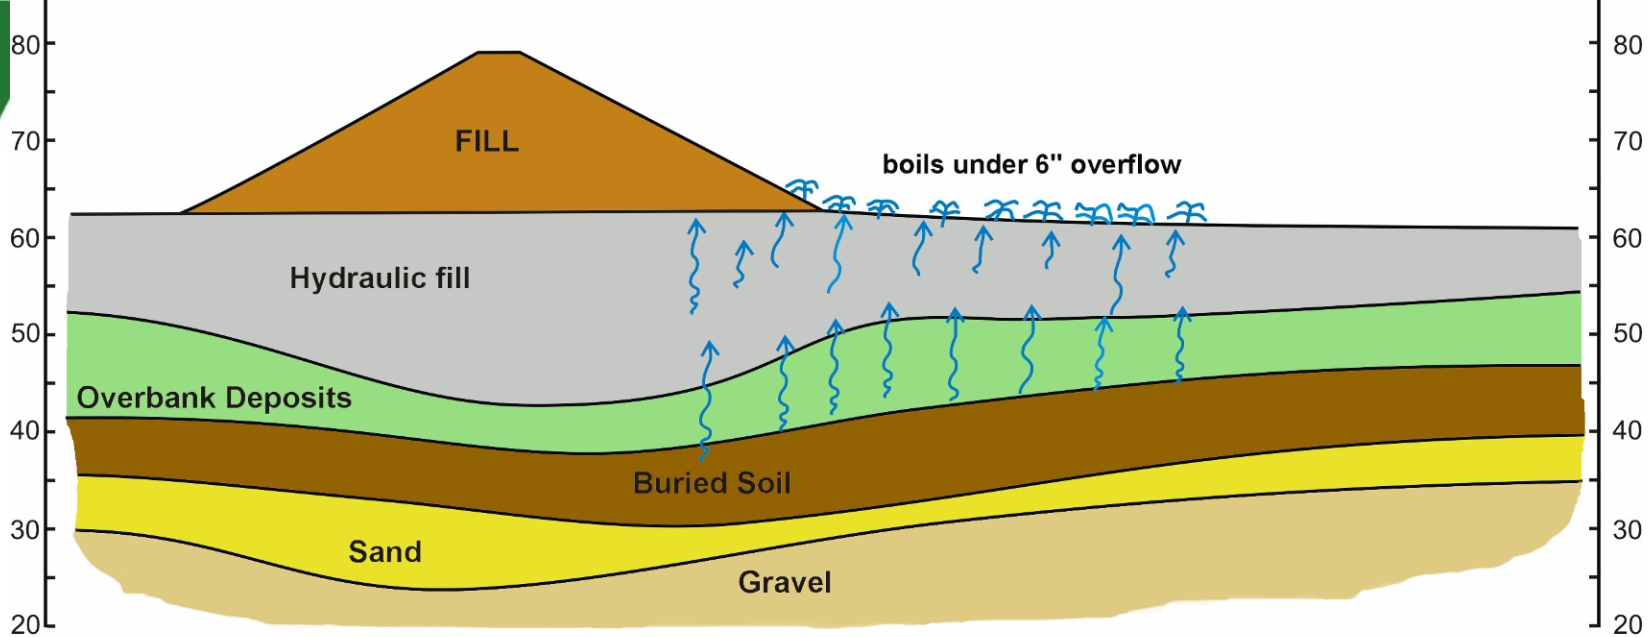
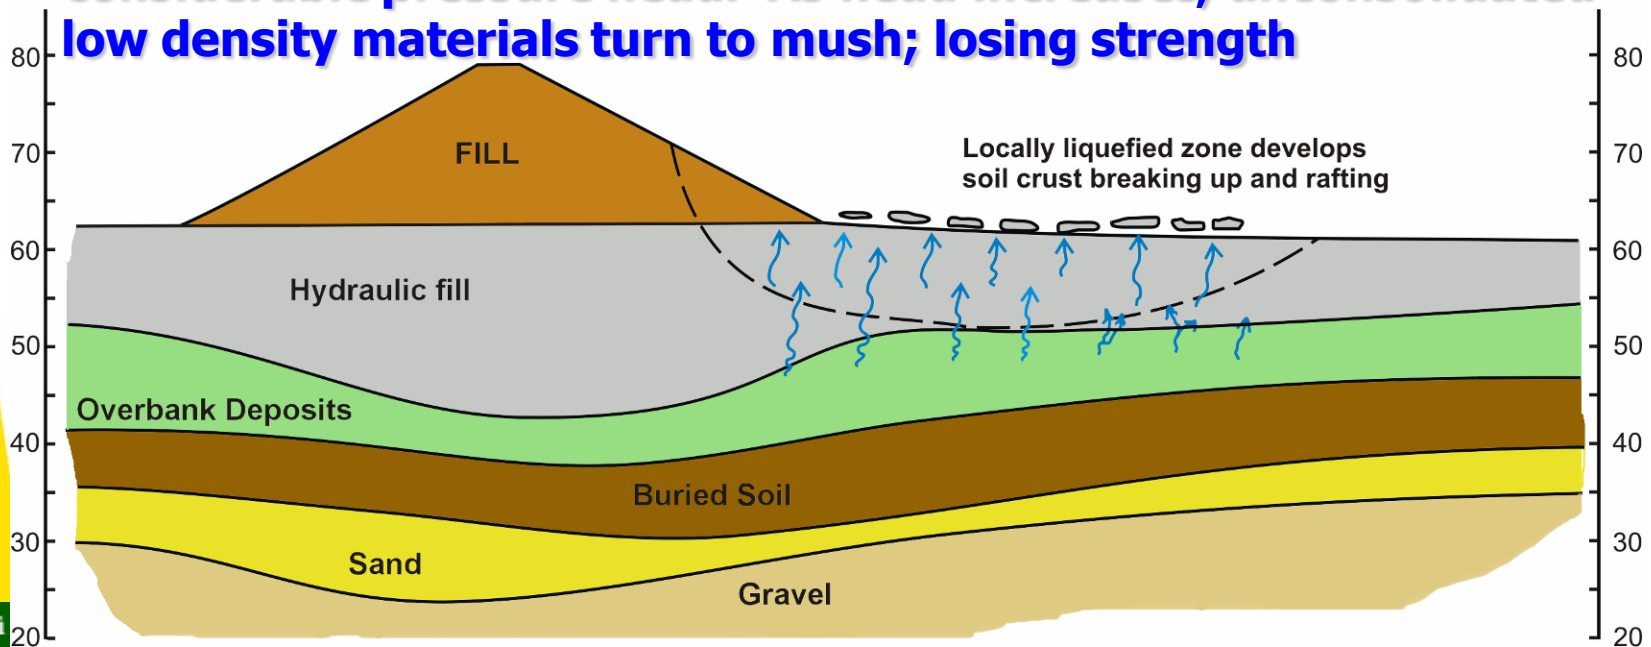
Hydraulic uplift is easily generated from confined aquifers under considerable pressure head. As head increases, unconsolidated low density materials turn to mush; losing strength

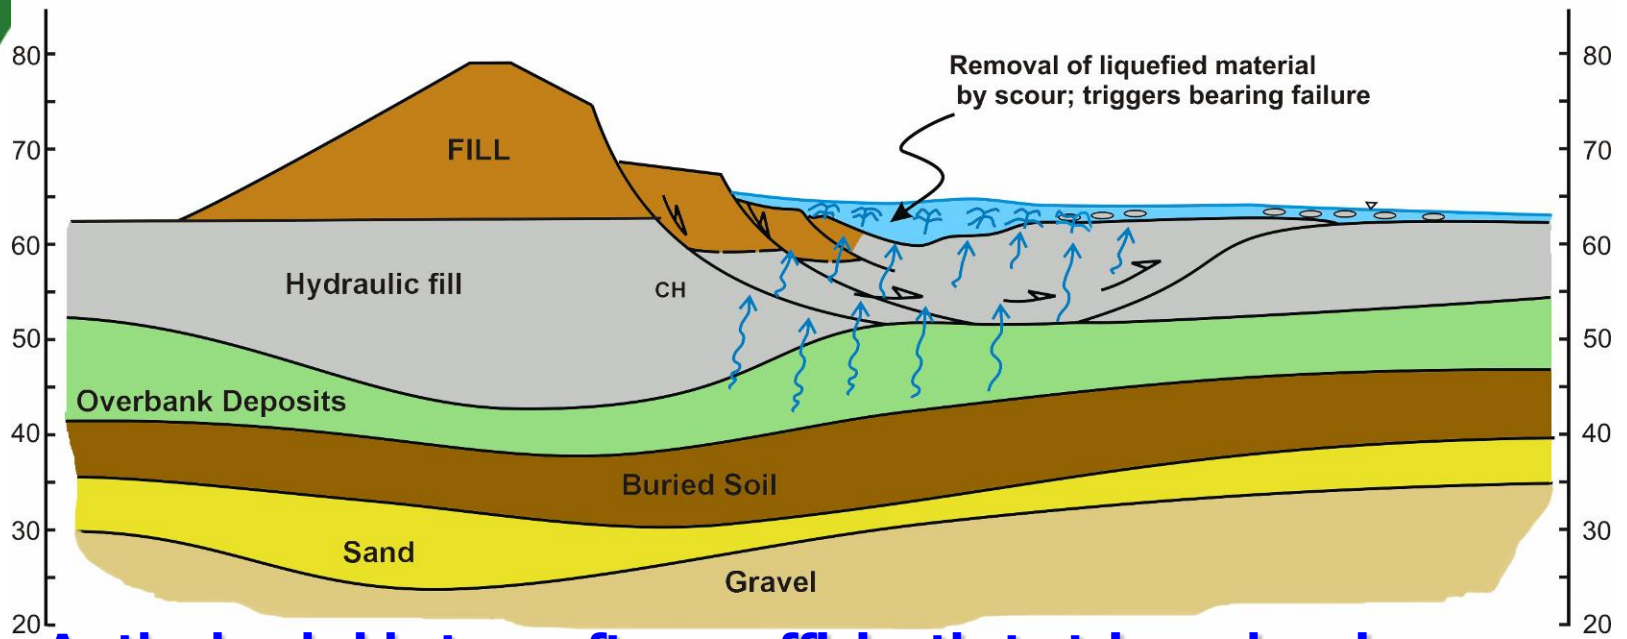
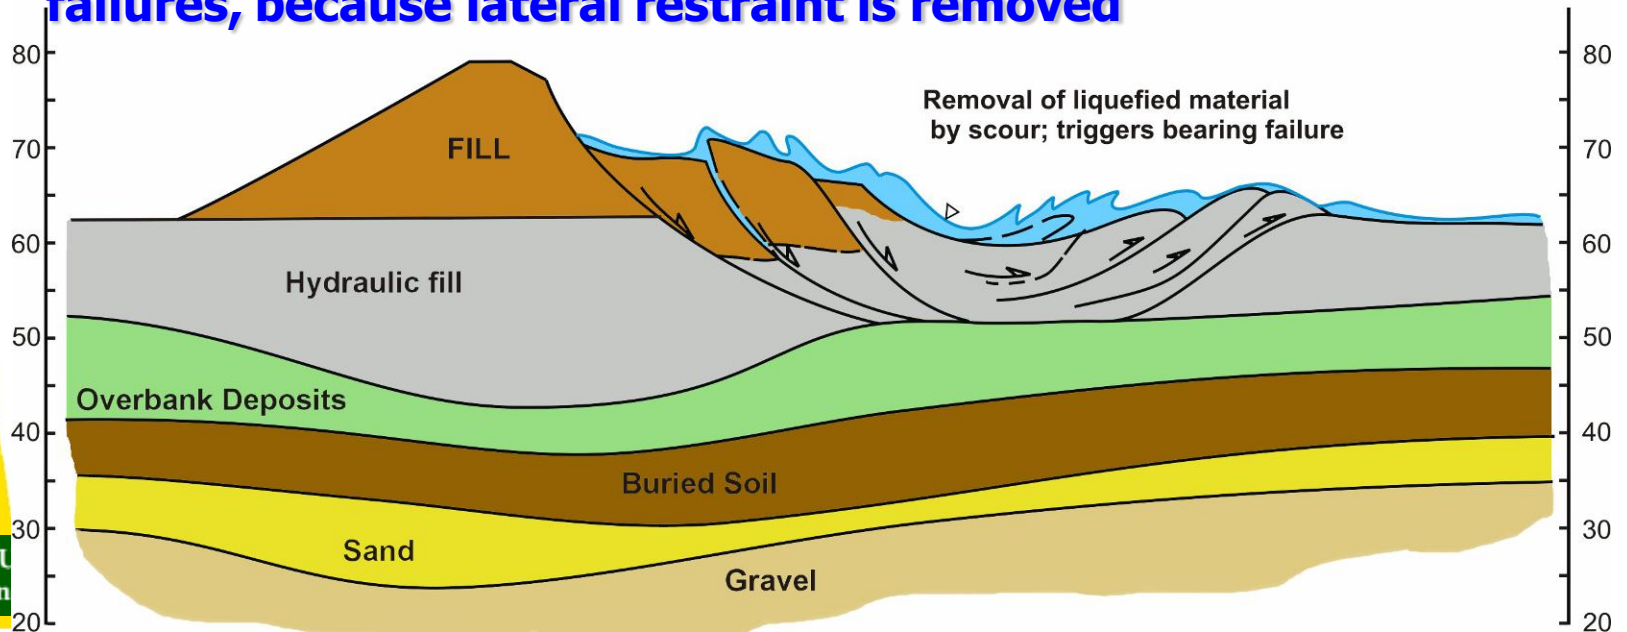
As the land side toe softens sufficiently to trigger bearing capacity failure; this is rapidly followed by retrogressive slope failures, because lateral restraint is removed

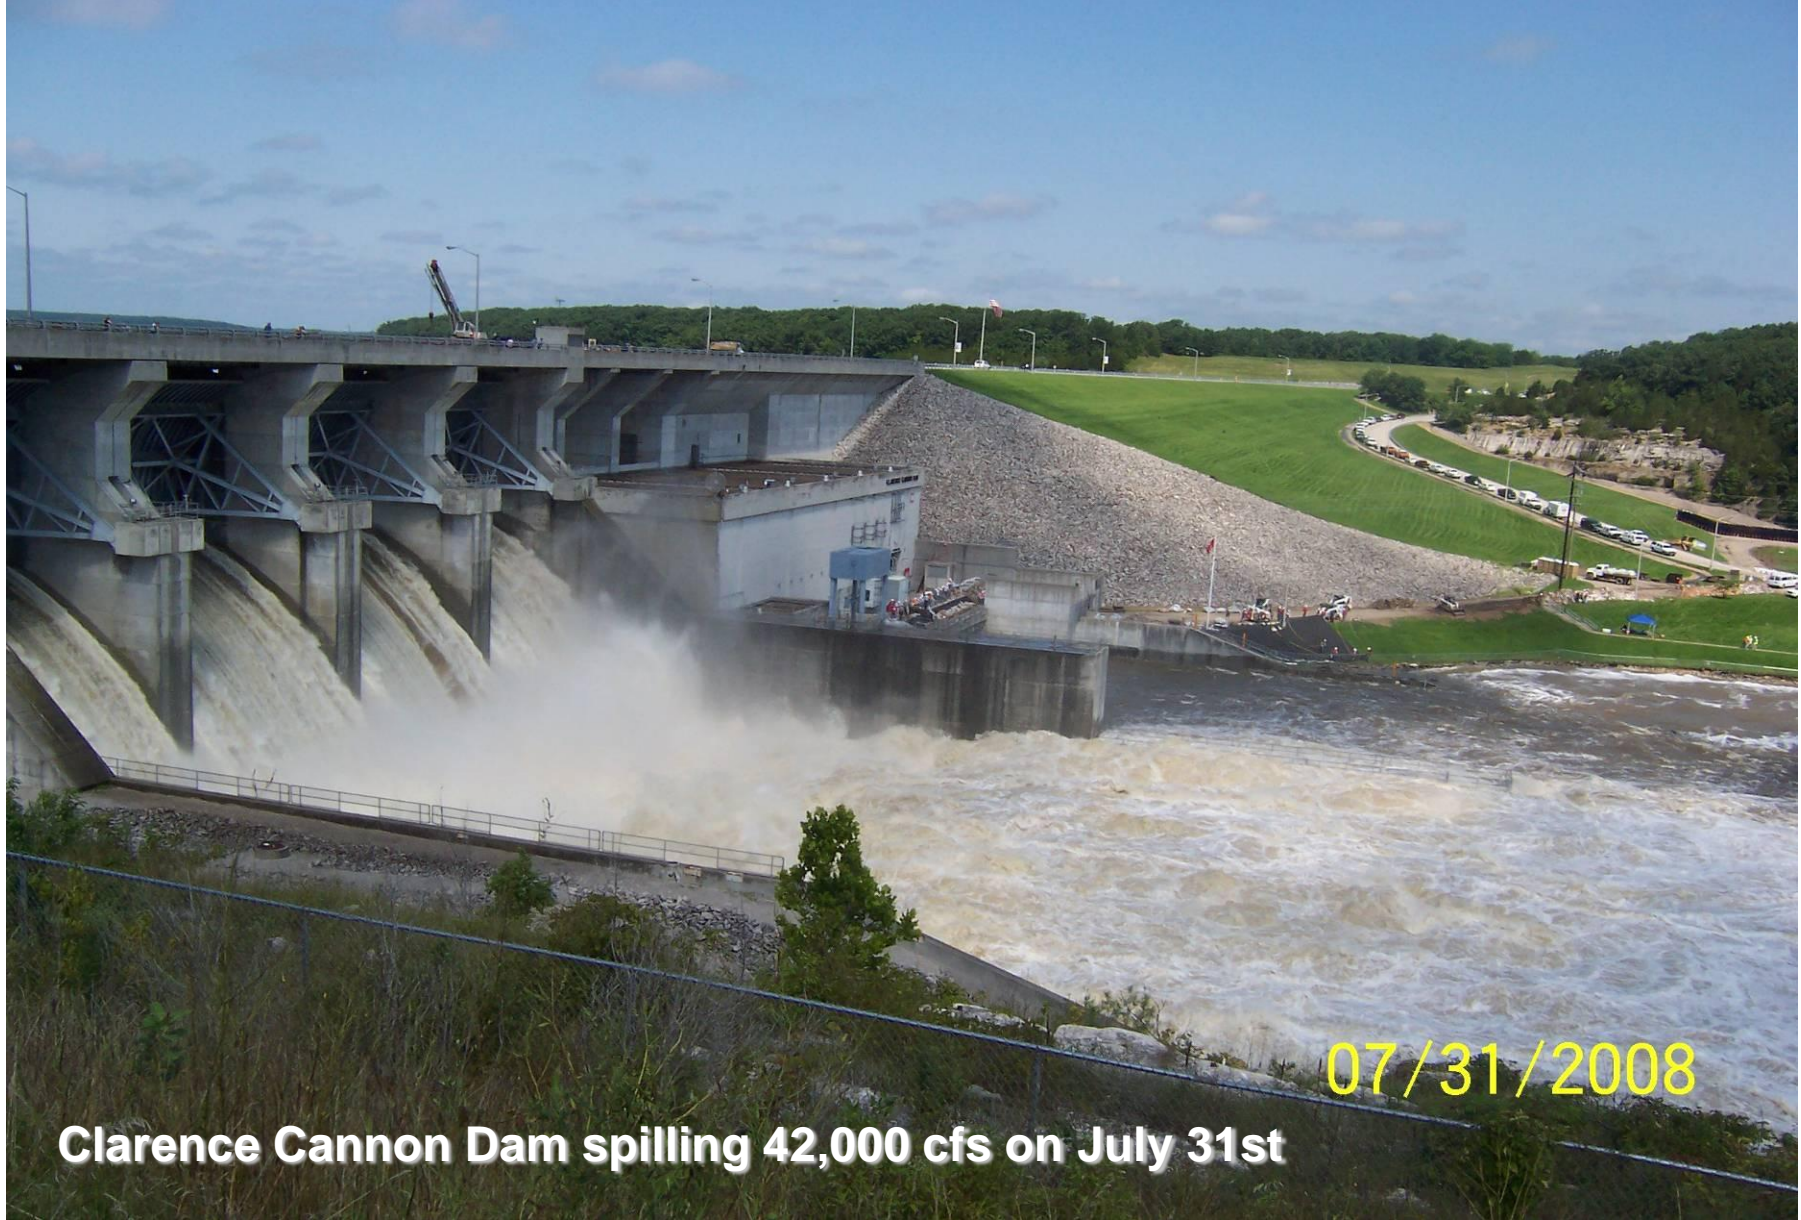
Clarence Cannon Dam spilling 42,000 cfs on July 31st

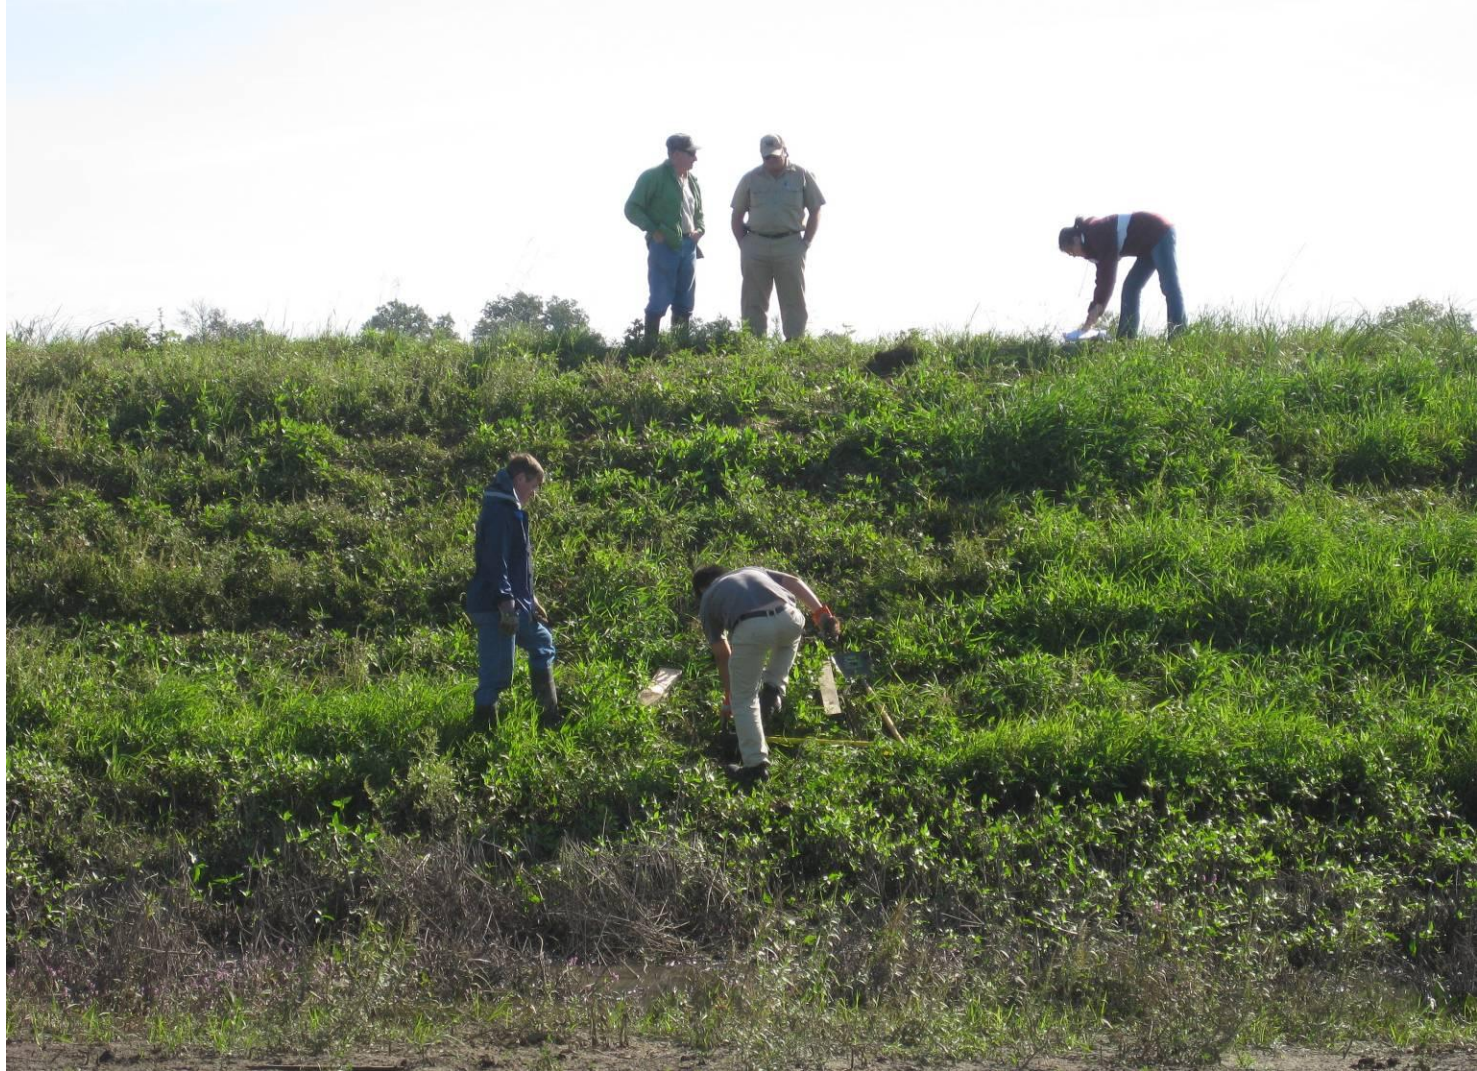
- **The Brevator District levees near Winfield survived 14 days of near-continuous overtopping, without failing**

- **Erosion tests of samples recovered from the Brevator levee revealed it had a much higher clay content than levees which did not survive overtopping**

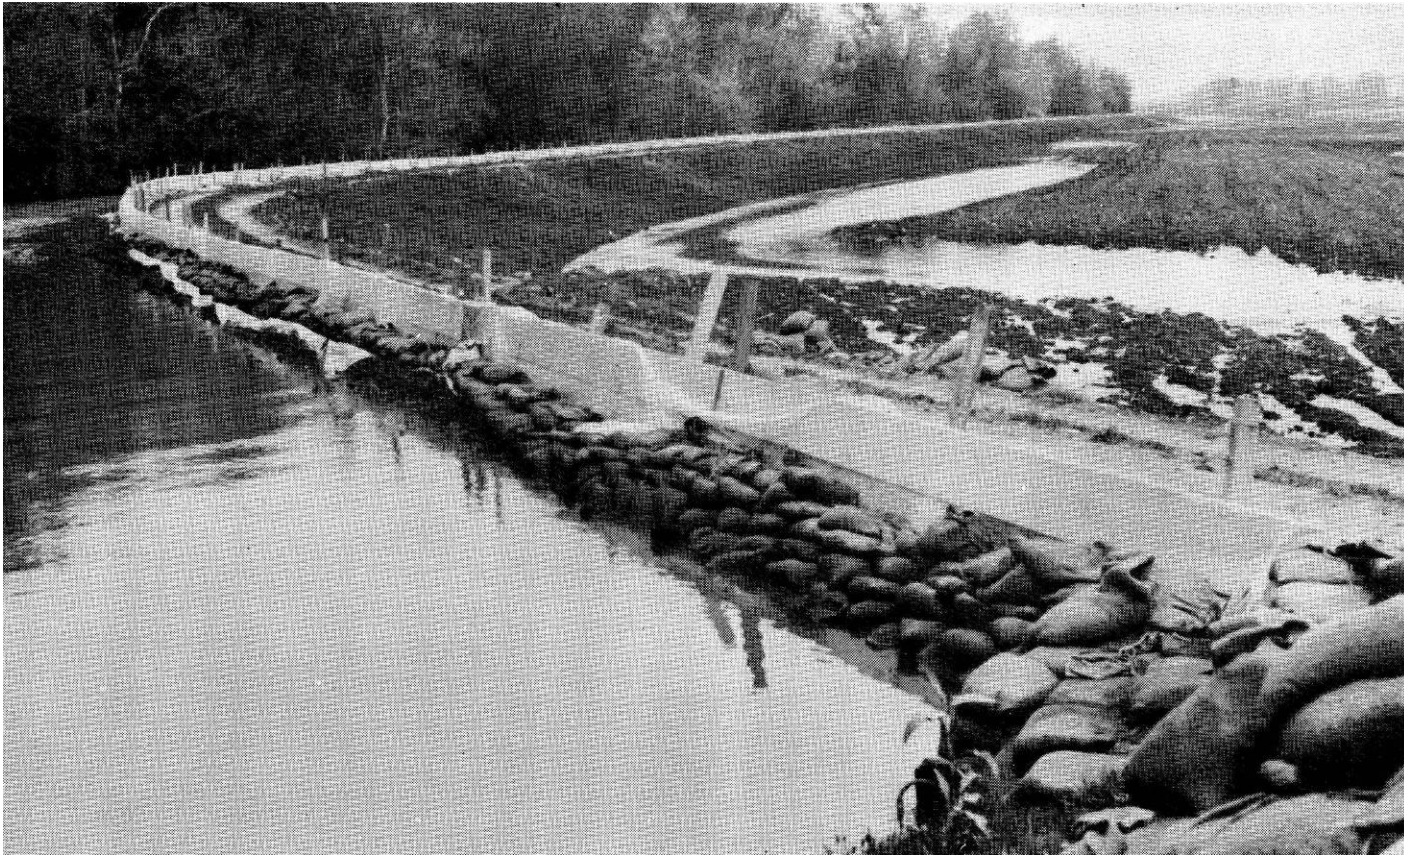
Flash Boards

- **Prior to 1993 timber flash boards with plastic sheeting and sandbags were used to heighten levees during flooding**

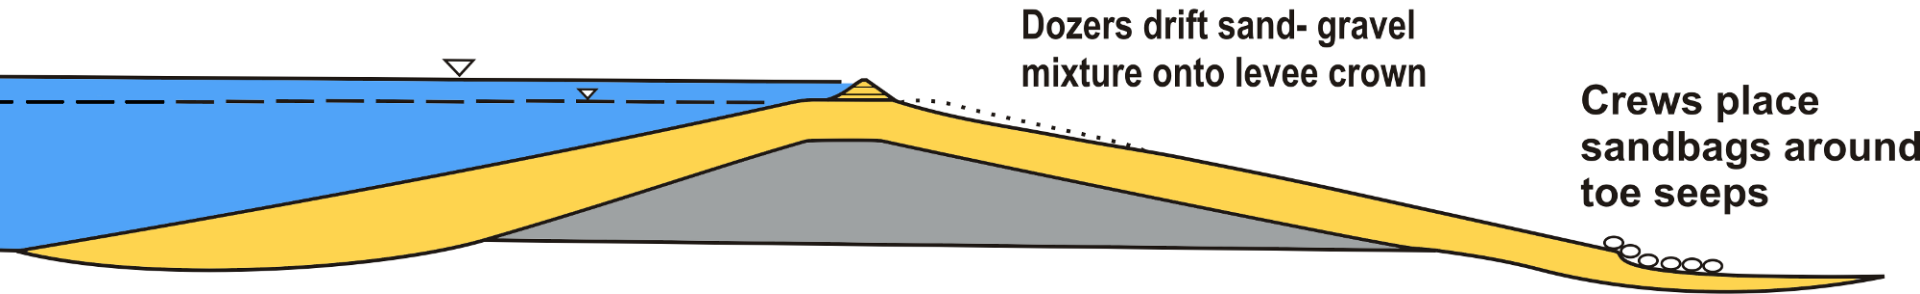
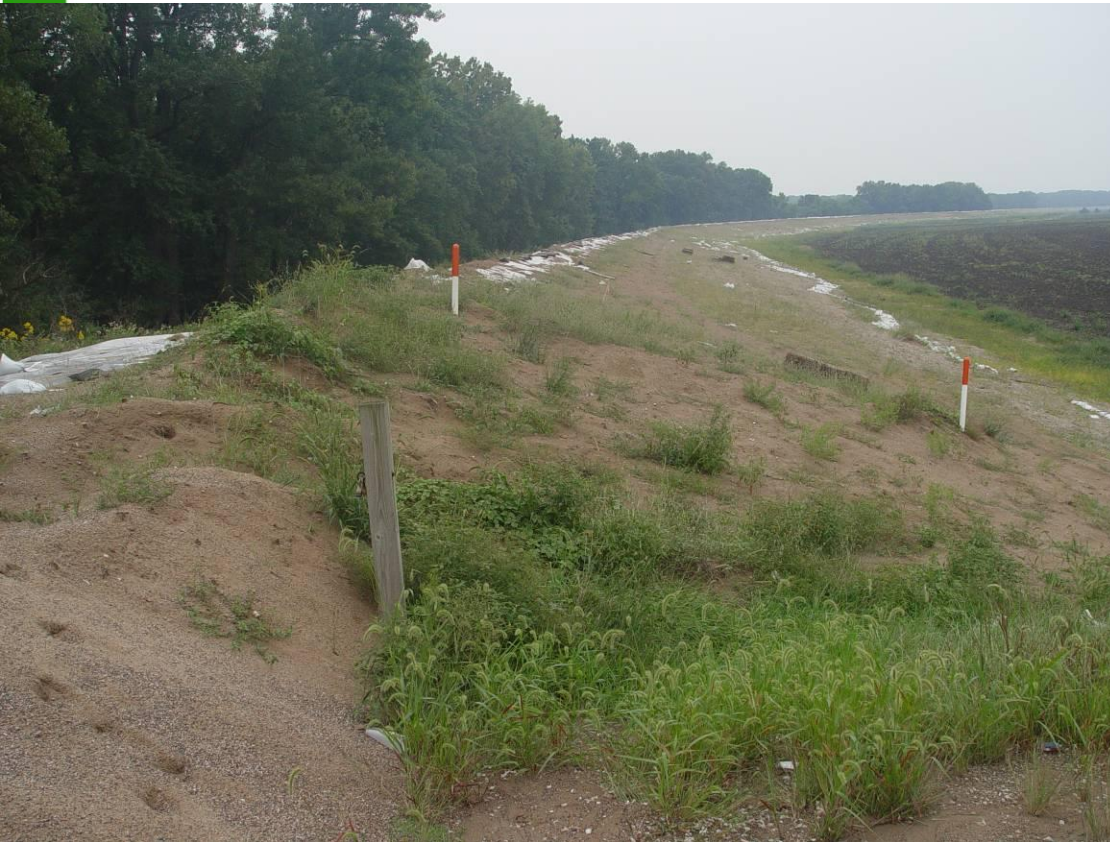
Increased Flood Storage Using “Push-Ups”

- After the 1993 floods the Rock Island District began using dozed sand “push-ups” instead of flash boards

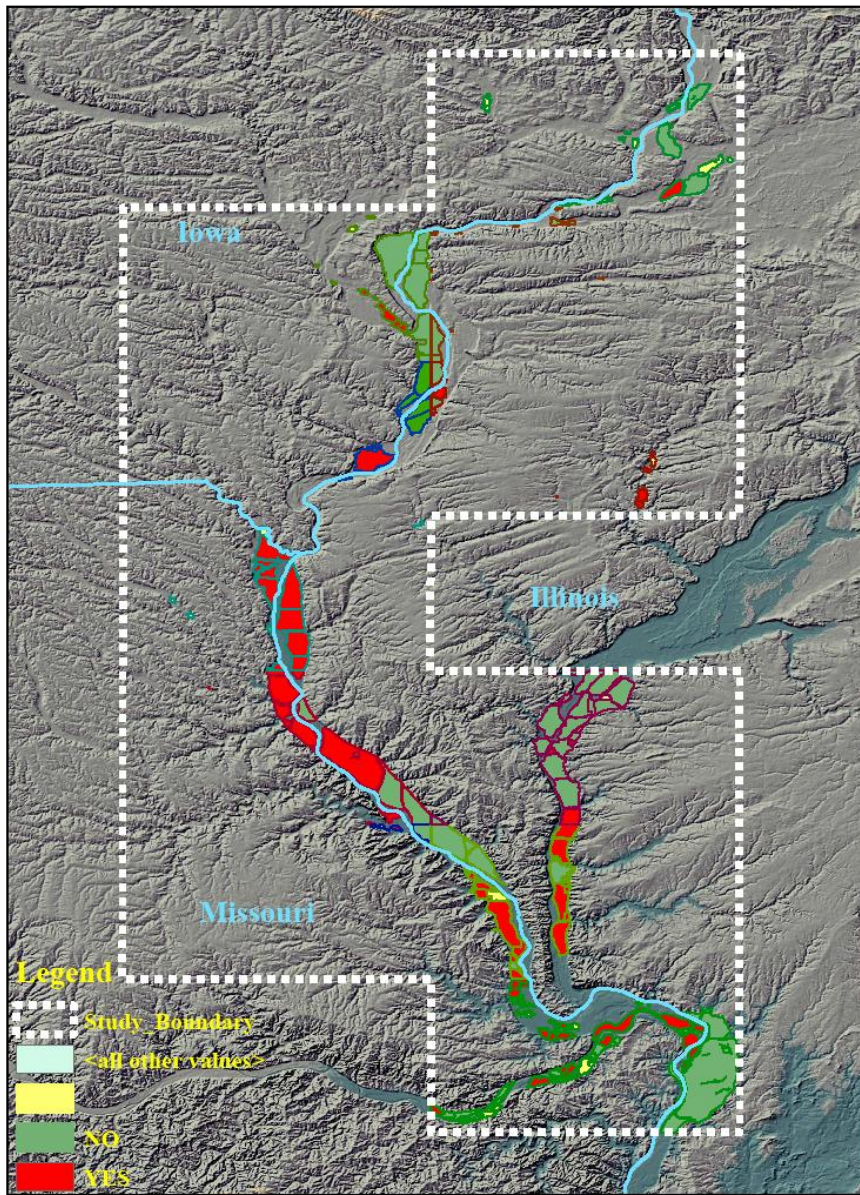
2008 Midwest Levee Investigation
1993 Levee Breach Locations

- The NSF-funded team is focusing on areas where levees have repeatedly failed
- And, places where levees survived sustained overtopping, sometimes for several weeks
