ENGINEERING GEOLOGIC CHARACTERIZATION OF LEVEE FAILURES IN NEW ORLEANS DURING HURRICANE KATRINA

J. David Rogers, Ph.D., P.E., R.G.

**2007 Annual Meeting
Association of Environmental and Engineering Geologists
Los Angeles, California
September 28, 2007**

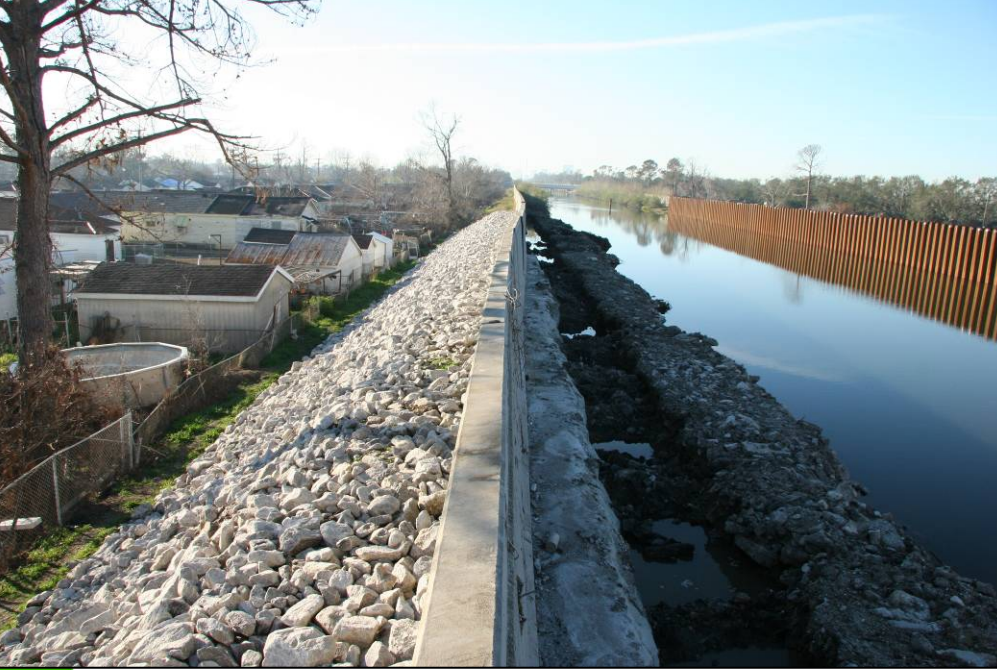
- View looking up the east side of the London Avenue Canal near Robert E. Le Boulevard crossing showing the **encroachment of homes against the slope of the levee**. This situation was common across New Orleans

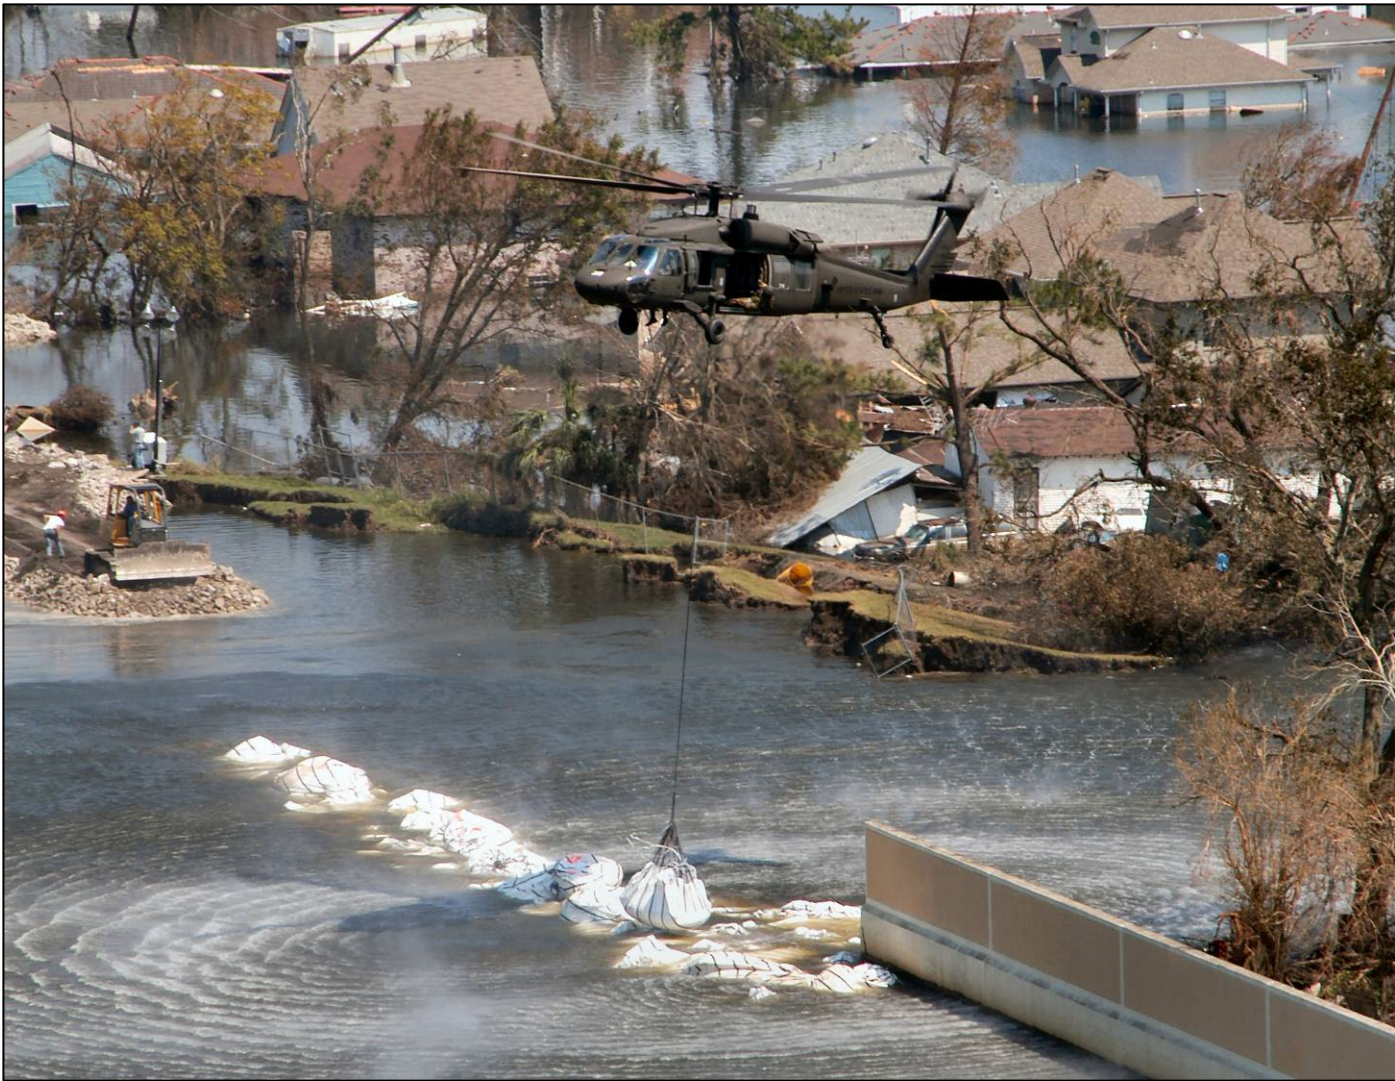
- **Army helicopters and contractors worked for weeks to fill the enormous gaps in the levee system, BEFORE pumping could begin.**

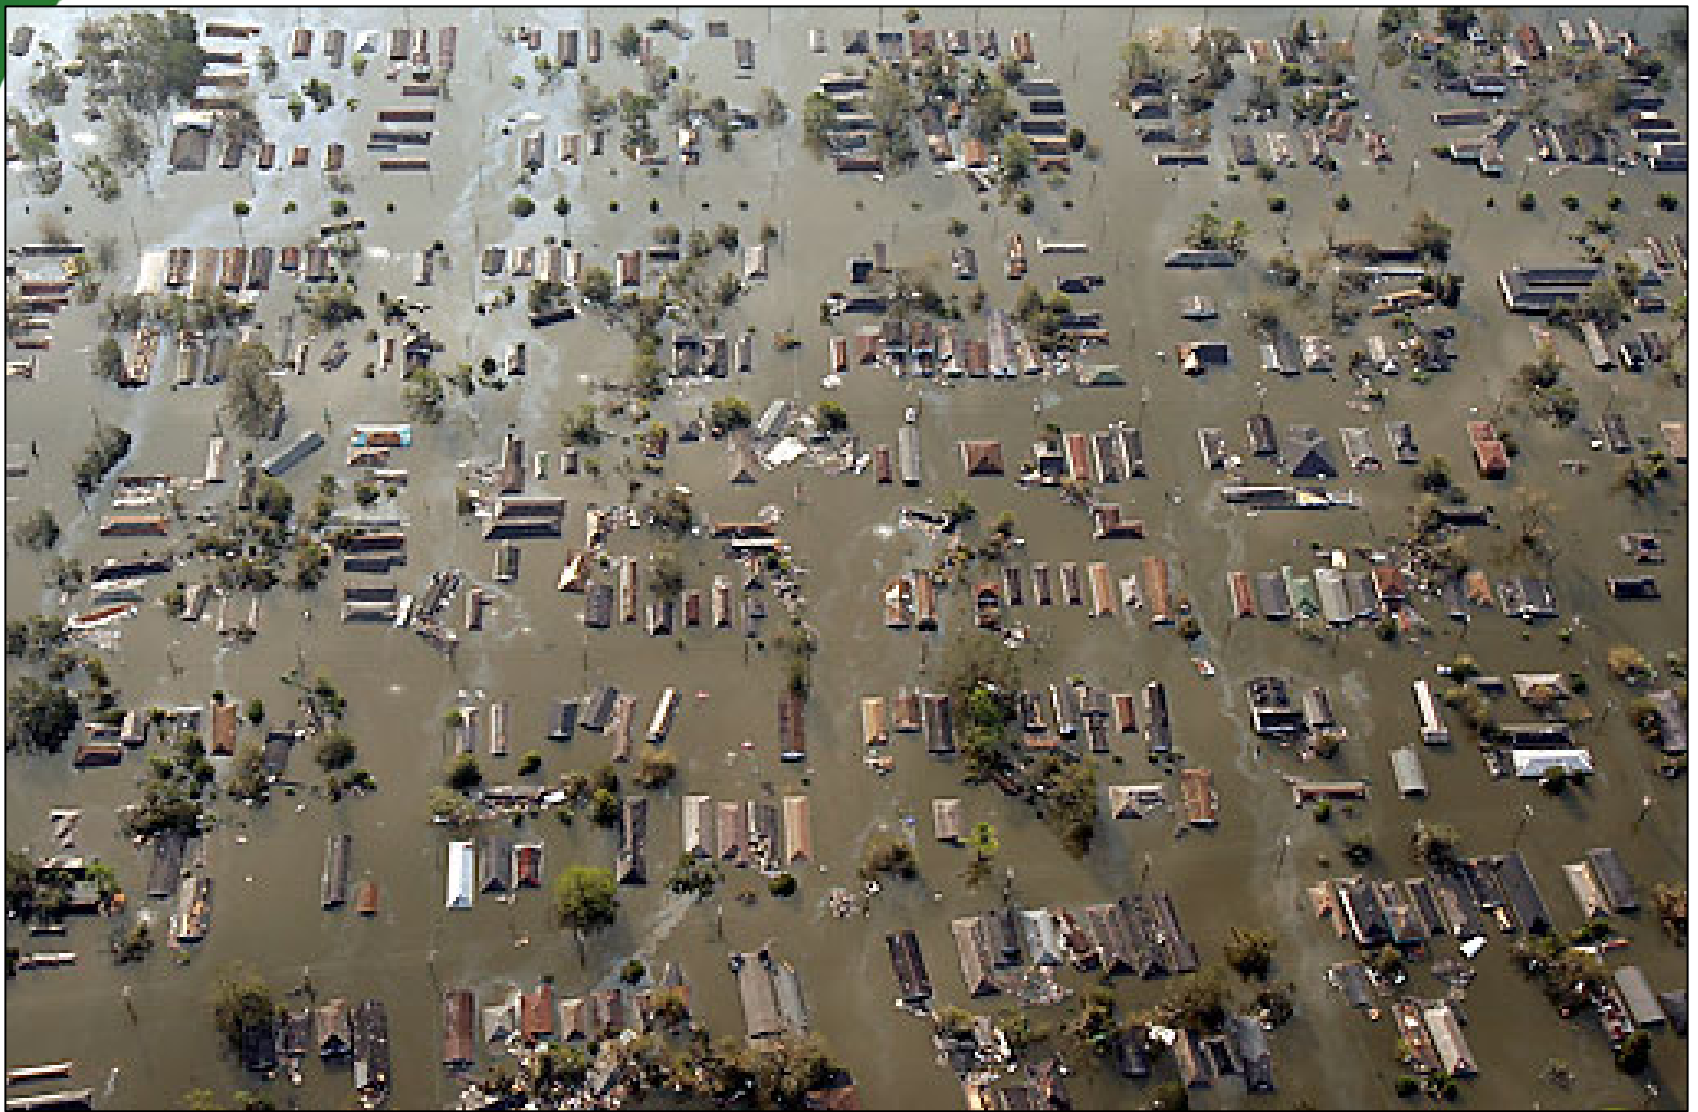
- **New Orleans neighborhoods were filled with as much as 12 feet of water, for up to 6 weeks**

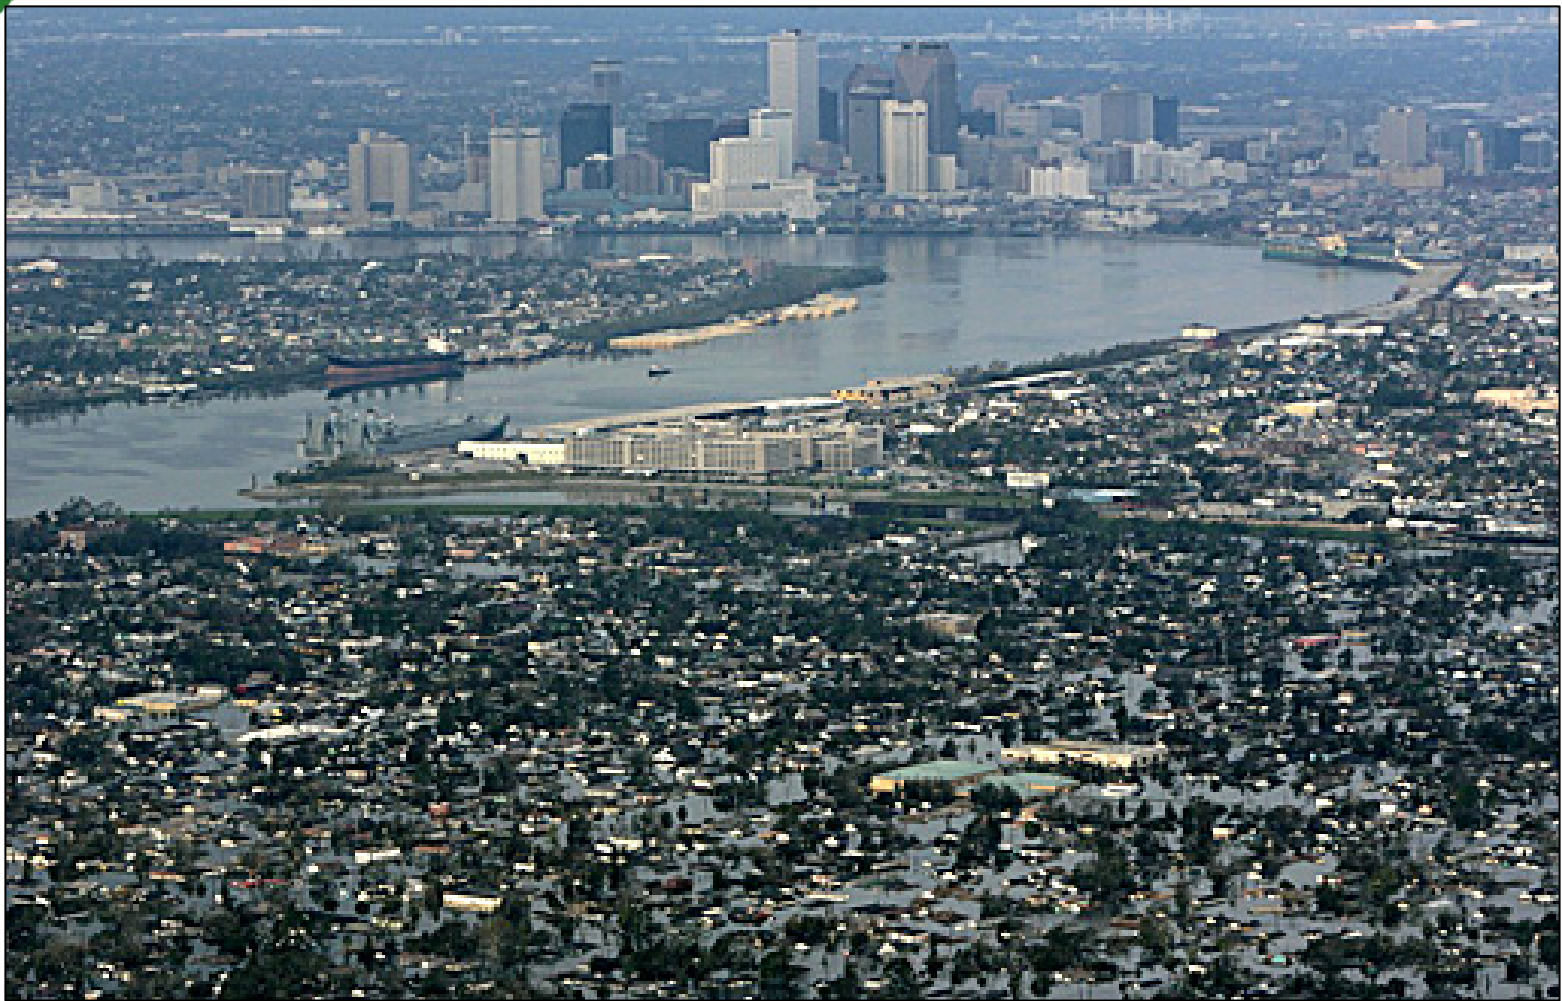
- Katrina left New Orleans under water, creating the worst flood in American history and the most expensive disaster, causing **\$24 billion** in claims to the **National Flood Insurance Program** and **\$200 billion** in overall damage.

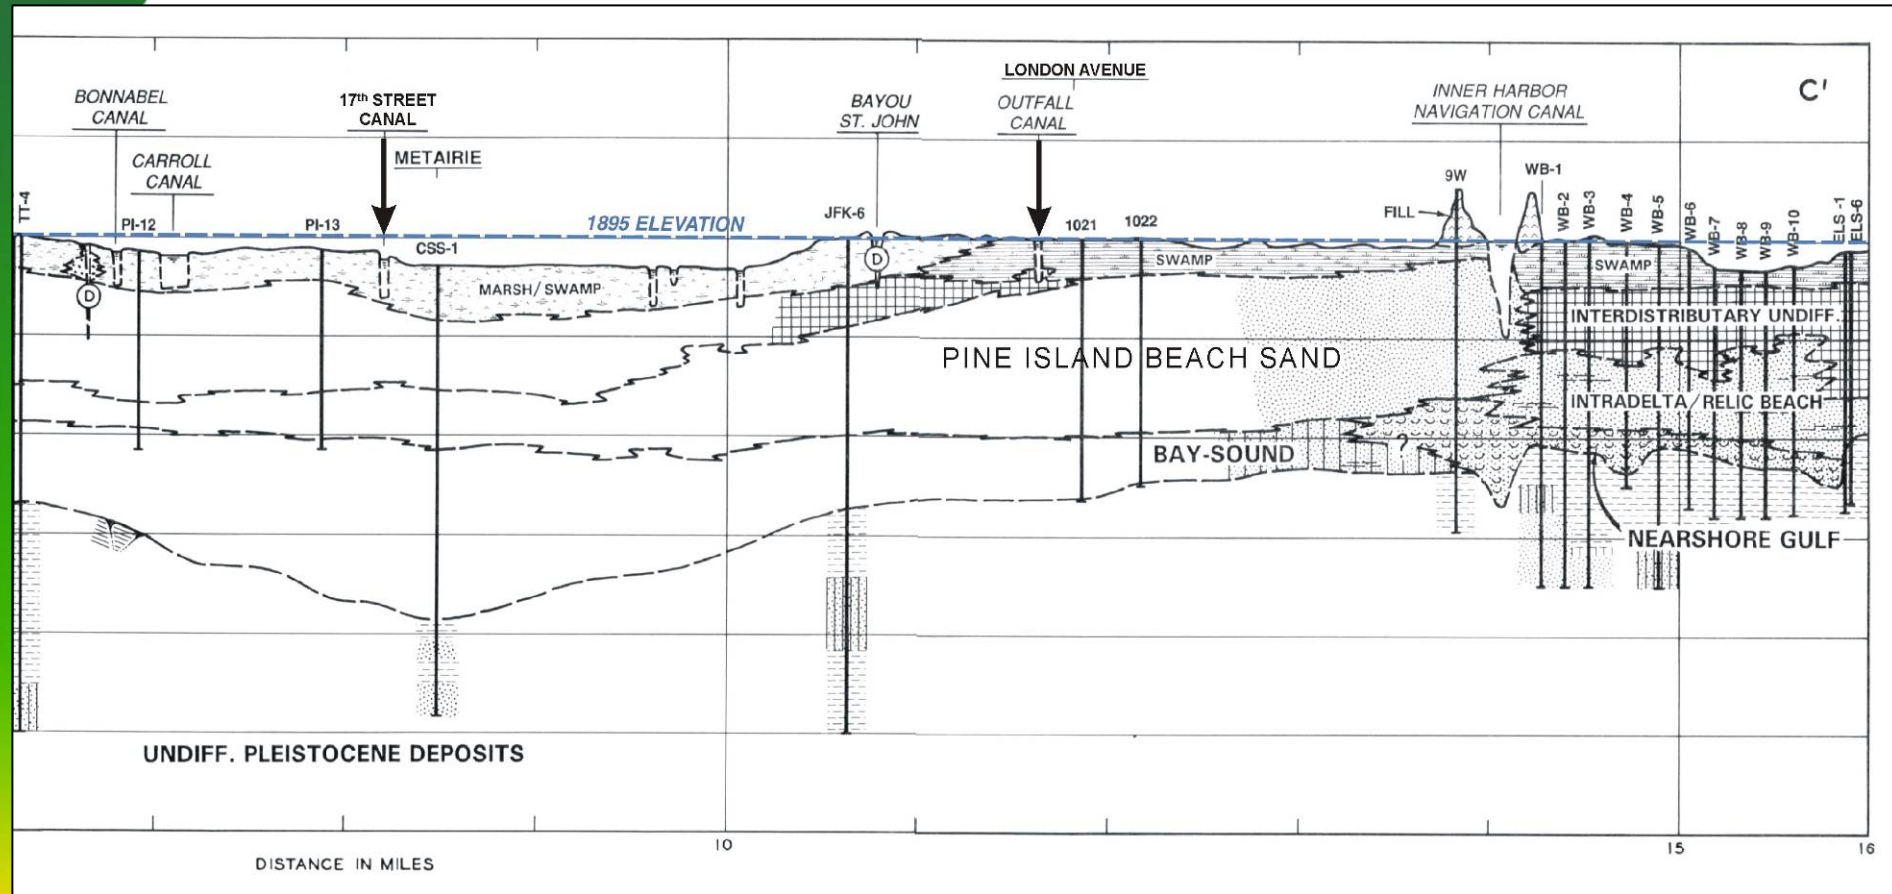
- **Geologic cross section along south shore of Lake Pontchartrain in the Lakeside, Gentilly, and Ninth Ward neighborhoods, where the 17th Street, London Avenue, and IHNC levees failed during Hurricane Katrina on Aug 29, 2005.**
- **Note the apparent settlement that has occurred since the city survey of 1895 (blue line), and the correlation between settlement and non-beach sediment thickness.**

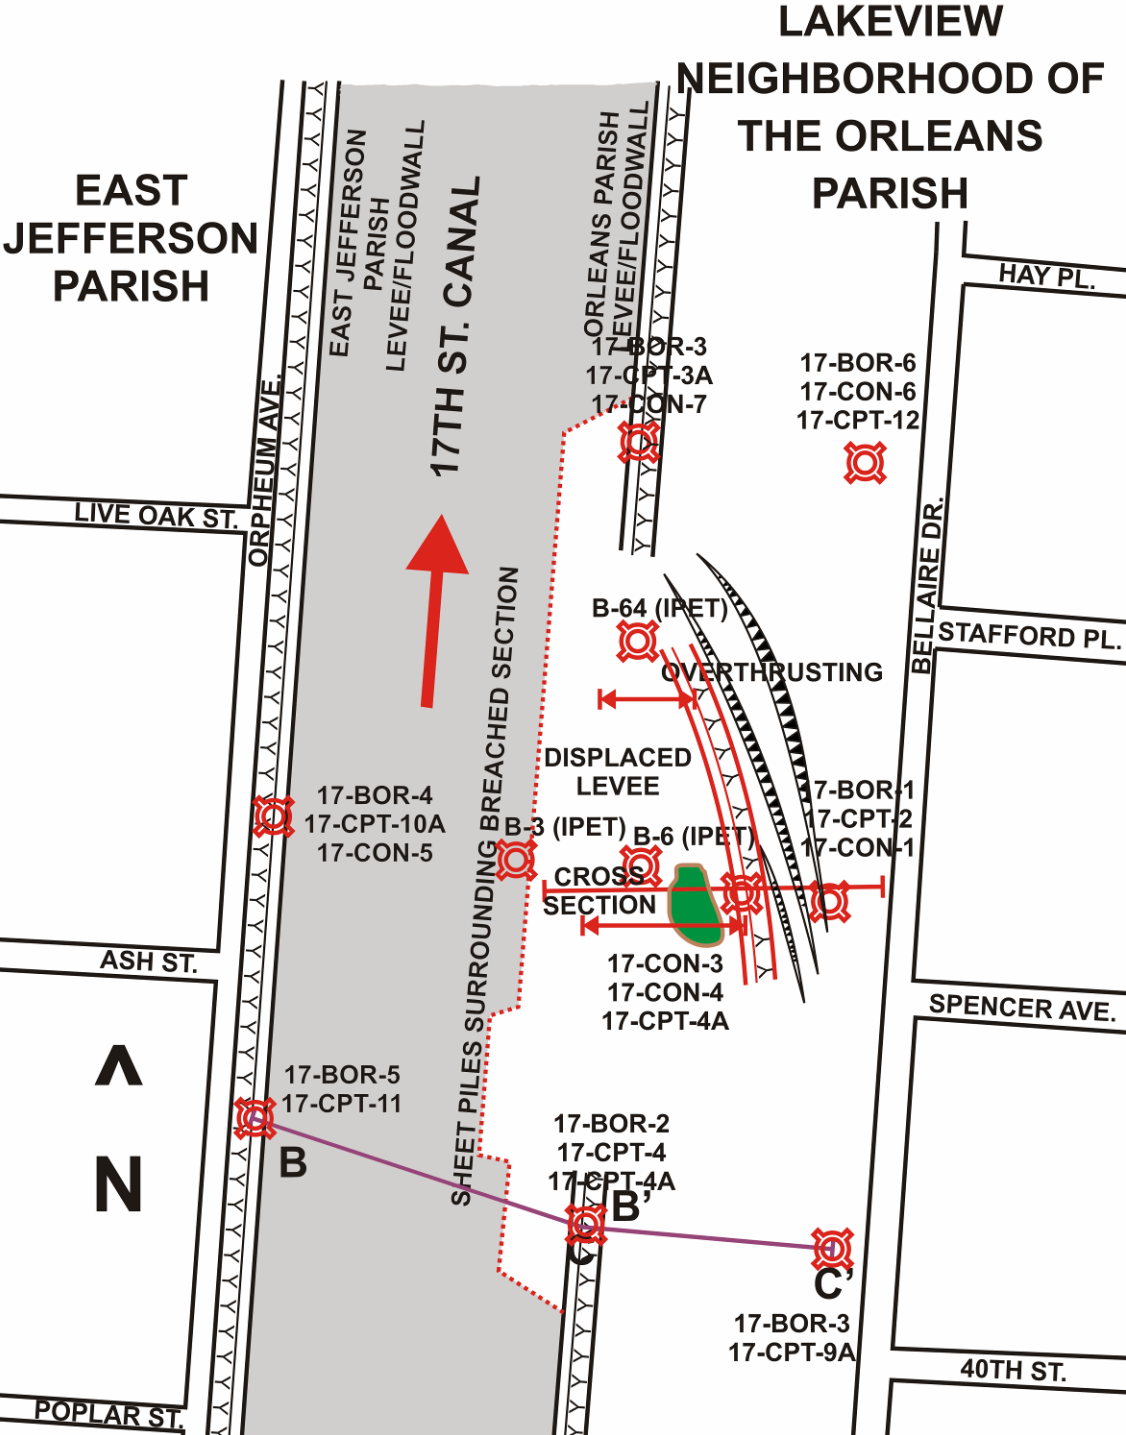
17th St Canal failure area

- Plan view of the 17th Street Canal breach site
- Locations of NSF team borings and CPT soundings noted in red
- The red lines indicate the positions of the NSF team's geologic sections.

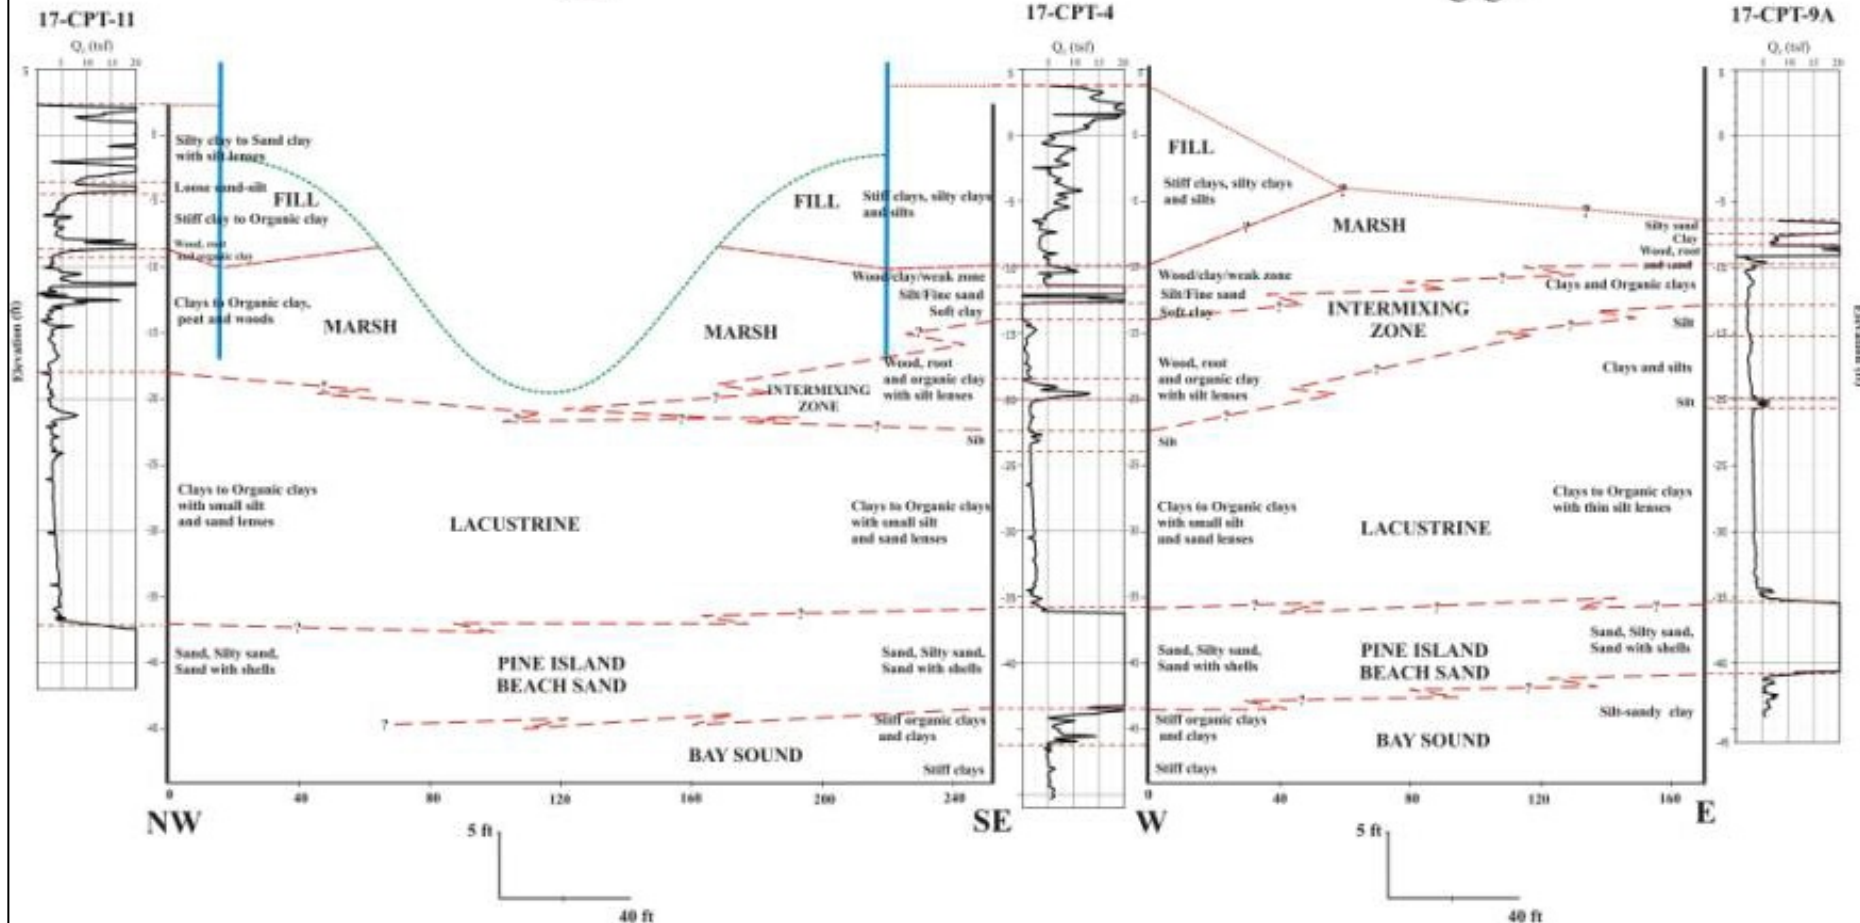
- **Stratigraphic interpretations across the 17th Street Canal breach.** The swamp much appeared to be thinning northerly, as does the underlying **Pine Island Beach Trend**. The lacustrine clays appear to thicken southward, as shown.
- The approximate positions of the flood walls (light blue) and canal bottom (dashed green) are based on information provided by the Corps of Engineers.

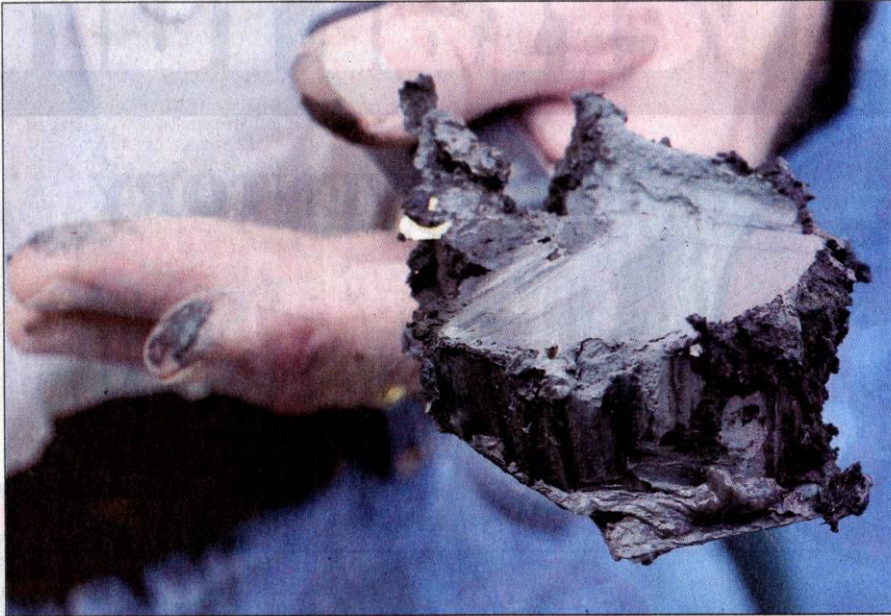
This piece of clay was just above the peat area at the site of the 17th Street Canal floodwall breach.

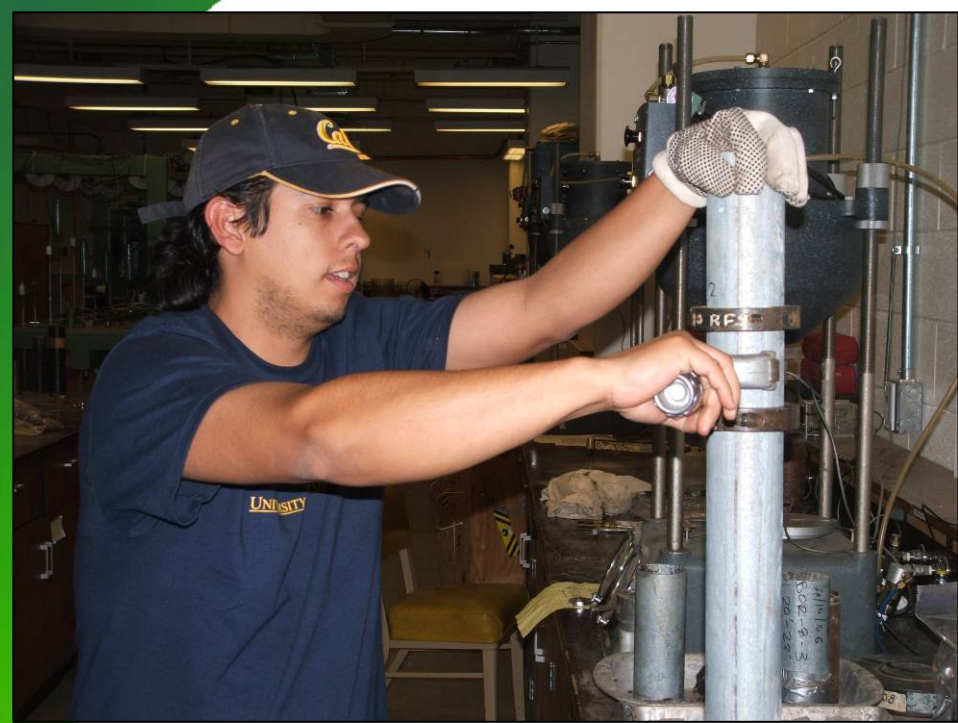
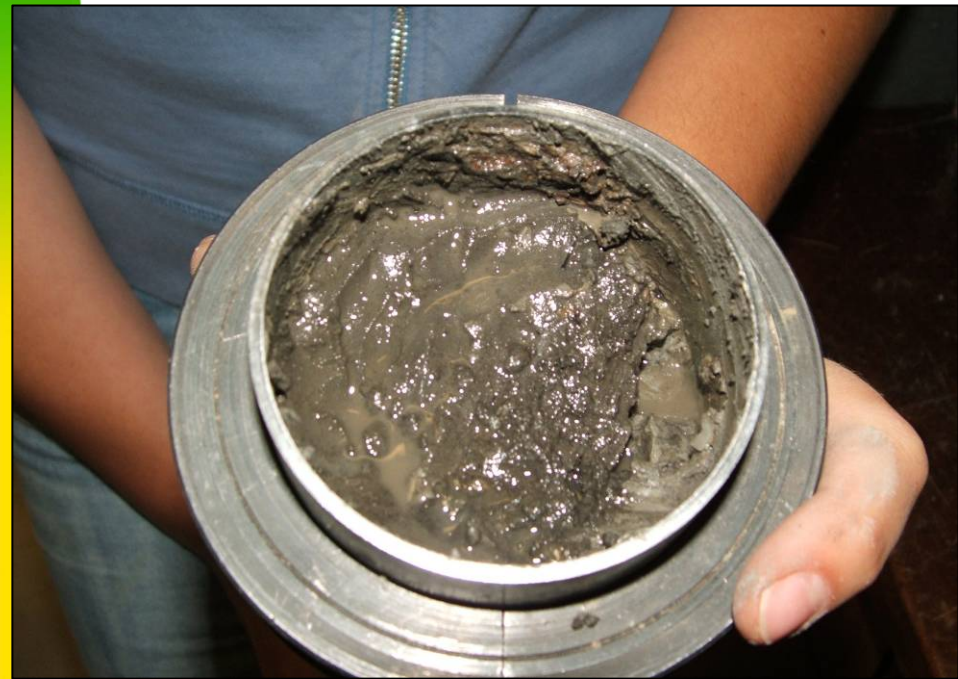
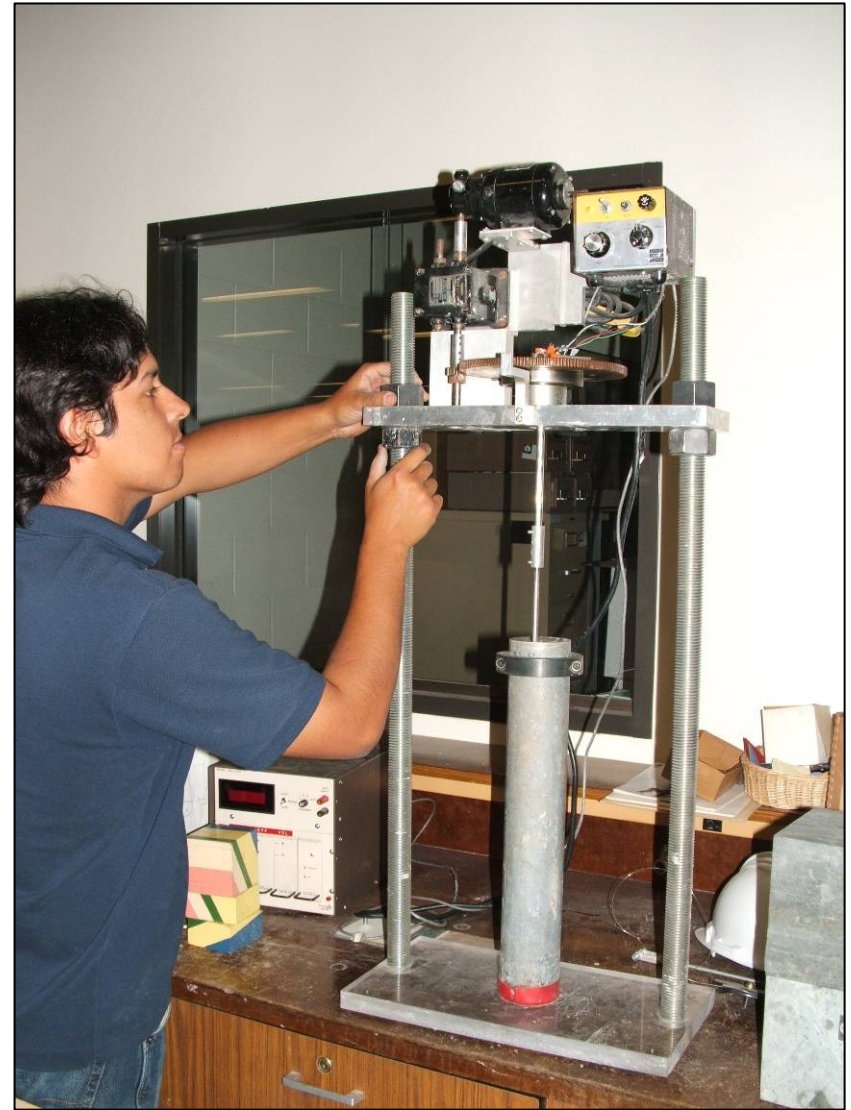
Miniature laboratory vane shear testing at U.C. Berkeley

- Sampling the slip surface was only the first hurdle
- Shear testing of this toothpaste consistency paludal clay proved far more difficult
- The results eventually showed a peak shear strength of 50 psf, degrading to zero after a half inch of rotation

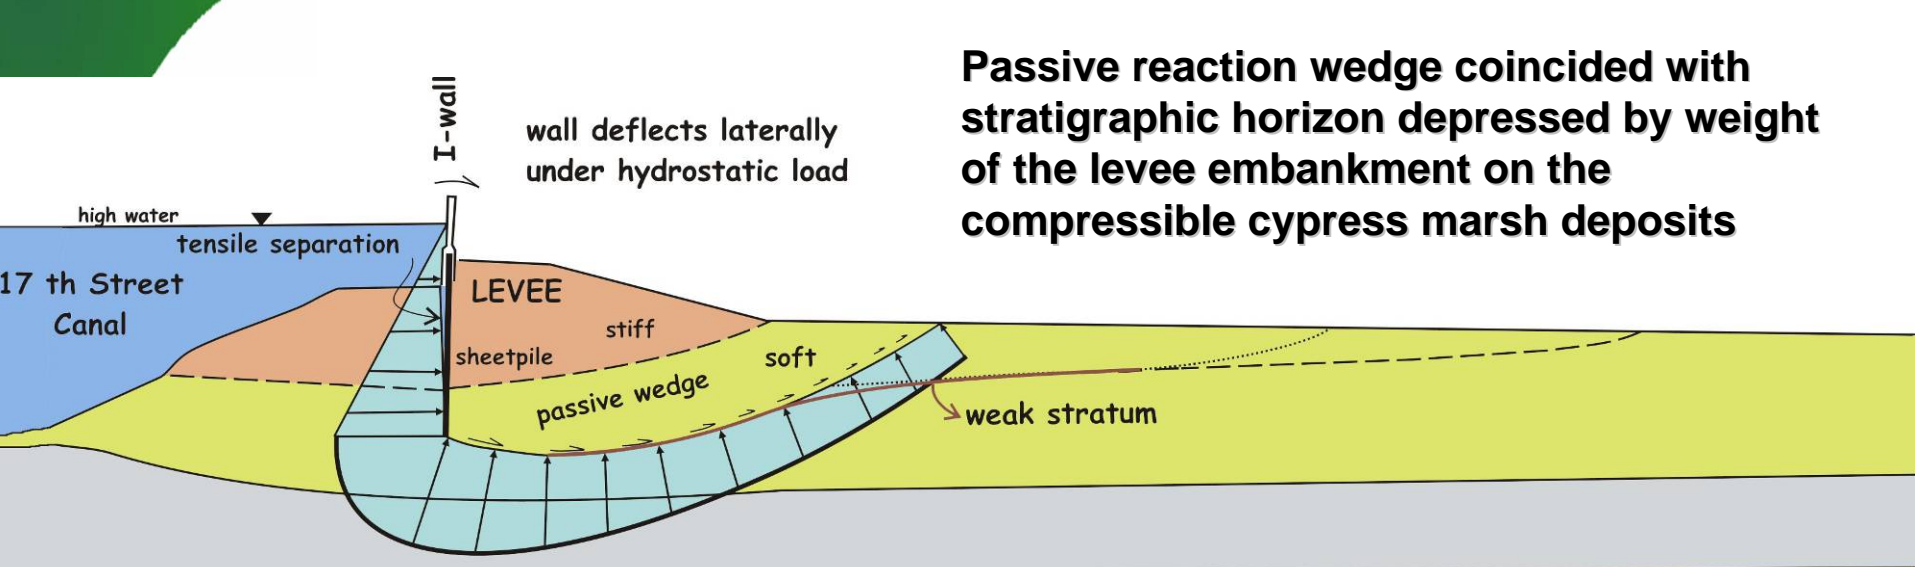
Passive reaction wedge coincided with stratigraphic horizon depressed by weight of the levee embankment on the compressible cypress marsh deposits

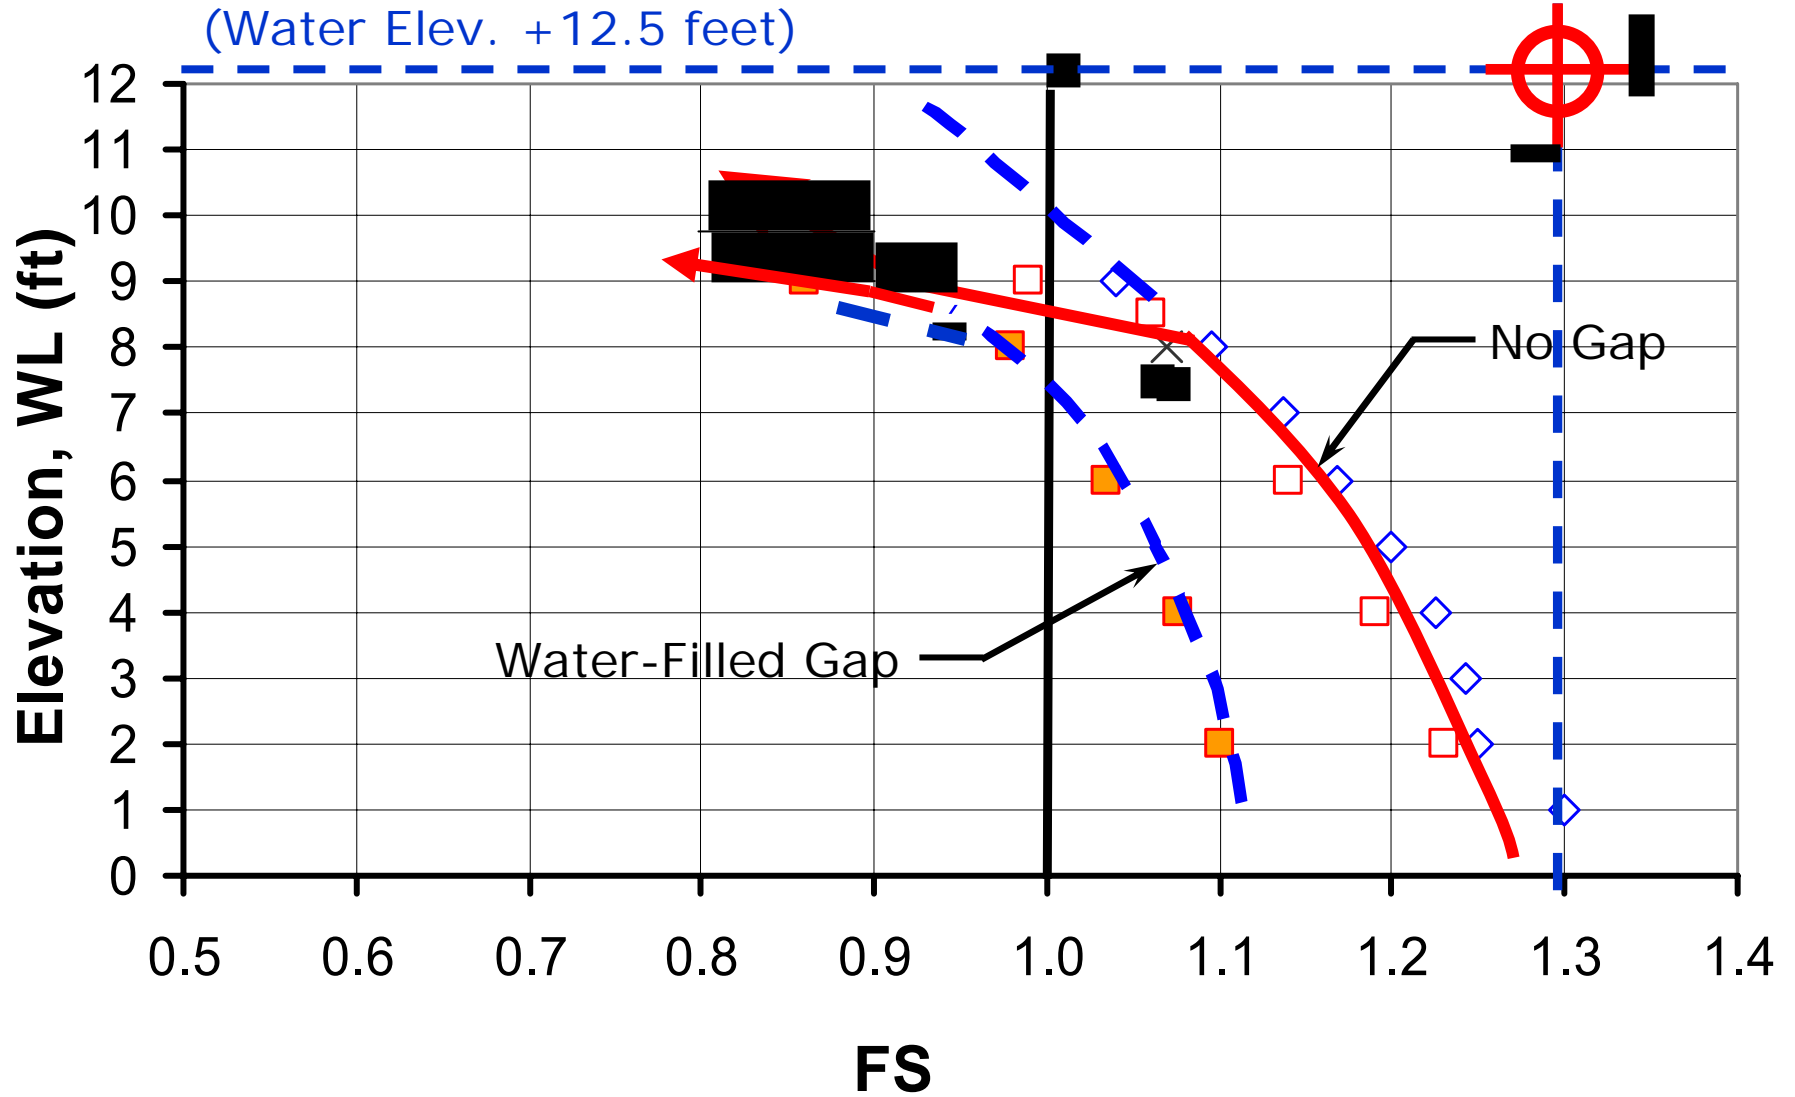
17th Street Canal East Side

(FS = 1.3)

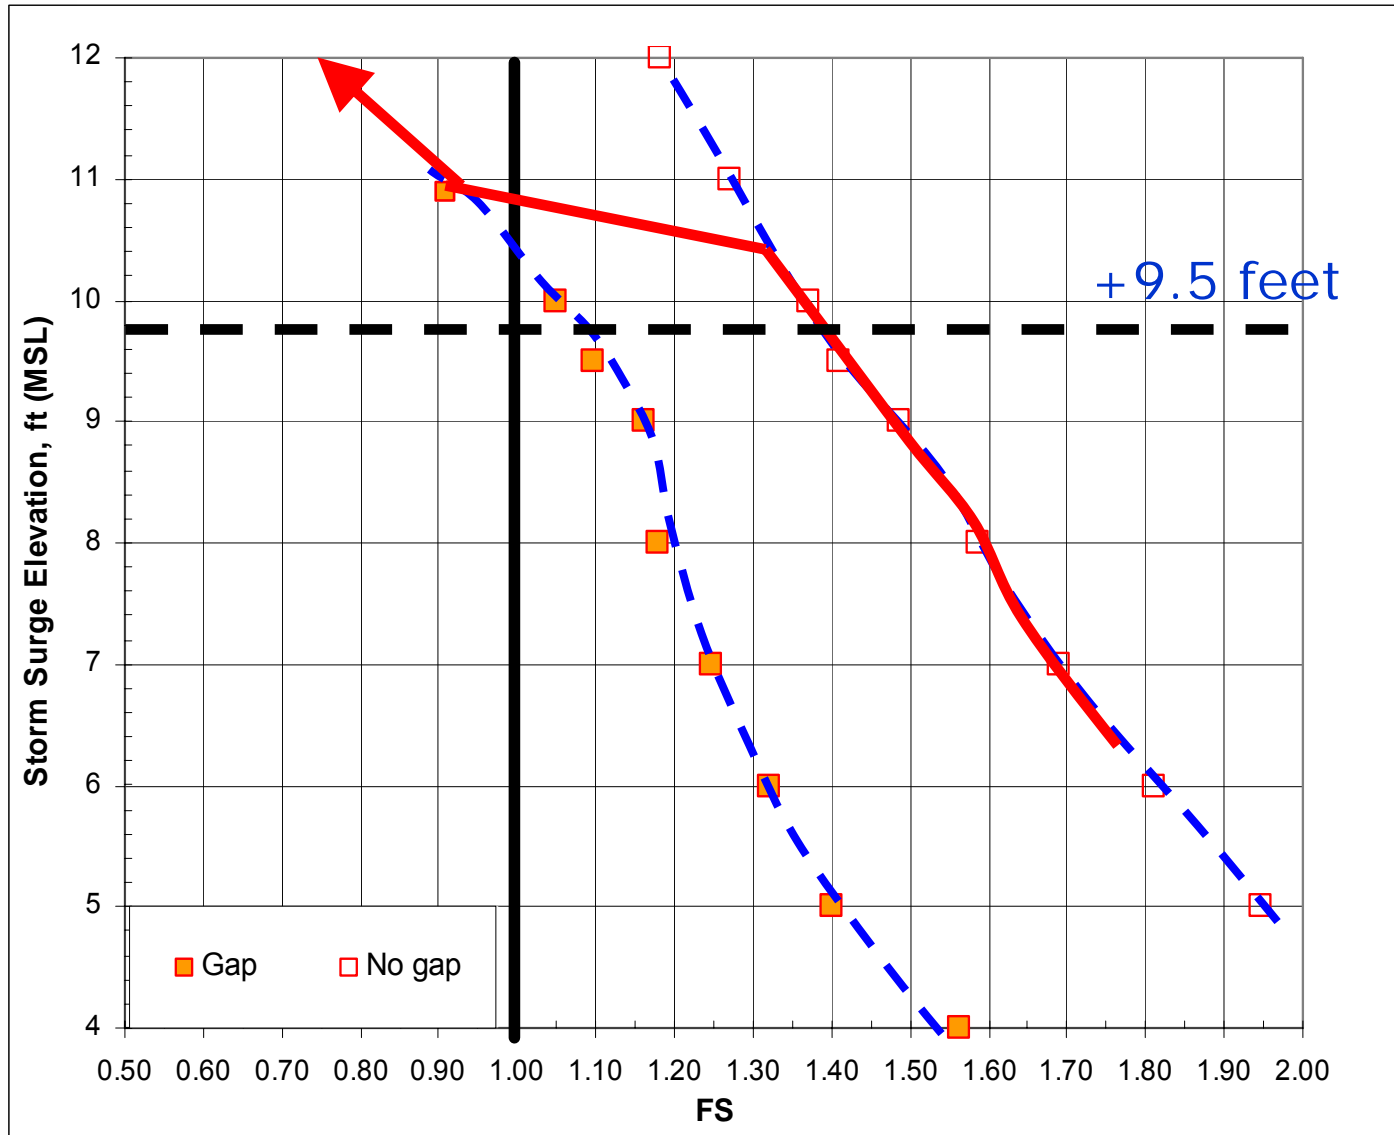
17th Street Canal, West Bank

- The NSF team assuaged that the bend in the flood wall on the west (unfailed) side of the 17th St Canal was evidence of an incipient failure
- The Corps didn't initially agree publicly

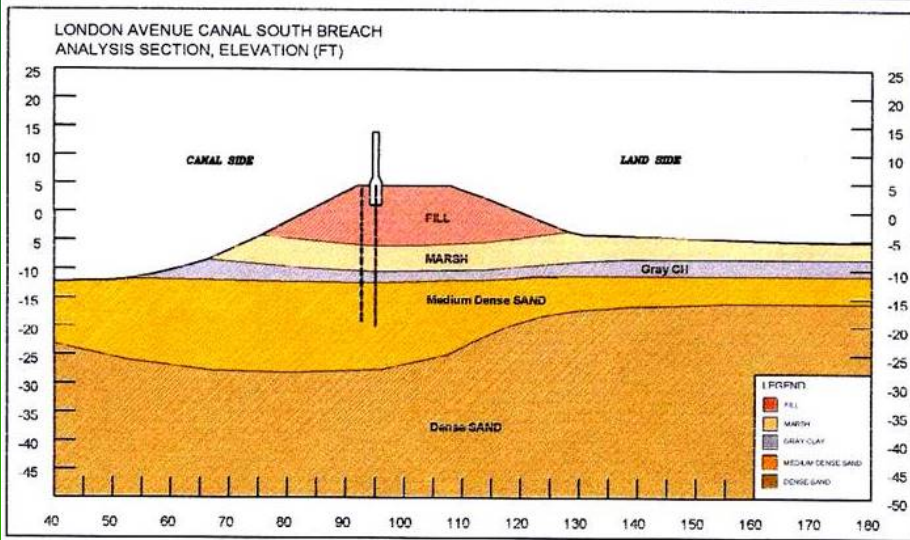
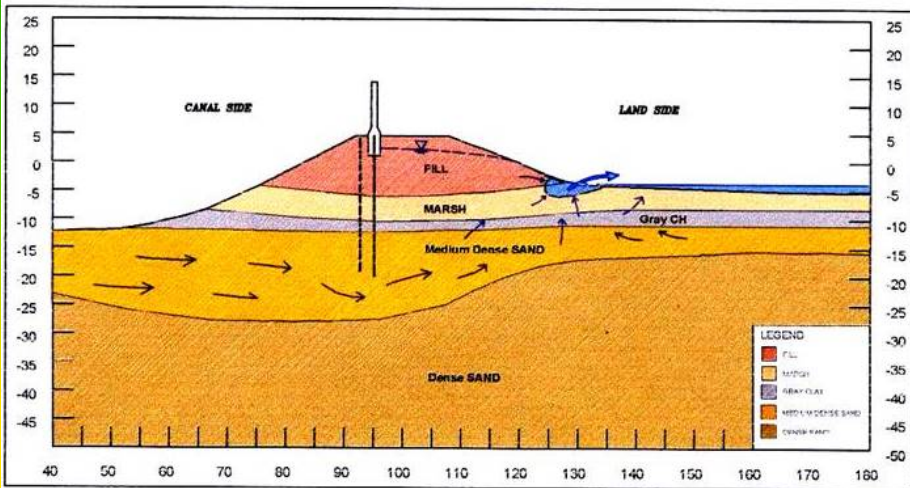
The South Breach of the London Avenue Canal was caused by **excess seepage pressures** developed in the sand underlying the canal, which had been dredged

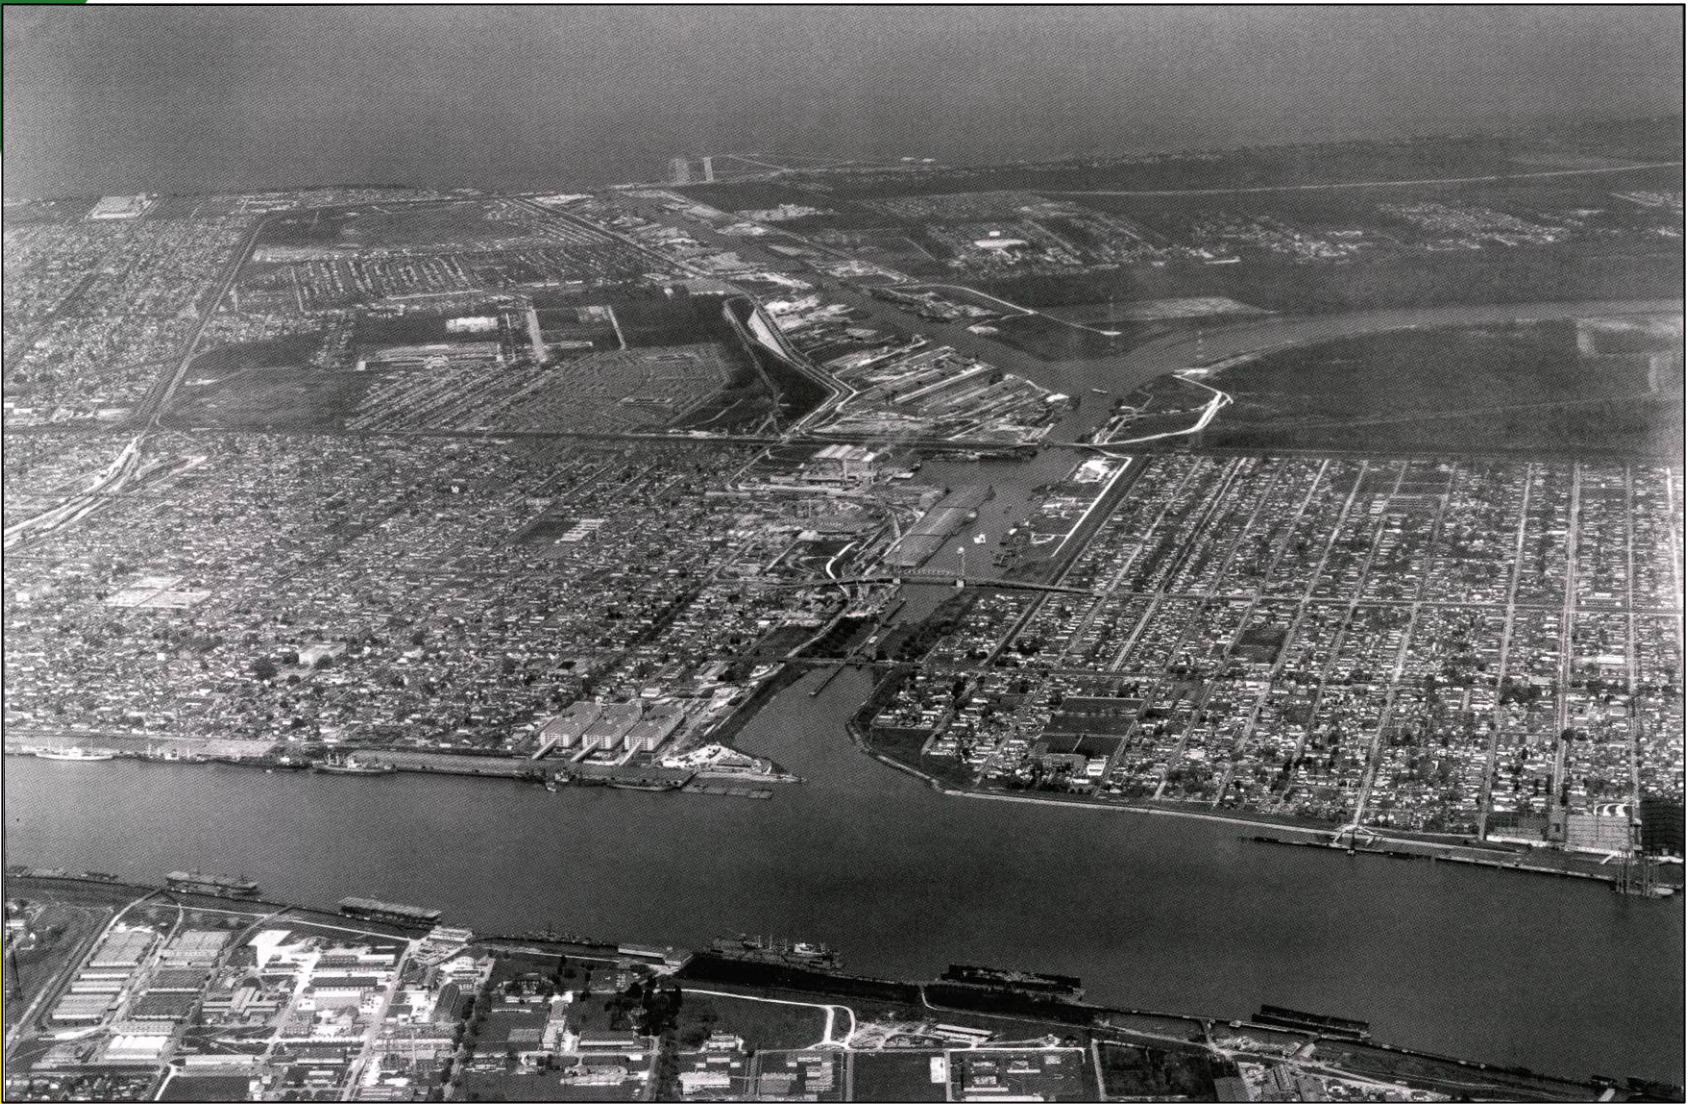
- Aerial oblique view of the **Inner Harbor Navigation Canal** between 1960-64, after the entry to the Mississippi River-Gulf Outlet Channel had been enlarged (upper right), connecting to the inner harbor area.

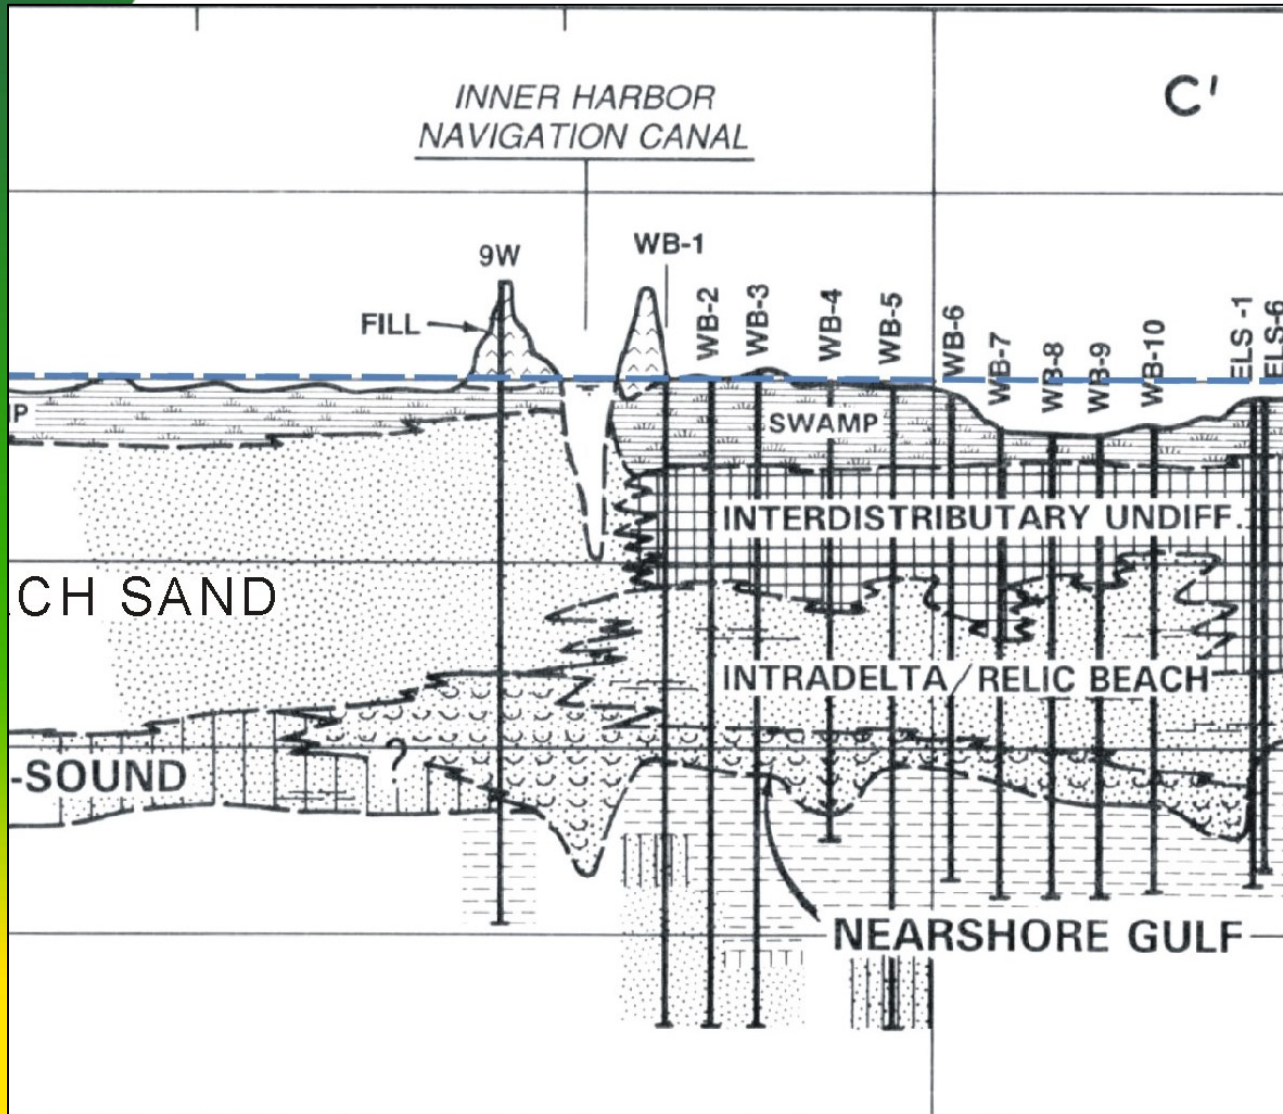
Geology under the IHNC

- The units lying beneath the IHNC channel vary from the west to the east side
