ENGINEERING GEOLOGIC CHARACTERIZATION OF LEVEE FAILURES IN NEW ORLEANS DURING HURRICANE KATRINA

J. David Rogers, Ph.D., P.E., R.G.

**2007 Annual Meeting
Association of Environmental and Engineering Geologists
Los Angeles, California
September 28, 2007**

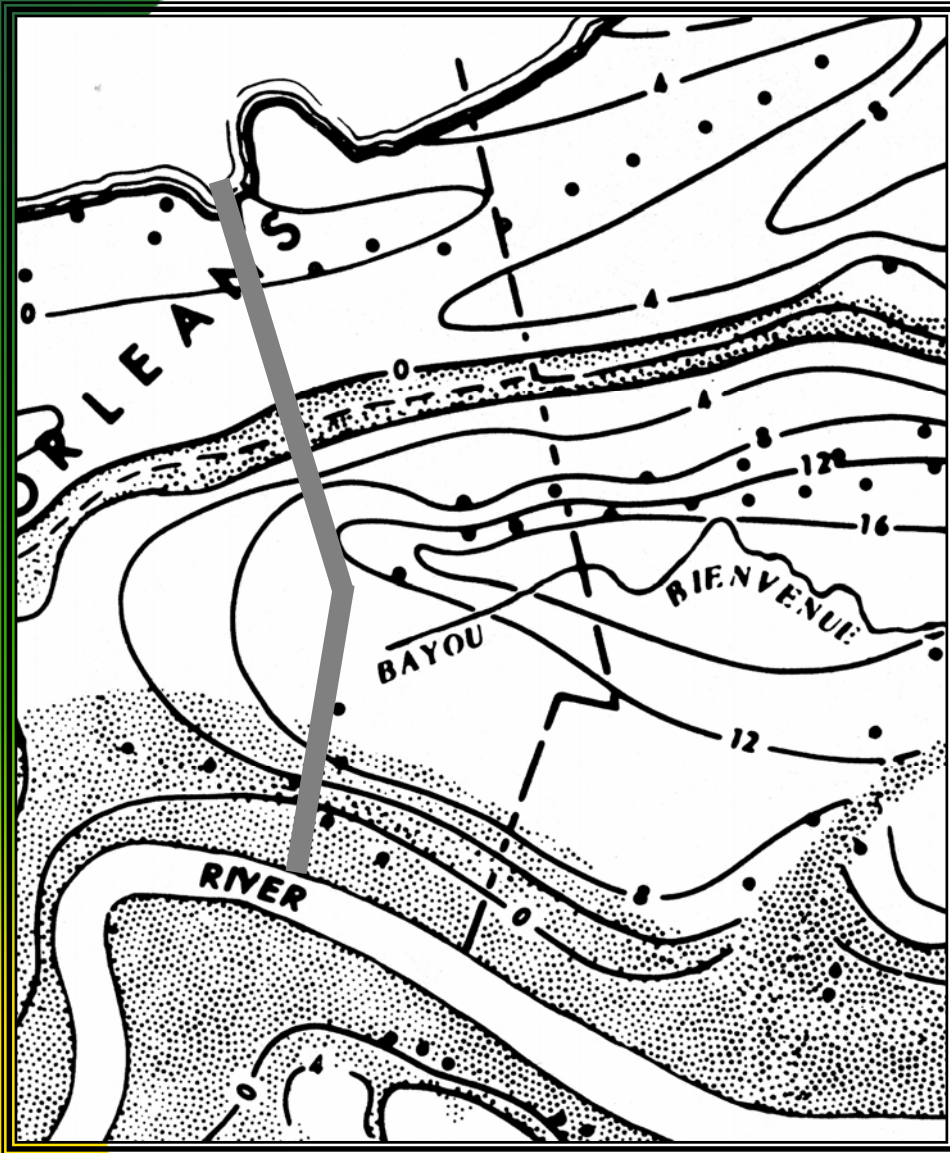
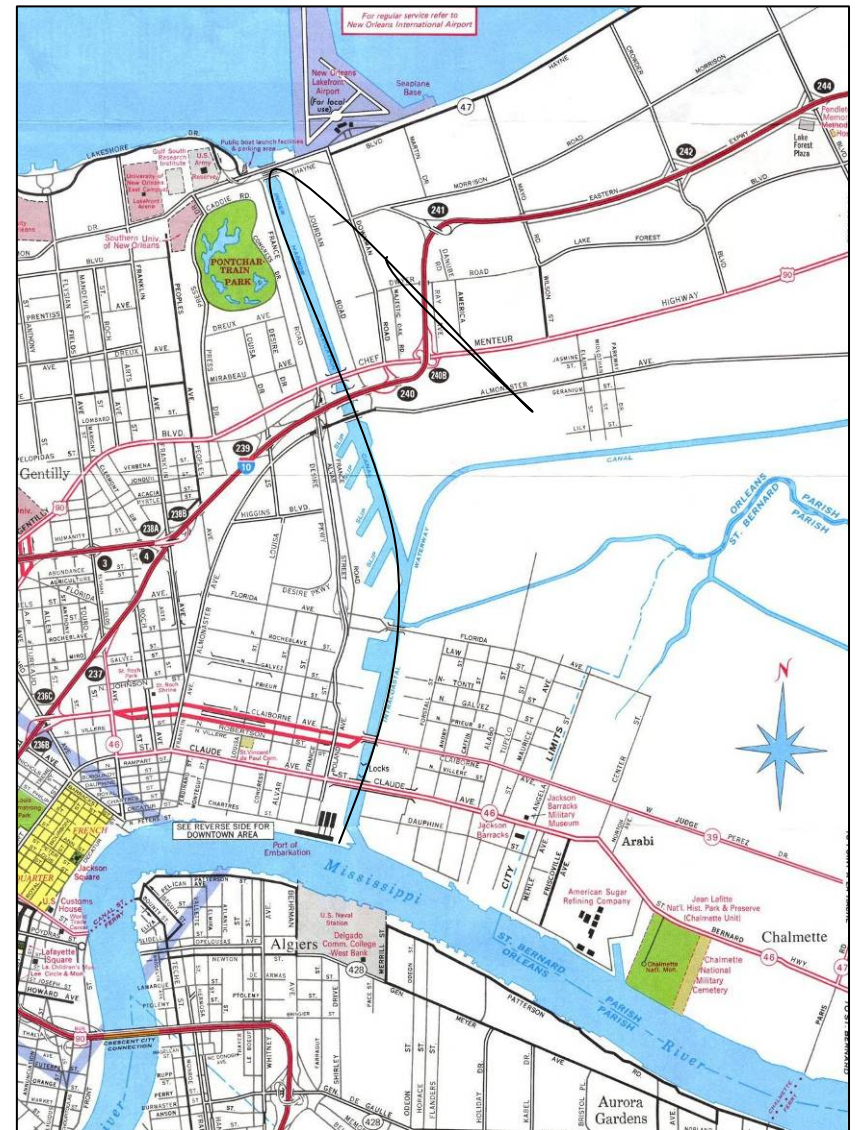
- Detail showing thickness of surficial peat in vicinity of the IHNC. Thickness varies from 0 to 12 feet along Section III, between Claiborne and Florida Avenues.

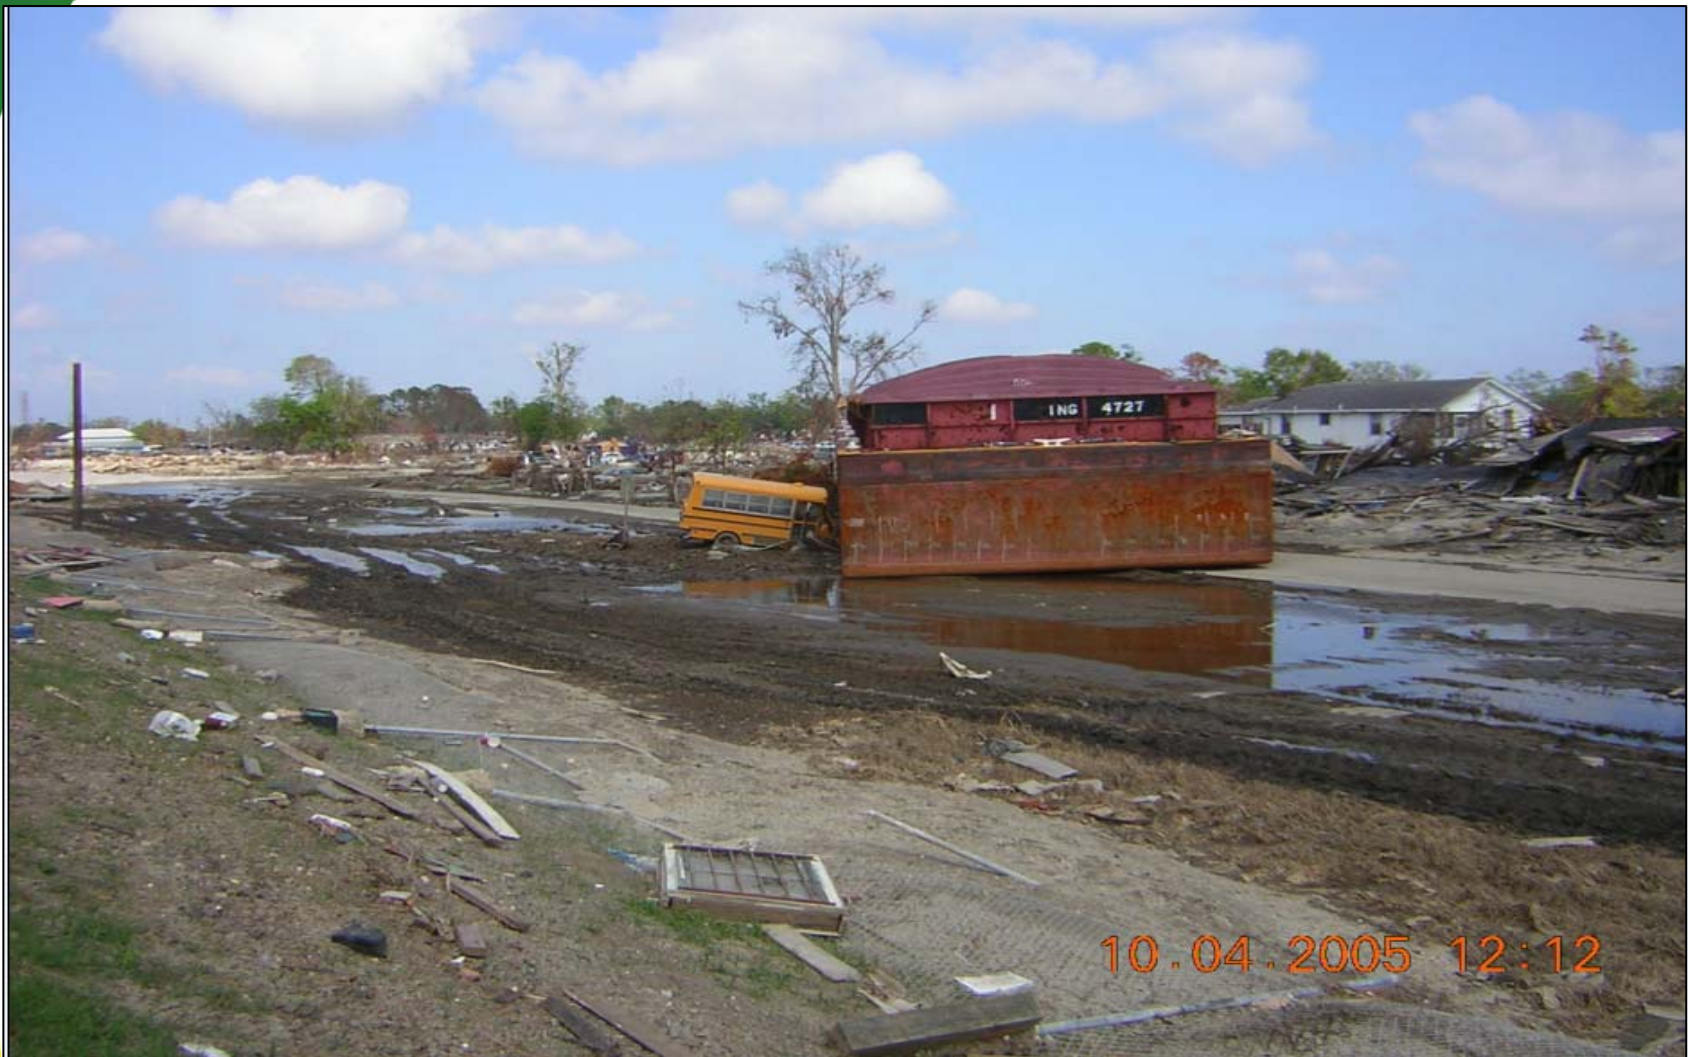
- **ING 4727 was built in 1990 as a dry cargo cover-top barge with a steel hull. It was 200 feet long, 35 feet wide, and 12 ft high, with a cargo volume of 84,659 ft³ (1877 tons). It was being leased to Lafarge North America, and was tied up along the MRGO channel.**

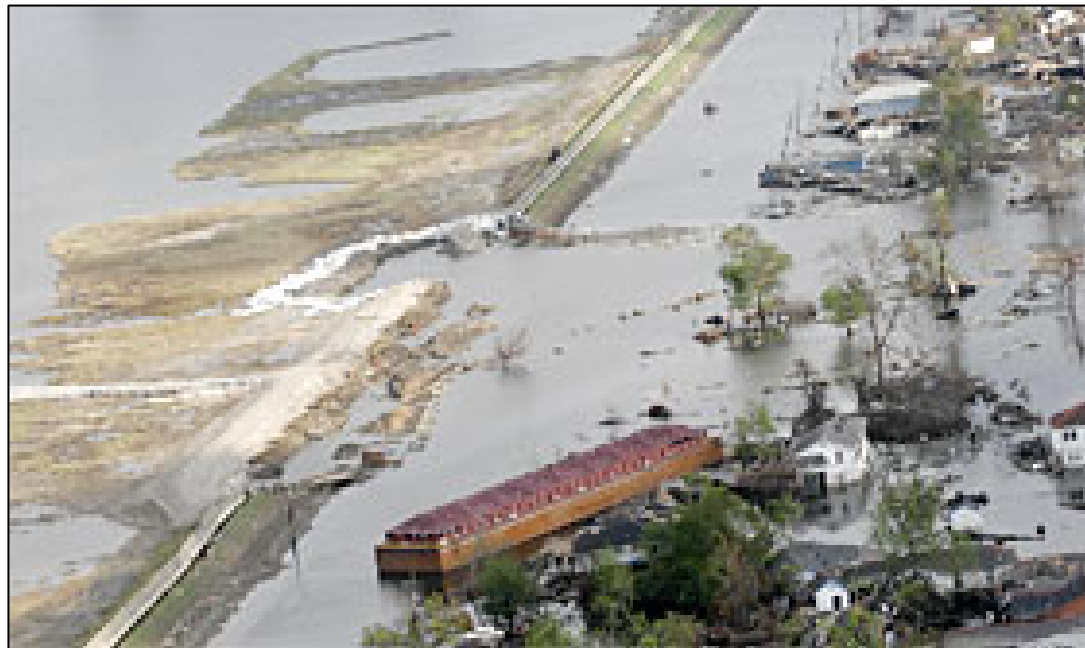
ANALYSES: Stability of Flood Wall East IHNC South Breach

Plaxis soft soil constitutive modeling of 7.5 ft deep scour trench and 4.5 ft gap – deformed mesh – true scale (max displacement of embankment crest = 1.2 ft)

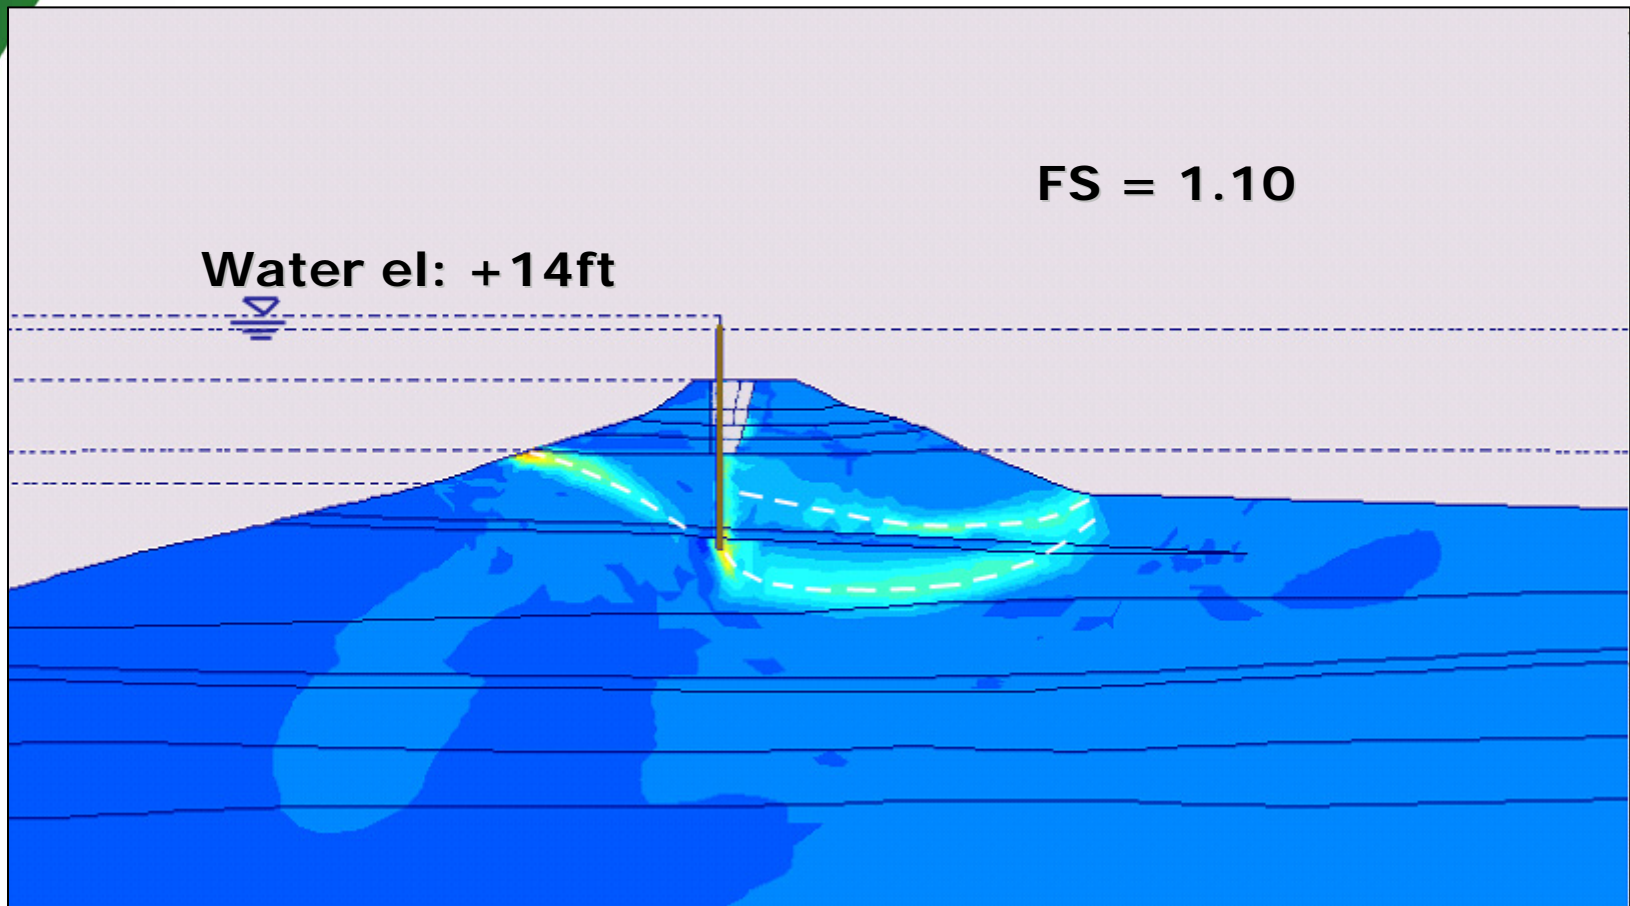
Shear strains predicted by the Plaxis model, assuming a 7.5 ft deep scour trench and 4.5 ft wall gap – using “best estimates” of c and ϕ – Factor of Safety = 1.10. Underseepage-induced pore pressure trapped along base of less pervious clay stratum, overlying the more pervious marsh deposits.

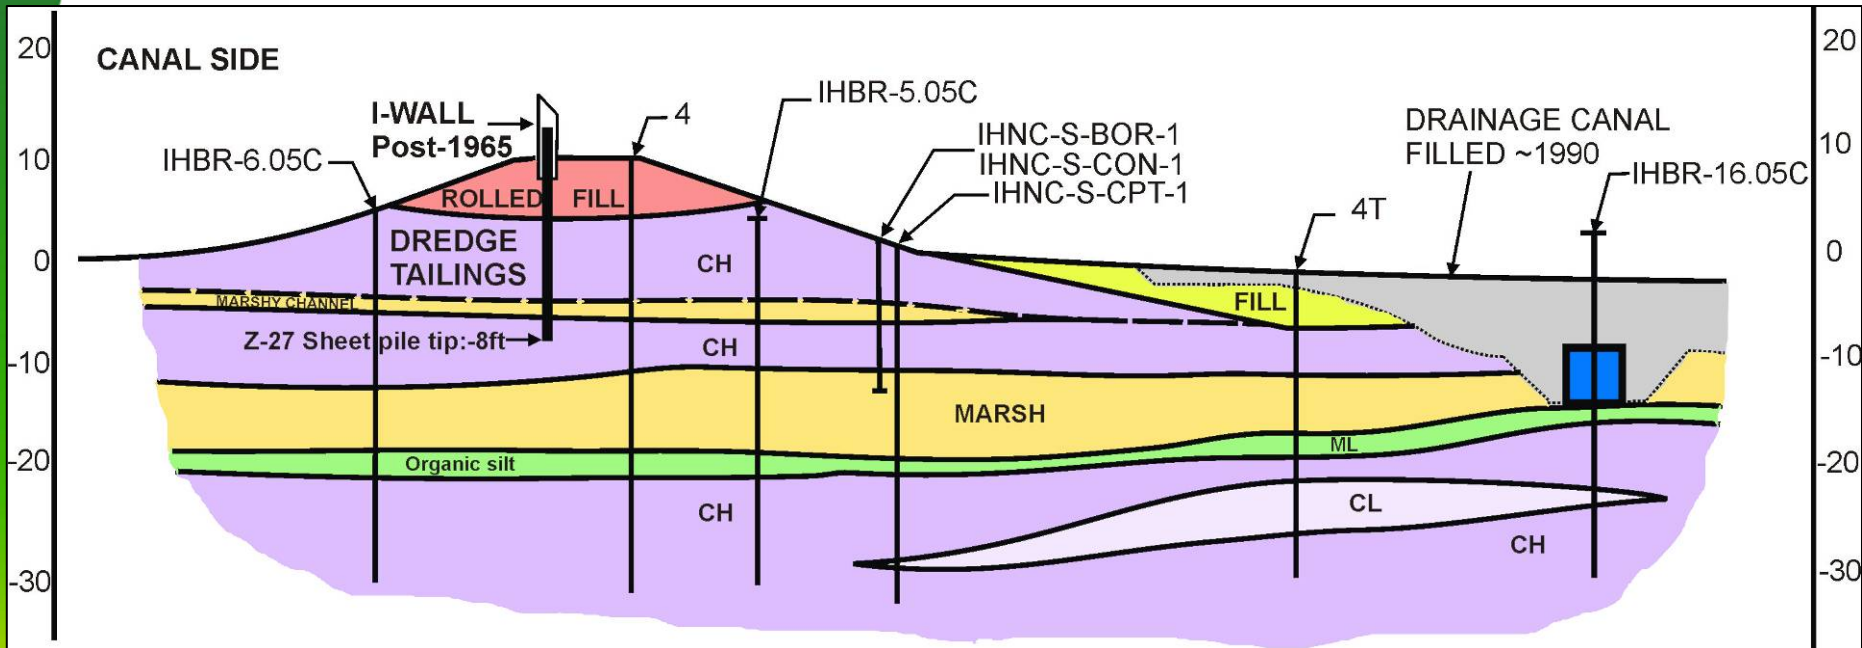
East Bank IHNC South Breach

Geologic cross-section showing projections of borings and tentative stratigraphic correlations for the 800 ft long IHNC East Bank-South Breach, adjacent to the Lower Ninth Ward

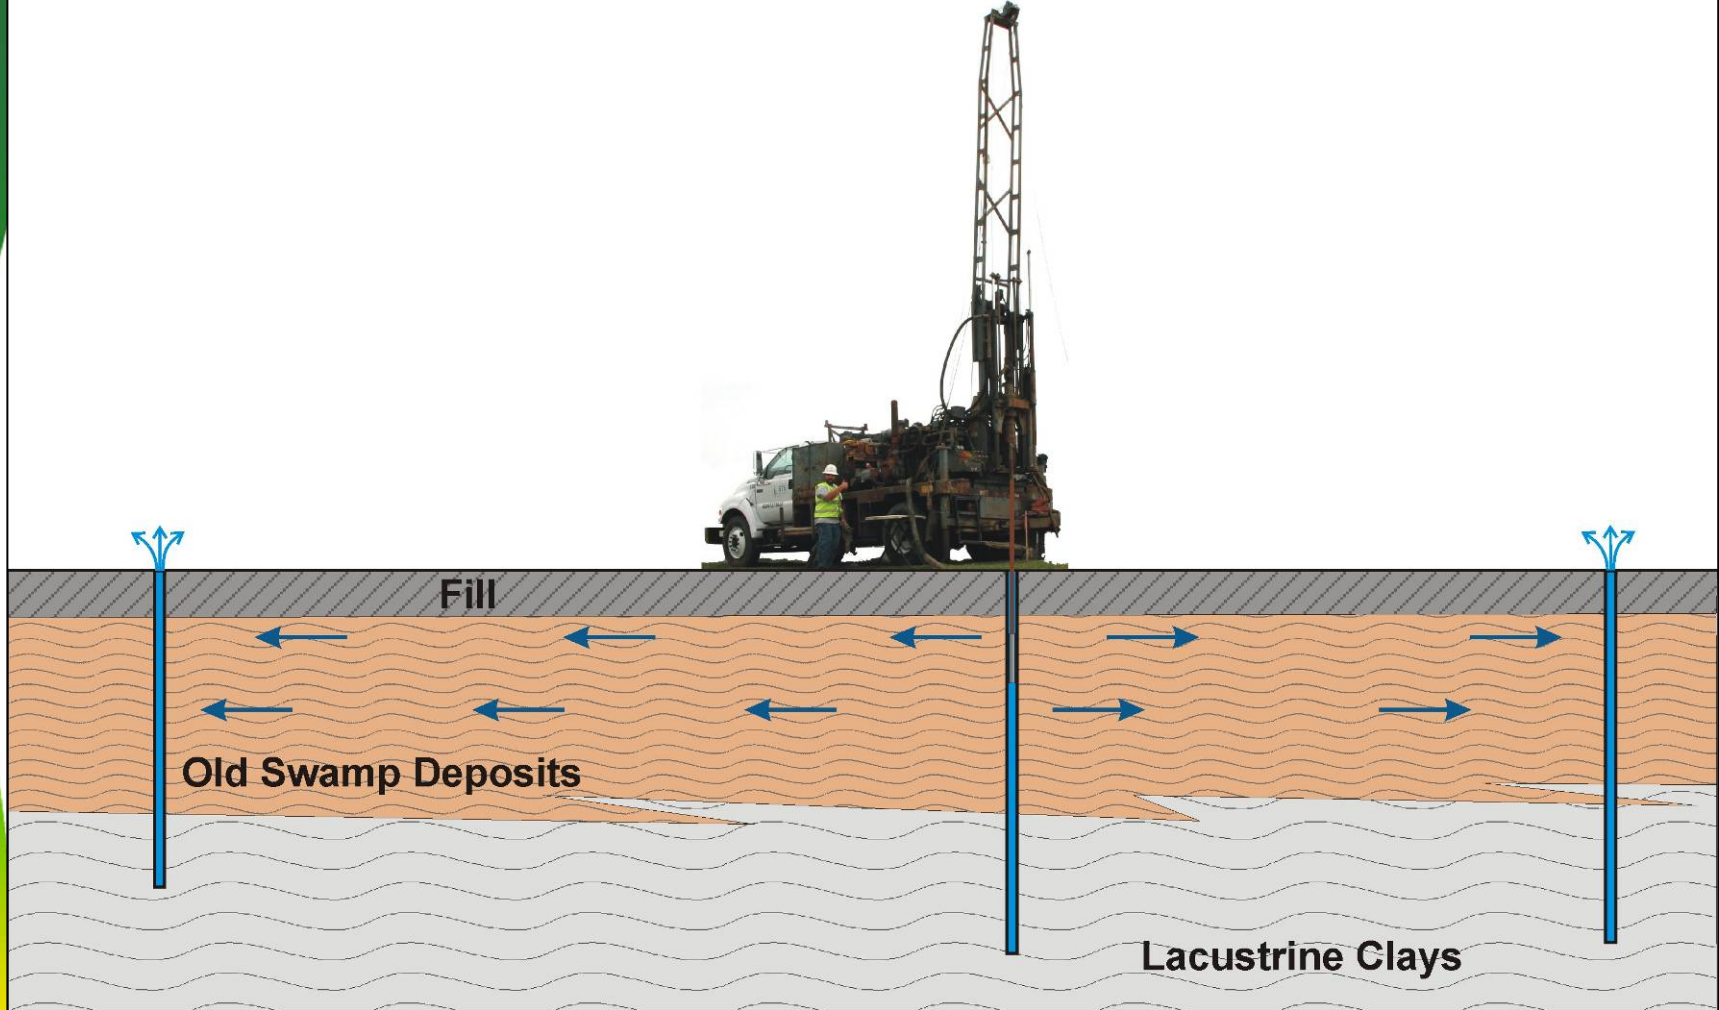
- The porous and **highly conductive** nature of the backswamp deposits was revealed during post-Katrina drilling and sampling operations.
- Highly conductive in horizontal plane, especially, parallel to original surface drainage.

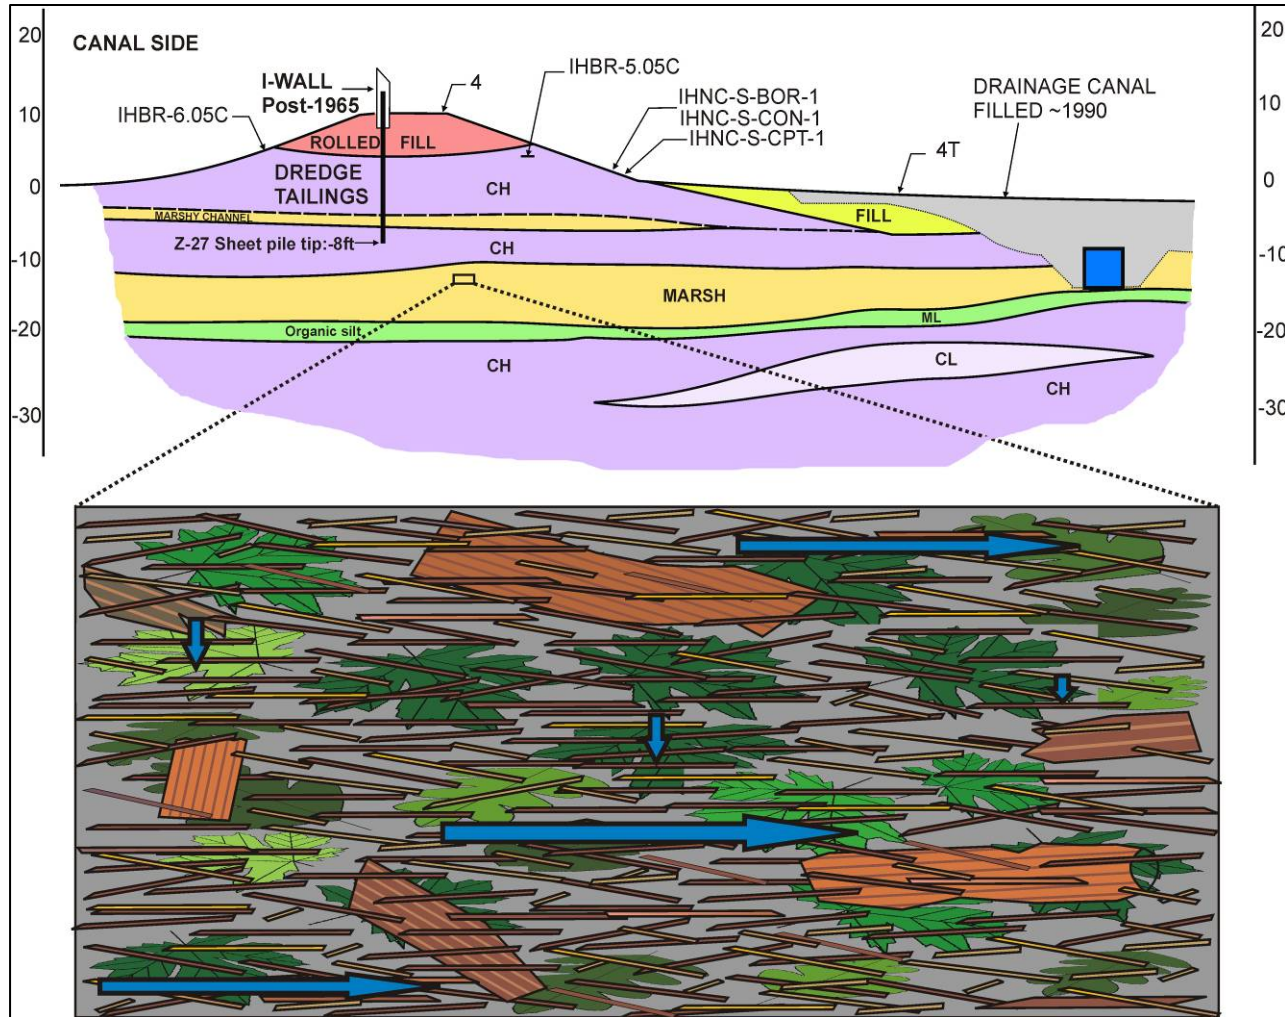
Anisotropy of backswamp deposits

- Sudden die-off of organics creates highly anisotropic fabric; preferentially layered

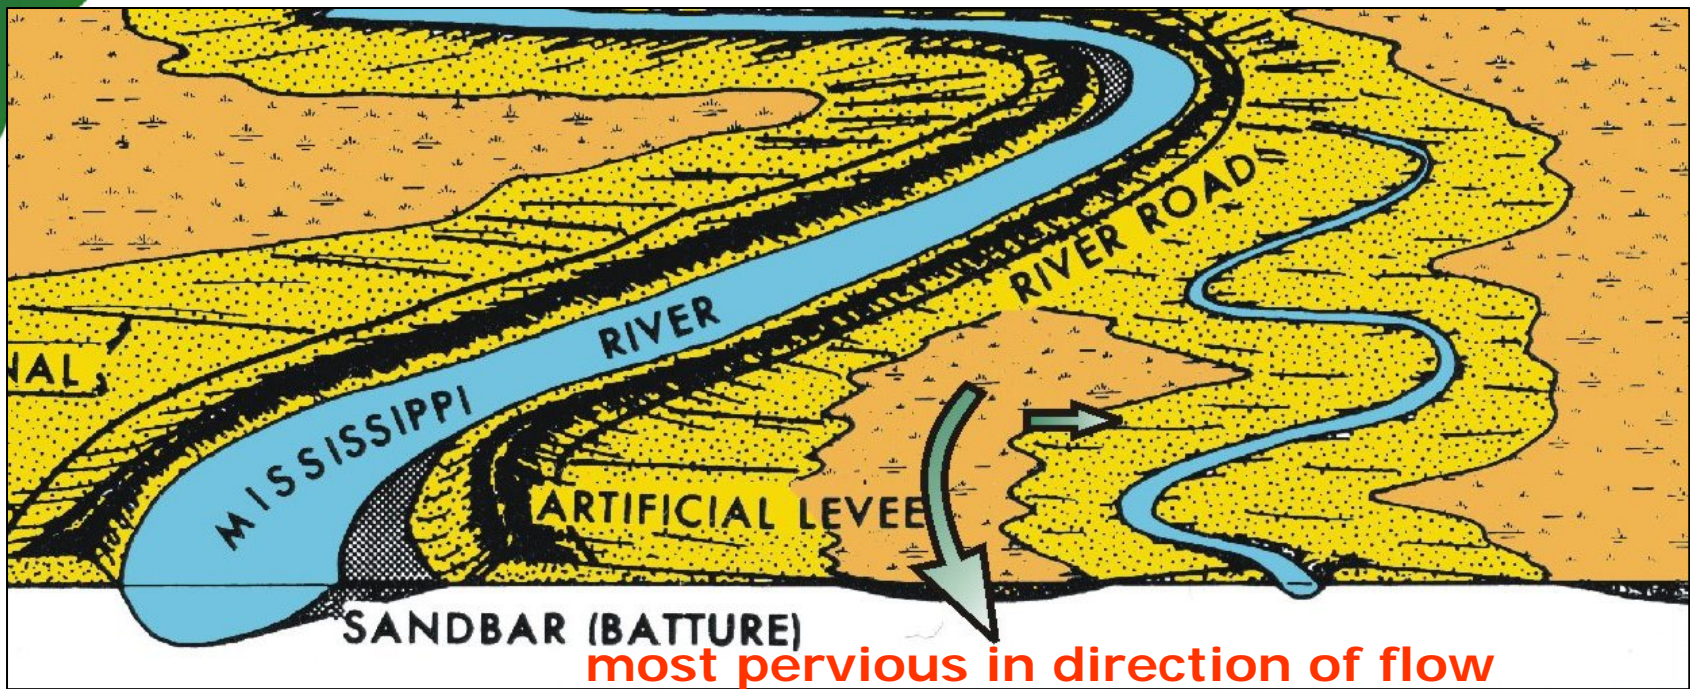
- **Drainage swales in the backswamps are subject to sieving of fines by runoff**
- **This causes hydraulic conductivity to increase along the runoff path, as opposed to other seepage paths, within the plane of sediment accretion**

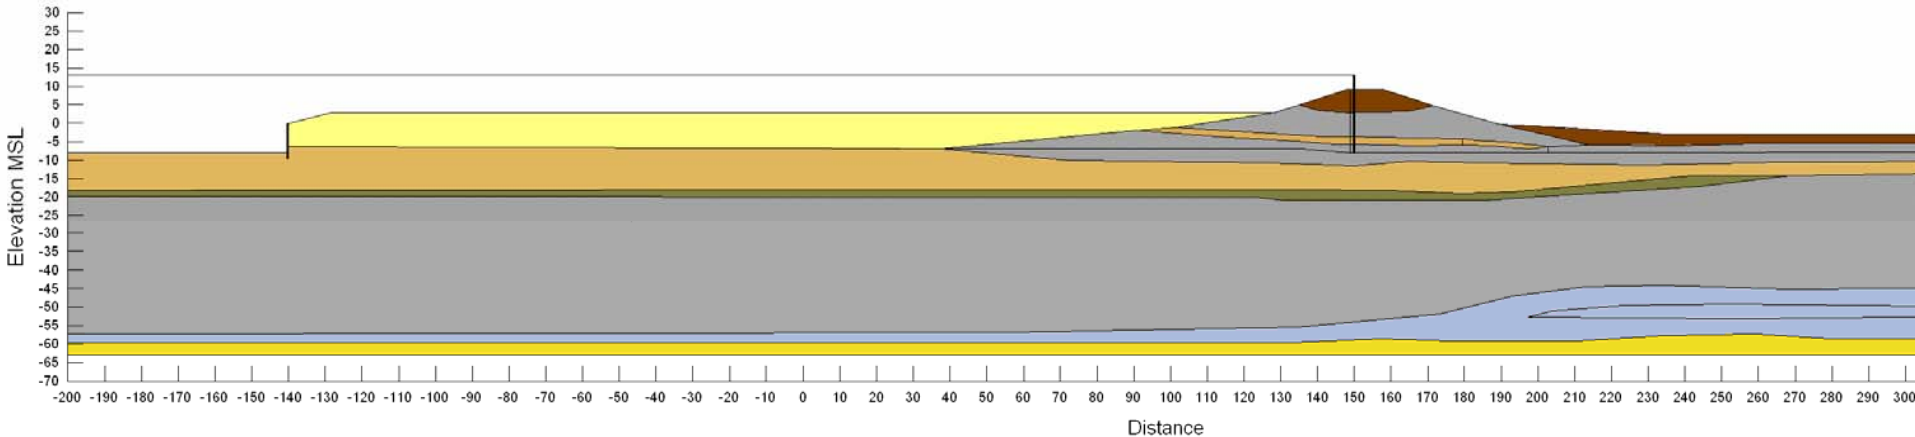
Geotechnical cross-section for conventional limit equilibrium and coupled seepage analyses of the east bank IHNC south breach.

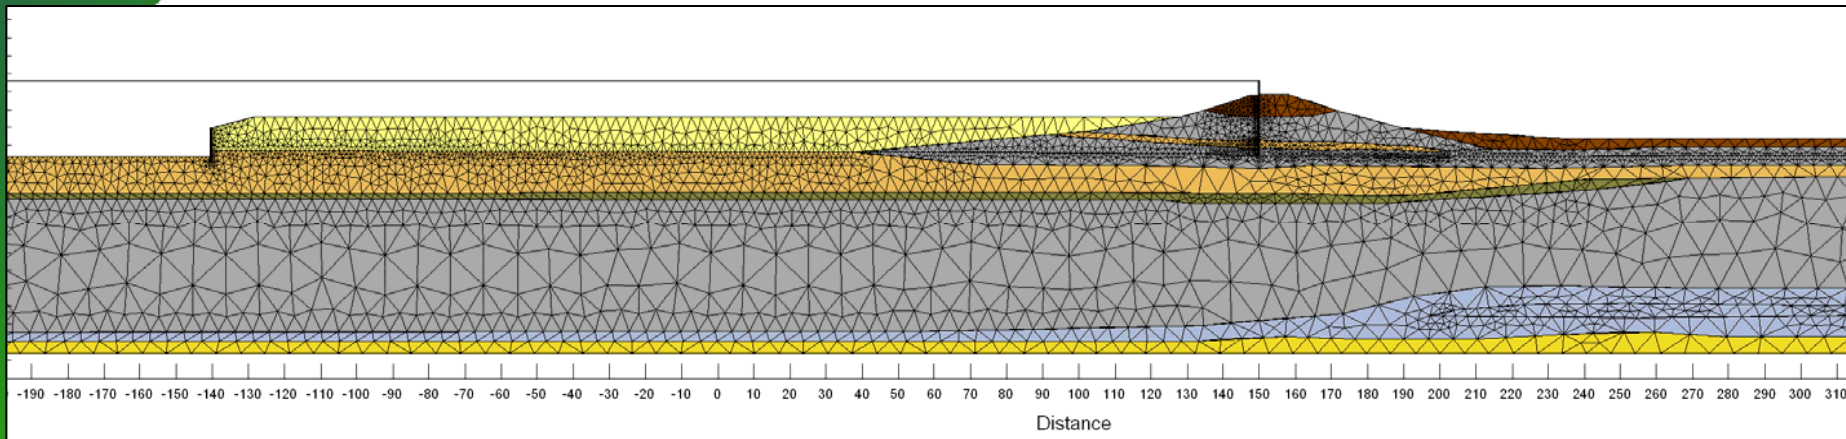
Finite difference mesh for seepage analyses for east bank IHNC south breach.

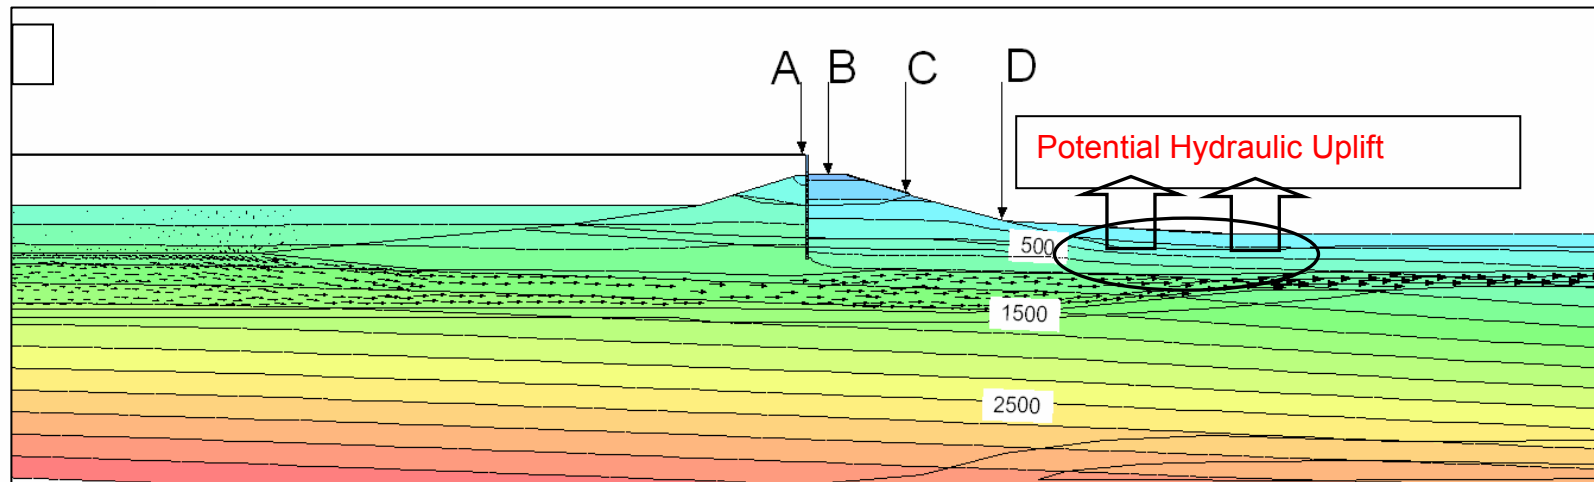
Pressure contours for the south breach on IHNC with storm surge at 14.4ft (MSL).

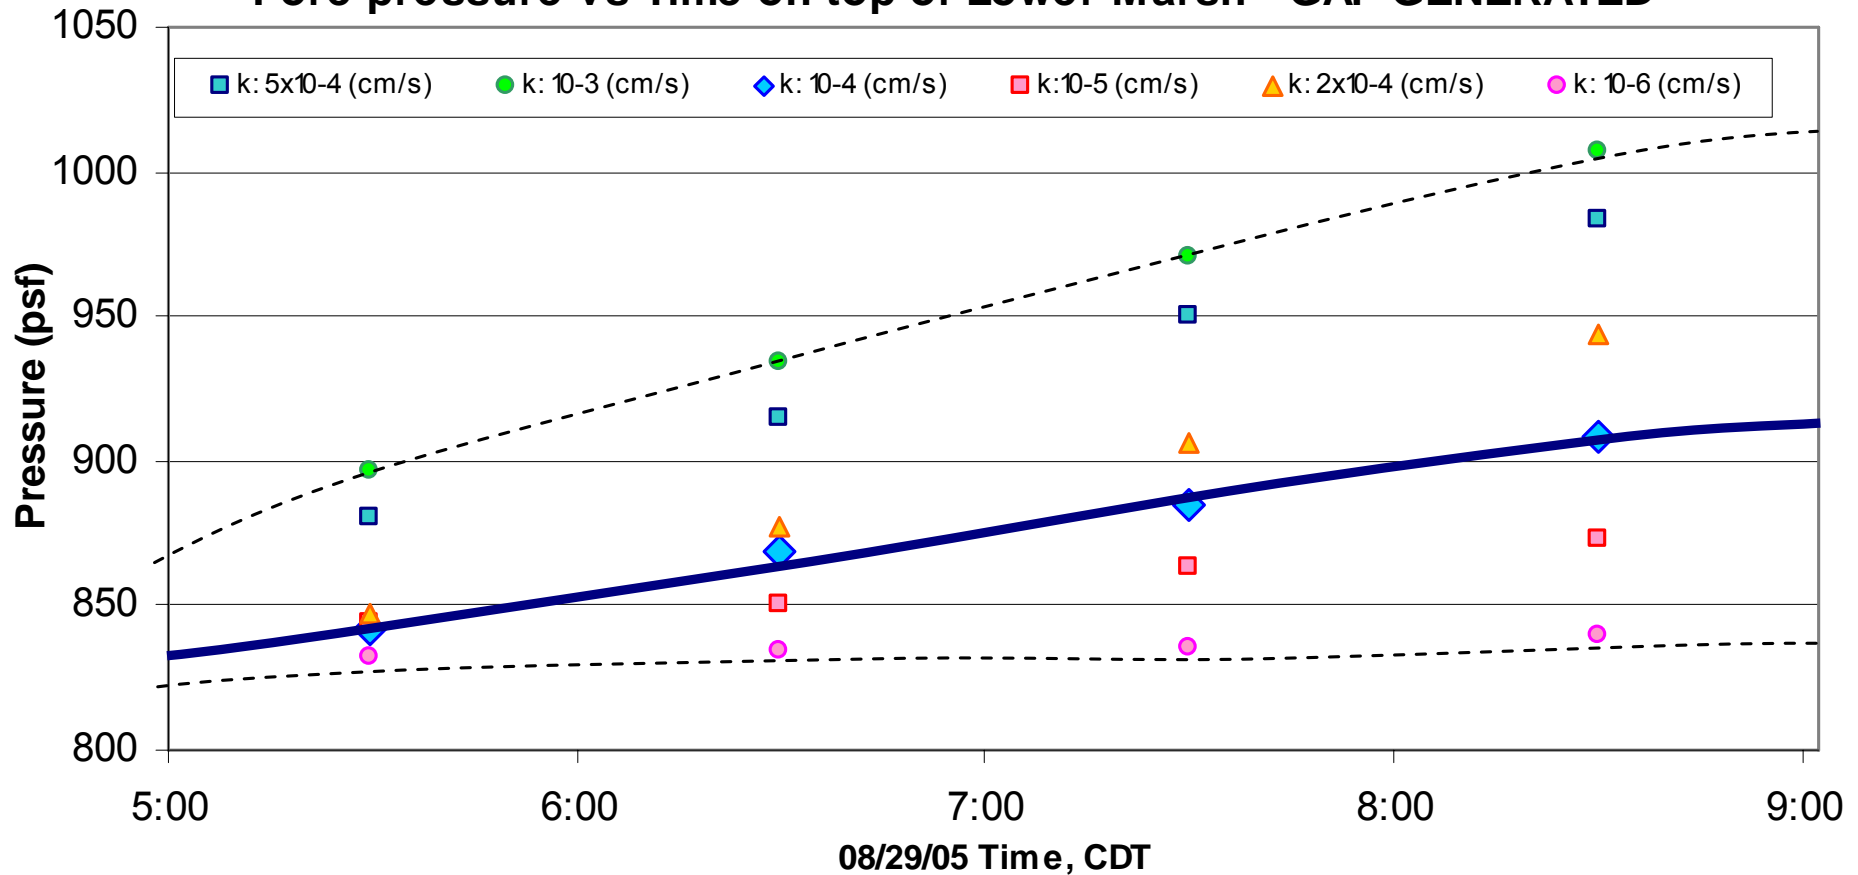
Pore pressure vs Time on top of Lower Marsh - GAP GENERATED

Estimated range in pore pressures at top of lower marsh unit **if the flood wall developed a gap**; assuming a range of horizontal hydraulic conductivity (k) in the marsh units, varying between 10^{-3} and 10^{-6} cm/sec
