Part 2

OVERTOPPING OF FLOOD CONTROL STRUCTURES

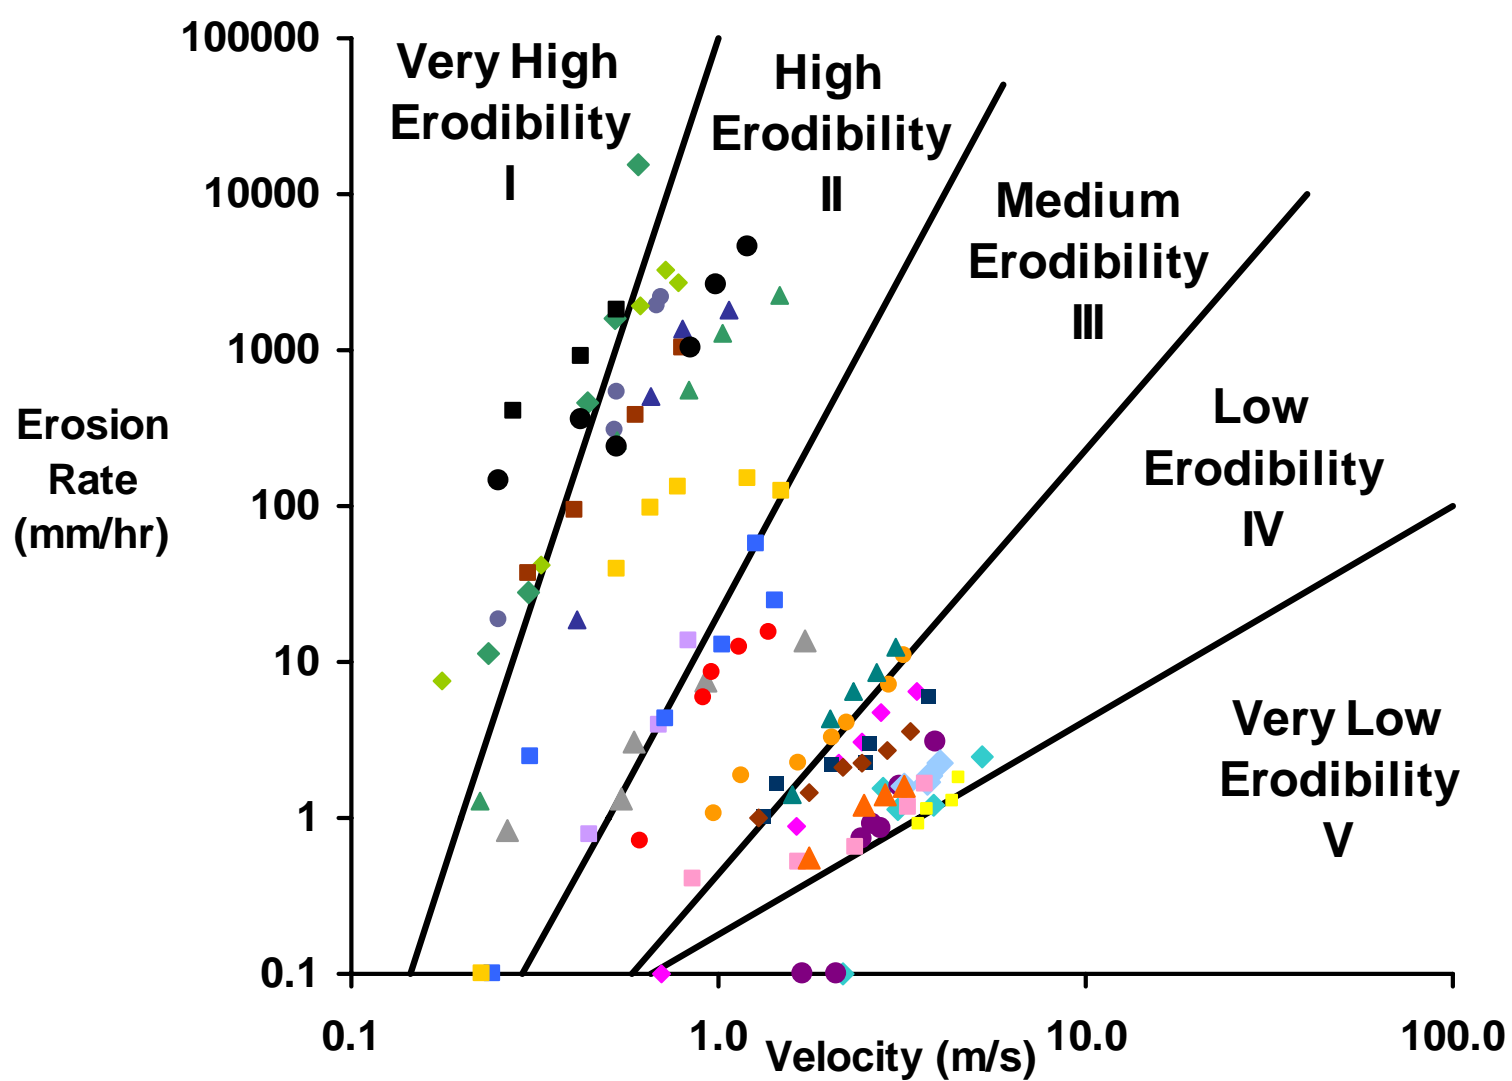
- | | | |

| ◆ S1-B1-(0-2ft)-TW | ▲ S1-B1-(2-4ft)-SW | ◆ S2-B1-(0-2ft)-TW |
| ● S2-B1-(2-4ft)-SW | ◆ S3-B1-(2-4ft)-SW | ■ S3-B2-(0-2ft)-SW |
| ■ S3-B3-(0-1ft)-SW | ◆ S4-(0-0.5ft)-LC-SW | ■ S4-(0-0.5ft)-HC-SW |
| ▲ S5-(0-0.5ft)-LT-SW | ● S6-(0-0.5ft)-LC-SW | ◆ S7-B1-(0-2ft)-TW |
| ● S7-B1-(2-4ft)-SW | ● S8-B1-(0-2ft)-TW | ■ S8-B1-(2-4ft)-L1-SW |
| ▲ S8-B1-(2-4ft)-L2-SW | ◆ S11-(0-0.5ft)-LC-TW | ■ S11-(0-0.5ft)-HC-TW |
| ■ S12-B1-(0-2ft)-TW | ▲ S12-B1-(2-4ft)-SW | ▲ S15-Canal Side-(0-0.5ft)-LC-SW |
| ■ S15-CanalSide-(0-0.5ft)-HC-SW | ● S15-Levee Crown-(0-0.5ft)-LT-SW | ■ S15-Levee Crown-(0.5-1.0ft)-LT-SW |
