Part 3

SYSTEMIC FAILURES OF FLOOD CONTROL INFRASTRUCTURE

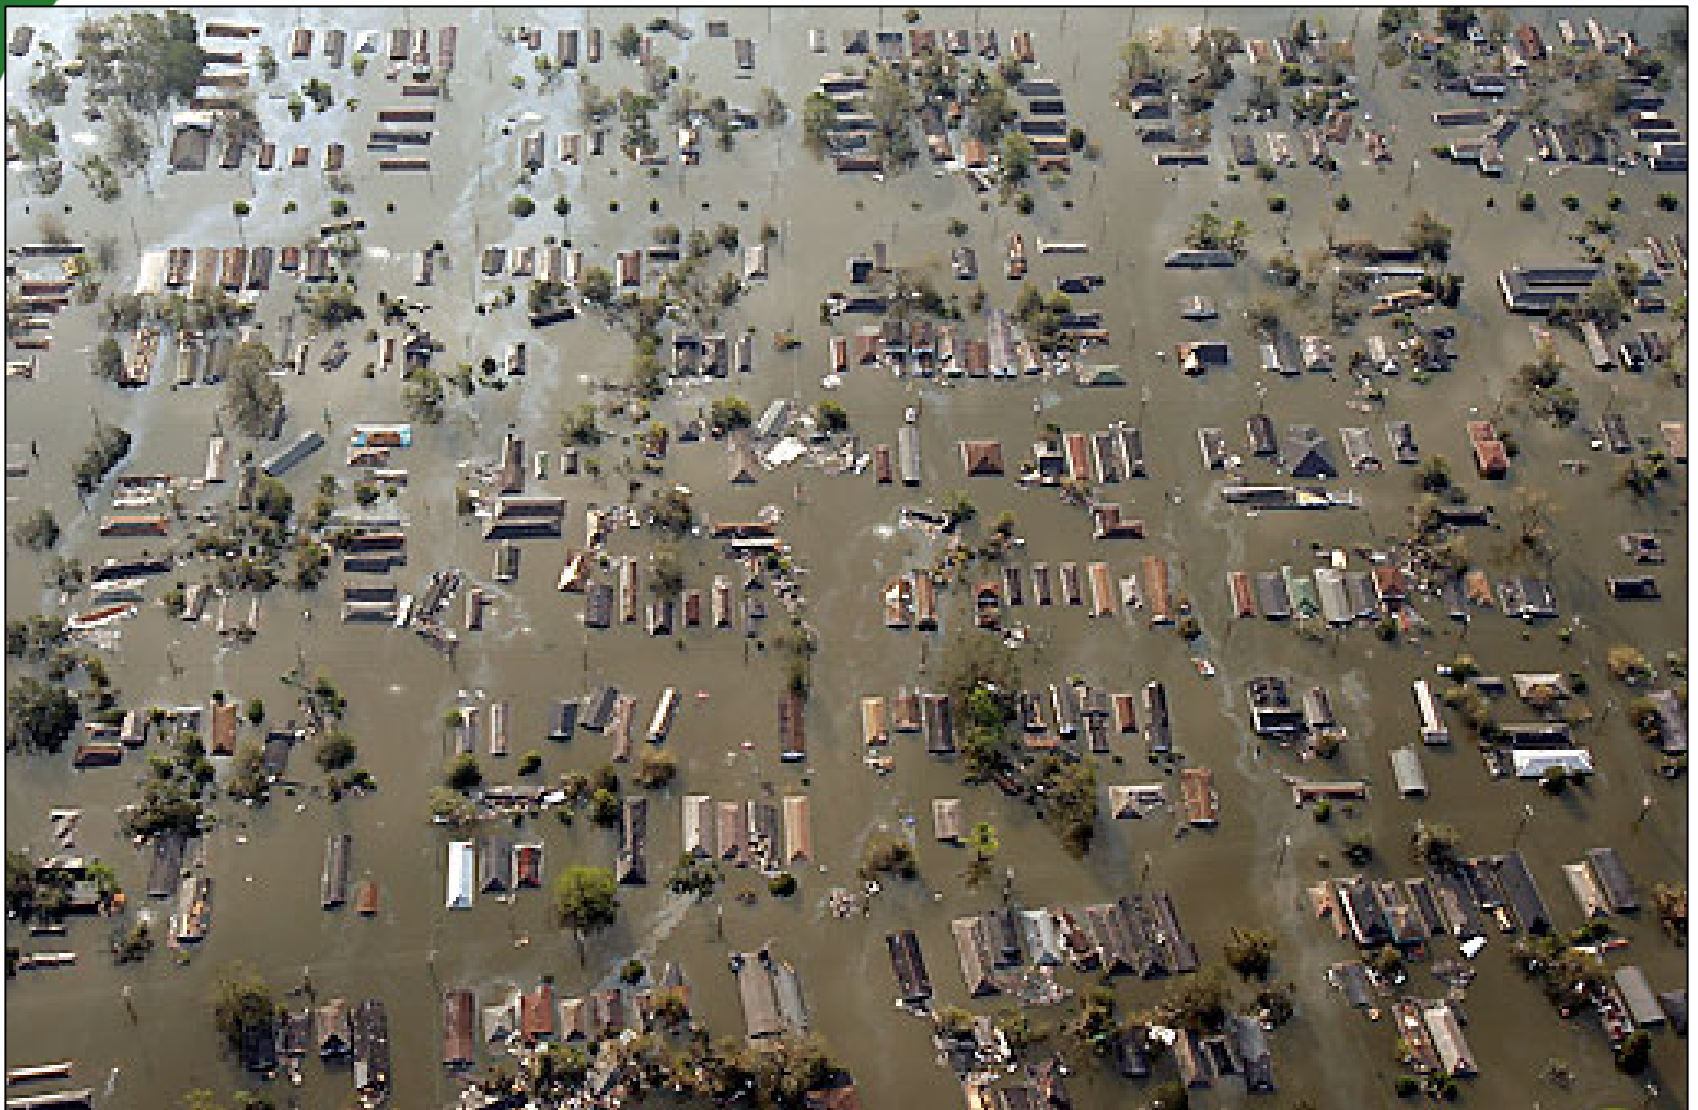
Figure 3 - 10 M SPOT Satellite Image: 2 Sept 2005
 With Water depth overlays

- **New Orleans neighborhoods were filled with as much as 12 feet of water, for up to 6 weeks**

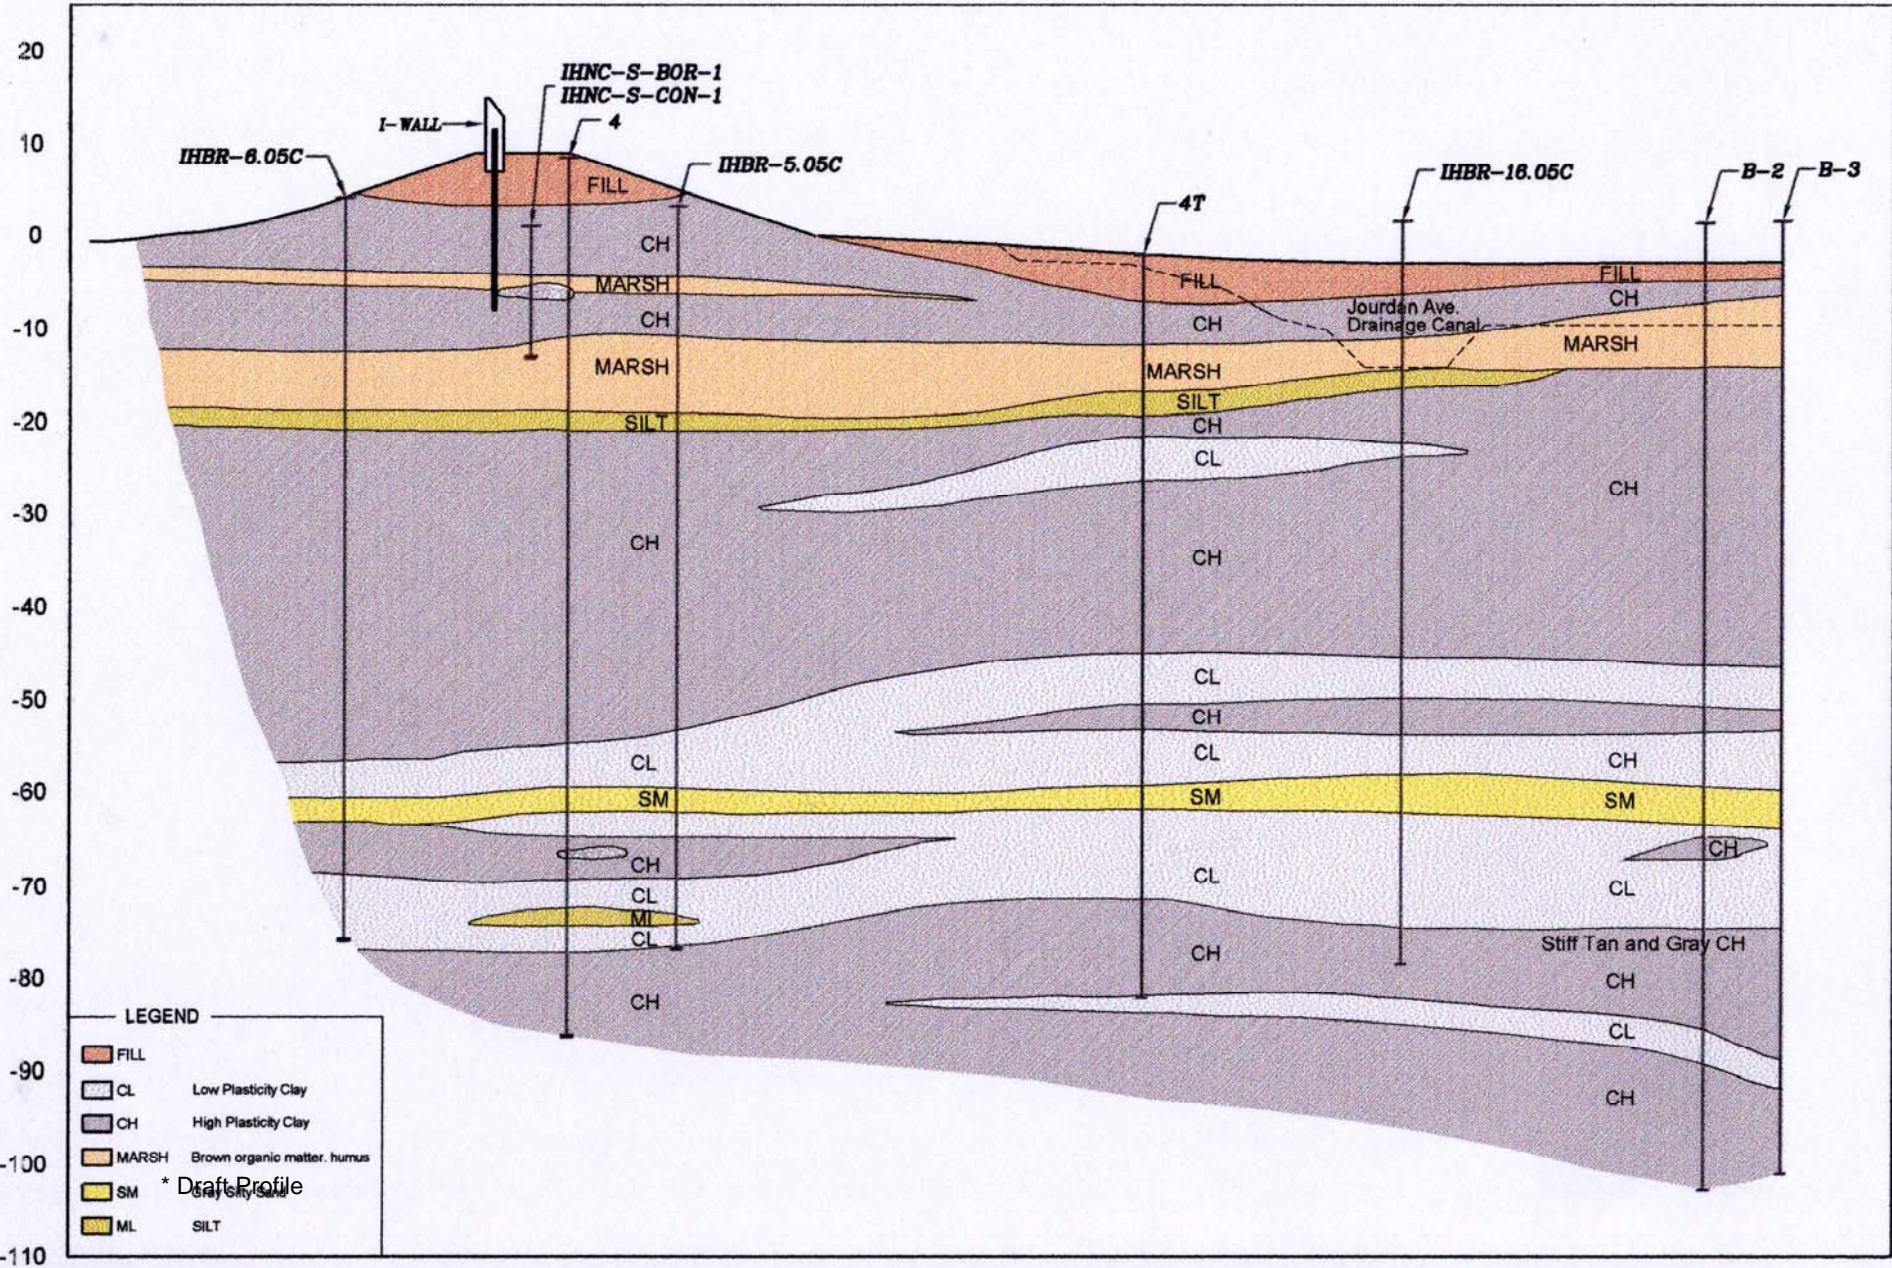
LOWER NINTH WARD, IHNC EAST BANK
 SOUTH OF SOUTHERN BREACH
 ELEVATION, FT (N.A.V.D.88)

Industrial Canal at the Ninth Ward

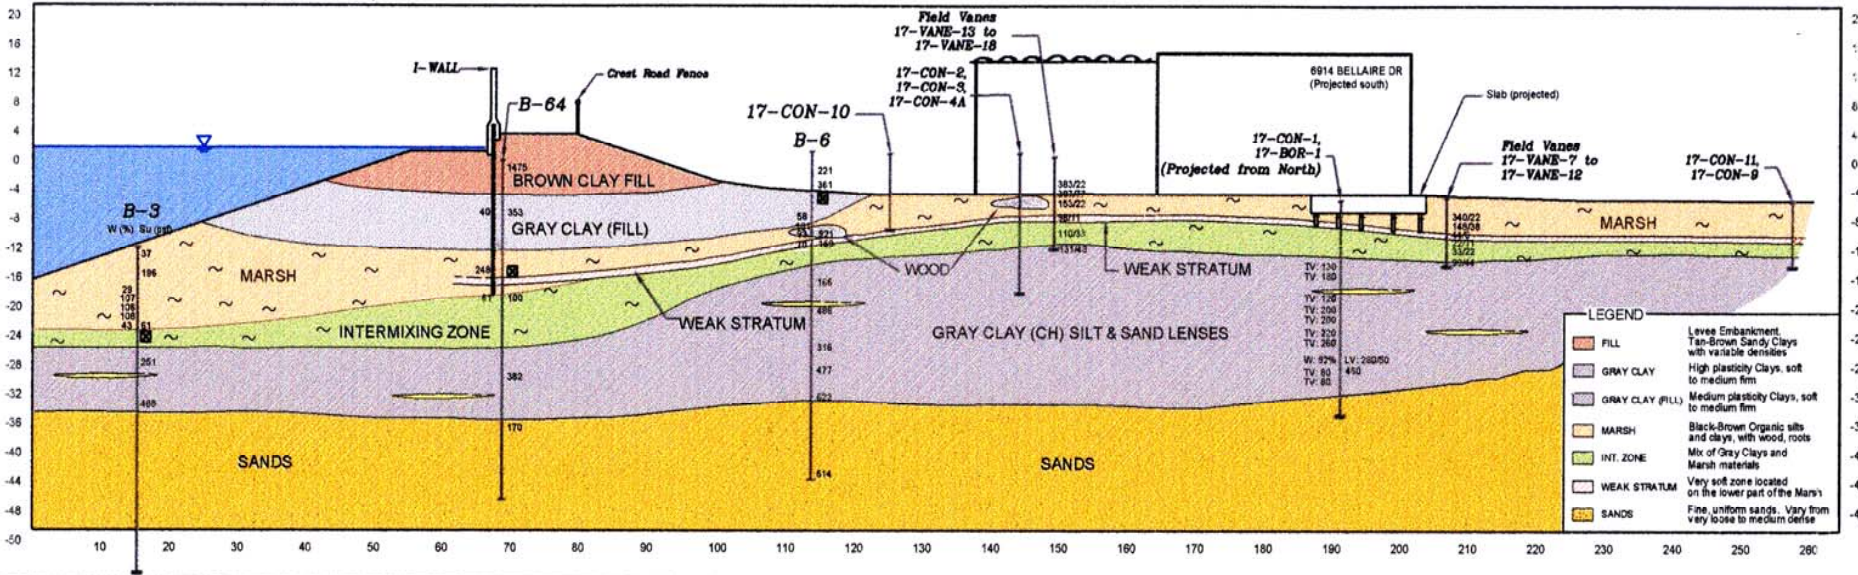
17th STREET CANAL EAST BANK BREACH
SECTION 1, ELEVATION (FT, N.A.V.D.)

ANALYSIS SECTION

OPENING OF THE GAP
