SITE CHARACTERIZATION AND FAILURE MODELS FOR THE PATERNO et al vs STATE OF CALIFORNIA FLOOD CASE

J. David Rogers, Ph.D., P.E., P.G.

Richard L. Meehan, P.E., G.E.

2007 Annual Meeting

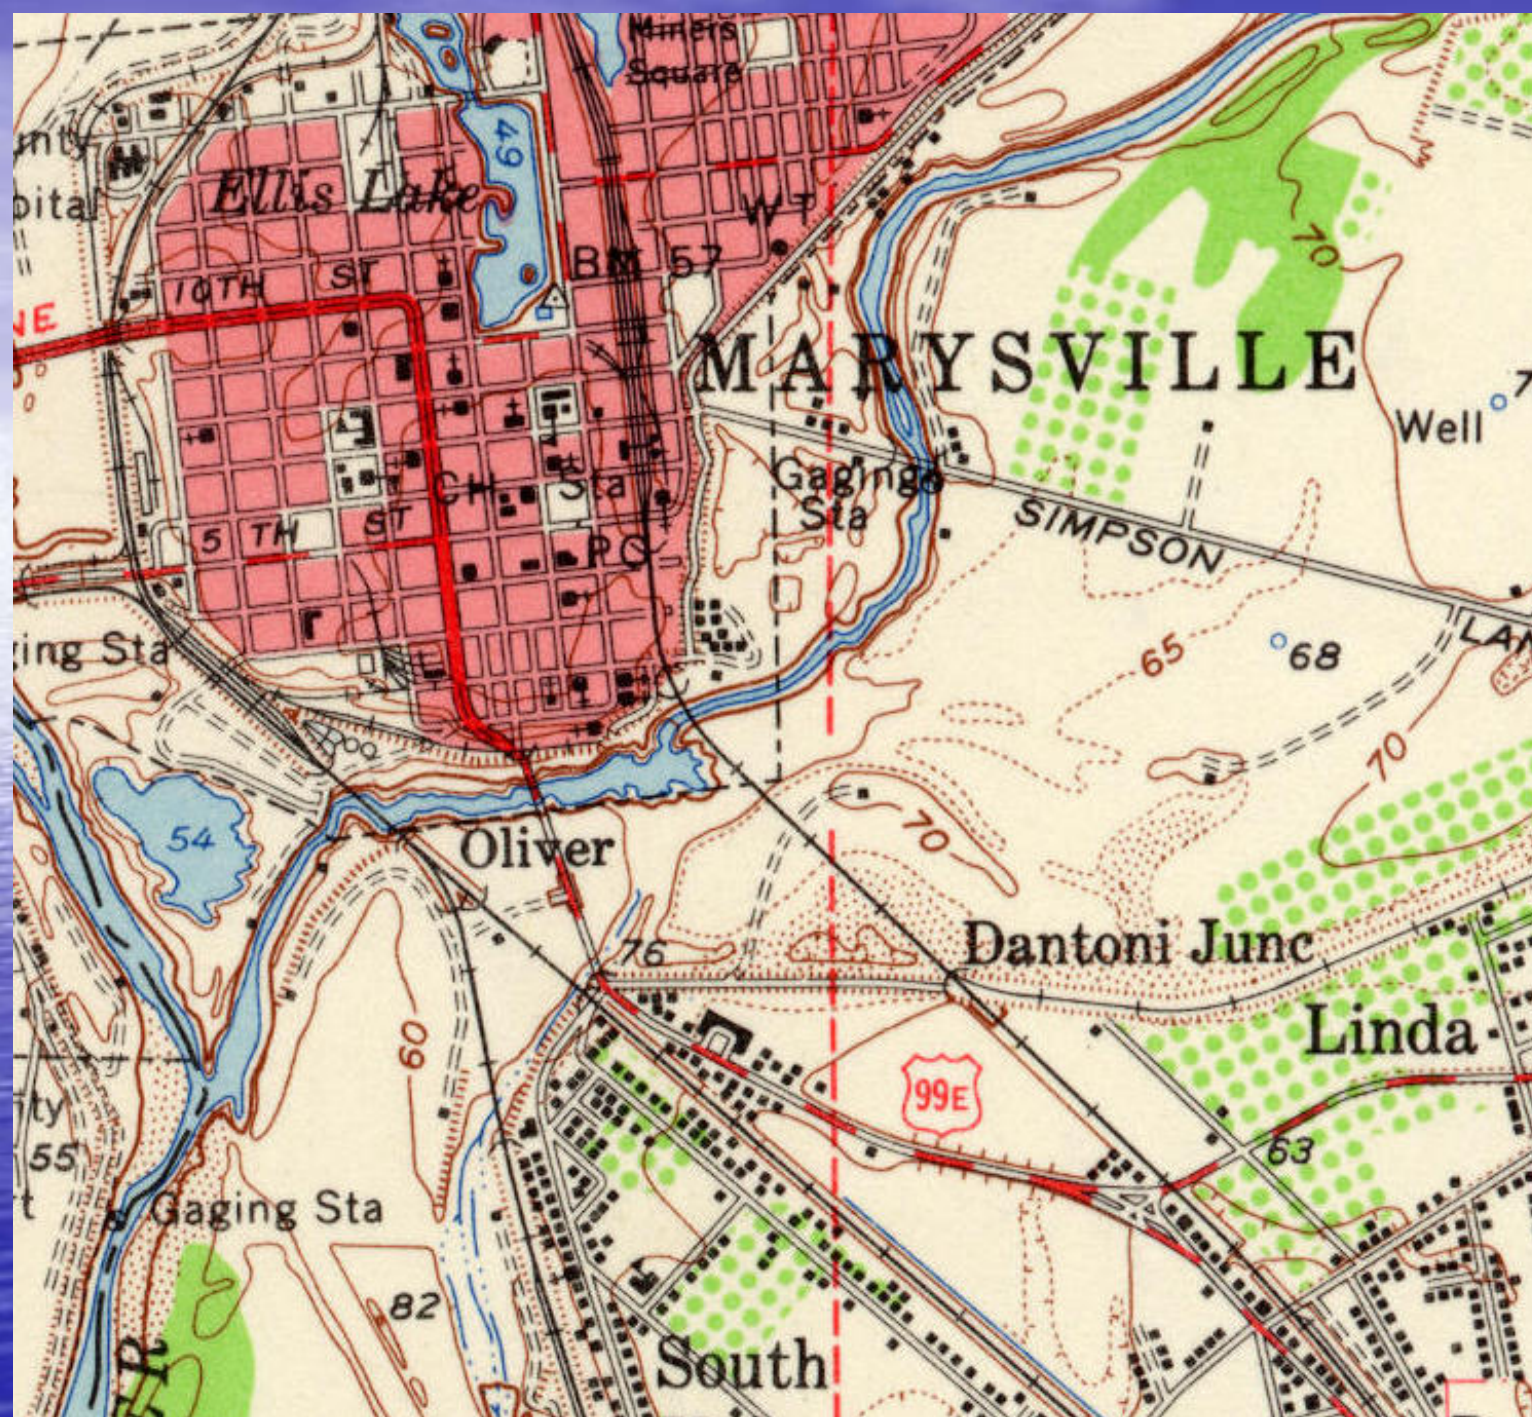
Valuable details
1952 7.5 minute USGS topo map
Note borrow pits for 1940 levee additions adjacent to 1986 breach
RR grade infilled on south side of Yuba Channel

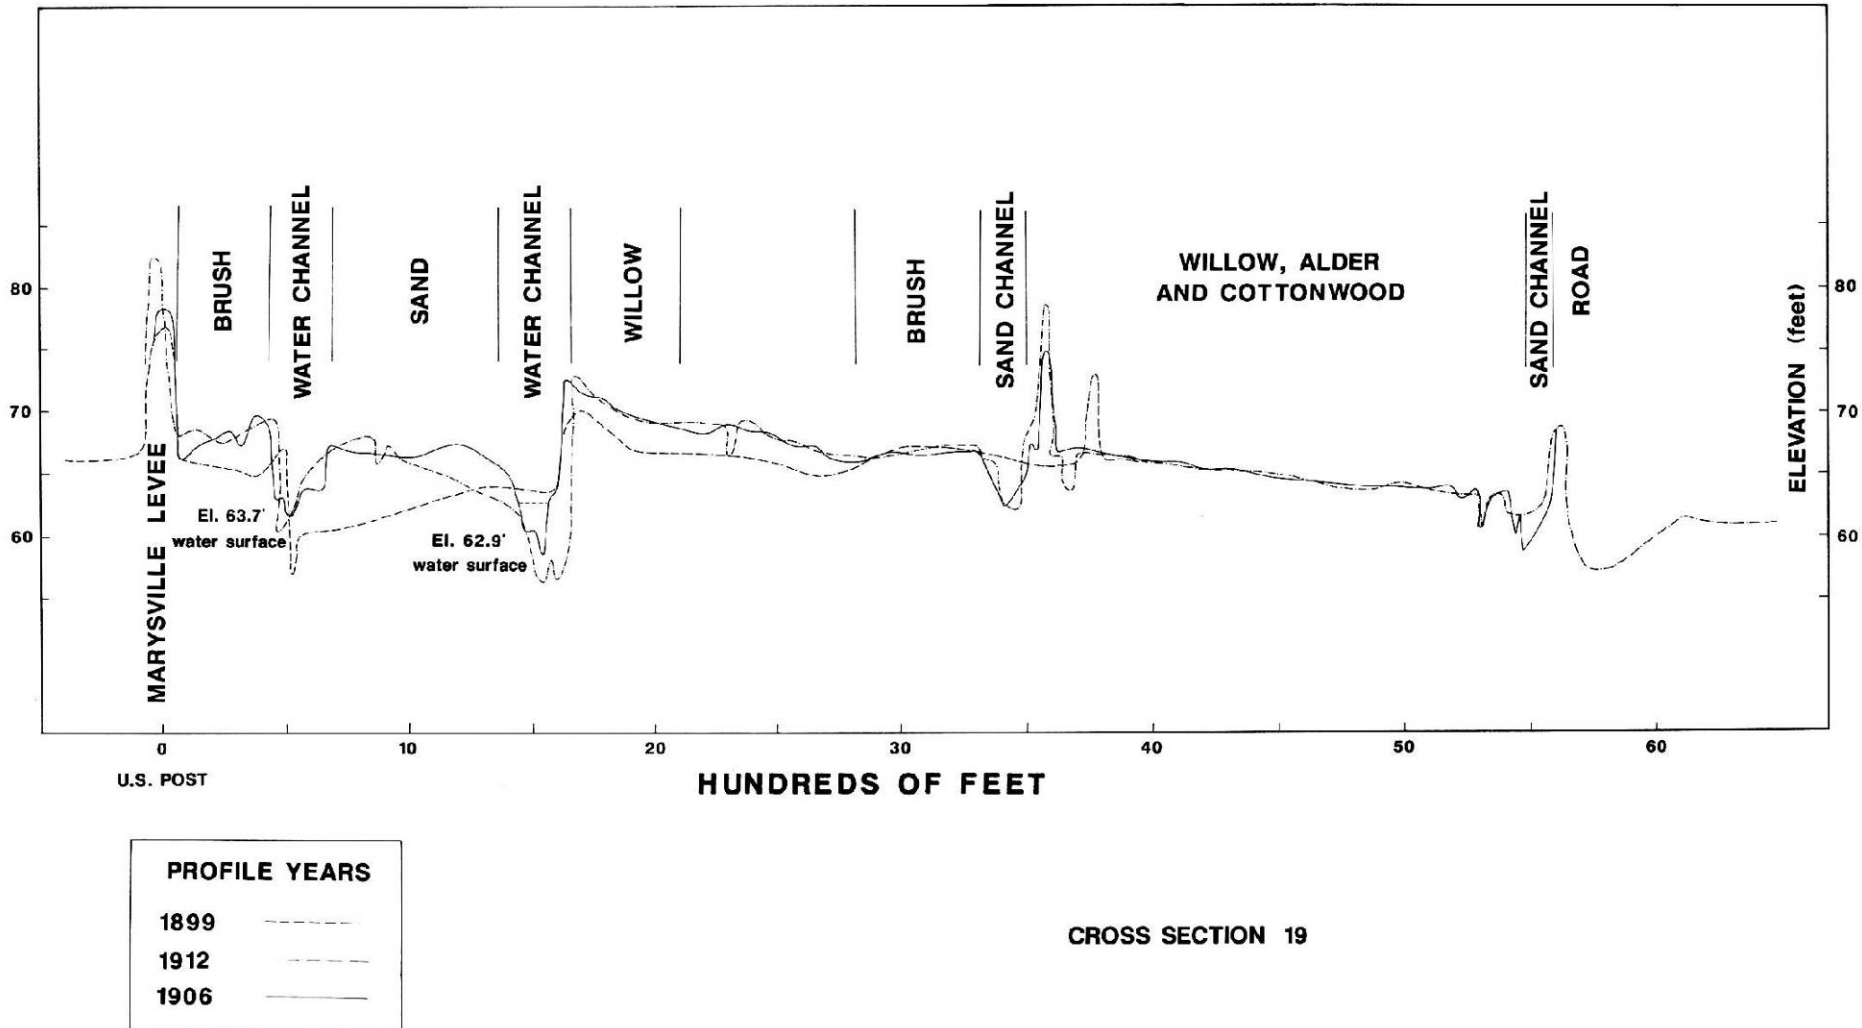
- This cross section through the lower Yuba River was also prepared by the Debris Commission in 1907. Note gradient of the clogged flood plain, diminishing with increasing distance from the main channel.

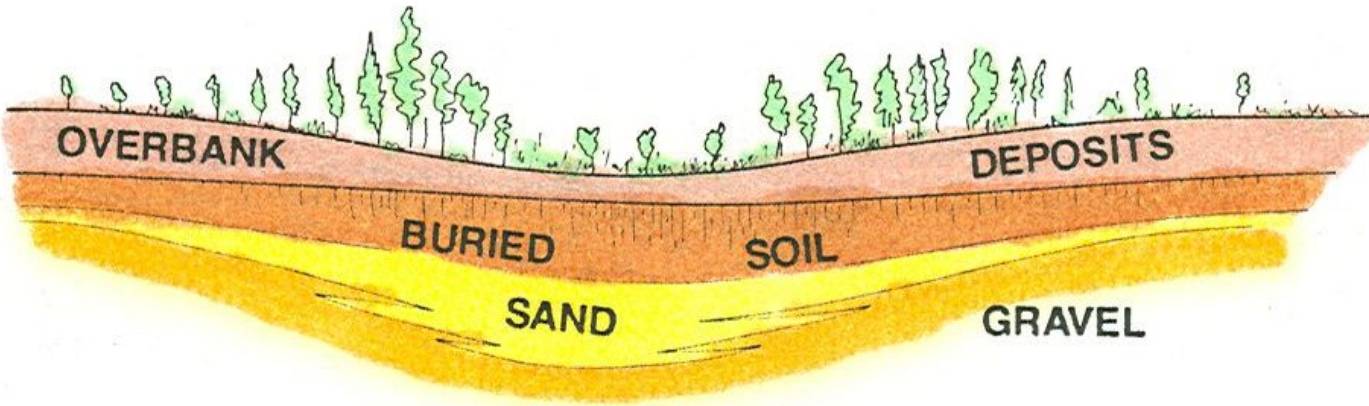
LIKELY FLOODPLAIN CONFIGURATION AROUND 1849

- The pre-1849 flood plain was inundated by silt from 1862 till at least 1884
- Note axis of swale, beneath breach area

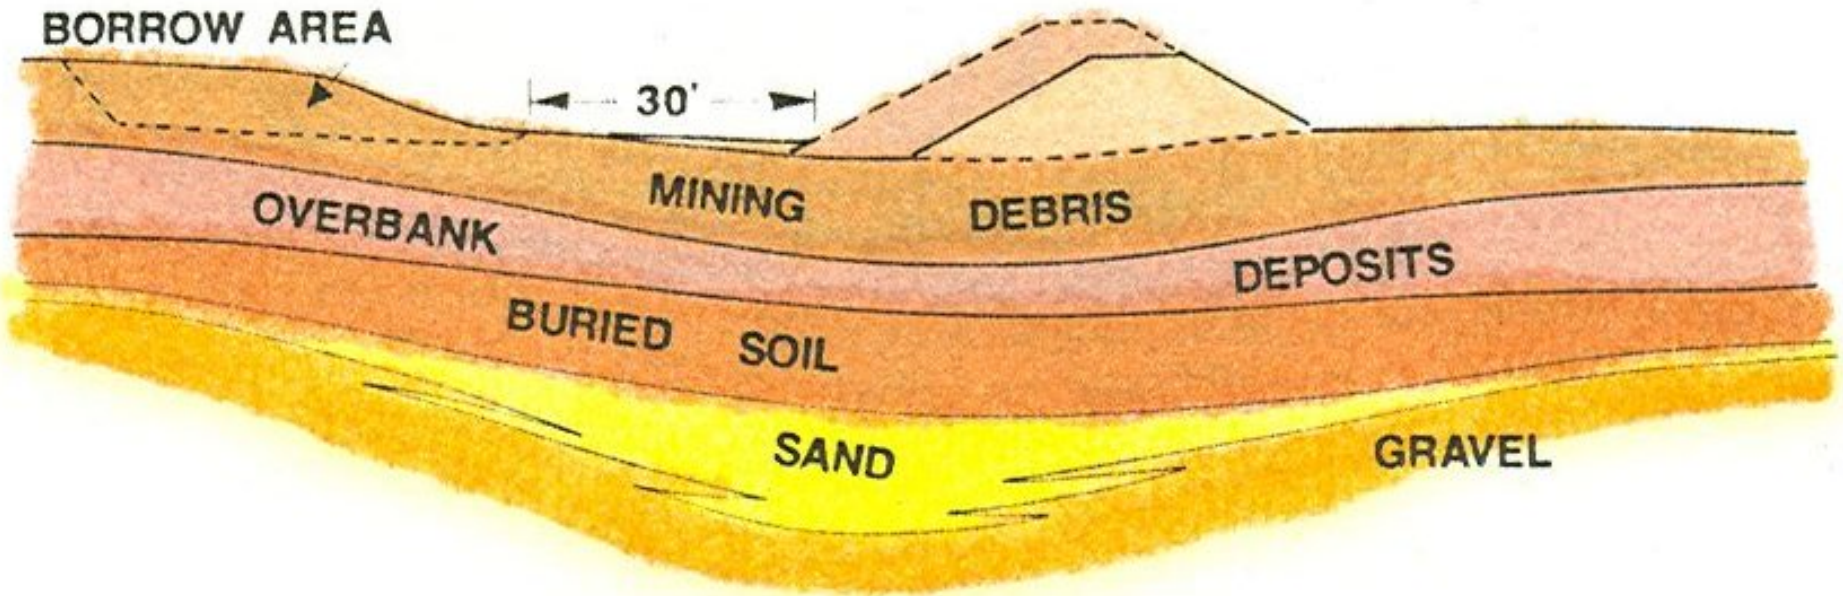
CONSTRUCTION OF THE MORRISON GRADE IN 1936

- The Morrison Grade was heightened in 1936, using borrow material from the river side of the embankment.

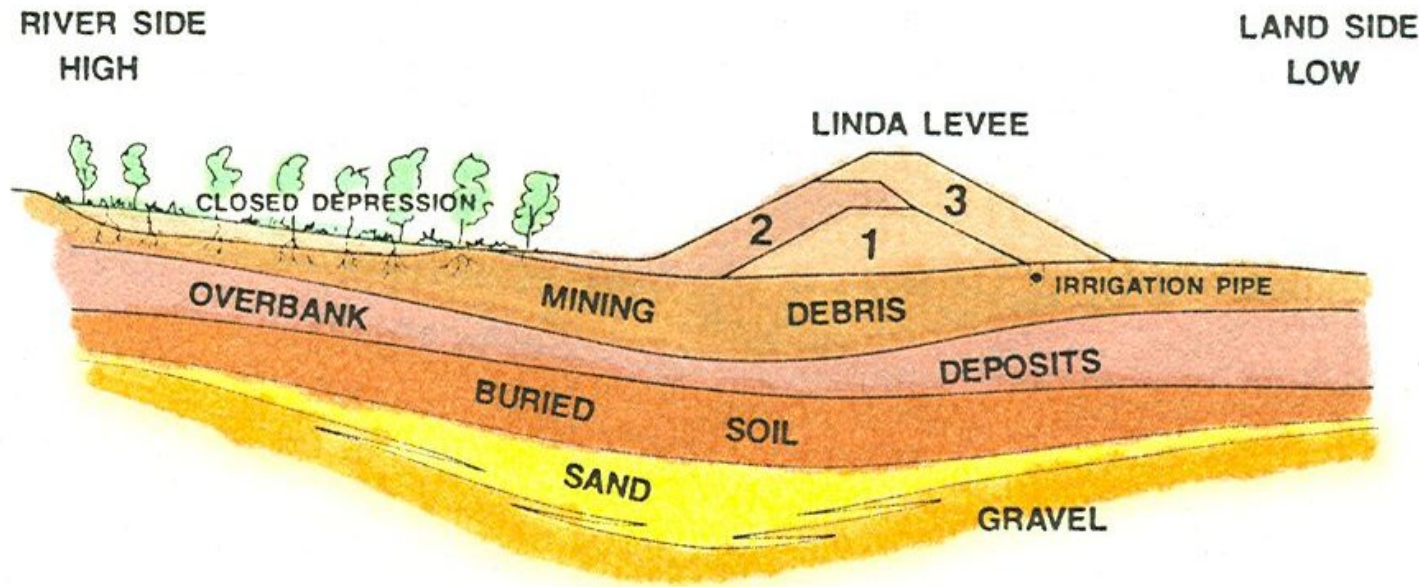
CORPS OF ENGINEERS LEVEE HEIGHTENING IN 1940

The Corps of Engineers raised the Morrison grade a third and final time in 1940

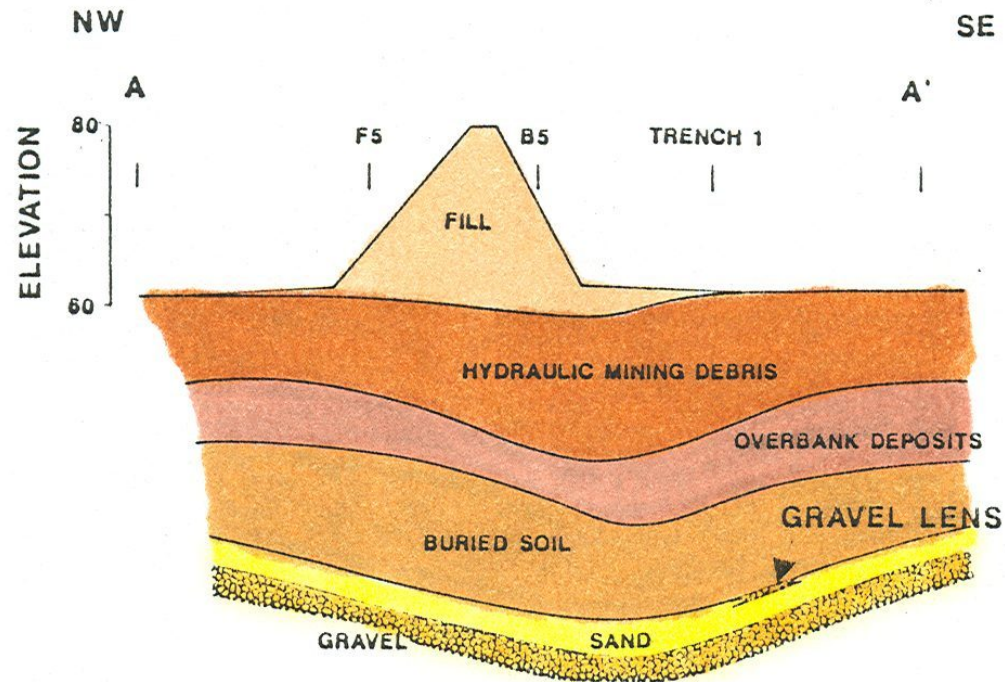
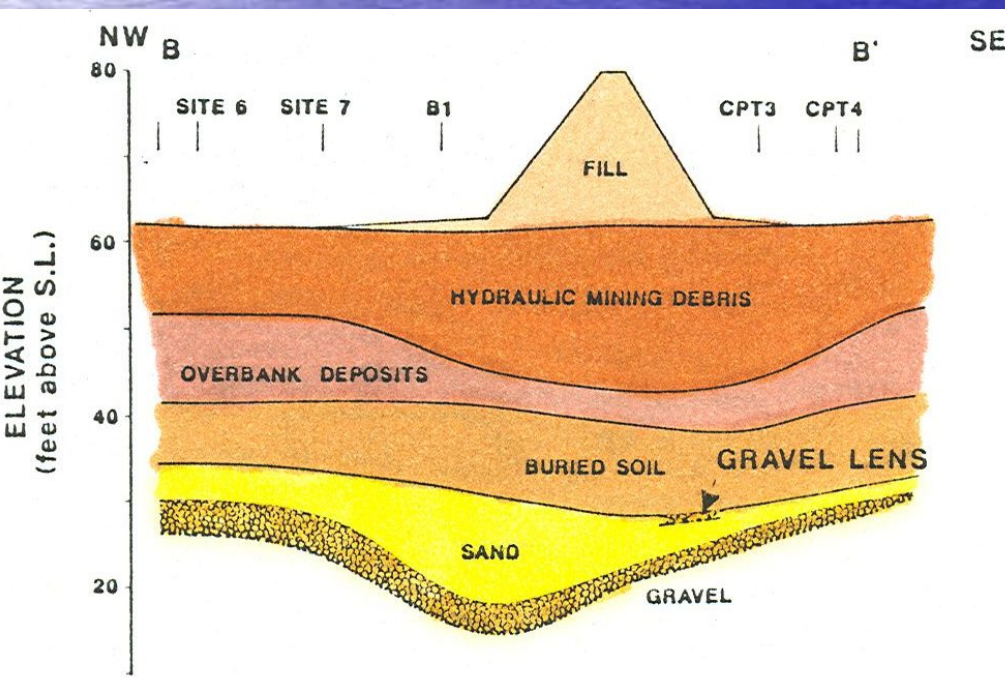
Sections through breach area

- Sections A-A' and B-B' were cut perpendicular to the 1907 swale, more or less aligned with the historic direction of flow of the Yuba River. Note axes of previous swales in succeeding deeper units.

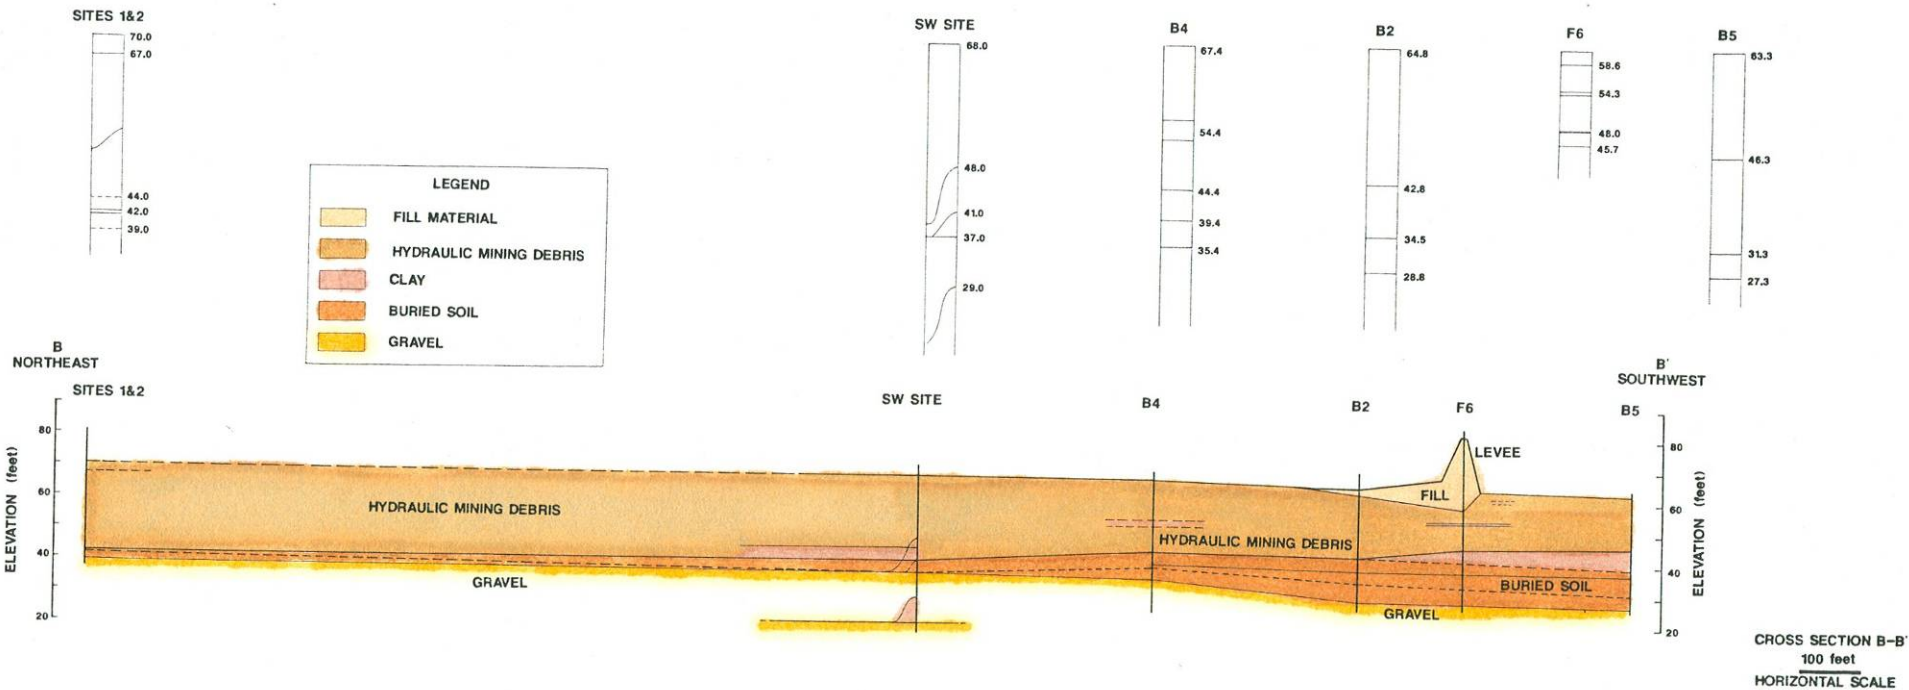
- Section B-B' extends from the breach area northwest, towards the main stem channel of the Yuba River.
- This is the section most engineers would choose for their obligatory seepage assessments.
- But the section is cut perpendicular to the overall "grain of flow"; the flow is normal to the viewing plane. This is not always useful in any anisotropy exists in underlying alluvial deposits.

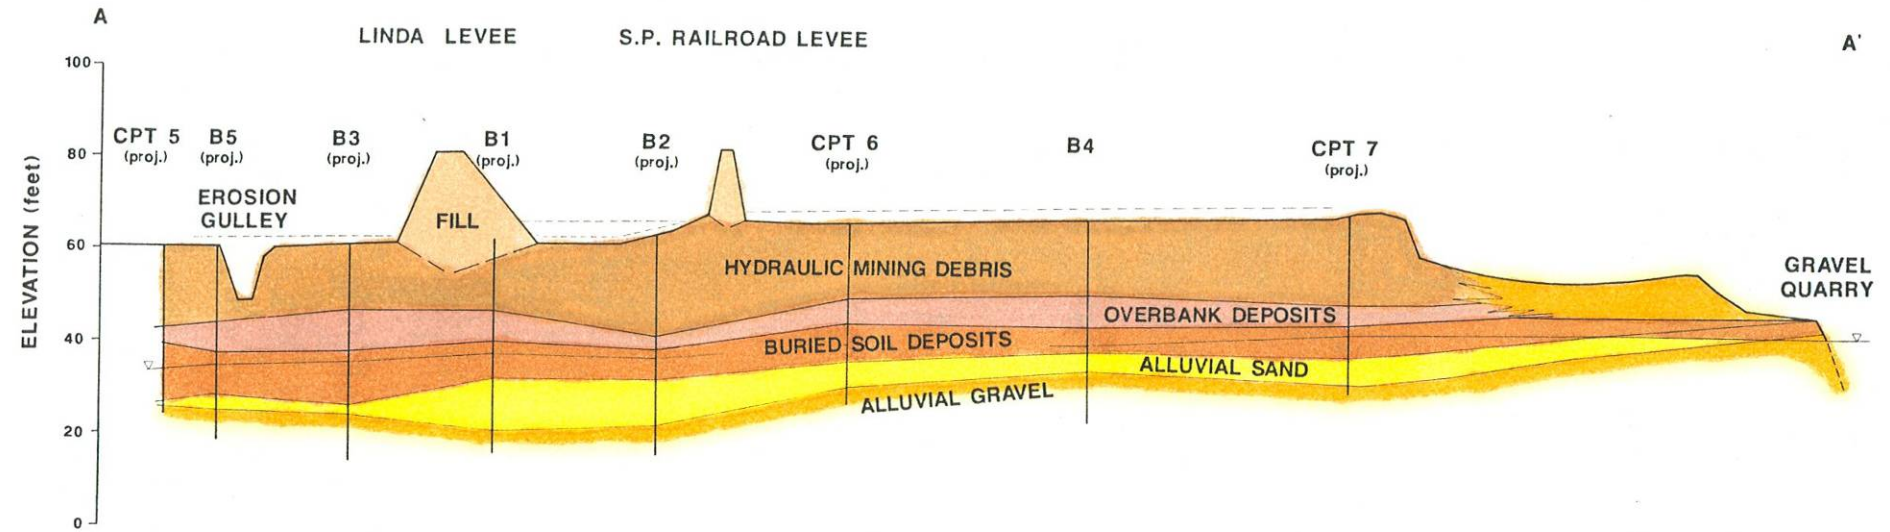
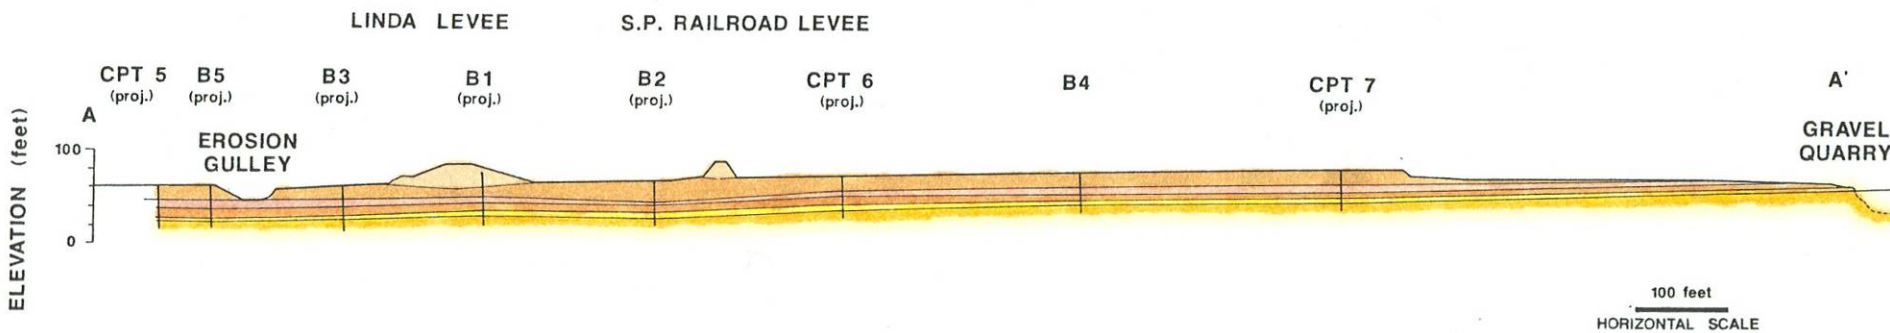
- Preliminary Section A-A' highlighted what might be a serious problem: highly conductive channels feeding *upward*, into a lower permeability cap, deposited in previous overflow channels.
- This is a classic "leaky aquifer" condition.

EXAGGERATED VERTICAL SCALE

ACTUAL VERTICAL SCALE

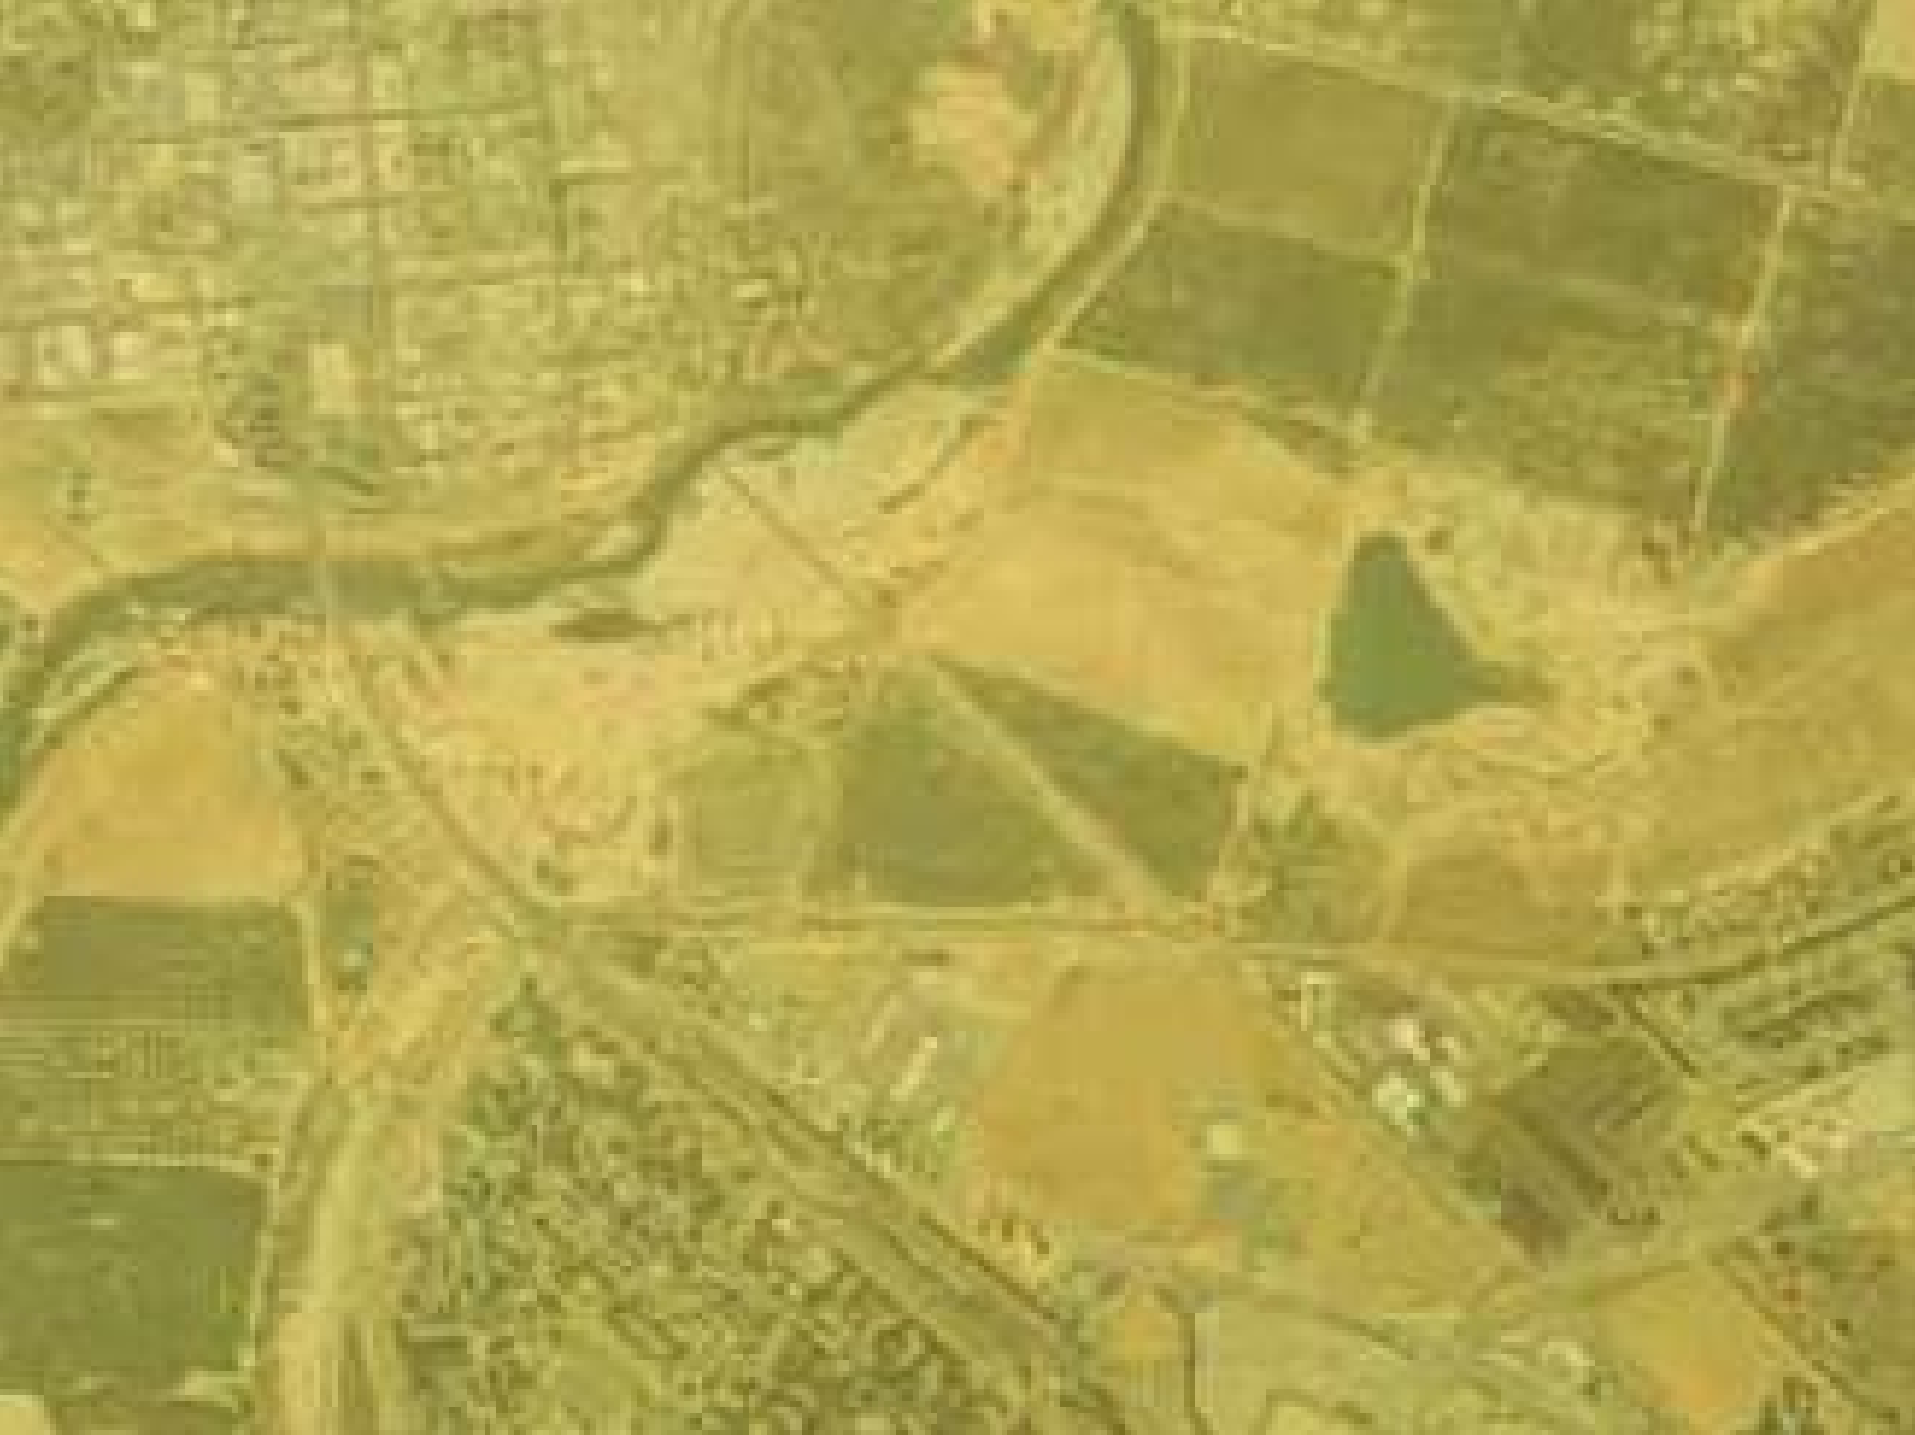
- Section A parallels the line of expected seepage and surface flow, from NE to SW. This was extended 1800 ft, to the Speckert Gravel Pit. Note slope of the alluvial materials between the pit and the levee.

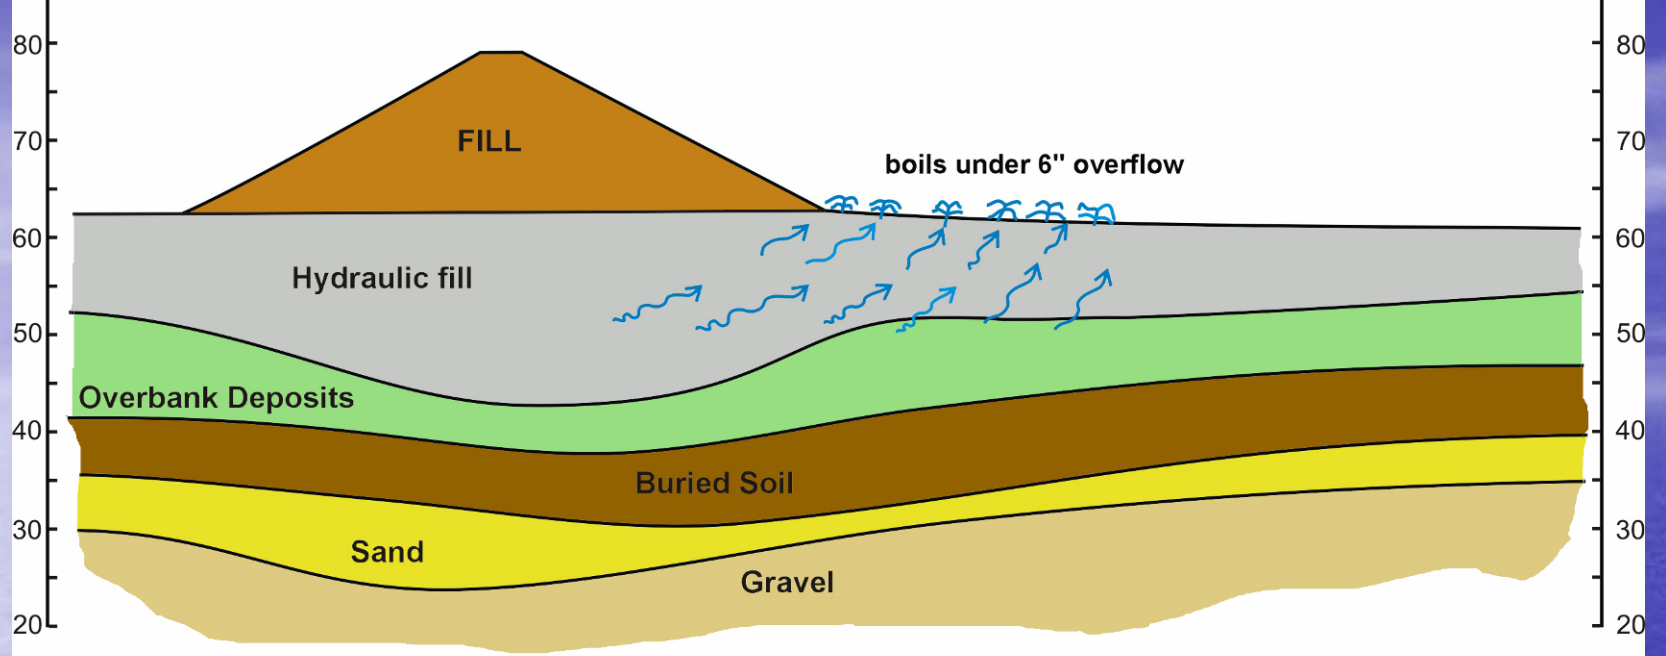
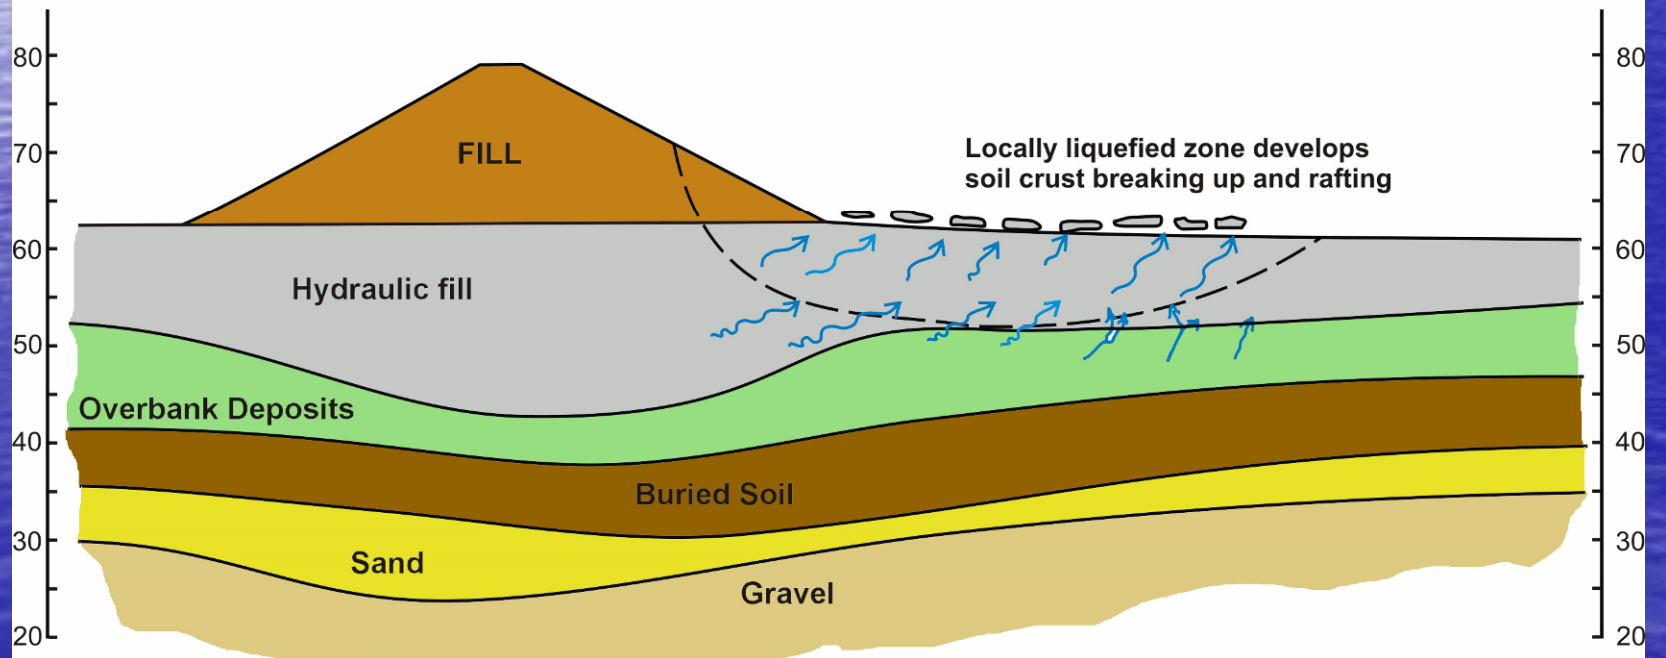
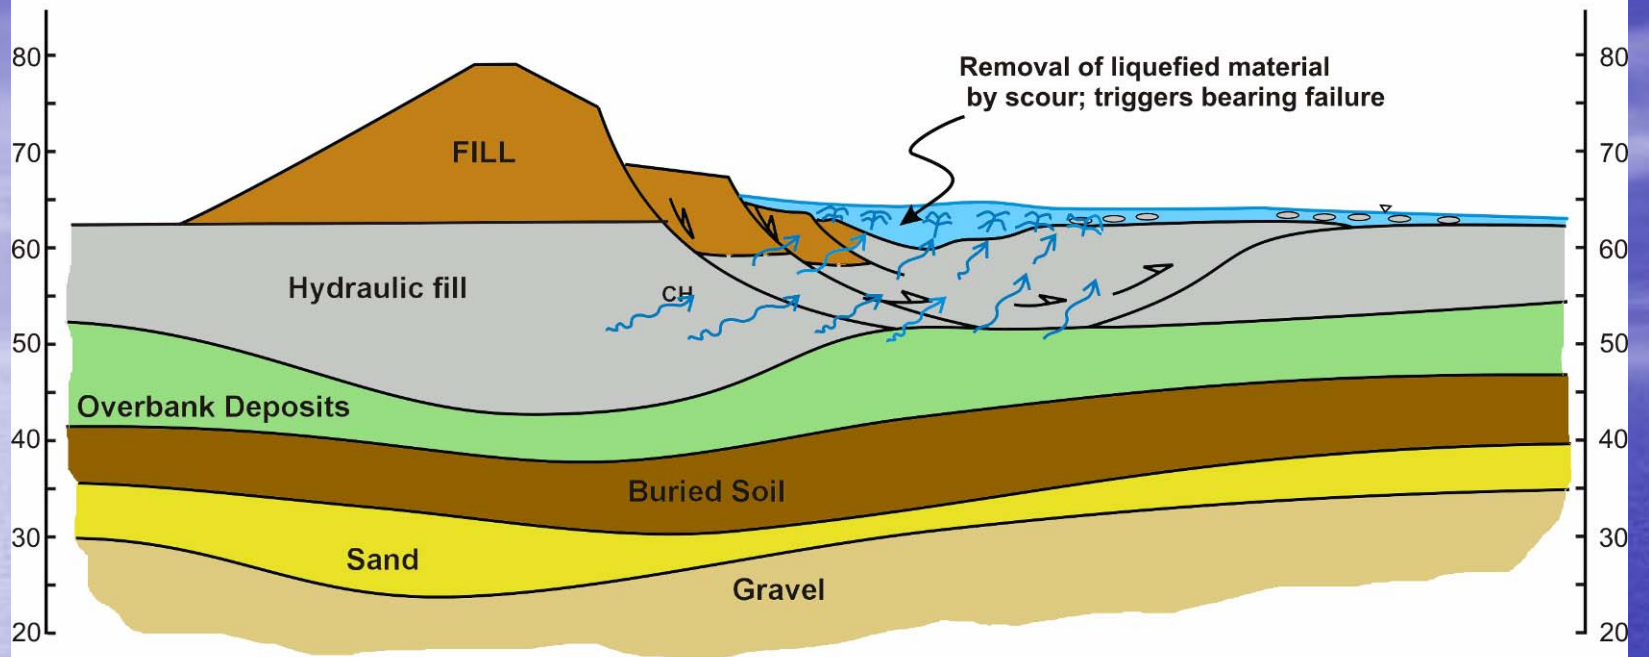
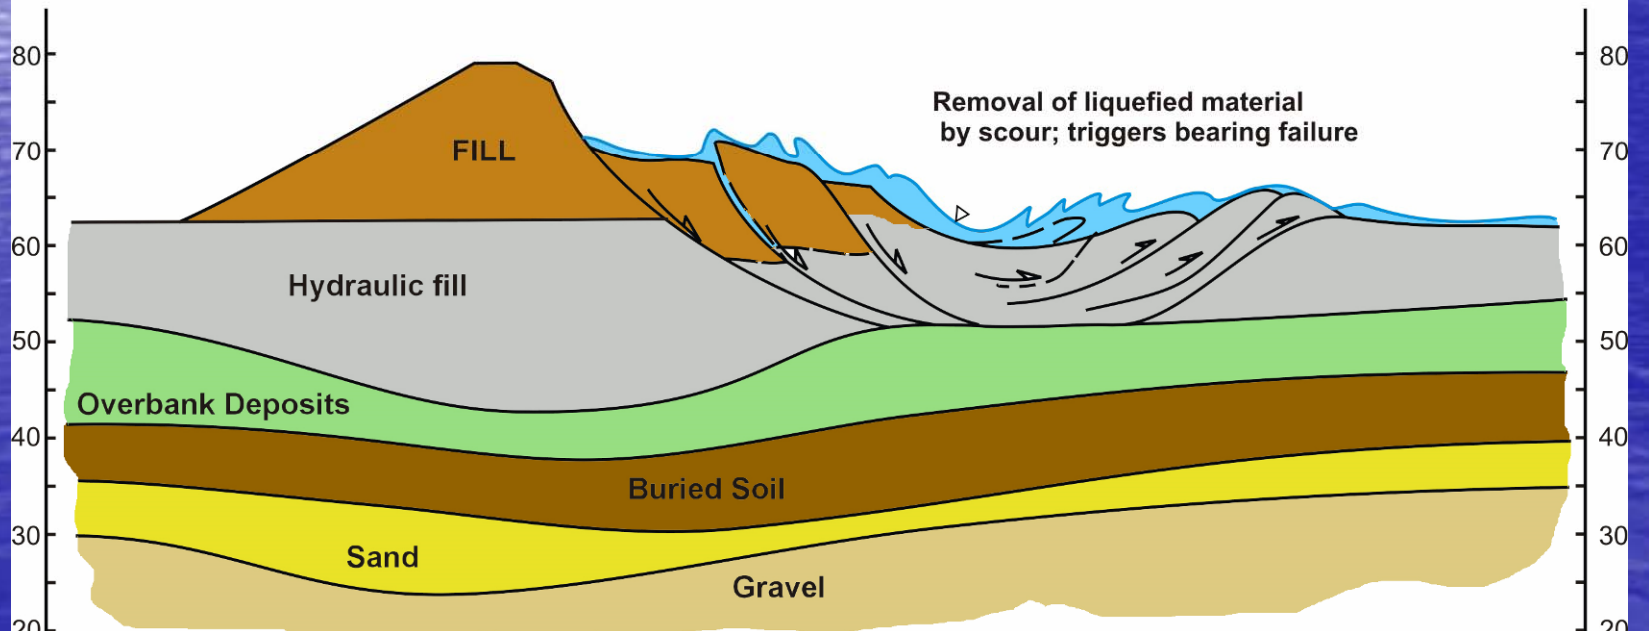
Three wetting fronts assail the levee simultaneously
