**GROUNDWATER CONTAMINATION AND SINKHOLE COLLAPSE
INDUCED BY LEAKY IMPOUNDMENTS
IN SOLUBLE ROCK TERRAIN**

By Thomas J. Aley
James H. Williams
James W. Massello

MISSOURI GEOLOGICAL SURVEY AND WATER RESOURCES

Aley, Thomas J., James H. Williams and James W. Massello, 1972, Groundwater contamination and sinkhole collapse induced by leaky impoundments in soluble rock terrain: Mo. Geol. Survey and Water Resources, Engineering Geology Series No. 5, 40 p., 10 figs., 1 tbl.

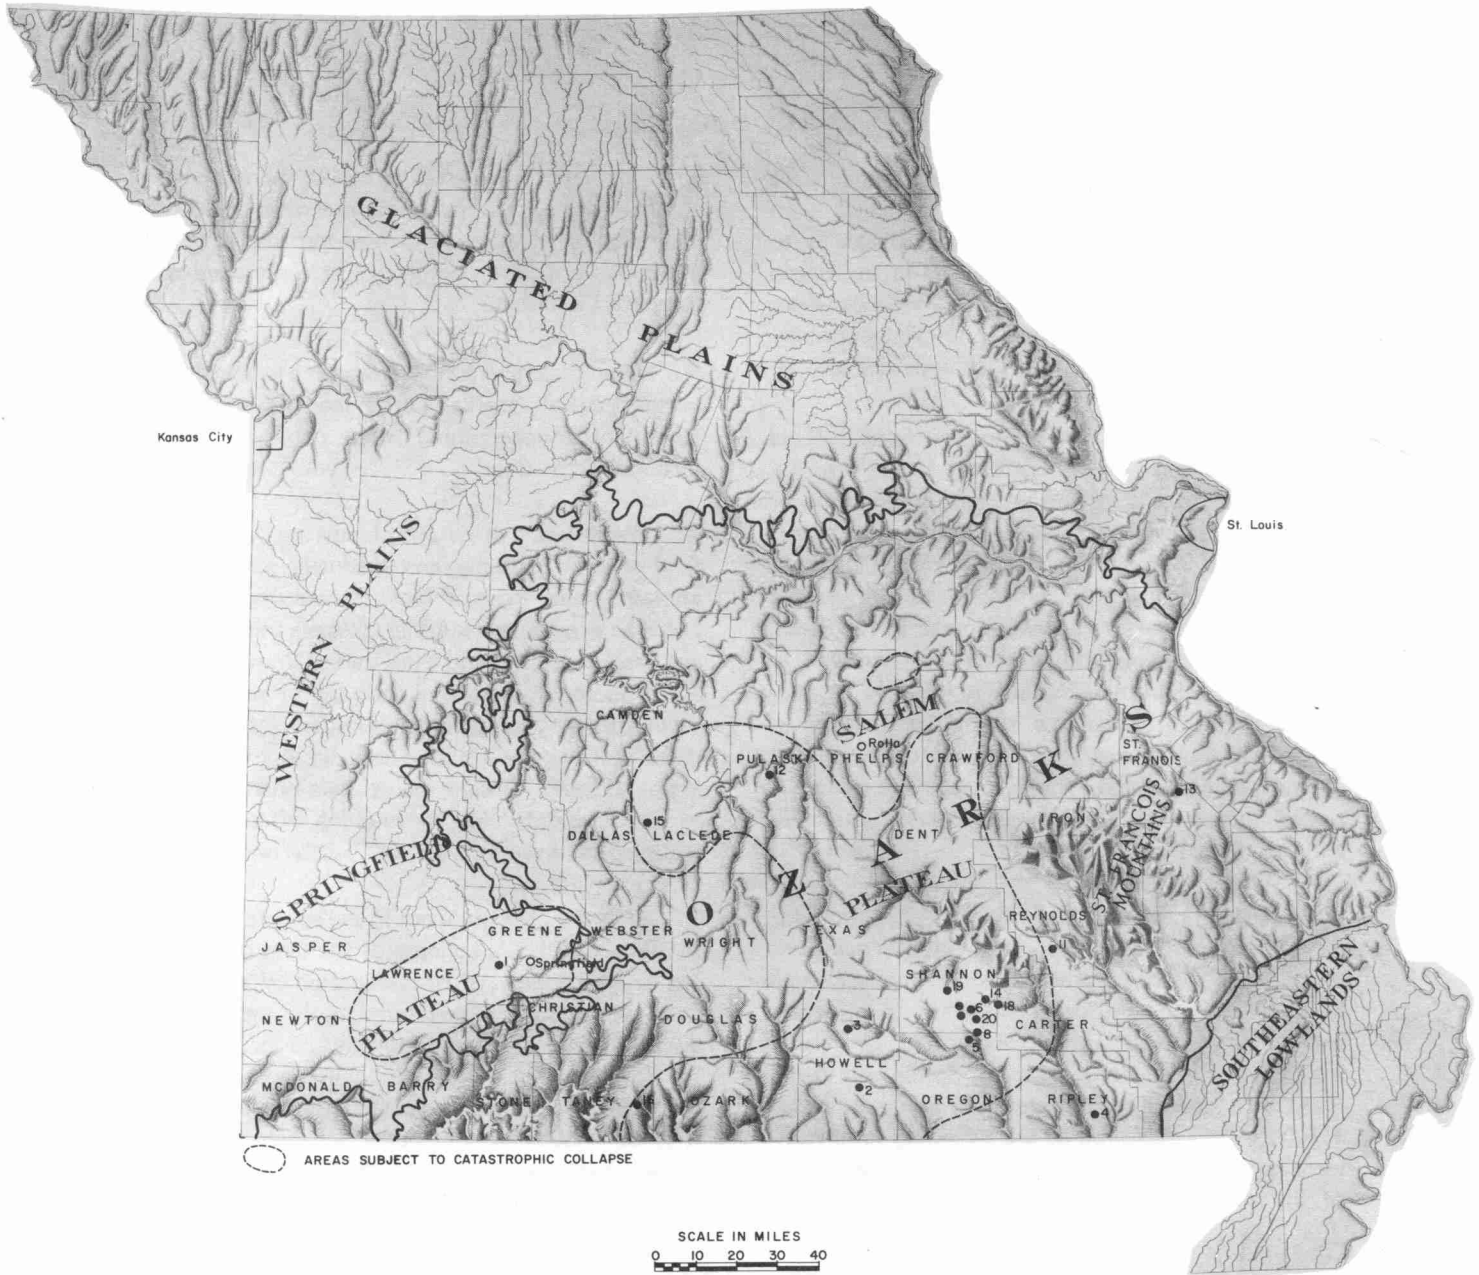
Figure 1

The Ozarks is a landform where soluble bedrock has been a major controlling factor. Approximately 70 percent of the bedrock is limestone or dolomite with significant areas subject to catastrophic sinkhole collapse (fig. 1). Typical karst landforms such as sinkholes, although predominant on the Springfield plateau, are not widespread in the Salem plateau. Nonetheless, other karst features such as large springs, abrupt variations in shallow groundwater levels, little surface runoff, and bedrock-controlled drainageways typify the region. In the central portion of the Ozarks, major watersheds of several hundred square miles are drained internally and have little surface flow.

Areas in Missouri that are particularly subject to catastrophic sinkhole collapse. Sites of collapses and groundwater contamination investigated for case history analyses are also shown.
