# **OVERVIEW OF THE TAUM SAUK UPPER RESERVOIR FAILURE**

**December 14, 2005**

**Reynolds County, Missouri**

**University of Missouri-Rolla**

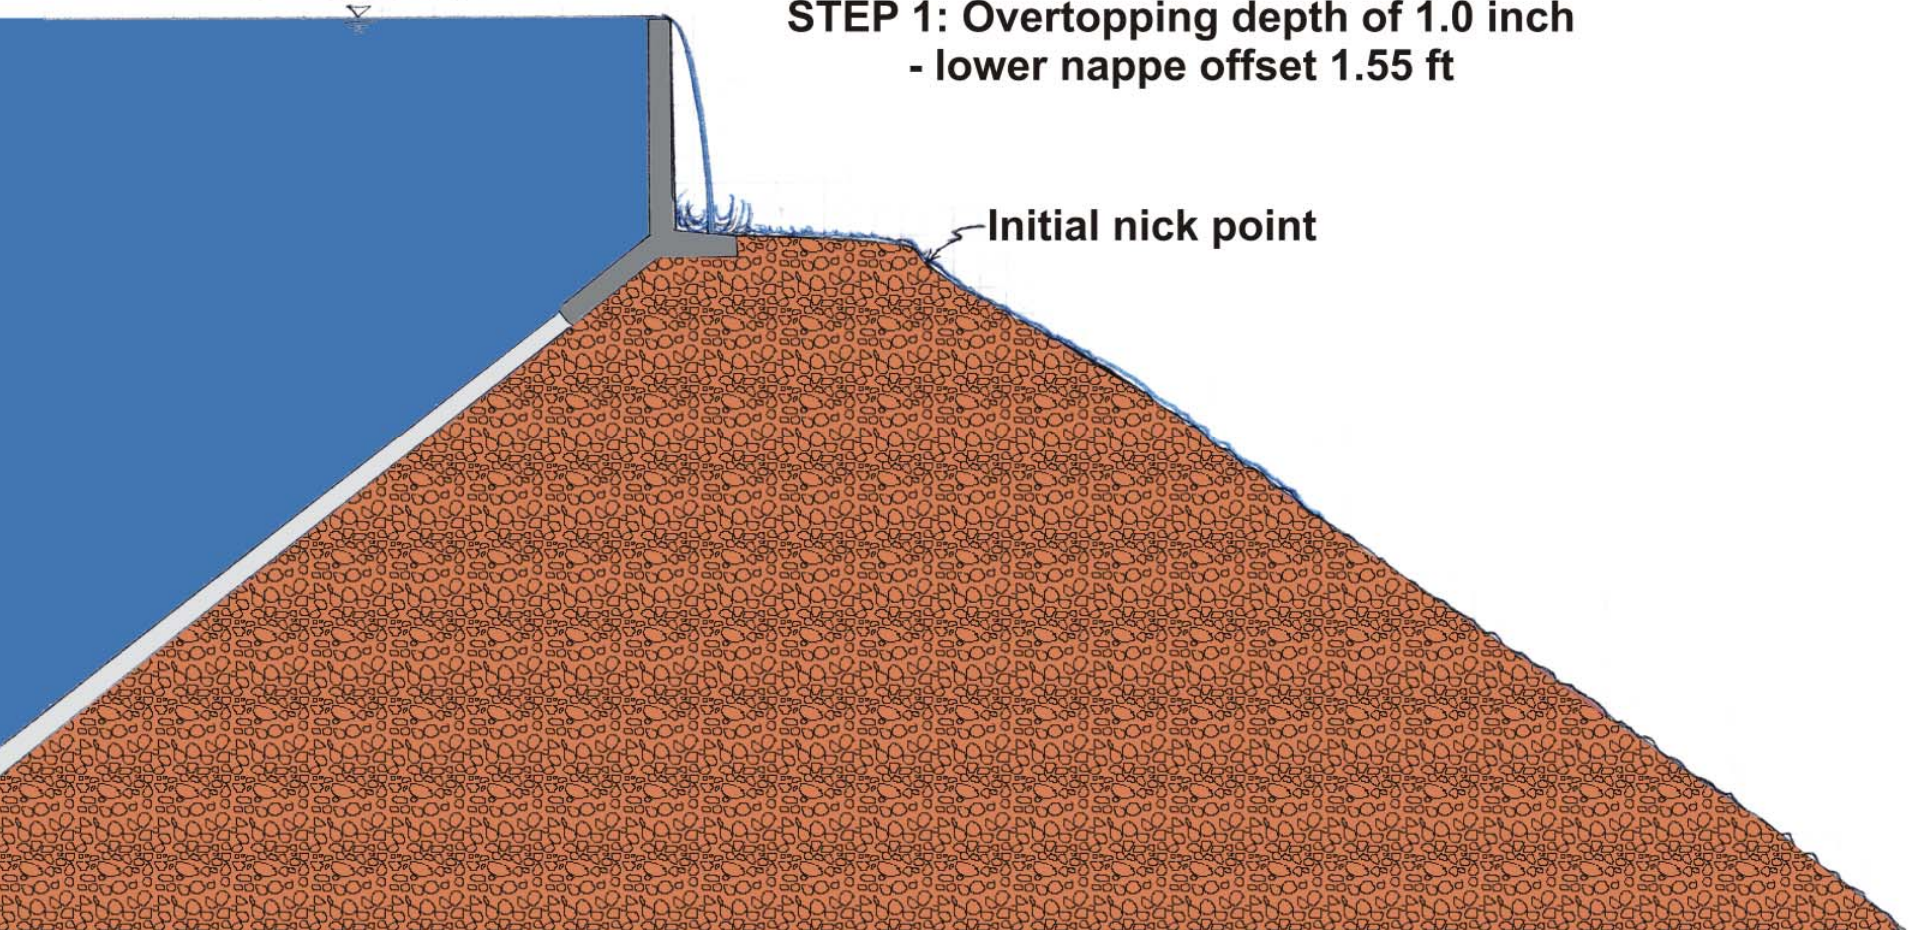
Time: ~5:09:00 AM

**STEP 1: Overtopping depth of 1.0 inch  
- lower nappe offset 1.55 ft**

Initial nick point

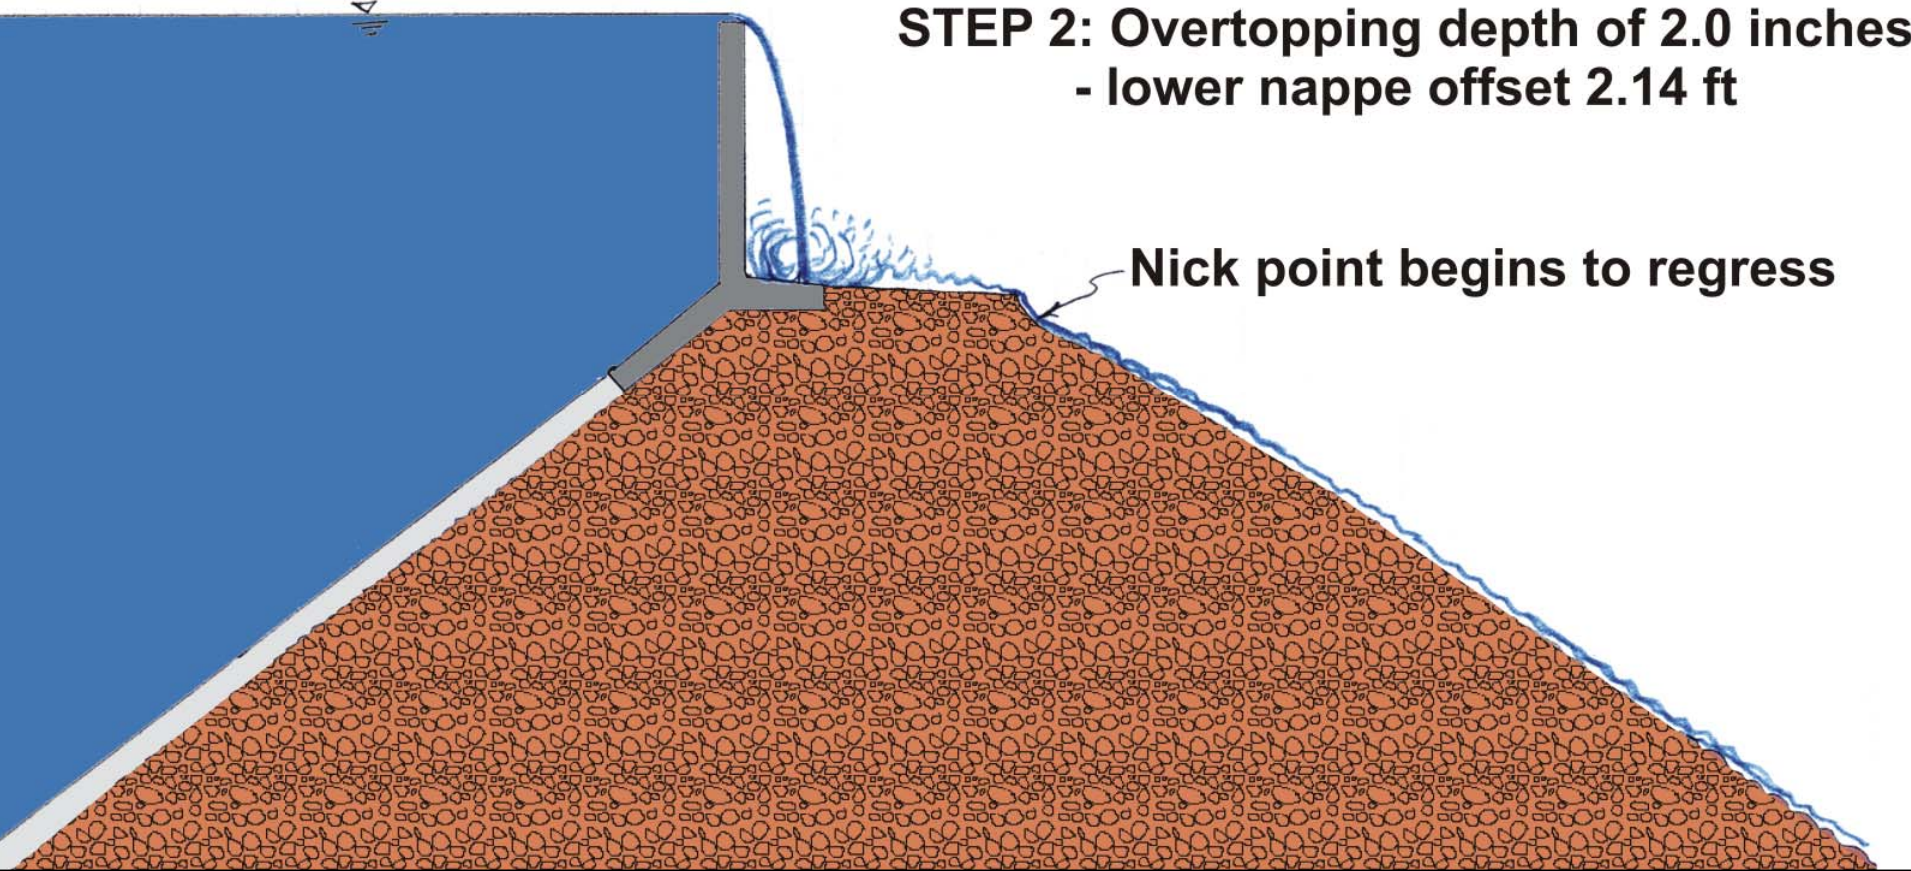
**Time: ~5:10:30 AM**

**STEP 2: Overtopping depth of 2.0 inches  
- lower nappe offset 2.14 ft**

**Nick point begins to regress**

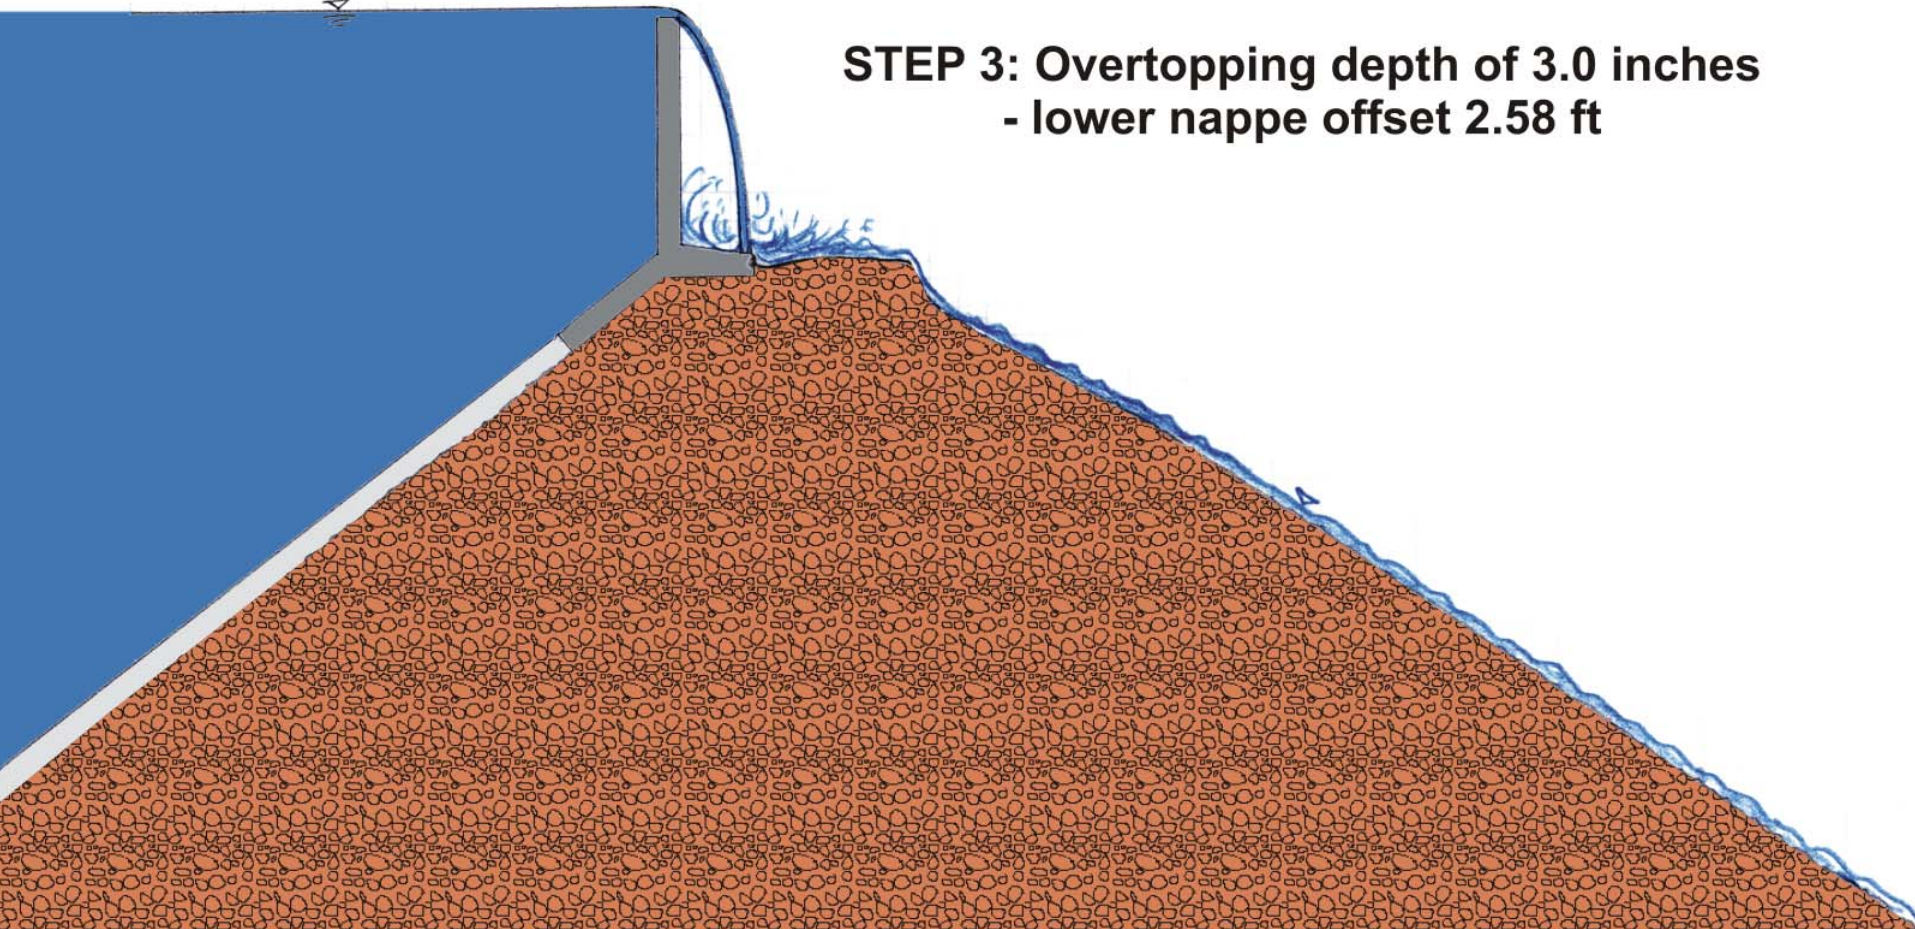
**Time: ~5:11:55 AM**

**STEP 3: Overtopping depth of 3.0 inches  
- lower nappe offset 2.58 ft**

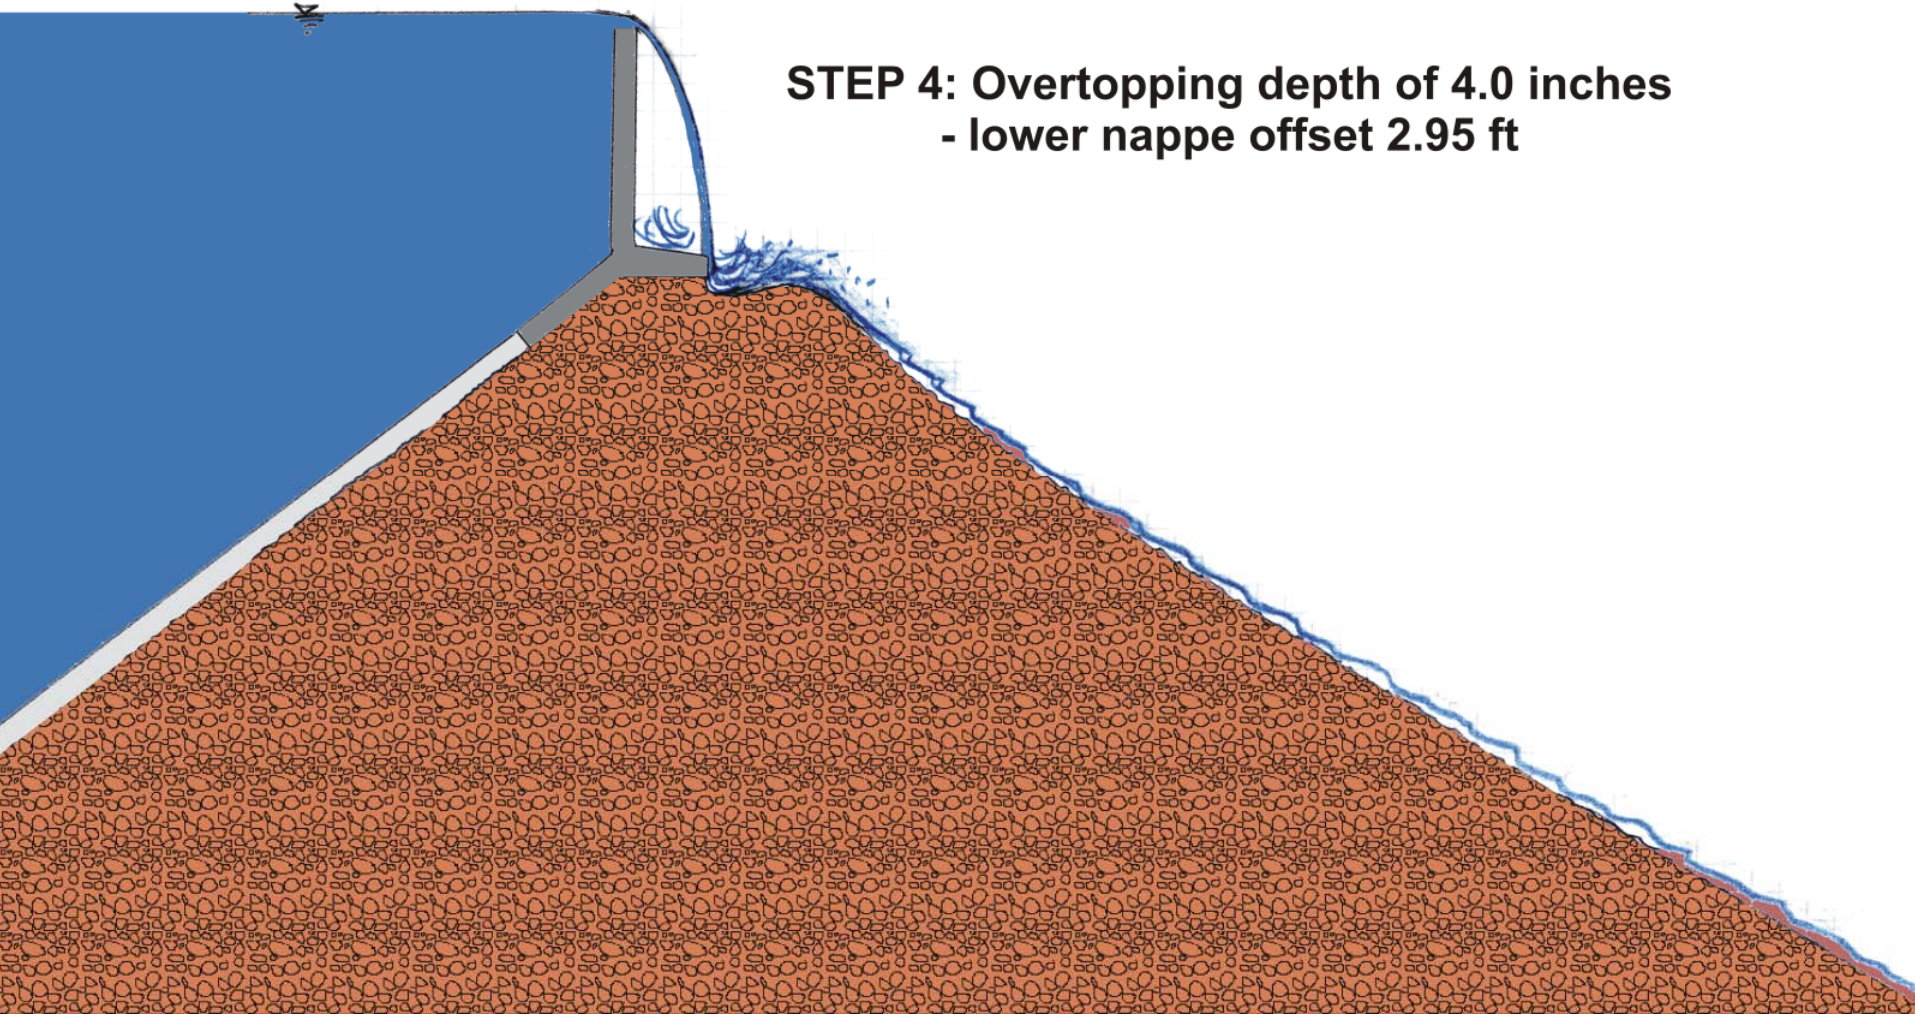
Time: ~5:12:55 AM

**STEP 4: Overtopping depth of 4.0 inches  
- lower nappe offset 2.95 ft**

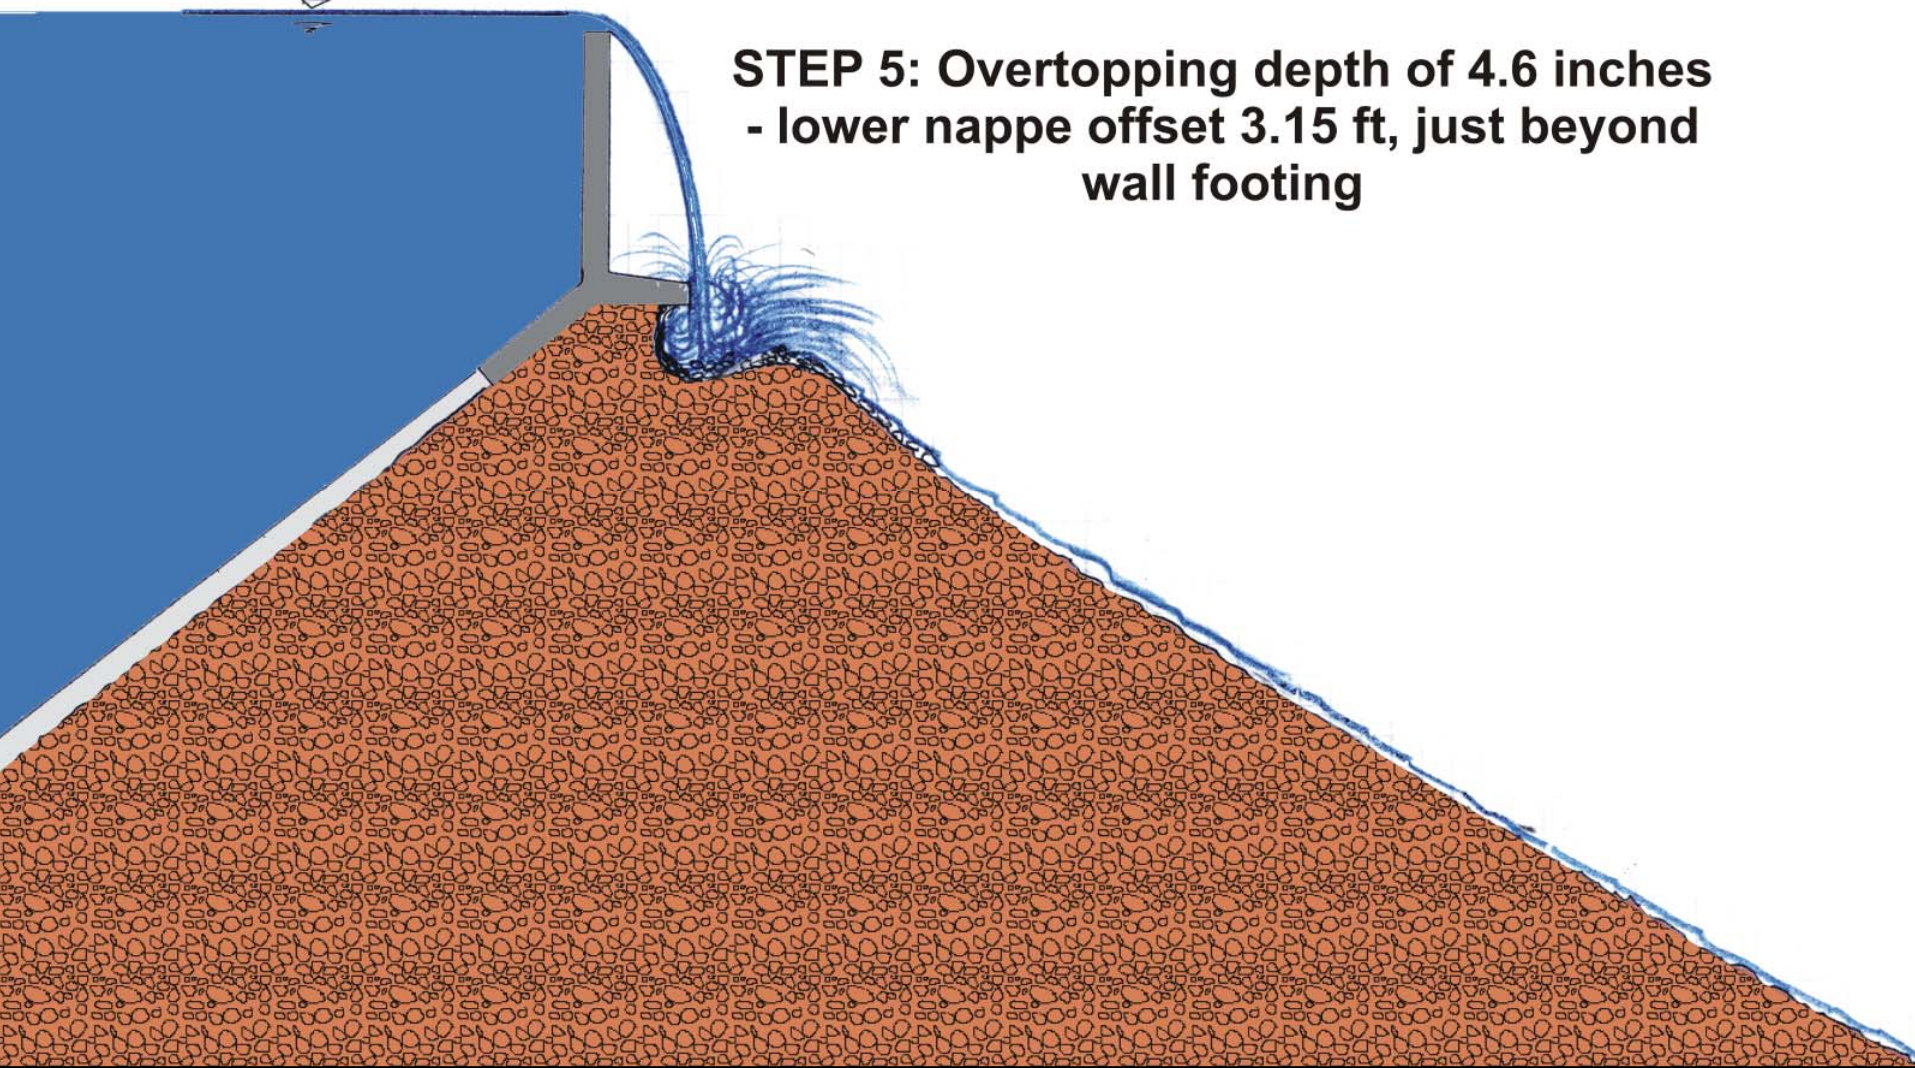
**Time: ~5:13:35 AM**

**STEP 5: Overtopping depth of 4.6 inches  
- lower nappe offset 3.15 ft, just beyond  
wall footing**

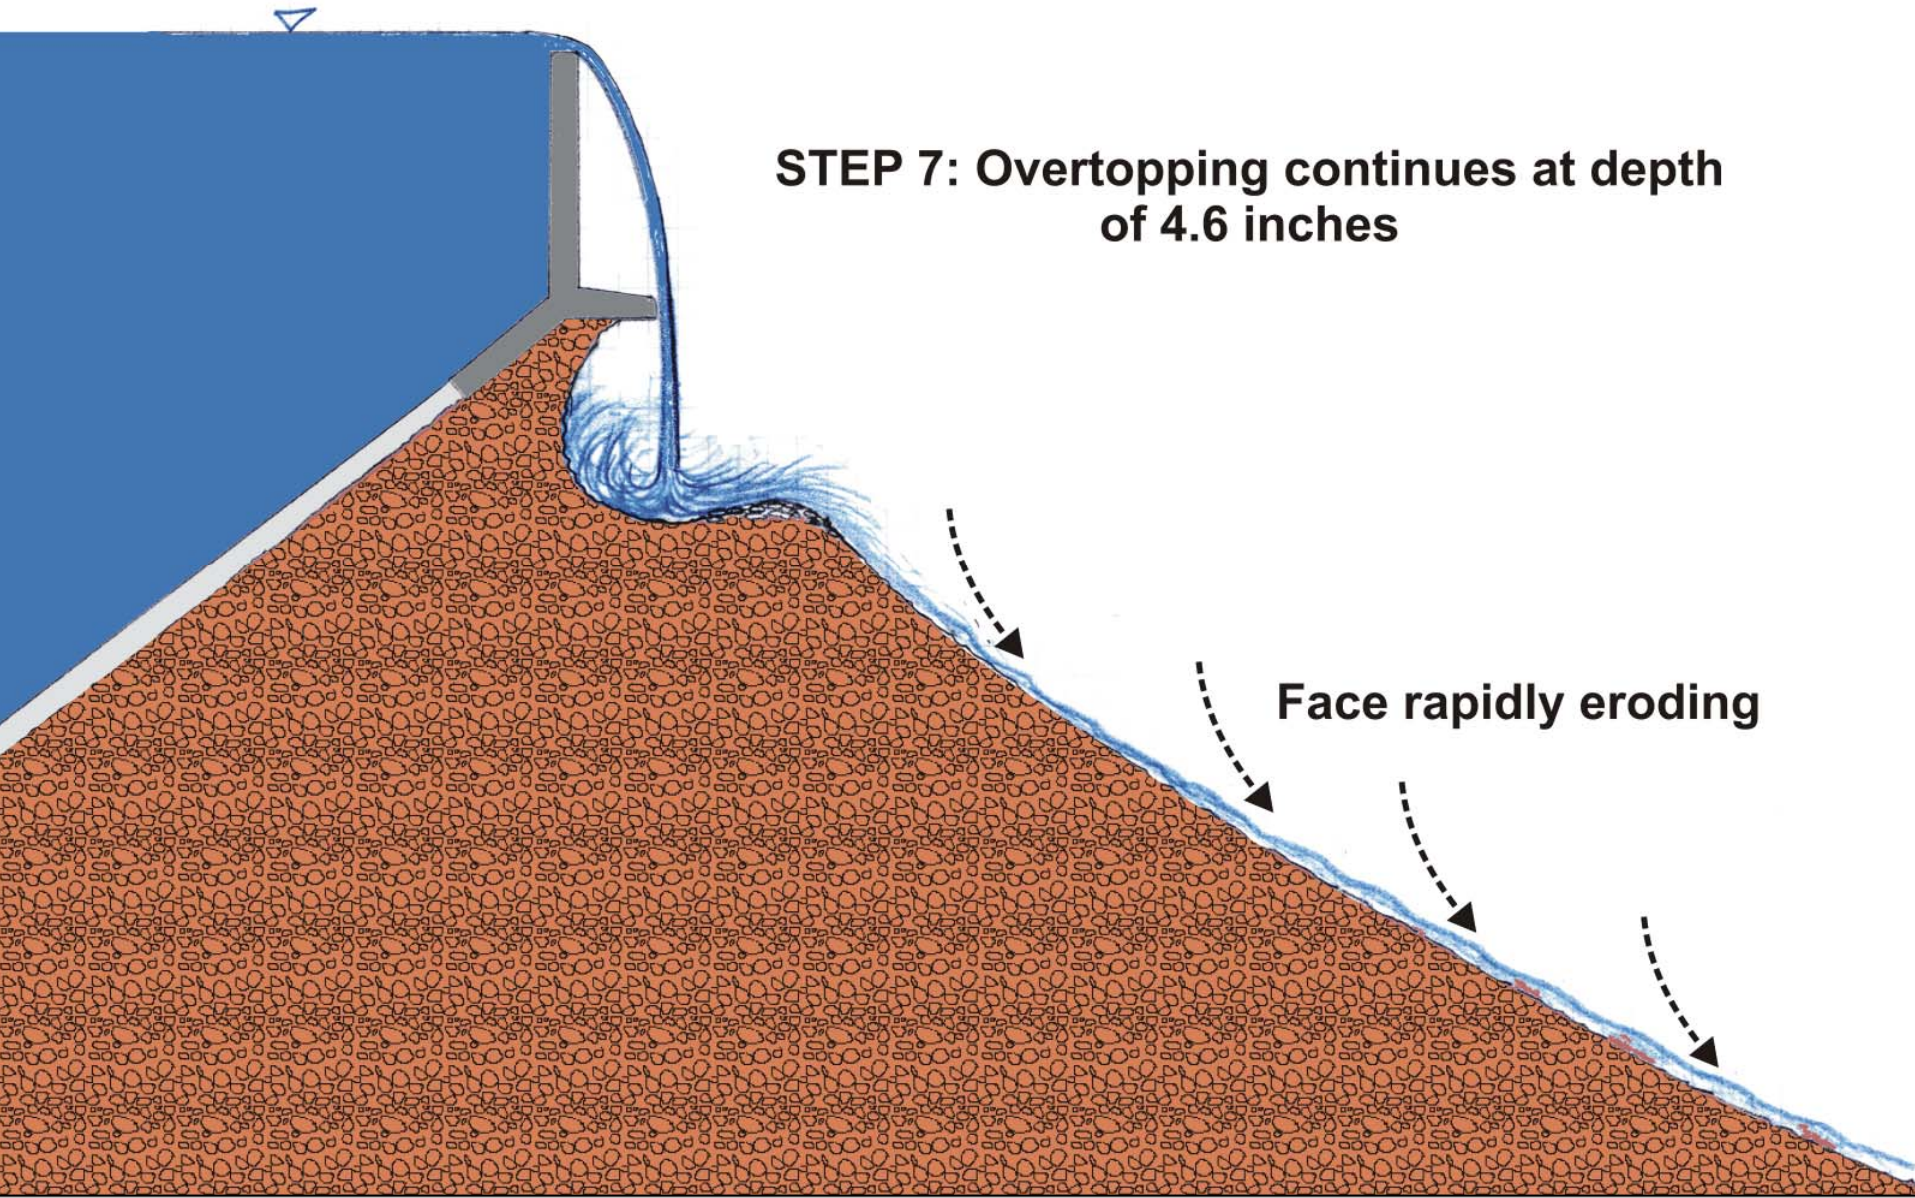
Time: ~5:14:00 AM

**STEP 7: Overtopping continues at depth  
of 4.6 inches**

**Face rapidly eroding**

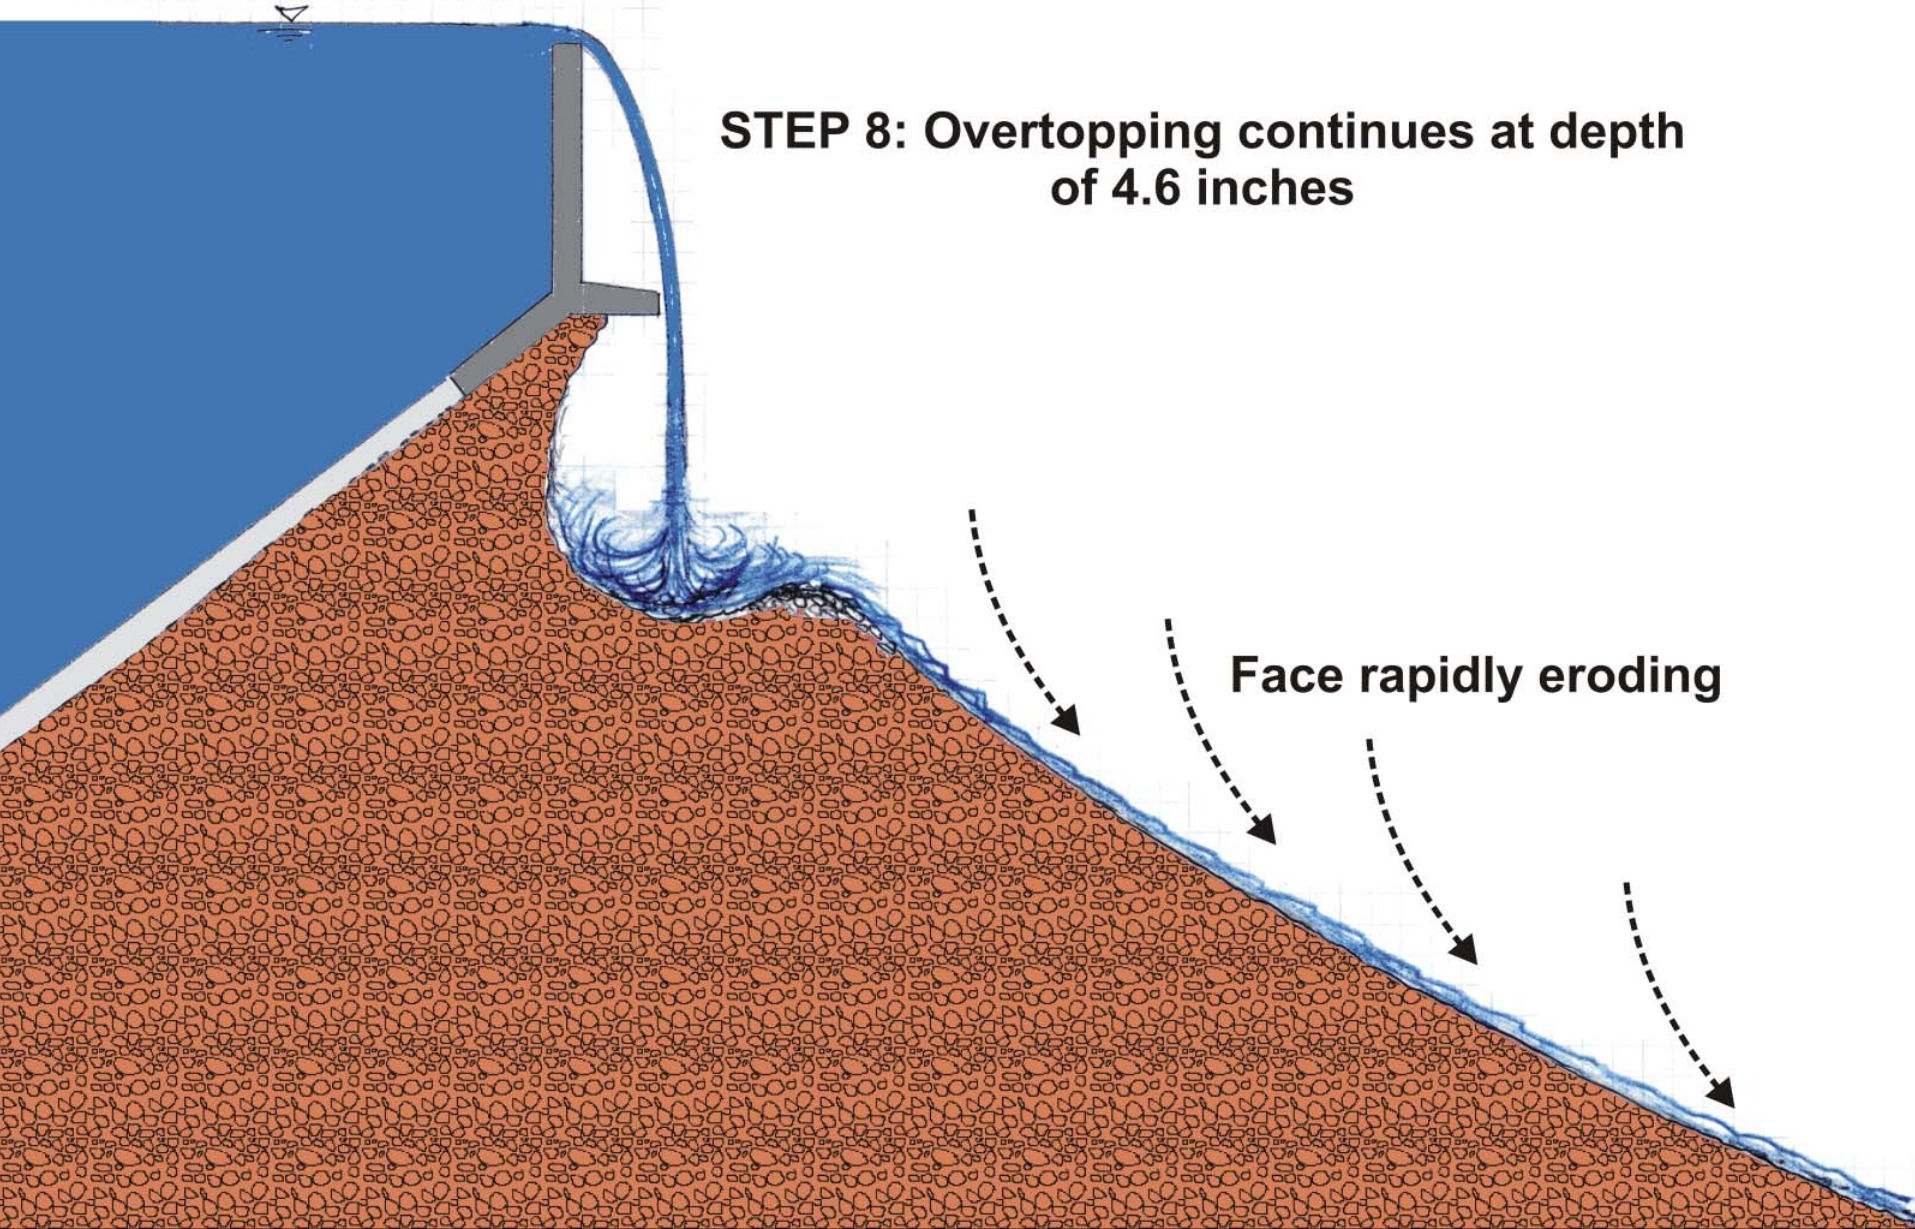
Time: ~5:14:15 AM

**STEP 8: Overtopping continues at depth of 4.6 inches**

**Face rapidly eroding**

**3 Dimensional effects allowed wall to stand with extensive undermining**

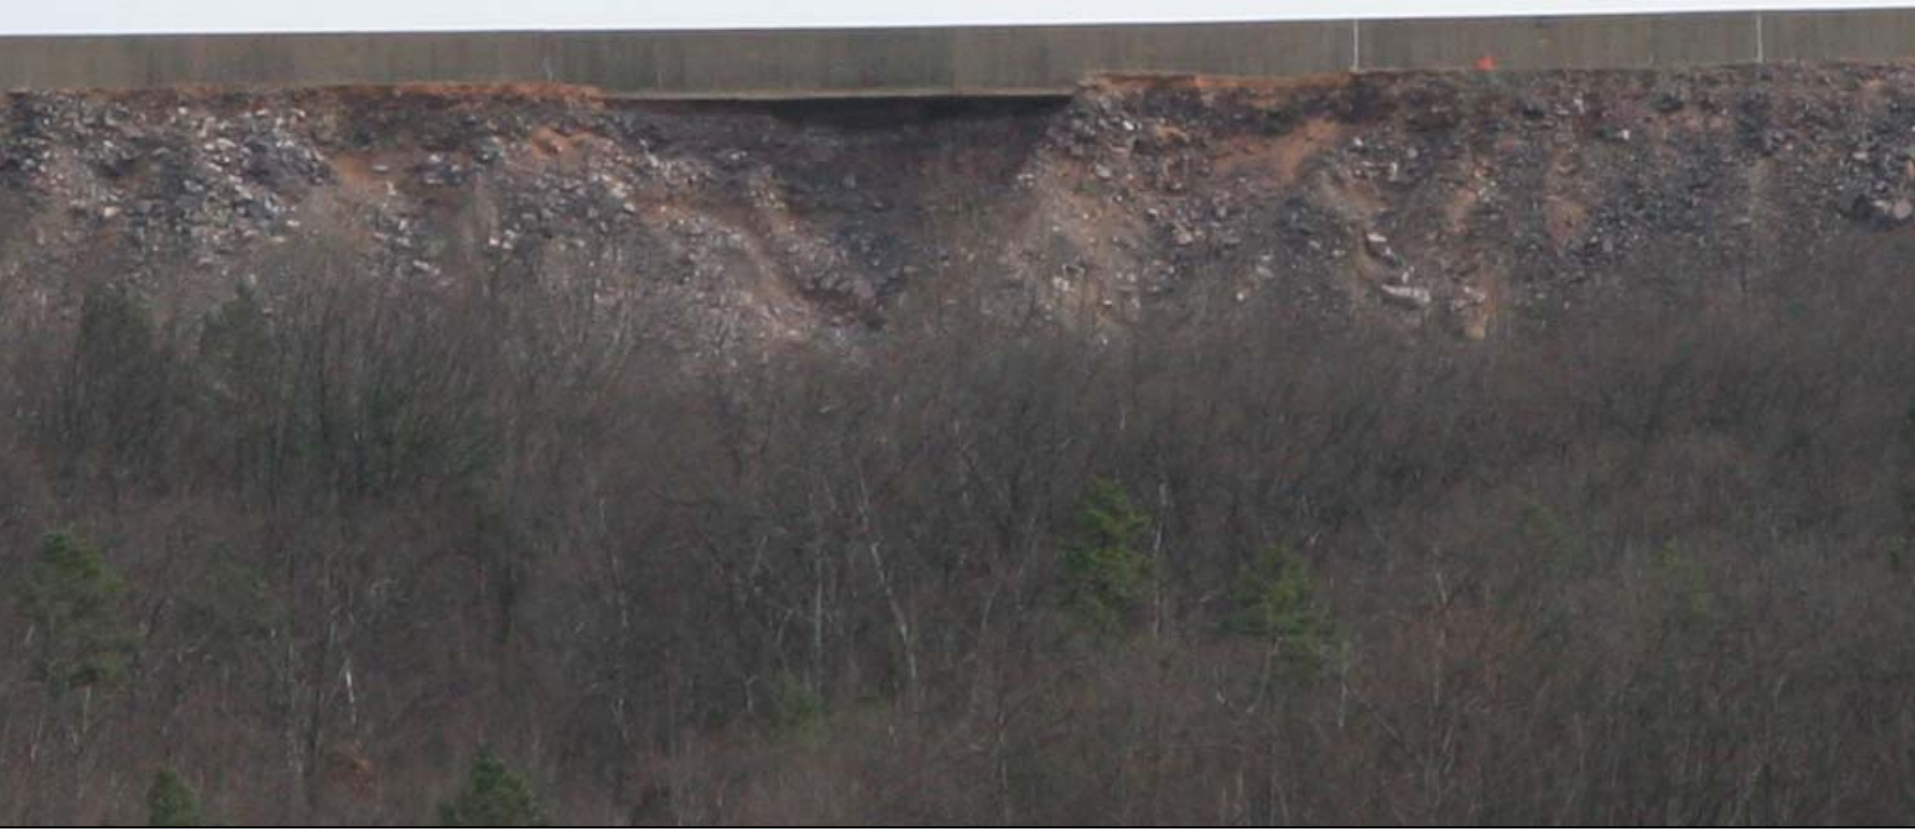
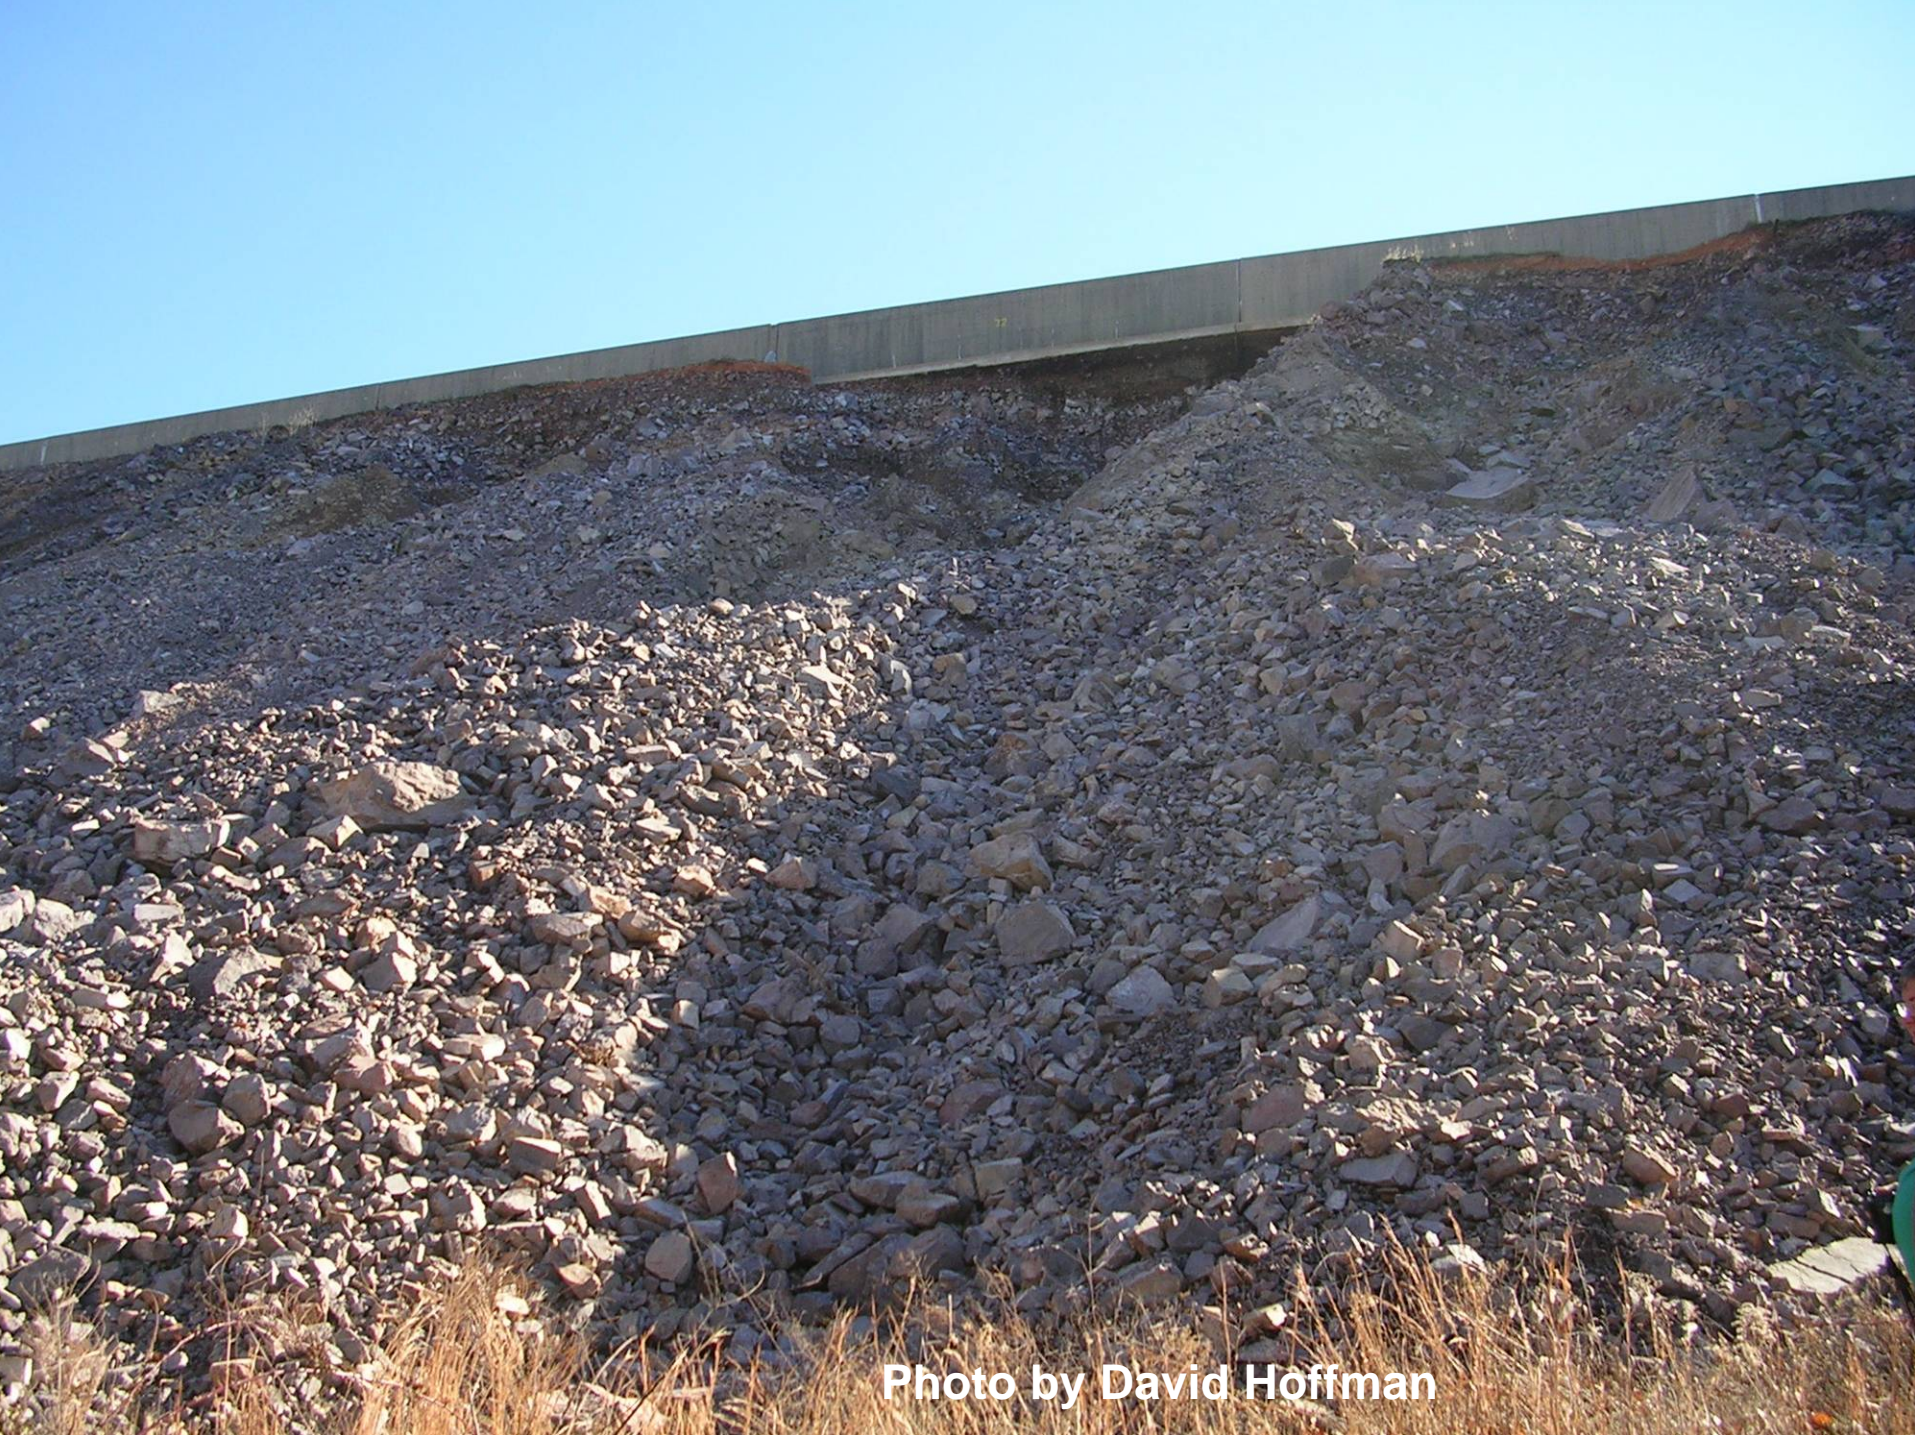
**Water pouring over the parapet wall scoured away the fill supporting the wall's foundation. A portion of the wall appears to have toppled, unleashing a flow of water that catastrophically eroded a 680 foot wide section of the embankment, emptying the reservoir in ~12 minutes.**

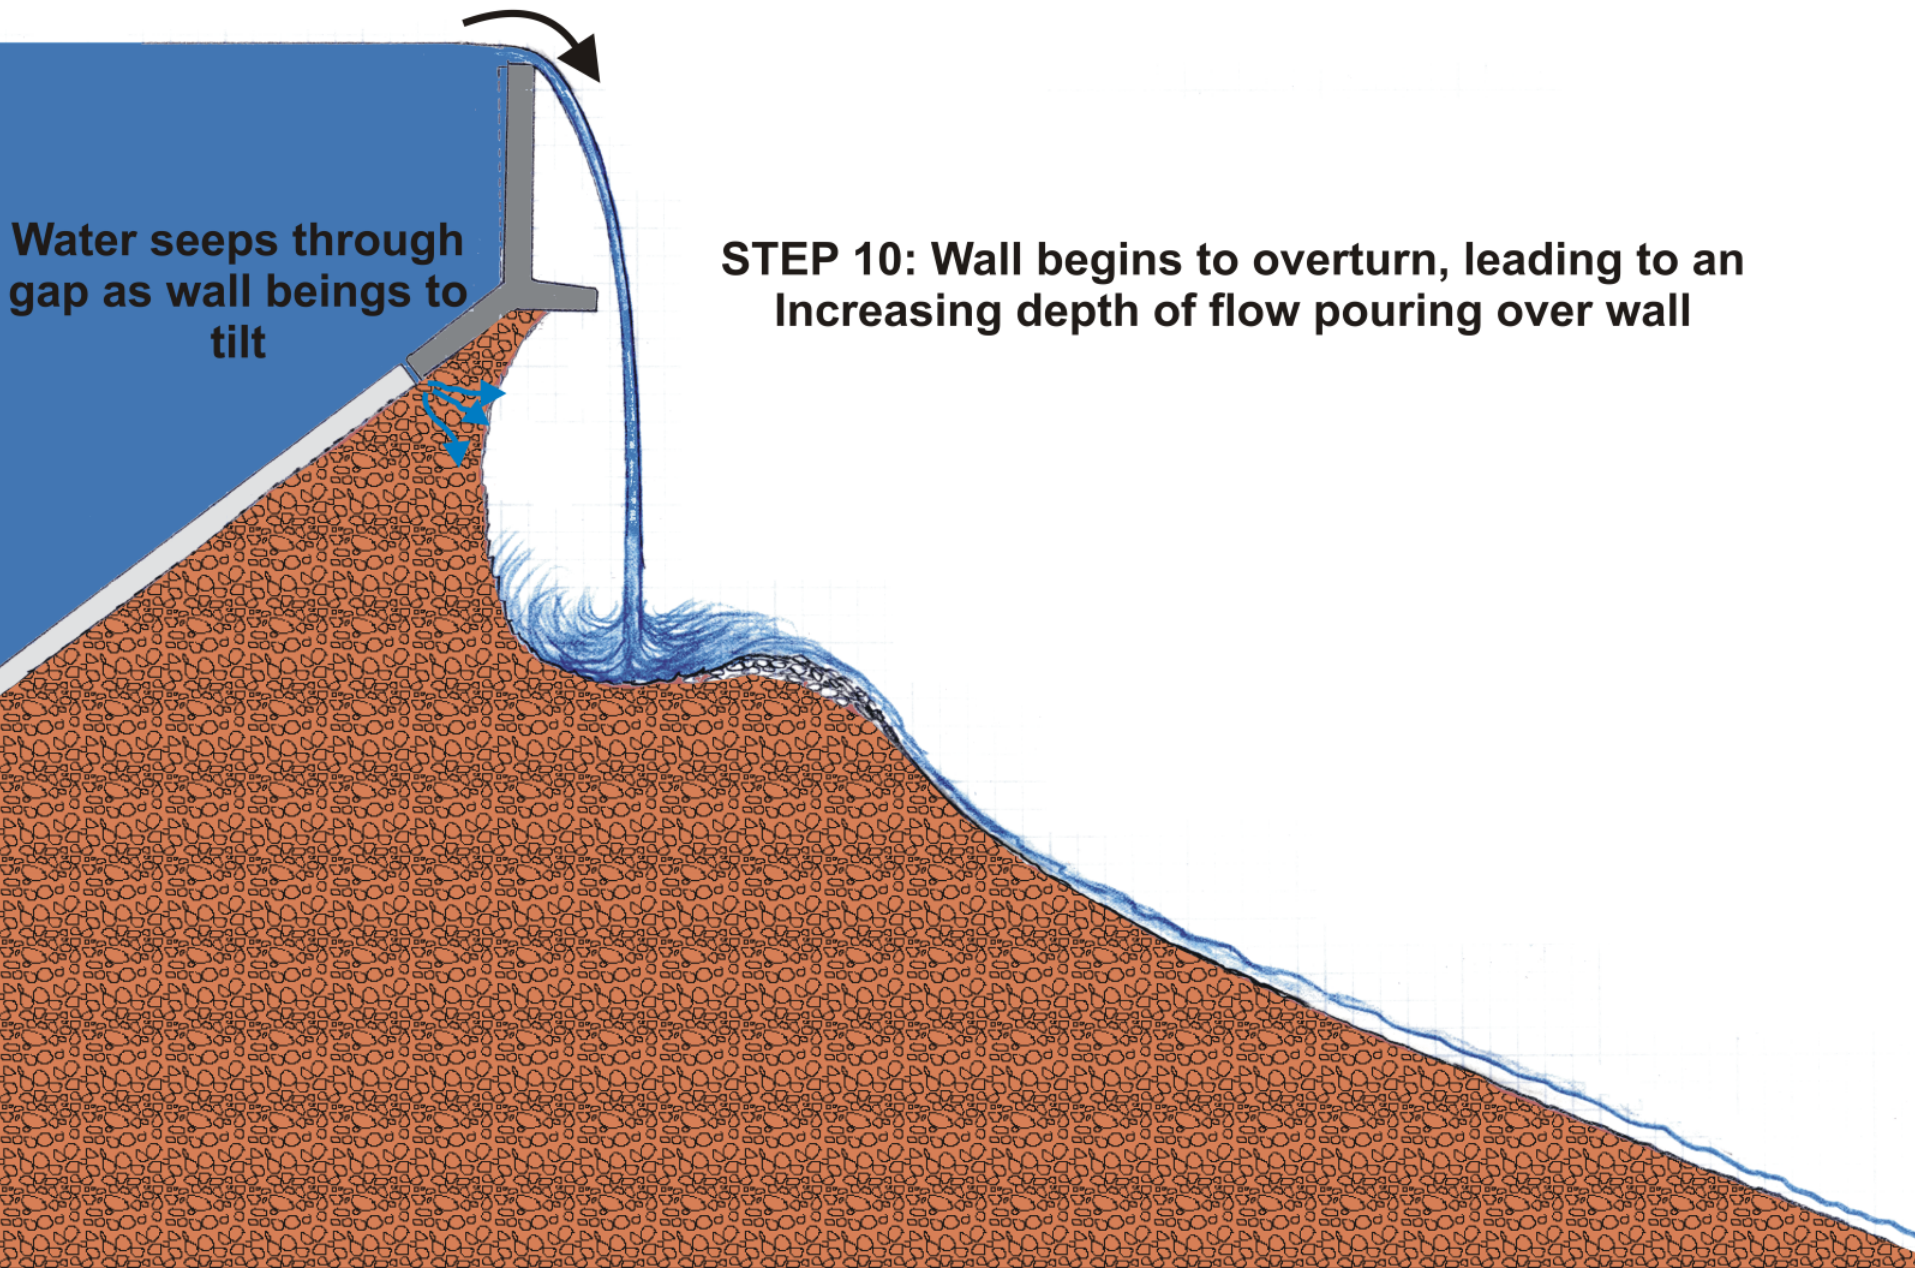
Time: ~5:15:00 AM

**Water seeps through gap as wall begins to tilt**

**STEP 10: Wall begins to overturn, leading to an increasing depth of flow pouring over wall**

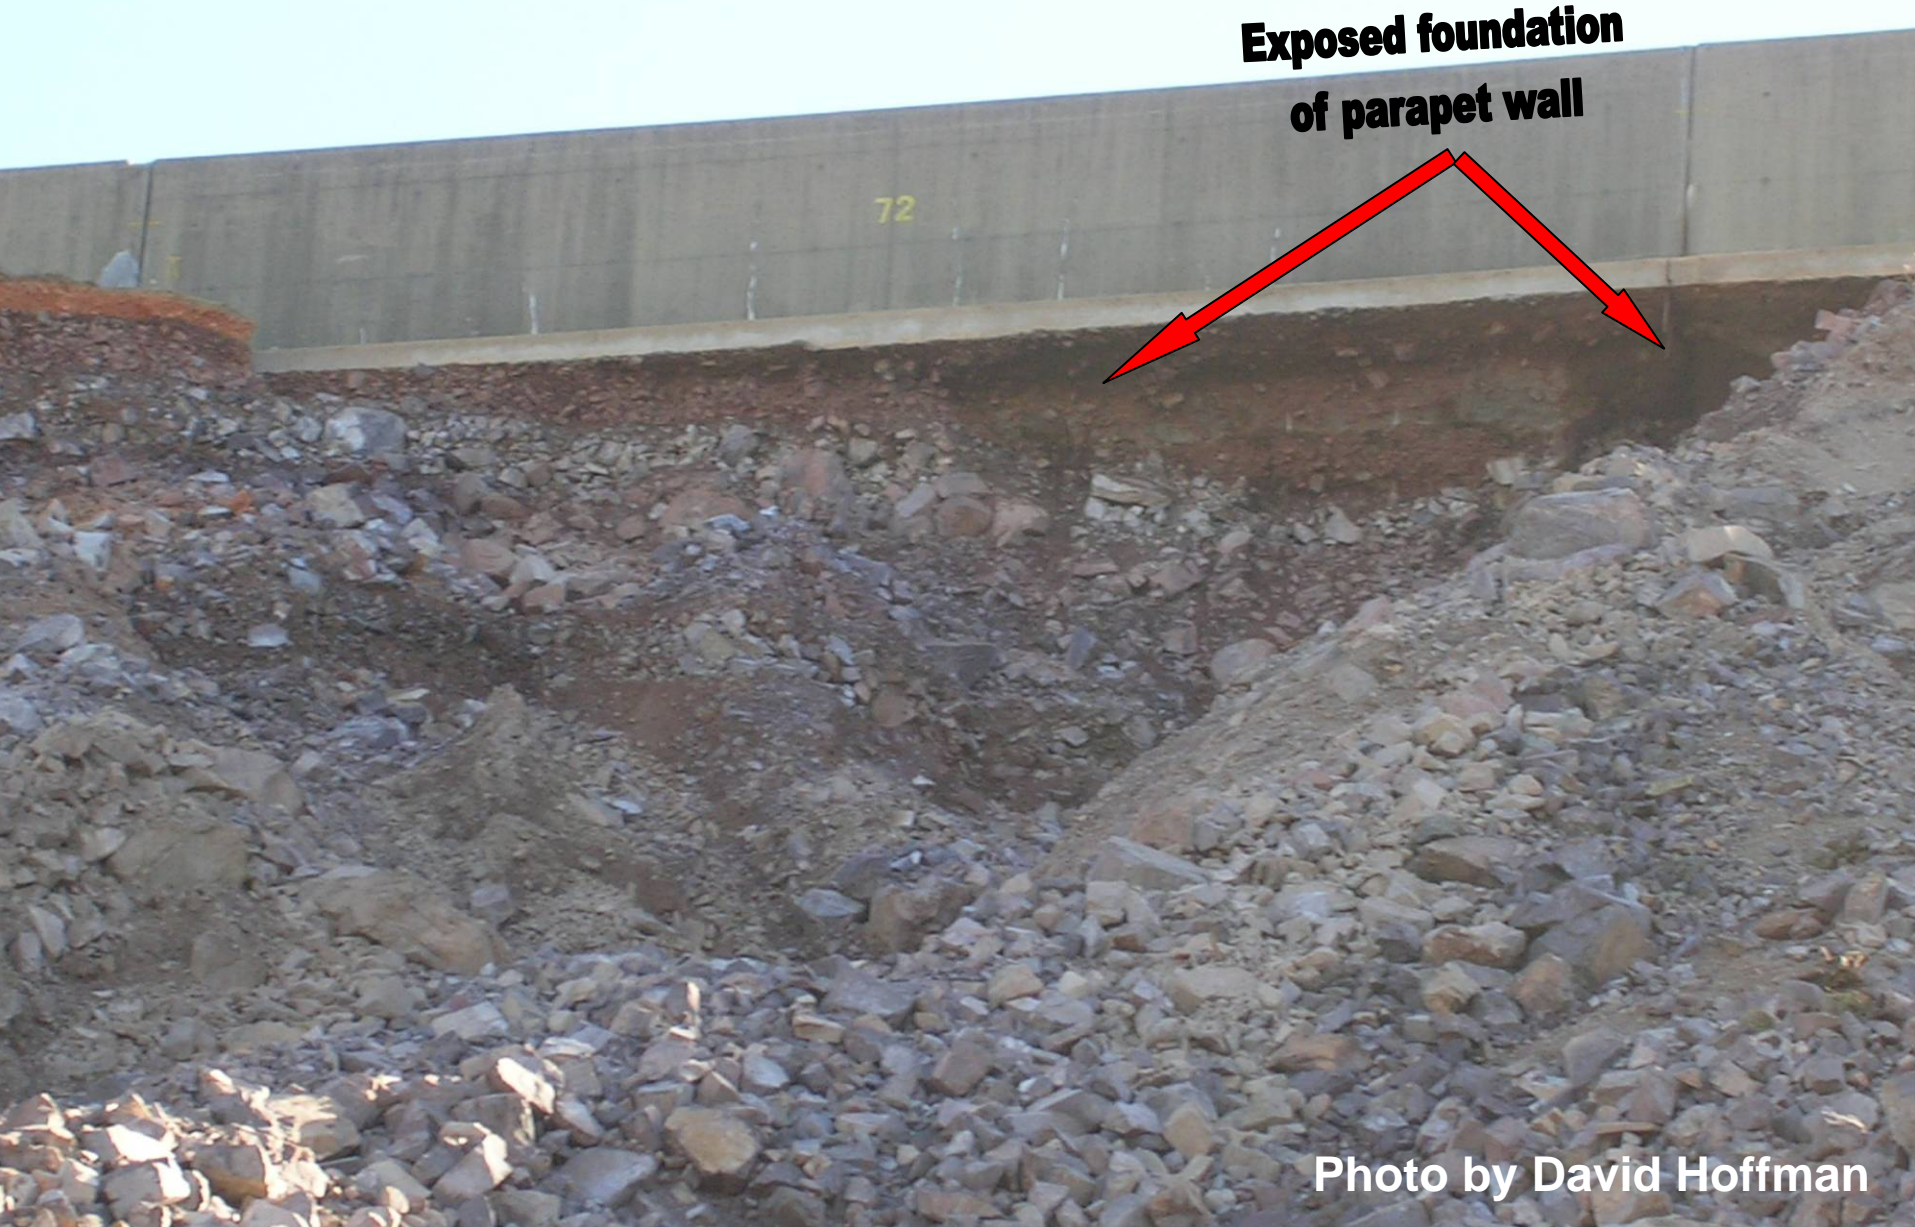
**Time: ~5:15:00 AM**

**STEP 12: Wall section fails via overturning,  
allowing ~15 ft of flow to begin sweeping  
away the remaining embankment**

**Wall panels toppled over after extensive undercutting, initiating the catastrophic failure sequence.**
