# **OVERVIEW OF THE TAUM SAUK UPPER RESERVOIR FAILURE**

**December 14, 2005**

**Reynolds County, Missouri**

**University of Missouri-Rolla**

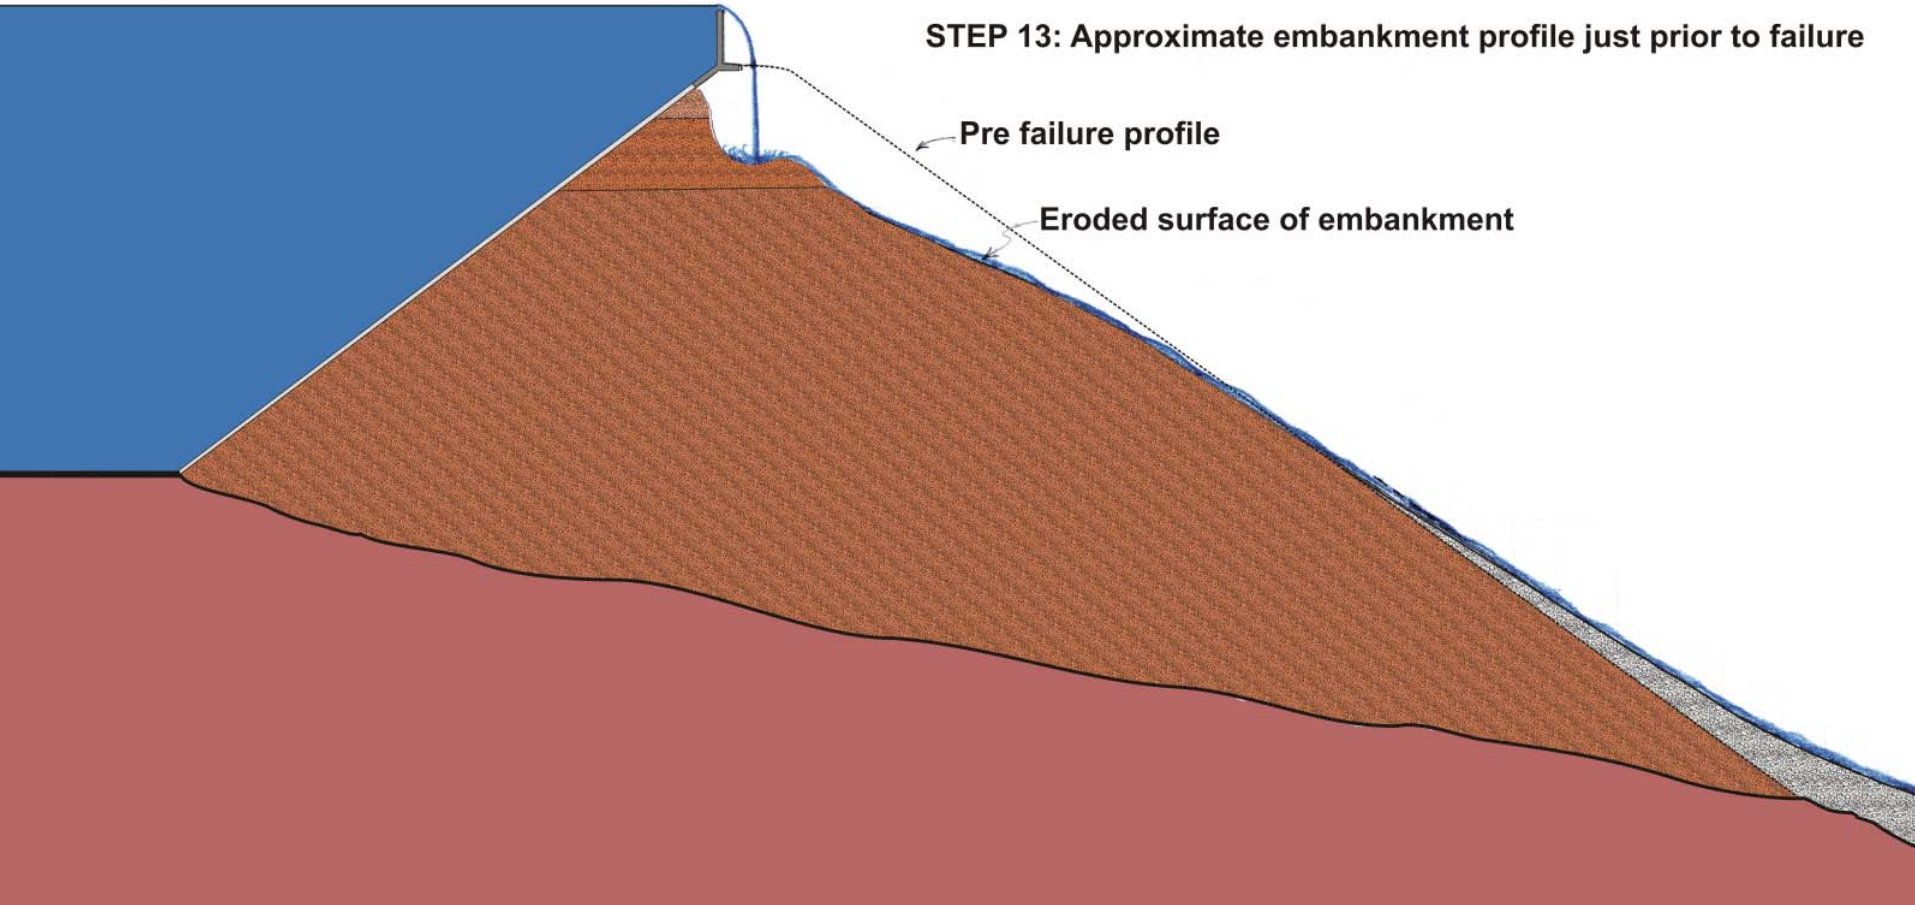
STEP 13: Approximate embankment profile just prior to failure

Pre failure profile

Eroded surface of embankment

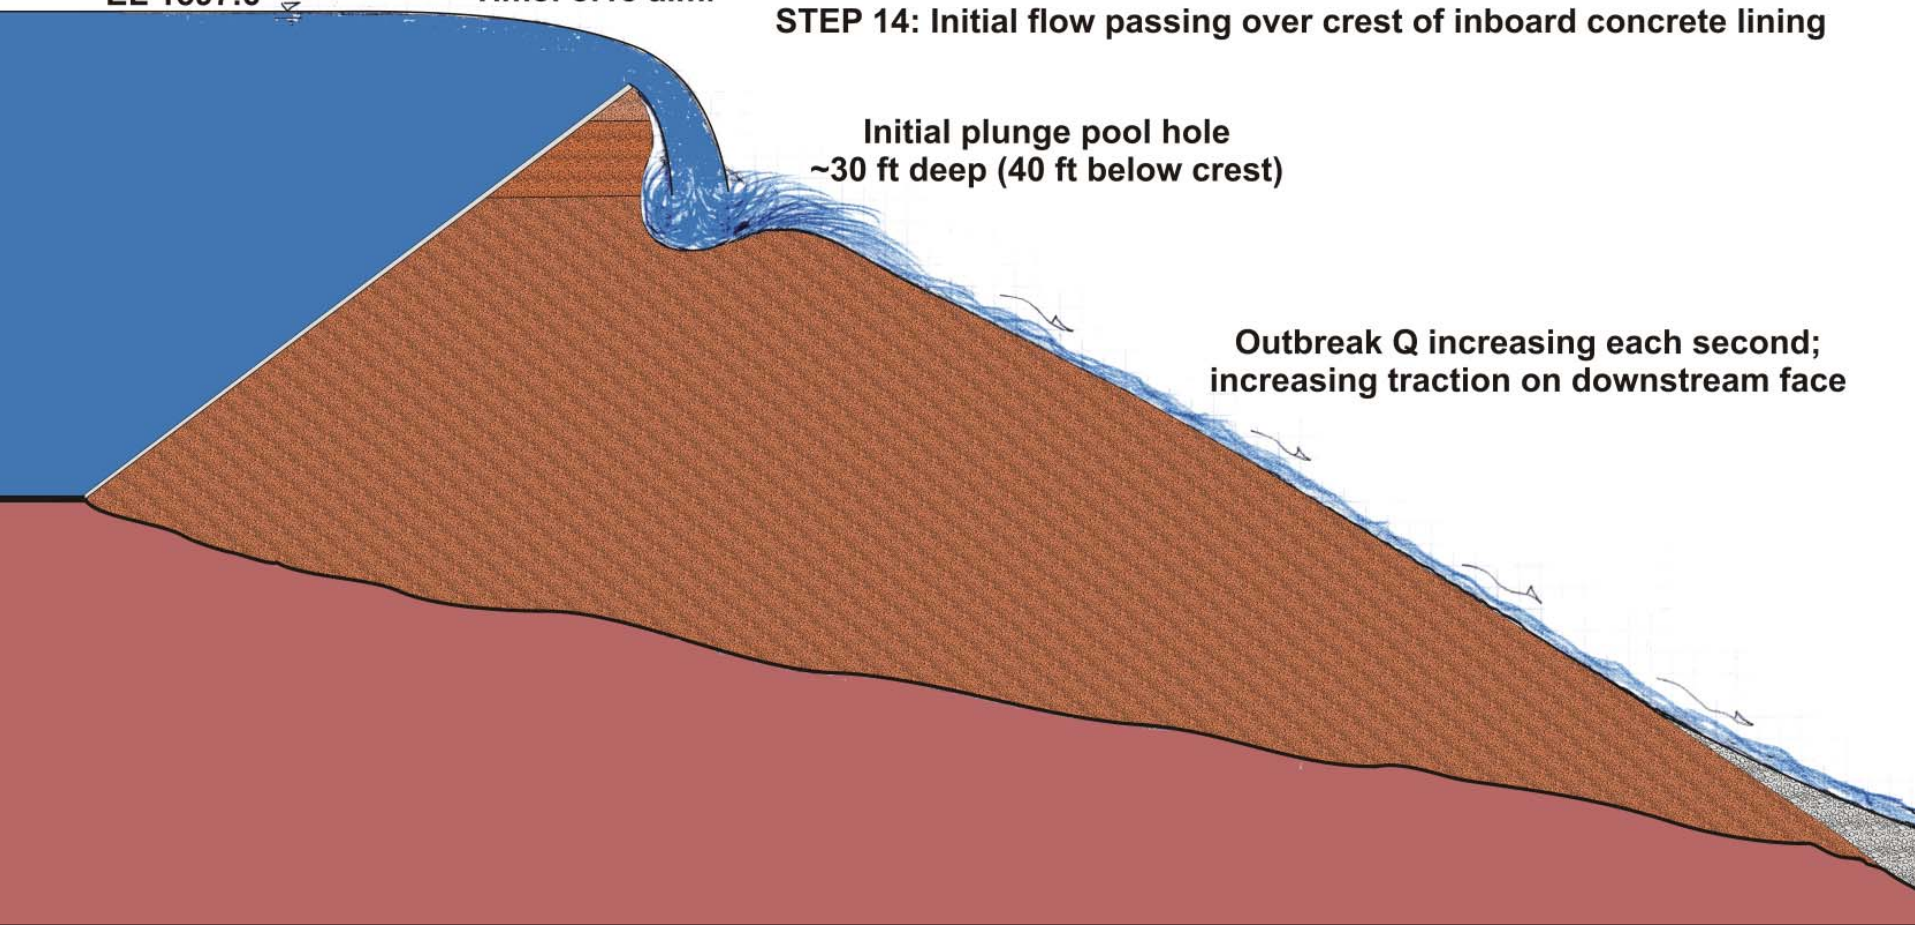
Time: 5:16:30 AM

Initial plunge pool hole  
~30 ft deep (40 ft below crest)

Outbreak Q increasing each second;  
increasing traction on downstream face

EL 1594.1' - Pool dropped ~3.5'

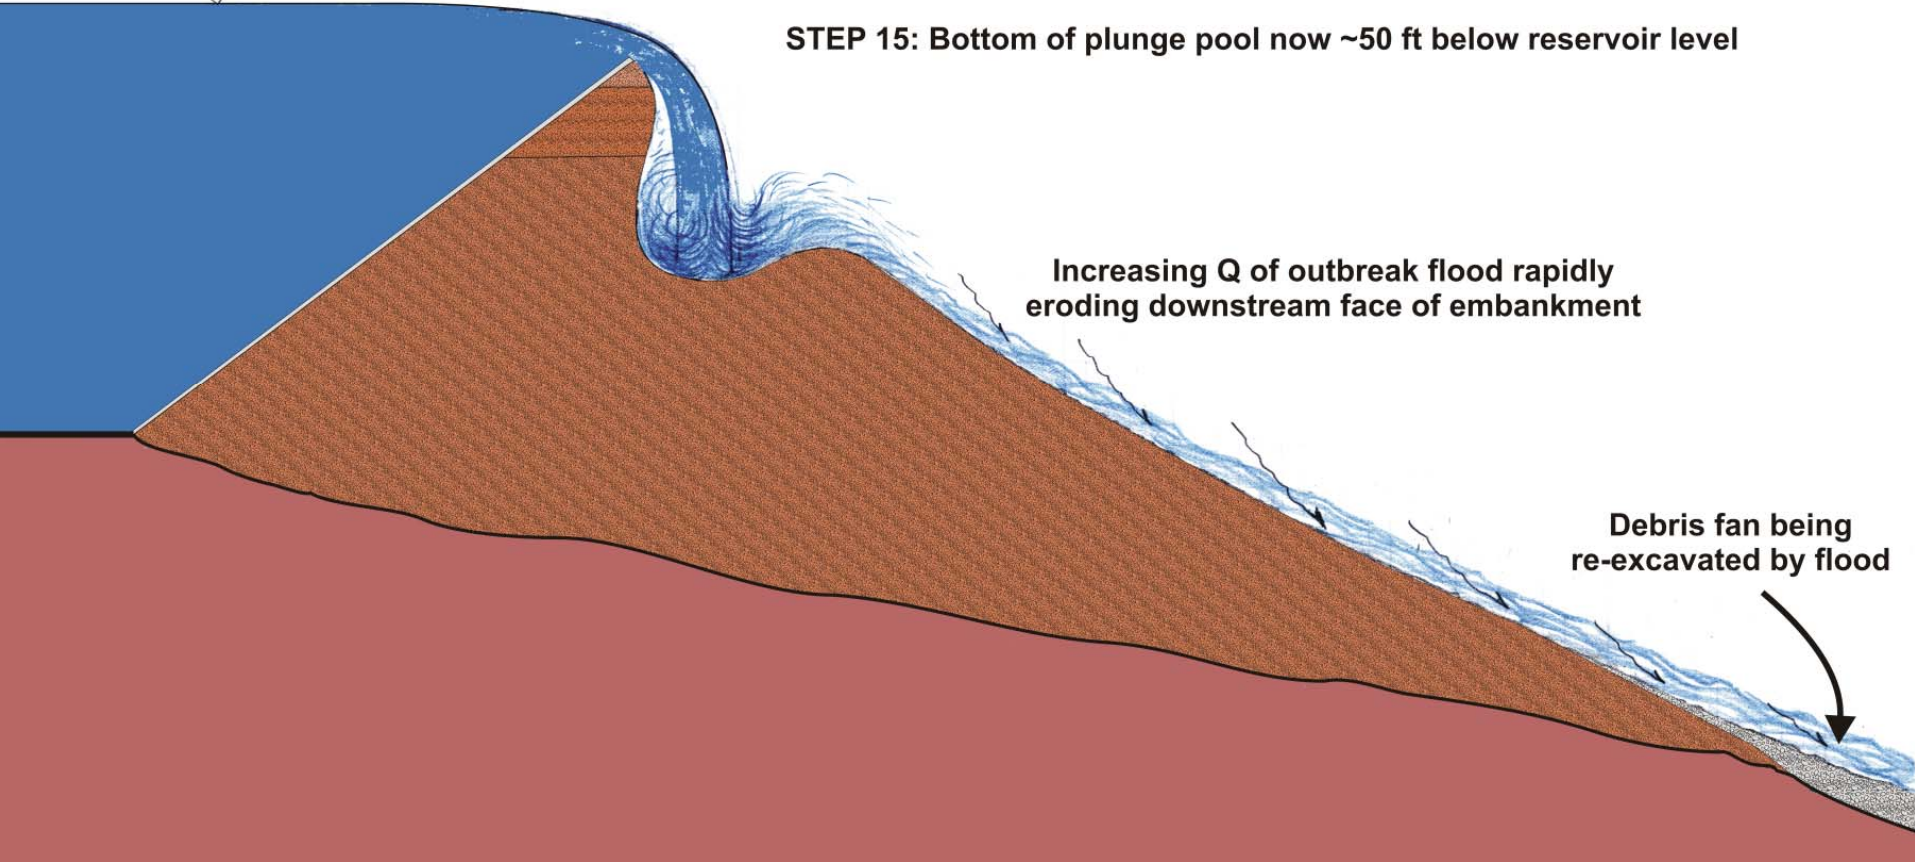
Time: 5:17:15 AM

Increasing Q of outbreak flood rapidly  
eroding downstream face of embankment

Debris fan being  
re-excavated by flood

EL 1591.1'

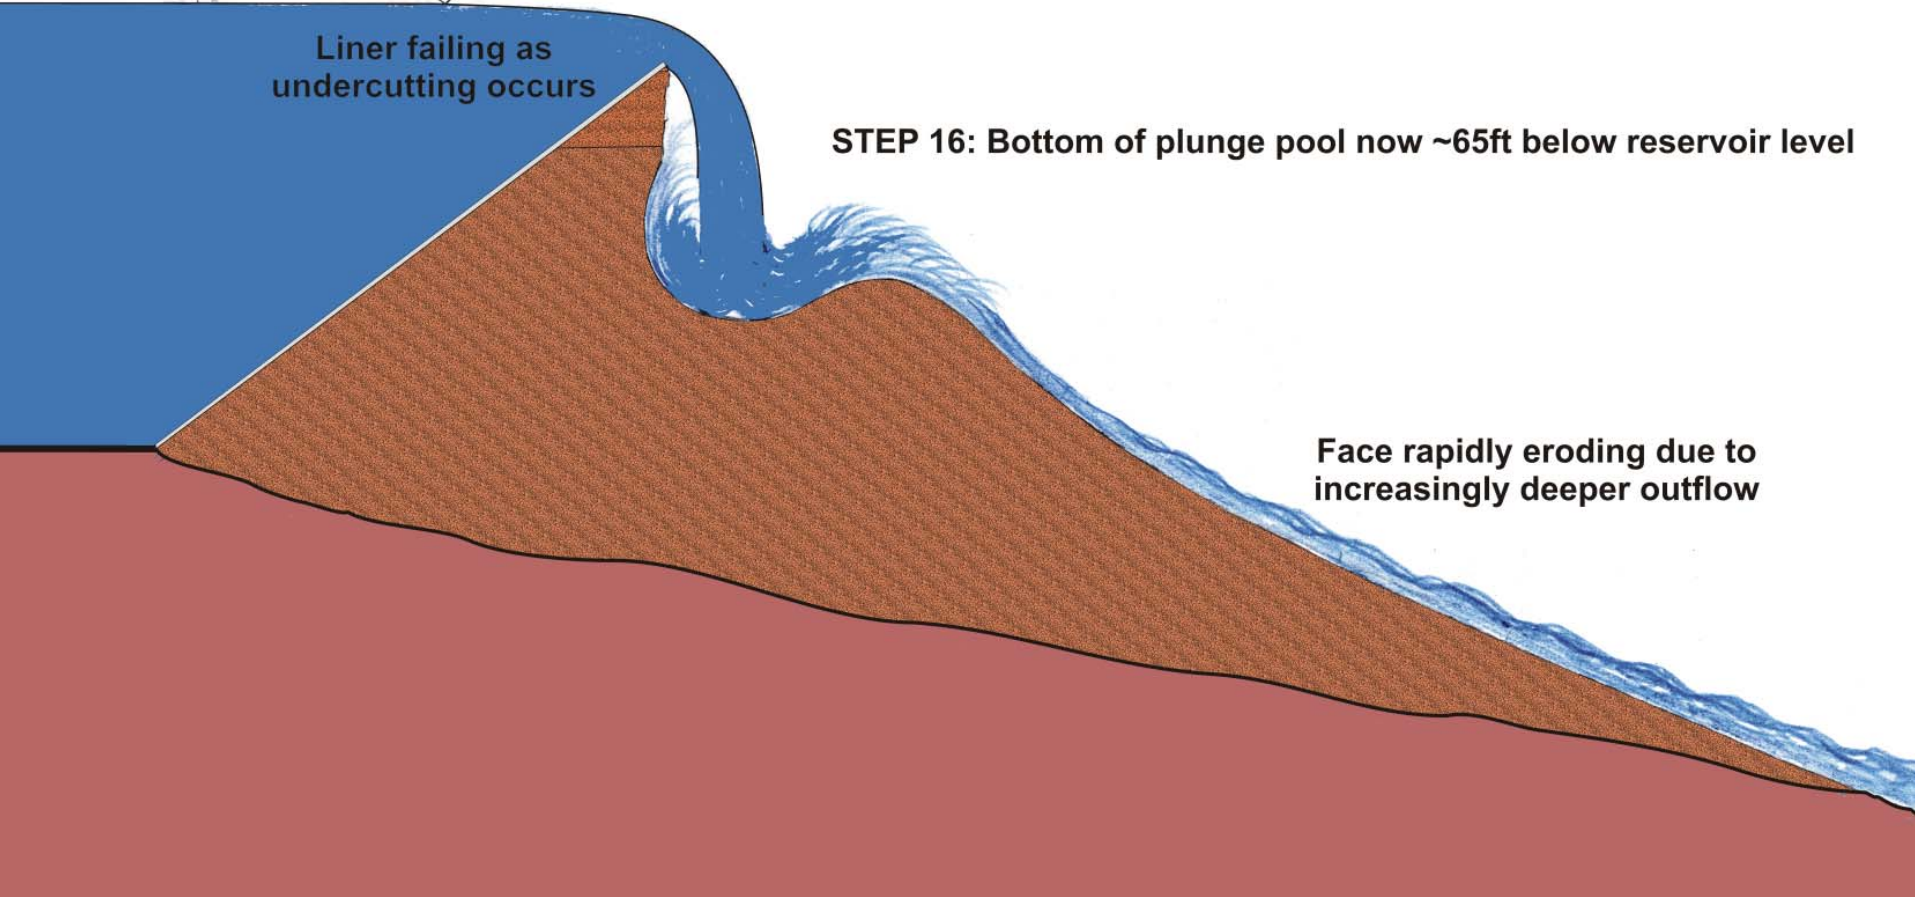
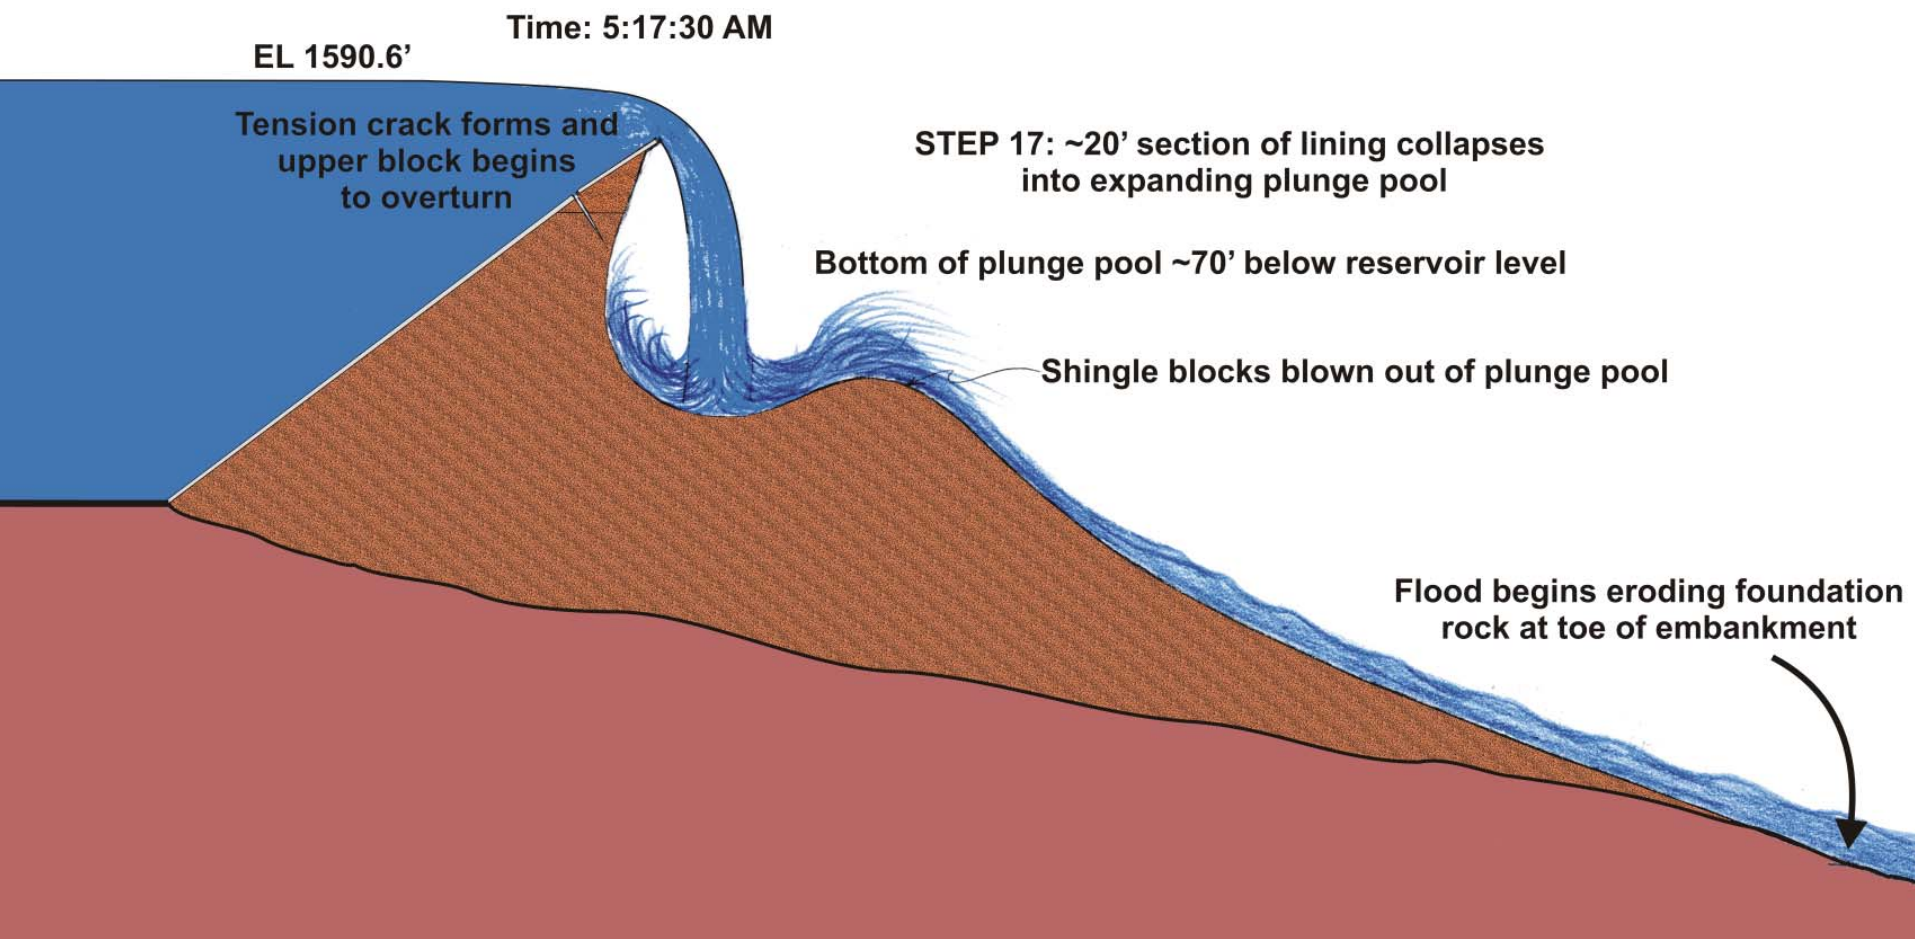
Reservoir pool dropped ~10'.5      Time: 5:18:15 AM  
EL 1587.1'

Liner failing as  
undercutting occurs

STEP 16: Bottom of plunge pool now ~65ft below reservoir level

Face rapidly eroding due to  
increasingly deeper outflow

~20' of head above  
concrete lining

STEP 18: Bottom of plunge pool ~65' below reservoir level  
Water falling 45-65'

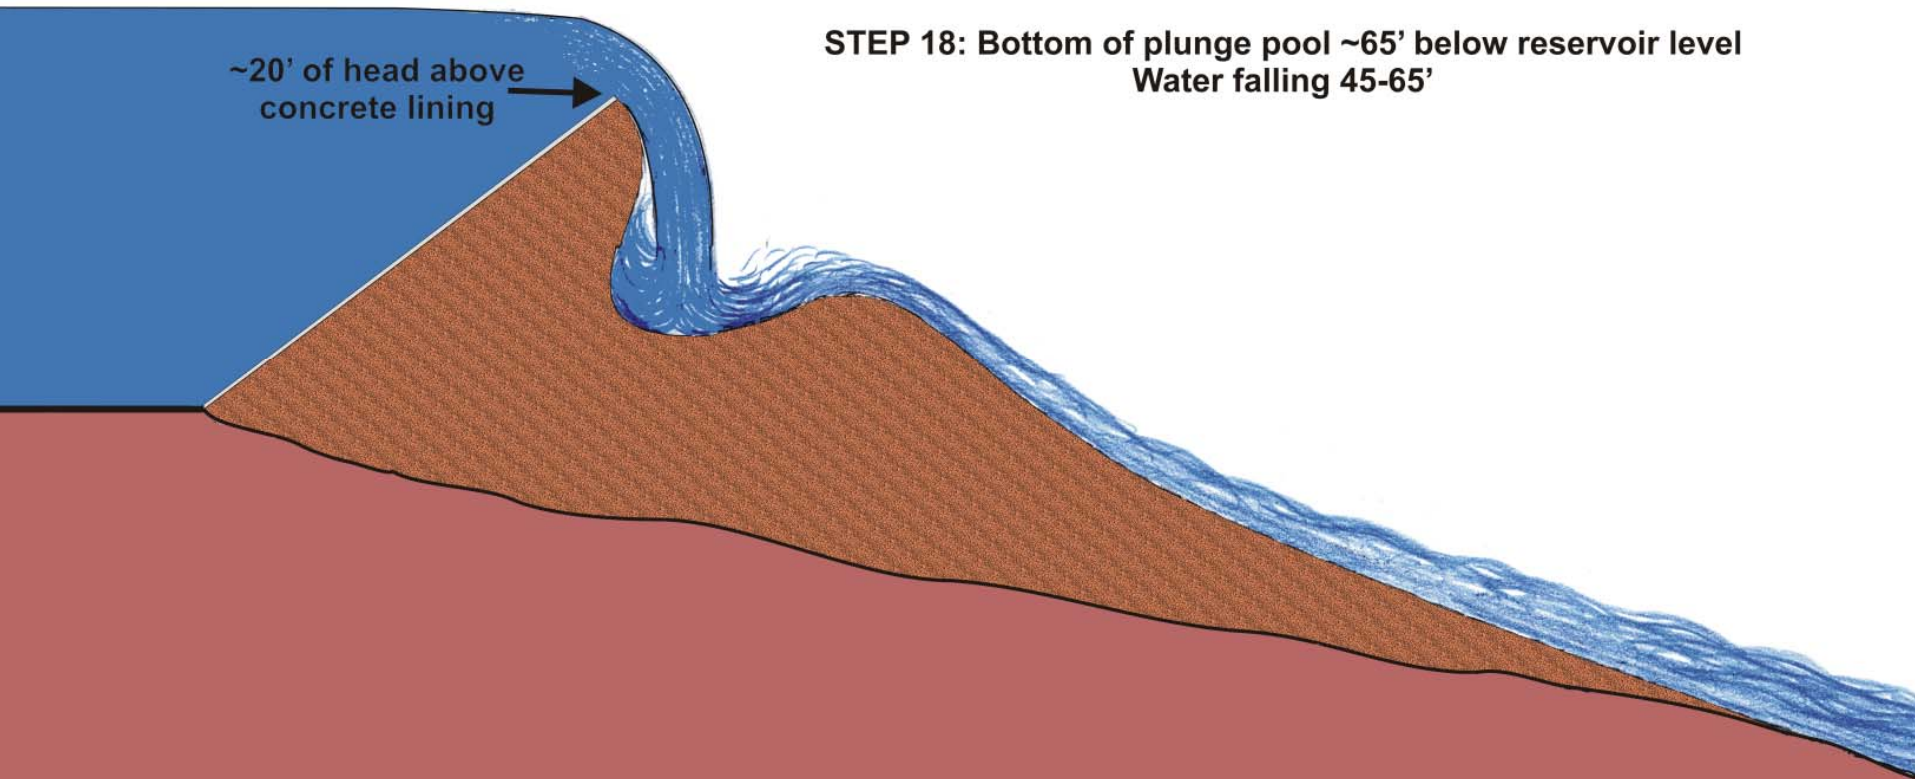
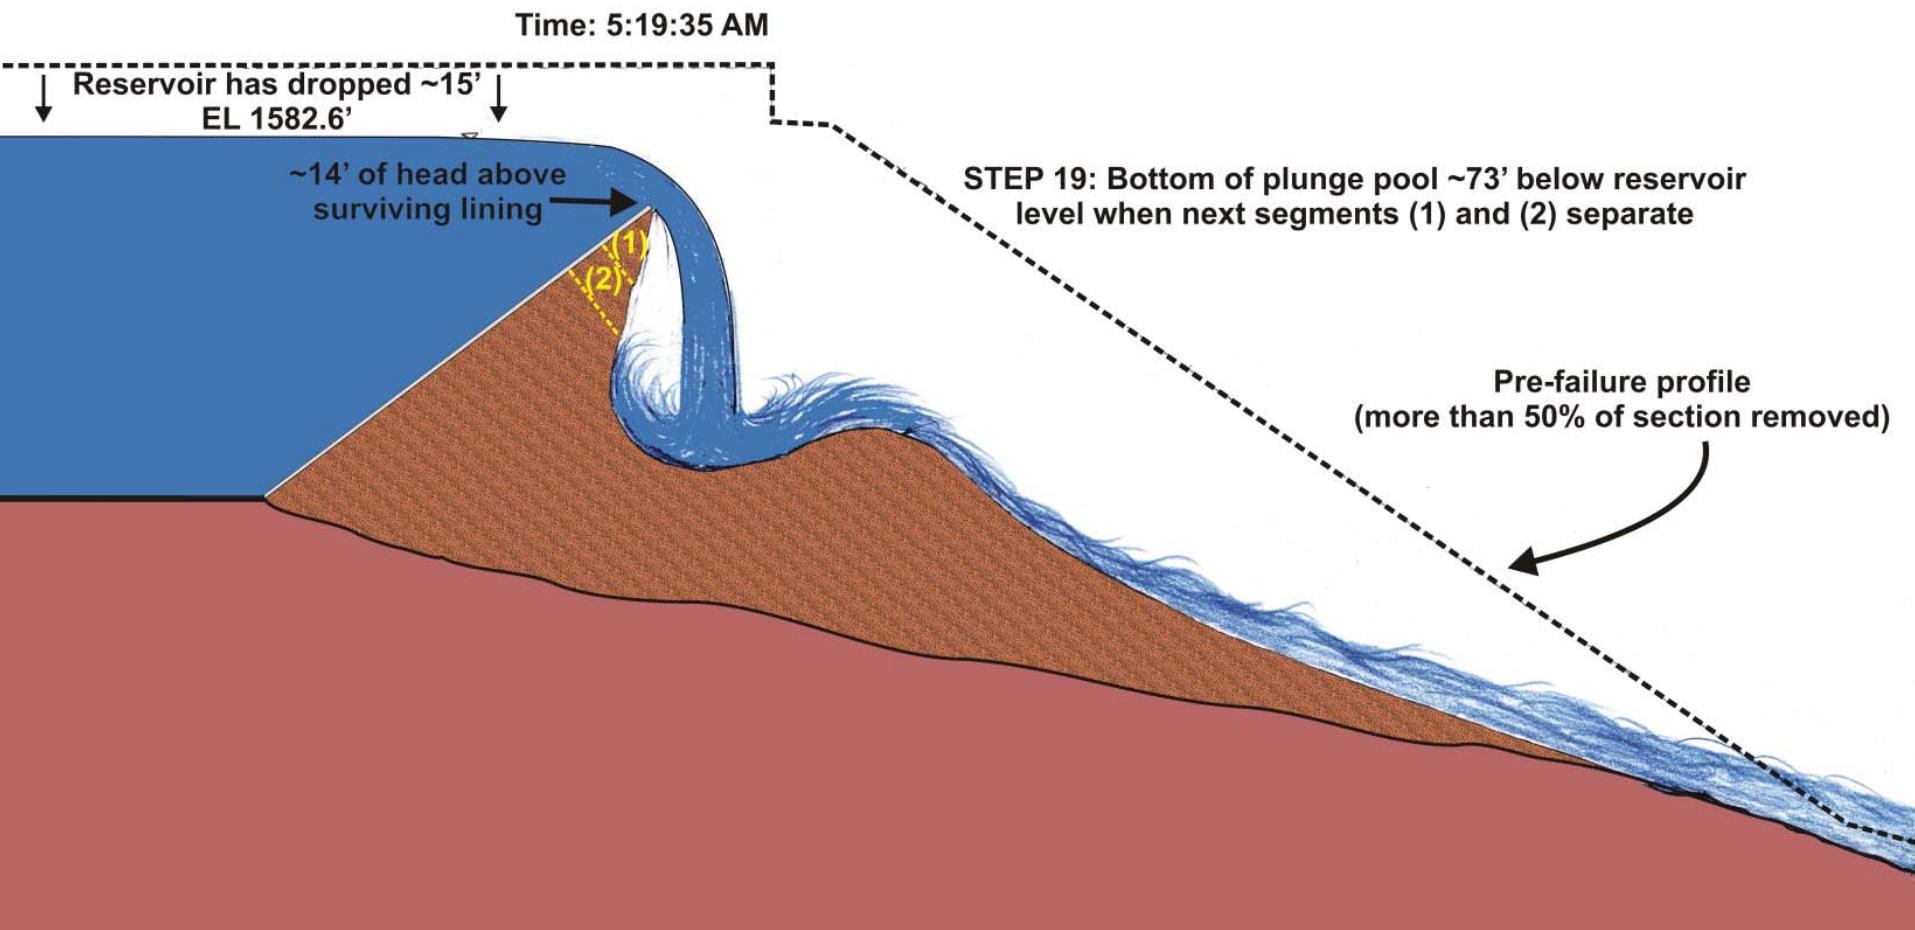
Time: 5:20:25 AM

EL 1577.1'

STEP 20: Liner and embankment removal continues

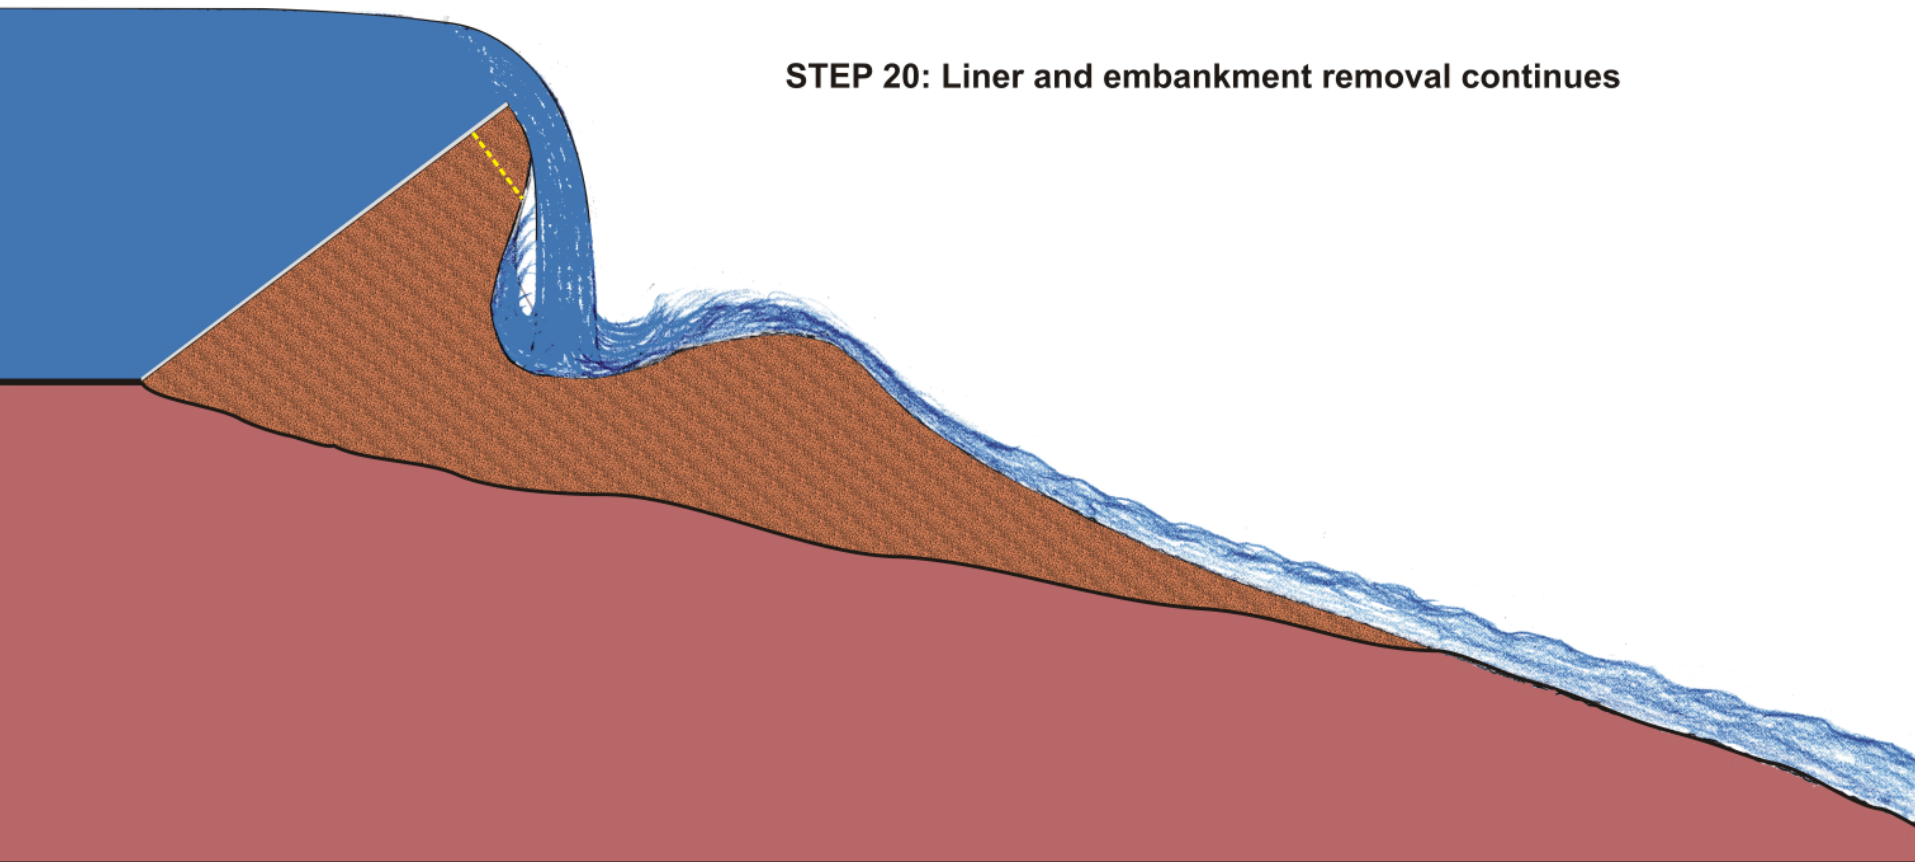
Time: 5:21:05 AM

EL 1572.0'

STEP 21: Excavation of plunge pool continues

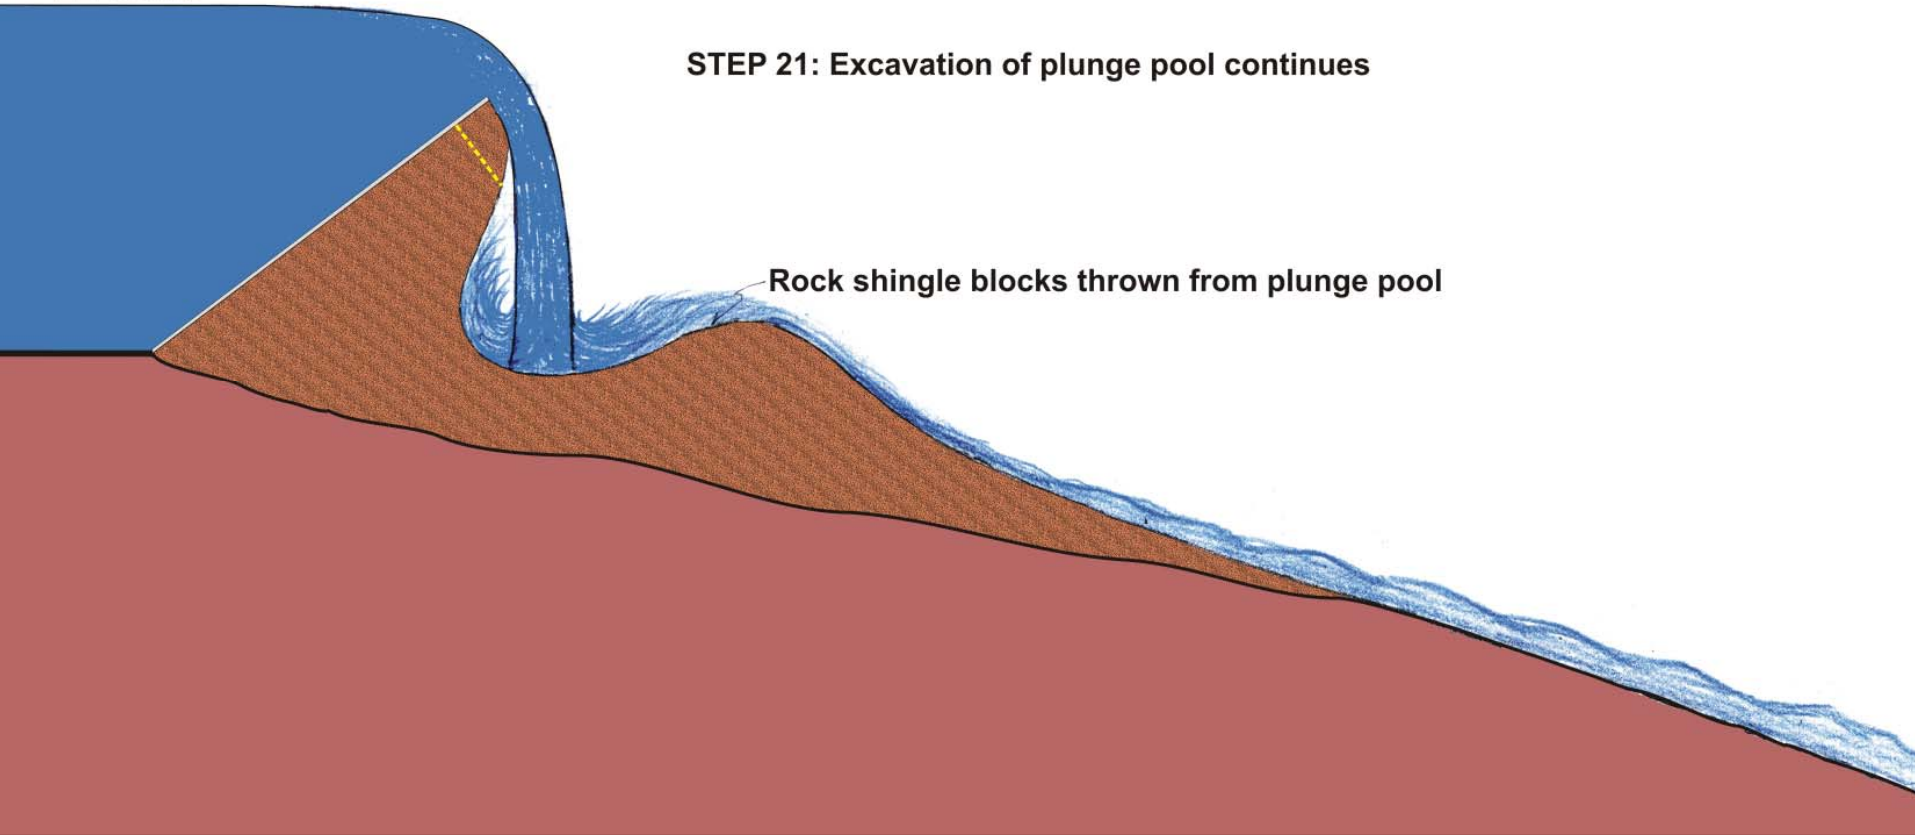
Time: 5:22:00 AM

Rock shingle blocks thrown from plunge pool

Pool dropped ~31.5'  
EL 1566.1'

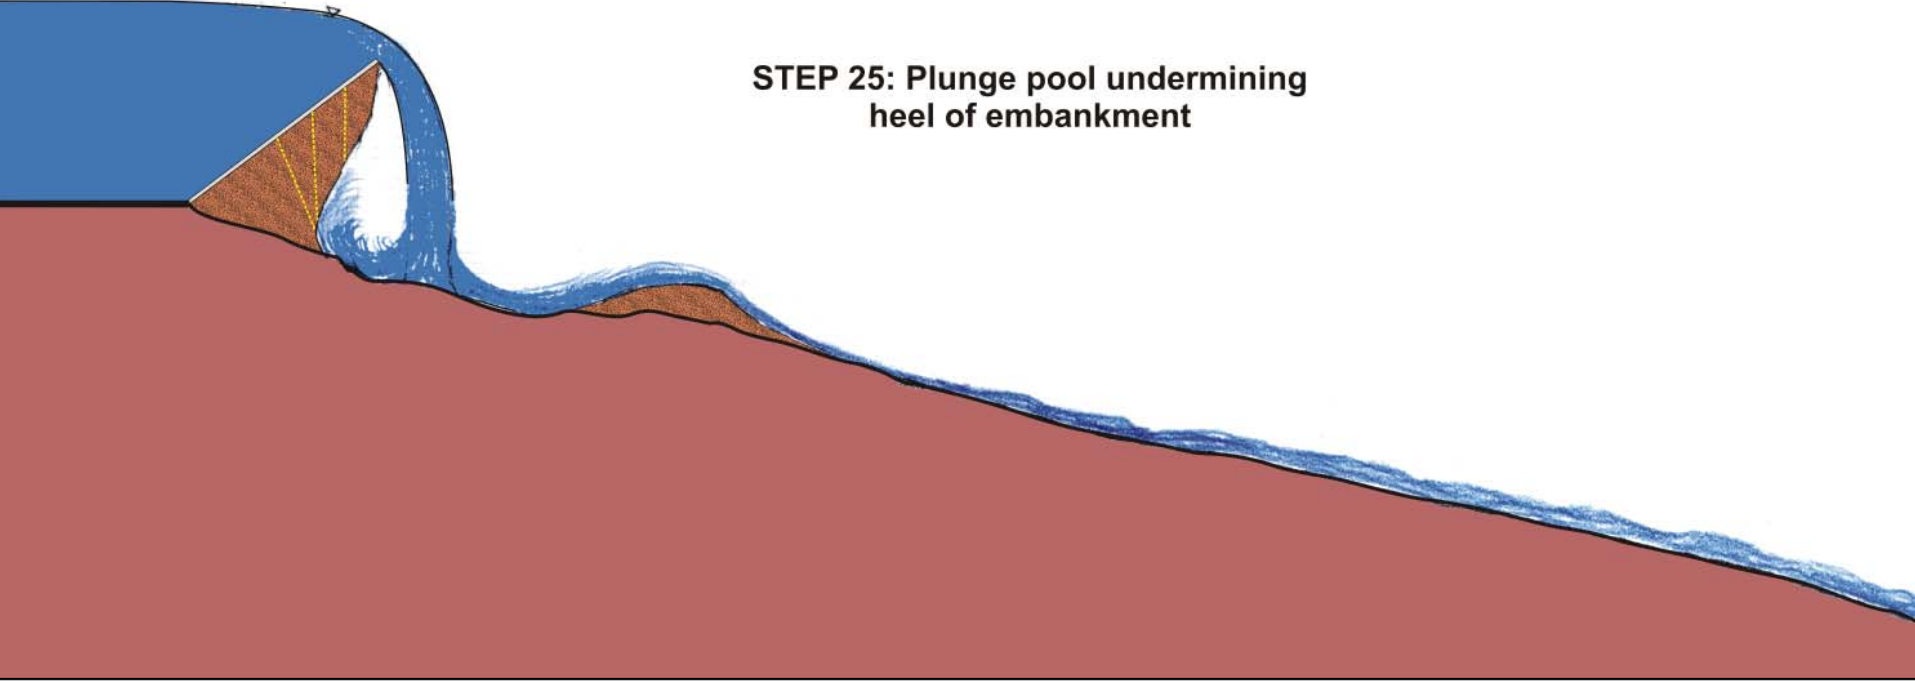
STEP 25: Plunge pool undermining  
heel of embankment

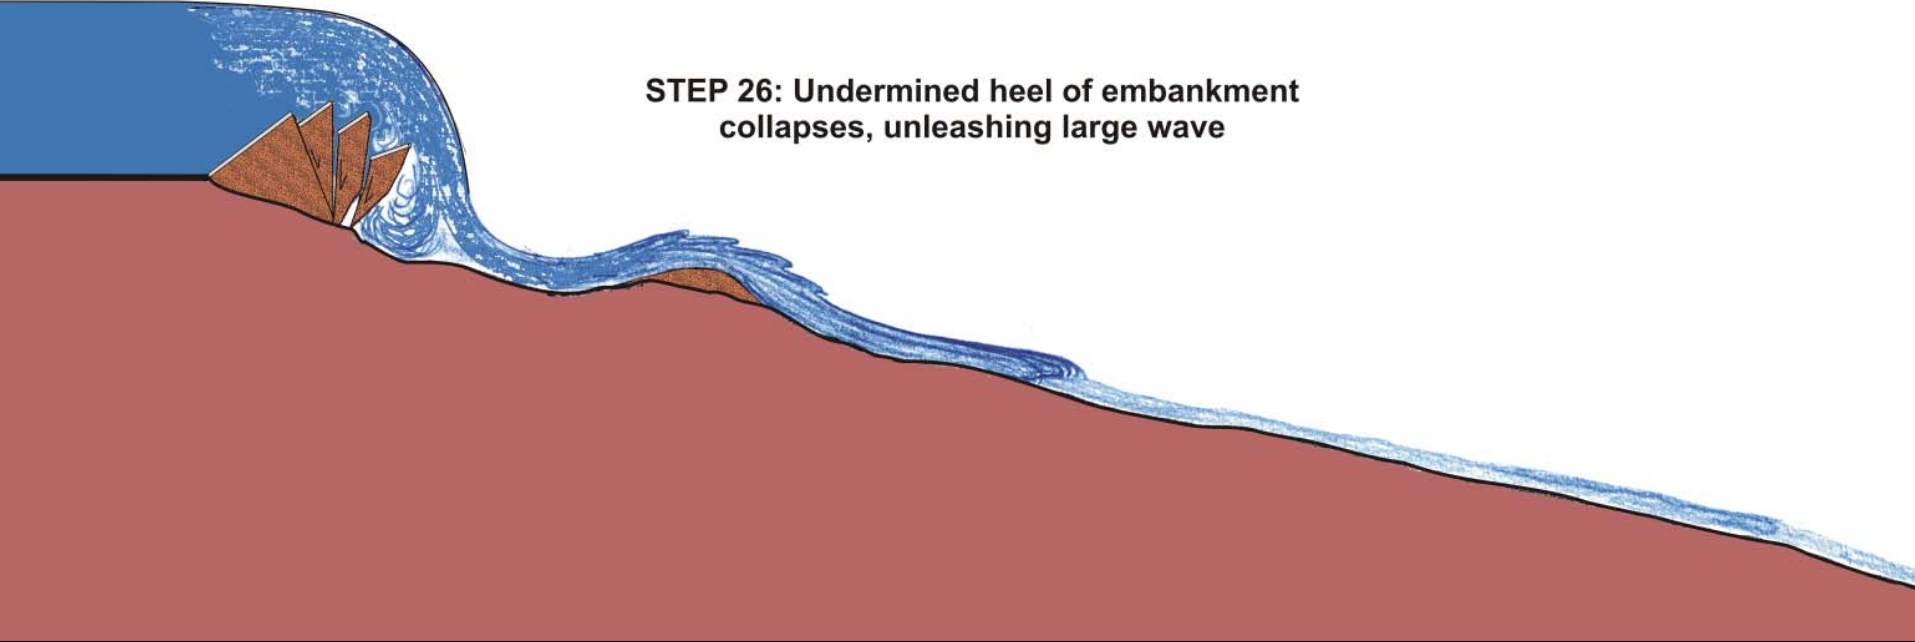
STEP 26: Undermined heel of embankment  
collapses, unleashing large wave

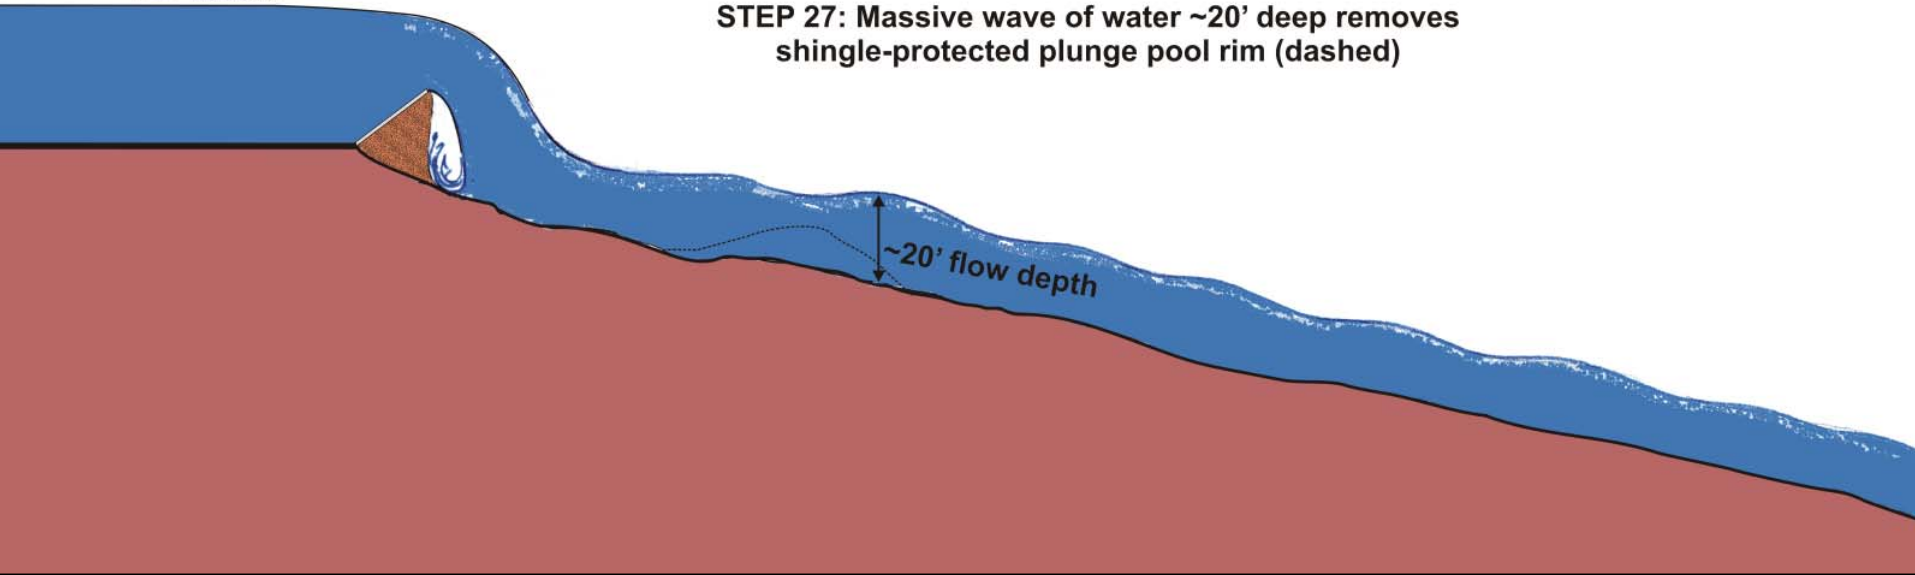
STEP 27: Massive wave of water ~20' deep removes  
shingle-protected plunge pool rim (dashed)

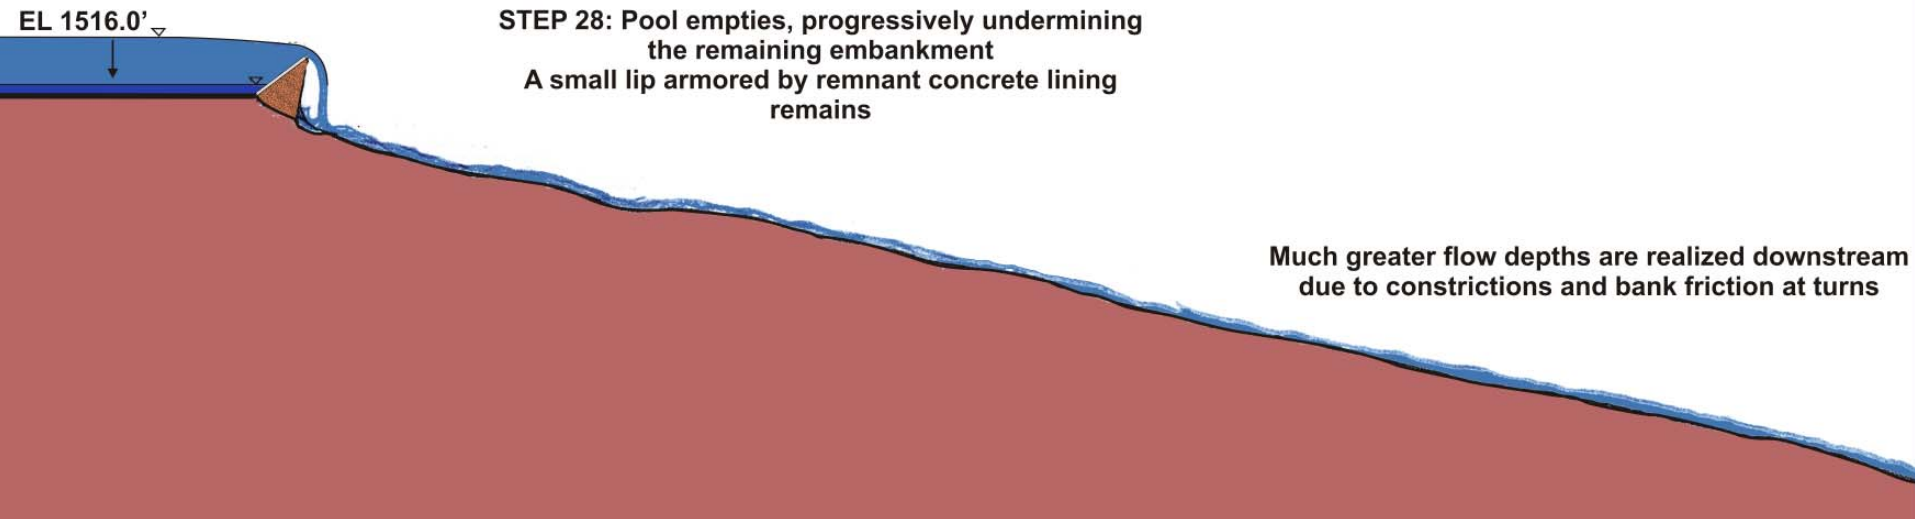
**STEP 28: Pool empties, progressively undermining the remaining embankment**  
A small lip armored by remnant concrete lining remains

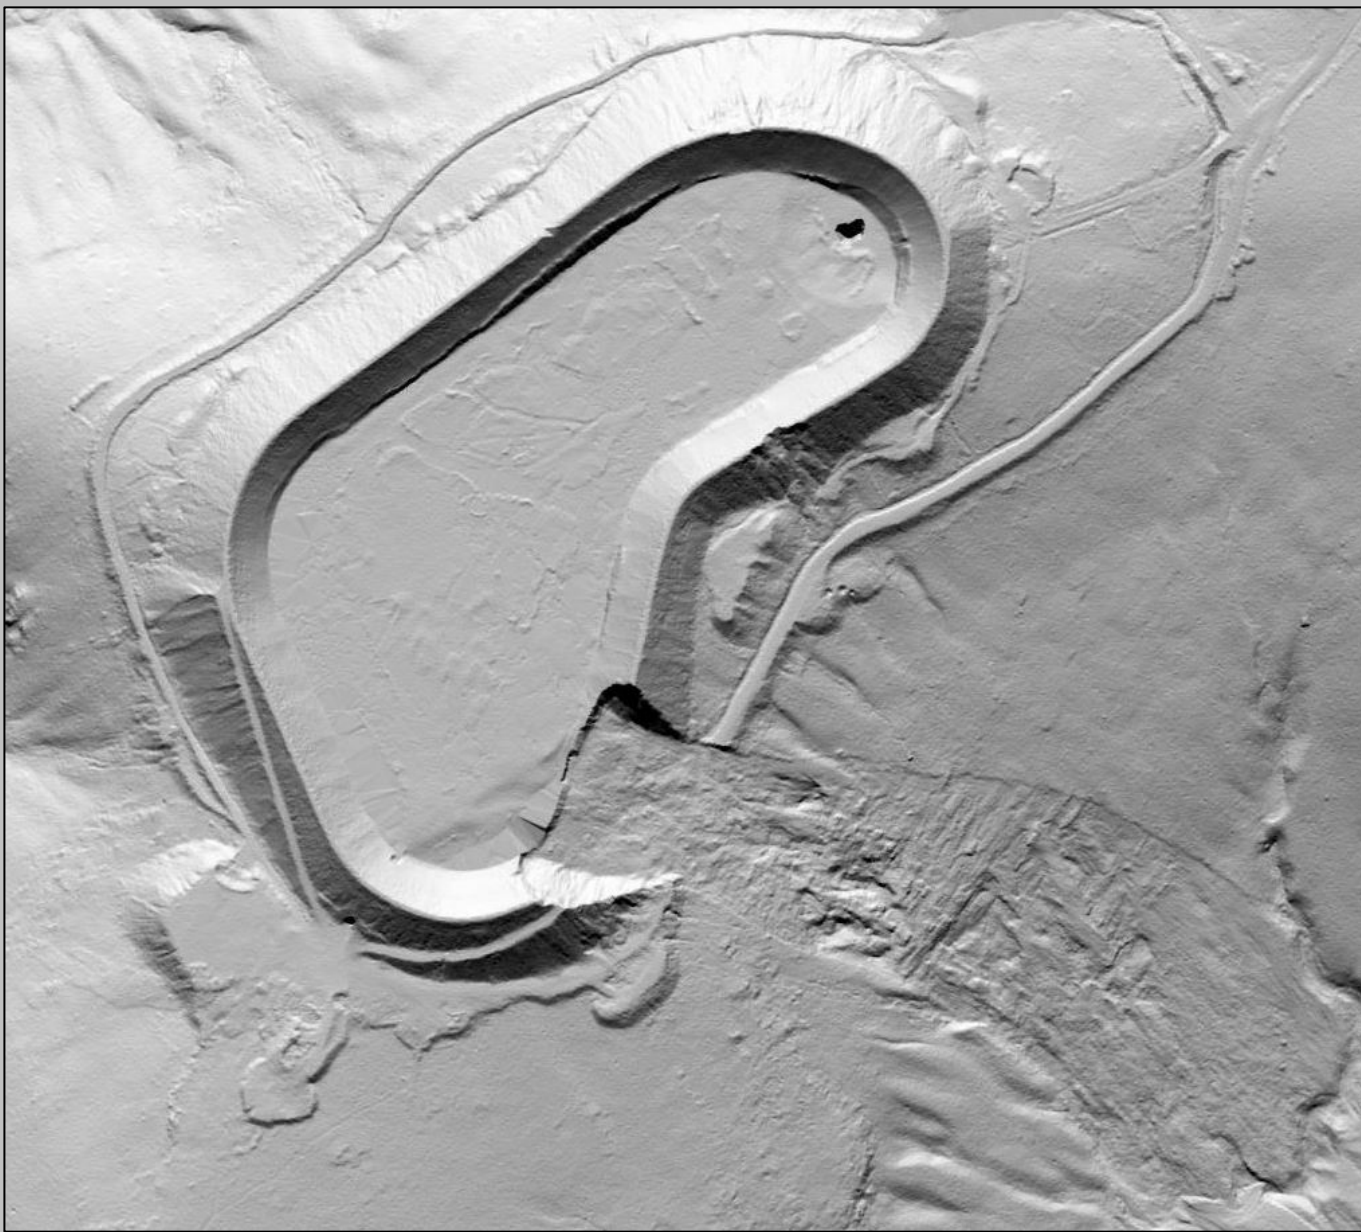
- **0.7 m LiDAR “bare earth” image of the Upper Reservoir area flown for MoDNR after the failure.**

- **Note details in LiDAR derived digital elevation model, and scour of the outbreak flood path.**
