# **OVERVIEW OF THE TAUM SAUK UPPER RESERVOIR FAILURE**

**December 14, 2005**

**Reynolds County, Missouri**

**University of Missouri-Rolla**

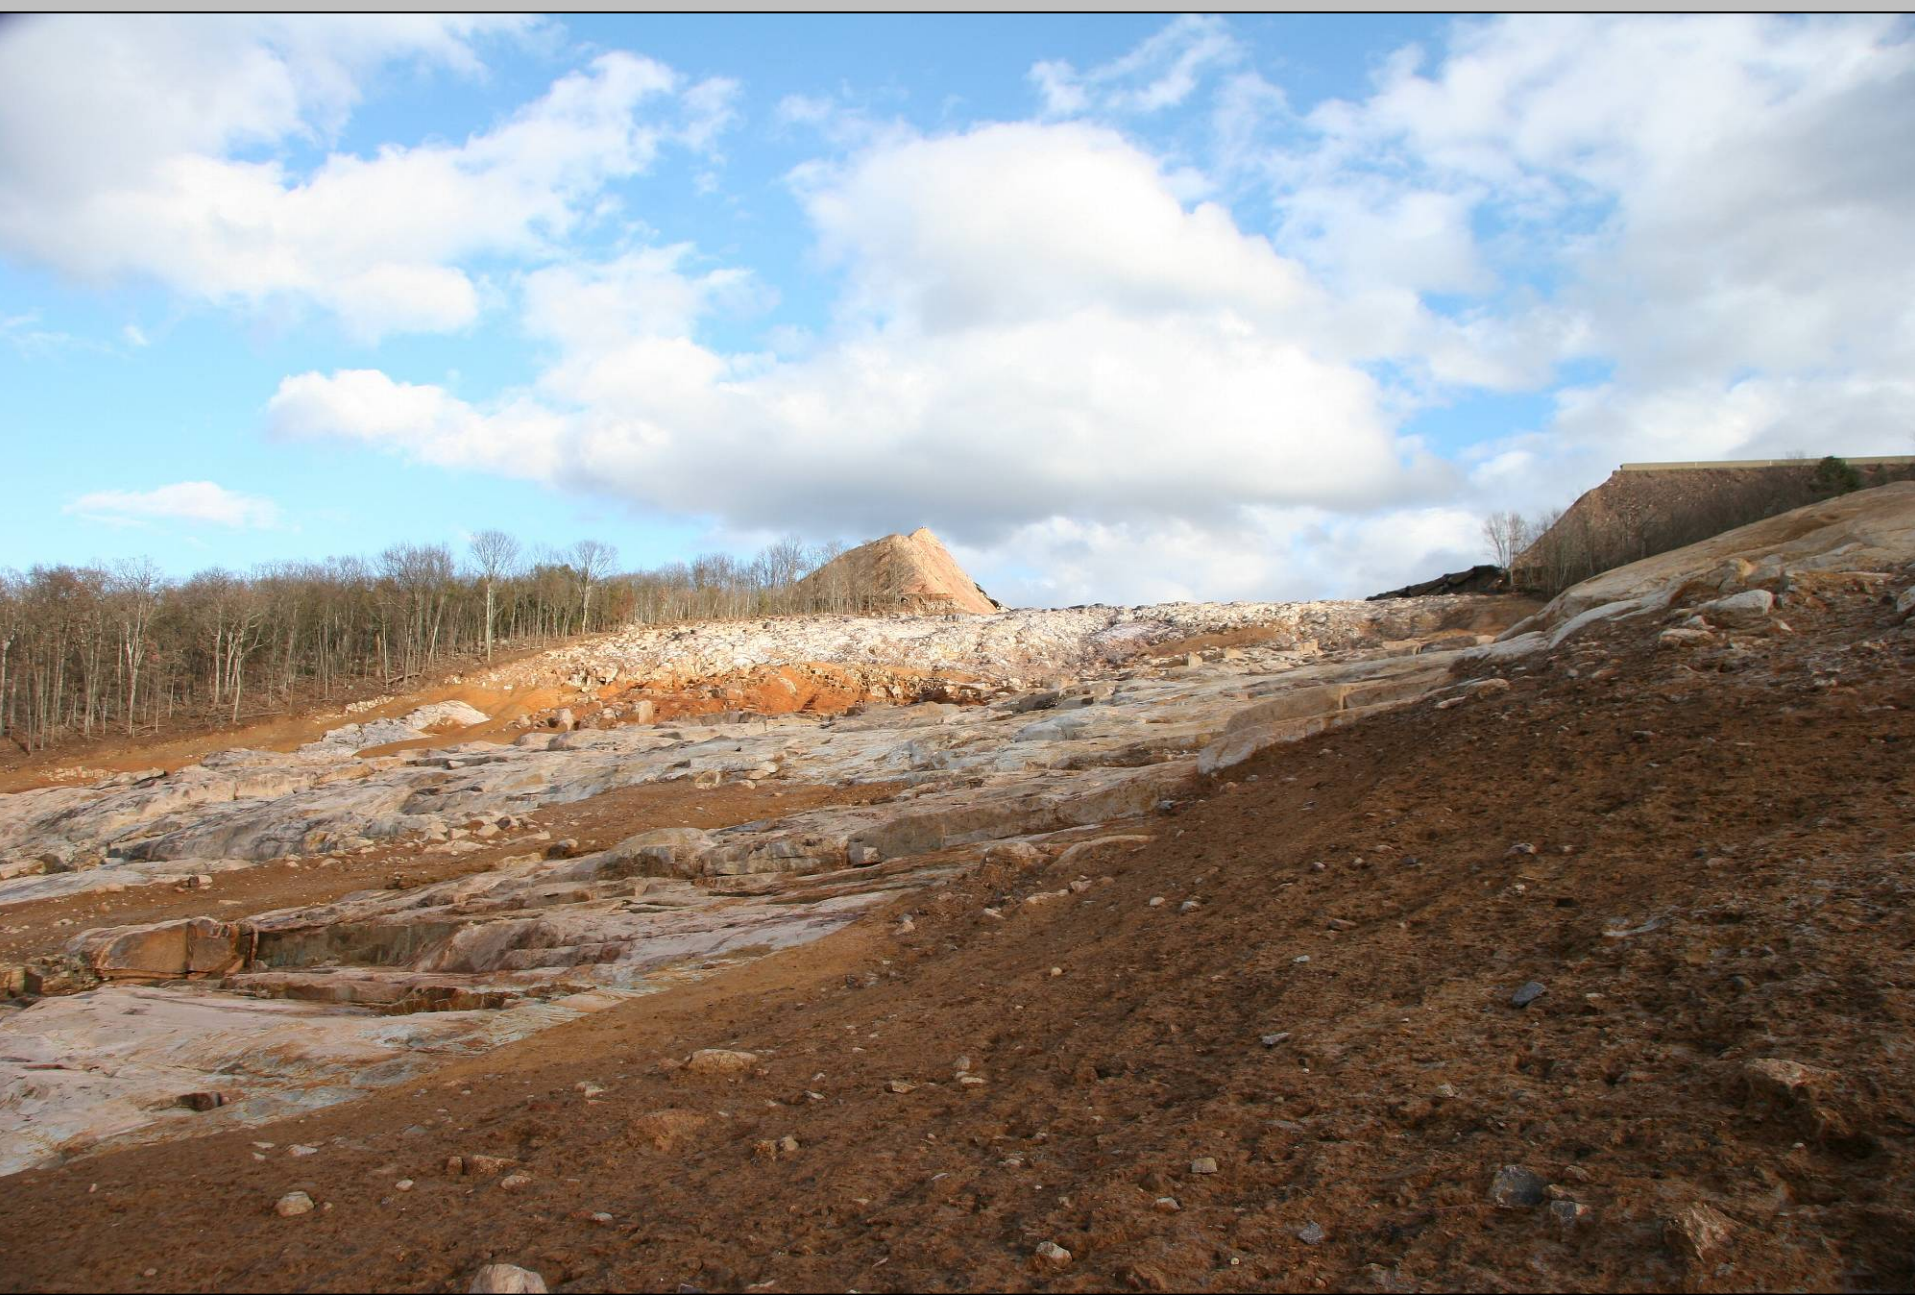
**Standing on residuum looking at exposures of the Munger Granite.**

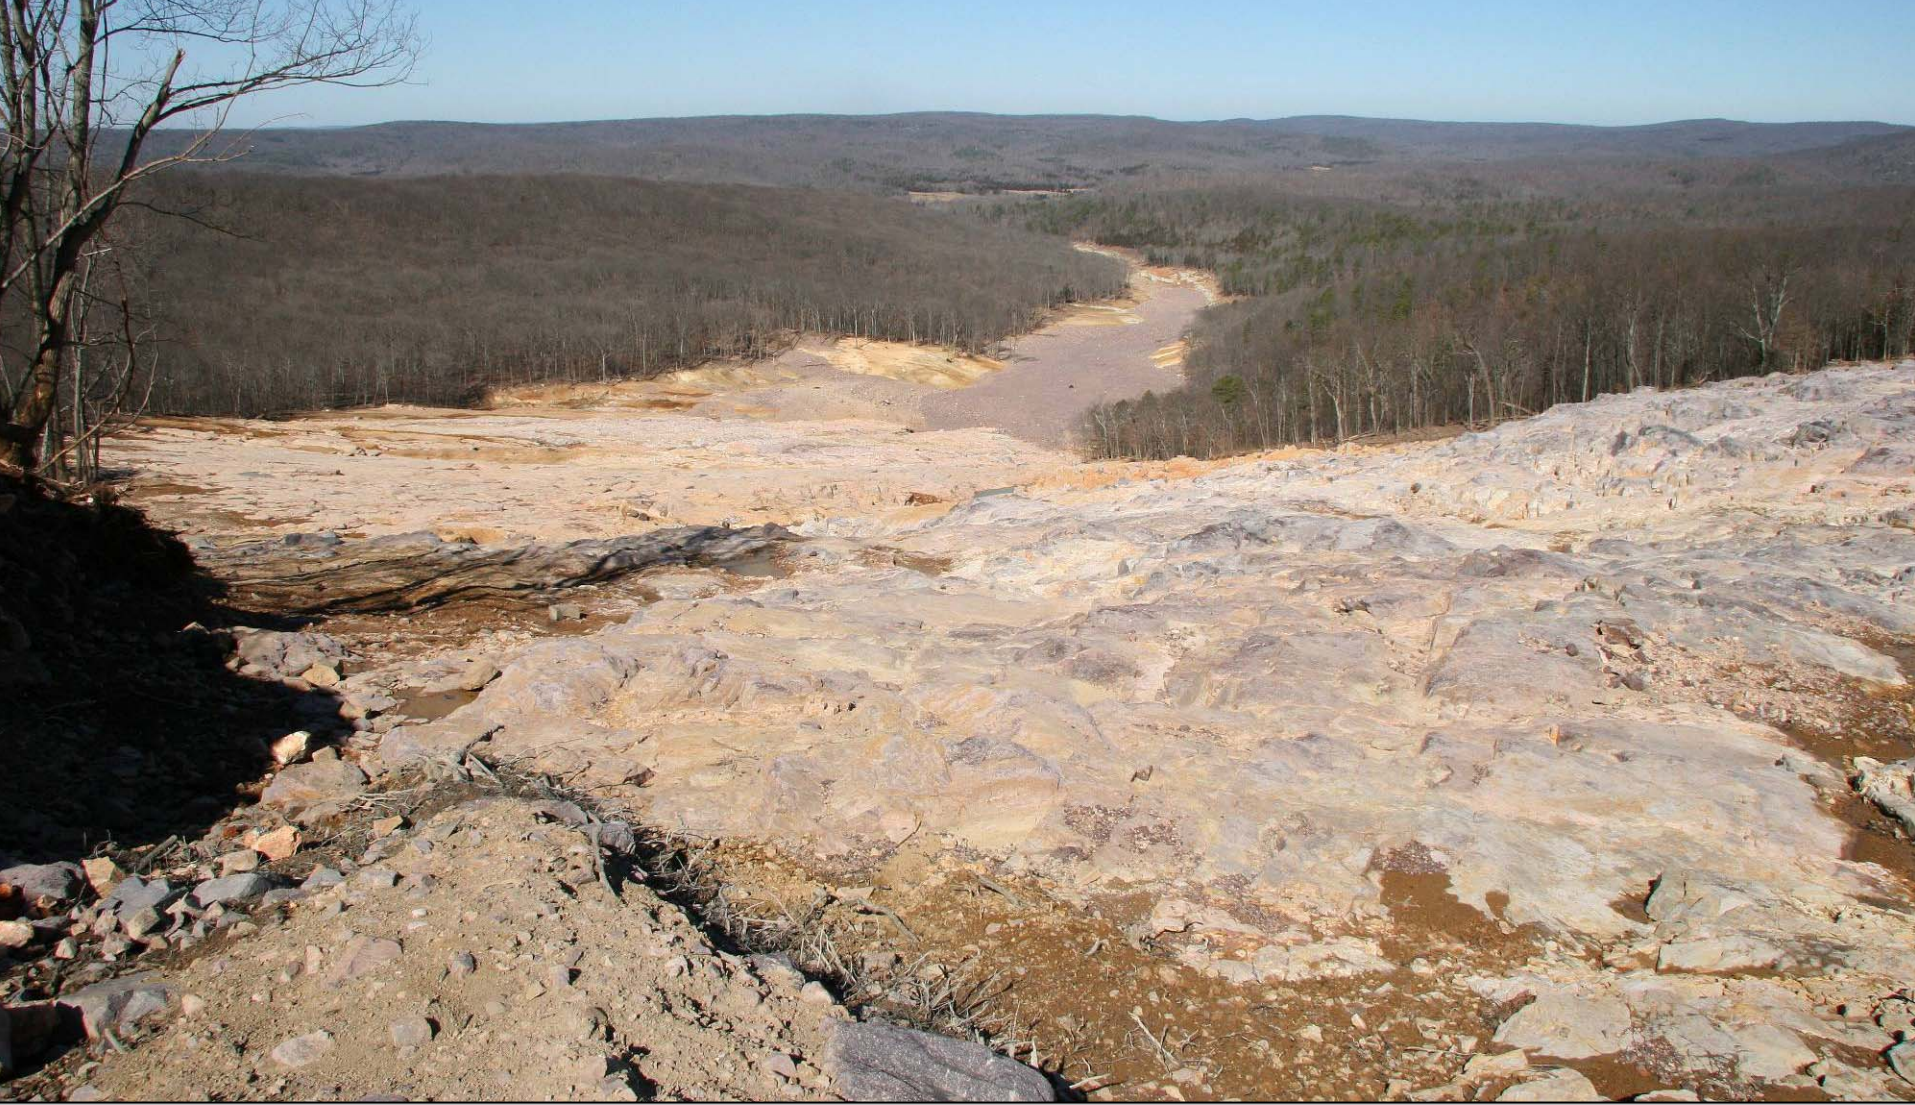
**The raging flood incorporated soil, rock, concrete, rebar, and HDPE liner, forming a very turbid flow. This flood accumulated soil, rock, and thousands of trees. The momentum of the water allowed it to ramp up the side slopes around the bends.**

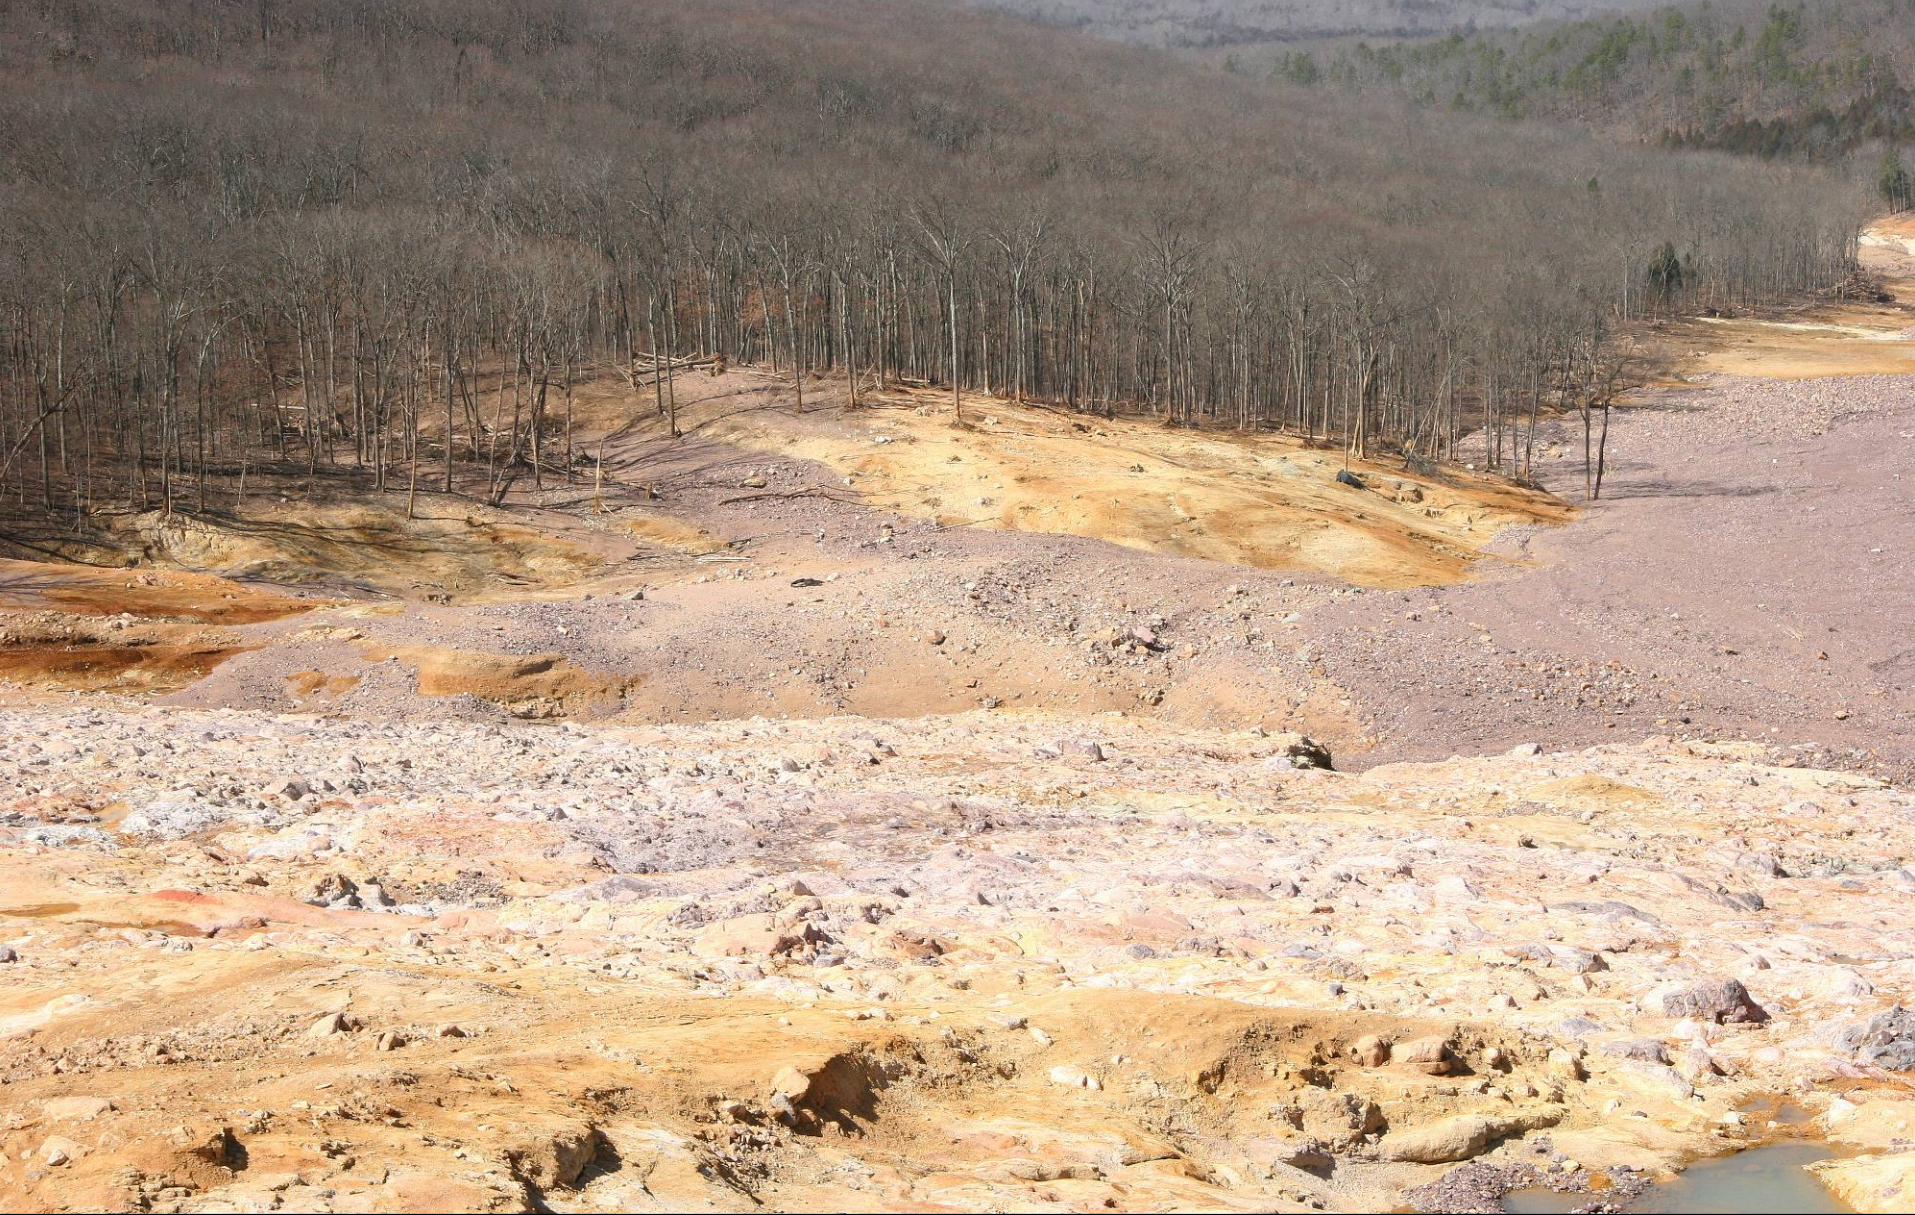
**The momentum of the surging waters allowed them to flow up and over this hill (an old landslide) constricting the valley ~100' above the valley floor.**

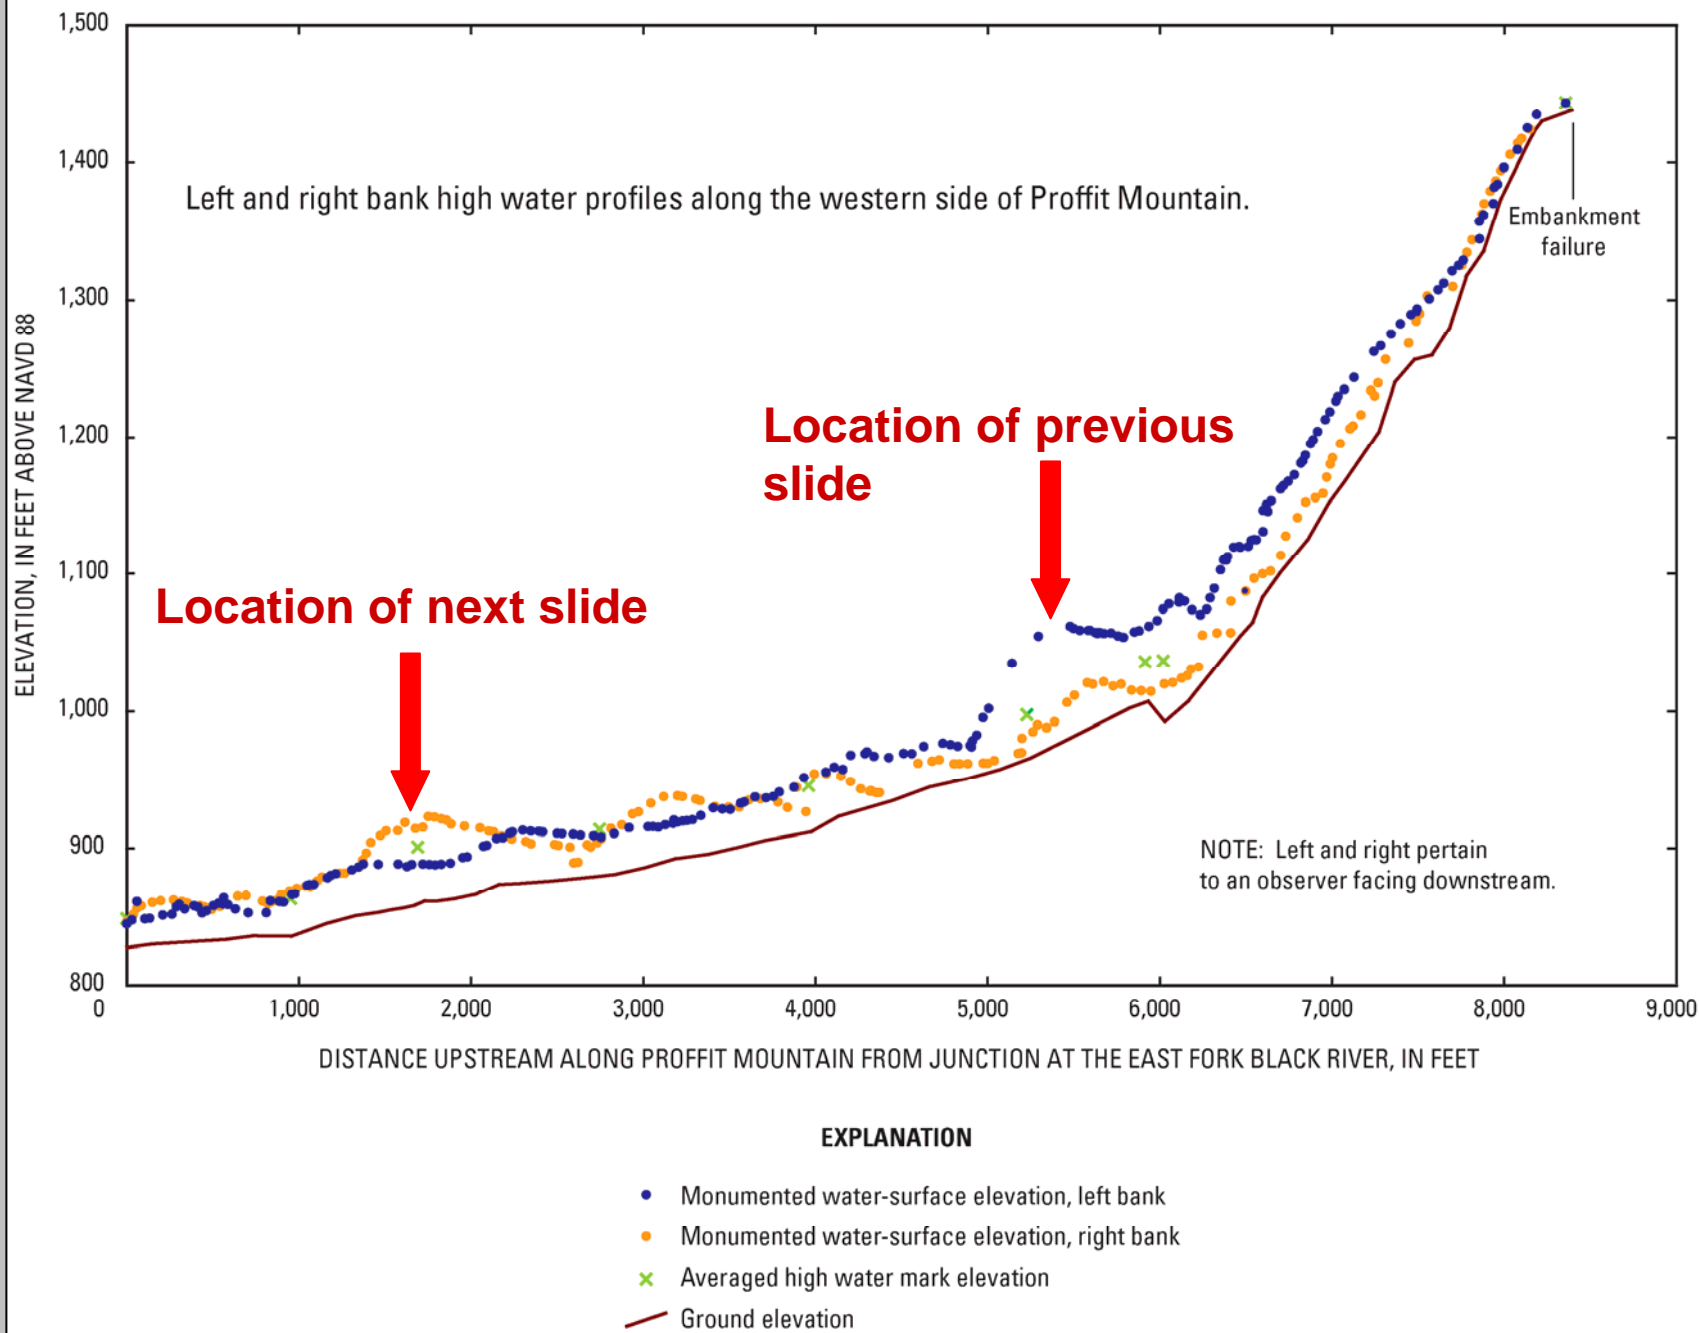
**Flows reached almost 100' in depth as the flood banked around turns.**

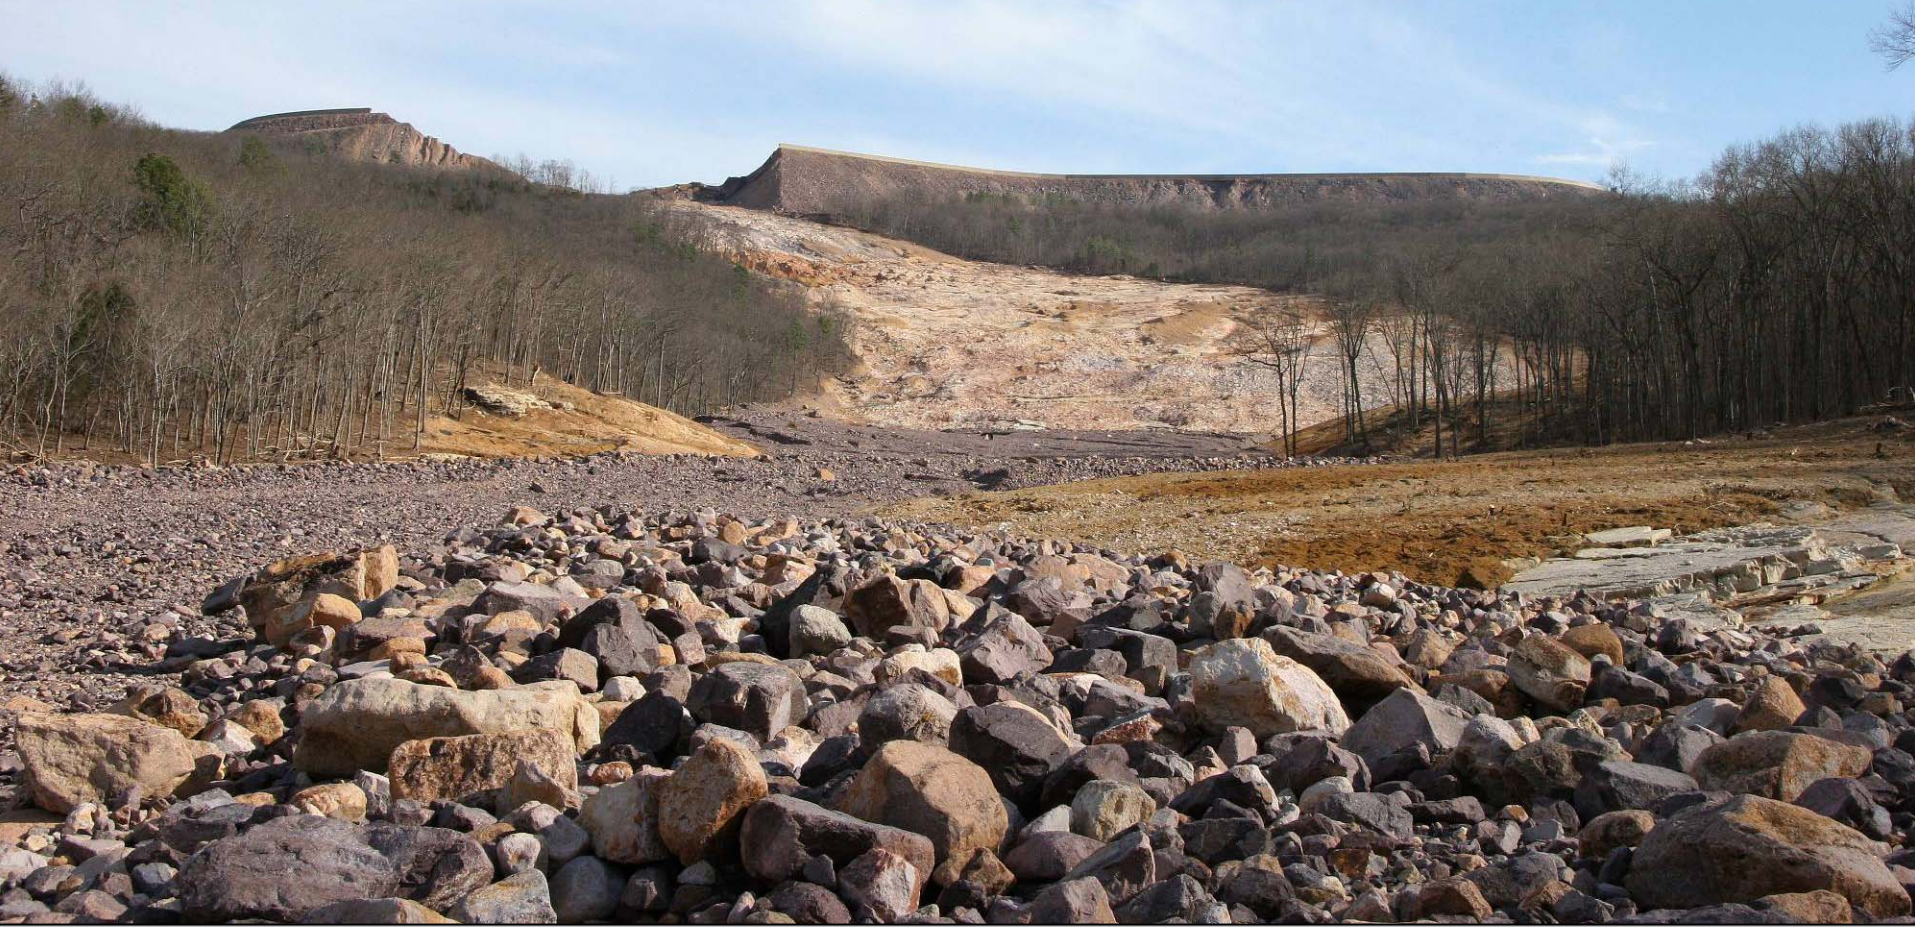
**A massive hydraulic jump (near center) developed as the gradient of the slope decreased where Ordovician carbonates onlap onto Precambrian igneous formations of Proffit Mountain. The water dropped over 400 feet down the now bare slope of Proffit Mountain.**

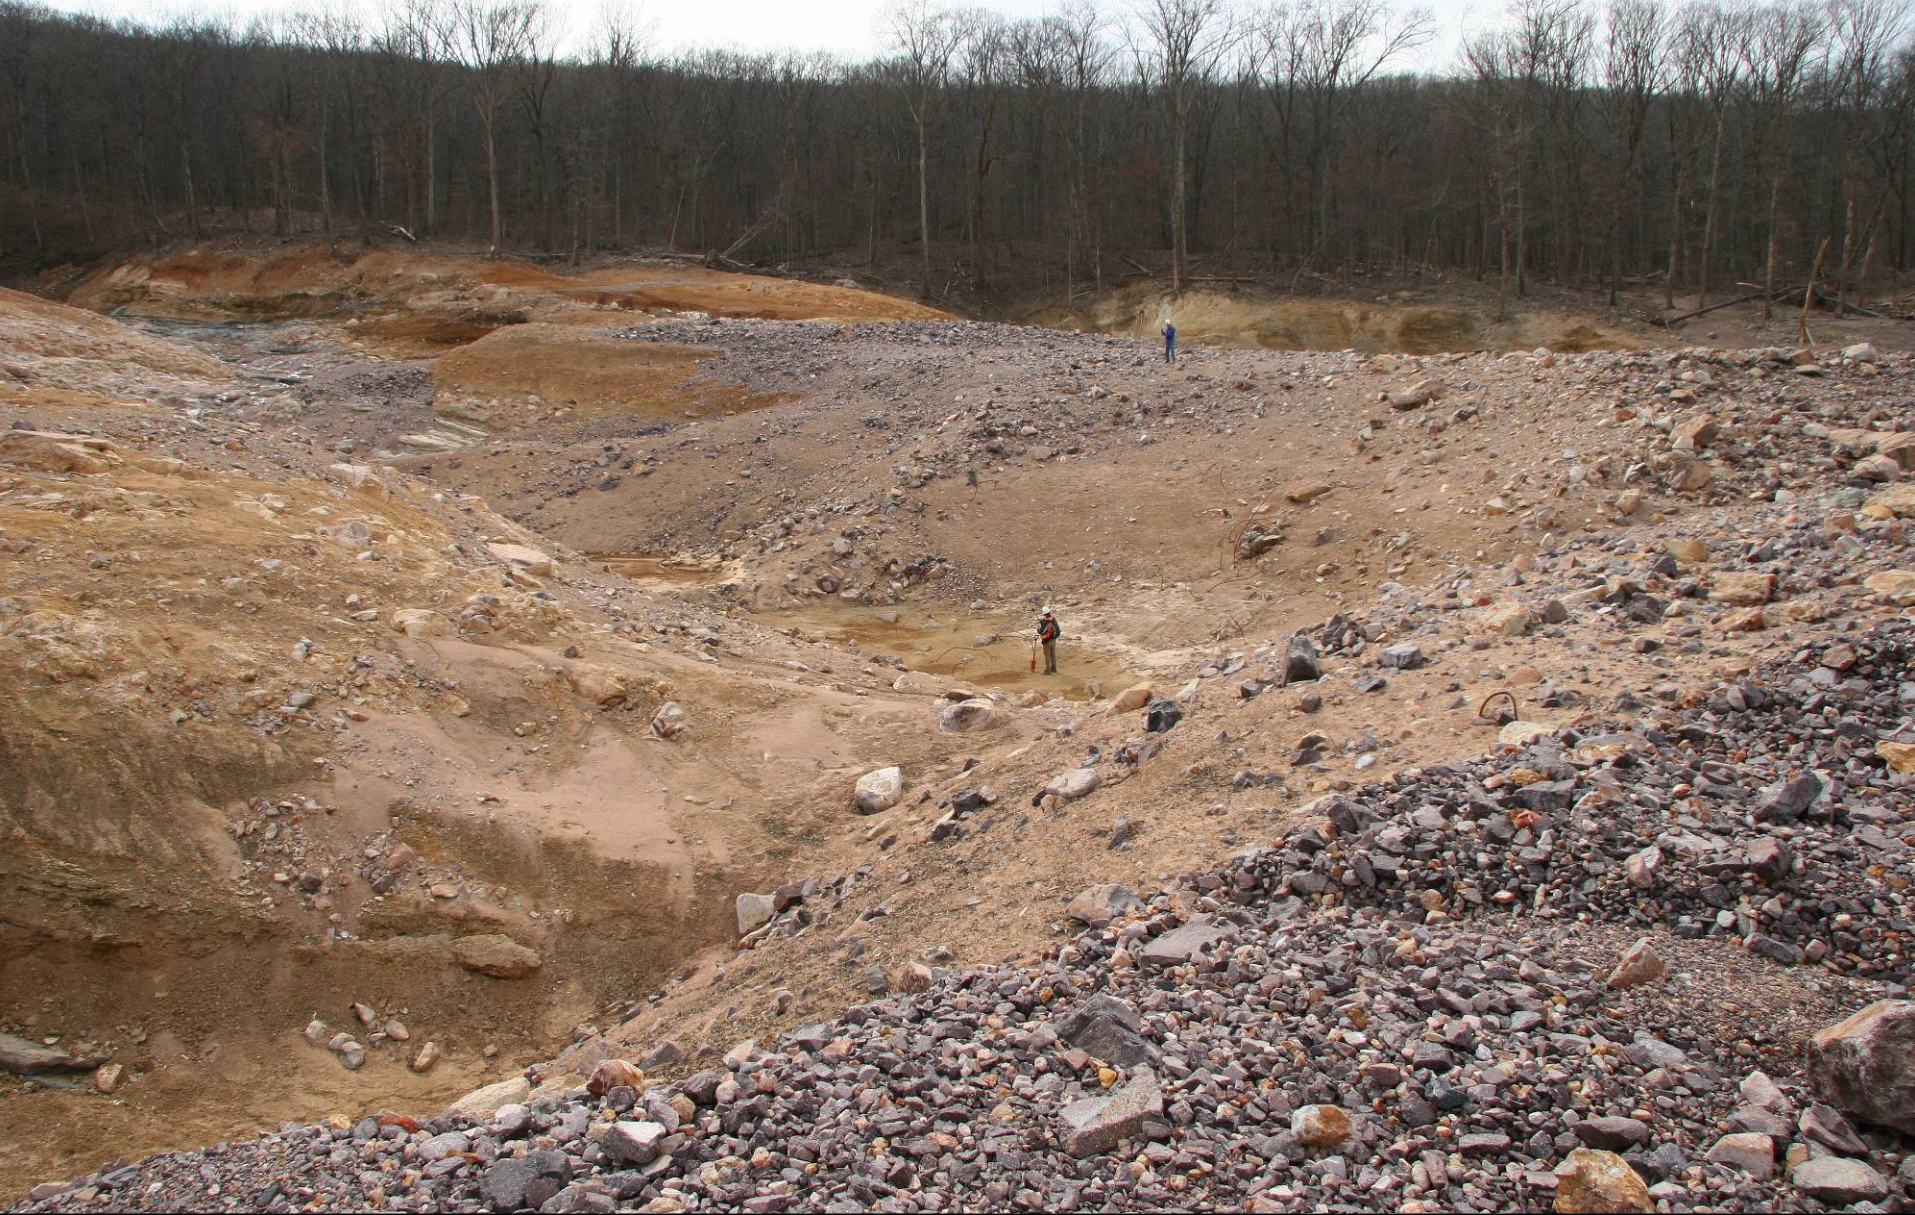
**A massive scour hole >20 feet deep formed at the hydraulic jump where the gradient suddenly decreased, shifting to a lower flow regime. The coarse fraction of the bedload began to drop out of the flow, although the bed of the channel was still very active. This transition appears to have been “rinsed” by one final wave of water.**

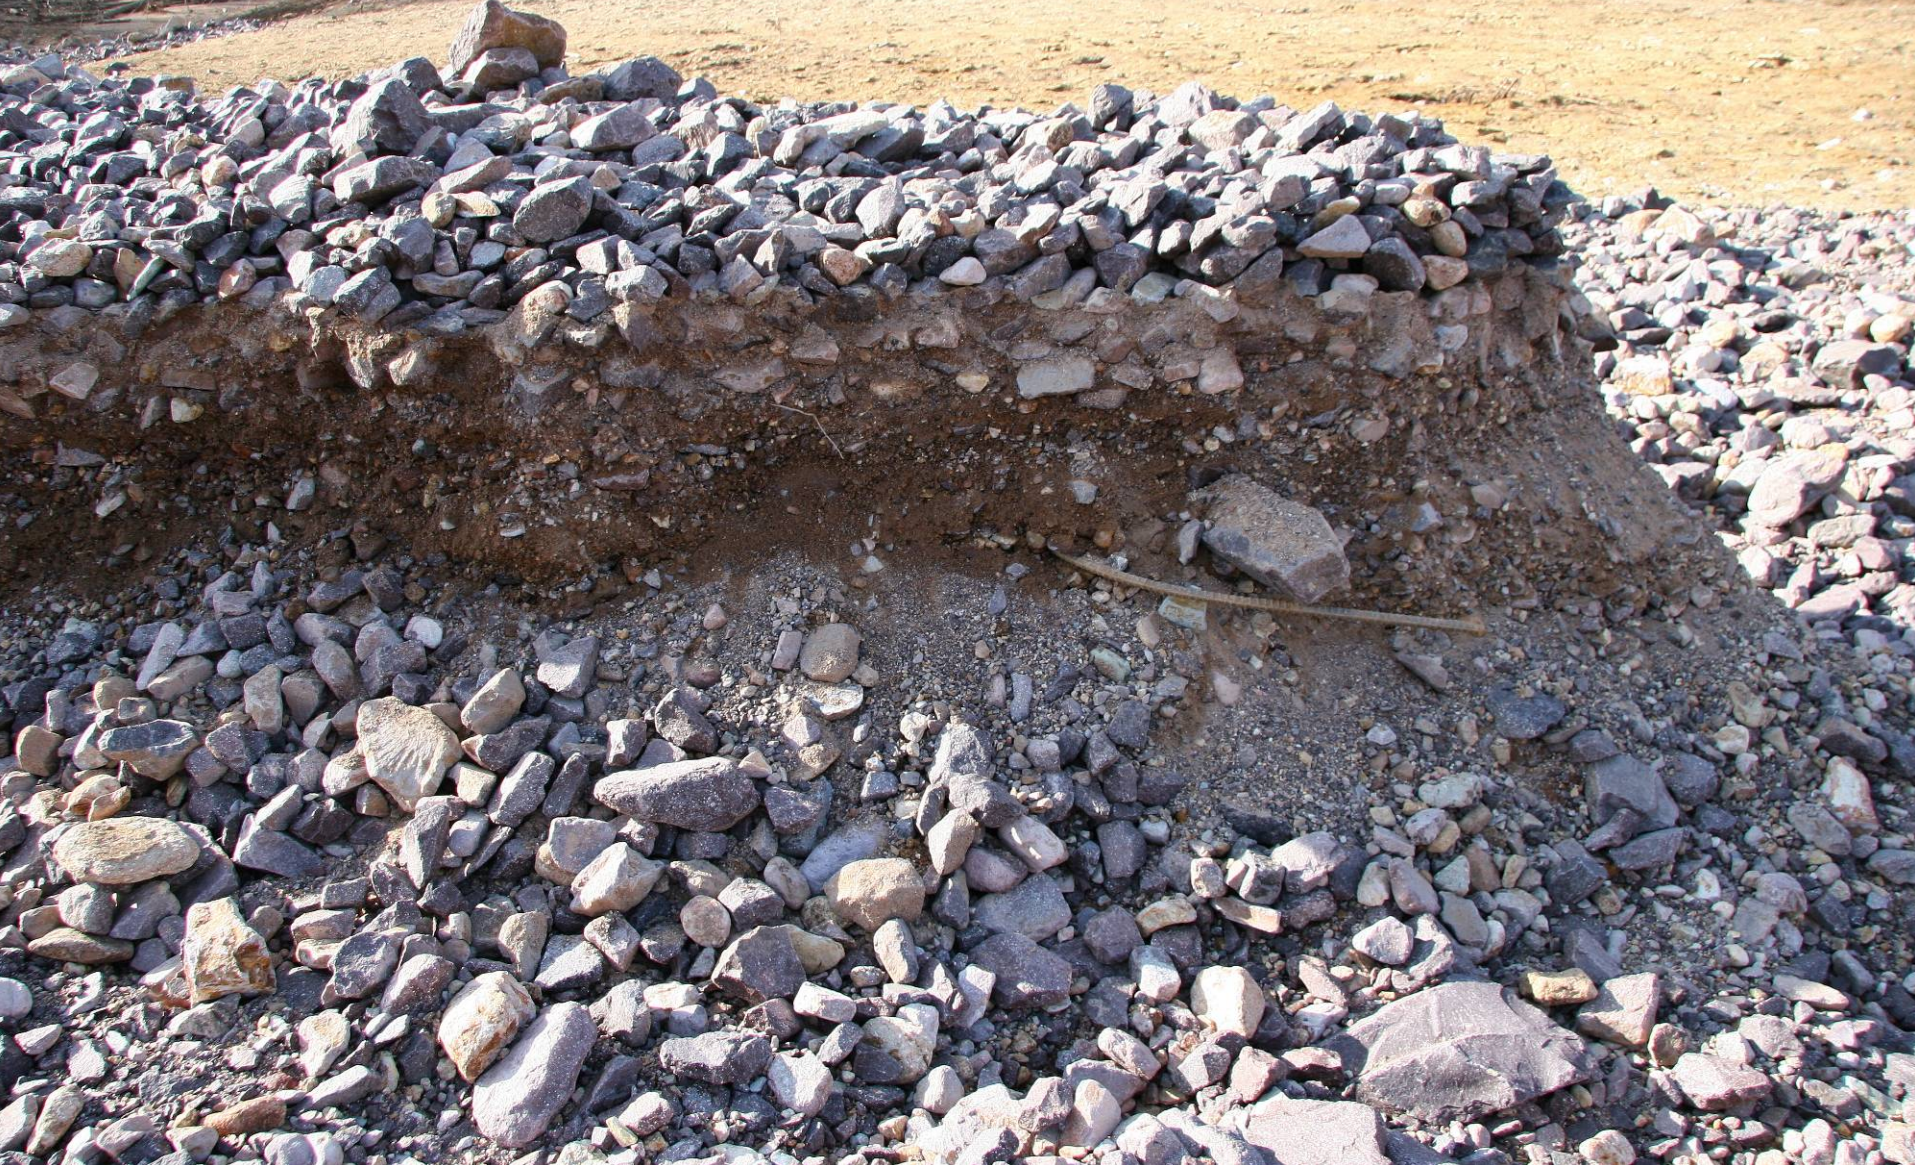
**Much of the coarse debris fraction appears to have been reworked and sluiced of fines by tail flows, as the flood waters subsided. Note the coarsening upward nature of this deposit and the inclusion of rebar from the shotcrete liner.**

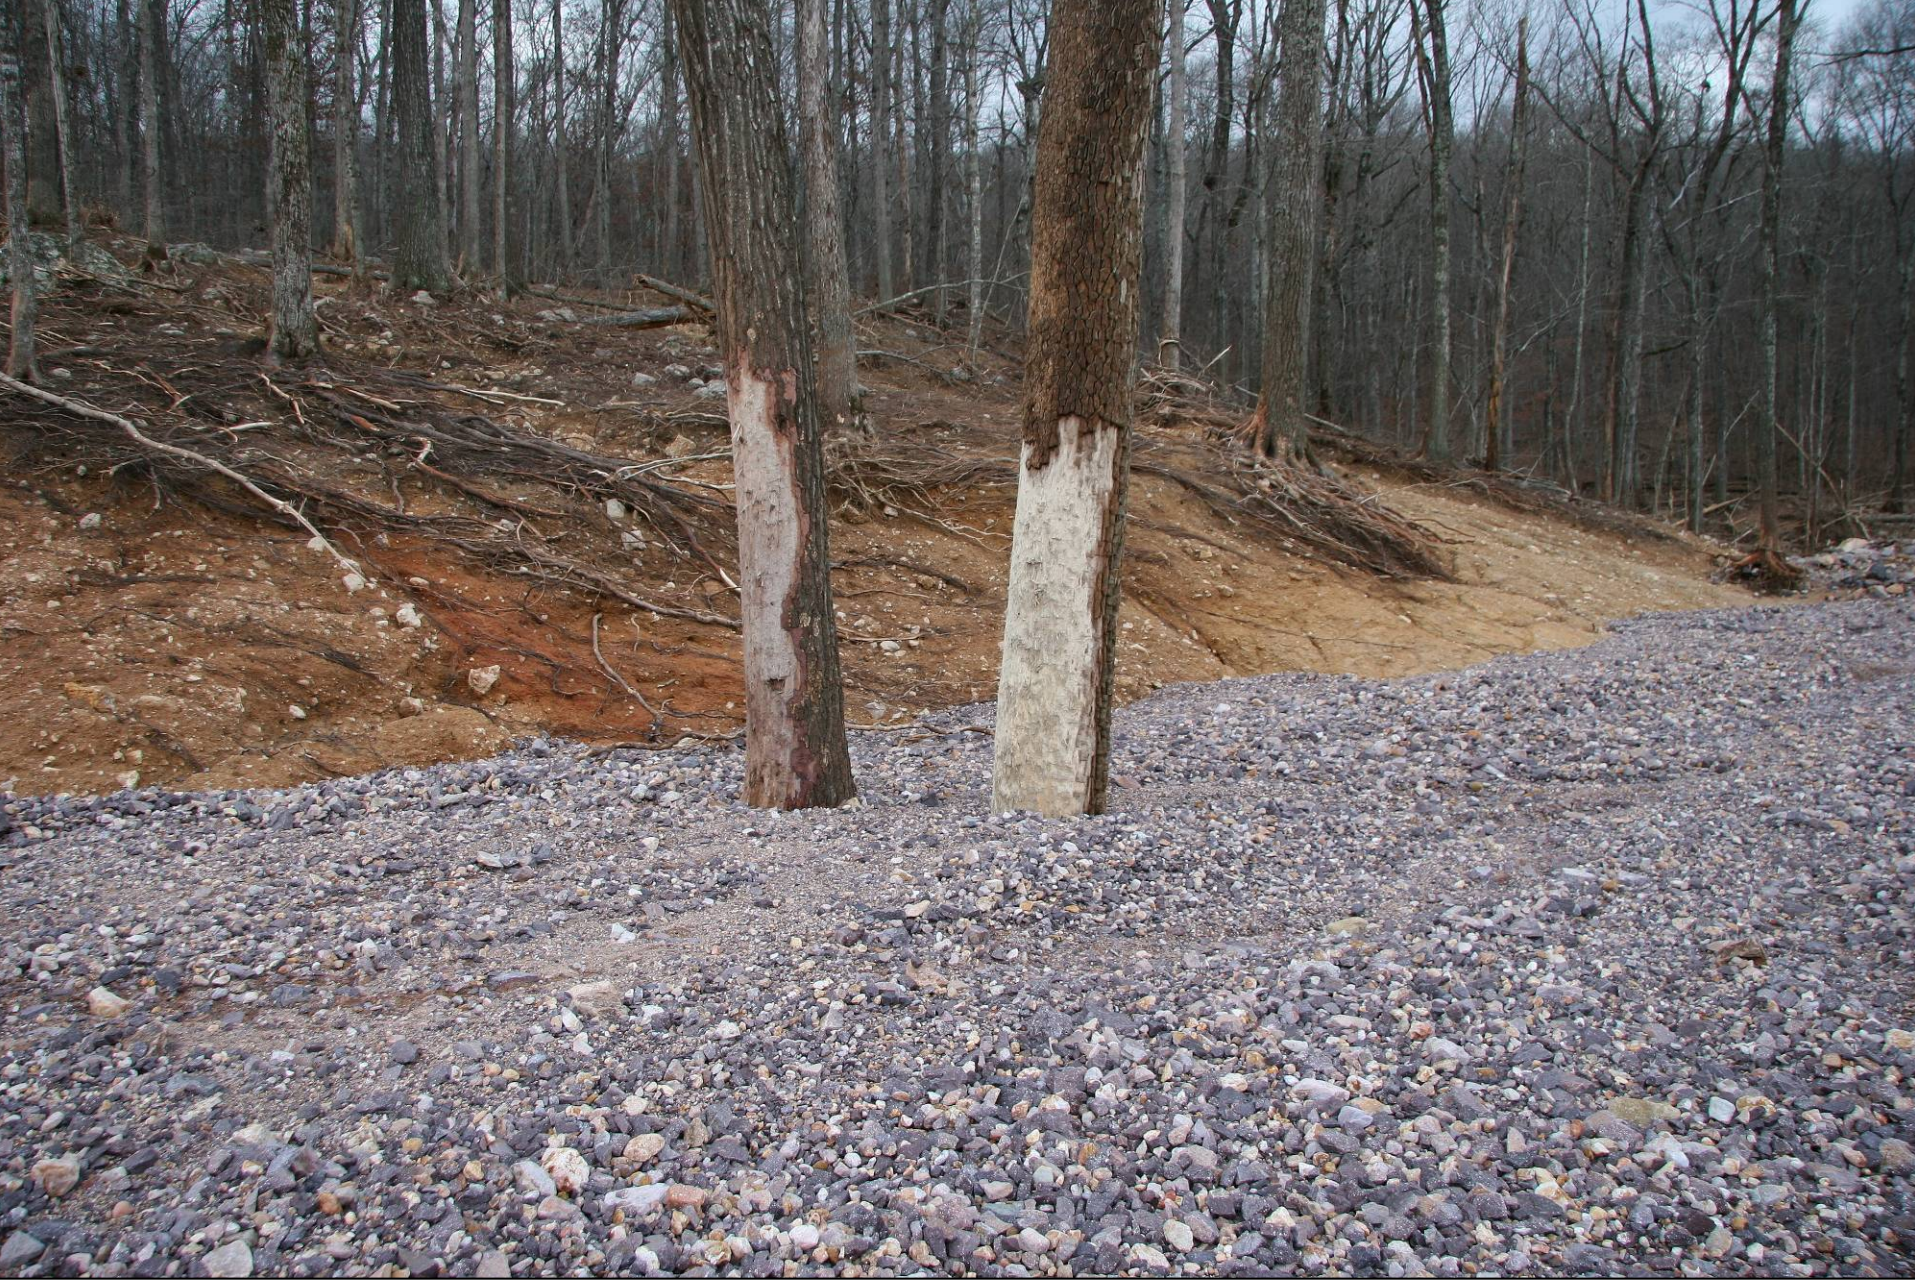
**The upstream side of two trees had all bark abraded away by the turbid flow.**

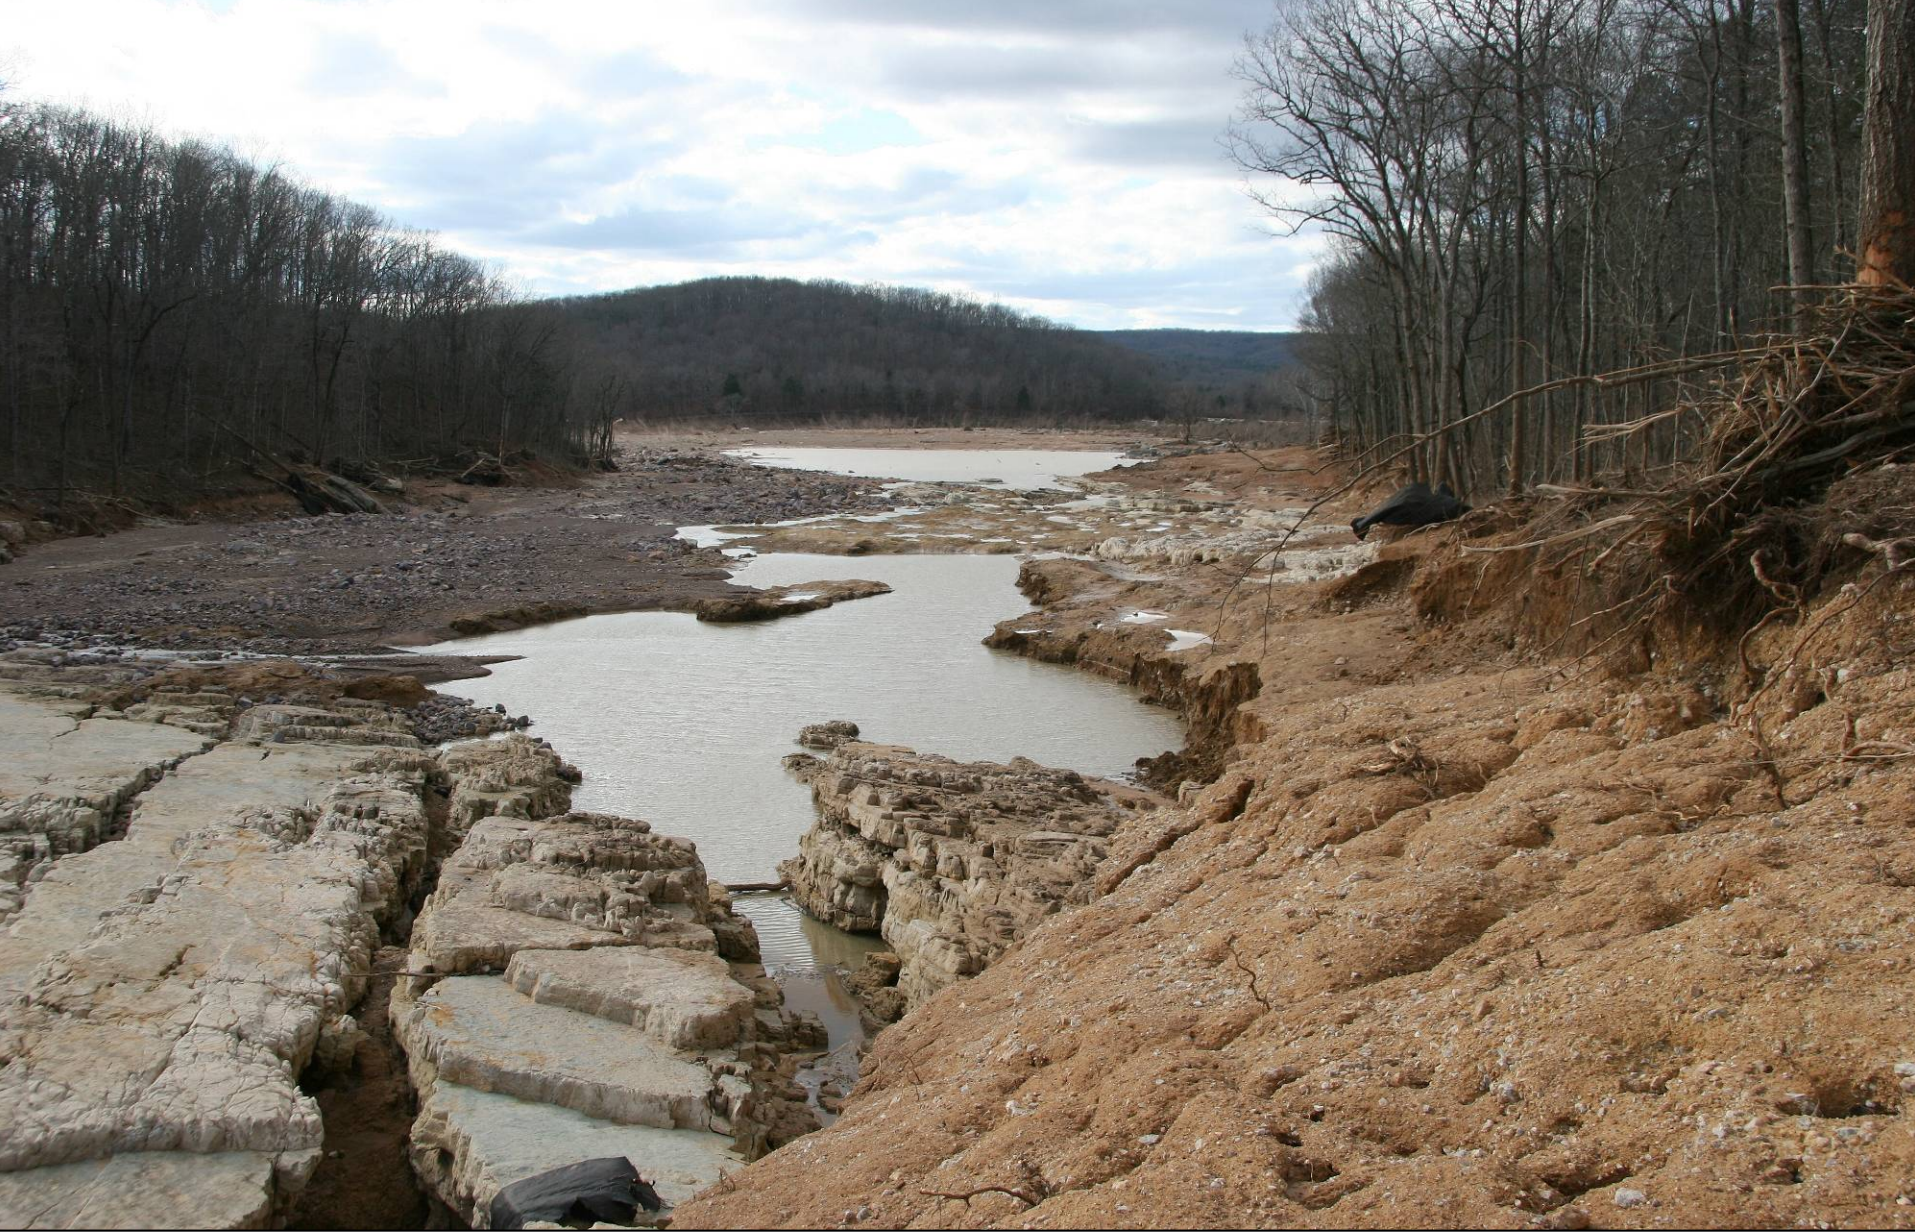
**The flood waters surged into the East Fork of the Black River, just upstream from Johnson's Shut-ins State Park, and about 700 ft below the reservoir.**

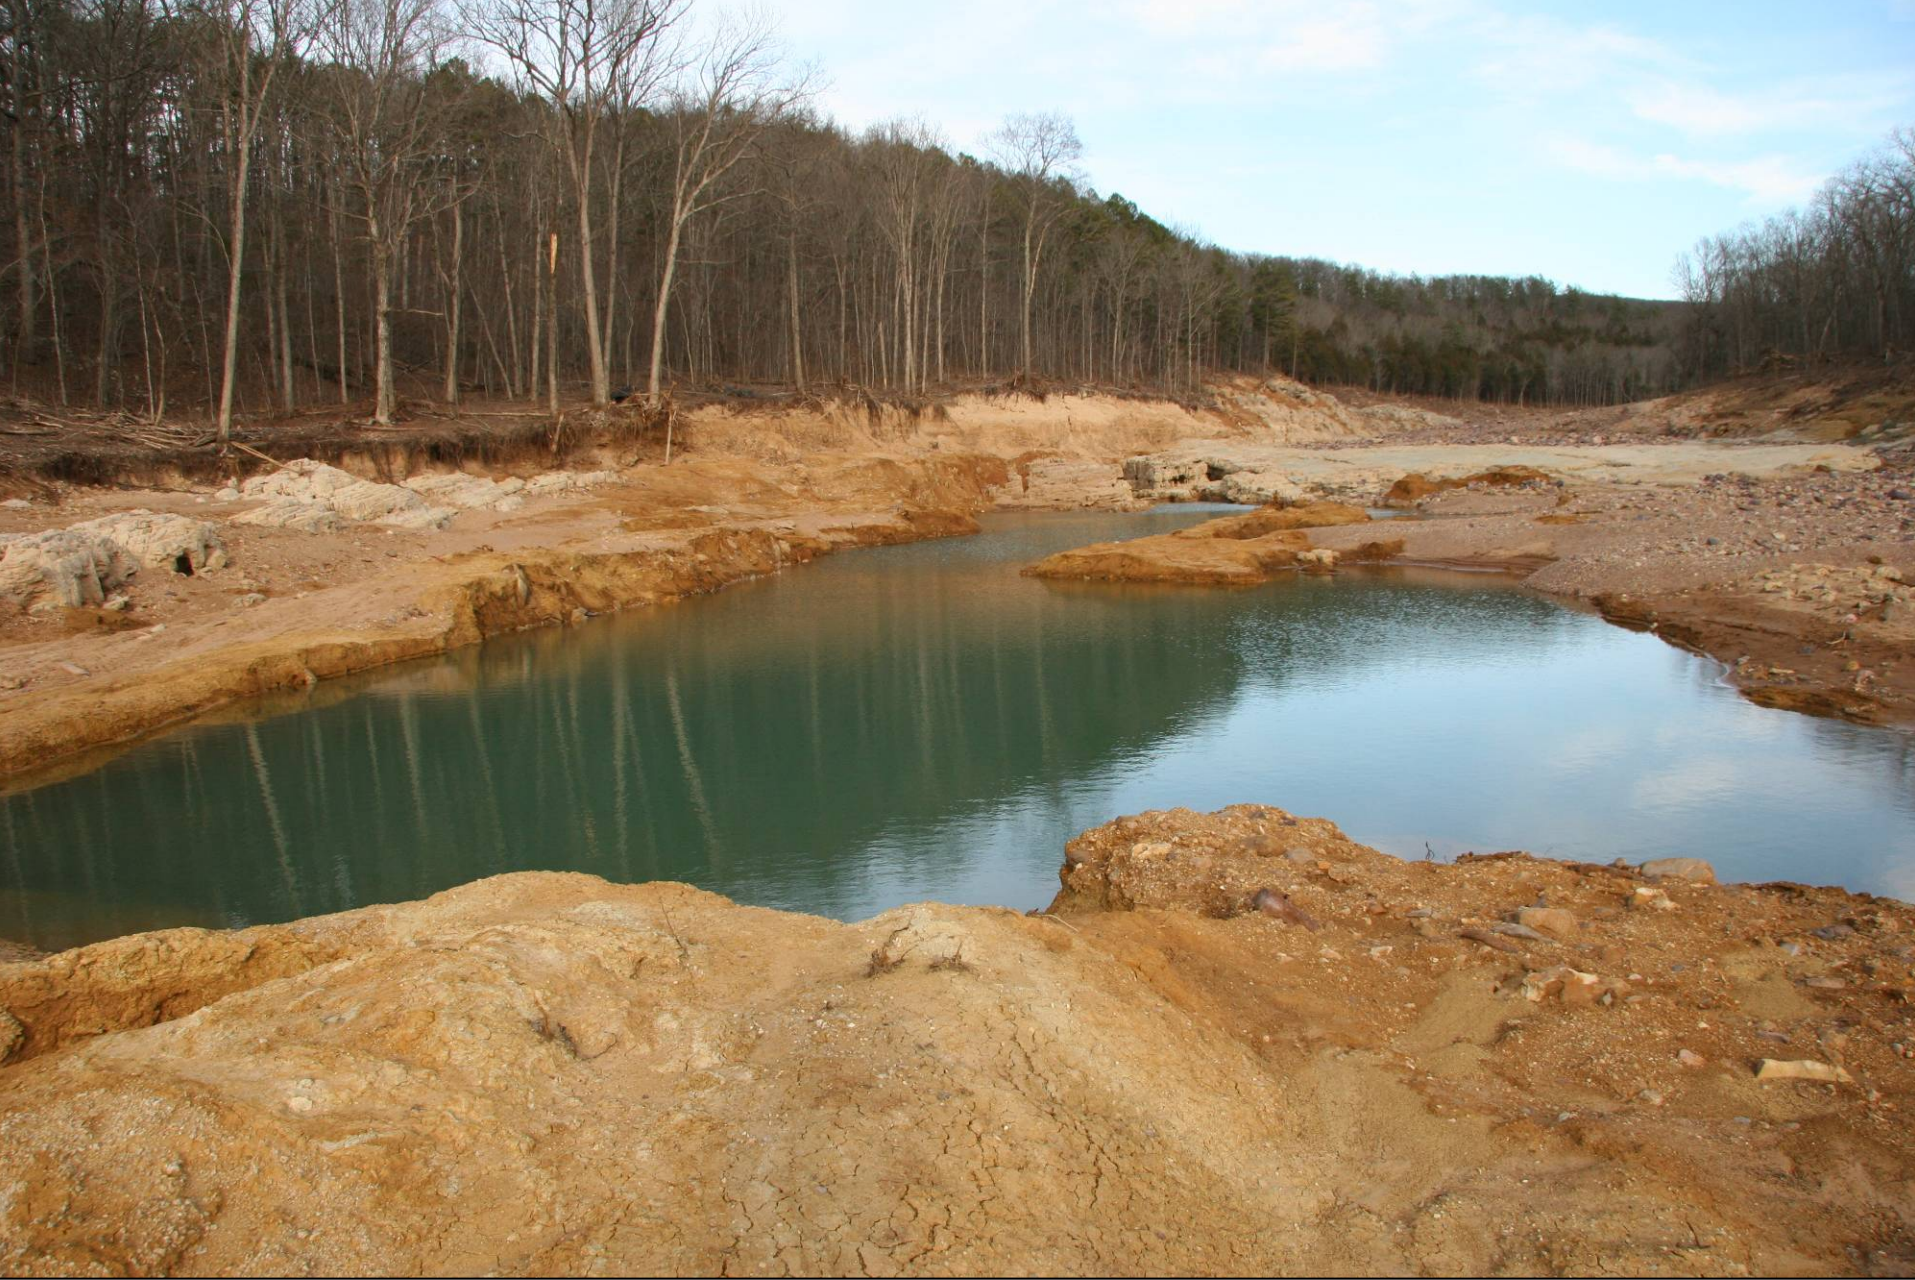
**Scour holes were excavated into the residuum and weathered carbonate rock near the junction with the flood plain of the Black River.**
