# **OVERVIEW OF THE TAUM SAUK UPPER RESERVOIR FAILURE**

**December 14, 2005**

**Reynolds County, Missouri**

**University of Missouri-Rolla**

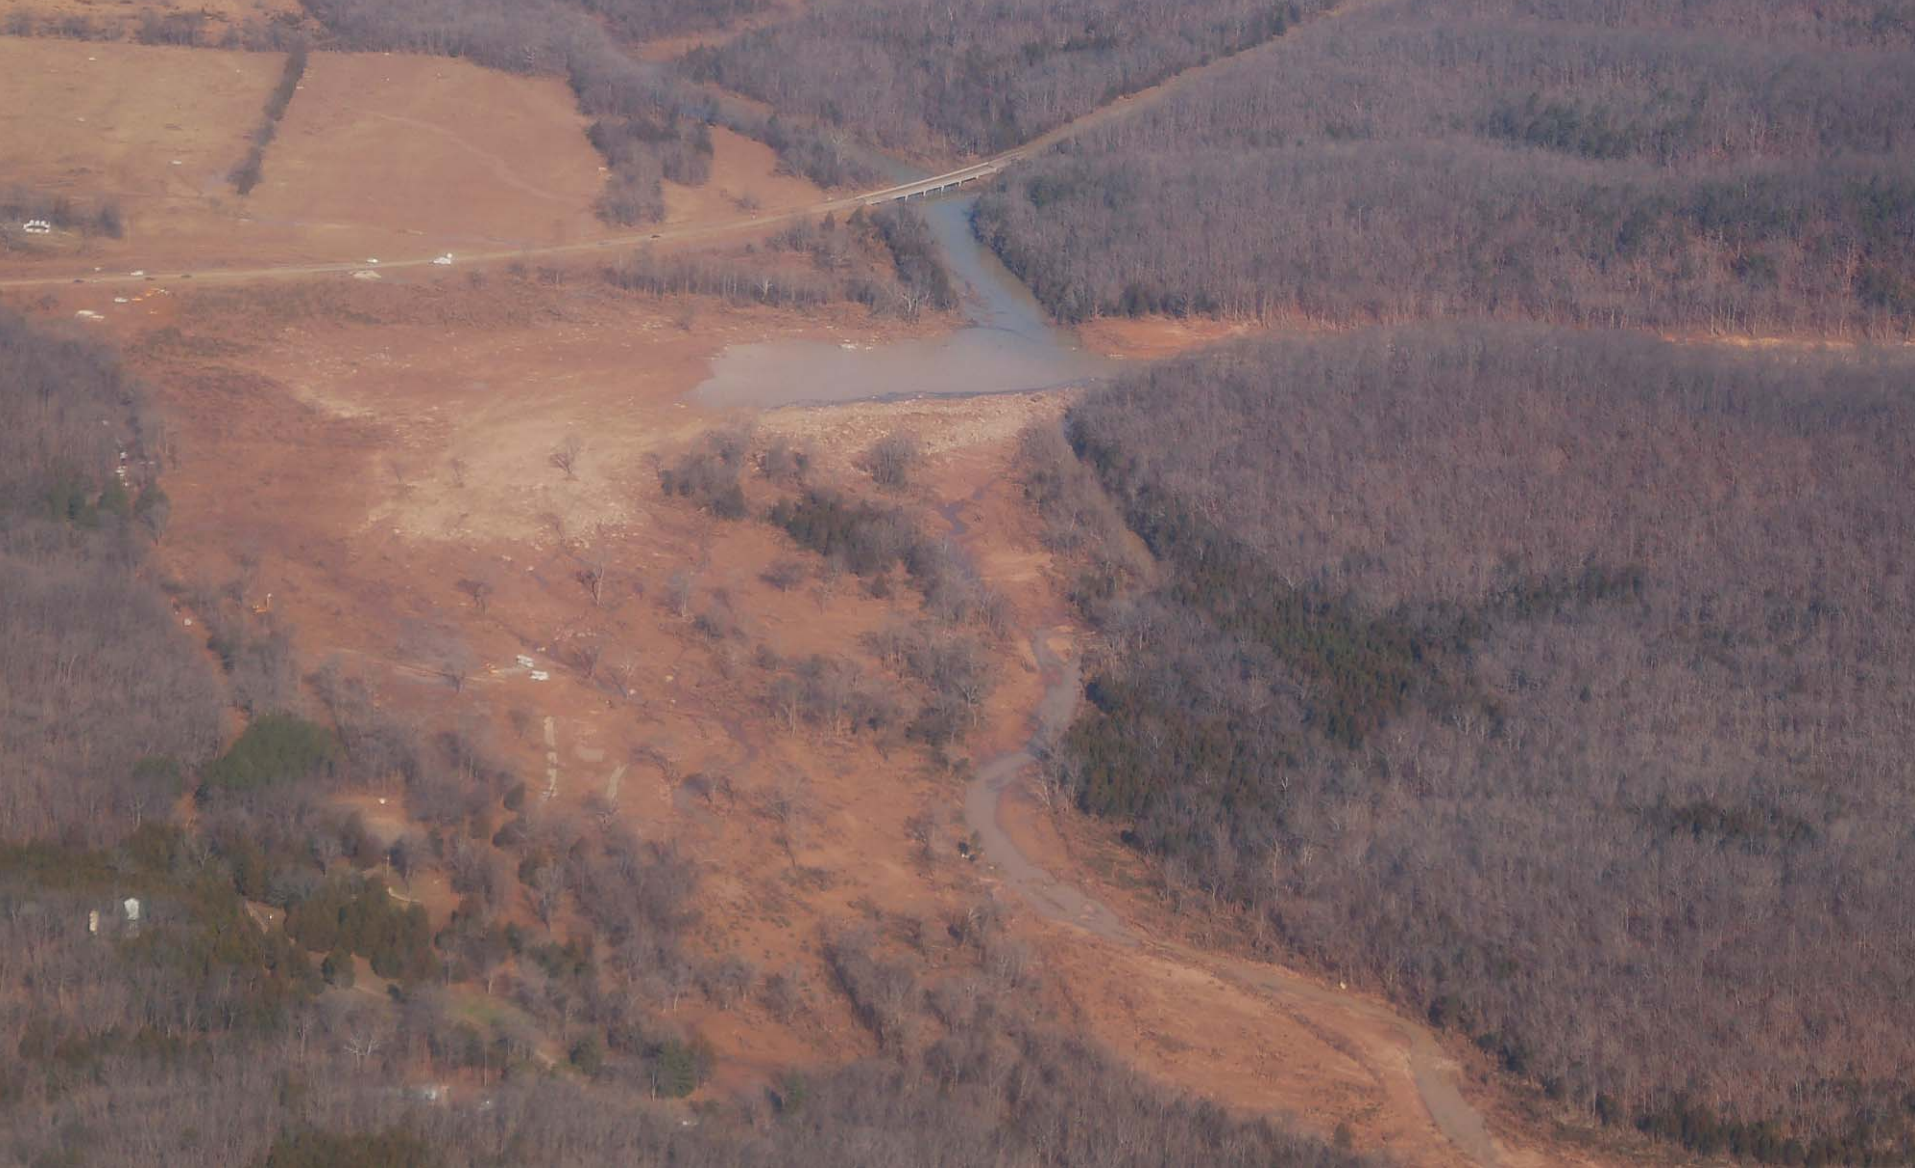
**As the flood roared into the Black River flood plain, it scoured a deep hole, seen here. The sudden drop in gradient caused the flood waters to drop its sediment, forming a debris dam that backed up this six acre lake (photo by Jeff Spooner USGS-MCGSC).**

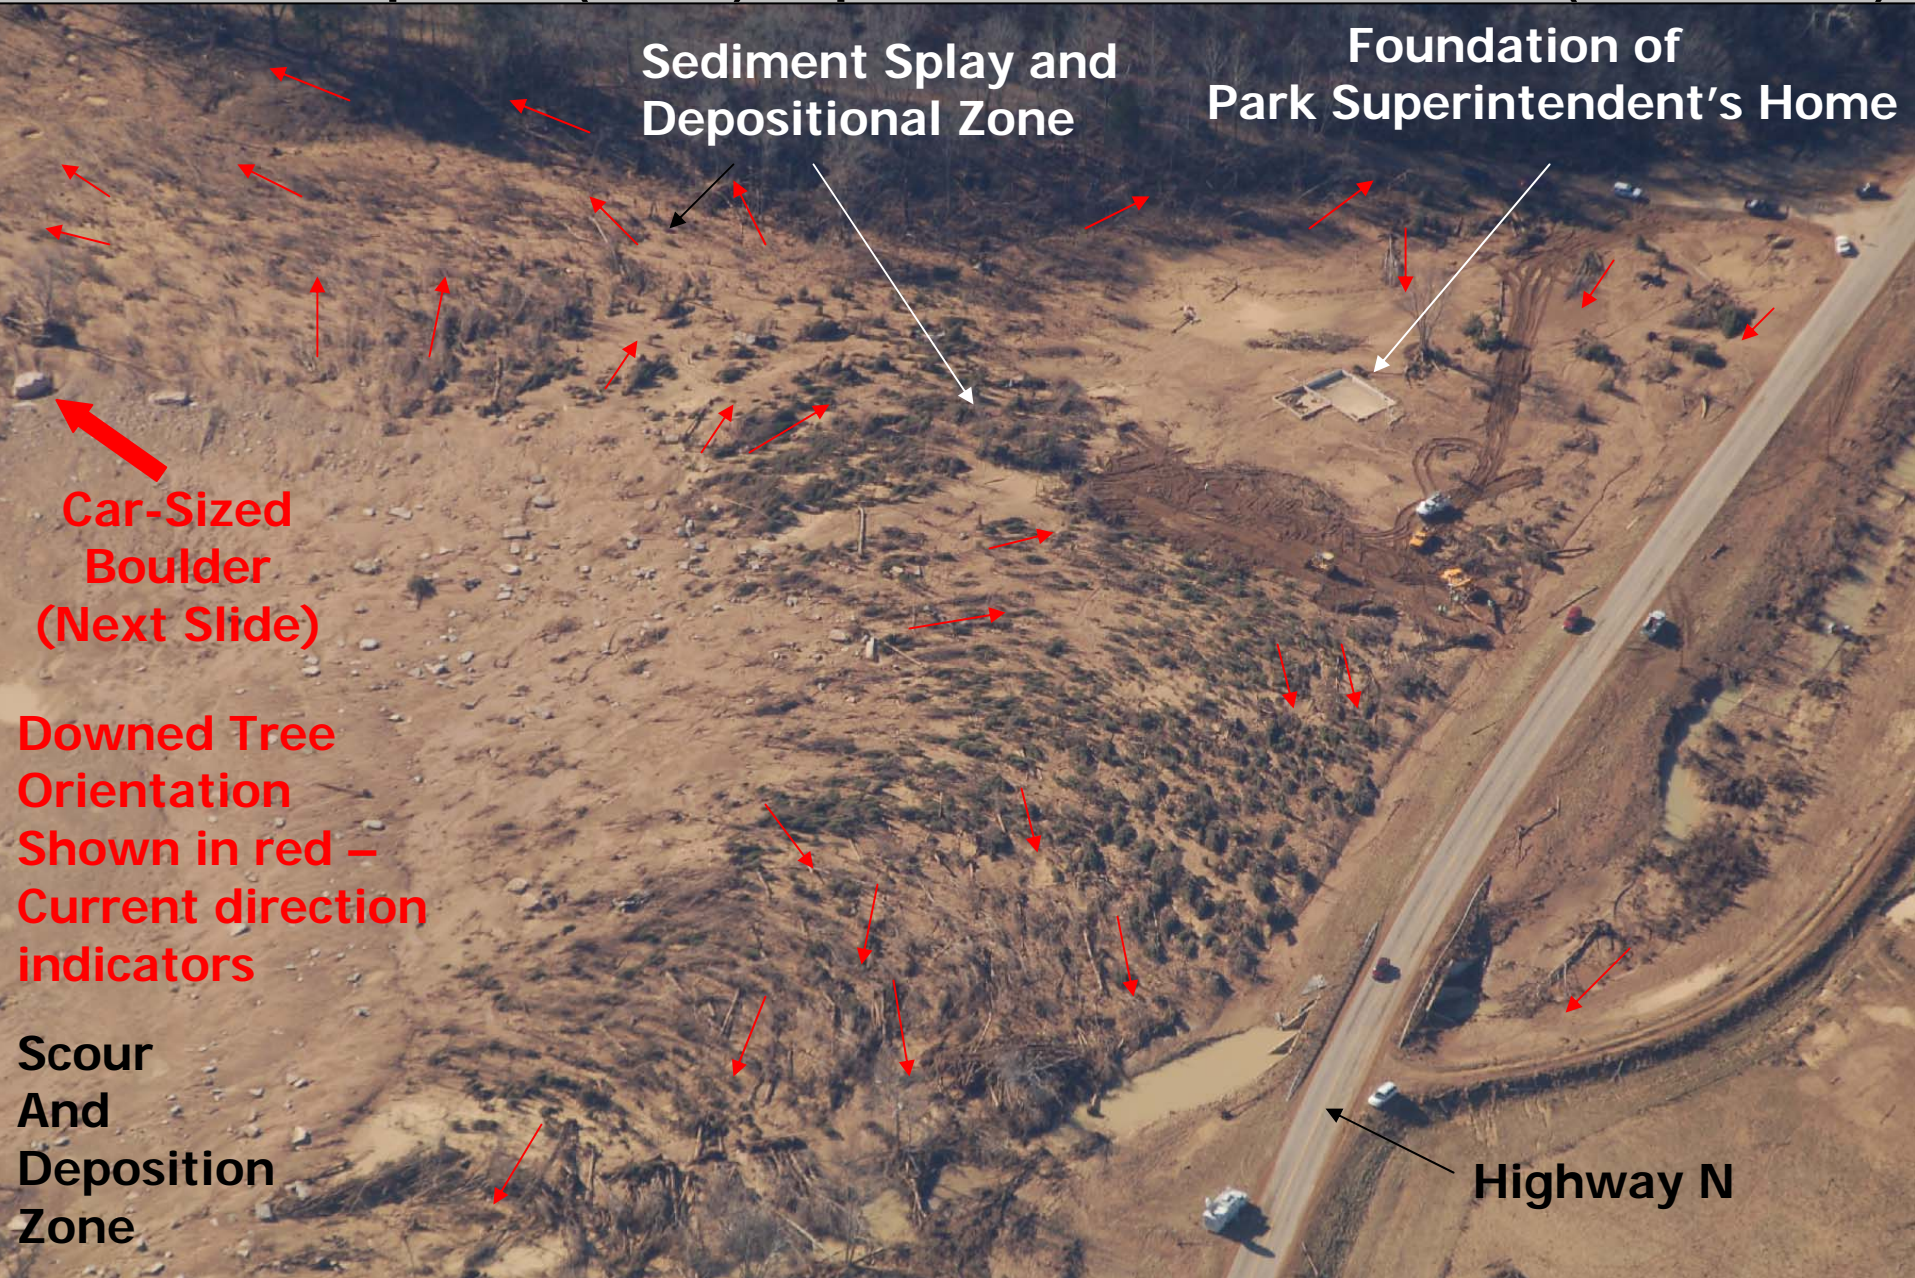
**Had the Park Superintendent's Home been 200 feet to the south (left), the family would have been washed down into the shut-ins and almost certainly killed.**

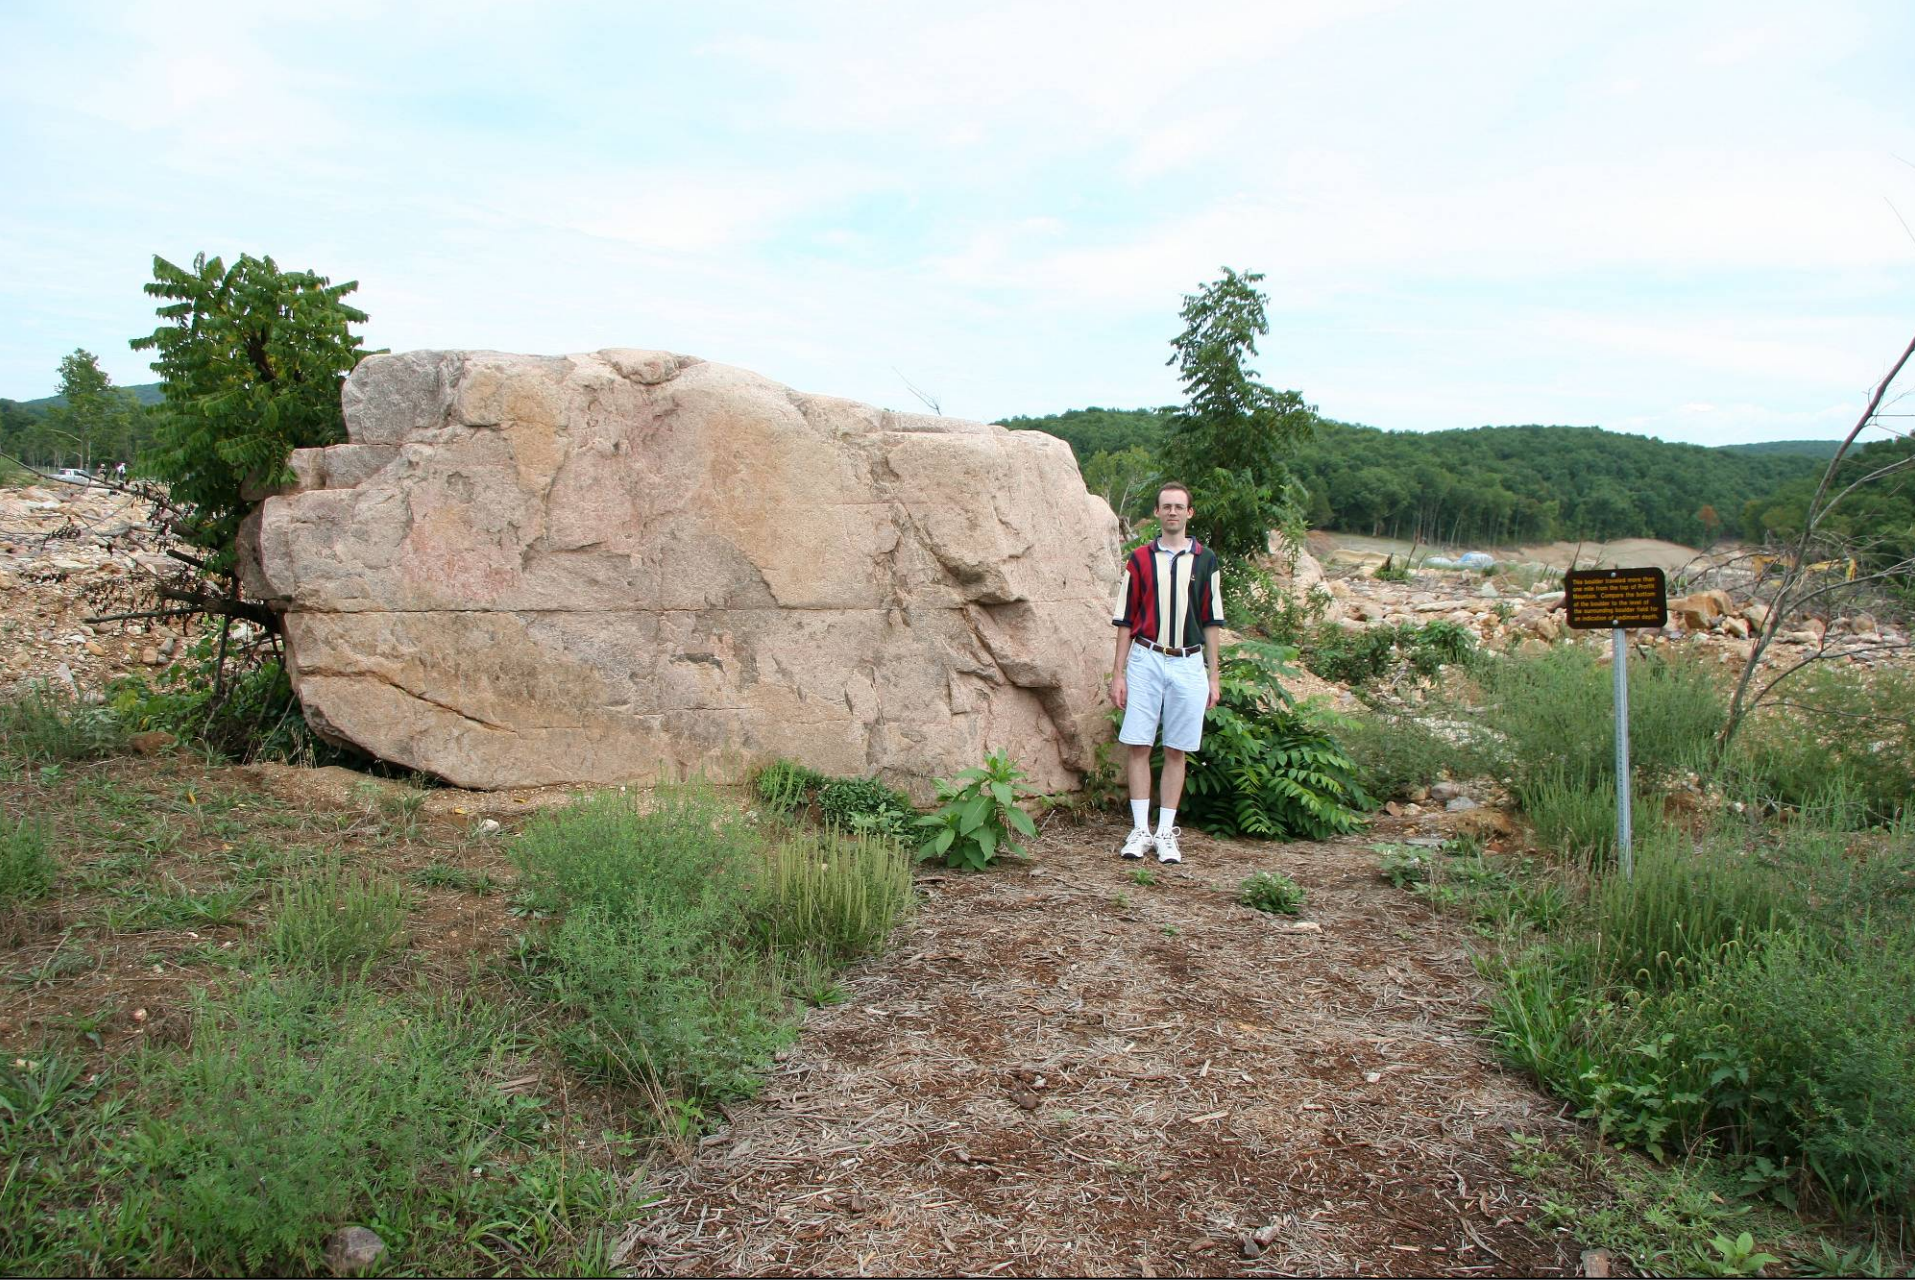
**This boulder was carried over a down the slopes of Proffit Mountain and was deposited just a few hundred feet from the Superintendent's home.**

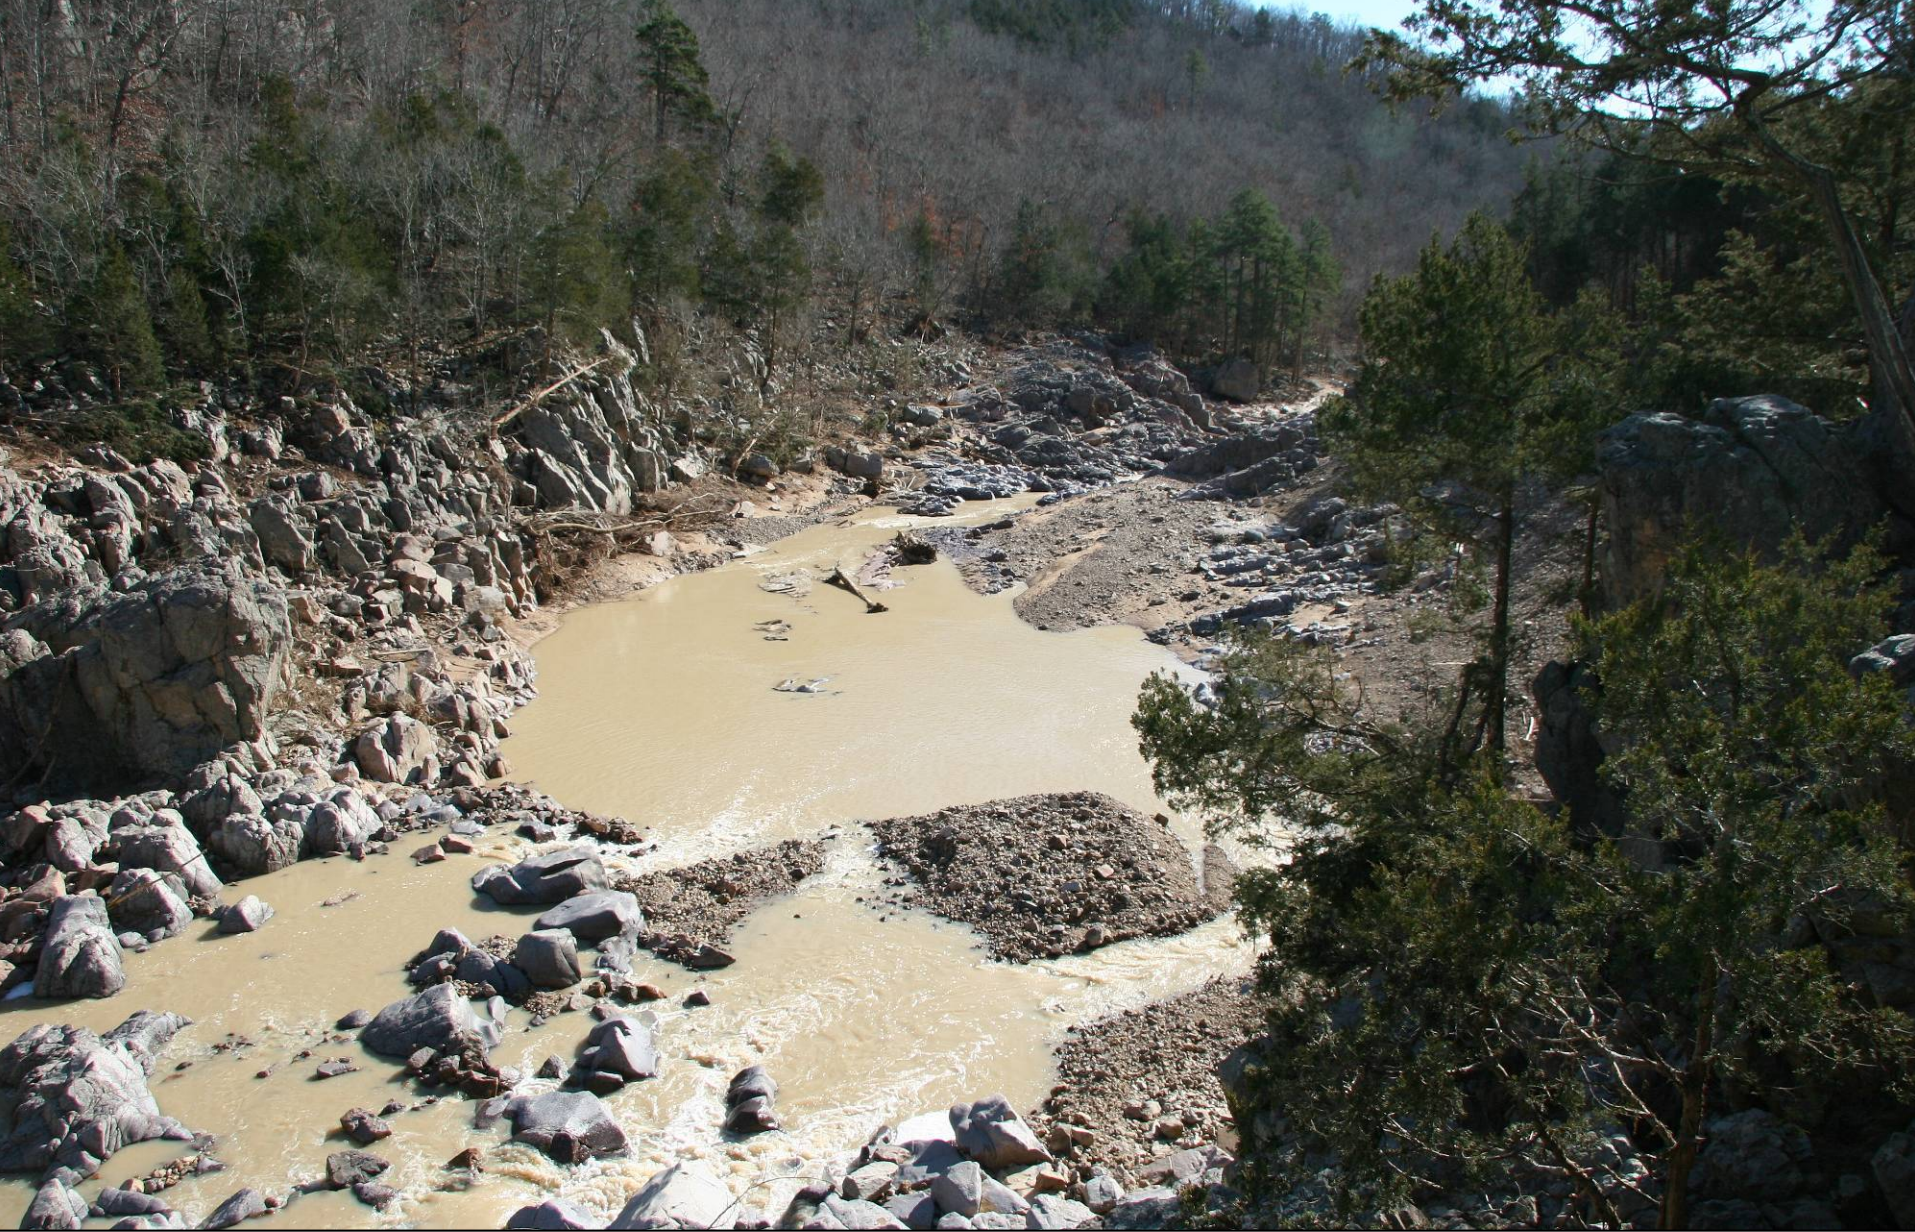
**A hydraulic jump formed as the flow changed from an upper to lower flow regime between the upper and lower shut-ins. Gravel was deposited in this once open hole after the transition to a low flow regime.**

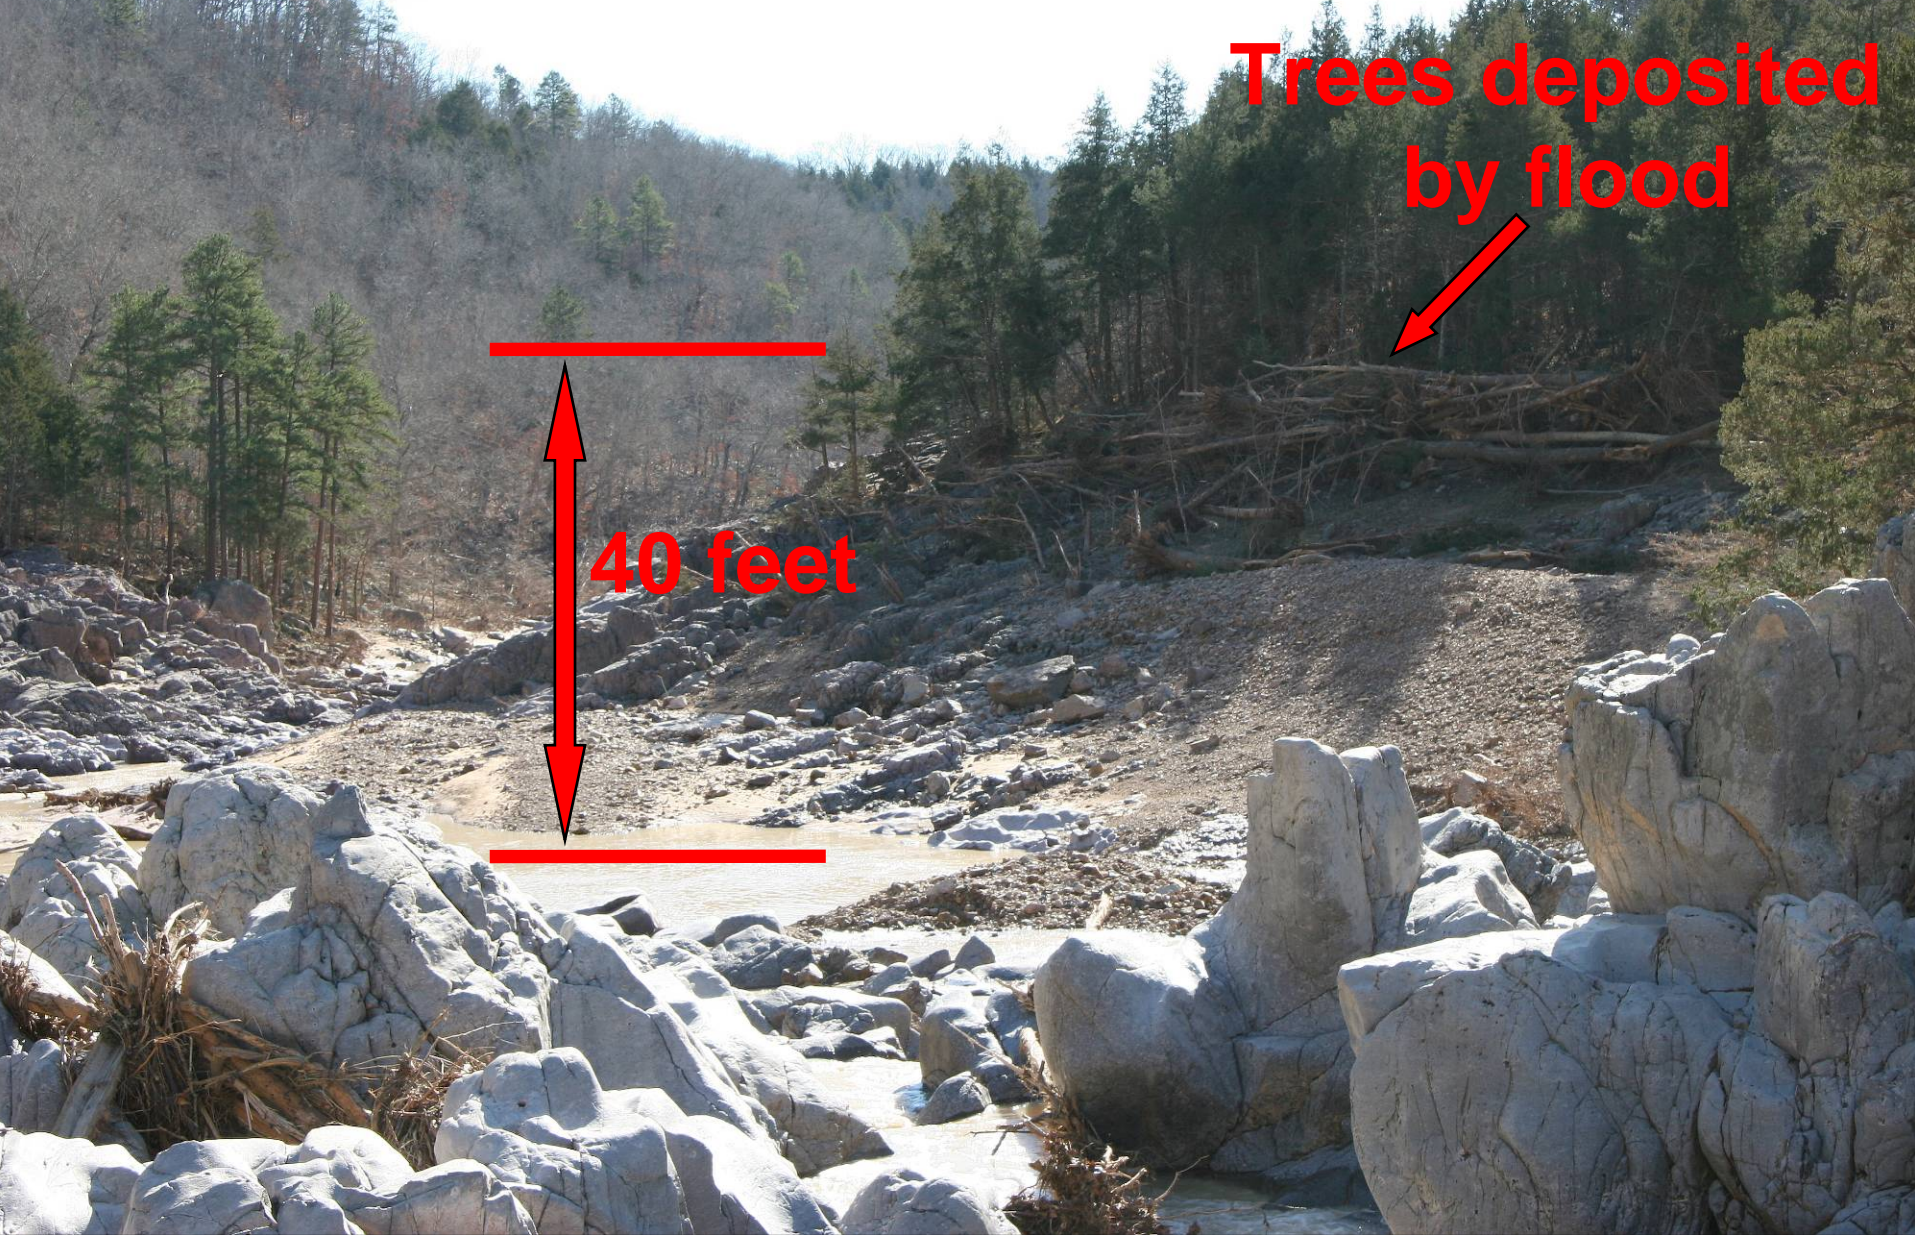
**Trees deposited  
by flood**

**A pile of trees was deposited 40 feet above the main channel by the flood. If anyone had been in the shut-ins at the time of the flood, they would have likely not realized there was a problem until it was too late to get out.**

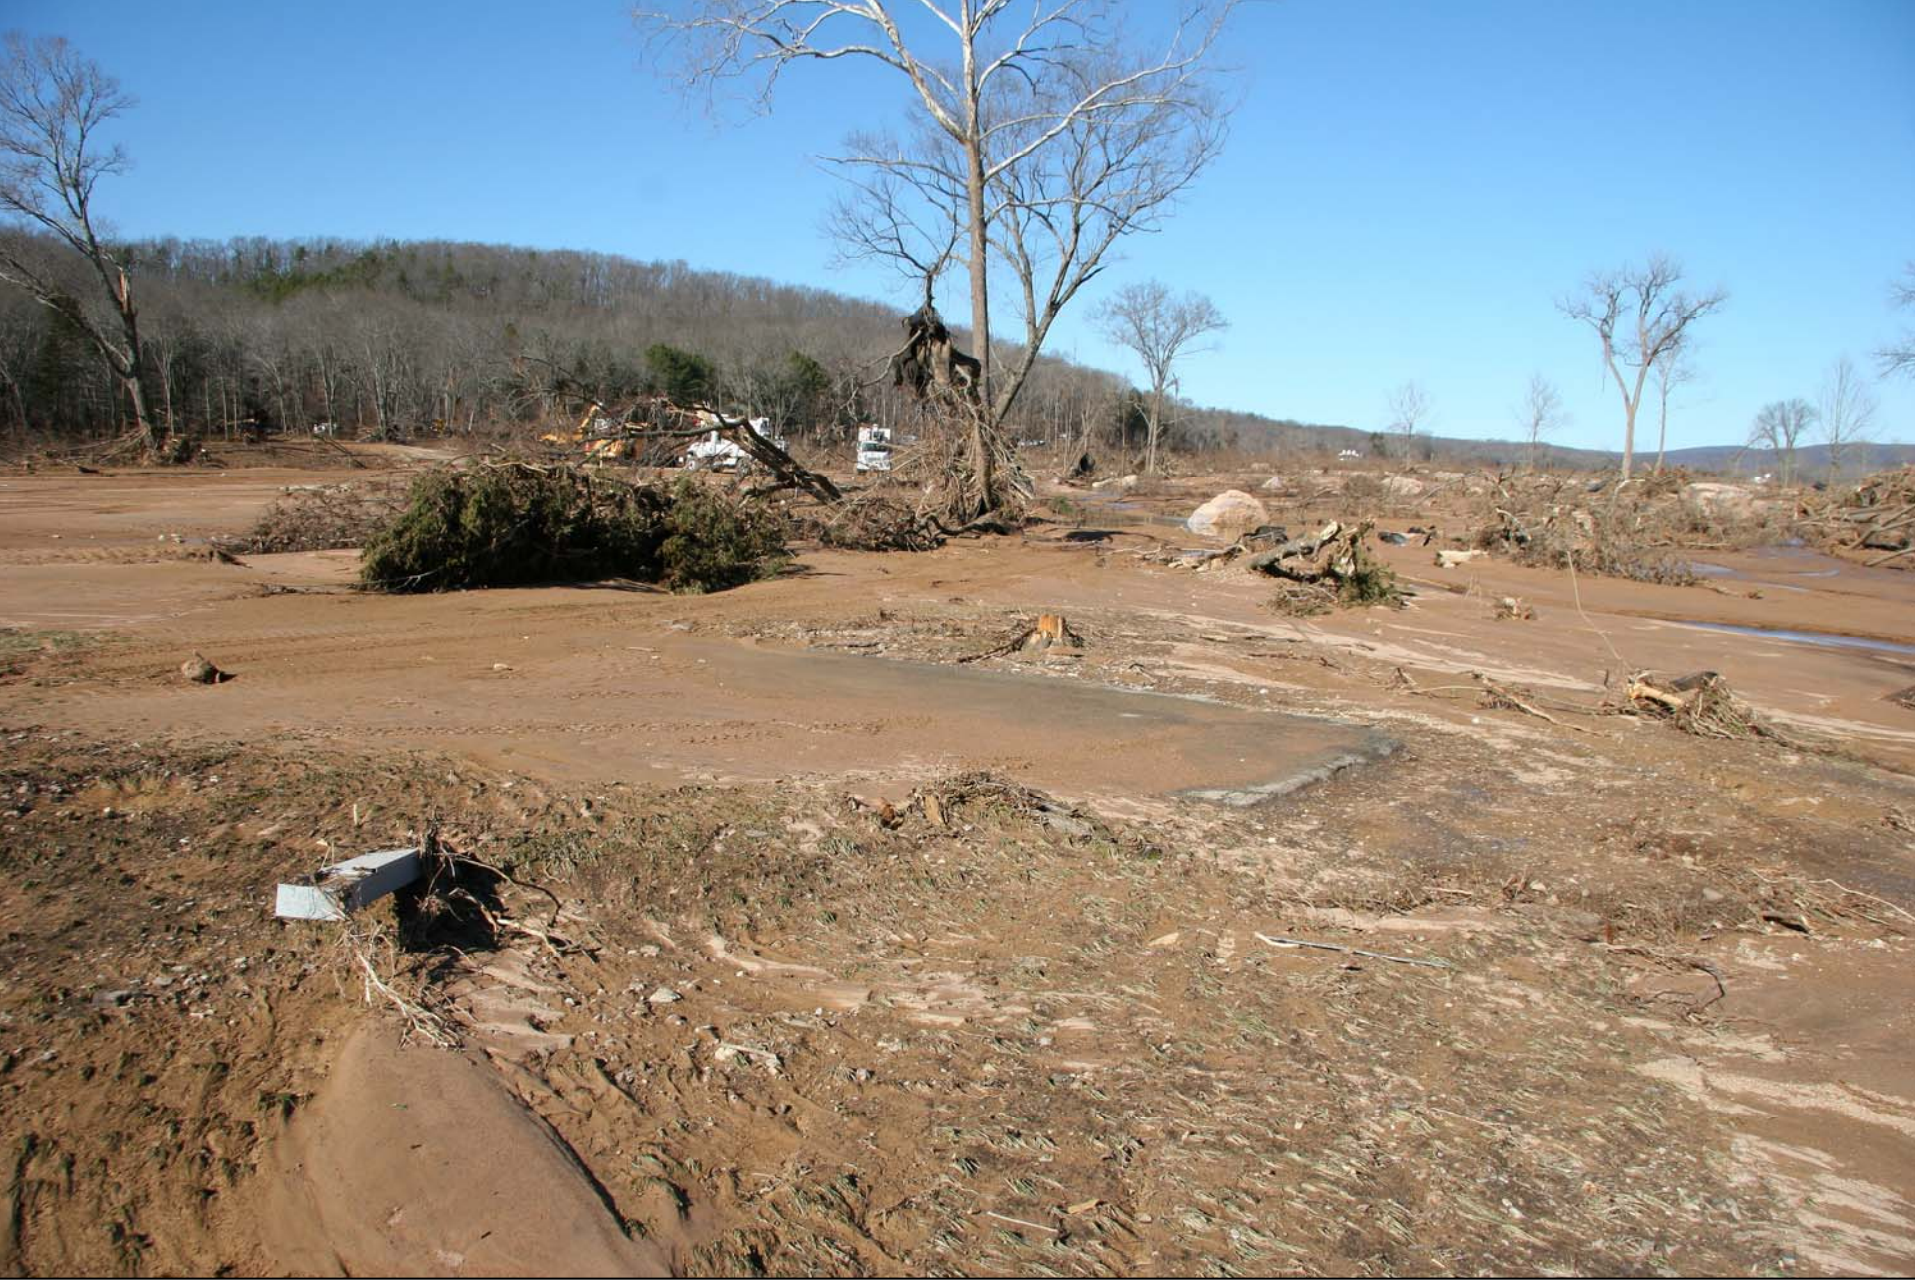
**Deposition of boulders, mud, and trees in the campground at Johnson's Shut-ins State Park.**

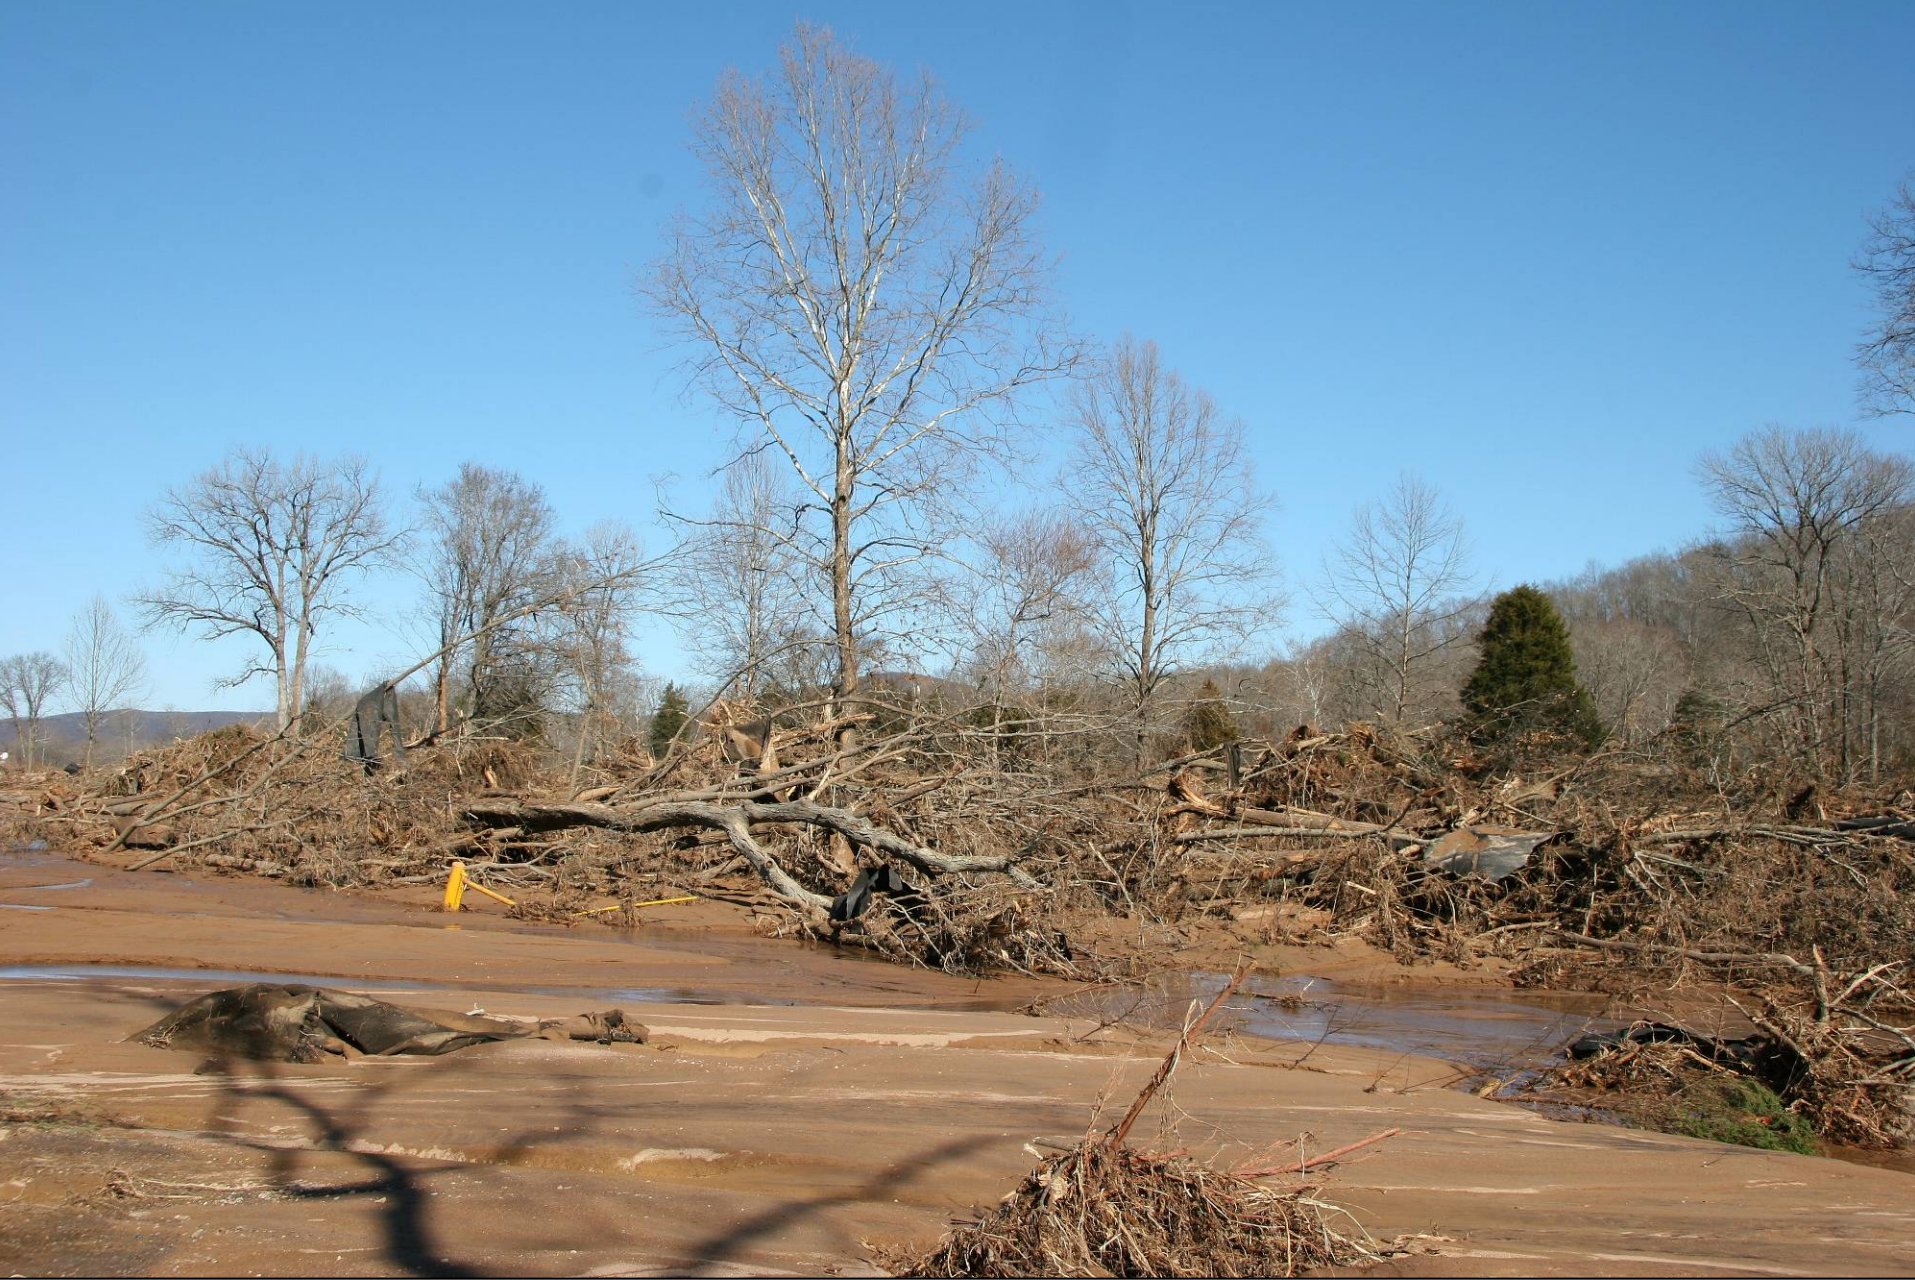
**Had campers been in the state park campground during the flood, they would have almost certainly been swept into the shut-ins and killed.**

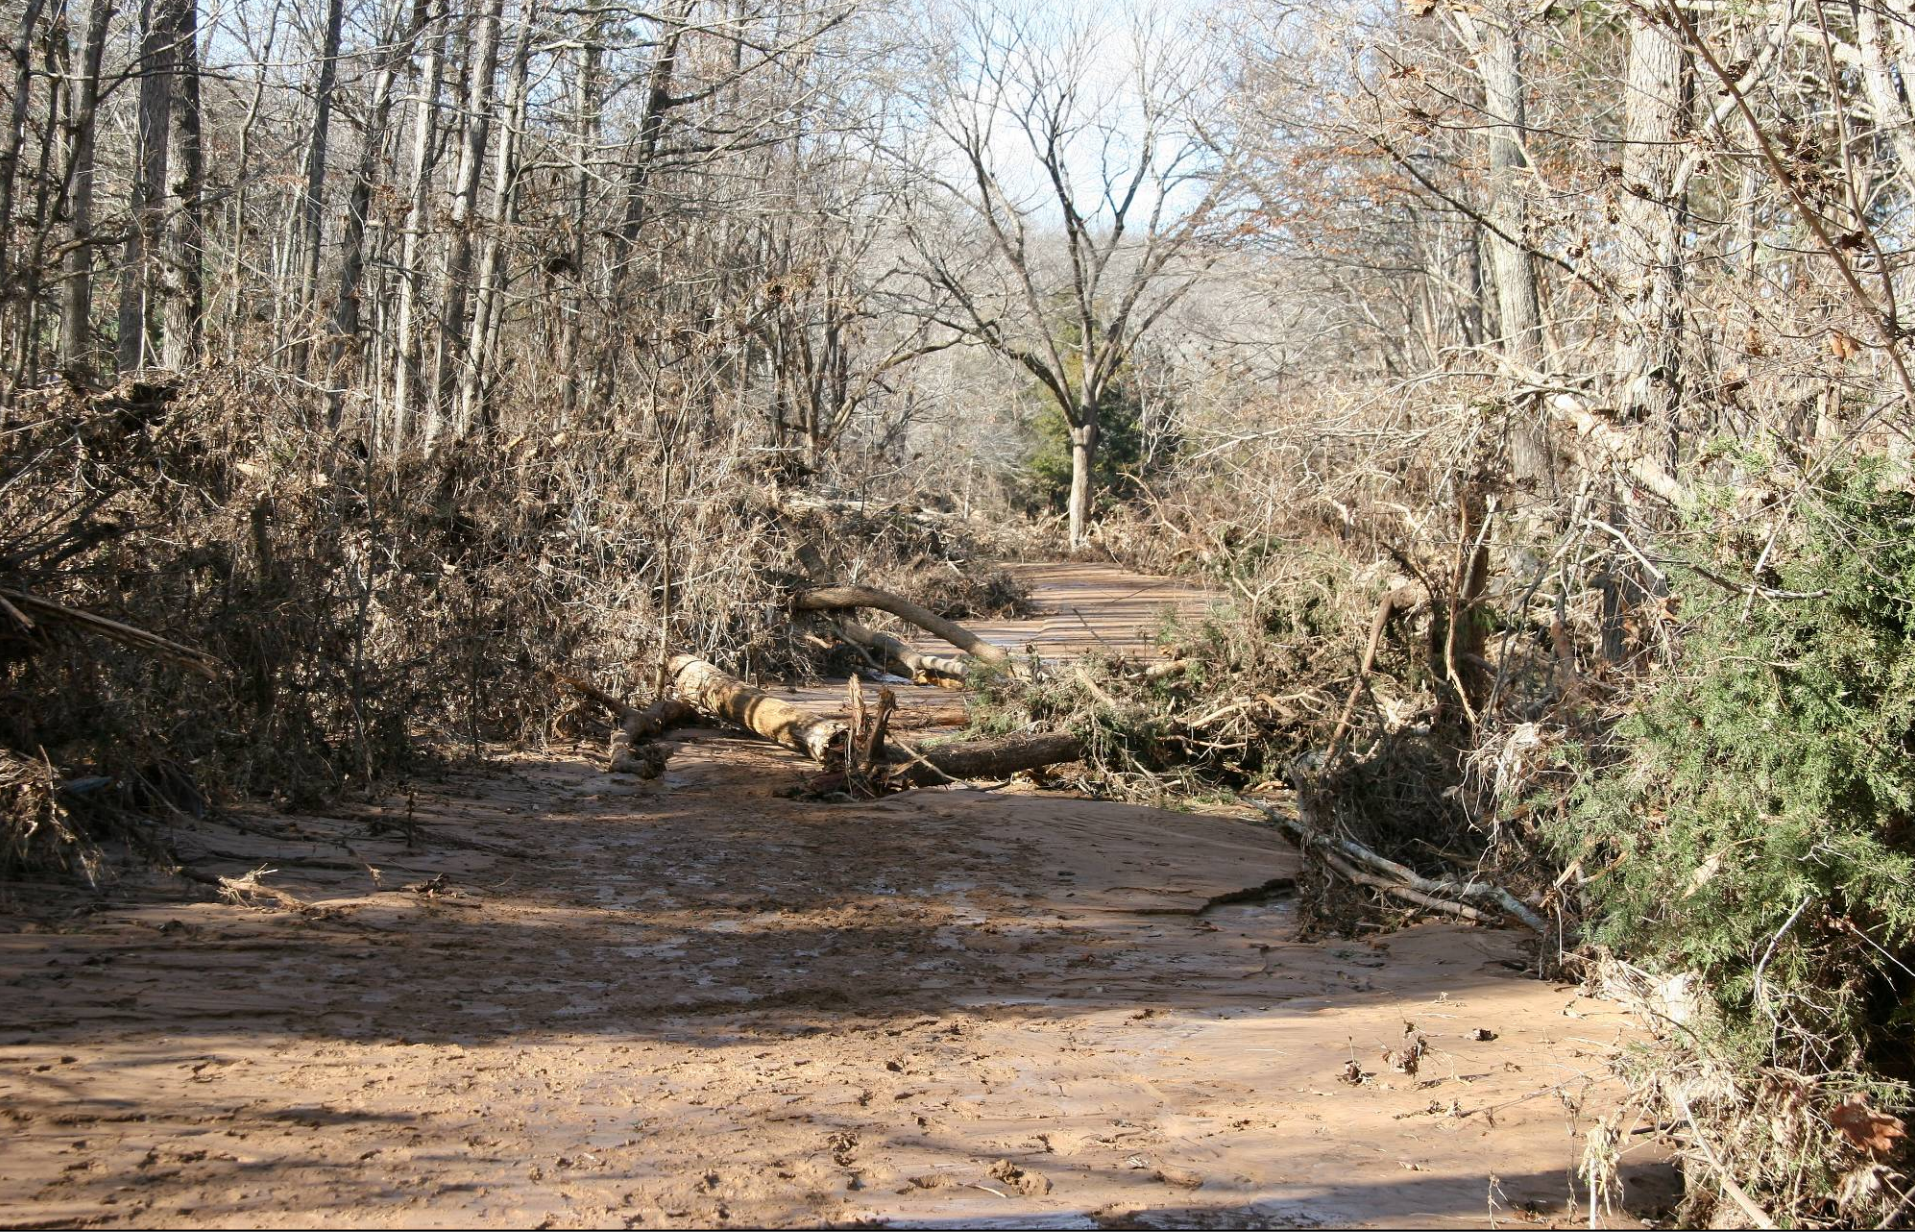
**The trail leading to the shut-ins was covered by a thick layer of mud and other debris. The shut-ins below restricted the flow and slowed the waters in this portion of the park.**

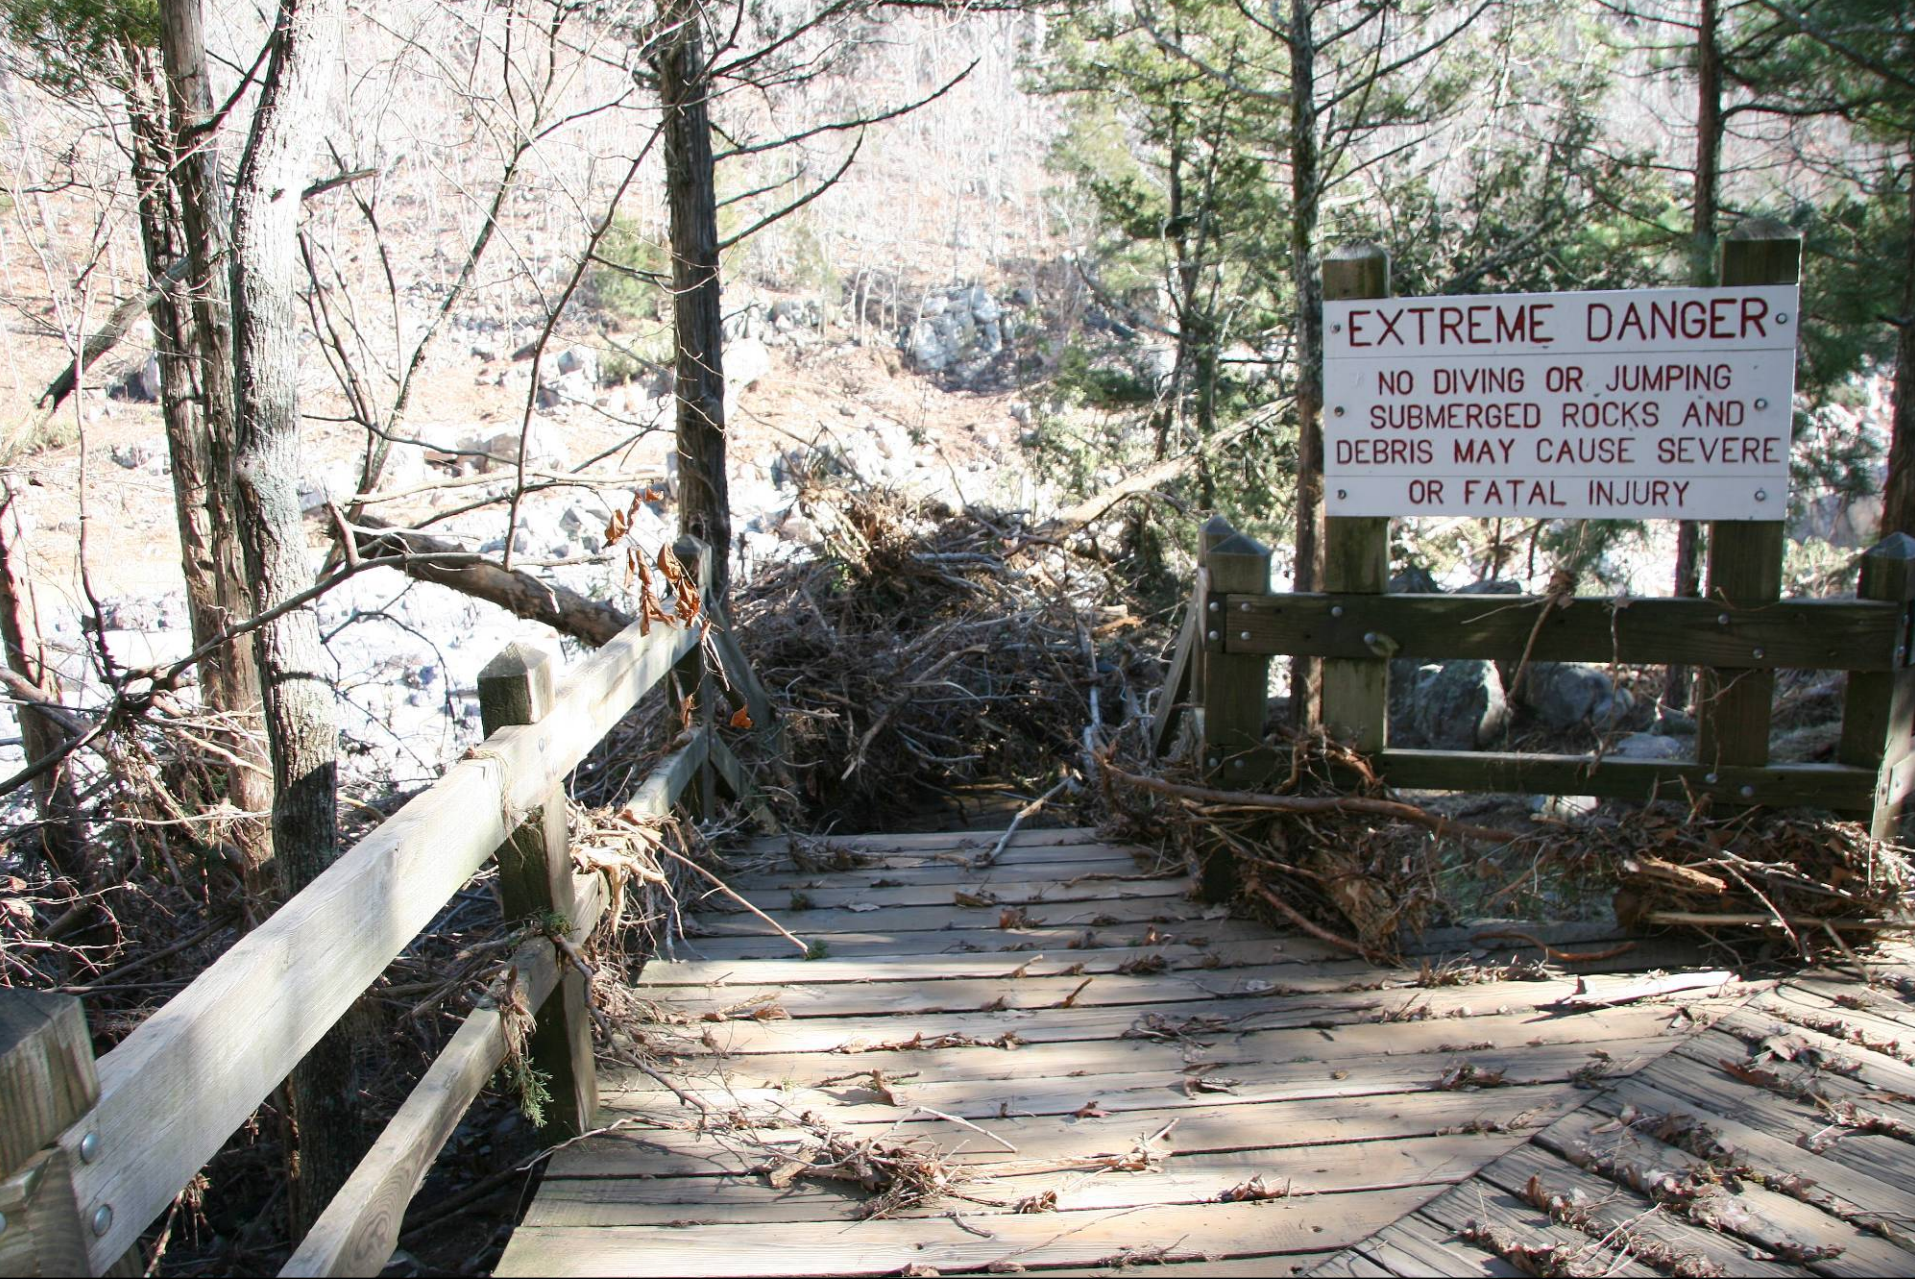
**The boardwalks leading to the shut-ins were damaged and covered by debris.**
