# **OVERVIEW OF THE TAUM SAUK UPPER RESERVOIR FAILURE**

**December 14, 2005**

**Reynolds County, Missouri**

**University of Missouri-Rolla**

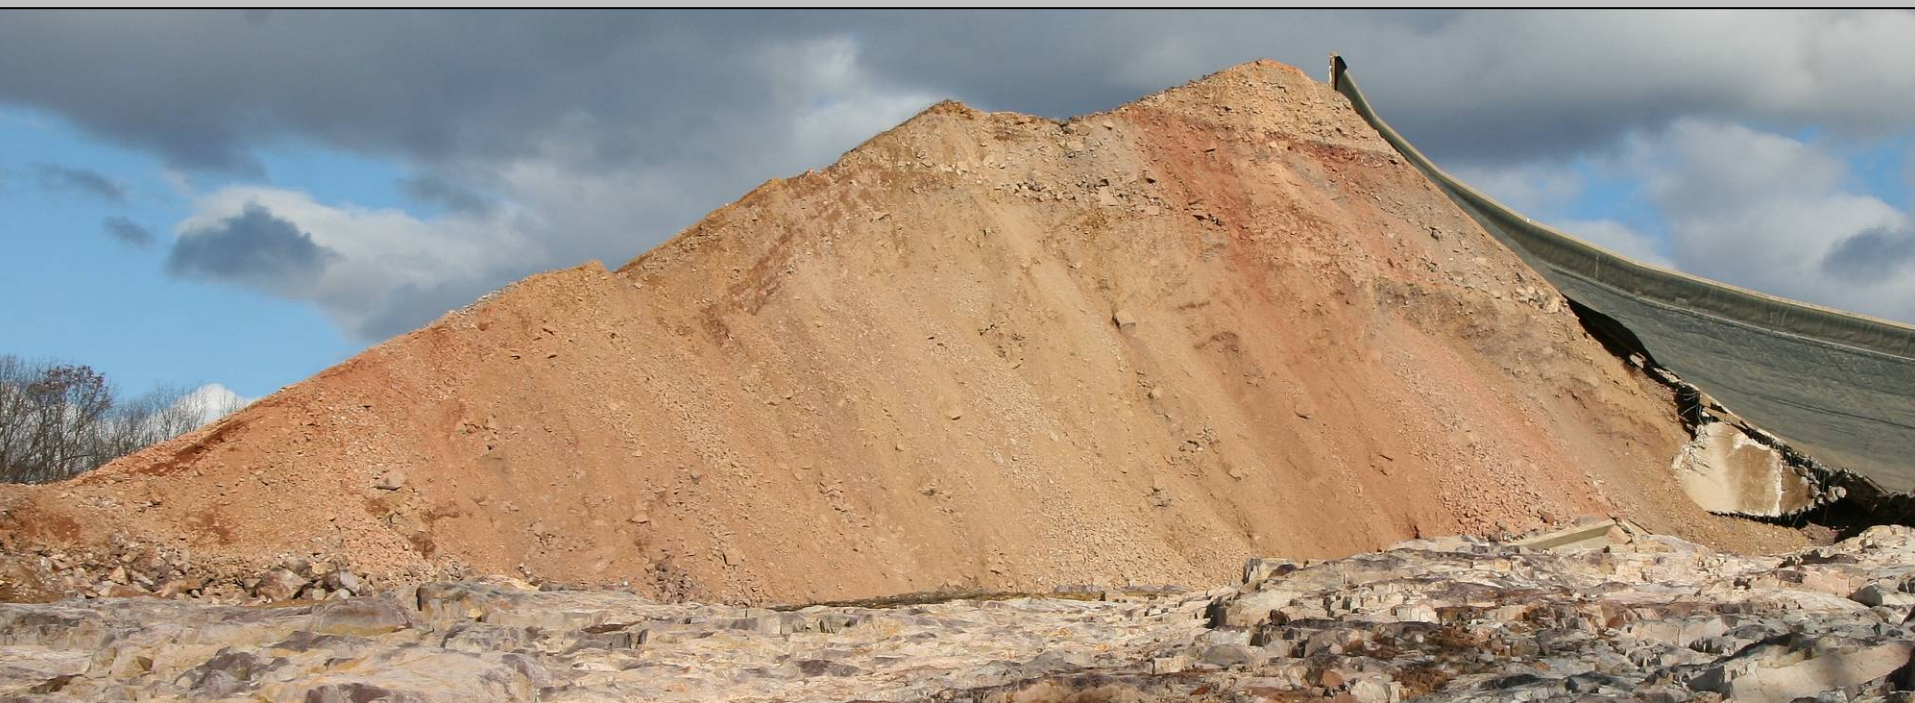
**The Upper Reservoir embankment was the last loose dumped (uncompacted) concrete-lined rockfill dike constructed in the U.S. The great majority of the dike was placed by end dumping (tipping) rock fill, and allowing it to stabilize at its angle of internal friction.**

**The upper 16 feet of the dike was placed as rolled fill, using four 4-foot thick lifts.**

**Note the three distinct zones, indicative of the different placement techniques.**

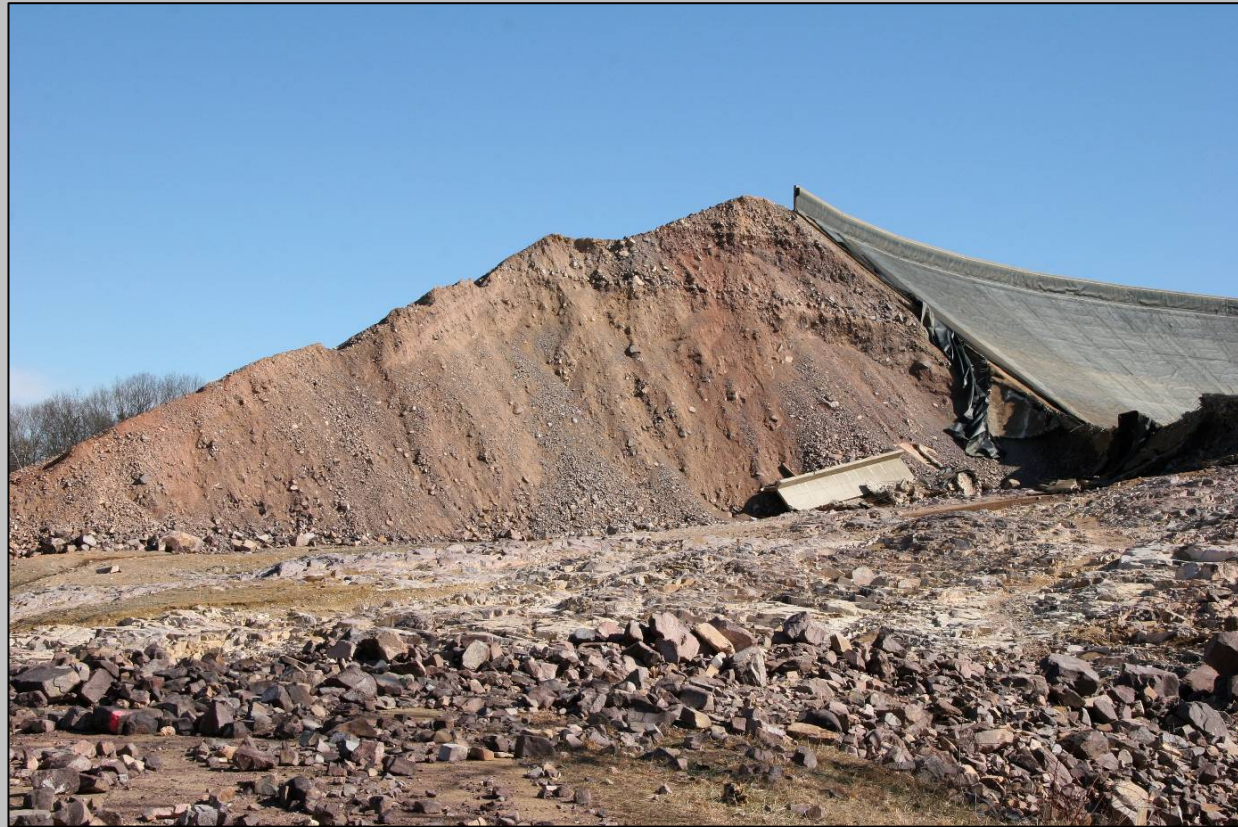
- The cross section of the dam exposed by its failure exhibited a high fines content. The rockfill contained about 20% fines while the project specifications limited the fines to 5% or less.
- This contributed to up to 2' of differential settlement, shifting of the concrete parapet walls, and a cracking of the concrete liner over the years. This also reduced drainage and thus, internal stability of the dam.

**Close up of “dirty” rockfill exposed at failure site. For scale, the large rocks are 10-12” in diameter.**

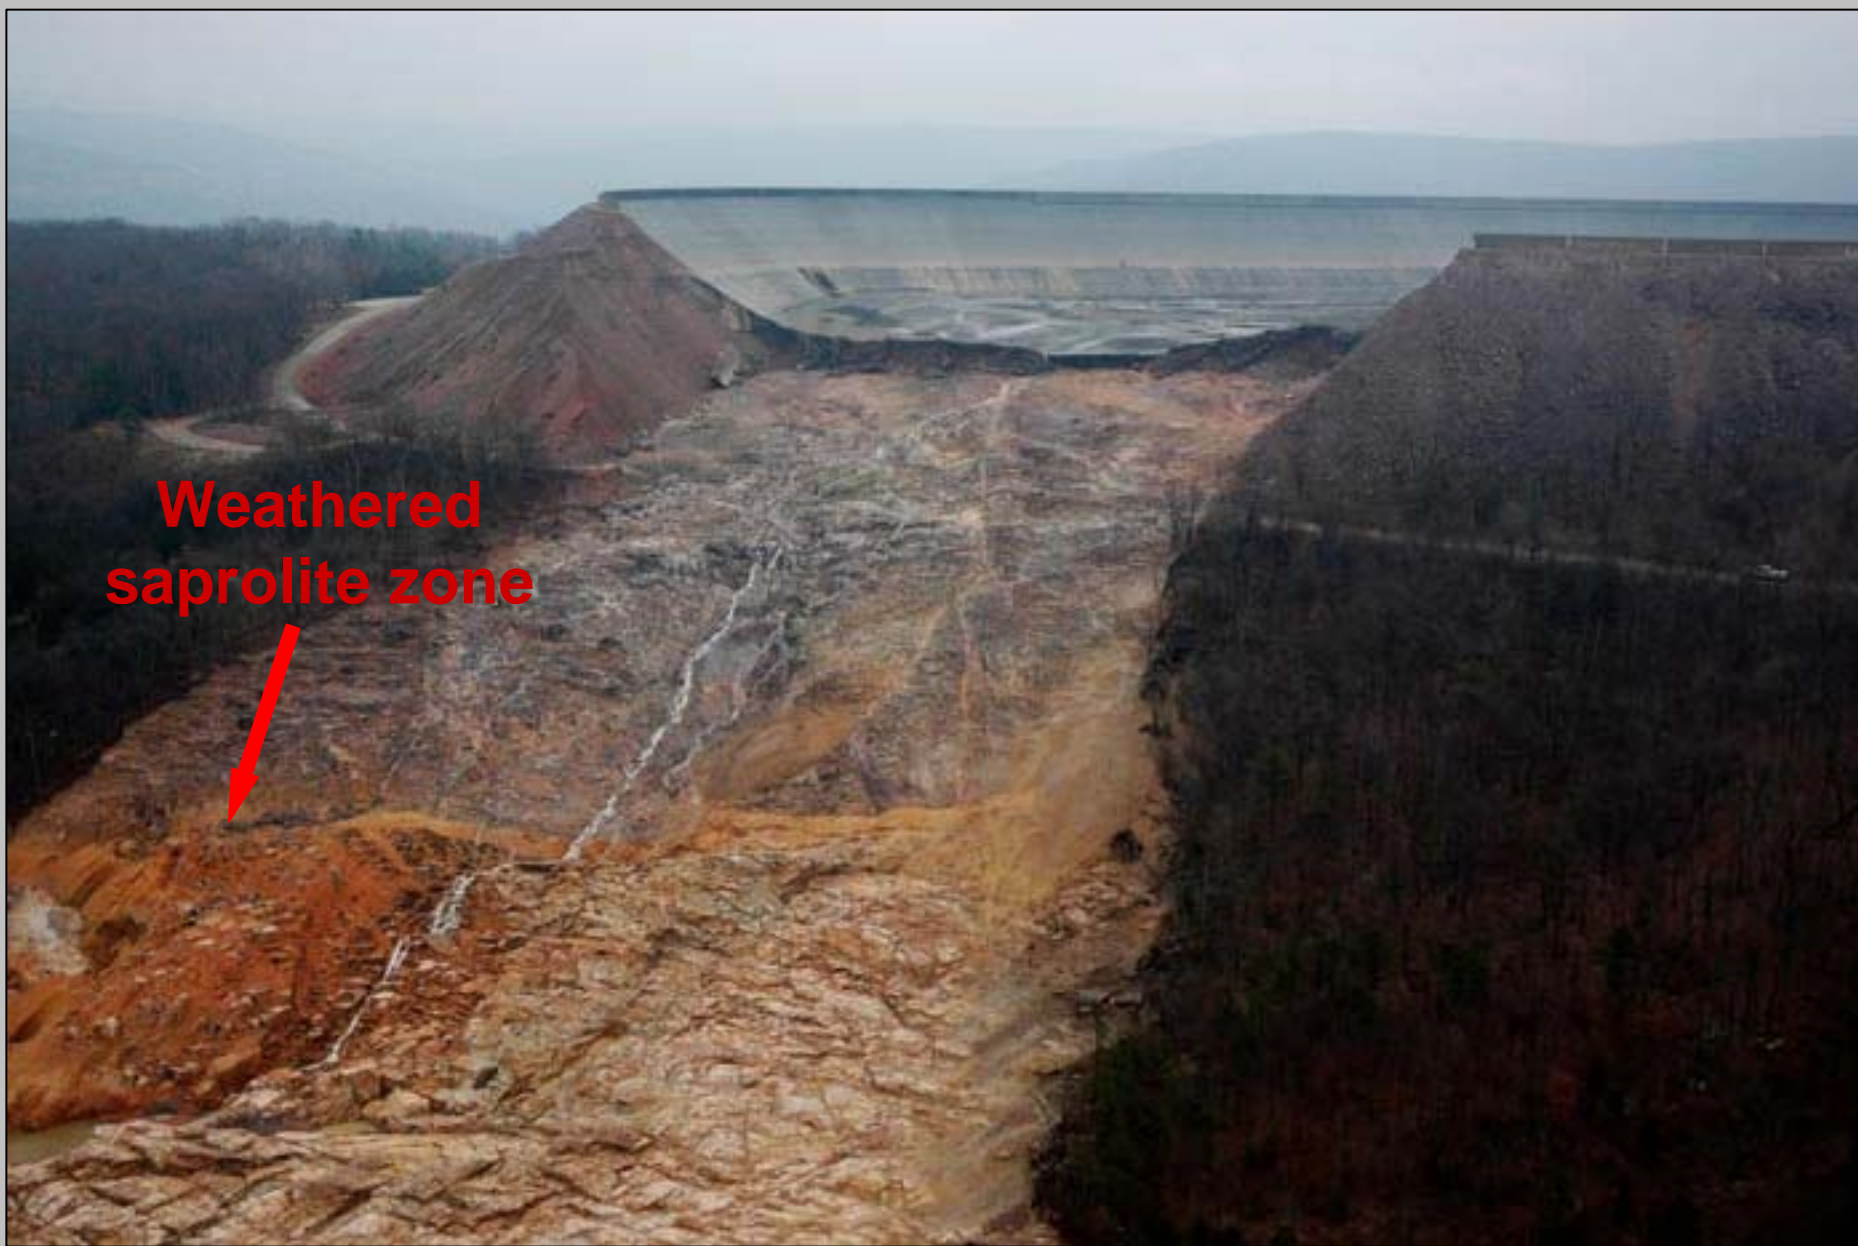
**Geologic units exposed by scouring of the outbreak flood. Note the reddish saprolite. Photo from the Associated Press**

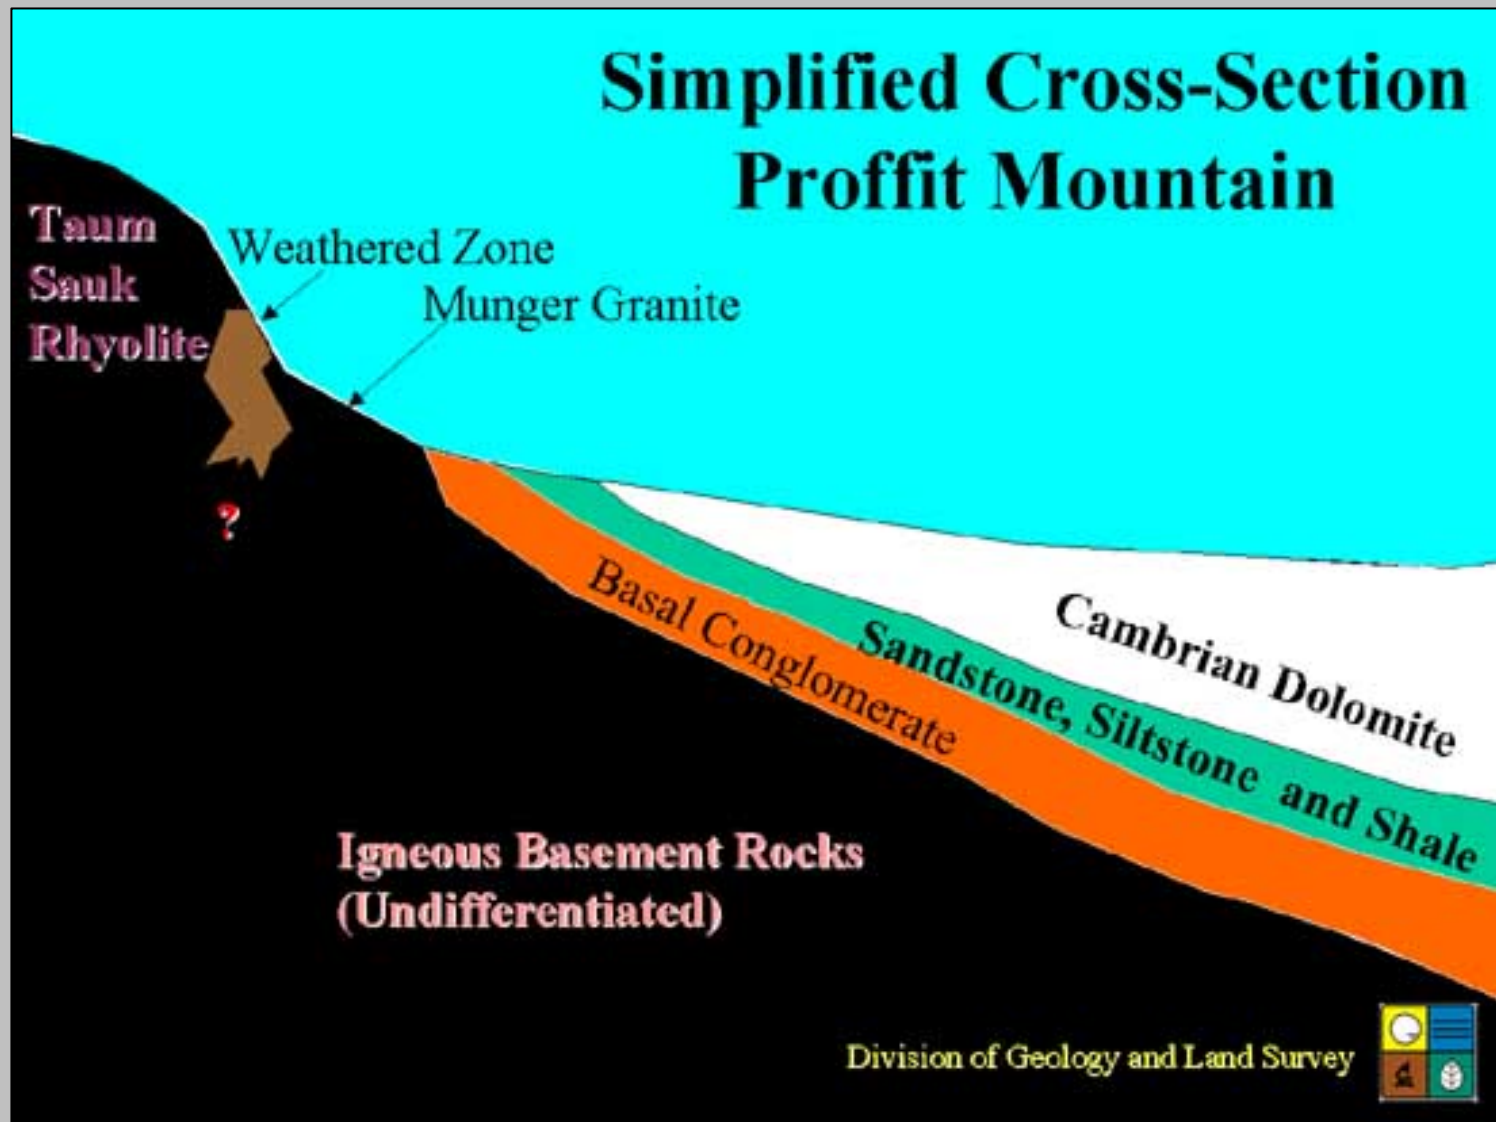
- Stratigraphic relationships between units exposed along path of outbreak flood, just below the reservoir. Note the weathered zone.

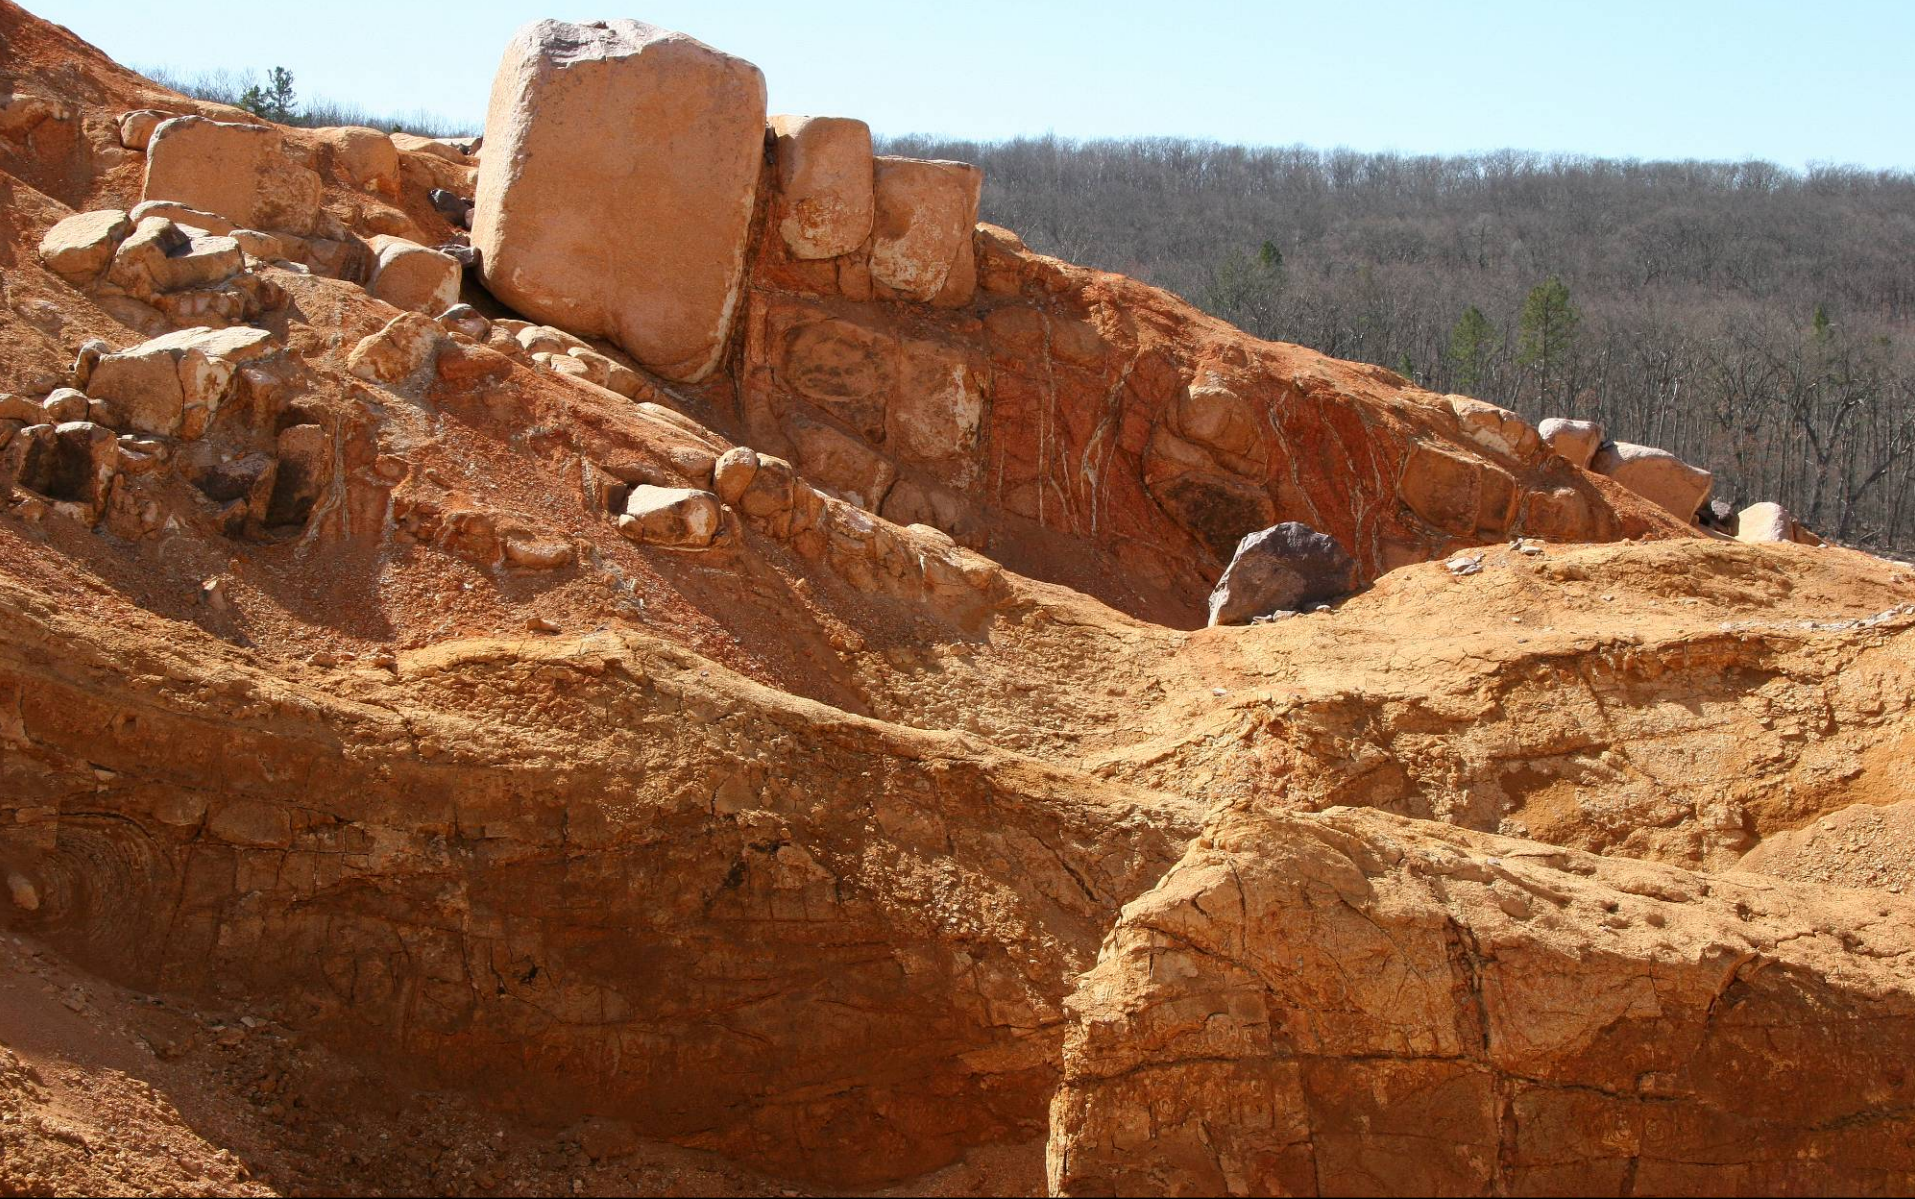
**Zones of deeply weathered granite and diabase were exposed on the upper slopes of Proffit Mountain during the flood. Materials similar to this may have ended up in the embankment fill during construction, contributing to the high rates of settlement.**

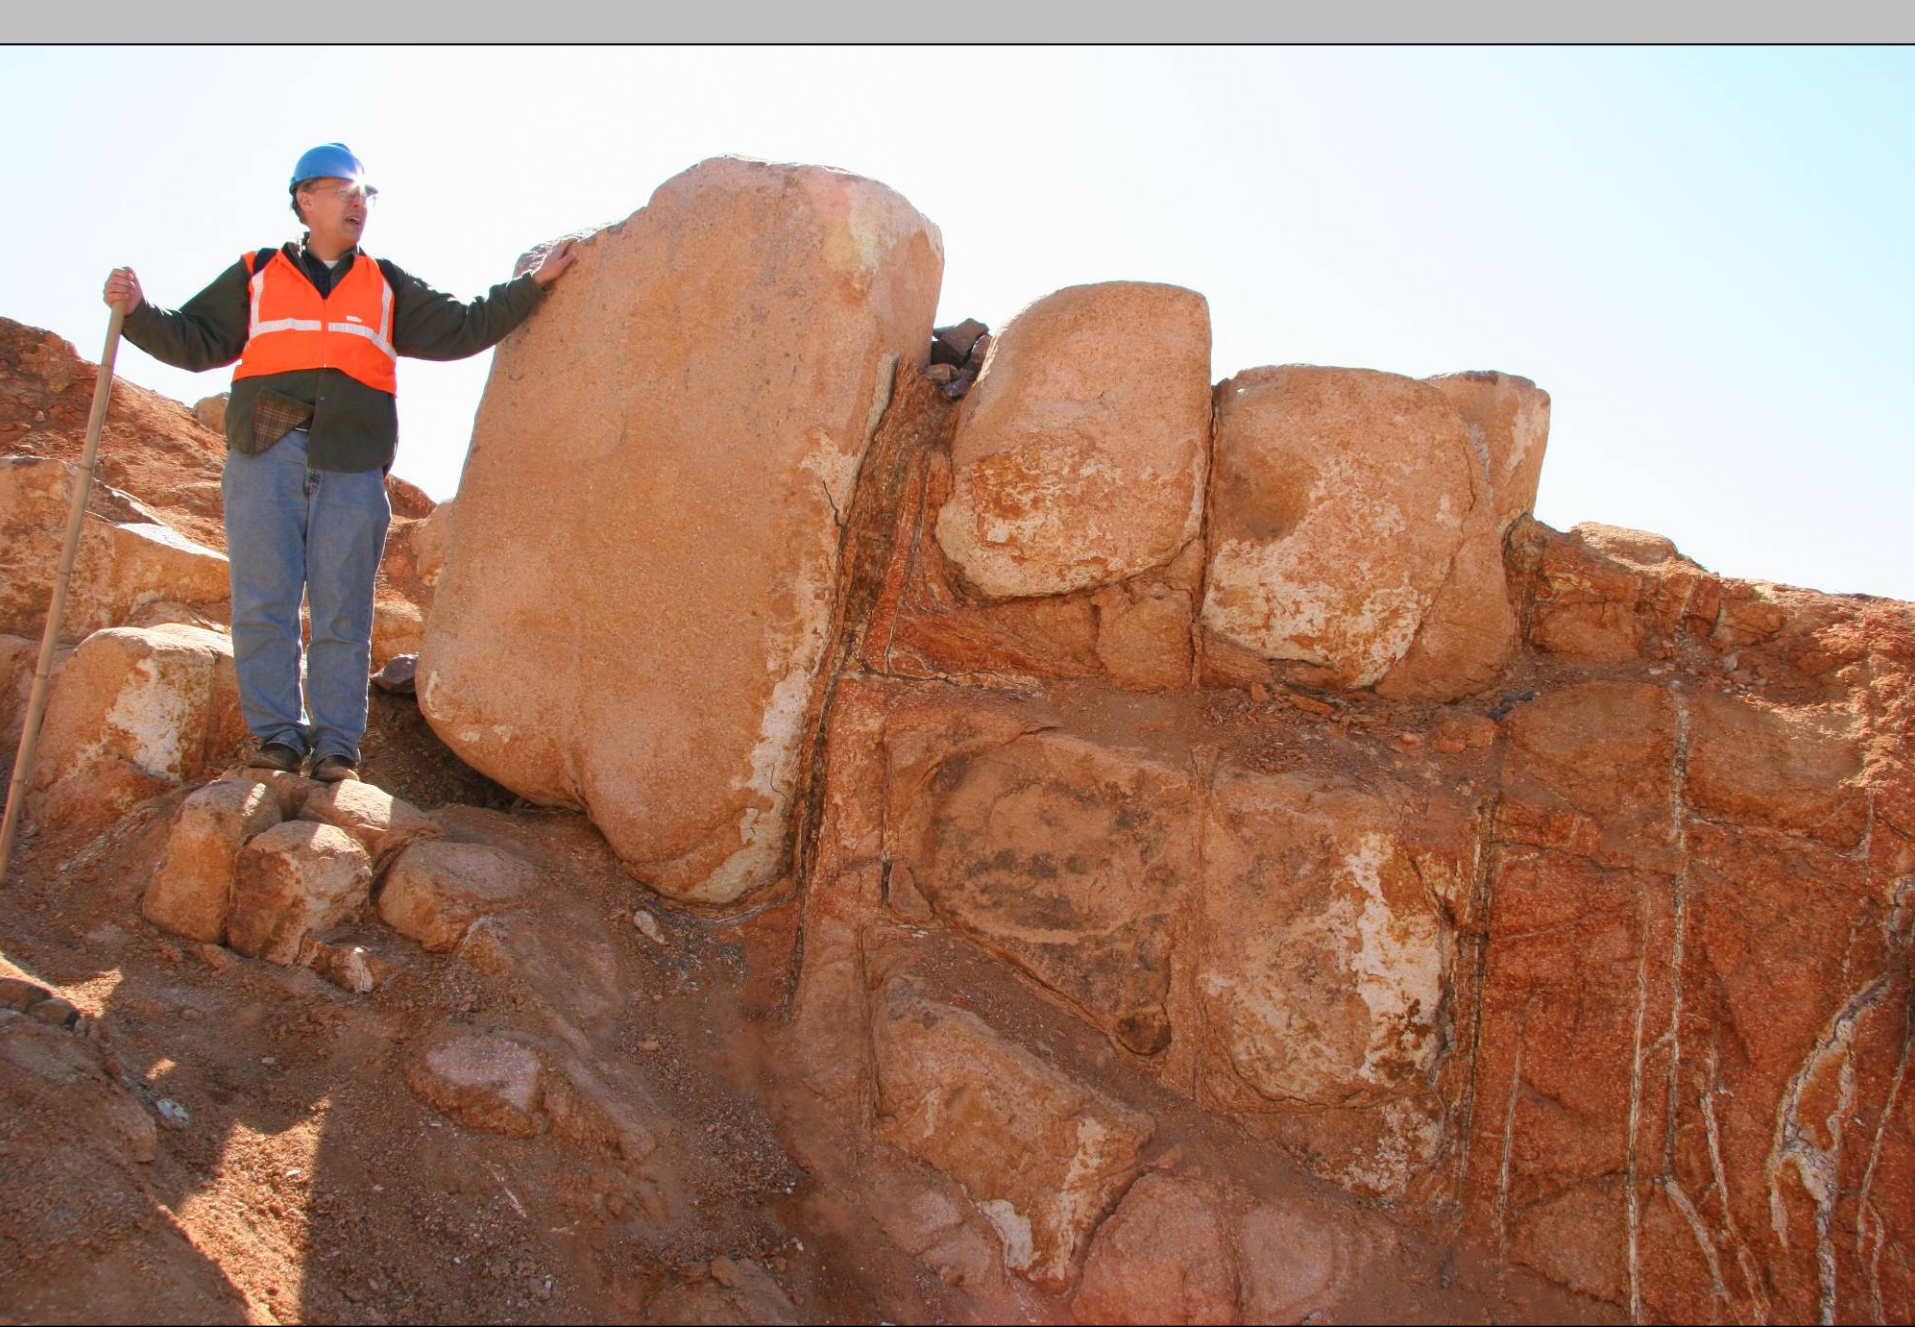
**This diabase dike (or sill) on the upper slopes of Proffit Mountain weathered to a weak soil-like material yet retained the rock's original fabric and fracture pattern.**

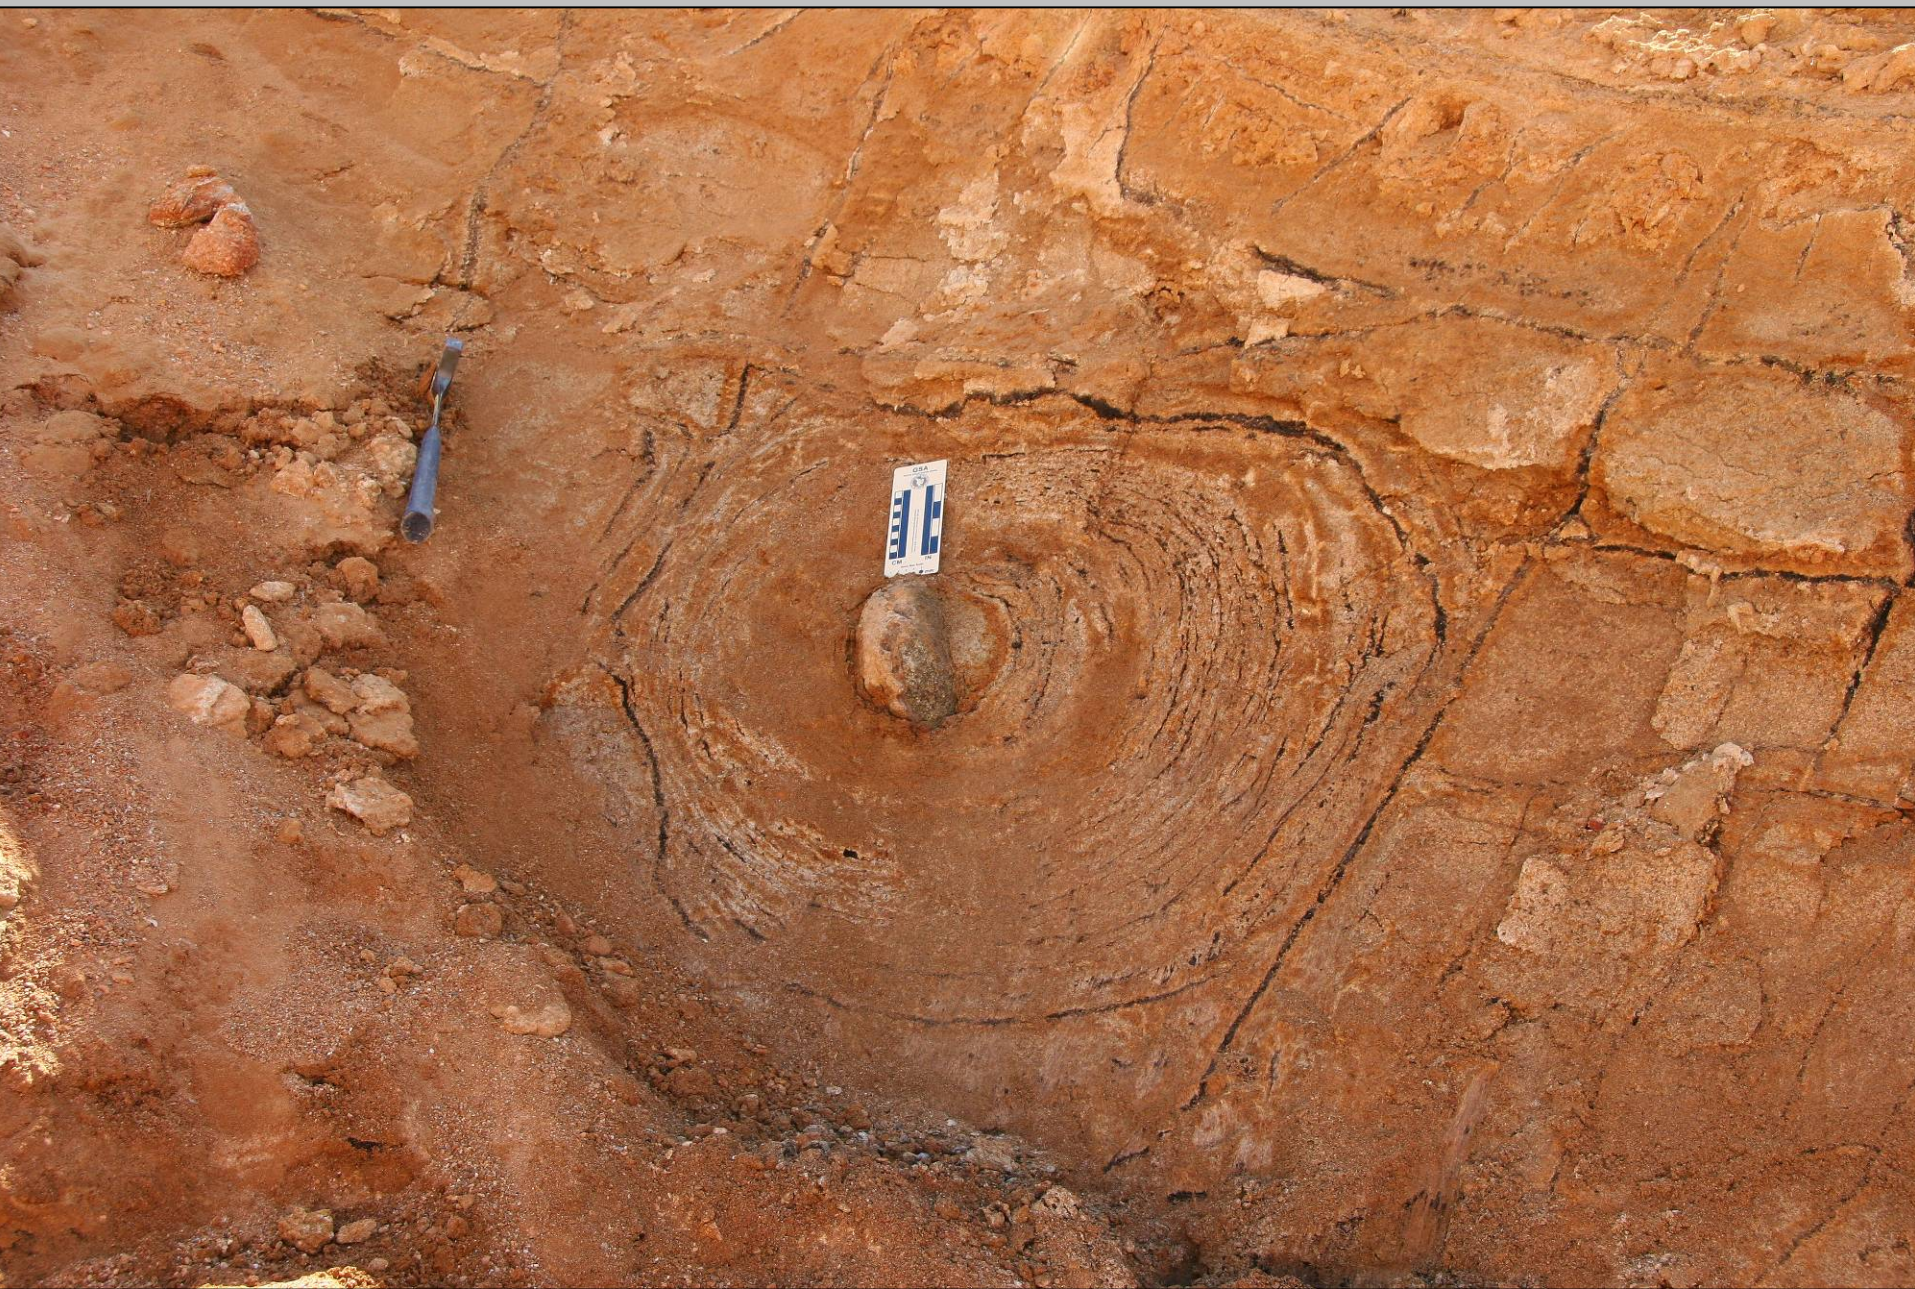
**Core stone and remnant spheroidal weathering rind in the saprolite matrix.**

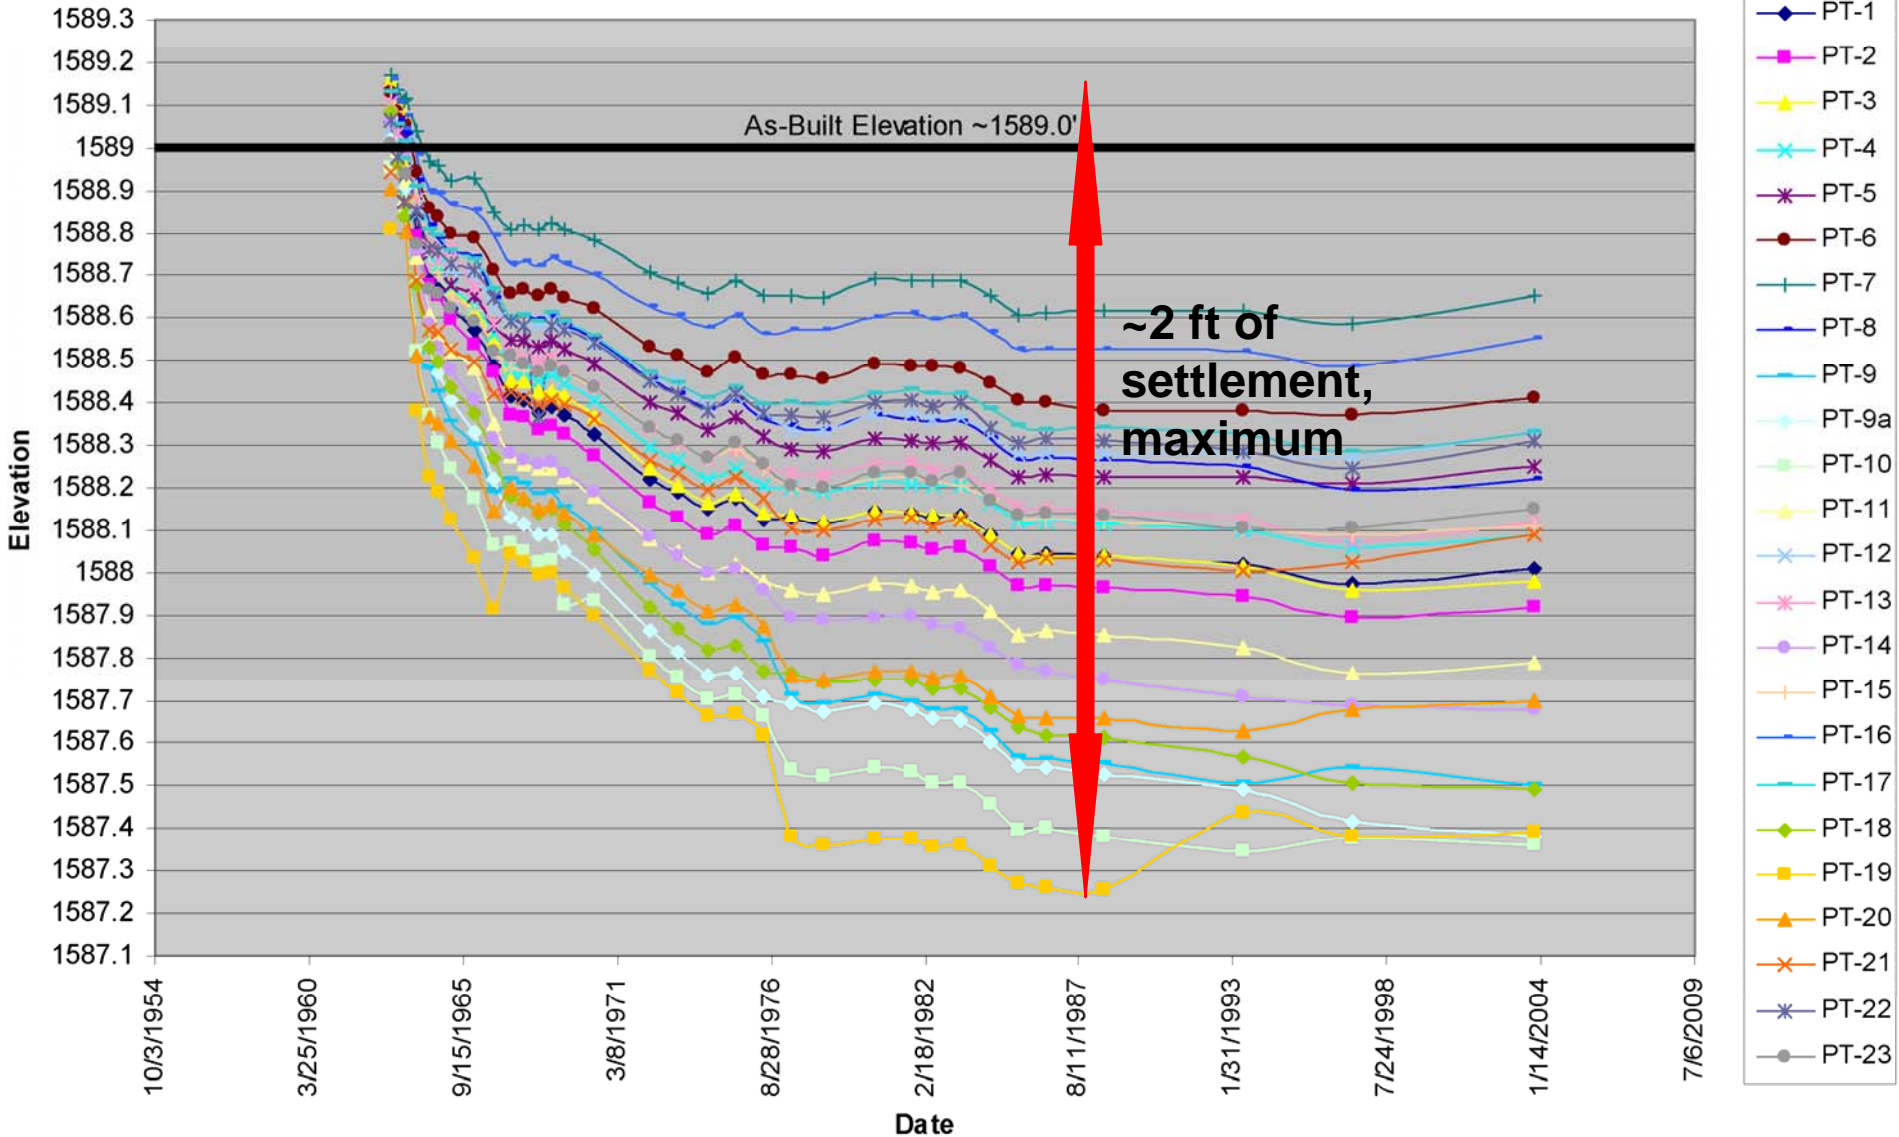
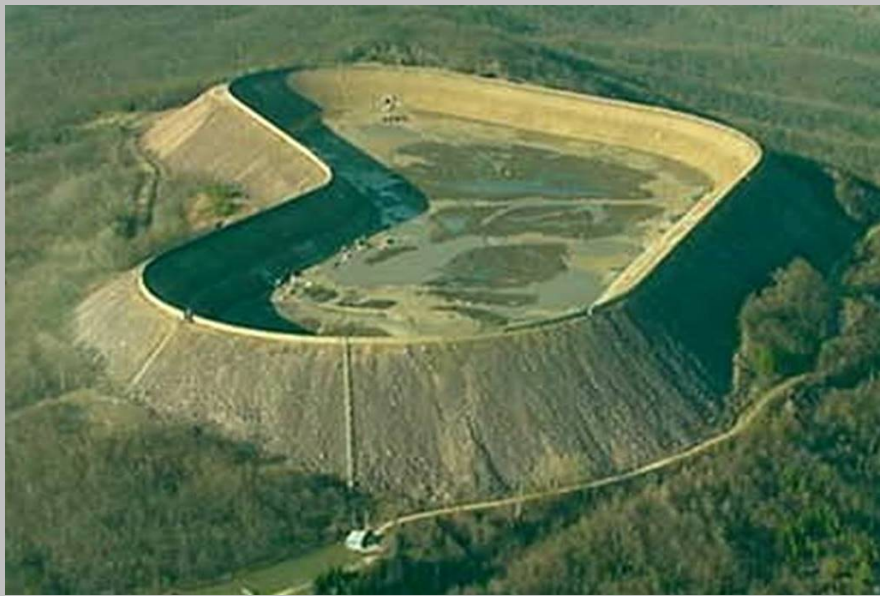
Total History  
Taum Sauk Pin Elevations

- The Taum Sauk embankment settled 0.50 to 0.8 ft in the first 4-1/2 years; between 0.53% and 0.73% of the embankment height.
- In 1967, J. Barry Cooke noted that the observed settlements were without precedent for a rockfill embankment, concluding that *“frequent zones of soft weathered rock”...“could not have been selectively wasted”* and that *“I believe that a fill of 100% competent rock would have stabilized and that the percentage of weathered rock in the Taum Sauk is the cause.”*
- According to Cooke’s 1967 review, the average settlement of 0.1 ft/year during the first 4-1/2 years was unexpectedly high and without precedent.

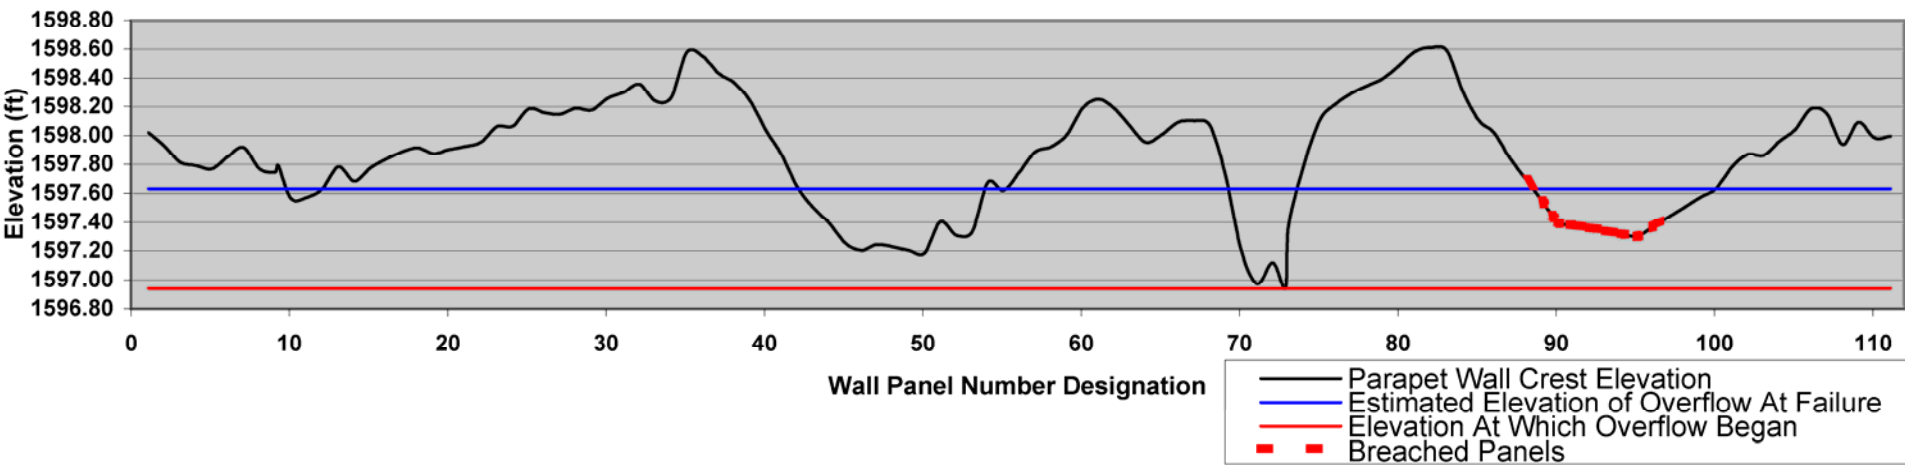
## Taum Sauk Upper Reservoir Parapet Wall Crest Elevation

- The upper reservoir was designed to have a 2' freeboard from the water surface to the top of the parapet wall.
- A staff gauge installed on the inside of the concrete parapet wall during construction had settled ~1 foot over the years.
- The old gauging system was operated relative to the staff gage so freeboard remained constant throughout the years, even with the settlement.
- The NEW gauging system was operated in terms of **absolute elevation**, which is 1' higher than the elevations stated on the staff gage. This resulted in the 1' reduction of freeboard.

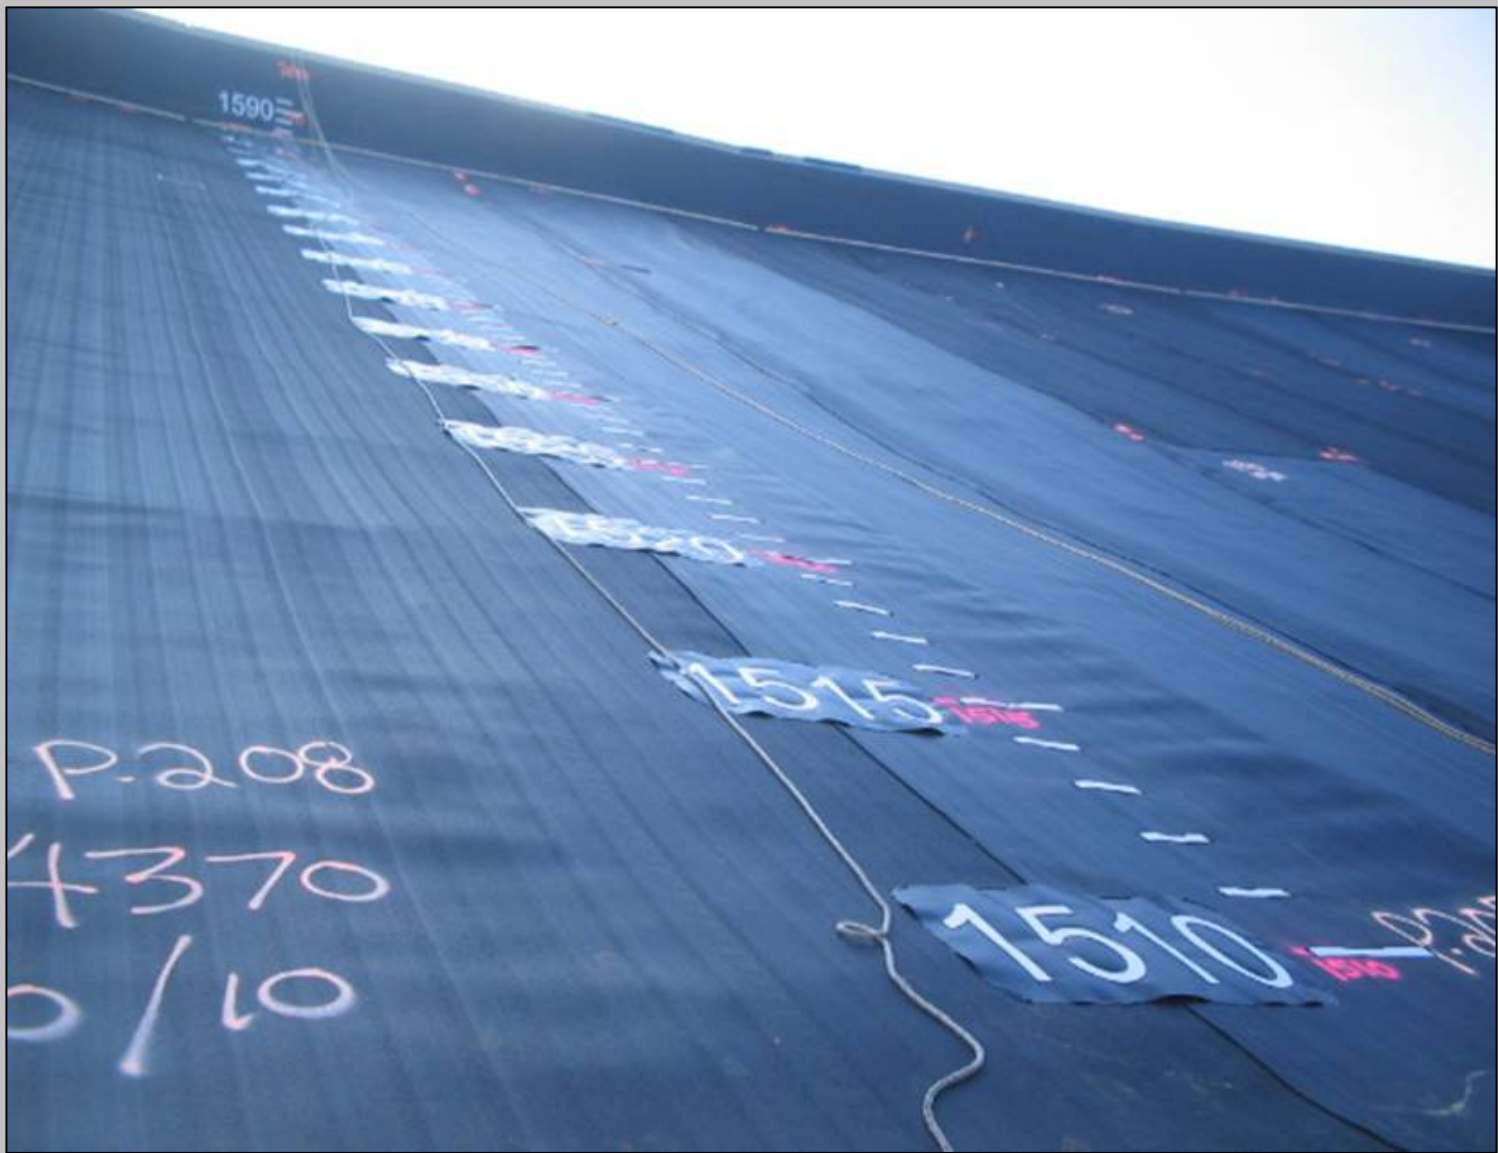
- **Throughout its life, the upper reservoir leaked. This leakage helped provide swimmers at Johnson's Shut-ins with a steady source of water during dry summers.**
- **Some leaks were serious and resulted in the shut-down of the plant during their repair.**
- **Most leaks were related to the cracking of the reinforced concrete liner as the underlying rockfill settled differentially.**
- **Leakage was reducing the efficiency of the operation by about 2% and the reservoir was lined with an HDPE geomembrane in fall 2004. This reduced leakage dramatically.**

**In 2004 AmerenUE installed an HDPE geomembrane liner to retard ongoing seepage losses from the upper reservoir, at a cost of ~\$2.4 million.**

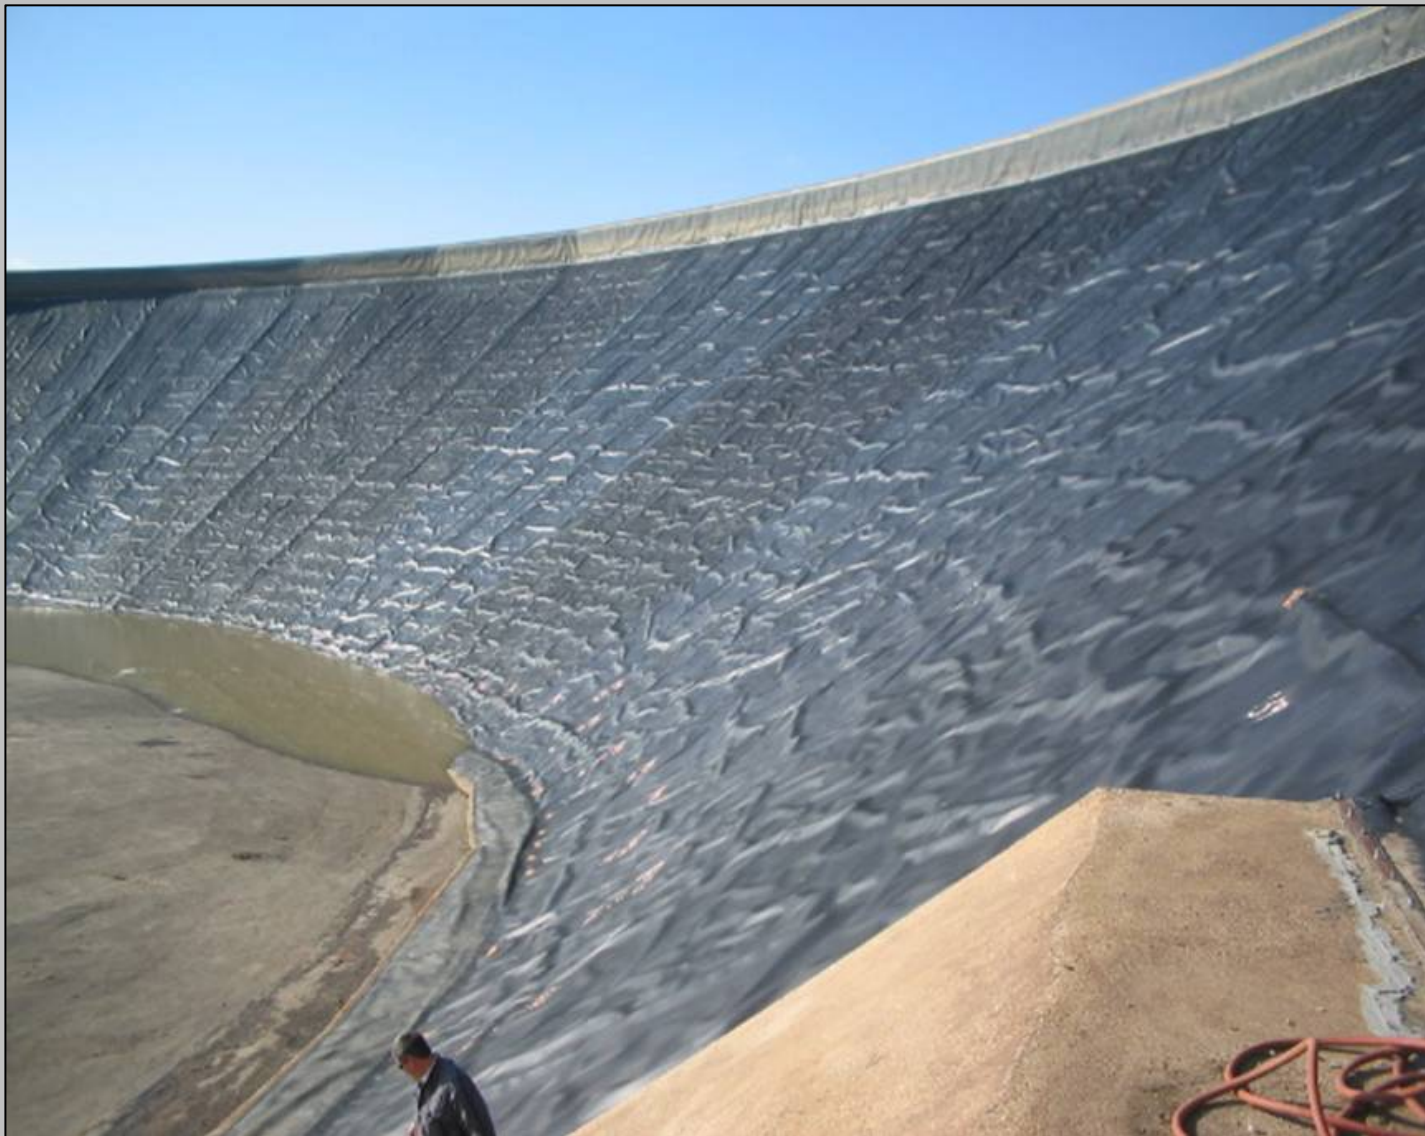
**GSI supervised the placement of 1.3 million square feet of 80 mil HPDE textured geomembrane and geocomposite material. They also covered five rock outcroppings on the side slope with 80 mil textured LLDPE material.**

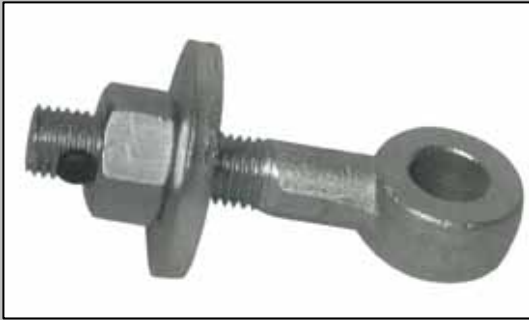
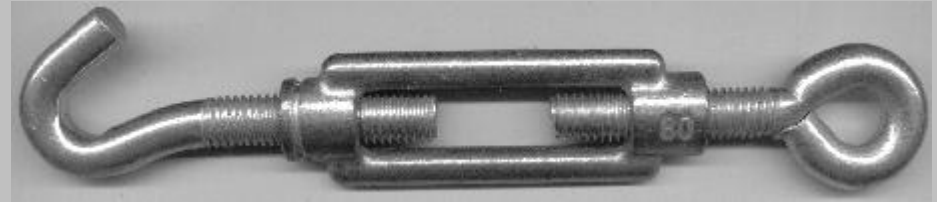
**Eye Bolt**

- **An untensioned steel cable was to be anchored to the top and bottom portions of the concrete lining with eye bolts, like that shown left above. The concrete ballast pipe was removed. Since a fourth pipe was already on site, it was installed as a spare, without anything inside.**
- **During placement, the eye bolts were discarded in favor of turnbuckles (right above), so the steel cable could be tensioned.**
  - 1. The turnbuckles loosened during cyclic loading caused by the filling and emptying to the reservoir, allowing the tubes to work themselves free.**
  - 2. The omission of a ballast pipe allowed the sensor tubes to move and deflect much more easily.**
- **These attachment details were not subjected to external peer review. Last minute connection details often prove to be problematic.**
