# **OVERVIEW OF THE TAUM SAUK UPPER RESERVOIR FAILURE**

**December 14, 2005**

**Reynolds County, Missouri**

**University of Missouri-Rolla**

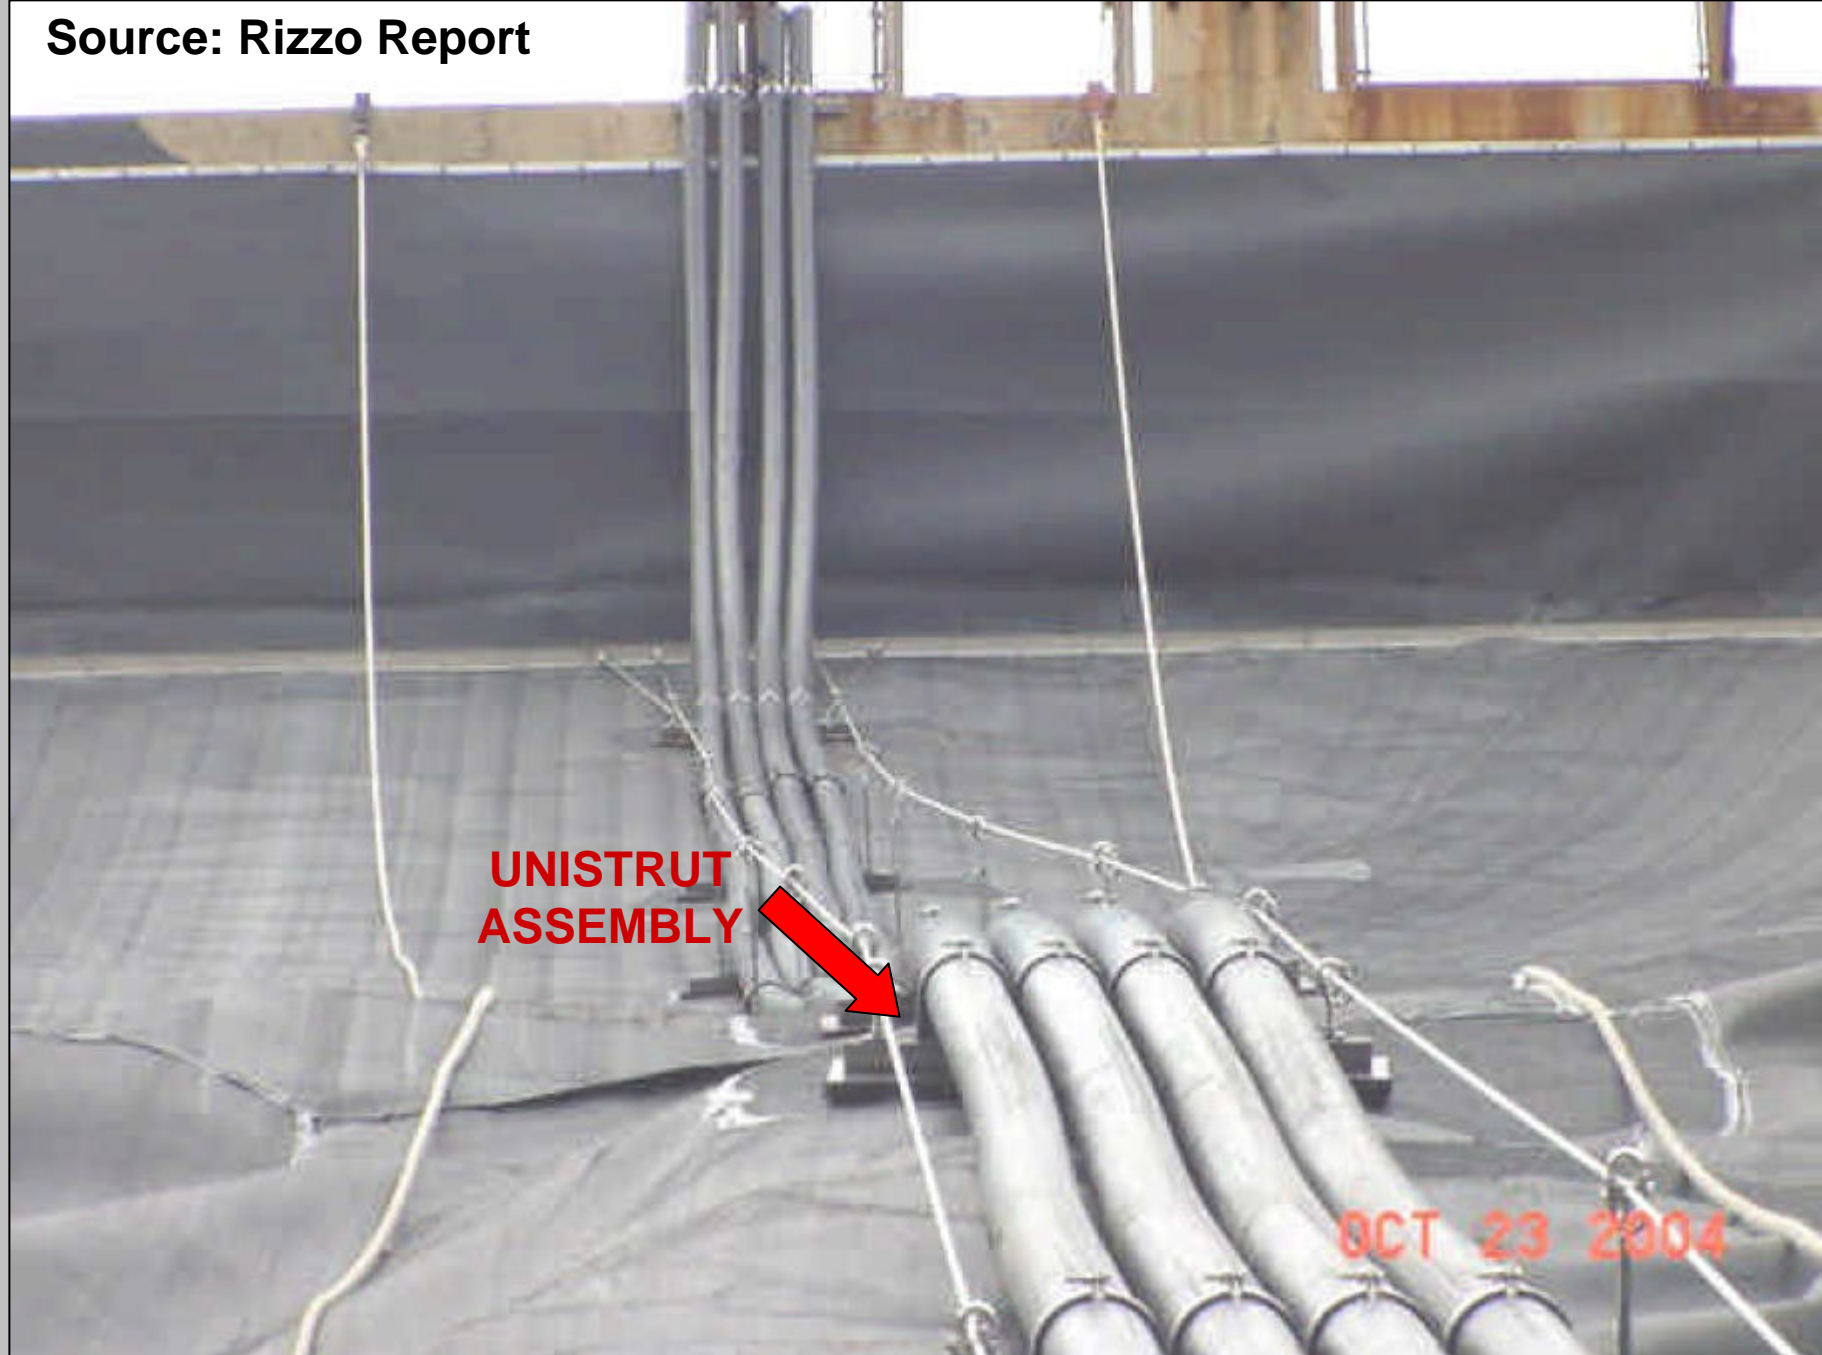
**Sensor pipes as constructed at Taum Sauk Upper Reservoir in 2004**

- The four pipes were held bound together by four U-bolts fastened to a piece of hardware called a unistrut. This hardware came apart as the turnbuckles loosened, allowing pipes to separate. This reduced the cumulative stiffness of the pipes, allowing them to deflect easier under the cyclic loading of reservoir filling/draining.

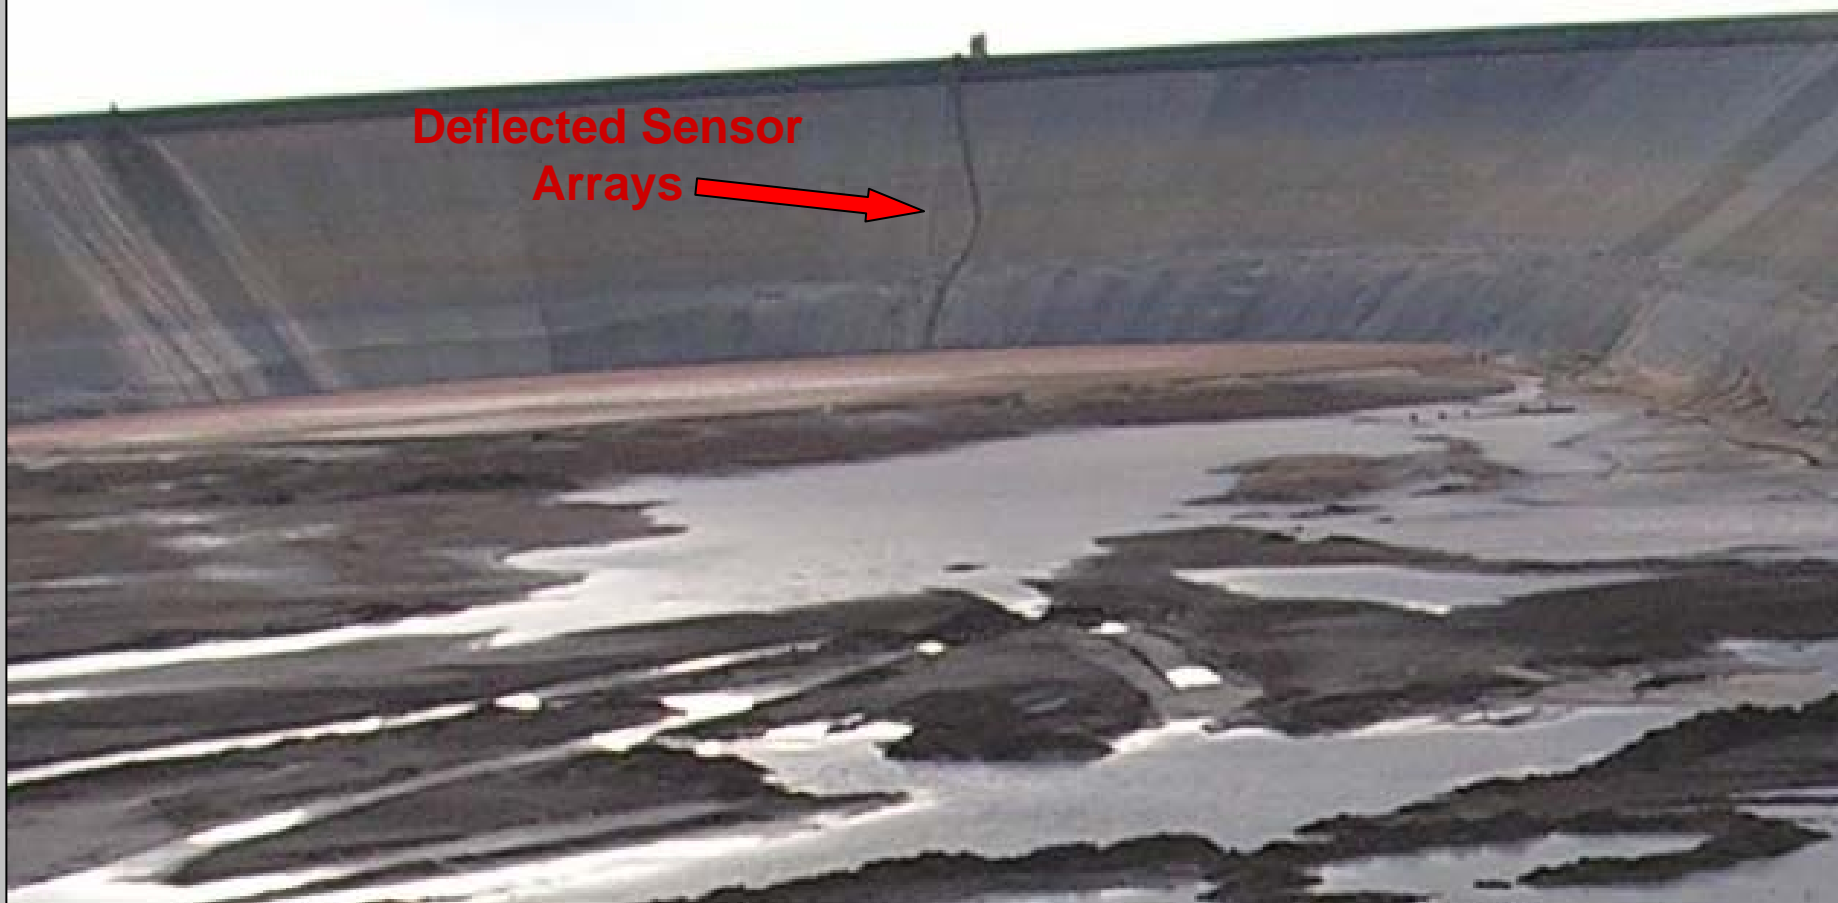
**Deflected Sensor  
Arrays**

Rock cut-fill transition

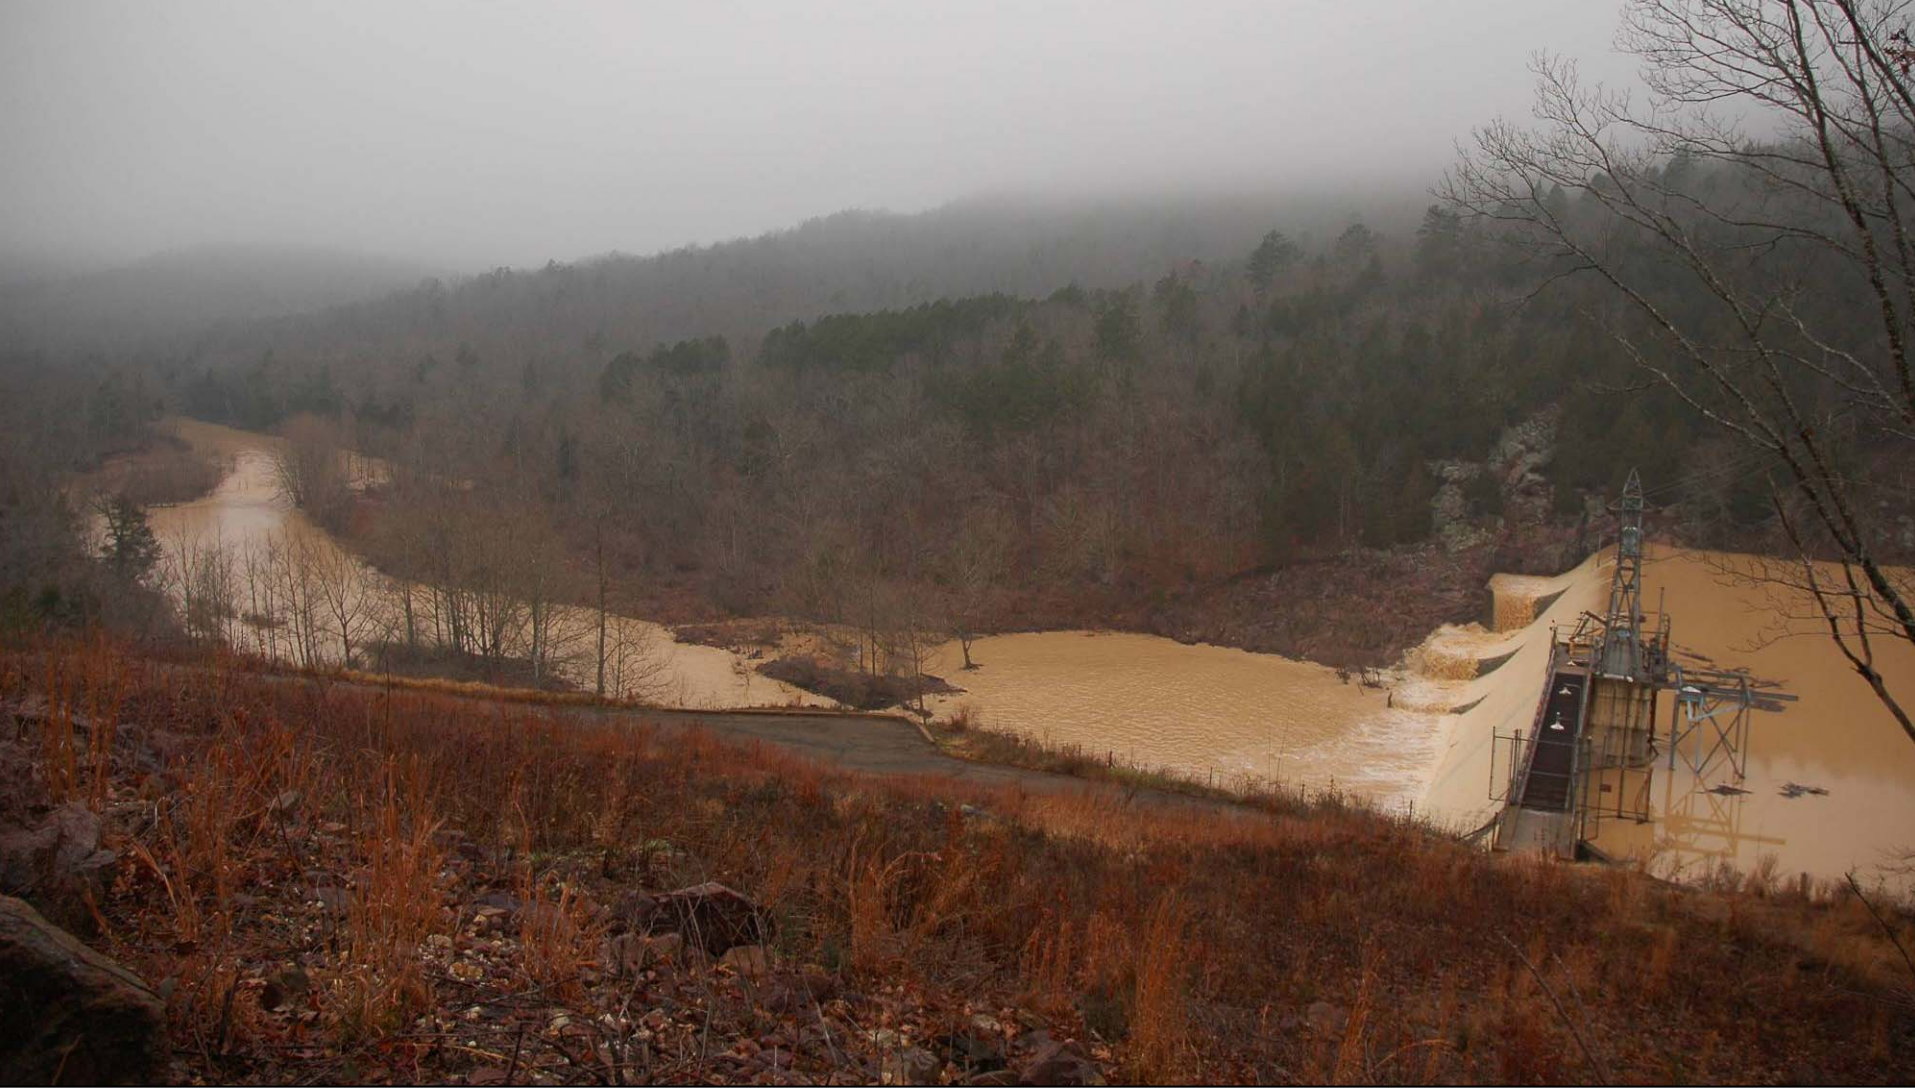
**The lower reservoir had been pumped down to fill the upper reservoir the night before. The partially empty lower reservoir captured much of the flood and associated debris, saving downstream towns such as Lesterville from the devastation although muddy water clouded the normally clear Black River. Had this reservoir not been present or also failed, downstream damage would have been much worse.**
