The 2005 Upper Taum Sauk Dam Failure: A Case History

J. DAVID ROGERS¹

Key Terms: *Dam Failure, Residuum, Fill Contamination, Overtopping-Induced Erosion*

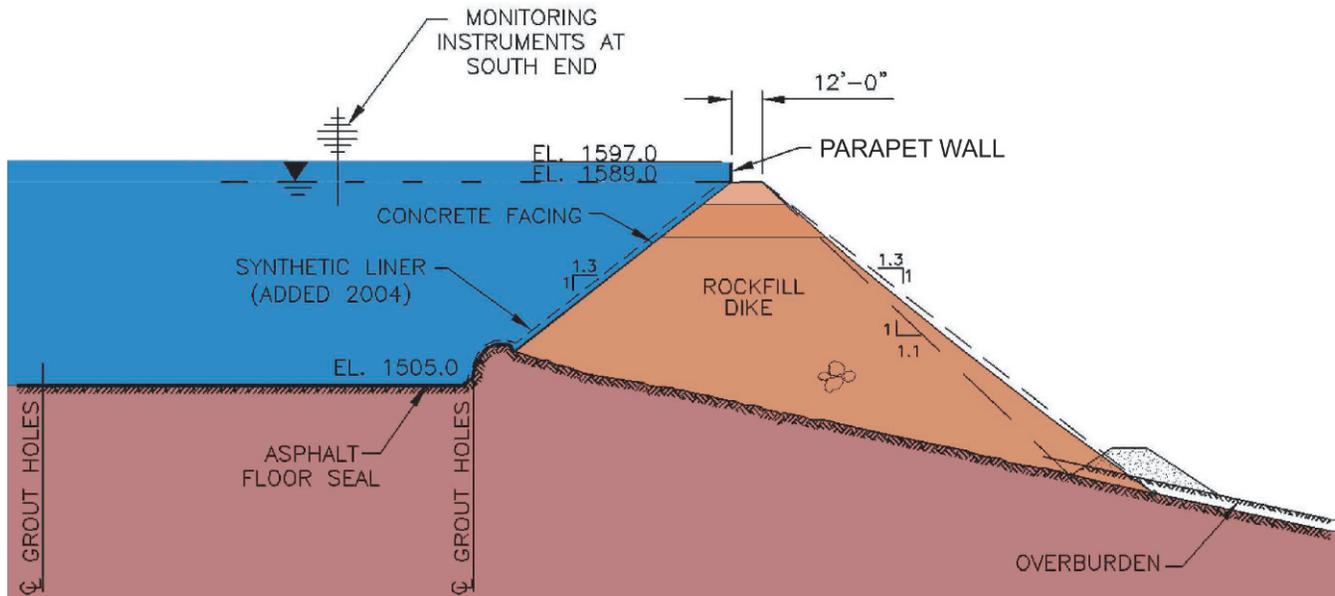
Figure 5. Typical section through the Upper Reservoir dike, illustrating how much of the dike was founded on a descending bedrock surface. Side slopes were to have been 1.3:1 (horizontal to vertical). Subsequent measurements show that the inboard side of the dike was most often inclined at 1.4:1 (Luna et al., 2007). The random rock and soil fill was end-dumped and sluiced, using a hydraulic monitor. Only the uppermost 16 ft (4.9 m) of the dike was placed using roller compaction.

sprayed with a jet of water to help consolidate the mass and fill in voids. The embankment materials were not mechanically compacted until the upper 16 ft (4.9 m) of fill, which was compacted in four separate 4-ft-thick (1.2 m) lifts. According to the report by the Federal Energy Regulatory Commission (FERC, 2006), this was the “last uncompacted concrete-faced rock-fill dam” constructed in the United States. The boundaries between the different methods of fill placement were easily observed in the breached section of the embankment after the failure (see Figure 7).

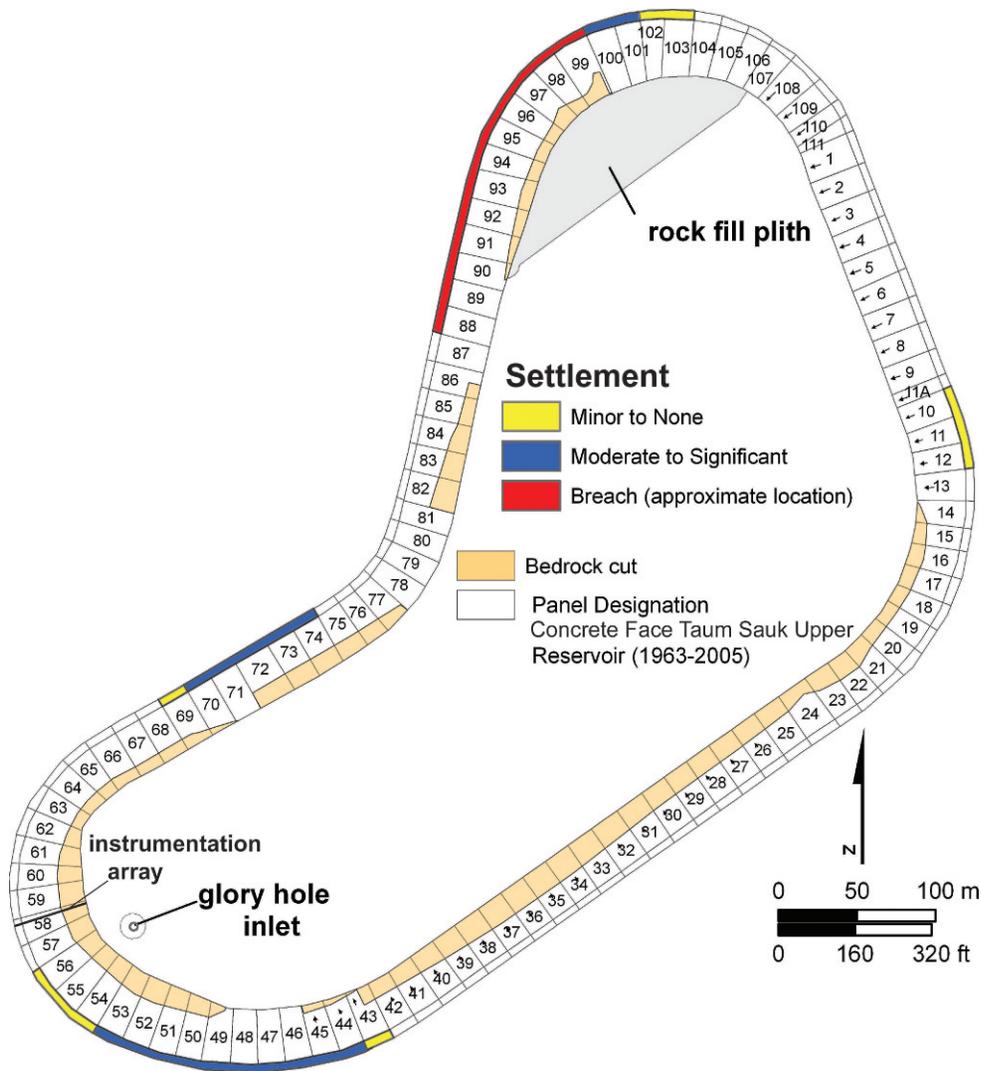
Figure 6. Plan view of Taum Sauk Upper Reservoir, showing all 111 concrete panels lining the inside face of the circular dike, which was capped by a 10-ft-high (3 m) cantilever retaining wall. The colored areas denote those portions of the wall that were overtopped on the morning of December 14, 2005. Note the variable height of cut on the inboard toe of the dike and height of embankment on the outboard side. Leakage and settlement problems manifested themselves between panels 89 and 107 in 1963–64, in the vicinity referred to as the “plinth” by FERC’s Taum Sauk Investigation Team (2006).

referred to in the descriptions that follow. Figure 6 also shows the locations where overflow occurred (shown in yellow and blue) and the breach that drained the reservoir (shown in red).

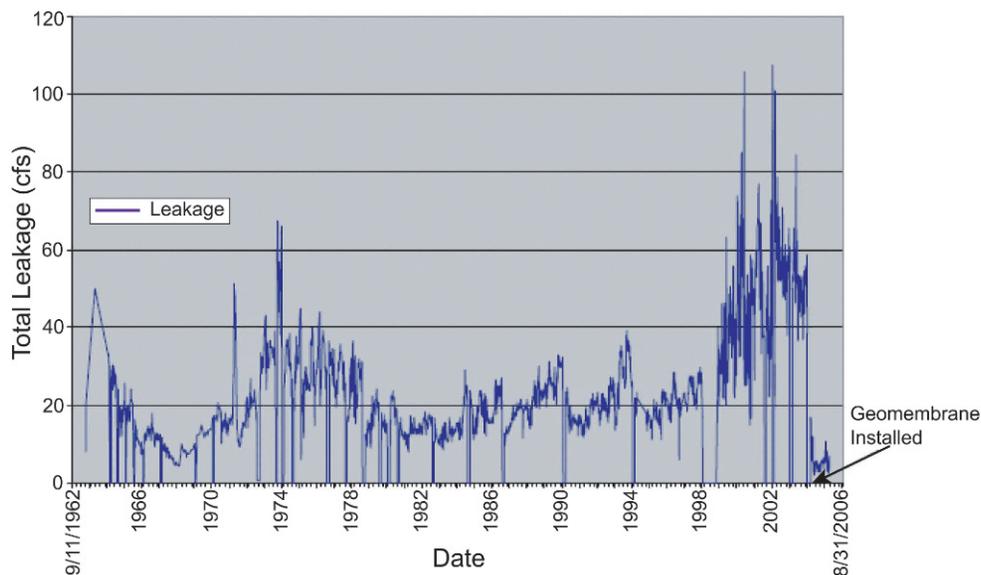
Between 1964 and 1999, the Upper Reservoir experienced repeated episodes of accelerating leakage that necessitated the employment of mitigation measures. These remedial measures periodically reduced the losses to acceptable levels, usually between 18 and 50 cfs (0.51 to 1.4 m³/s) (Figure 9). In 1999, the project utilization underwent a three-fold increase, to two cycles of filling and draining about 70 percent of the reservoir volume ~300 days per year. This change in the operation tempo soon exacerbated the leakage problems, triggering increased losses of between 100 to 300 percent (Figure 9). By mid-2000, the Upper Reservoir was losing about 110 acre-ft

Figure 9. Leakage from the Upper Reservoir exhibits a gradual upward trend until the basin was lined in 2004, dramatically reducing seepage losses (taken from FERC Independent Panel of Consultants Report, 2006).

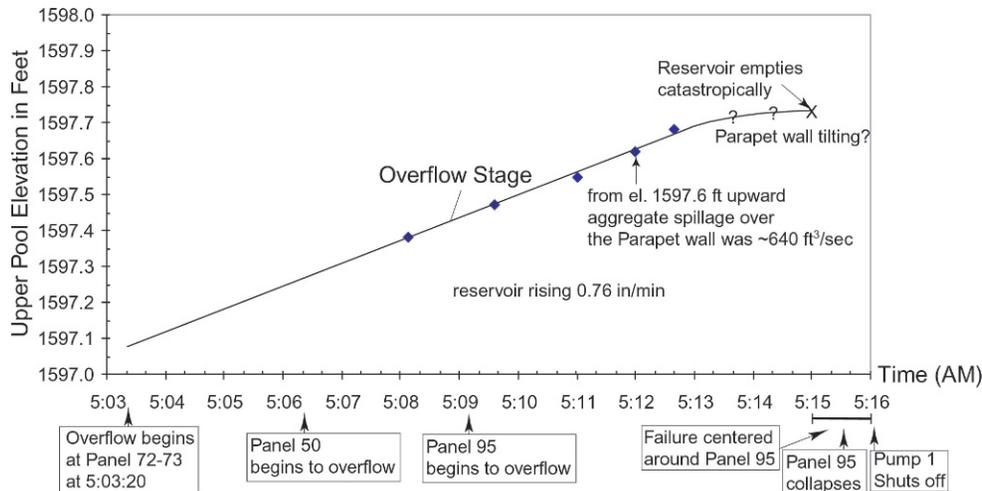
Figure 11. Reconstruction of Upper Reservoir stage versus time during the interval when the reservoir breached, between 5:03 and 5:16 AM on December 14, 2005. Note how the three principal zones of spillage began at 5:03, 5:06, and 5:09, with the last zone being the one that undercut the parapet wall first. The wall toppled over just about the same time that the last pump shut down.

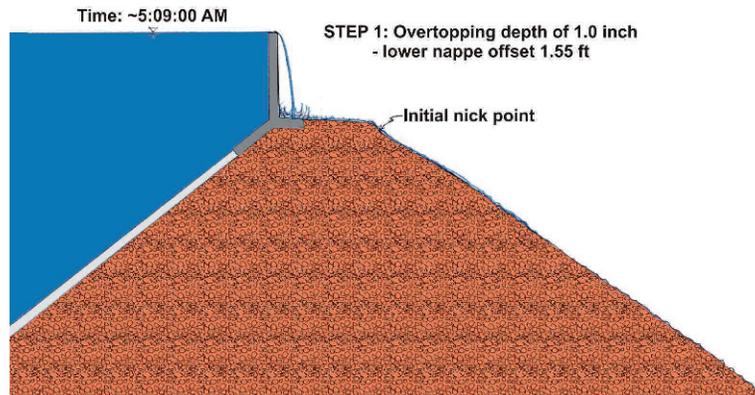
Figure 15. This presents the first figure from the reconstructed failure sequence illustrating the onset of overtopping around 6 minutes prior to failure. Water is spilling onto the 3-ft-wide (91.44 cm) parapet wall footing and just beginning to erode the crest of the embankment.

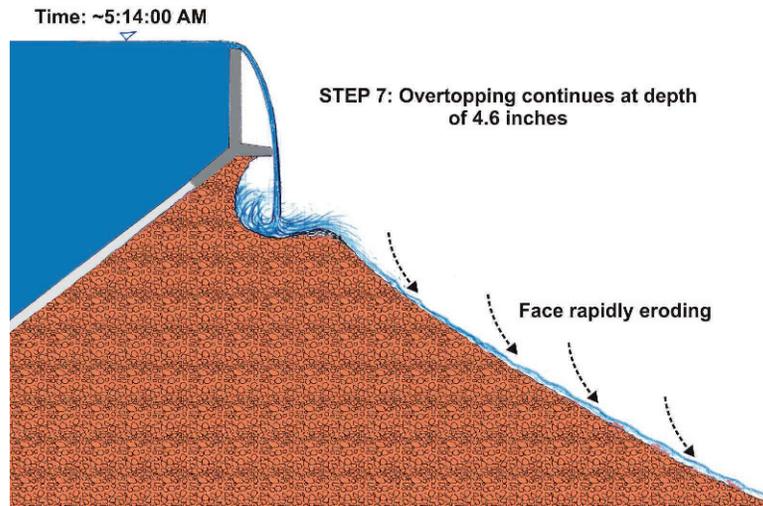
Figure 16. This step of the reconstructed failure sequence illustrates the undermining of the parapet wall and rapid erosion of the upper embankment. The wall remained standing at this point due to the hydrostatic load on the inclined portion of the wall footing and three-dimensional effects engendered by the adjacent panels.

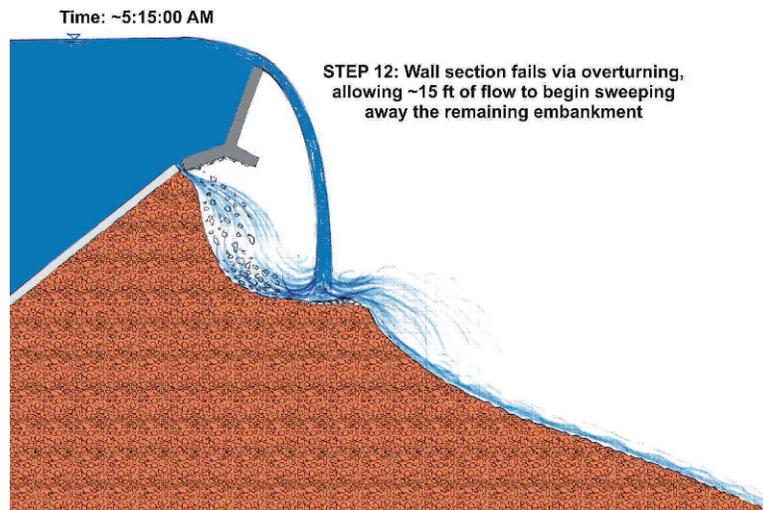
Figure 17. This step portrays how the parapet wall likely toppled in vicinity of panel 95, initiating the catastrophic failure of the reservoir by suddenly unleashing approximately 15 ft (4.6 m) of flow over the remaining embankment.

schematically in Figure 17. These combinations would suggest that the impact velocities likely began around 26 ft/s (7.87 m/s) and increased to as much as 44 ft/s (13.4 m/s), which would be expected to erode rock rip-rap (Figure 28). In this manner, the rapid excavation of the “plunge pool” immediately beneath the embankment crest would be expected.

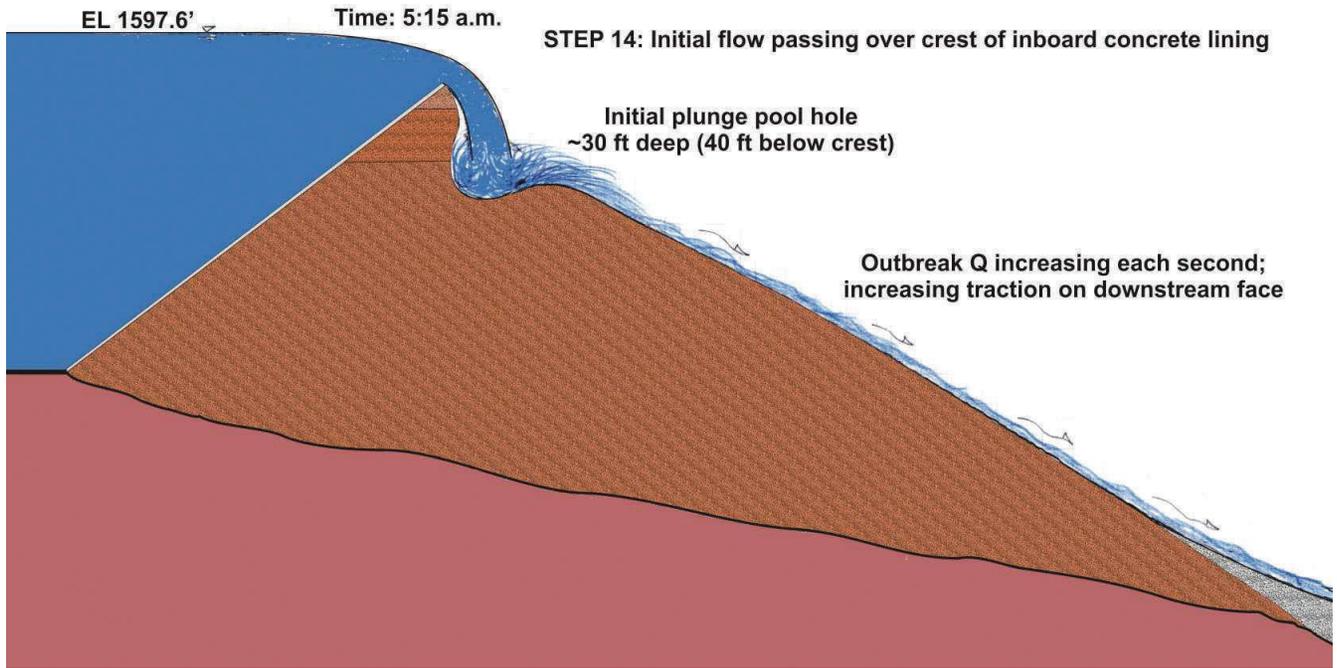
Figure 18. This figure illustrates approximately 15 ft (4.6 m) of water overflowing the embankment immediately after toppling of the parapet wall. The reinforced concrete liner behaved as a thin-crested weir, promoting the formation of a deep plunge pool.

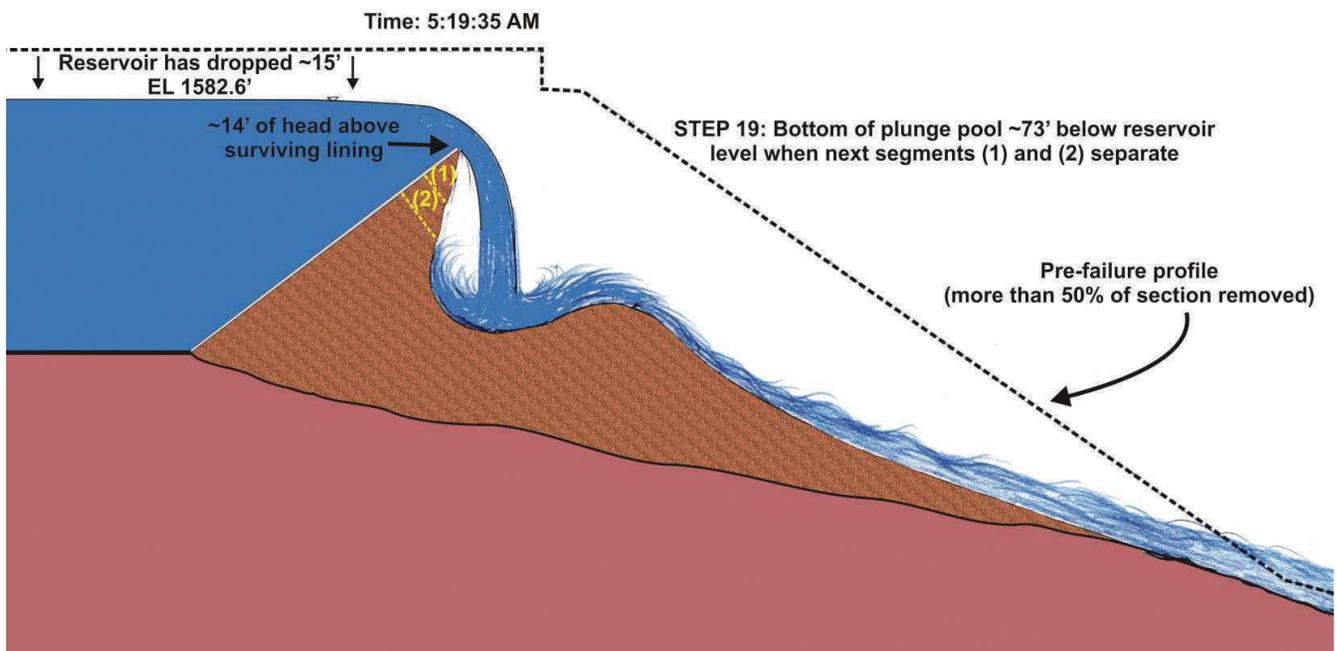
Figure 19. The embankment and concrete liner are progressively removed by the outflow. About half of the embankment remains at this stage.

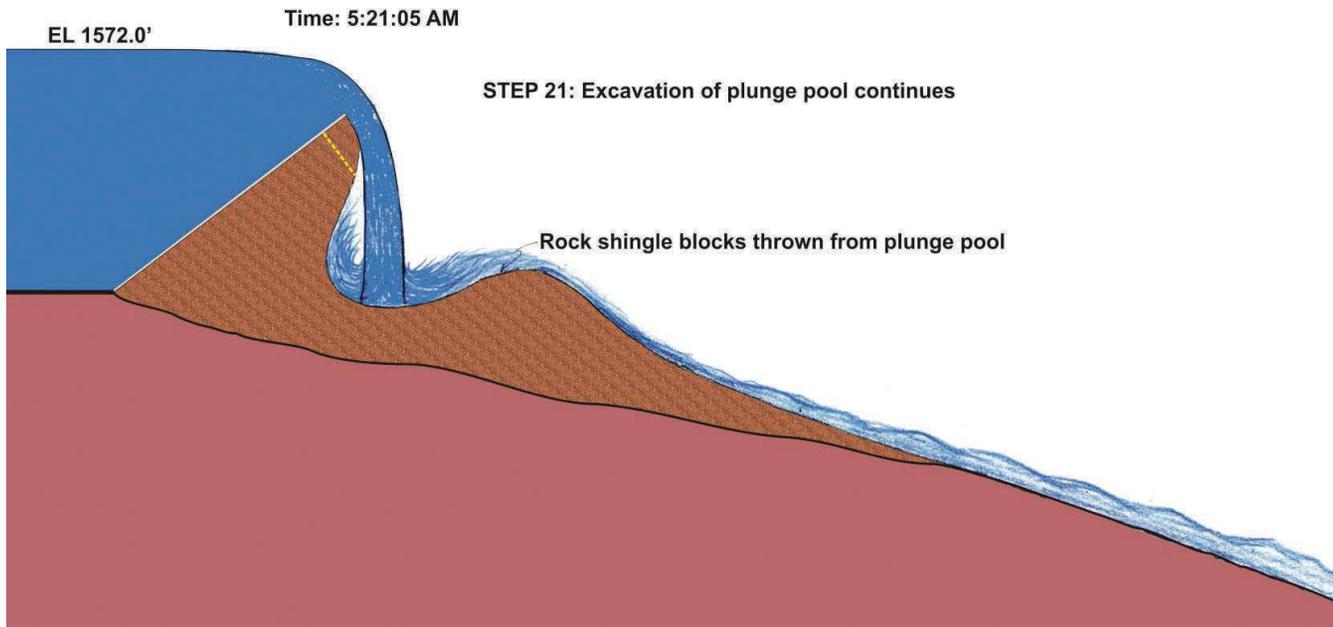
Figure 20. A continuation of the sequence shows deepening of the plunge pool and ejection of large shingle blocks/boulders from the plunge pool.

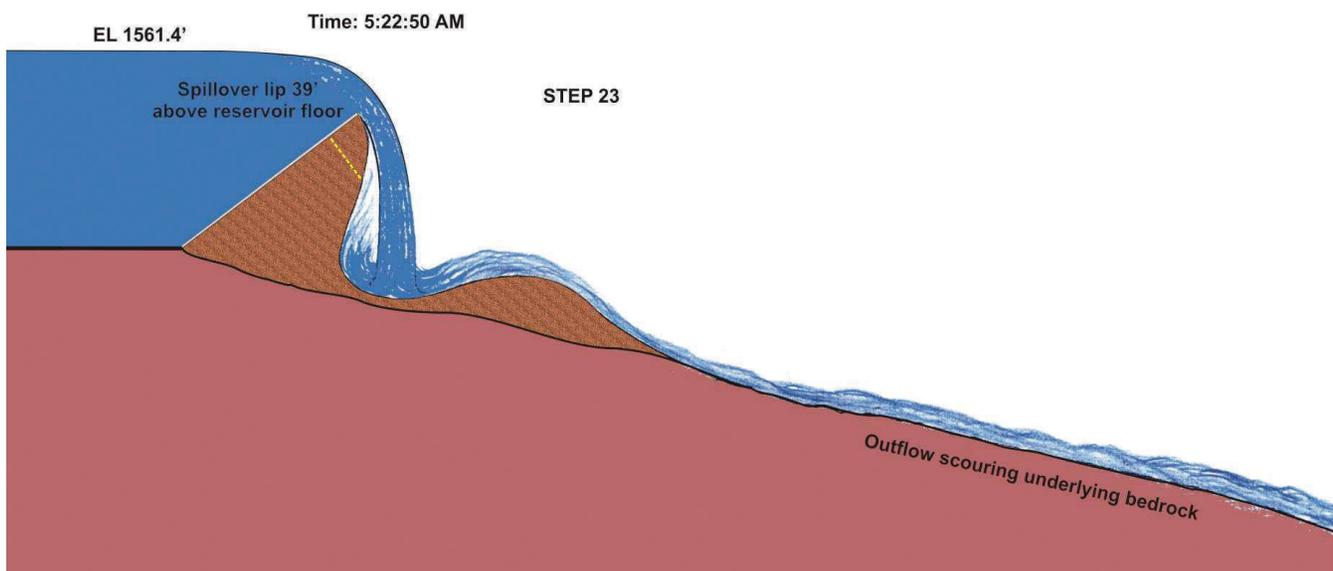
Figure 21. The plunge pool deepens toward the foundation interface and outflow has exposed much of the underlying bedrock, which is then scoured, exposing zones of saprolite.

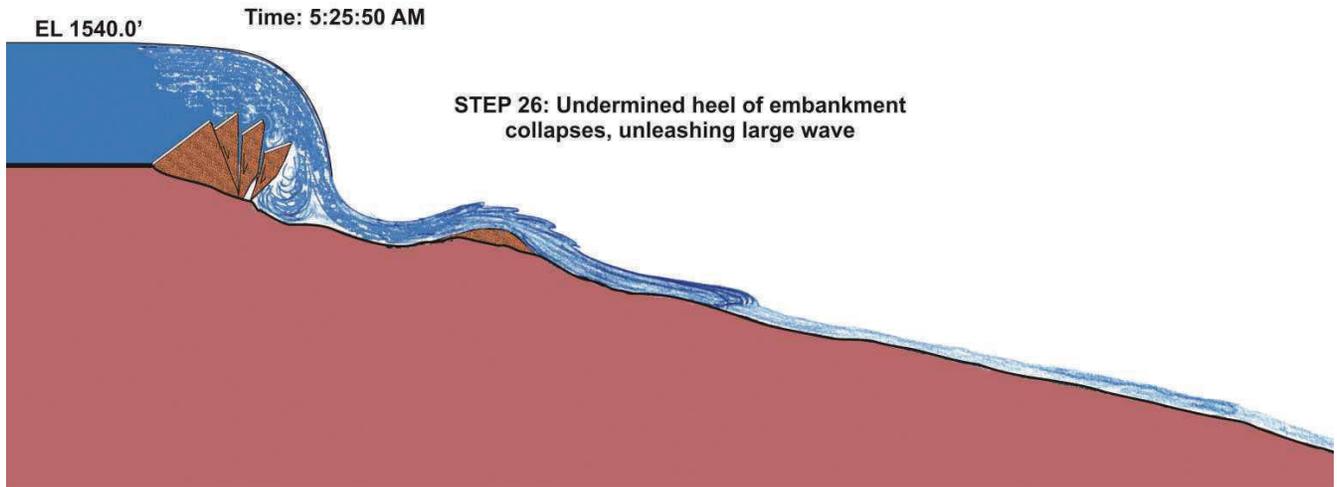
Figure 22. The embankment undergoes one last block collapse involving the concrete liner, sending one final surge down the mountain side, which deposits a coarse imbricate layer over finer-grained strata in the natural swale below.

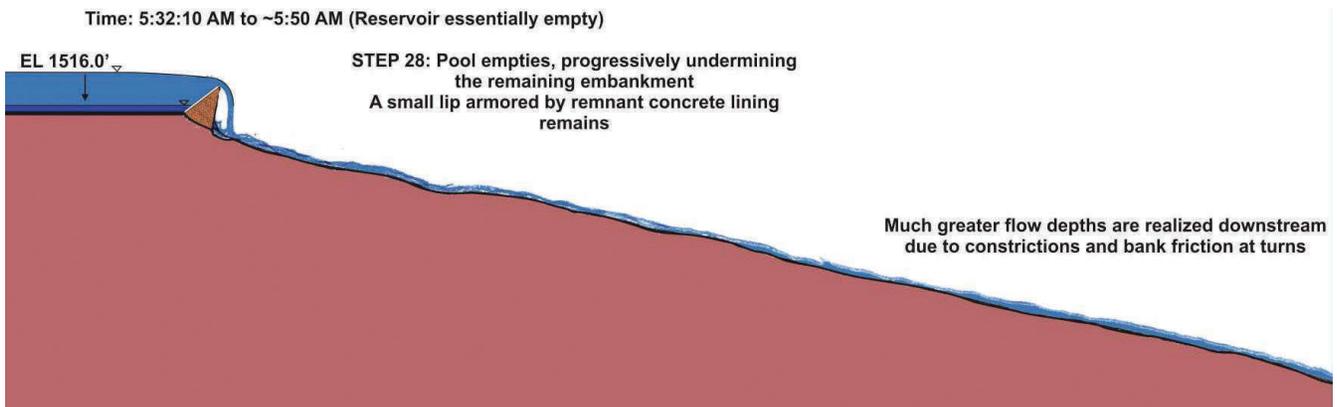
Figure 23. A small lip formed by the concrete liner armored the final last remnants of the embankment. Several feet of water remained in the basin formed by the “plinth” in the northwest corner of the Upper Reservoir.

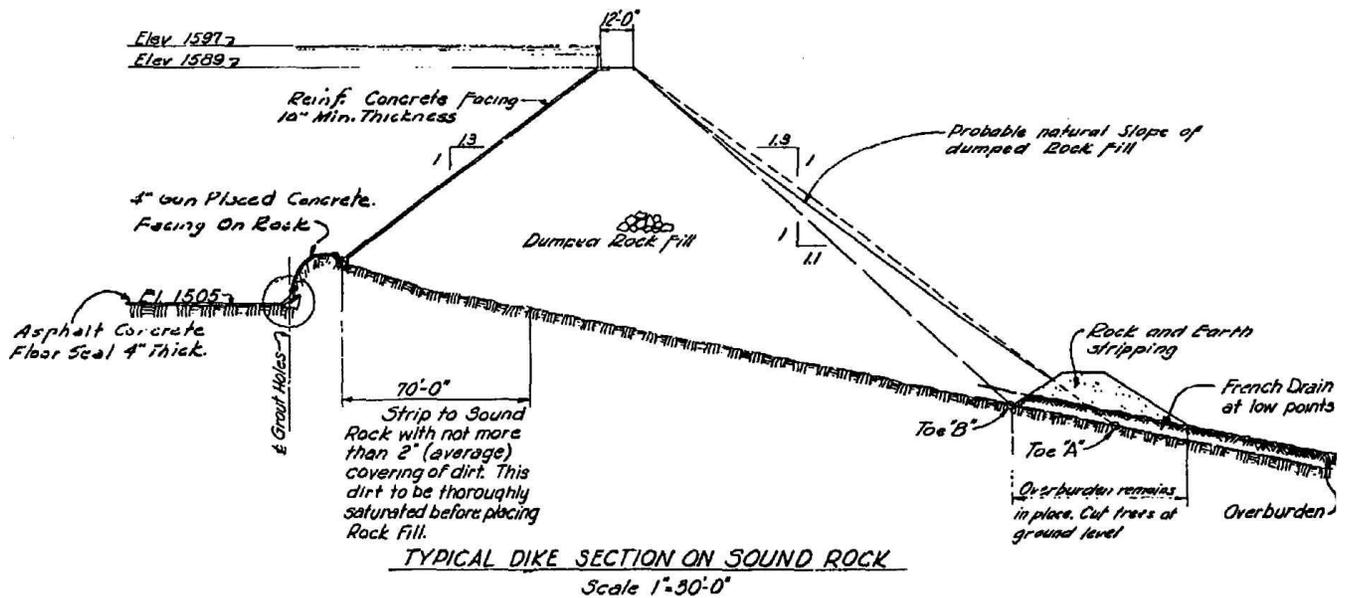
The design section for the original embankment (Figure 26) indicated that only the surficial cover was to be removed, leaving no more than 2 in. (5 cm) of soil or residuum in place. This recommendation assumed that everything beneath the soil would

As mentioned previously, the design specifications only specified stripping of surficial soil cover to minimum thickness of 2 in. (5 cm) over the bedrock (Figure 26). The specifications also note that the remaining soils were to be saturated prior to placement of rock fill. Post-failure investigations included exploratory drilling through the embankment-foundation interface to ascertain the character of the contact. These borings revealed that up to 18 in. (46 cm) of residual soil had not been stripped off prior to placement of the rock fill in some locations. Soils containing tree roots and other organic matter were also observed beneath the breached section of the embankment (see Figure 31). This oversight likely exacerbated some of the seepage the project suffered during its initial year of operations, when the reservoir floor across this “plinth area,” behind panels 89–107 experienced problems with seepage caused by uplift and heave of the reservoir floor. The entire floor of the reservoir had originally been paved with two 2-in. (5 cm) layers of asphalt to curtail infiltration. However, as soon as the reservoir was filled, they began experiencing problems with seepage through cracks that developed in the asphalt, especially in the “plinth” area abutting the northwest corner. Between August 1963 and May 1964, leakage

Figure 26. Typical section through the rock-fill dike where it was assumed to be founded on sound bedrock on a descending grade, taken from the project specifications in 1959–60 (from FERC Taum Sauk Investigation Team, 2006).

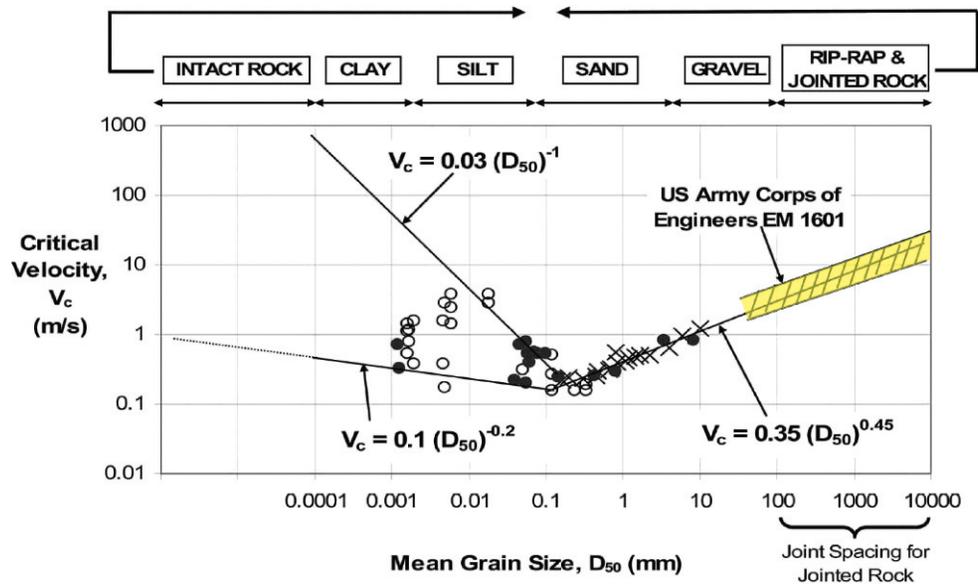
This marked disparity in fines content could be expected to influence erodibility by water rushing down the face of an inclined embankment. Briaud (2008) presented tables that depict the critical velocity for scour as a function of mean grain size, shown in Figure 28. This chart suggests that gravel and rip-rap

Figure 28. Critical velocity triggering erosion versus mean grain size, taken from Briaud (2008). The yellow shaded zone represents data for coarse gravel, rip-rap, and jointed rock. Sediment carrying capacity of non-cohesive materials like sand and gravel is a power function of velocity. Data points are from measurements at Texas A&M and Army Corps of Engineers Waterways Experiment Station, described in Briaud (2008).

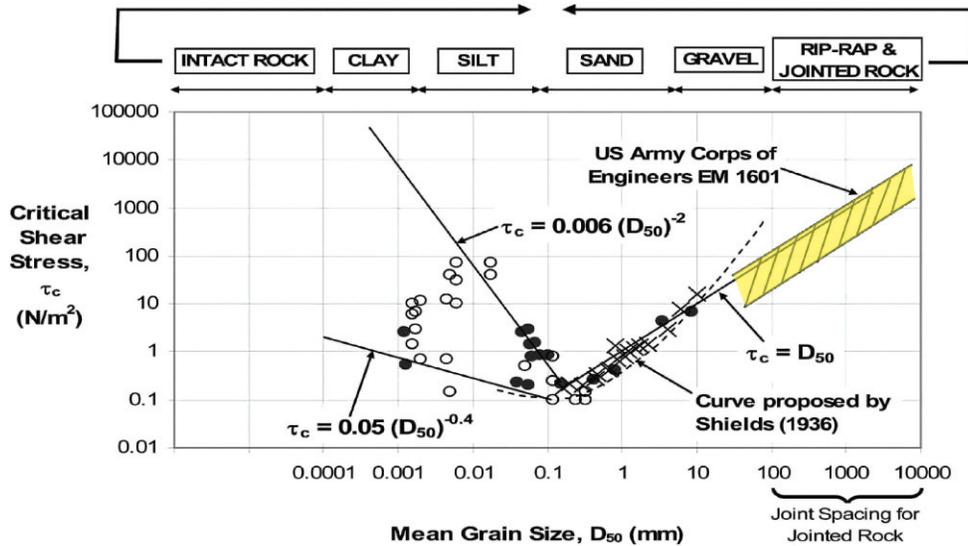
As shown in Figure 29, when the critical shear stress, τ_c , exceeds 2.1 lb/ft² (100 N/m²) for median grain sizes (D_{50} values) greater than ~4 in. (100 mm), velocity-triggered erosion of such materials can be

expected. The value of 4 in. (100 mm) was the upper range of D_{50} values for this embankment in vicinity of panels 88–99 (Rizzo & Associates, 2006). The striking contrast between panels 44–54 and 88–99 is their fines content. The rock fill placed at panels 44–54 appears much cleaner, with less fines content, even though it was significantly higher (125 ft versus 95 ft). It would appear that water spilling onto this portion of the embankment was more readily lost in its open void space, generating lower velocities and boundary shear stresses that fostered rapid erosion at the water-soil interface (Briaud, 2008). The embankment in vicinity of panels 70–74 and 88–99 was visibly more contaminated with fines. The matrix of fine-grained soils prevented infiltration of the overflowing water, allowing much higher runoff velocities to develop, causing considerably increased levels of erosion, because in low cohesion materials (sand and gravel), sediment carrying capacity is a power function of velocity (Colby, 1964; Toffaleti, 1969).

Figure 29. Critical boundary shear stress as a function of mean grain size, taken from Briaud (2008). The yellow shaded zone represents data for coarse gravel, rip-rap, and jointed rock. Data points are from measurements at Texas A&M and Army Corps of Engineers Waterways Experiment Station, described in Briaud (2008).
