# INVESTIGATION OF LEVEE PERFORMANCE IN HURRICANE KATRINA: Levee Failures Along the Inner Harbor Navigation Channel

J. David Rogers, Ph.D., P.E., R.G., C.E.G., C.HG.

**OVERVIEW:  
East Side IHNC  
Failures  
During Hurricane  
Katrina**

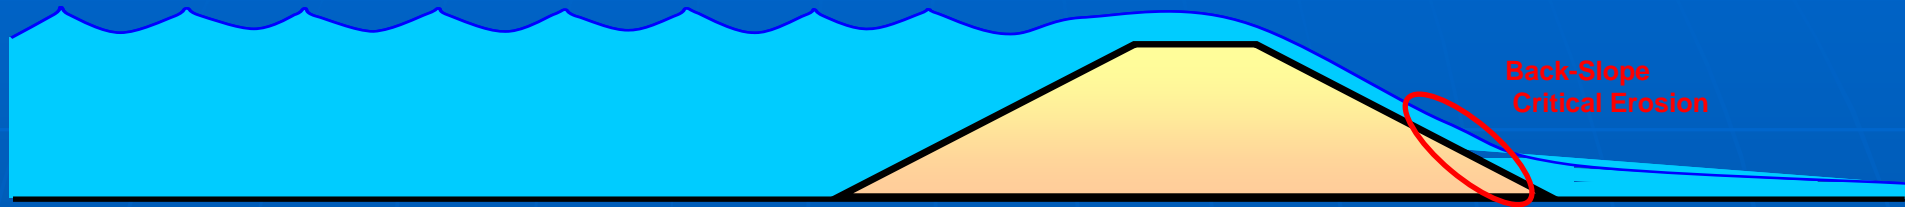
Velocity-induced scour at toe of back slope, at flow transition.  
Accelerates when vegetation stripped off, depending on  
cohesion of embankment materials

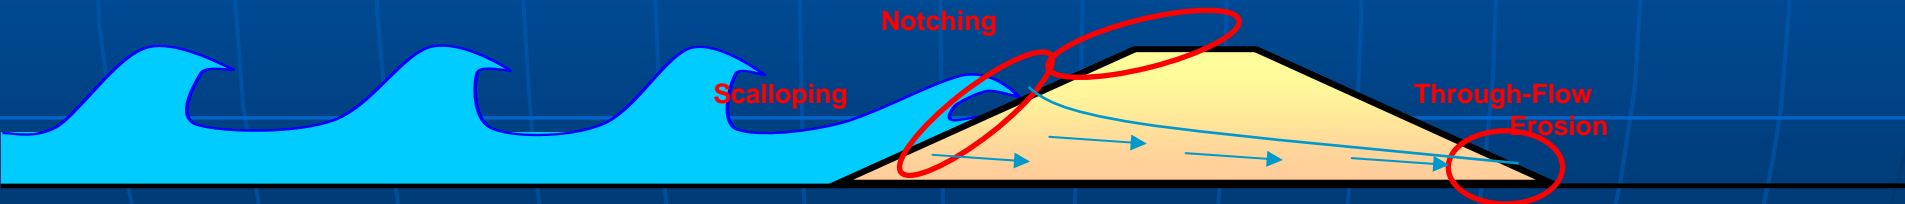
Scalloping and notching on the fetch side of the levee, due to wave pounding; and piping fomented by emergent seepage at the toe of the back slope

Note: damage at back slope toe looks similar for both modes

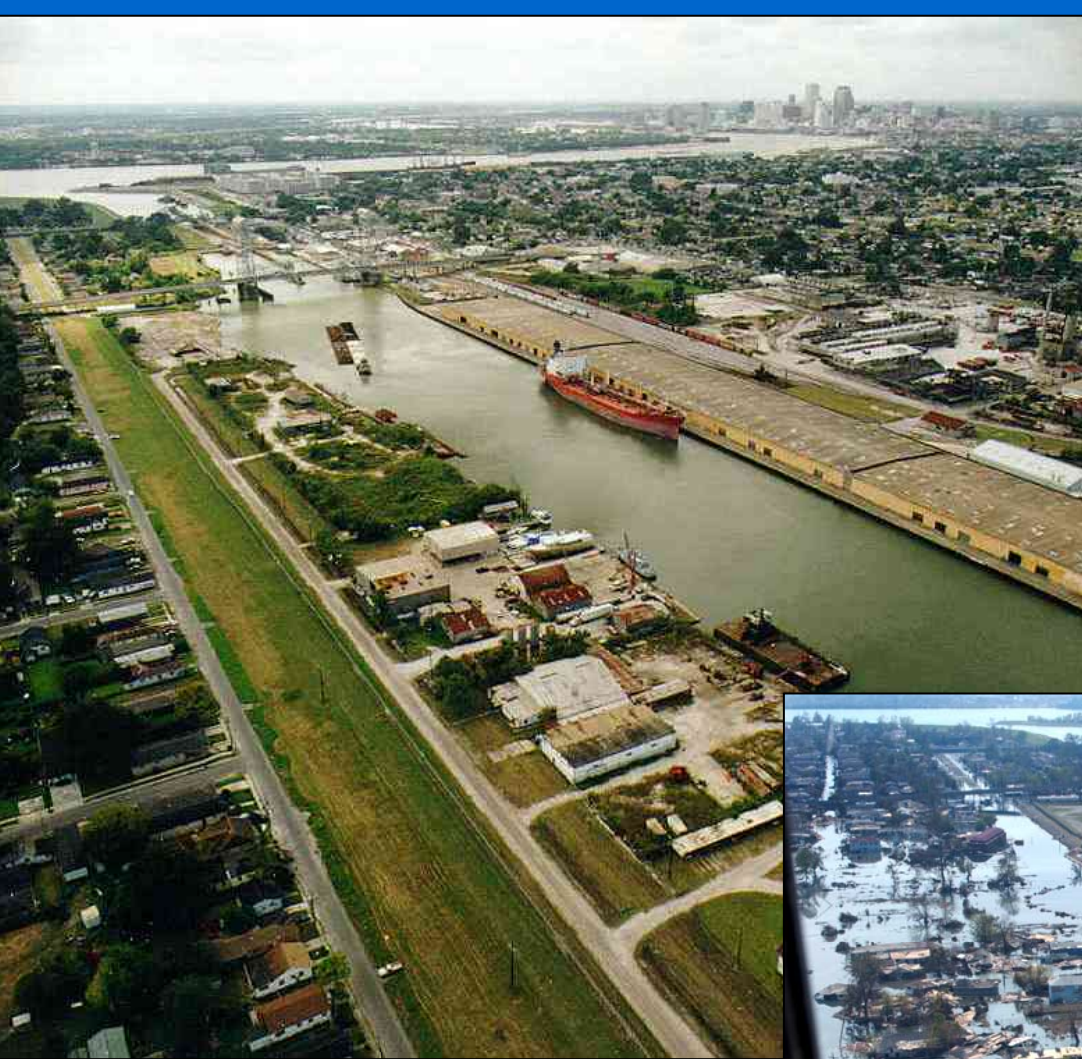
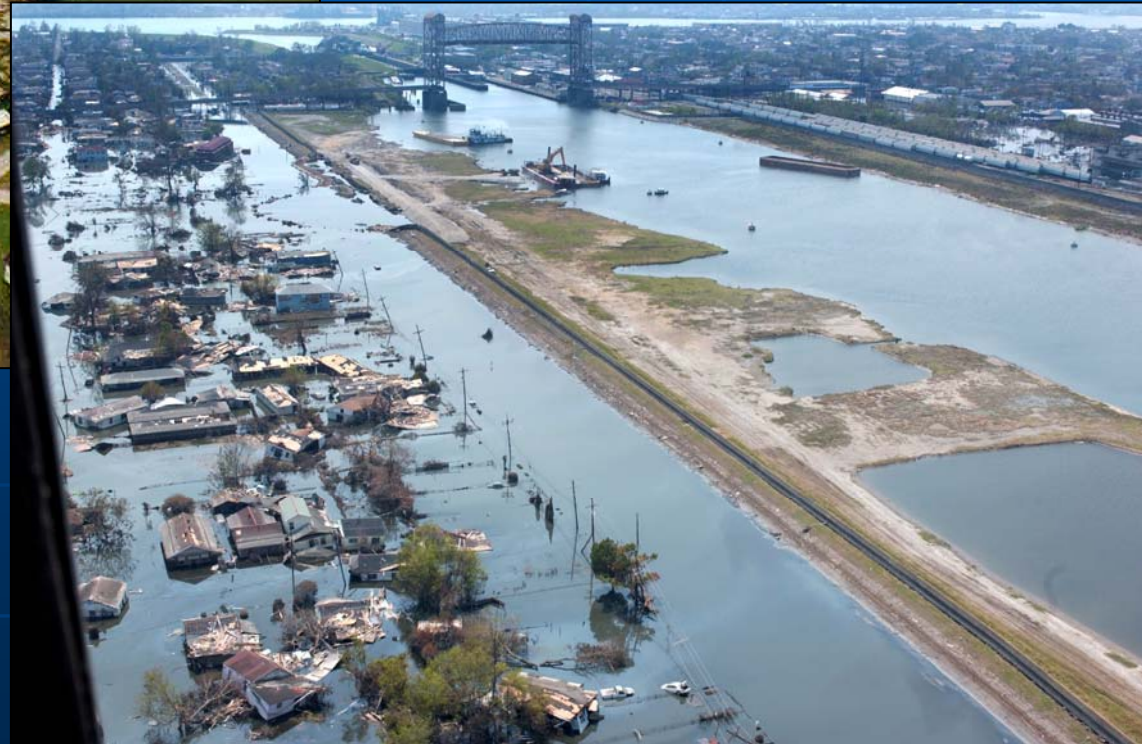
# East Side IHNC South Breach

Polluted and run-down industrial leases along east side of the IHNC were demolished and cleaned up in 2001-03, leaving exposed shell fill

Same area after re-flooding by Hurricane Rita in late September 2005

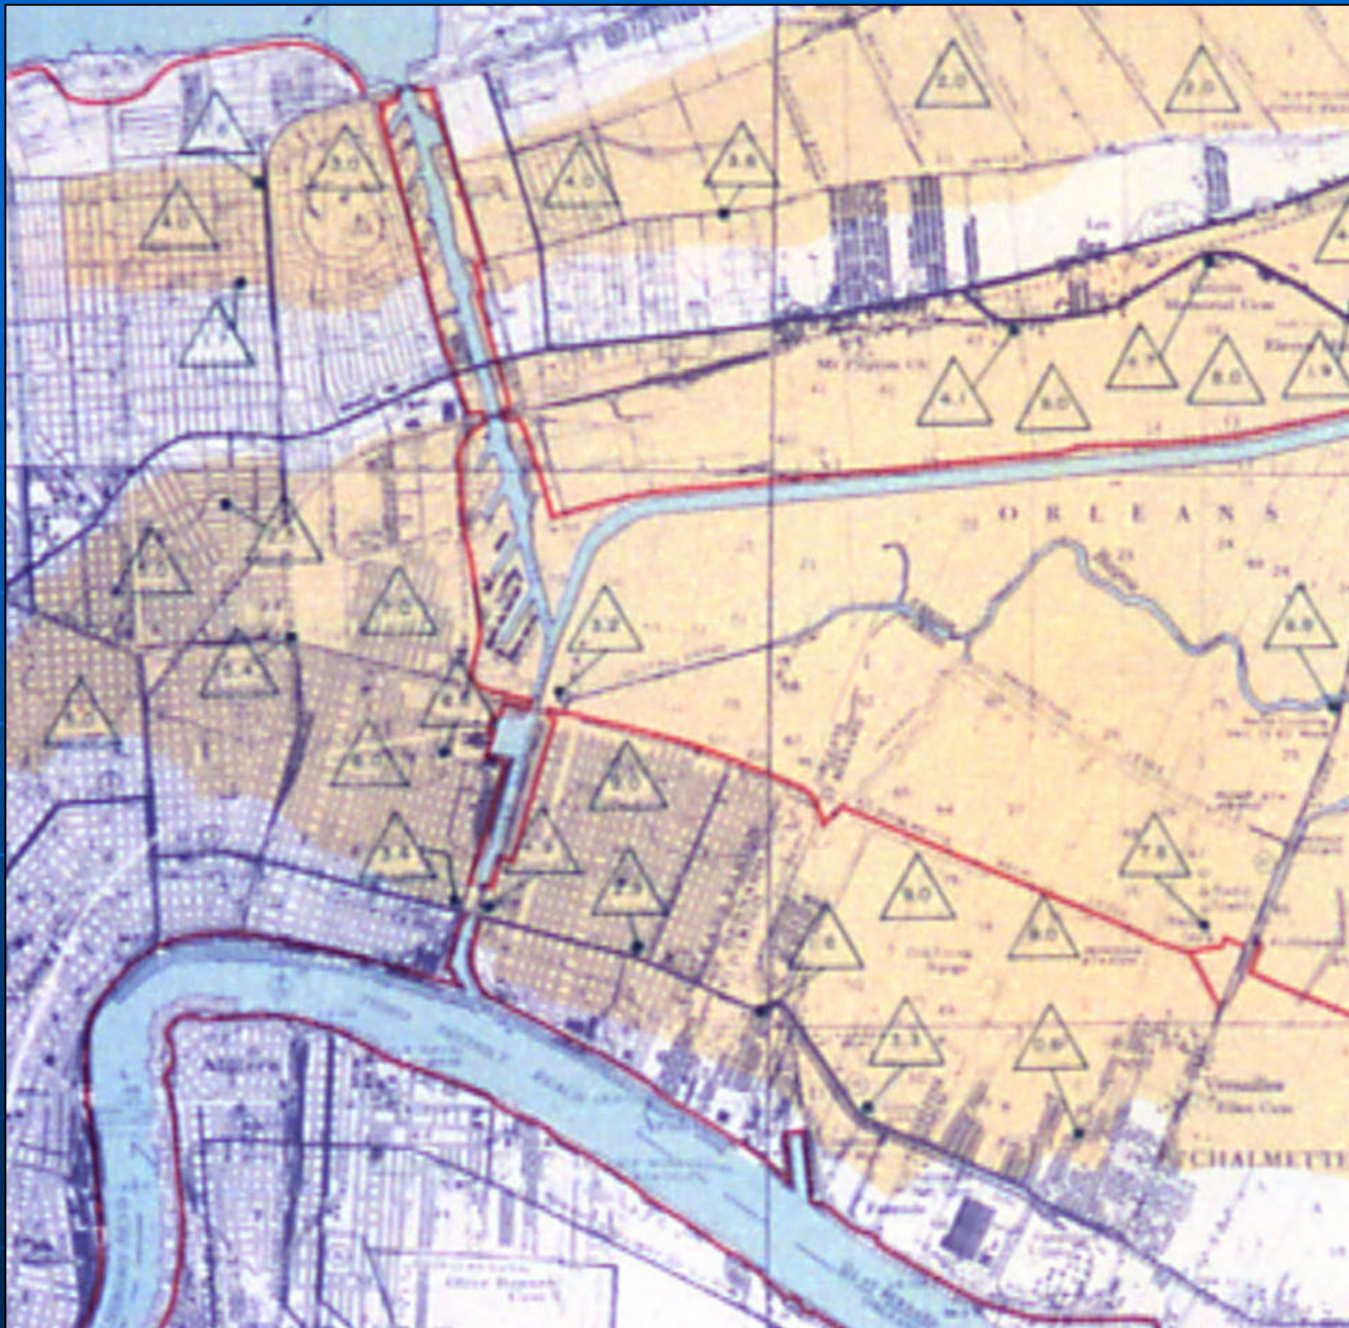
# 1965 flooding

The Lower Ninth Ward was flooded by overtopping of the levees along the IHNC in 1947 and 1965

The levee was heightened using rolled fill after both floods

Sheetpiles added after Hurricane Camille in 1969

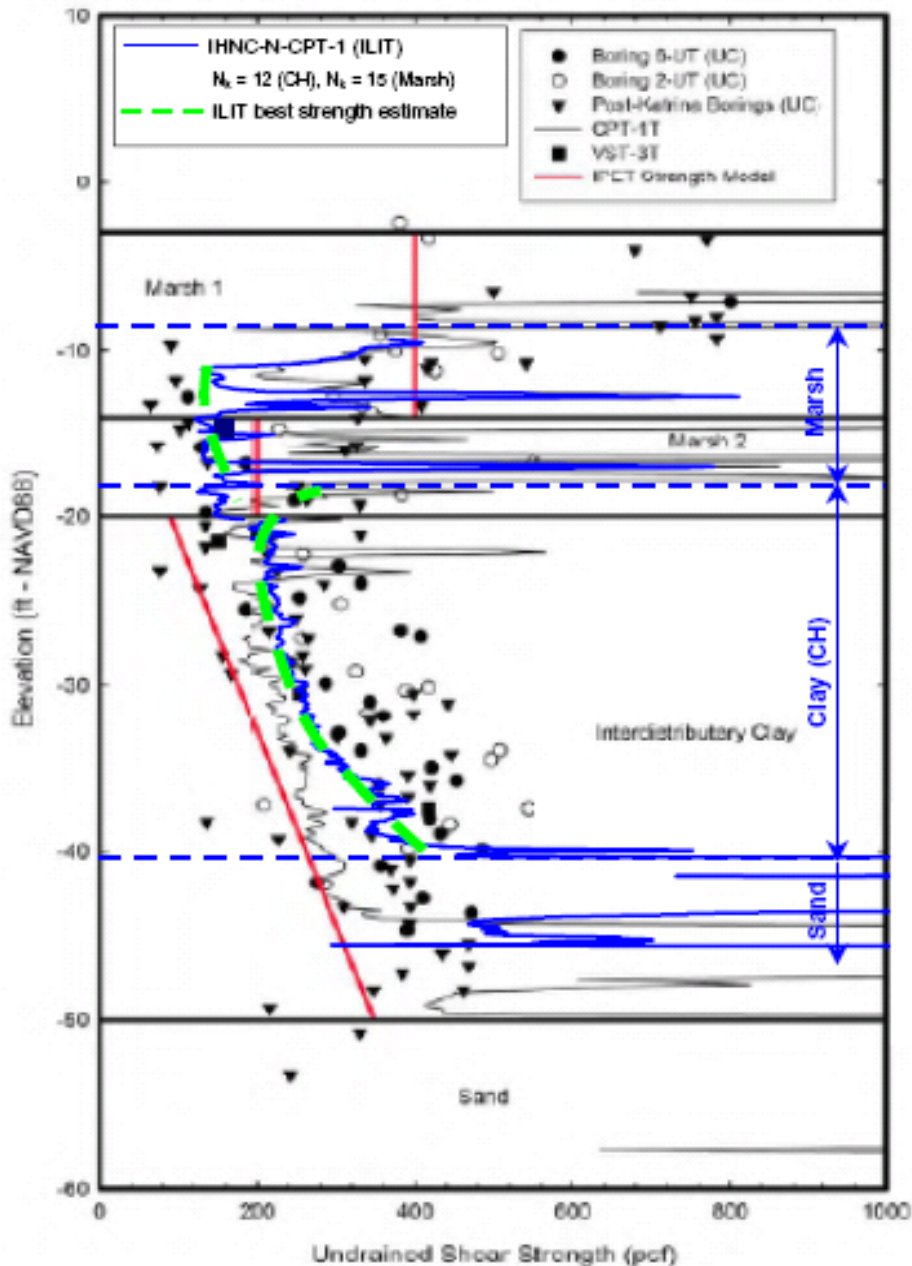
## Undrained shear strength vs depth at the East IHNC North Breach

**Blue lines** shows profile of CPT-1, with NGI tip corrections for the three units encountered

**Green line** shows strength profile selected by the NSF team

**Red lines** shows strength profile used by the IPET team; which allows a rotational stability failure sometime between 5:30 and 6:00 AM

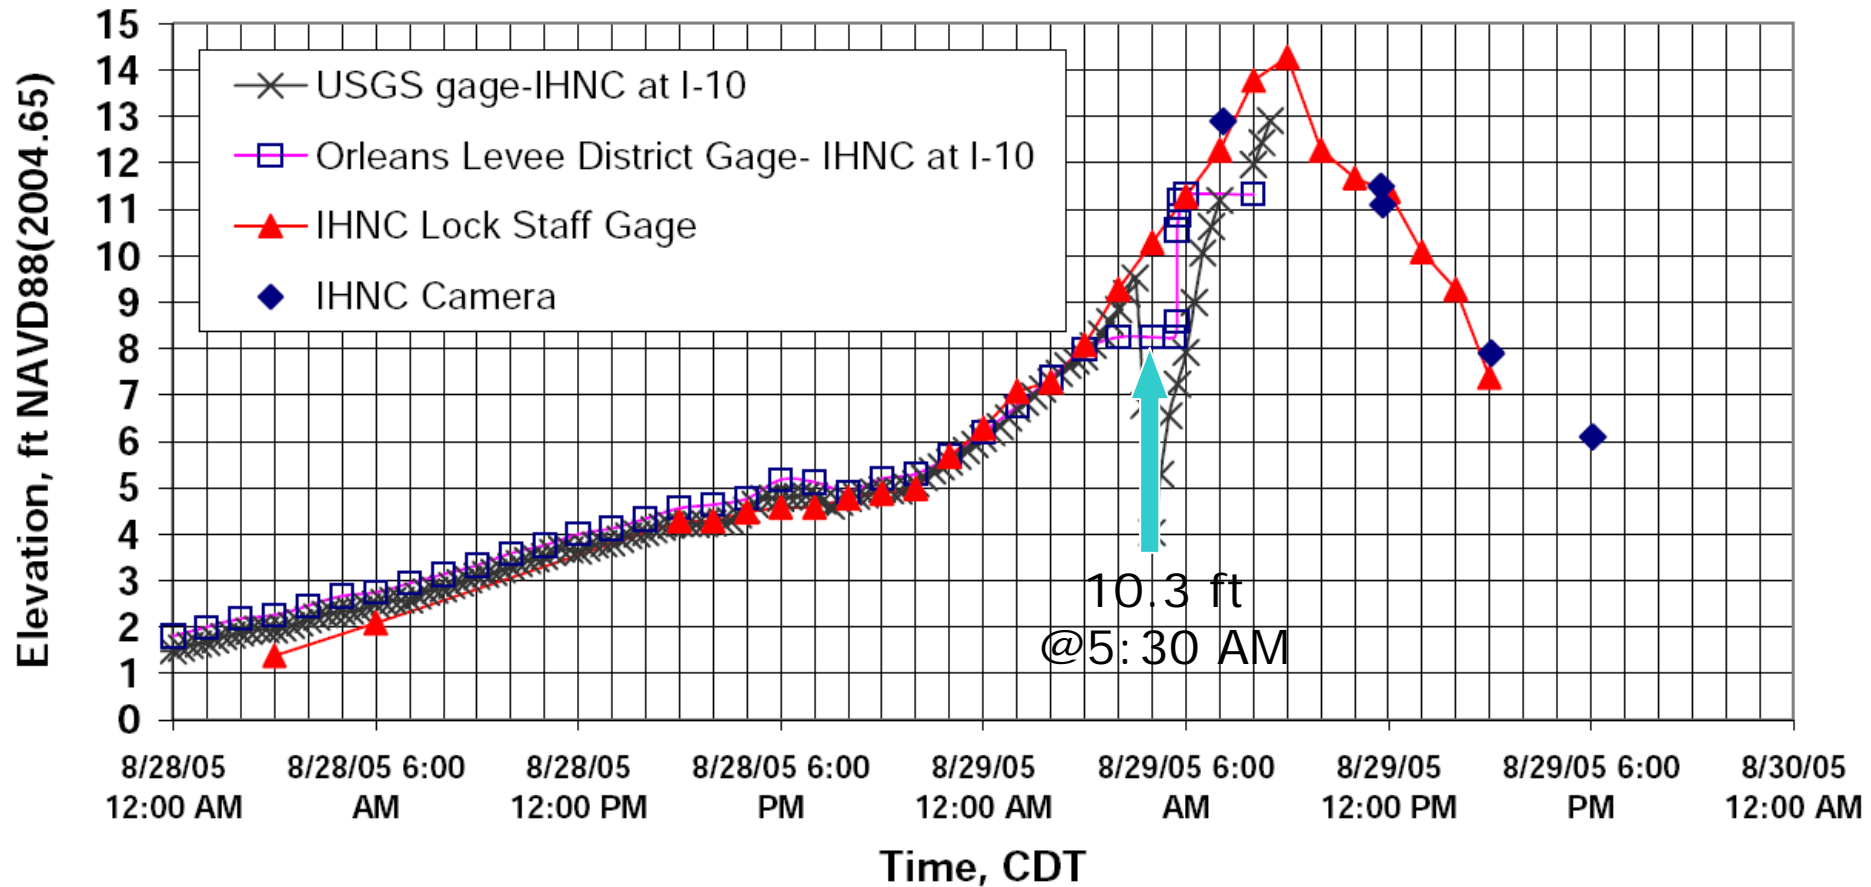
## Hydrographs on IHNC

The storm surge caused by Katrina began three days before it made landfall, seen here as the gradual increase at left, about 0.32 ft/hr. Around midnight on August 29<sup>th</sup>, the rate increased 4X, to about 1.2 ft/hr . These rates and levels were used in our seepage analyses.

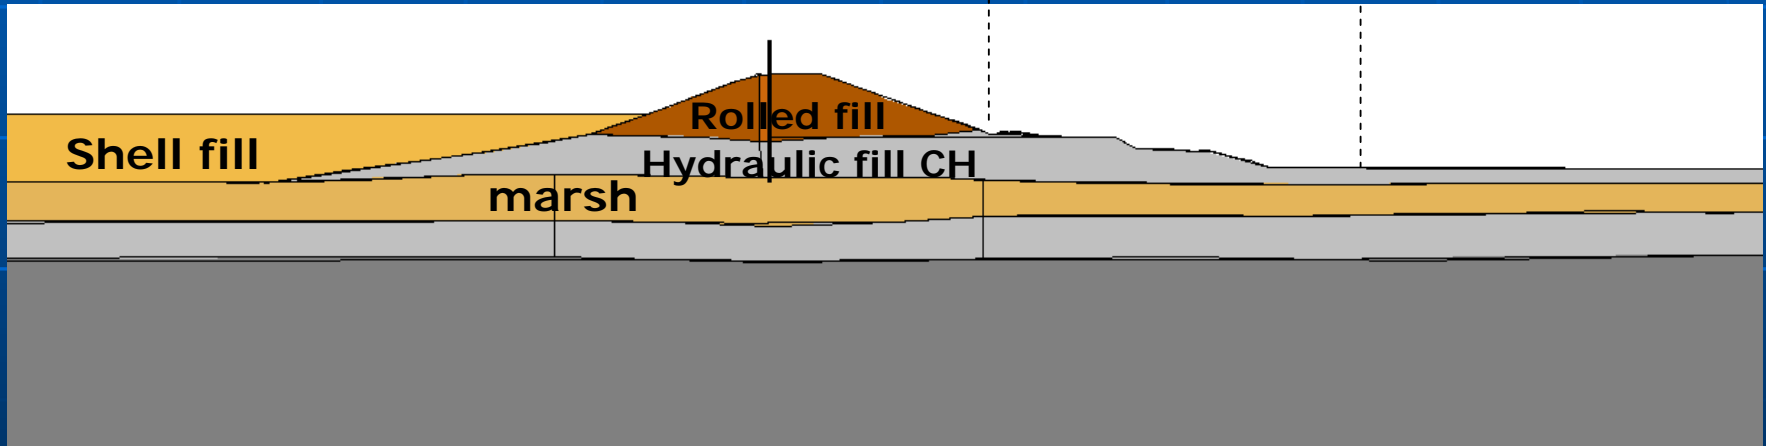
## East Bank IHNC North Breach

Cross section used for limit equilibrium and coupled seepage analyses. Upper plot shows pore pressure versus horizontal distance and time for this section.

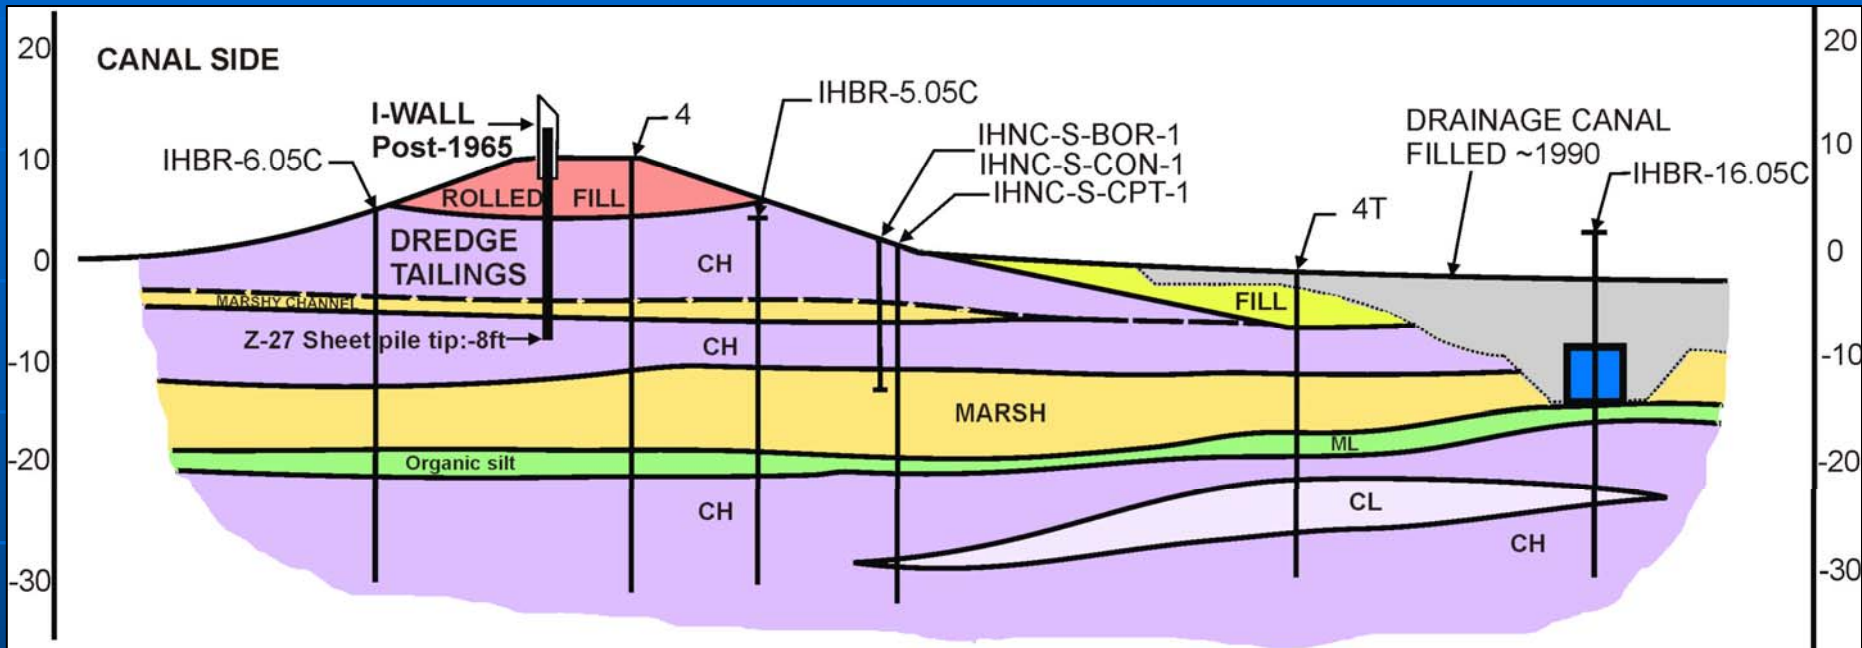
# East Bank IHNC South Breach

Geologic cross-section showing projections of borings and tentative stratigraphic correlations for the 800 ft long IHNC East Bank-South Breach, adjacent to the Lower Ninth Ward

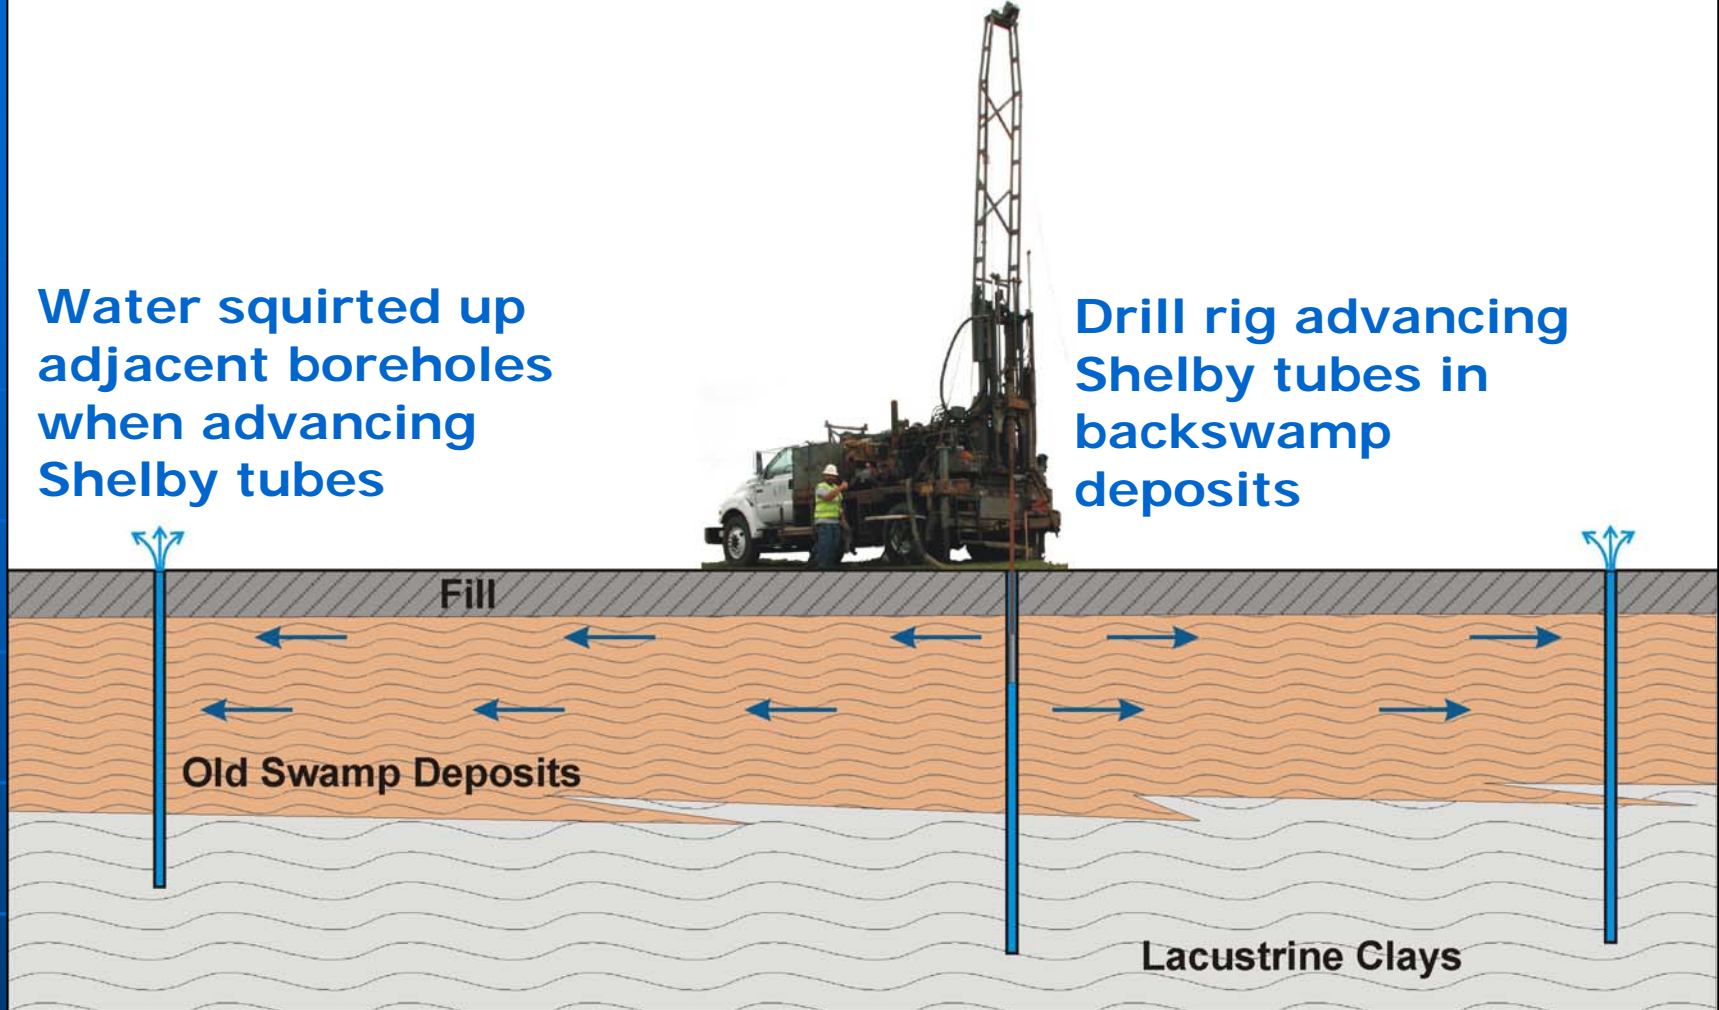
Water squirted up adjacent boreholes when advancing Shelby tubes

Drill rig advancing Shelby tubes in backswamp deposits

- The porous and highly conductive nature of the backswamp deposits was revealed during post-Katrina drilling and sampling operations.
- Highly conductive in horizontal plane, especially, parallel to original surface drainage.

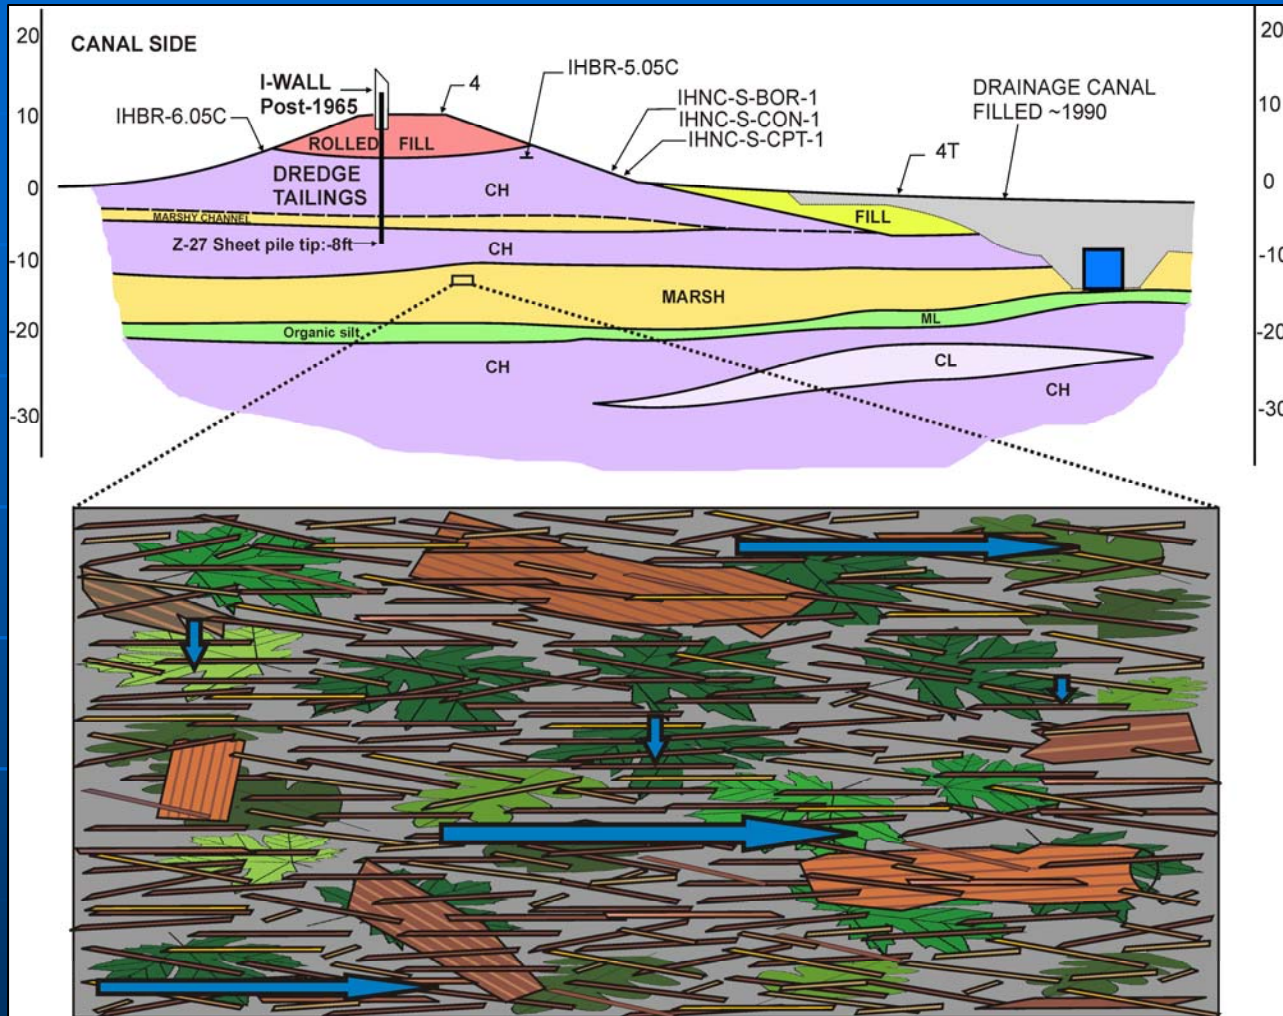
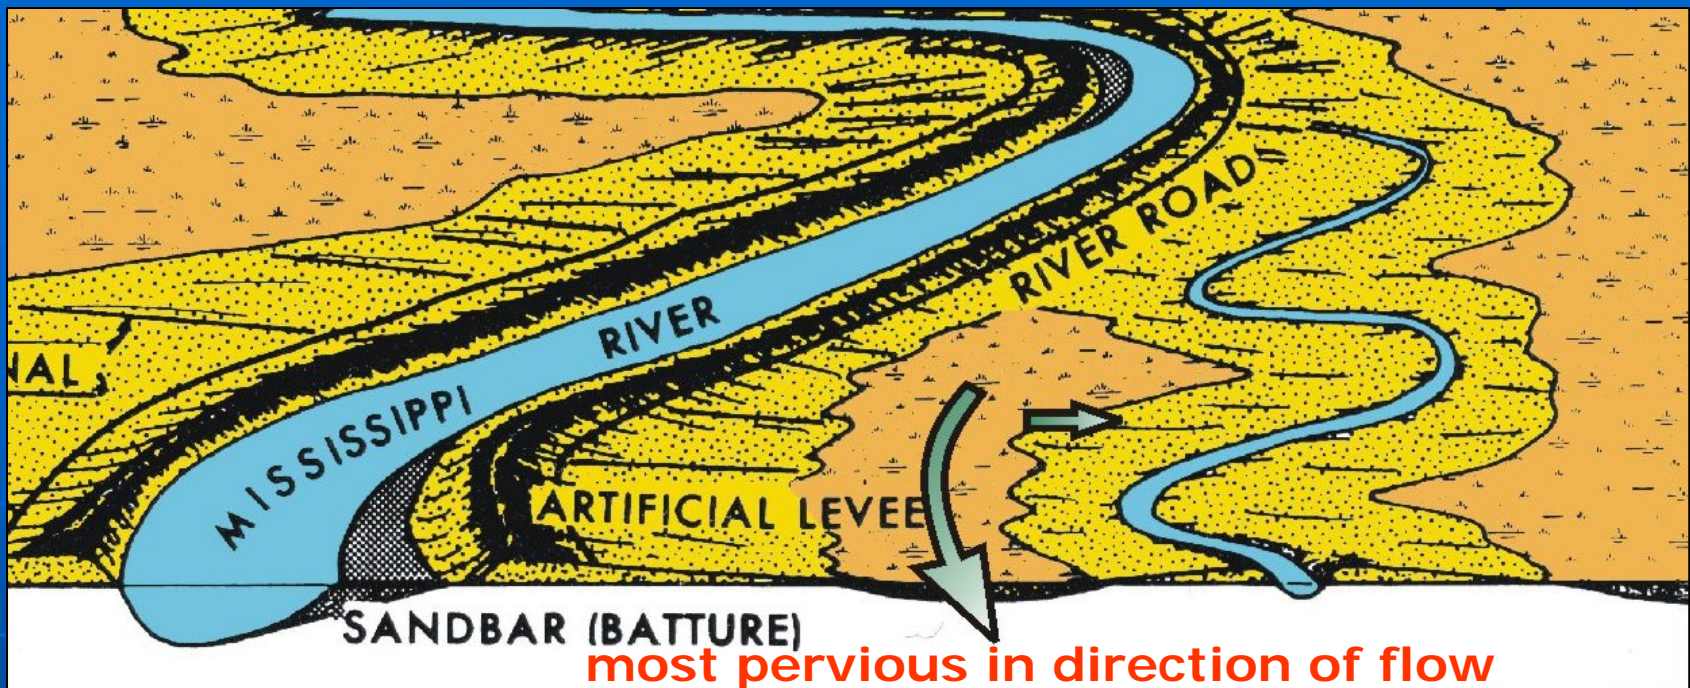
# Anisotropy of backswamp deposits

- Sudden die-off of organics creates highly anisotropic fabric; preferentially layered

- Drainage swales in the backswamps are subject to sieving of fines by runoff
- This causes hydraulic conductivity to increase along the runoff path, as opposed to other seepage paths, within the plane of sediment accretion

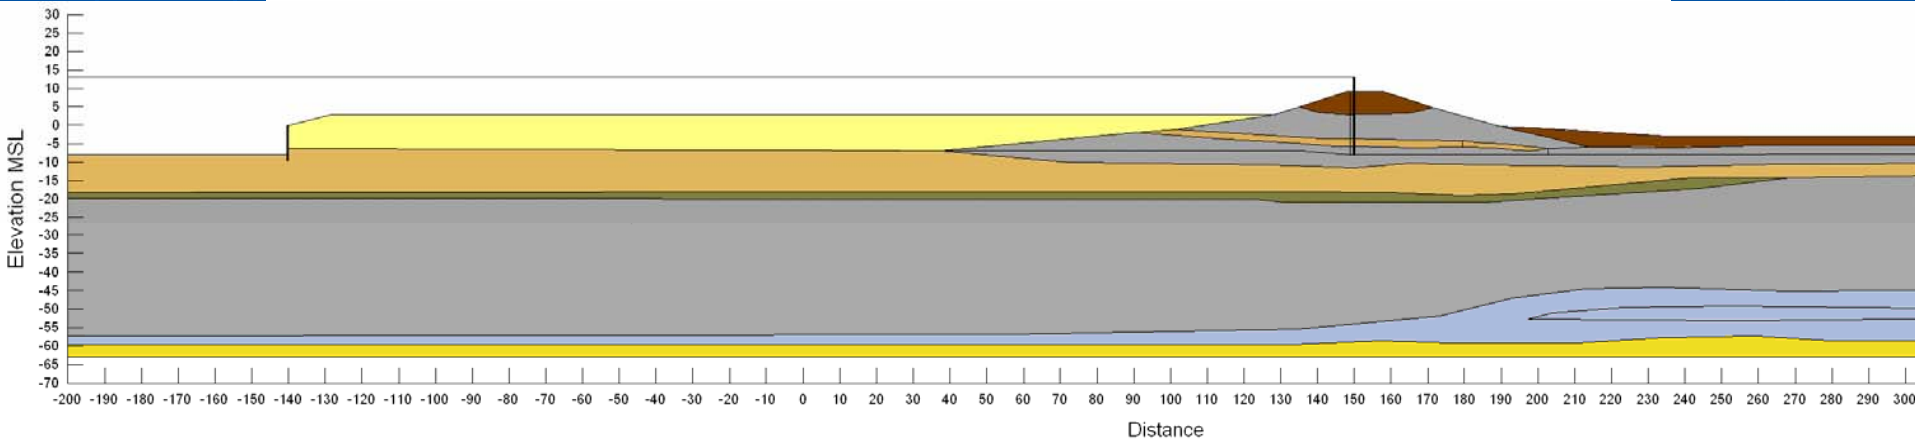
**Geotechnical cross-section for conventional limit equilibrium and coupled seepage analyses of the east bank IHNC south breach.**

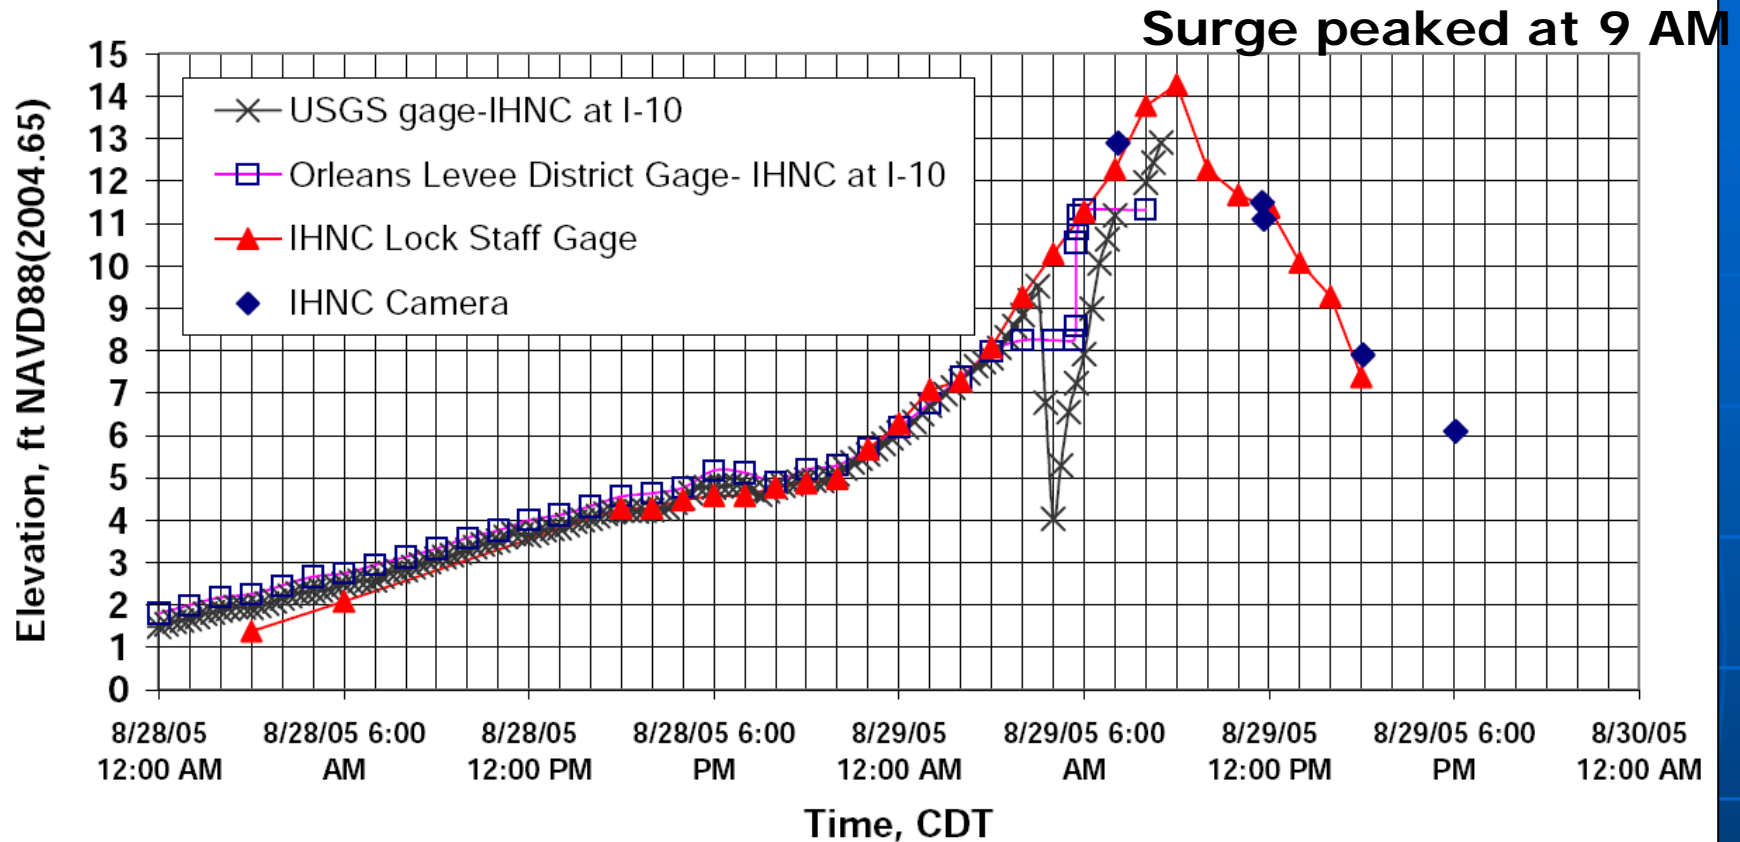
## Hydrographs on IHNC

The horizontal permeability in the pervious marsh deposits likely varies between  $1 \times 10^{-3}$  and  $1 \times 10^{-6}$  cm/sec., locally (with the marsh stratum), depending on a number of factors.

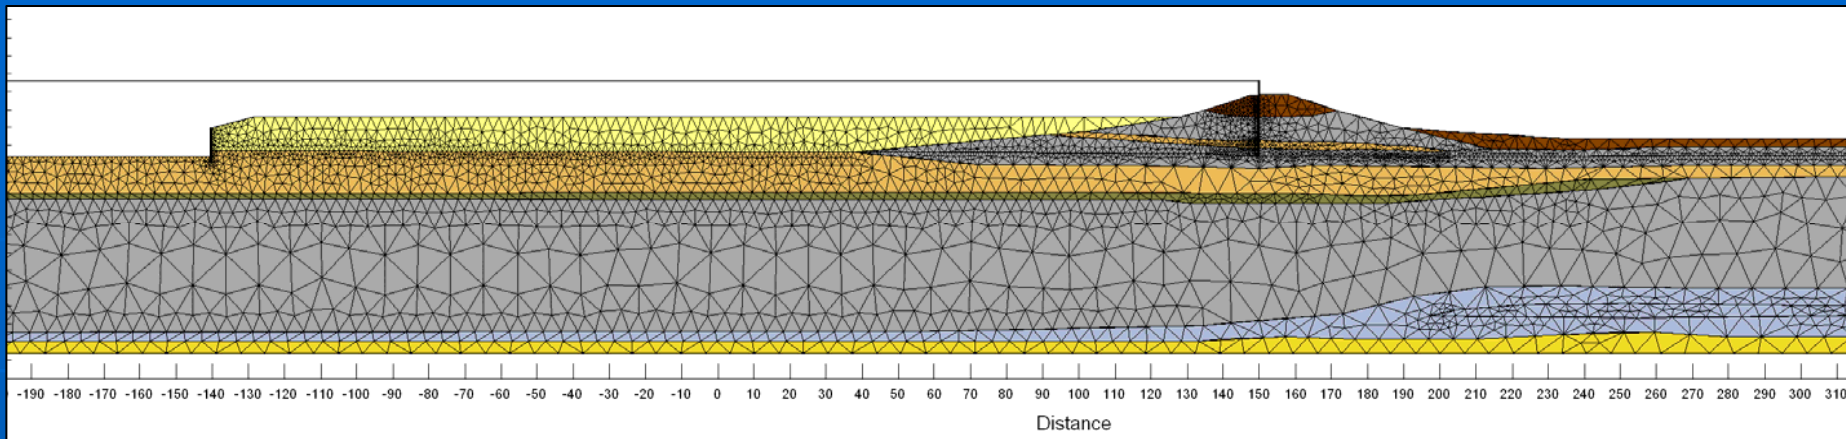
**Finite difference mesh for seepage analyses for east bank IHNC south breach.**

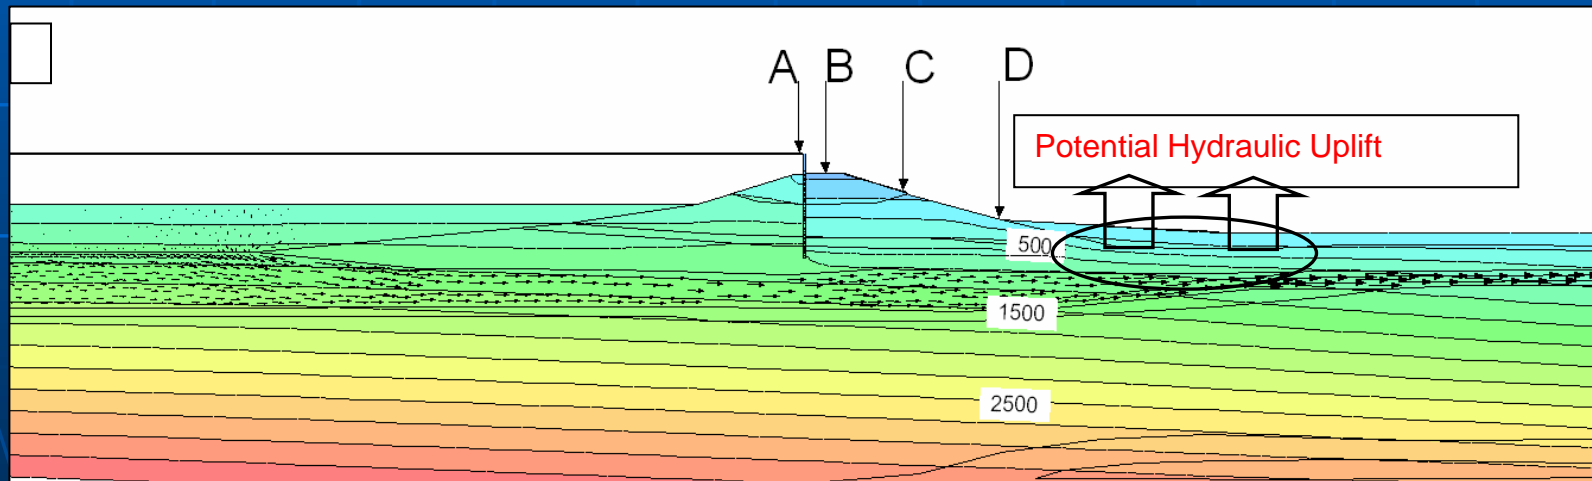
**Pressure contours for the south breach on IHNC with storm surge at 14.4ft (MSL).**

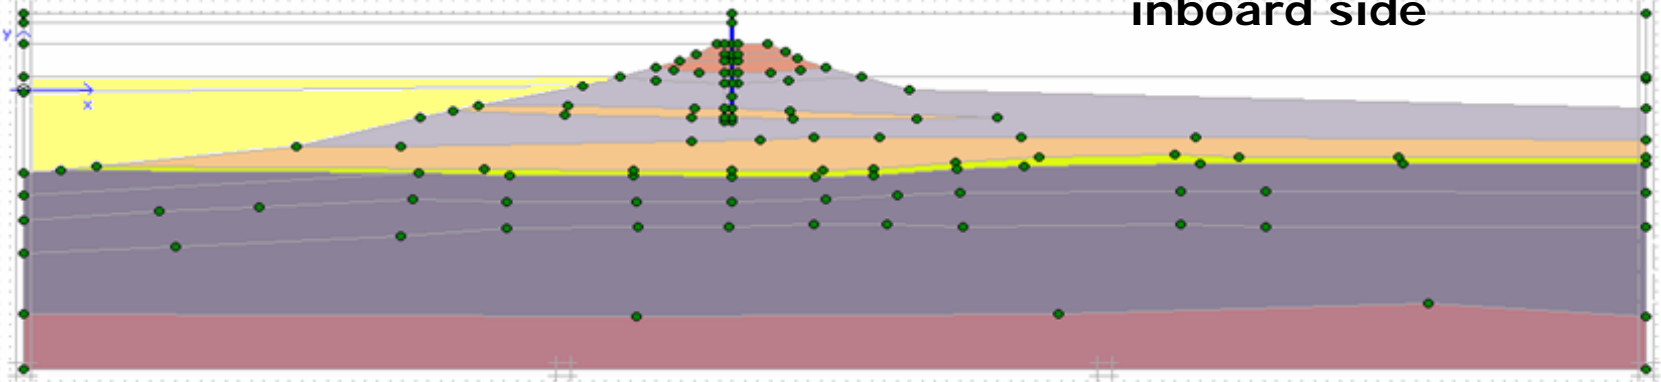
**Ignored backfilled  
drainage canal on  
inboard side**

**Geometry and input parameters for FEM (PLAXIS) stability analyses for Lower Ninth Ward, IHNC East Bank, South Breach.**

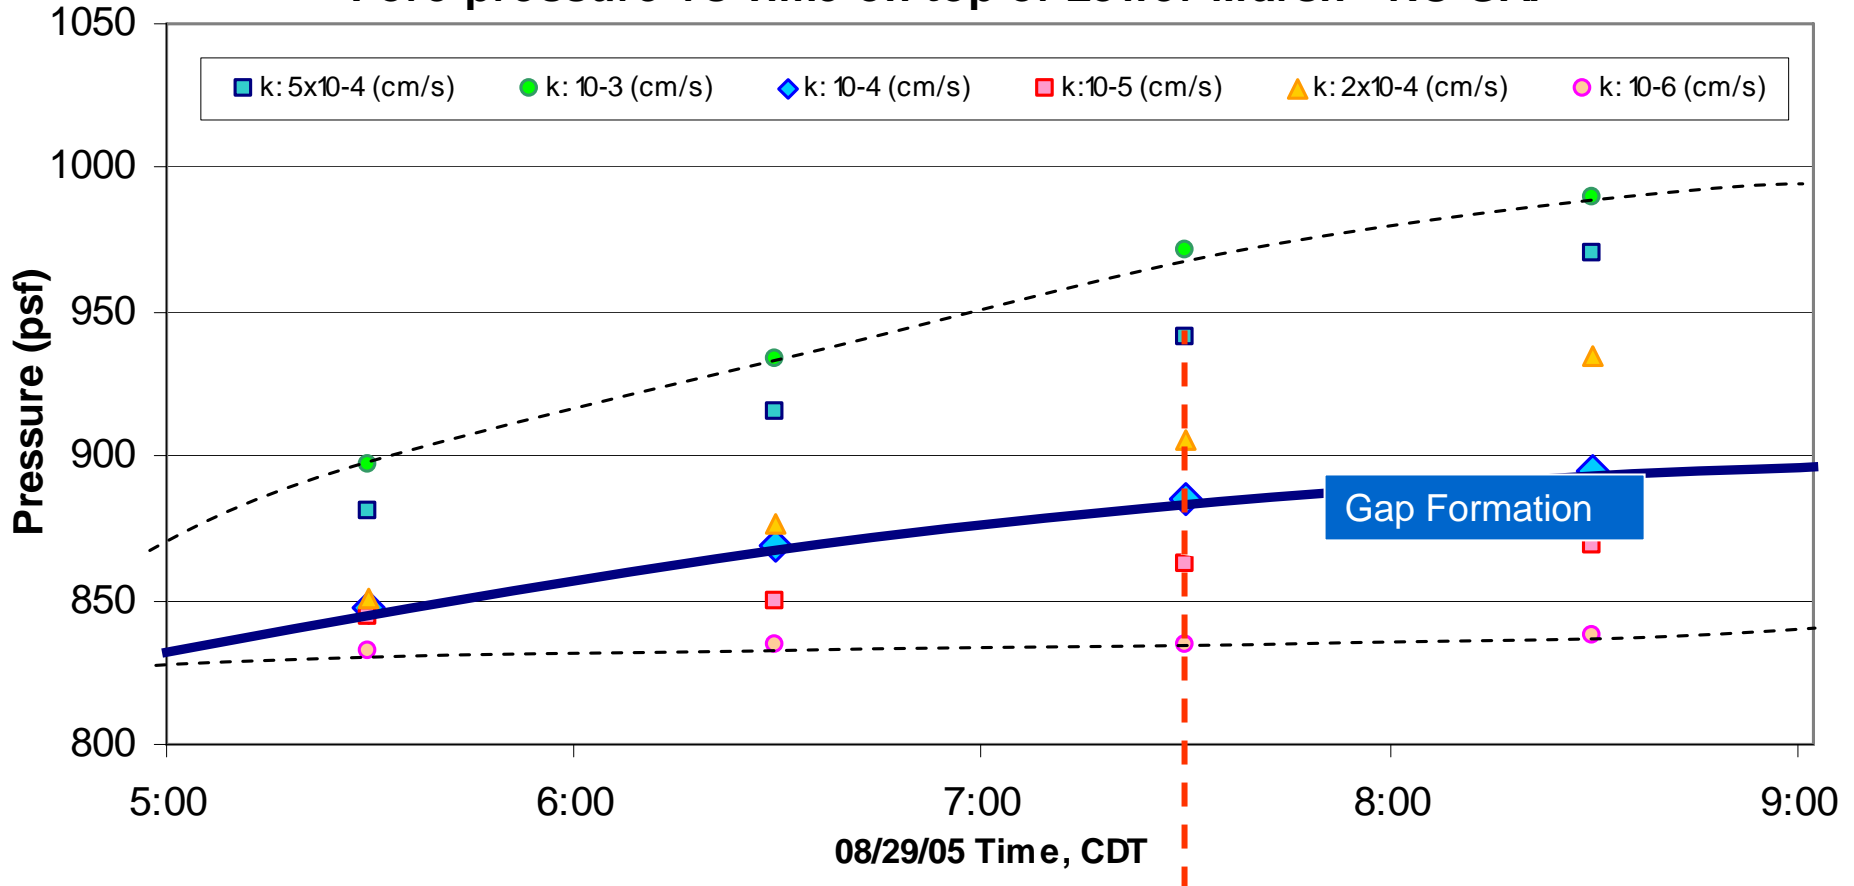
## Pore pressure vs Time on top of Lower Marsh - NO GAP

Estimated range in pore pressures at top of lower marsh unit assuming a range of horizontal hydraulic conductivity (k) in the marsh units, varying between  $10^{-3}$  and  $10^{-6}$  cm/sec

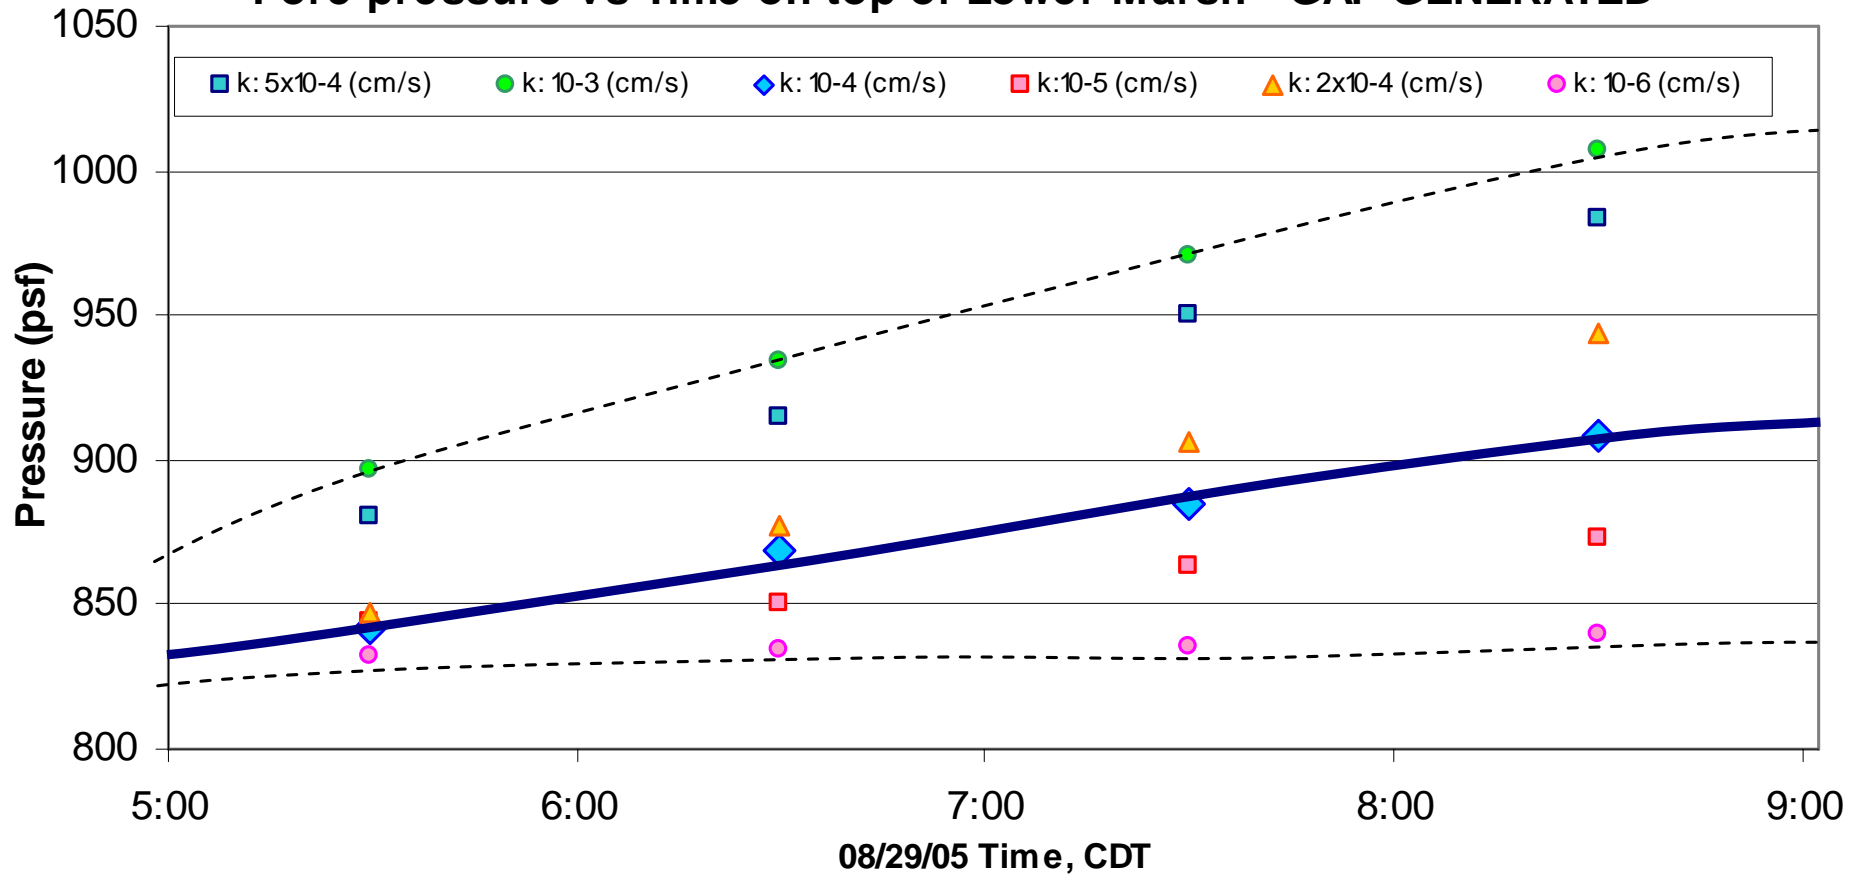
## Pore pressure vs Time on top of Lower Marsh - GAP GENERATED

Estimated range in pore pressures at top of lower marsh unit **if the flood wall developed a gap**; assuming a range of horizontal hydraulic conductivity (k) in the marsh units, varying between  $10^{-3}$  and  $10^{-6}$  cm/sec
