# INVESTIGATION OF LEVEE PERFORMANCE IN HURRICANE KATRINA: Levee Failures Along the Inner Harbor Navigation Channel

J. David Rogers, Ph.D., P.E., R.G., C.E.G., C.HG.

**OVERVIEW:  
East Side IHNC  
Failures  
During Hurricane  
Katrina**

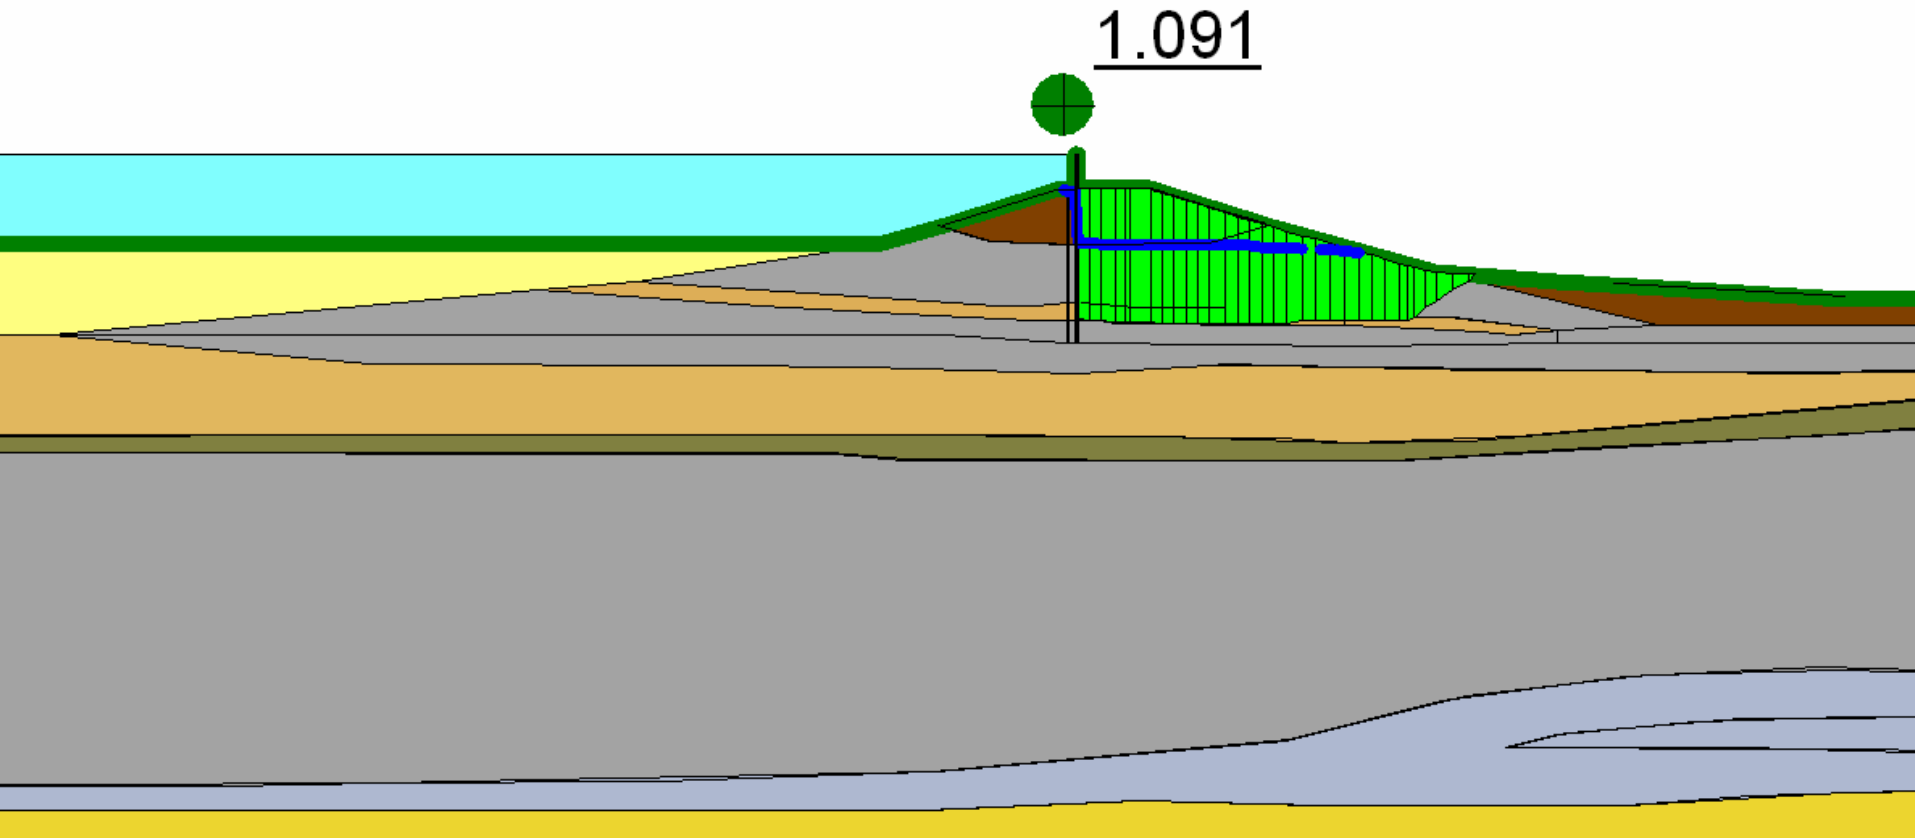
# Slope stability – shallow failure mode (in upper marsh) – $FS=1.091$

Limit equilibrium analyses
