**IMPORTANCE OF GEOLOGIC
CHARACTERIZATION FOR LEVEE
FOUNDATION AND BORROW MATERIALS AS
STUDIED AT THE INDIAN GRAVES LEVEE
DISTRICT, ADAMS COUNTY, IL**

AEG Annual Meeting - September 24, 2009

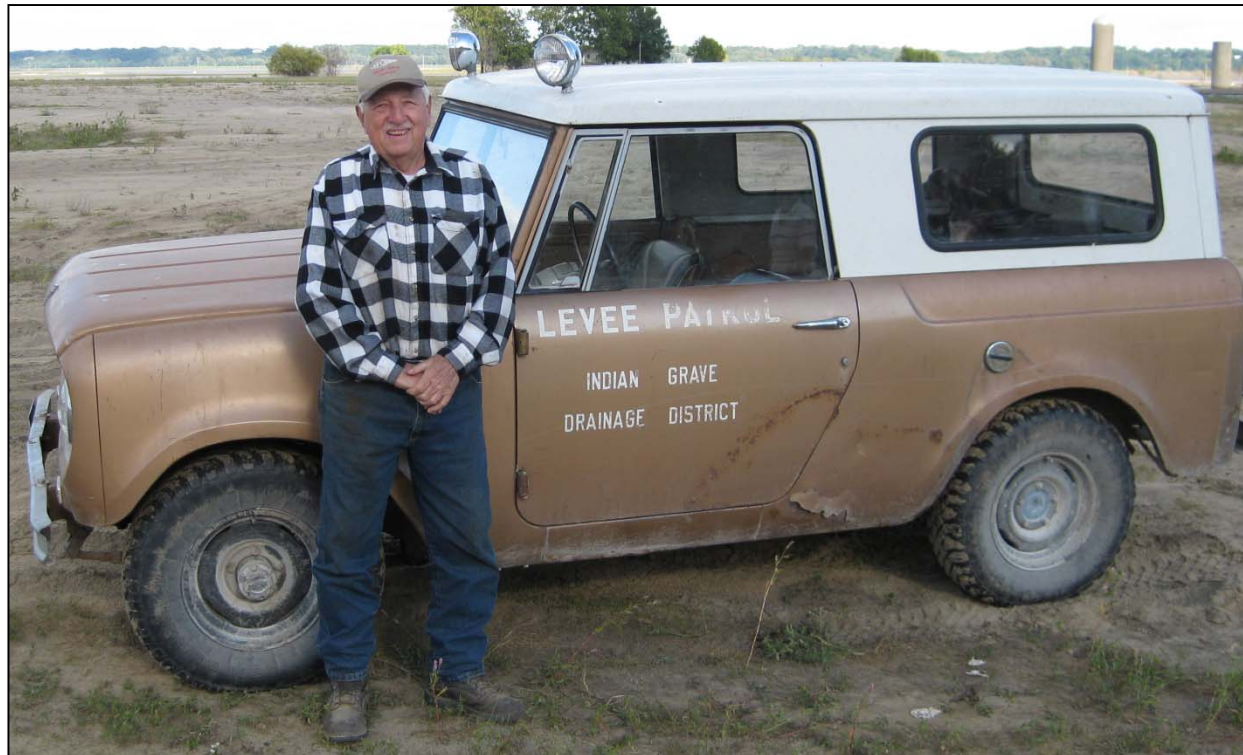
- NSF funded Midwest Levee Investigation studied breached levees in Missouri, Illinois, and Iowa after record or near record 2008 summer flooding
- Although other sites were visited throughout 3 states, the Indian Grave Levee District exhibited conditions common through much of the study area and most attention was focused on this site.
