# **ENGINEERING GEOLOGIC CHARACTERIZATION OF LEVEE FAILURES IN NEW ORLEANS DURING HURRICANE KATRINA**

**J. David Rogers, Ph.D., P.E., R.G.**

**Member, National Science Foundation Independent Levee Investigation Team and  
Karl F. Hasselmann Chair in Geological Engineering  
University of Missouri-Rolla**

**2006 Annual Meeting  
Association of Environmental and Engineering Geologists  
Boston, Massachusetts  
November 1, 2006**

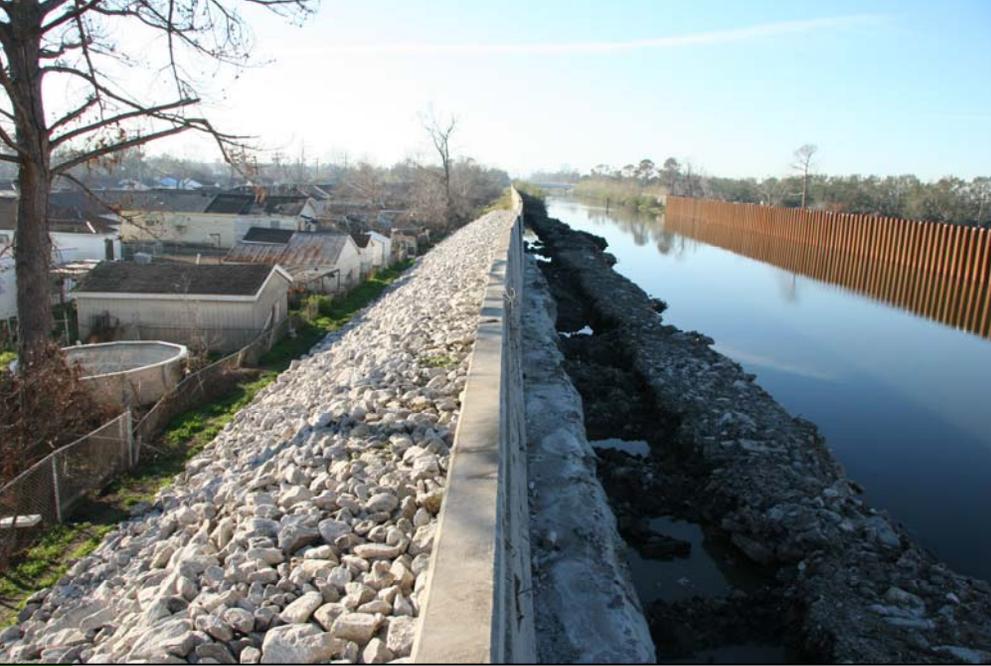
- View looking up the east side of the London Avenue Canal near Robert E. Le Boulevard crossing showing the **encroachment of homes against the slope of the levee**. This situation was common across New Orleans

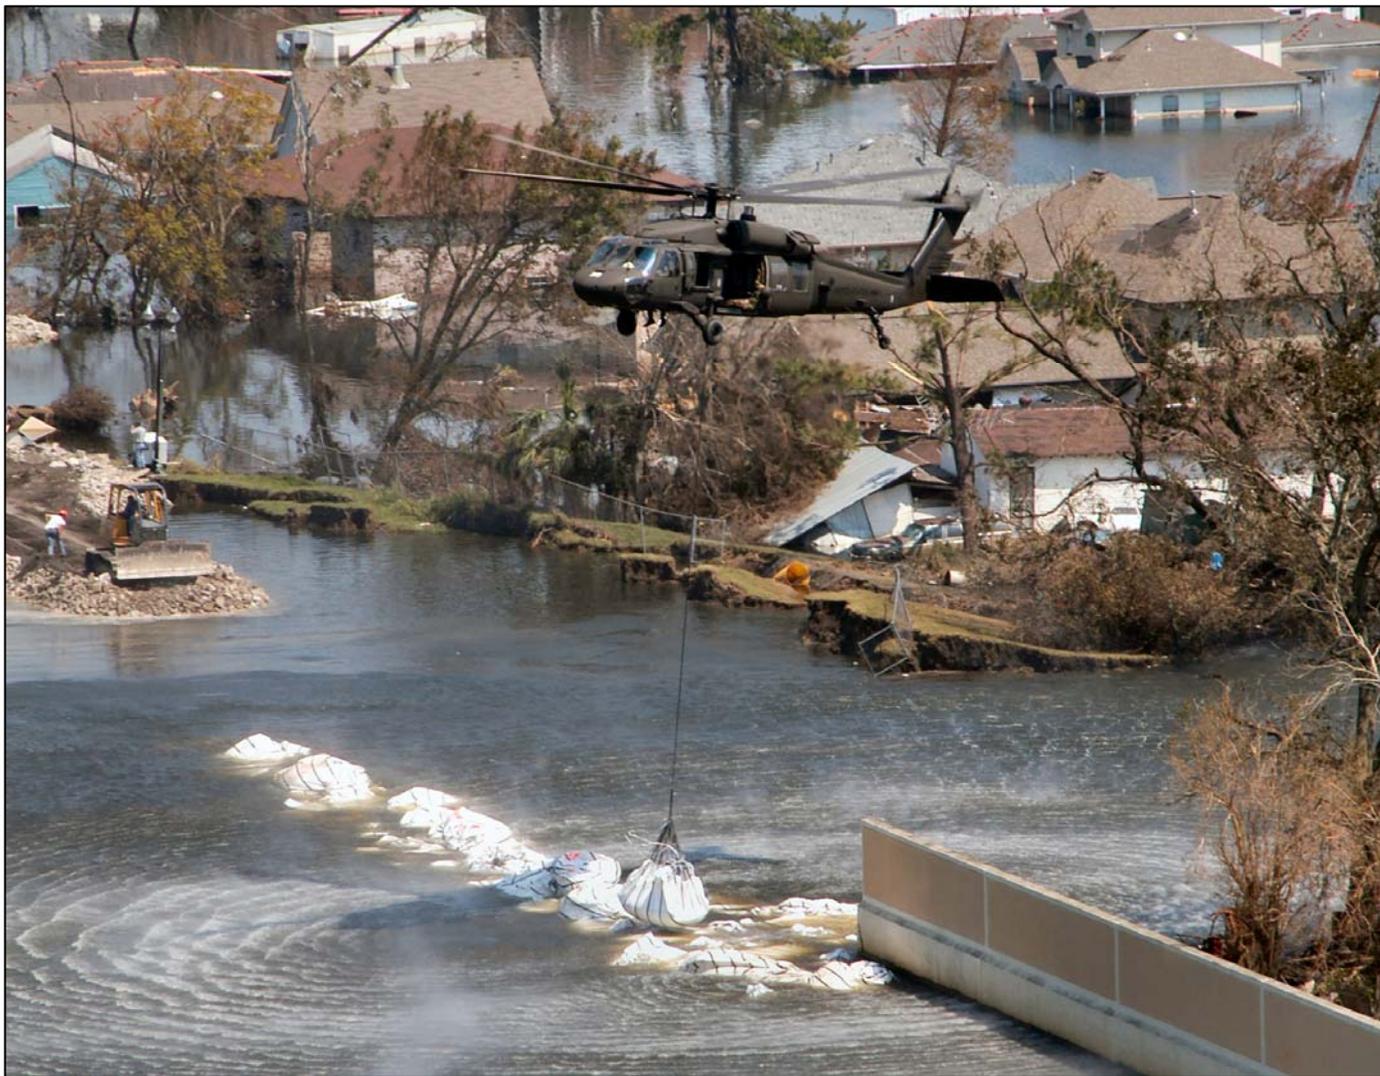
- **Army helicopters and contractors worked for weeks to fill the enormous gaps in the levee system, BEFORE pumping could begin.**

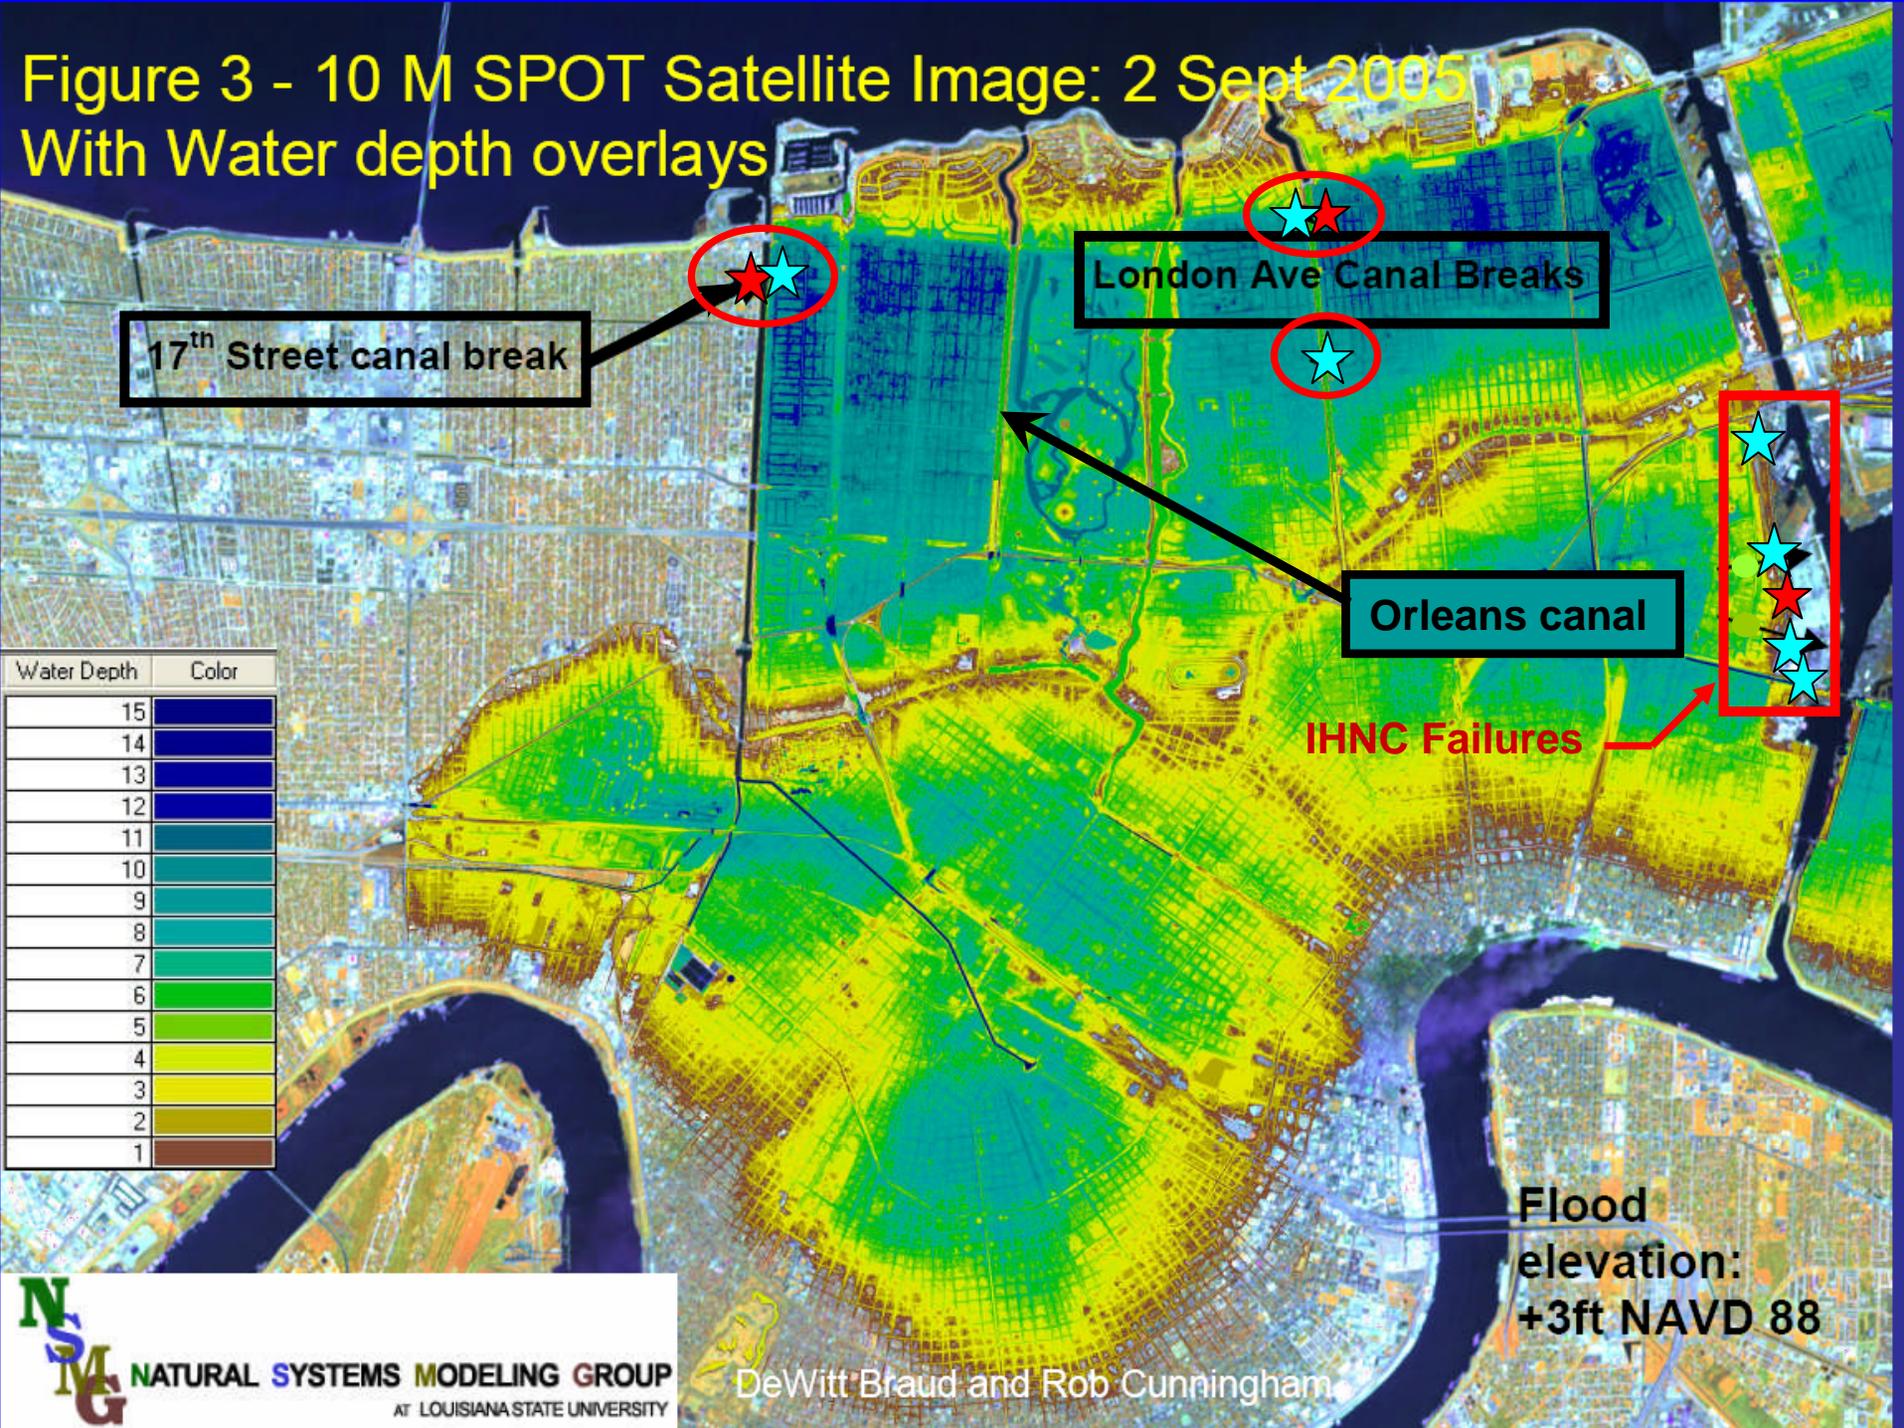
Figure 3 - 10 M SPOT Satellite Image: 2 Sept 2005  
 With Water depth overlays

17<sup>th</sup> Street canal break

London Ave Canal Breaks

Orleans canal

IHNC Failures

Flood elevation:  
 +3ft NAVD 88

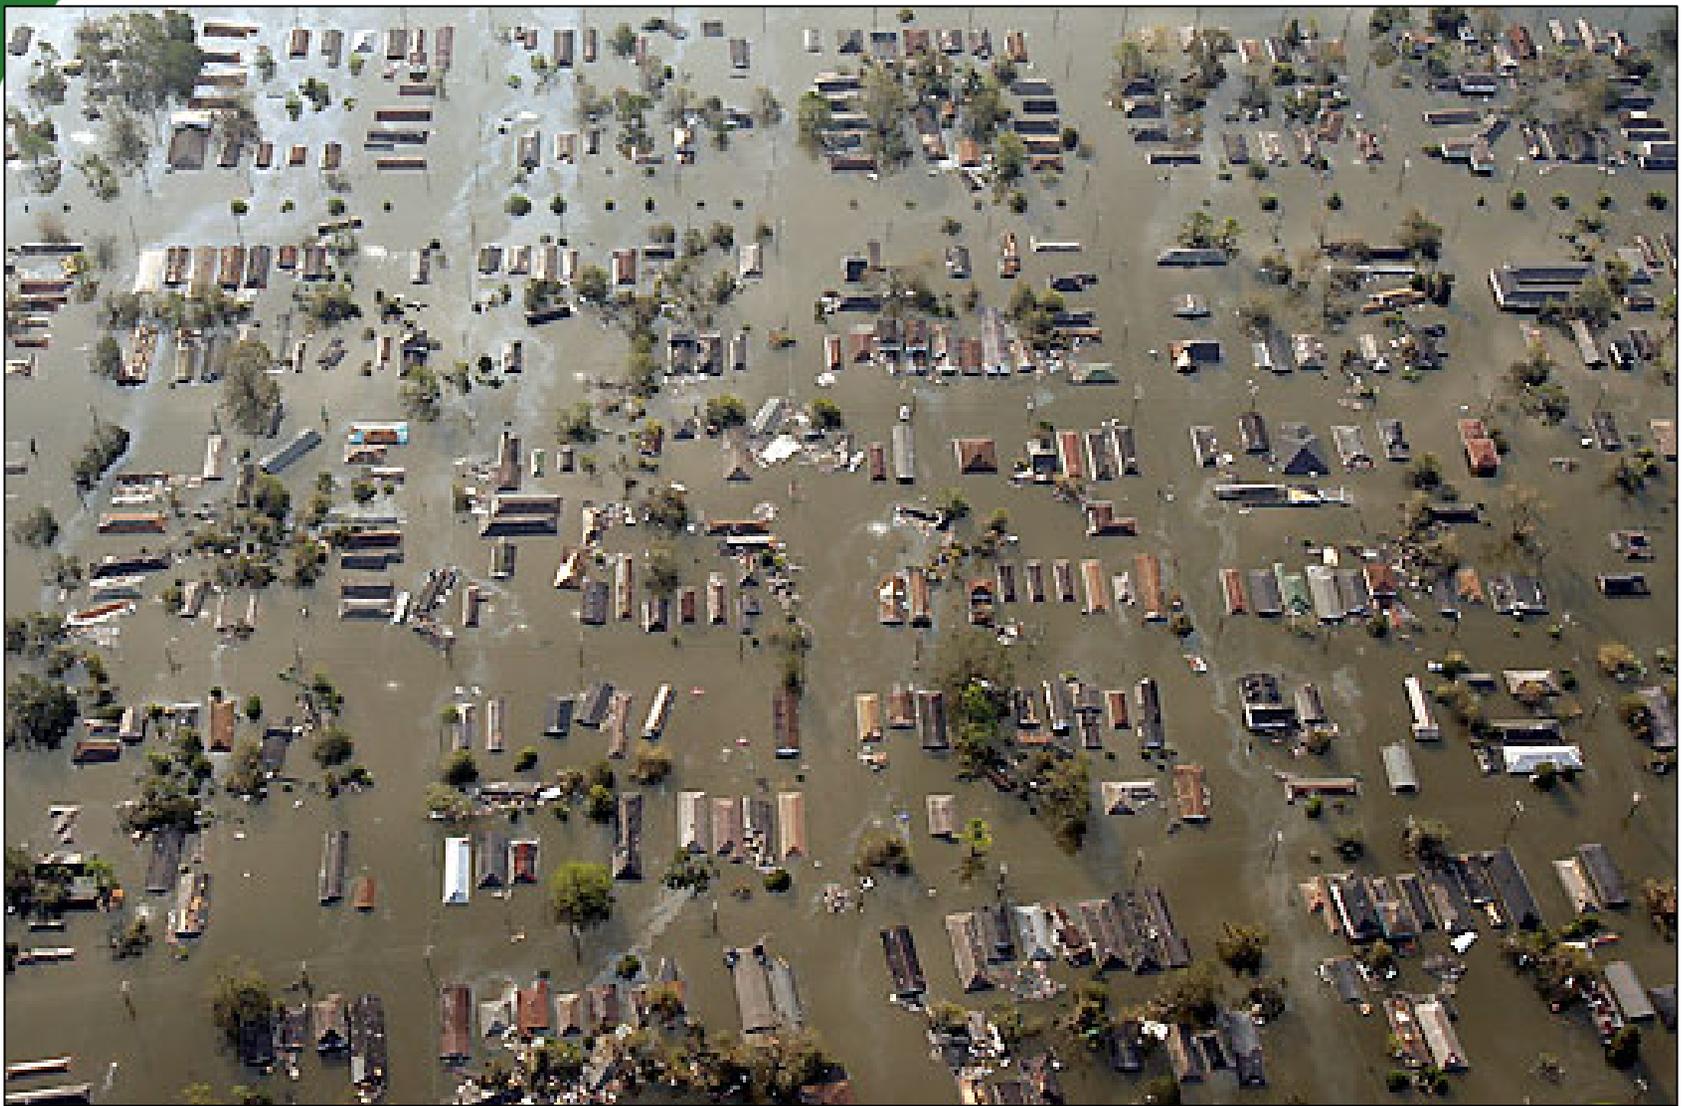
- **New Orleans neighborhoods were filled with as much as 12 feet of water, for up to 6 weeks**

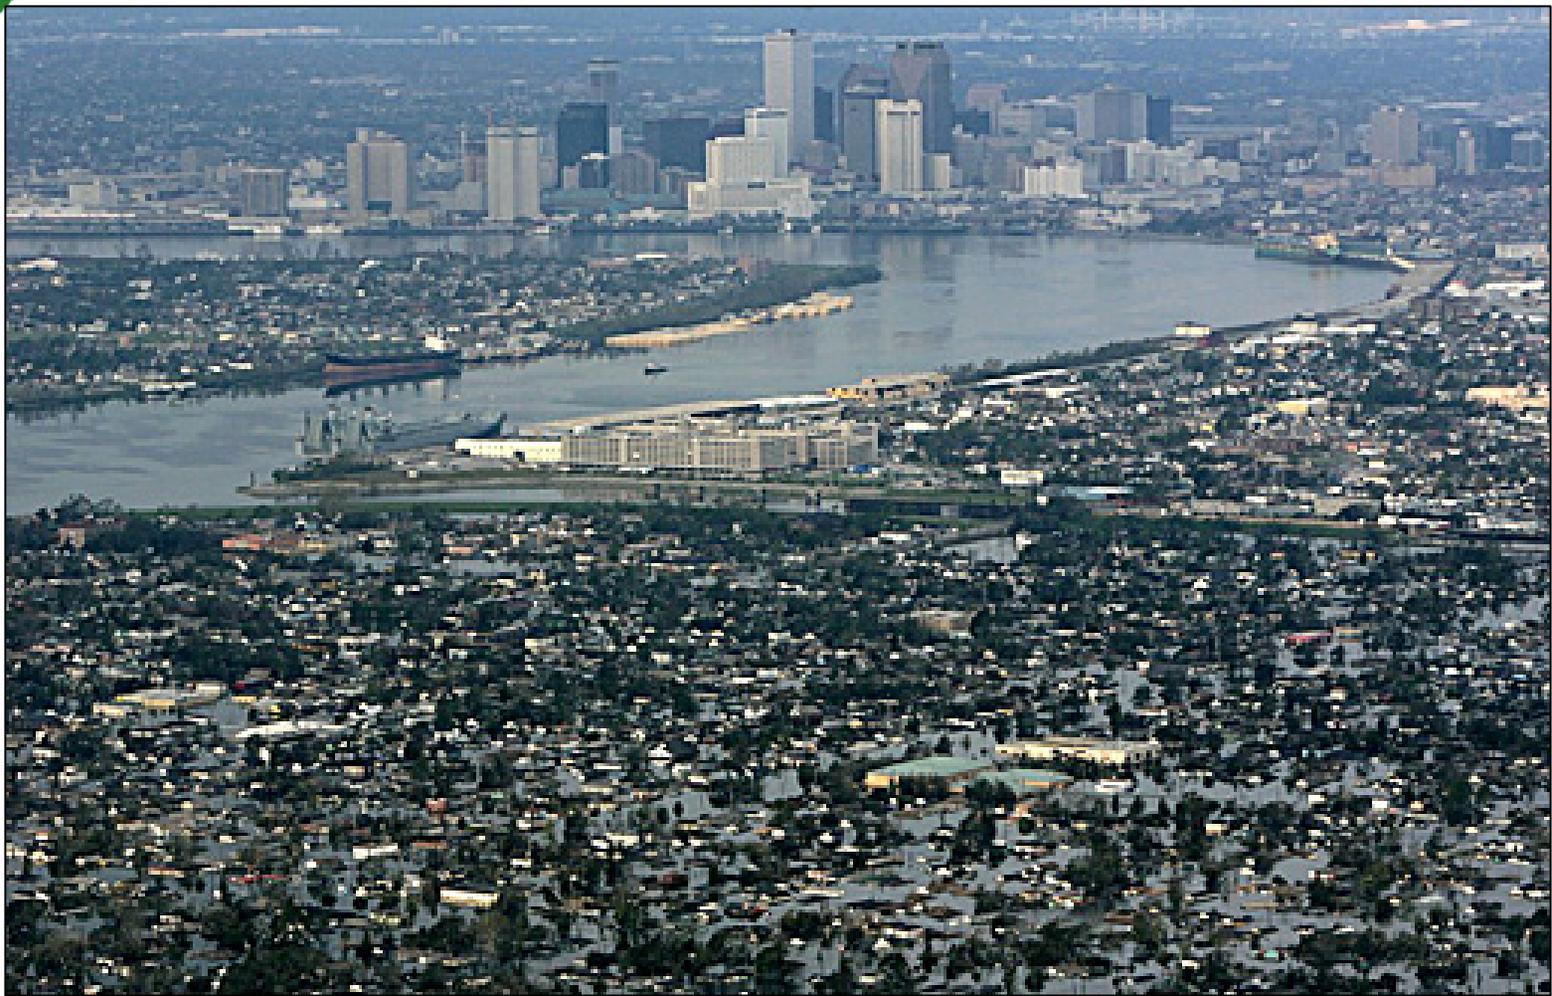
- Katrina left New Orleans under water, creating the worst flood in American history and the most expensive disaster, causing **\$24 billion** in claims to the **National Flood Insurance Program** and **\$200 billion** in overall damage.

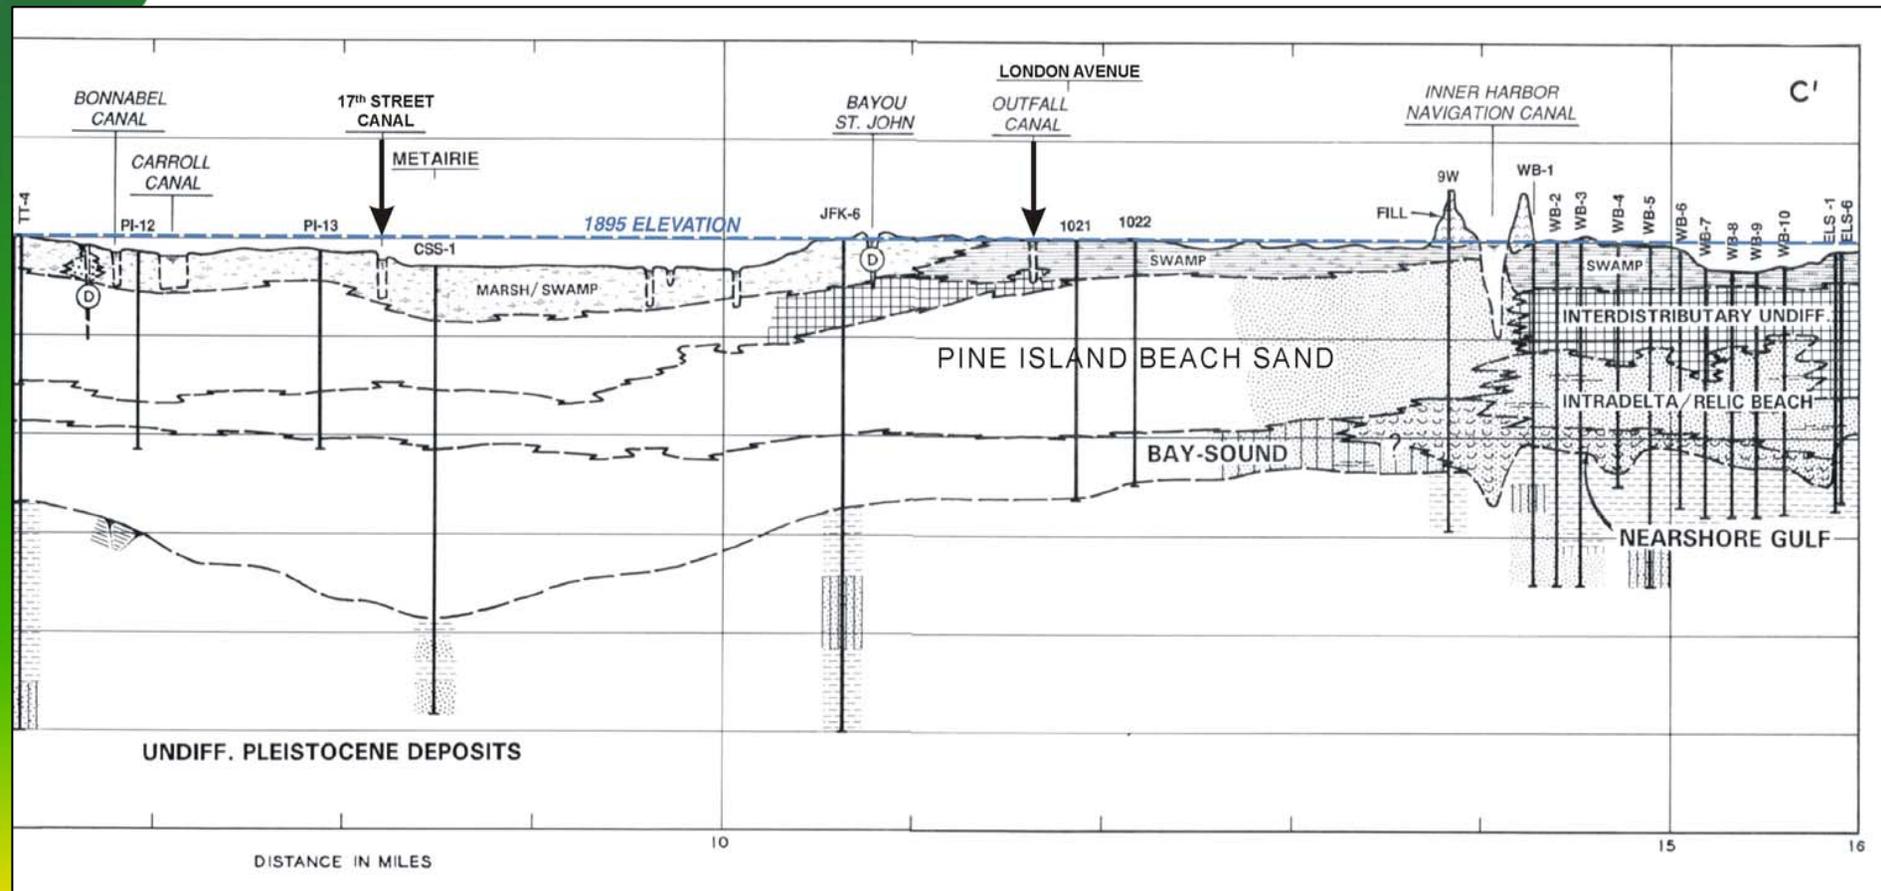
- **Geologic cross section along south shore of Lake Pontchartrain in the Lakeside, Gentilly, and Ninth Ward neighborhoods, where the 17<sup>th</sup> Street, London Avenue, and IHNC levees failed during Hurricane Katrina on Aug 29, 2005. Notice the apparent settlement that has occurred since the city survey of 1895 (blue line), and the correlation between settlement and non-beach sediment thickness.**

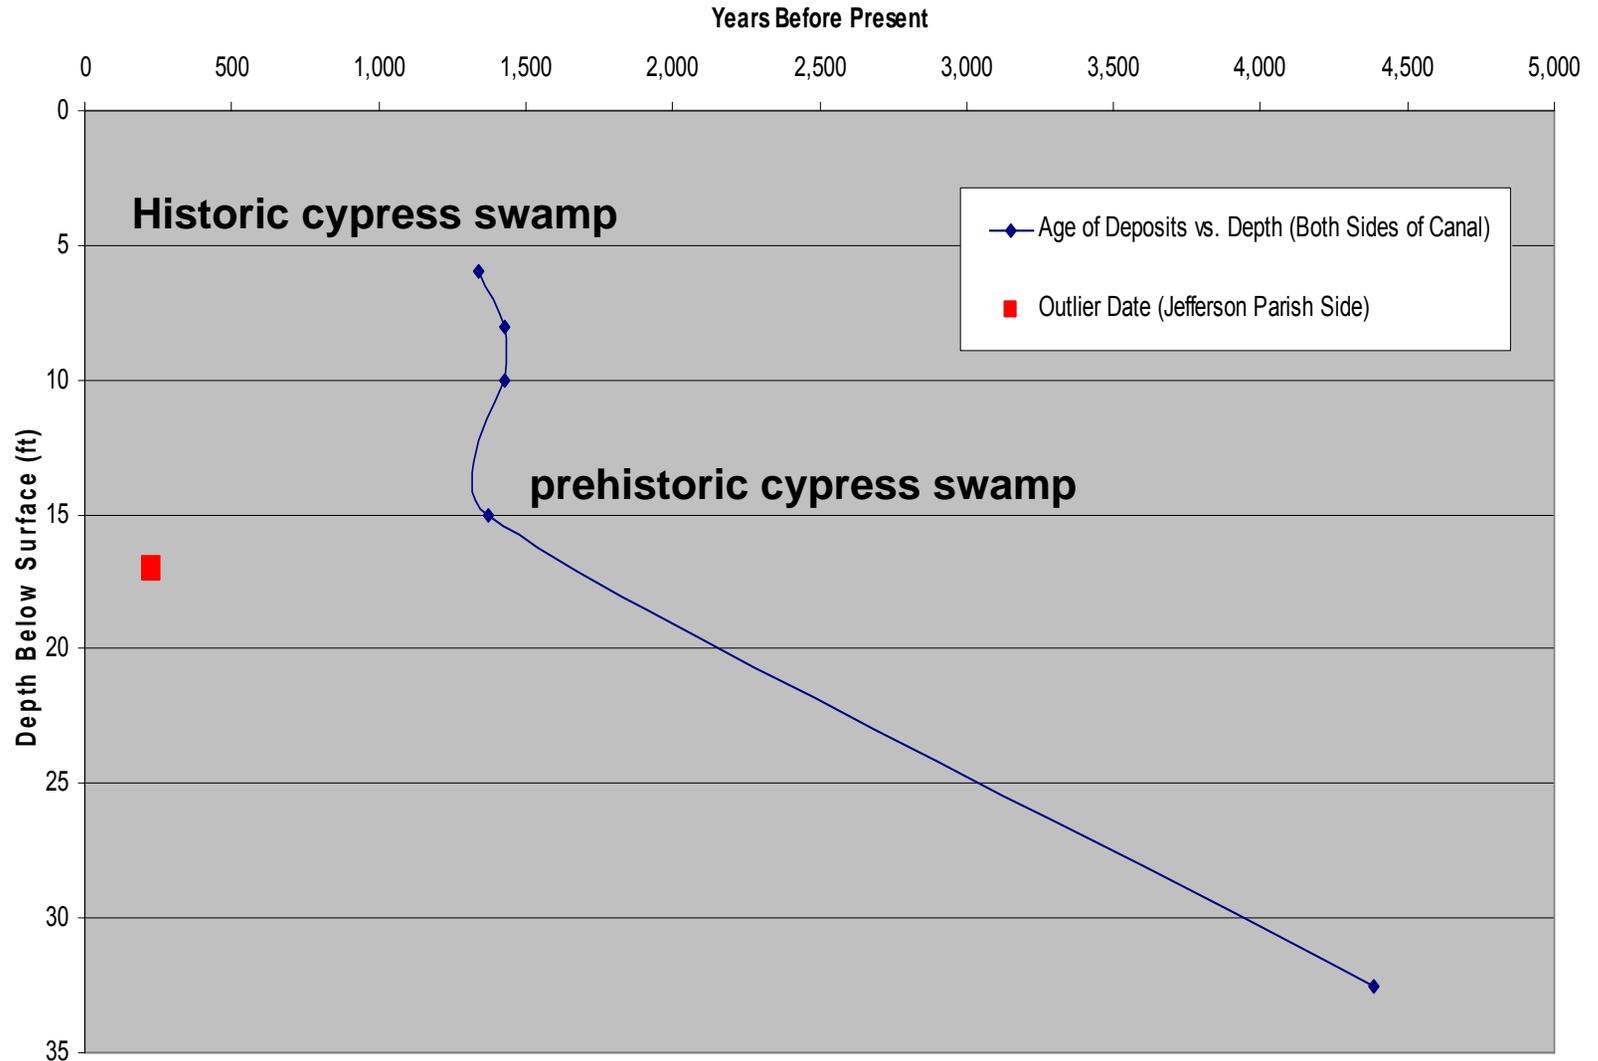
## Age of Deposits vs. Depth in Vicinity of 17th St. Canal Breach

- **C14 dates and depths suggest a rapidly filling paludal environment during the late Holocene**

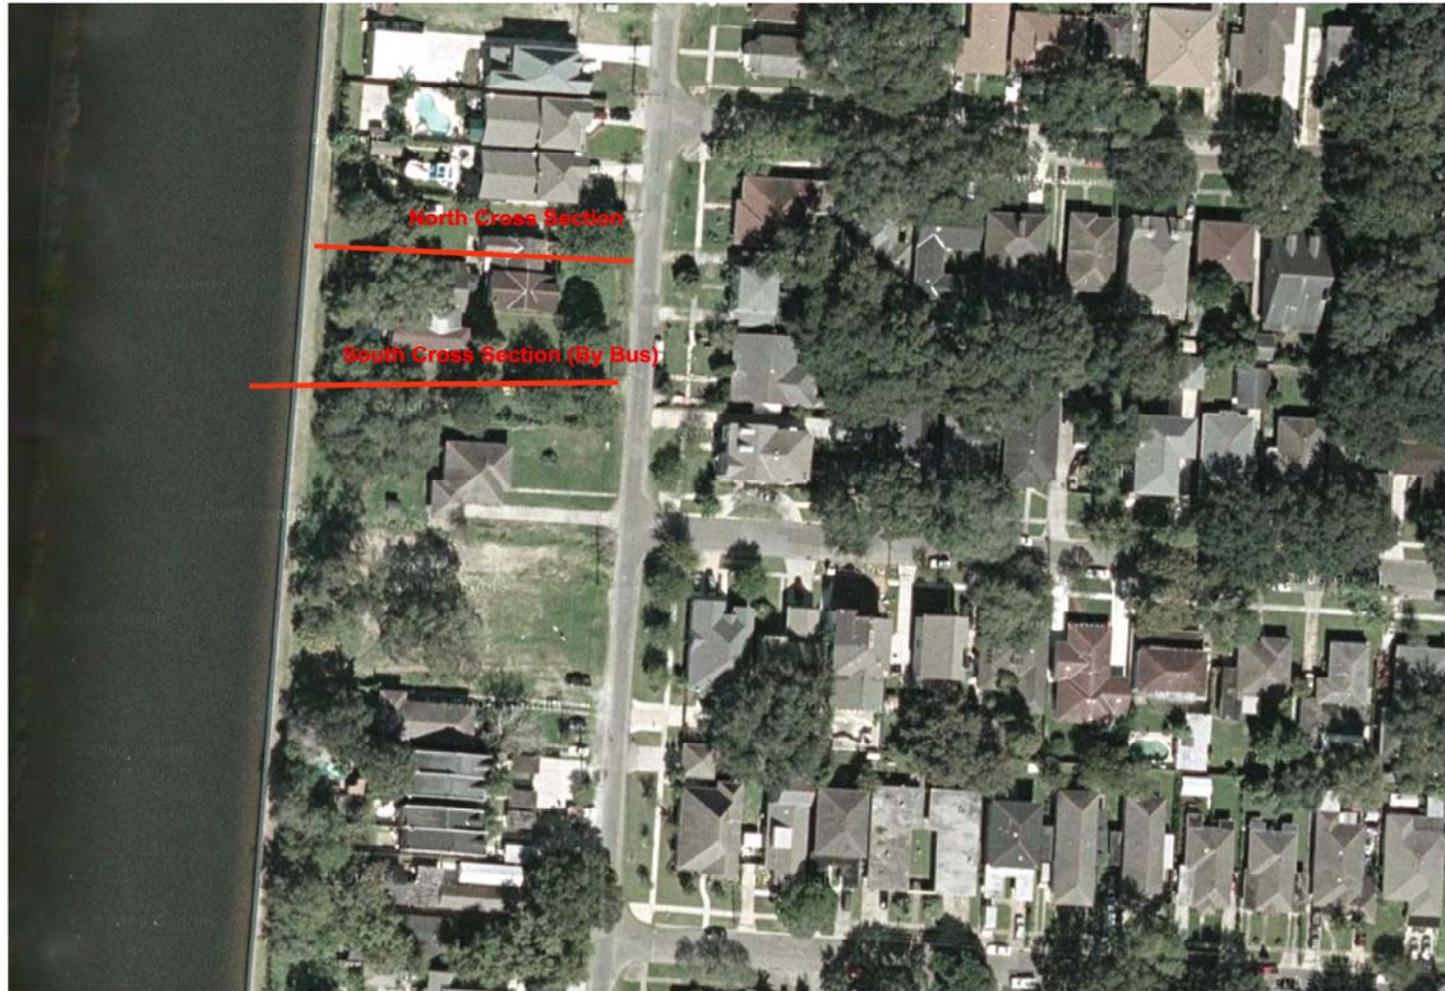
## 17th St. OUTFALL CANAL LEVEE BREAK CROSS SECTION LOCATIONS

- **Aerial photo of the 17<sup>th</sup> Street Canal breach site before the failure of August 29, 2005. The red lines indicate the positions of the NSF team's geologic sections.**

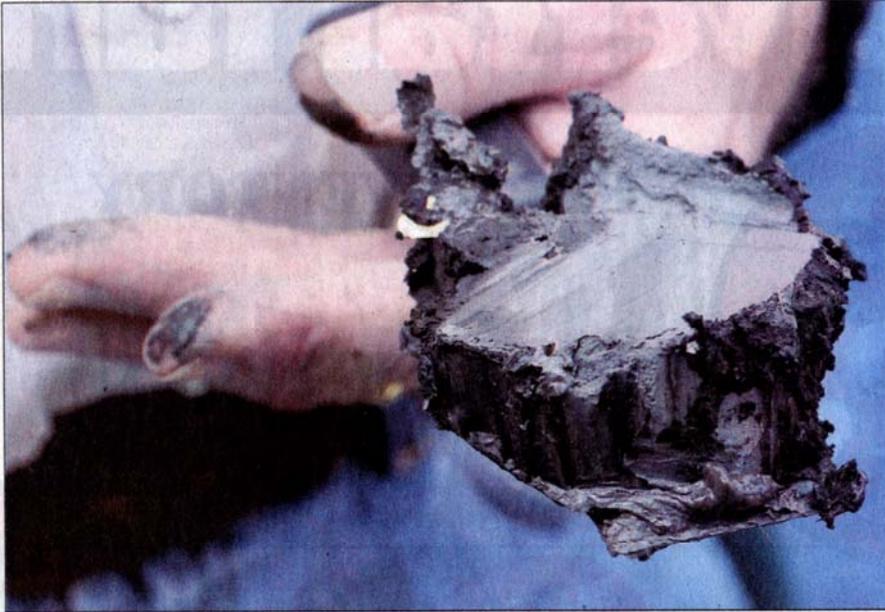
This piece of clay was just above the peat area at the site of the 17th Street Canal floodwall breach.

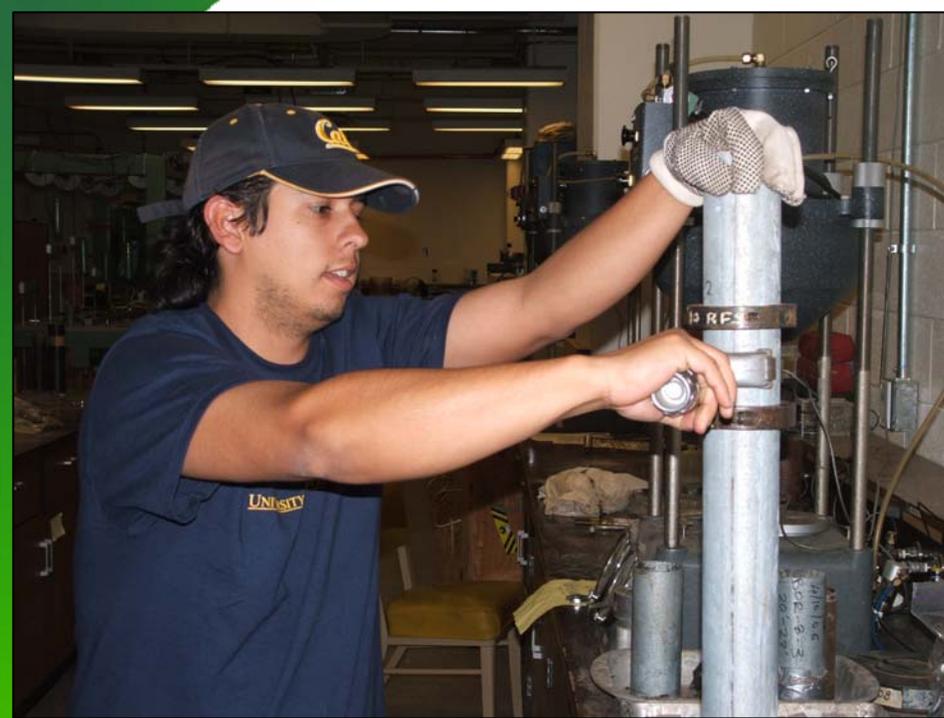
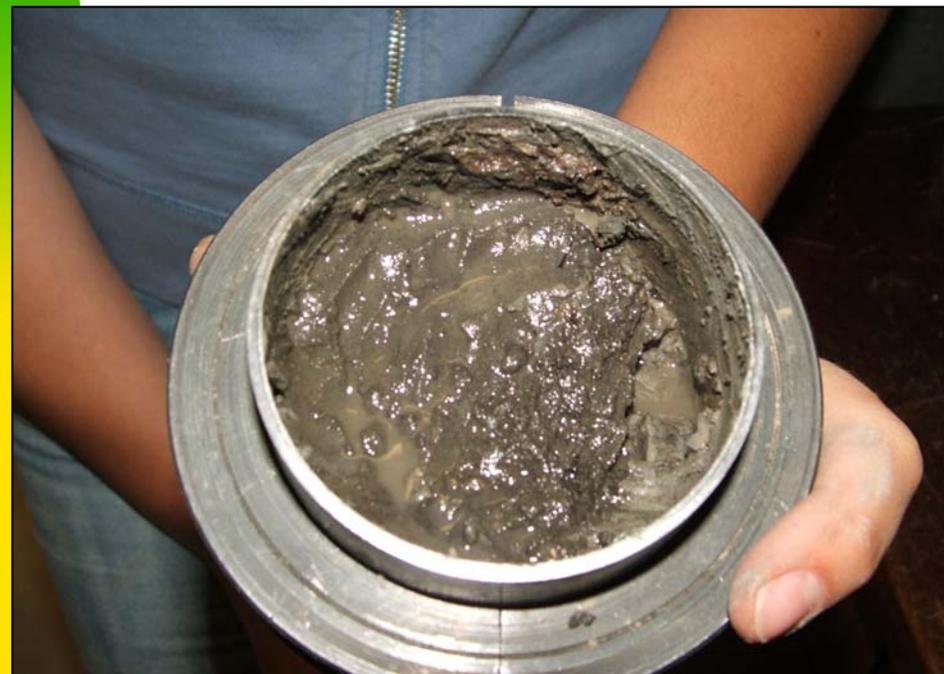
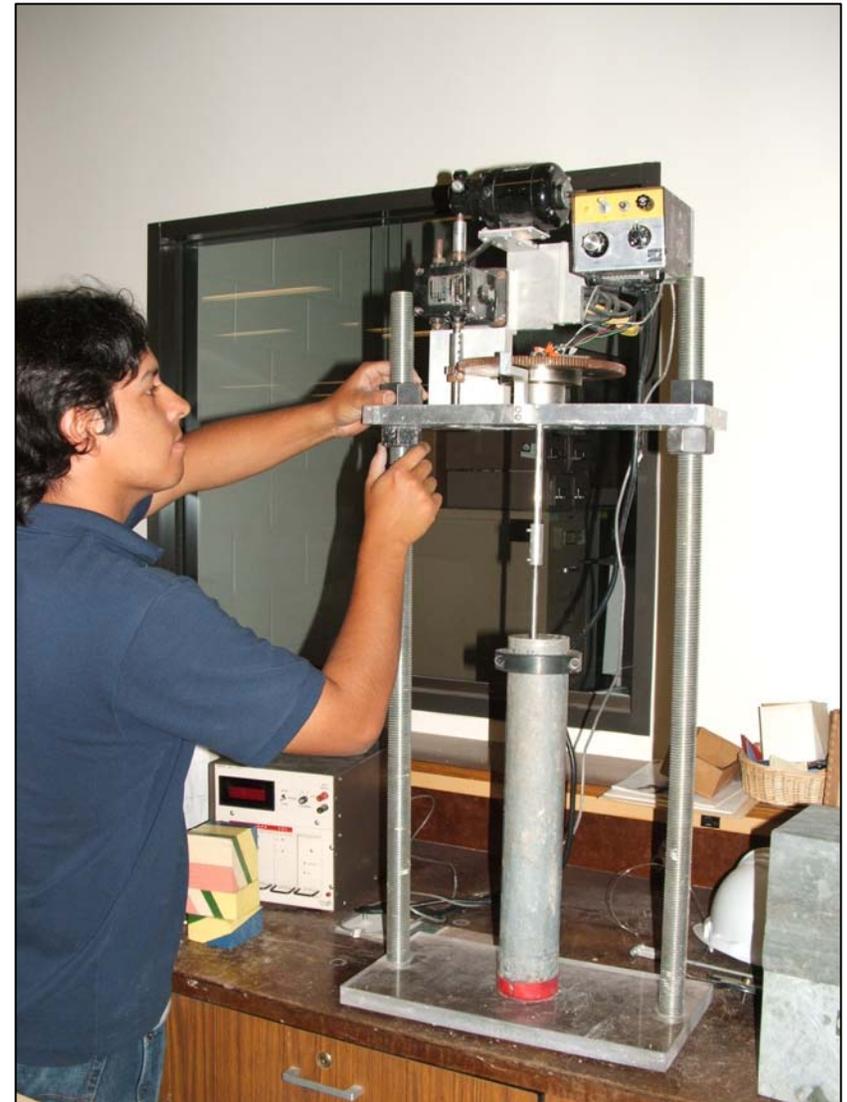
# Miniature laboratory vane shear testing at U.C. Berkeley

- Sampling the slip surface was only the first hurdle
- Shear testing of this toothpaste consistency paludal clay proved far more difficult
- The results eventually showed a peak shear strength of 50 psf, degrading to zero after a half inch of rotation

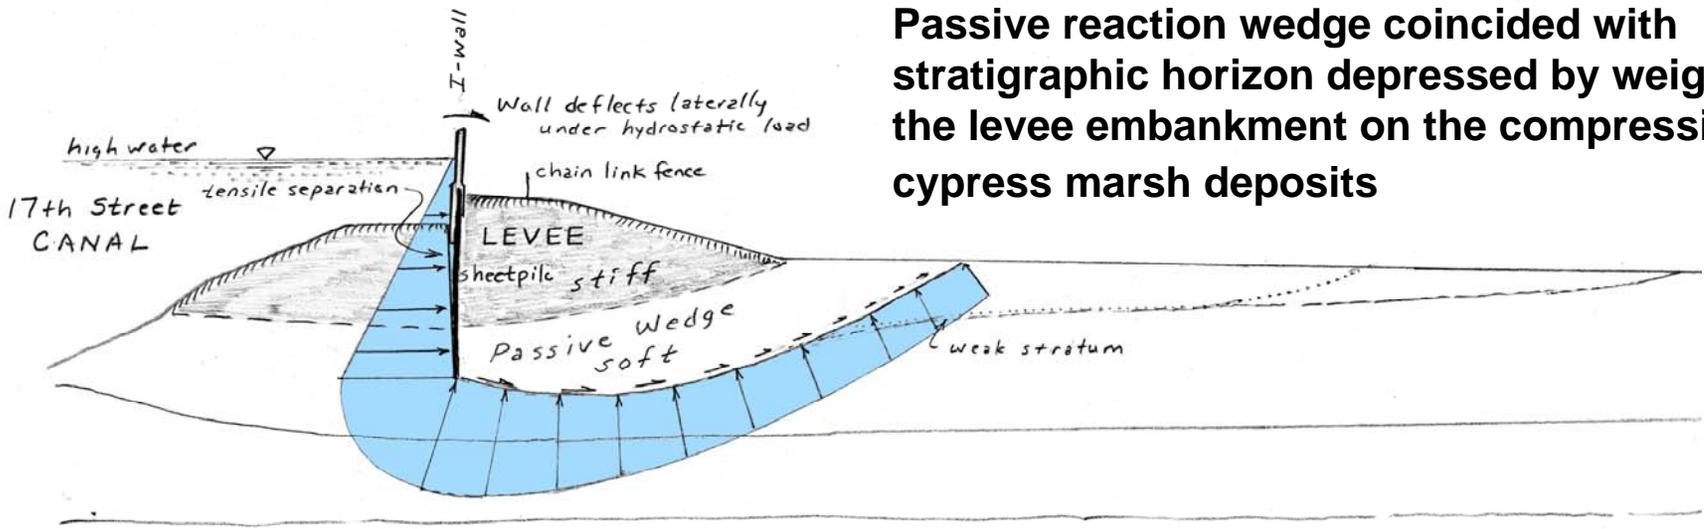
Passive reaction wedge coincided with stratigraphic horizon depressed by weight of the levee embankment on the compressible cypress marsh deposits

Traction shears noted along base of embankment. Note initial back rotation component of motion and development of planar thrusting

Initial loading conditions. Storm surge rises to within 4 feet of flood wall crest. Hydrostatic pressures on sheetpile supported I-wall highlighted in blue. Translational failure begins.

**Progression of translational failure sequence. Multiple thrust sheets develop in partially saturated crust, comprised of sandy fill over organic cypress swamp deposits. Buckles like a rug being rolled up.**

**Final stages of translational failure sequence. Lower section shows failed levee after 51 feet of displacement. The void was quickly backfilled with gravel as part of sealing the breach.**

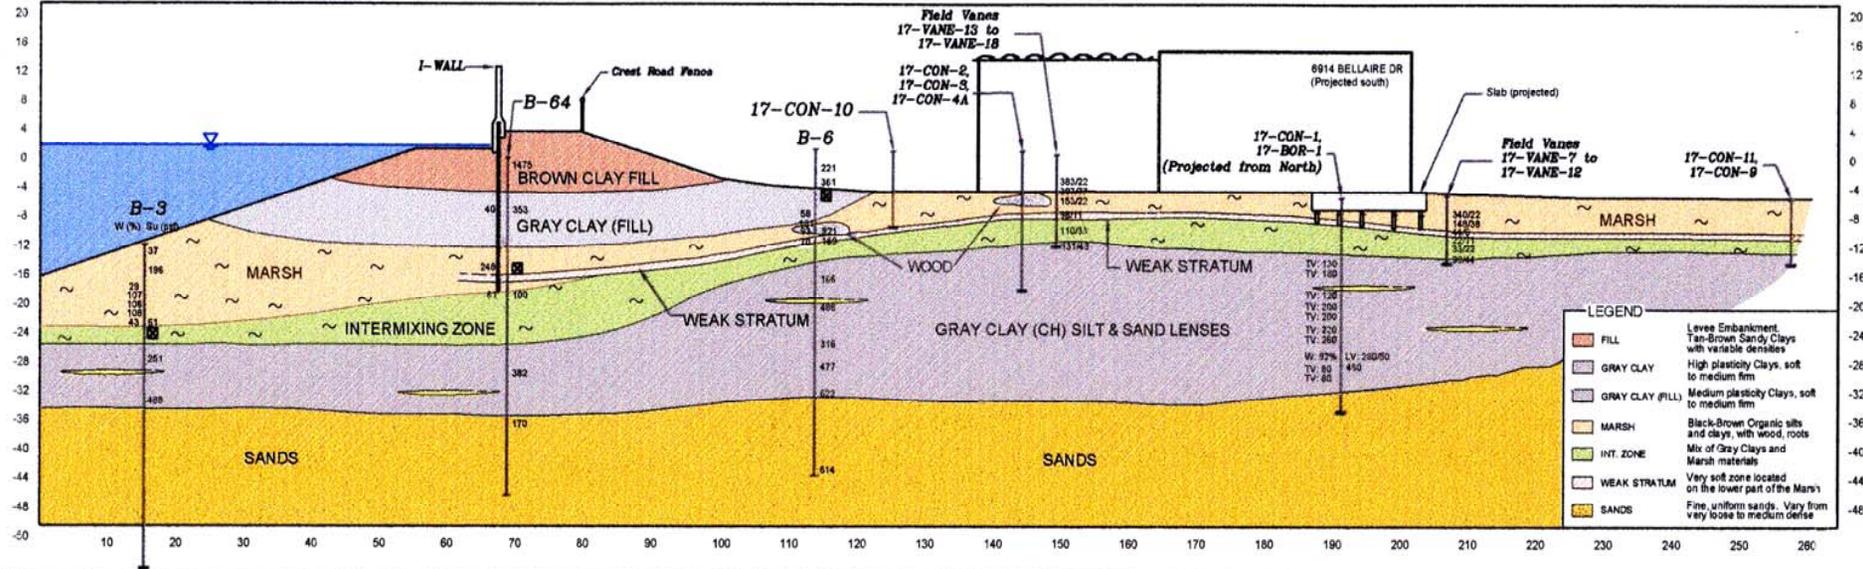
ANALYSIS SECTION

17th STREET CANAL EAST BANK BREACH  
SECTION 1, ELEVATION (FT, N.A.V.D.)

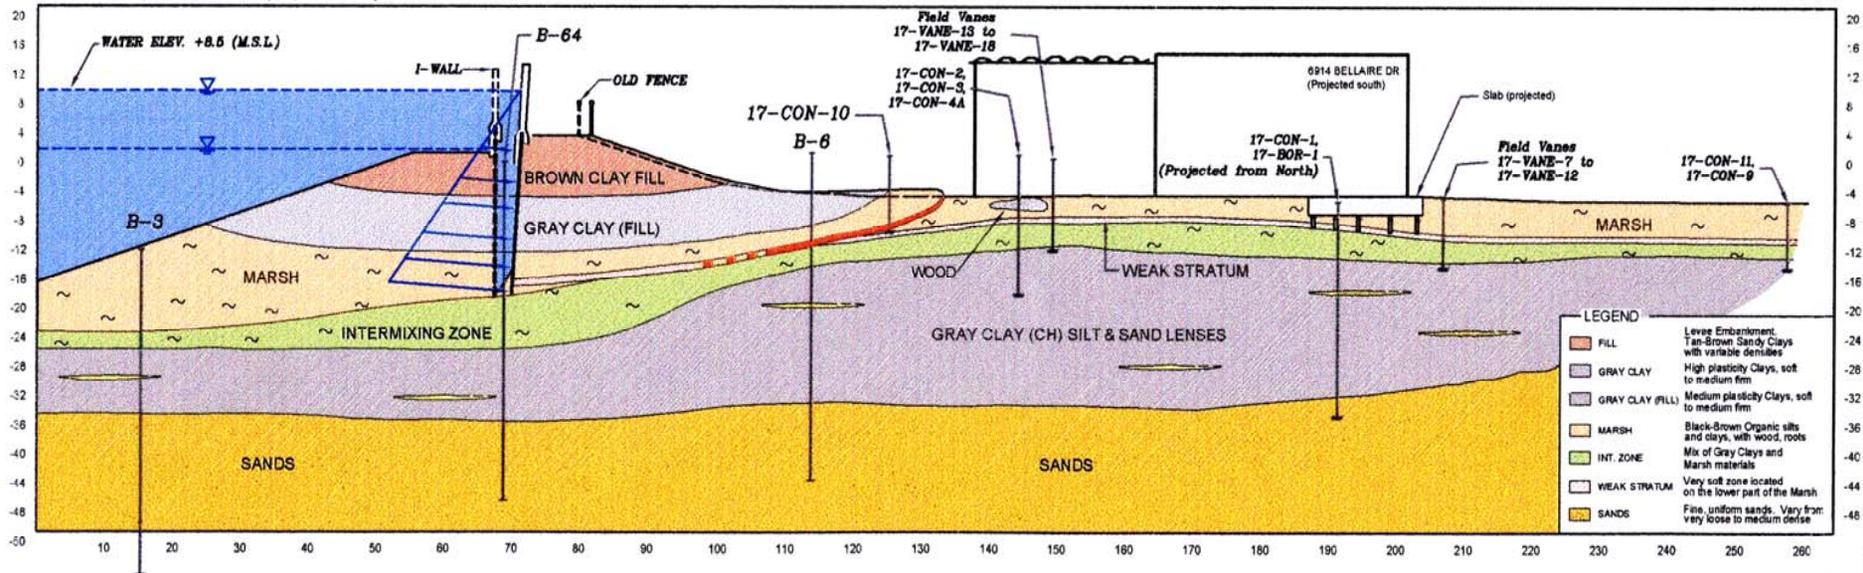
OPENING OF THE GAP

17th STREET CANAL EAST BANK BREACH  
SECTION 1, ELEVATION (FT, N.A.V.D.)

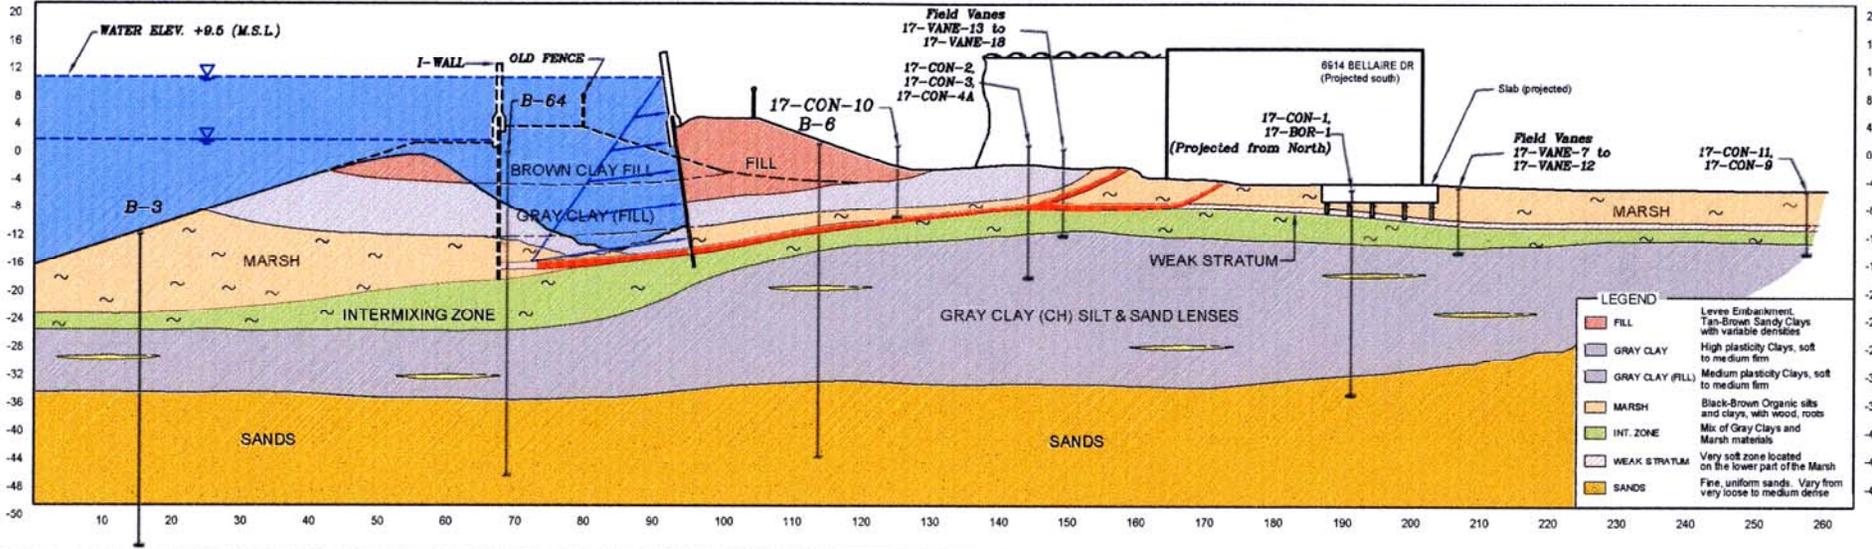
LATERAL TRANSLATION IN PROGRESS

17th STREET CANAL EAST BANK BREACH  
SECTION 1, ELEVATION (FT. N.A.V.D.)

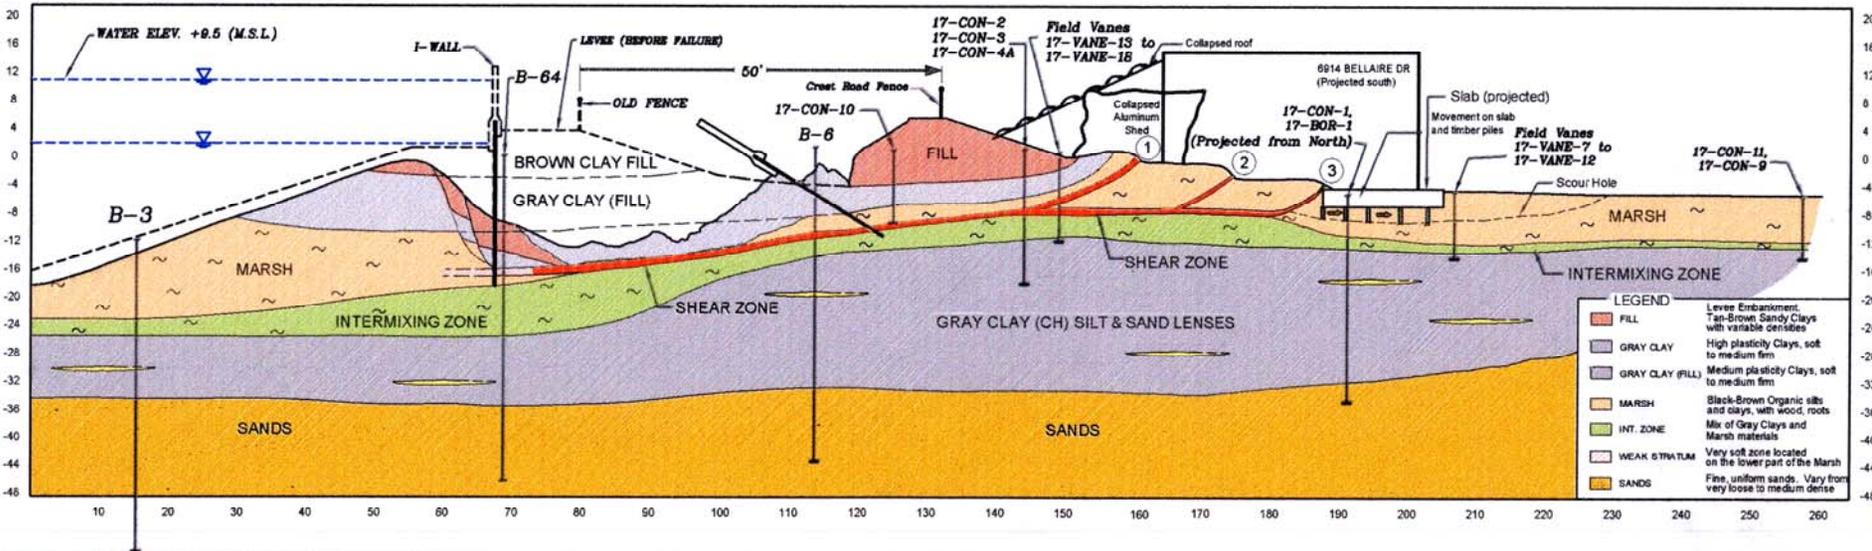
DISPLACED

17th STREET CANAL EAST BANK BREACH  
SECTION 1, ELEVATION (FT. N.A.V.D.)
