# **ENGINEERING GEOLOGIC CHARACTERIZATION OF LEVEE FAILURES IN NEW ORLEANS DURING HURRICANE KATRINA**

**J. David Rogers, Ph.D., P.E., R.G.**

**Member, National Science Foundation Independent Levee Investigation Team and  
Karl F. Hasselmann Chair in Geological Engineering  
University of Missouri-Rolla**

**2006 Annual Meeting  
Association of Environmental and Engineering Geologists  
Boston, Massachusetts  
November 1, 2006**

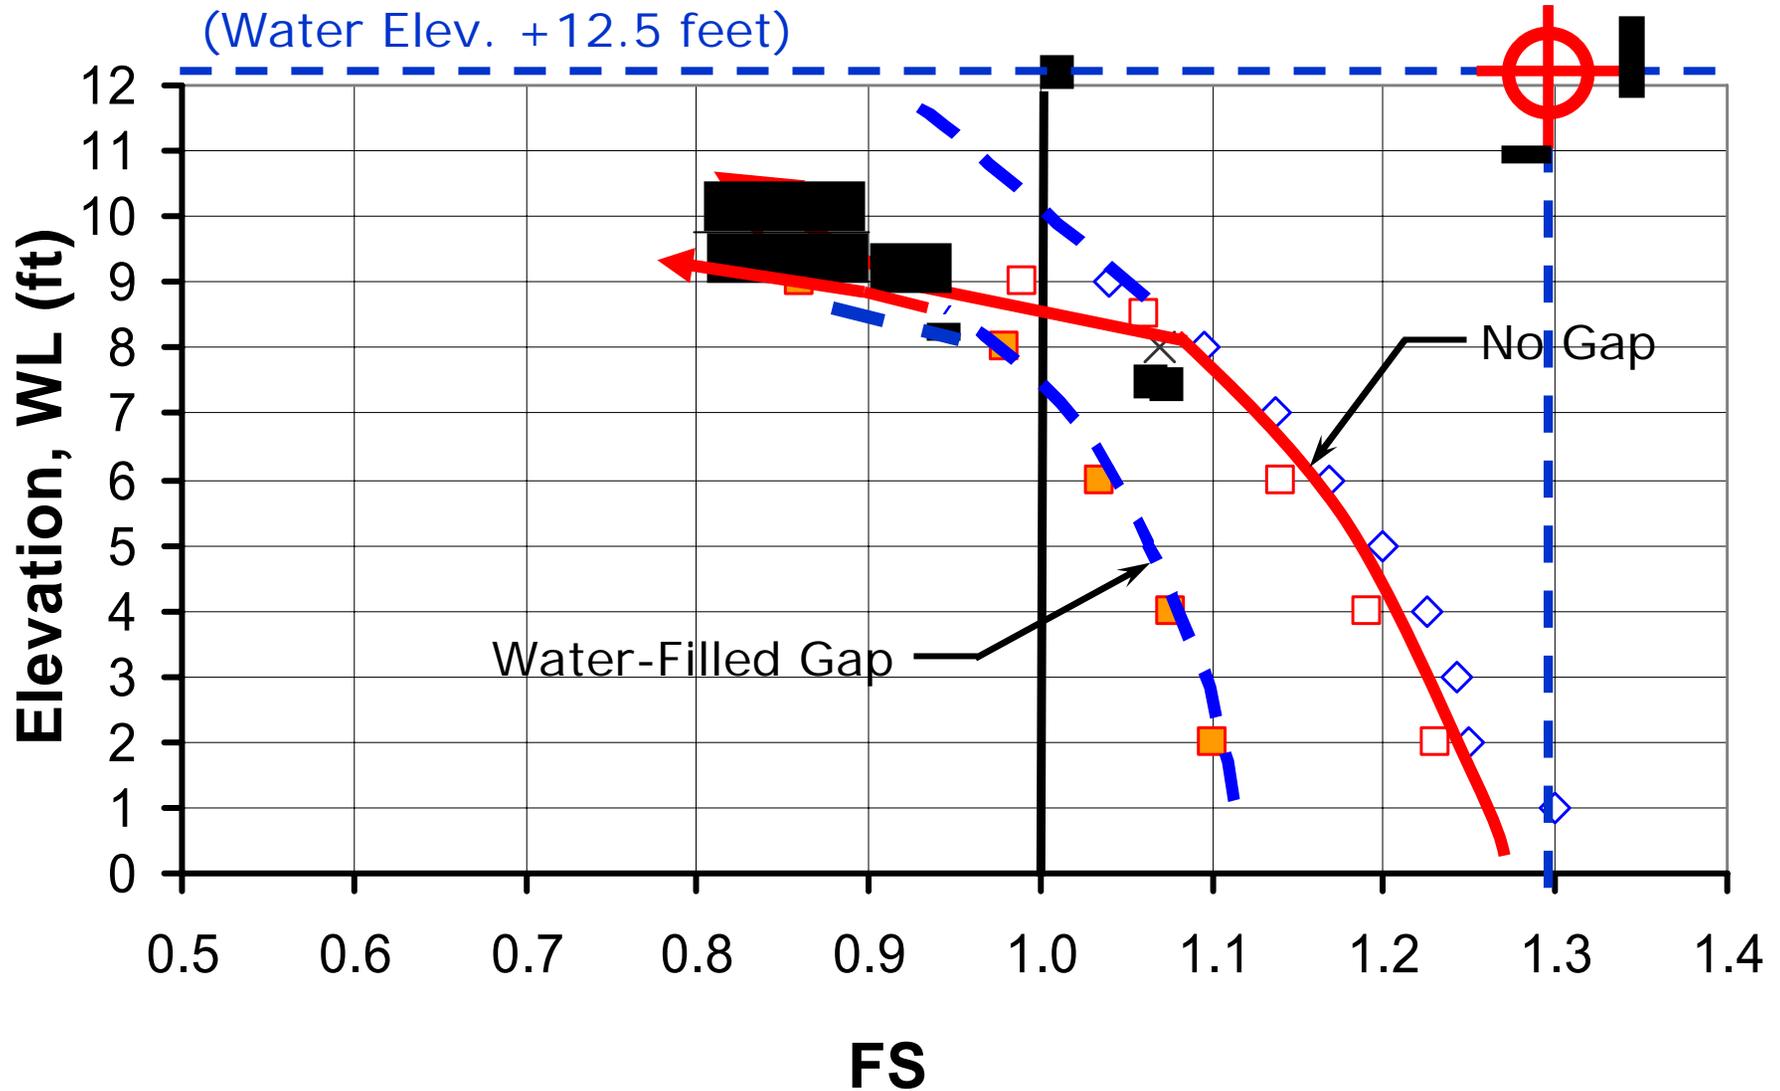
# 17<sup>th</sup> Street Canal East Side

(FS = 1.3)

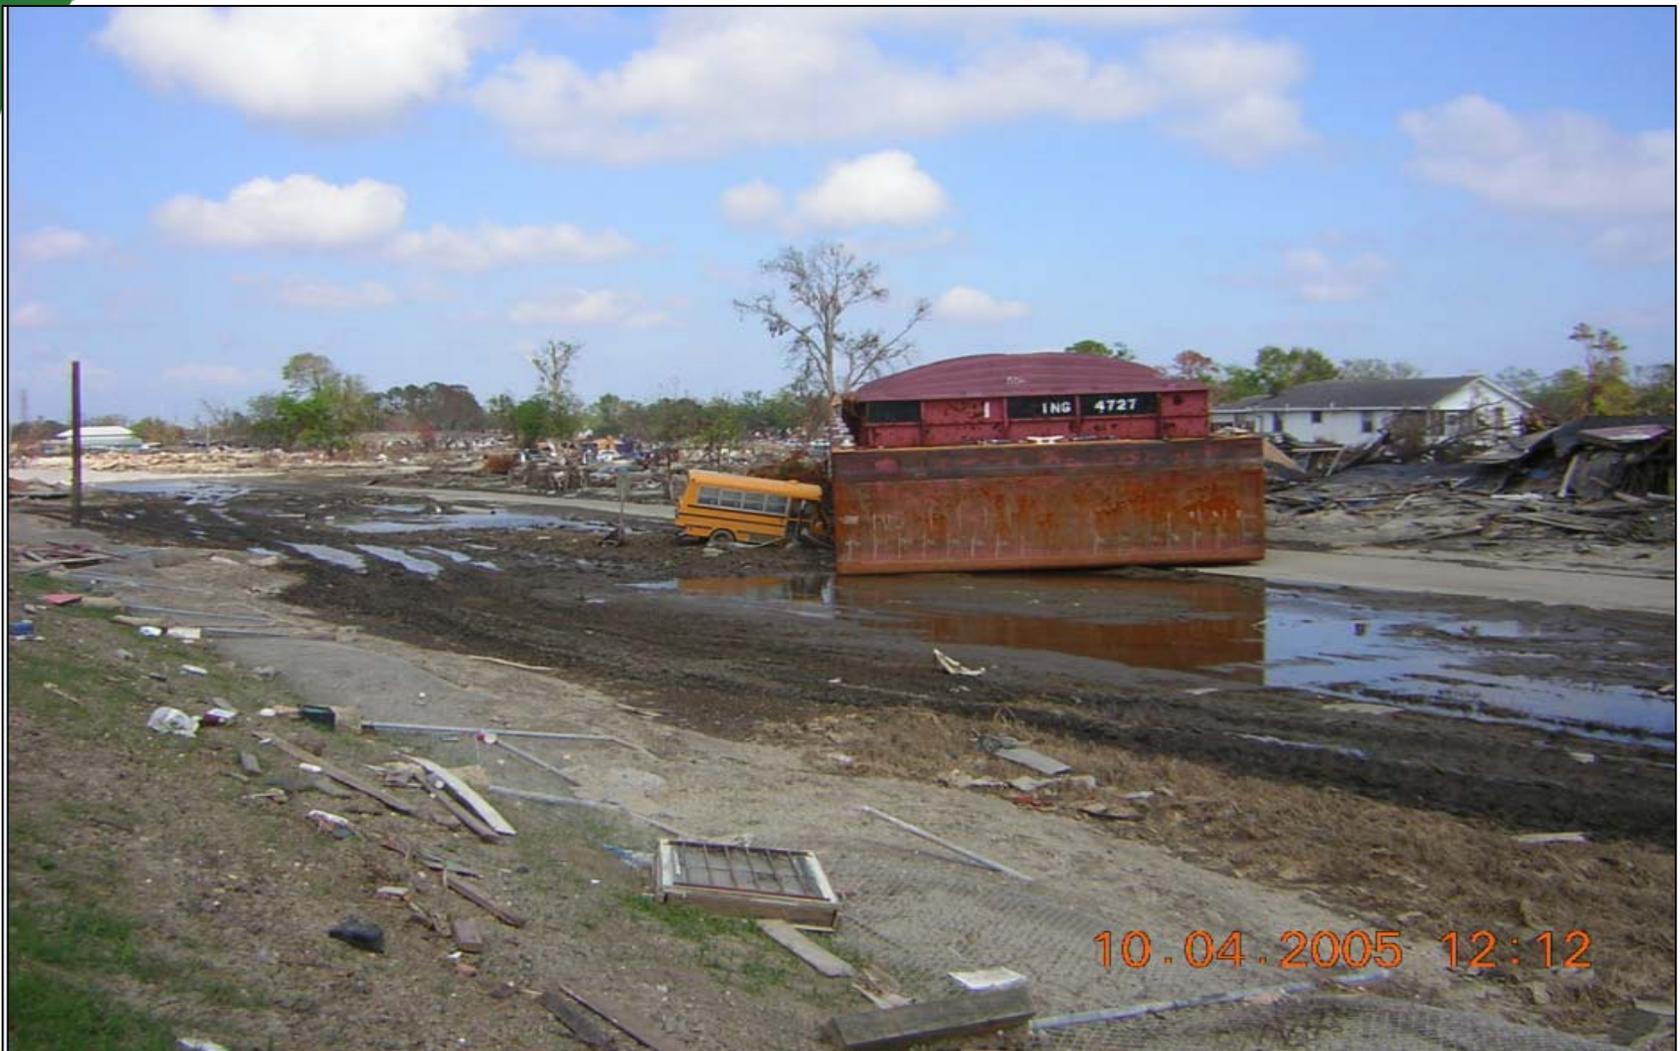
- **ING 4727 was built in 1990 as a dry cargo cover-top barge with a steel hull. It was 200 feet long, 35 feet wide, and 12 ft high, with a cargo volume of 84,659 ft<sup>3</sup> (1877 tons). It was being leased to Lafarge North America, and was tied up along the MRGO channel.**

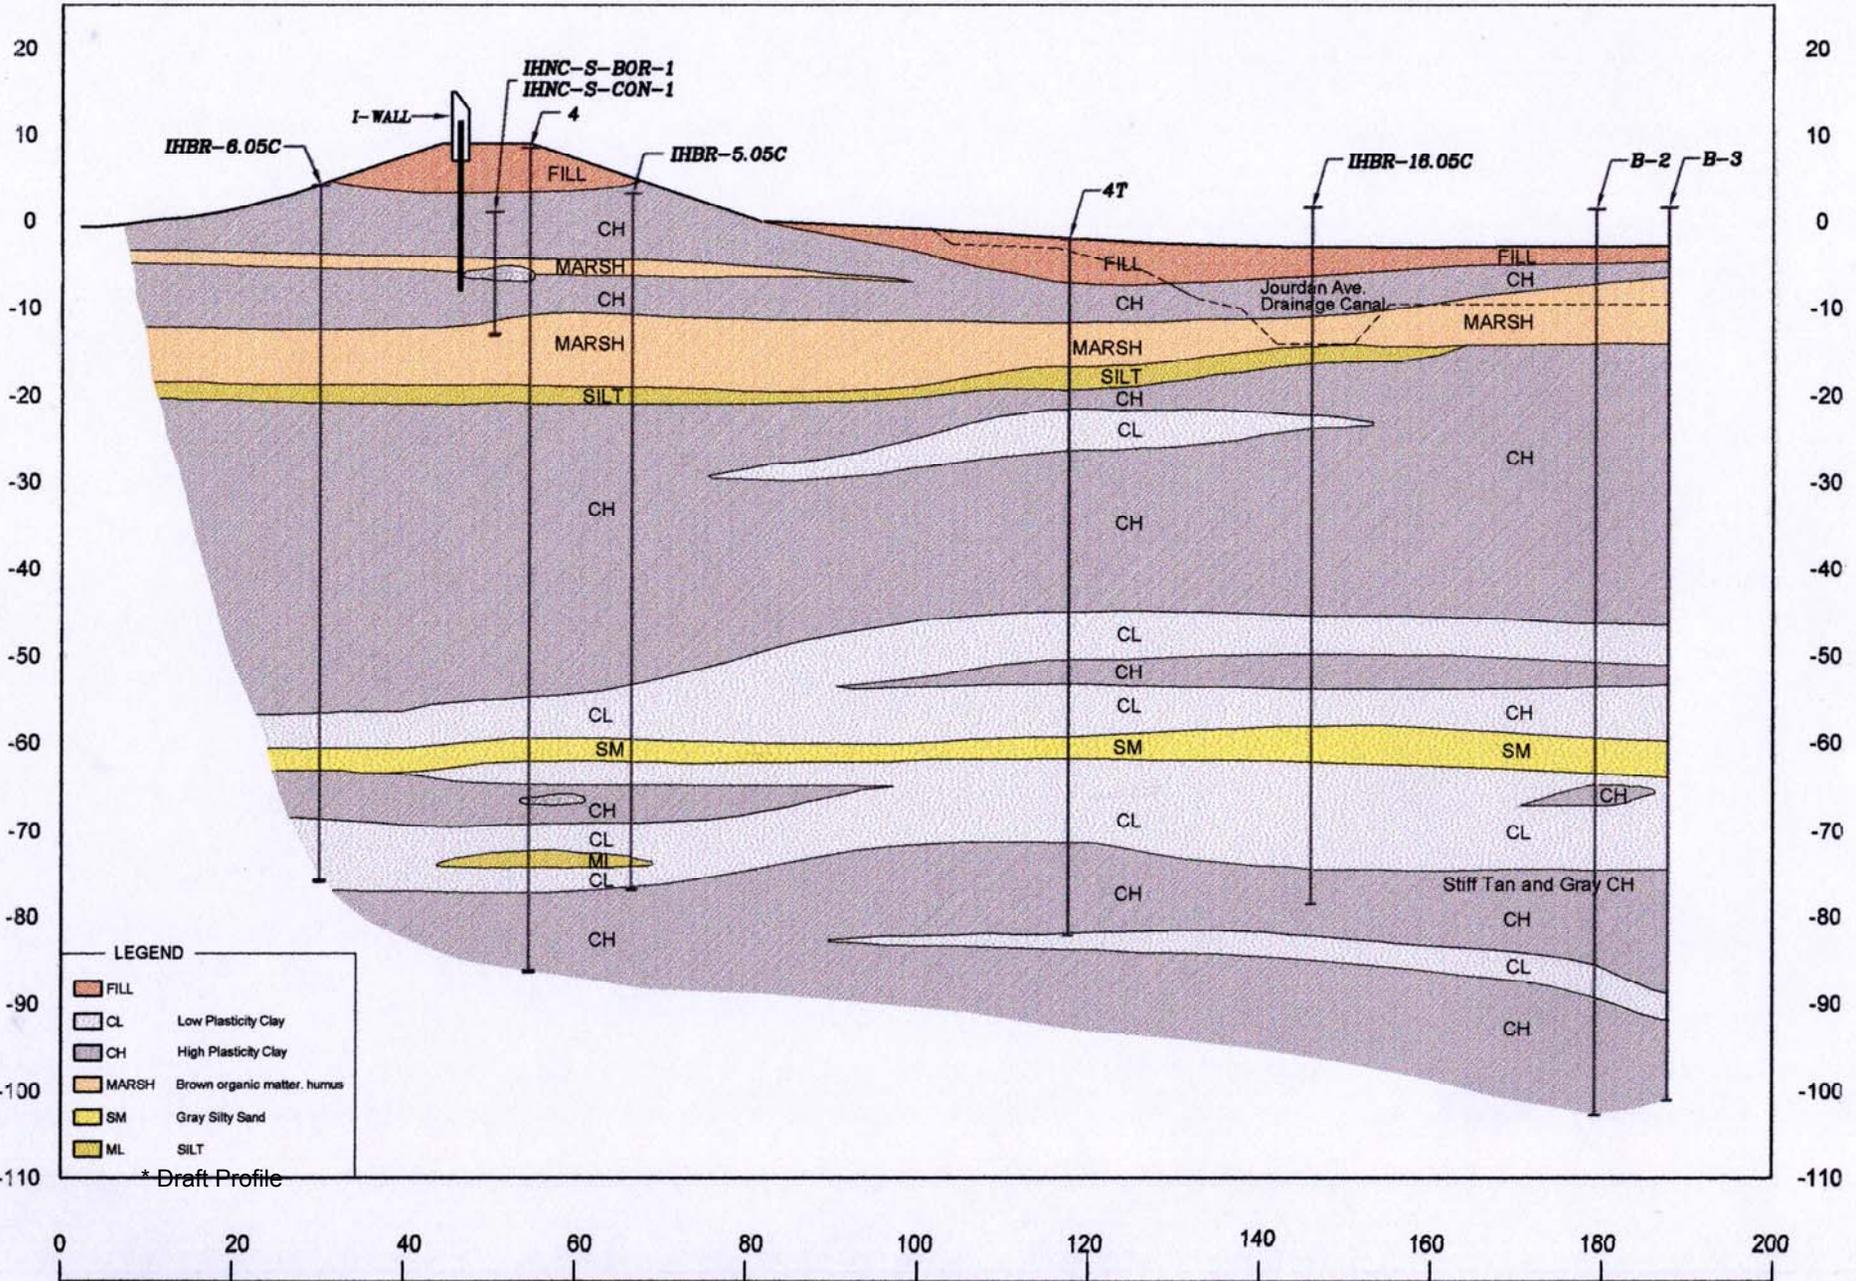
LOWER NINTH WARD, IHNC EAST BANK  
 SOUTH OF SOUTHERN BREACH  
 ELEVATION, FT (N.A.V.D.88)
