LANDSLIDES of the PANAMA CANAL

J. David Rogers, Ph.D., P.E., P.G.

2011 Pacific Section Meeting

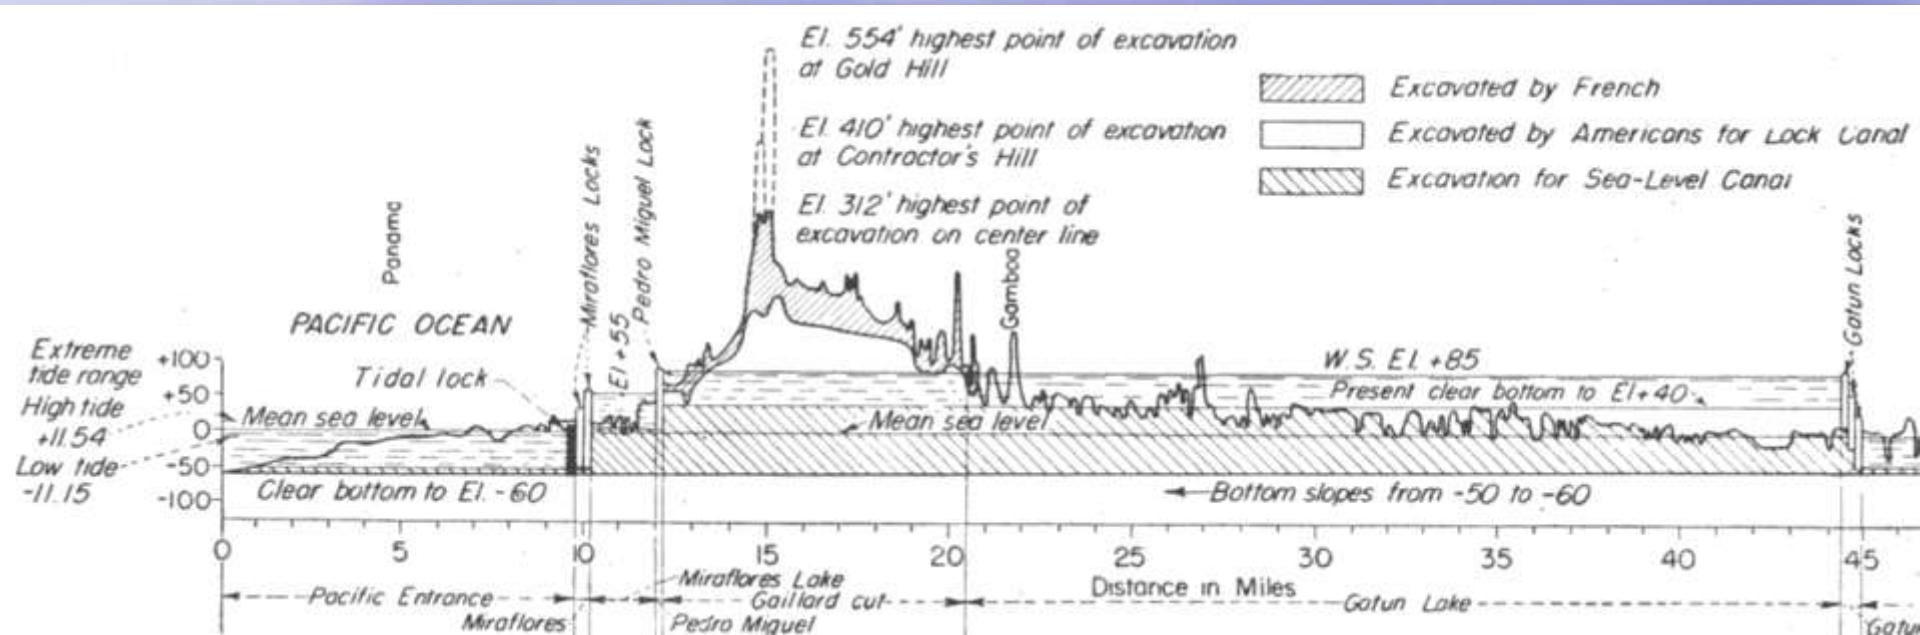
Longitudinal Section Along the Panama Canal

- The deepest excavations for the Panama Canal were concentrated near the Continental Divide, as shown in this vertically exaggerated section.

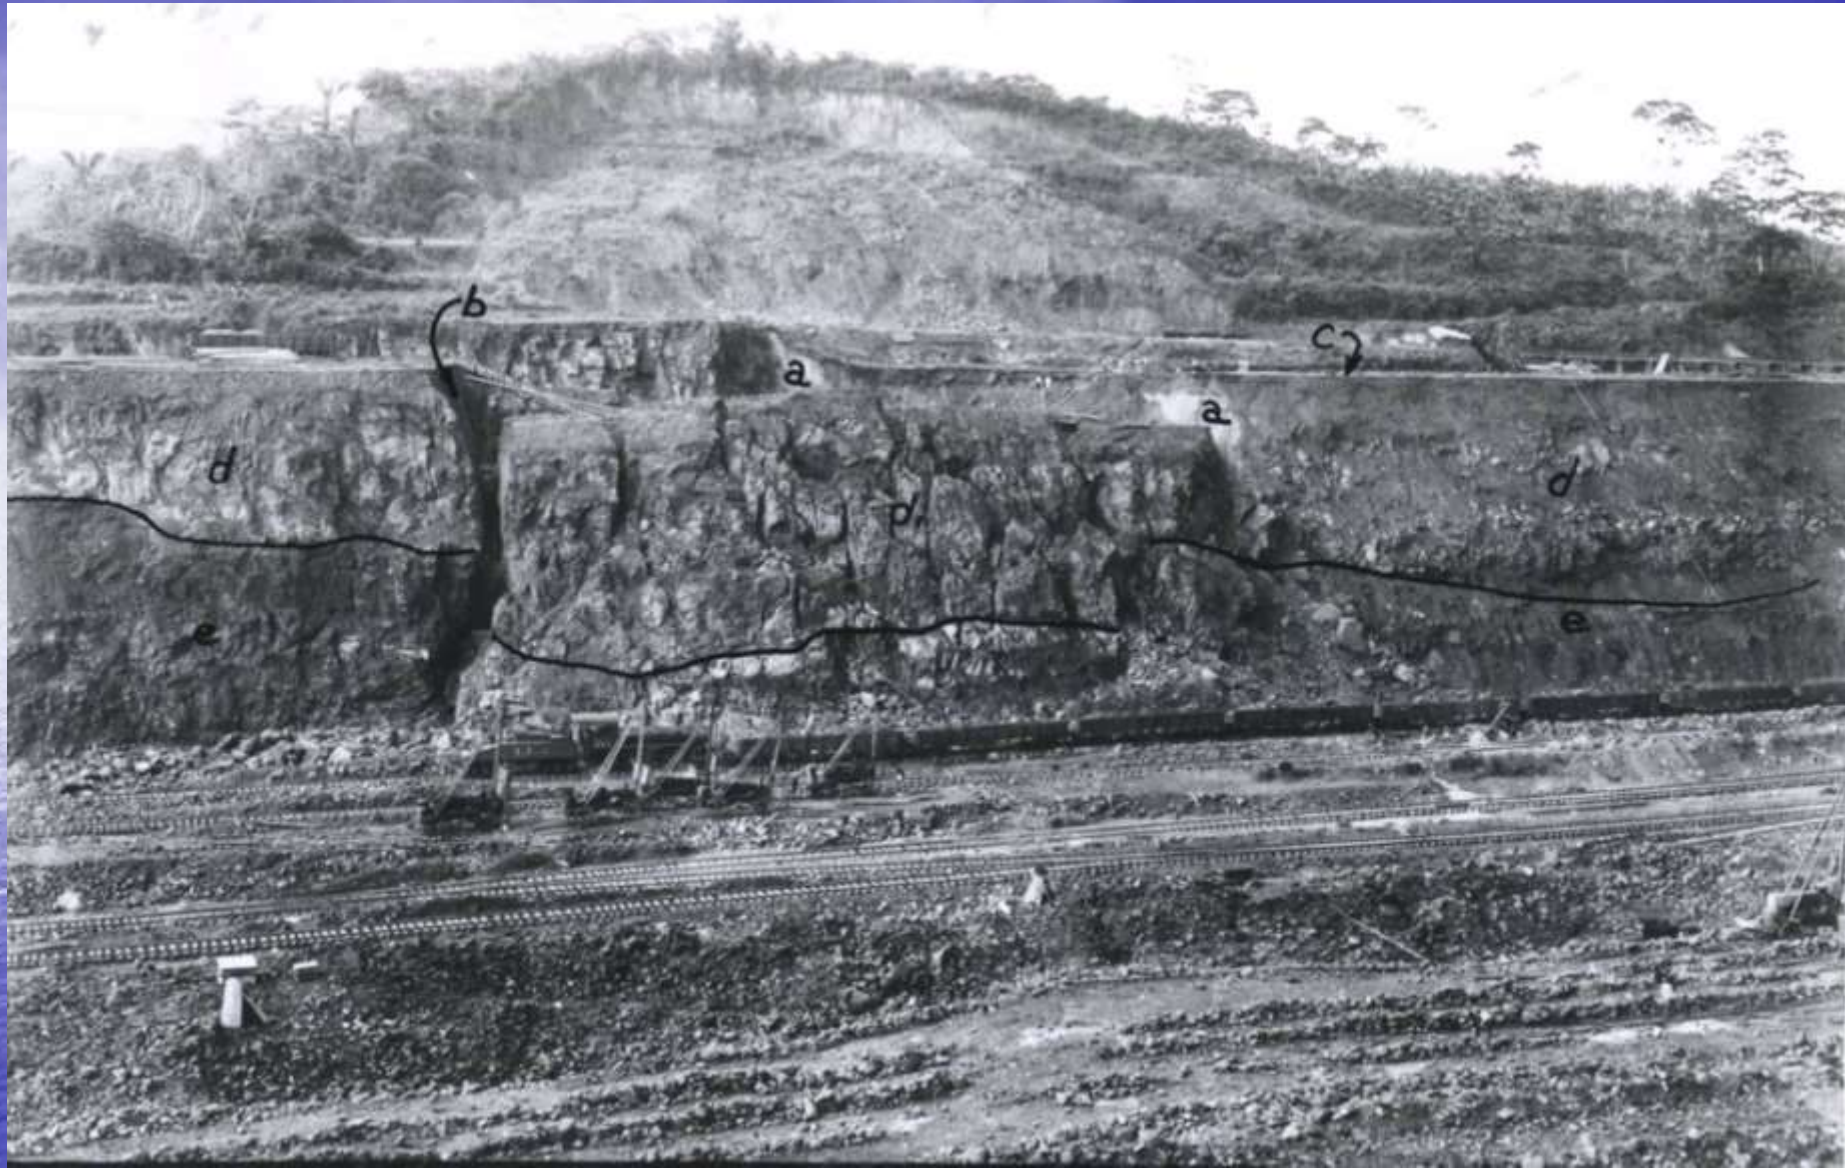
- **Block glide day-lighting into canal excavation in May 1910. This is one of the earliest slides that was scientifically evaluated by Army Engineers.**

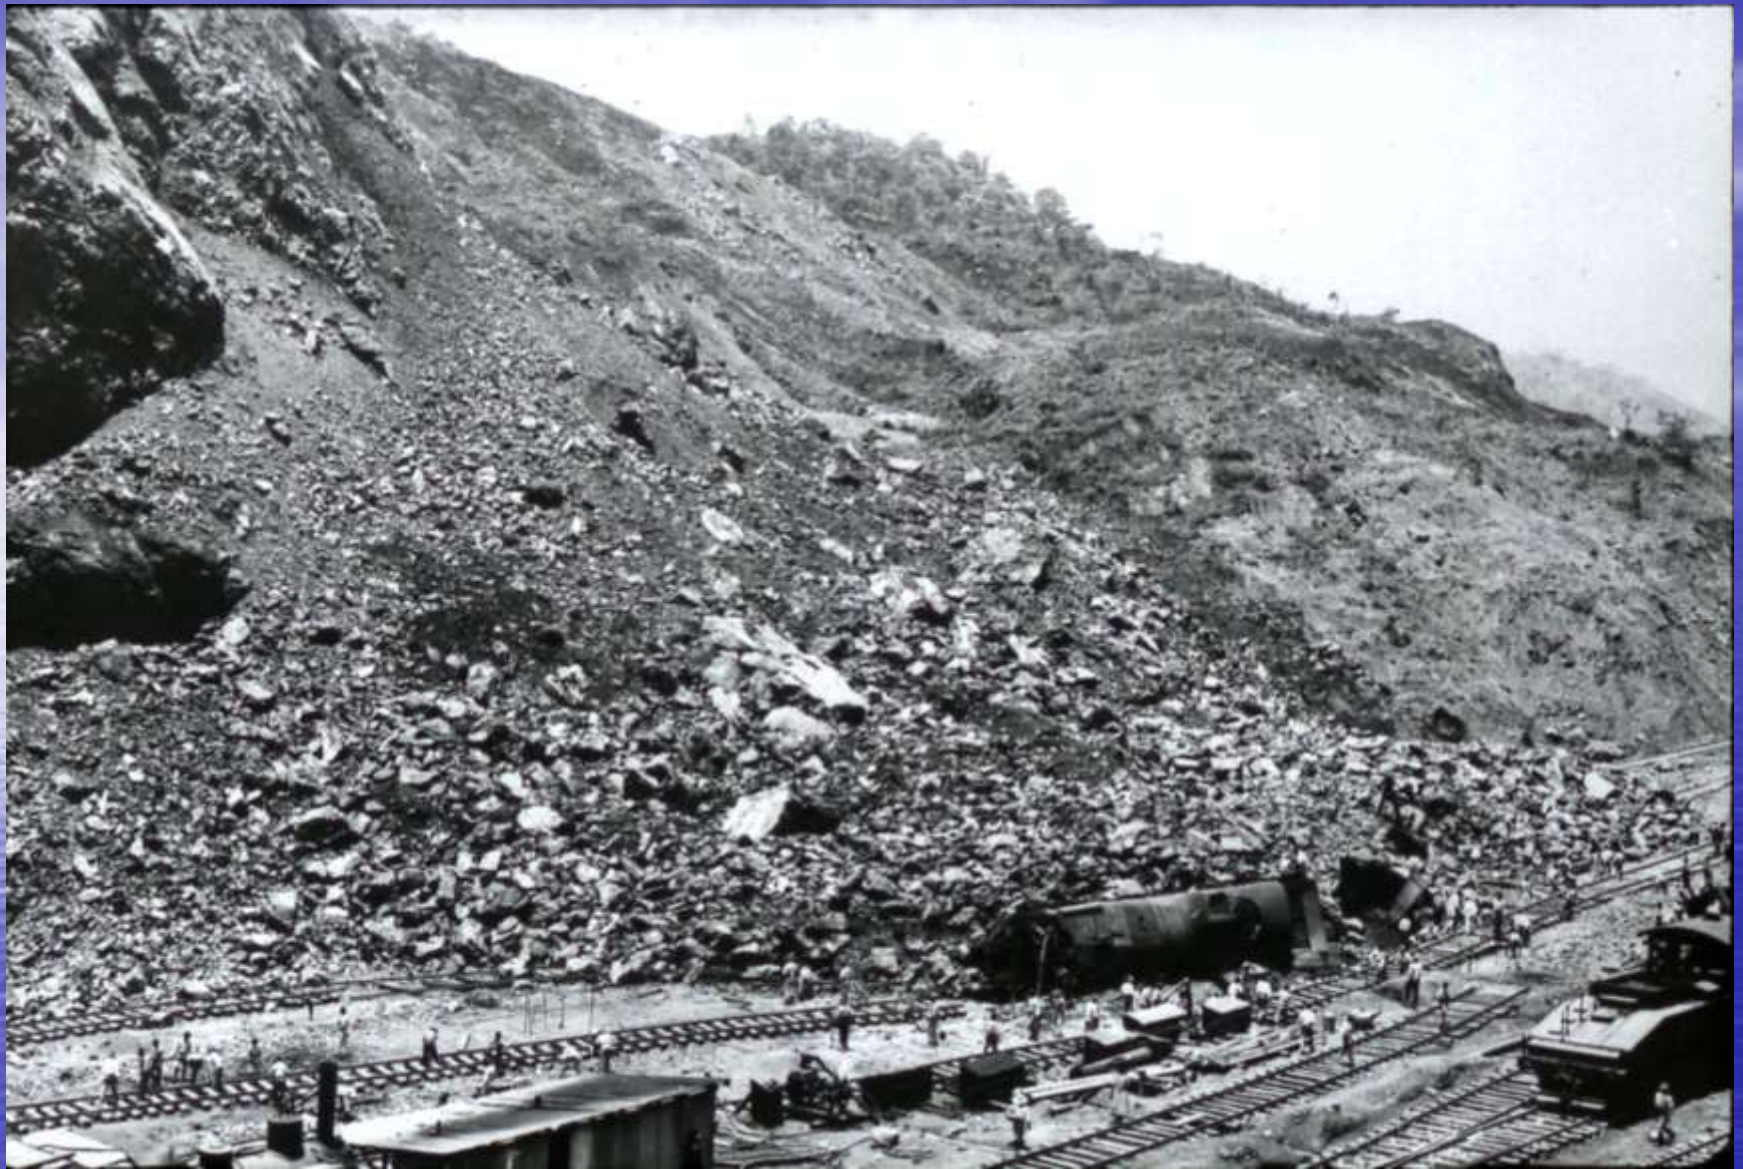
- **One of the early landslides at Cucaracha, on the south side of Gold Hill, near the Continental Divide, on July 5, 1911.**

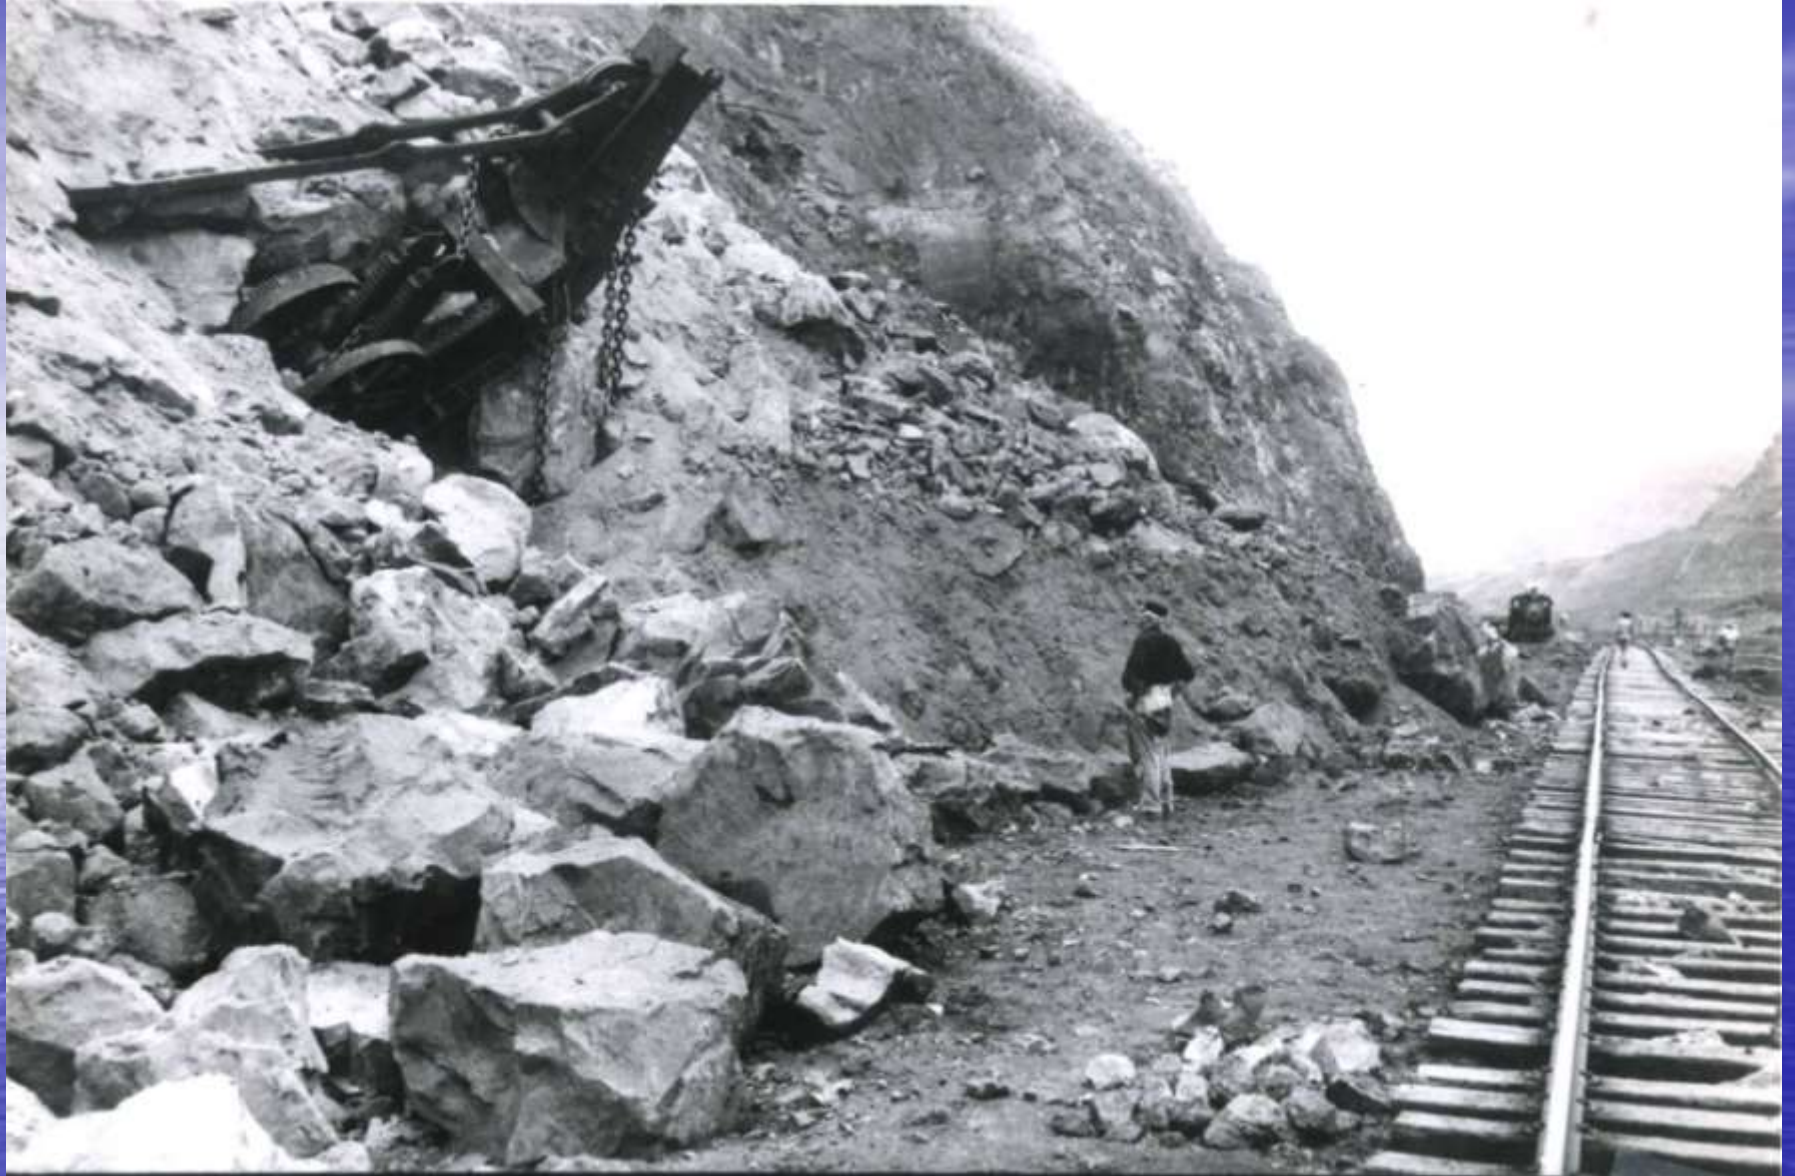
- **Ground view of the same slide of July 5, 1911 at Cucaracha, showing buried steam shovel.**

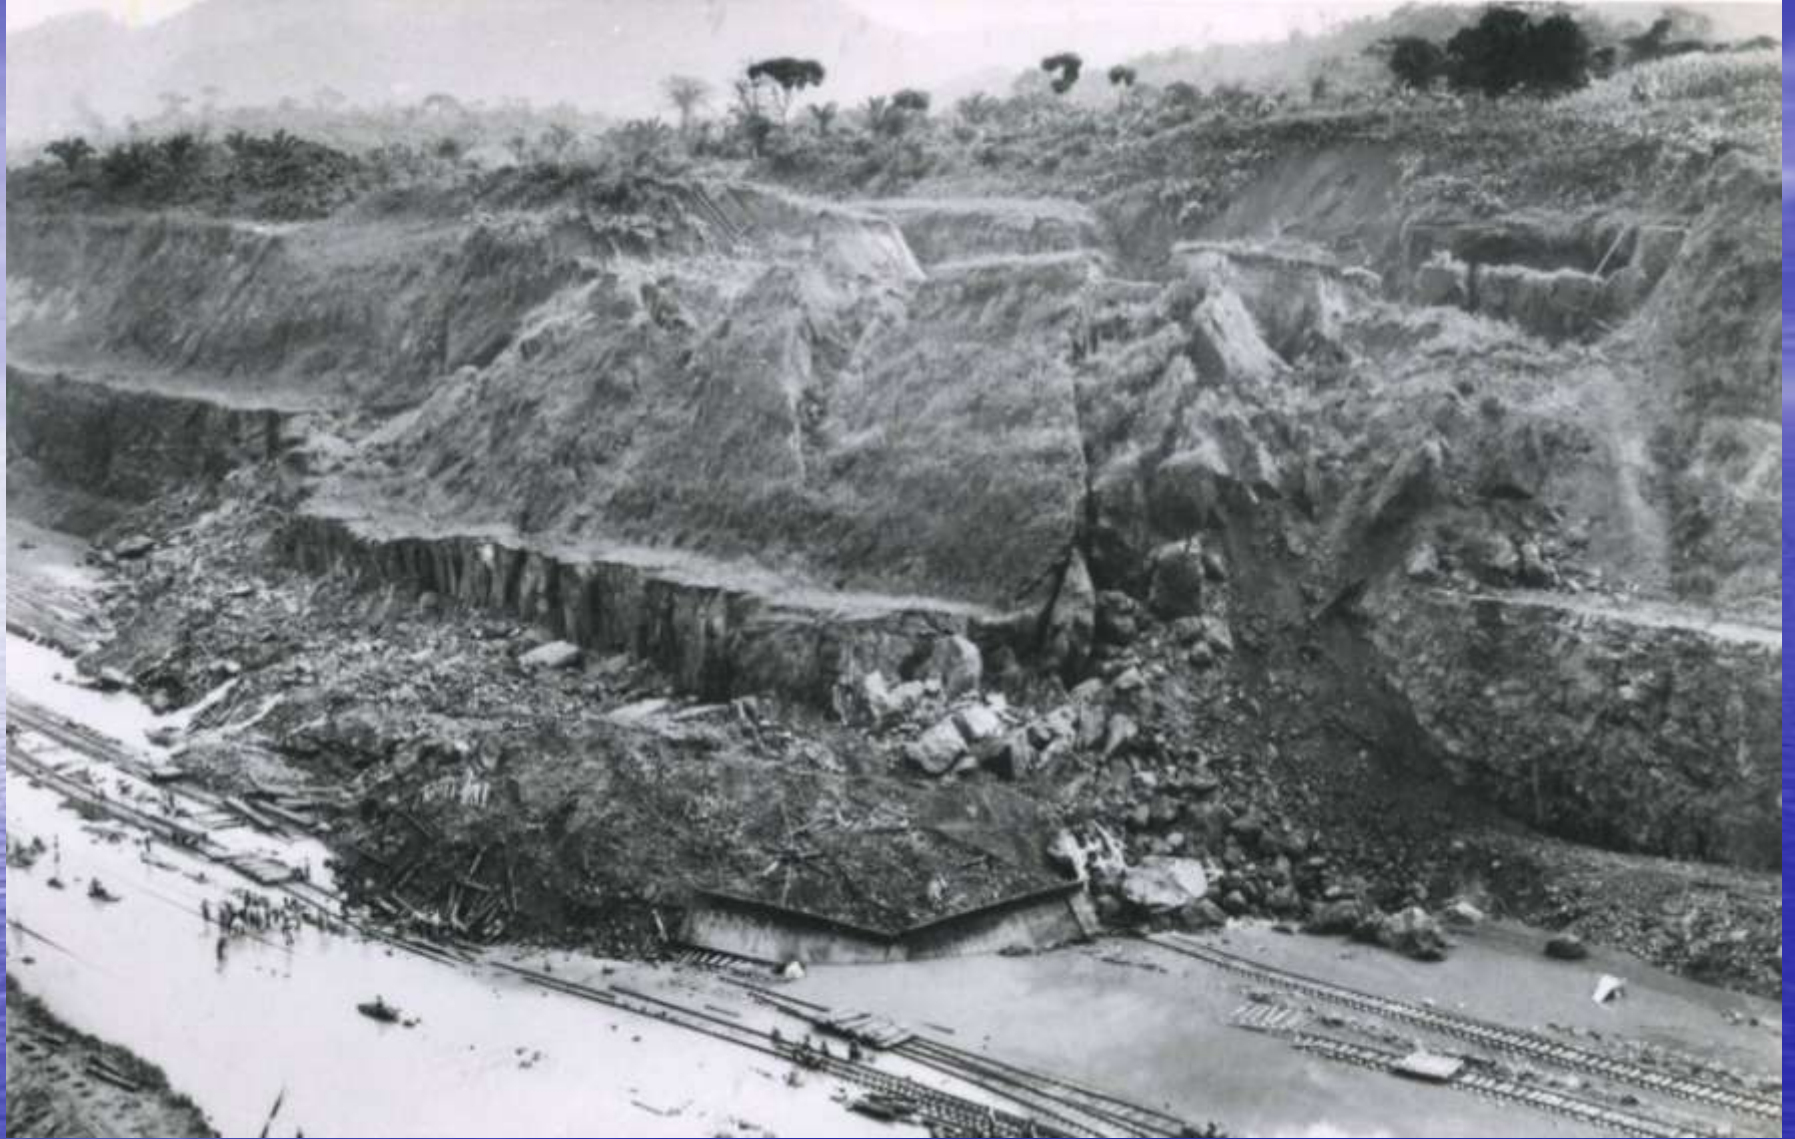
- **Cut slope failure on the Obispo Division on August 21, 1912. Note ponded water.**

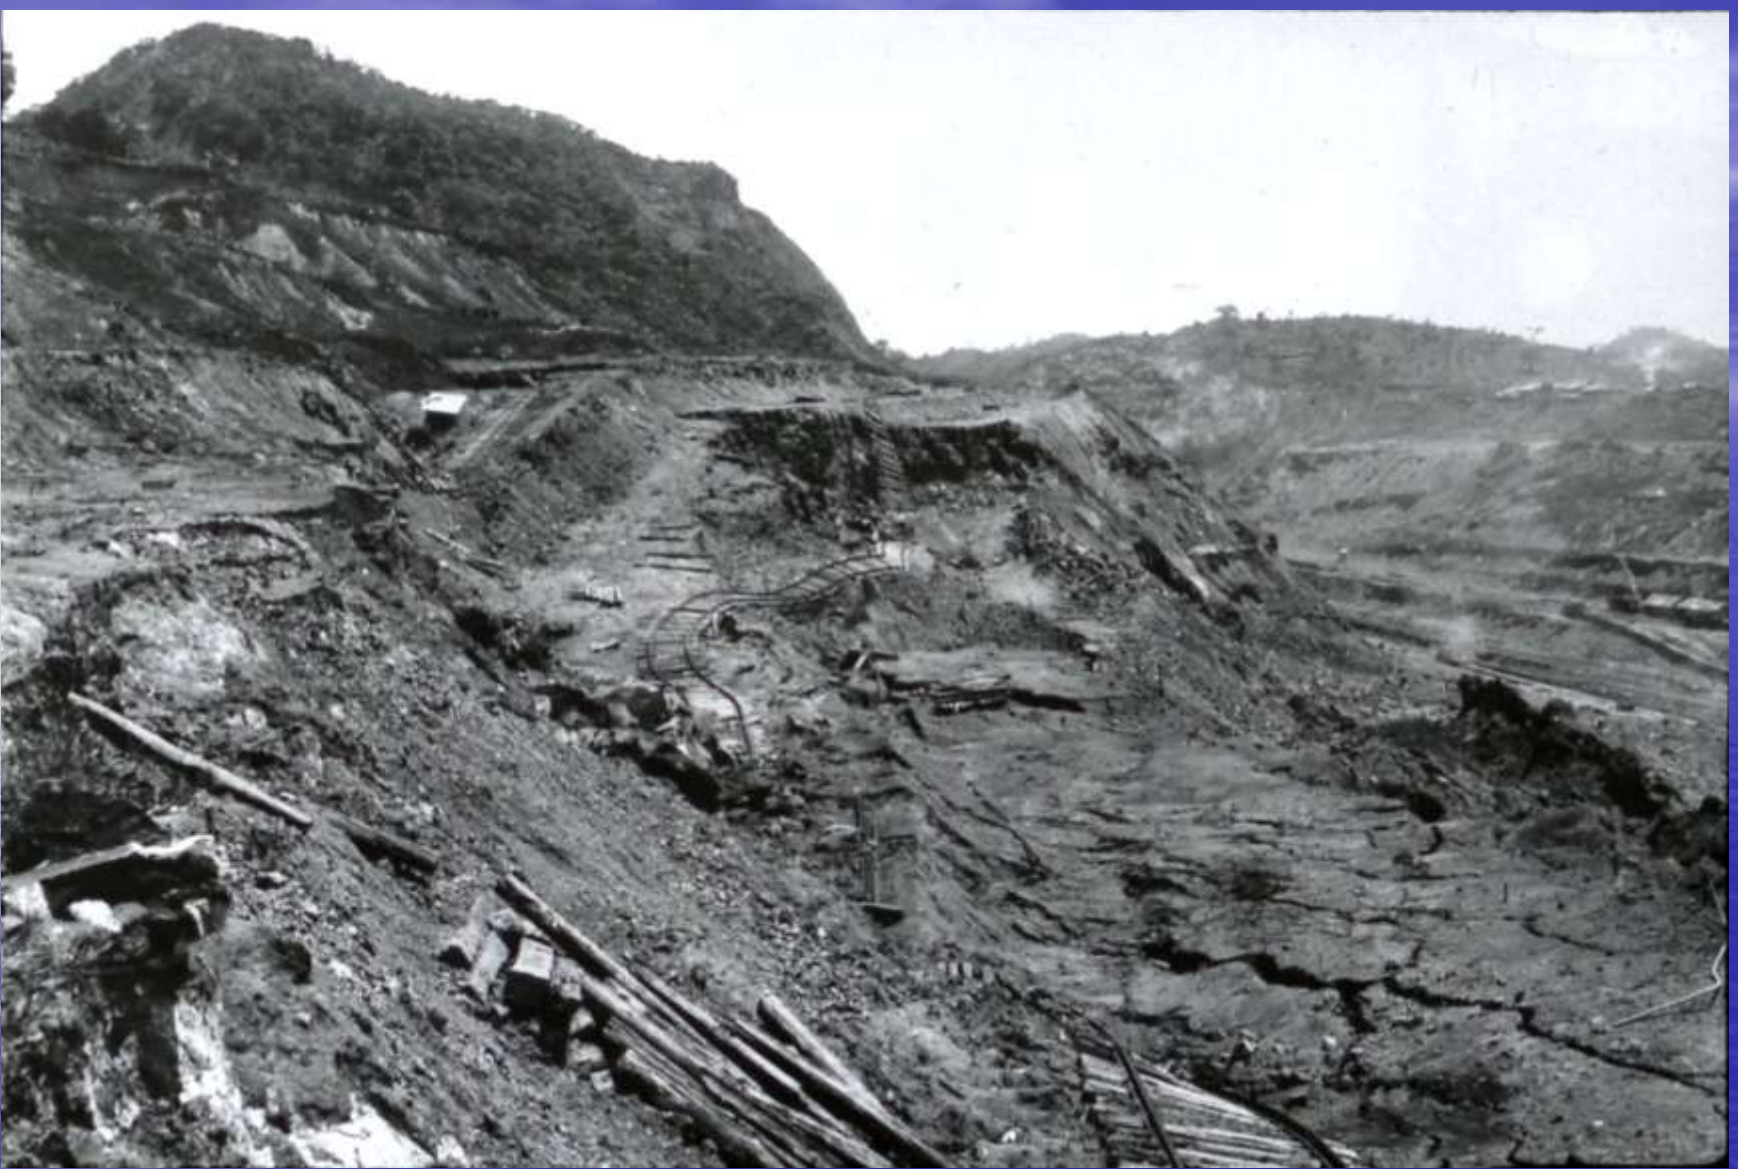
- **Crown scarp of the East Culebra Slide on September 19, 1912, looking south.**

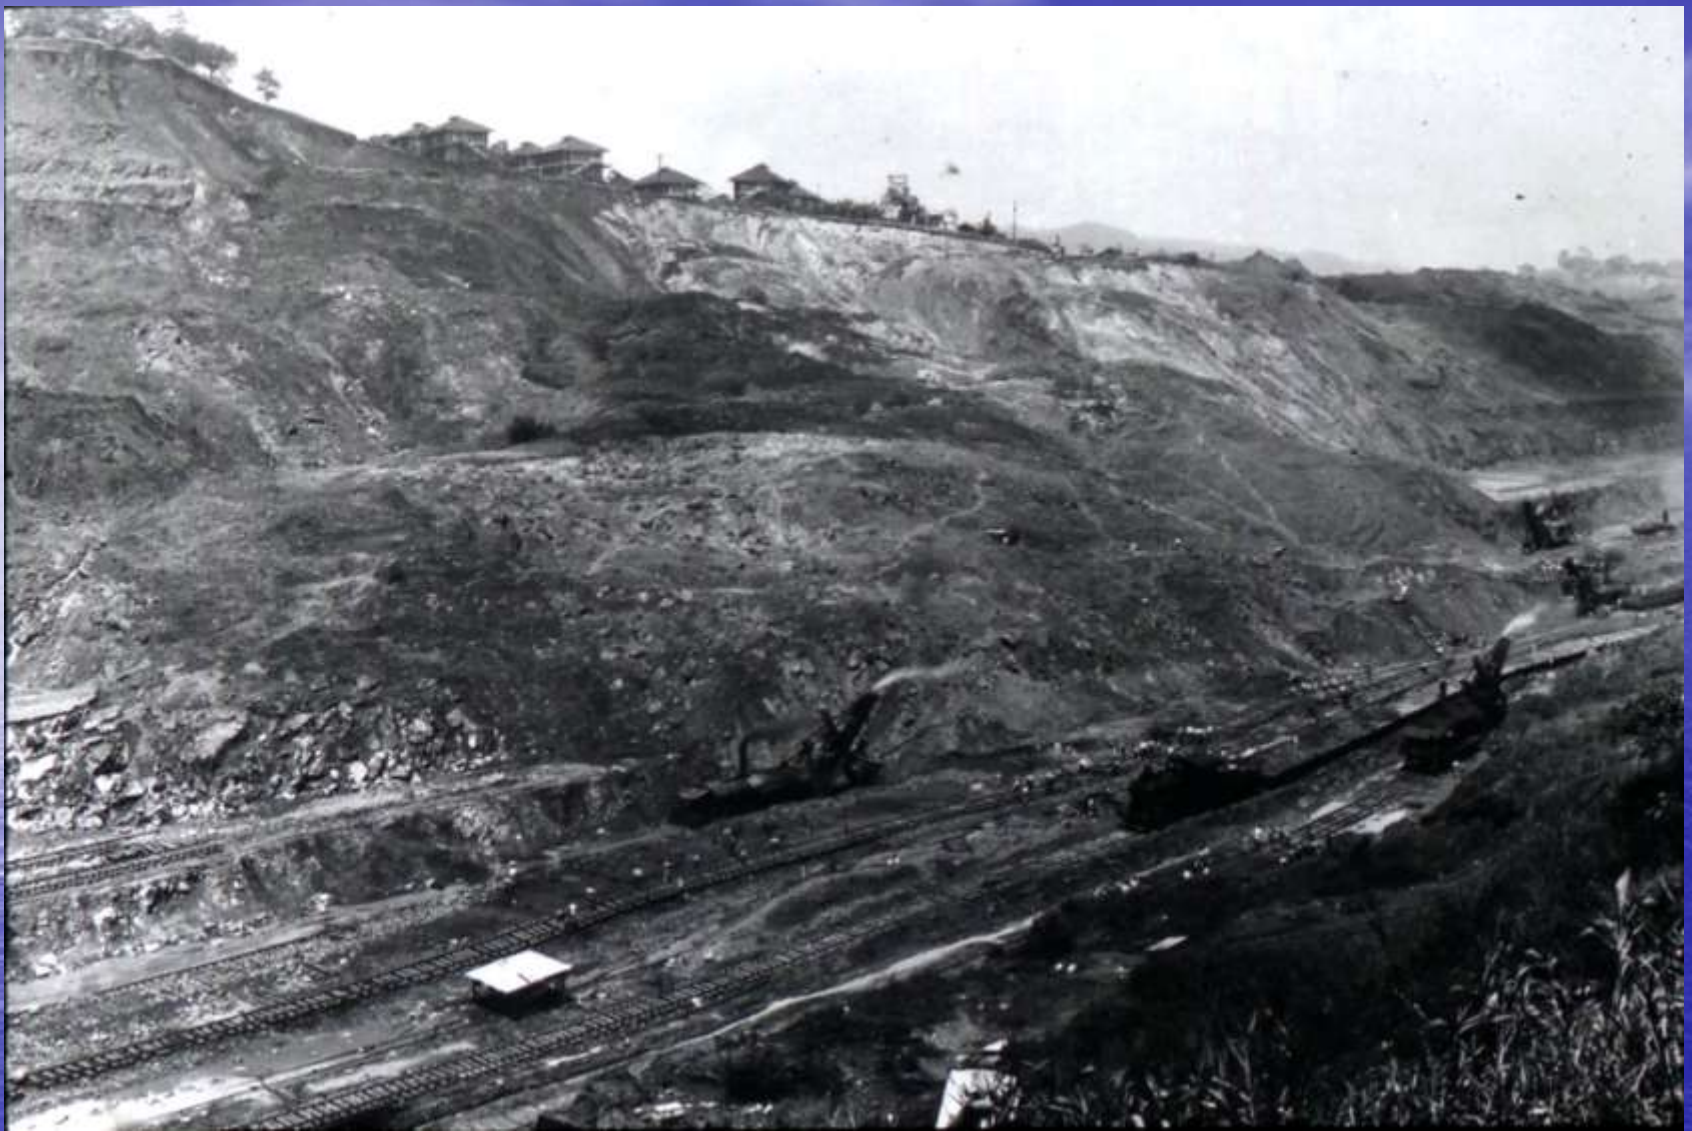
- **Excavating the toe of the West Culebra slide with steam shovels, and allowing the slide debris to disintegrate and slide into the hole.**

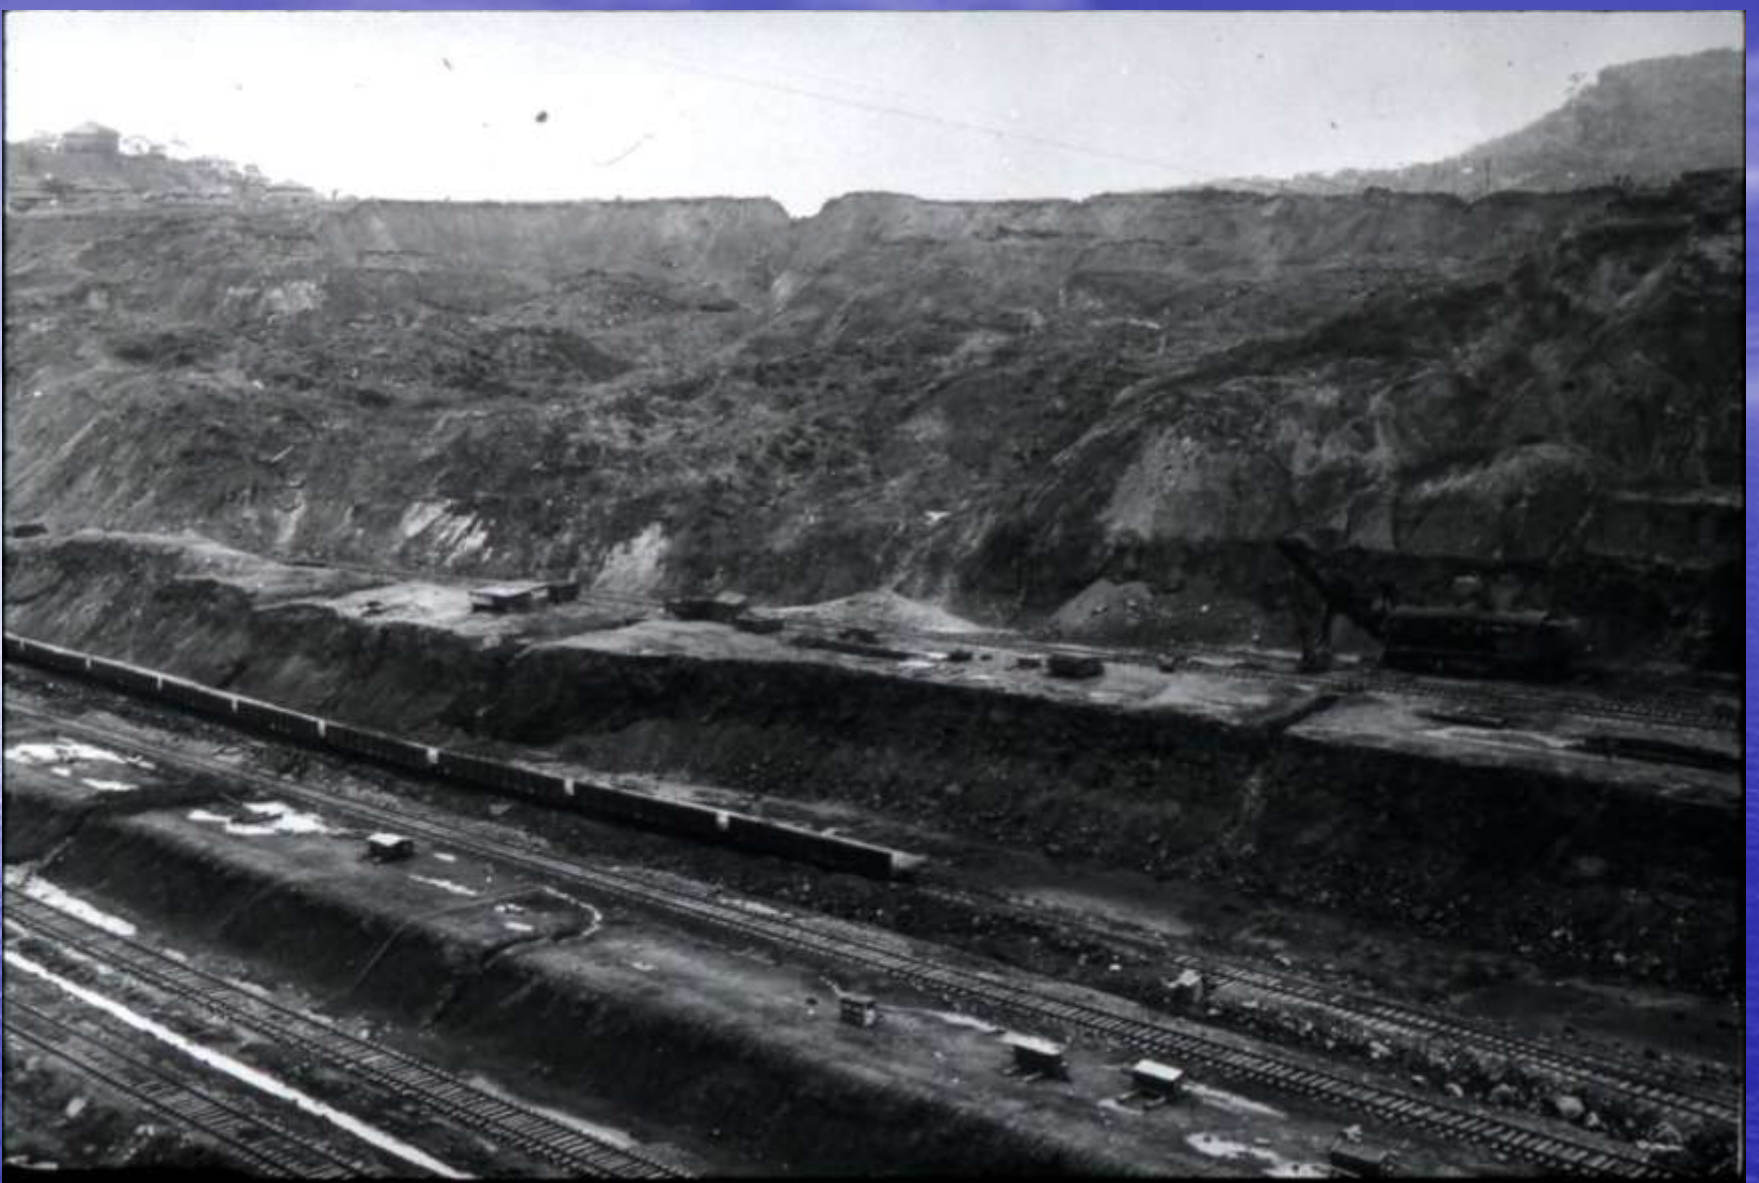
- **The shovels work desperately to fill side-dumping gondola cars and keep pace with the onslaught of earthen debris.**

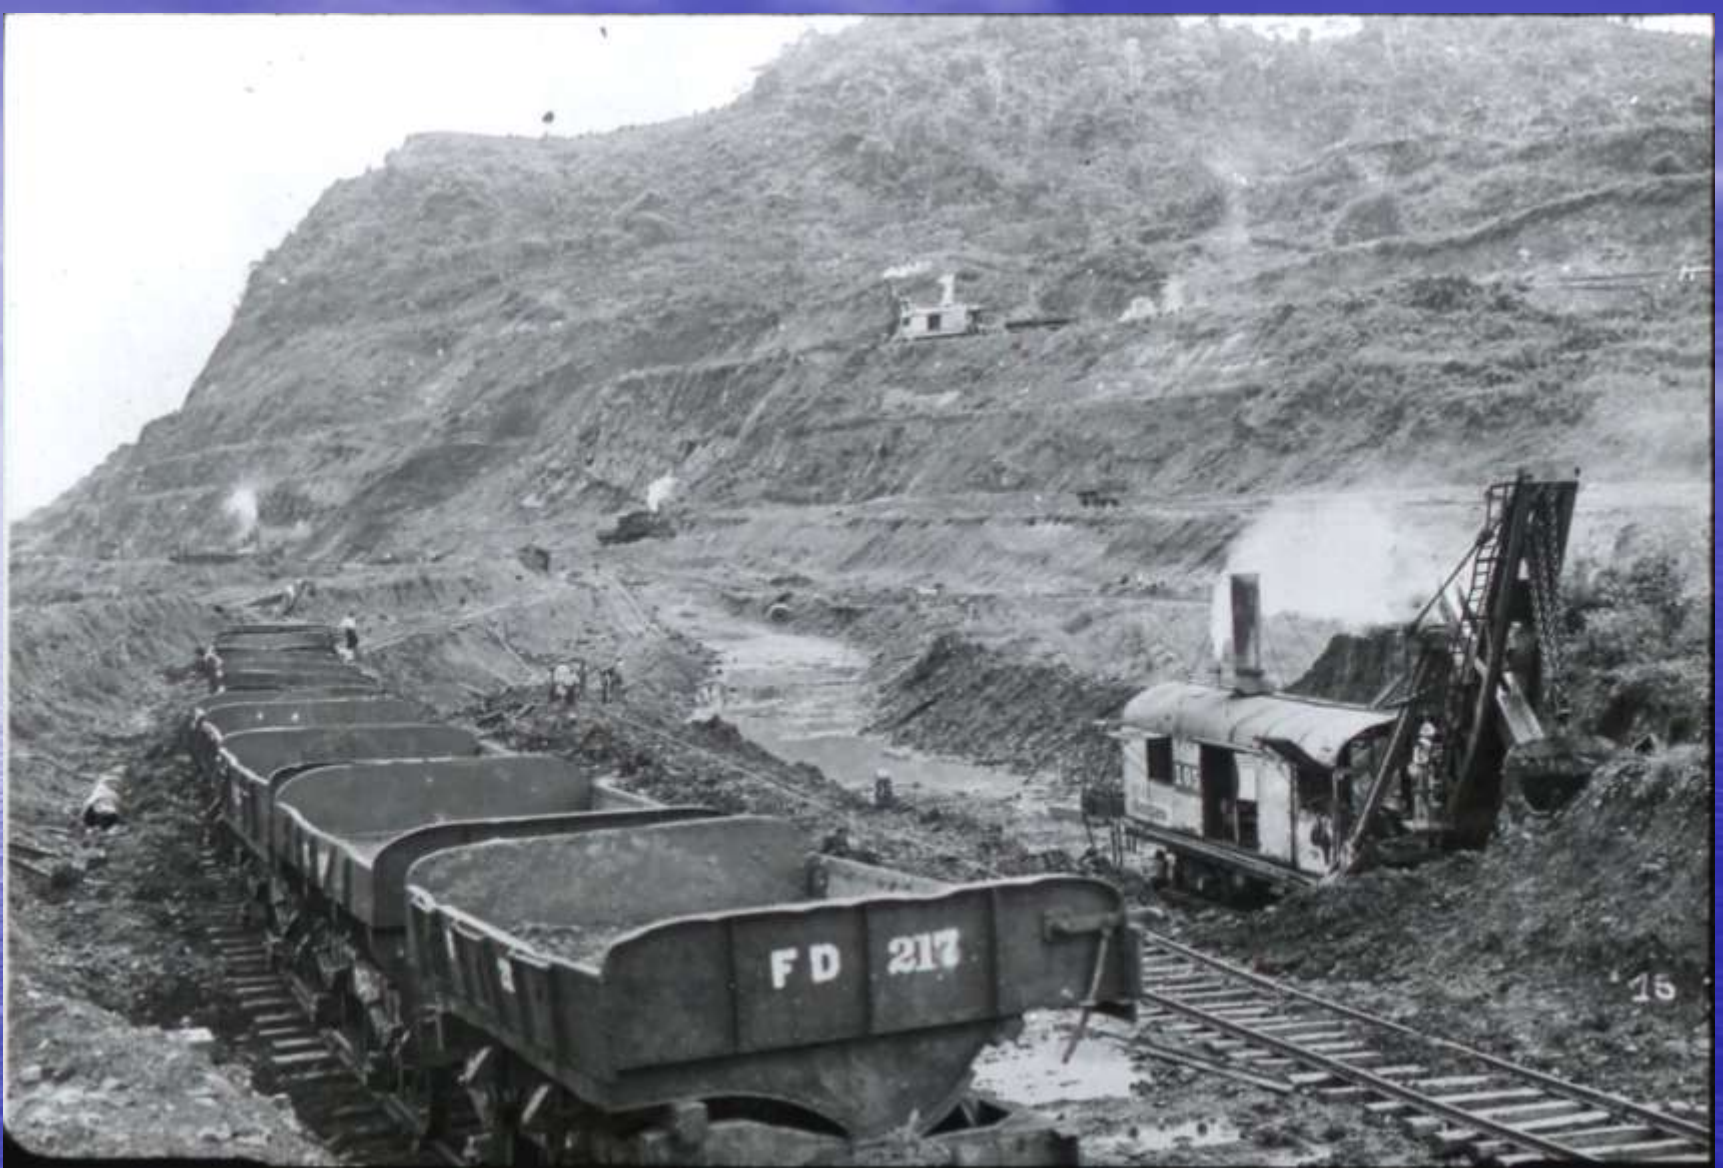
- **Close-up view of the rail-mounted shovels excavating slide debris at Culebra. Side-dumping gondola cars in foreground.**

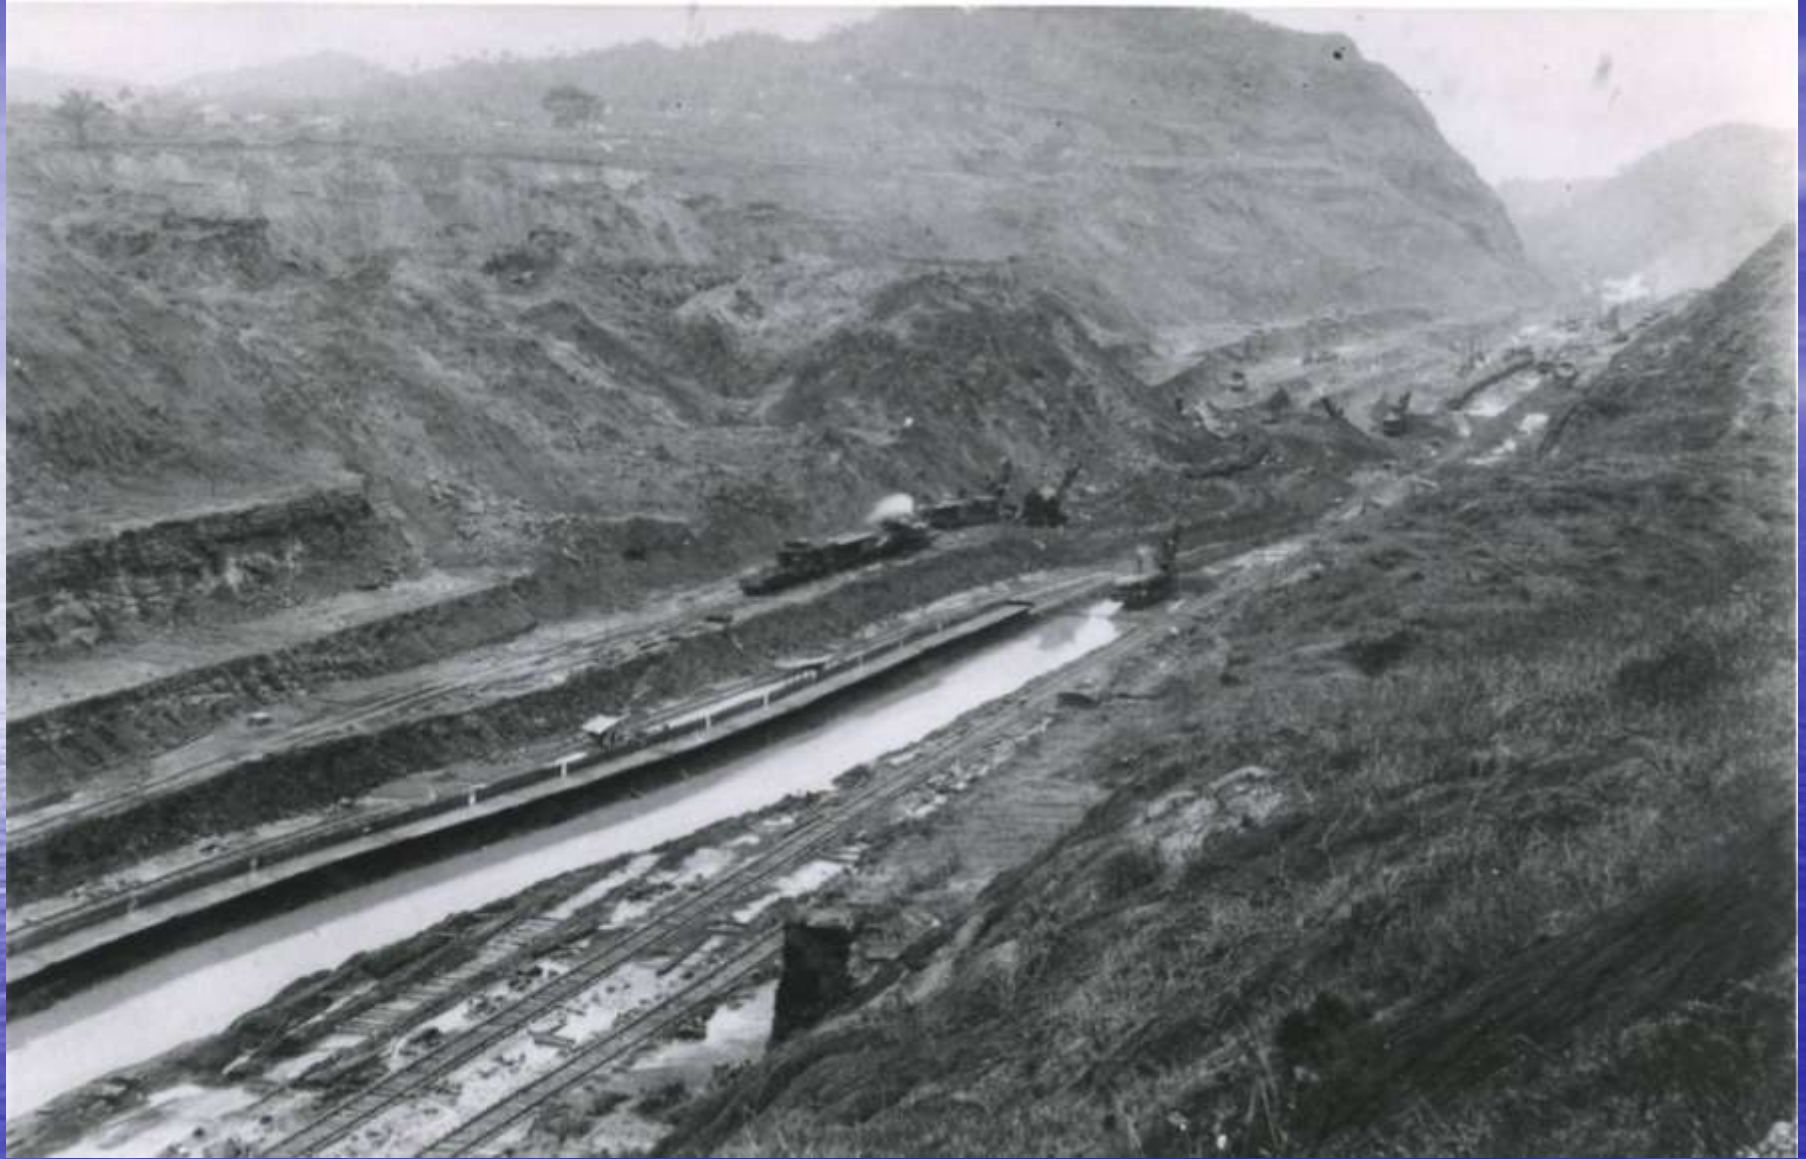
- **Large deep-seated slump on the East Culebra Slide blocks the canal excavation, May 27, 1913.**

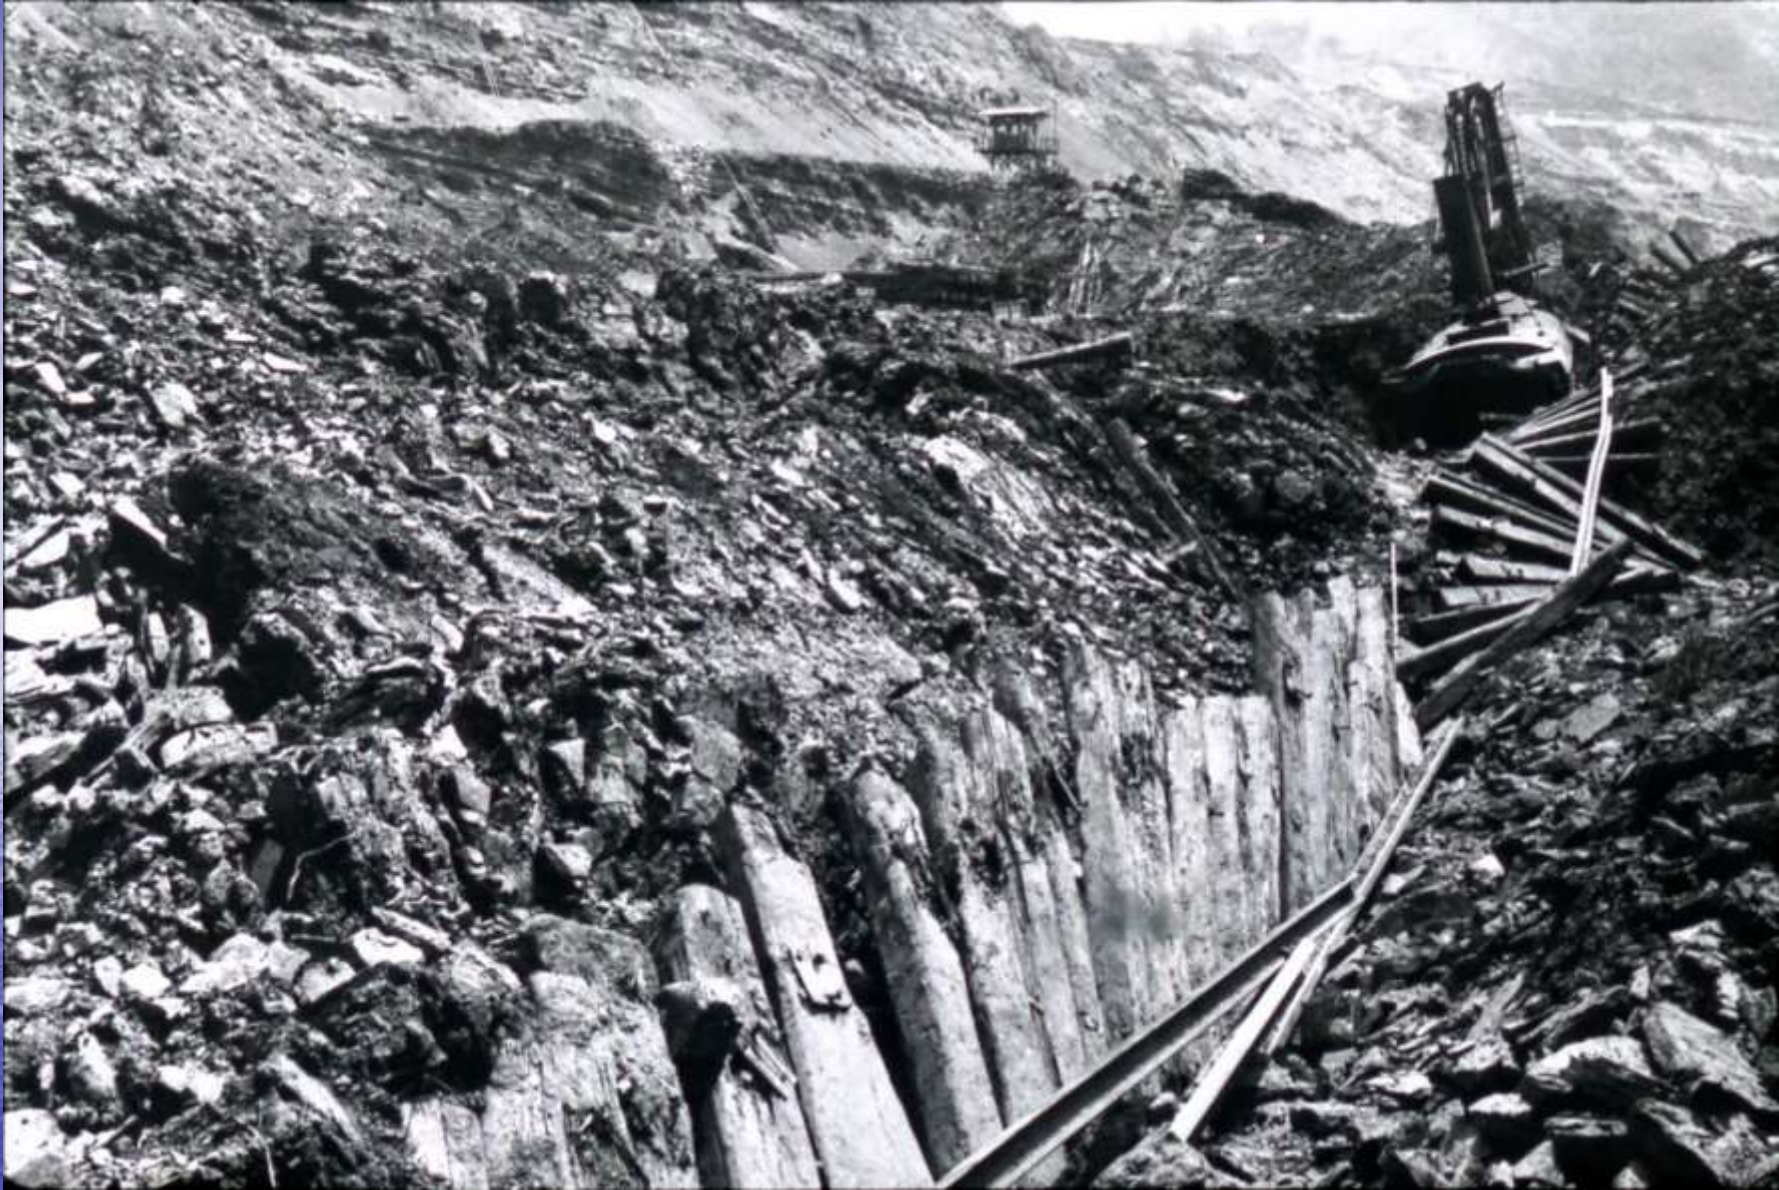
- **Buried steam shovel and shredded tracks at East Culebra.**
