LANDSLIDES of the PANAMA CANAL

J. David Rogers, Ph.D., P.E., P.G.

2011 Pacific Section Meeting

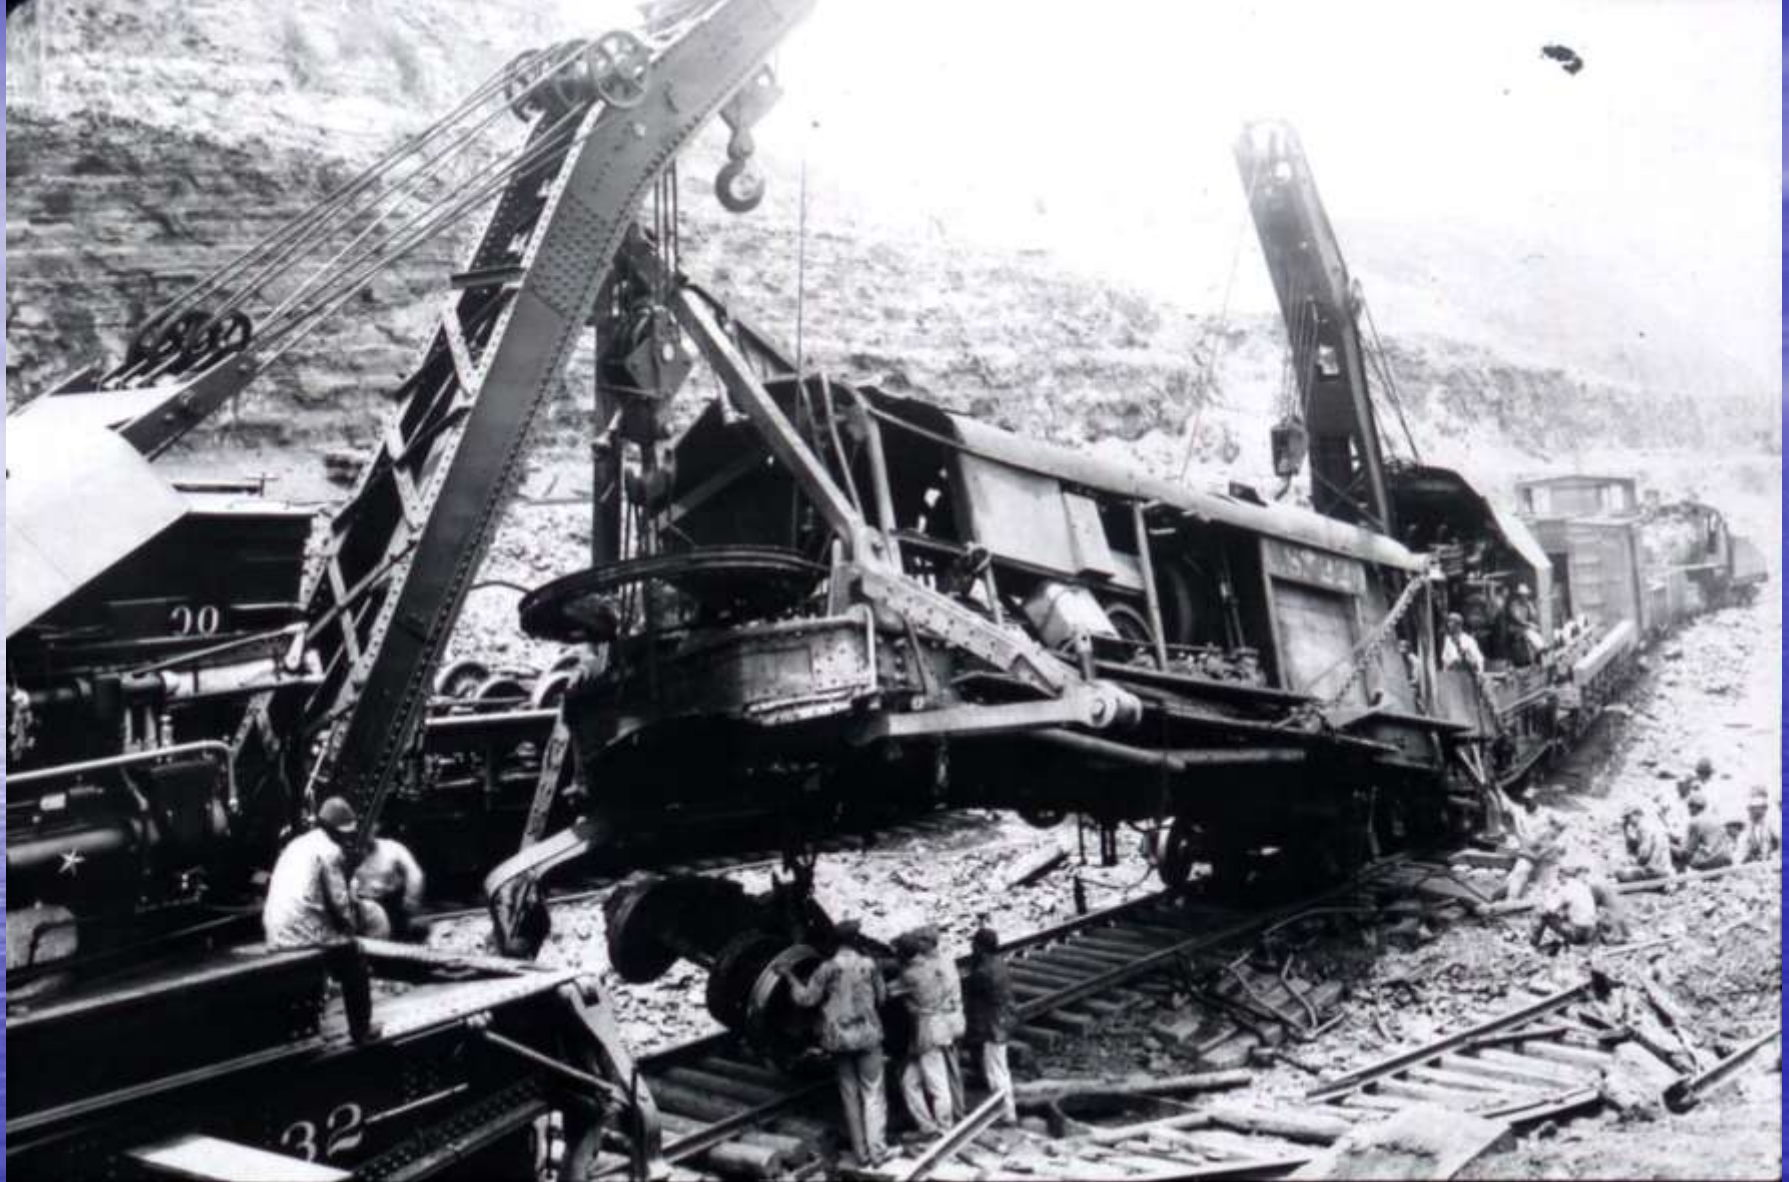
- **Work crews salvaging one of the buried Bucyrus-Erie rail-mounted shovels.**

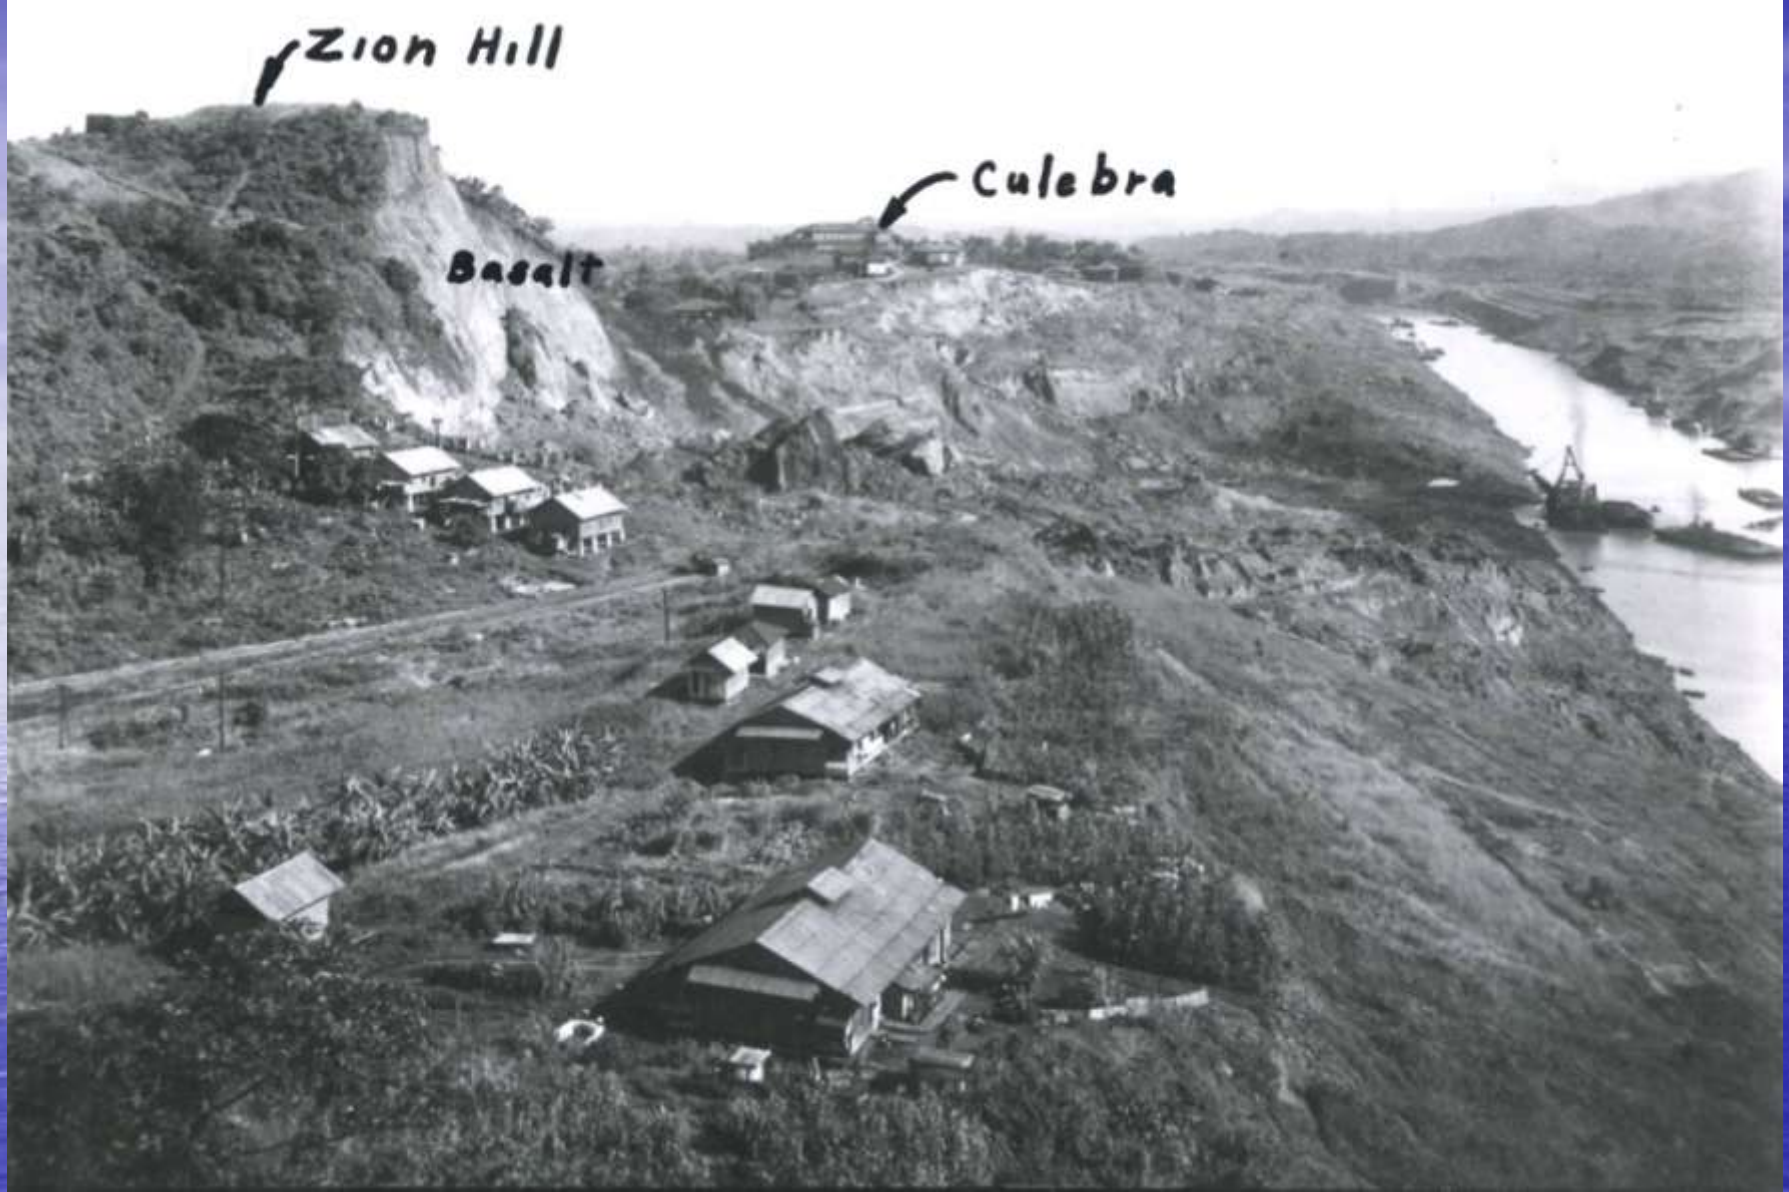
- **Zion Hill and West Culebra Slide in July 1916, taken from Contractor's Hill, looking north.**

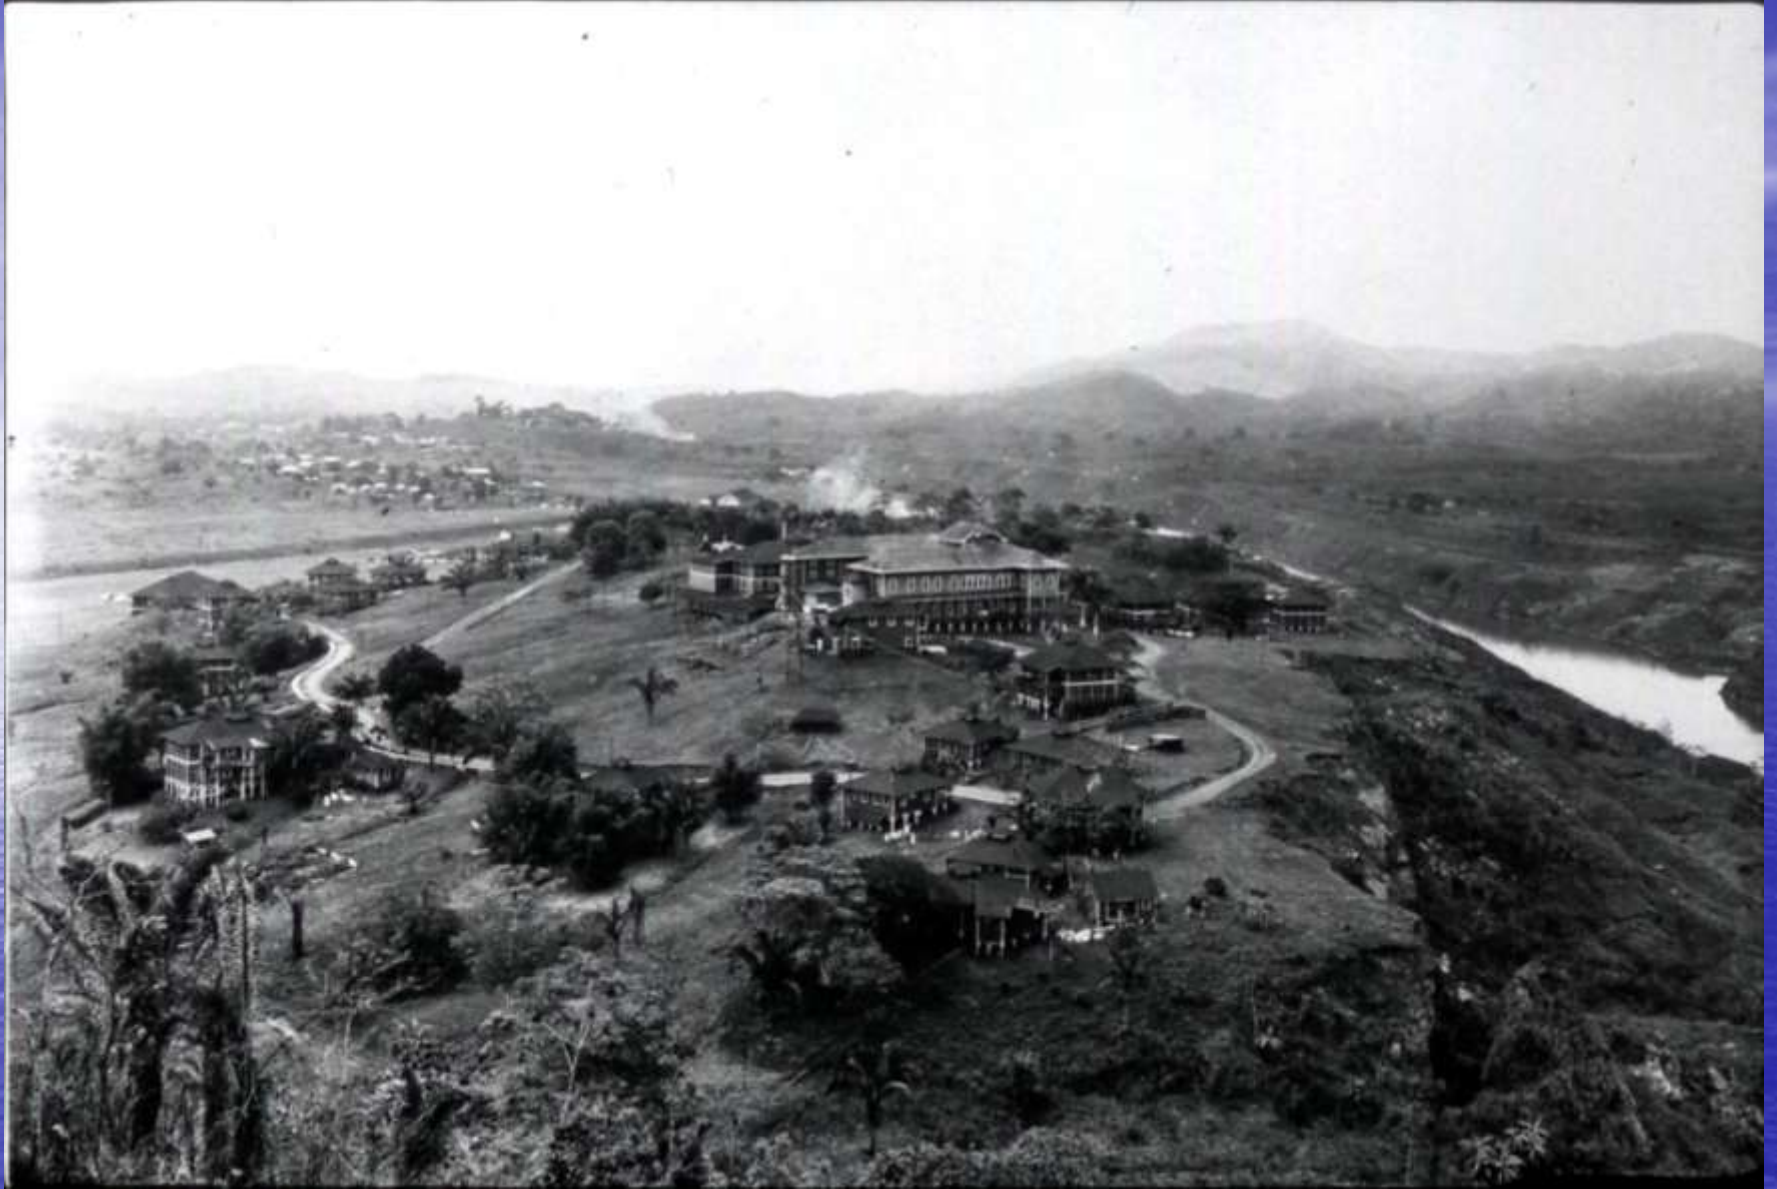
- **The headscarp of the West Culebra Landslide swallowed up part of the town of Culebra**

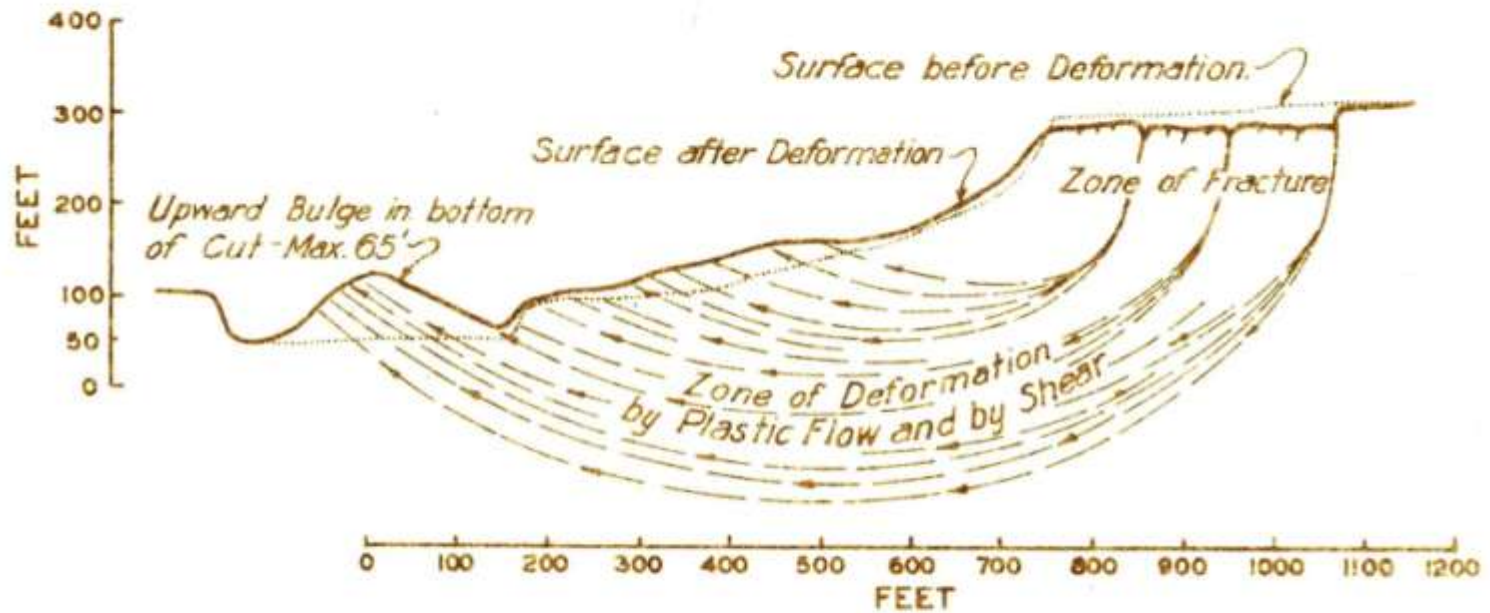
FIG. 2

IDEAL CROSS-SECTION WEST SIDE GAILLARD CUT, NEAR CULEBRA, TO SHOW DEVELOPMENT OF DEEP DEFORMATION TYPE OF SLIDE IN CUCARACHA ROCKS.

Modified from Plate 59
ICC Annual Report-1912.

- Concept of zone of flowage in West Culebra Slide, as hypothesized in 1912

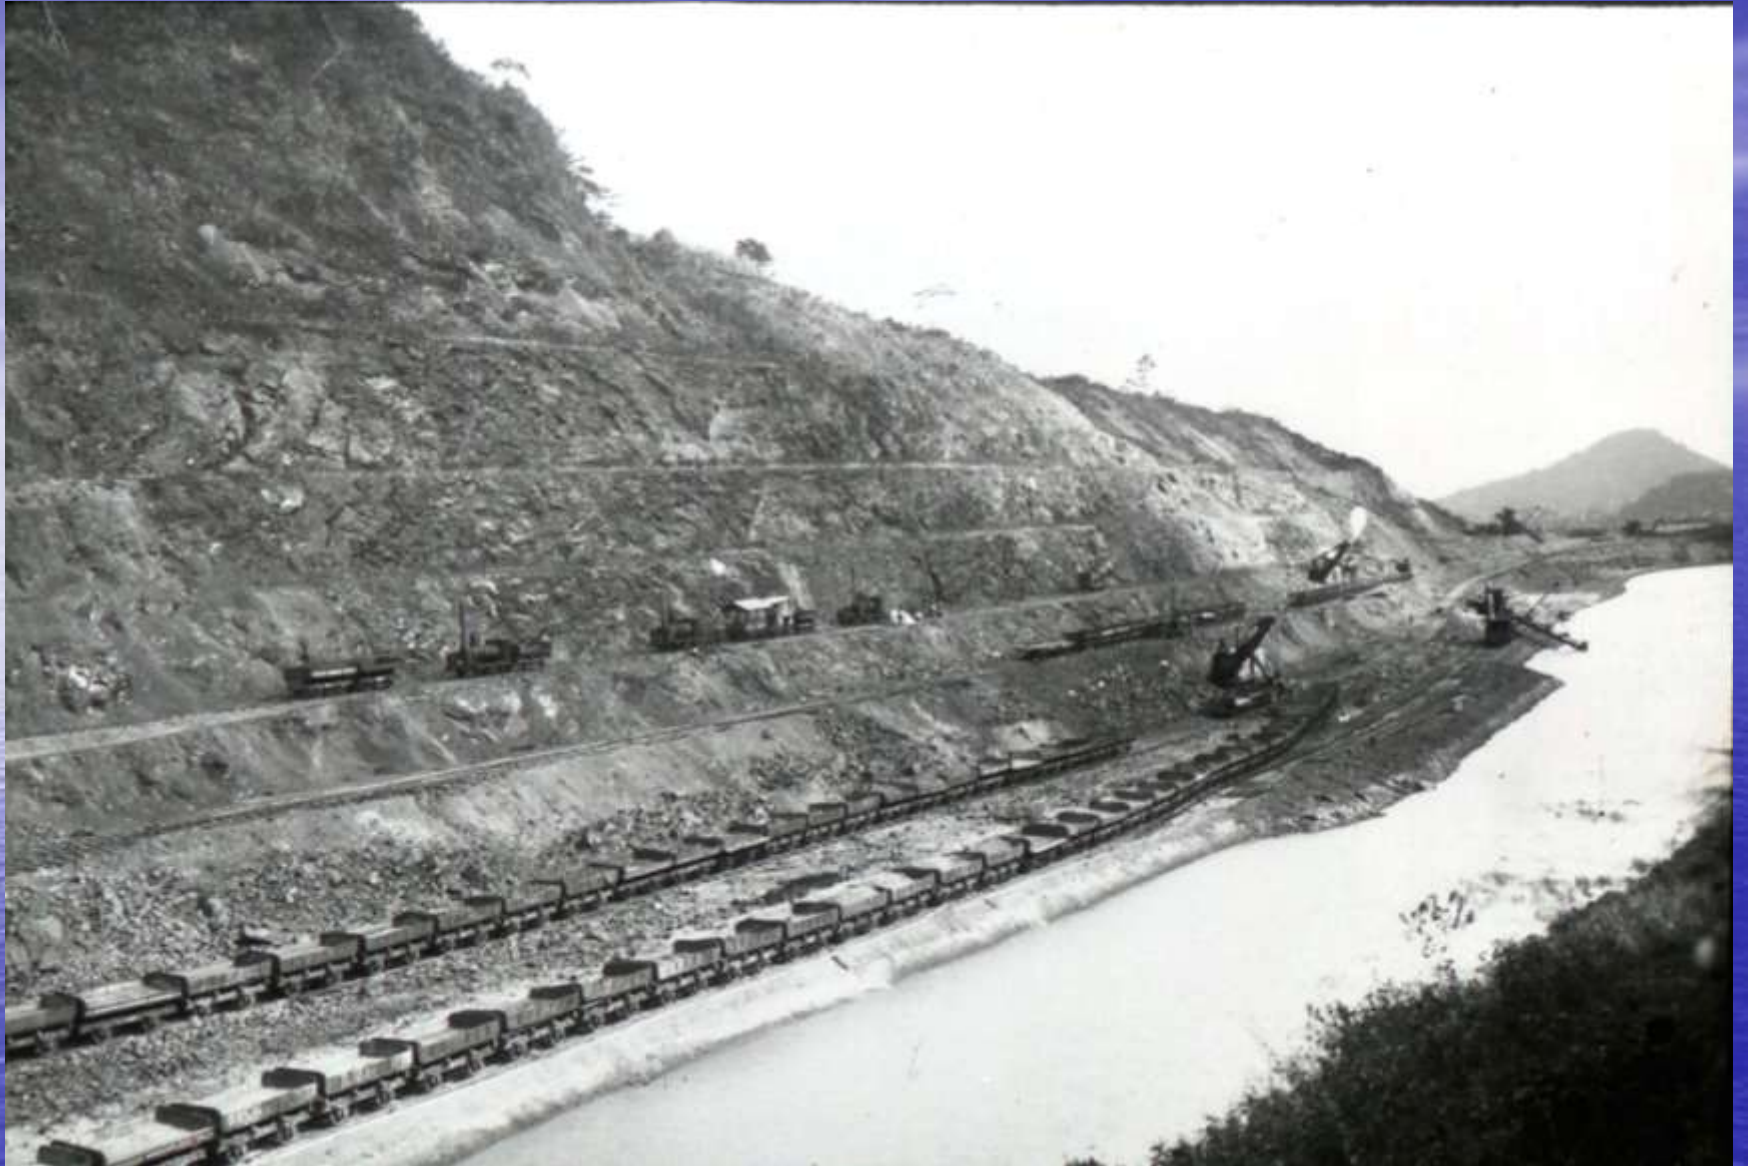
- **The massive cut at Gold Hill and Cucaracha, just before the first big slide**

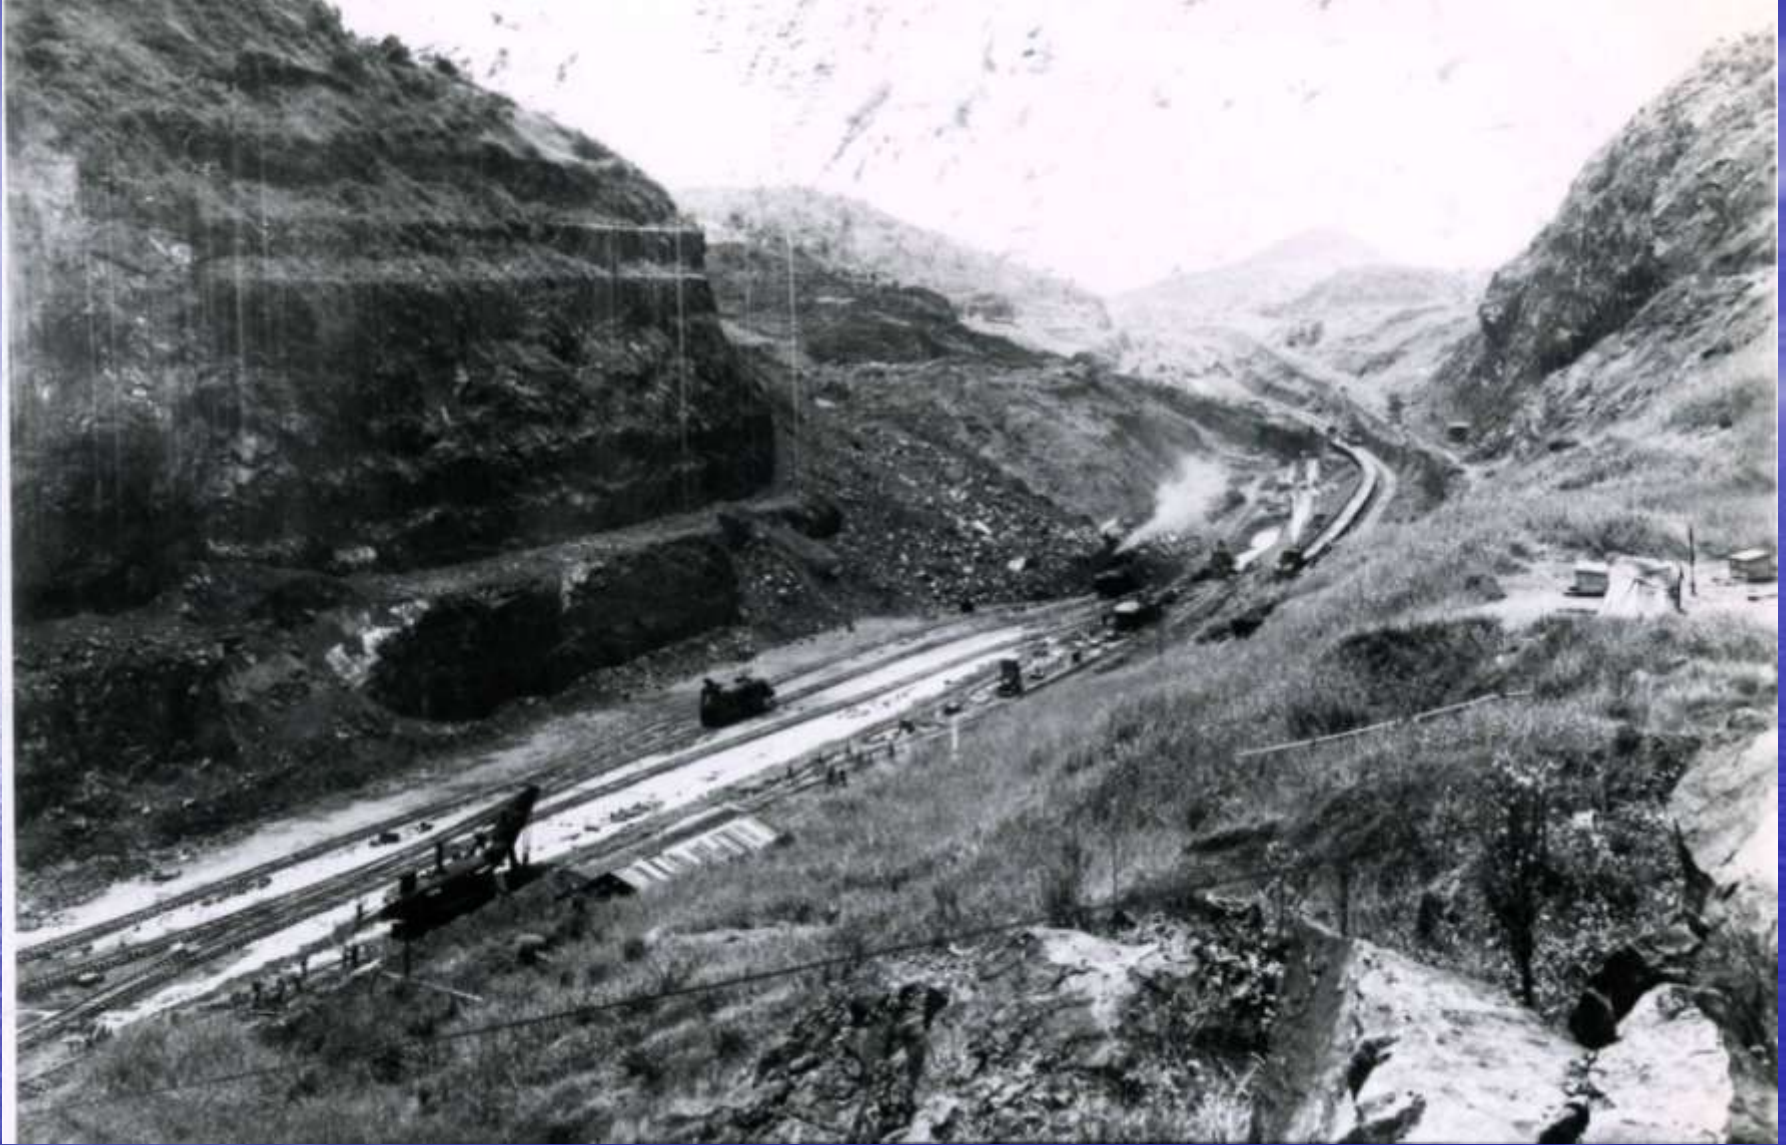
- **Excavating debris at the toe in the wake of the first massive slide at Cucaracha, on August 20, 1913.**

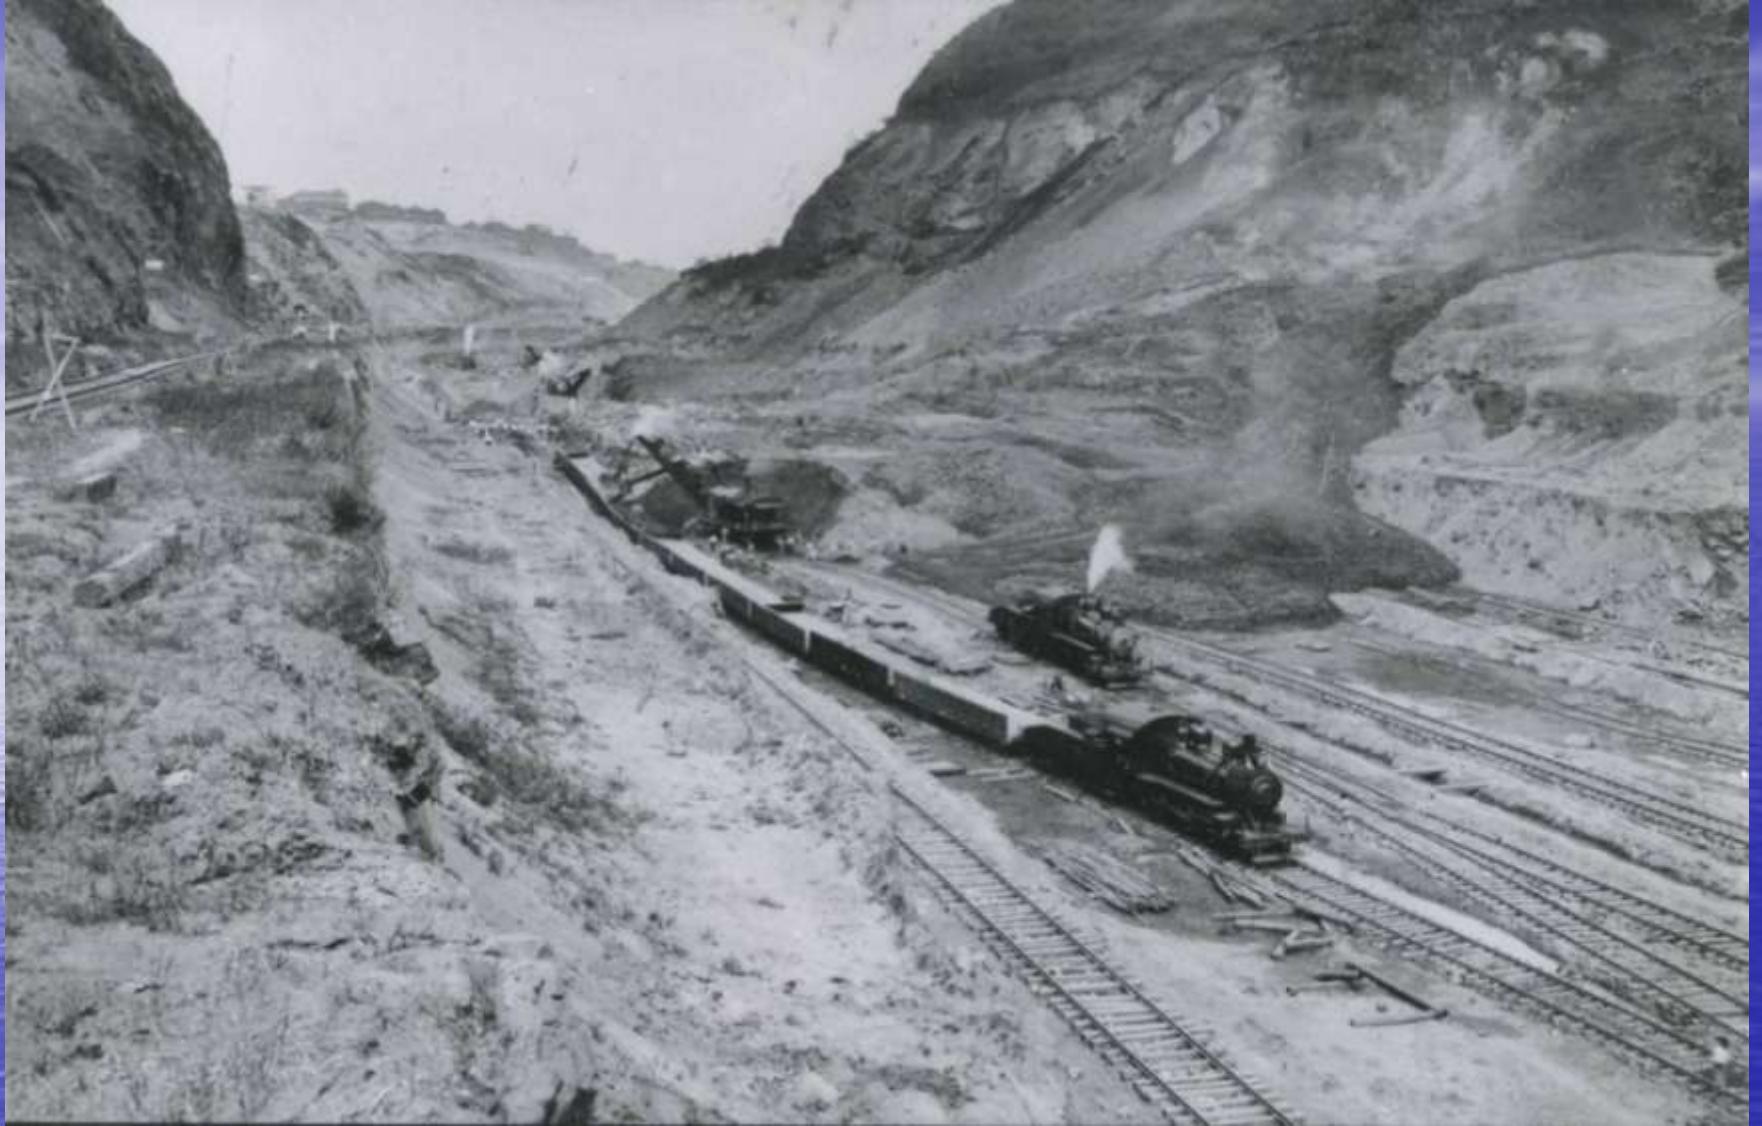
- **Flowage off the Cucaracha Landslide on February 2, 1913. A harbinger of what was to come...**

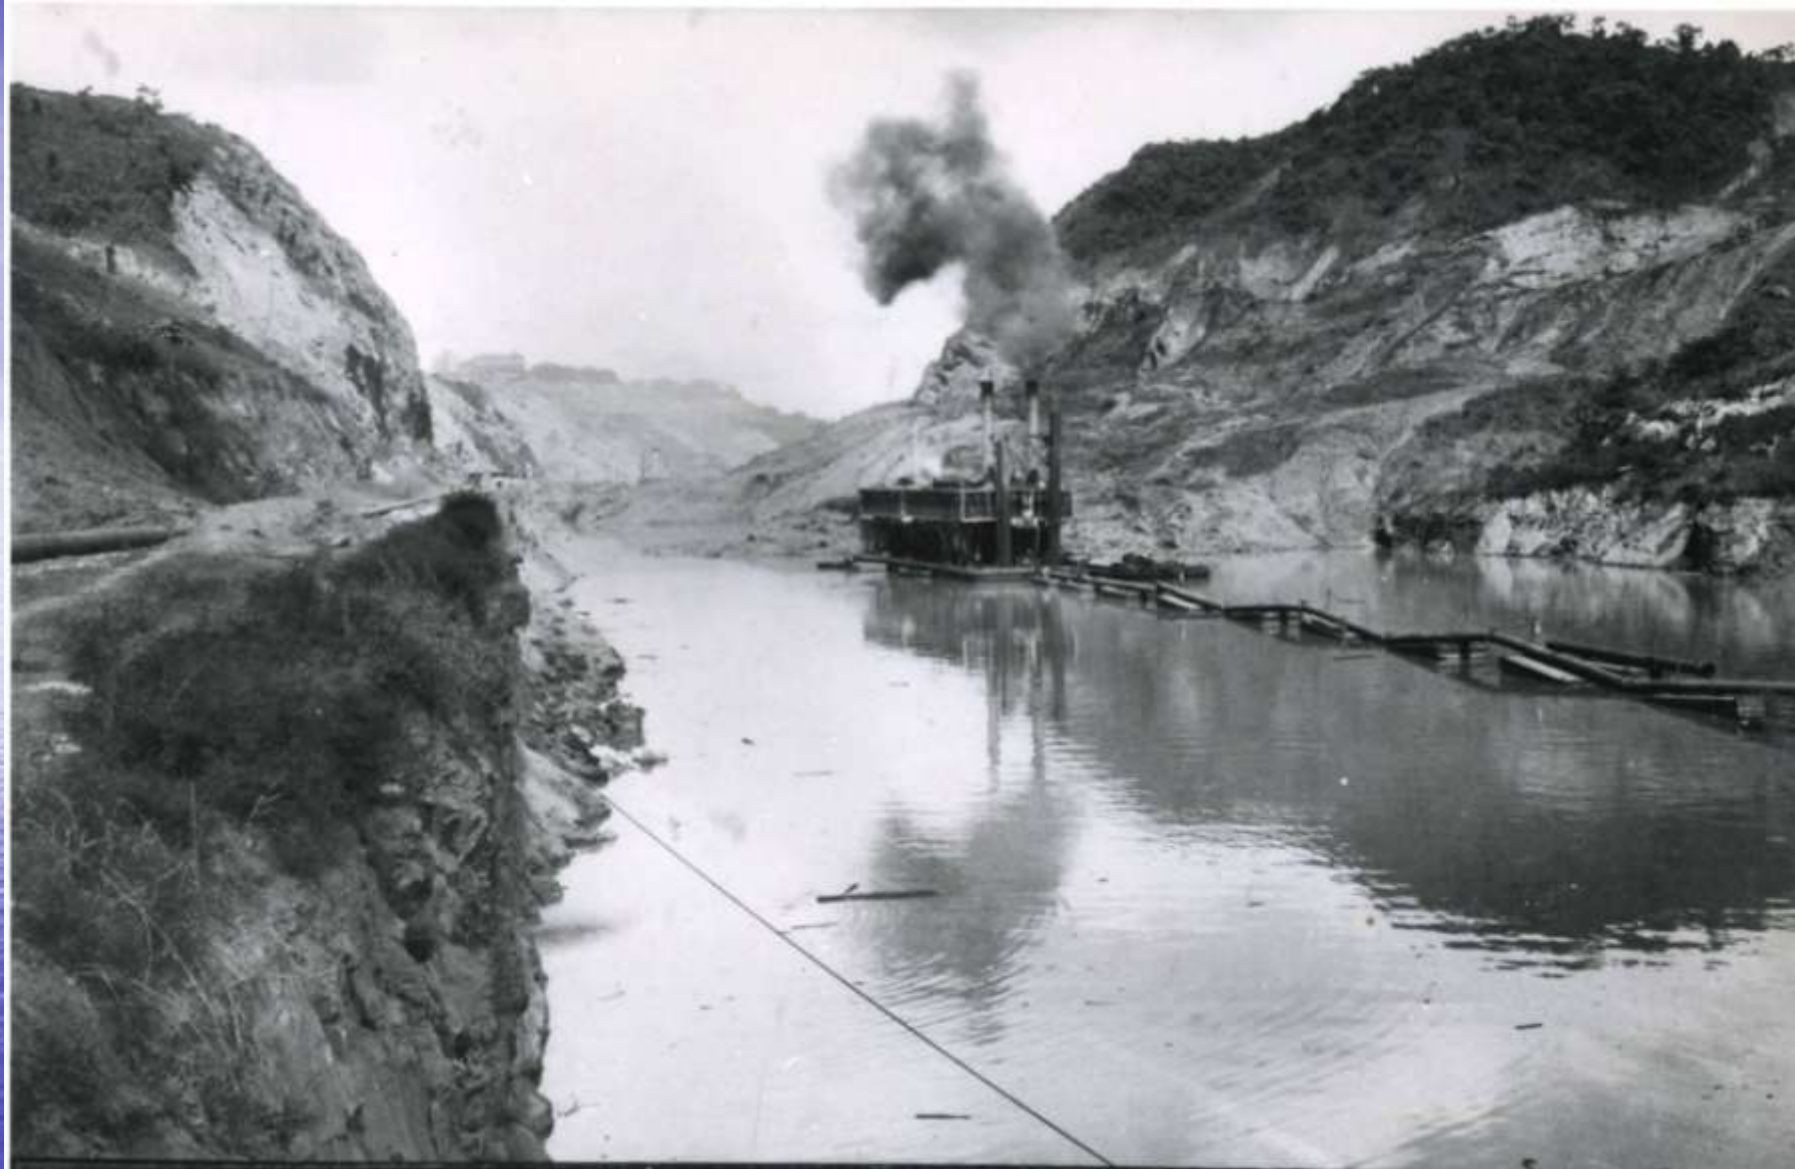
- **The south end of the canal is flooded as far as Cucaracha, October 28, 1913**

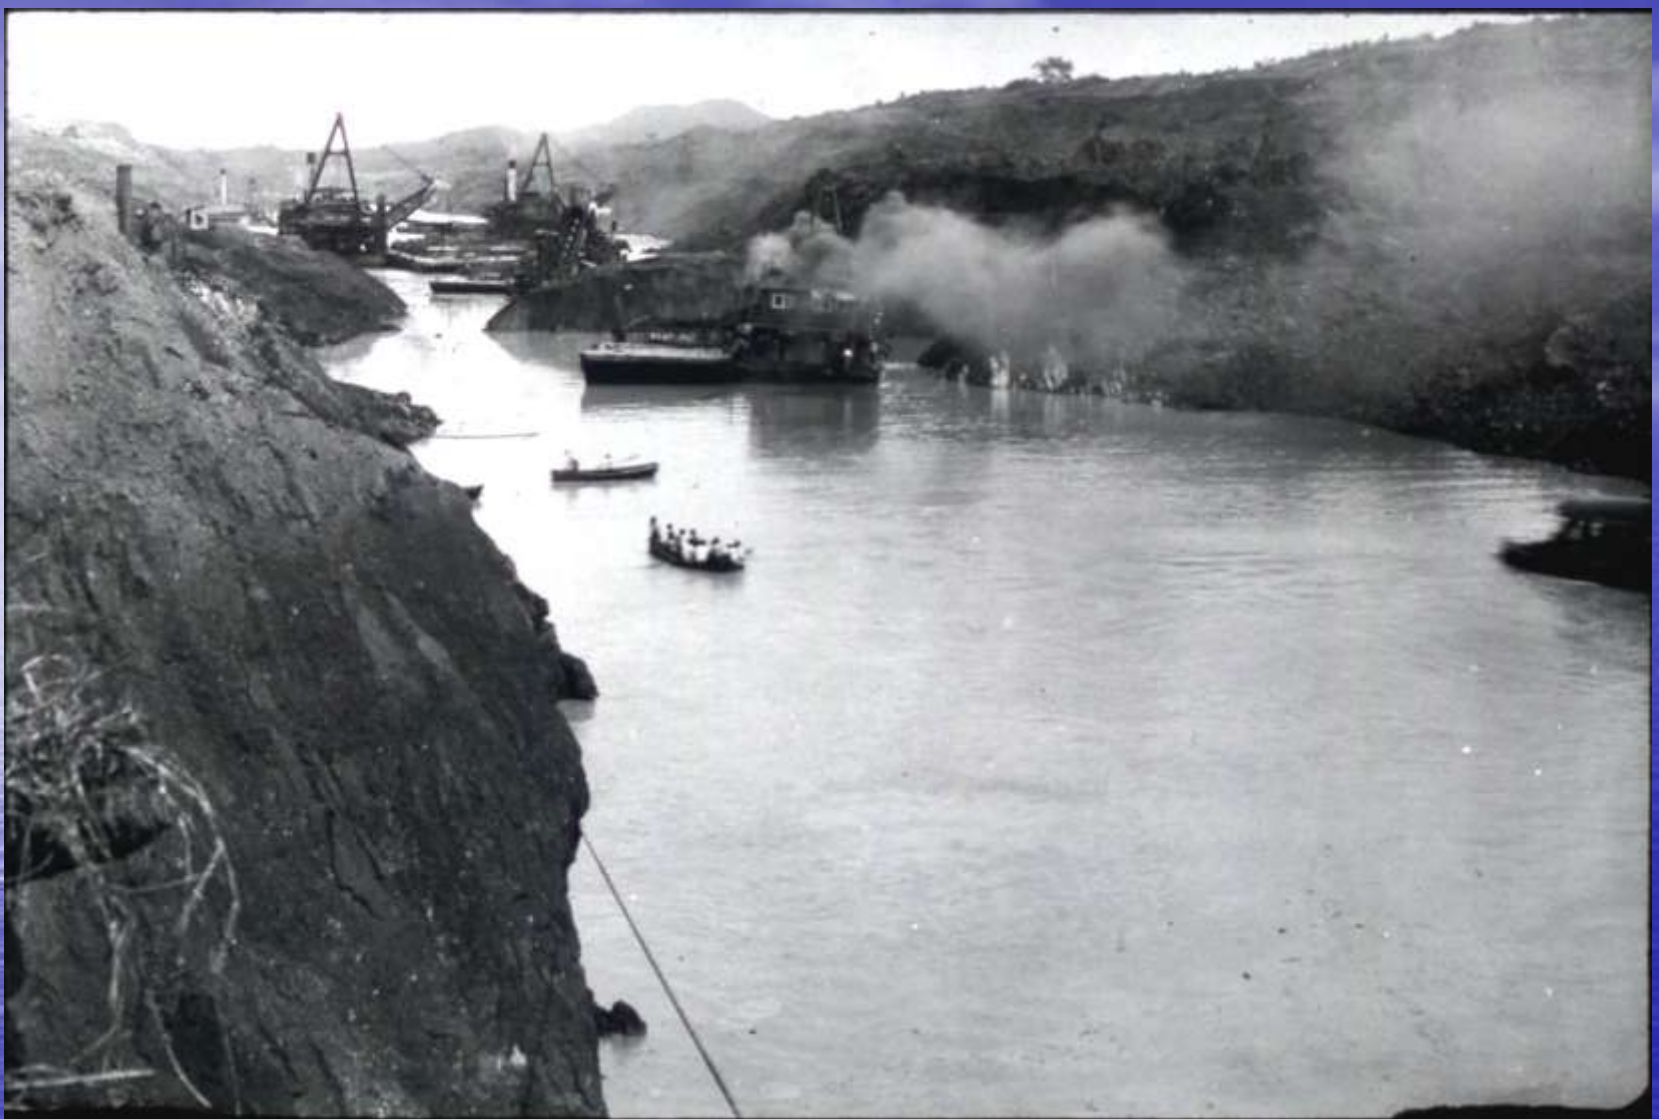
- **Colonel Goethals flooded the canal excavation across the Continental Divide to facilitate dredging and subaqueous excavation by shovels.**

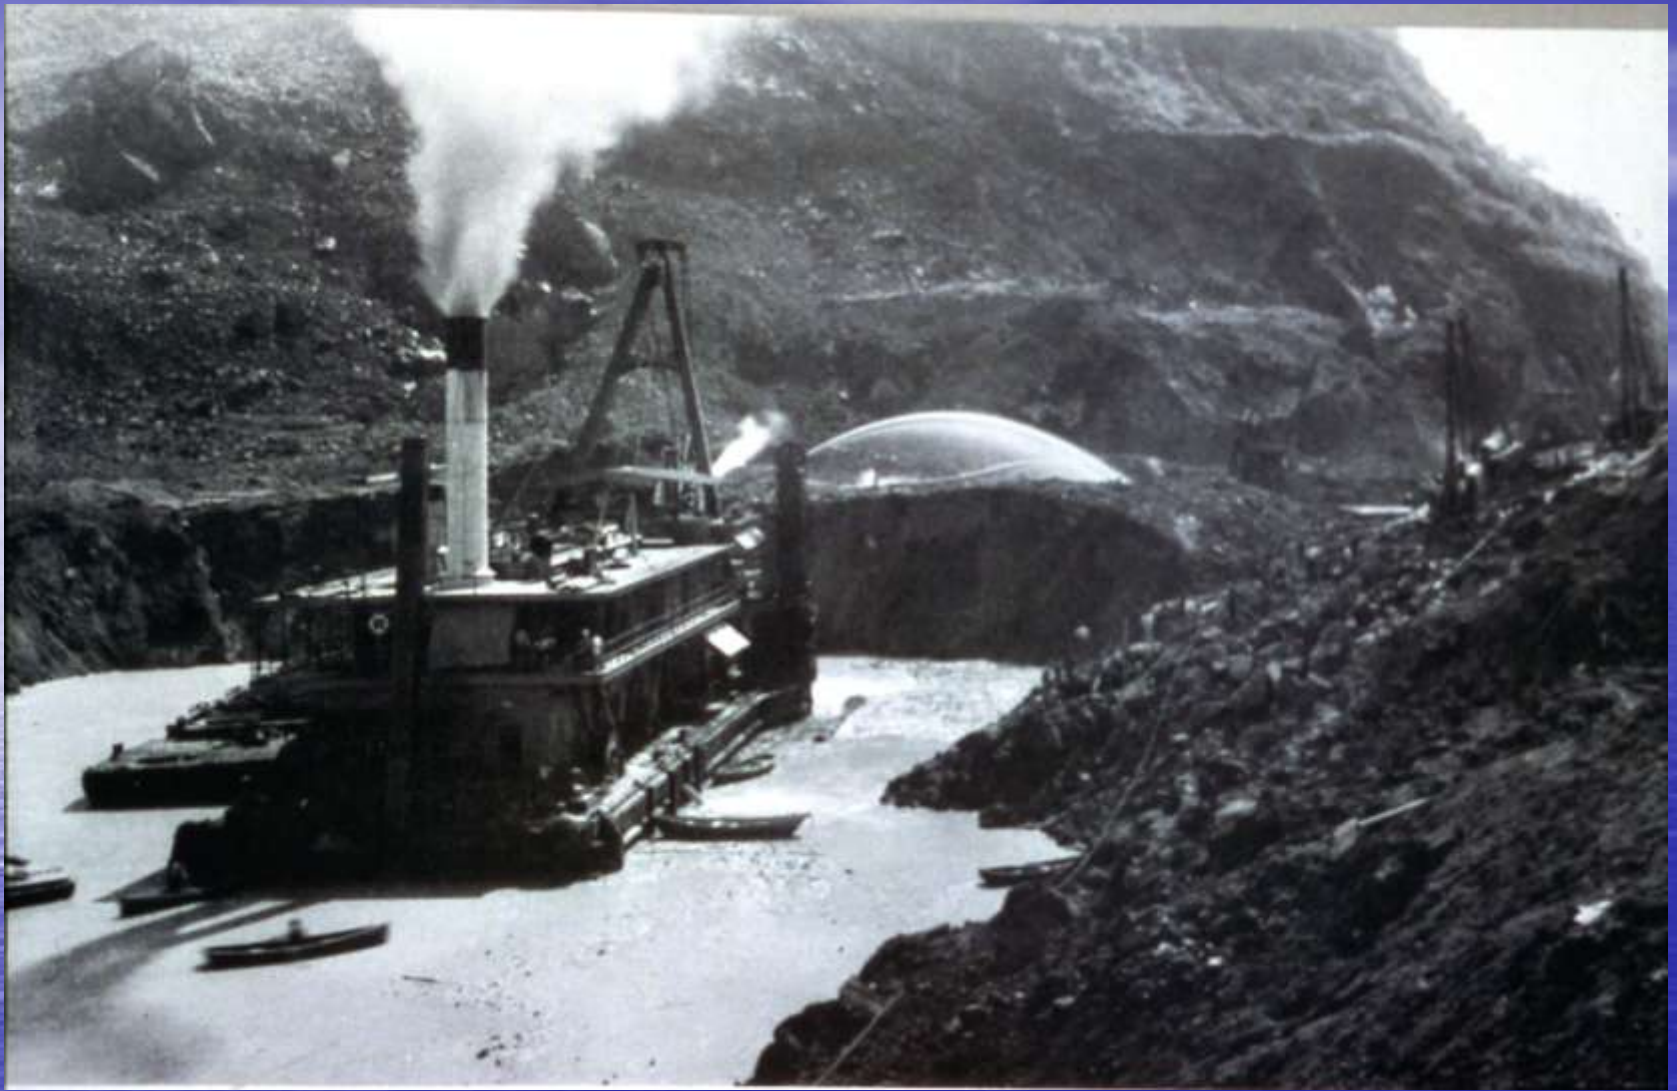
- **Shovel dredge working the face of the East Culebra Slide after the canal was flooded.**

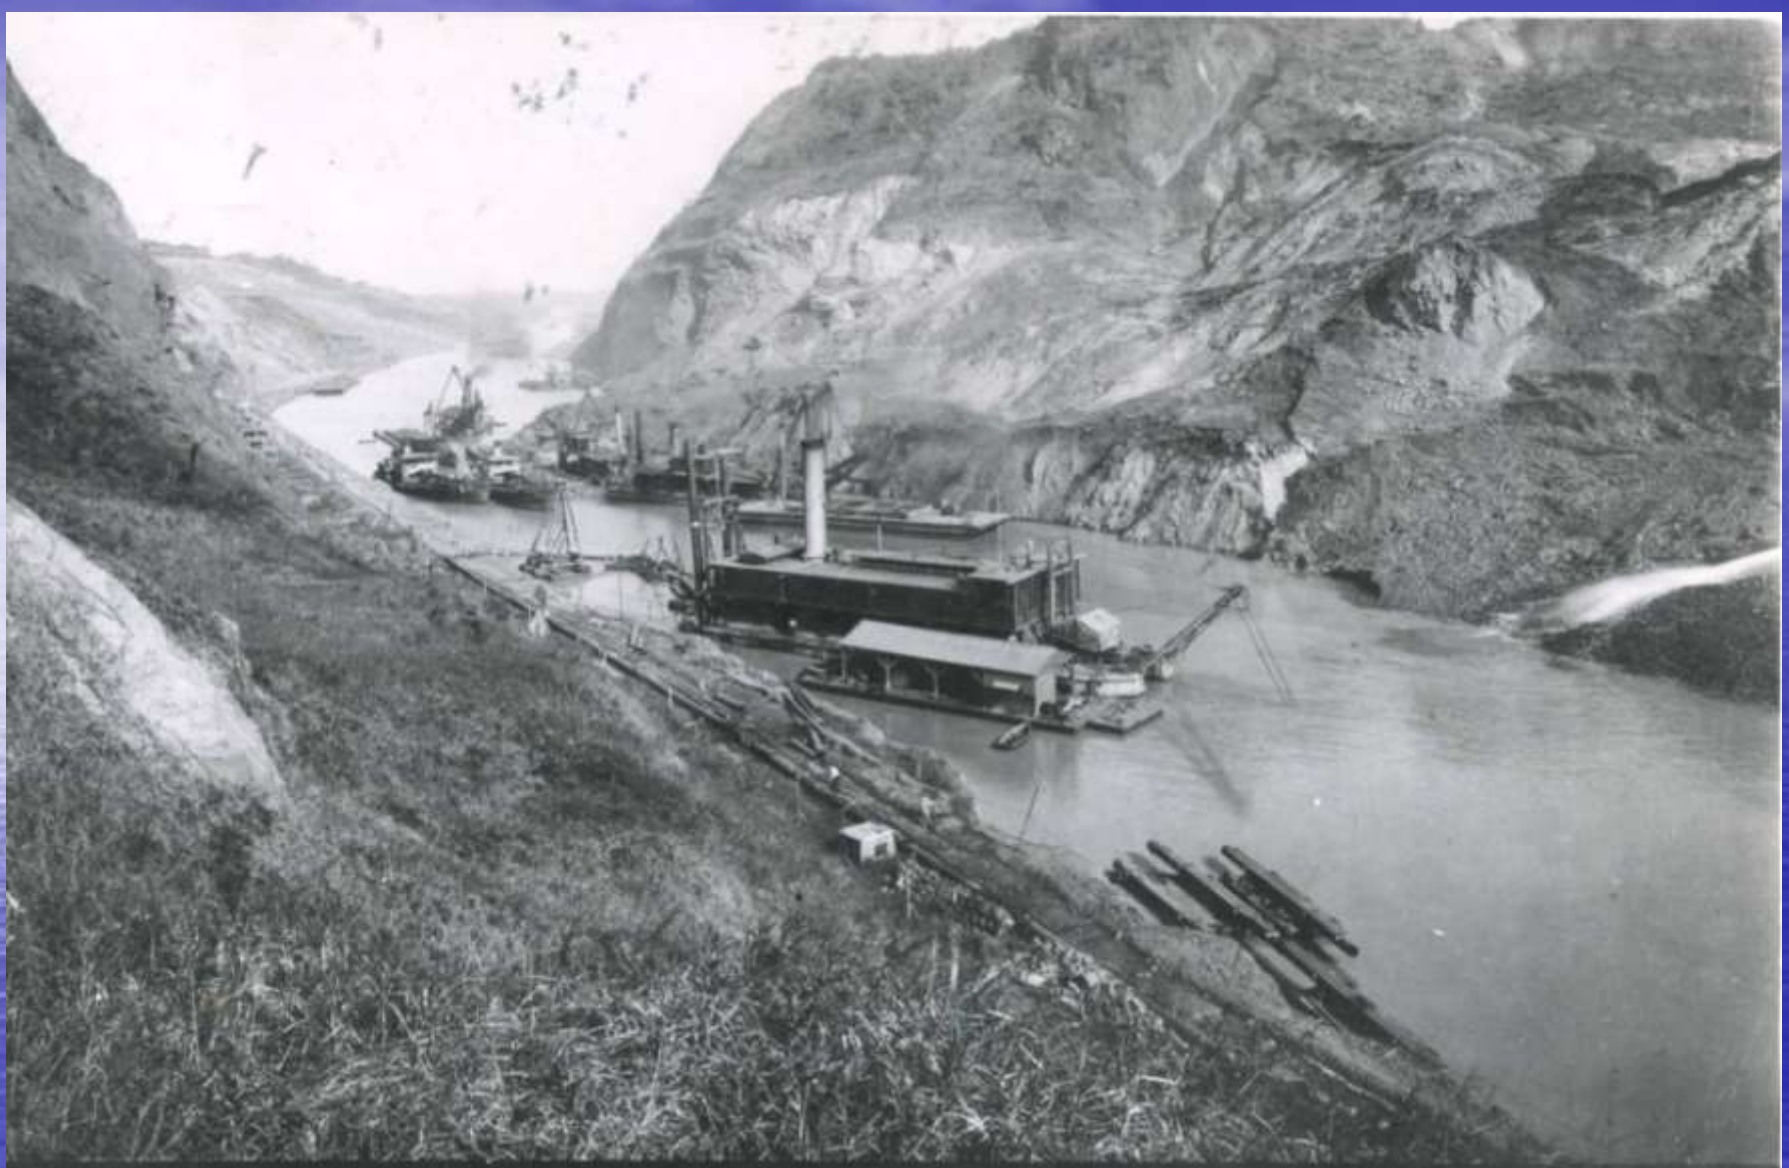
- **Fleet of suction dredges working the toe of the Cucaracha Slide - February 8, 1914**
